| <b>DTC</b> | <b>B1198/76</b> | <b>Short in Rear P/T Squib (LH) Circuit (to B+)</b> |

## CIRCUIT DESCRIPTION

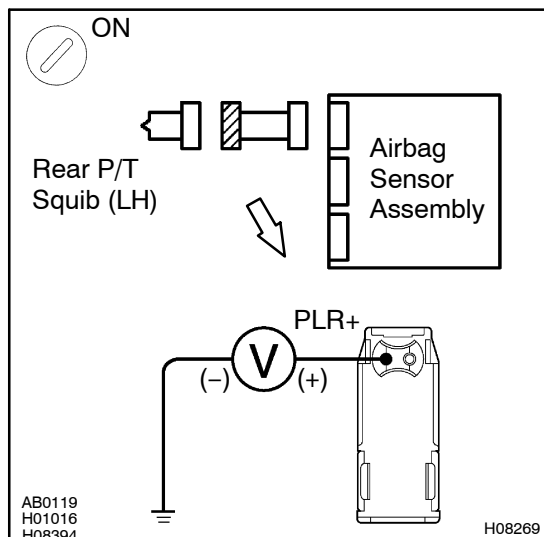
| <b>2</b> | <b>Check rear P/T squib (LH) circuit.</b> |

- Turn the ignition switch to ON.
- For the connector (on the rear seat belt pretensioner side) between the rear seat belt pretensioner (LH) and the airbag sensor assembly, measure the voltage between PLR+ and body ground.

**Voltage: 0 V**

**Repair or replace harness or connector between rear seat belt pretensioner (LH) and airbag sensor assembly.**

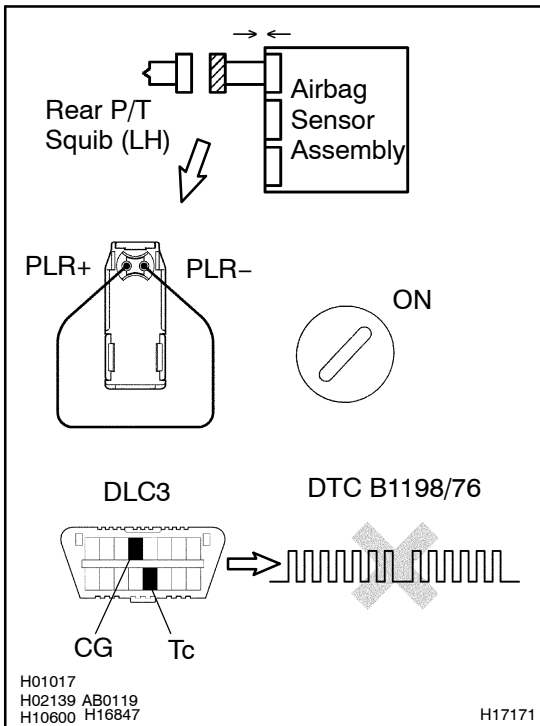
### 3 Check airbag sensor assembly.

- Connect the connector to the airbag sensor assembly.
- Using a service wire, connect PLR+ and PLR- of the connector (on the rear seat belt pretensioner side) between the rear seat belt pretensioner (LH) and the airbag sensor assembly.
- Connect negative (-) terminal cable to the battery, and wait at least for 2 seconds.

- Turn the ignition switch to ON and wait at least for 20 seconds.
- Clear the DTC stored in memory (See step 5 on [page DI-484](#)).
- Turn the ignition switch to LOCK, and wait at least for 20 seconds.
- Turn the ignition switch to ON, and wait at least for 20 seconds.
- Check the DTC (See [page DI-484](#)).

**DTC B1198/76 is not output.**

**Replace airbag sensor assembly.**

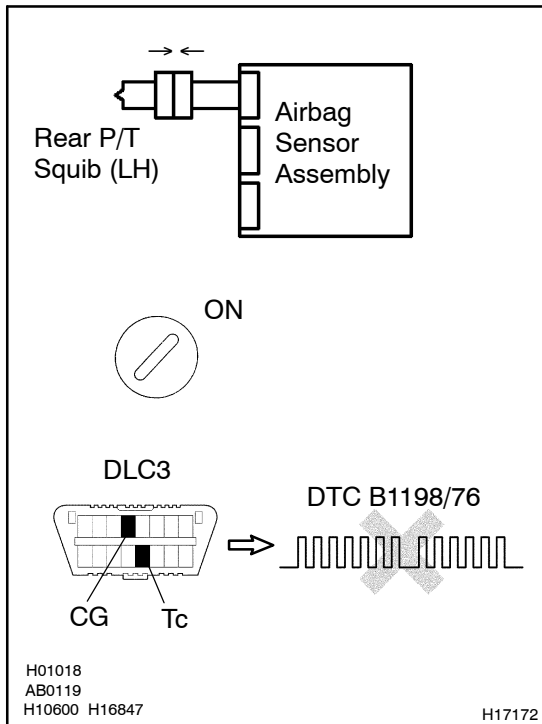
#### 4 Check rear P/T squib (LH).

- Turn the ignition switch to LOCK.
- Disconnect negative (-) terminal cable from the battery, and wait at least for 90 seconds.
- Connect the rear seat belt pretensioner (LH) connector.
- Connect negative (-) terminal cable to the battery, and wait at least for 2 seconds.

- Turn the ignition switch to ON, and wait at least for 20 seconds.
- Clear the DTC stored in memory (See step 5 on [page DI-484](#)).
- Turn the ignition switch to LOCK, and wait at least for 20 seconds.
- Turn the ignition switch to ON, and wait at least for 20 seconds.
- Check the DTC ([See page DI-484](#)).

**DTC B1198/76 is not output.**

**Replace rear seat belt pretensioner (LH).**
