## CIRCUIT INSPECTION

### Power Source Circuit

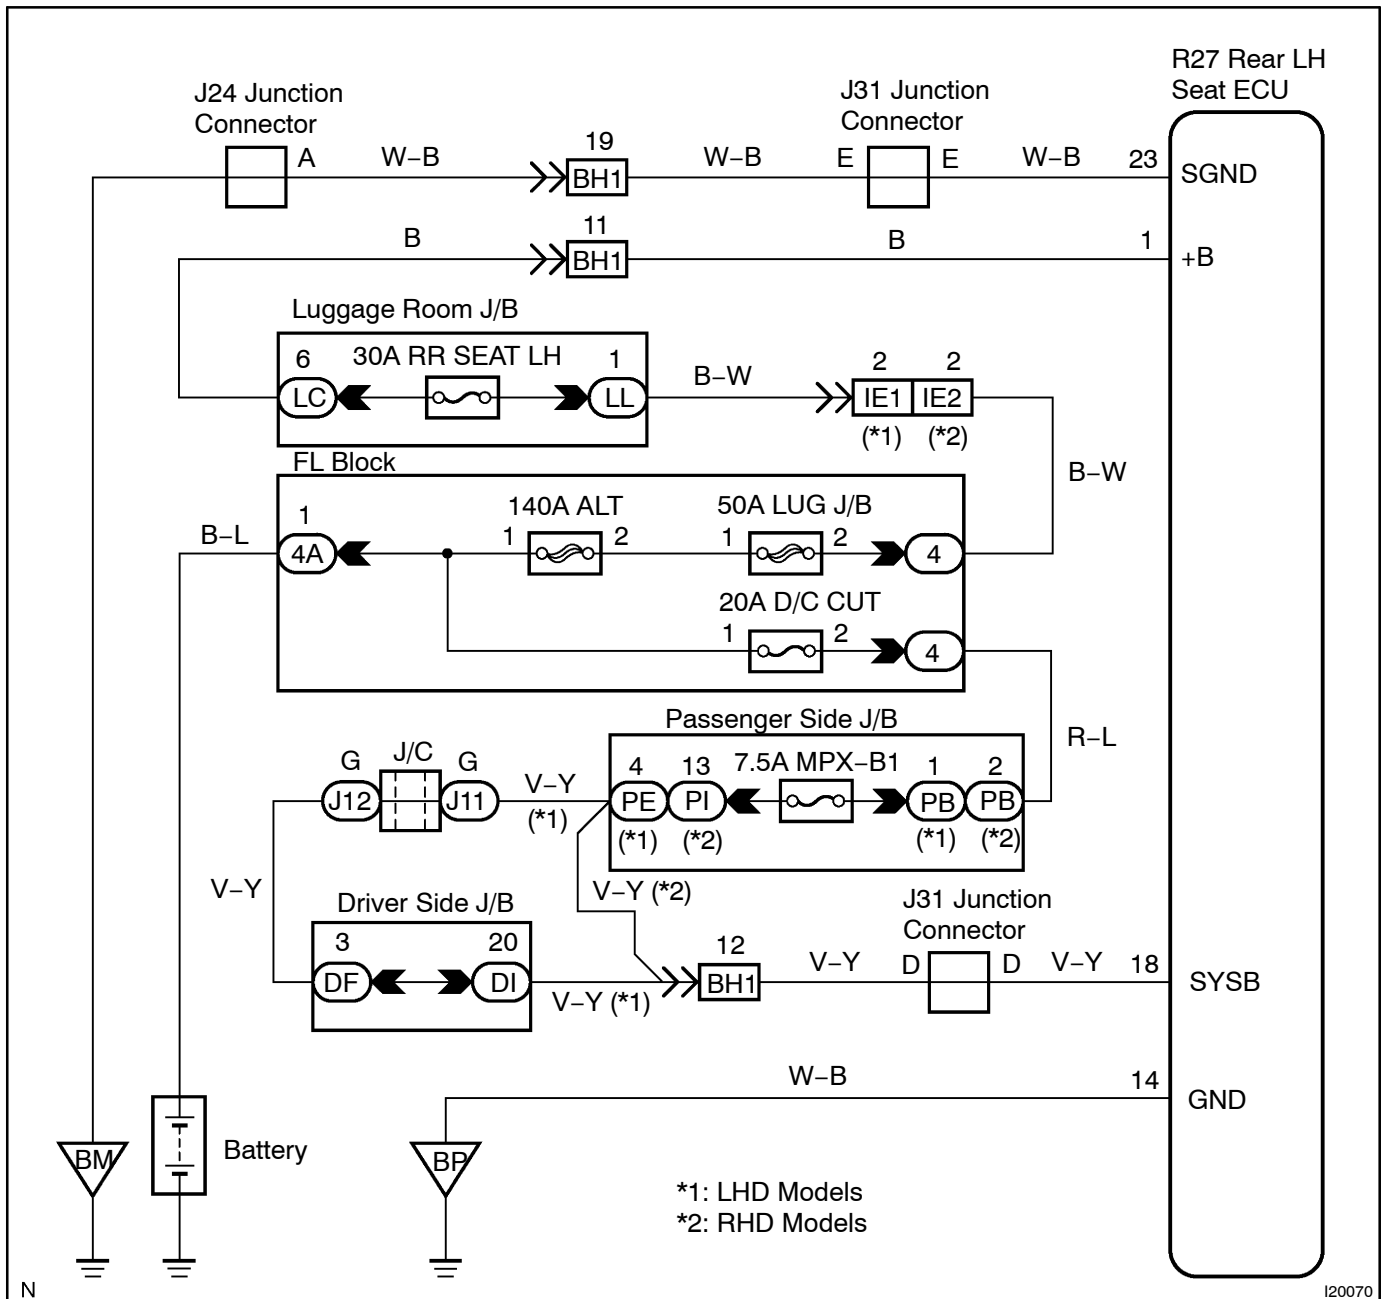
## WIRING DIAGRAM

This circuit provides power to operate the Rear LH Seat ECU.

Measure voltage between terminals +B, SYSB and GND.

Voltage: 10 – 14 V
