# CIRCUIT INSPECTION

| DTC | B1242 | Wireless Door Lock Tuner Circuit Malfunction |

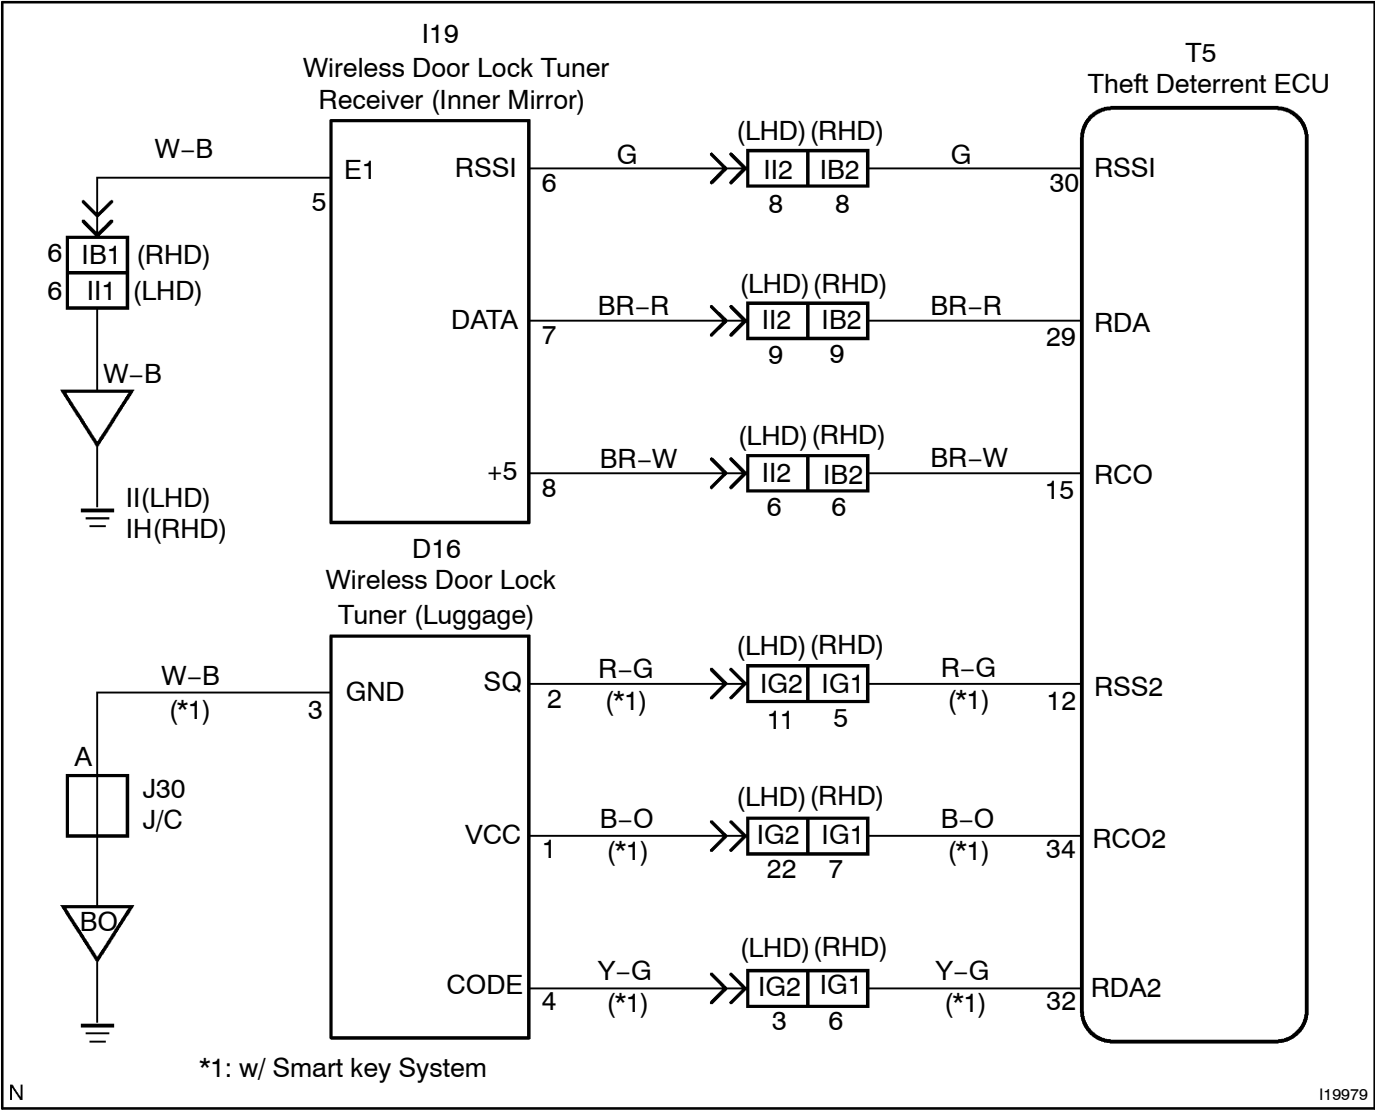
## WIRING DIAGRAM

This DTC is detected when GND short occurs on the RDA or RSSI lines of the tuner, or on the RDA2 or RSS2 lines (w/Smart) of the LUGGAGE tuner. If this DTC is detected, check the circuit that has communication malfunction.

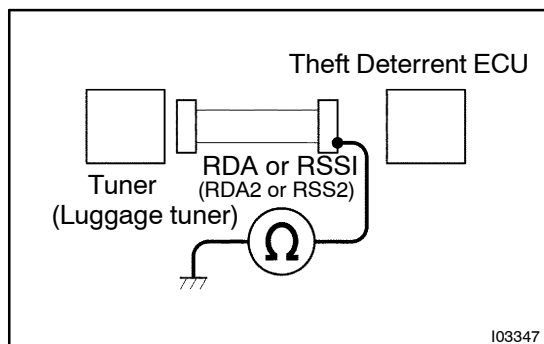
## 1 Check wire harness.

Disconnect the connectors of the wireless tuner and theft deterrent ECU.

Check continuity between terminals DATA of the wireless tuner and RDA of the theft deterrent ECU.

**OK:****Continuity****HINT:**

Check the wire harness that has communication malfunction.

**NG****Repair or replace wireless tuner.****OK**

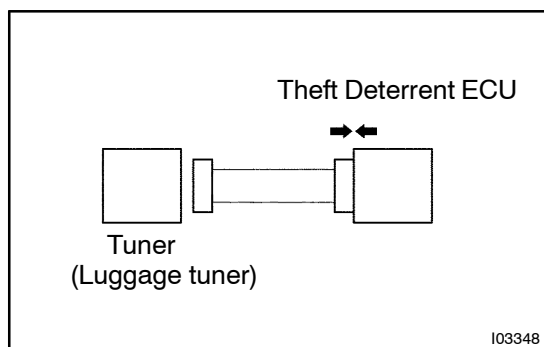
## 2 Check theft deterrent ECU.

Connect the connector of the theft deterrent ECU.

Check the DTC.

B1242 is not output.

**NG****Replace theft deterrent ECU**  
(See page IN-35).**OK****Replace wireless tuner (luggage receiver).**
