REPAIR WELDS

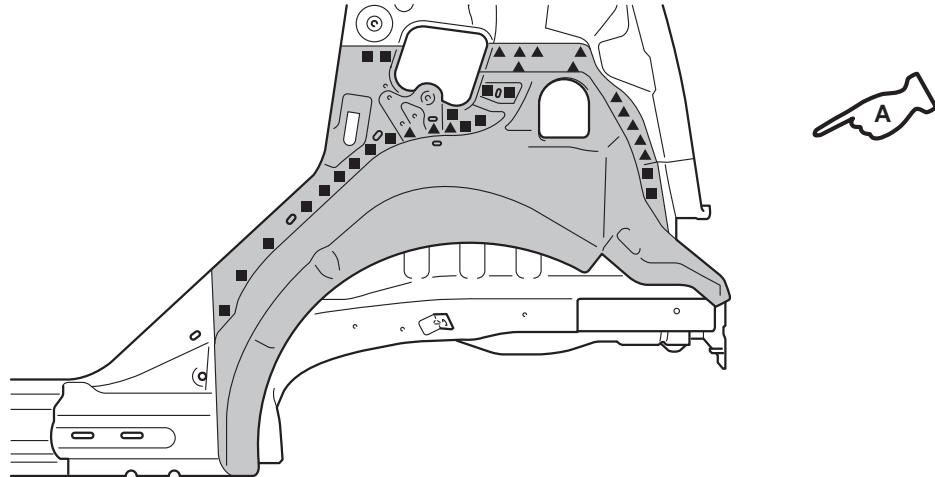
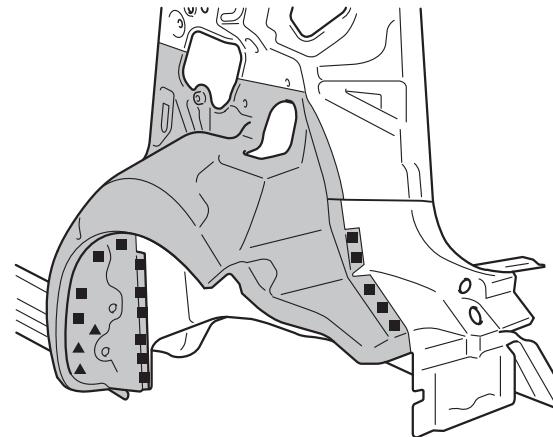
(With the quarter outer panel and fuel filler neck bracket removed)
