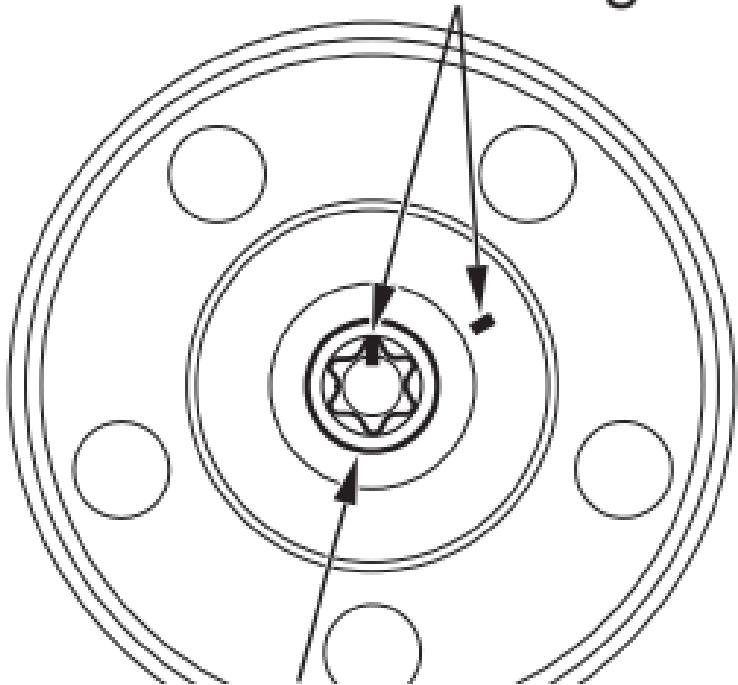
Figure A

Paint markings

Crankshaft
pulley centre bolt

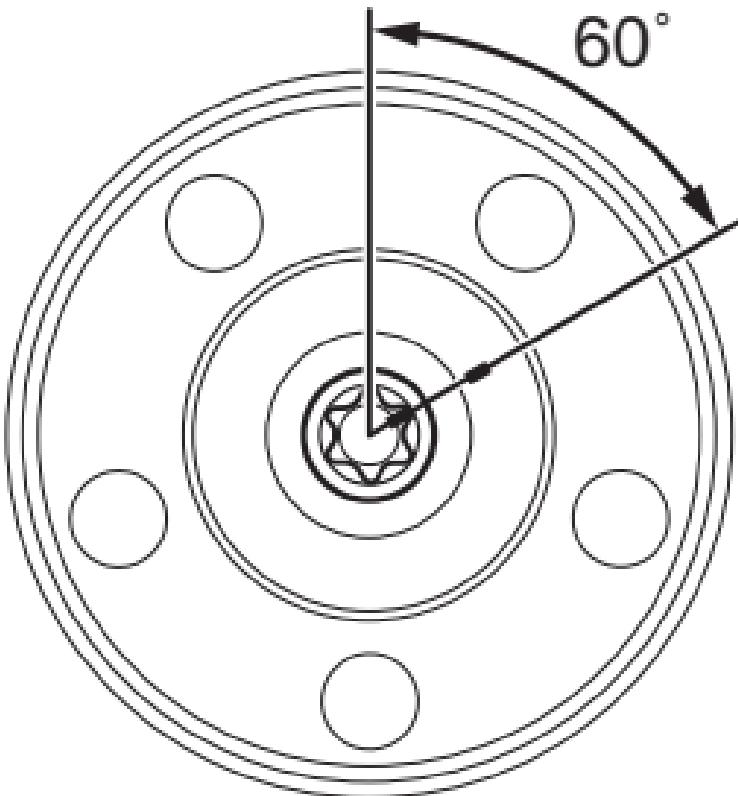
Figure B

60°
