# Connector: B-231

Junction block (Rear view)

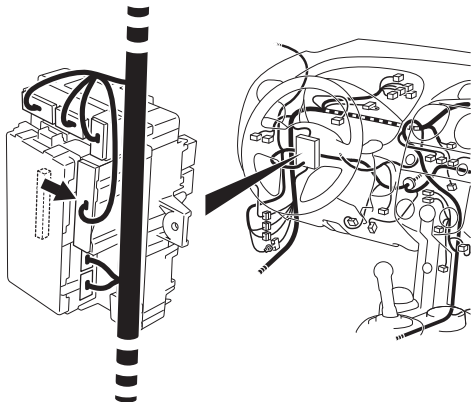
Harness side

16	15	14	13	12	11	10	9	8	7	6	5	4	3	2	1
32	31	30	29	28	27	26	25	24	23	22	21	20	19	18	17
