# FE.FG

## SERVICE MANUAL 2008 Model FOREWORD

This Service Manual contains maintenance and repair methods for the Mitsubishi Fuso Truck FE. FG Series. Read this manual carefully as an aid in providing correct, efficient maintenance. Please note that the information and specifications contained within this manual may change without notice. This is due to product modifications and continued vehicle improvements that are made throughout the model years. Should you encounter any discrepancy in the information provided, please do not hesitate to contact your nearest Mitsubishi Fuso Dealer or Mitsubishi Fuso Truck of America, Inc.

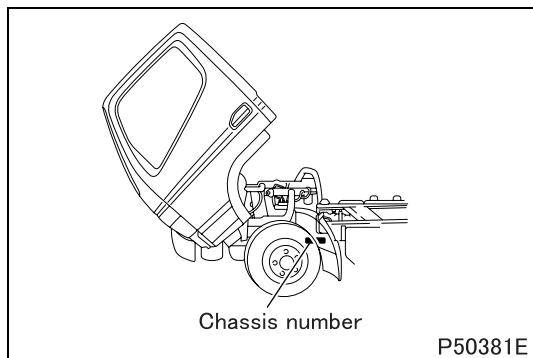
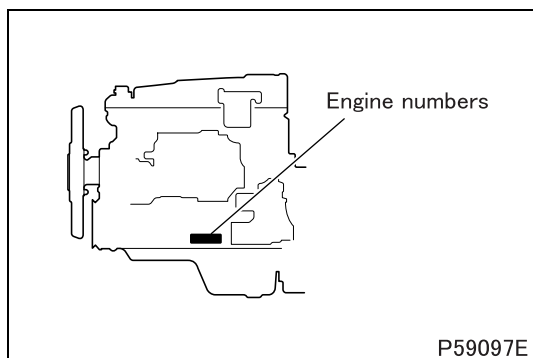
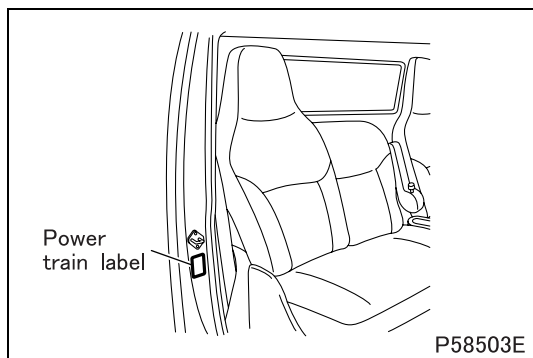
- Chassis and engine numbers are allocated to each vehicle and engine respectively in the order of production. These numbers are required at vehicle inspection for registration.

- Power train label located in the position illustrated indicates the vehicle model, chassis number and information relevant to the vehicle's power - train components.

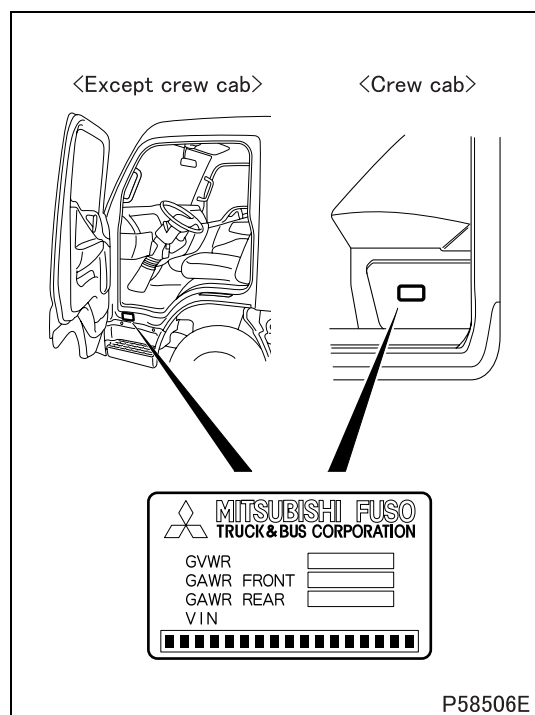
- The vehicle identification number is punch-marked on the plate, which is attached in the position as illustrated. The vehicle identification number consists of a 17-digit set of alphanumeric characters. Each digit represents the following specifications.

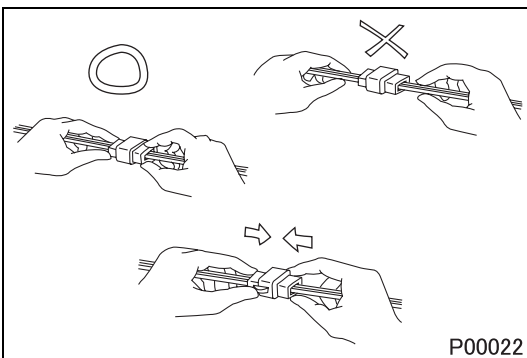
- When separating connectors, grasp the connectors themselves rather than the harnesses.
- To separate locking connectors, first push them in the direction of the arrows. To reconnect locking connectors, push them together until they click.

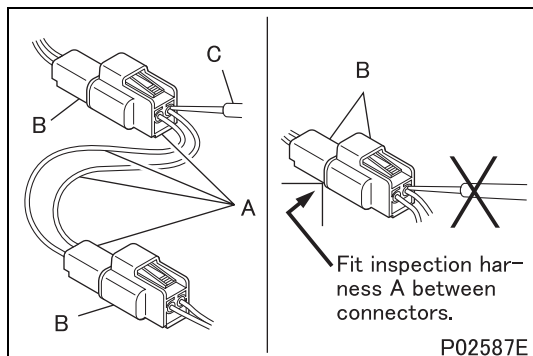
- Connect an inspection harness and connector A between the connectors B of the circuit to be inspected. Perform the inspection by applying a test probe C to the connectors of the inspection harness. Do not insert the test probe C into the wire-entry sides of the waterproof connectors since this would damage their waterproof seals and lead to rust.

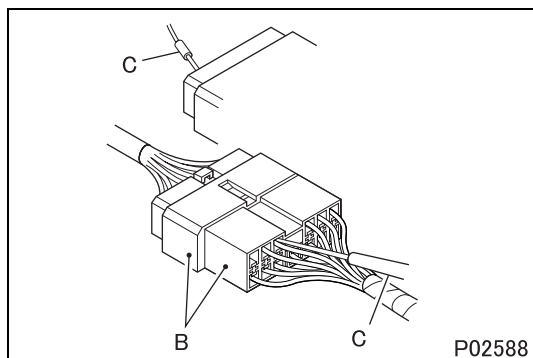
- Perform the inspection by inserting a test probe C into the wire-entry sides of the connectors. An extra-narrow probe is required for control unit connectors, which are smaller than other types of connector. Do not force a regular-size probe into control unit connectors since this would cause damage.

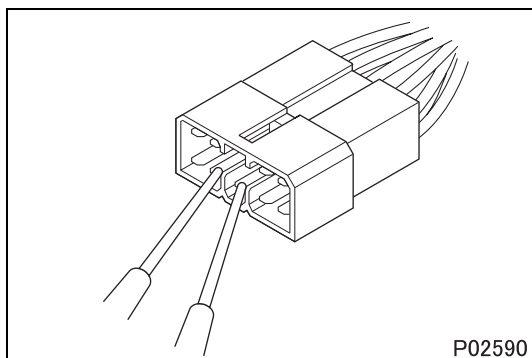
- Perform the inspection by carefully inserting a test probe into the terminals. Do not force the test probe into the terminals since this could deform them and cause poor connections.

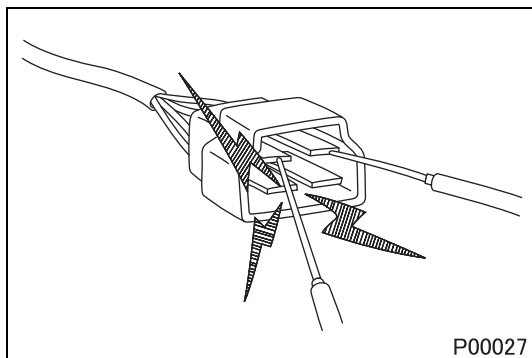
- Perform the inspection by applying test probes directly to the pins.

- Be careful not to short-circuit pins together with the test probes. With control unit connectors, short-circuiting of pins can cause damage to the control unit's internal circuitry.

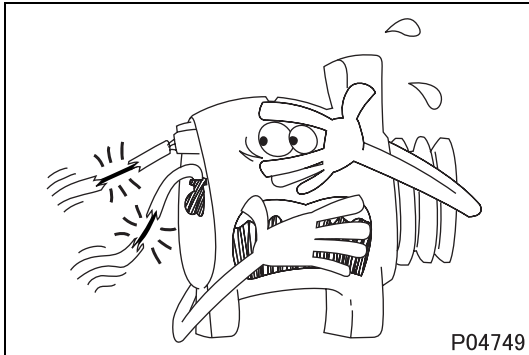
- Never operate an alternator with the B and L terminals short-circuited. Operation with the B and L terminals connected together would damage the diode trio.

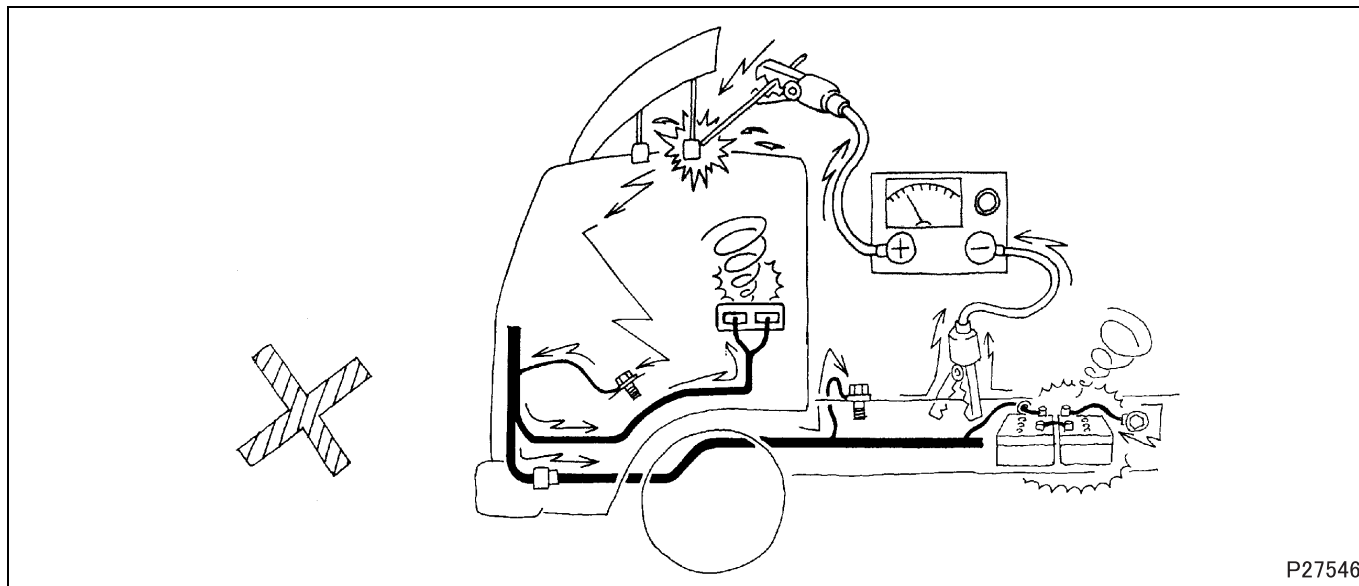
- When arc welding is performed, current from the welder flows to ground via the vehicle's metal parts. Unless appropriate steps are taken, this current can damage control units, other electrical devices and wiring harnesses. And any electrical device near the point on the vehicle to which the (–) cable of the welder is connected, might be largely damaged.

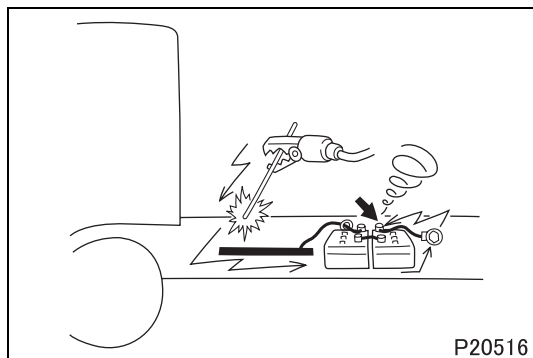
- Current flows backward as shown below.

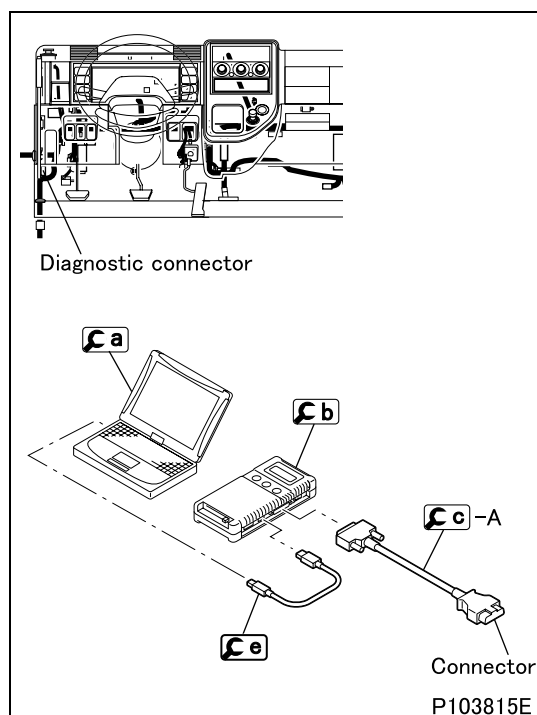
## (1.1) To perform system inspection

- Move the starter switch to the LOCK position.
- Connect **a**, **b**, **c-A** and **e** as shown.
- Connect **c-A** connector to the diagnostic connector on the vehicle.

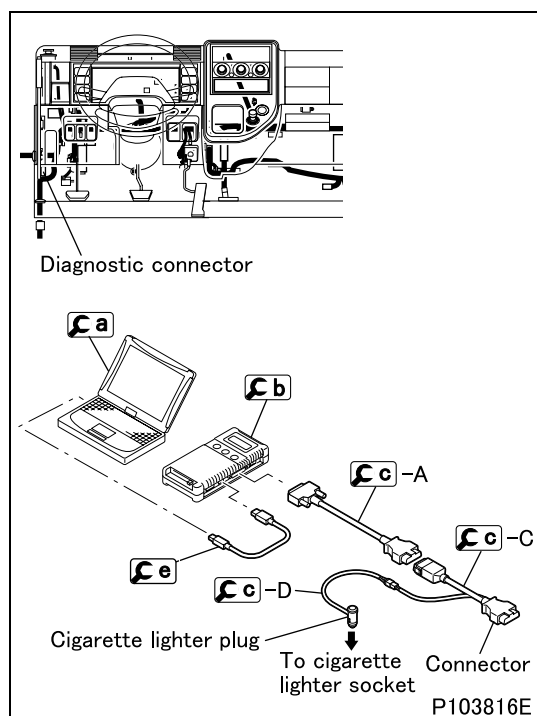
## (1.2) To use drive recorder function

- Move the starter switch to the LOCK position.
- Connect **a**, **b**, **c-A**, **c-C**, **c-D** and **e** as shown.
- Connect **c-C** connector to the diagnostic connector on the vehicle.
- Connect the cigarette lighter plug of **c-D** to the cigarette lighter socket on the vehicle.

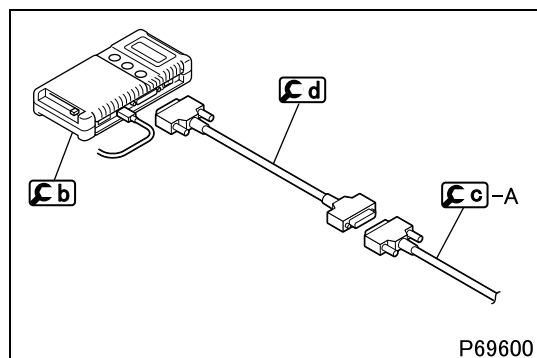
## (1.3) To extend the Multi-Use Tester test harness

- Connect **d** to **c-A** to extend the test harness to use the Multi-Use Tester outside the vehicle.

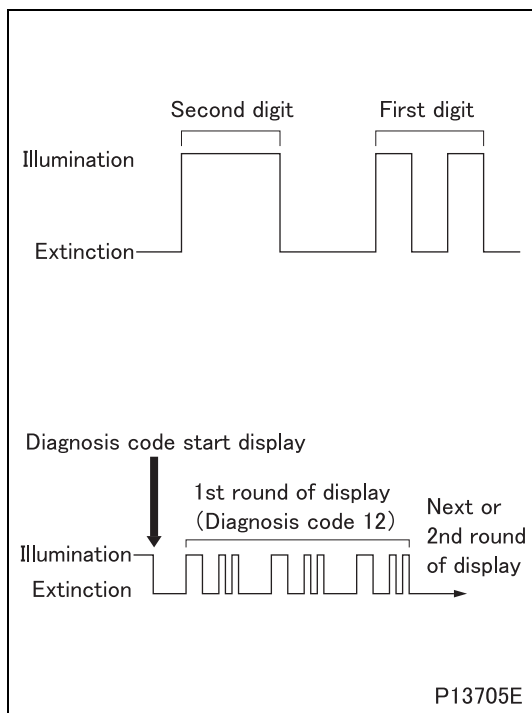
## (1) Reading diagnosis codes by flashing of warning lamp

- To read a diagnosis code, observe how many times the warning lamp flashes and how long each illumination lasts.
- The duration of illumination differs between the first and second digits.
  - Second digit: 1.2 sec.
  - First digit: 0.4 sec.
- A diagnosis code consists of the flashing of second digit and the flashing of first digit in that order. If a diagnosis code has "0" in the second digit, only the first digit will be displayed.
- The diagnosis code 01 will be displayed if the system is normal.
- The same diagnosis code will be displayed 3 times in a row before moving to the display of the next code.
- After the last diagnosis code is displayed, the first code will be displayed again 3 times in a row and then the subsequent codes. This will be repeated.

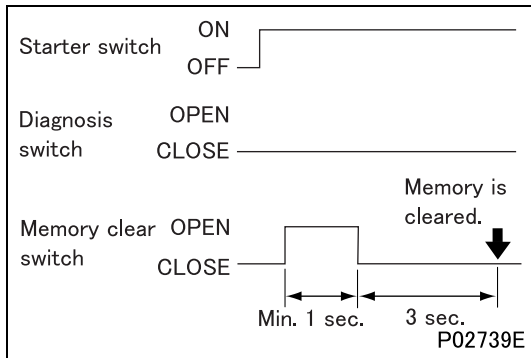
### (3.3) Erasing diagnosis codes

- Turn the starter switch to the ON position (do not start the engine).
- Open the memory clear switch and reconnect it; all diagnosis codes stored in electronic control unit memory will be erased. To cancel diagnosis code erasure after opening the memory clear switch, turn the starter switch to the OFF position and then reconnect the memory clear switch.

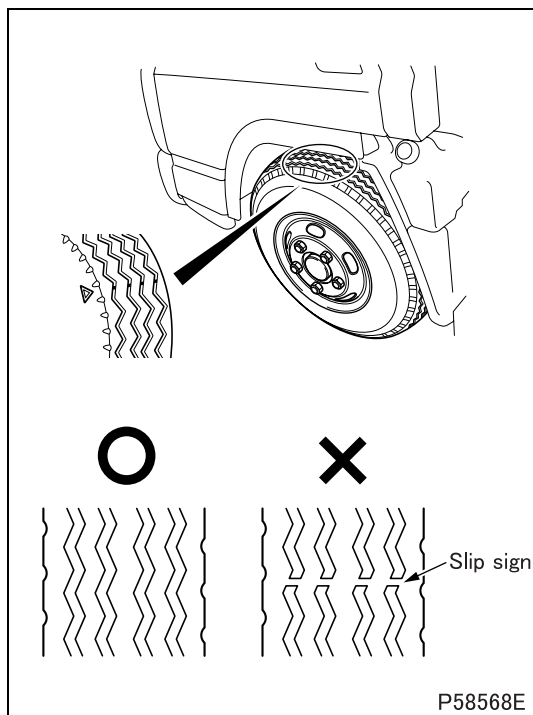
- Make certain that there is no difference in the air pressure between the inner and outer rear tires.
- Make certain you use valve caps on the air valves.
- It is not necessary to increase the air pressure for high-speed driving.

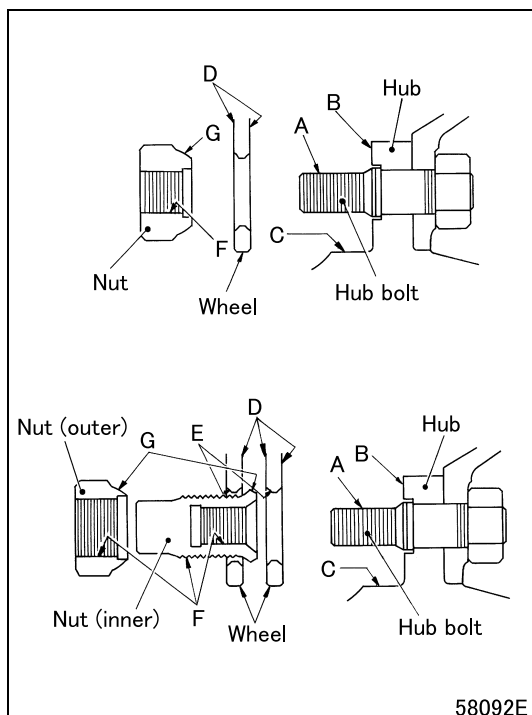
## Mounting tires

To prevent wheel nuts and hub bolt from becoming loose and to prevent mounted parts (tire assemblies and hub) from being damaged, remove rust, dust, additional coatings of paint, and foreign particles from the following areas:

- A: Hub bolt thread area
- B: Wheel mounting surface of hub
- C: Wheel alignment area of hub
- D: Disc wheel mating surface
- E: Disc wheel nut mounting surface
- F: Wheel nut thread area
- G: Wheel nut spherical area

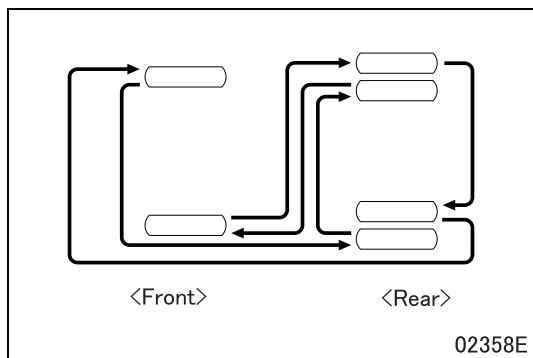
- When the tread patterns for all tires are identical:

Tires wear differently, according to the location where they are mounted. To make this wear uniform and prolong the life of your tires, they should be rotated every 10,000 km (6,000 miles) in the rotation order shown below:

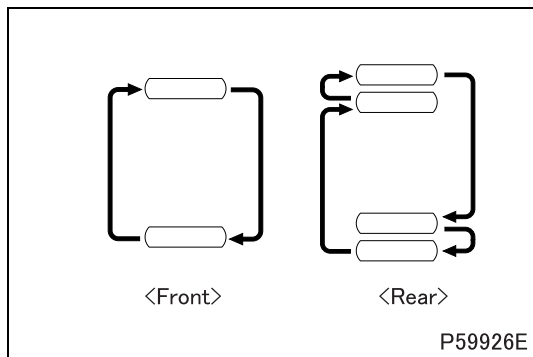
- When the tread patterns are different for the front and rear tires:

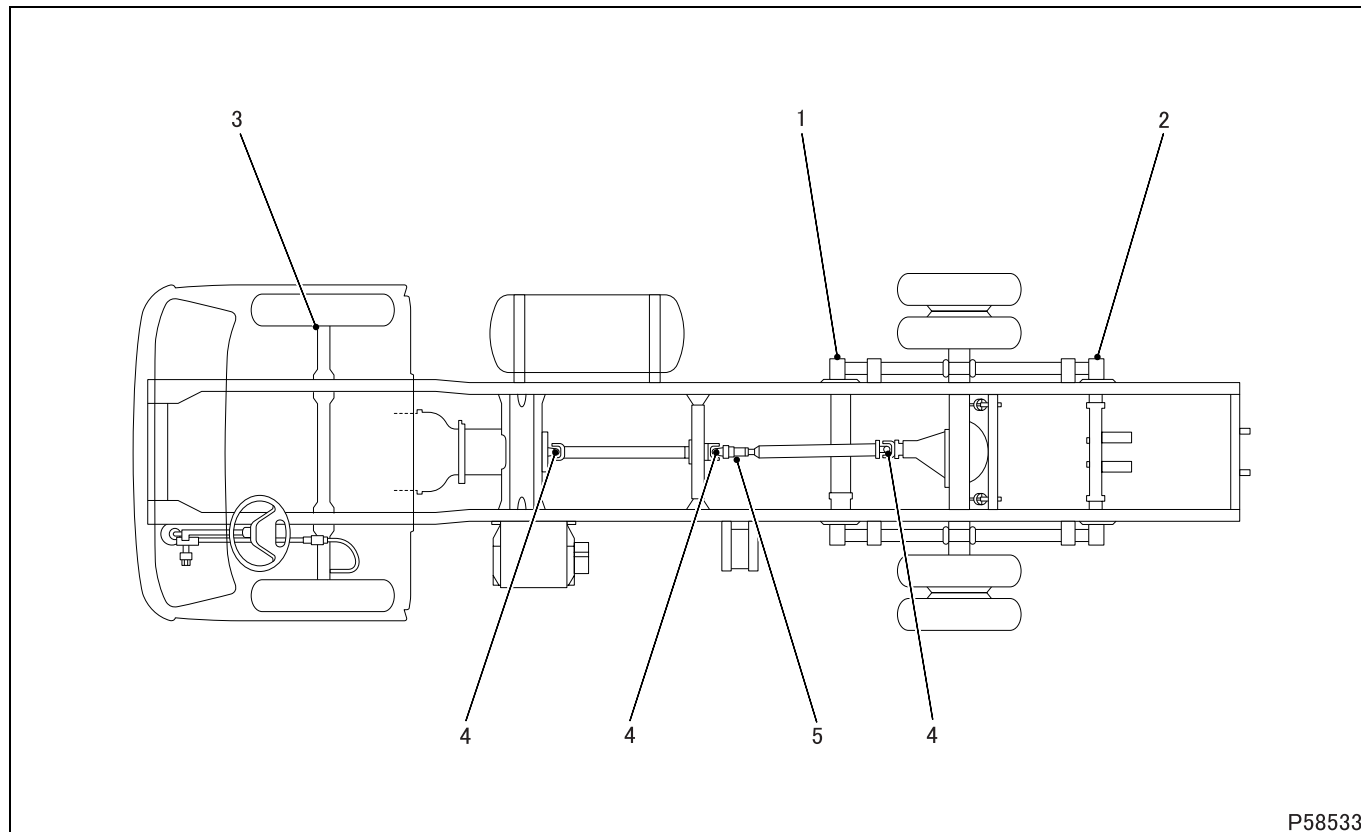
<FE>

Carefully clean away all dust and dirt from the grease nipples, and use the specified type of grease. The areas to be greased are shown in the following illustration.

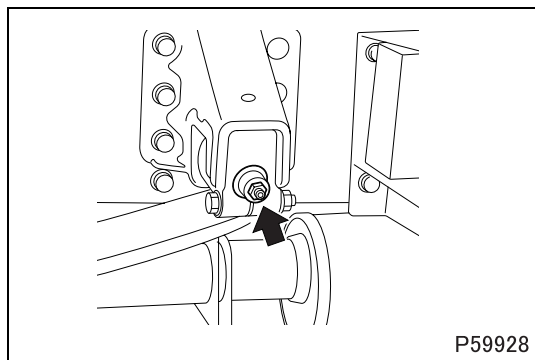
1. Rear spring pin front (left and right, 2 points)

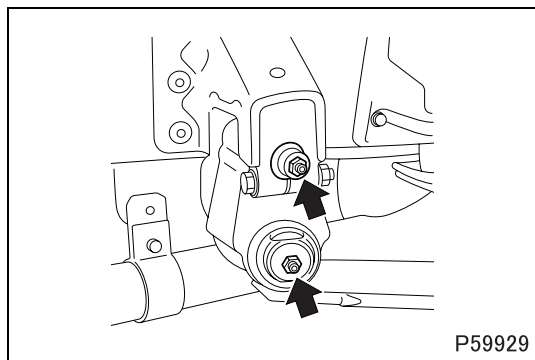
2. Rear spring pin rear (left and right, 4 points)

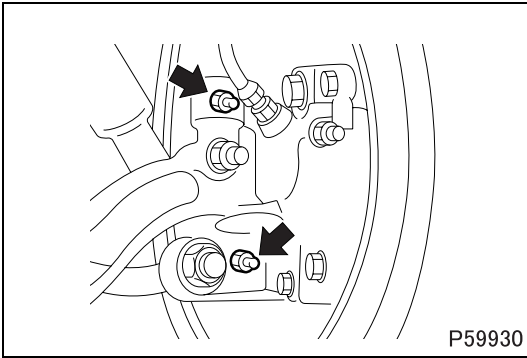
3. Kingpin bearing (left and right, 4 points)

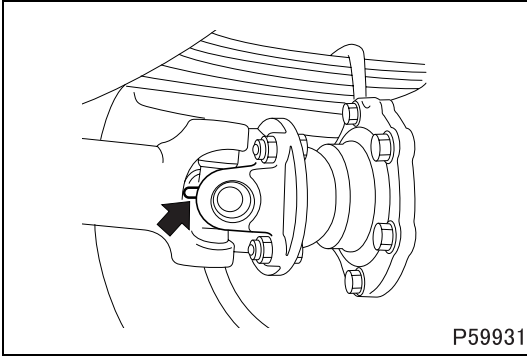
4. Propeller shaft universal joint's-all

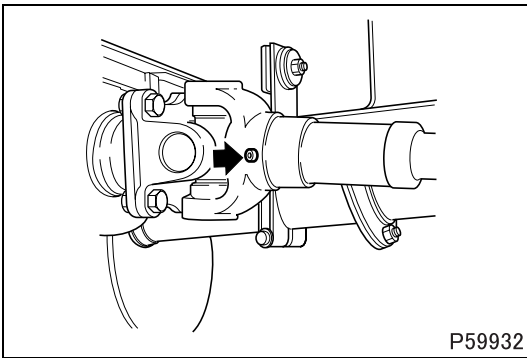
5. Propeller shaft slip joint

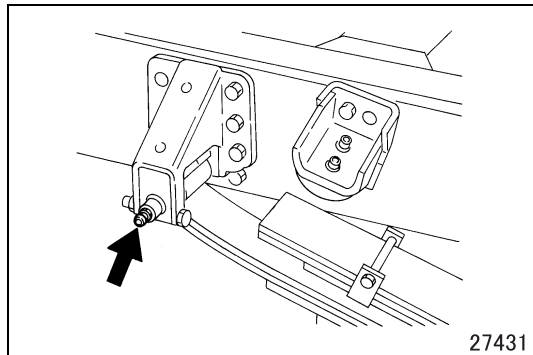
1. Rear spring pin front (left and right, 2 points)

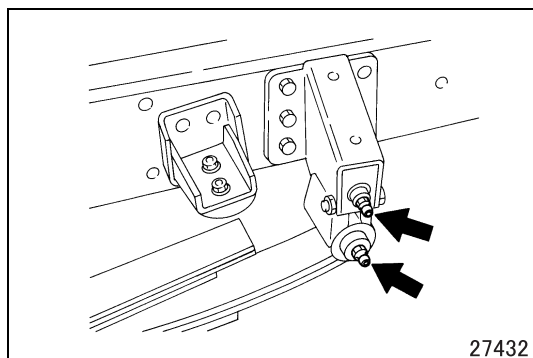
2. Rear spring pin rear (left and right, 4 points)

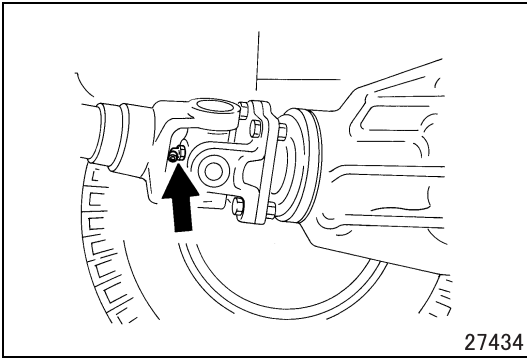
3. Propeller shaft universal joint's-all

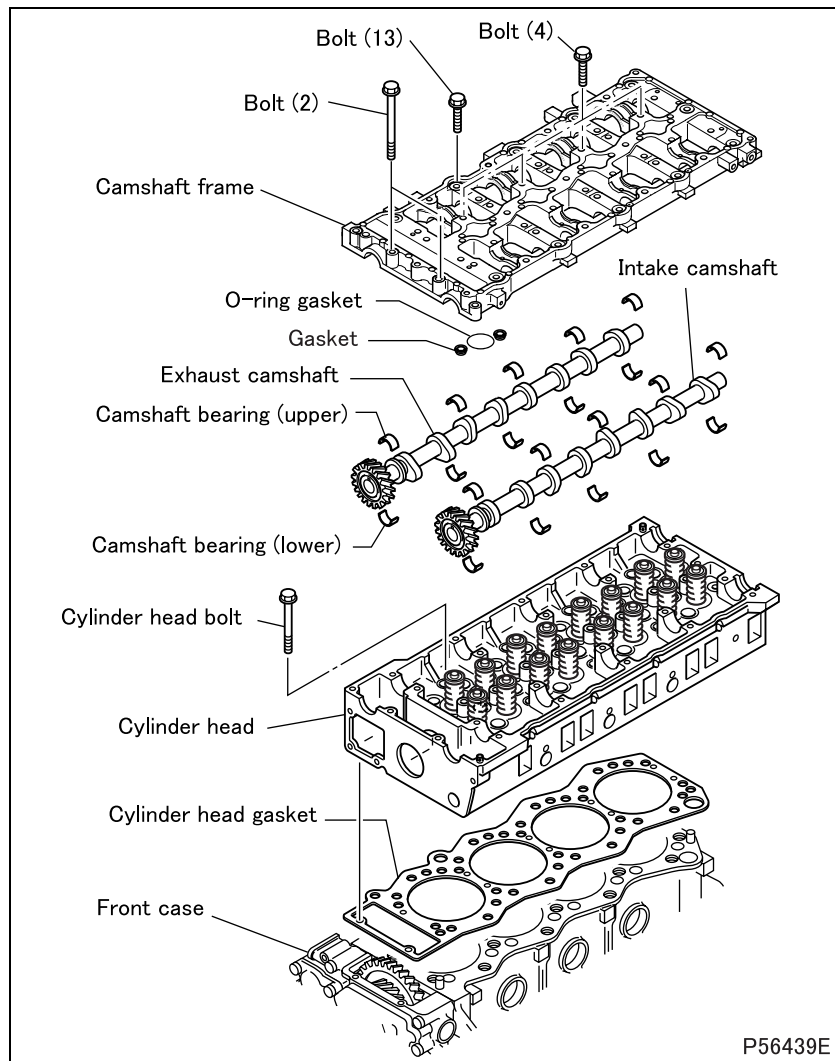
## 2. Cylinder Head, Cylinder Head Gasket, Camshaft and Camshaft Frame

- The camshaft is supported at its journals from below by the cylinder head and retained from above by the camshaft frame.
- The upper and lower camshaft bearings are identical, but cannot be interchanged when they are reinstalled.
- The exhaust camshaft and the intake camshaft have identical gears but different cams.
- The thirteen shortest bolts and four shorter bolts fasten the camshaft frame onto the cylinder head.
- The two long bolts fasten the camshaft frame to the front case.

- The camshaft frame and cylinder head are manufactured as a matched set. Never replace the camshaft frame or the cylinder head individually.
- Do not change the upper and lower camshaft bearing combinations. Do not interchange the position of an upper and lower camshaft bearing set with that of another.

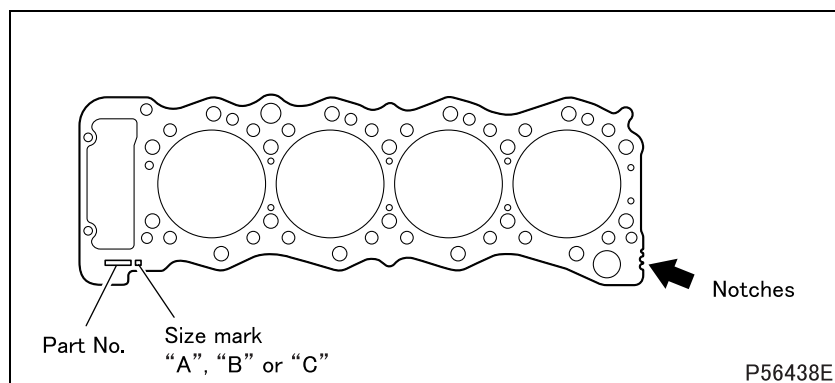
### 2.1 Cylinder head gasket

- Select and use a cylinder head gasket of a thickness that can accommodate the piston projection.
- The size (thickness) class of the gasket can be identified by the shape of the notches and size mark cut on the edge of each gasket.

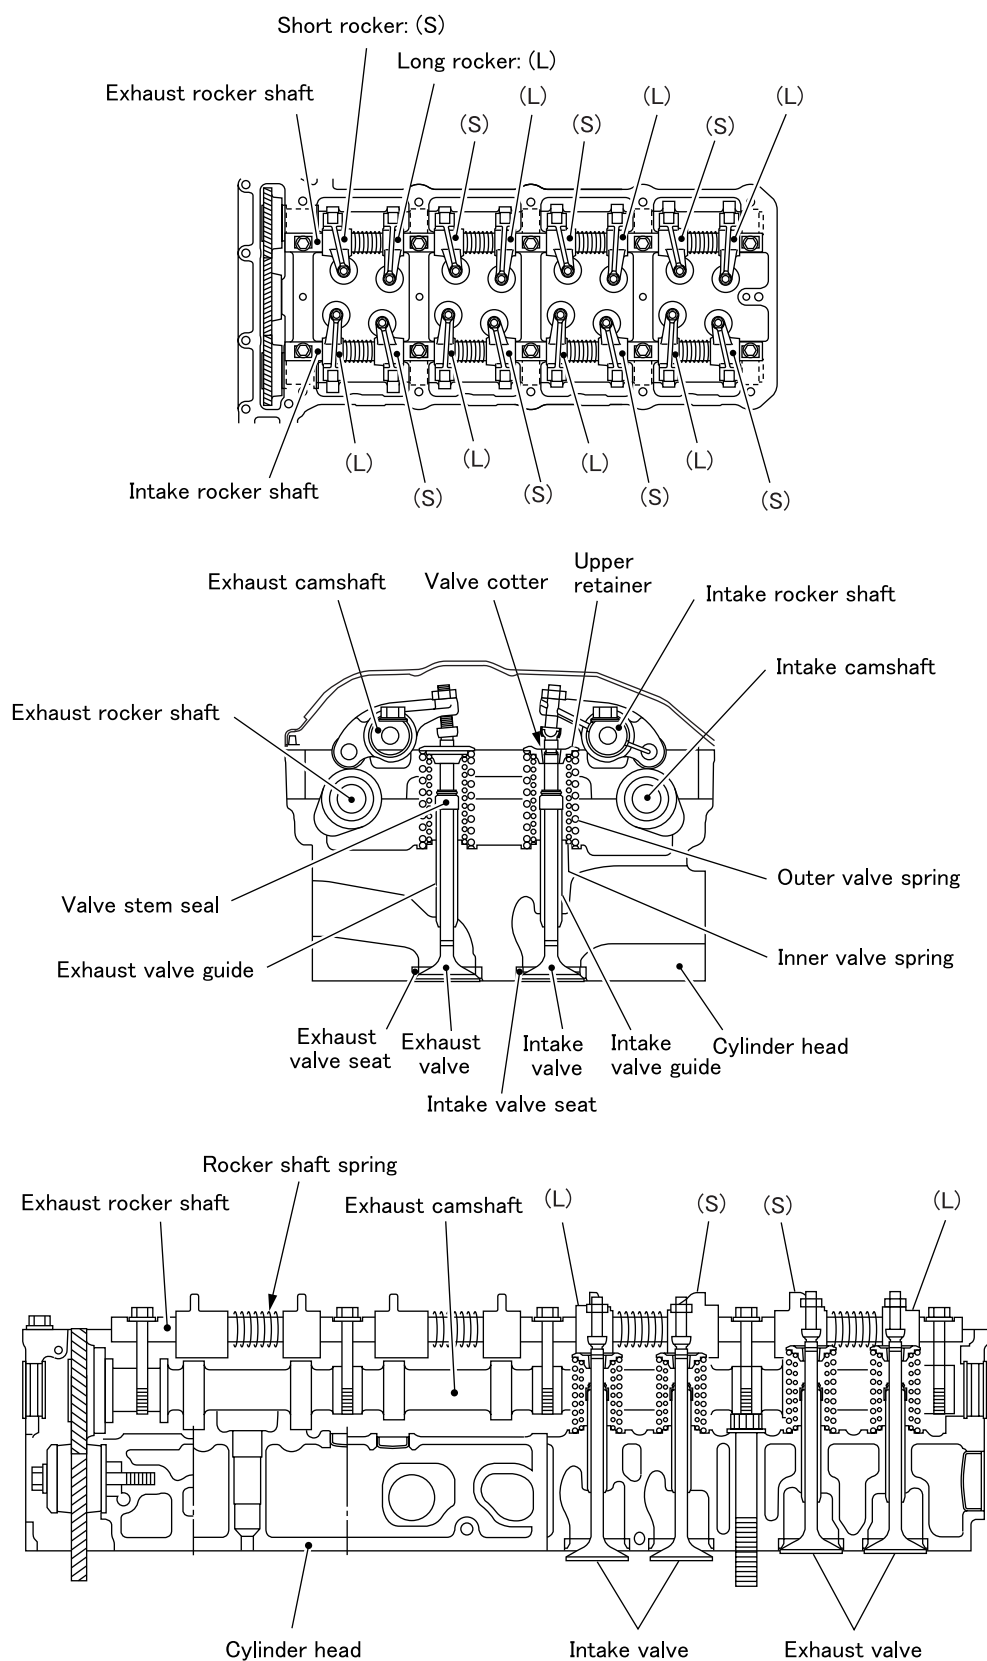
### 3. Valve Mechanism

- The short rockers and the long rockers are installed differently, as shown in the illustration.
- Each valve has an inner valve spring and an outer valve spring.

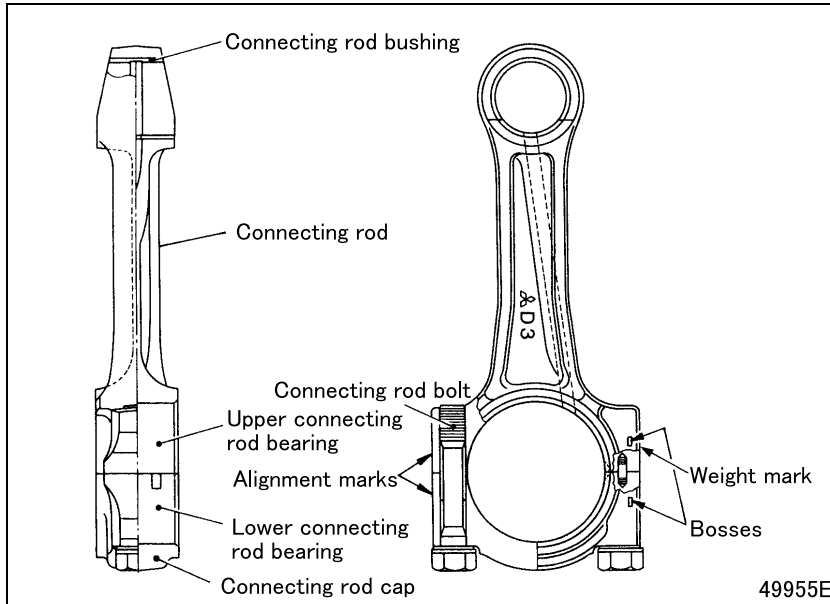
## 4. Connecting Rod

Weight mark:  
"C" to "G"  
(with "G" as the maximum)

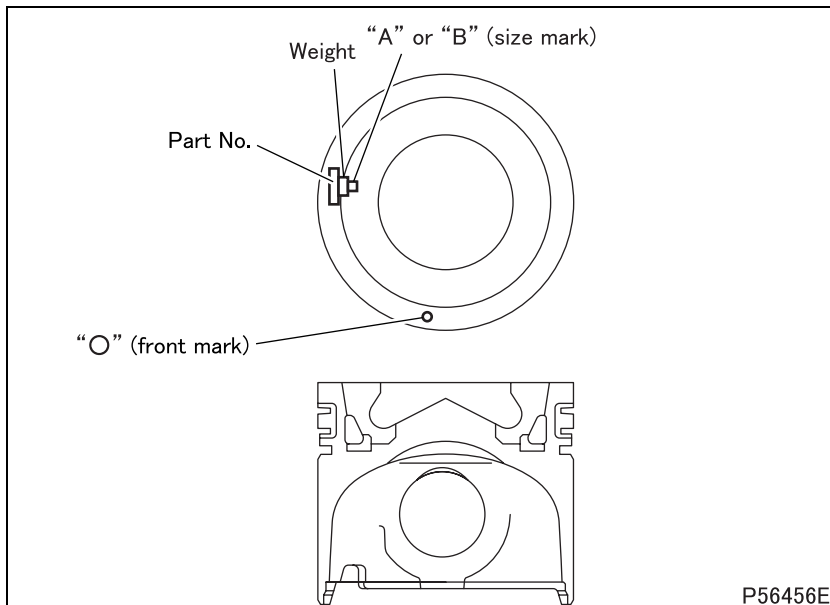
## 5. Piston

- Each piston must be mated with a cylinder in the upper crankcase that has the same size mark as the piston. The pistons are marked with either "A" or "B", where "B" stands for the larger and "A" for the smaller of the two available diameters.
- The pistons have been made light-weight by use of a special aluminum alloy, as well as by the reduction of their height.

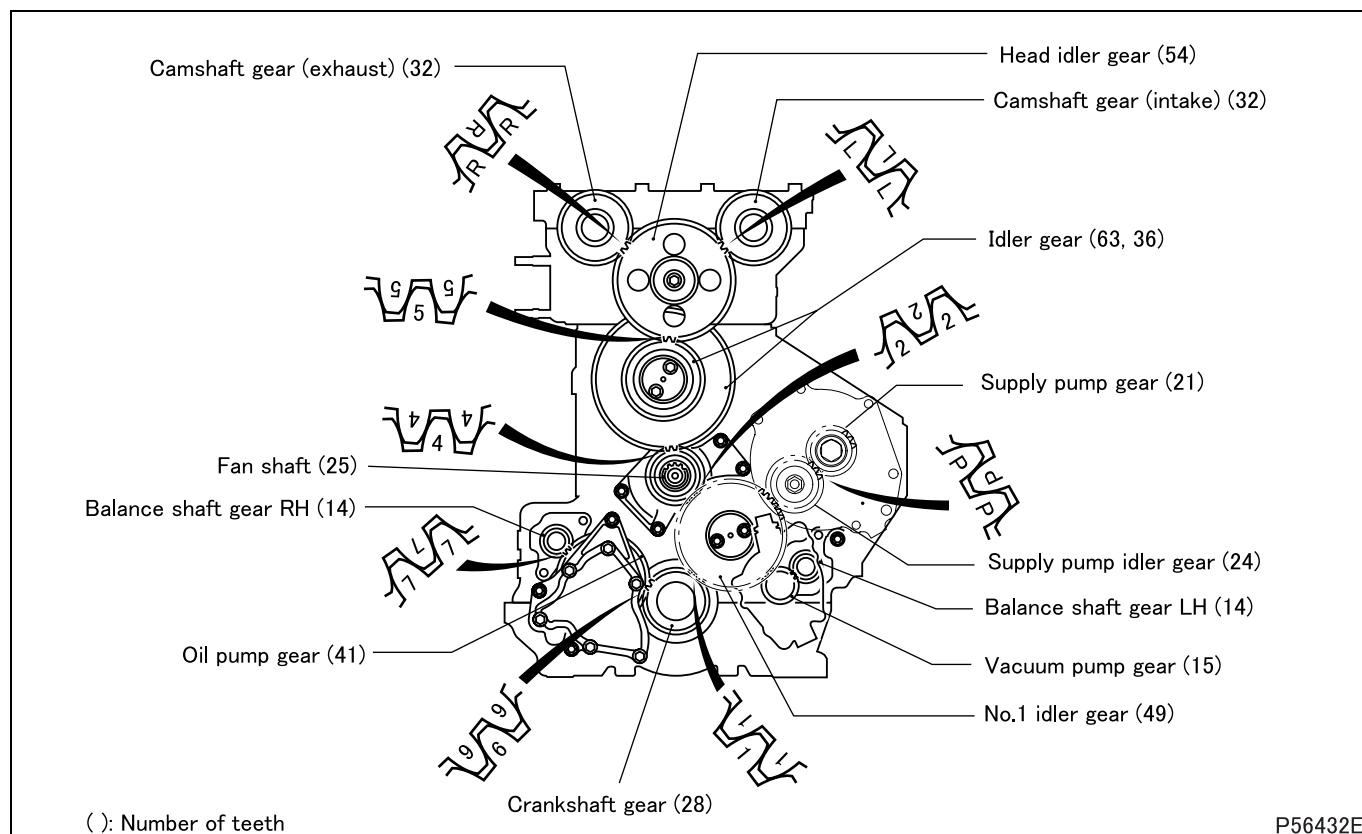
## 6. Timing Gears

- All gears, except the vacuum pump gear, each has timing mark(s) to ensure correct engagement during assembly.

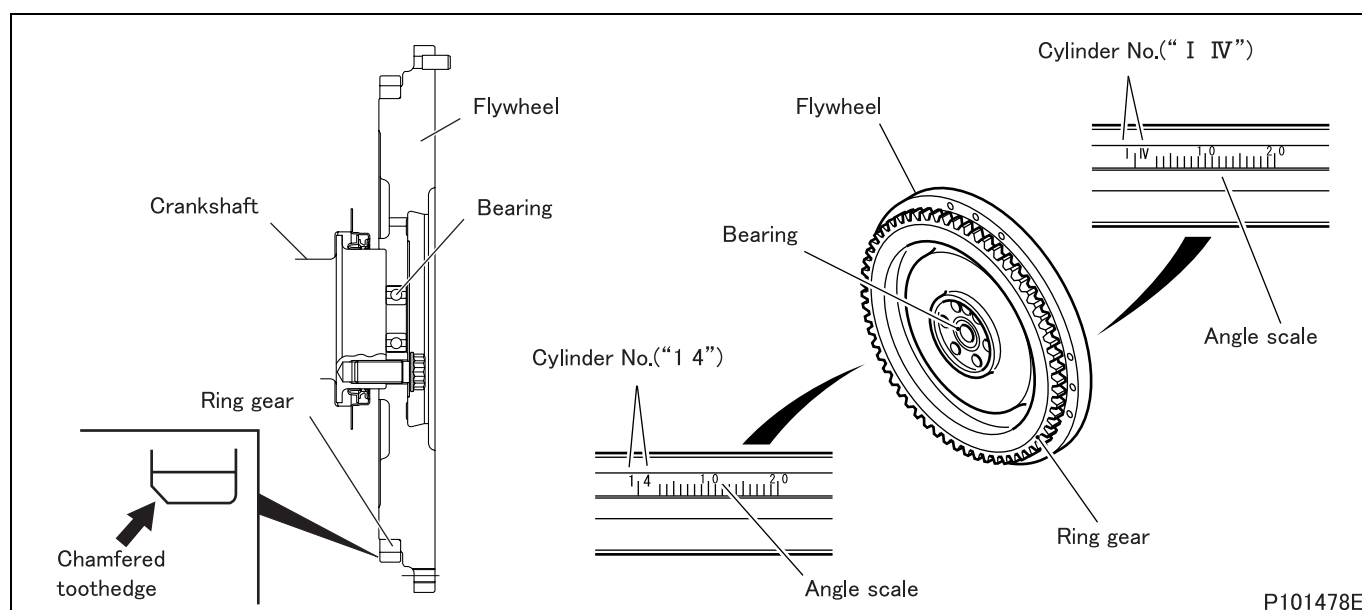
## 7. Flywheel

- One side of each flywheel ring gear tooth is chamfered to facilitate the engagement of the starter pinion.

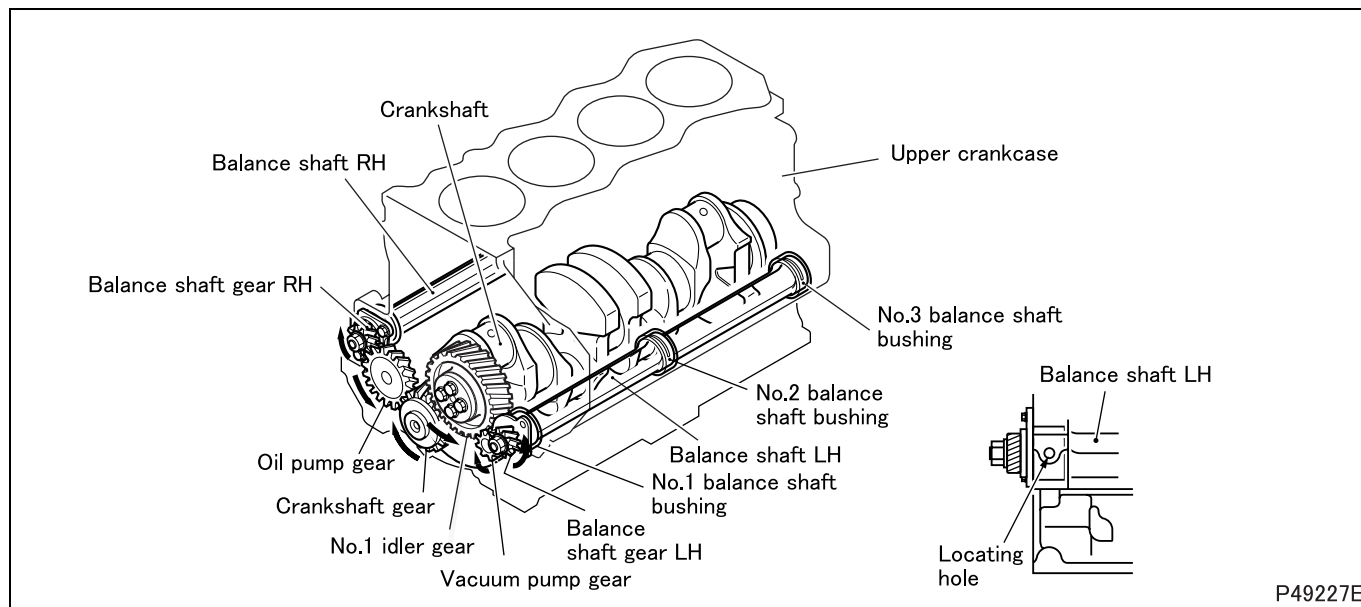
## 8. Balance Shafts

- The balance shaft RH and balance shaft LH are mounted in the upper crankcase on the right and left sides of the crankshaft. The balance shafts reduce the vibration of the engine caused by the rotation of the crankshaft.
- The balance shaft RH and balance shaft LH are both driven by timing gears. Each balance shaft is held in the upper crankcase by way of three balance shaft bushings.
- The balance shaft LH has a locating hole to enable correct installation.

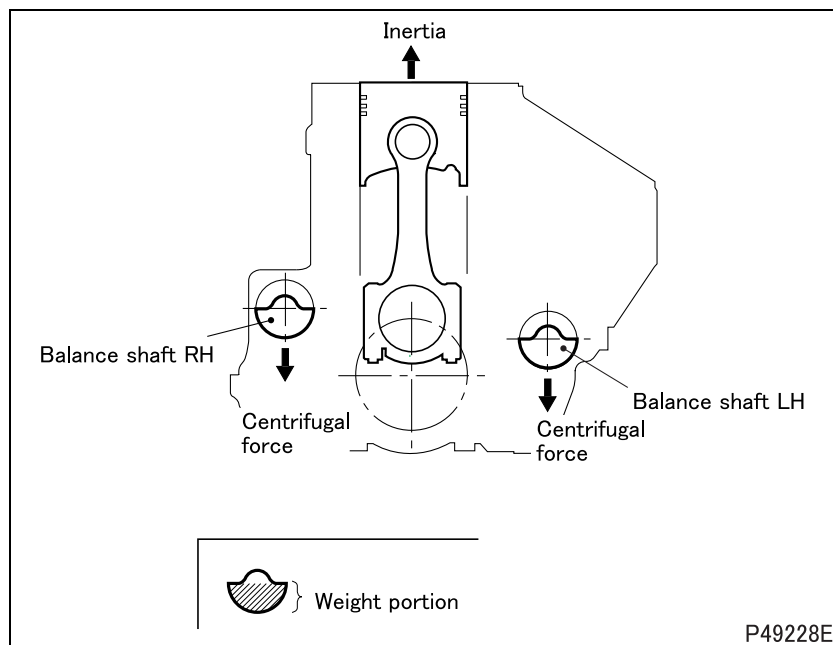
### 8.1 Reduction of vertical vibration (secondary vibration element)

- When the piston moves up and down, vertical vibrations are generated at the top dead center (TDC) and bottom dead center (BDC) due to inertia.
- The balance shaft LH and the balance shaft RH rotate so that their weight portions are at the bottom positions when a piston is at TDC and at the top positions when the piston is at BDC, i.e., the weight portions are always on the opposite side to the piston head.

- This creates centrifugal forces in the balance shaft RH and balance shaft LH, the total of which is equal in amount to the inertia force that the piston creates when it is at TDC or BDC. These centrifugal forces in the balance shafts cancel out the inertia forces resulting from piston's movements and reduce the amount of vertical vibration.

- The balance shafts also reduce the moment created around the crankshaft (which constitutes secondary vibration elements) when the engine is running in the middle-to-high speed range.

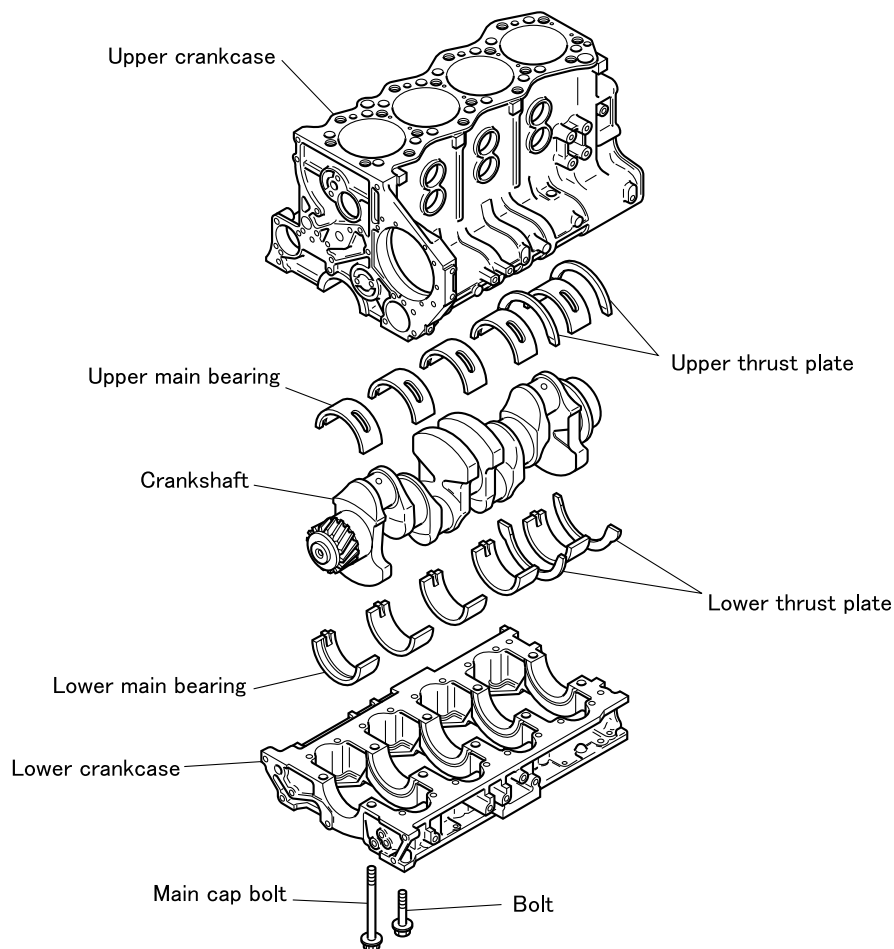
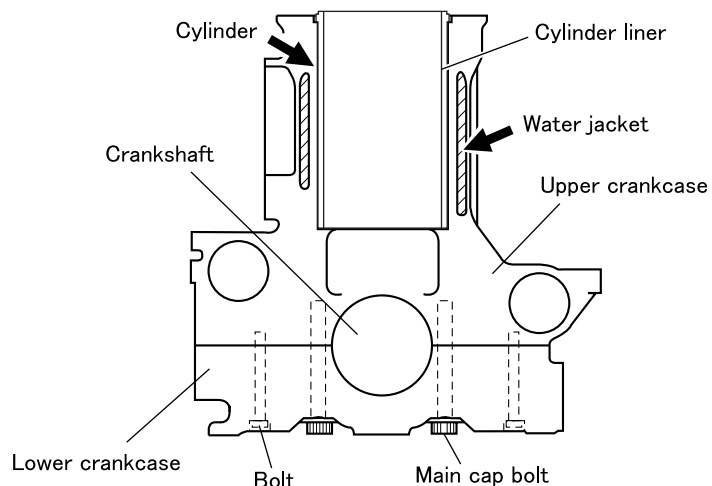
## 9. Crankcase and Main Bearings

- The crankcase is a two-piece type consisting of an upper crankcase and a lower crankcase, which hold the crankshaft in between.
- Cylinder liners are inserted into the cylinder bores in the upper crankcase.
- An water jacket is formed in the walls of these cylinders to cool them down.
- The main cap bolts and the bolts that fasten the upper and lower crankcases together are tightened using a special method.

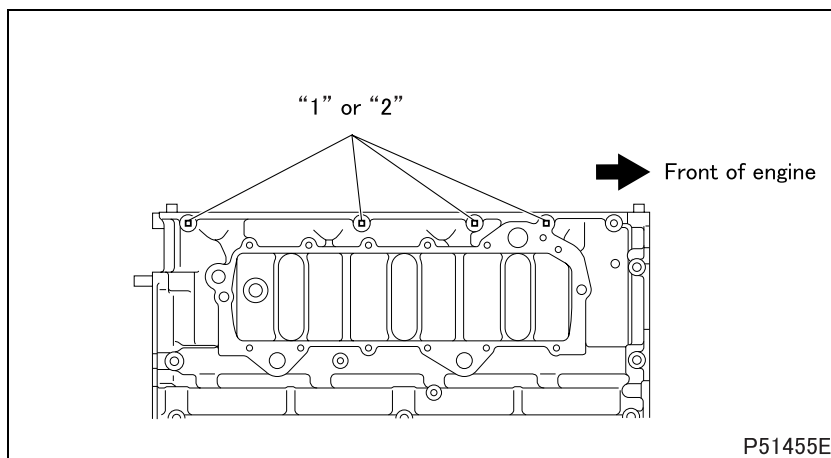
- The upper crankcase is marked with a size mark ("1" or "2") to be used as a reference in selecting cylinder liners.
- The first to fourth size marks from the front of the engine correspond to the No. 1 to No. 4 cylinders.

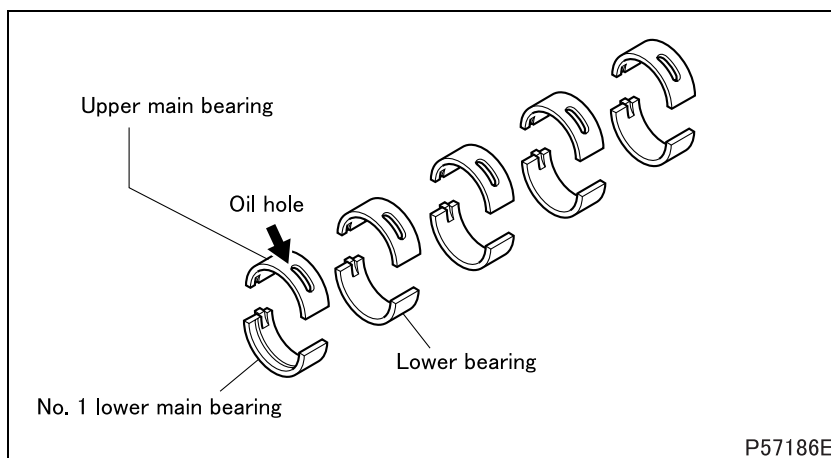
## 9.2 Main bearing

- The upper main bearings have oil holes through which engine oil is supplied to the crankshaft journals.
- An oil groove is provided in the No. 1 lower bearing.

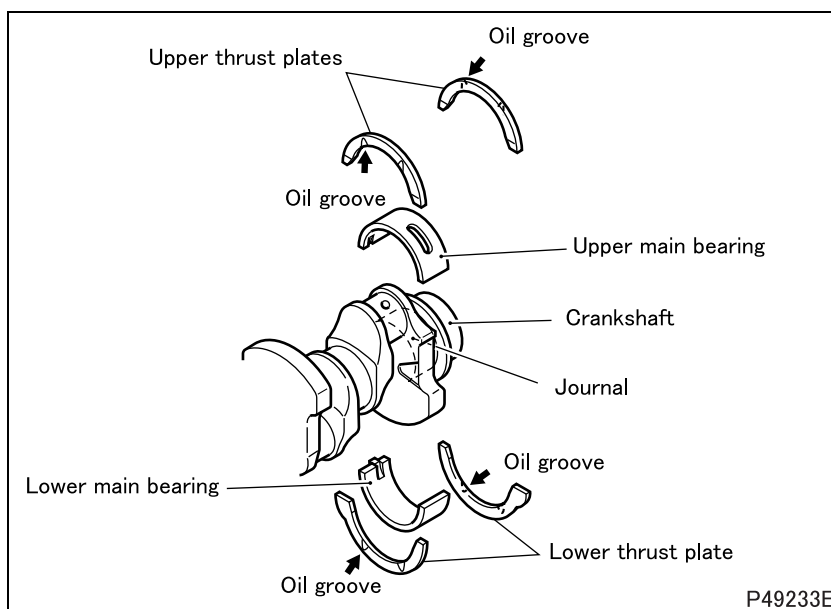
## 9.3 Thrust plates

- Two upper and lower thrust plate pairs are installed on both sides of the upper and lower main bearings at the rearmost journal of the crankshaft.
- Select the thrust plates of a thickness that can accommodate the crankshaft end play. The thrust plates each have two oil grooves, which assures their minimum friction against the crankshaft journal.

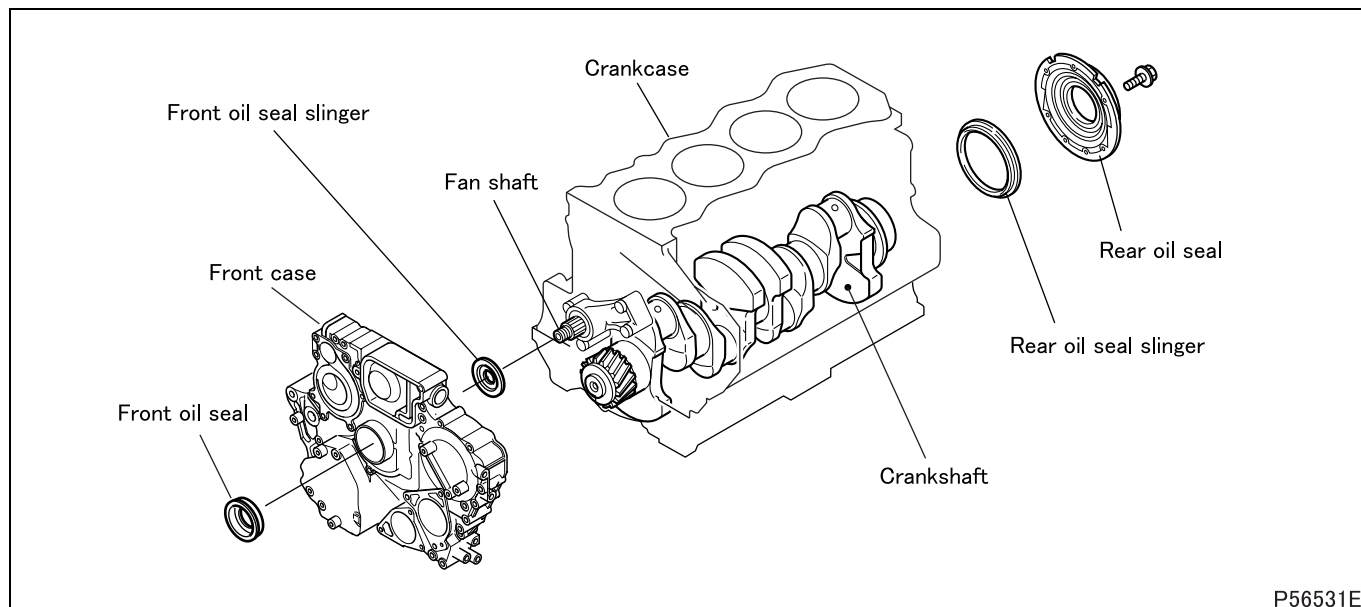
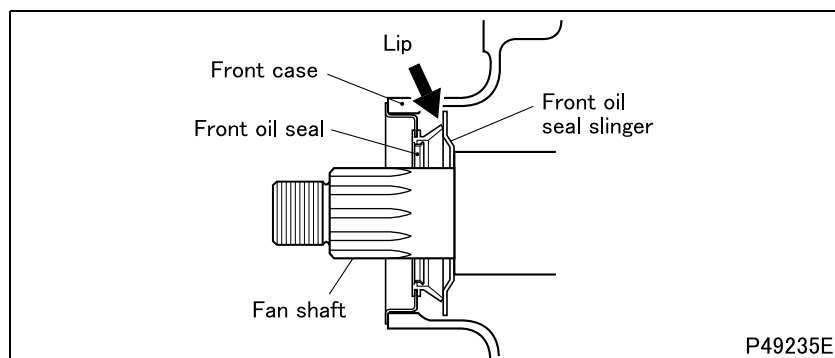
### 10.1 Front oil seal

- The front oil seal is fitted in the front case and prevents oil from leaking by contact of its lip with the front oil seal slinger.
- The front oil seal slinger is press-fitted onto the fan shaft.

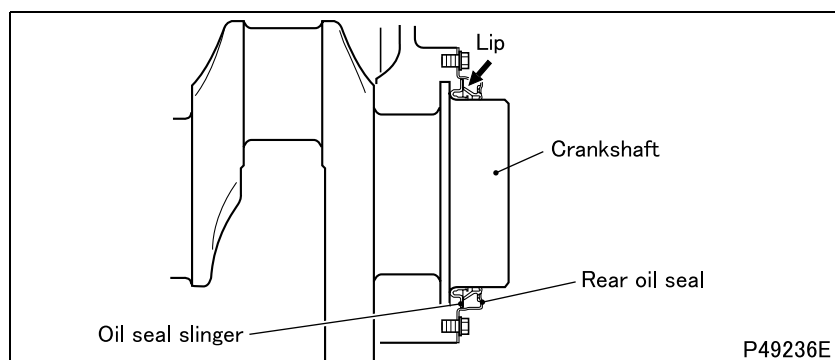
### 10.2 Rear oil seal

- The rear oil seal is fitted in the crankcase assembly and prevents oil from leaking by contact of its lip with the rear oil seal slinger.
- The rear oil seal slinger is press-fitted onto the rear end of the crankshaft.

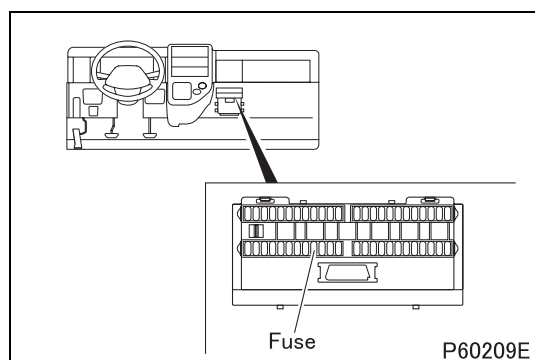
- Remove the fuse (M9) to prevent fuel from being injected when the engine is cranked by the starter.
