# FE.FG

## SERVICE MANUAL 2008 Model FOREWORD

This Service Manual contains maintenance and repair methods for the Mitsubishi Fuso Truck FE. FG Series. Read this manual carefully as an aid in providing correct, efficient maintenance. Please note that the information and specifications contained within this manual may change without notice. This is due to product modifications and continued vehicle improvements that are made throughout the model years. Should you encounter any discrepancy in the information provided, please do not hesitate to contact your nearest Mitsubishi Fuso Dealer or Mitsubishi Fuso Truck of America, Inc.

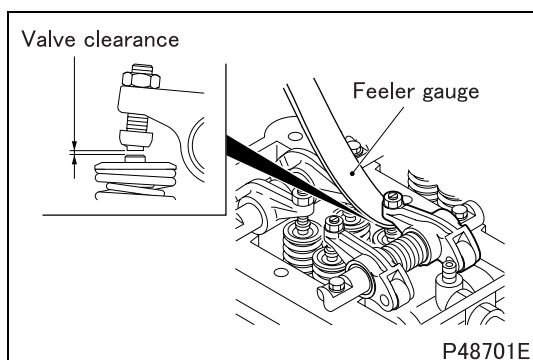
- With the No. 1 or No. 4 cylinder piston at TDC, measure the clearance of the valves marked with a circle in the table below.

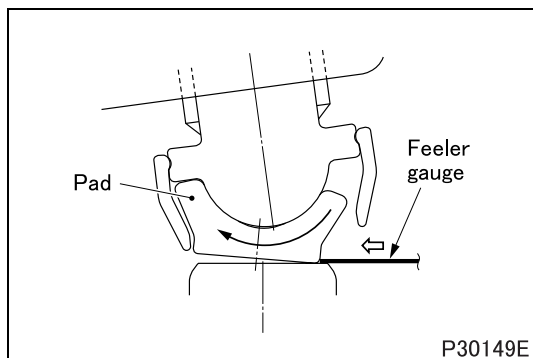
- The feeler gauge cannot be inserted under the adjusting screw pad without carrying out the above step, as the pad will block the feeler gauge as shown in the illustration.

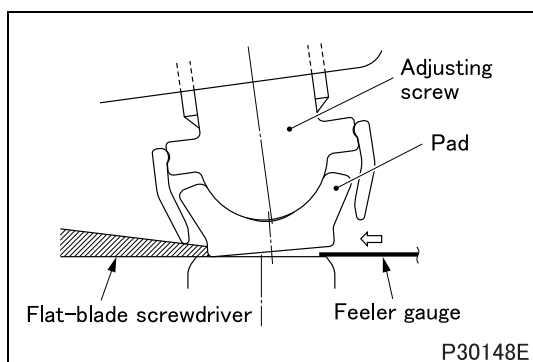
- To insert the feeler gauge under the adjusting screw pad, push the pad at the bottom on one side with a flat-blade screwdriver or a similar tool. Insert the feeler gauge into the small space created under the other side of the pad, as shown in the illustration.
- The feeler gauge must have a slight drag when taking measurements.
- If the feeler gauge can be moved without any resistance, the measurement will be incorrect.
- If the measurements are not within the standard value range, adjust the value clearance by the following procedures.

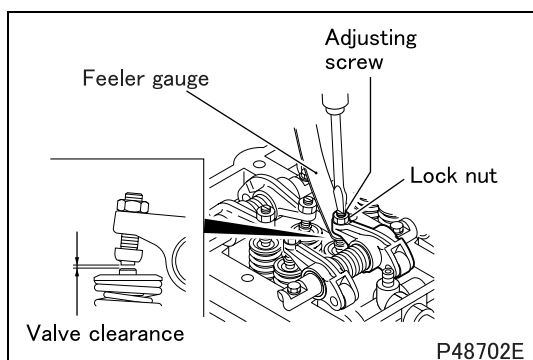
#### [Adjustment]

- Adjust the valve clearance by loosening the lock nut and rotating the adjusting screw so that the feeler gauge can only be moved with a slight drag.
- After the adjustment, hold the adjusting screw in position with a screwdriver and tighten the lock nut to the specified torque.
- Recheck the valve clearance with the feeler gauge, and readjust if the measurements are not within the specified value range.

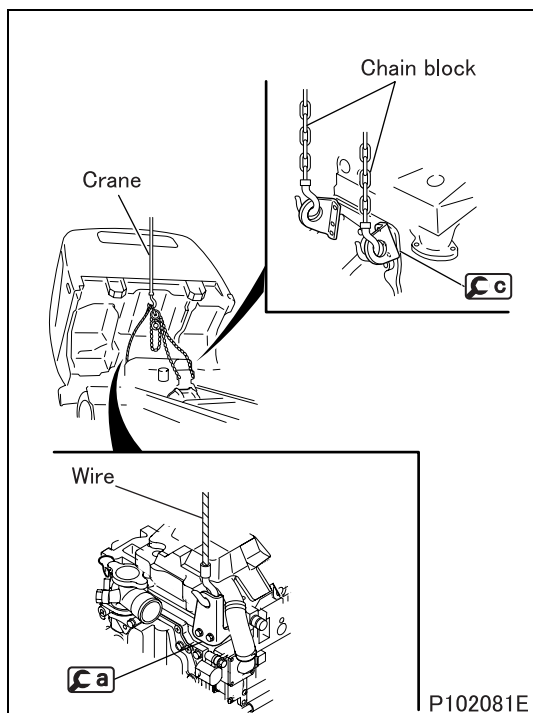
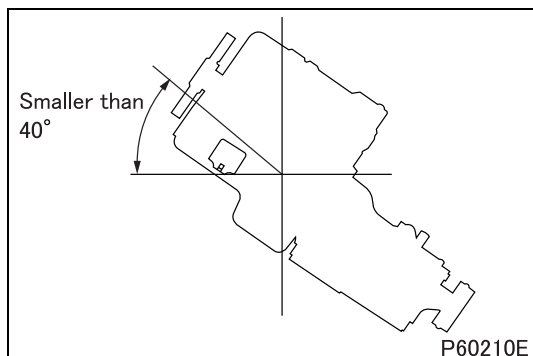
### ■ Removal: Engine and transmission

- Hook the wire rope on **Ca** and hitch the chain block to **Cc**. Then, pull all the slack out of the slings by a crane.

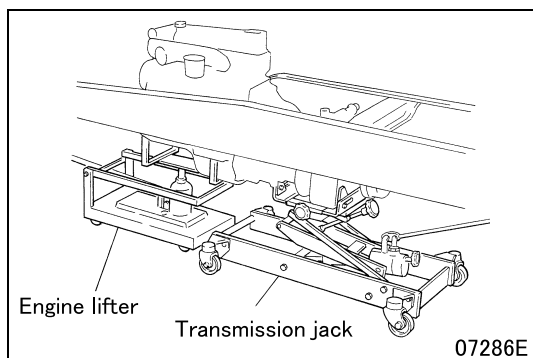
### ■ Removal: Engine and transmission assembly

- Support the engine and transmission assembly with an engine lifter and a transmission jack.
- Check that all wiring and piping have been disconnected from the engine.

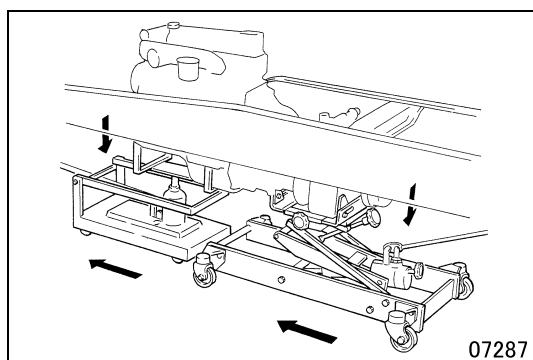
- Lower the engine and transmission assembly to the greatest extent possible while keeping it horizontally balanced.
- Jack up the vehicle and slide the engine and transmission assembly forward.

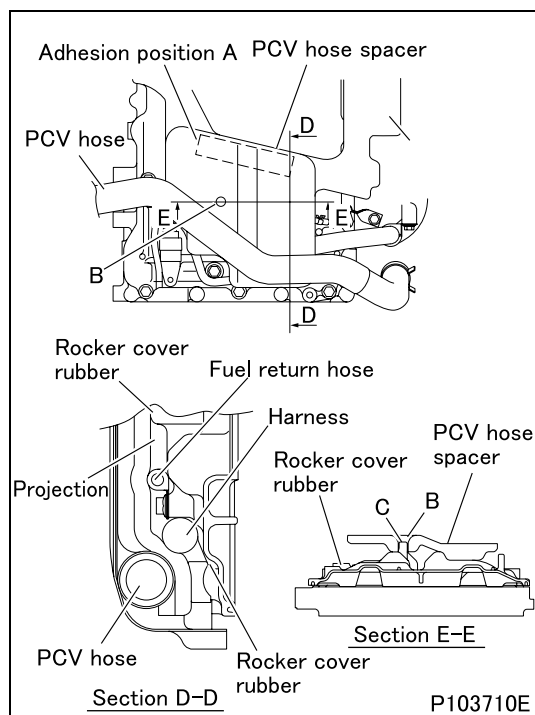
### ■ Installation: PCV hose spacer

- Apply a sheet of double-sided adhesive tape at the adhesion position A on the PCV hose spacer.
- Install the PCV hose spacer while aligning the hole B in the spacer with the projection C on the rocker cover rubber. Be careful not to crush the fuel return hose with the projection on the PCV hose spacer.

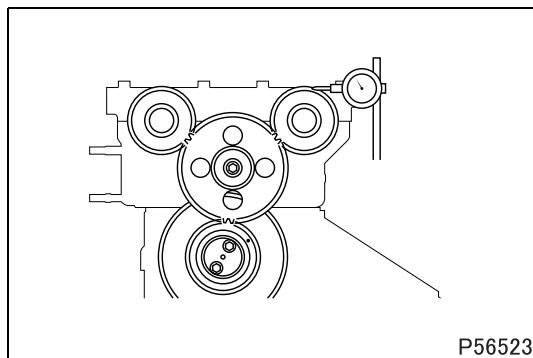
### ■ Inspection: Backlash between gears

- Measure the backlash at three or more locations for each pair of gears.
- If any of the measurements exceeds the specified limit, replace the defective part(s).

| Location | Maintenance item | | Standard value | Limit | Remedy |
|---|---|---|---|---|---|
| – | Backlash | Head idler gear-to-camshaft gear | 0.080 to 0.126 {0.0031 to 0.0050} | 0.3 {0.012} | Replace |

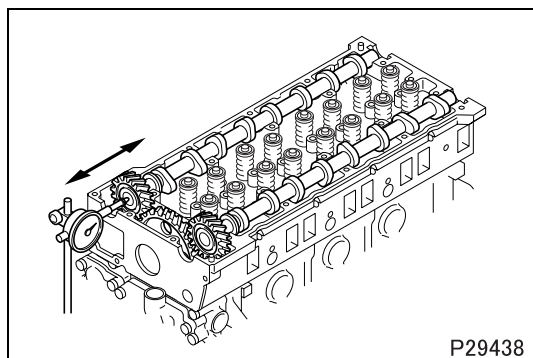
### ■ Inspection: Camshaft end play

- If the end play exceeds the specified limit, replace the defective part(s).

| Location | Maintenance item | | Standard value | Limit | Remedy |
|---|---|---|---|---|---|
| – | End play | Camshaft | 0.10 to 0.20 {0.0039 to 0.0079} | 0.3 {0.012} | Replace |

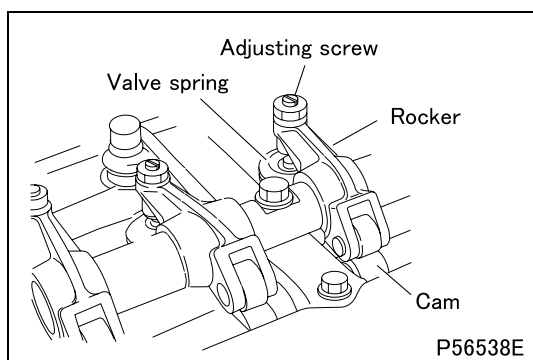
## ■ Releasing valve spring tension

- Before removing the bolts in the next process, loosen the adjusting screws on the rockers whose valve springs are compressed (due to the cams lifting these rockers). This operation is necessary to release the tension in the valve springs, thus preventing other parts from undue forces when the bolts are removed.

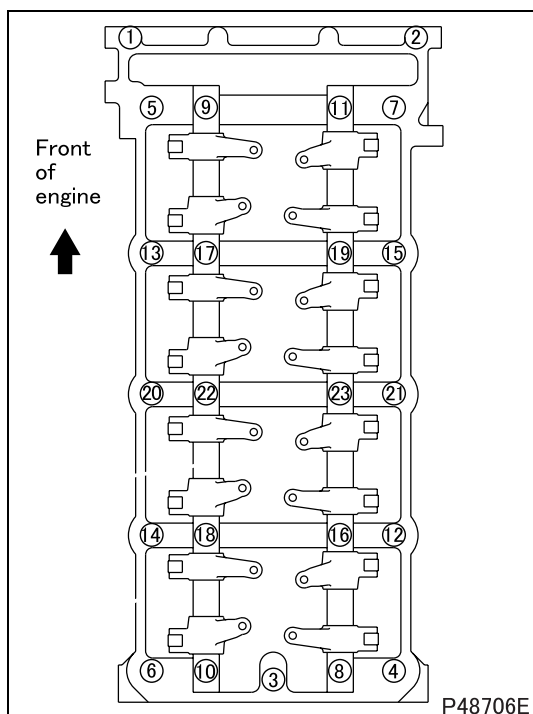
## ■ Removal: Rocker shafts and camshaft frame

- Loosen the rocker shaft installation bolts (10 places) and the camshaft frame installation bolts (13 places) in several passes in the order indicated in the illustration (1 to 23). Then, remove the rocker shafts and the camshaft frame.

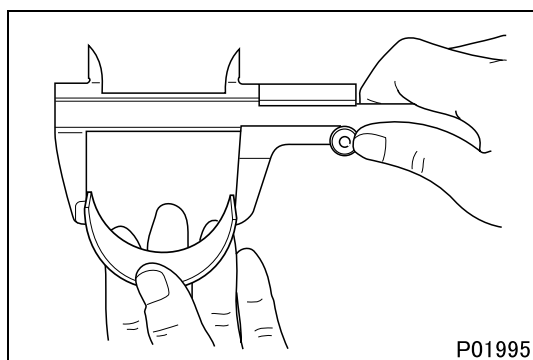
## ■ Inspection: Camshaft bearing free span

- Do not force the bearings open.
- If the measurement is less than the limit, replace upper and lower bearings as a set.

| Location | Maintenance item | | Standard value | Limit | Remedy |
|---|---|---|---|---|---|
| <b>6, 10</b> | Camshaft bearing span (when free) | | – | 35.5 {1.40} | Replace |

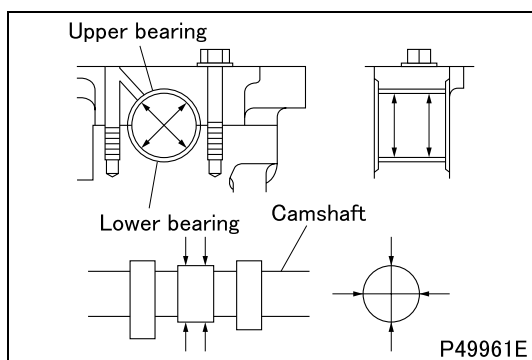
### ■ Inspection: Camshaft bearing-to-camshaft clearance

- If the measurement is not within the standard value range, replace the defective part(s).

| Location | Maintenance item | | Standard value | Limit | Remedy |
|---|---|---|---|---|---|
| <b>6, 8, 10</b> | Camshaft bearing-to-intake camshaft clearance | | 0.07 to 0.12 {0.0028 to 0.0047} | 0.16 {0.024} | Replace |
| <b>6, 9, 10</b> | Camshaft bearing-to-exhaust camshaft clearance | | 0.07 to 0.12 {0.0028 to 0.0047} | 0.16 {0.024} | Replace |

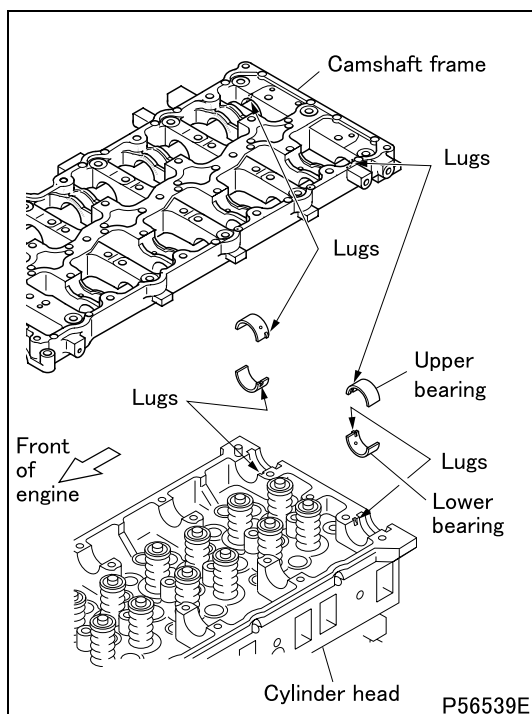
### ■ Installation: Camshaft

- Install the upper camshaft bearing on the camshaft frame and the lower camshaft bearing on the cylinder head by fitting their lugs into the notches in the camshaft frame and cylinder head.

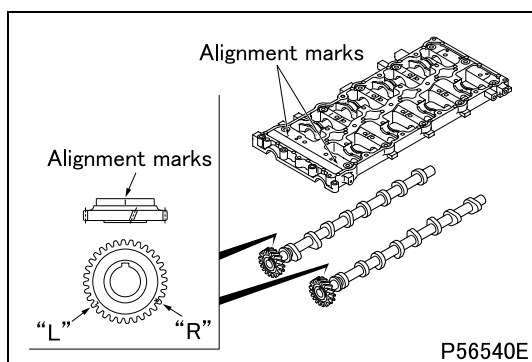
- Place the No. 1 cylinder piston at the top dead center on the compression stroke.
- Align the mating marks on the camshaft gears with those on the camshaft frame when installing the camshafts.
- Each camshaft gear also has mating mark "L" or "R" for alignment with the head idler gear. This mark may not be exactly aligned with that on the head idler gear, as the position that the head idler gear takes when it is installed may make it impossible to align them. Such a misalignment does not lead to any undesirable consequences.

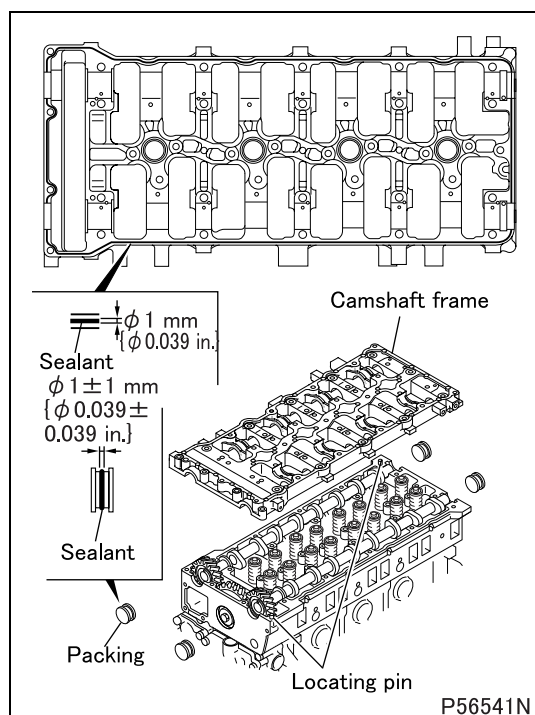
## ■ Installation: Rocker shafts and camshaft frame

- Clean the sealant application surfaces on each part.
- Apply sealant to the entire periphery of the four packings evenly and without any breaks.
- Apply sealant to the camshaft frame evenly and without any breaks.
- Mount the camshaft frame and packing on the cylinder head within three minutes of applying the sealant, being careful not to dislodge the sealant in the process.

- Reapply sealant to the areas specified above if any of the bolts is loosened or removed after the rocker shafts and camshaft frame are installed.

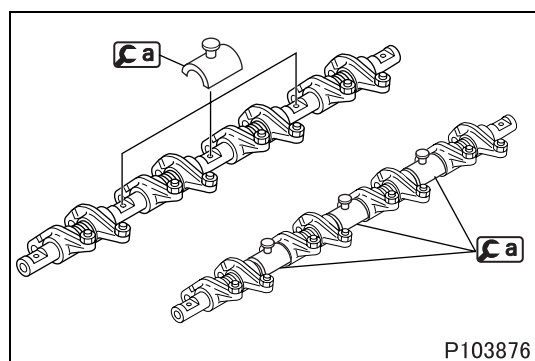
- Install **Ca** on the rocker shafts to prevent the rocker arms from moving away from each other.

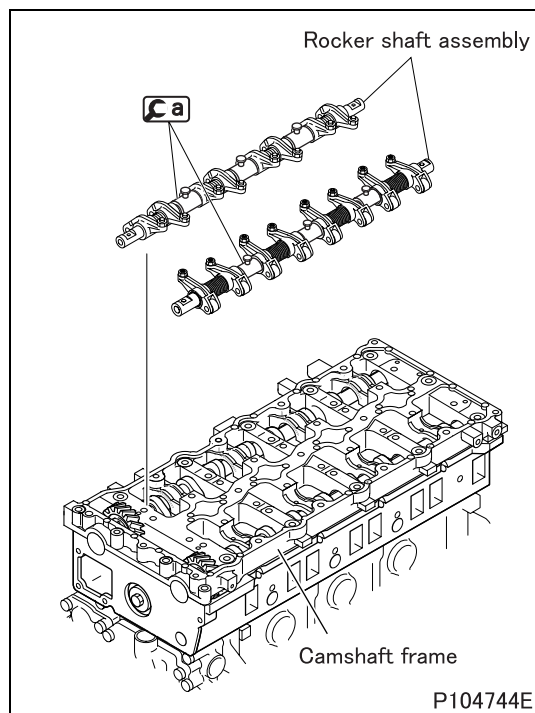
- Set the rocker shafts to the camshaft frame and then remove **Ca**.

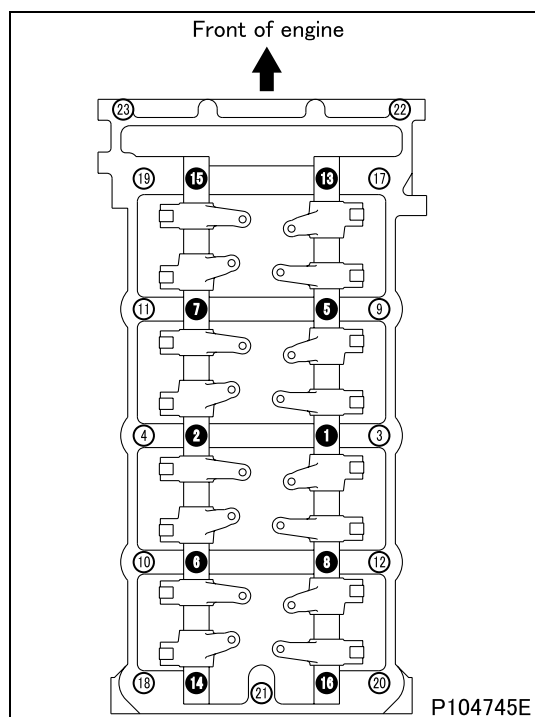
- Tighten the bolts (1 to 23) to the specified torque in the order indicated in the illustration.  
White numbered bolts are to tighten both the camshaft frame and rocker shaft.

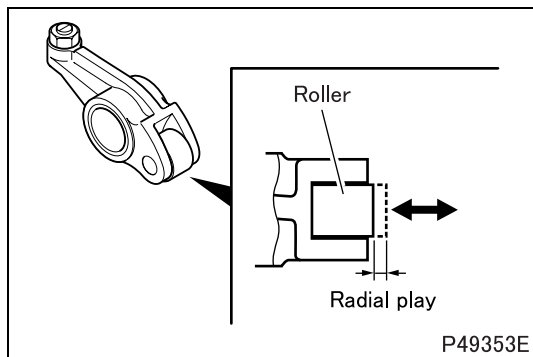
#### ■ Inspection: Rocker (roller) radial clearance

- Replace the rocker if the radial play measurement is not within the standard value range.

| Location | Maintenance item | Standard value | Limit | Remedy |
|---|---|---|---|---|
| 3, 7 | Rocker (roller) radial play | 0.038 to 0.100<br>{0.0015 to 0.0039} | – | Replace |

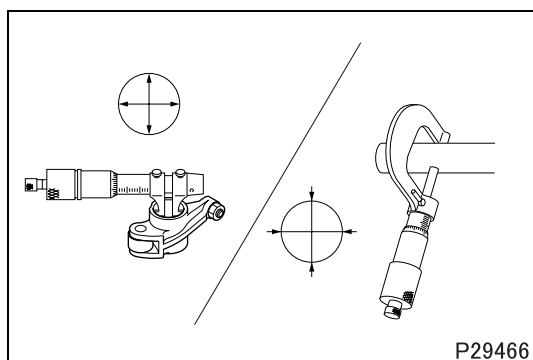
#### ■ Inspection: Rocker bushing-to-rocker shaft clearance

- Replace the bushing if the measurement exceeds the specified limit.

| Location | Maintenance item | Standard value | Limit | Remedy |
|---|---|---|---|---|
| 2, 6,<br>8, 9 | Rocker bushing-to-rocker shaft clearance | 0.01 to 0.08<br>{0.00039 to 0.0031} | 0.12<br>{0.0047} | Replace |

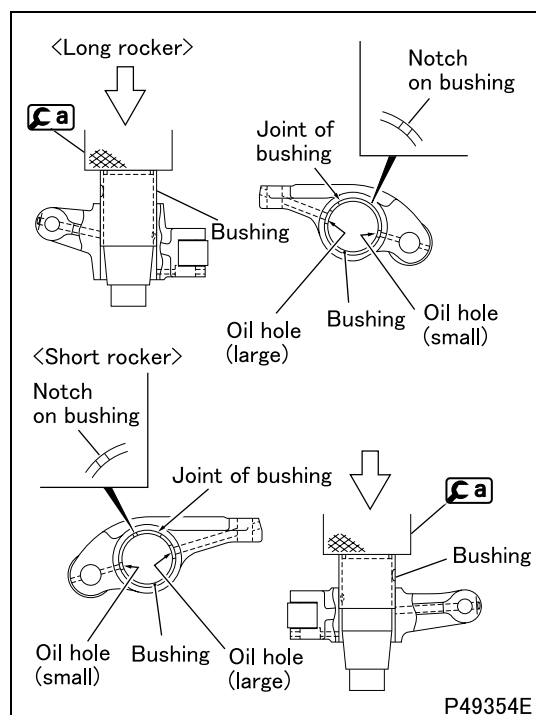
## [Installation]

- Press-fit each rocker bushing in the rocker with its ends facing in the illustrated directions.

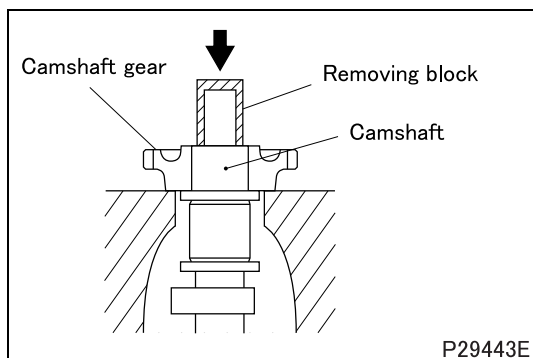
### ■ Removal: Camshaft gears

- Remove the camshaft gear by pushing on the camshaft using a press.

- Do not use a hammer to remove the camshaft gear. Be sure to use a press for this purpose.

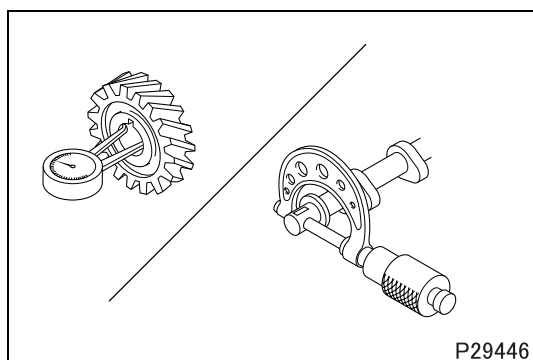
### ■ Inspection: Camshaft gear-to-camshaft interference

- If the measurement is not within the standard value range, replace the defective part(s).

| Location | Maintenance item | | | Standard value | Limit | Remedy |
|---|---|---|---|---|---|---|
| 1, 3, 4, 6 | Camshaft gear-to-camshaft interference | | | 0.007 to 0.041<br>{0.00028 to 0.0016} | — | Replace |

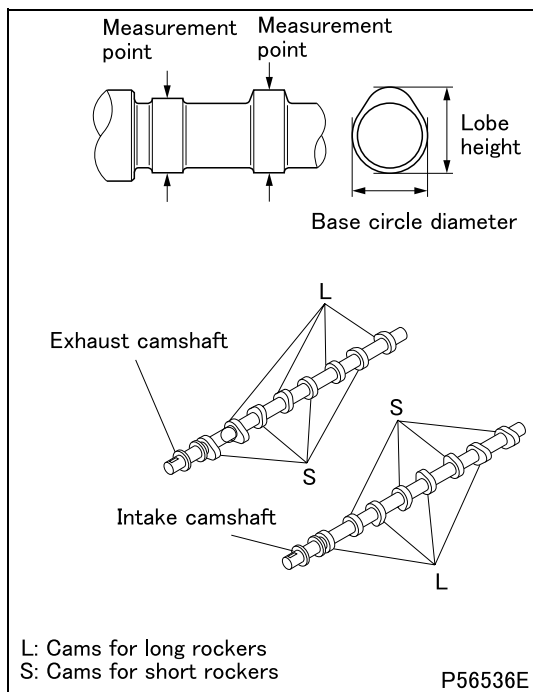
### ■ Inspection: Camshaft

#### (1) Cam lift

- Replace the camshaft if the difference between the cam lobe height and base circle diameter measurements is less than the specified limit.

- The cams for the long rockers (L) are different from the cams for the short rockers (S).

| Location | Maintenance item | | | Standard value | Limit | Remedy |
|---|---|---|---|---|---|---|
| 3 | Intake camshaft | Cam lift | Cams for long rockers | 7.219 {0.284} | — | Replace |
| 6 | Exhaust camshaft | Cam lift | Cams for long rockers | 7.111 {0.279} | — | Replace |

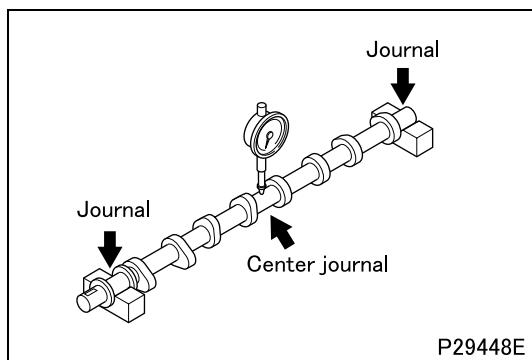
## (2) Bend

- Place supports under the journals at the ends of the camshaft and measure the bend of the camshaft at the central journal. The amount of camshaft bend is obtained by giving the camshaft one turn and dividing the dial gauge reading by two.
- If the measurement exceeds the specified limit, replace the camshaft.

| Location | Maintenance item | | | Standard value | Limit | Remedy |
|---|---|---|---|---|---|---|
| | | Bend | | | 0.01 {0.00039} | 0.03 {0.0012} |

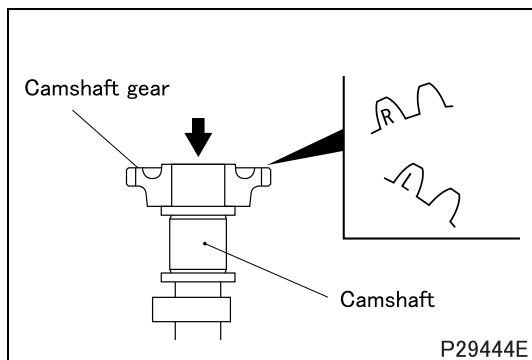
## ■ Installation: Camshaft gears

- Heat the camshaft gears to approximately 150°C {302°F} with a gas burner.

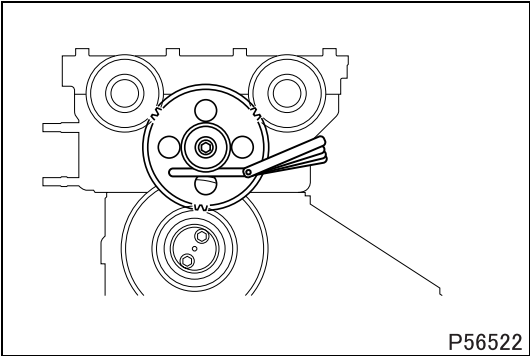
#### ■ Inspection: Head idler gear end play

- If the measurement exceeds the specified limit, replace the defective part(s).

| Location | Maintenance item | Standard value | Limit | Remedy |
|---|---|---|---|---|
| – | Head idler gear end play | 0.1 to 0.2<br>{0.0039 to 0.0079} | 0.3 {0.012} | Replace |

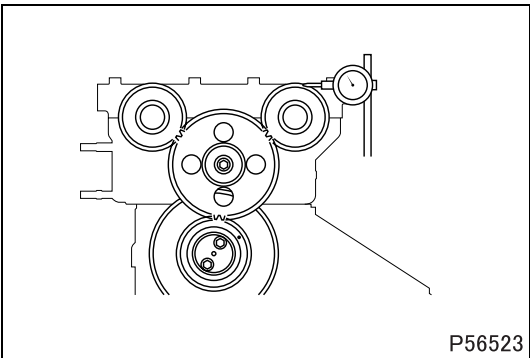
#### ■ Inspection: Backlash between gears

- Measure the backlash at three or more locations for each pair of gears.
- If any of the measurements exceeds the specified limit, replace the defective part(s).

| Location | Maintenance item | Standard value | Limit | Remedy |
|---|---|---|---|---|
| – | Backlash between head idler gear and idler gear | 0.103 to 0.158<br>{0.0041 to 0.0062} | 0.3 {0.012} | Replace |

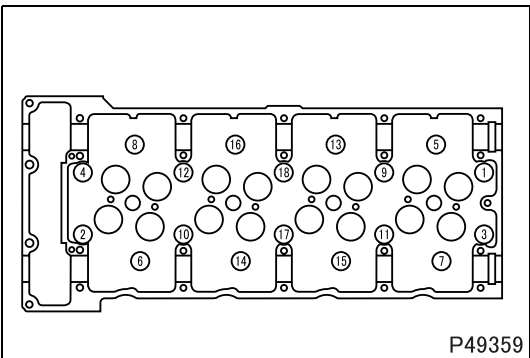
#### ■ Removal: Cylinder head

- Loosen the cylinder head bolts (1 to 18) in several passes in the order indicated in the illustration and remove the cylinder head.

- When removing the cylinder head gasket, be careful not to scratch the cylinder head, the upper crankcase and the front case.

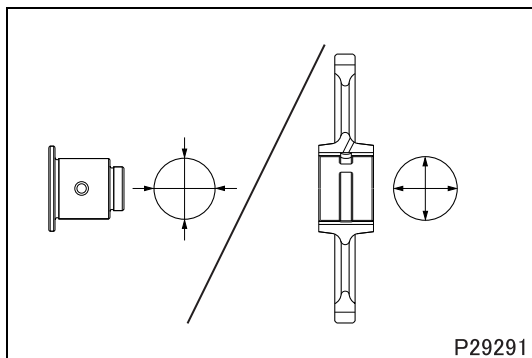
### ■ Inspection: Head idler shaft-to-head idler gear bushing clearance

- Replace the bushing if the measurement exceeds the specified limit.

| Location | Maintenance item | Standard value | Limit | Remedy |
|---|---|---|---|---|
| 3, 4 | Head idler shaft-to-head idler gear bushing clearance | 0.01 to 0.05<br>{0.00039 to 0.0020} | 0.1 {0.0039} | Replace |

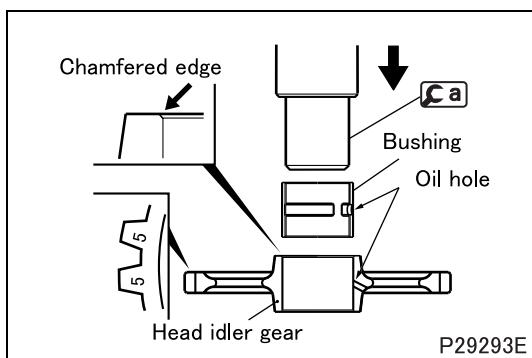
#### [Installation]

- Position the bushing on the head idler gear with their ends facing the illustrated directions and their oil holes on the same line.
- Using **Ca**, press the bushing into the head idler gear until it is flush with the lower edge of the chamfer on the head idler gear.
- Remeasure the clearance between the bushing and head idler shaft.
- Ream the bushing if the measurement is less than the standard value.

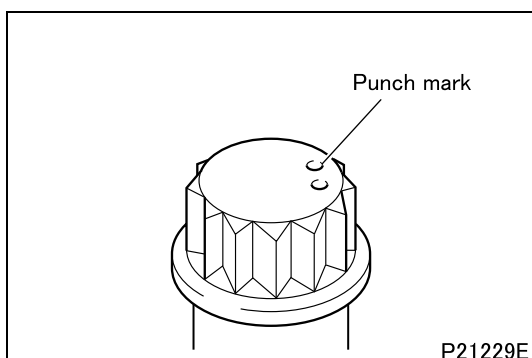
### ■ Installation: Cylinder head

- Before fitting the cylinder head bolts, check the punch marks on each bolt's head. Do not use the bolt if there are three punch marks.
- The punch marks indicate the number of times each bolt has been tightened using the torque-turn tightening method. Any bolt that already has three punch marks must be replaced.

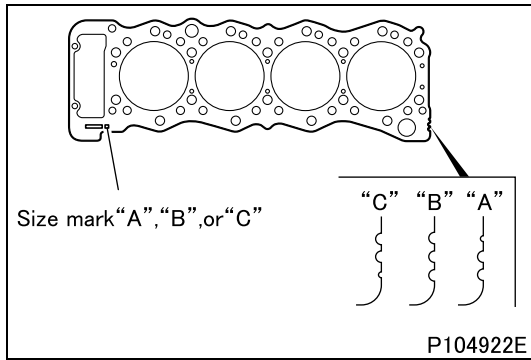
- The cylinder head gasket comes in three sizes. Choose the gasket appropriate for the cylinder head by the following procedure.
- Measure the amount of piston projection for every cylinder. (See "PISTONS, CONNECTING ROD AND CYLINDER LINERS" section.)
- Select a cylinder head gasket with the appropriate thickness for the average of the piston projection measurements from the table below.
- If any of the piston projection measurements is more than 0.05 mm {0.0020 in.} larger than the average value, then use the gasket one class higher than that class (A→B, B→C).

- Replacement of the piston or connecting rod alters the piston projection. Always measure the amount of piston projection after either or both of them are replaced.

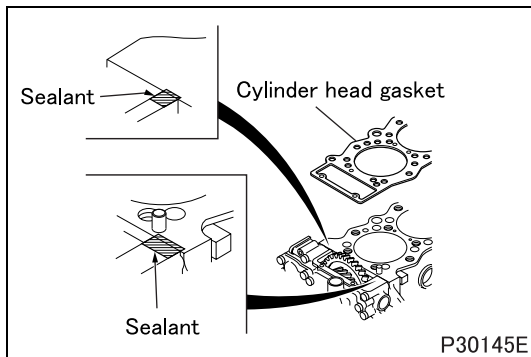
- Clean the sealant application surfaces of each part.
- Apply sealant to the top surfaces of the joints between the upper crankcase and front case (at two places).
- Install the cylinder head and its gasket on the upper crankcase within three minutes of applying the sealant, being careful not to dislodge the sealant.

- Do not run the engine within one hour of mounting the cylinder head. If any cylinder head bolts are loosened or removed, be sure to reapply sealant to the surfaces specified above.

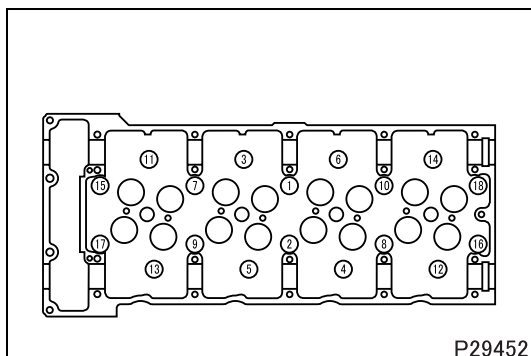
- Tighten the cylinder head bolts (1 to 18) to a torque of 147 N·m {110 ft.lbs, 15 kgf·m} (wet) in the order indicated in the illustration. Then, tighten them further by 90° in the same order.
- After tightening each bolt, make a punch mark on the head of the bolt to indicate the number of times that it has been used.

- The cylinder head bolts are tightened using the torque-turn method. Any cylinder head bolt that has three marks indicating that the bolt has been tightened three times already must be replaced with a new one.
- Do not forget to install the thrust plate.

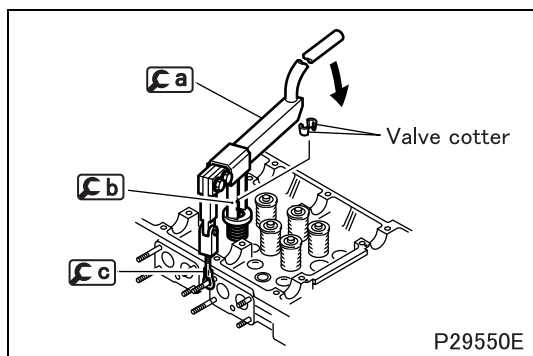
### ■ Removal: Valve cotters

- Remove the valve cotters by evenly compressing the valve springs.

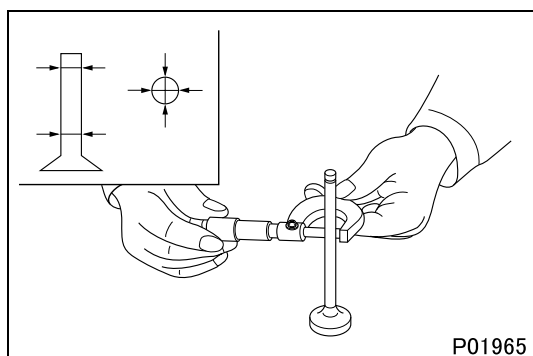
### ■ Inspection: Intake valves and exhaust valves

- If a valve is corrected or replaced with a new one as a result of the following inspection, make sure to lap the valve and valve seat.

#### (1) Inspection of valve stem

- Replace the valve if the stem's outside diameter is below the limit or is severely worn.

| Location | Maintenance item | | Standard value | Limit | Remedy |
|---|---|---|---|---|---|
| 6 | Exhaust valve | Stem outside diameter | $\phi 8 \begin{smallmatrix} -0.060 \\ -0.075 \end{smallmatrix}$ { $\phi 0.31 \begin{smallmatrix} -0.0024 \\ -0.0030 \end{smallmatrix}$ } | $\phi 7.85$<br>{ $\phi 0.31$ } | Replace |
| 7 | Intake valve | Stem outside diameter | $\phi 8 \begin{smallmatrix} -0.025 \\ -0.040 \end{smallmatrix}$ { $\phi 0.31 \begin{smallmatrix} -0.00098 \\ -0.0016 \end{smallmatrix}$ } | $\phi 7.85$<br>{ $\phi 0.31$ } | Replace |

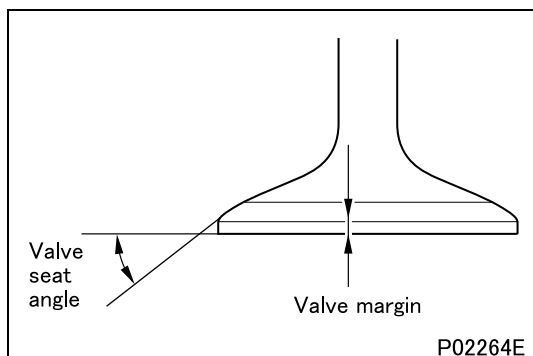
#### (2) Valve seat angle

- Reface or replace the valve if the measured valve is not within the standard value range.

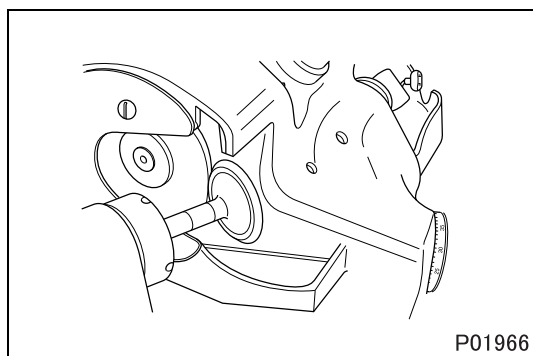
### Refacing

- Limit grinding to a necessary minimum.
- If the valve margin is below the limit after grinding, replace the valve.
- After grinding, make sure to lap the valve and valve seat.

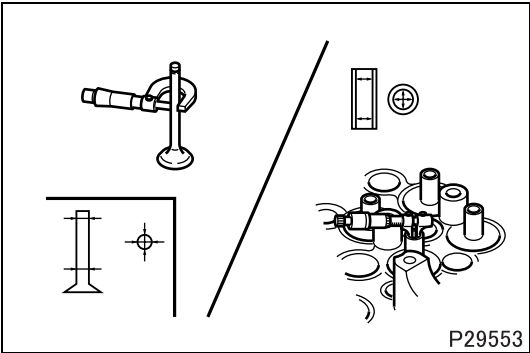
## ■ Inspection: Valve-to-valve guide clearance

- If the clearance exceeds the specified limit, replace the defective part(s).

| Location | Maintenance item | | Standard value | Limit | Remedy |
|---|---|---|---|---|---|
| 6, 8 | Exhaust valve stem-to-valve guide clearance | | 0.07 to 0.10<br>{0.0028 to 0.0039} | 0.2 {0.0079} | Replace |
| 7, 9 | Intake valve stem-to-valve guide clearance | | 0.03 to 0.06<br>{0.0012 to 0.0024} | 0.2 {0.0079} | Replace |

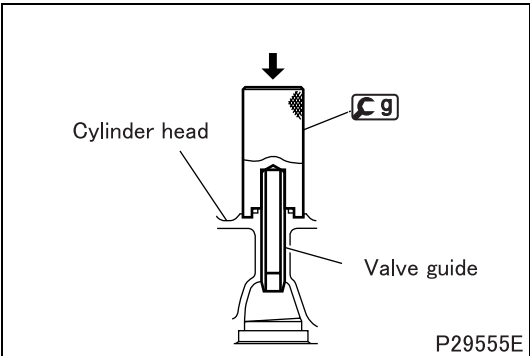
### [Installation]

- Install the valve guide until **cg** sits snugly on the cylinder head.

- The valve guides must be pressed to the specified depth. Be sure to use **cg** for this operation.
- Exhaust valve guides are longer than intake valve guides. Make sure to install the correct type of guide in each location.

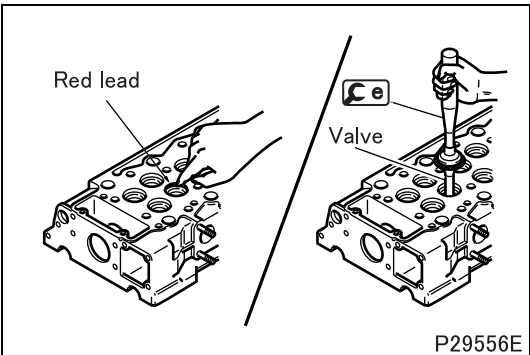
## ■ Inspection: Contact between valve and valve seat

- Before starting inspection, check that the valve and valve guide are intact.
- Apply an even coat of red lead to the valve contact surface of the valve seat.
- Strike the valve once against the valve seat. Do not rotate the valve during this operation.

| | Corrective action |
|---|---|
| Minor defect | Lapping |
| Serious defect | Reface or replace valve and valve seat |

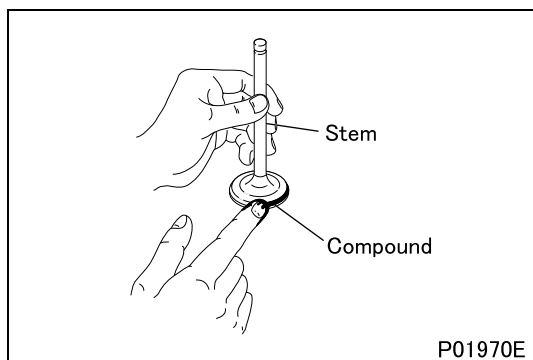
### Lapping

- Perform the valve lapping in the following procedure.
- Apply a thin coat of lapping compound to the seat contact surface of the valve.
- Start with an intermediate-grit compound (120 to 150 grit) and finish with a fine-grit compound (200 grit or more). Do not put any compound on the stem.
- Adding a small amount of engine oil to the lapping compound can facilitate even application.

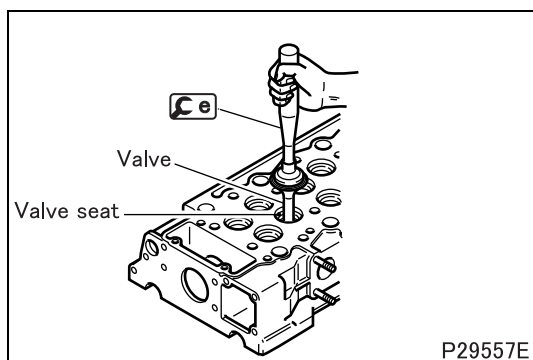
- Strike the valve several times against the valve seat while rotating the valve a little at a time.
- Wash away the compound with diesel fuel.
- Apply engine oil to the valve contact surface of the valve seat and rub in the valve and seat well.
- Inspect the contact pattern of the valve and valve seat again.
- If the contact pattern is still defective, replace the valve seat.

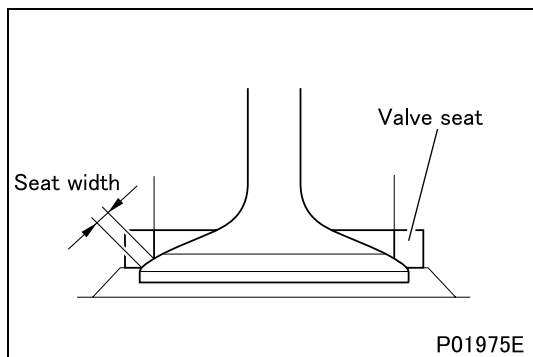
#### (1) Valve seat width

- If the measurement exceeds the limit, reface or replace the valve seat.

| Location | Maintenance item | | Standard value | Limit | Remedy |
|---|---|---|---|---|---|
| 10 | Exhaust valve seat width | | 2.5 ± 0.2<br>{0.098 ± 0.0079} | 3.5 {0.14} | Replace |
| 11 | Intake valve seat width | | 2 ± 0.2<br>{0.079 ± 0.0079} | 2.8 {0.11} | Replace |

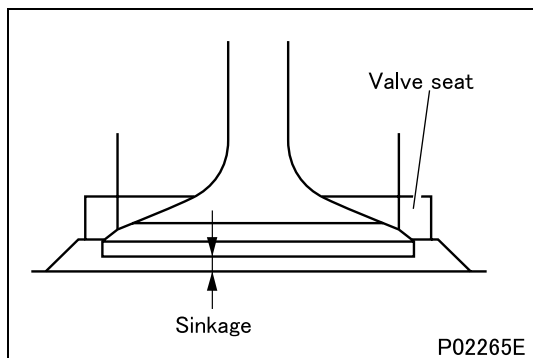
#### (2) Valve sinkage from cylinder head bottom surface

- Make sure that the valve and valve seat are pressed together tightly when measuring the sinkage.
- If the measurement exceeds the limit, replace the defective part(s).

| Location | Maintenance item | | Standard value | Limit | Remedy |
|---|---|---|---|---|---|
| | | Sinkage from cylinder head<br>bottom surface | 1.5 ± 0.25<br>{0.059 ± 0.0098} | 2.0 {0.079} | Replace |

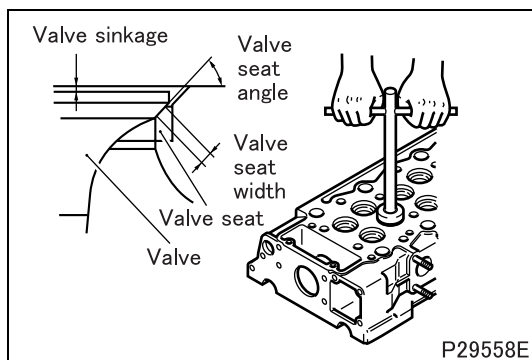
## Refacing the valve seat

- Grind the valve seat using a valve seat cutter or valve seat grinder.
- Place a sandpaper of around #400 between the cutter and valve seat and grind the valve seat lightly.
- Use a 15° or 75° cutter to cut the valve seat to a width within the standard range. If the valve seat cannot be refaced to a width within the standard range, replace it.

- **Make sure that the valve seat refacing does not cause the valve sinkage to exceed the specified limit.**

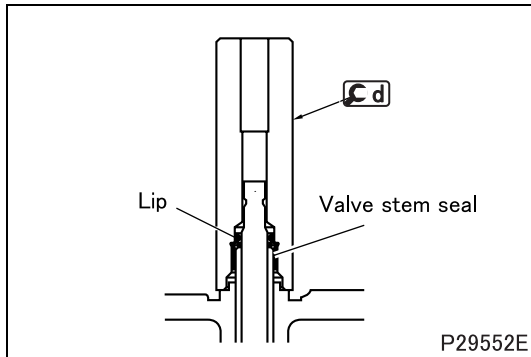
## ■ Installation: Valve stem seal

- Apply engine oil to the lip of the valve stem seal.
- Install the valve stem seal until **C d** sits snugly on the cylinder head.
- After installing the valve stem seal, check that its spring is not deformed or damaged.

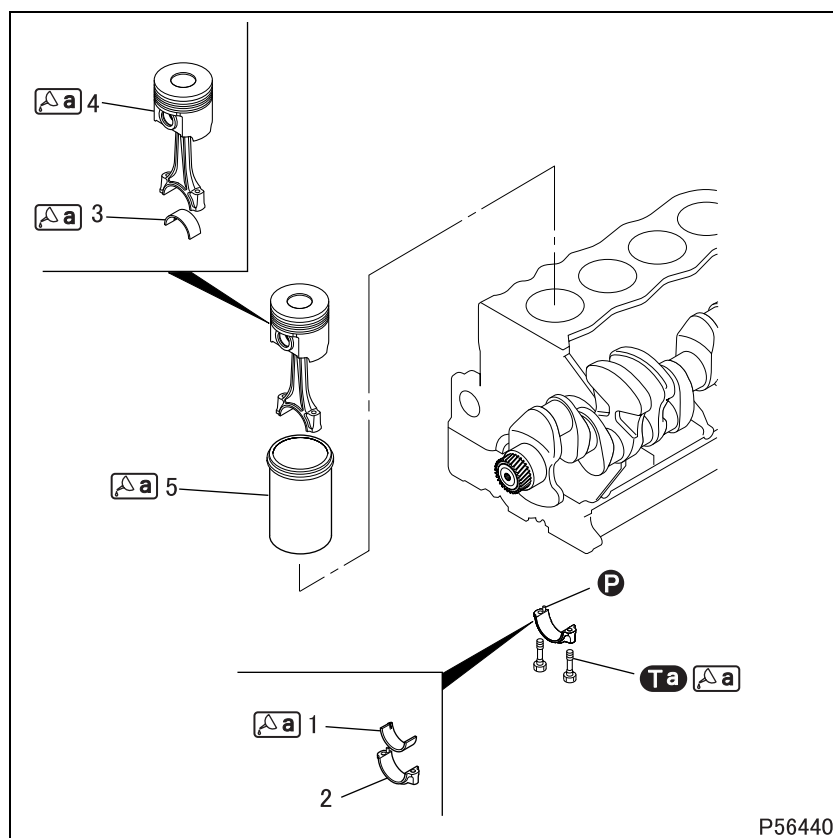
- 1 Lower connecting rod bearing
- 2 Connecting rod cap
- 3 Upper connecting rod bearing
- 4 Piston and connecting rod assembly (See later sections.)
- 5 Cylinder liner

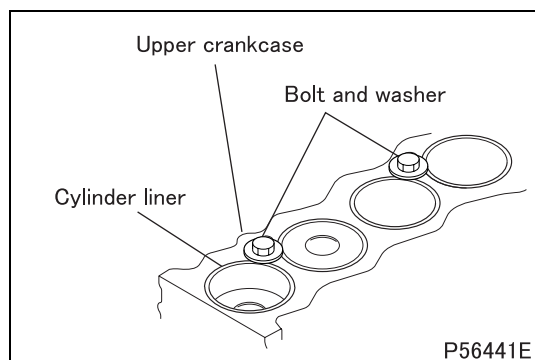
## ■ Retaining cylinder liners

- The cylinder liners slip out of the upper crankcase easily when the upper crankcase is turned over or the crankshaft is rotated with pistons inside liners. To prevent this from happening, retain the flange of each cylinder liner in position with a bolt and washer.

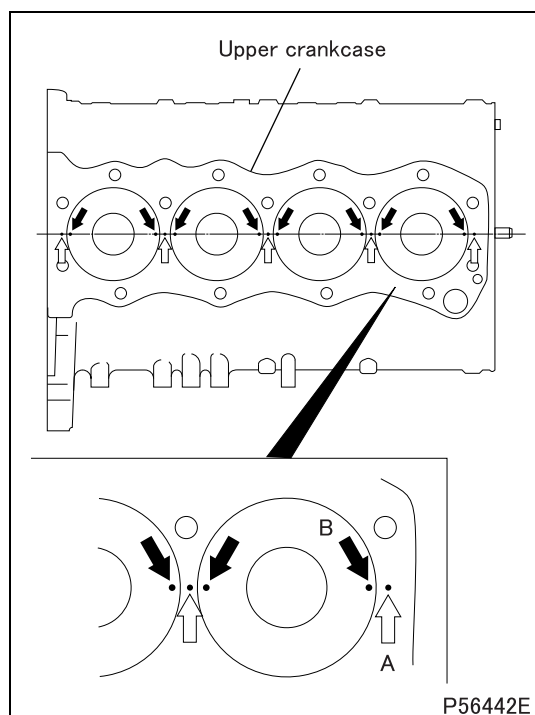
## ■ Inspection: Piston projection from upper crankcase top surface

- The amount of piston projection affects engine performance and must therefore be inspected without fail.

- Set the piston at the top dead center.
- Mark reference points A (five points in total) on the top surface of the upper crankcase as shown in the illustration. Using each of the marks as a zero point, measure the amount of piston projection relative to the zero point (height of measurement point B – height of reference point A).
- Make the measurements at the two measurement points B for each cylinder (eight points in total) using the reference point A nearest to each measurement point, and calculate the average value of all the measurements.
- If the average value is out of the standard value range, check the clearances between all relevant parts.
- Select and use a cylinder head gasket that can accommodate the average piston projection (average value of the eight measurements). (See CYLINDER HEAD AND VALVE MECHANISM section.)

| Location | Maintenance item | | Standard value | Limit | Remedy |
|---|---|---|---|---|---|
| – | Piston projection from crankcase top surface (average value) | | –0.088 to 0.094<br>{–0.0035 to 0.037} | – | Replace |

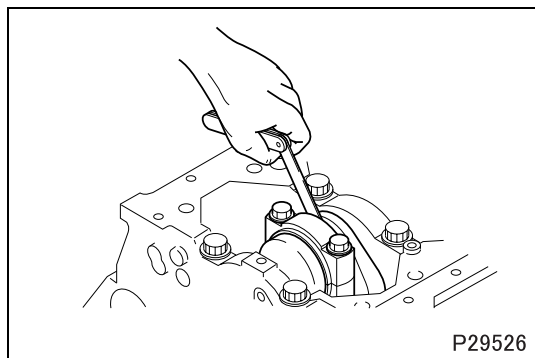
## ■ Inspection: Connecting rod end play

- Measure the end play for every connecting rod.
- If any measurement exceeds the specified limit, replace the defective part(s).

| Location | Maintenance item | | Standard value | Limit | Remedy |
|---|---|---|---|---|---|
| – | Connecting rod end play | | 0.15 to 0.45<br>{0.0059 to 0.018} | 0.6 {0.024} | Replace |

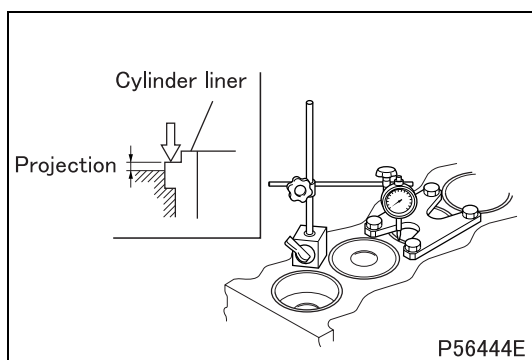
- Measure the amount of projection of the cylinder liner flange above the upper crankcase top surface.
- If the measurement is not within the standard value range, inspect the state of installation of the cylinder liner and then replace the defective part(s).
- If the difference in the amount of projection between neighboring cylinders is not within the standard value range, inspect the state of installation of the cylinder liner and then replace the defective parts.

- **Insufficient projection of the flange can lead to a reduced pressure around the bore of the cylinder head gasket, causing gas leakage.**

| Location | Maintenance item | | Standard value | Limit | Remedy |
|---|---|---|---|---|---|
| 5 | Cylinder liner | Flange projection above crankcase top surface | 0.01 to 0.07<br>{0.00039 to 0.0028} | – | Replace |

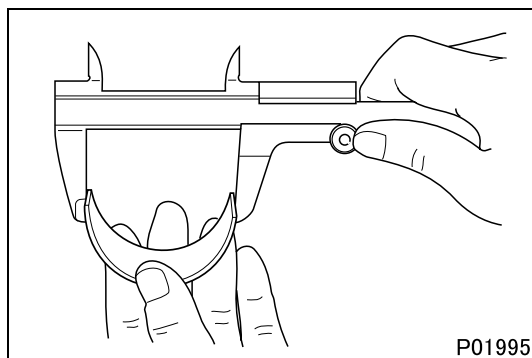
#### ■ Inspection: Connecting rod bearing span when free

- **Do not attempt to manually expand the bearings.**
- If the span is less than the specified limit, replace both the upper and lower bearings.

| Location | Maintenance item | | Standard value | Limit | Remedy |
|---|---|---|---|---|---|
| 1, 3 | Connecting rod bearing | Span when free | – | Less than 69.5 {2.74} | Replace |

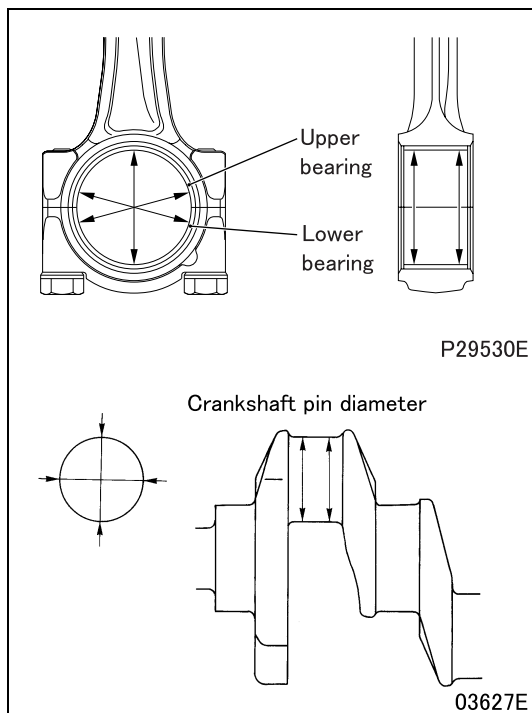
#### ■ Inspection: Connecting rod bearing-to-crankshaft oil clearance

- Fit the lower bearing to the connecting rod cap and the upper bearing to the connecting rod, then tighten the bolts to a torque of 30 N·m {22 ft.lbs, 3.1 kgf·m}.
- Measure the inside diameter of the bearing and the diameter of the crankshaft pin.
- If the clearance exceeds the limit, replace the defective part(s).
- If a bearing has to be replaced with an undersized one, machine the crankshaft pin to the specified undersize diameter.

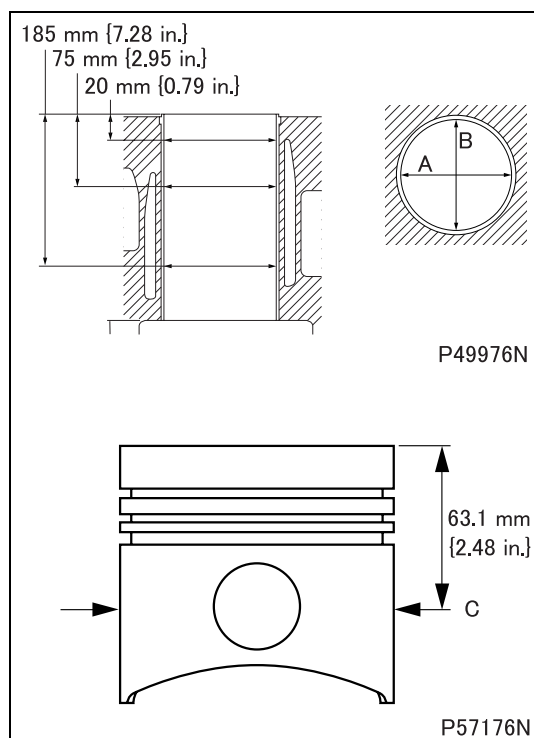
## ■ Inspection: Piston-to-cylinder liner clearance

- If the measurement is not within the standard value range, replace the defective part(s).

A: Cylinder bore measurement (in direction of crankshaft axis)  
 B: Cylinder bore measurement (in direction perpendicular to crankshaft axis)

C: Piston diameter measurement (in direction perpendicular to piston pin hole)

| Location | Maintenance item | | Standard value | Limit | Remedy |
|---|---|---|---|---|---|
| 4, 5 | Piston-to-cylinder liner clearance | | 0.181 to 0.201<br>{0.0071 to 0.0079} | – | Replace |

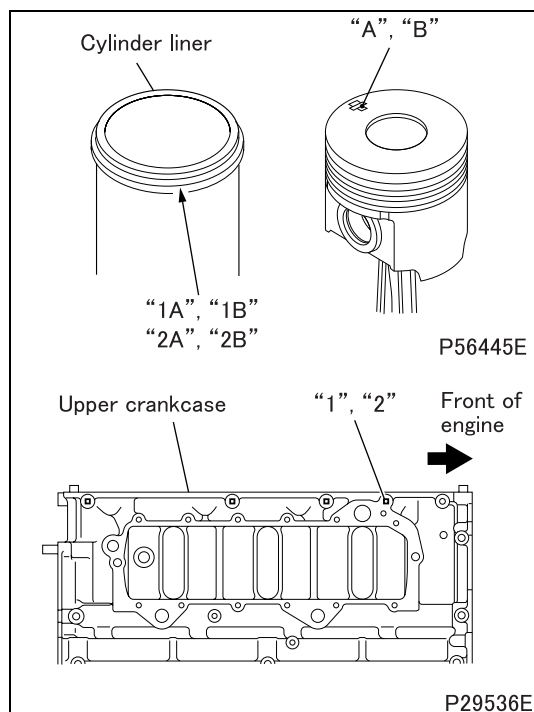
## [Installation]

- When replacing cylinder liners, select the cylinder liners which correspond to the size marks on the upper crankcase and the piston.

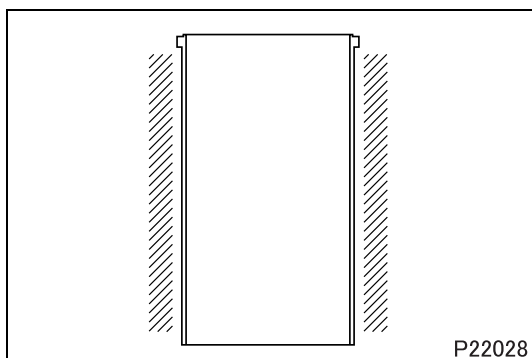
- Apply a thin coat of engine oil to the surfaces surrounding the cylinder liner of the upper crankcase (the shaded areas in the illustration).

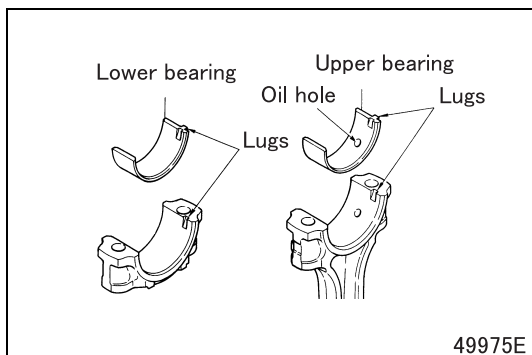
### ■ Installation: Connecting rod bearings

- Do not reverse the positions of the lower bearing and the upper bearing (with oil hole) when installing, as this may cause seizure in the engine.

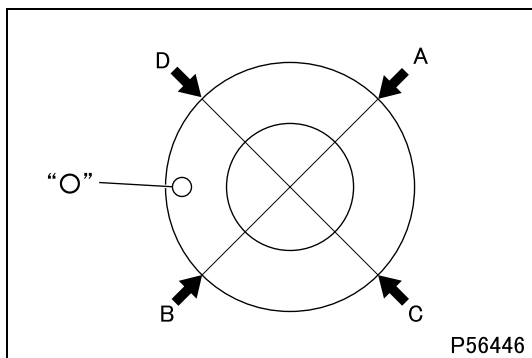
### ■ Installation: Piston and connecting rod assembly

- Check that the piston ring end gaps are in their correct positions.
  - A: 1st compression ring gap
  - B: 2nd compression ring gap
  - C: Oil ring gap
  - D: Oil ring expander spring gap

“O”: Front mark on piston

- With the manufacturer's marks (found near the piston ring end gaps) facing up, install the piston rings so that the end gap of each ring is positioned as illustrated.

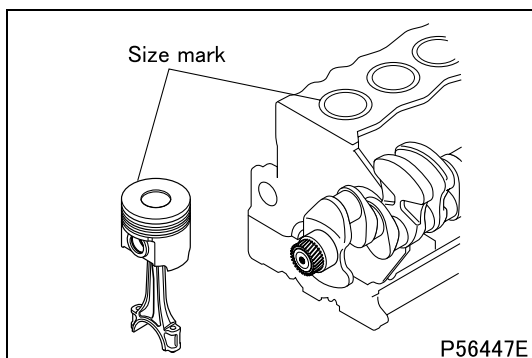
- Check that the pistons and the cylinder liners have identical size marks (“A” or “B”).
- Install the pistons in the cylinder liners. Be careful not to scratch the inner surface of the liner and the crankshaft pins.

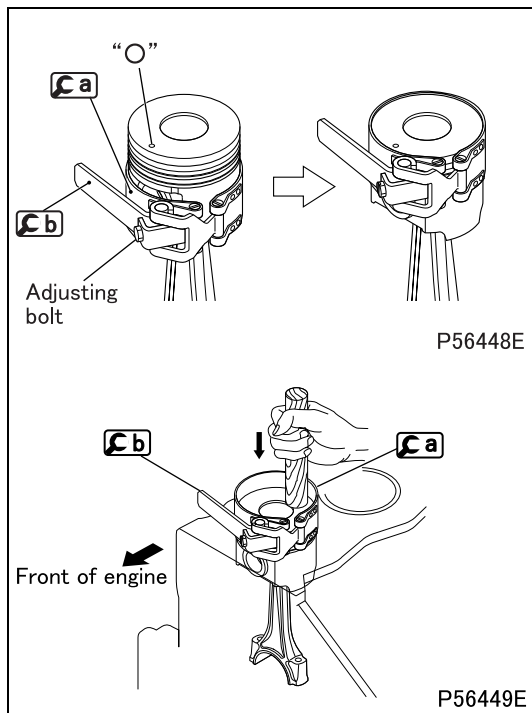
- Face the front mark "O" of the piston toward the front of the engine.
- Using the adjusting bolt of (a), adjust the inside diameter of (b) such that it matches the piston's skirt diameter.
- Remove the tools from the piston and apply engine oil to the following parts before reinstalling the tools around the piston rings:
  - Outside surface of piston
  - Inside surface of (a)
  - Inside surface of cylinder liner

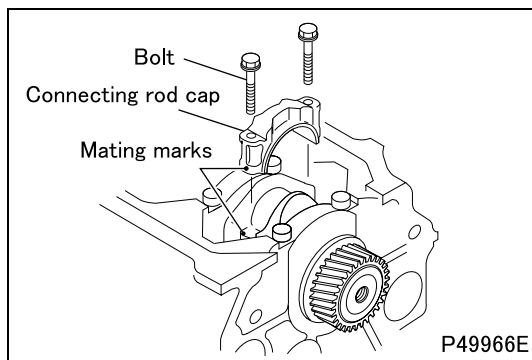
- After installing the piston and connecting rod assembly, align the mating marks on the connecting rod and connecting rod cap and tighten the bolts alternately in the following manner.
  - First tighten the bolt to a torque of 29 N·m {21 ft.lbs, 3.0 kgf·m}.
  - Tighten the bolt further by turning it clockwise by  $90^\circ \pm 5^\circ$ .
