# FE.FG

## SERVICE MANUAL 2008 Model FOREWORD

This Service Manual contains maintenance and repair methods for the Mitsubishi Fuso Truck FE. FG Series. Read this manual carefully as an aid in providing correct, efficient maintenance. Please note that the information and specifications contained within this manual may change without notice. This is due to product modifications and continued vehicle improvements that are made throughout the model years. Should you encounter any discrepancy in the information provided, please do not hesitate to contact your nearest Mitsubishi Fuso Dealer or Mitsubishi Fuso Truck of America, Inc.

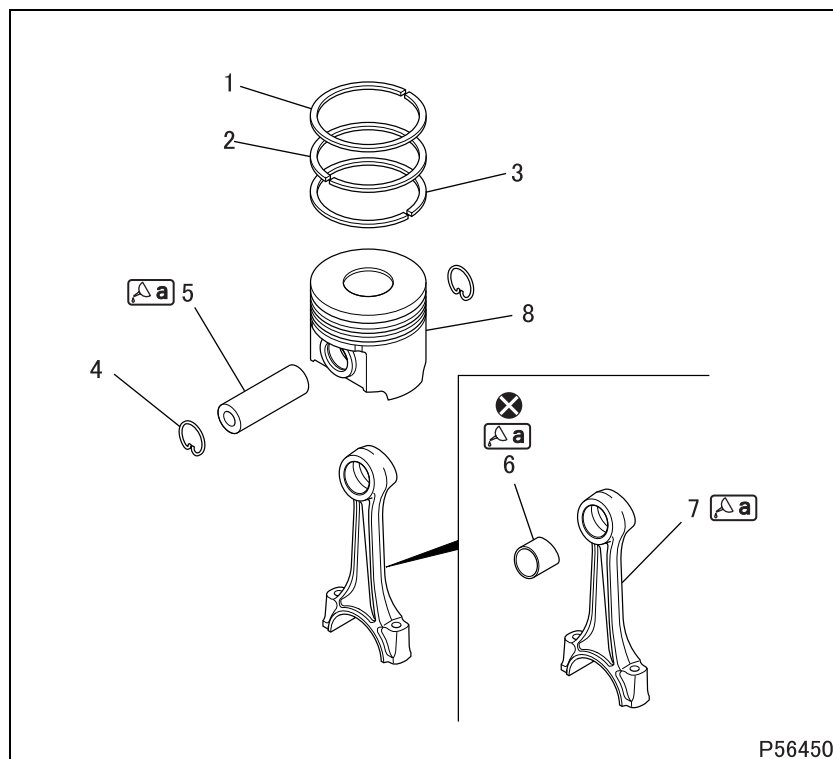
## Piston and Connecting Rod

- 1 1st compression ring
- 2 2nd compression ring
- 3 Oil ring
- 4 Snap ring
- 5 Piston pin
- 6 Connecting rod bushing
- 7 Connecting rod
- 8 Piston

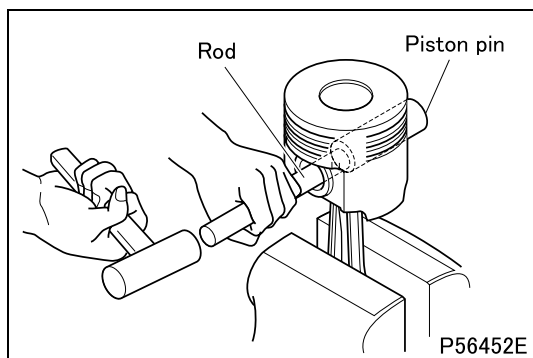
#### ■ Removal: Piston pin

- Remove the piston pin by striking it with a rod and hammer.
- If the piston pin is difficult to remove, first heat the piston in hot water or with a piston heater.

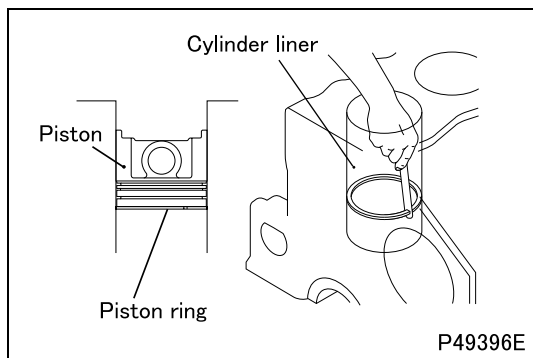
#### ■ Inspection: Piston ring end gap

- Using the crown of a piston, push the piston ring horizontally into a cylinder in the cylinder liner until it reaches the lower part of the cylinder liner, where there is relatively small wear.
- Taking care not to move the piston ring, measure the end gap.
- If any of the rings has a gap exceeding the specified limit, replace all the piston rings as a set.

| Location | Maintenance item | | Standard value | Limit | Remedy |
|---|---|---|---|---|---|
| 1 to 3 | Piston ring end gap | 1st compression ring | 0.3 to 0.45<br>{0.012 to 0.018} | 1.5<br>{0.059} | Replace |

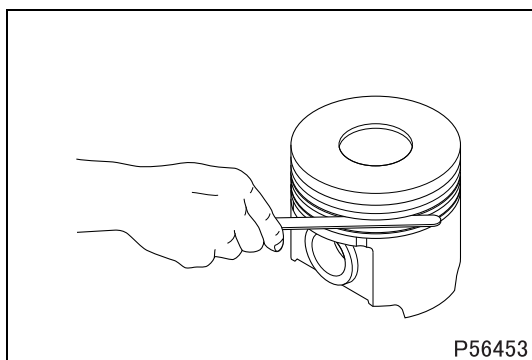
## ■ Inspection: Piston ring side clearance in piston groove

- Remove any carbon deposits from the ring groove in the piston.
- Measure the side clearance of each ring around the piston's entire periphery.
- If any of the measurements exceeds the specified limit, replace the defective part(s). If any of the piston rings is defective, replace all the rings on the piston as a set.

| Location | Maintenance item | | Standard value | Limit | Remedy |
|---|---|---|---|---|---|
| 1 to 3, 8 | Piston ring side clearance in piston groove | 1st compression ring | 0.129 to 0.178<br>{0.0051 to 0.0070} | 0.2<br>{0.0079} | Replace |

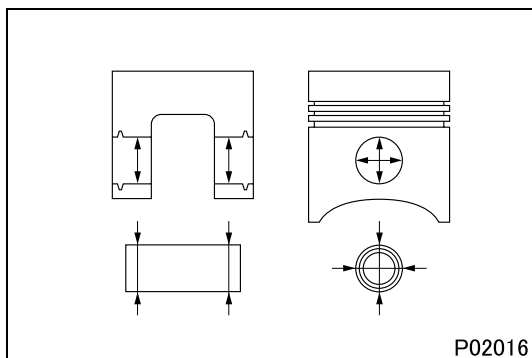
## ■ Inspection: Piston pin-to-piston clearance

- If the measurement exceeds the specified limit, replace the defective part(s).

| Location | Maintenance item | | Standard value | Limit | Remedy |
|---|---|---|---|---|---|
| 4, 8 | Piston pin-to-piston clearance | | 0.004 to 0.022<br>{0.00016 to 0.00087} | 0.05<br>{0.0020} | Replace |

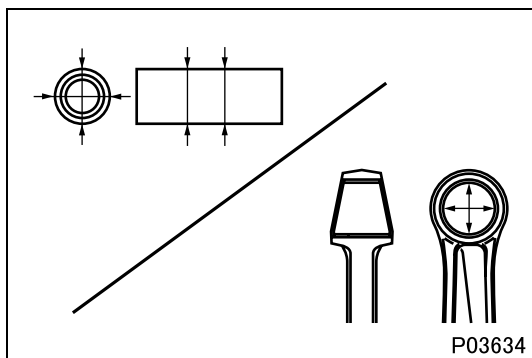
## ■ Inspection: Piston pin-to-connecting rod bushing clearance

- If any of the measurements exceeds the specified limit, replace the bushing.

| Location | Maintenance item | | Standard value | Limit | Remedy |
|---|---|---|---|---|---|
| 4, 6 | Piston pin-to-connecting rod bushing clearance | | 0.020 to 0.055<br>{0.00079 to 0.0022} | 0.1<br>{0.0039} | Replace |

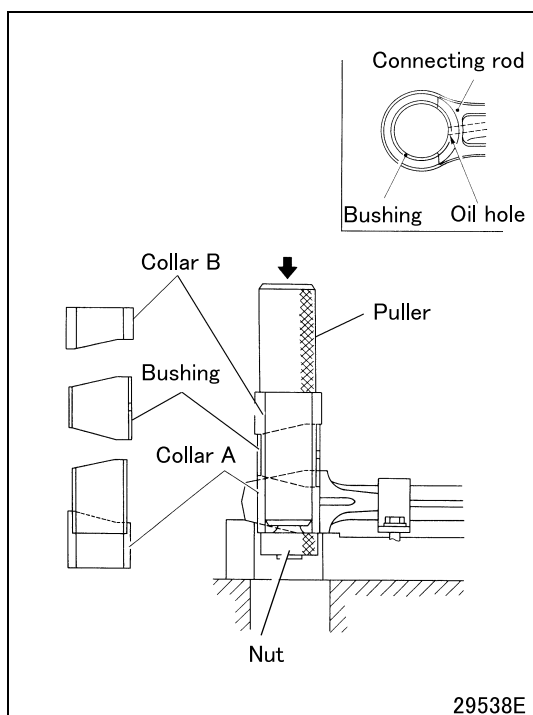
### [Removal]

- Remove the upper bearing (if fitted) from the big end of the connecting rod.
- Mount the connecting rod on the base and lock it in position with the bracket and plate.
- Fit collar A over the puller with its ends facing in the illustrated directions. Then, slowly apply a pressure of approximately 49 kN {11020 lbs, 5000 kgf} to the puller with a press to force out the connecting rod bushing.

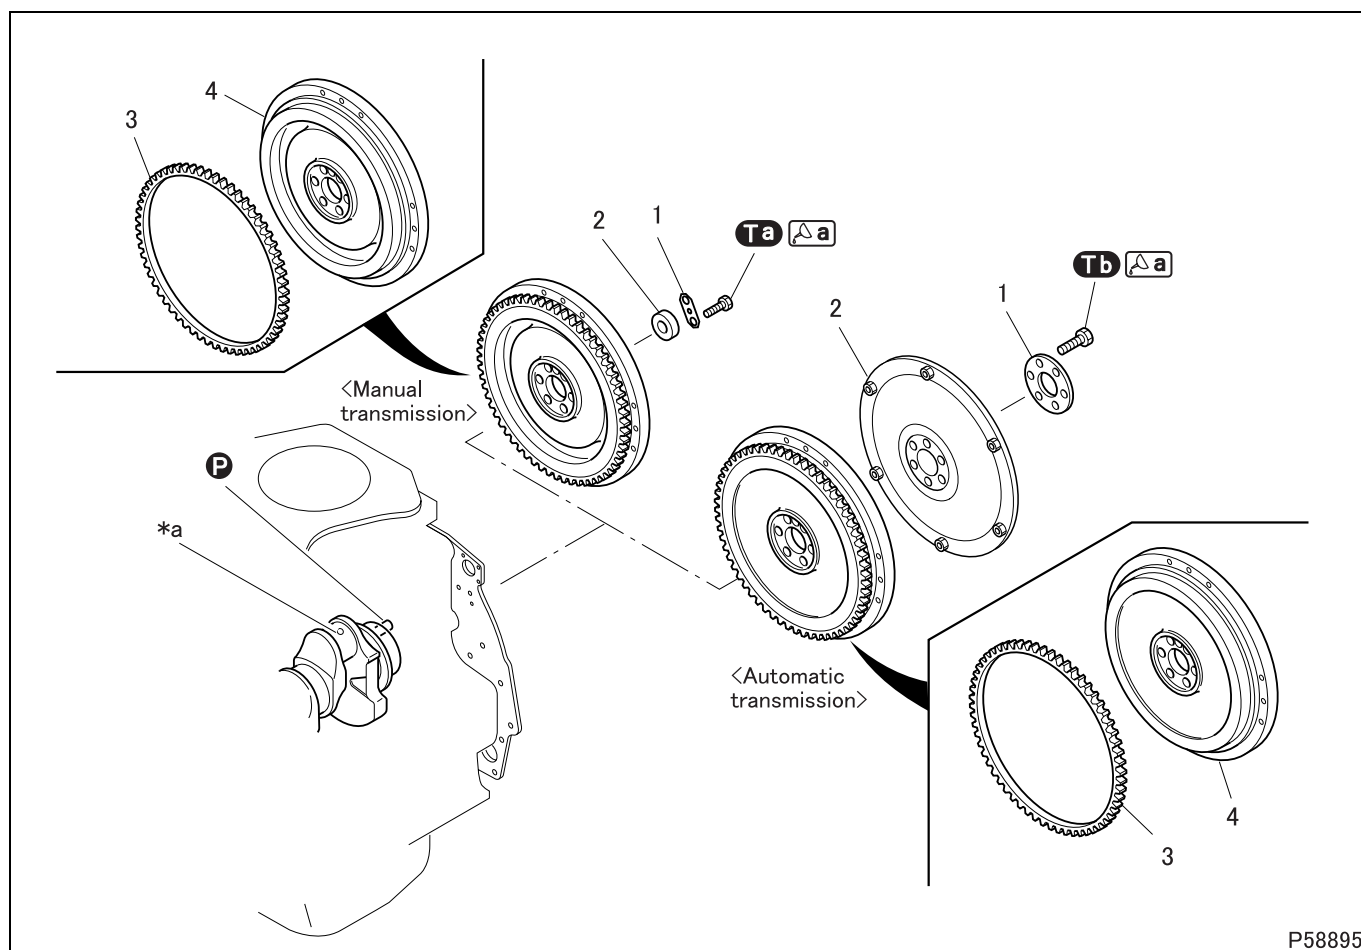
P58895

## ● Disassembly sequence

- 1 Plate <Manual transmission>  
Wear plate <Automatic transmission>
- 2 Bearing <Manual transmission>  
Drive plate <Automatic transmission>

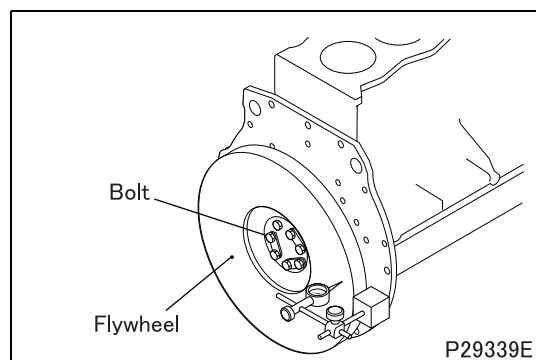
### ■ Inspection: Flywheel runout <Manual transmission>

- If the runout exceeds the specified limit, check that the bolts are tightened correctly and that there are no abnormalities on the crankshaft mounting surface. If the runout is still excessive even after necessary steps have been taken according to the check results, rectify or replace the flywheel.

| Location | Maintenance item | | Standard value | Limit | Remedy |
|---|---|---|---|---|---|
| 4 | Flywheel <Manual transmission> | Friction surface runout (when fitted) | — | 0.2 {0.0079} | Rectify or replace |

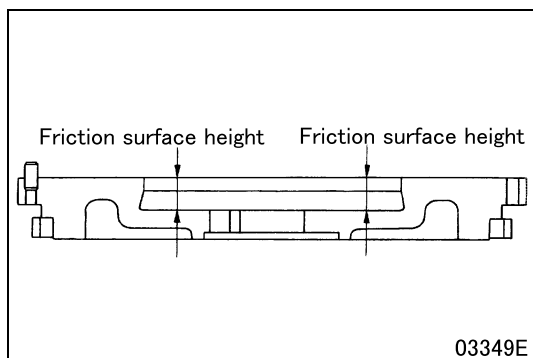
### ■ Inspection: Flywheel <Manual transmission>

#### (1) Friction surface height

- If the height is below the specified limit, replace the flywheel.

| Location | Maintenance item | | Standard value | Limit | Remedy |
|---|---|---|---|---|---|
| | | Friction surface height | 19.5 {0.77} | 18.5 {0.73} | Replace |

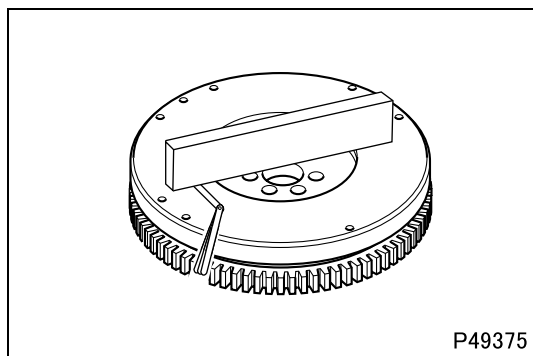
#### (2) Friction surface distortion

- If the measured amount of distortion is above the specified limit, rectify or replace the flywheel.

| Location | Maintenance item | | Standard value | Limit | Remedy |
|---|---|---|---|---|---|
| | | Friction surface distortion | 0.05 {0.0020} or less | 0.2 {0.0079} | Rectify or replace |

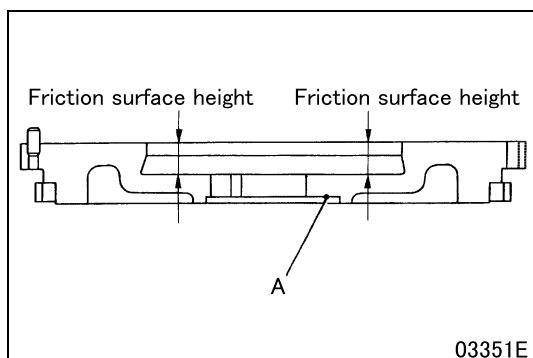
### Rectification of friction surface

- Rectify the friction surface so that its height is not below the specified limit, and it is parallel with surface A within specification.

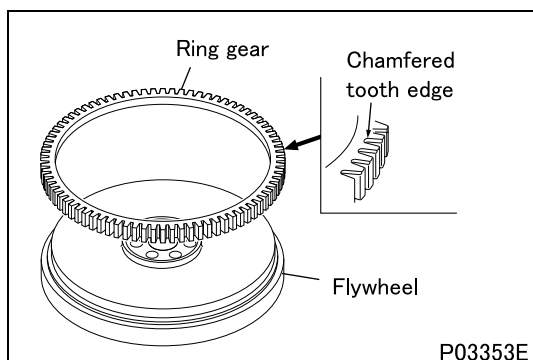
### ■ Installation: Ring gear

- Heat the ring gear evenly with a gas burner or the like until it reaches approximately 200°C {390°F}.

- Fit the ring gear with the side having non-chamfered tooth edges toward the flywheel.

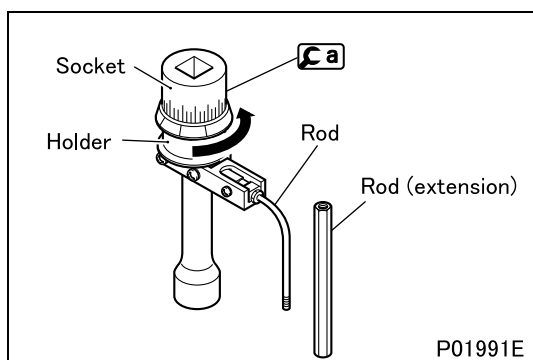
### ■ Installation: Flywheel <Manual transmission>

- Tighten all the bolts to 59 N·m {44 ft.lbs, 6.0 kgf·m} and then additionally tighten them by the following procedure.
- Rotate the holder of **a** counterclockwise to pretension the internal spring.

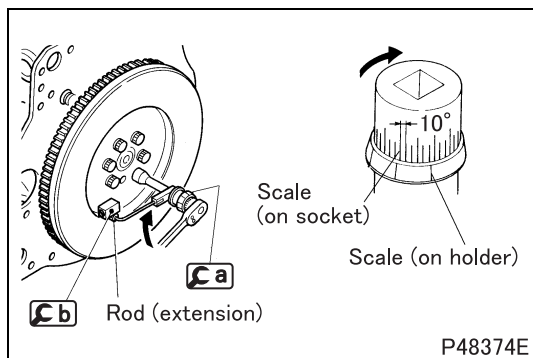
- Fit **a** on the bolt and set **b** so that the rod (extension) is held pressed against it by the spring force.
- Align a scale mark on the socket with a scale mark on the holder. (This point will be the point of reference, or the 0° point.)
- Starting with this point of reference, turn the socket clockwise with a wrench by  $40^\circ \pm 5^\circ$  (one graduation on the socket scale represents  $10^\circ$ ).

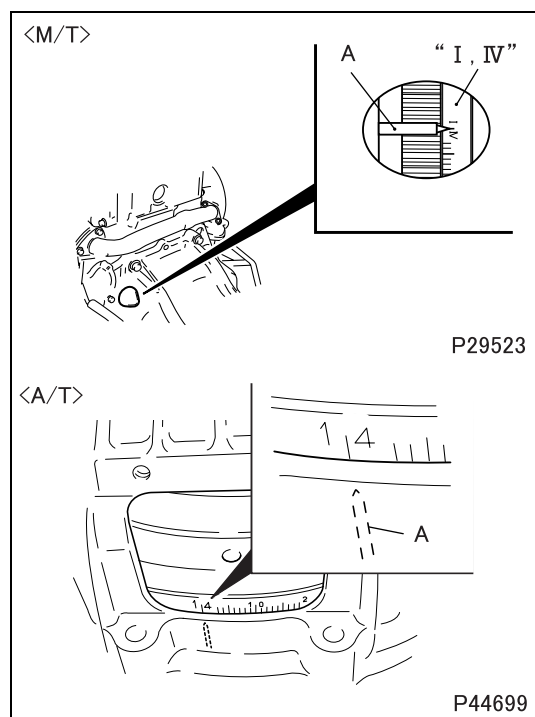
### ■ Removal: Vacuum pump

- The vacuum pump also serves for positioning the balance shaft LH. Therefore, before removing the vacuum pump, hold the balance shaft in position by the following procedure.
- Align the pointer A to between the inscribed lines (I and IV or 1 and 4) on the flywheel. (Place No.1 cylinder piston at the top dead center on compression stroke.)

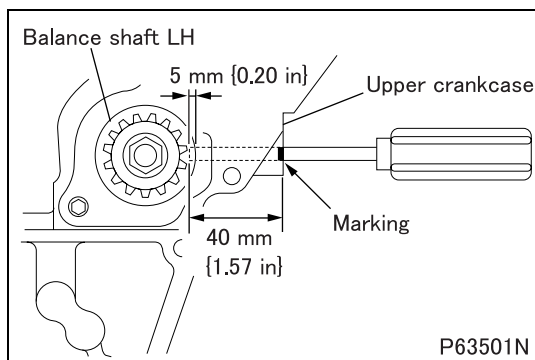
- Remove the upper crankcase plug.
- Mark a screwdriver or the like ( $\phi 4.5$  mm { $\phi 0.18$  in} or less) at a point 40 mm {1.57 in} apart from its tip.
- Insert the screwdriver or the like ( $\phi 4.5$  mm { $\phi 0.18$  in} or less) into the plug hole until it lightly touches the balance shaft LH.

- **Do not press the screwdriver hard against the balance shaft LH, as this may damage No.1 journal of the balance shaft.**

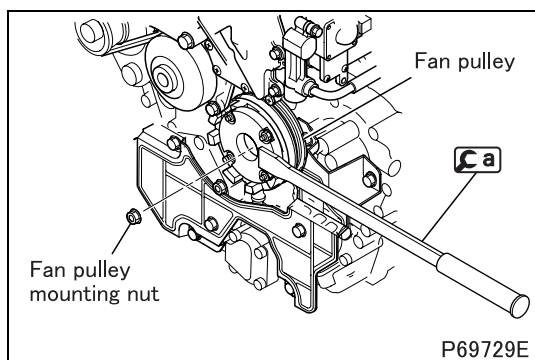
## ■ Removal: Fan pulley

- Put in position on the studs of the fan pulley and fix the tool by using nuts.
- While holding , loosen the fan pulley mounting nut.

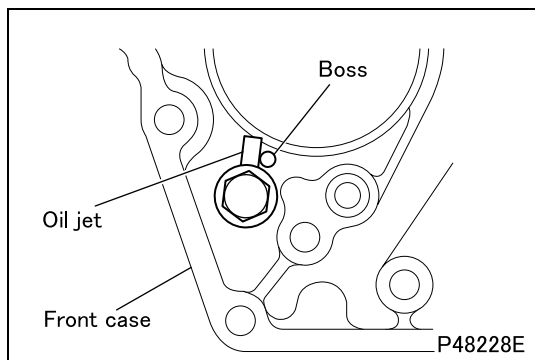
## ■ Installation: Oil jet

- When installed, the oil jet must be in contact with the front case and its nozzle must face in the illustrated direction.

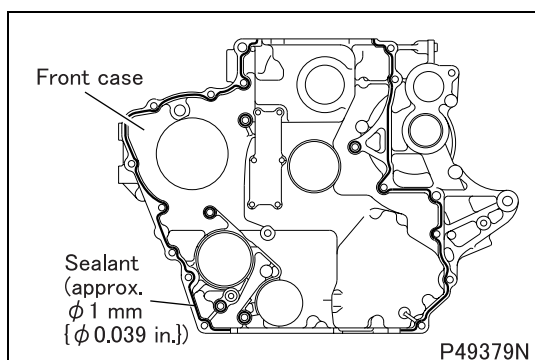
## ■ Installation: Front case

- Clean the sealant application surfaces of each part.
- Apply evenly thick beads of sealant to the upper crankcase mounting surface of the front case without any breaks.
- Mount the front case within three minutes of applying the sealant, being careful not to dislodge the sealant.

- **Do not run the engine within one hour of installing the front case.**
- **If the front case mounting bolts are loosened or removed, be sure to reapply sealant to the front case.**

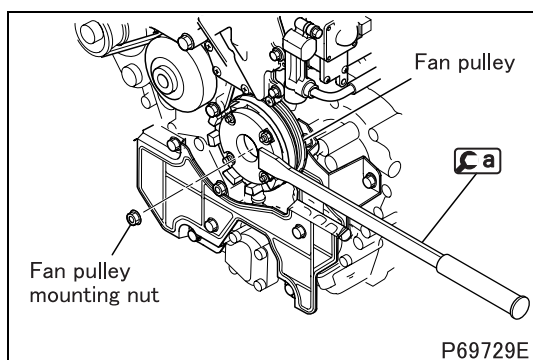
### ■ Installation: Fan pulley

- Put **Ca** in position on the studs of the fan pulley and fix the tool by using nuts.
- Tighten the fan pulley mounting nut to the specified torque while holding **Ca**.

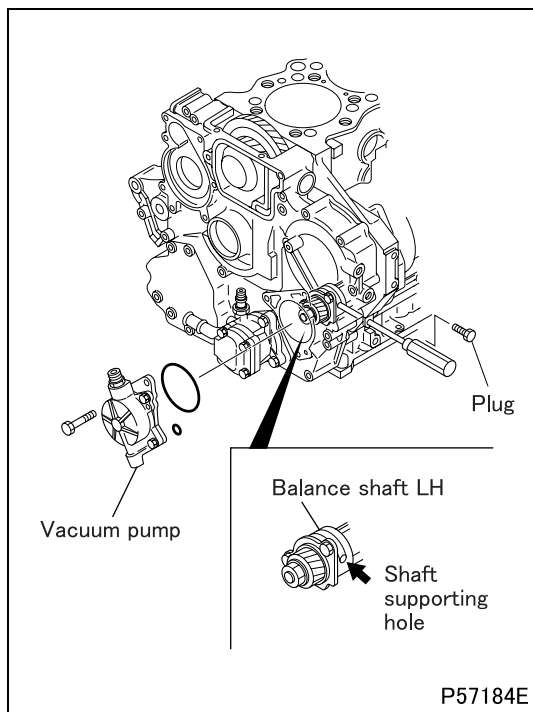
### ■ Installation: Vacuum pump

- The vacuum pump also serves as an element holding the balance shaft LH in place. Therefore, before installing the vacuum pump, hold the balance shaft LH in the correct position by the following procedure.
  - Place the No. 1 cylinder piston at the top dead center on compression stroke.
  - Remove the upper crankcase plug.
  - Insert a screwdriver or a similar tool into the plug hole until it lightly touches the balance shaft LH.

- **Do not press the screwdriver strongly against the balance shaft LH, as this may damage the No. 1 journal of the balance shaft.**
- Turn the balance shaft LH slowly until the screwdriver aligns with the shaft support hole at the No. 1 journal and insert the screwdriver into the hole.
- Install the vacuum pump.
- After installing the vacuum pump, remove the screwdriver and reinstall the plug.

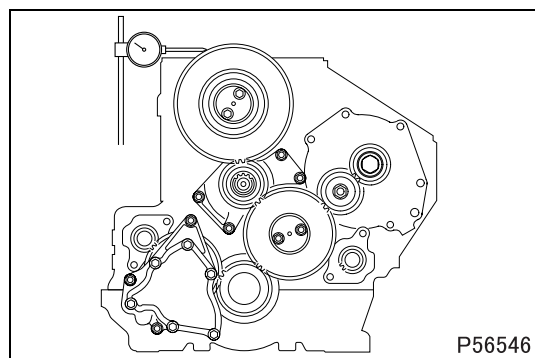
### ■ Inspection: Backlash between gears

- For each pair of gears, measure the backlash at more than three teeth.
- If any of the measurements exceeds the specified limit, replace the defective part(s).

| Location | Maintenance item | | Standard value | Limit | Remedy |
|---|---|---|---|---|---|
| - | Backlash between gears | Idler gear and fan shaft | 0.09 to 0.14<br>{0.0035 to 0.0055} | 0.3 {0.012} | Replace |

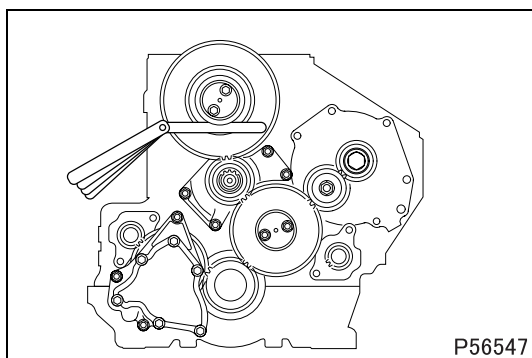
### ■ Inspection: End play of each gear and shaft

- If the measurement exceeds the specified limit, replace the defective part(s).

| Location | Maintenance item | | Standard value | Limit | Remedy |
|---|---|---|---|---|---|
| - | End play of gears and shafts | Idler gear | 0.10 to 0.20<br>{0.0039 to 0.0079} | 0.3 {0.012} | Replace |

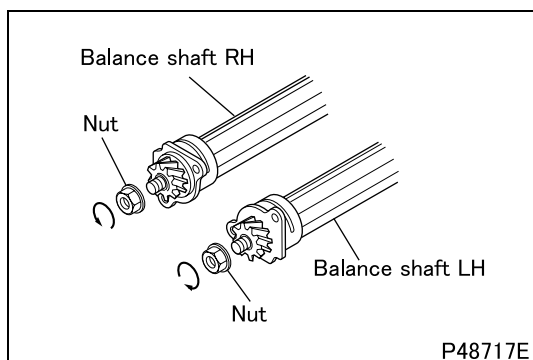
### ■ Removal: Balance shaft

- Remove the balance shaft RH by turning its nut counterclockwise, and the balance shaft LH by turning its nut clockwise.

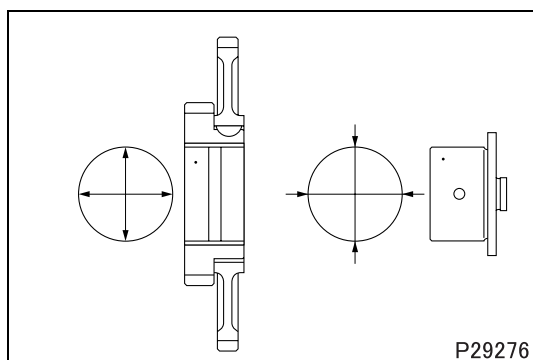
### ■ Inspection: Idler gear bushing-to-idler shaft clearance

- If the measurement exceeds the specified limit, replace the bushing.

| Location | Maintenance item | | Standard value | Limit | Remedy |
|---|---|---|---|---|---|
| 2, 4 | Idler gear bushing-to-idler shaft clearance | | 0.02 to 0.06<br>{0.00079 to 0.0024} | 0.1 {0.0039} | Replace |

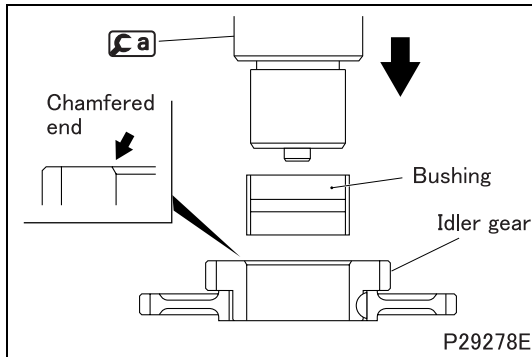
## [Installation]

- Place the idler gear with its ends facing as illustrated.
- Press-fit the idler gear bushing until **a** sits snugly on the chamfered end of the idler gear.
- After press-fitting the bushing, measure the clearance.
- If the measurement is less than the minimum of the standard value range, ream the idler gear bushing until the clearance falls within the standard value range.

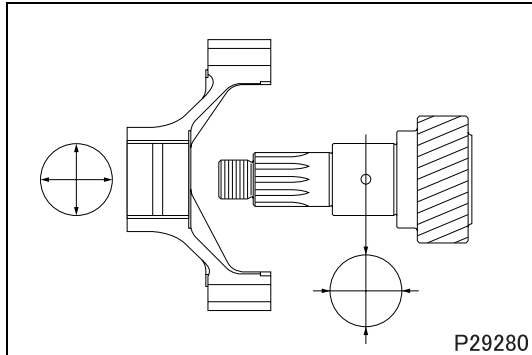
## ■ Inspection: Fan shaft case bushing-to-fan shaft clearance

- Replace the fan shaft case bushing if the measurement exceeds the specified limit.

| Location | Maintenance item | | Standard value | Limit | Remedy |
|---|---|---|---|---|---|
| 5, 8 | Fan shaft case bushing-to-fan shaft clearance | | 0.03 to 0.07<br>{0.0012 to 0.0028} | 0.1 {0.0039} | Replace |

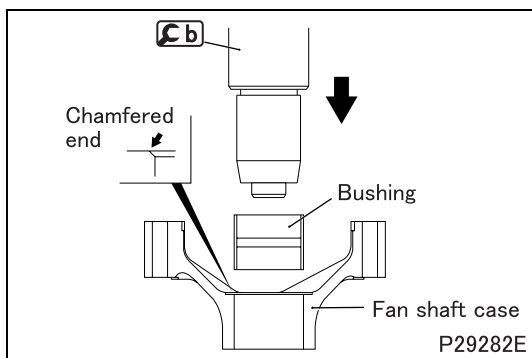
## [Installation]

- Position the fan shaft case with its ends facing in the illustrated directions.
- Press in the bushing until **b** rests snugly on the chamfered end of the fan shaft case.
- After press-fitting the bushing, remeasure the clearance between it and the fan shaft.
- Ream the bushing if the measurement is below the standard value range.

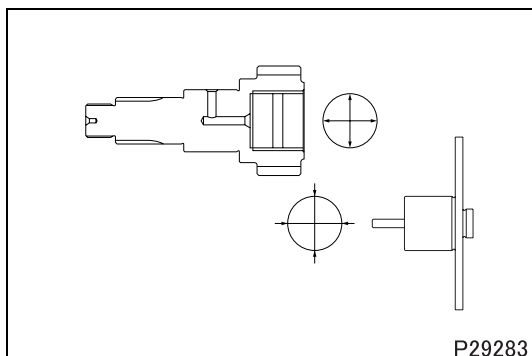
## ■ Inspection: Fan shaft-to-fan gear shaft clearance

- Replace the fan shaft if the measurement exceeds the specified limit.

| Location | Maintenance item | | Standard value | Limit | Remedy |
|---|---|---|---|---|---|
| 8, 9 | Fan shaft-to-fan gear shaft clearance | | 0.01 to 0.05<br>{0.00039 to 0.0020} | 0.1 {0.0039} | Replace |

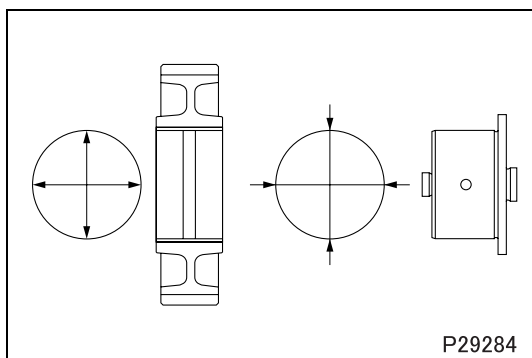
■ **Inspection: No. 1 idler gear bushing-to-No. 1 idler shaft clearance**

- Replace the bushing if the measurement exceeds the specified limit.

| Location | Maintenance item | | Standard value | Limit | Remedy |
|---|---|---|---|---|---|
| 11, 13 | No. 1 idler gear bushing-to-No. 1 idler shaft clearance | | 0.03 to 0.07<br>{0.0012 to 0.0028} | 0.1 {0.0039} | Replace |

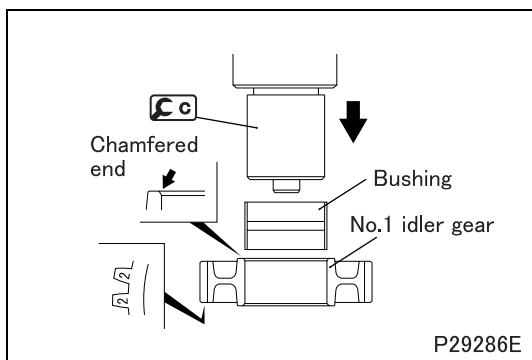
[Installation]

- Position the No. 1 idler gear with its ends facing in the illustrated directions.
- Press in the gear bushing until **Cc** sits snugly on the chamfered end of the No. 1 idler gear.
- After press-fitting the bushing, remeasure the clearance between it and the No. 1 idler shaft.
- Ream the bushing if the measurement is below the standard value range.

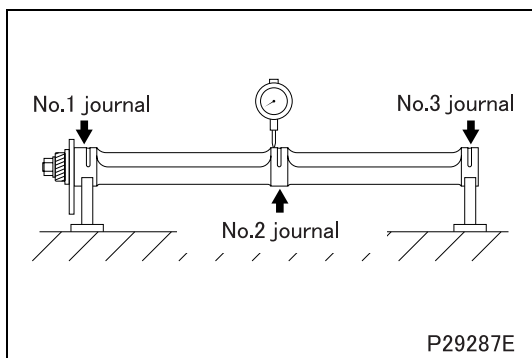
■ **Inspection: Balance shaft bend**

- Place supports under the No. 1 and No. 3 journals of the balance shaft and measure the bend of the balance shaft at the No. 2 journal. The amount of balance shaft bend is obtained by giving the balance shaft one turn and the dial gauge reading by two.
- If the measurement exceeds the specified limit, replace the balance shaft.

| Location | Maintenance item | | Standard value | Limit | Remedy |
|---|---|---|---|---|---|
| 20 | Balance shaft RH bend | | 0.025 {0.00098} | 0.05 {0.0020} | Replace |
| 25 | Balance shaft LH bend | | 0.025 {0.00098} | 0.05 {0.0020} | Replace |

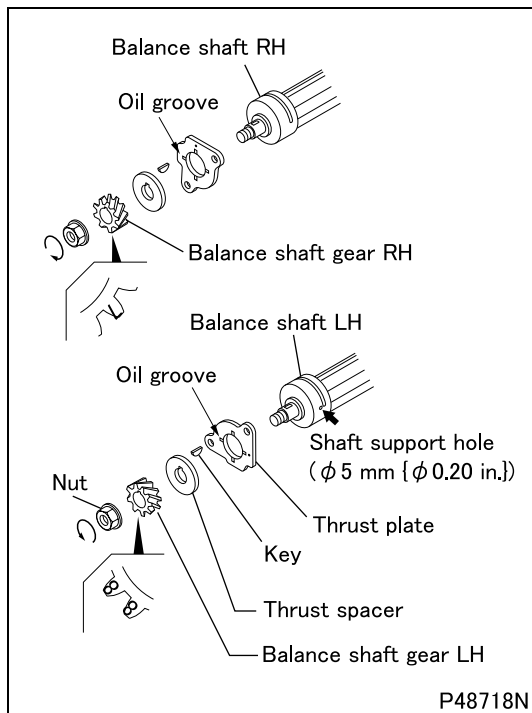
### ■ Installation: Balance shafts

- Install all the indicated parts on each balance shaft with their ends facing in the illustrated directions.
- Install the balance shaft RH by turning its nut clockwise, and the balance shaft LH by turning its nut counterclockwise.

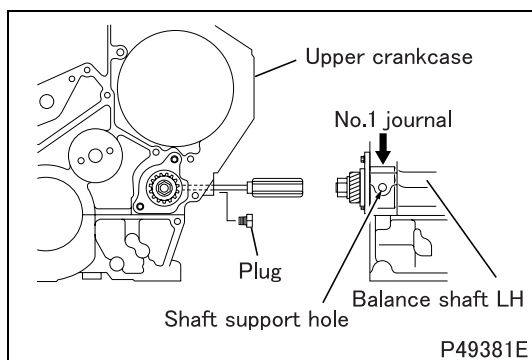
- Install the balance shaft RH assembly and the balance shaft LH assembly into the crankcase according to the following procedures, which include different instructions between the two balance shafts.

- The balance shaft RH can be installed in the crankcase without following any special procedure. (The positioning of the gear of the balance shaft RH will be finally determined by installing the oil pump.)

- Remove the plug on the upper crankcase.
- Insert a screwdriver through the plug hole and into the shaft support hole (diameter: 5 mm {0.20 in.}) on the No. 1 journal of the balance shaft LH to hold the shaft against rotation.

- Align the mating marks on each timing gear.
- This positions the balance shaft LH correctly. Leave the balance shaft in this state until installation of the front case and vacuum pump is completed.

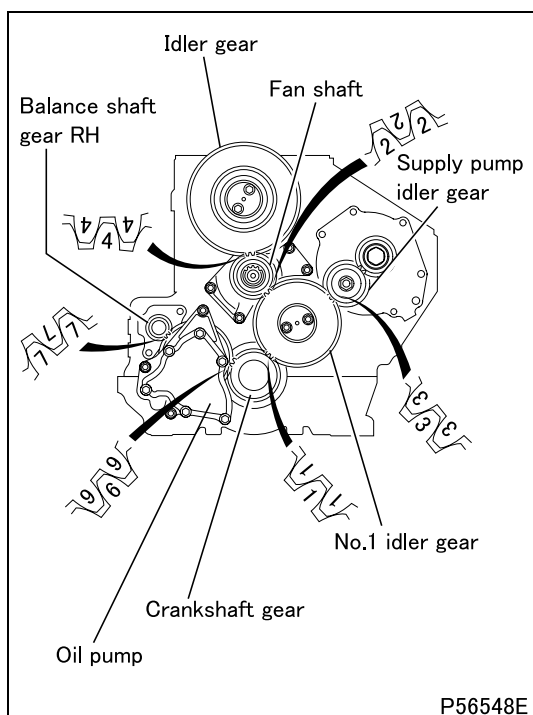
### ■ Installation: Timing gears

- Place the No. 1 cylinder piston at top dead center to position the crankshaft gear.
- Install the oil pump gear by aligning mating mark "6" with that on the crankshaft gear, and mating mark "7" with that on the balance shaft gear RH.
- Install the No. 1 idler gear by aligning mating mark "1" with that on the crankshaft gear.
- Install the fan shaft by aligning mating mark "2" with that on the No. 1 idler gear.
- Install the idler gear by aligning mating mark "4" with that on the fan shaft.
- Install the supply pump idler gear by aligning mating mark "3" with that on the No.1 idler gear.

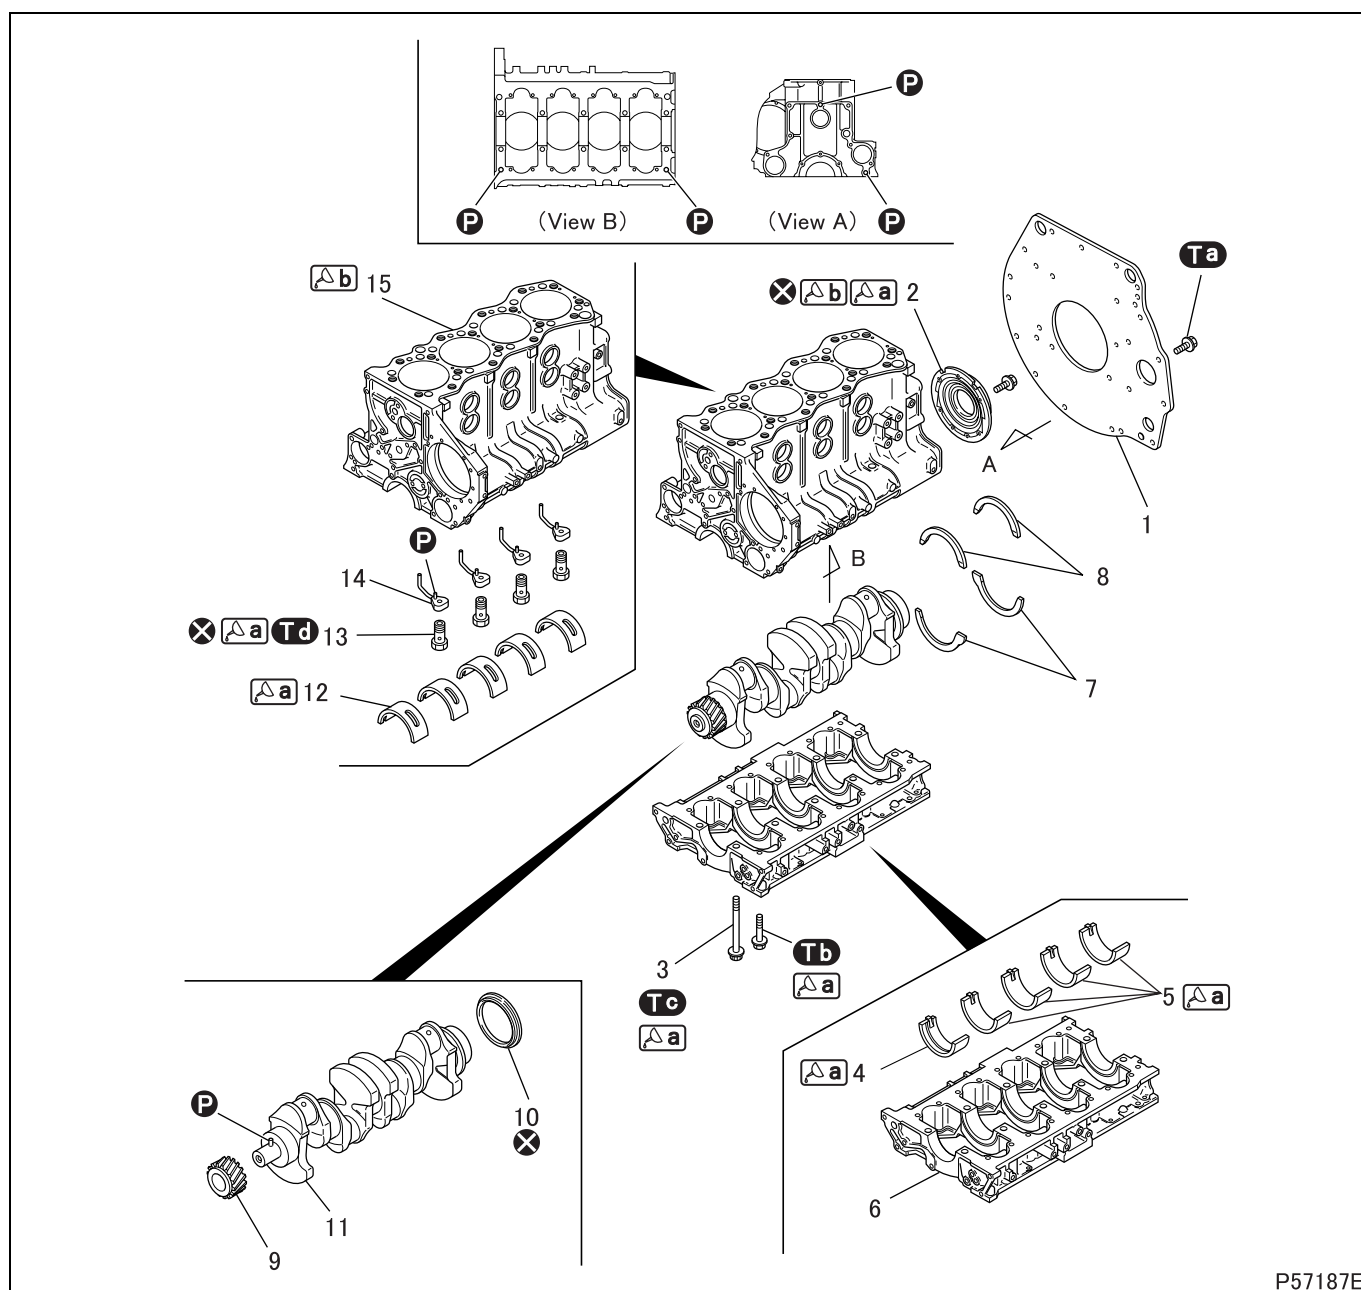
## ● Disassembly sequence

- The lower crankcase and the upper crankcase are machined as a matched set, and cannot be replaced individually.

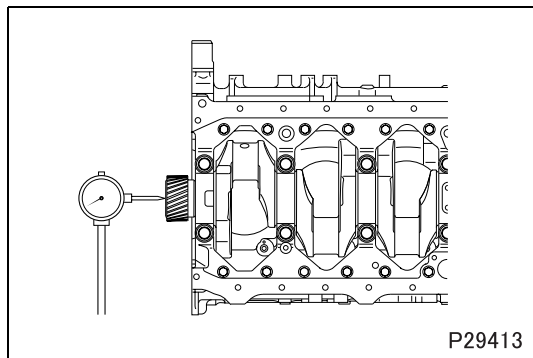
### ■ Inspection: Crankshaft end play

- If the measurement exceeds the specified limit, replace the thrust plates with oversize ones.
- Available oversizes:  
+0.15 mm, +0.30 mm, +0.45 mm {0.0059, 0.012, 0.018 in.}
- Replace the crankshaft if the end play is too large to adjust using oversize thrust plates.

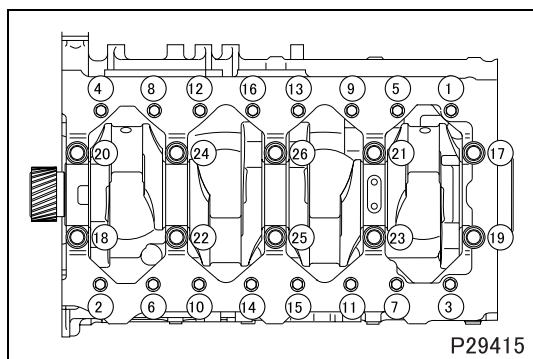
### ■ Removal: Lower crankcase

- Loosen the bolts little by little in the order indicated in the illustration (1 to 16).
- After loosening the bolts, loosen the main cap bolts little by little in the order indicated in the illustration (17 to 26), then remove the main cap bolts.

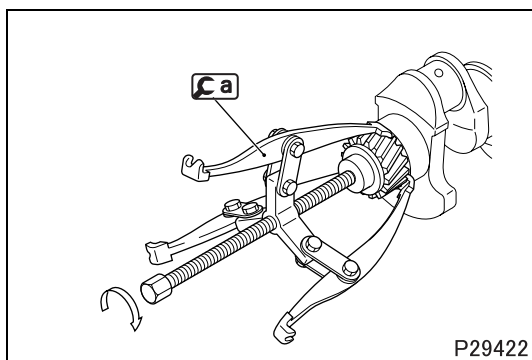
### ■ Removal: Crankshaft gear

- Do not tap off the crankshaft gear as this can damage it.

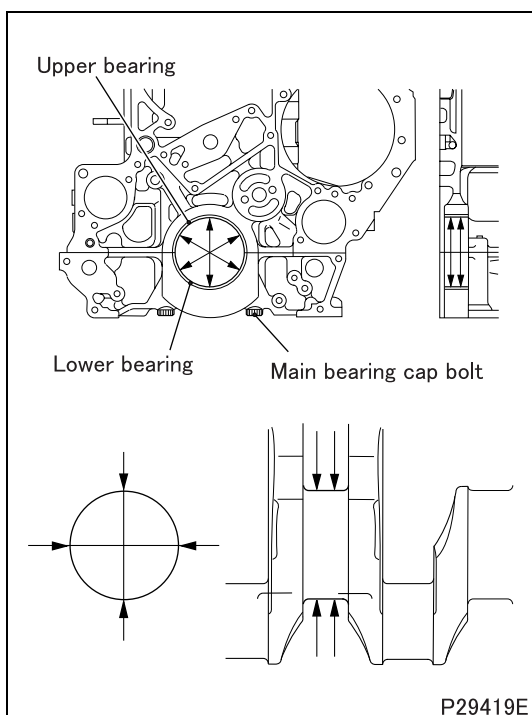
### ■ Inspection: Main bearing-to-crankshaft clearance

- Fit the upper bearing into the upper crankcase and the lower bearing into the lower crankcase.
- Tighten the main bearing cap bolts to a torque of 49 N·m {36 ft.lbs, 5.0 kgf·m}.
- Measure the inside diameter of the main bearing and the diameter of the corresponding crankshaft journal.
- If the difference between the measurements exceeds the specified limit, machine the crankshaft journal to one of the specified undersize dimensions indicated on the next page.

- Do not attempt to manually expand the bearings.
- If the measurement is less than the limit, replace upper and lower bearings as a set.

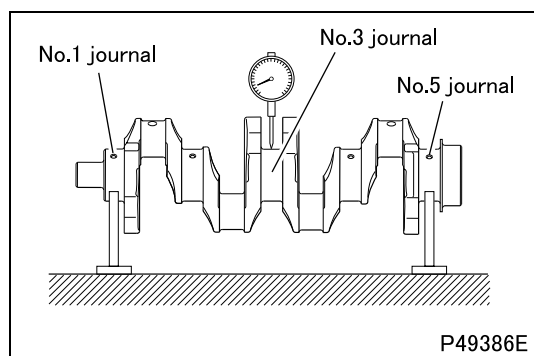
## ■ Inspection: Crankshaft

### (1) Bend

- Support the crankshaft at its No. 1 journal and No. 5 journal. Measure the extent of bending in the crankshaft at the center of the No. 3 journal. The amount of crankshaft bend is obtained by giving the crankshaft one turn and dividing the dial gauge reading by two.
- If the measurement exceeds the specified limit, replace the crankshaft.

| Location | Maintenance item | | | Standard value | Limit | Remedy |
|---|---|---|---|---|---|---|
| 11 | Crankshaft | Bend | | 0.02 {0.00079} or less | 0.05<br>{0.0020} | Replace |

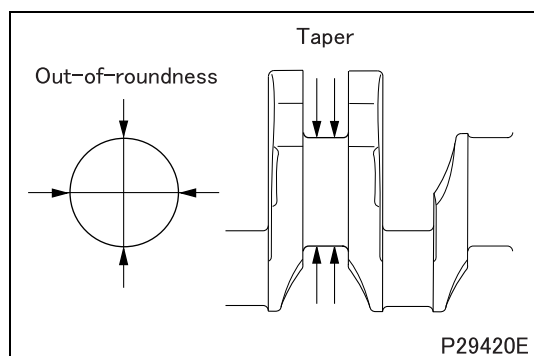
### (2) Out-of-roundness and taper of crankshaft journals and pins

- If any of the measurements exceeds the specified limits, grind the crankshaft journal(s) and/or pin(s) to undersize(s) or replace the crankshaft.

| Location | Maintenance item | | | Standard value | Limit | Remedy |
|---|---|---|---|---|---|---|
| | | Pins and journals | Out-of-roundness | 0.01 {0.00039} or less | 0.03<br>{0.0012} | Rectify or replace |

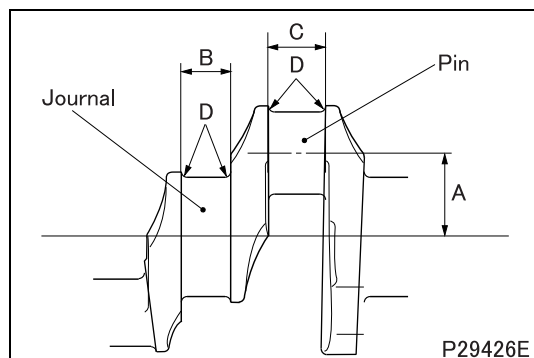
## Grinding of crankshaft

- If the crankshaft is ground to an undersize, the main bearings must be replaced with the undersize ones of the corresponding undersize.
- Confirm the dimension of each position from the service standards table and rectify the crankshaft while observing the following procedures.
- Do not change the center-to-center distance A between the journal and pin.
- Do not change the journal width B and the pin width C.
- Finish the fillets D smoothly.
- Carry out a magnetic inspection to check for cracks possibly caused by grinding. Also, check that the hardness of the surface has not dropped below Shore hardness number (Hs) 75.
- Replace the crankshaft if defects are evident.

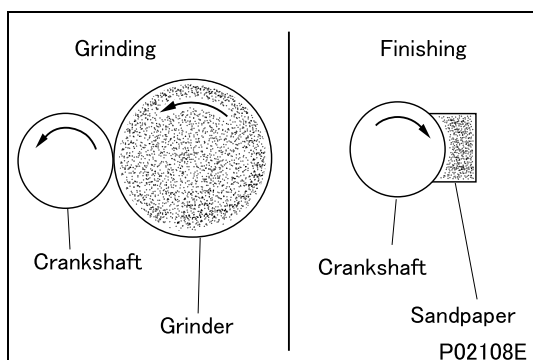
- When grinding, turn both the crankshaft and the grinder counter-clockwise as viewed from the crankshaft front end.
- When finishing the crankshaft with whetstone or sandpaper, rotate the crankshaft clockwise.

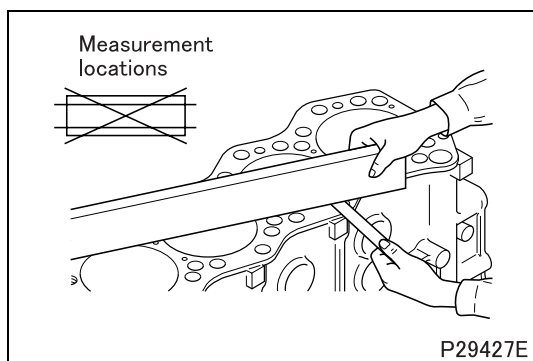
#### ■ Inspection: Distortion of upper crankcase top surface

- If the measurement exceeds the specified limit, grind the crankcase top surface with a surface grinder.
- Limit the amount of removed metal to make sure that the amount of piston projection above the crankcase top surface stays within the standard value range. (See PISTONS, CONNECTING ROD AND CYLINDER LINERS section.)

| Location | Maintenance item | | | Standard value | Limit | Remedy |
|---|---|---|---|---|---|---|
| 15 | Upper crankcase | Distortion of upper crankcase top surface | | 0.07 {0.0028} or less | 0.2 {0.0079} | Rectify or replace |

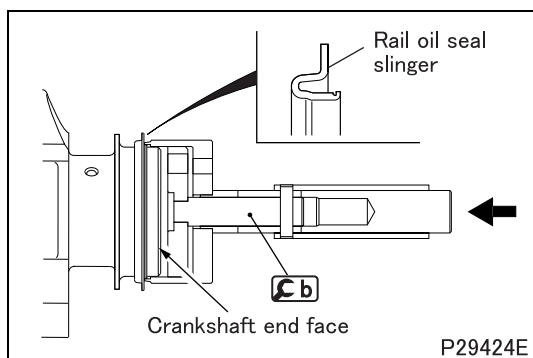
#### ■ Installation: Rear oil seal slinger

- Press in the rear oil seal slinger until **Cb** sits snugly on the crankshaft end surface.

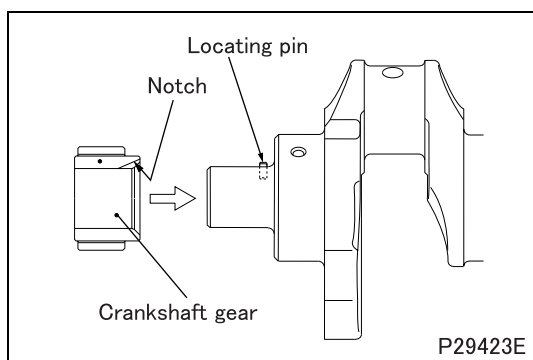
#### ■ Installation: Crankshaft gear

- Heat the crankshaft gear to approximately 150°C {300°F} with a gas burner or the like.

- Align the locating pin in the crankshaft with the slot in the crankshaft gear. Drive the gear into position by lightly striking its end face with a plastic hammer.

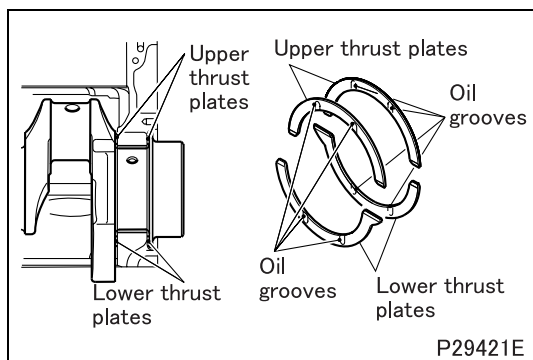
## ■ Installation: Thrust plate

- Install the thrust plates on both sides of the rearmost main bearing with the oil grooves on the inner plates facing inward and those on the outer plates outward as shown in the illustration.

- **Be sure to orient the oil grooves as indicated above, otherwise seizures may occur in the engine.**
- Use oversize thrust plates when adjusting the crankshaft end play. The upper and lower thrust plates on the same side must be of the same size. The thrust plates on one side may differ in size from those on the other side.

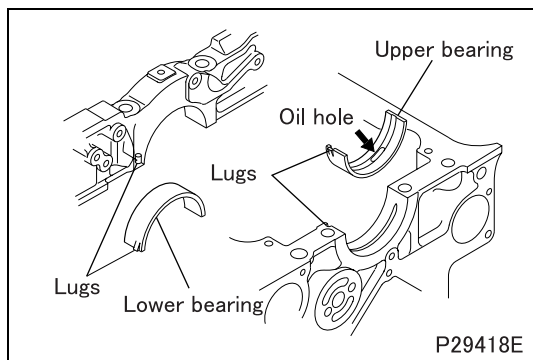
## ■ Installation: Main bearings

- Install the main bearings with their lugs aligned as shown in the illustration. When the crankshaft journals have been ground to an undersize, use undersize main bearings.  
Available main bearing undersizes:  
0.25 mm {0.0098 in.}, 0.50 mm {0.020 in.}, 0.75 mm {0.030 in.}, 1.00 mm {0.039 in.}

- **The upper main bearing has an oil hole. The lower main bearing has no oil hole. Do not confuse the upper and lower bearings, as this can cause seizure in the engine.**

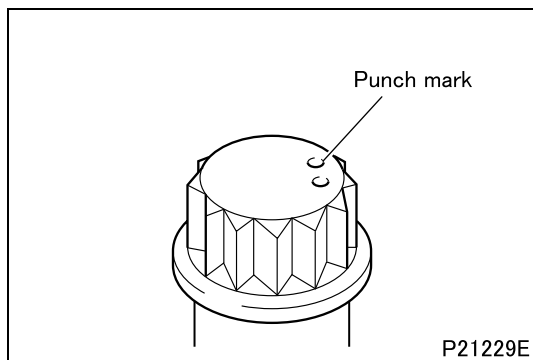
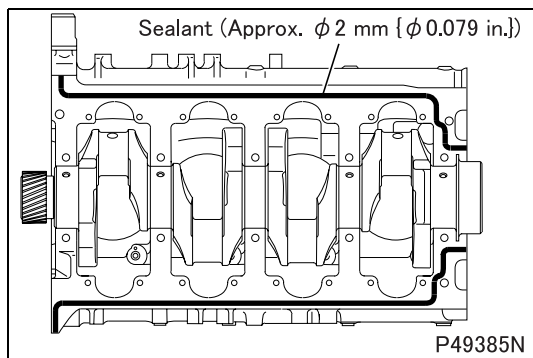
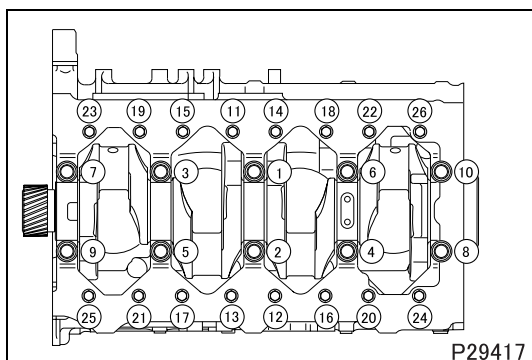
## ■ Installation: Lower crankcase

- **Before installing the main bearing cap bolts, check the number of punch marks on the head of each bolt. (A bolt with two or less marks is reusable.)**
- **The number of punch marks corresponds with the number of times the main cap bolt has been tightened using the torque-turn tightening method. Any bolt that has three marks (i.e. that has been used three times) must be replaced.**
- Clean all sealant application surfaces.
- Apply evenly thick beads of sealant to the upper crankcase without any breaks as shown in the illustration.
- Install the lower crankcase within three minutes of applying the sealant, being careful not to dislodge the sealant.

- Apply engine oil to the main cap bolt threads and seating surfaces of the bolt heads, then tighten them to a torque of 49 N·m {36 ft.lbs, 5.0 kgf·m} in the order indicated in the illustration (1 to 10).
- Tighten each main cap bolt further by 90° in the same order.
- Finally, tighten each bolt to the specified torque in the order indicated in the illustration (11 to 26).

- **After installing the bolts, wait at least an hour before starting the engine.**
- **Apply new beads of sealant whenever the main cap bolts have been loosened or removed.**

- **The bolts that have been tightened using the torque-turn method must never be additionally tightened after the final angular tightening.**

- After installing the main bearing caps, rotate the crankshaft by hand. If it cannot be rotated smoothly, inspect the main bearing caps for correct installation.

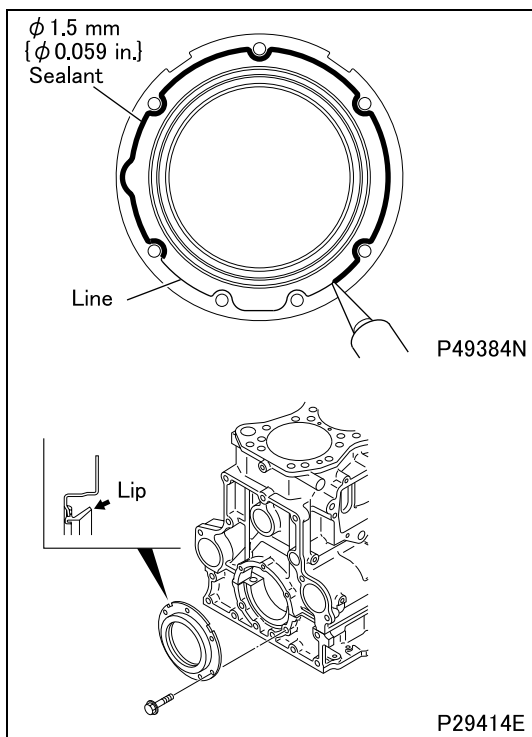
#### ■ Installation: Rear oil seal

- Apply engine oil to the lip of the rear oil seal.
- Clean the seal surface of the crankshaft.
- Apply a bead of sealant along the line on the rear oil seal evenly without any breaks.
- Install the rear oil seal within three minutes after applying the sealant. Be careful not to let the applied sealant slip out of place during installation.

- **After fitting the rear oil seal, wait at least an hour before starting the engine.**
- **Apply a new bead of sealant whenever the mounting bolts of the rear oil seal have been loosened.**

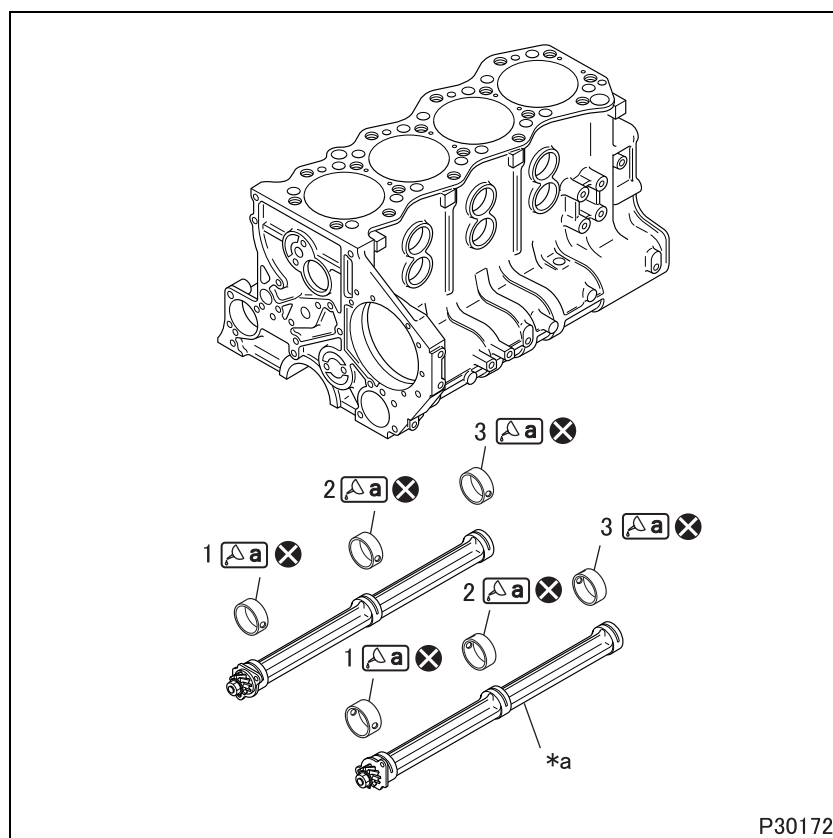
## ● Disassembly sequence

- 1 No. 1 balance shaft bushing
- 2 No. 2 balance shaft bushing
- 3 No. 3 balance shaft bushing

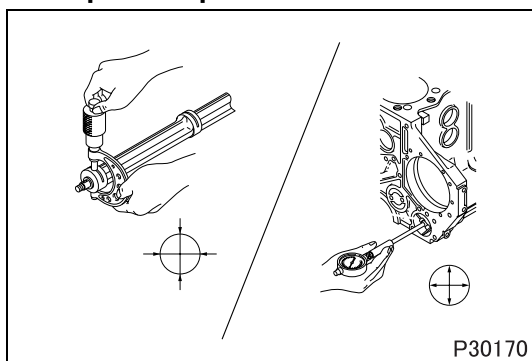
### ■ Inspection: Balance shaft-to-balance shaft bushing clearance

- Replace the bushing if the measurement exceeds the specified limit.

| Location | Maintenance item | | Standard value | Limit | Remedy |
|---|---|---|---|---|---|
| 1 to 3,<br>*a | Balance shaft journal-to-balance shaft bushing clearance | No. 1 | 0.055 to 0.099<br>{0.0022 to 0.0039} | 0.15<br>{0.0059} | Replace |

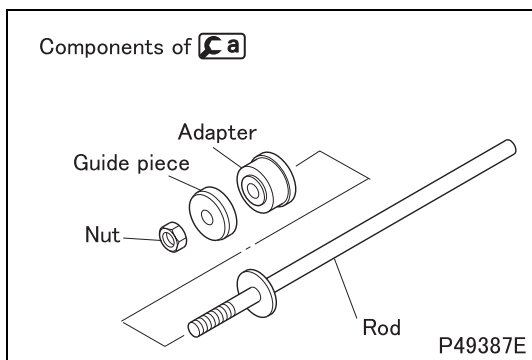
### Replacement of balance shaft bushing

- Replace the bushing using **Ca**.

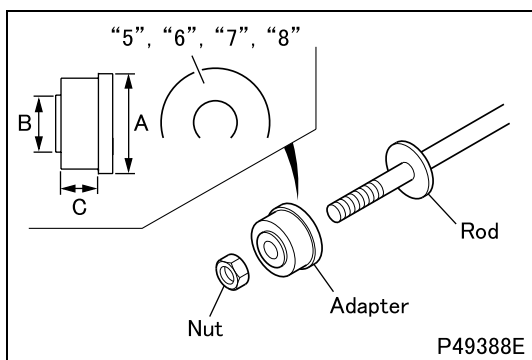
### [Removal]

- To remove the bushings, use the rod fitted with an adapter corresponding to the size of each bushing.

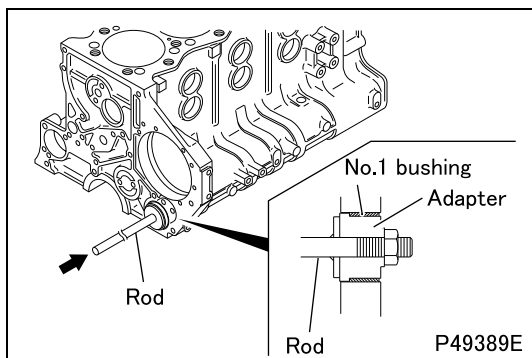
- Remove the No. 1 bushing by tapping on the rod from the front of the engine.
