# FE.FG

## SERVICE MANUAL 2008 Model FOREWORD

This Service Manual contains maintenance and repair methods for the Mitsubishi Fuso Truck FE. FG Series. Read this manual carefully as an aid in providing correct, efficient maintenance. Please note that the information and specifications contained within this manual may change without notice. This is due to product modifications and continued vehicle improvements that are made throughout the model years. Should you encounter any discrepancy in the information provided, please do not hesitate to contact your nearest Mitsubishi Fuso Dealer or Mitsubishi Fuso Truck of America, Inc.

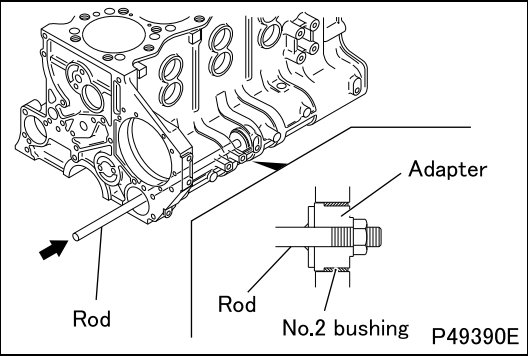
- Remove the No. 2 bushing by tapping on the rod from the front of the engine.

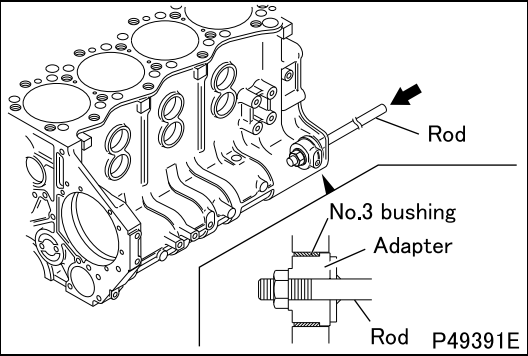
- Remove the No. 3 bushing by tapping on the rod from the back of the engine.

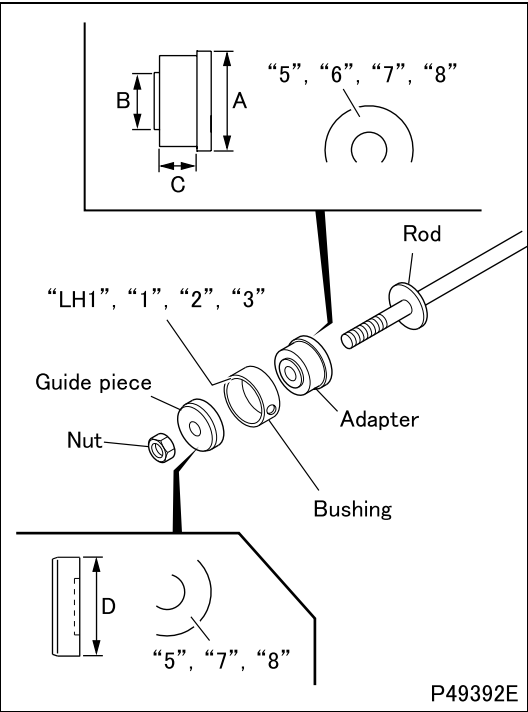
## [Installation]

- To install the bushings, use the rod fitted with an adapter corresponding to the size of each bushing. Each bushing has an identification mark. These identification marks are used to distinguish between the No. 1, No. 2 and No. 3 bushings. If the identification mark is not clear, measure the outside diameter of the bushing and use the measurement as a means of identification.

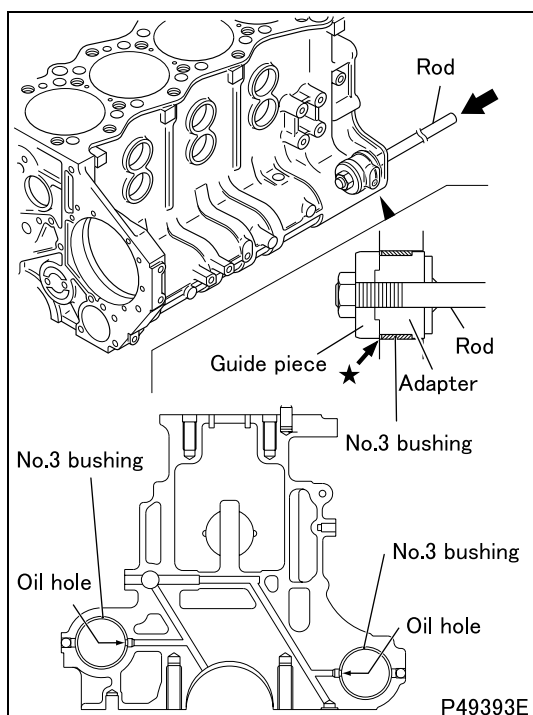
- Align the oil hole in the No. 3 bushing with the oil hole in the upper crankcase.
- Force the No. 3 bushing into the upper crankcase as deep as the ★ mark in the illustration by tapping on the rod from the rear of the engine.

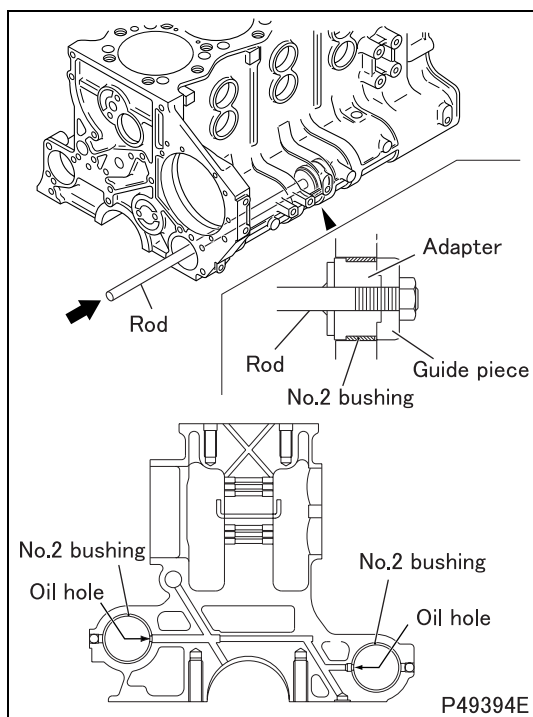
- Align the oil hole in the No. 2 bushing with the oil hole in the upper crankcase.
- Force the No. 2 bushing into the upper crankcase to the illustrated position by tapping on the rod from the front of the engine.

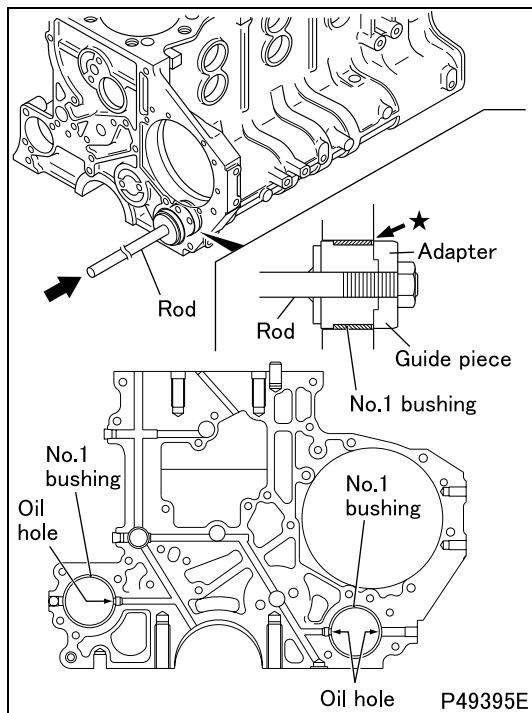
- Align the oil hole(s) in the No. 1 bushing with the oil hole(s) in the upper crankcase.
- Force the No. 1 bushing into the upper crankcase as deep as the ★ mark in the illustration by tapping on the rod from the front of the engine.

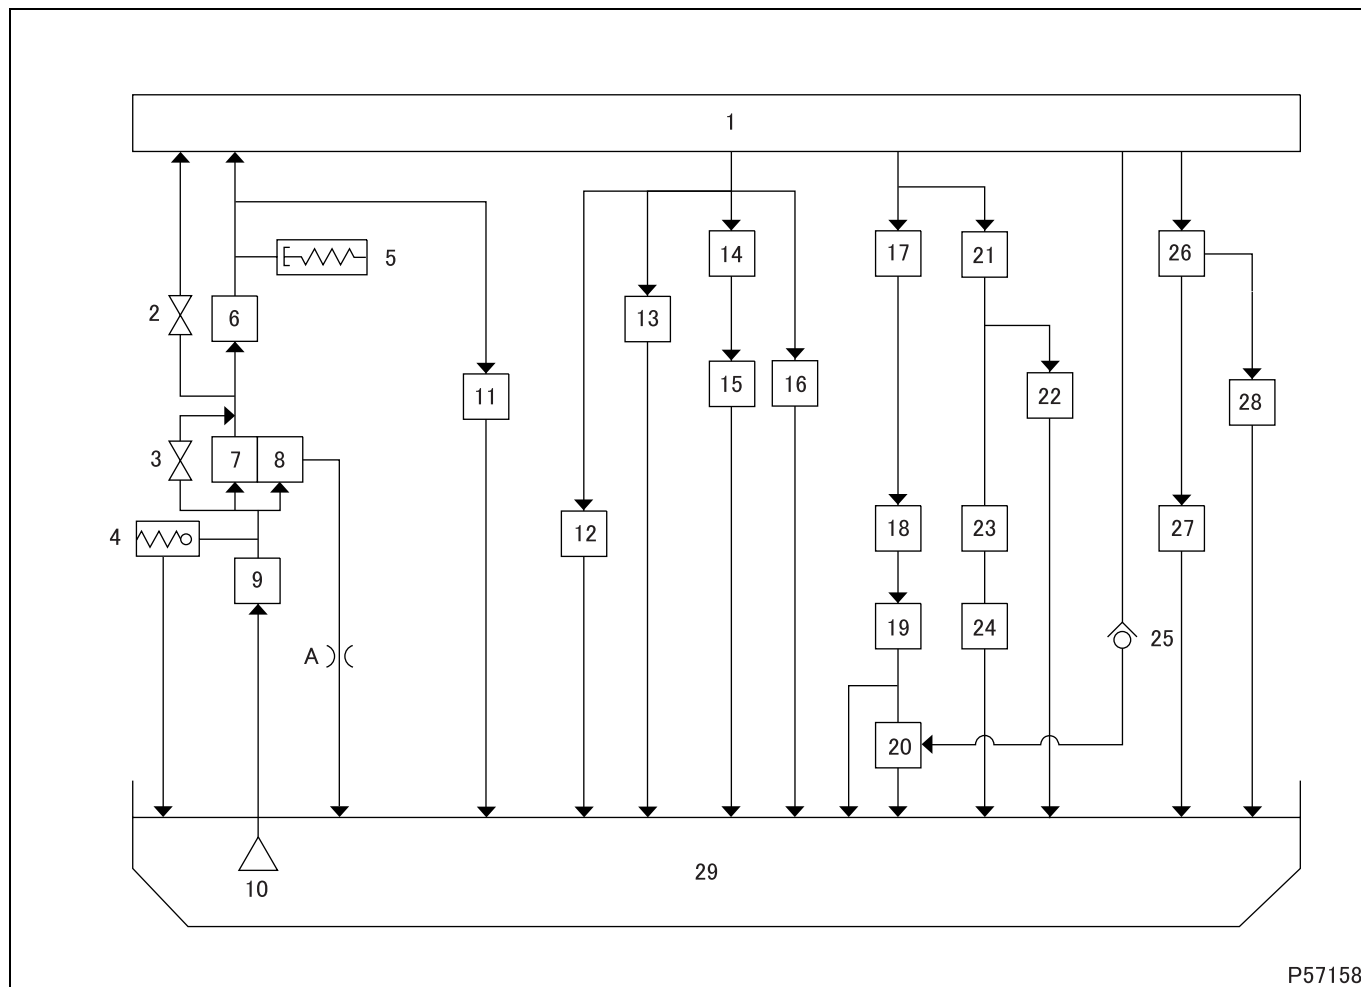
P57158

## 1. Lubrication System

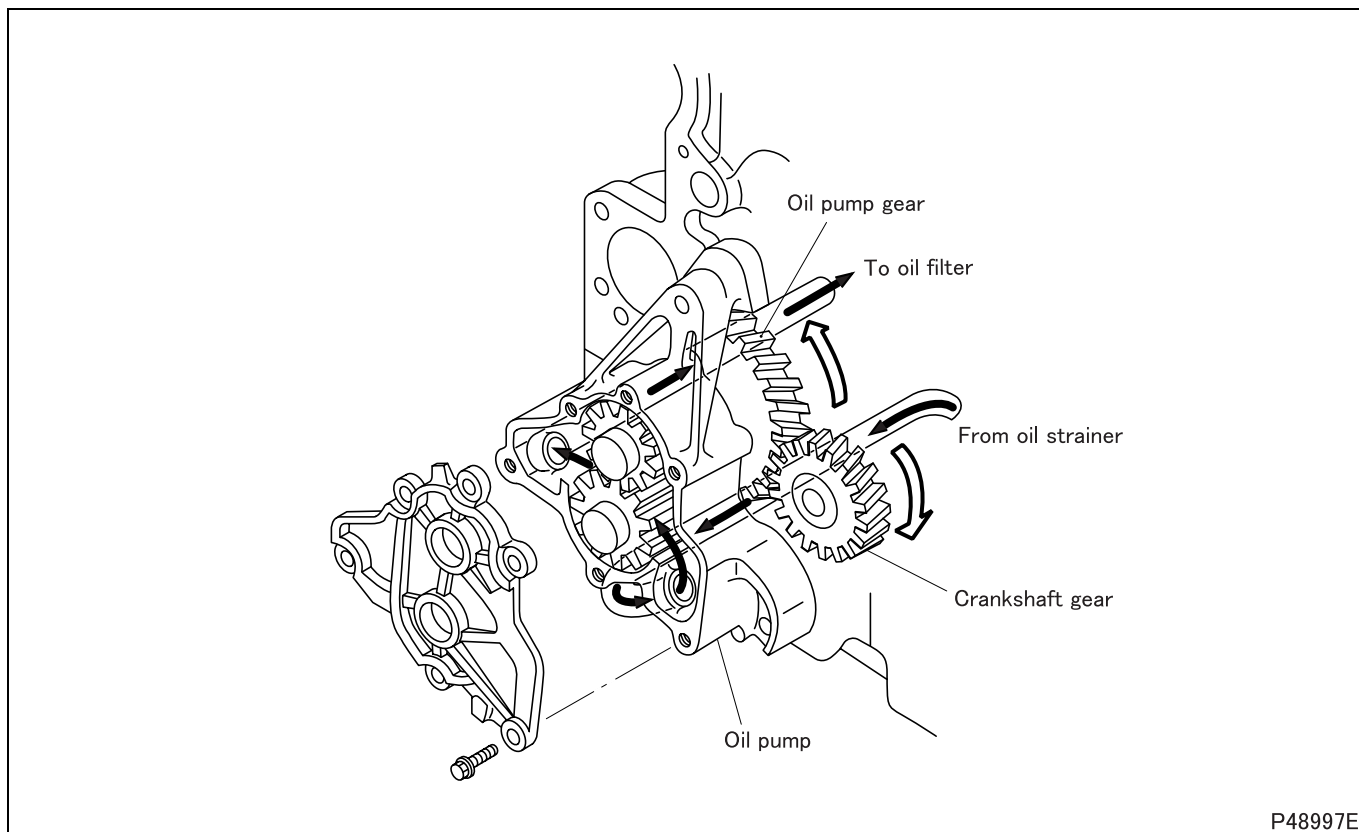
## 2. Oil Pump

- This engine uses a gear-type oil pump driven by the rotation of the crankshaft transmitted through the engagement of the crankshaft gear and the oil pump gear.

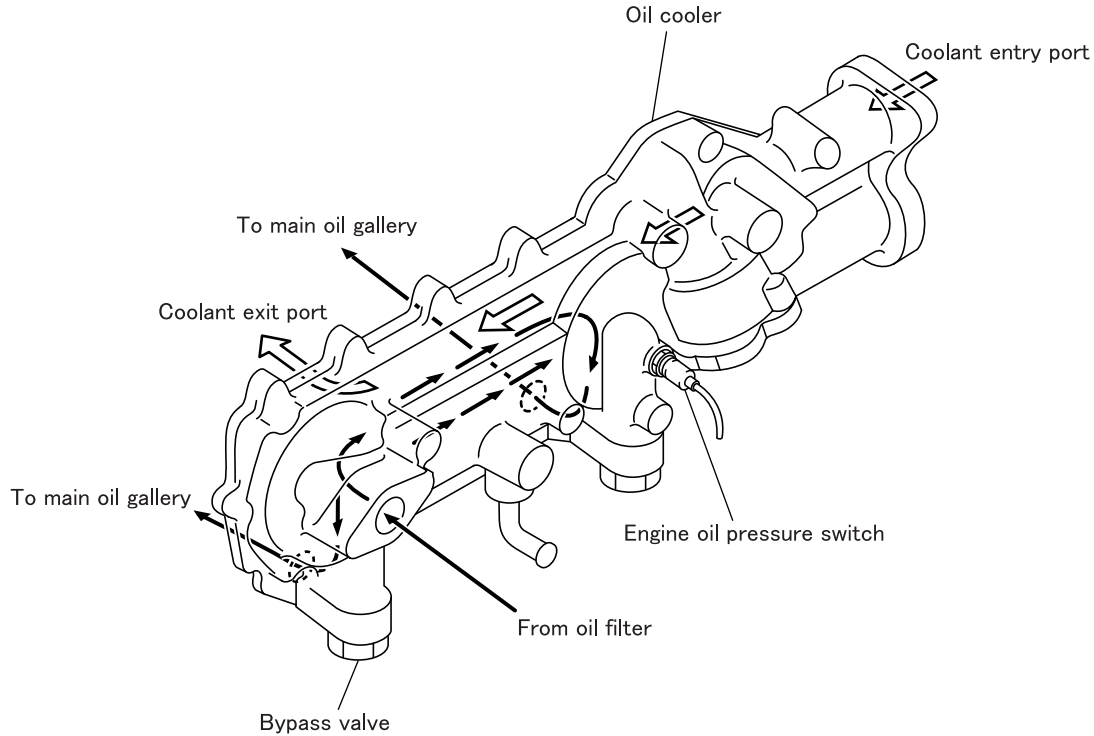
P57159E

### 3. Oil Cooler

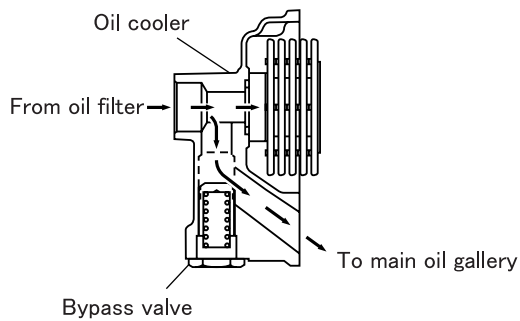
P48999E

#### 3.1 Bypass valve

- When the engine oil is cool and its viscosity is high, or when the oil cooler element becomes clogged and restricts the flow of the engine oil, the bypass valve opens to let the engine oil bypass the oil cooler and flow directly to the main oil gallery.

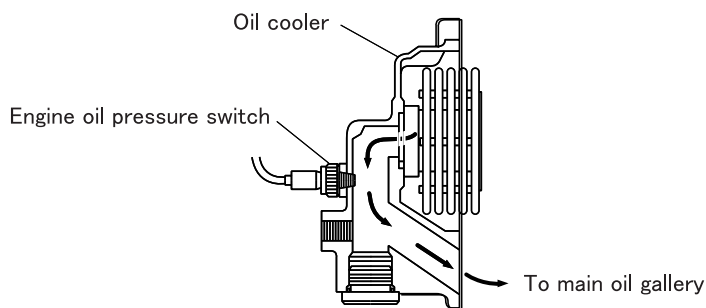
P49000E

#### 3.2 Engine oil pressure switch

- When the pressure of the engine oil to the main oil gallery drops below the specified level, an electrical contact inside the engine oil pressure switch closes.
- This causes a warning lamp on the meter cluster to illuminate and notify the operator of the excessive pressure drop.

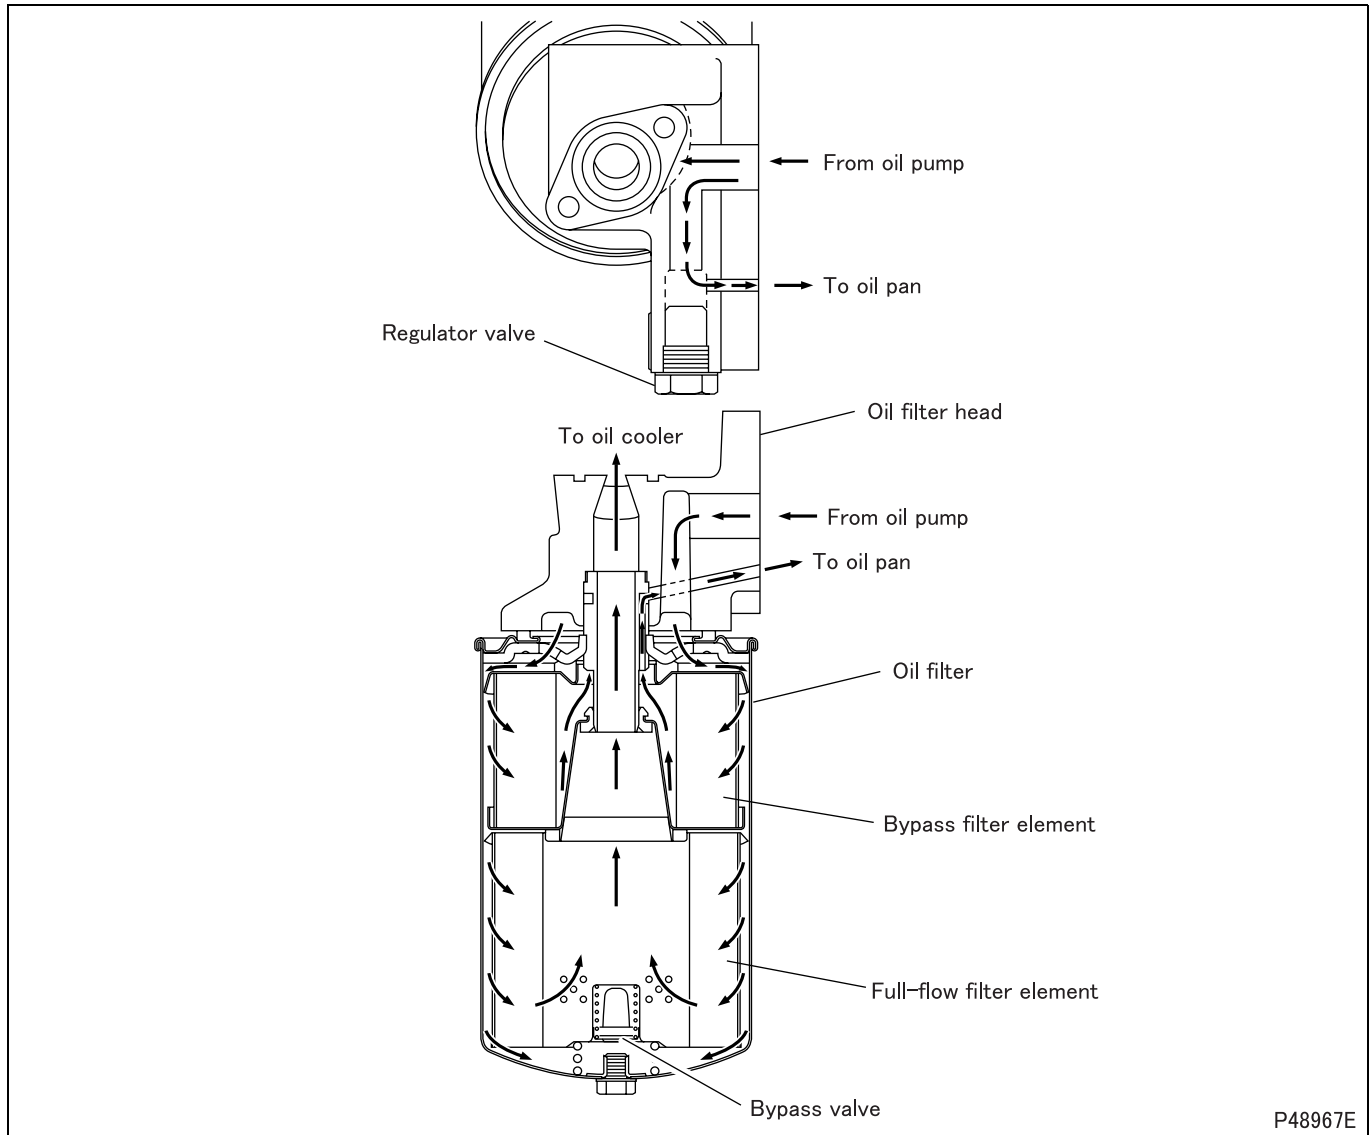
## 4. Oil Filter

- The oil filter used in this engine is a spin-on, paper-filter type that incorporates both a bypass filter and a full-flow filter.
- A bypass valve is installed in the lower part of the oil filter. When the filter elements are clogged, this valve opens to let the engine oil bypass the filter elements and flow directly to the oil cooler, thereby preventing seizures in the engine.
- A regulator valve is installed on the oil filter head. When the oil pressure in the main oil gallery exceeds the specified level, the regulator valve opens to adjust the oil pressure by returning part of the engine oil to the oil pan.

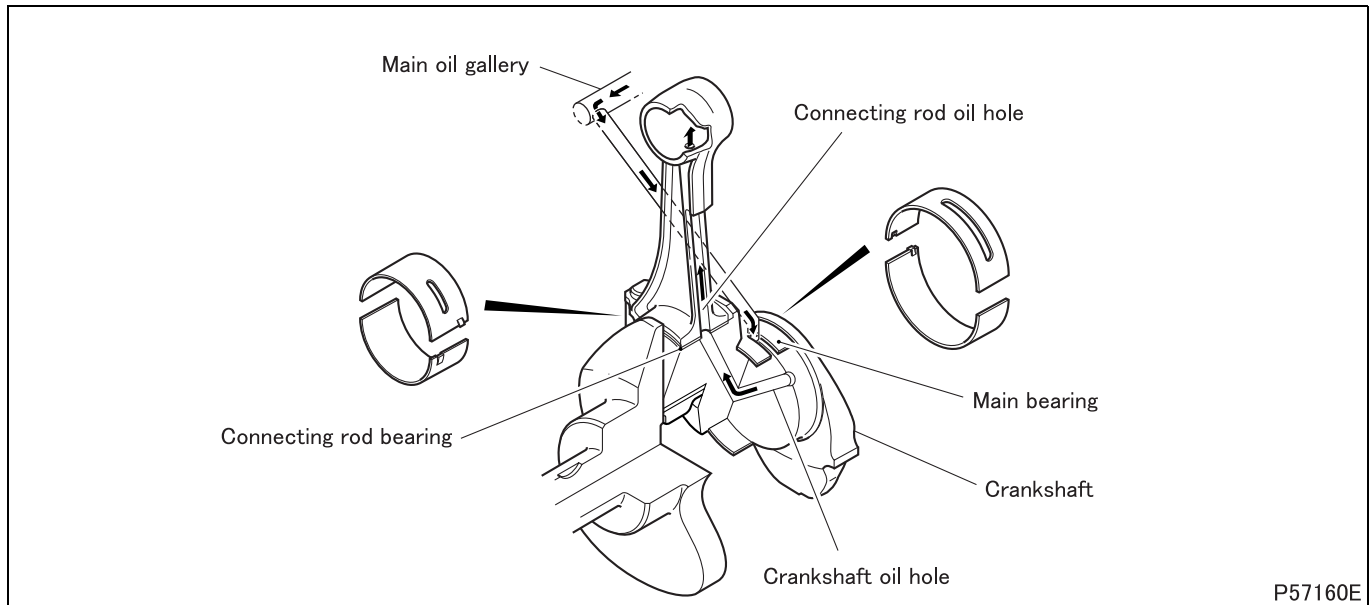
### 5.1 Main bearing and connecting rod bearing

- Engine oil supplied through an oil passage in the crankshaft lubricates the big end (connecting rod bearing) of each connecting rod. Simultaneously, engine oil supplied through an oil passage in the connecting rod lubricates the connecting rod's small end.

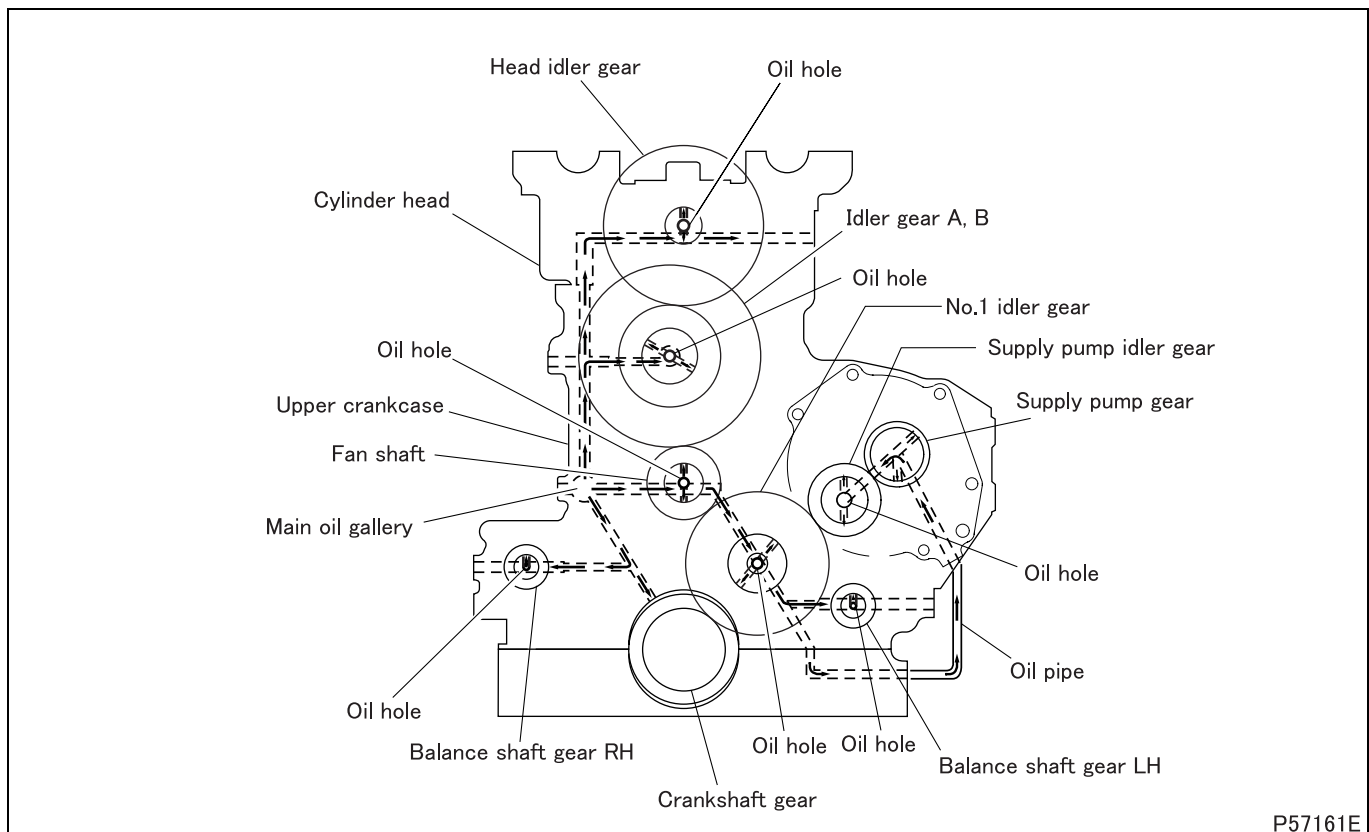
### 5.2 Timing gears

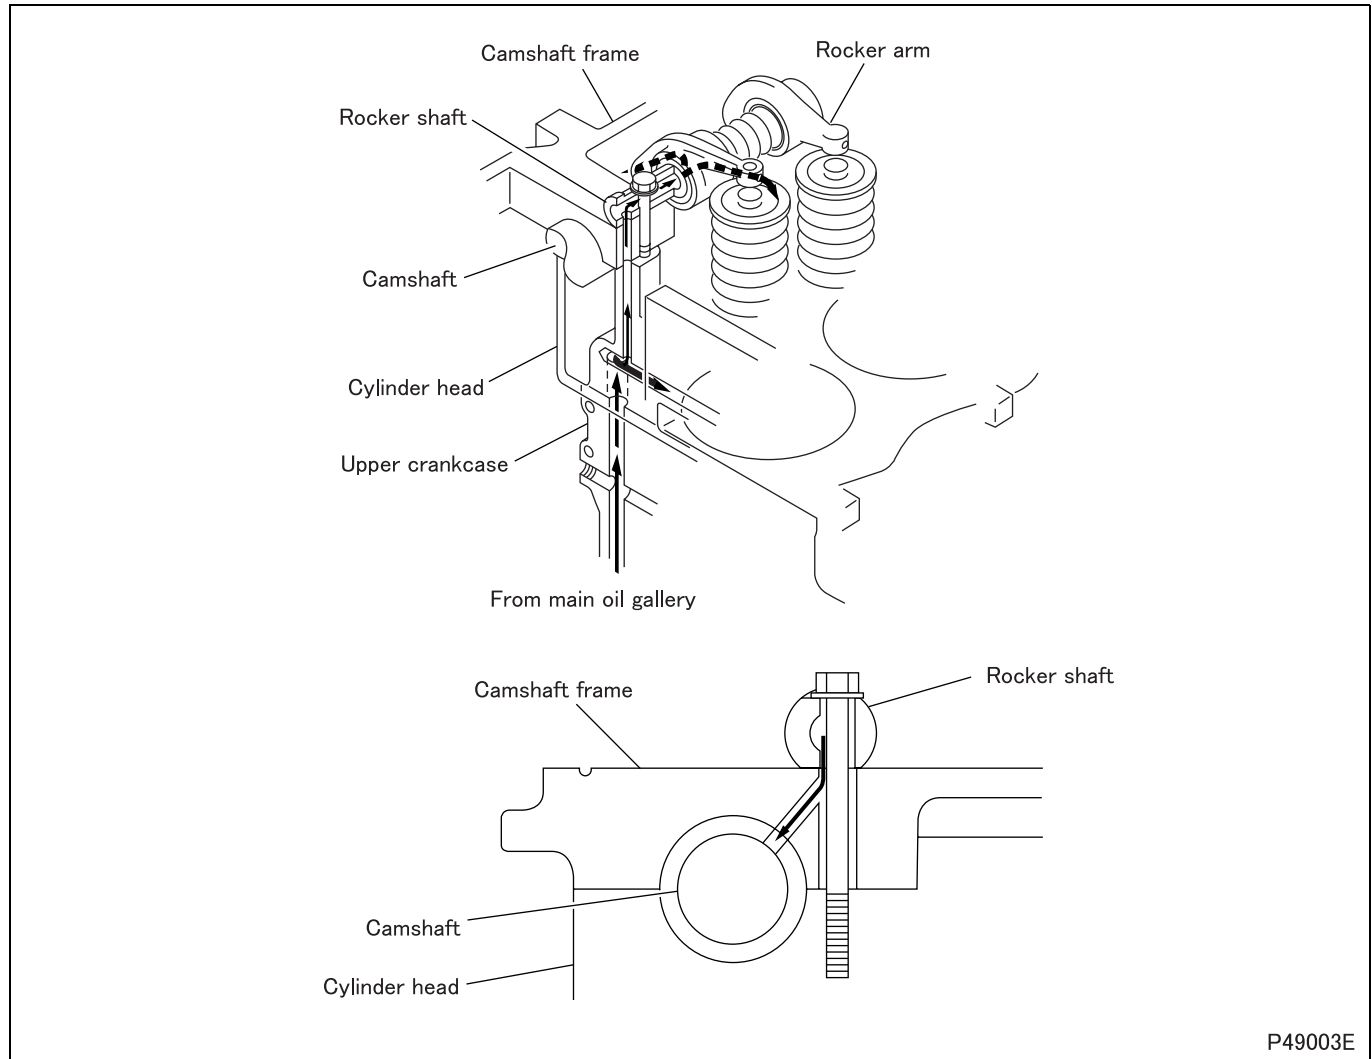
## 5.3 Valve mechanism

- The engine oil flows from the main oil gallery to the rocker shaft through the oil passages in the upper crankcase, cylinder head, and camshaft frame.
- The engine oil in the rocker shaft lubricates the rocker arms and camshaft, then returns to the oil pan.

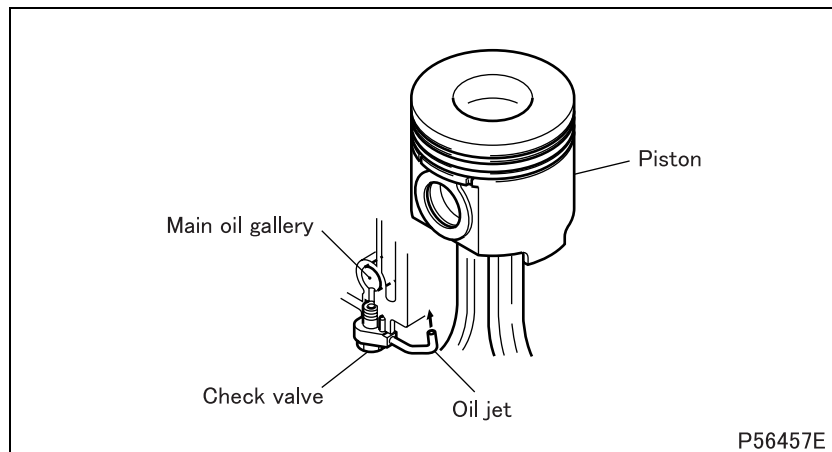
## 5.4 Check valves and oil jets

- An oil jet is fitted in the lower part of the main oil gallery for each cylinder.
- Engine oil is sprayed out of the oil jet into the piston to cool the piston.
- Each oil jet is fitted with a check valve that opens and closes at predetermined oil pressure levels. At low engine speeds, the check valve closes to maintain the required volume of oil in the lubrication system and prevent reductions in oil pressure.

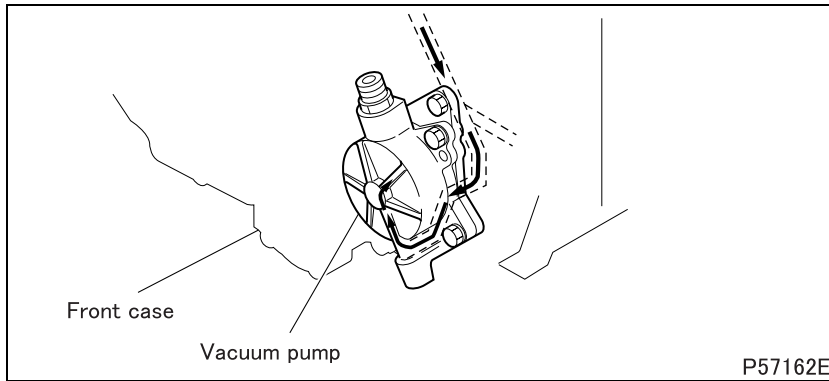
### 5.5 Vacuum pump

- Engine oil flows through the oil passages in the front case to the vacuum pump.
- The oil in the pump lubricates the vanes, and then is discharged into the front case from the air discharge port of the vacuum pump along with air, and returns to the oil pan.

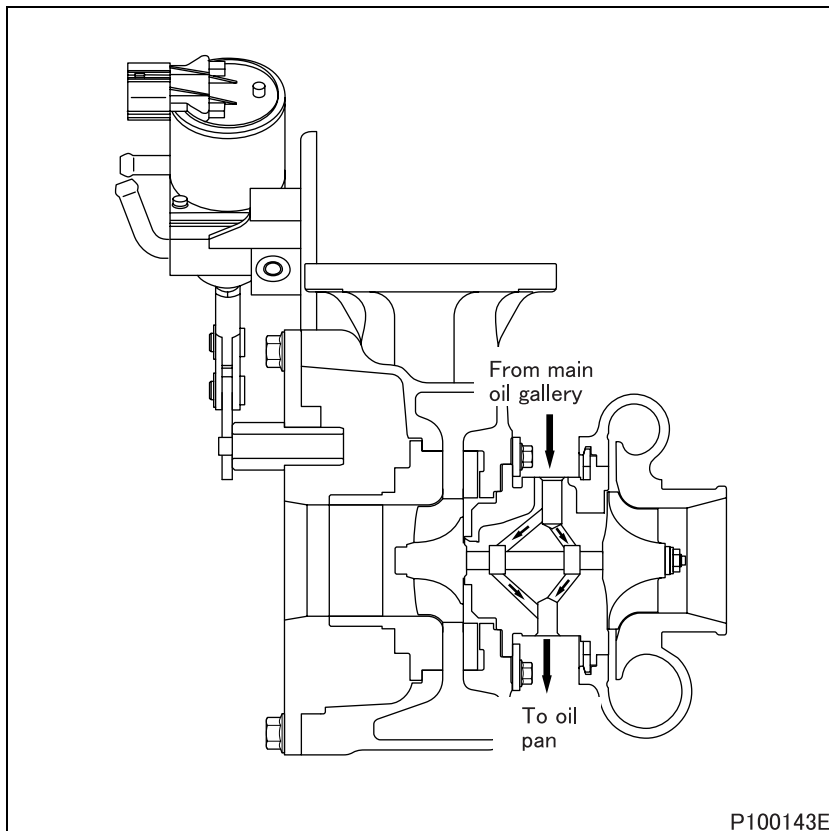
### 5.6 Turbocharger

- Engine oil is fed to the bearing housing from the main oil gallery through the oil pipe to lubricate the inside of the turbocharger.
- The piston rings, which are installed on both sides of the turbine wheel shaft, serve as oil seals.

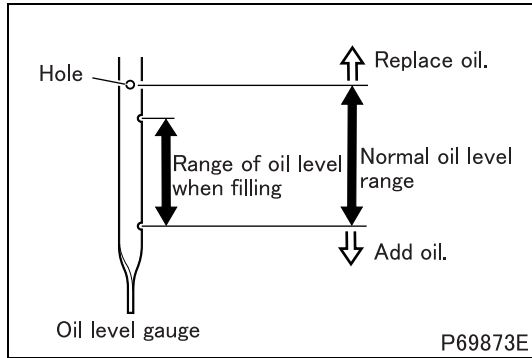
## 3. Engine Oil Level Inspection

- When regenerating the DPF (diesel particulate filter), a part of the injected fuel may mix into the engine oil and may increase the quantity of oil.
- If the oil level is out of the normal range, add or replace the engine oil.

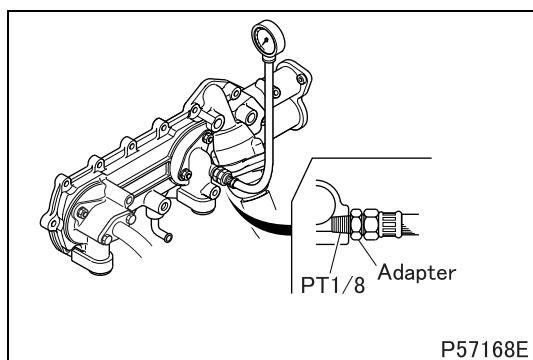
- Using an adapter, connect an oil pressure gauge to the engine oil pressure switch mounting hole.
- Warm up the engine until the oil temperature reaches 70 to 90°C {158 to 195°F}.
- Measure the oil pressure while running the engine at a minimum speed and then at maximum speed, both under no load.
- If the measurements are below the specified limits, overhaul the lubrication system.
- After taking the measurements, apply sealant to the threads of the oil pressure switch and tighten the switch to the specified torque.

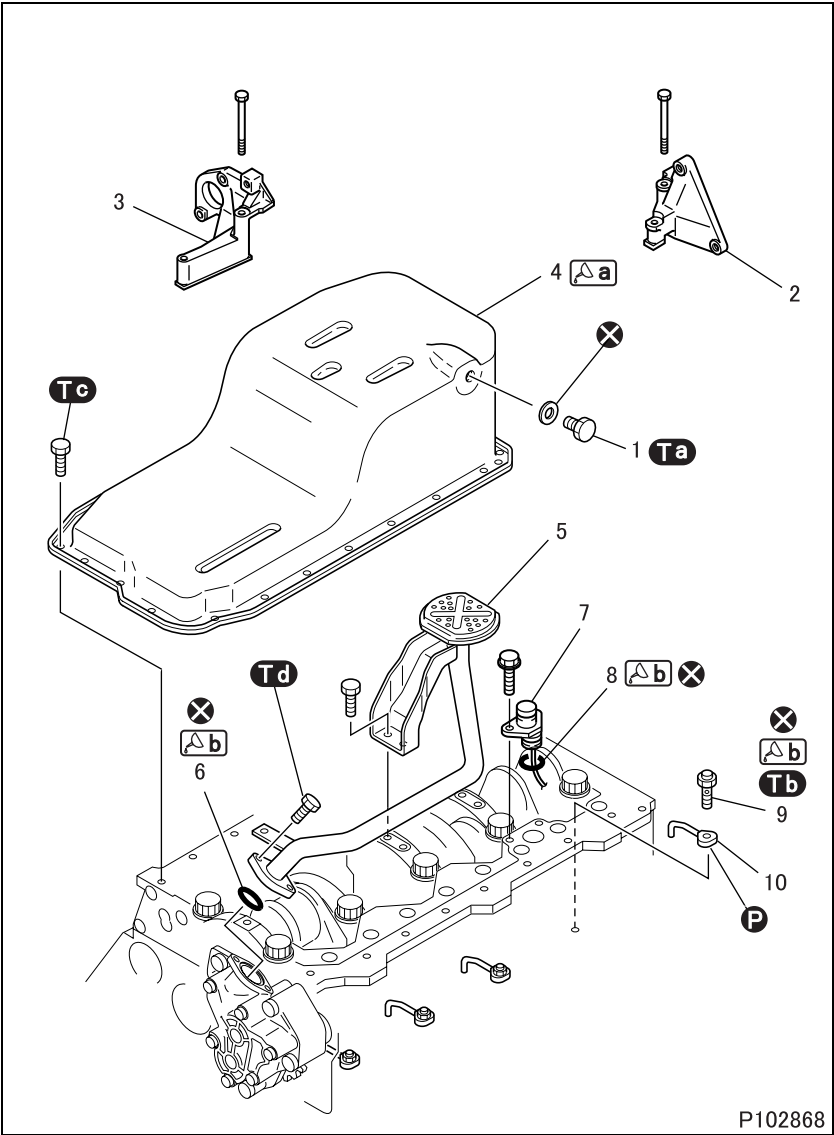
- 1 Drain plug
- 2 Stiffner RH
- 3 Stiffner LH
- 4 Oil pan
- 5 Oil strainer
- 6 O-ring
- 7 Engine oil level sensor
- 8 O-ring
- 9 Check valve
- 10 Oil jet

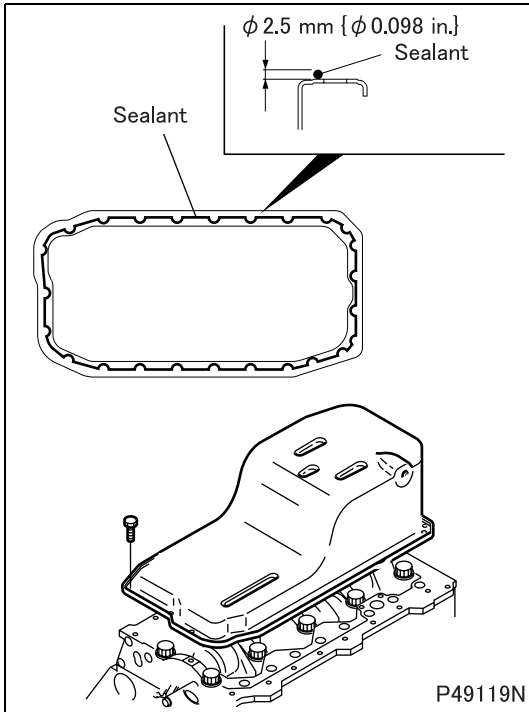
### ■ Installation: Oil pan

- Clean the mating surfaces of each part.
- Apply a bead of sealant to the mating surface of the oil pan evenly and without any breaks as shown in the illustration.
- Mount the oil pan within three minutes of applying the sealant. Make sure that the sealant stays in place.

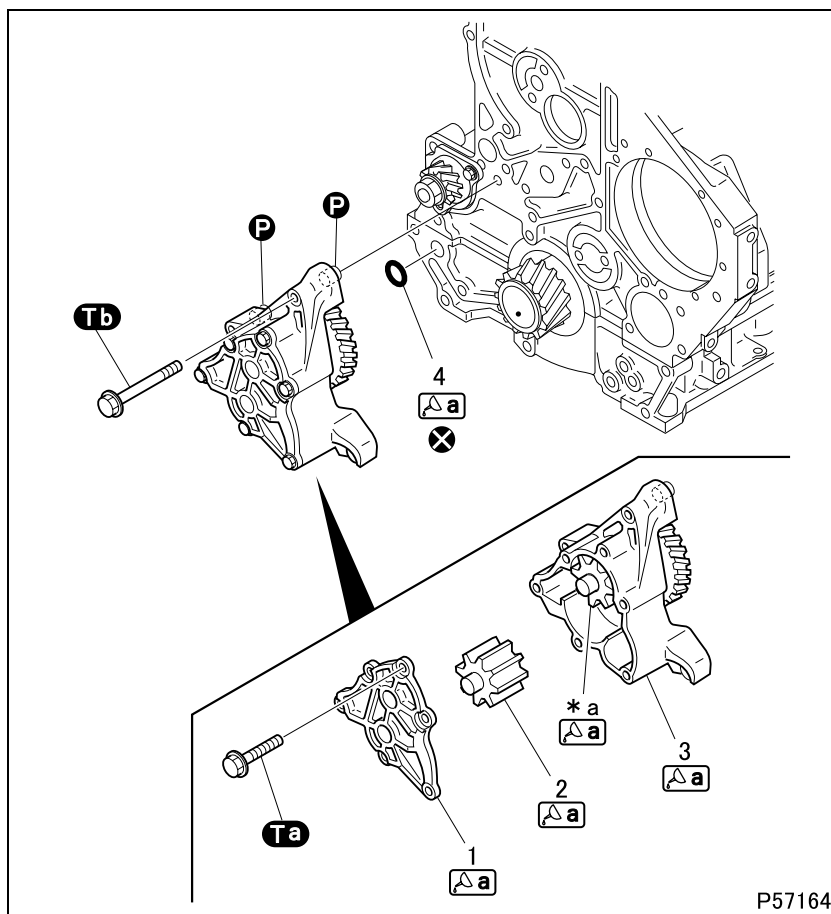
- 1 Oil pump cover
- 2 Driven gear
- 3 Gear and case assembly
- 4 O-ring

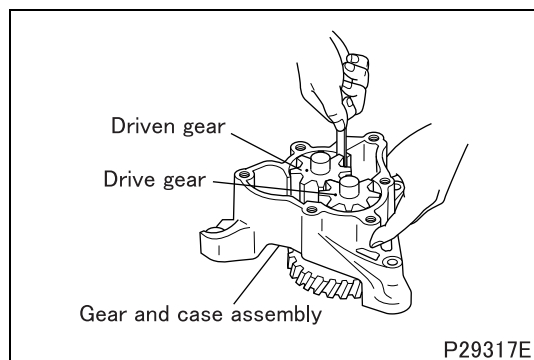
##### (2) Gear and case assembly-to-tooth tip clearance for each gear

| Location | Maintenance item | Standard value | Limit | Remedy |
|---|---|---|---|---|
| | Gear and case assembly-to-tooth tip clearance for each gear | 0.13 to 0.22<br>{0.0051 to 0.0087} | 0.23<br>{0.0091} | Replace |

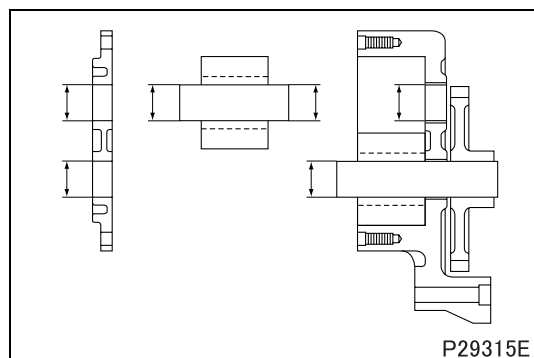
#### ■ Inspection: Oil pump cover, driven gear, and gear and case assembly

- Measure the clearance between each gear's shaft and the oil pump cover, as well as between each gear's shaft and the gear and case assembly.
- If the measurements are not within the standard value range, replace the oil pump.

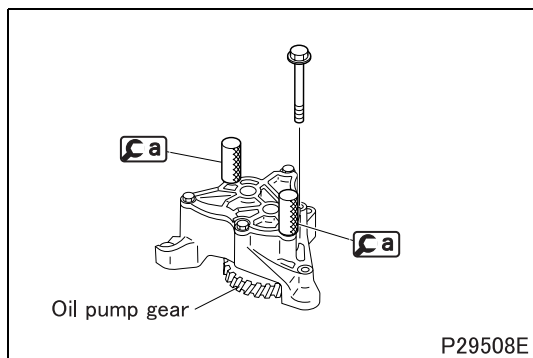
### ■ Installation: Oil pump cover and gear and case assembly

- Apply engine oil to each component.
- Hold the oil pump cover in place on the gear and case assembly by fitting two **Ca**s in the illustrated locations.
- Install a bolt into an empty bolt hole and tighten it to the specified torque.
- Remove the two **Ca**s. Install the rest of the bolts and tighten them to the specified torque.
- After installing all the bolts, turn the oil pump gear by hand and check that it rotates smoothly.
- Disassemble and reassemble the oil pump cover and gear and case assembly if the oil pump gear does not rotate smoothly.

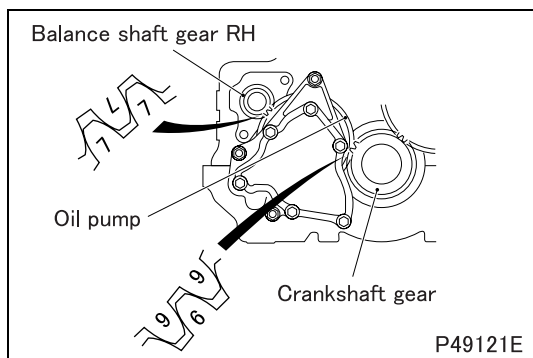
### ■ Installation: Oil pump

- Place the No.1 cylinder piston at top dead center to bring the crankshaft gear to an appropriate position.
- Inject approximately 5 cm<sup>3</sup> {0.3 cu. in.} of engine oil.
- Align the mating mark "6" on the crankshaft gear and the mating mark "7" on the balance shaft gear RH with the corresponding mating marks on the oil pump gear, and then install the oil pump gear.

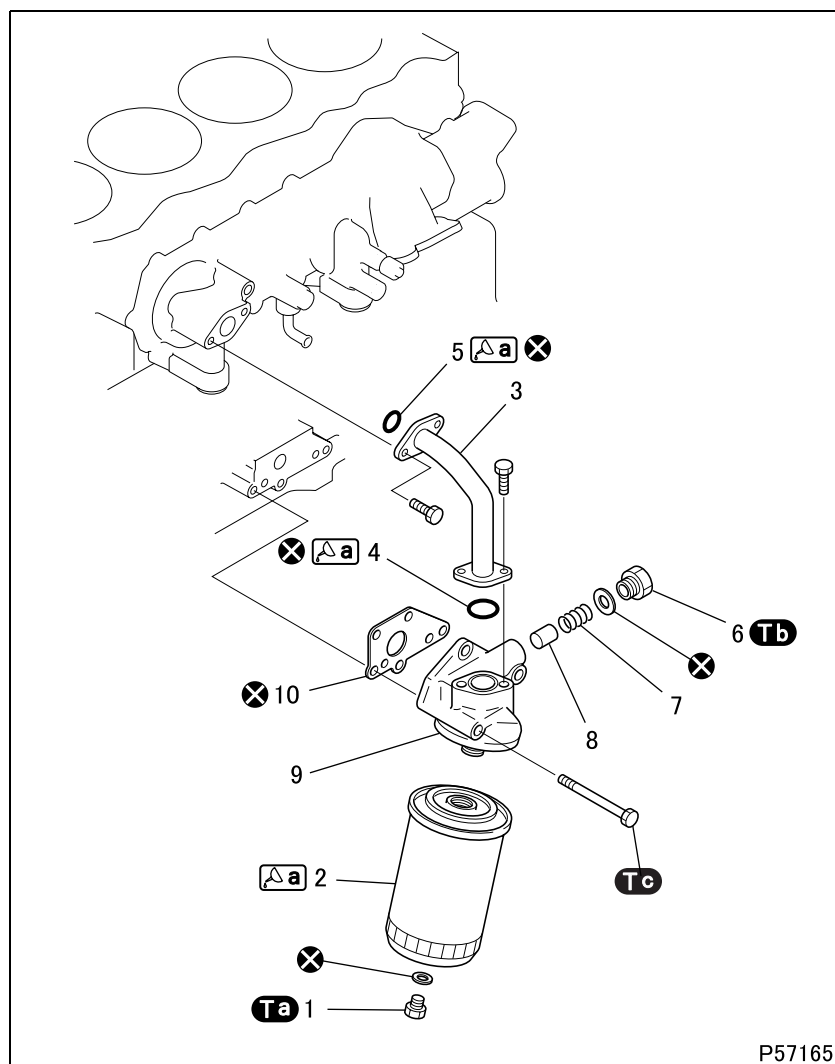
- 1 Drain plug
- 2 Oil filter
- 3 Oil pipe
- 4 O-ring
- 5 O-ring
- 6 Plug
- 7 Regulator valve spring
- 8 Regulator valve
- 9 Oil filter head
- 10 Gasket

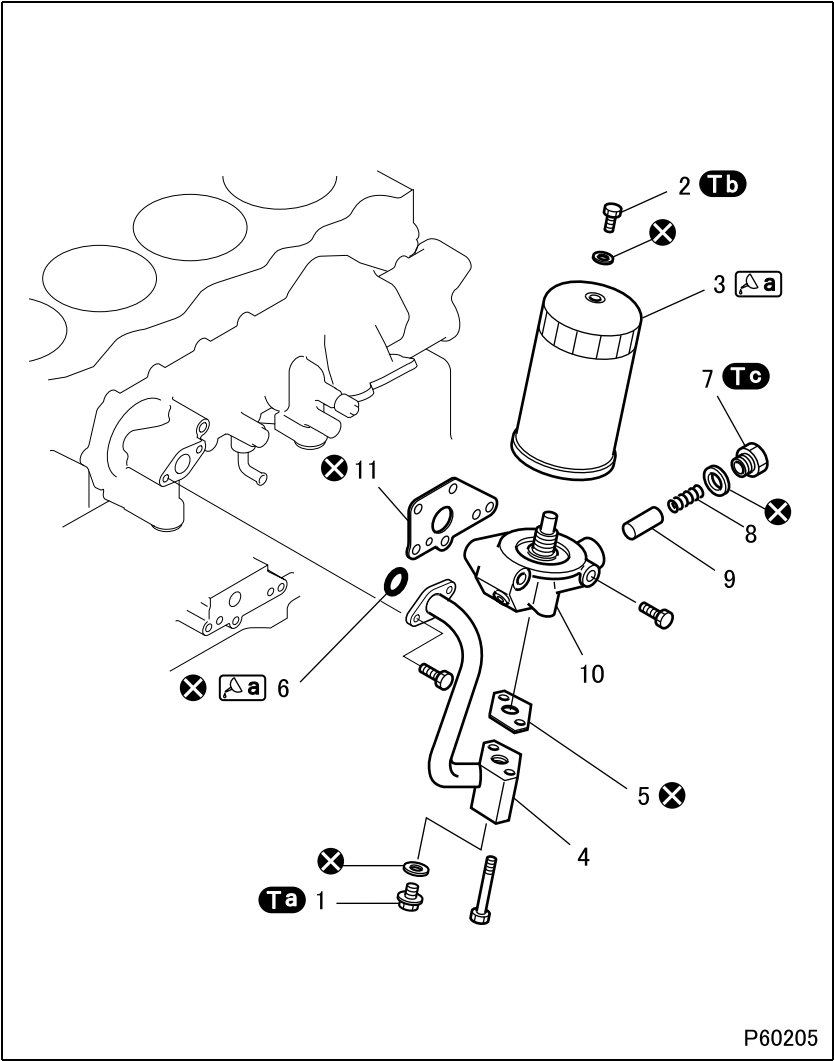
- 1 Drain plug
- 2 Drain plug
- 3 Oil filter
- 4 Oil pipe
- 5 Gasket
- 6 O-ring
- 7 Plug
- 8 Regulator valve spring
- 9 Regulator valve
- 10 Oil filter head
- 11 Gasket

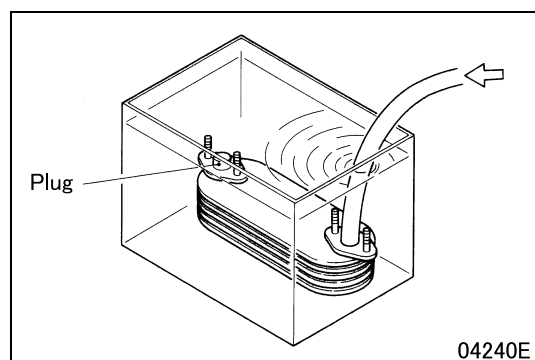
#### ■ Inspection: Oil cooler element

- Plug the outlet of the oil cooler element and connect a hose to the engine oil inlet port. Then, immerse the oil cooler element in a tank of water.
- Apply a specified air pressure for 15 seconds through the hose, and check for any air leaks.
- Replace the element if it leaks air.

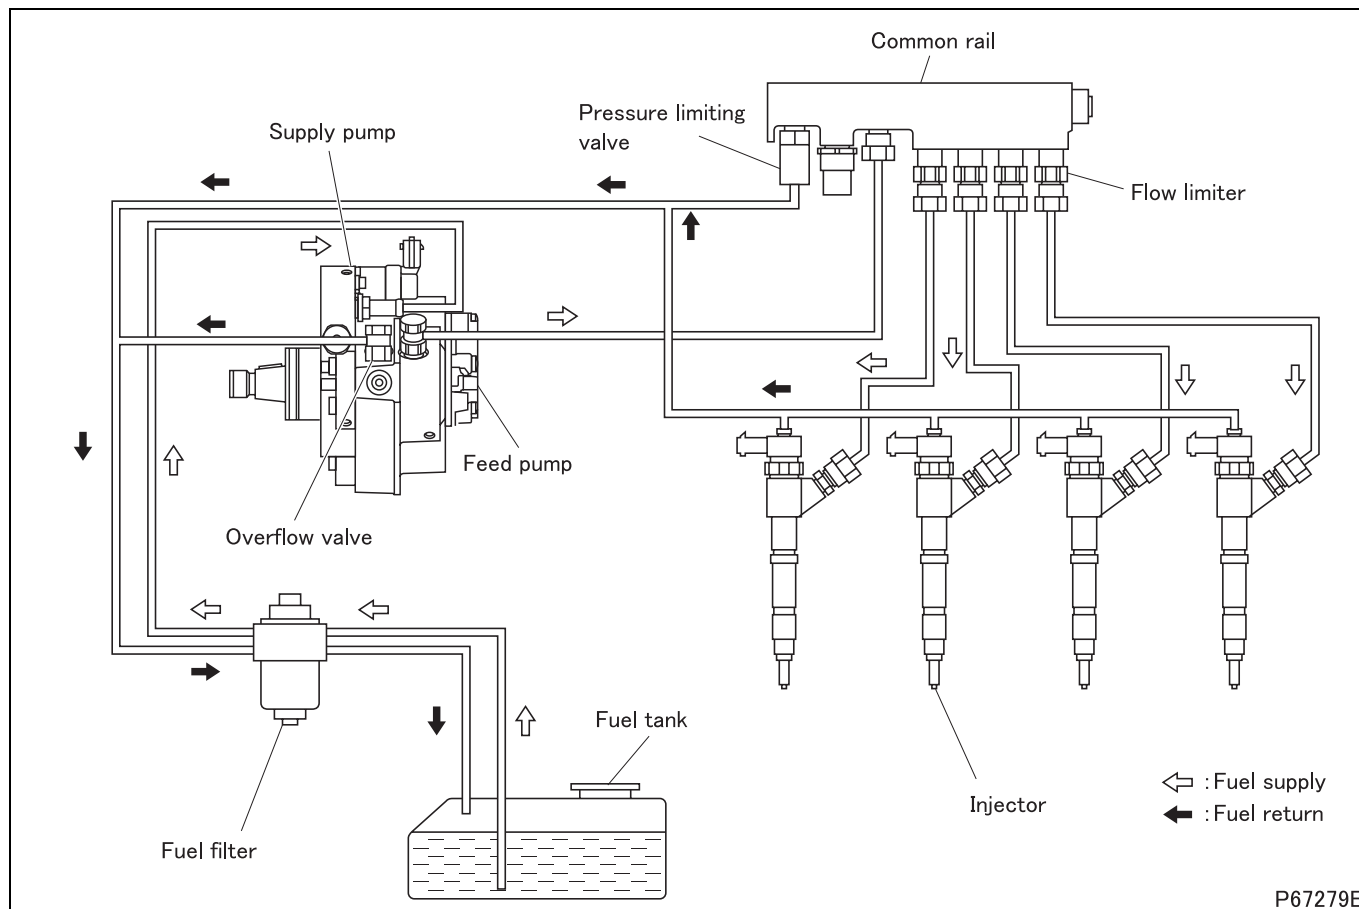
## 1. Fuel System (Flow of Fuel)

- The feed pump, which is driven by the camshaft inside the supply pump, draws up the fuel from inside the fuel tank and sends it through the fuel filter, where dust and other impurities in the fuel are filtered out.

- If fuel leaks from an injection pipe at the pipe joint, the flow limiter is activated to close the fuel passage, preventing the fuel from flowing elsewhere.

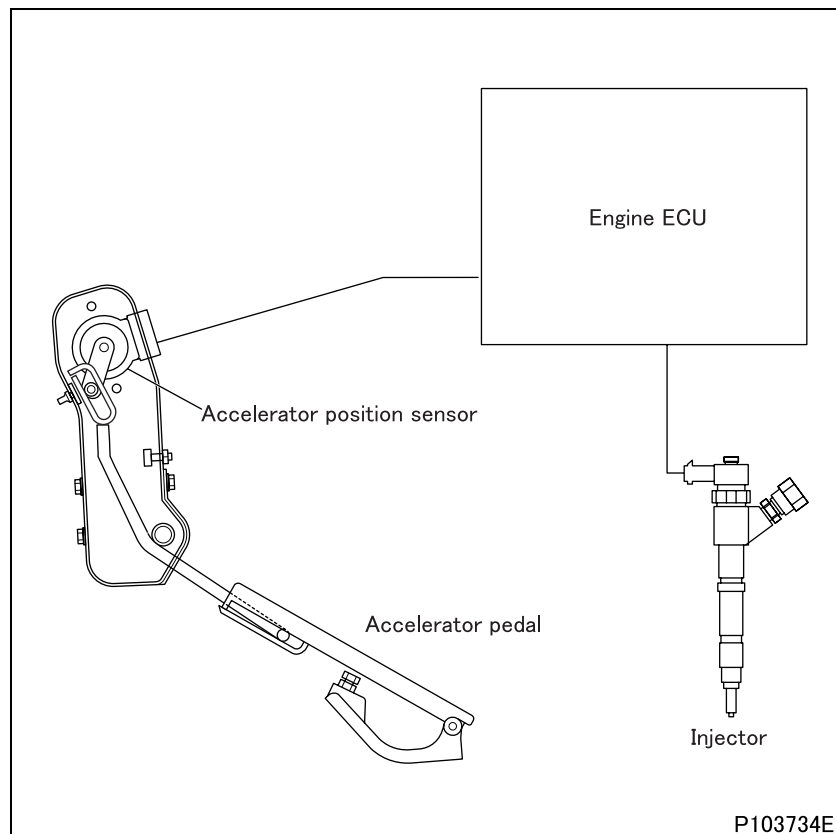
## 2. Engine Control

- The engine is electronically controlled by the engine electronic control unit (ECU).
- The accelerator position sensor detects how much the accelerator pedal is pressed and sends the corresponding electronic signal to the engine electronic control unit, which calculates an appropriate amount of fuel based on the signals and controls fuel injection accordingly.
