# FE.FG

## SERVICE MANUAL 2008 Model FOREWORD

This Service Manual contains maintenance and repair methods for the Mitsubishi Fuso Truck FE. FG Series. Read this manual carefully as an aid in providing correct, efficient maintenance. Please note that the information and specifications contained within this manual may change without notice. This is due to product modifications and continued vehicle improvements that are made throughout the model years. Should you encounter any discrepancy in the information provided, please do not hesitate to contact your nearest Mitsubishi Fuso Dealer or Mitsubishi Fuso Truck of America, Inc.

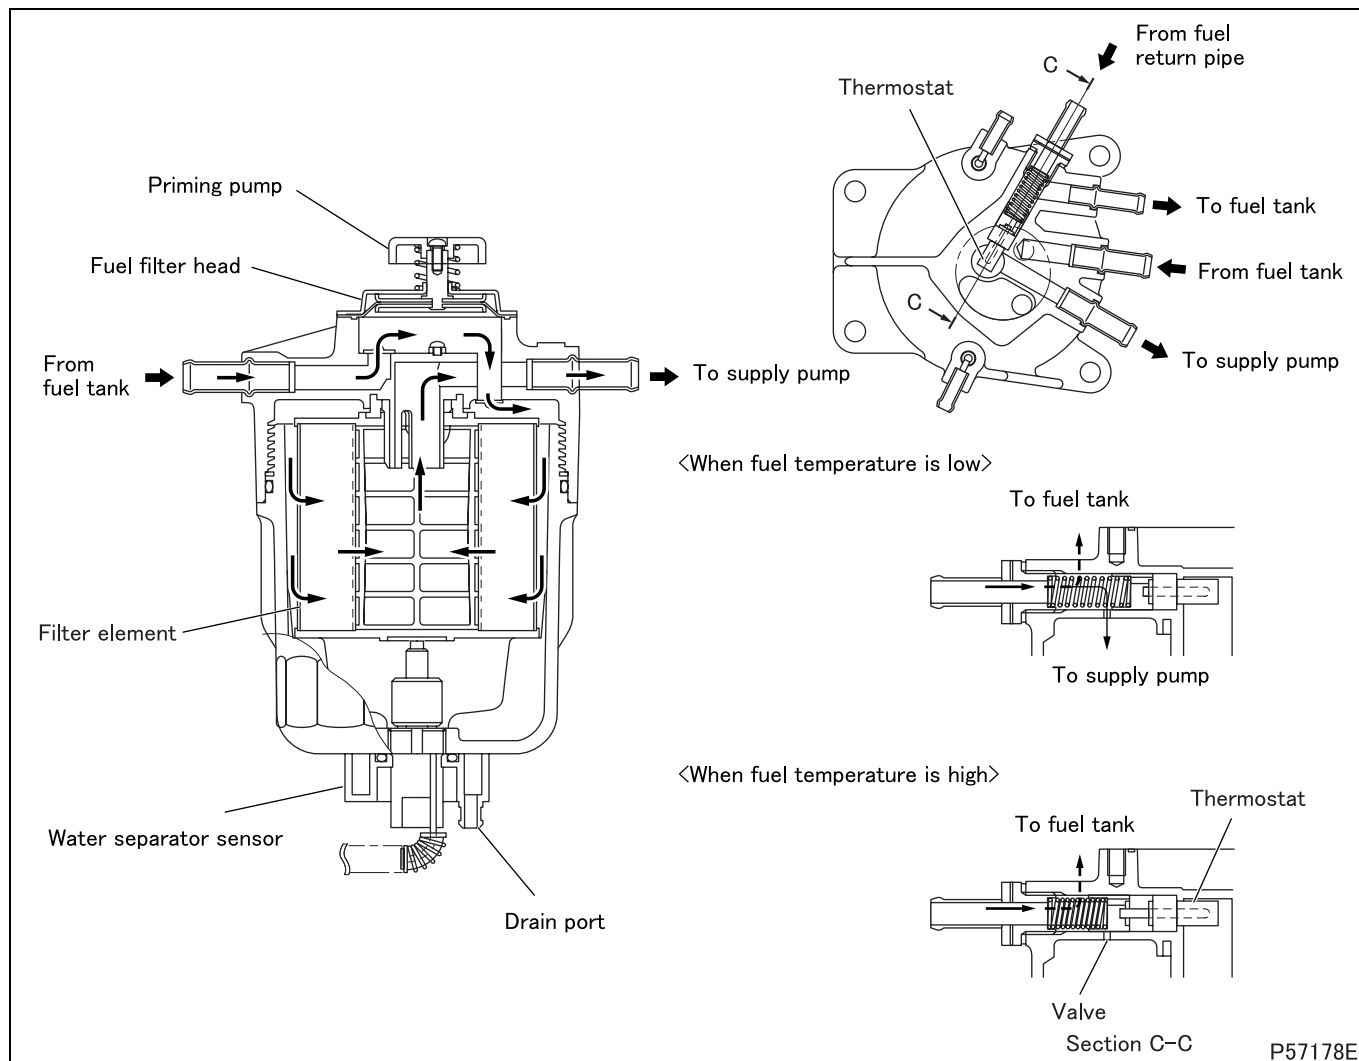
### 3. Fuel Filter

- The fuel filter removes impurities in the fuel through the filter element and also separates water from fuel.
- The water that has been separated from the fuel collects at the bottom of the fuel filter. A water separator sensor is installed in the fuel filter, which activates the warning lamp on the meter cluster when the water reaches a certain level.

- The water can be drained through the drain port by loosening the water separator sensor.
- A priming pump is provided at the fuel filter head. The priming pump is used for air-bleeding the fuel system.

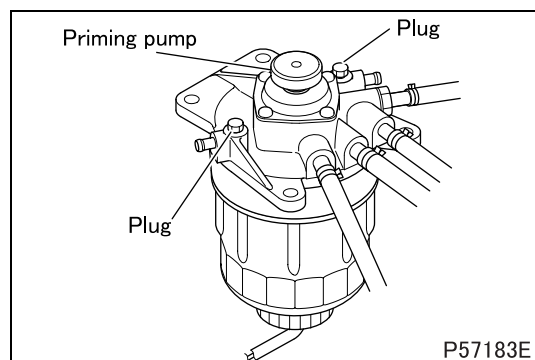
- Loosen one of the plugs on the fuel filter.
- Move the priming pump up and down to pump out the fuel.
- Continue operating the priming pump until the fuel flowing out of the plug is free of air bubbles.
- When no more air bubbles are evident, tighten the plug to the specified torque.
- Feed the fuel some more by operating the priming pump further until a strong resistance is felt.
- When the fuel temperature is low, you may not feel the resistance. Be sure to operate the priming pump several times even in such a case.
- Wipe up any spilled fuel and start the engine.
- Check that there is no fuel leakage.

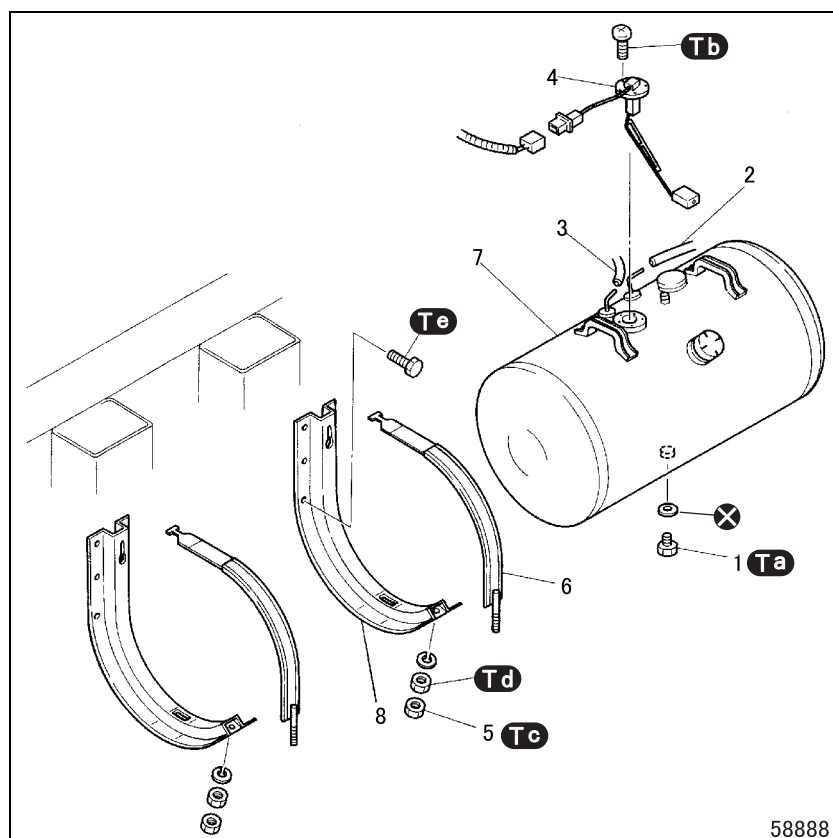
- 1 Drain plug
- 2 Suction hose
- 3 Return hose
- 4 Fuel level sensor
- 5 Lock nut
- 6 Fuel tank band
- 7 Fuel tank
- 8 Fuel tank bracket

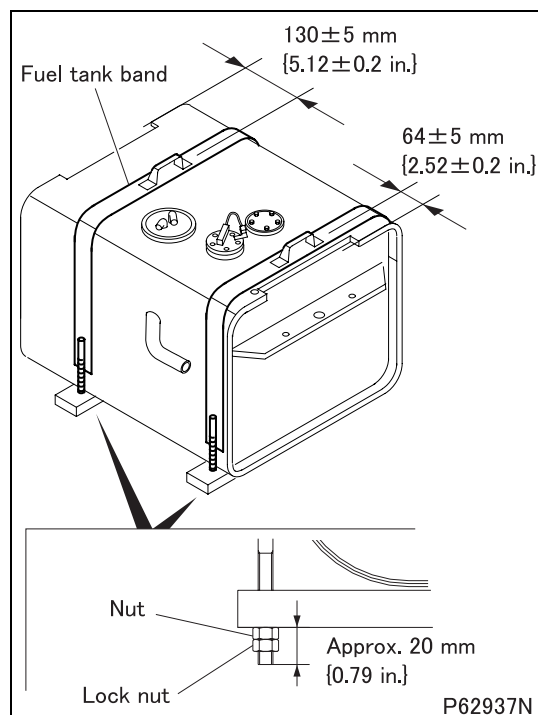
### ■ Installation: Fuel tank band

- Install the fuel tank band so that the position of the band and the protrusion of the band thread is as illustrated.

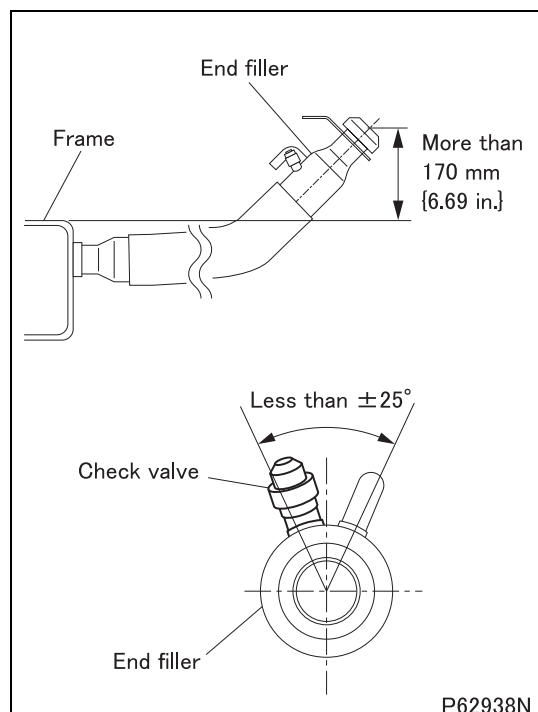
### ■ Installation: End filler

- Install the end filler so that the installing positions of the end filler mouth and the check valve are as illustrated.

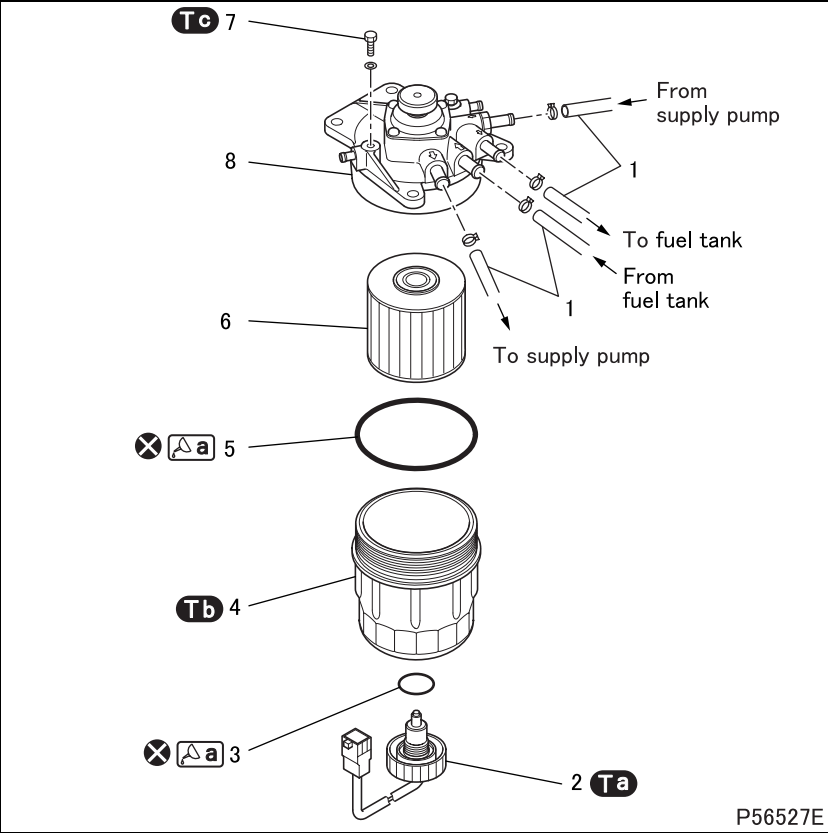
# FUEL FILTER

## Disassembly sequence

- 1 Fuel hose
- 2 Water separator sensor
- 3 O-ring
- 4 Case
- 5 O-ring
- 6 Filter element
- 7 Plug
- 8 Fuel filter head

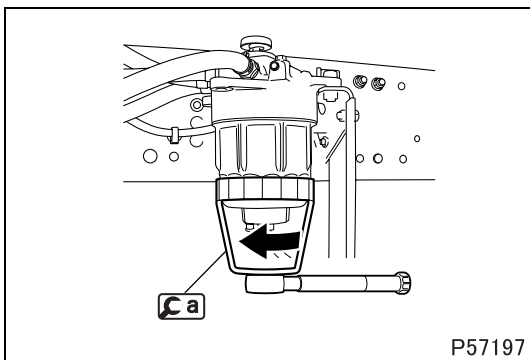
#### ■ Removal: Case

- Loosen the water separator sensor and drain fuel from the case.
- Remove the case using **Ca**.

- Be careful not to damage the case.

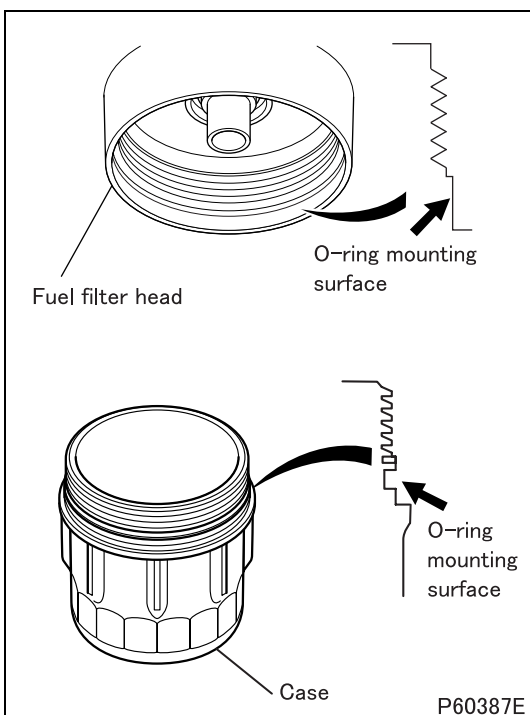
#### ■ Installation: Case

- Clean the O-ring mounting surface of the fuel filter head.

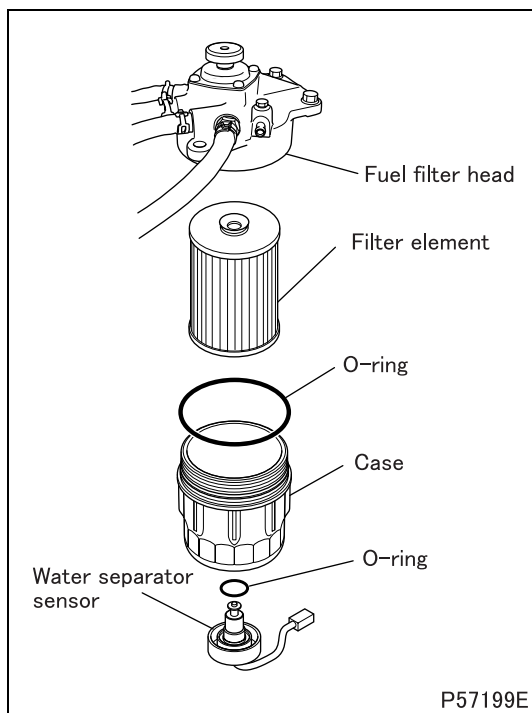
- Replace the filter element and O-ring with new one.
- Apply a thin coat of engine oil to the O-ring, and install it on the case and water separator sensor.

- Replace the filter element and O-ring with new one.
- Apply a thin coat of engine oil to the O-ring, and install it on the case and water separator sensor.

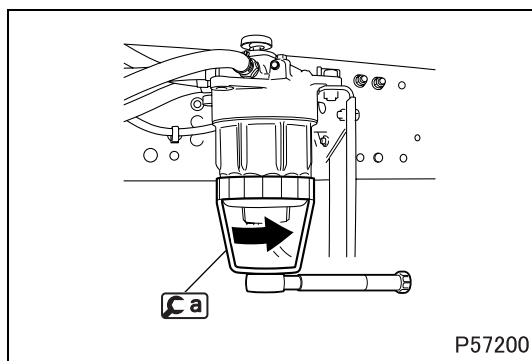
- Use

to tighten the case to the specified torque.
- Install the water separator sensor, and then air-bleed the fuel system.
- Start the engine, and check that there is no fuel leakage.
- Reinstall the fuel filter if there is any leakage.

to tighten the case to the specified torque.
- Install the water separator sensor, and then air-bleed the fuel system.
- Start the engine, and check that there is no fuel leakage.
- Reinstall the fuel filter if there is any leakage.

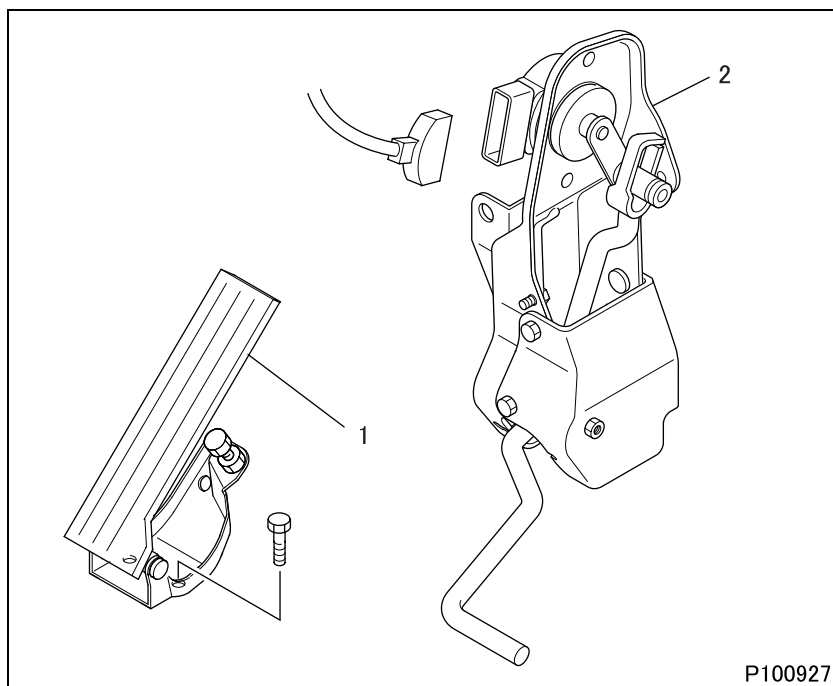
# ENGINE CONTROL

## ● Removal sequence

- 1 Accelerator pedal (See later sections.)
- 2 Accelerator link (See later sections.)

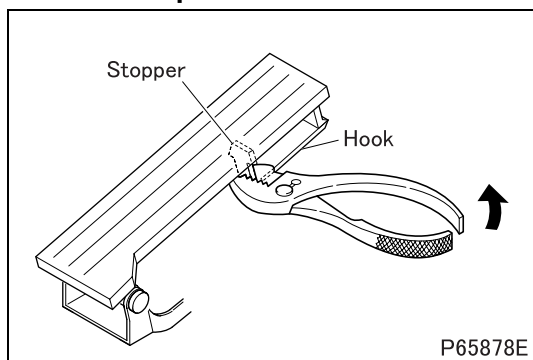
### ■ Removal: Accelerator pedal

- Using pliers, pinch the hook of the stopper on the accelerator pedal. Separate the stopper from the pedal while turning the hook by about 15 degrees.

- Do not yank on the stopper, as this may damage it.

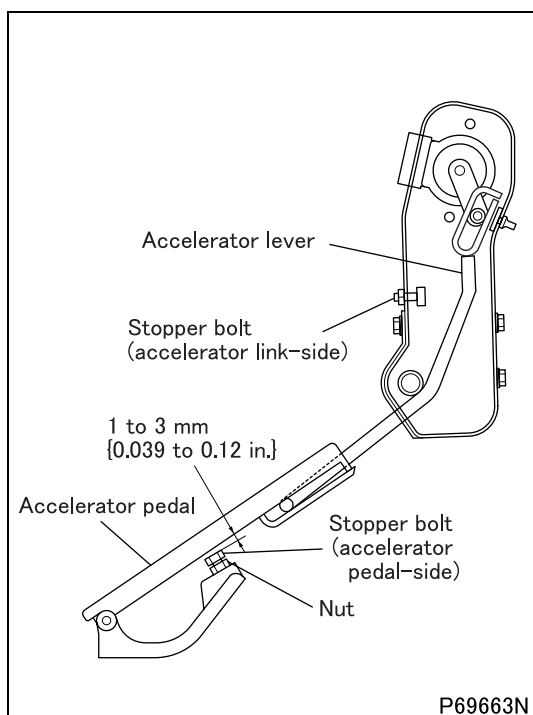
### ■ Installation: Accelerator pedal

- Press the accelerator pedal until the accelerator lever touches the accelerator link stopper bolt.
- Check that the clearance between the stopper and the stopper bolt contact surface of the pedal is as indicated in the illustration.
- If the clearance is not within the indicated value range, adjust the stopper bolt and lock it with the nut.

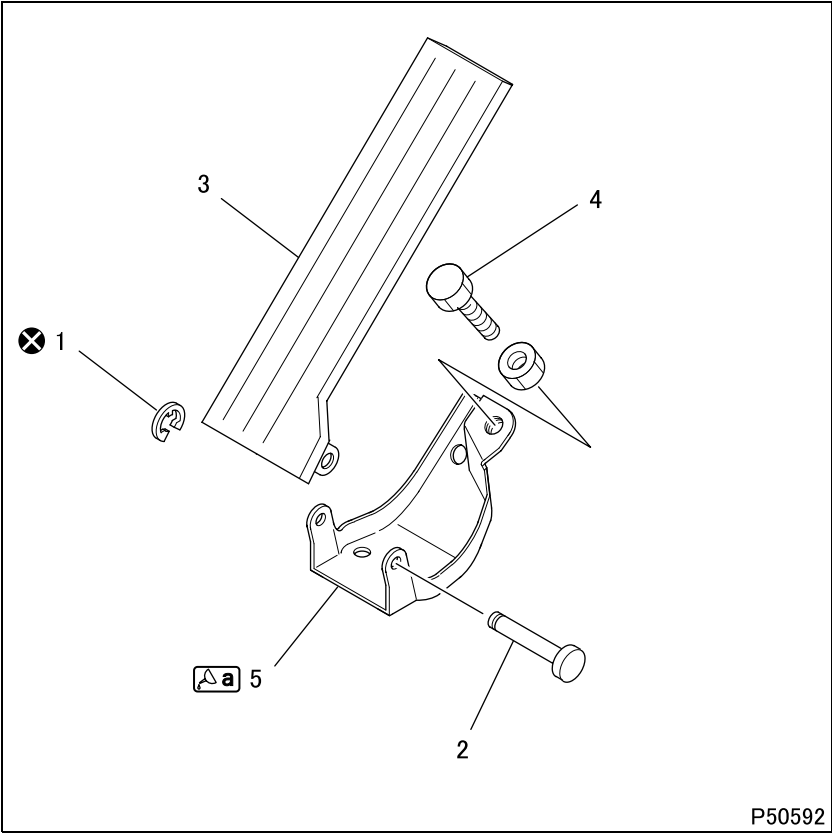
Accelerator Pedal

● Disassembly sequence

- 1 E-ring
- 2 Clevis pin
- 3 Accelerator pedal
- 4 Stopper bolt
- 5 Accelerator pedal bracket

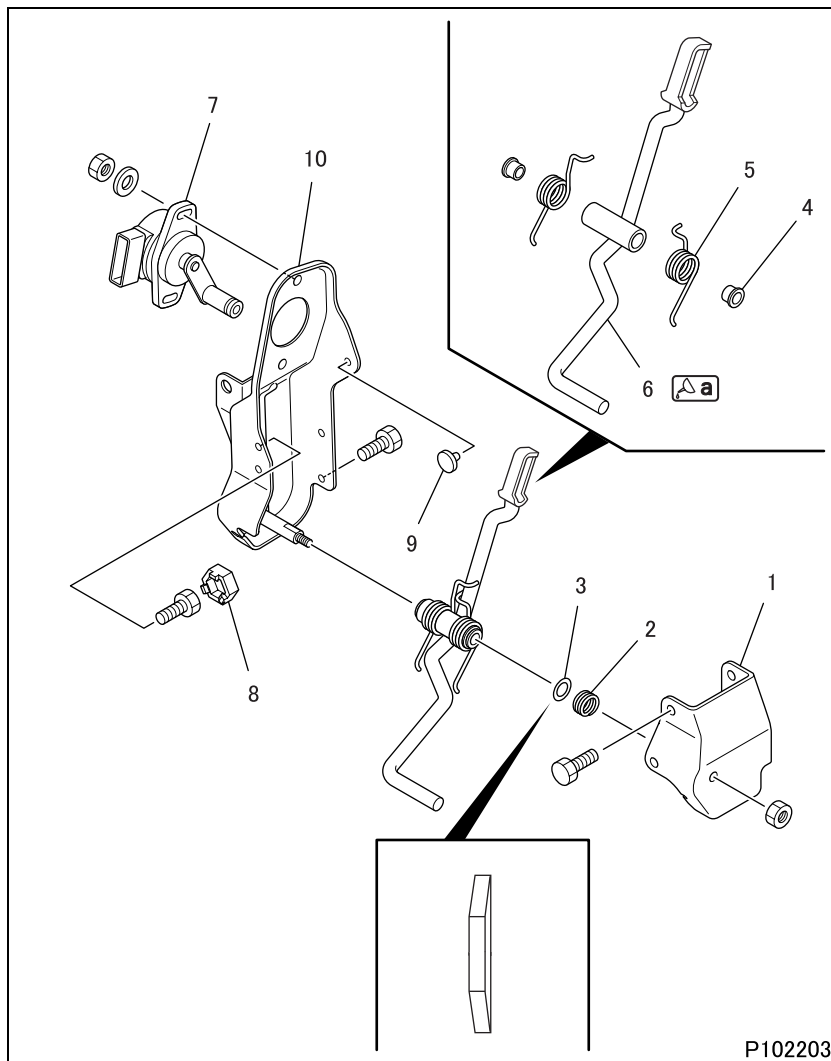
## Accelerator Linkage

### ● Disassembly sequence

- 1 Cover
- 2 Spring
- 3 Washer
- 4 Bushing
- 5 Return spring
- 6 Accelerator lever
- 7 Accelerator position sensor and  
accelerator switch assembly
- 8 Lever stopper
- 9 Rubber stopper
- 10 Accelerator link bracket

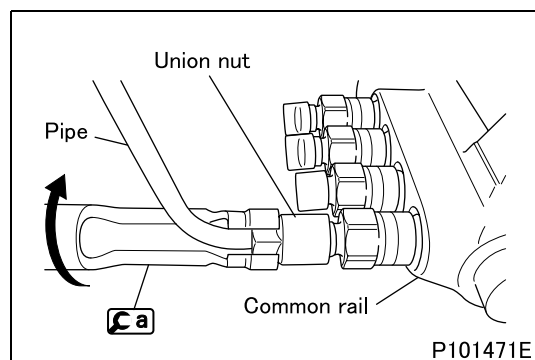
**■ Removal: Injection pipe and fuel pipe**

- Position

**a** on the pipe and then loosen the union nut.

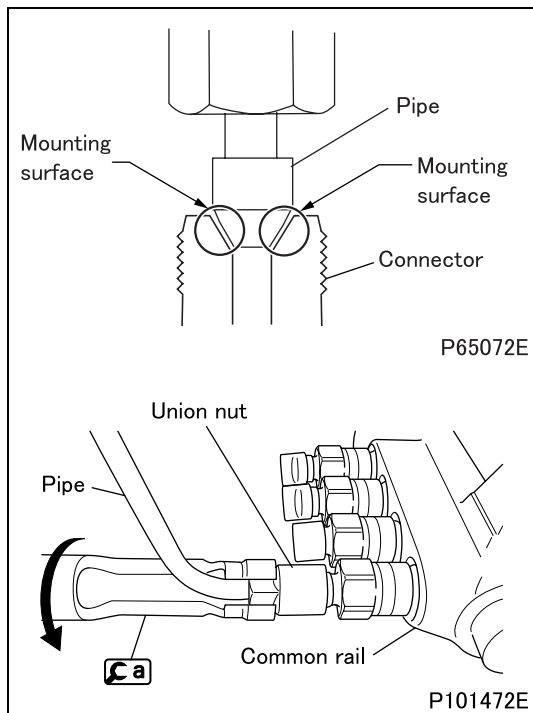
### ■ Installation: Injection pipe and fuel pipe

- Ensure that the pipe and mounting surfaces of the connector are flat and free from damage.
- Bring the pipe into intimate contact with mounting surfaces of the connector evenly, and temporarily tighten it without applying an excessive force.
- After temporary tightening, position the torque wrench on

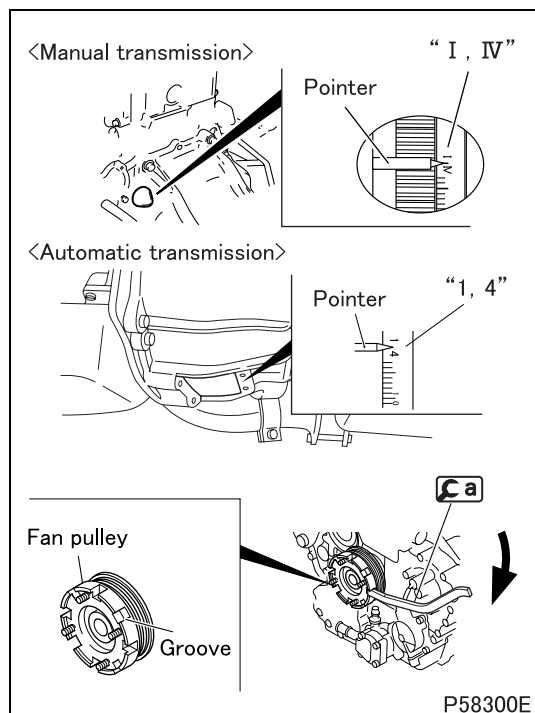
■ **Installation: Supply pump**

- Remove the rocker cover.
- Bring the No. 1 cylinder piston to the top dead center (TDC) on the compression stroke by the following procedure:
- Hook **Ca** on a groove in the fan pulley.
- Turn the fan pulley in the illustrated direction so that the pointer is aligned with the “I, IV” or “1” to “4” mark on the inscribed scale on the flywheel.
- This will place either the No. 1 or No. 4 cylinder piston at TDC on the compression stroke. The cylinder in which the rocker arms for both the intake and exhaust valves can be pushed down by hand by the valve clearance amounts has its piston at TDC. Rotate the engine by one full turn to switch the TDCs of the No. 1 and No. 4 cylinder pistons.

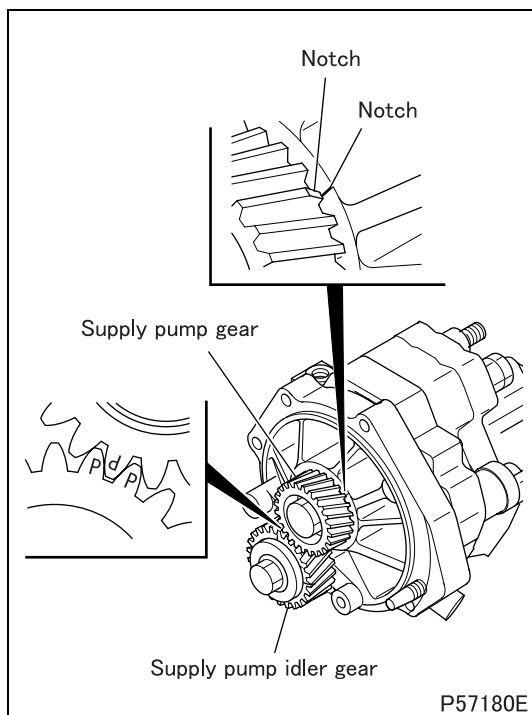
- Align the match mark “P” on the supply pump idler gear with that of the supply pump gear.
- Align the notch on the flange plate with the notch on the supply pump gear.
- Check that the notch on the flange plate and the notch on the supply pump gear are correctly aligned, and then push the supply pump.

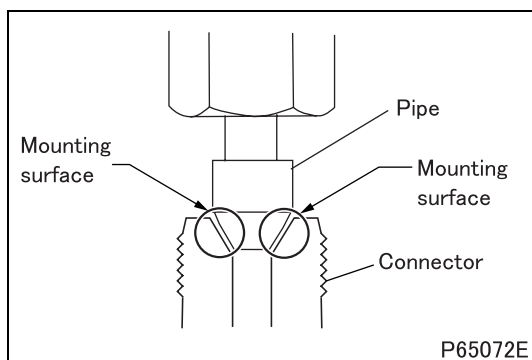
## ■ Installation: Fuel pipe

- Ensure that the pipe and mounting surfaces of the connector are flat and free from damage.
- Bring the pipe into intimate contact with mounting surfaces of the connector evenly, and temporarily tighten it without applying an excessive force.
- Tighten it to the specified torque after temporary tightening.

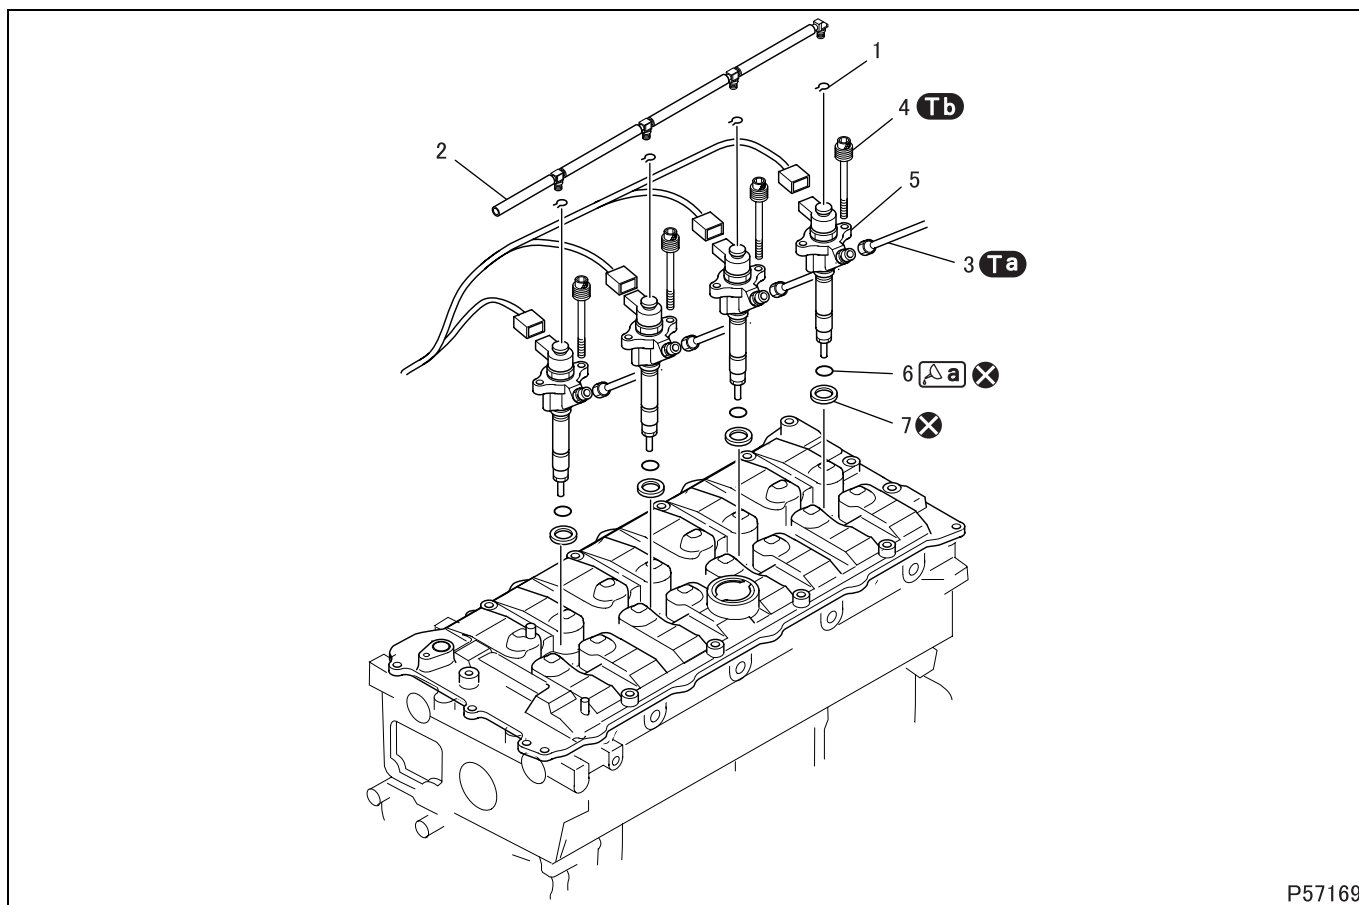
# INJECTOR

## ● Disassembly sequence

- 1 Snap ring
- 2 Fuel return hose
- 3 Injection pipe
- 4 Bolt (with hexagonal hole)

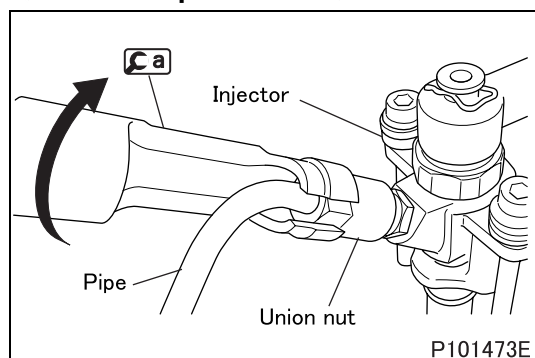
### ■ Removal: Injection pipe

- Position

**a** on the pipe and then loosen the union nut.

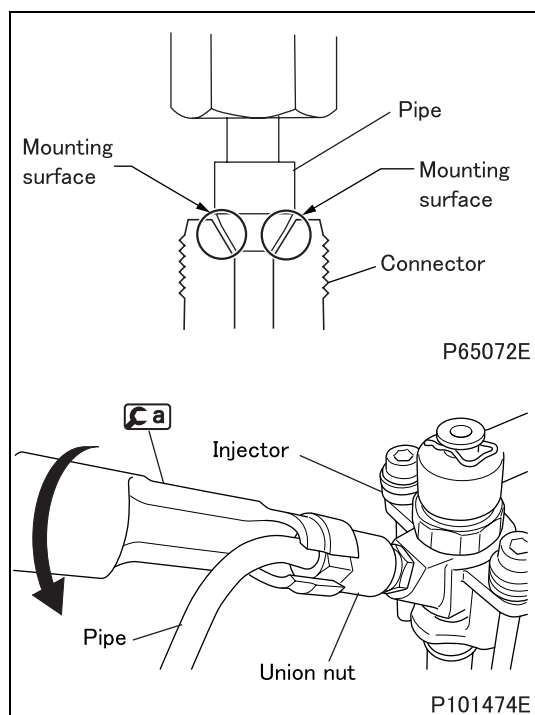
### ■ Installation: Injection pipe

- Ensure that the pipe and mounting surfaces of the connector are flat and free from damage.
- Bring the pipe into intimate contact with mounting surfaces of the connector evenly, and temporarily tighten it without applying an excessive force.
- After temporary tightening, position the torque wrench on **Ca** and then tighten them to the specified torque.

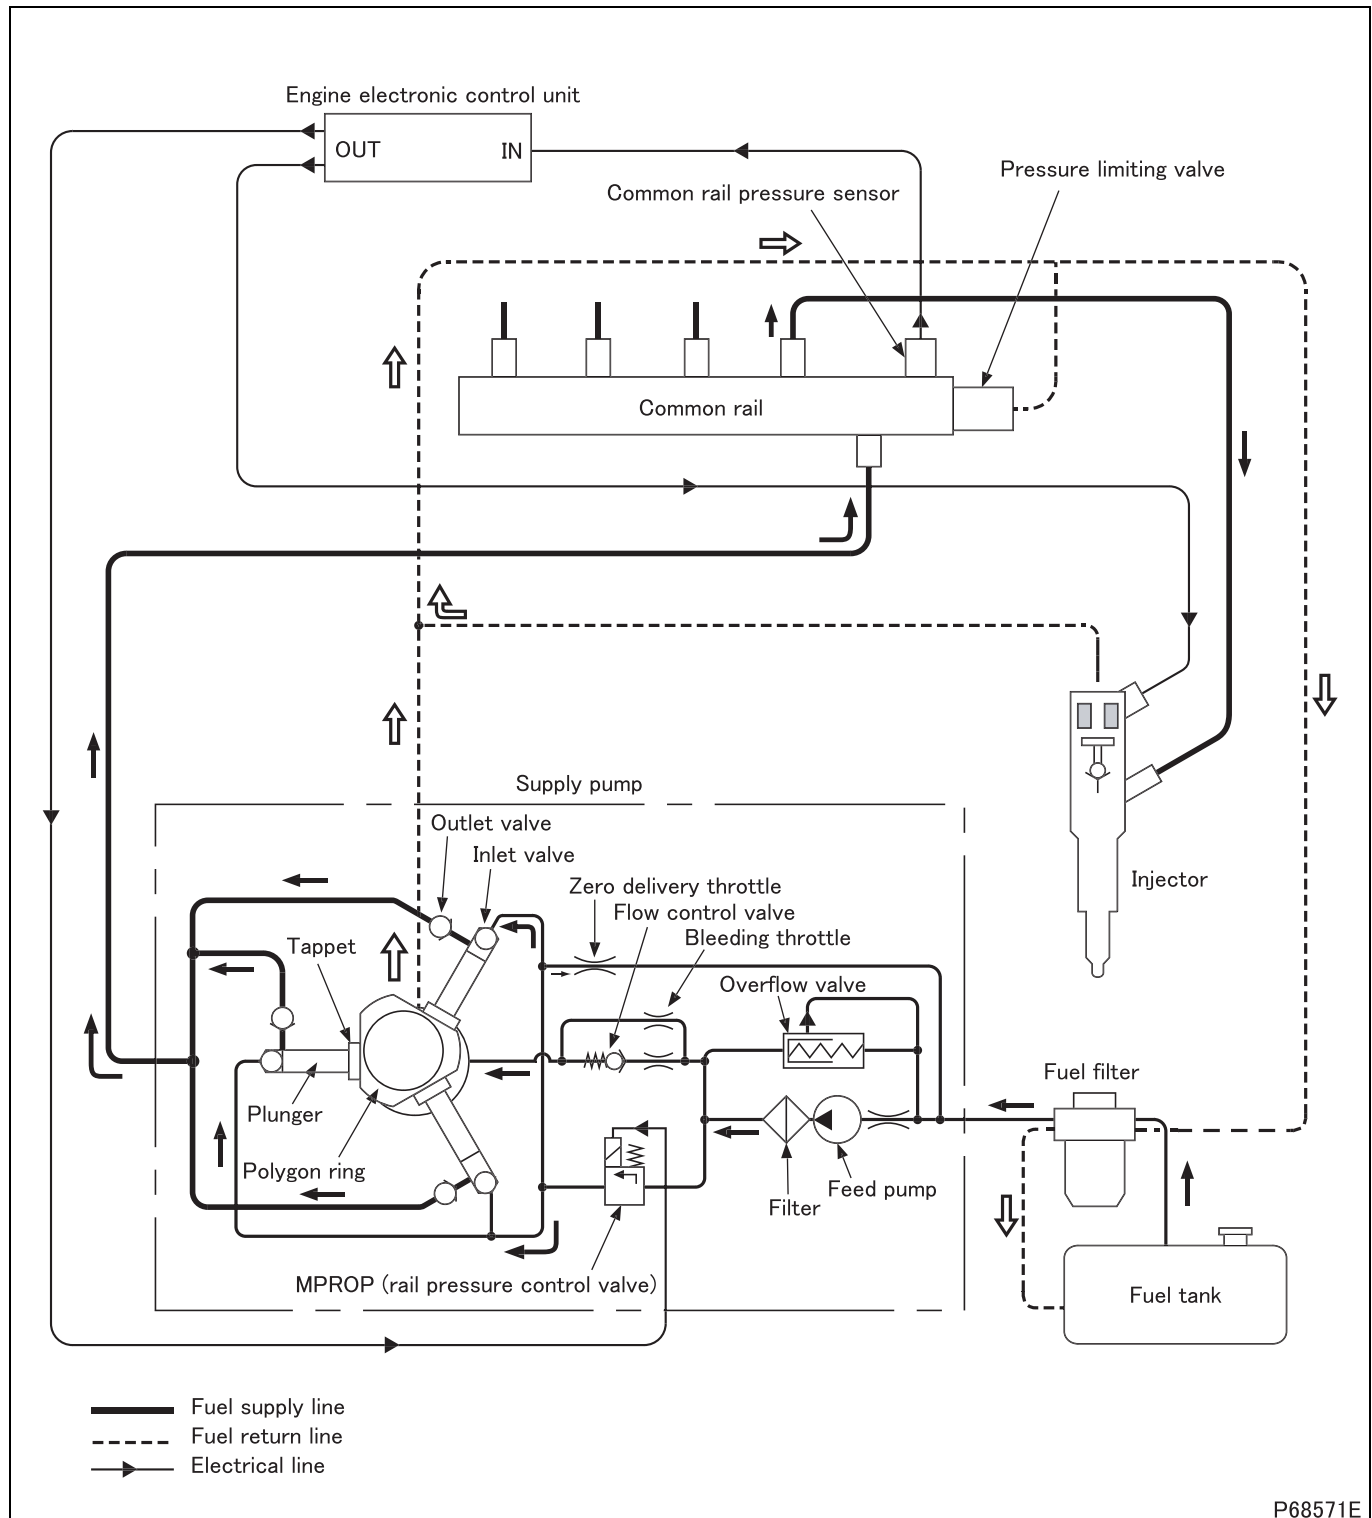
- When the engine is cranked by means of the starter switch, the feed pump (this is located inside the supply pump) simultaneously draws fuel from the fuel tank and feeds it via the fuel filter to the MPROP (rail pressure control valve). A quantity of fuel metered by the MPROP is supplied via the inlet valves to the plunger chambers.
- The fuel in the plunger chambers is pressurized. The outlet valves are then opened, and the fuel is fed under pressure to the common rail.
- The pressurized fuel is held in the common rail and then uniformly fed to the injectors.
- In response to signals from the engine electronic control unit, a magnetic valve in each injector causes the injector to inject fuel into the relevant combustion chamber at the optimal timing and in the optimal quantity.

- In the common rail system, an electronic control unit monitors various aspects of the engine (engine speed, throttle opening, coolant temperature, etc.) using information from sensors. In accordance with these data, the electronic control unit effects control over the fuel injection quantity, fuel injection timing, and fuel injection pressure in order to optimize the engine's operation.
- The electronic control unit has a diagnosis function that enables it to recognize abnormalities in the common rail system's major components and alert the driver to them.
- The common rail system consists mainly of an electronically controlled supply pump; injectors; a common rail; and the electronic control unit and sensors that are used to control the other components.

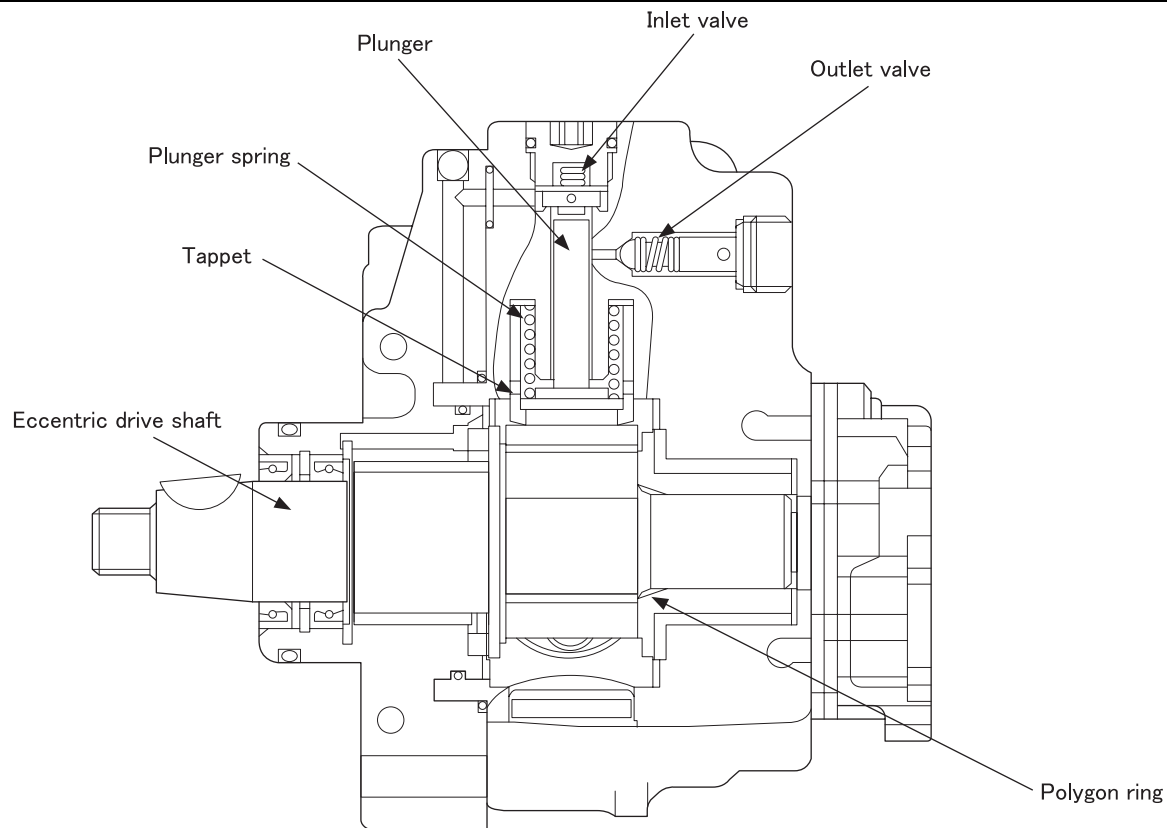
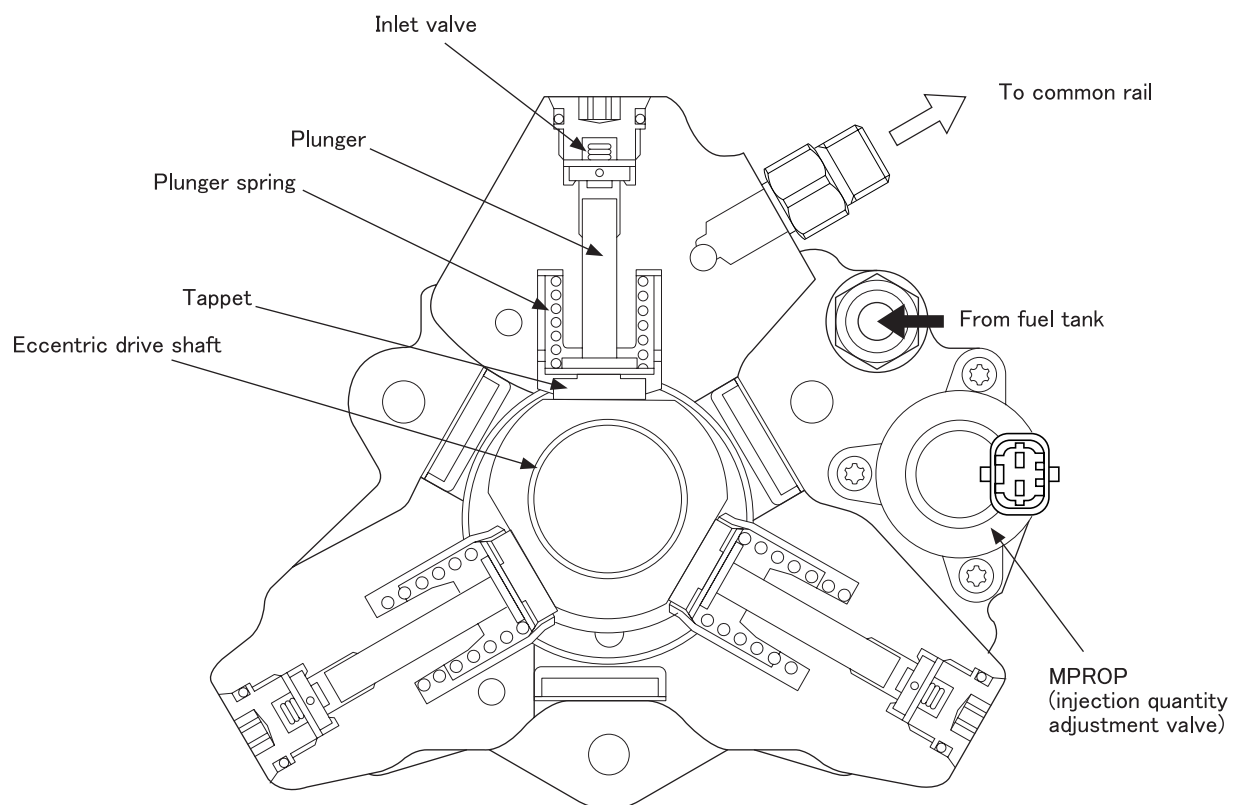
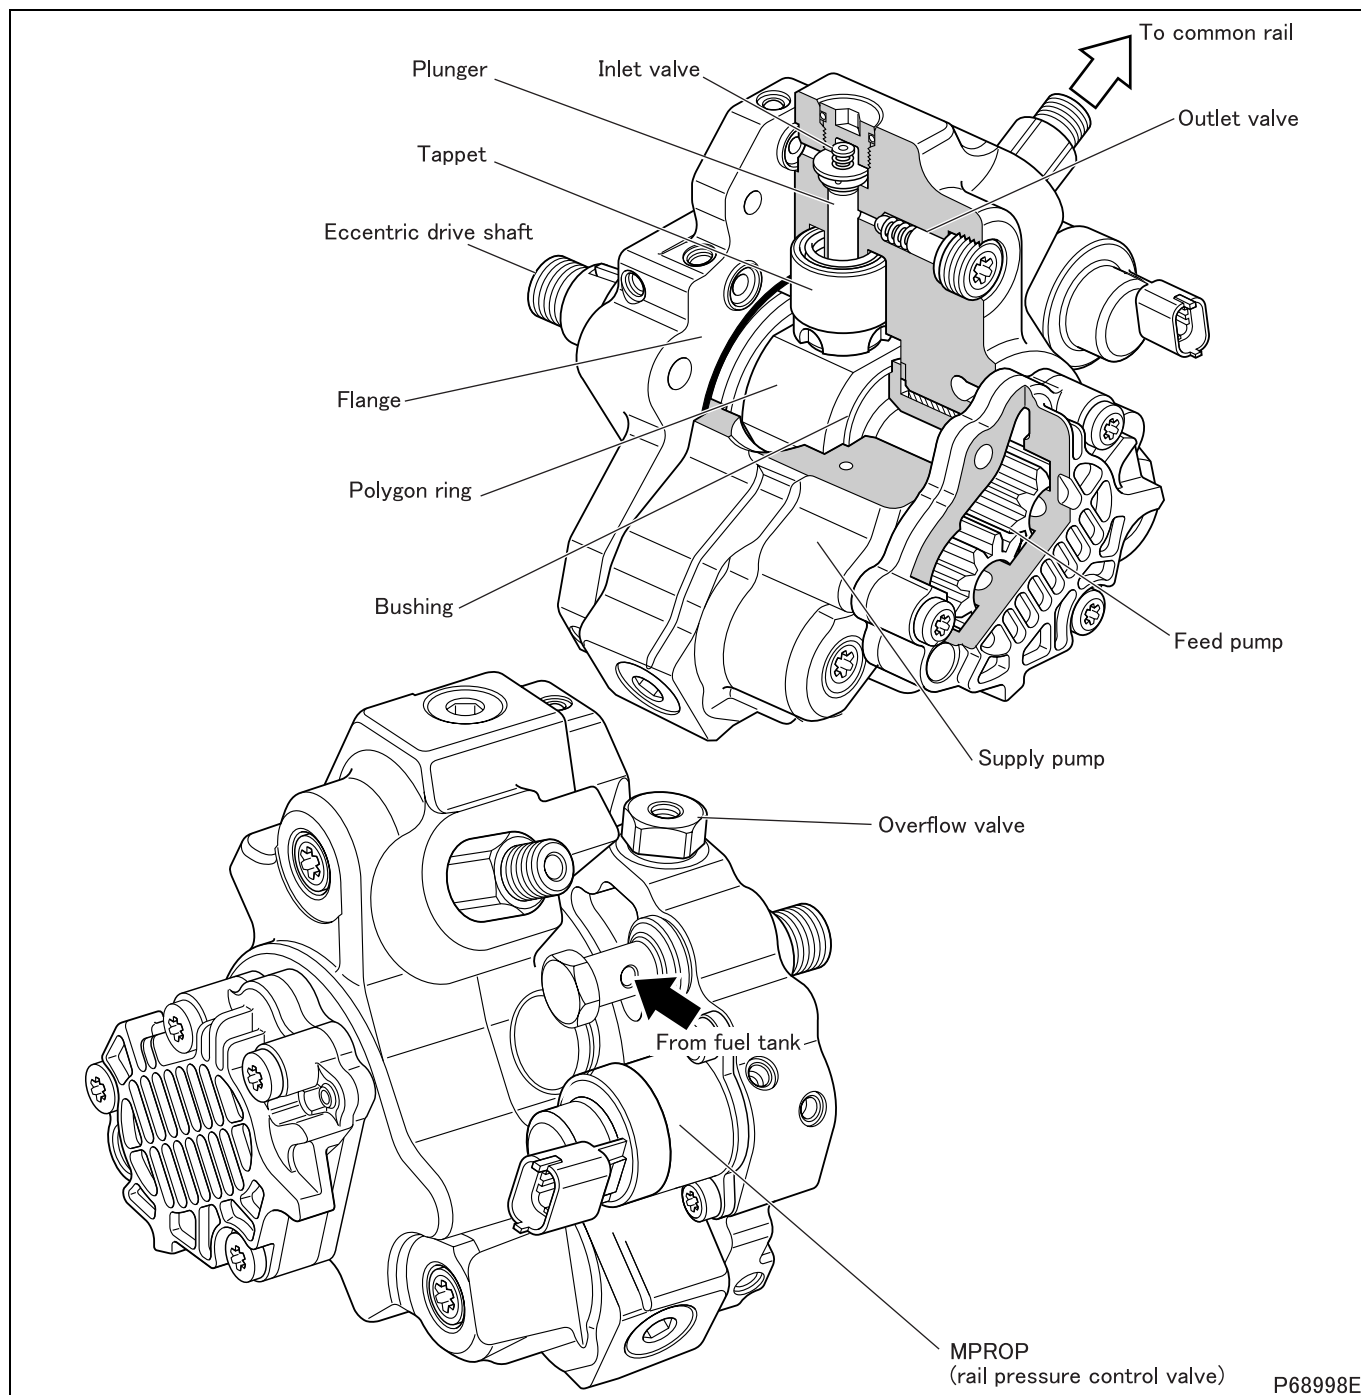
## 1.1 Supply pump

- The supply pump pressurizes fuel and supplies it in a highly pressurized state.
- Fuel drawn from the fuel tank by the feed pump is not supplied directly to the plungers. It is supplied first to the MPROP (rail pressure control valve), which controls the amount of fuel reaching the plungers.
- If the fuel pressure exceeds a certain level, the overflow valve returns fuel to the inlet side of the feed pump. This operation keeps the fuel pressure constant.
- Rotation of the eccentric drive shaft causes (via the tappets) up-down movement of the plungers. Fuel in the plunger chambers is thus highly pressurized.

- **Be sure to connect the MPROP (rail pressure control valve) connector to the engine harness before starting the engine. If the engine were started with the MPROP connector not connected, control of the supply pump by the engine electronic control unit would not be possible and a fault would ensue.**

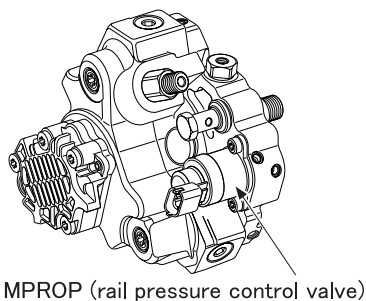
MPROP (rail pressure control valve)

- The MPROP receives fuel from the feed pump and feeds fuel toward the plungers of the supply pump in such a quantity that the fuel pressure corresponds to that required by the engine electronic control unit.
- When the MPROP is not operating, i.e., when current is not flowing, fuel flows at its maximum rate. When current flows, the piston in the MPROP is pressed down such that fuel is not fed toward the plungers.

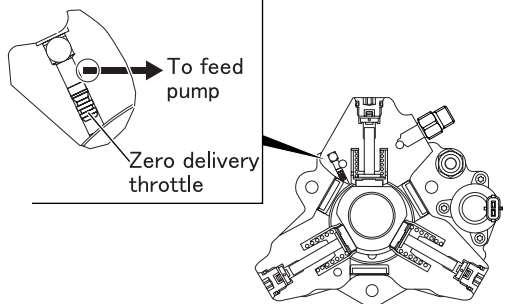
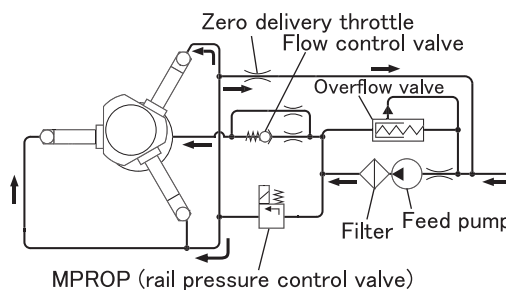
### (2) Zero delivery throttle

- A small amount of fuel can flow through the MPROP (rail pressure control valve) even when no fuel is to be supplied. The zero delivery throttle prevents this fuel flow by returning the fuel to the inlet port side of the feed pump to zero the fuel delivery to the plunger.

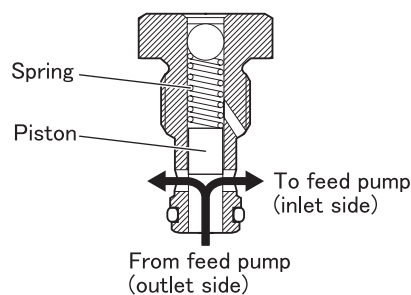
### (3) Overflow valve

- The overflow valve limits the pressure of the fuel sent from the feed pump to the predetermined level.
- When fuel pressure exceeds the predetermined level, it overcomes the spring force of the overflow valve to move the piston, returning the fuel to the inlet side of the feed pump. The fuel which has overflowed enters into the eccentric drive shaft chamber to lubricate the parts in the chamber.

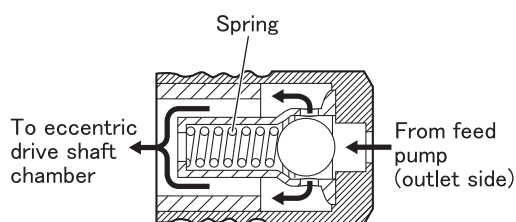
### (4) Flow control valve

- The flow control valve sends the fuel from the feed pump into the eccentric drive shaft chamber for lubrication of parts in the chamber.
- When the revolution of the feed pump increases, fuel pressure also increases. It overcomes the spring force of the flow control valve to move the ball, sending the fuel to the eccentric drive shaft chamber for lubrication of parts in the chamber.

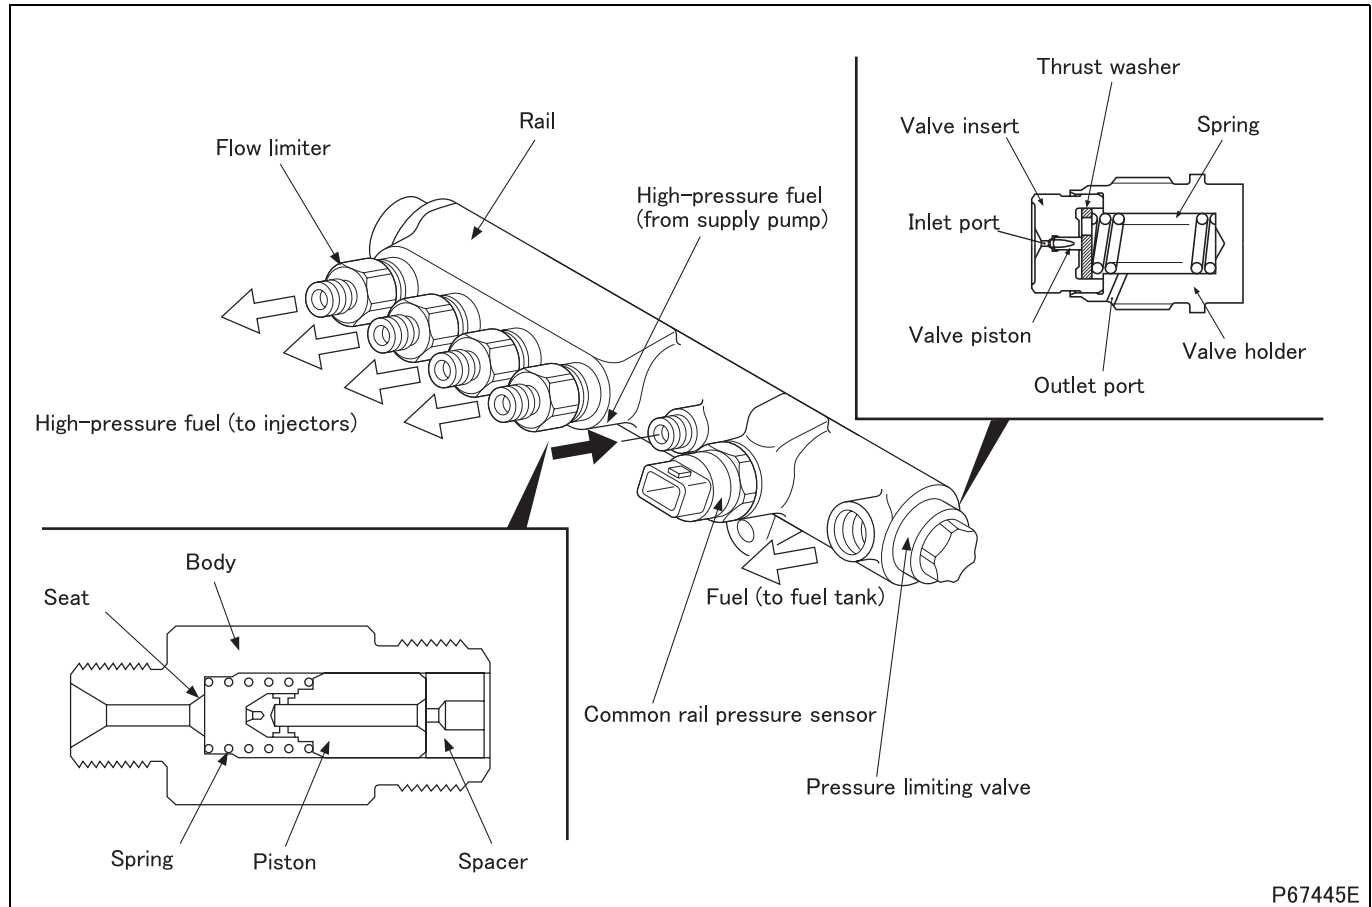
P67445E

## 1.2 Common rail

- The common rail distributes to the injectors high-pressure fuel that has been fed from the supply pump.
- Each flow limiter prevents an abnormal outflow of fuel. It does so by blocking the fuel passage in the event of fuel leakage from the injection pipe or excessive injection of fuel from the injector.
- The common rail pressure sensor is used in feedback control. It senses the fuel pressure inside the common rail and feeds a corresponding signal to the electronic control unit.
- If the fuel pressure in the common rail exceeds a certain, set level, the piston in the pressure limiting valve pushes and compresses the spring such that fuel is able to escape. The pressure limiting valve thus prevents the fuel pressure from becoming higher than the set pressure.
