# FE.FG

## SERVICE MANUAL 2008 Model FOREWORD

This Service Manual contains maintenance and repair methods for the Mitsubishi Fuso Truck FE. FG Series. Read this manual carefully as an aid in providing correct, efficient maintenance. Please note that the information and specifications contained within this manual may change without notice. This is due to product modifications and continued vehicle improvements that are made throughout the model years. Should you encounter any discrepancy in the information provided, please do not hesitate to contact your nearest Mitsubishi Fuso Dealer or Mitsubishi Fuso Truck of America, Inc.

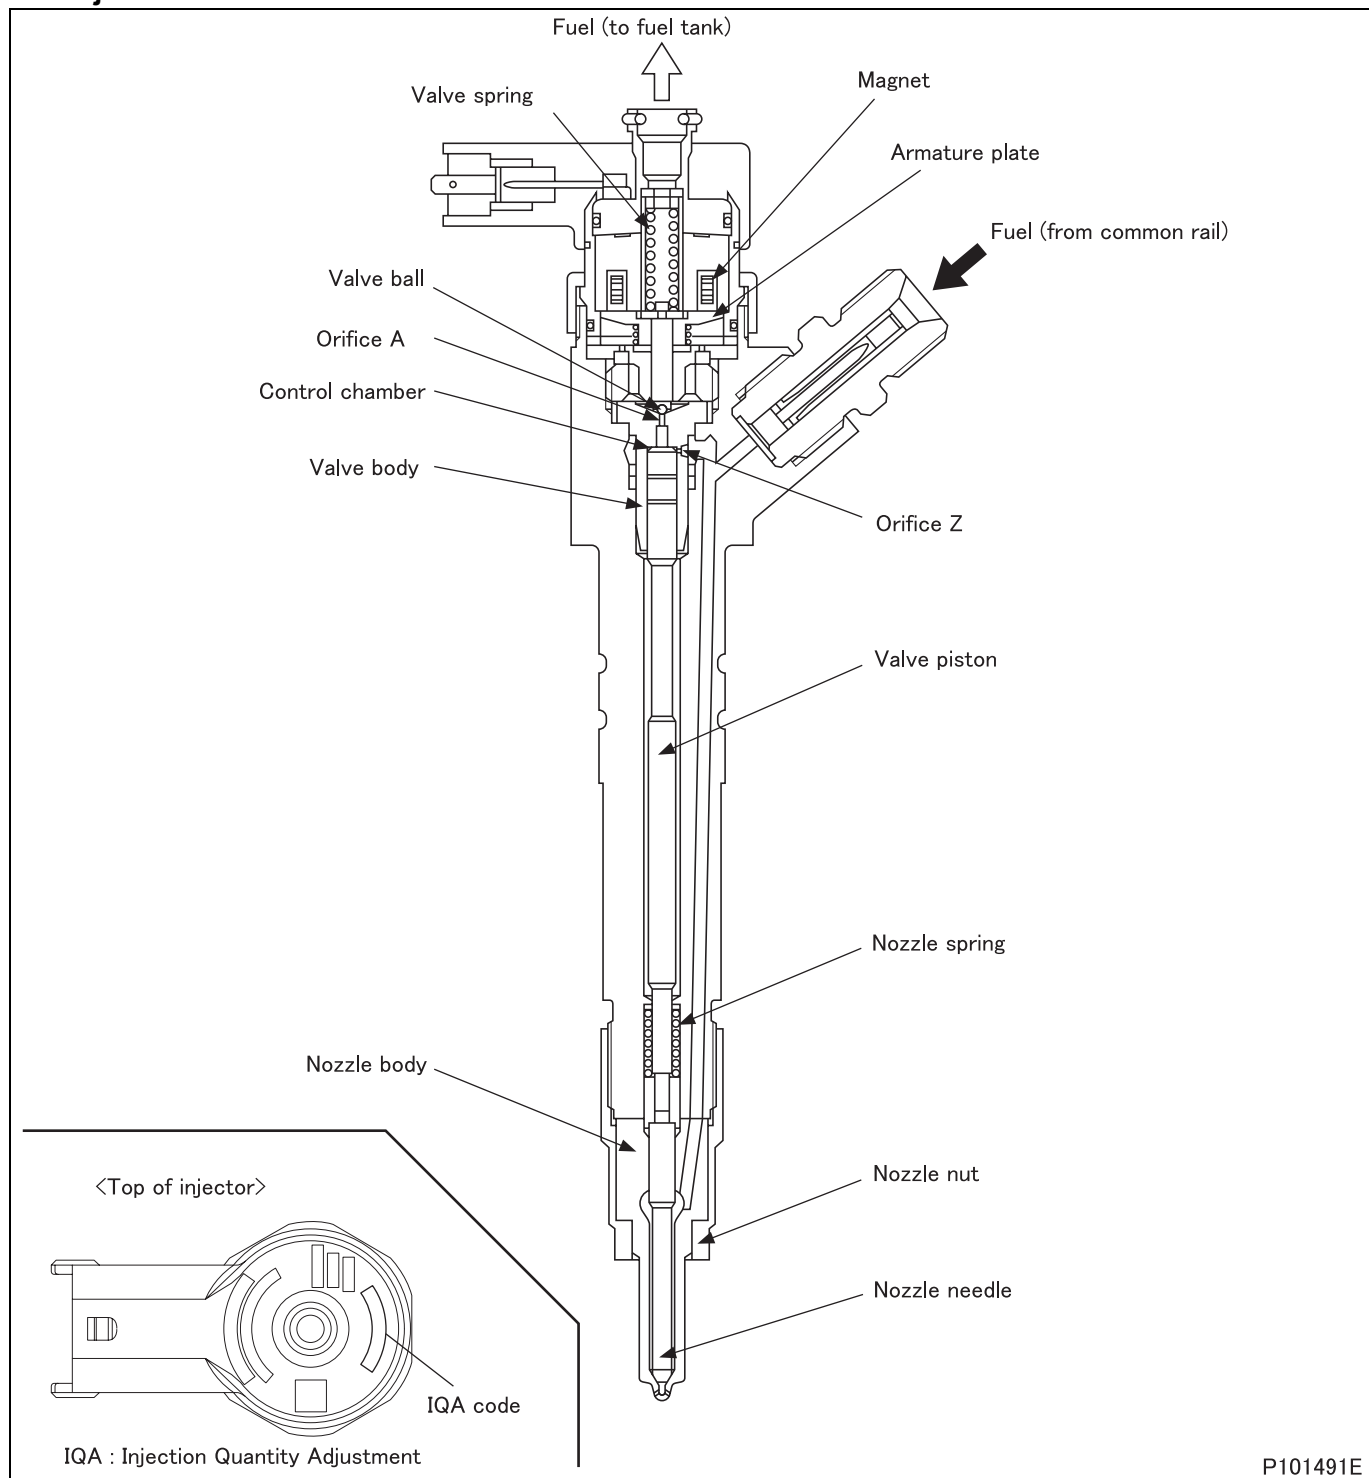
### 1.3 Injector

- In accordance with electrical signals from the engine electronic control unit, the injector supplies high-pressure fuel from the common rail to the relevant combustion chamber of the engine at the optimal timing and in the optimal quantity.
- The injector is divided into the control section and injector section.
  - The control section consists of the control chamber, magnet, spring, armature plate, valve ball, valve body, valve piston, orifice A, and orifice Z. The valve piston is located between the control section and the injector section.
  - The injector section consists of the nozzle body, nozzle needle, nozzle spring, and nozzle nut.
- On the top of the injector is marked the IQA (Injection Quantity Adjustment) code for entry of injector correction data into the engine electronic control unit.
- The fluctuation of each injector in injection quantity is thereby restrained.

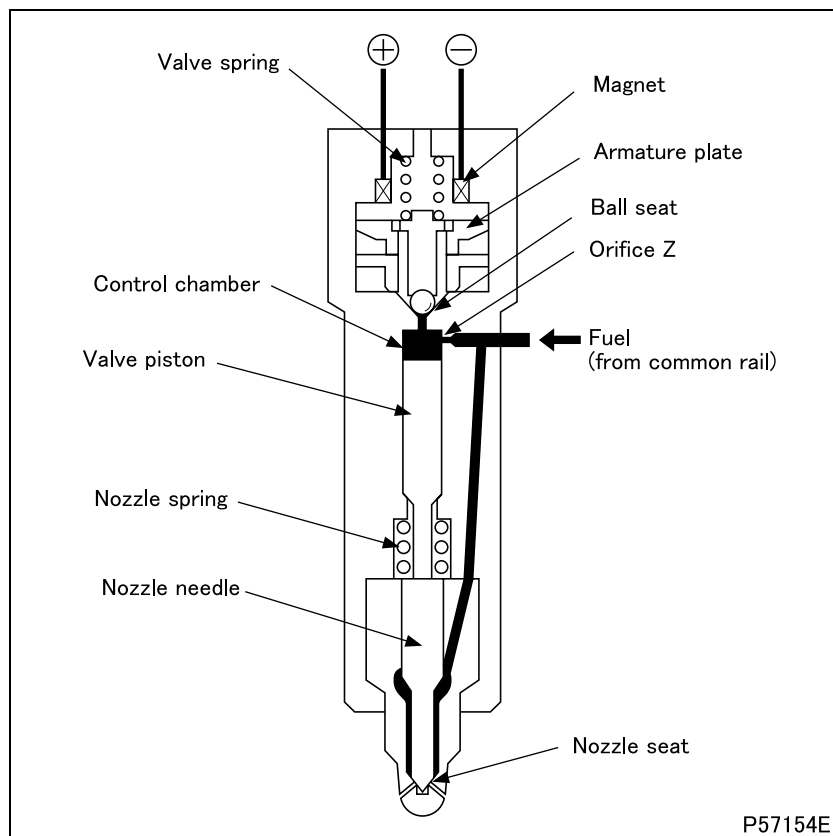
### (1.1) Injection not taking place

- With the magnet not energized, the armature plate is pushed up by the valve spring such that the ball seat is closed.
- The high-pressure fuel acts upon the control chamber via orifice Z. The same pressure acts upon the nozzle needle.
- The fuel pressure acting on the nozzle needle cannot overcome the valve piston and nozzle spring, so the nozzle needle stays in its downward-pushed position and injection does not take place.

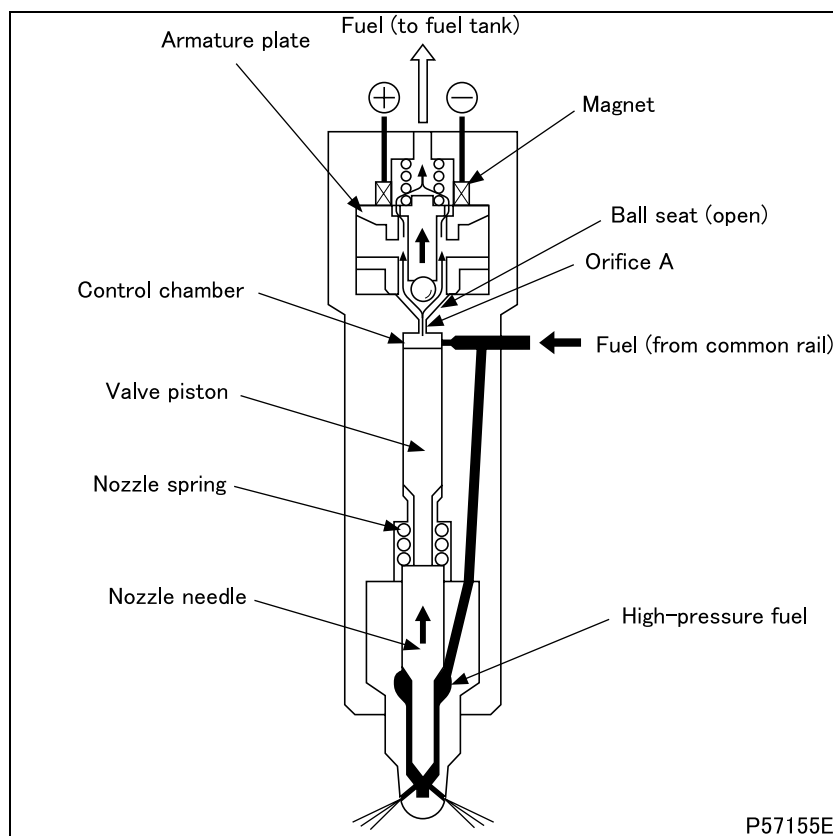
### (1.2) Start of injection

- When the magnet is energized, the resulting electromagnetic force draws the armature plate upward, causing the ball seat to open.
- Fuel in the control chamber passes through the ball seat and orifice A and flows to the fuel tank.
- With the pressure in the control chamber reduced, the fuel acting on the nozzle needle overcomes the valve piston and nozzle spring, pushing up the nozzle needle such that injection starts.
- If the magnet remains energized, the injection rate reaches its maximum level.

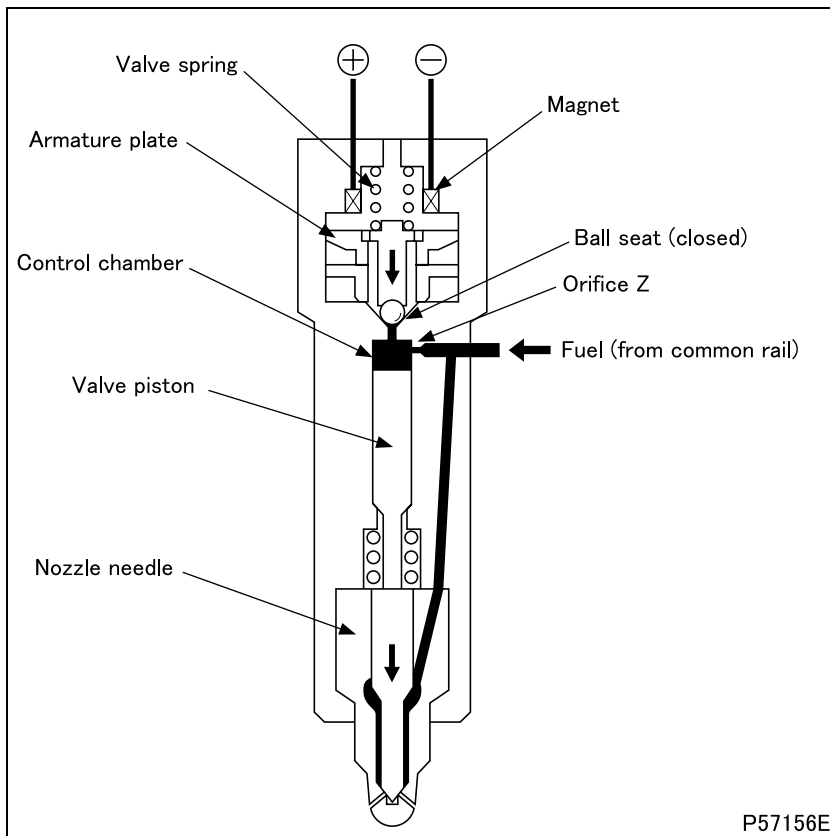
### (1.3) End of injection

- When energization of the magnet is stopped, the armature plate is pushed downward by the valve spring such that the ball seat closes. At this time, fuel flows into the control chamber via orifice Z, pushing down the valve piston and nozzle needle such that injection finishes.

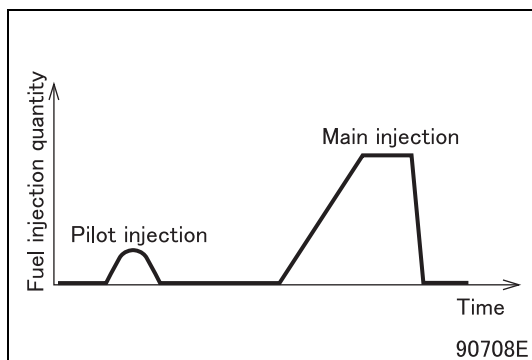
### (1) Pilot injection

- Pilot injection entails the injection of an extremely small amount of fuel ahead of the main injection.
- Pilot injection suppresses heat generation early in the injection cycle and thus suppresses NOx generation and noise at the start of combustion.

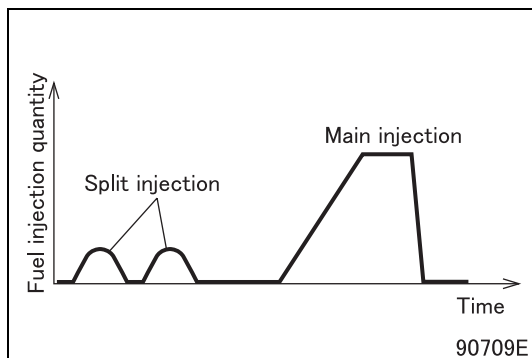
### (2) Split injection control

- Split injection entails the injection of an extremely small amount of fuel two or more times ahead of the main injection.
- Split injection increases the fuel's combustibility and thus enhances the engine's cold startability.

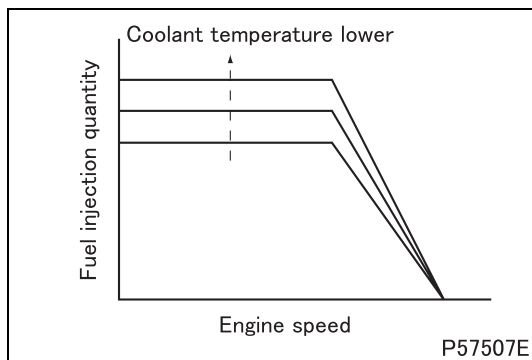
### (1) Fuel injection quantity during engine startup

- During engine startup, the fuel injection quantity is determined in accordance with the engine speed and coolant temperature.

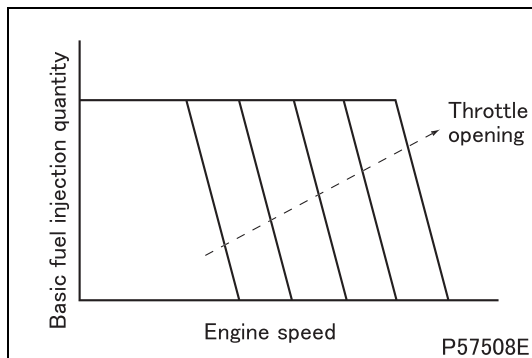
### (2) Basic fuel injection quantity

- The basic fuel injection quantity is determined in accordance with the engine speed and throttle opening.

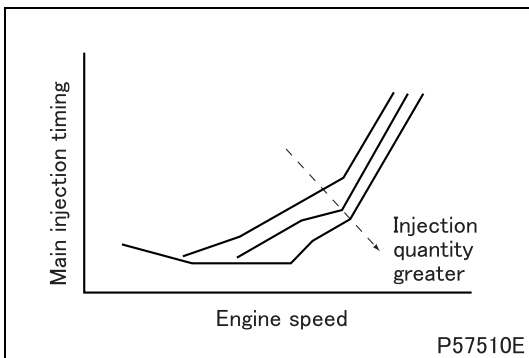
#### (1) Main injection timing

- The main injection timing is calculated from the fuel injection quantity and engine speed.

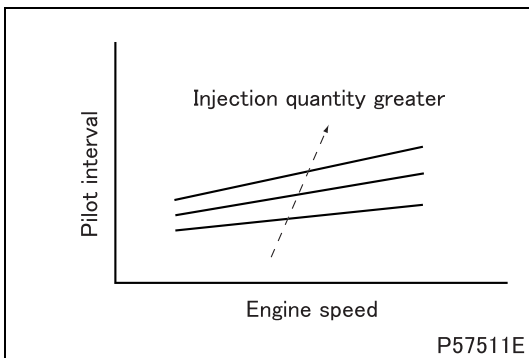
#### (2) Pilot injection timing (pilot interval)

- The pilot interval is calculated from the fuel injection quantity and engine speed.

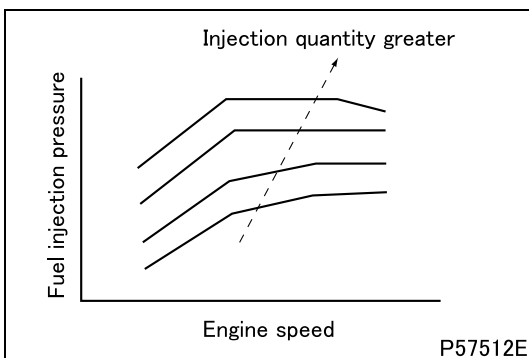
### 2.5 Fuel injection pressure control

- The fuel injection pressure is calculated from the fuel injection quantity and engine speed.

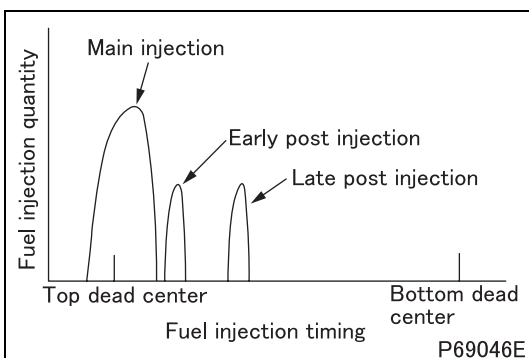
### 2.6 Fuel injection control for DPF regeneration

- Fuel injection control for diesel particulate filter regeneration is performed in such a way, with early post injection and late post injection added after conventional fuel injection (main injection), exhaust gas temperature is increased to burn out particulate matter (PM) collected in the DPF.

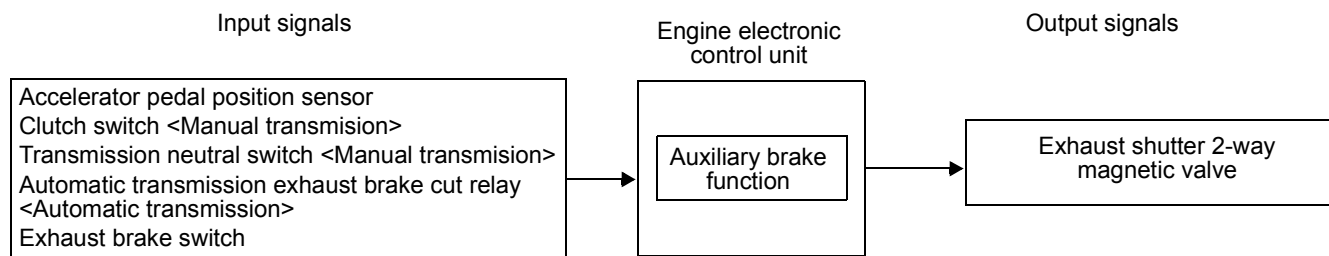
## 2.7 Auxiliary brake function

- The auxiliary brake function activates or deactivates the exhaust shutter 2-way magnetic valve according to the vehicle condition to control the exhaust brake.

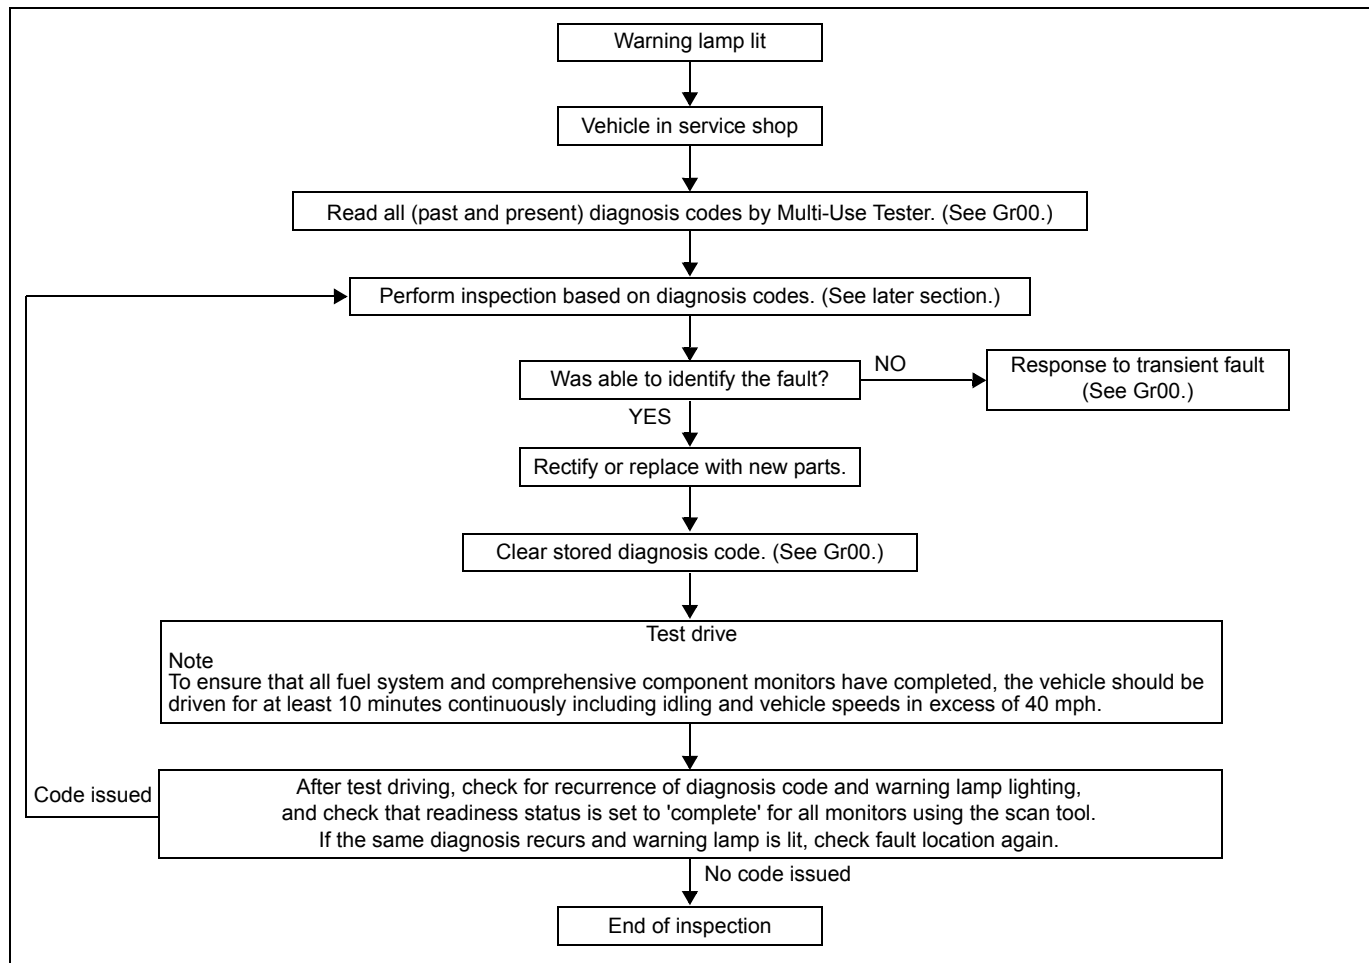
## 1. Diagnosis Procedure

- Perform the inspection in accordance with the following flowchart.

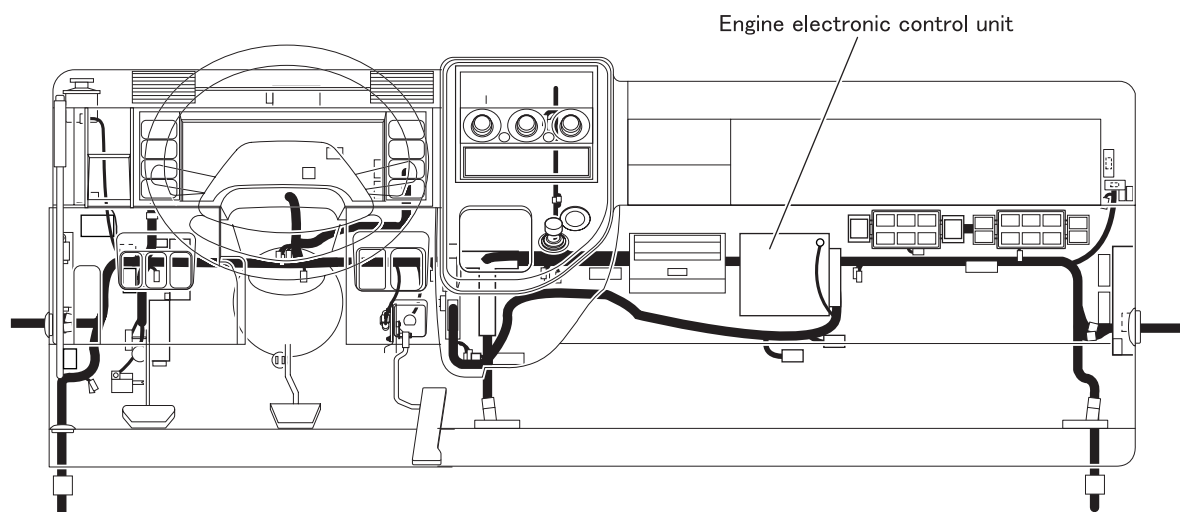
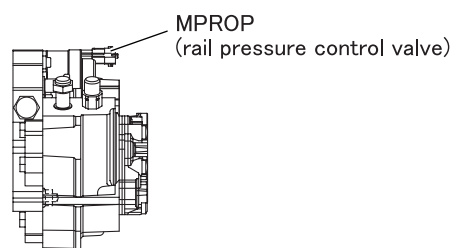
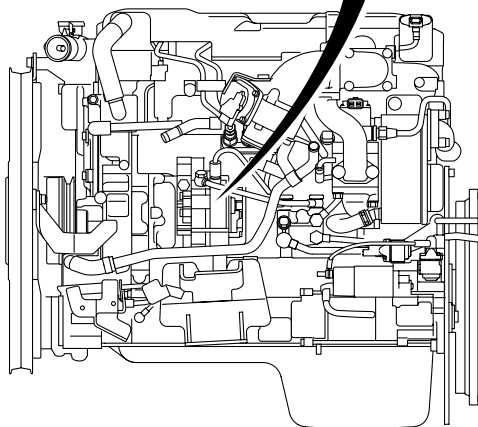
## [Parts Identification and Location]

Left side view of engine

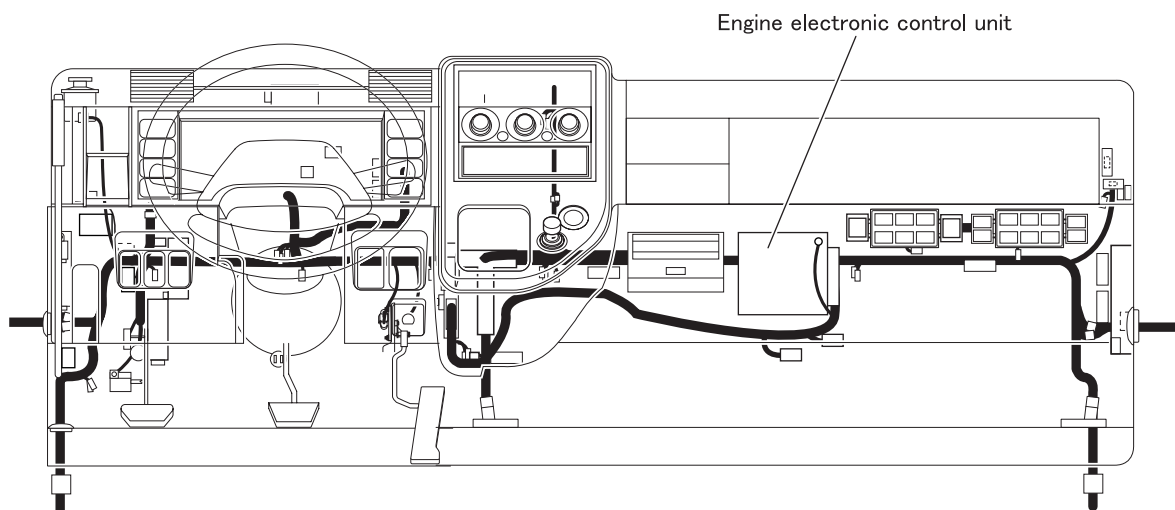
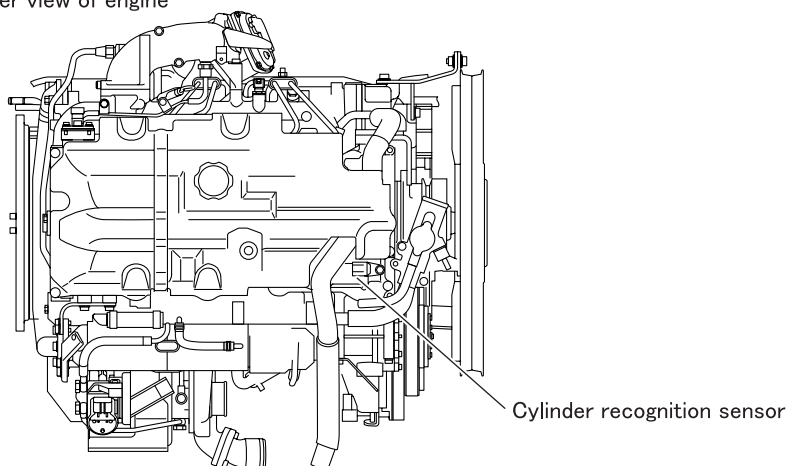
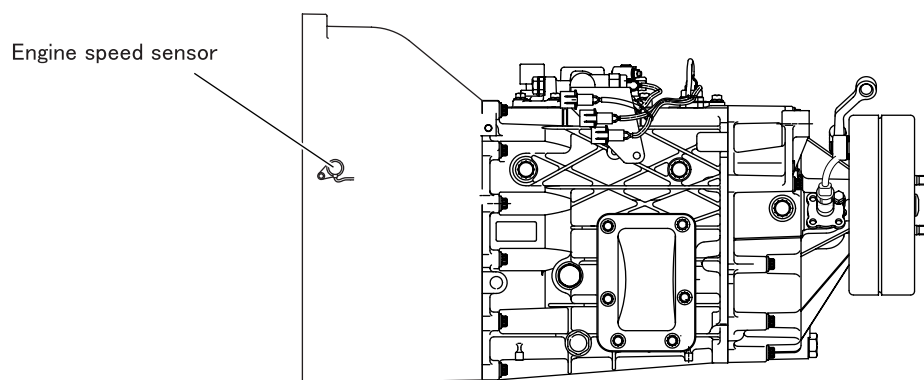
## [Parts Identification and Location]

Upper view of engine

Left side view of transmission

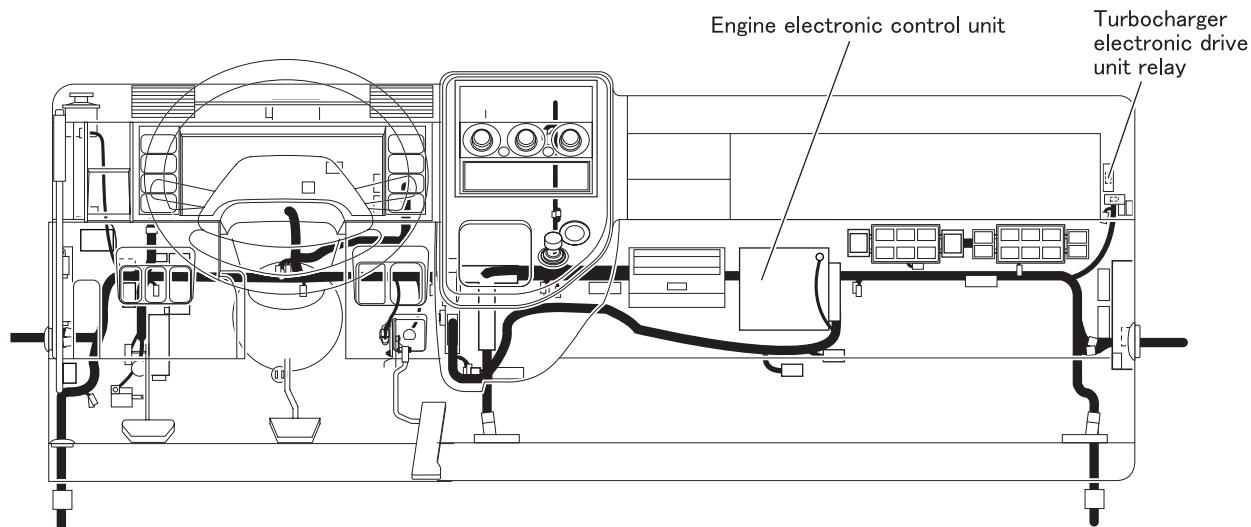
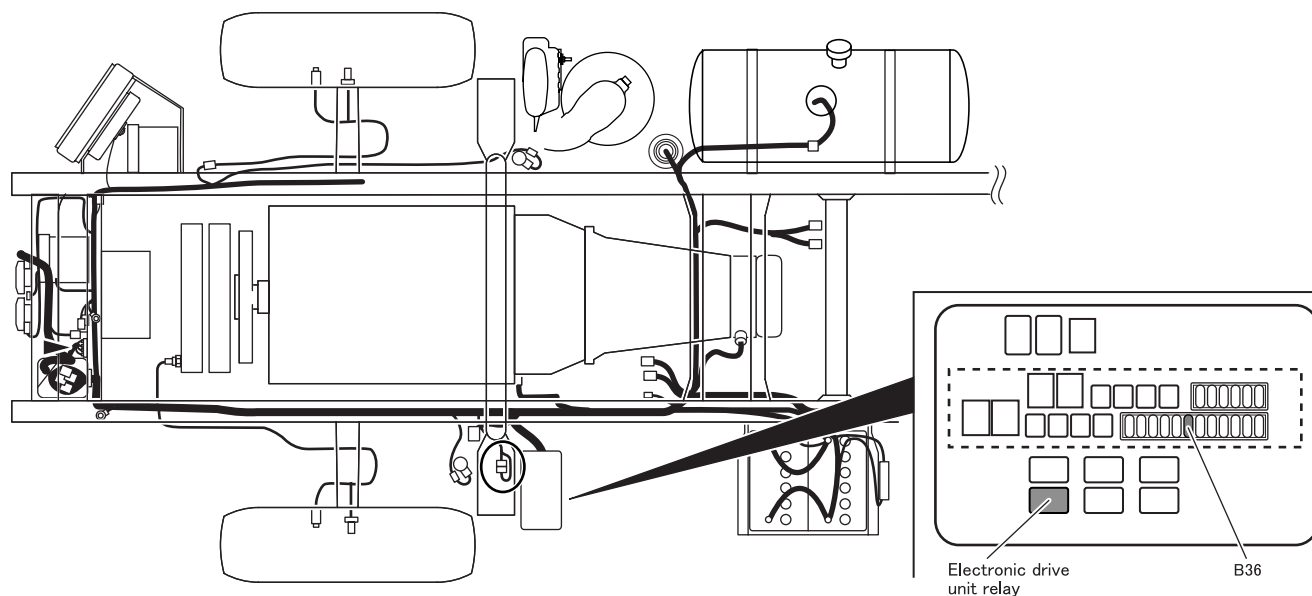
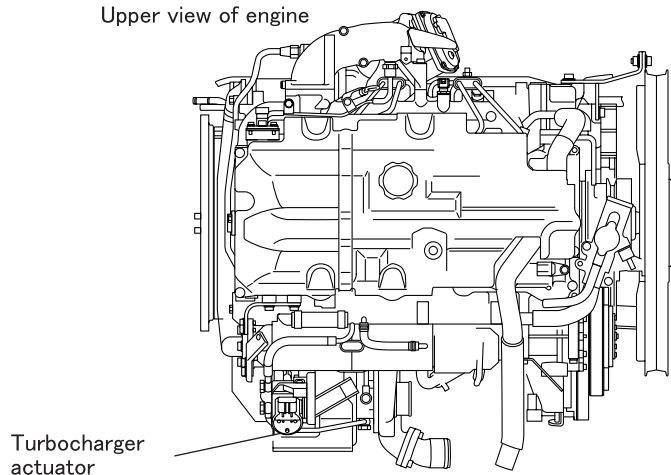
[Parts Identification and Location]

Upper view of engine

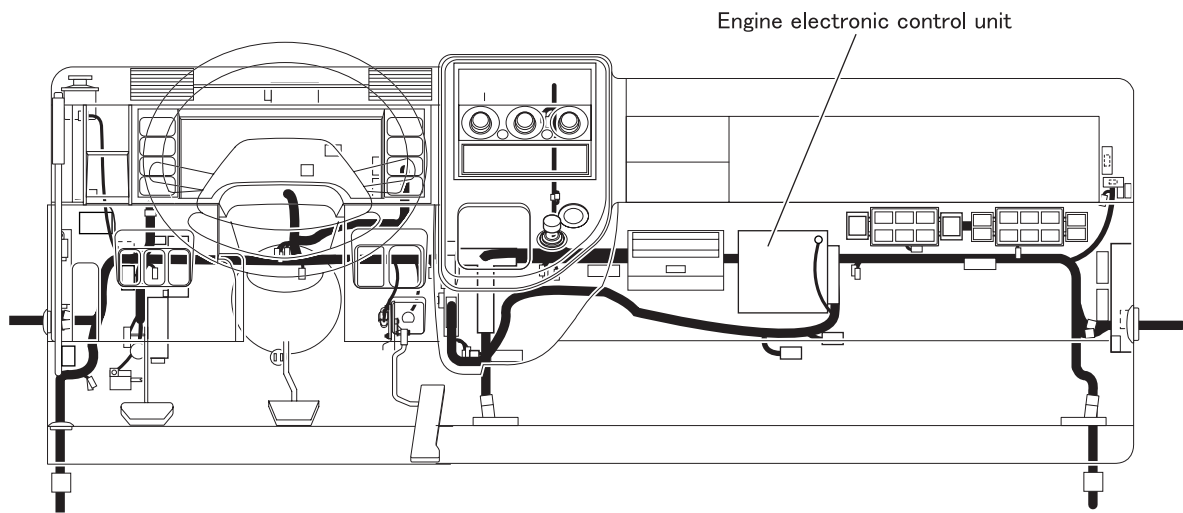
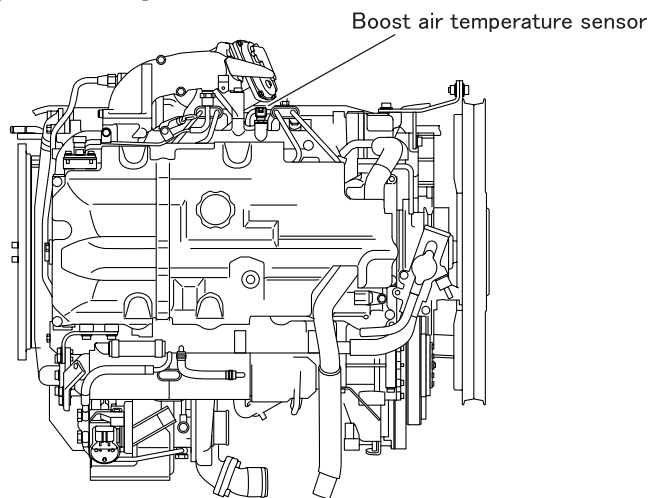
## [Parts Identification and Location]

Upper view of engine

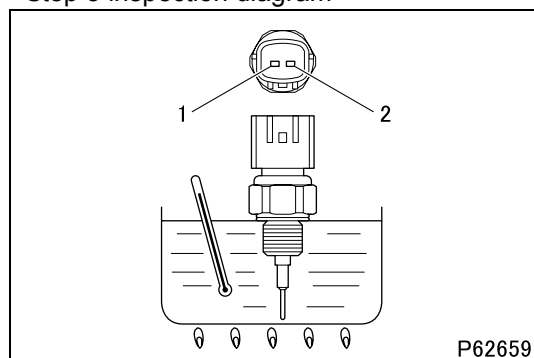
<Step 5 inspection diagram>

| NO | | Replacement of sensor | | |

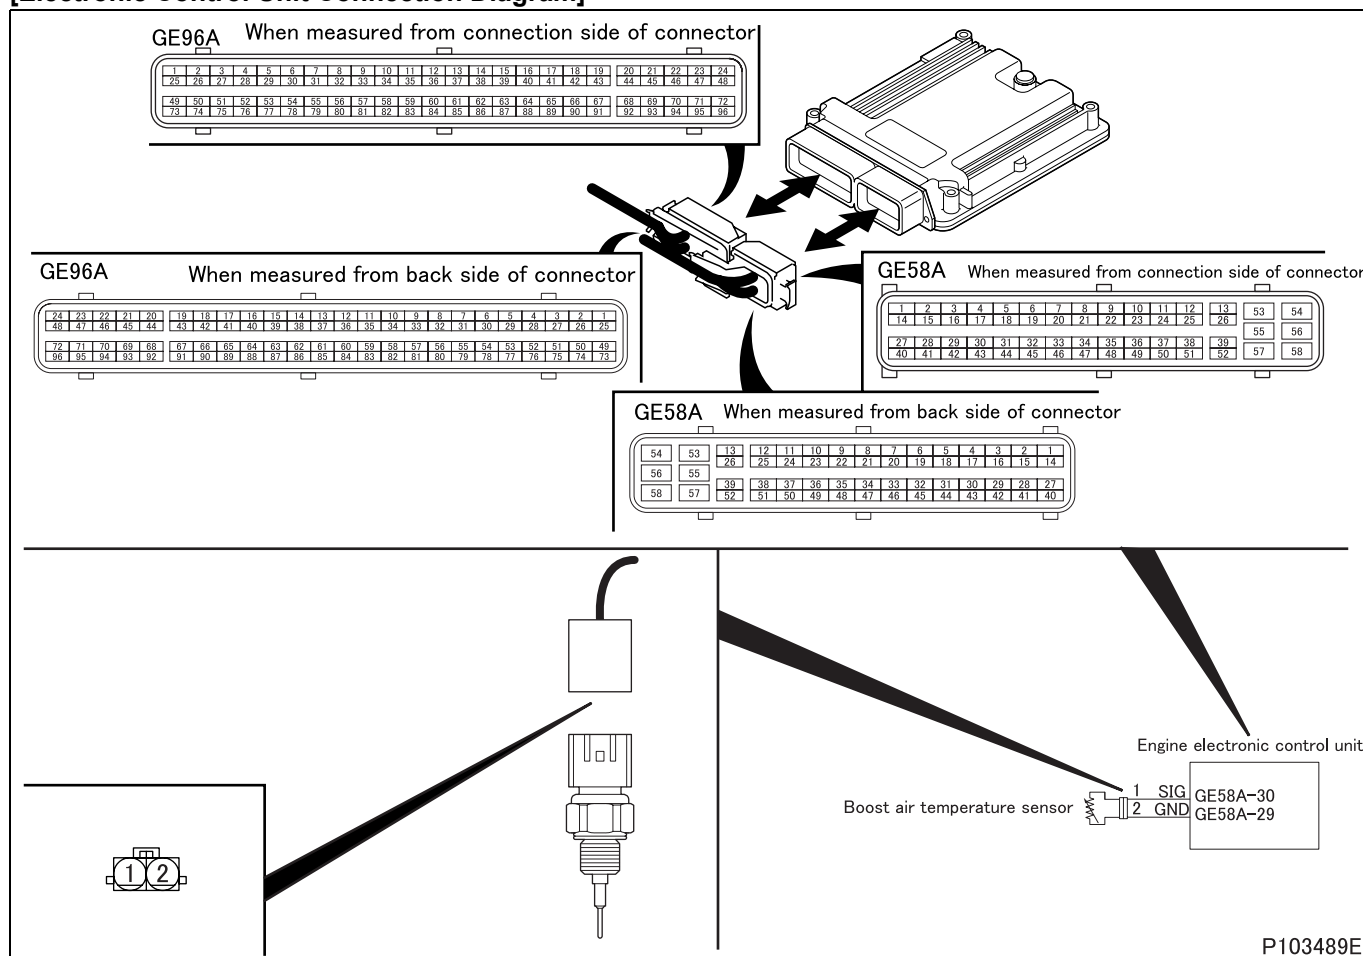
## [Electronic Control Unit Connection Diagram]

Failure of boost air temperature sensor

- Output voltage of boost air temperature sensor remains over 4.9 V for 1 second. (sensor temperature:  $-37^{\circ}\text{C}$  { $-34.6^{\circ}\text{F}$ } or lower)  
(Warning lamp is lit and diagnosis code is displayed on third establishment of code generation condition.)

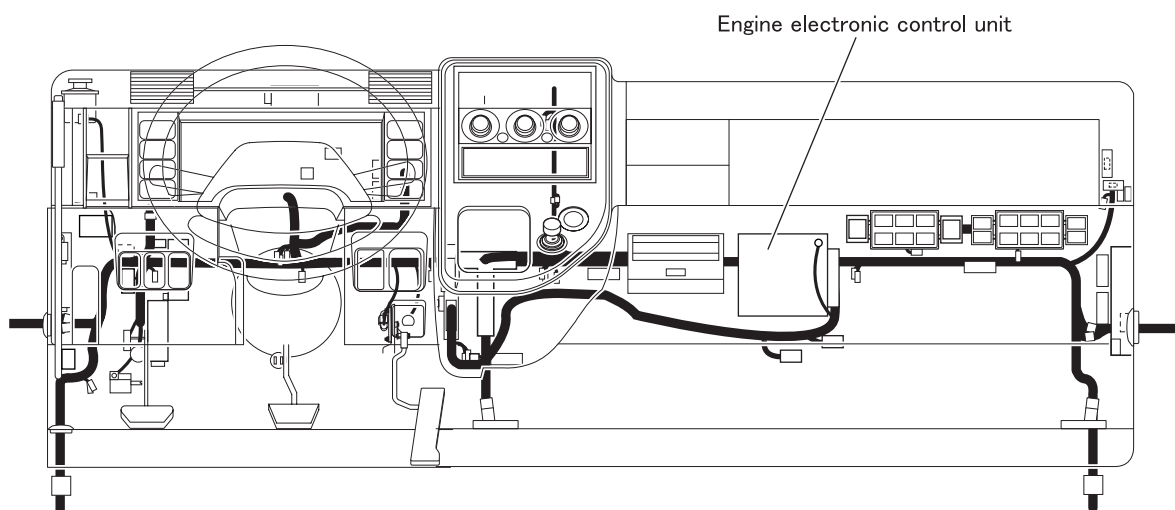
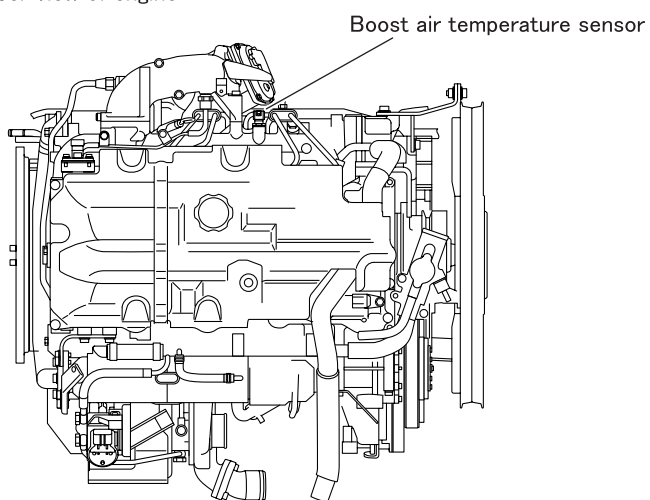
## [Parts Identification and Location]

Upper view of engine

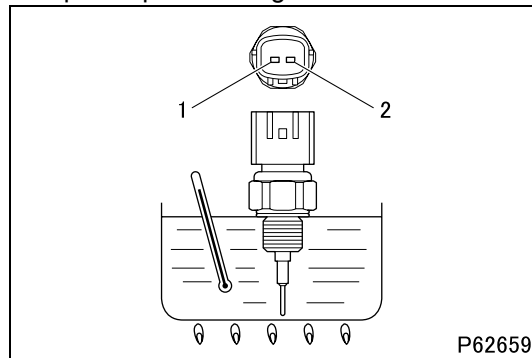
<Step 5 inspection diagram>

| | Inspection condition | | <ul style="list-style-type: none"> <li>Put boost air temperature sensor in container filled with engine oil.</li> <li>Heat the oil to each of the specified temperatures. Stir the oil well while doing so.</li> </ul> | |
| | | NO | Replacement of sensor | |

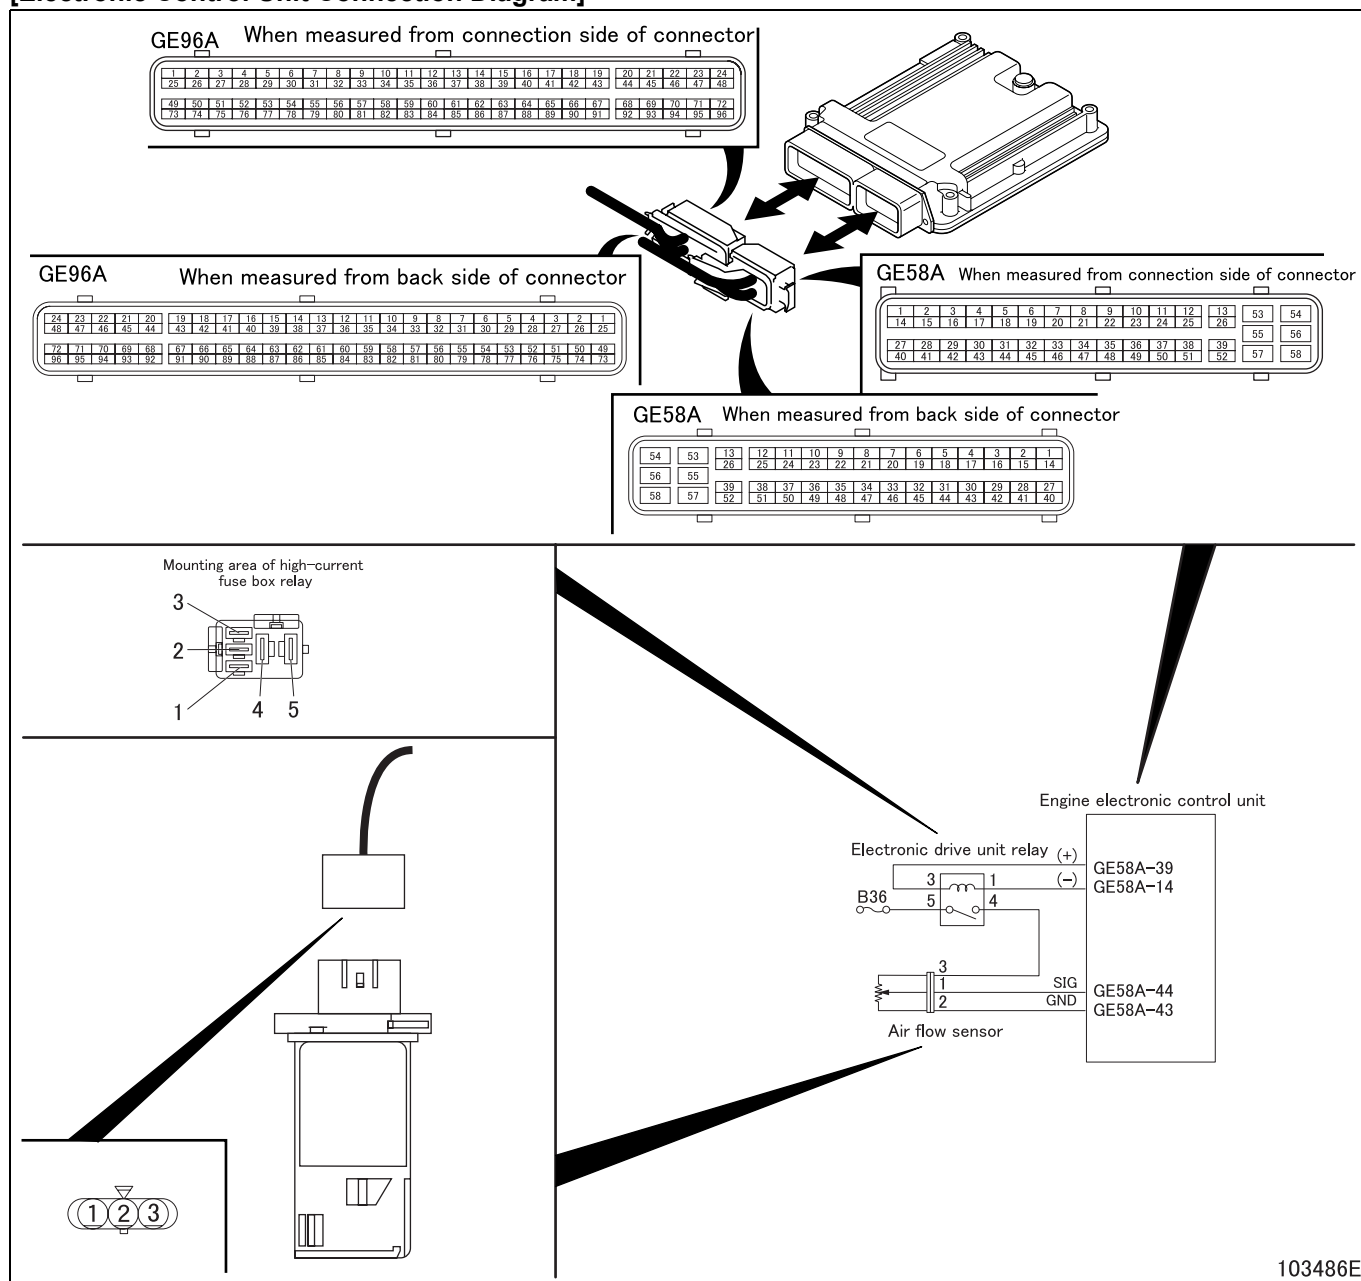
## [Electronic Control Unit Connection Diagram]

- Difference shows intake air flow rate remains considerably high (1.5 or more) or low (0.6 or less) for 5 seconds. (Warning lamp is lit and diagnosis code is displayed on third establishment of code generation condition.)

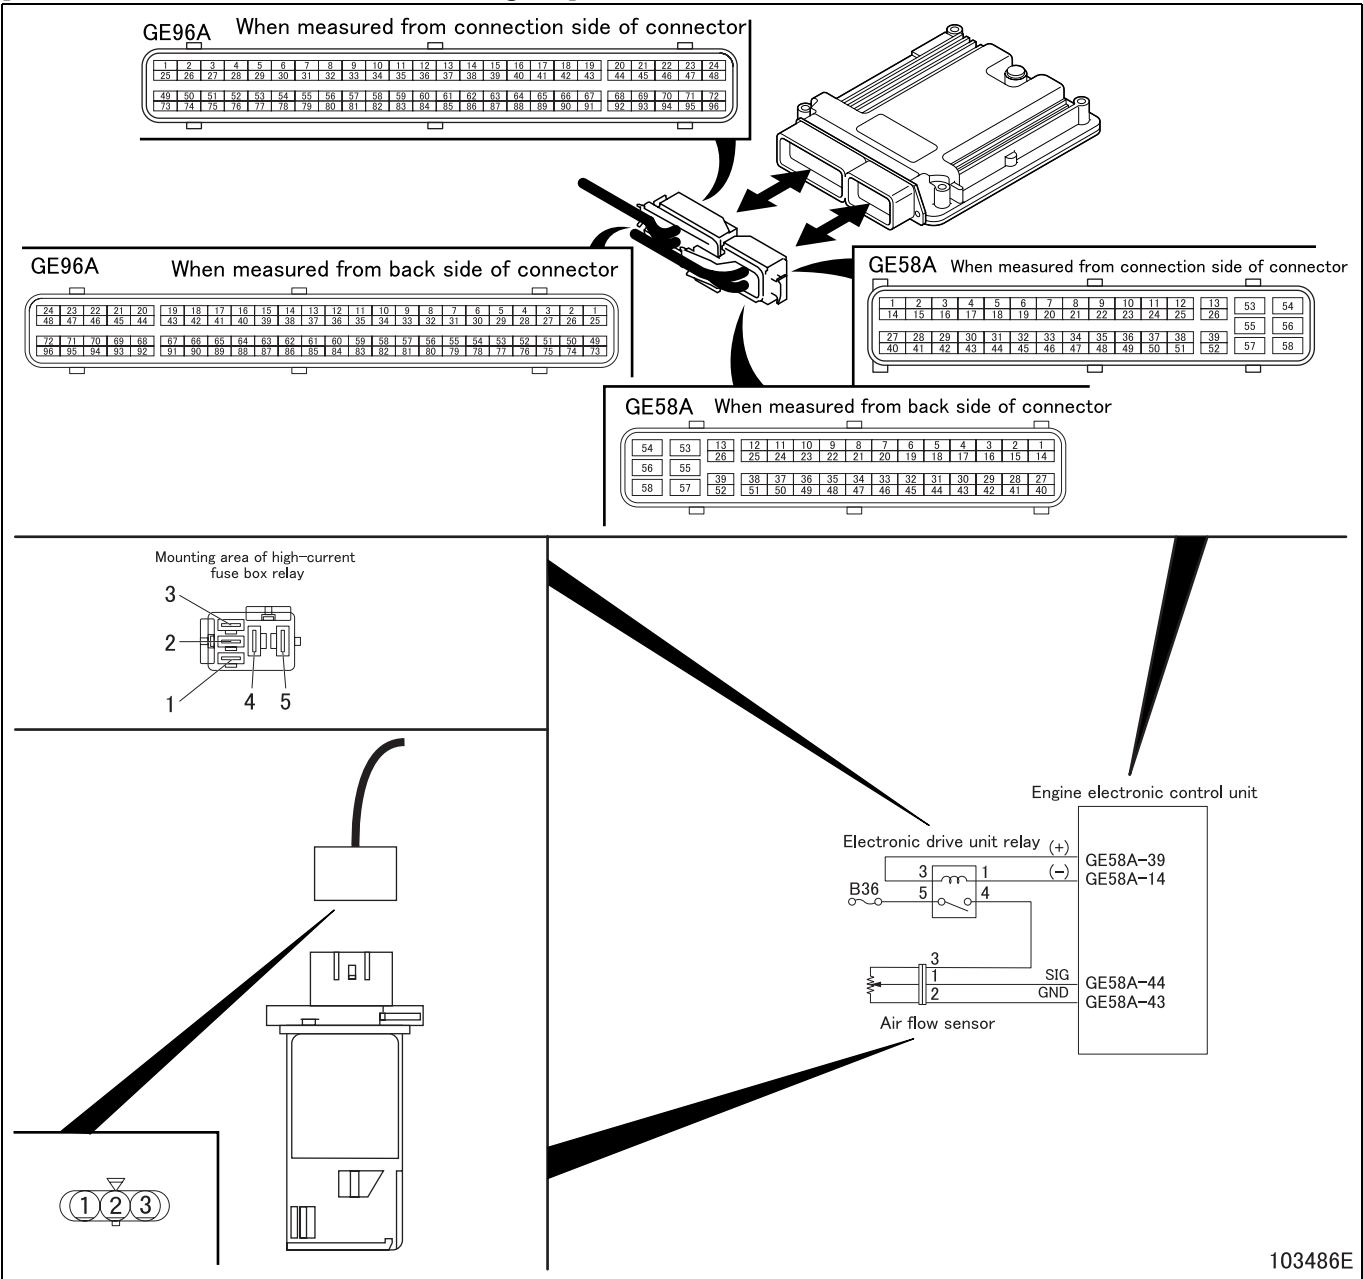
## [Electronic Control Unit Connection Diagram]

Failure of air flow sensor

- Air flow output from air flow sensor remains below 1 kg/hr for 3 seconds.  
(Warning lamp is lit and diagnosis code is displayed on third establishment of code generation condition.)

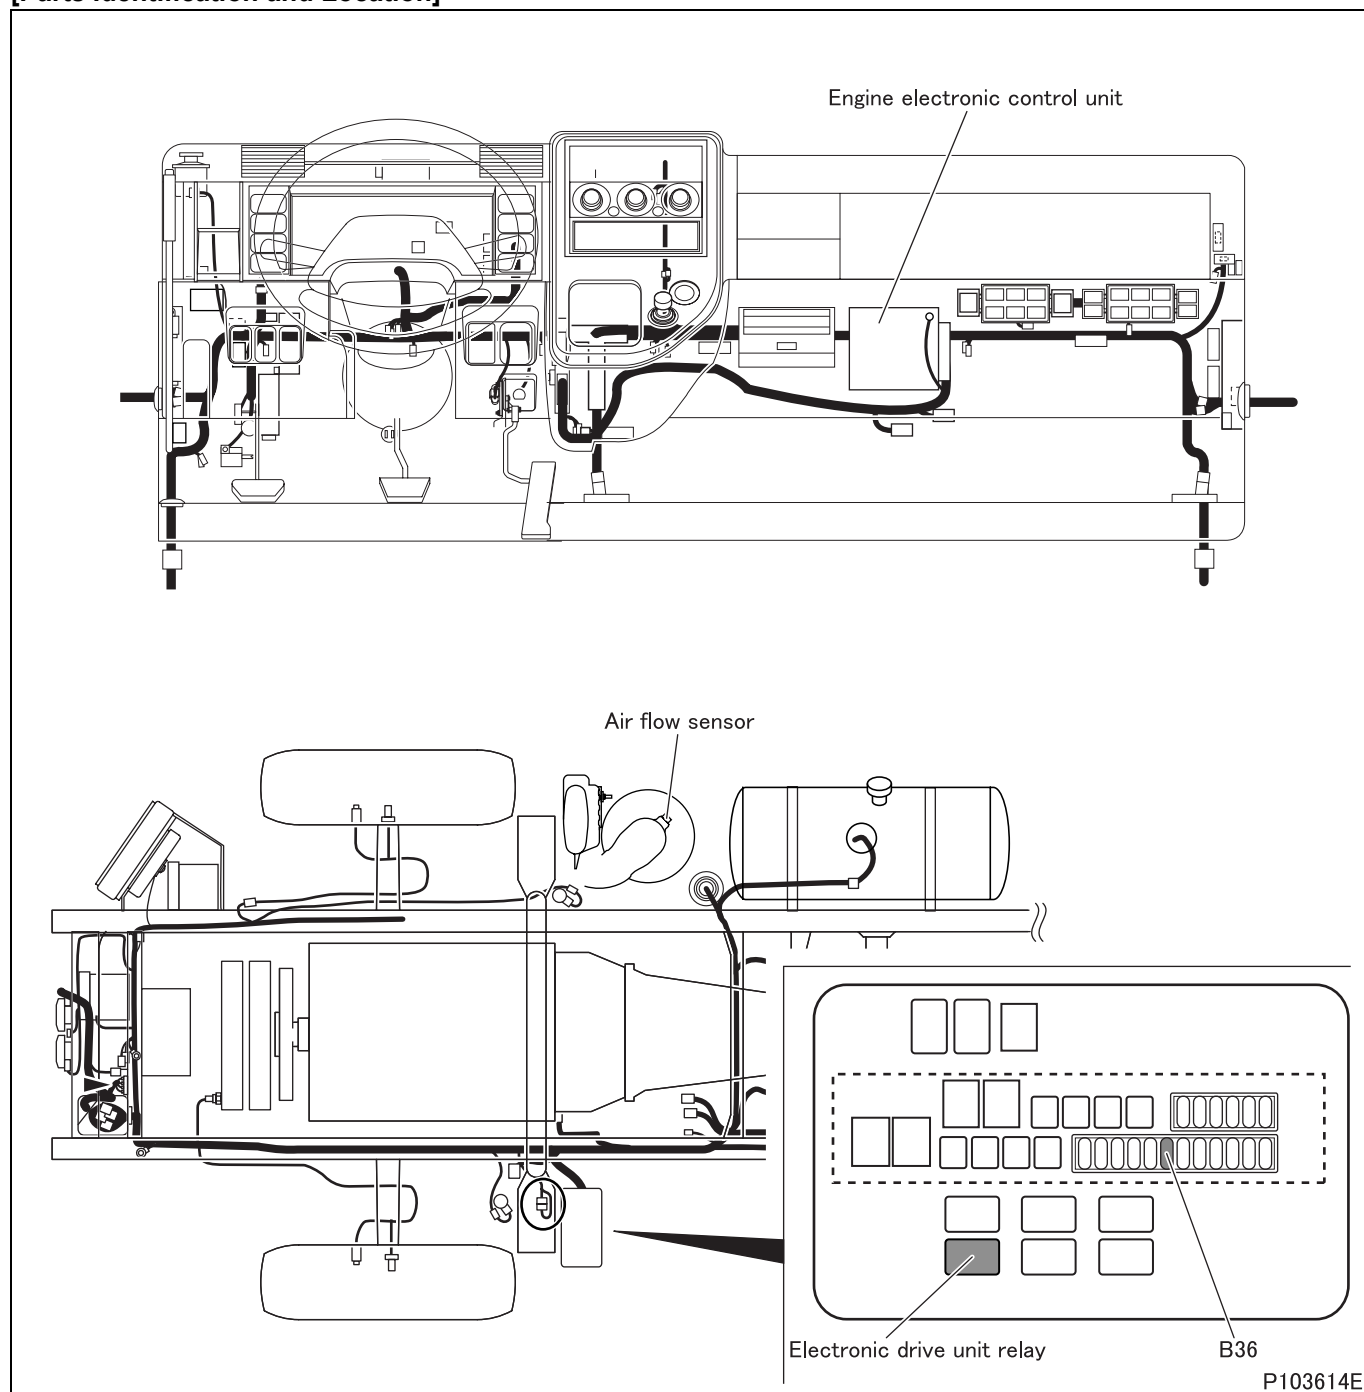
## [Parts Identification and Location]

Failure of air flow sensor

- Air flow output from air flow sensor remains over 970 kg/hr for 3 seconds.  
(Warning lamp is lit and diagnosis code is displayed on third establishment of code generation condition.)

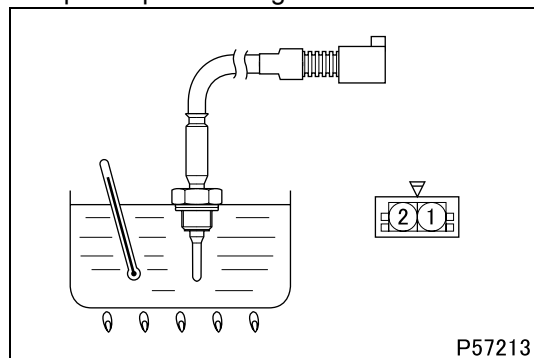
## &lt;Step 5 inspection diagram&gt;

| NO | | Replacement of sensor | | |

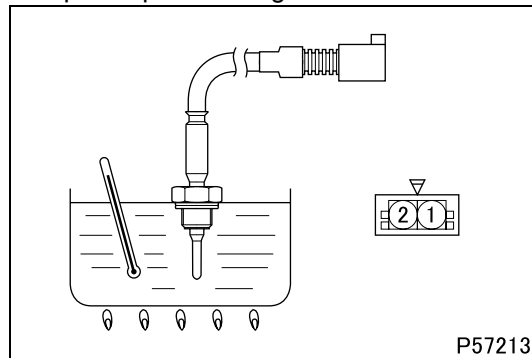
<Step 5 inspection diagram>

| | | NO | Replacement of sensor |

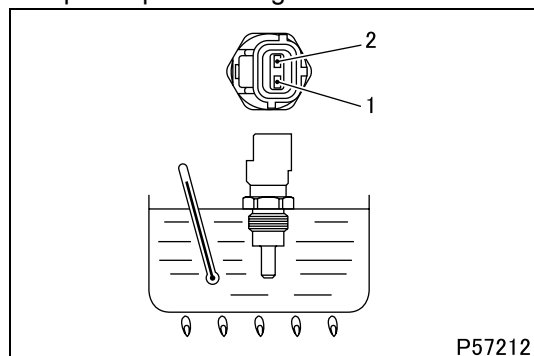
## &lt;Step 5 inspection diagram&gt;

| NO | | Replacement of sensor | |

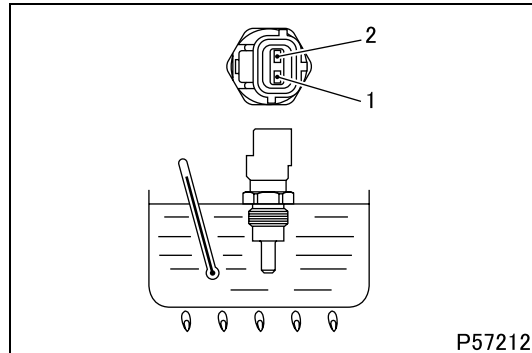
<Step 5 inspection diagram>

| | | NO | Replacement of sensor |

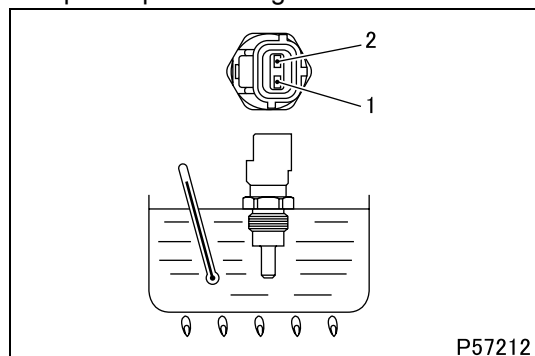
<Step 5 inspection diagram>

| NO | | Replacement of sensor | |
