# FE.FG

## SERVICE MANUAL 2008 Model FOREWORD

This Service Manual contains maintenance and repair methods for the Mitsubishi Fuso Truck FE. FG Series. Read this manual carefully as an aid in providing correct, efficient maintenance. Please note that the information and specifications contained within this manual may change without notice. This is due to product modifications and continued vehicle improvements that are made throughout the model years. Should you encounter any discrepancy in the information provided, please do not hesitate to contact your nearest Mitsubishi Fuso Dealer or Mitsubishi Fuso Truck of America, Inc.

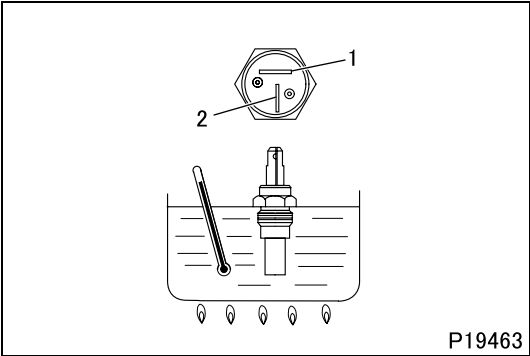
<Step 7 inspection diagram>

| NO | | Replacement of sensor | |

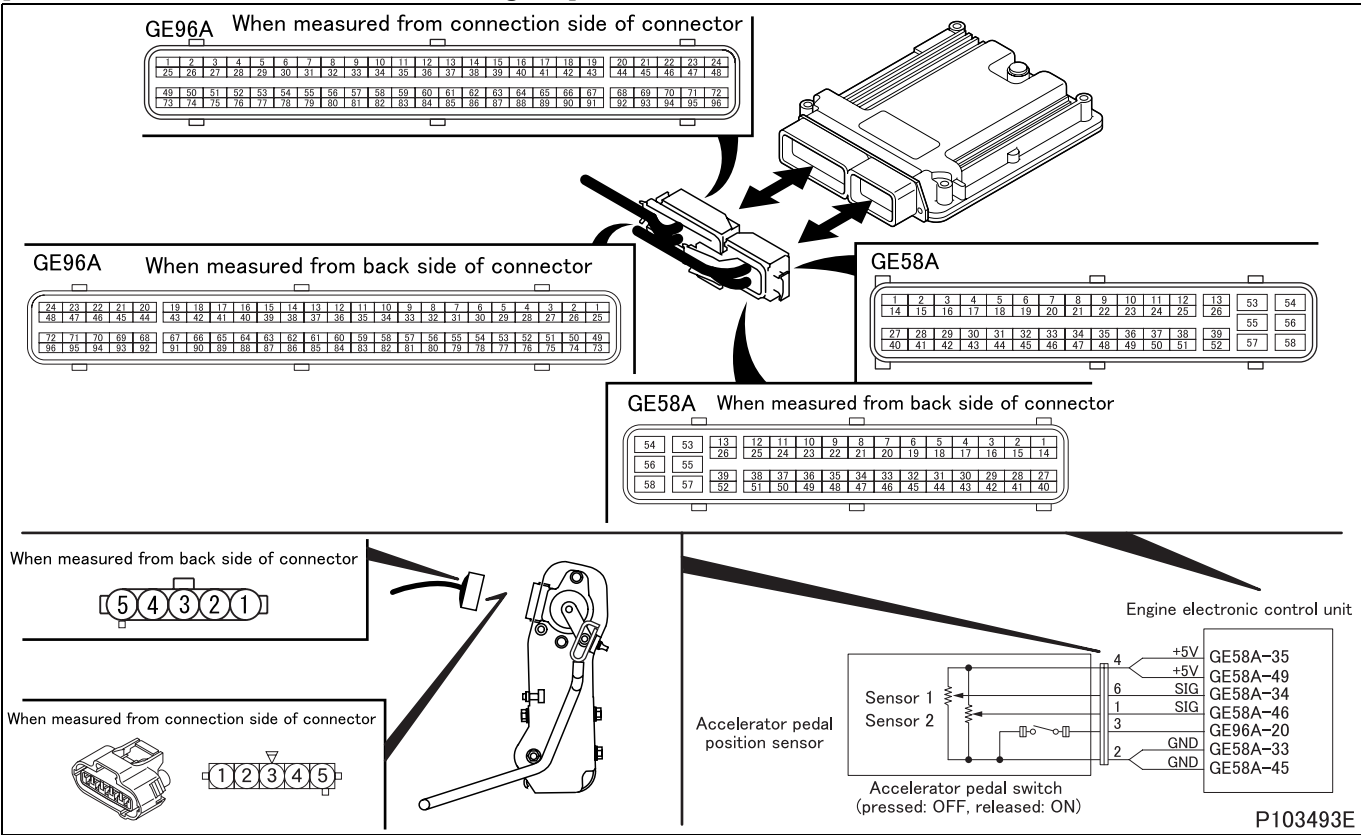
## [Electronic Control Unit Connection Diagram]

Diagnosis code: P0122/Flash code: 24

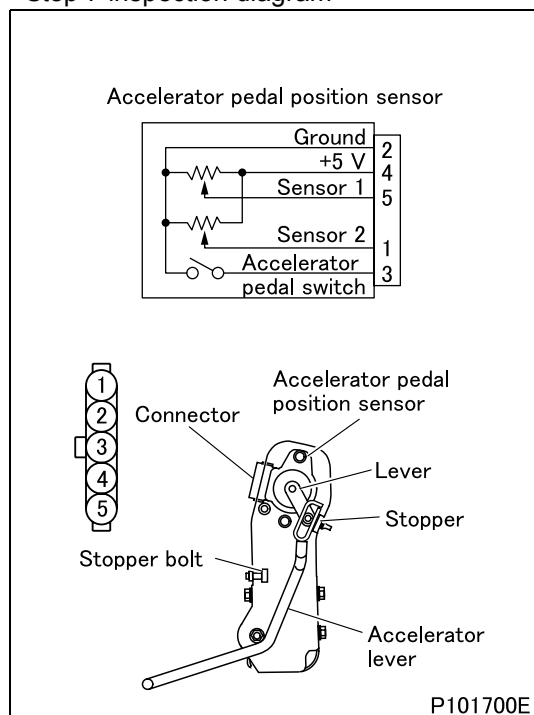
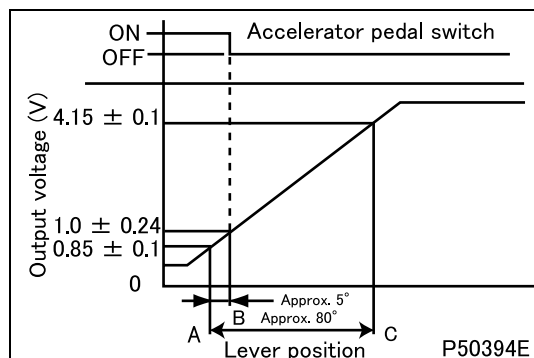
<Step 7 inspection diagram>

| NO | | Adjustment of sensor (If the measurement deviates from the standard value after adjustment, replace the sensor.) (See “INSPECTION OF ELECTRICAL PARTS” – “INSPECTION OF ACCELERATOR PEDAL POSITION SENSOR”.) | |

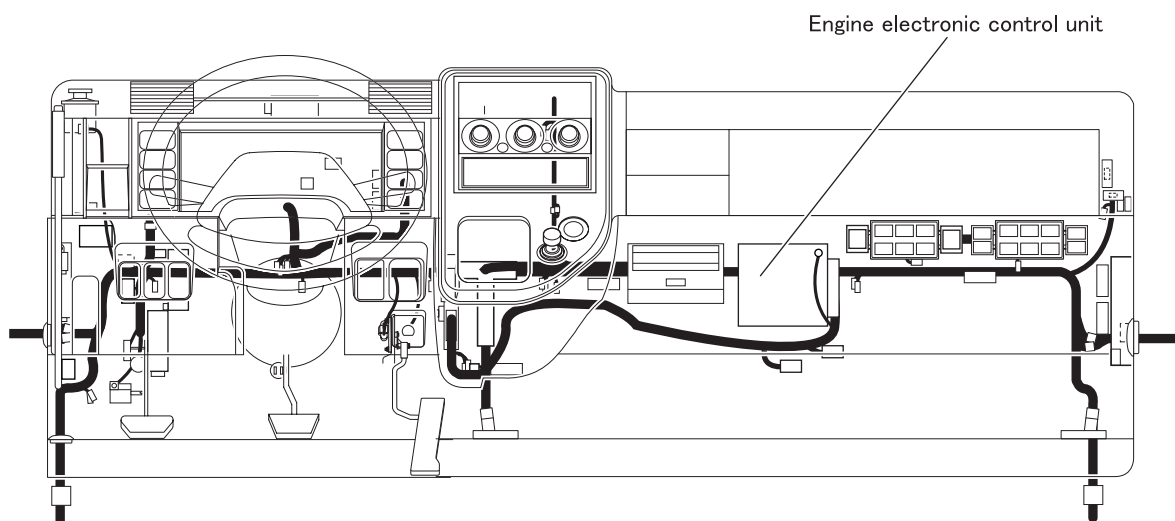
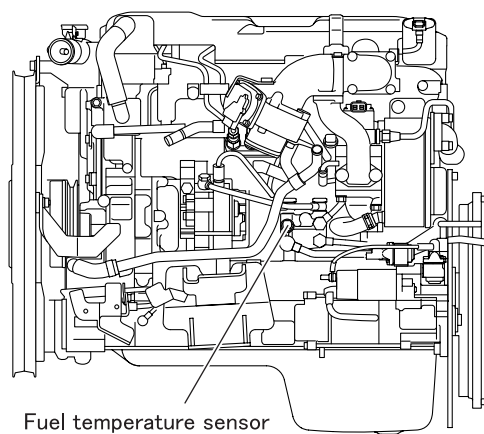
## [Parts Identification and Location]

Left side view of engine

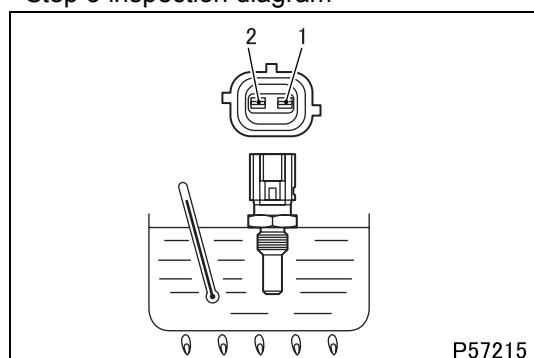
<Step 5 inspection diagram>

| | | NO | Replacement of sensor | |

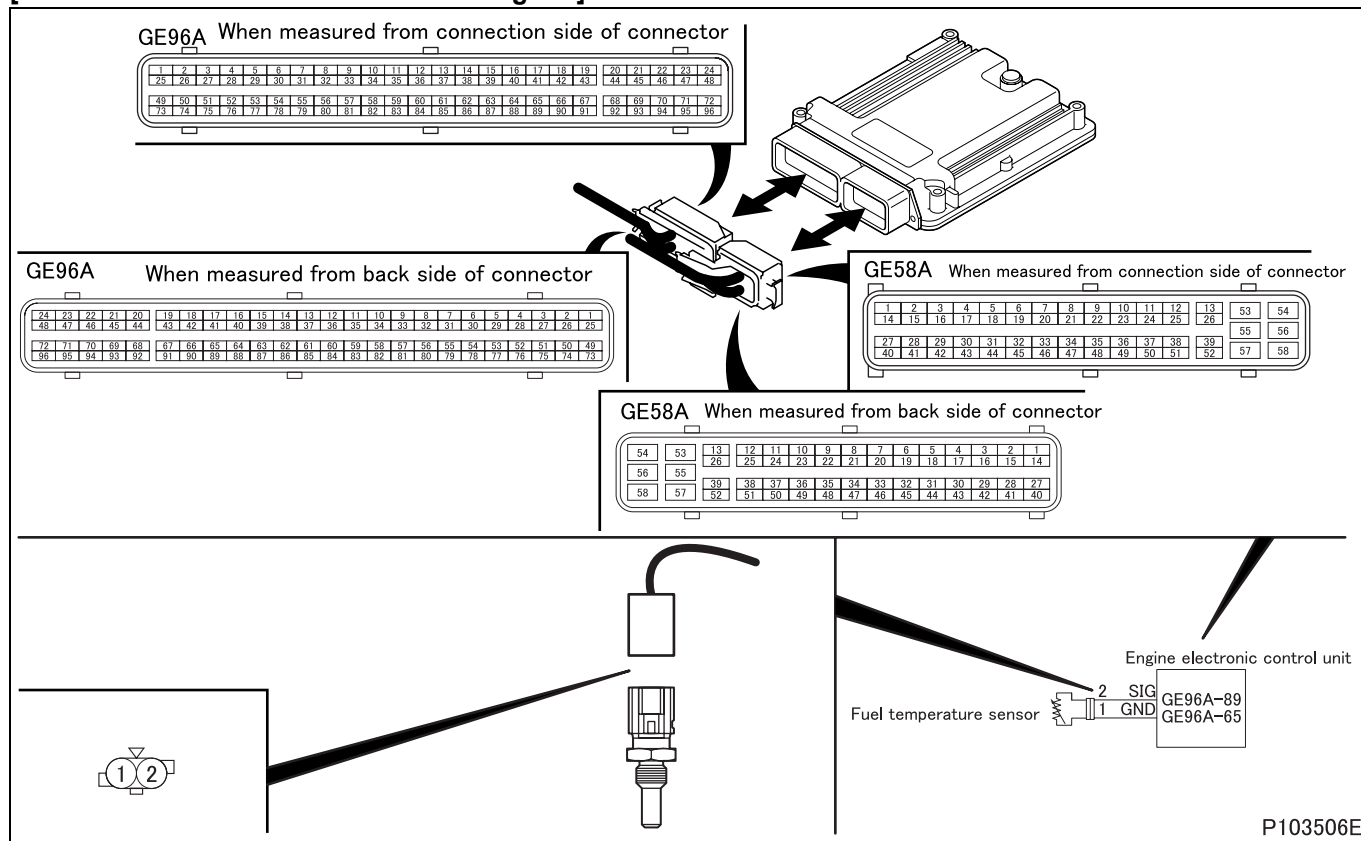
## [Electronic Control Unit Connection Diagram]

- Recovered if signal becomes normal with starter switch in ON position.  
(Warning lamp is extinguished and diagnosis code is cleared simultaneously with recovery.)

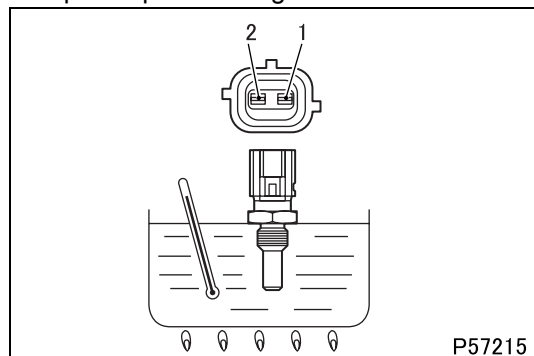
<Step 5 inspection diagram>

| Step 6 | Inspection items | | Inspection of harness between electronic control unit and sensor (power supply) | |
| | Maintenance item | | Check circuit between sensor connector terminal No. 1 and electronic control unit connector (GE96A) terminal No. 89. | |
| | Inspection condition | | Disconnect each device from harness and measure from connection side of harness connector. | |

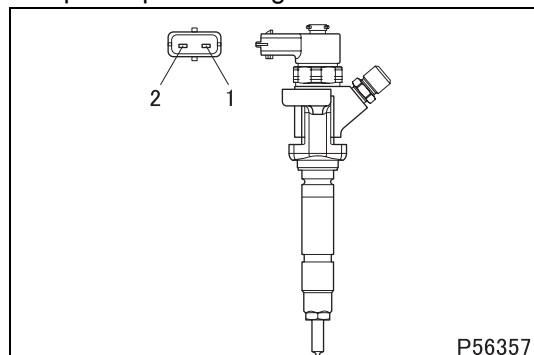
<Step 5 inspection diagram>

| Step 6 | Inspection items | | Inspection of harness between injector magnetic valve and electronic control unit (power supply) |
| | Maintenance item | | Check circuit between injector magnetic valve connector terminal No. 2 and electronic control unit connector (GE96A) terminal No. 72. |

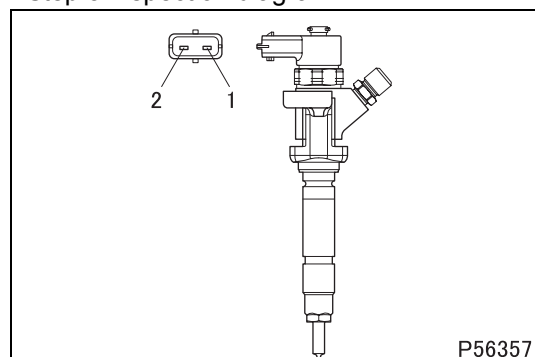
<Step 5 inspection diagram>

| Step 6 | Inspection items | | Inspection of harness between injector magnetic valve and electronic control unit (power supply) |
| | Maintenance item | | Check circuit between injector magnetic valve connector terminal No. 2 and electronic control unit connector (GE96A) terminal No. 96. |

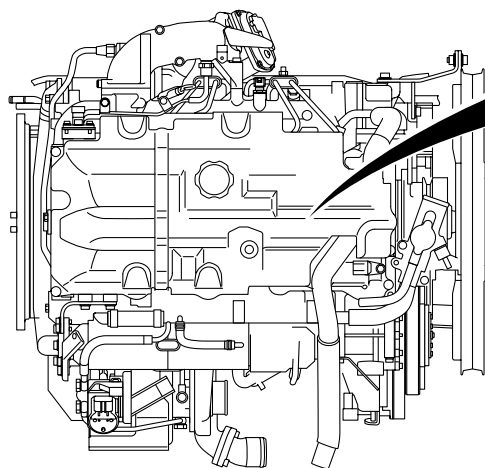
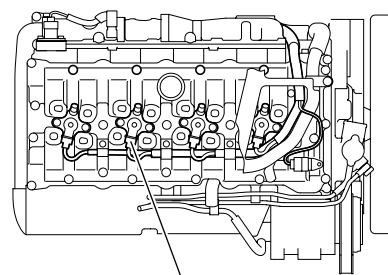
Upper view of engine

Injector magnetic valve

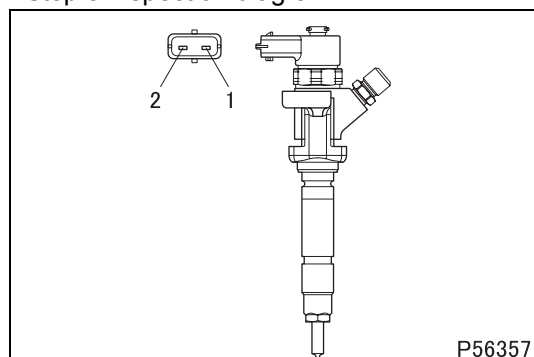
<Step 5 inspection diagram>

| Step 6 | Inspection items | | Inspection of harness between injector magnetic valve and electronic control unit (power supply) |
| | Maintenance item | | Check circuit between injector magnetic valve connector terminal No. 2 and electronic control unit connector (GE96A) terminal No. 71. |

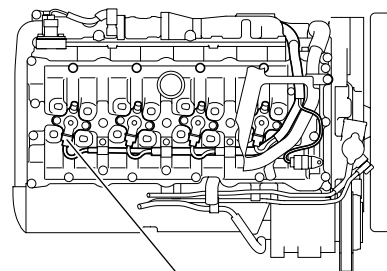
Upper view of engine

Injector magnetic valve

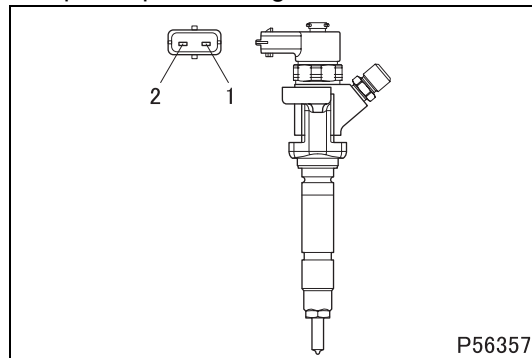
<Step 5 inspection diagram>

| Step 6 | Inspection items | | Inspection of harness between injector magnetic valve and electronic control unit (power supply) |
| | Maintenance item | | Check circuit between injector magnetic valve connector terminal No. 2 and electronic control unit connector (GE96A) terminal No. 95. |

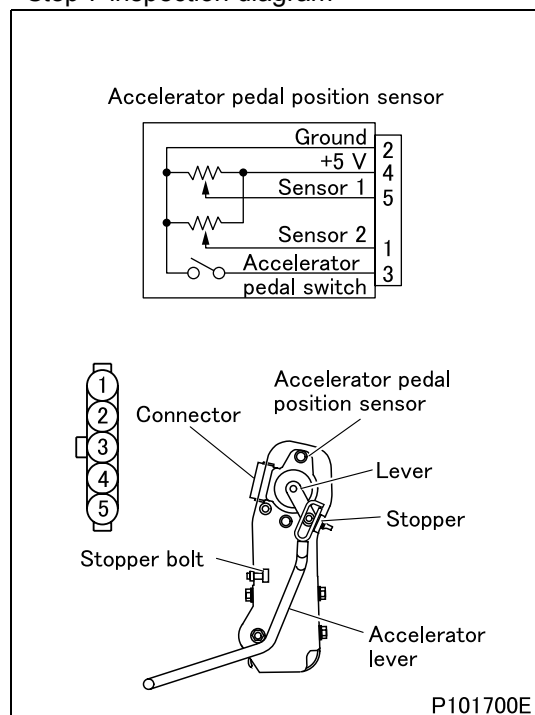
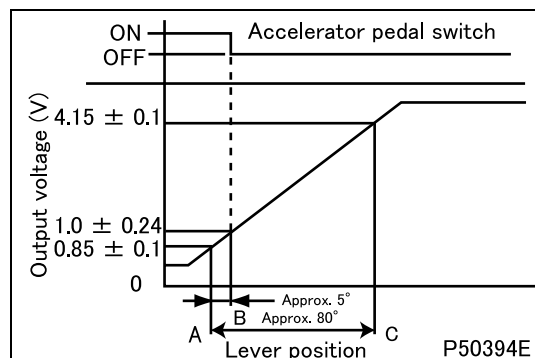
<Step 7 inspection diagram>

| Step 8 | Inspection items | | Inspection by sensor connector |
| | Maintenance item | | Measure value of voltage between connector terminal No. 4 (+) and 2 (-). |

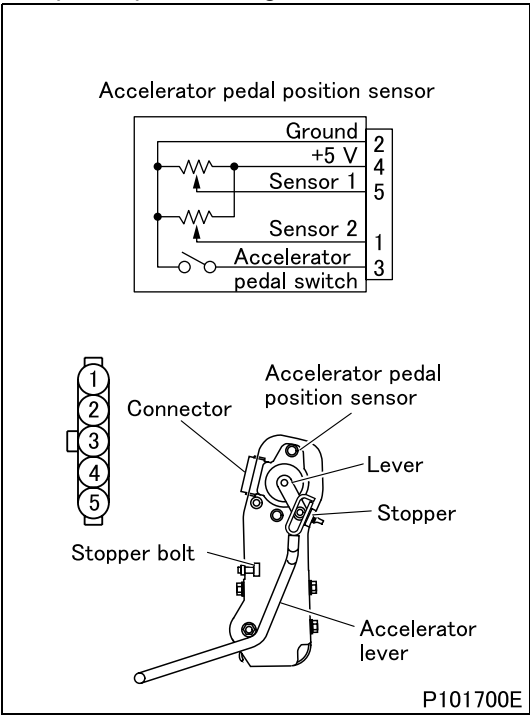
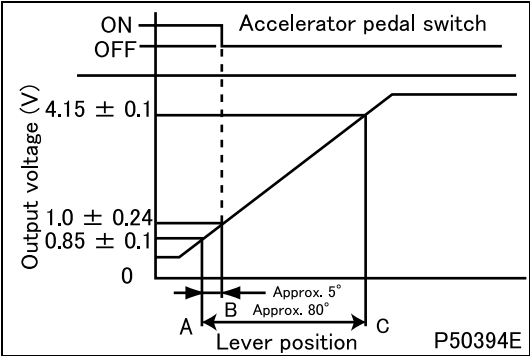
<Step 7 inspection diagram>

| Step 8 | Inspection items | | Inspection by sensor connector |
| | Maintenance item | | Measure value of voltage between connector terminal No. 4 (+) and 2 (-). |

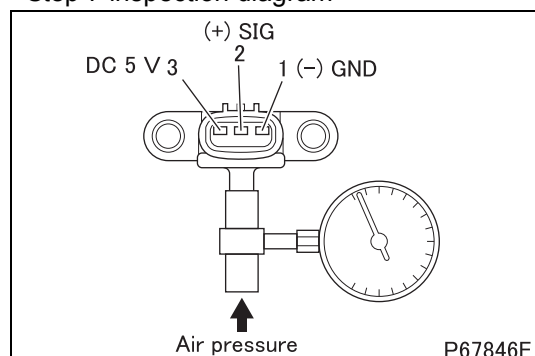
<Step 7 inspection diagram>

| Step 8 | Inspection items | | Inspection of harness between electronic control unit and sensor (power supply) | |
| | Maintenance item | | Measure value of voltage between connector terminal No. 3 (+) and 1 (–). | |

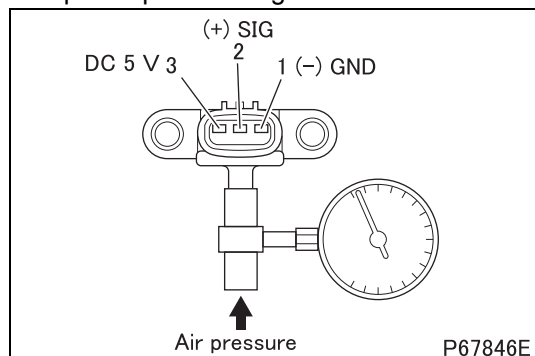
<Step 7 inspection diagram>

| Step 8 | Inspection items | | Inspection of harness between electronic control unit and sensor (power supply) | |
| | Maintenance item | | Measure value of voltage between connector terminal No. 3 (+) and 1 (–). | |

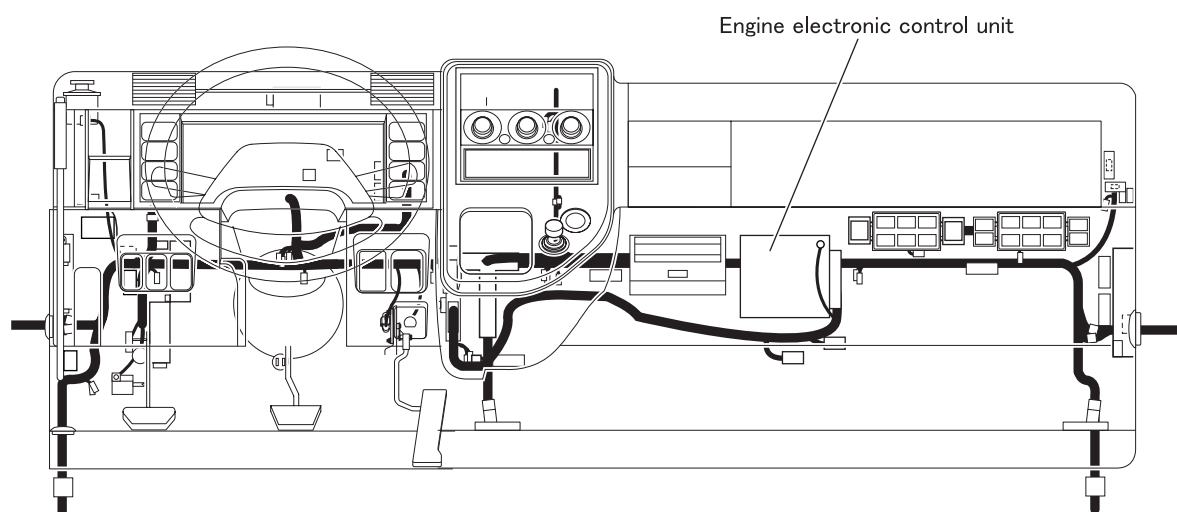
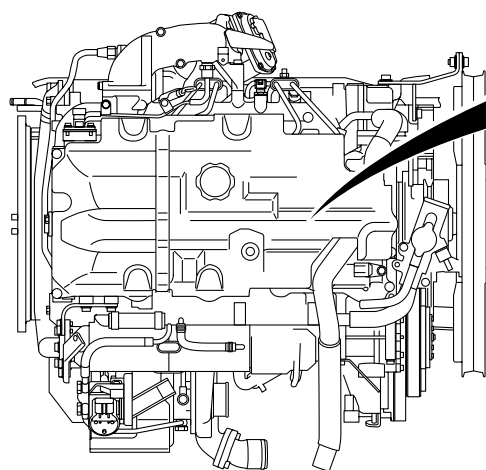
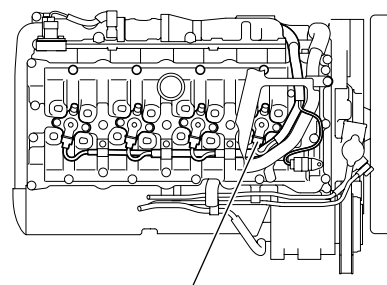
## [Parts Identification and Location]

Upper view of engine

Injector magnetic valve

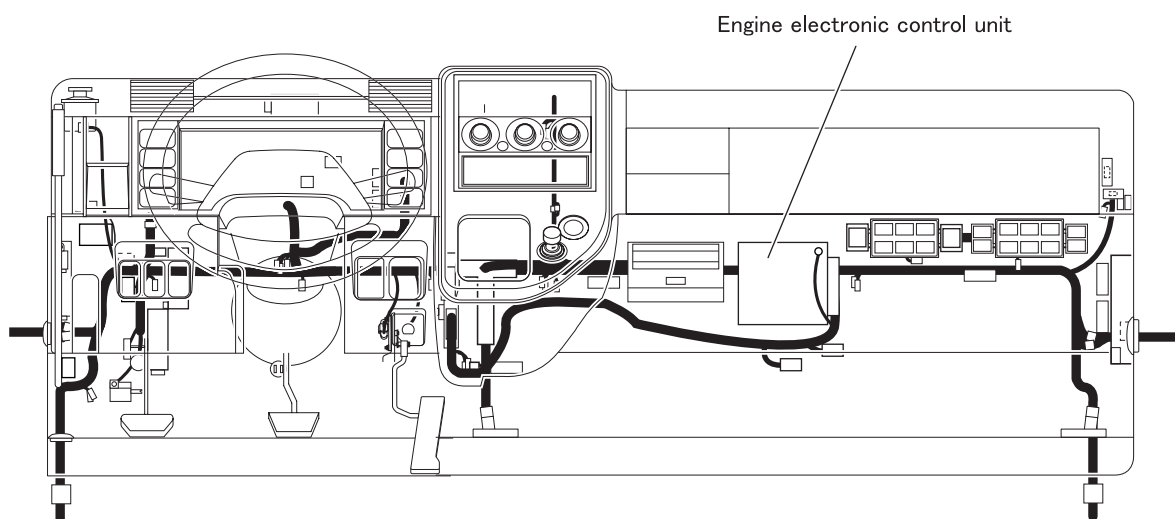
## [Parts Identification and Location]

Upper view of engine

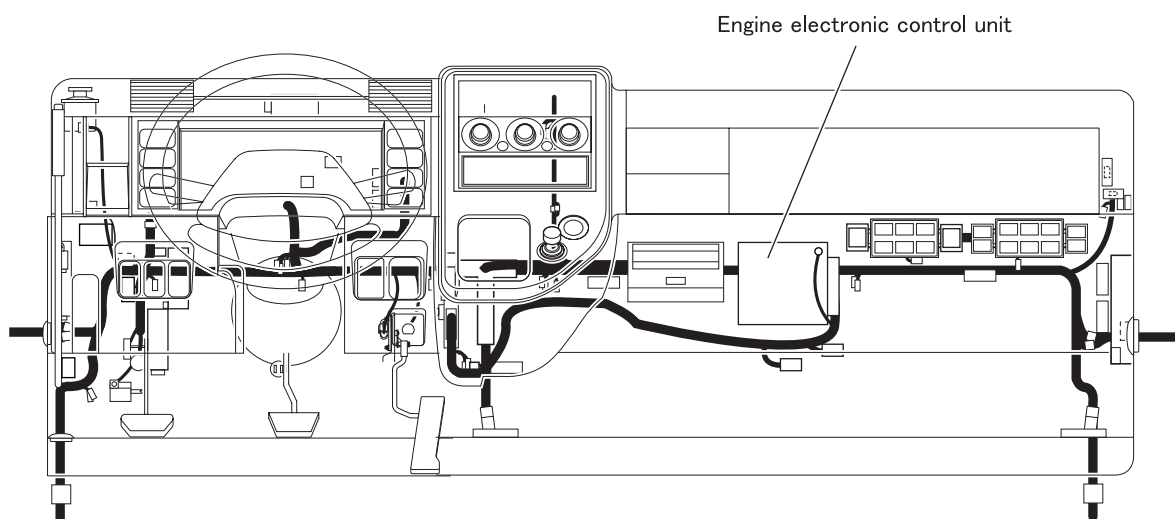
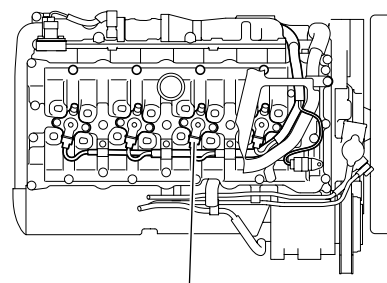
## [Parts Identification and Location]

Upper view of engine

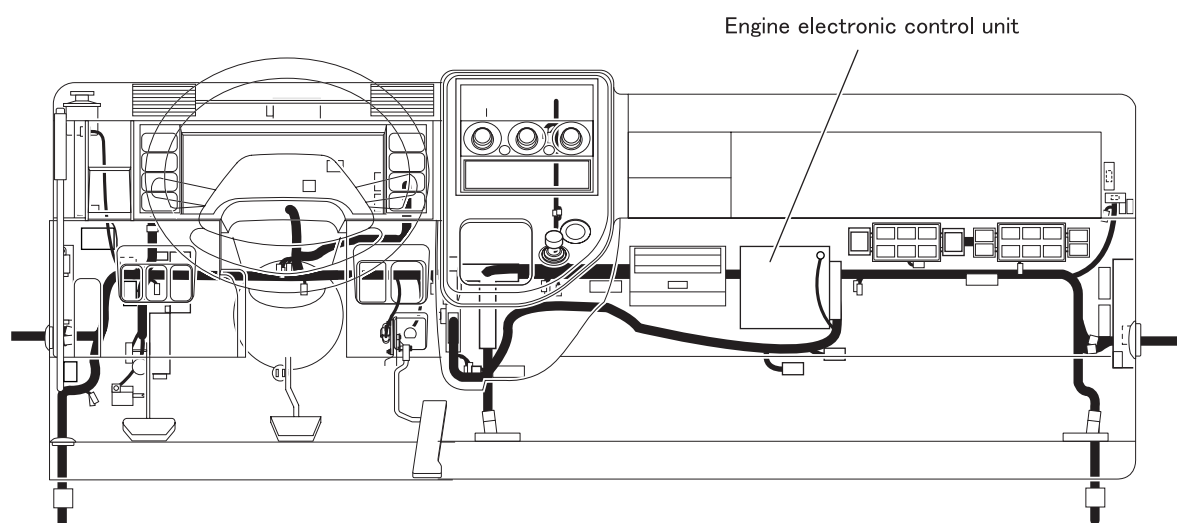
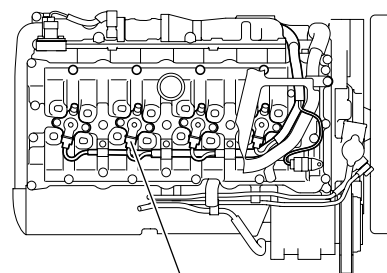
## [Parts Identification and Location]

Upper view of engine

Injector magnetic valve

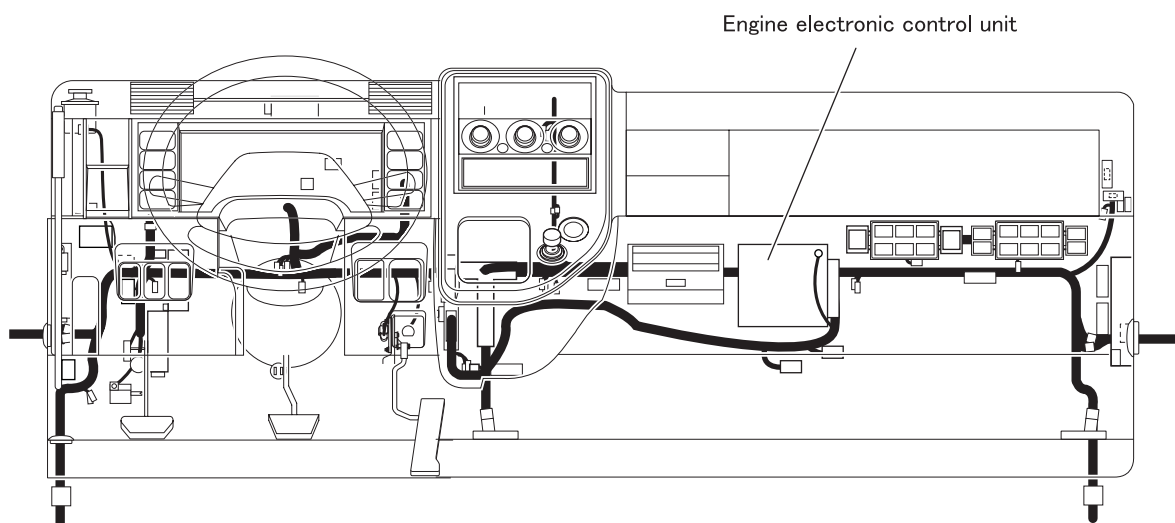
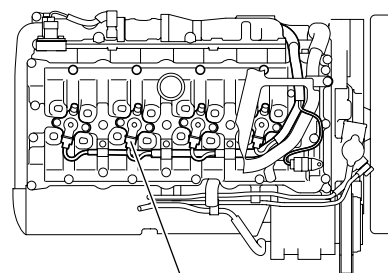
## [Parts Identification and Location]

Upper view of engine

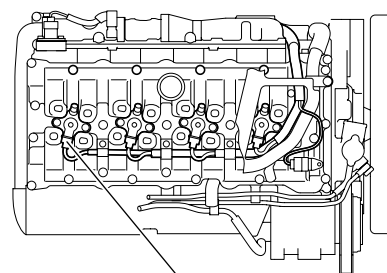
P103631E

Upper view of engine

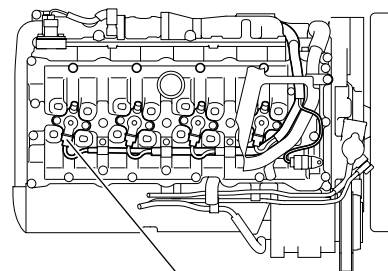
P103631E

Upper view of engine

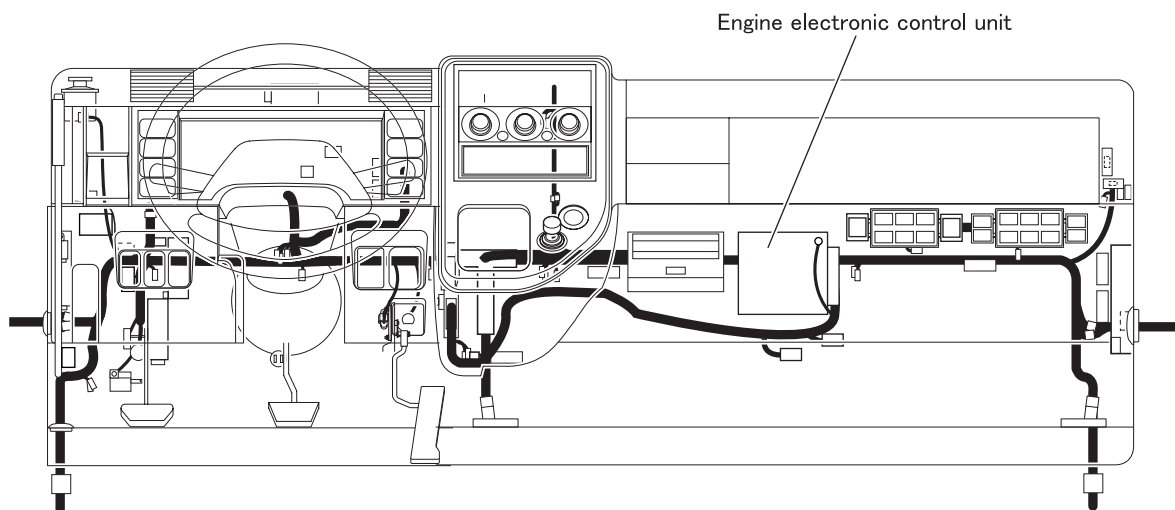
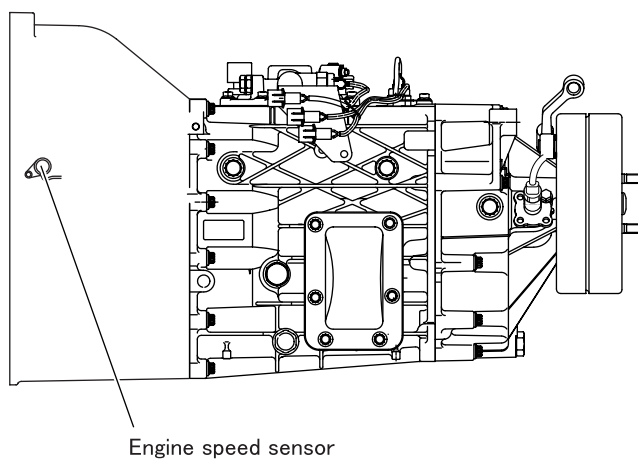
## [Parts Identification and Location]

Left side view of transmission

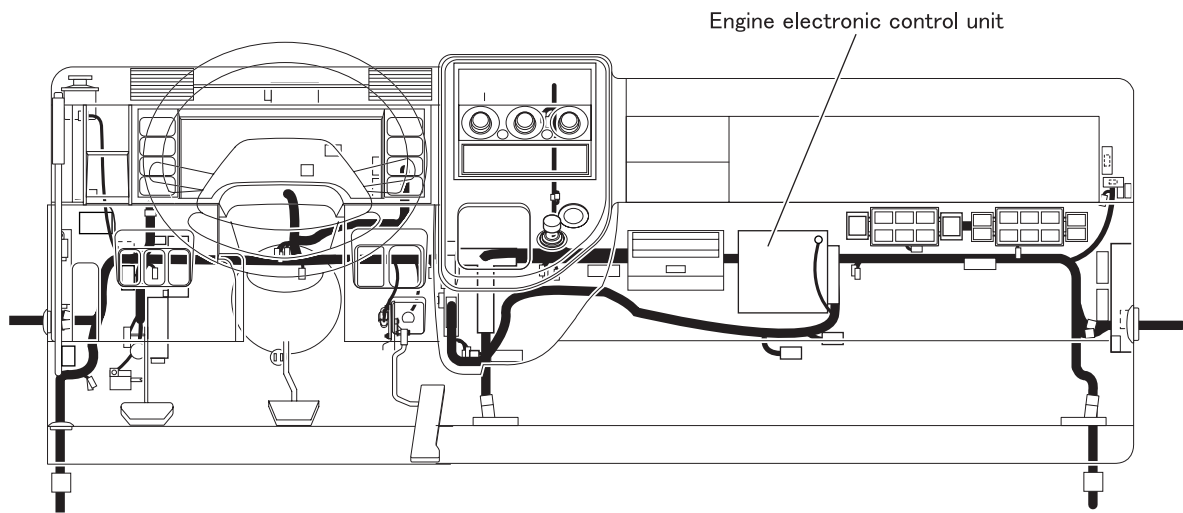
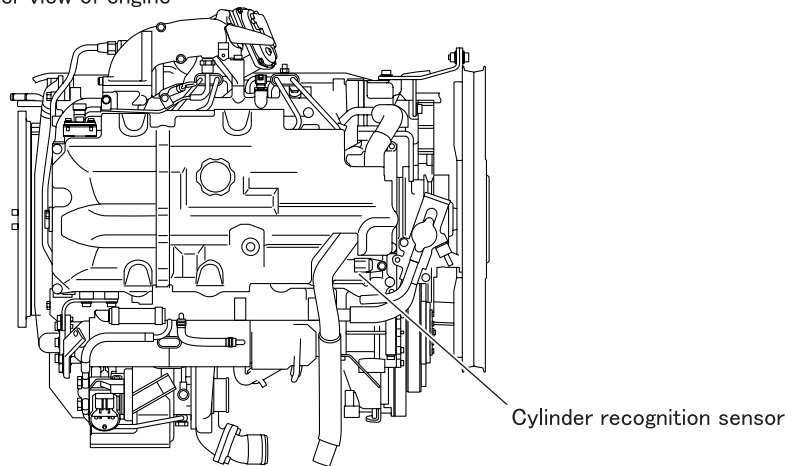
## [Parts Identification and Location]

Upper view of engine

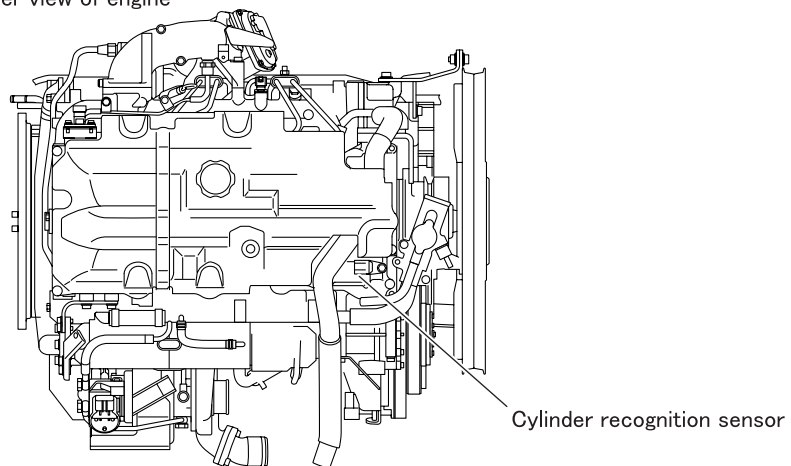
P103619E

Upper view of engine

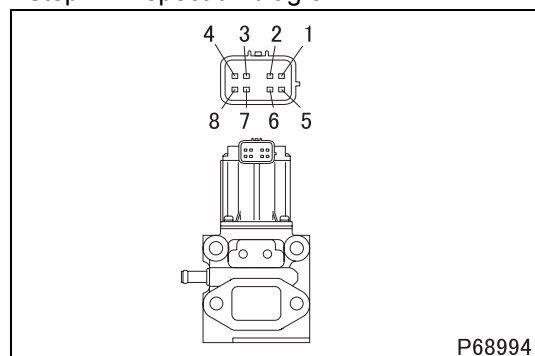
<Step 12 inspection diagram>

| Step 13 | Inspection items | | Inspection of exhaust gas recirculation valve connector (position sensor: power supply) |
| | Maintenance item | | Measure value of voltage between connector terminal No. 1 (+) and 5 (-). |

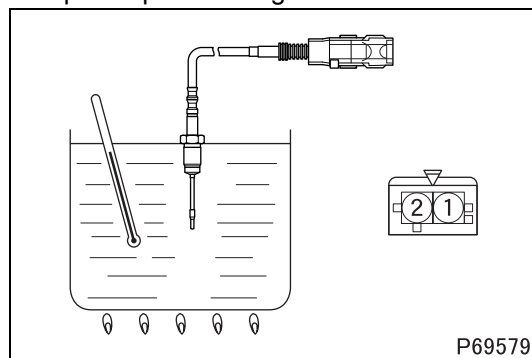
## <Step 5 inspection diagram>

| Step 6 | Inspection items | | Inspection of harness between electronic control unit and sensor (power supply) | |
| | Maintenance item | | Check circuit between electronic control unit connector (GE96A) terminal No. 39 and sensor connector terminal No. 2. | |

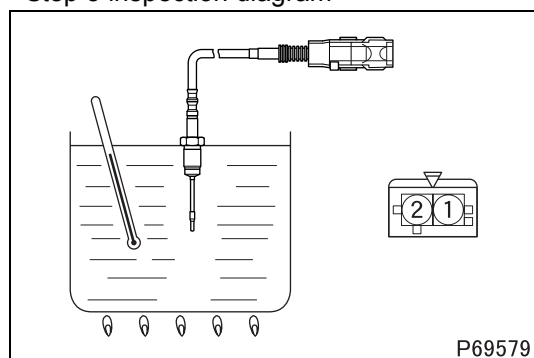
## &lt;Step 5 inspection diagram&gt;

| Step 6 | Inspection items | | Inspection of harness between electronic control unit and sensor (power supply) | |
| | Maintenance item | | Check circuit between electronic control unit connector (GE96A) terminal No. 39 and sensor connector terminal No. 2. | |

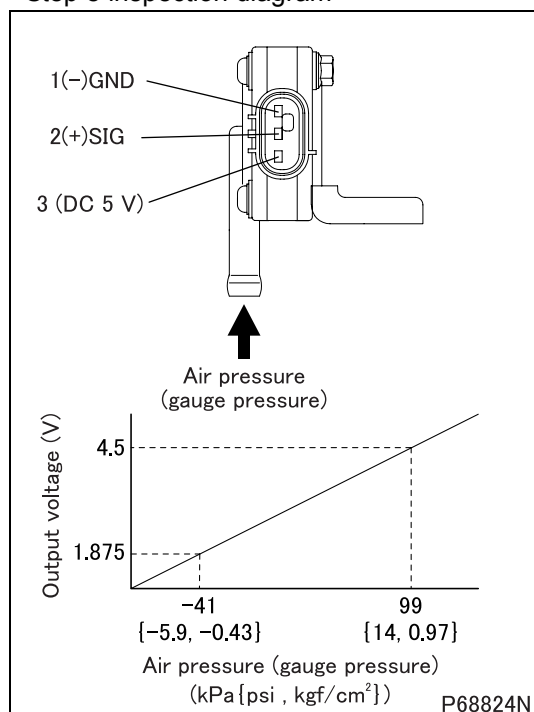
<Step 8 inspection diagram>

| Step 9 | Inspection items | | Inspection by sensor connector |

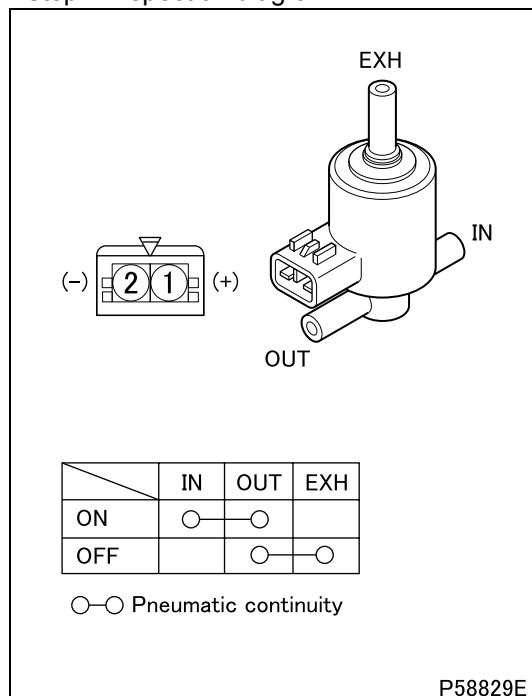
<Step 4 inspection diagram>

| Step 5 | Inspection items | | Inspection of harness between exhaust shutter 2-way magnetic valve and electronic control unit (power supply) | |
| | Maintenance item | | Check circuit between exhaust shutter 2-way magnetic valve connector terminal No. 1 and electronic control unit connector (GE96A) terminal No. 76. | |

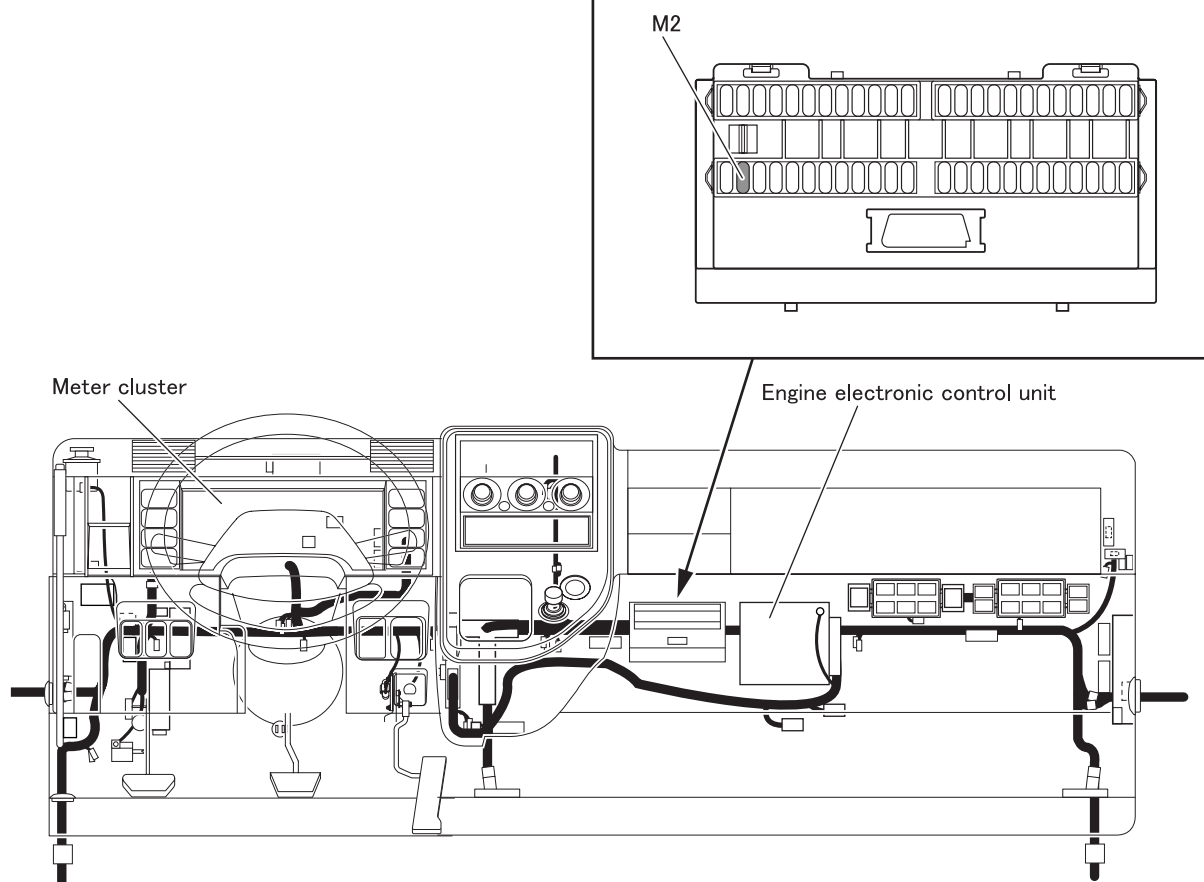
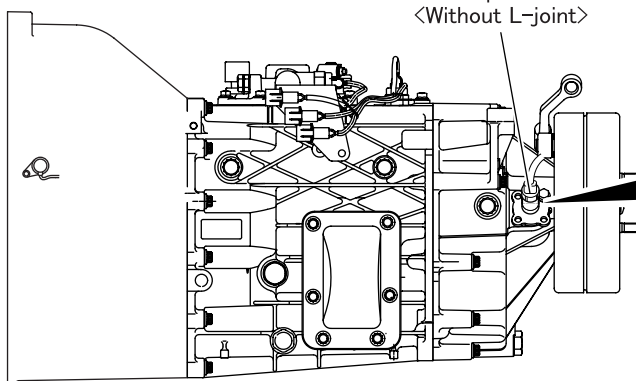
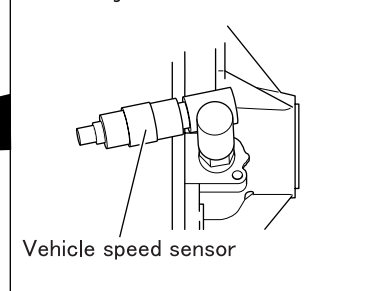
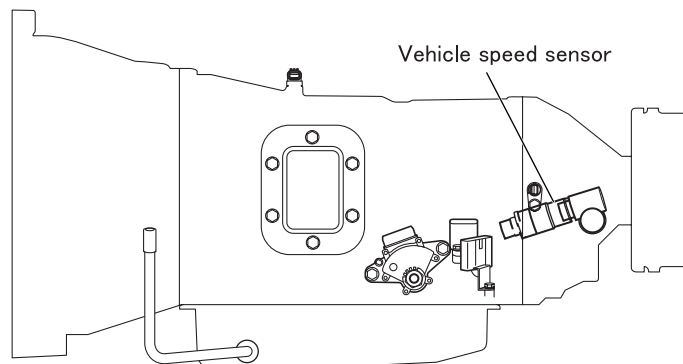
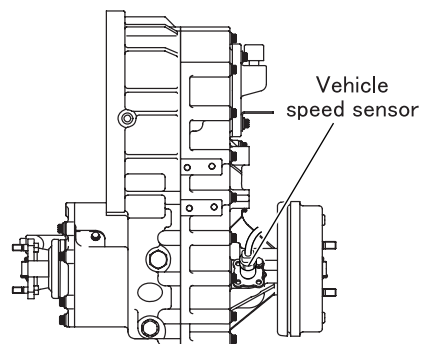
## [Parts Identification and Location]

Left side view of manual transmission

&lt;With L-joint&gt;

Left side view of automatic transmission

Transfer (FG)

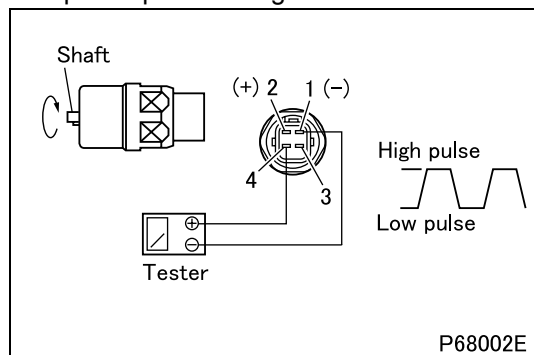
<Step 5 inspection diagram>

| Step 6 | Inspection items | | Inspection of sensor harness (power supply) | |
| | Maintenance item | | Check circuit between connector terminal No. 2 and fuse (M2). | |

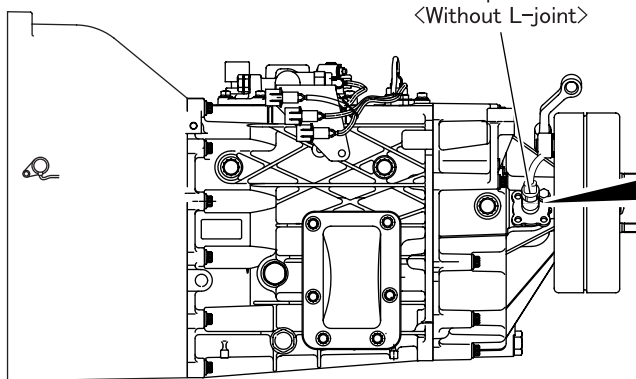
Left side view of manual transmission

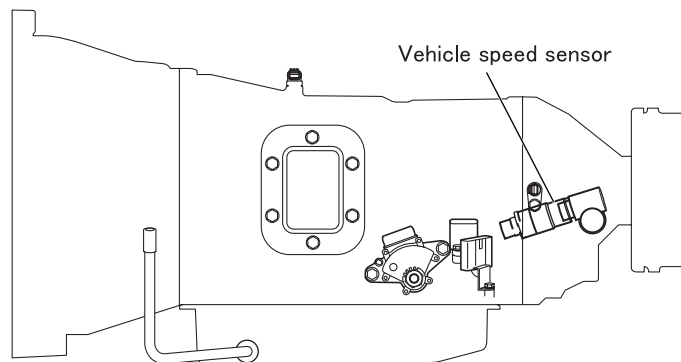
Left side view of automatic transmission

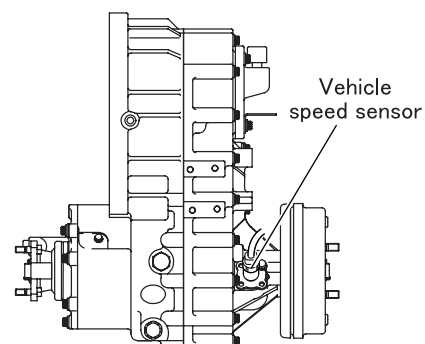
Transfer (FG)

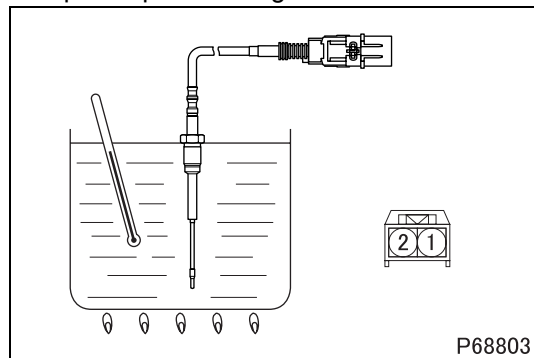
<Step 5 inspection diagram>

| | Inspection condition | | <ul style="list-style-type: none"> <li>Put DPF temperature sensor 1 in container filled with engine oil.</li> <li>Heat the oil to each of the specified temperatures. Stir the oil well while doing so.</li> </ul> | |

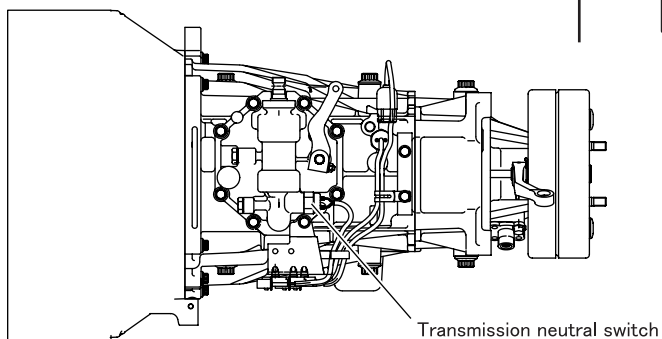
Upper view of manual transmission

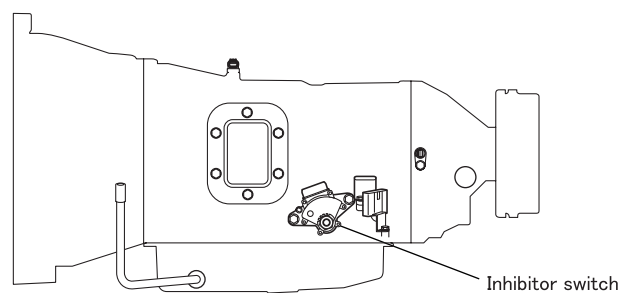
Left view of automatic transmission

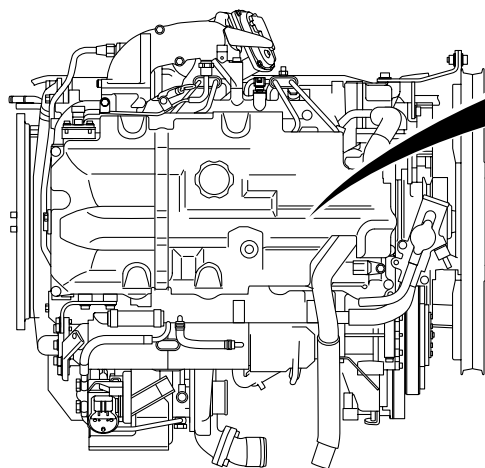
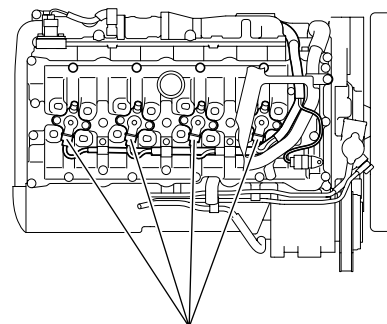
Top view of engine

Injector magnetic valve

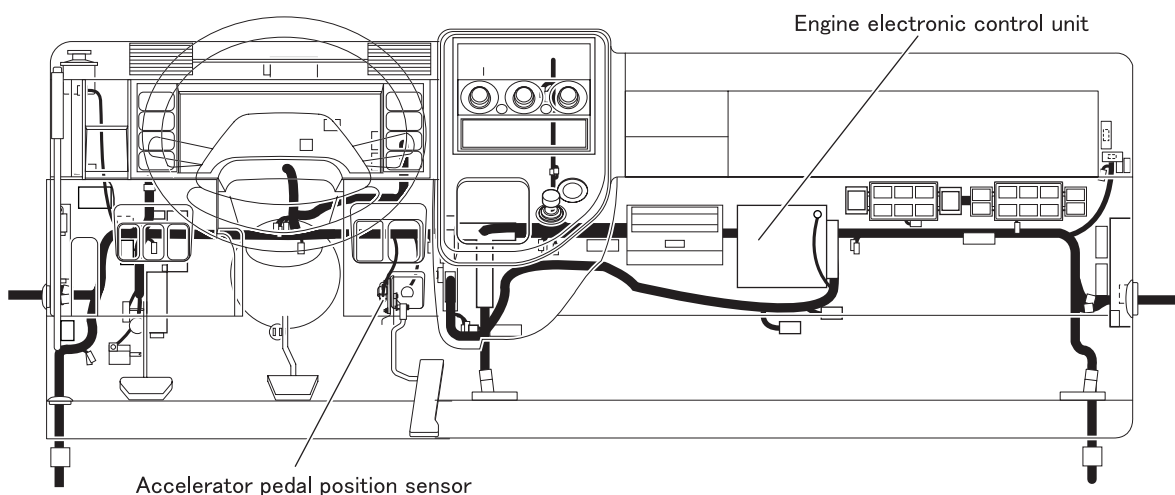
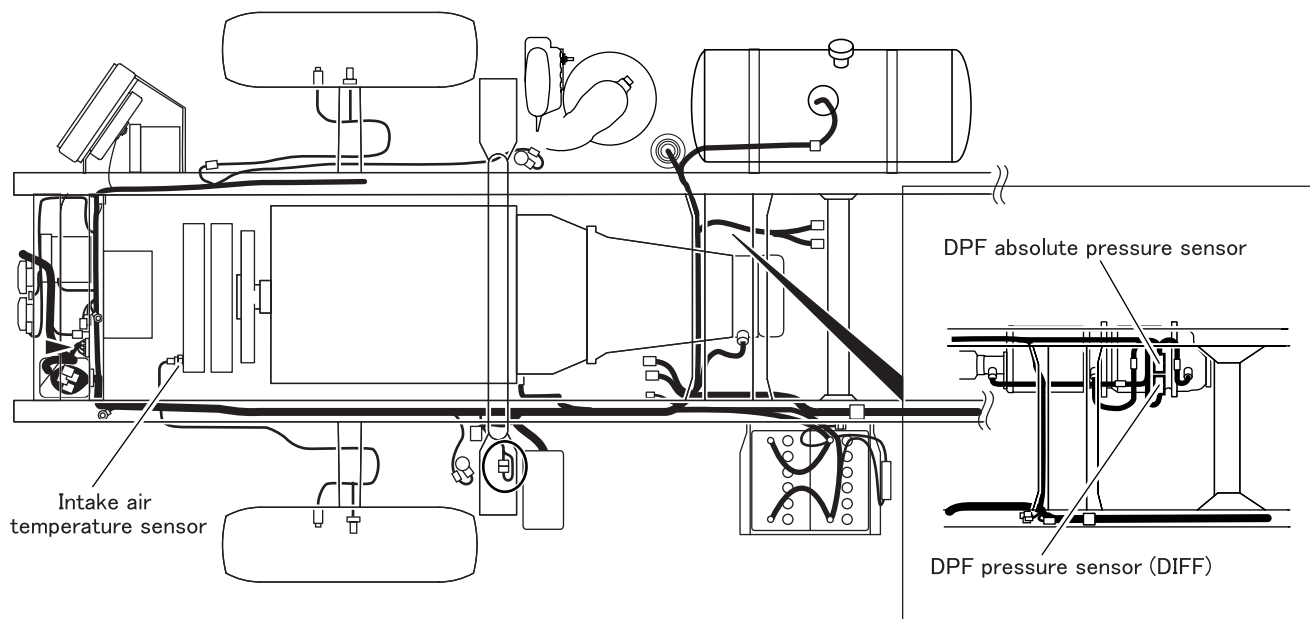
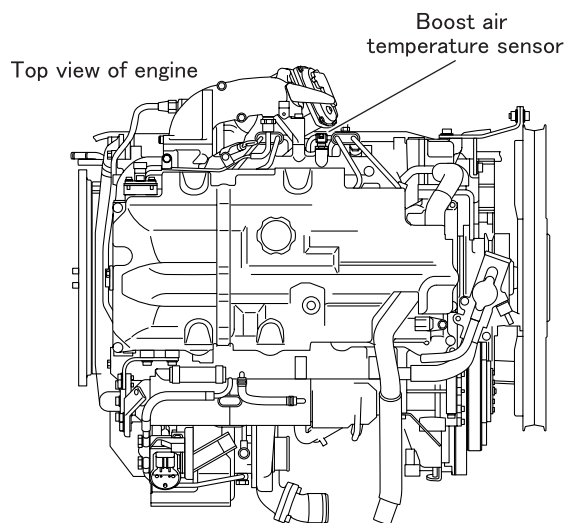
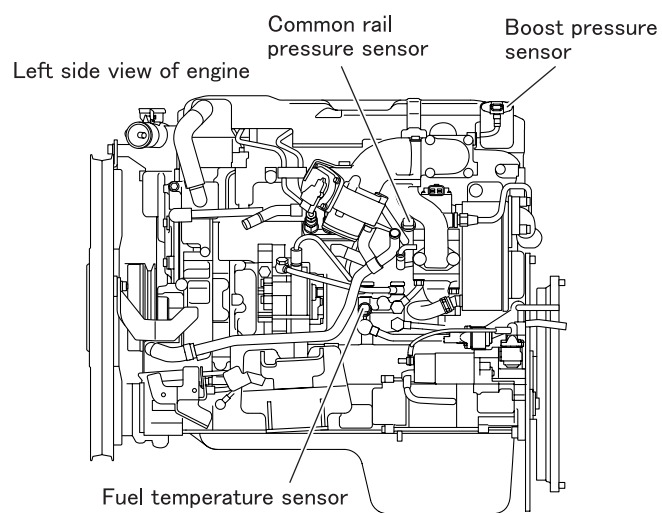
## [Parts Identification and Location]
