# FE.FG

## SERVICE MANUAL 2008 Model FOREWORD

This Service Manual contains maintenance and repair methods for the Mitsubishi Fuso Truck FE. FG Series. Read this manual carefully as an aid in providing correct, efficient maintenance. Please note that the information and specifications contained within this manual may change without notice. This is due to product modifications and continued vehicle improvements that are made throughout the model years. Should you encounter any discrepancy in the information provided, please do not hesitate to contact your nearest Mitsubishi Fuso Dealer or Mitsubishi Fuso Truck of America, Inc.

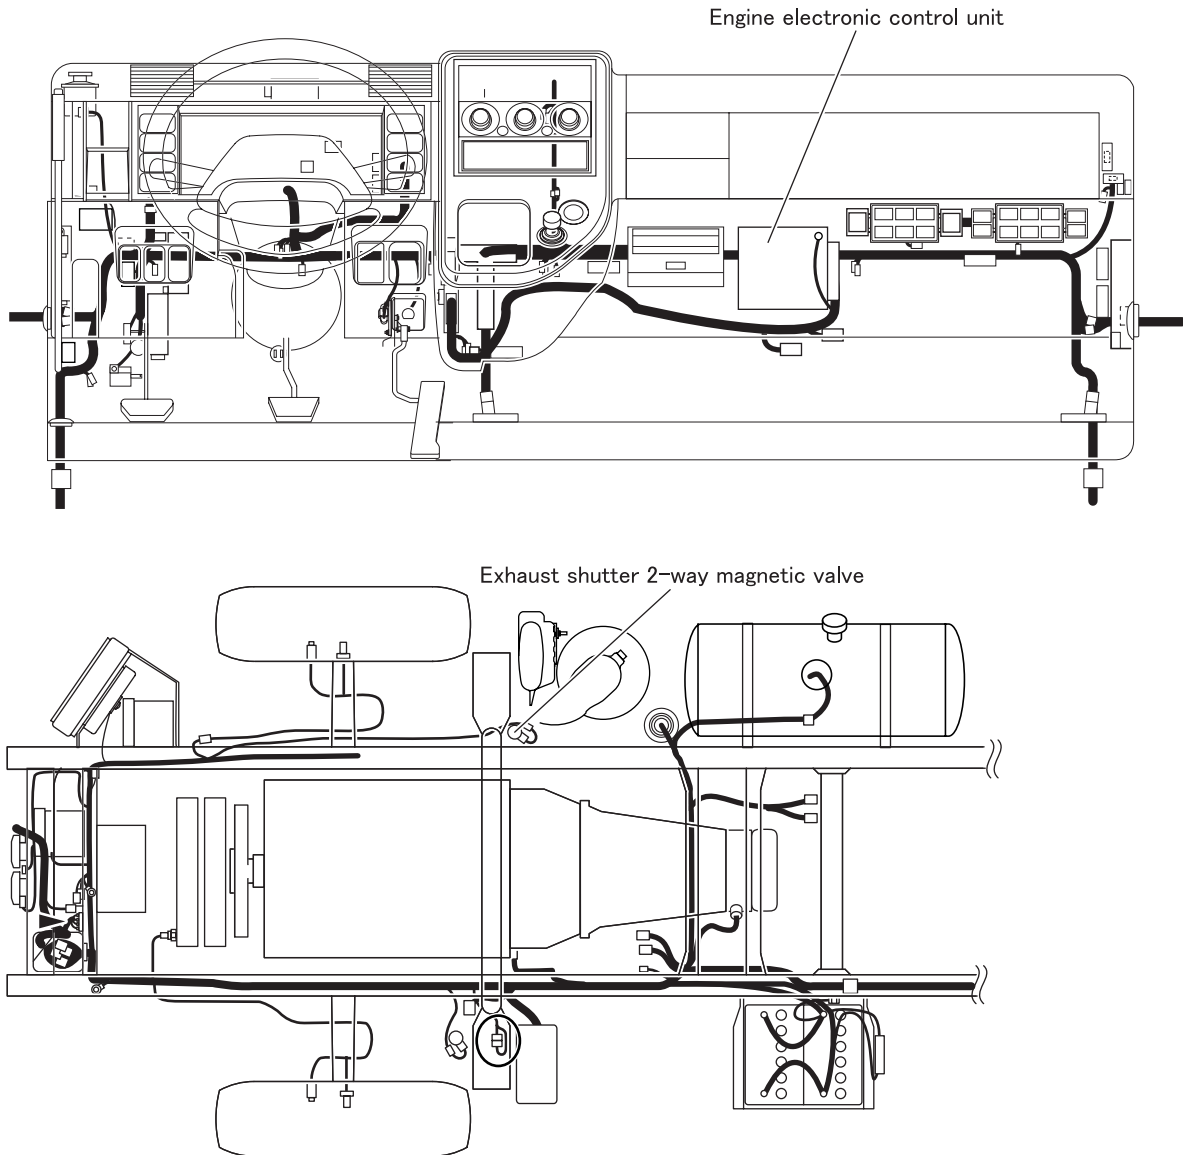
P107381E

## [Parts Identification and Location]

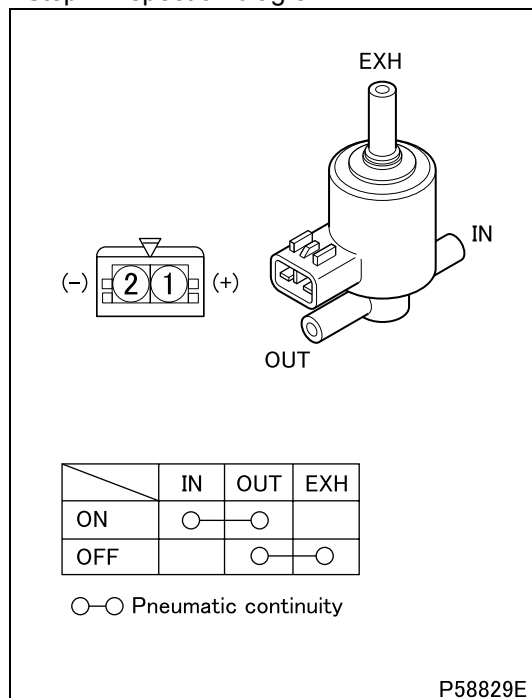
<Step 4 inspection diagram>

| | Inspection condition | | Gradually increase from zero the voltage applied to terminals No. 1 (+) and 2 (-). | |

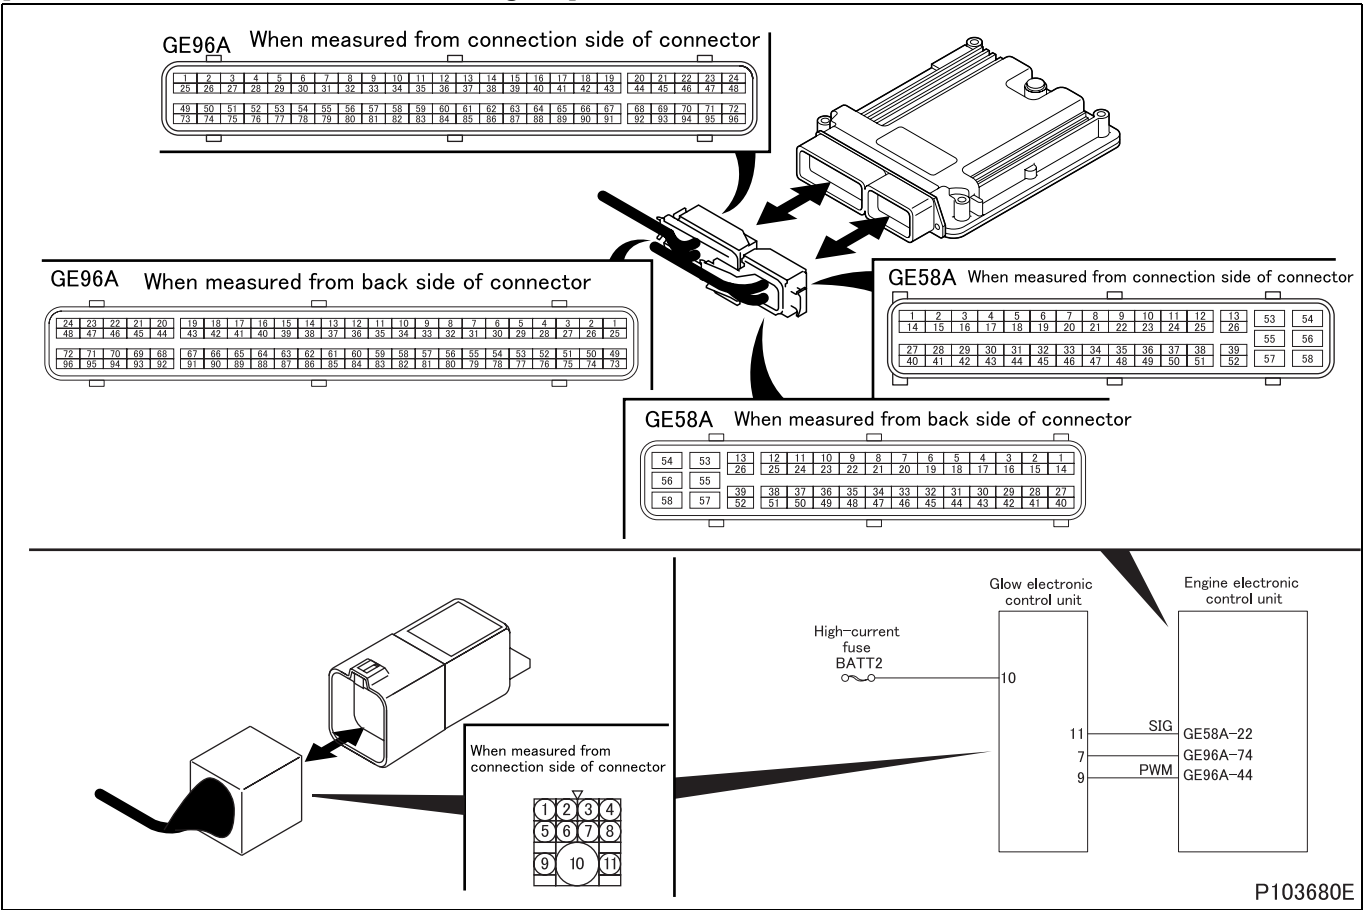
## [Electronic Control Unit Connection Diagram]

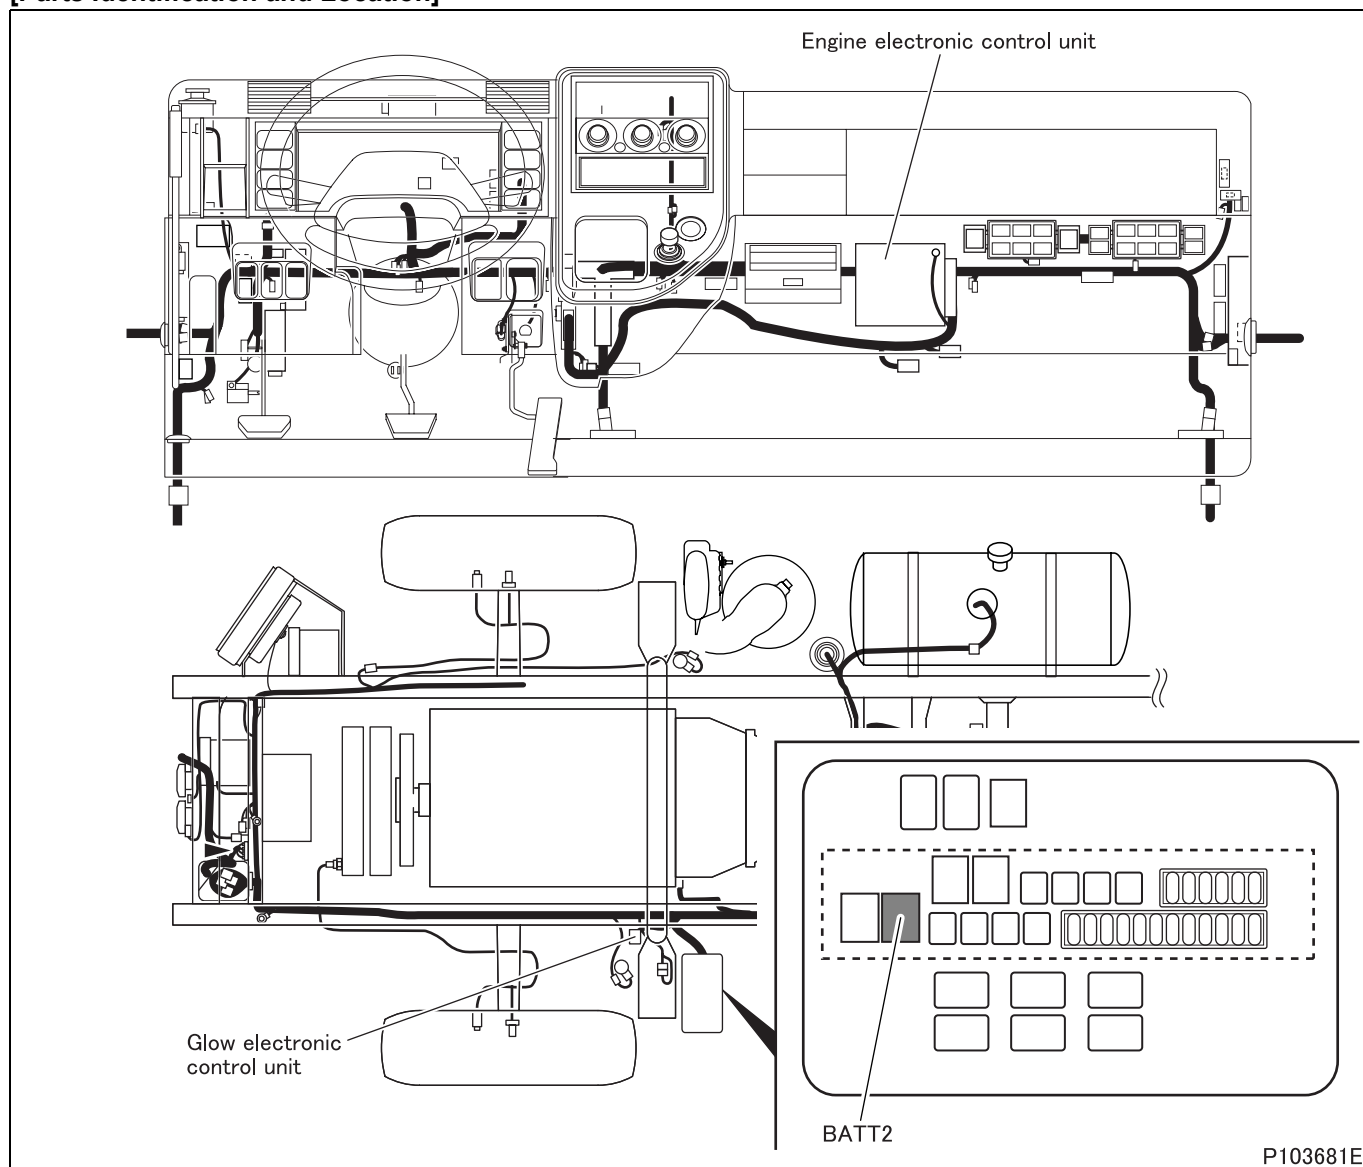
[Parts Identification and Location]

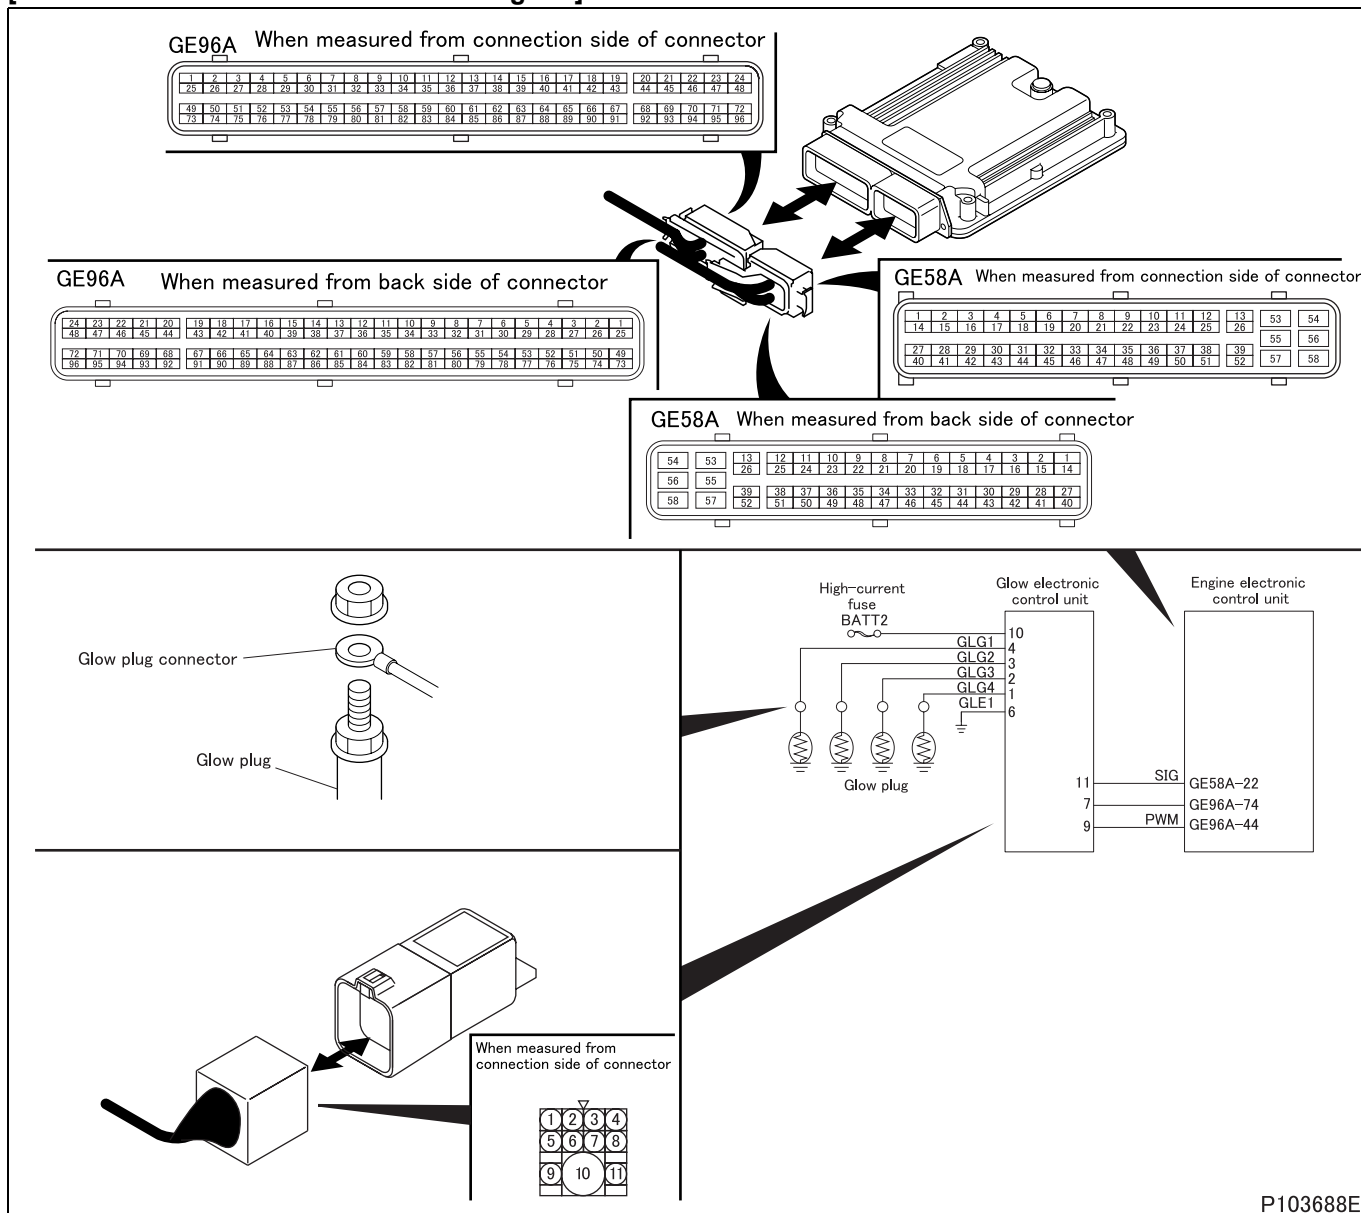
P103688E

## [Electronic Control Unit Connection Diagram]

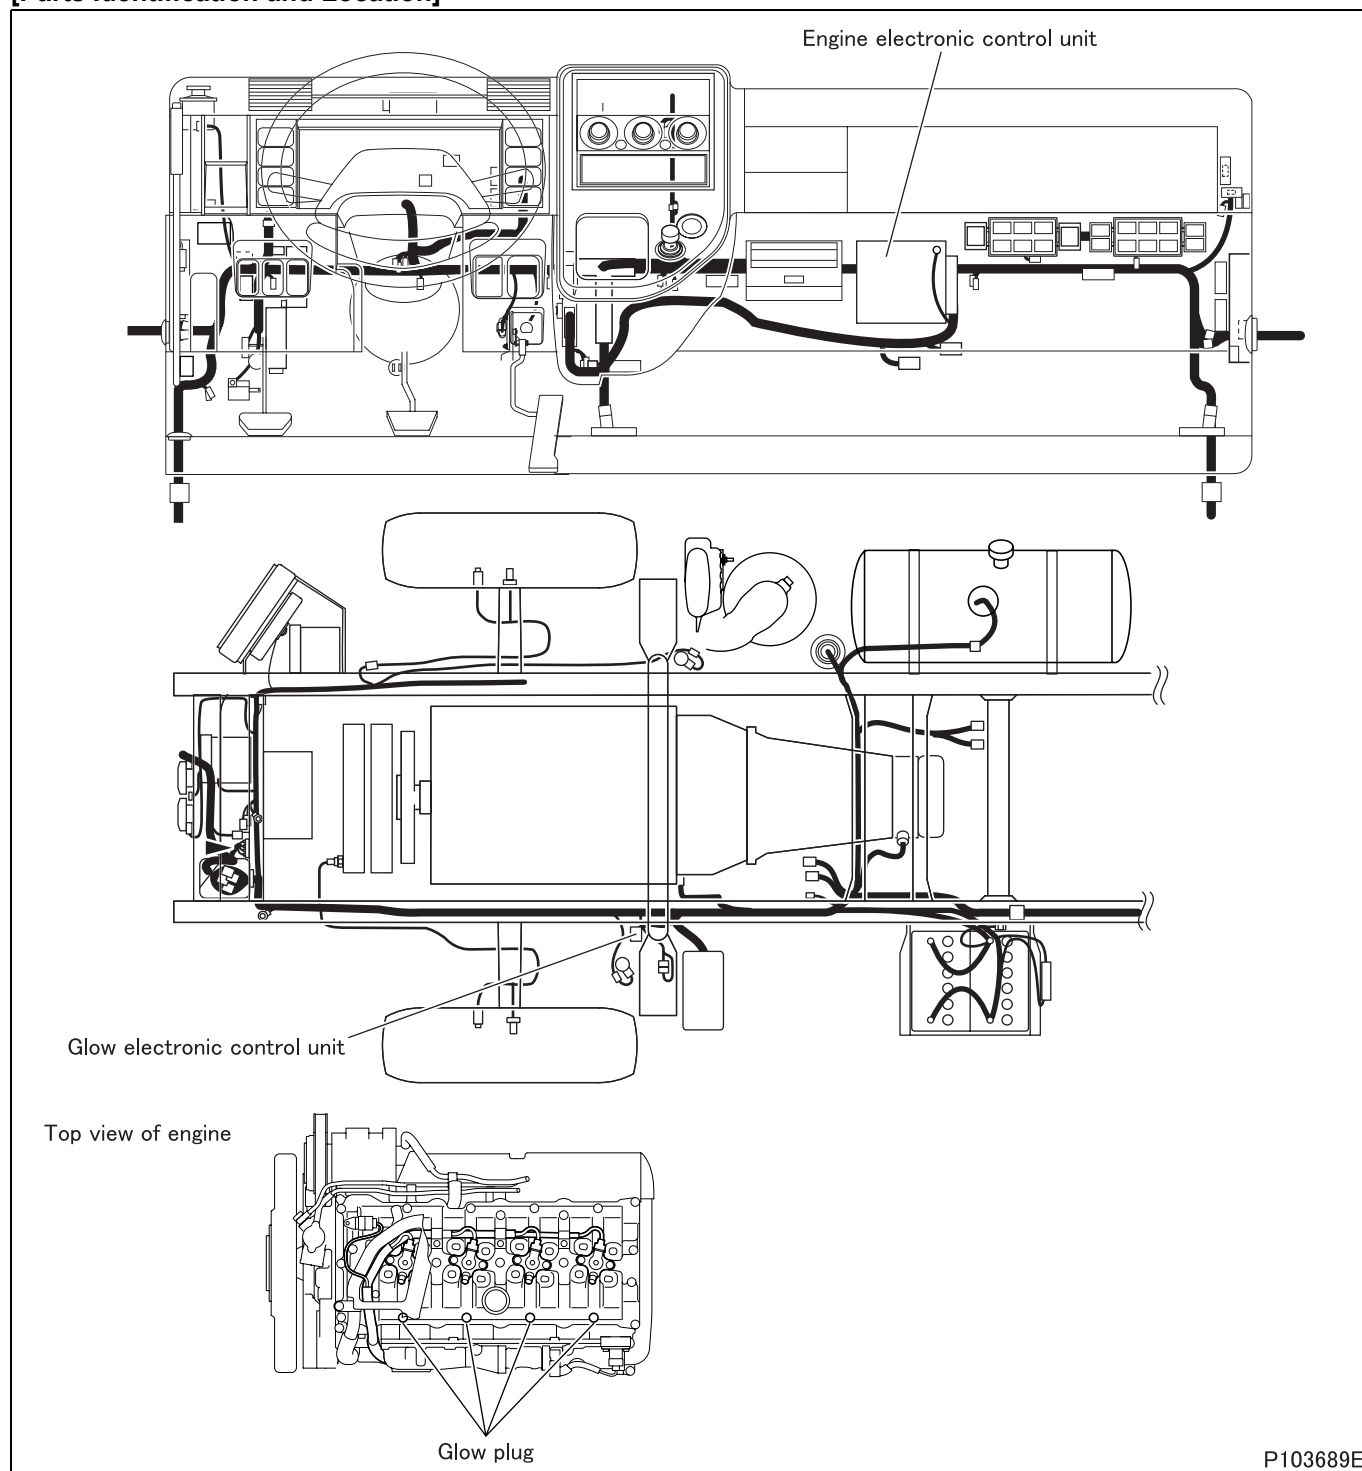
P103689E

## [Parts Identification and Location]

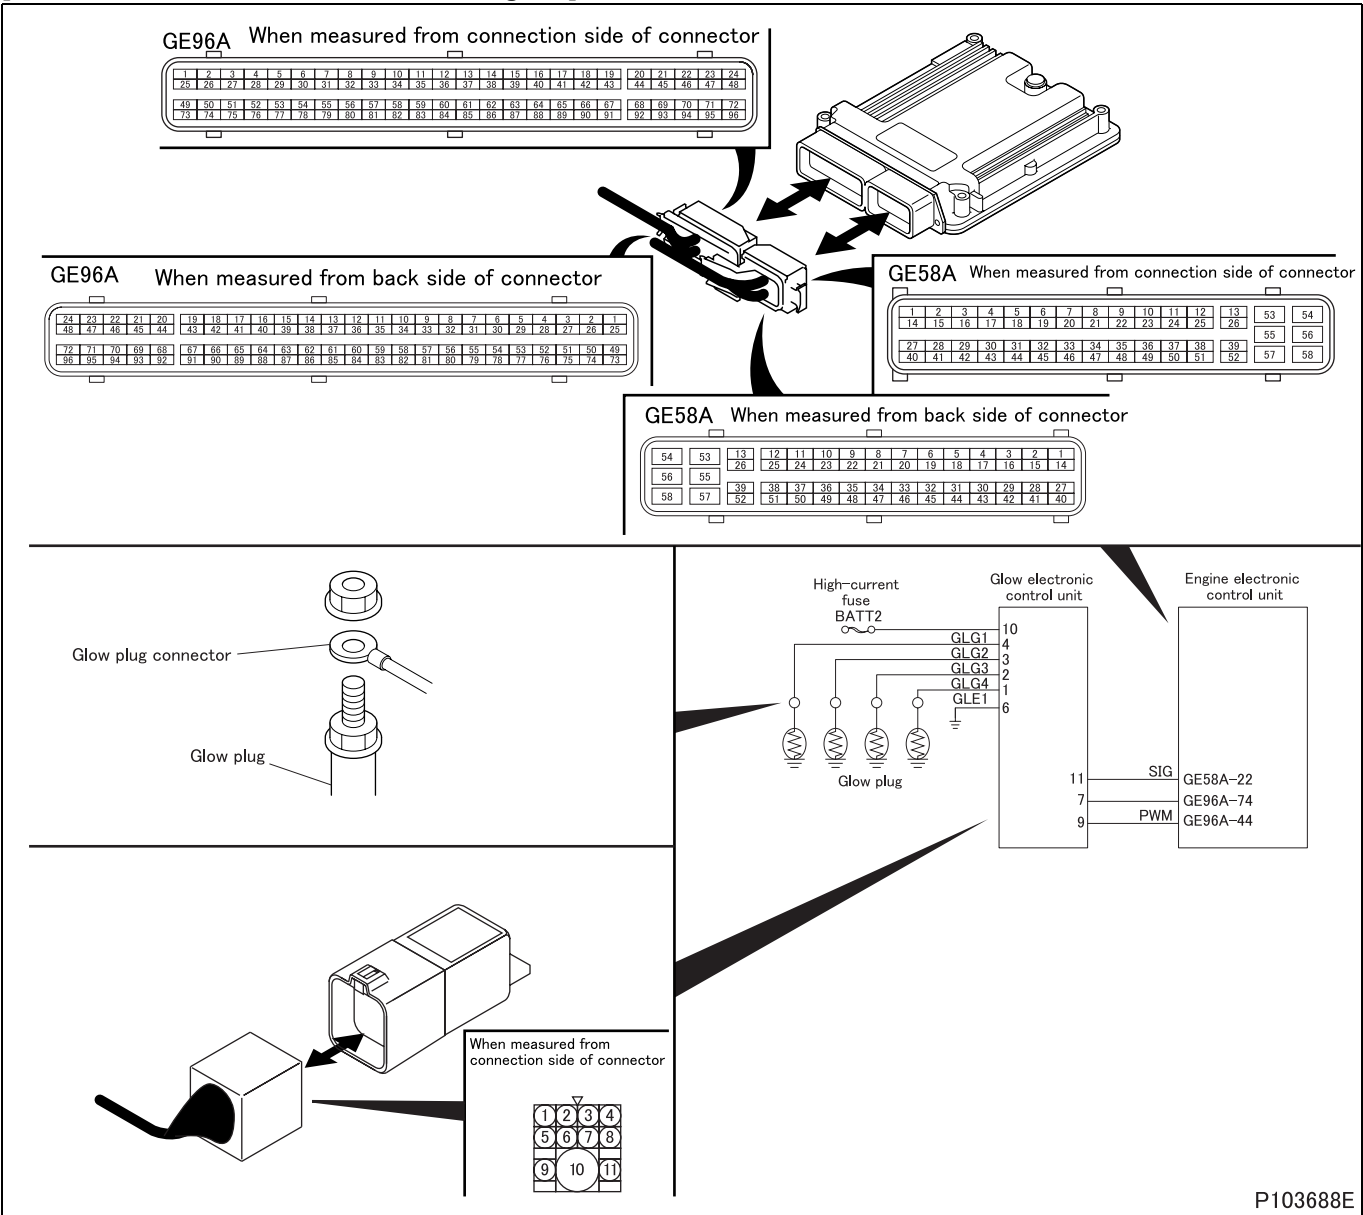
P103688E

## [Electronic Control Unit Connection Diagram]

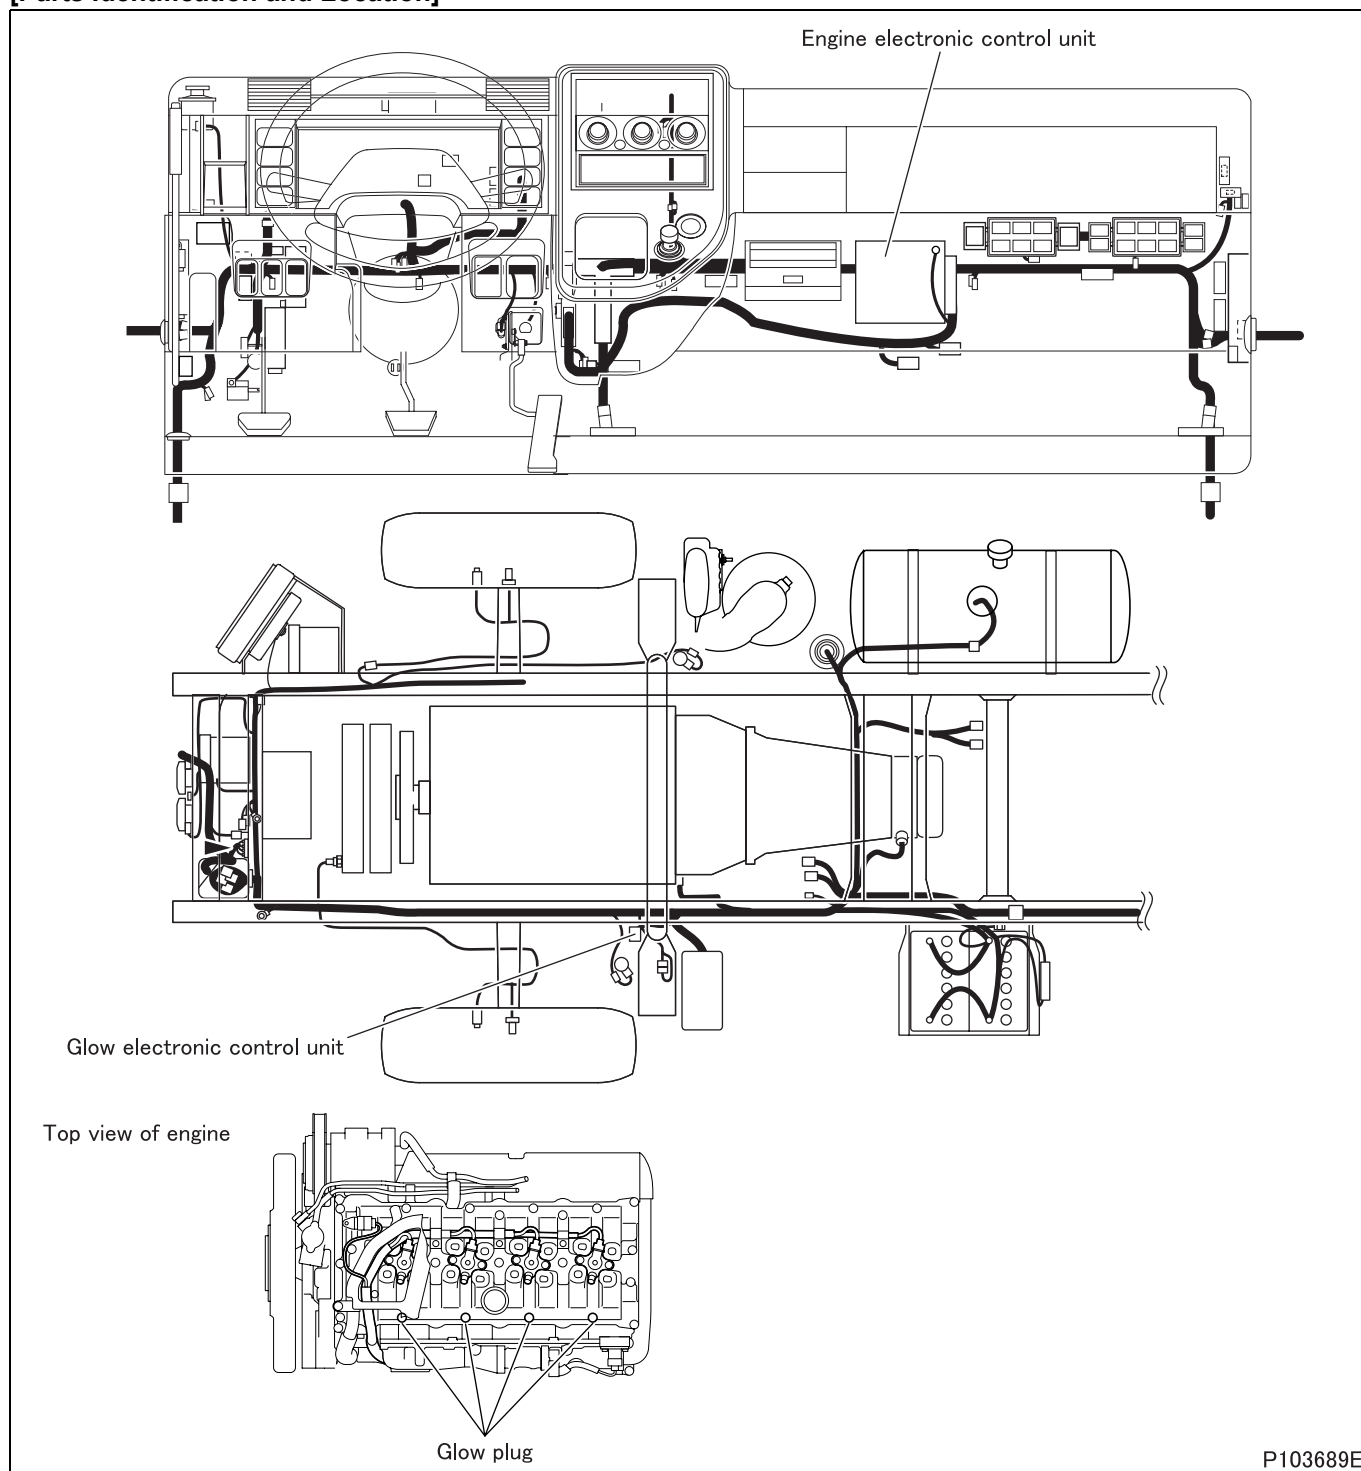
## [Parts Identification and Location]

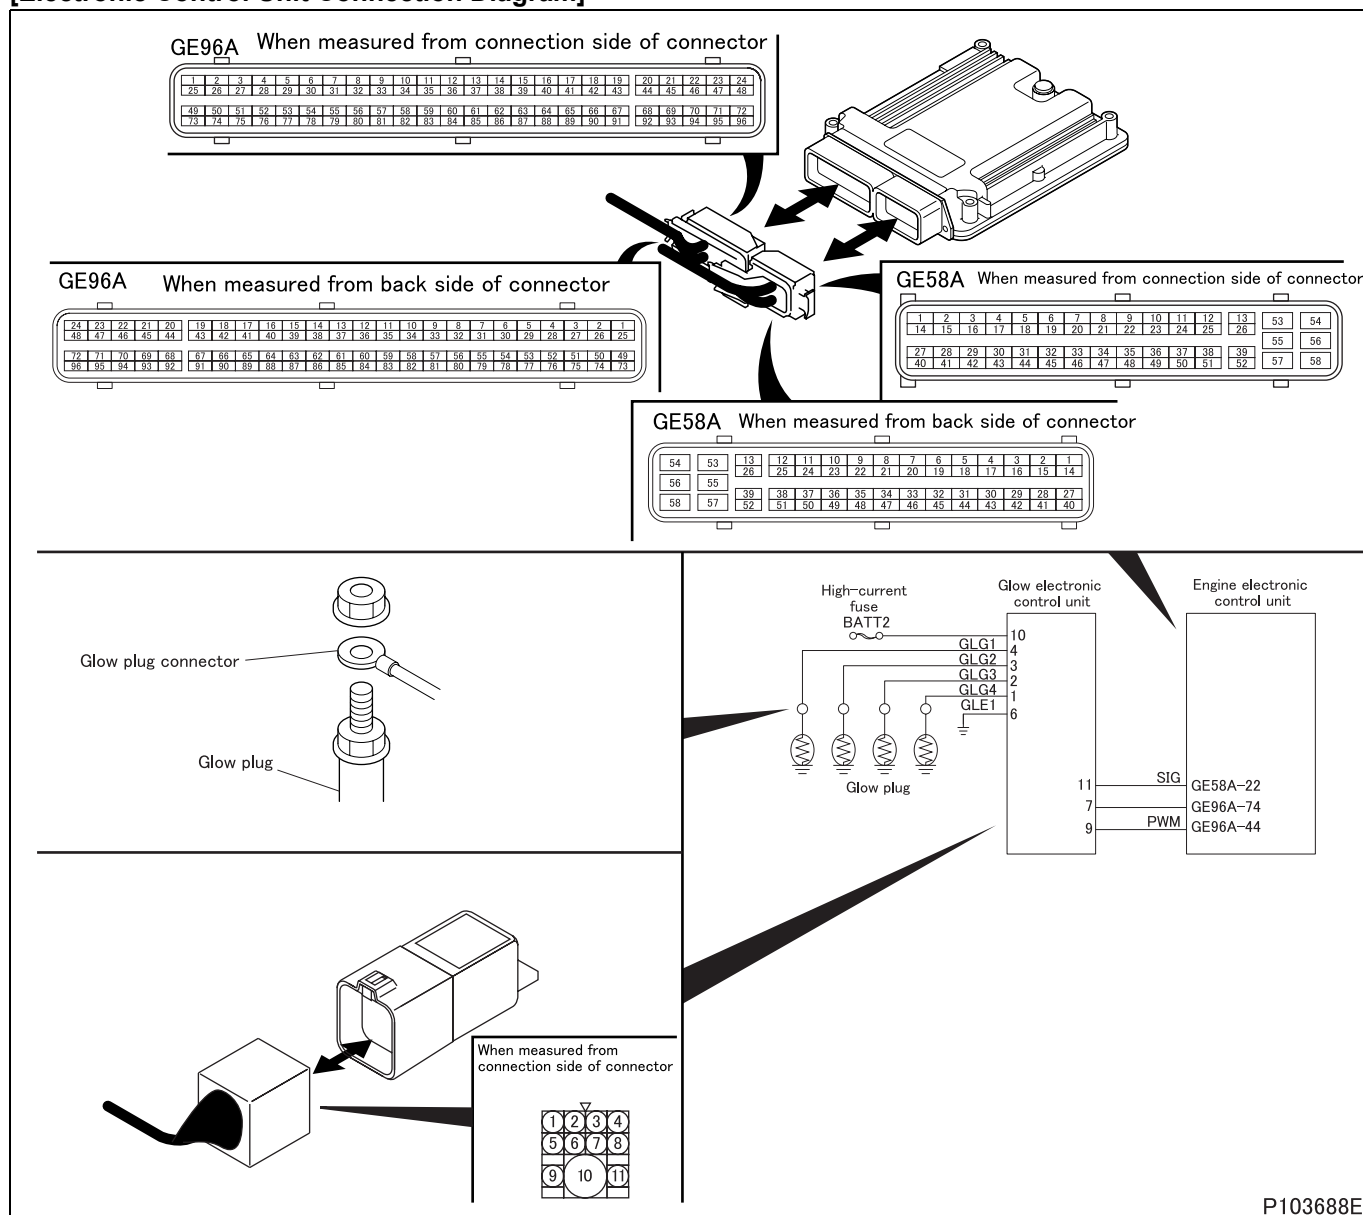
P103688E

## [Electronic Control Unit Connection Diagram]

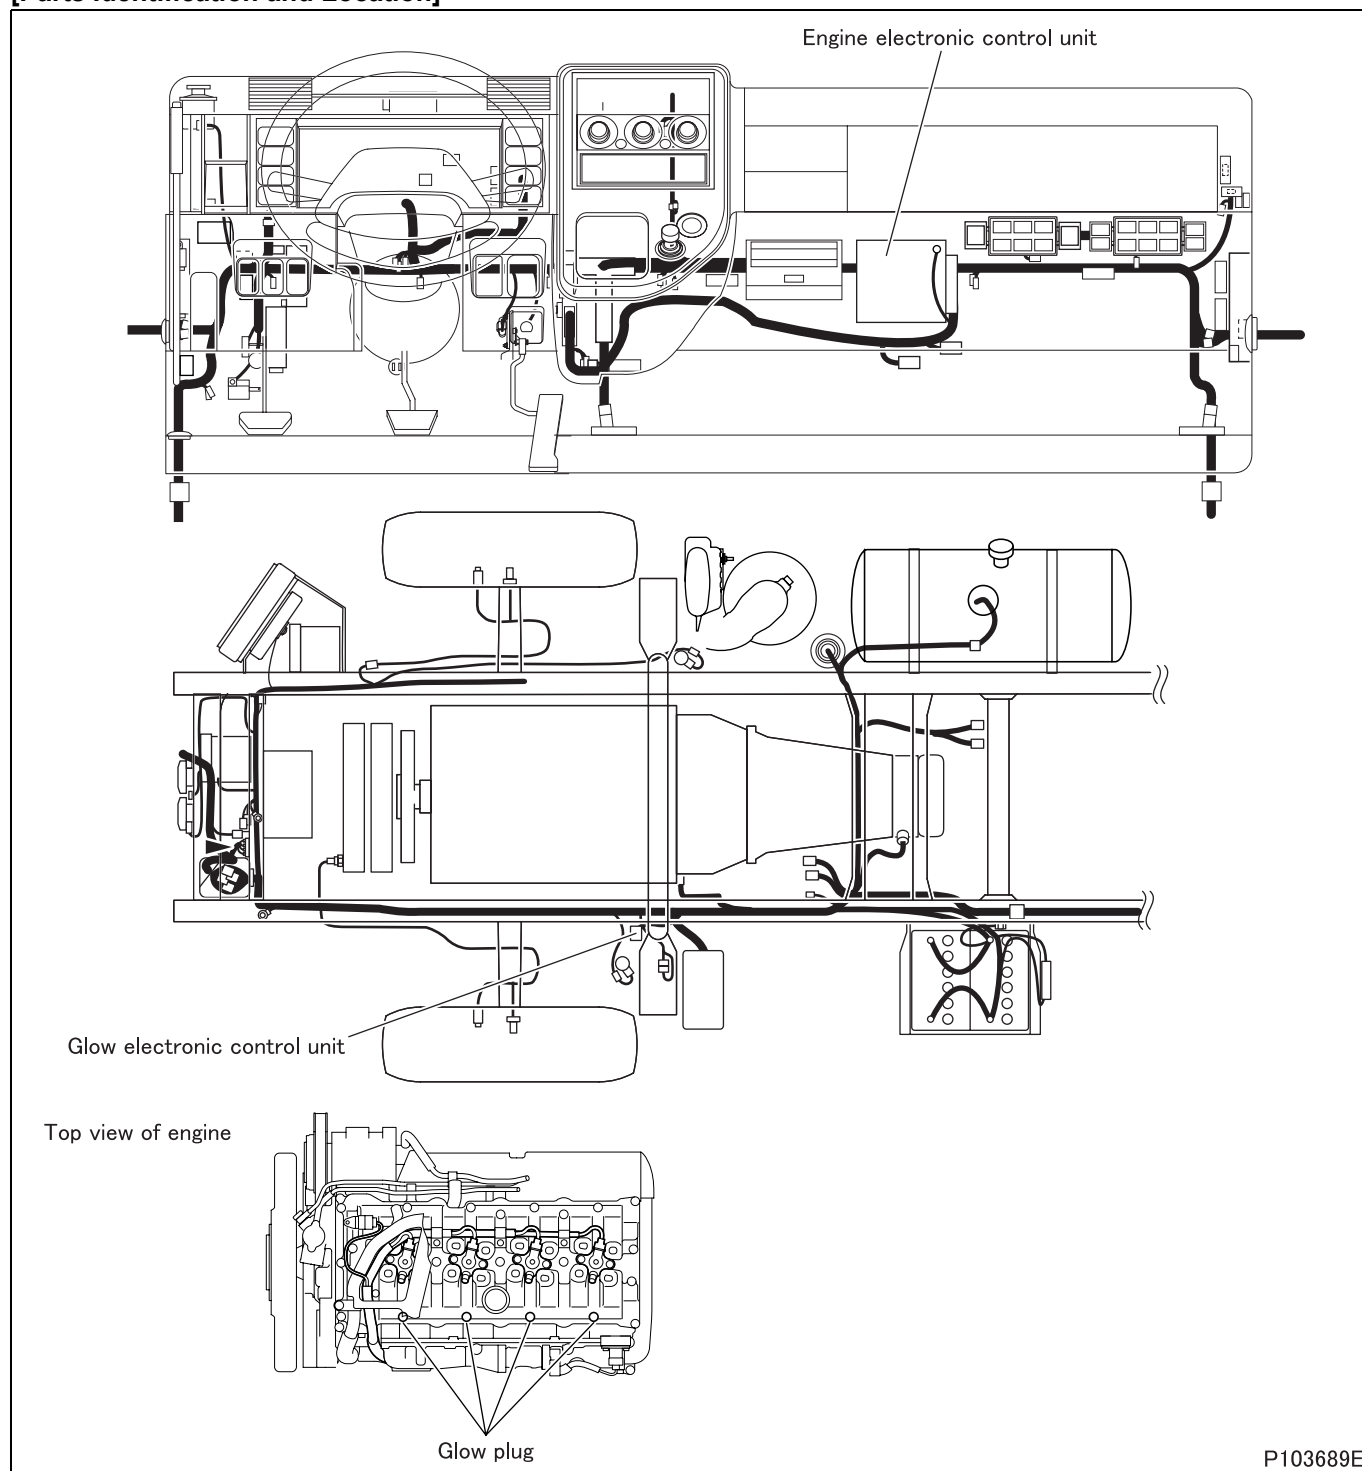
P103689E

## [Parts Identification and Location]

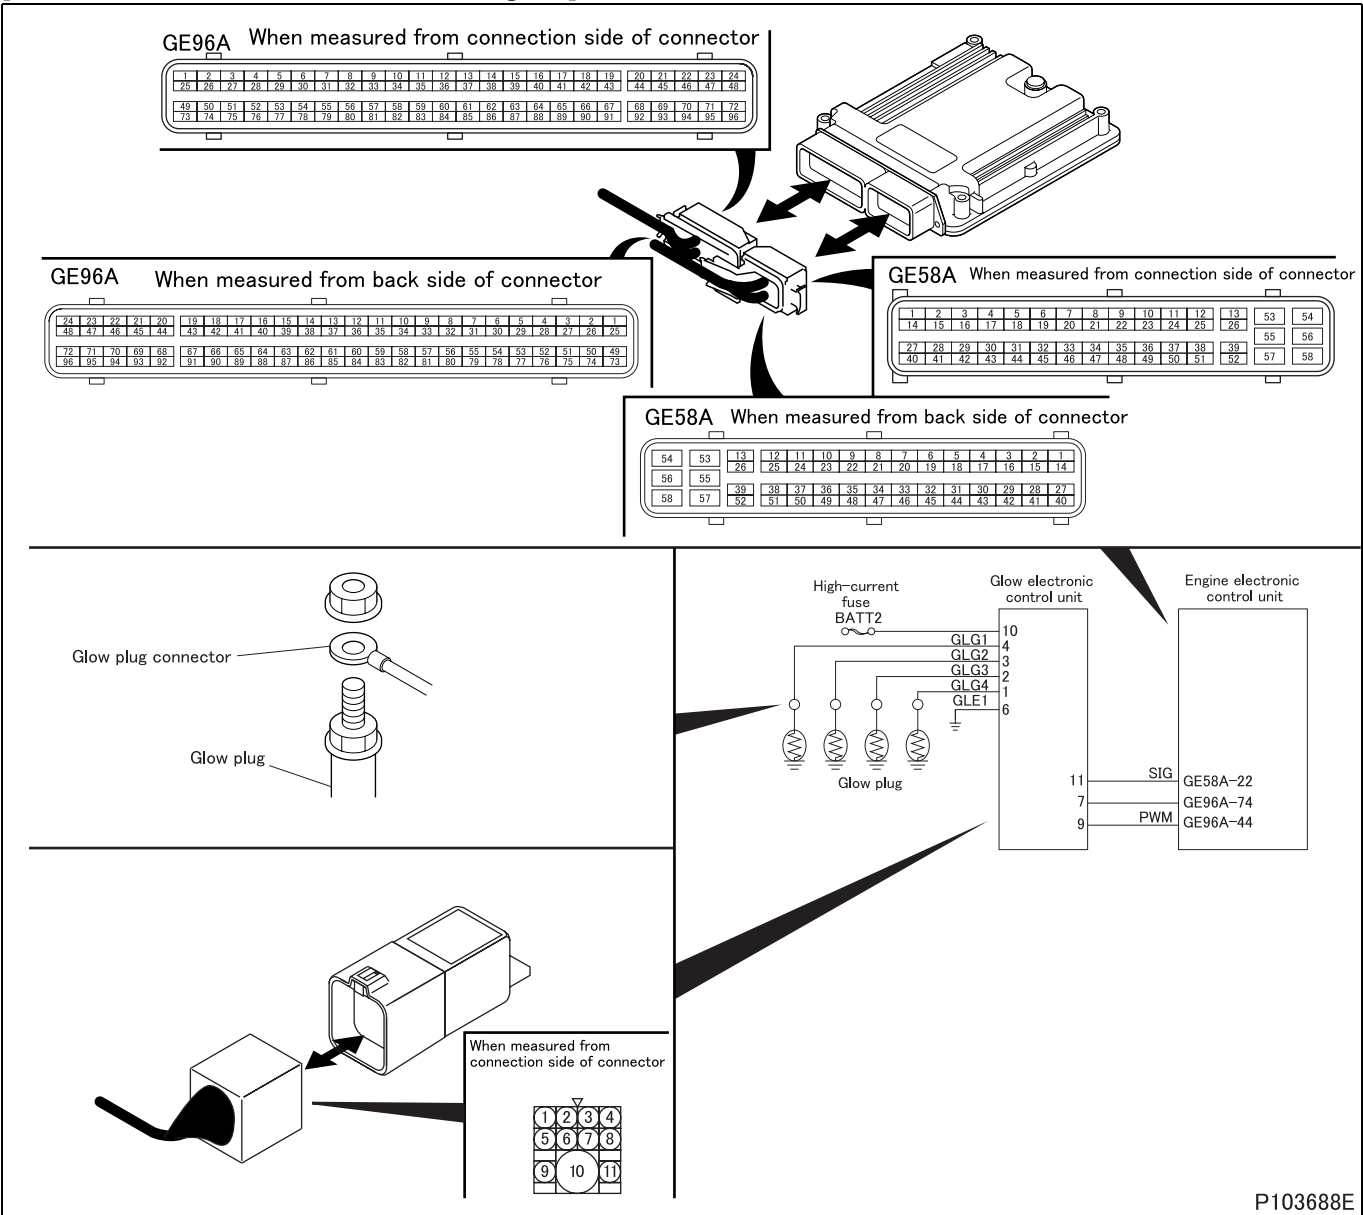
P103688E

## [Electronic Control Unit Connection Diagram]

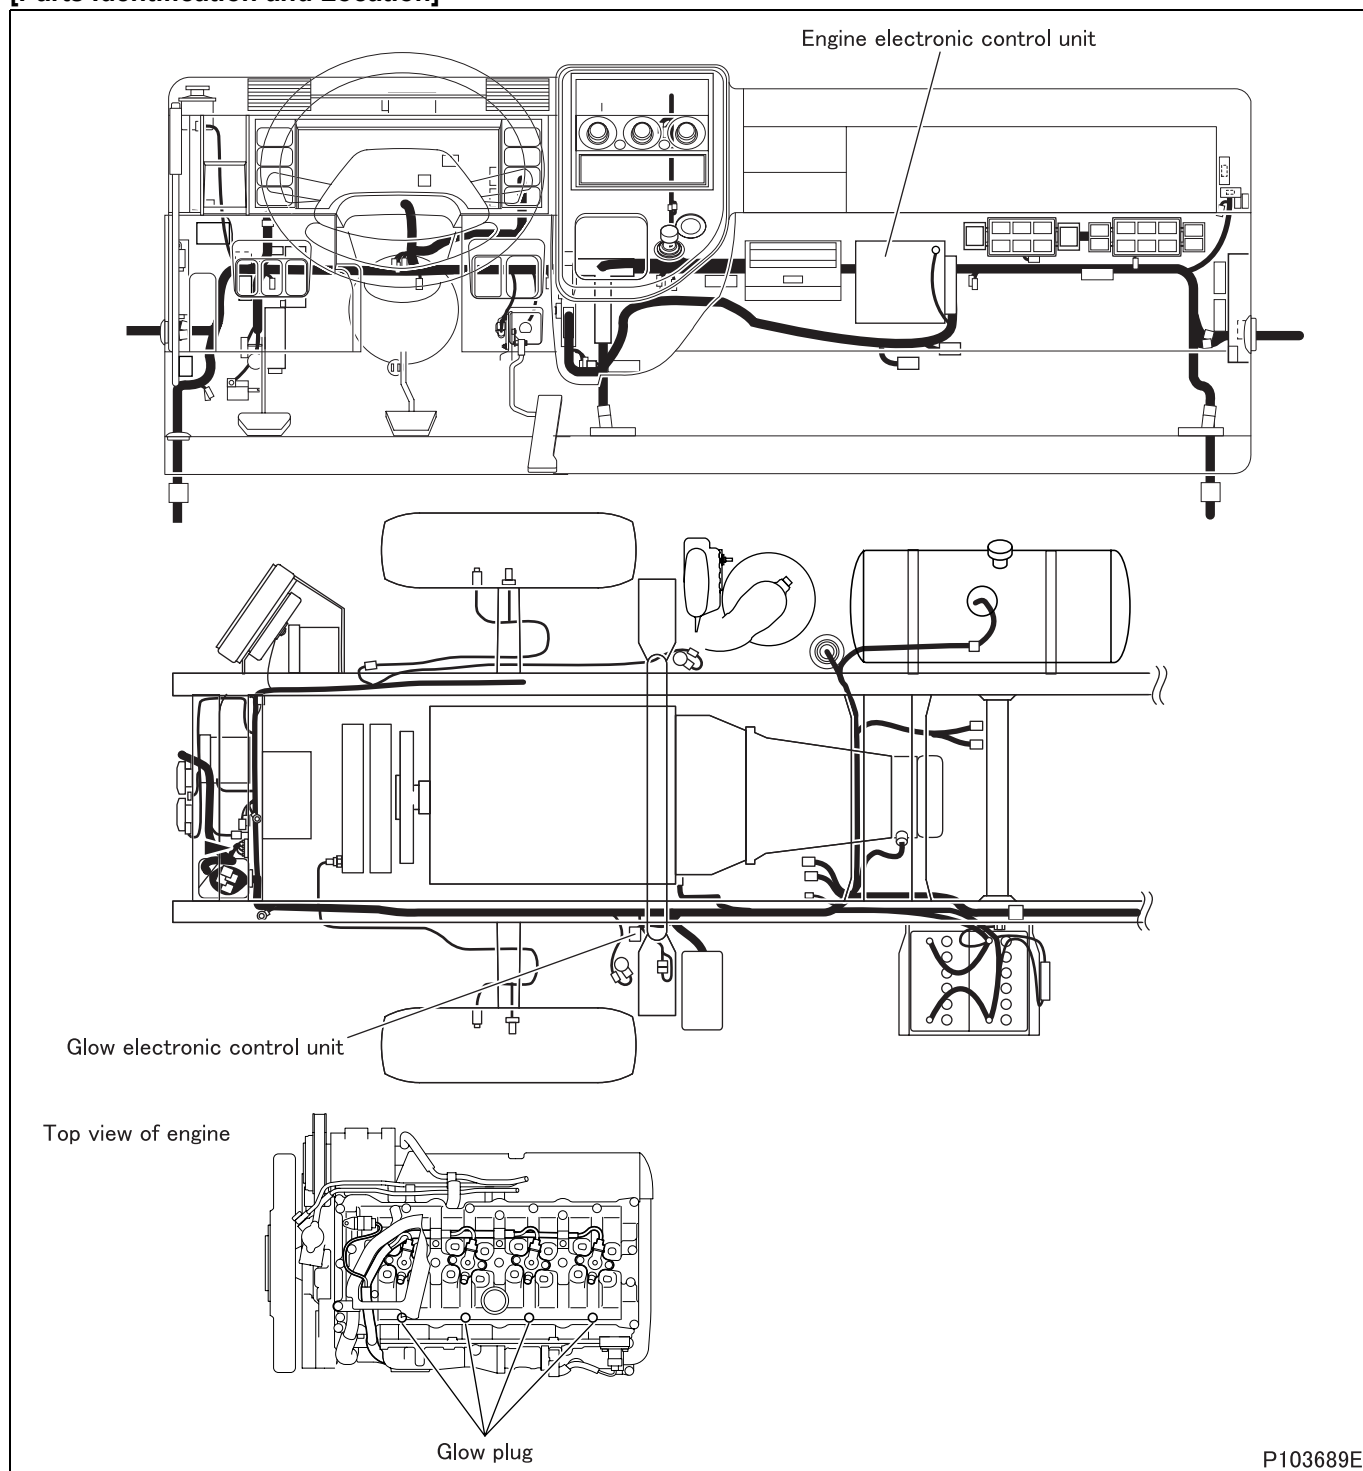
## [Parts Identification and Location]

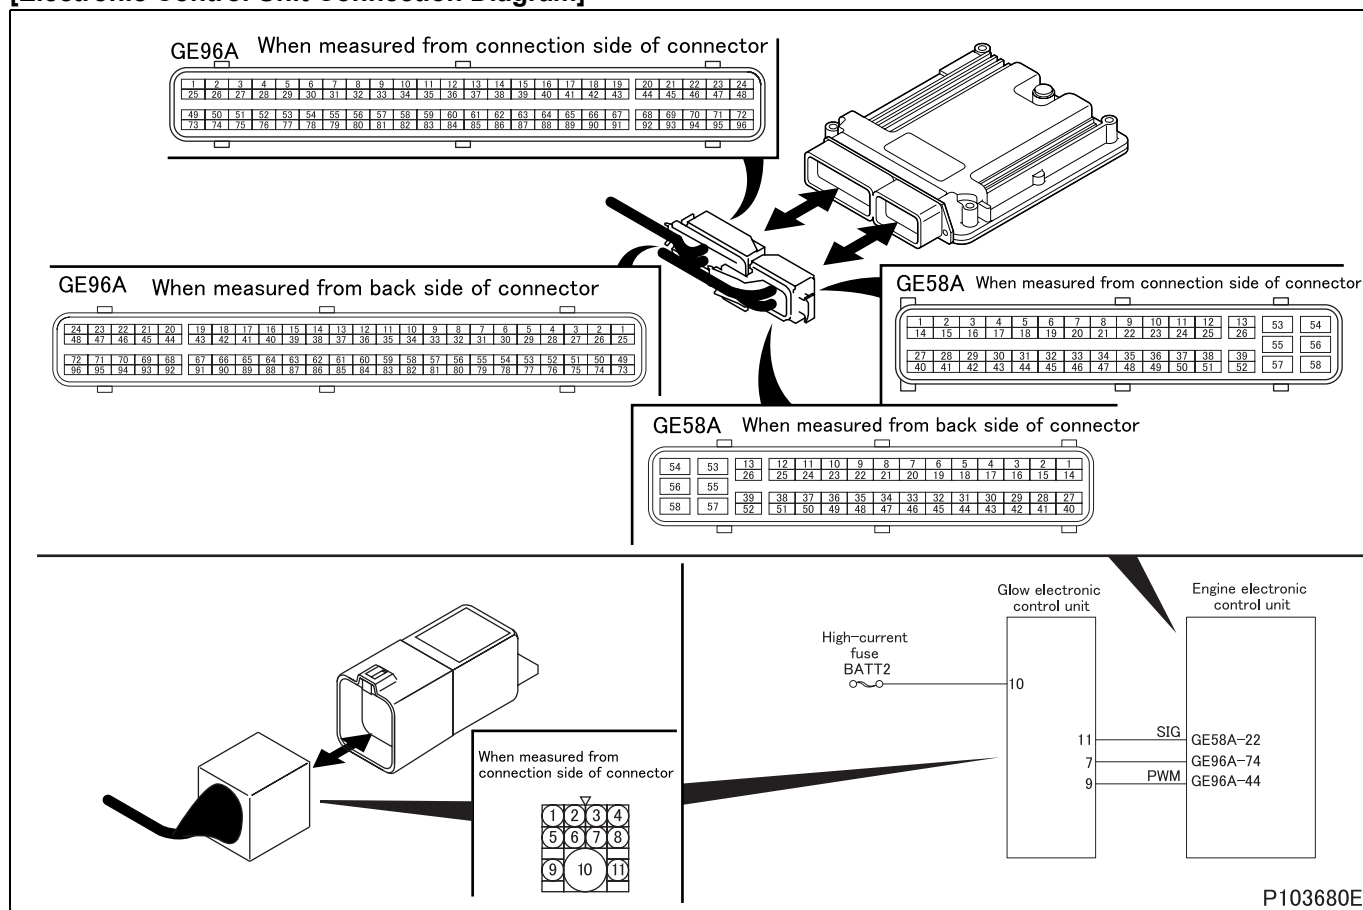
## [Electronic Control Unit Connection Diagram]

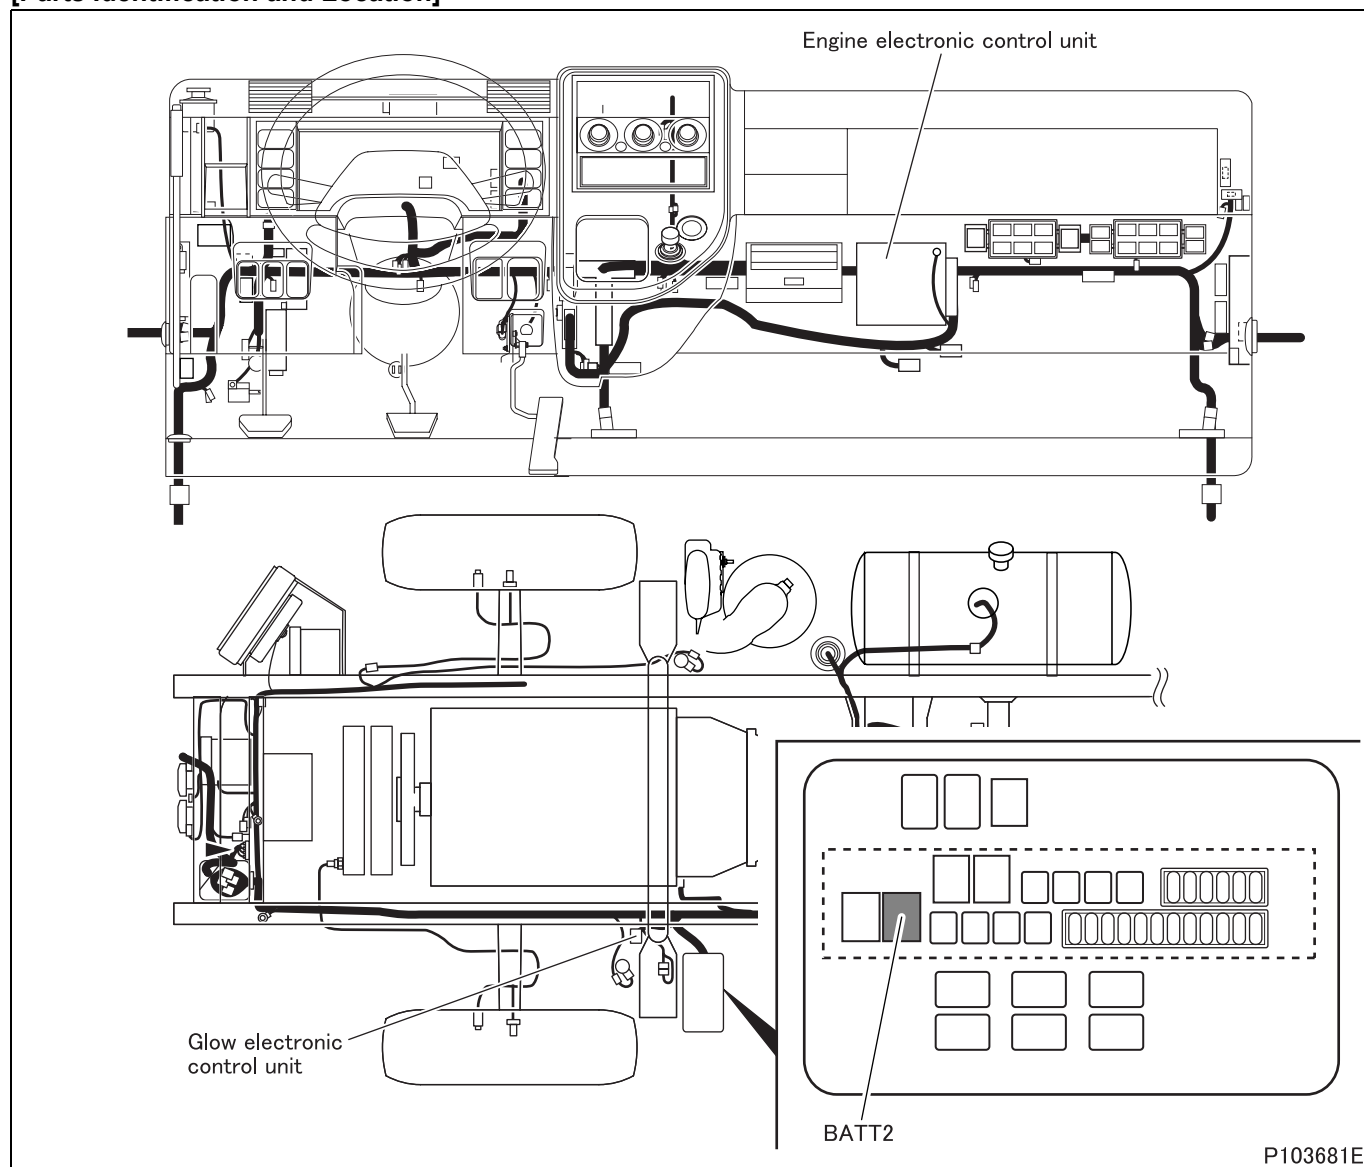
## [Parts Identification and Location]
