# FE.FG

## SERVICE MANUAL 2008 Model FOREWORD

This Service Manual contains maintenance and repair methods for the Mitsubishi Fuso Truck FE. FG Series. Read this manual carefully as an aid in providing correct, efficient maintenance. Please note that the information and specifications contained within this manual may change without notice. This is due to product modifications and continued vehicle improvements that are made throughout the model years. Should you encounter any discrepancy in the information provided, please do not hesitate to contact your nearest Mitsubishi Fuso Dealer or Mitsubishi Fuso Truck of America, Inc.

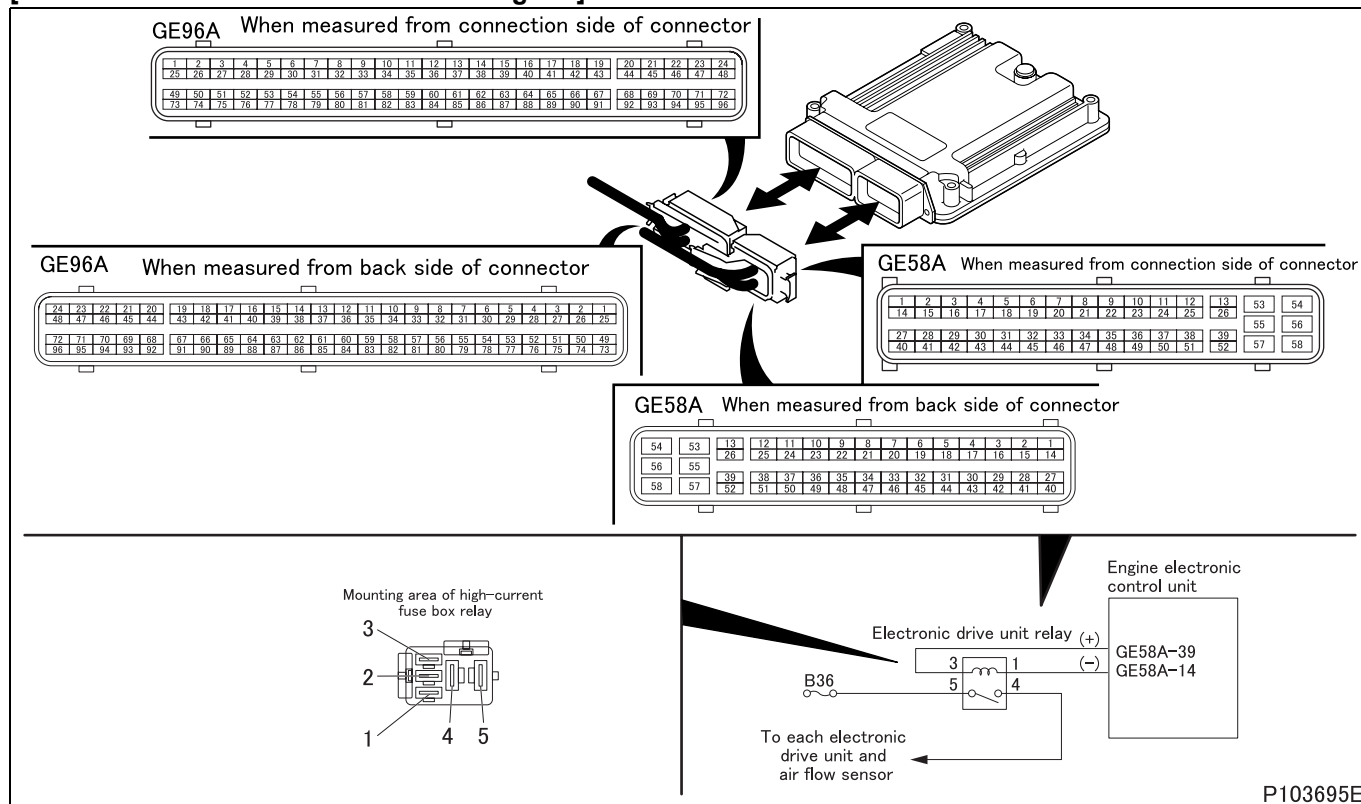
P103695E

# [Electronic Control Unit Connection Diagram]

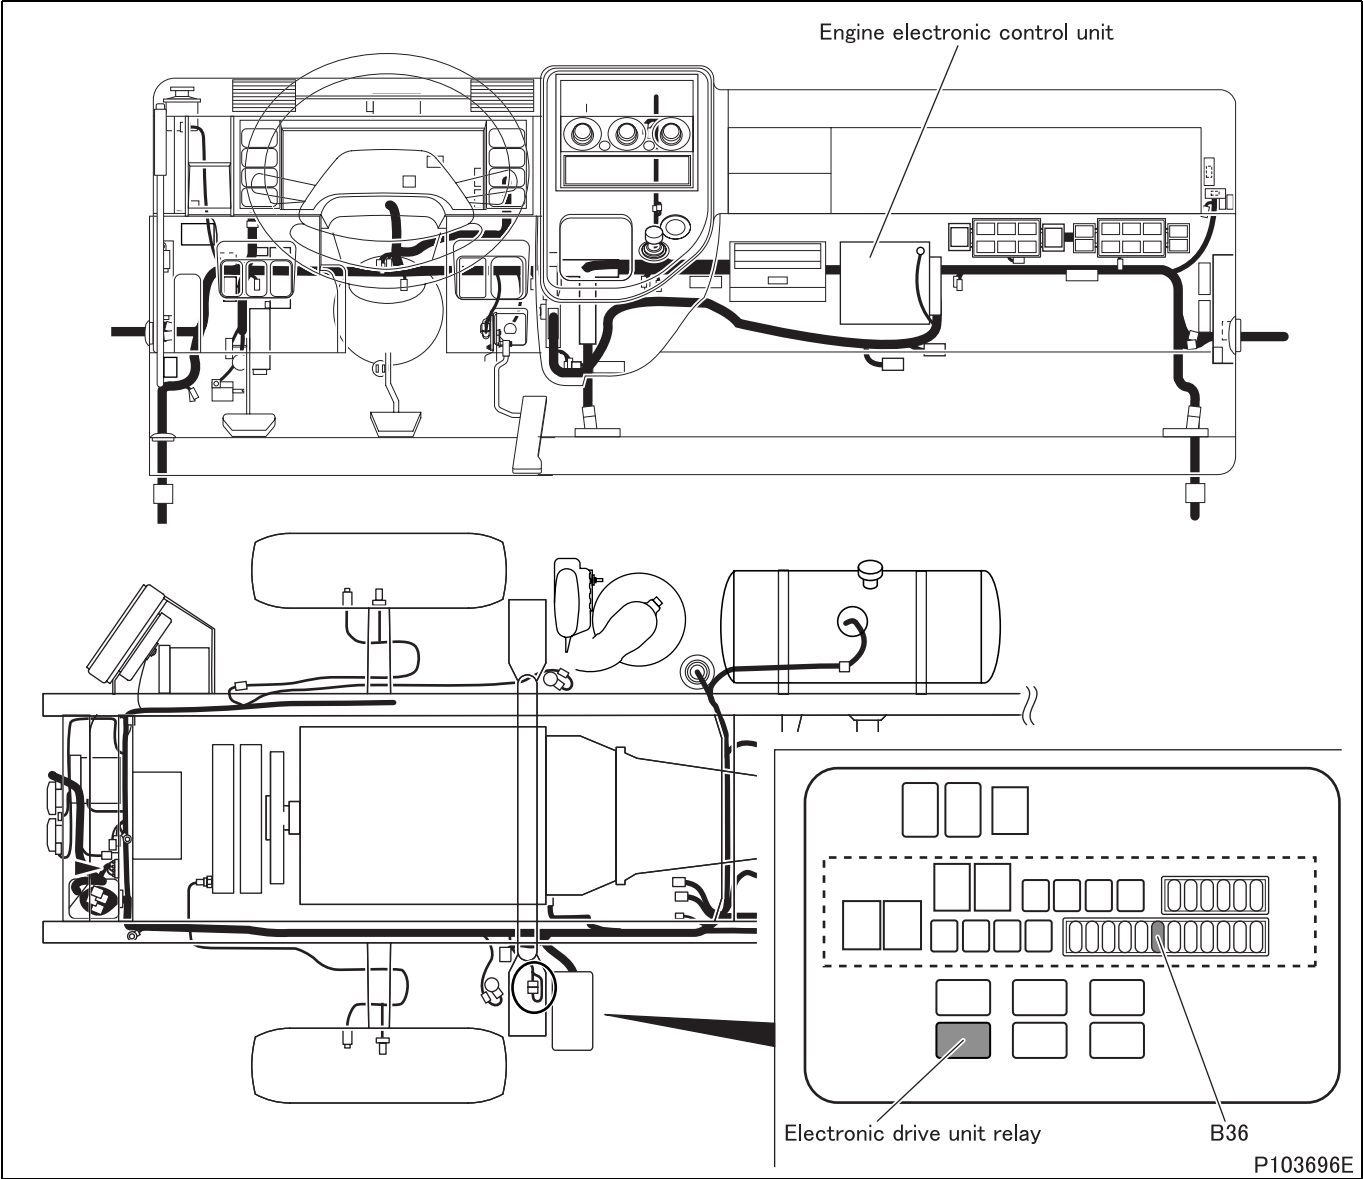
## [Parts Identification and Location]

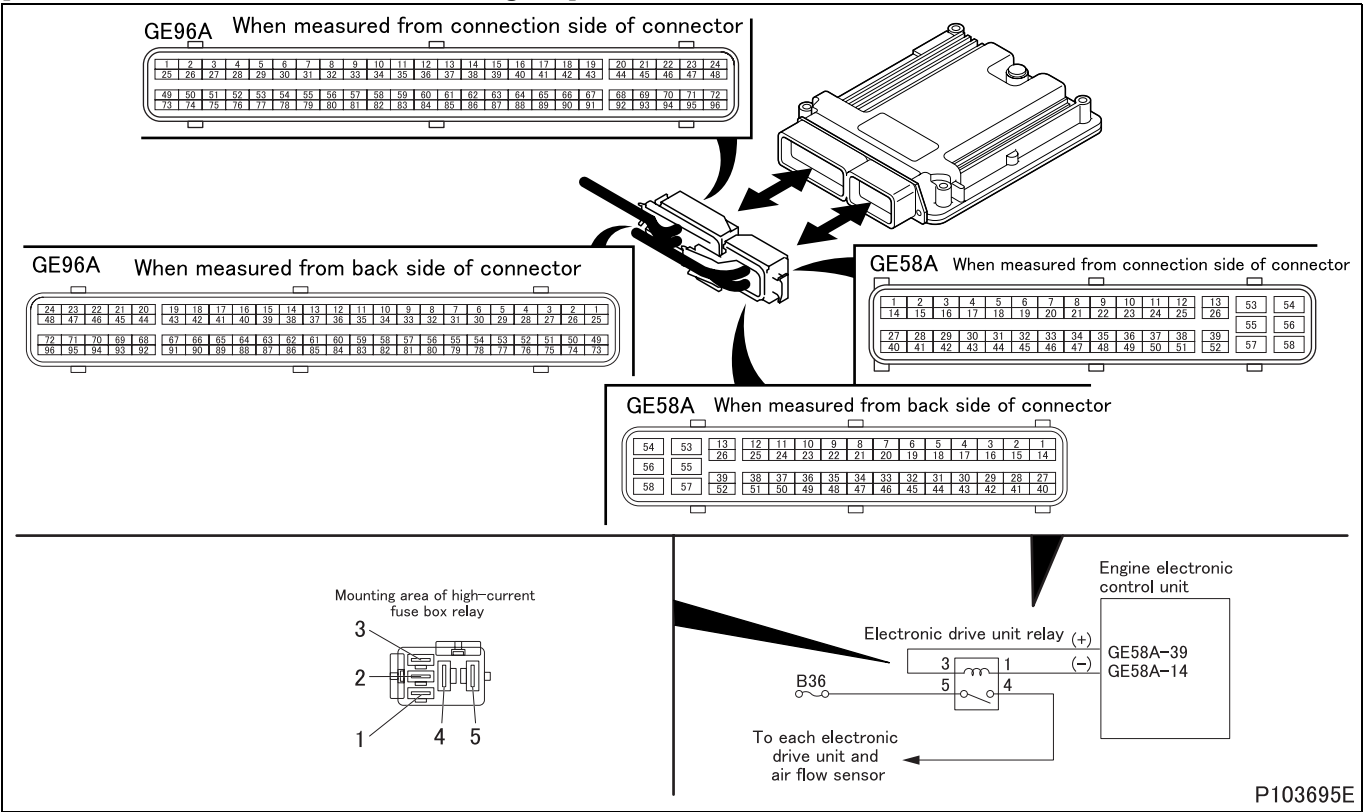
## [Electronic Control Unit Connection Diagram]

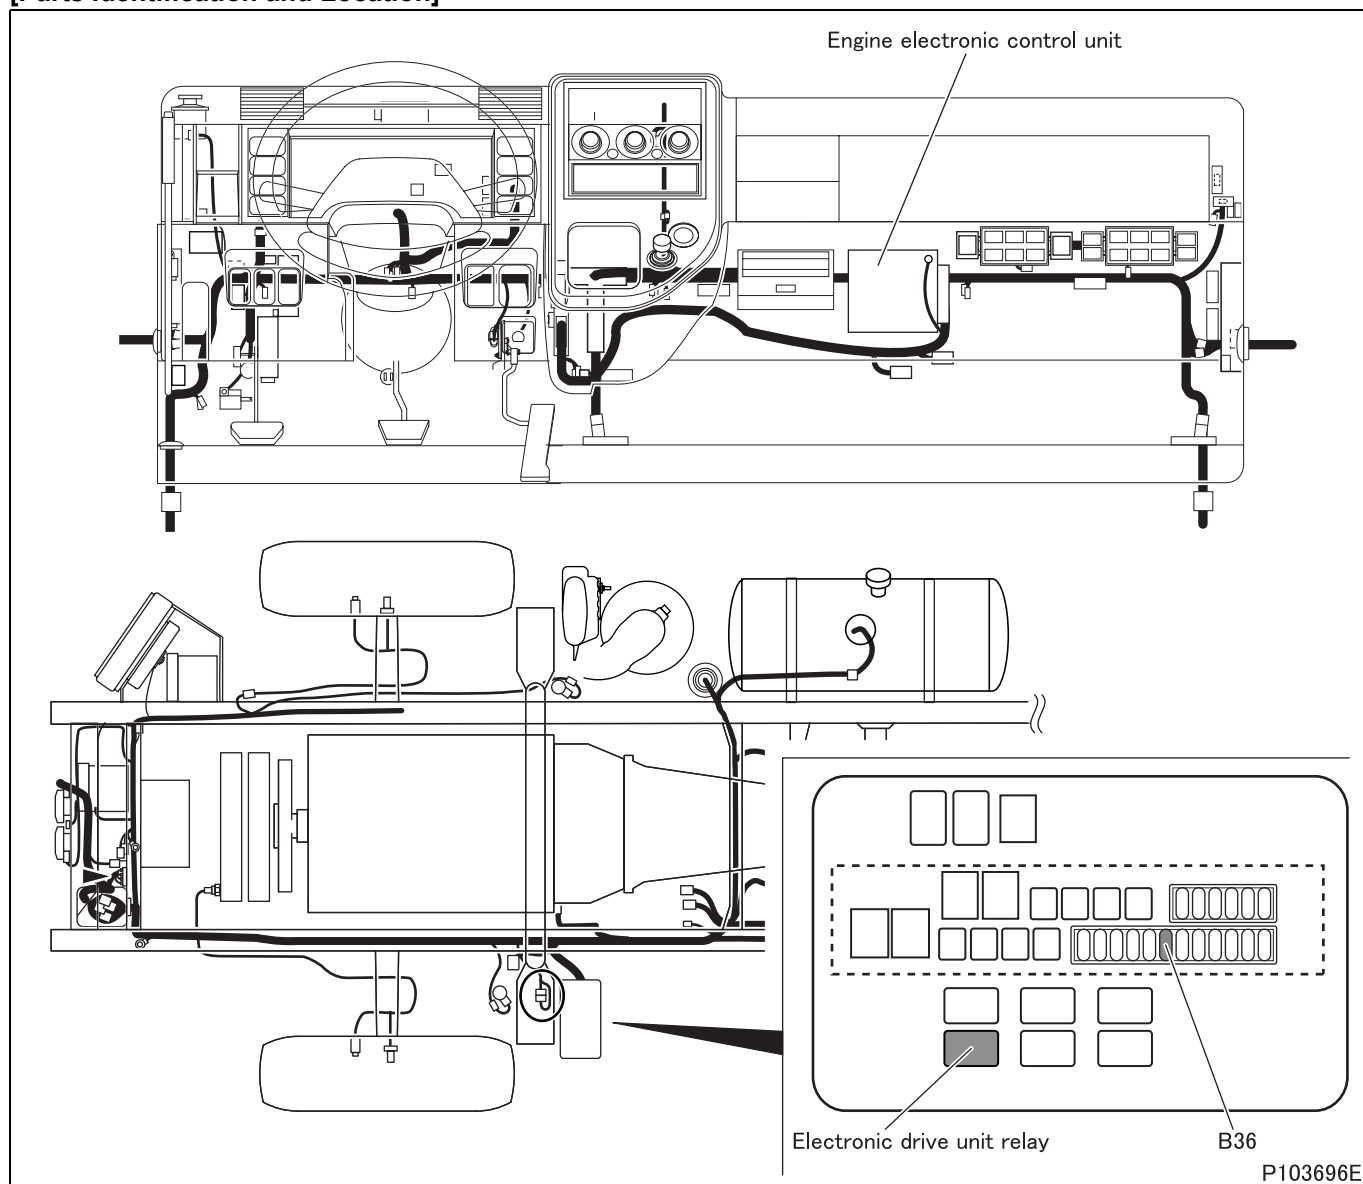
[Parts Identification and Location]

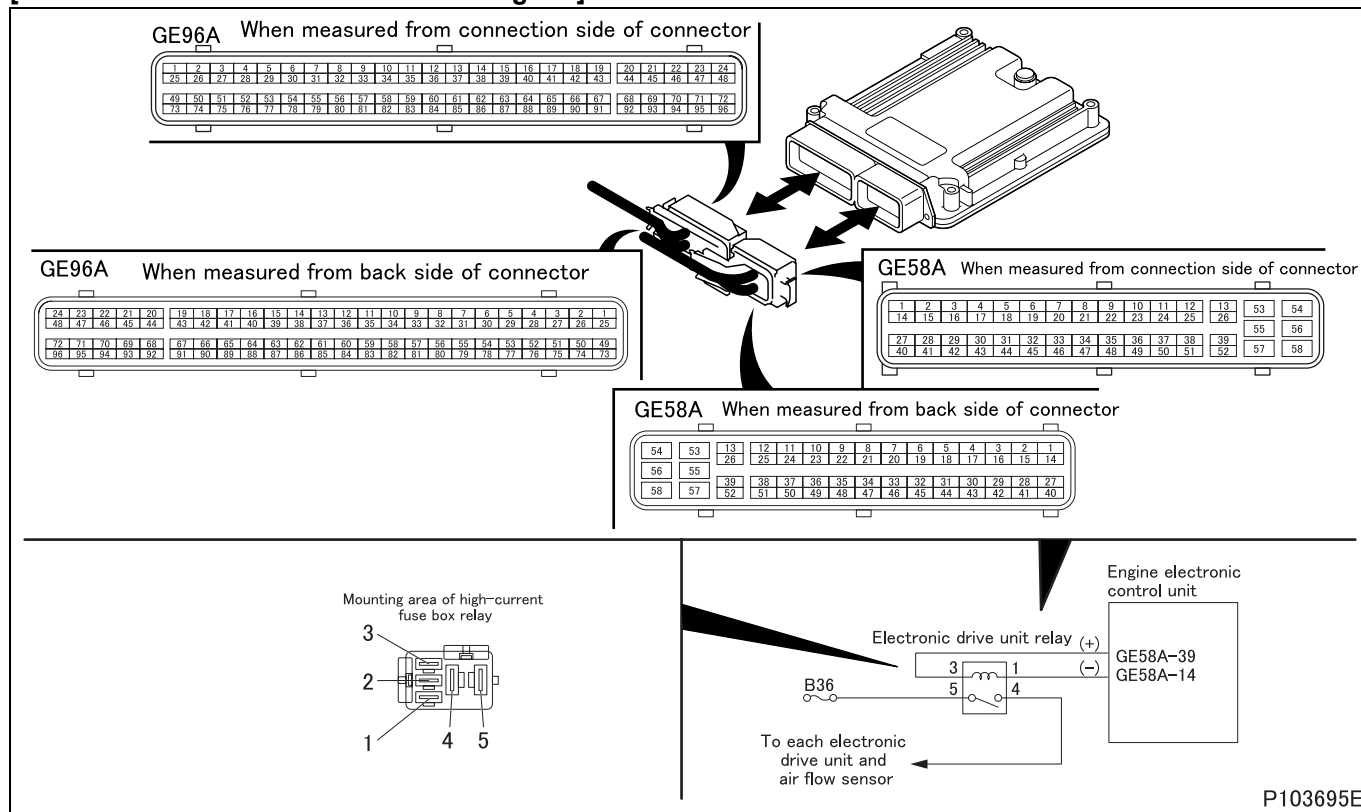
## [Electronic Control Unit Connection Diagram]

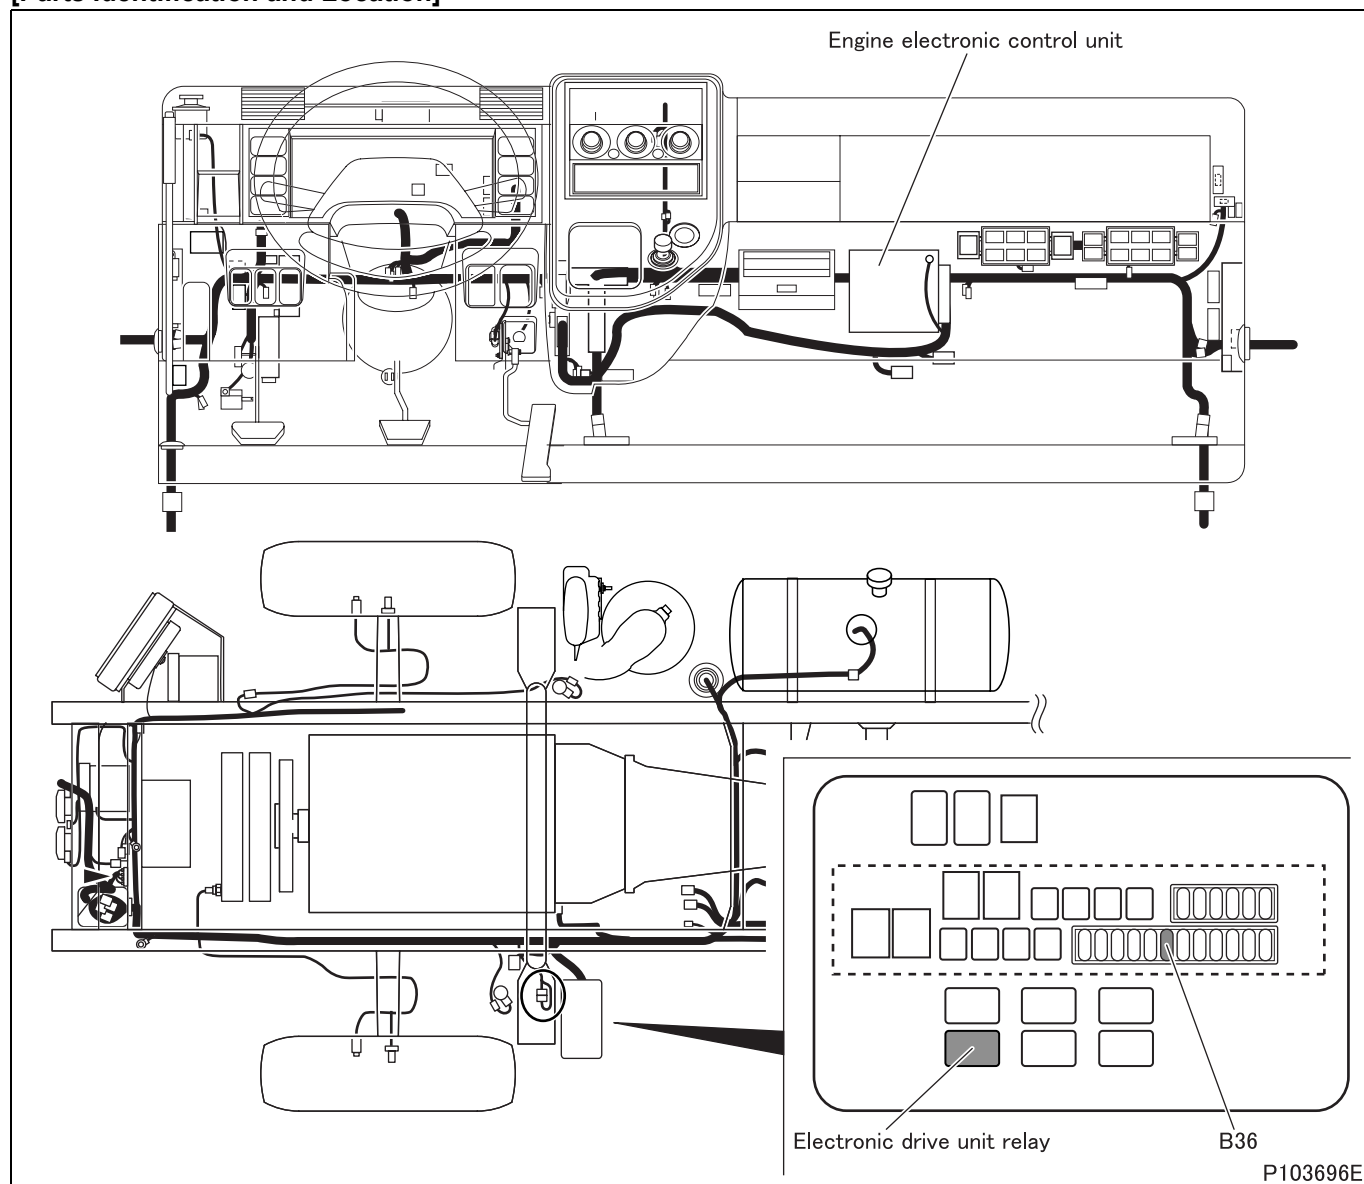
## [Parts Identification and Location]

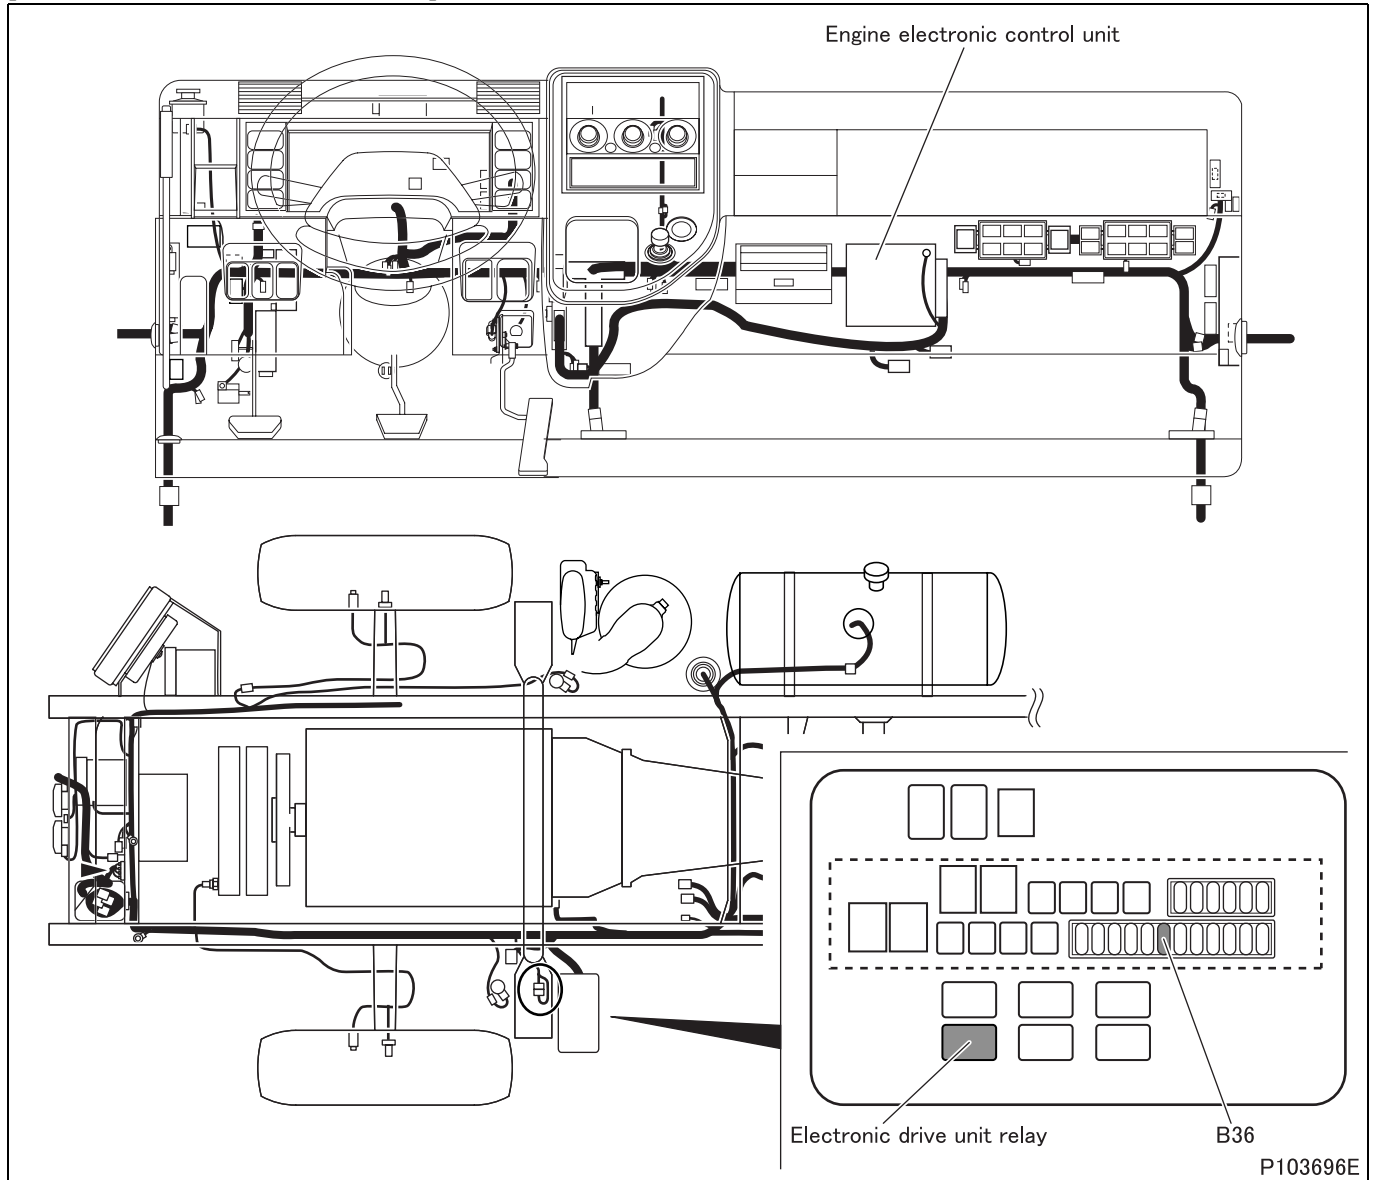
[Parts Identification and Location]

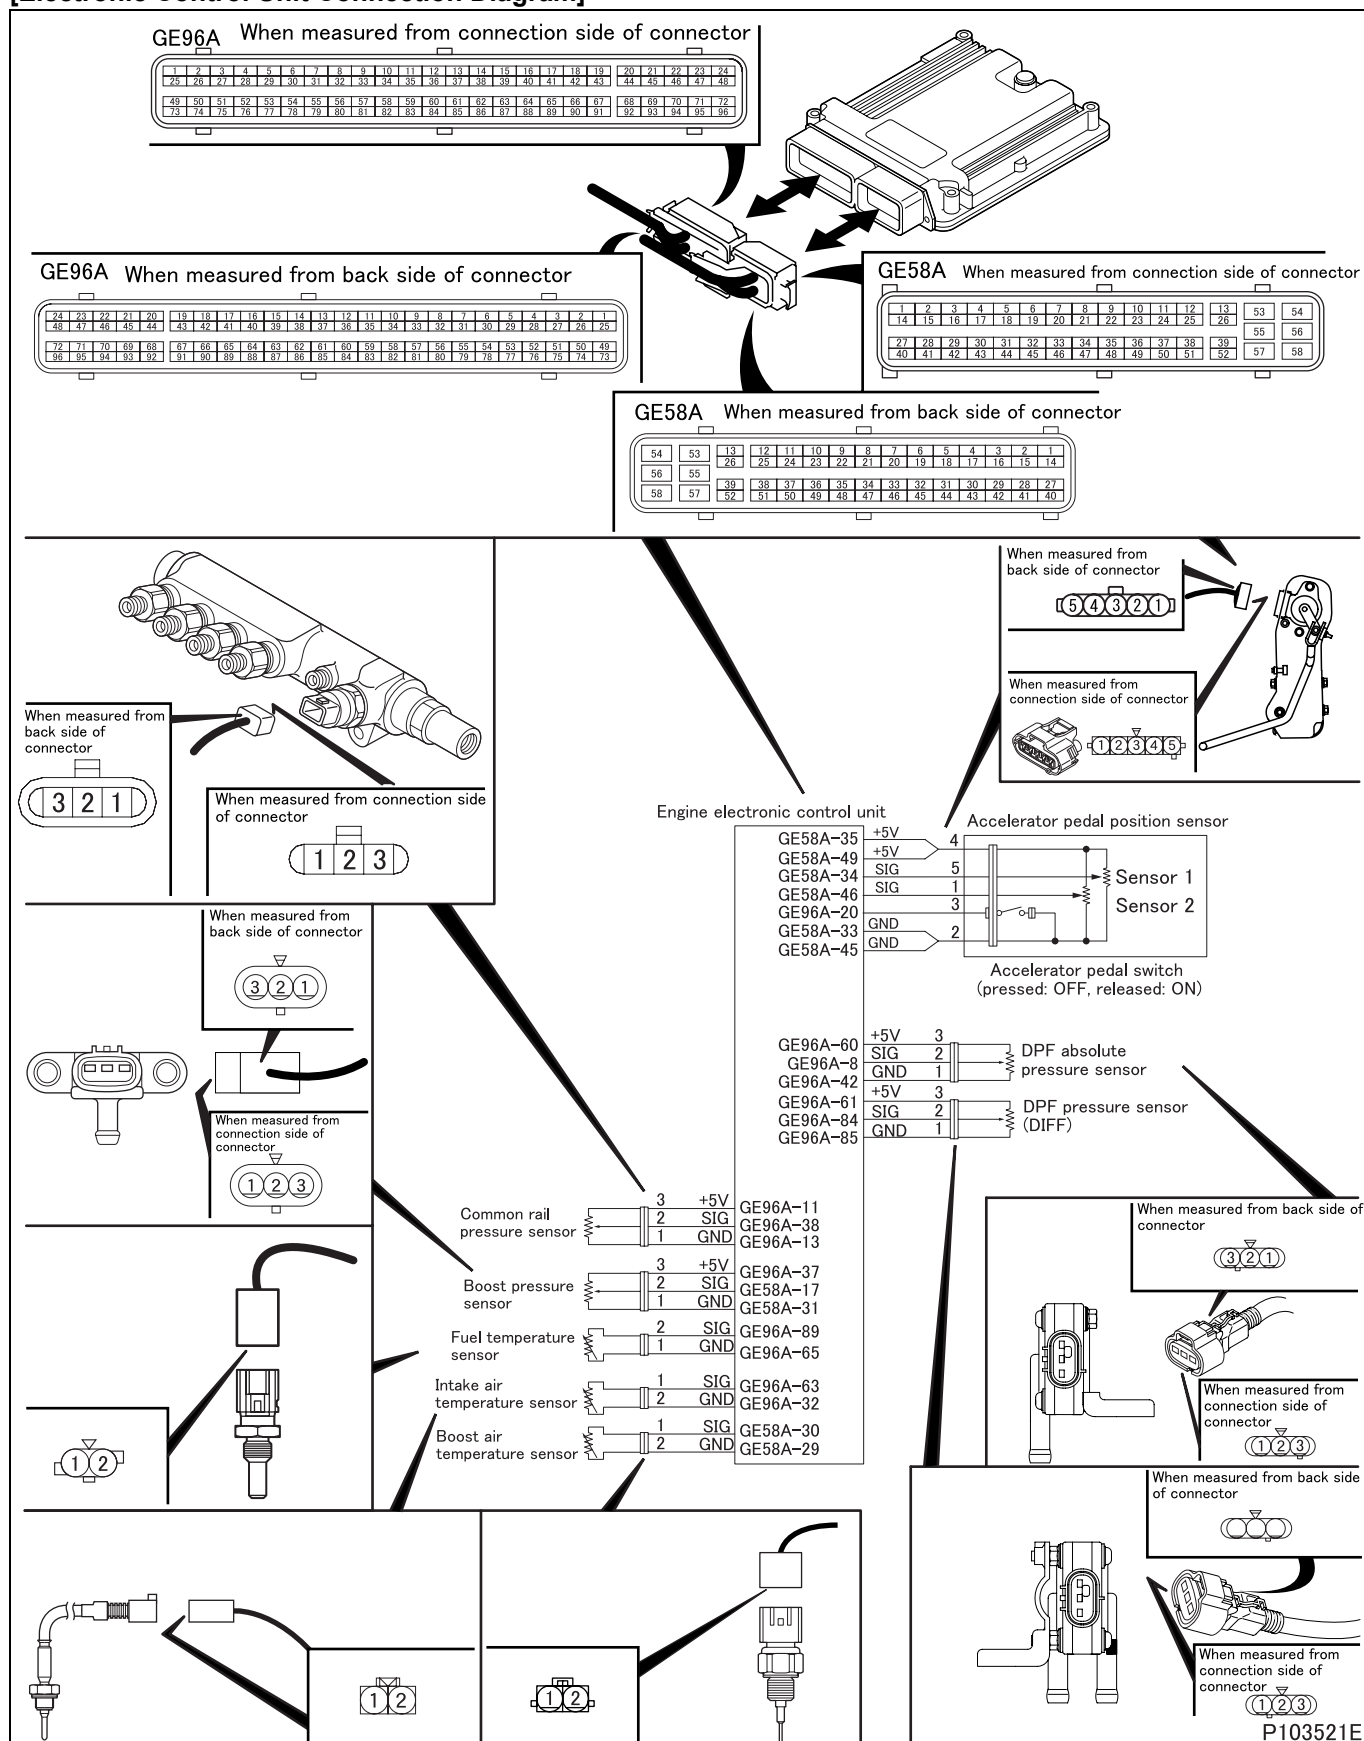
## [Electronic Control Unit Connection Diagram]

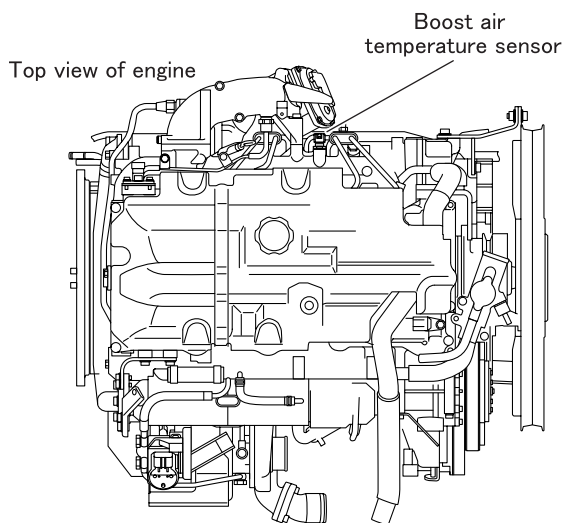
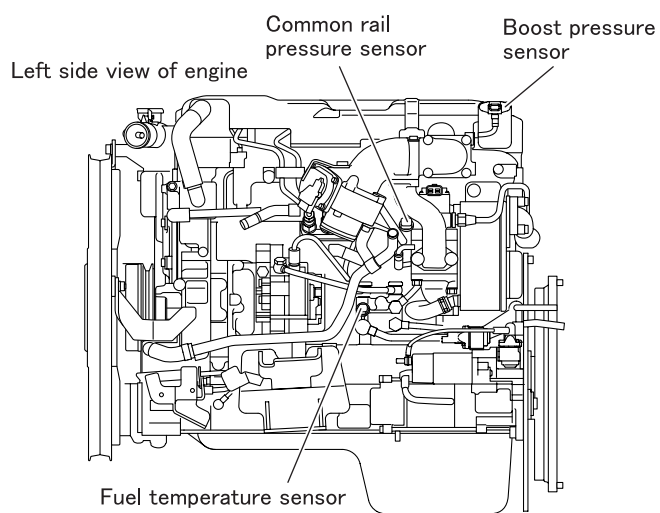
[Parts Identification and Location]

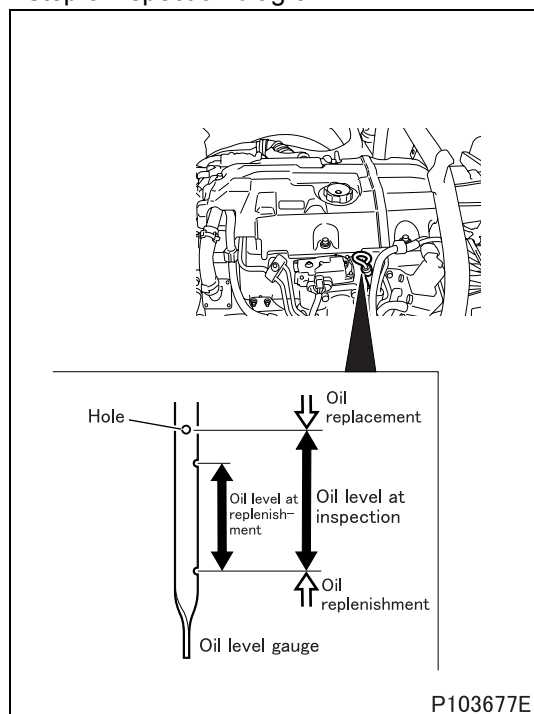
<Step 3 inspection diagram>

| Step 3 | Inspection items | | Inspection of oil level |
| | Maintenance item | | Inspection of engine oil level |

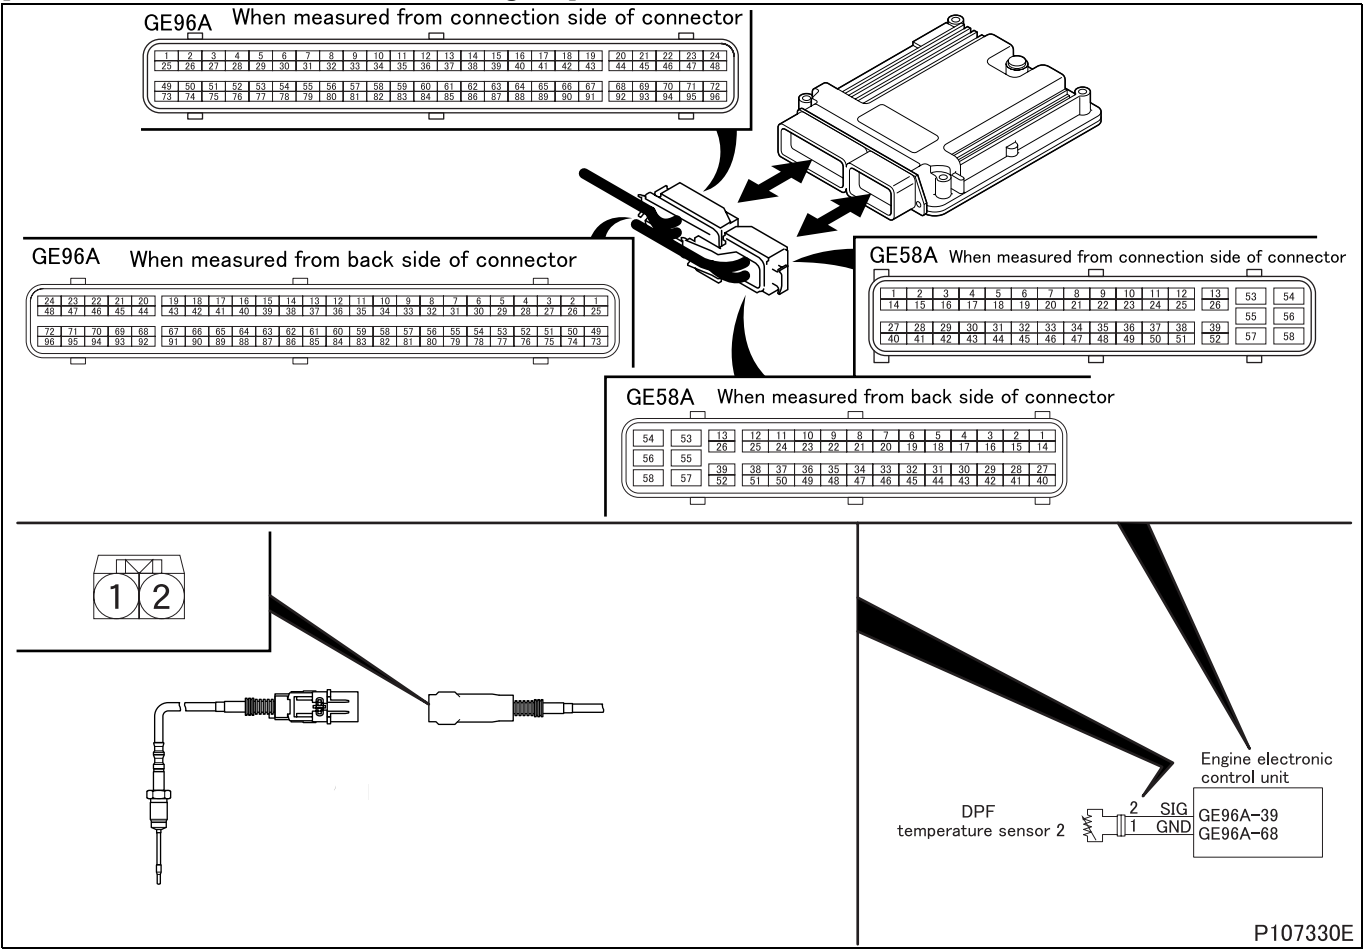
## [Electronic Control Unit Connection Diagram]

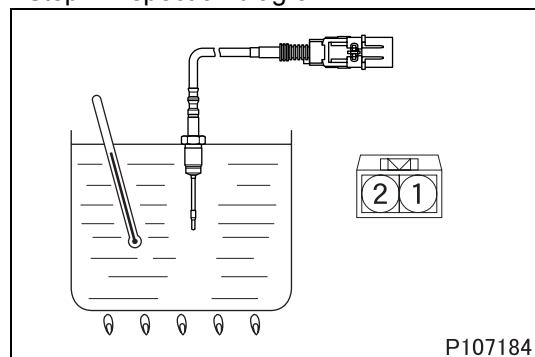
<Step 2 inspection diagram>

| | Inspection condition | | <ul style="list-style-type: none"> <li>Put DPF temperature sensor 2 in container filled with engine oil.</li> <li>Heat the oil to each of the specified temperatures. Stir the oil well while doing so.</li> </ul> |

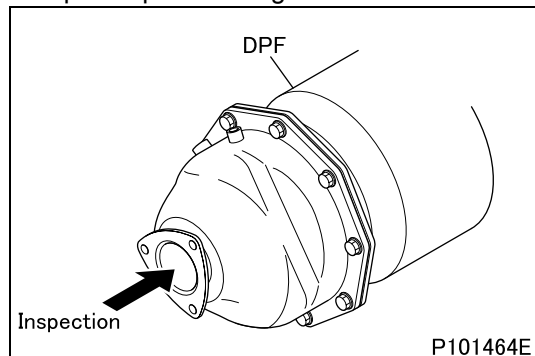
<Step 5 inspection diagram>

| | Inspection condition | | Remove diesel particulate filter. |

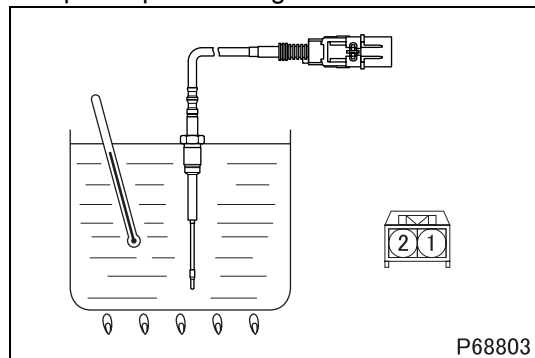
<Step 2 inspection diagram>

| | Inspection condition | | <ul style="list-style-type: none"> <li>Put DPF temperature sensor 1 in container filled with engine oil.</li> <li>Heat the oil to each of the specified temperatures. Stir the oil well while doing so.</li> </ul> |

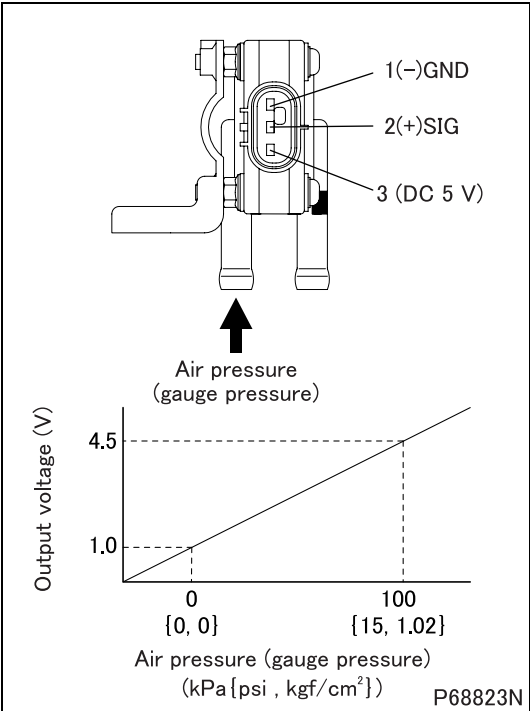
<Step 5 inspection diagram>

| | Inspection condition | | <ul style="list-style-type: none"><li>• Apply voltage DC 5 V across terminals No. 3 (+) and 1 (-).</li><li>• Gradually increase applied air pressure.</li></ul> | |

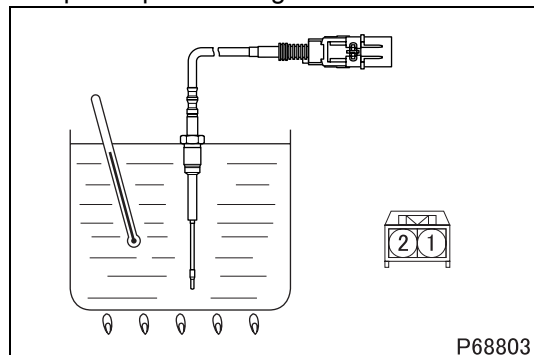
## &lt;Step 2 inspection diagram&gt;

| | Inspection condition | | <ul style="list-style-type: none"> <li>Put DPF temperature sensor 1 in container filled with engine oil.</li> <li>Heat the oil to each of the specified temperatures. Stir the oil well while doing so.</li> </ul> |

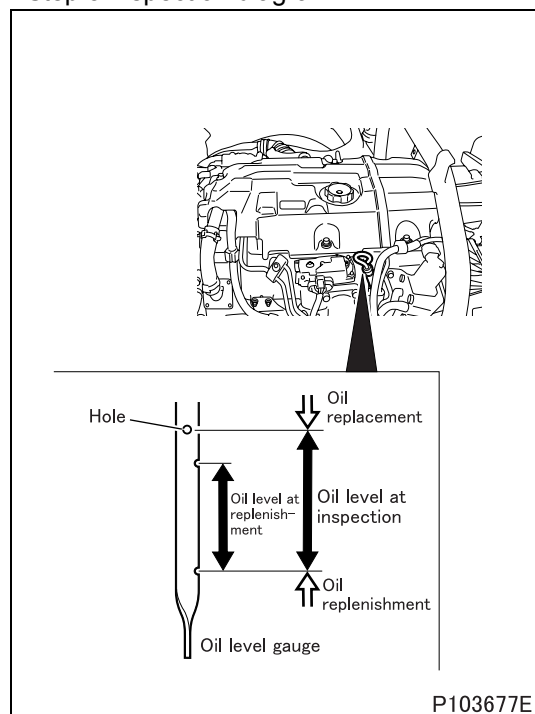
<Step 3 inspection diagram>

| | Inspection condition | | Engine is stopped. |

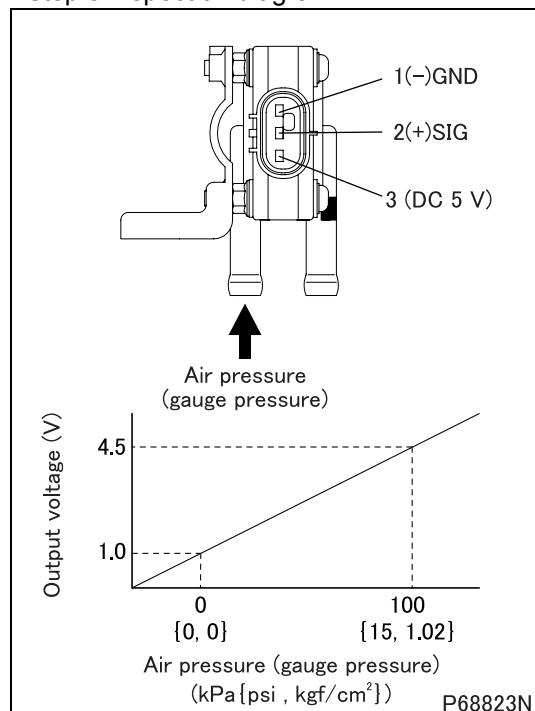
<Step 5 inspection diagram>

| | Inspection condition | | <ul style="list-style-type: none"> <li>Apply voltage DC 5 V across terminals No. 3 (+) and 1 (-).</li> <li>Gradually increase applied air pressure.</li> </ul> |

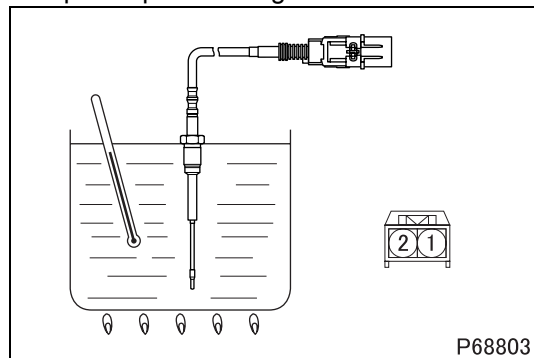
<Step 2 inspection diagram>

| | Inspection condition | | <ul style="list-style-type: none"> <li>Put DPF temperature sensor 1 in container filled with engine oil.</li> <li>Heat the oil to each of the specified temperatures. Stir the oil well while doing so.</li> </ul> |

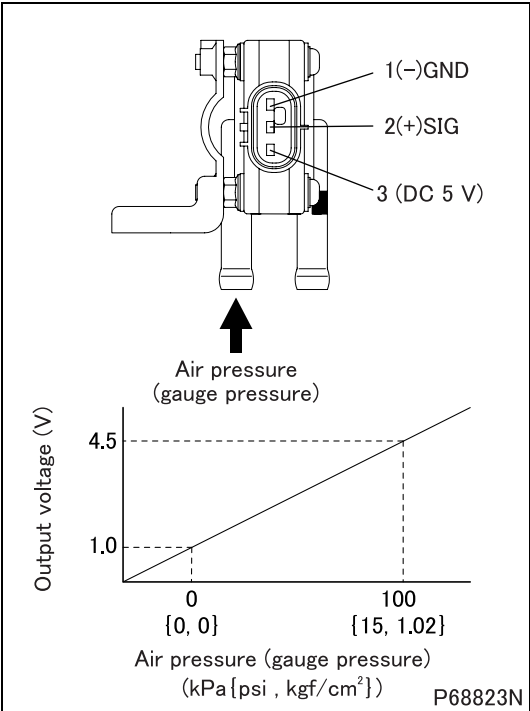
<Step 5 inspection diagram>

| | Inspection condition | | <ul style="list-style-type: none"><li>• Apply voltage DC 5 V across terminals No. 3 (+) and 1 (-).</li><li>• Gradually increase applied air pressure.</li></ul> |

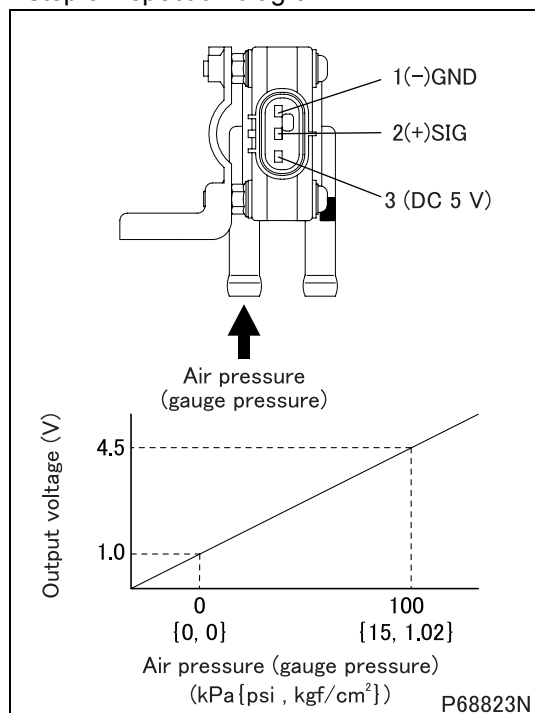
<Step 5 inspection diagram>

| | Inspection condition | | <ul style="list-style-type: none"> <li>Apply voltage DC 5 V across terminals No. 3 (+) and 1 (-).</li> <li>Gradually increase applied air pressure.</li> </ul> |

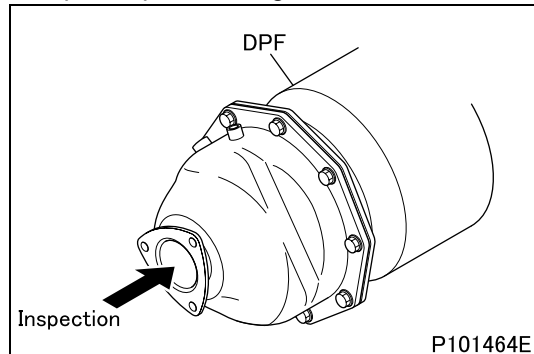
<Step 5 inspection diagram>

| | Inspection condition | | Remove diesel particulate filter. |

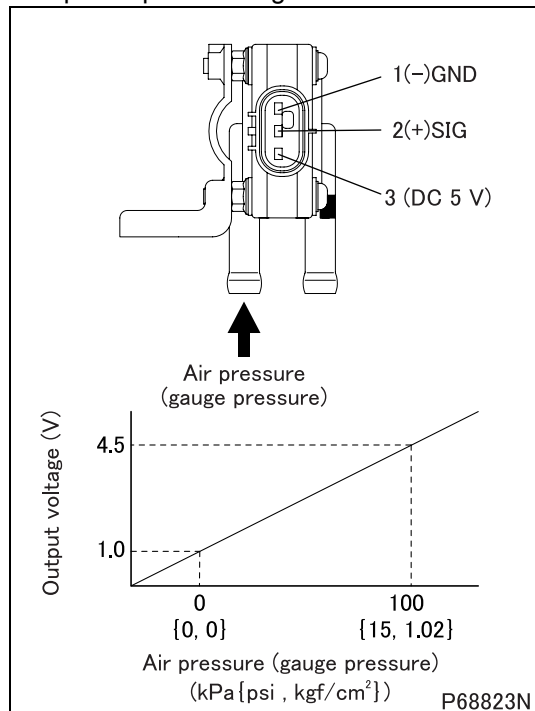
<Step 7 inspection diagram>

| | Inspection condition | | <ul style="list-style-type: none"> <li>Apply voltage DC 5 V across terminals No. 3 (+) and 1 (-).</li> <li>Gradually increase applied air pressure.</li> </ul> |

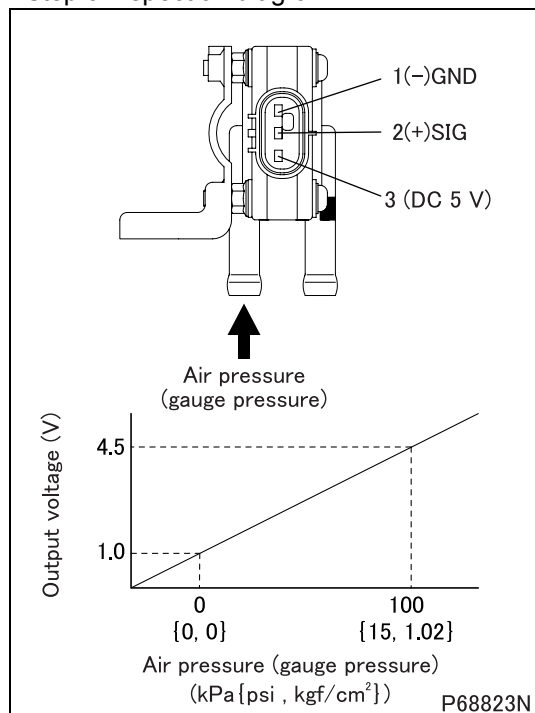
<Step 9 inspection diagram>

| | Maintenance item | | Measure value of voltage between connector terminal No. 2 (+) and 1 (-). | |

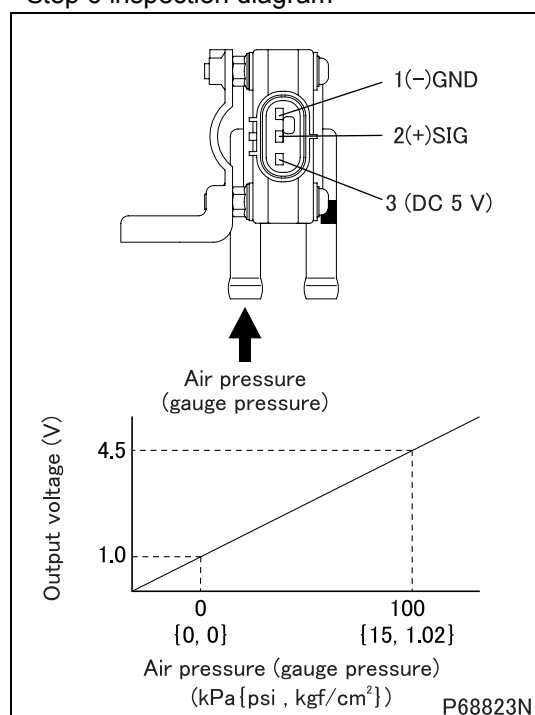
<Step 6 inspection diagram>

| | Inspection condition | | <ul style="list-style-type: none"> <li>Apply voltage DC 5 V across terminals No. 3 (+) and 1 (—).</li> <li>Gradually increase applied air pressure.</li> </ul> |

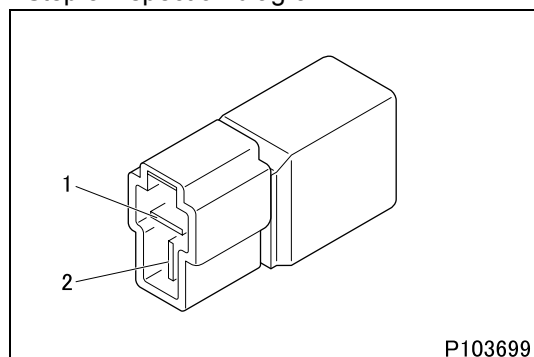
<Step 3 inspection diagram>

| | Inspection condition | | Disconnect connector and measure resistor side. |

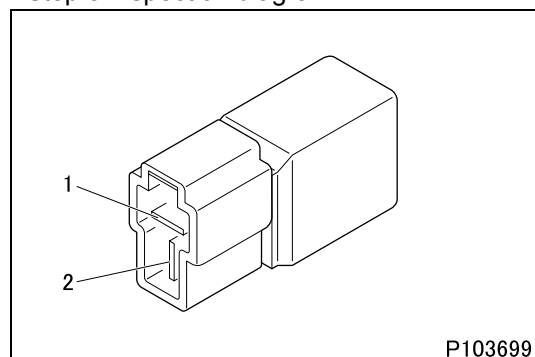
<Step 3 inspection diagram>

| | Inspection condition | | Disconnect connector and measure resistor side. |

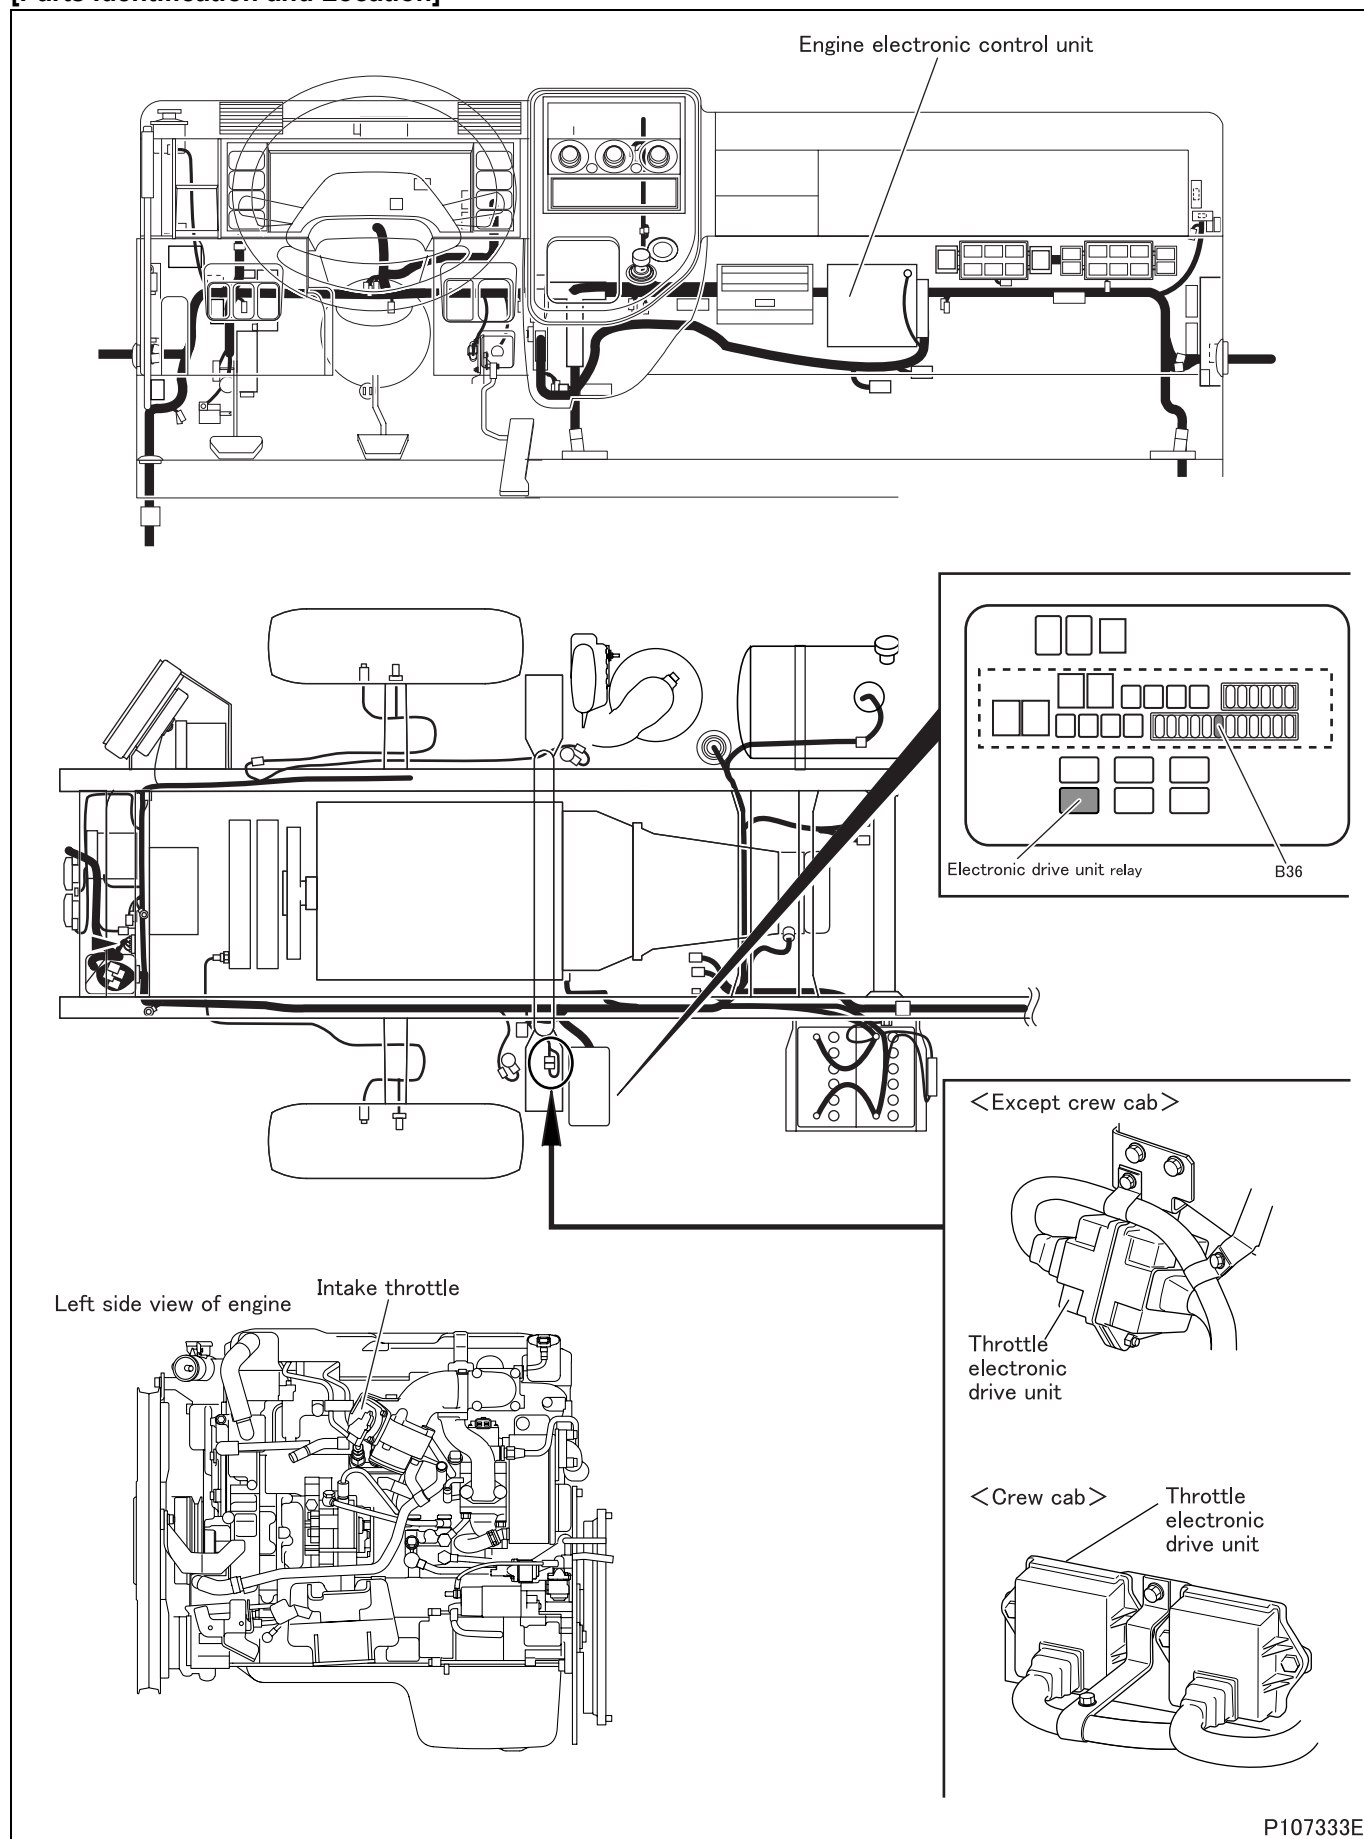
P107333E

## [Parts Identification and Location]
