# FE.FG

## SERVICE MANUAL 2008 Model FOREWORD

This Service Manual contains maintenance and repair methods for the Mitsubishi Fuso Truck FE. FG Series. Read this manual carefully as an aid in providing correct, efficient maintenance. Please note that the information and specifications contained within this manual may change without notice. This is due to product modifications and continued vehicle improvements that are made throughout the model years. Should you encounter any discrepancy in the information provided, please do not hesitate to contact your nearest Mitsubishi Fuso Dealer or Mitsubishi Fuso Truck of America, Inc.

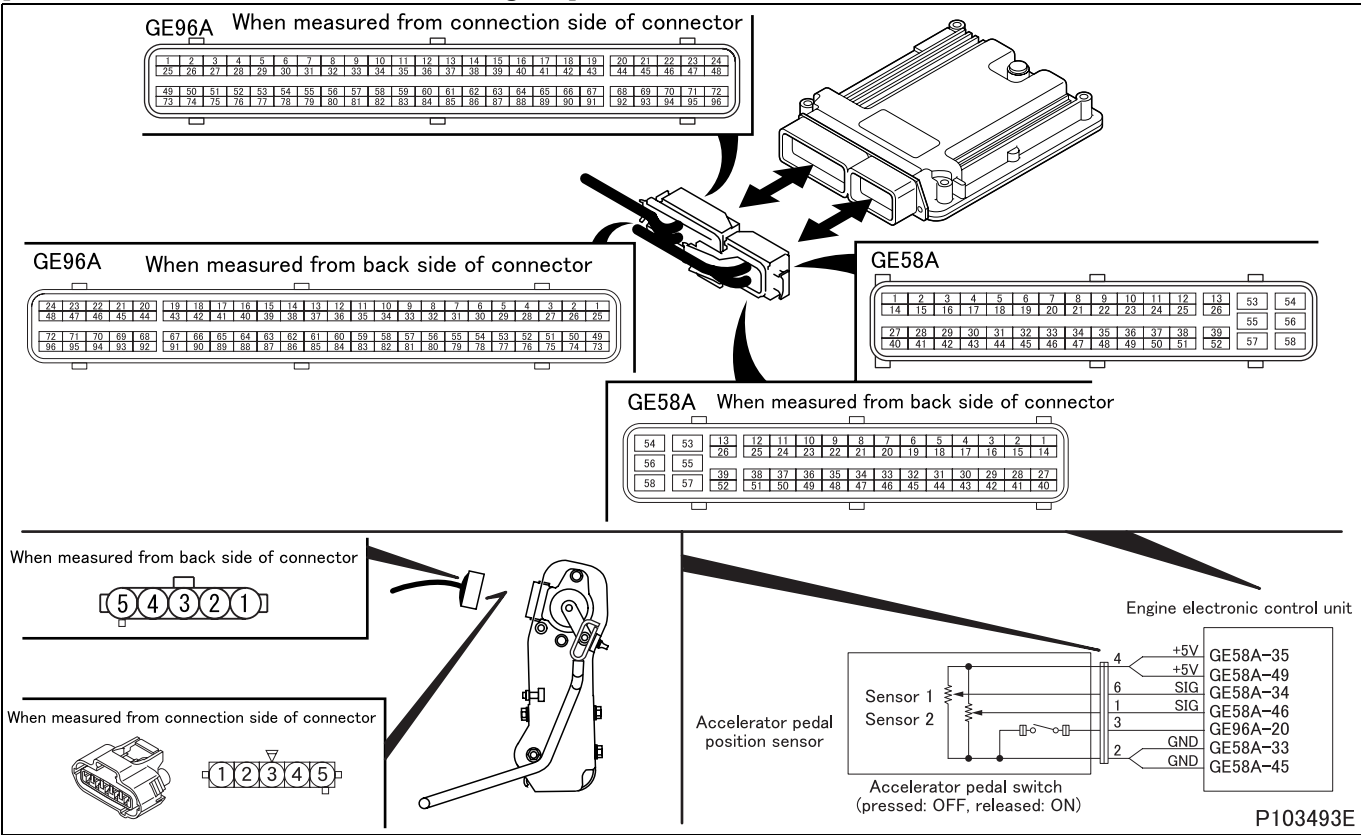
## [Electronic Control Unit Connection Diagram]

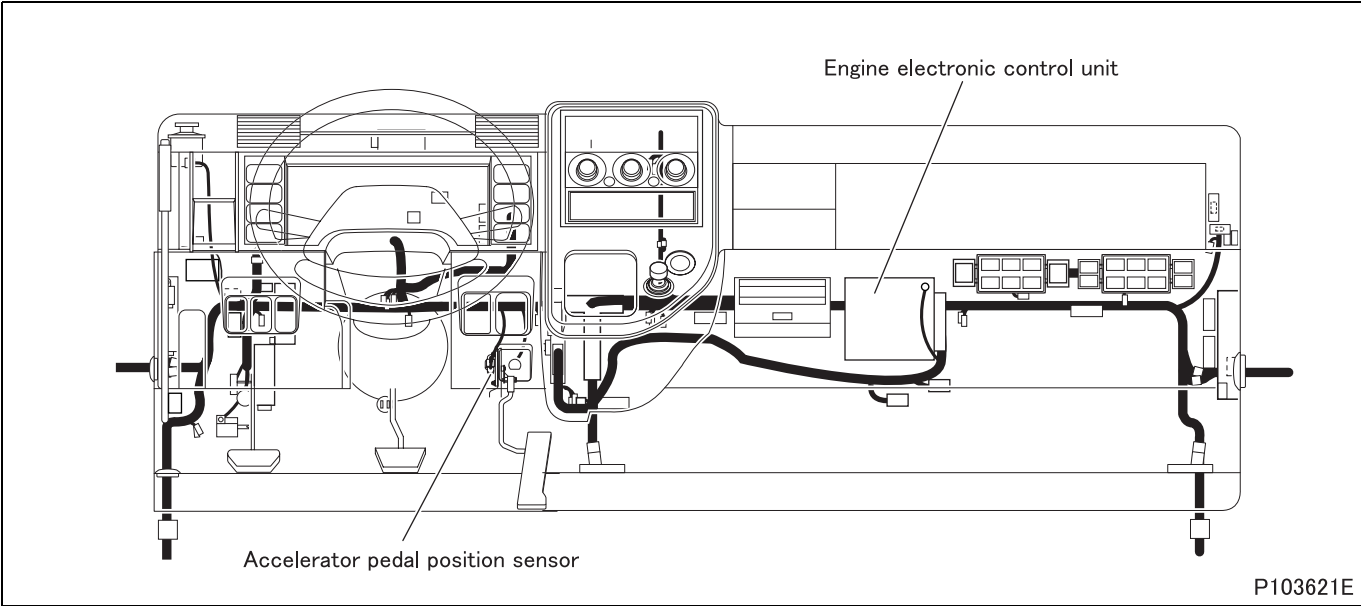
## [Parts Identification and Location]

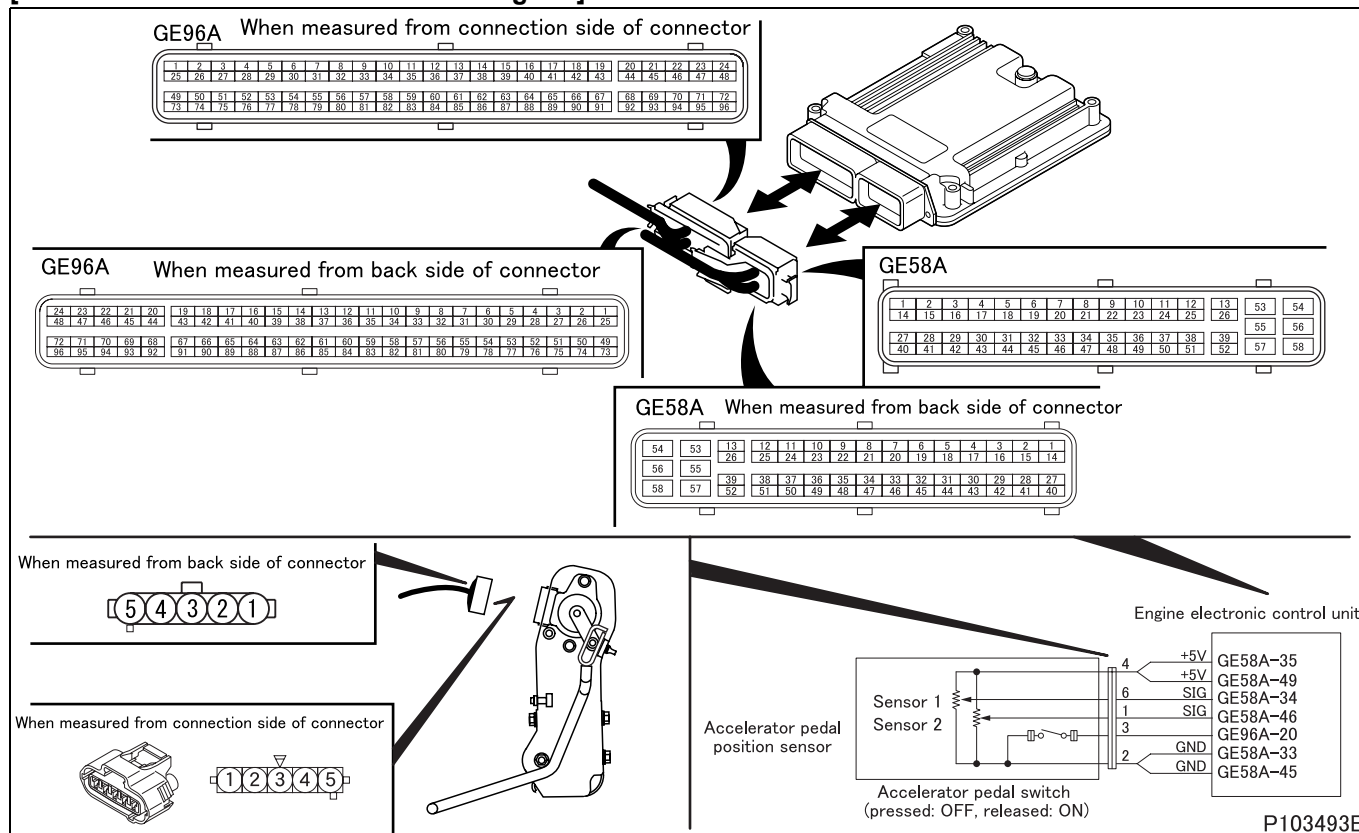
## [Electronic Control Unit Connection Diagram]

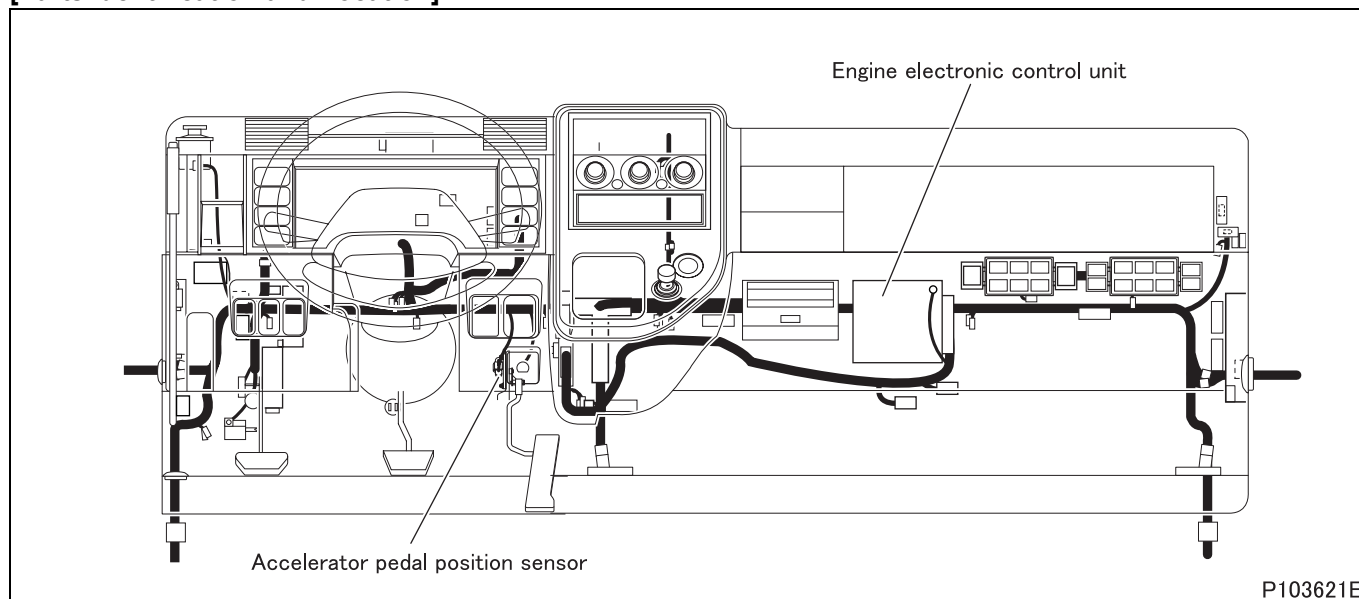
## [Parts Identification and Location]

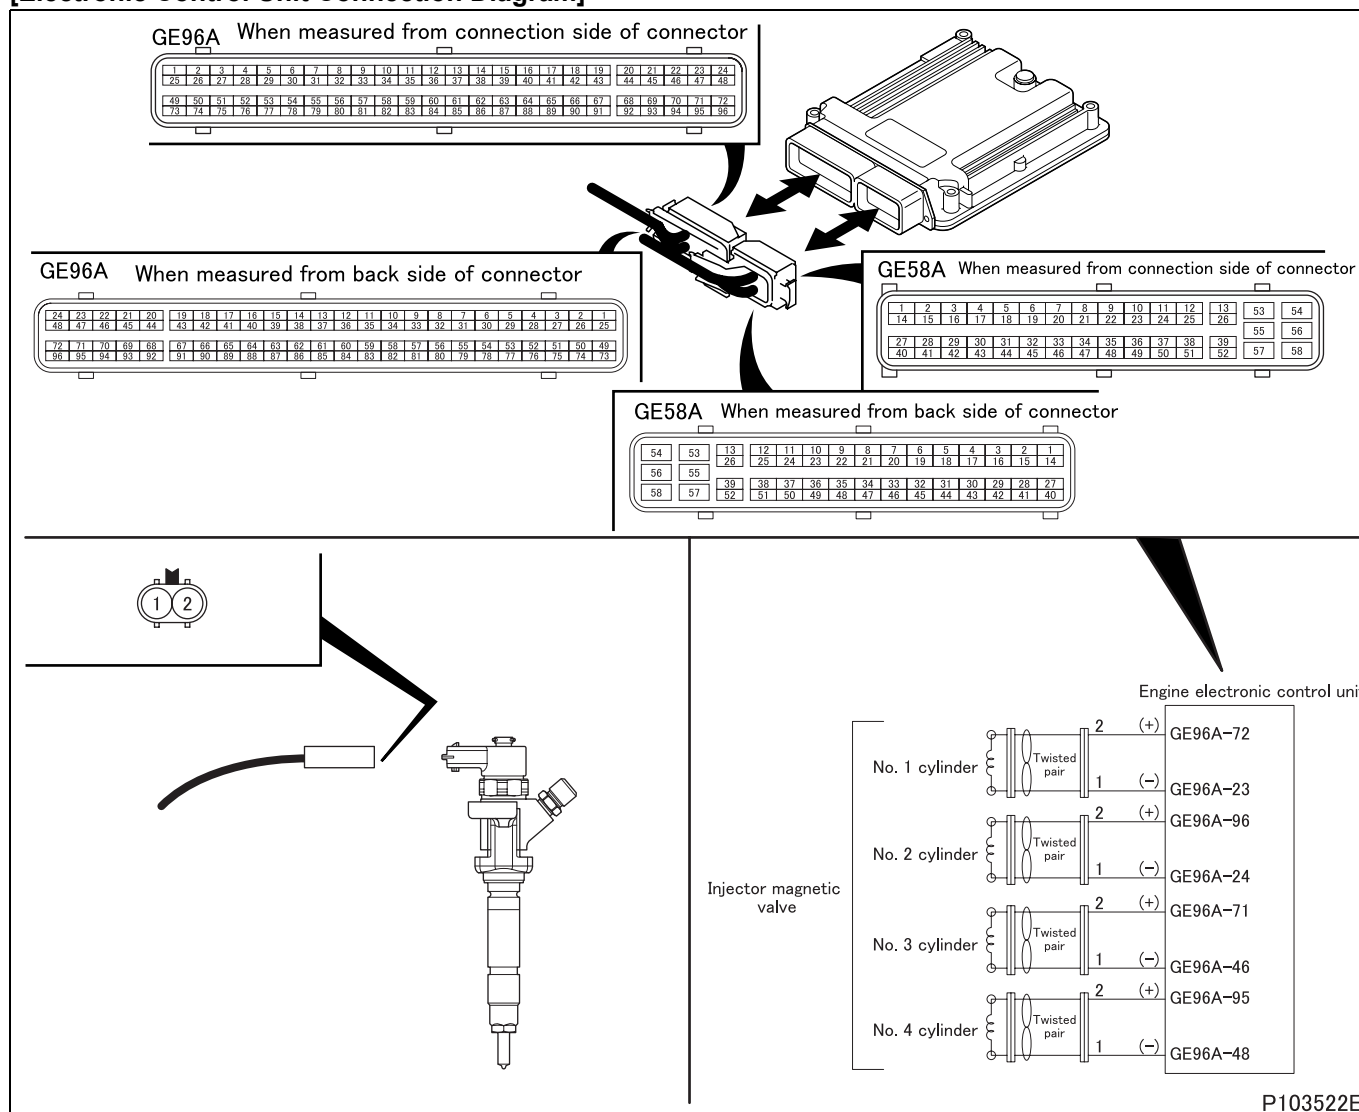
P103522E

## [Electronic Control Unit Connection Diagram]

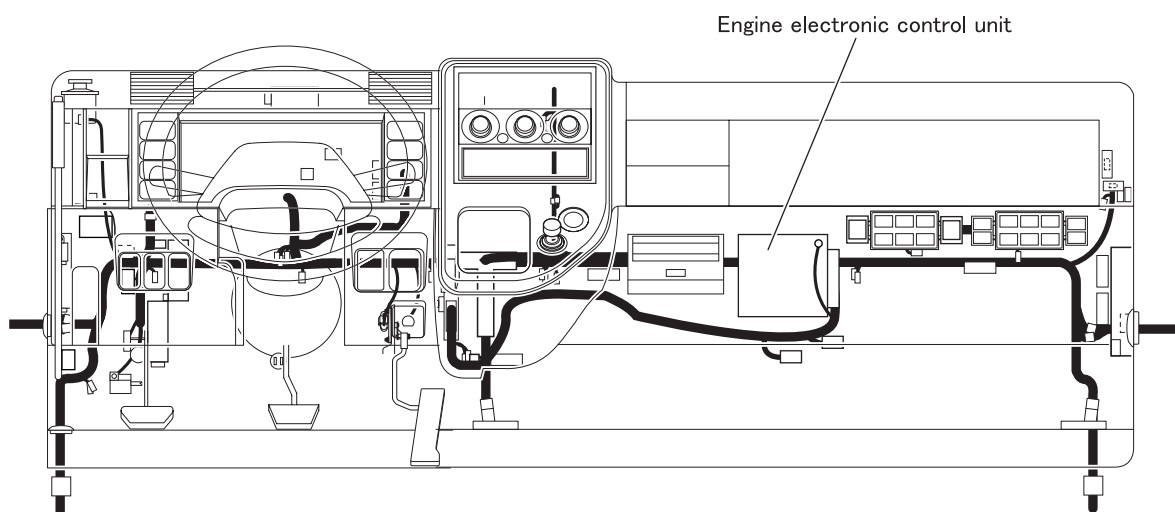
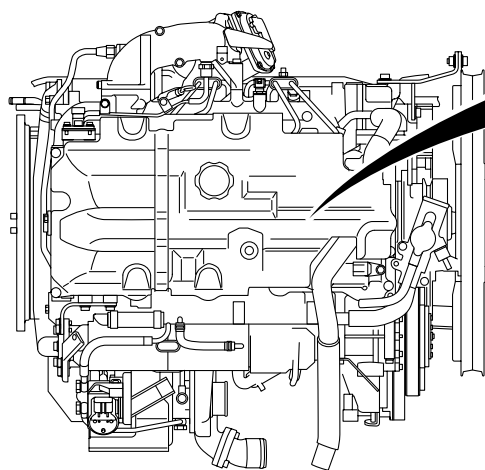
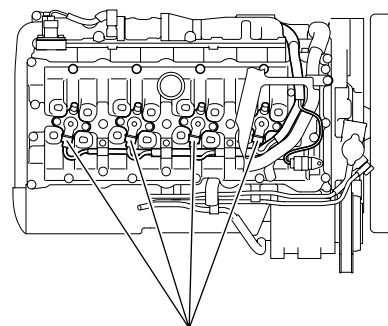
P103648E

## [Parts Identification and Location]

Top view of engine

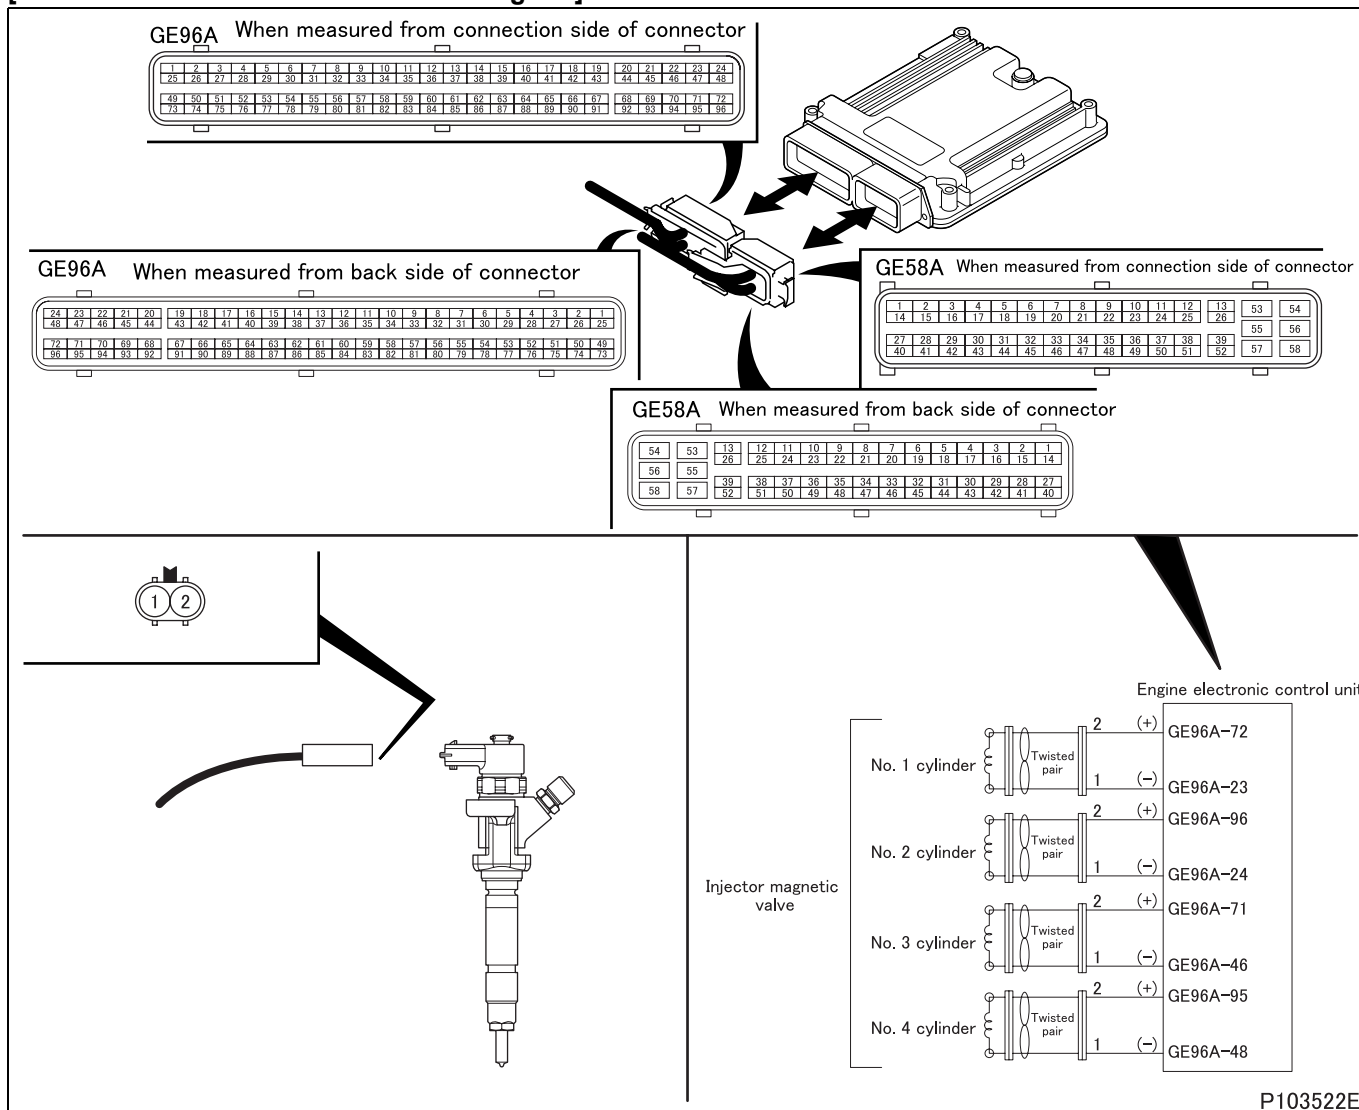
P103522E

## [Electronic Control Unit Connection Diagram]

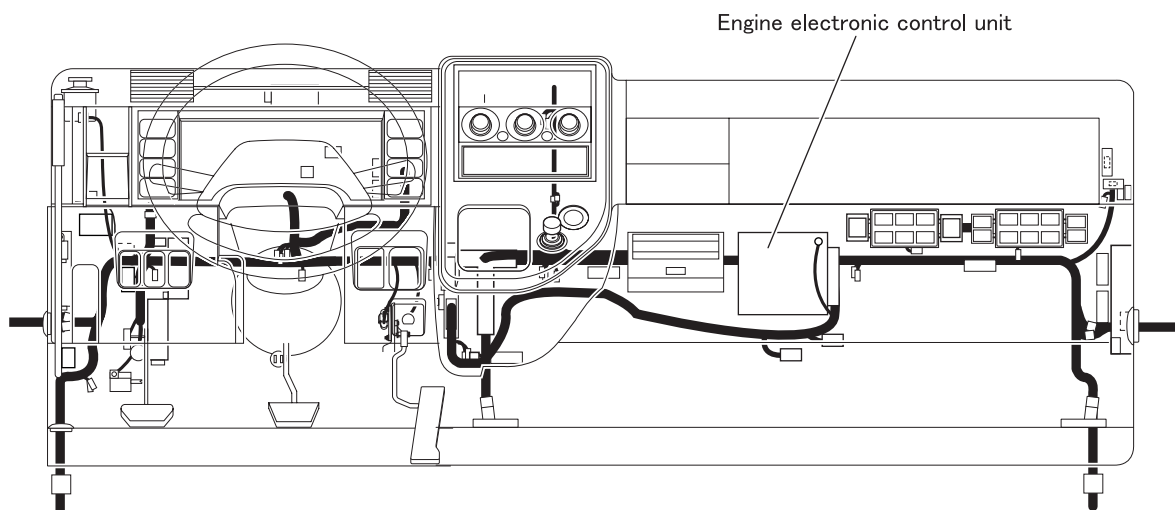
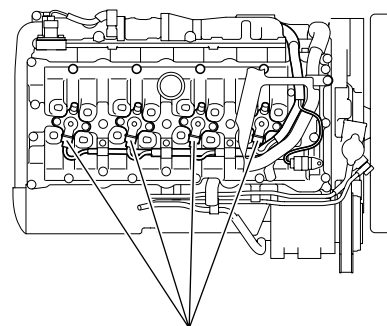
P103648E

## [Parts Identification and Location]

Top view of engine

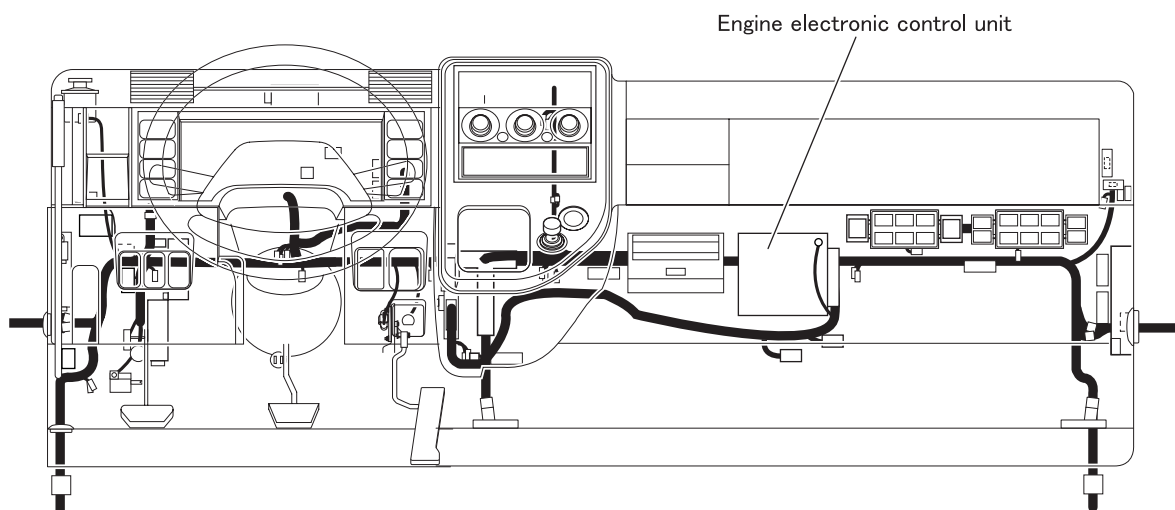
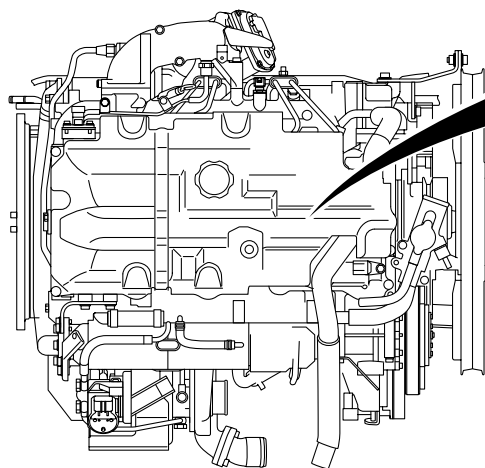
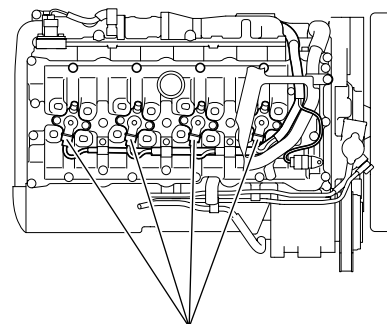
P103648E

## [Parts Identification and Location]

Top view of engine

Injector magnetic valve

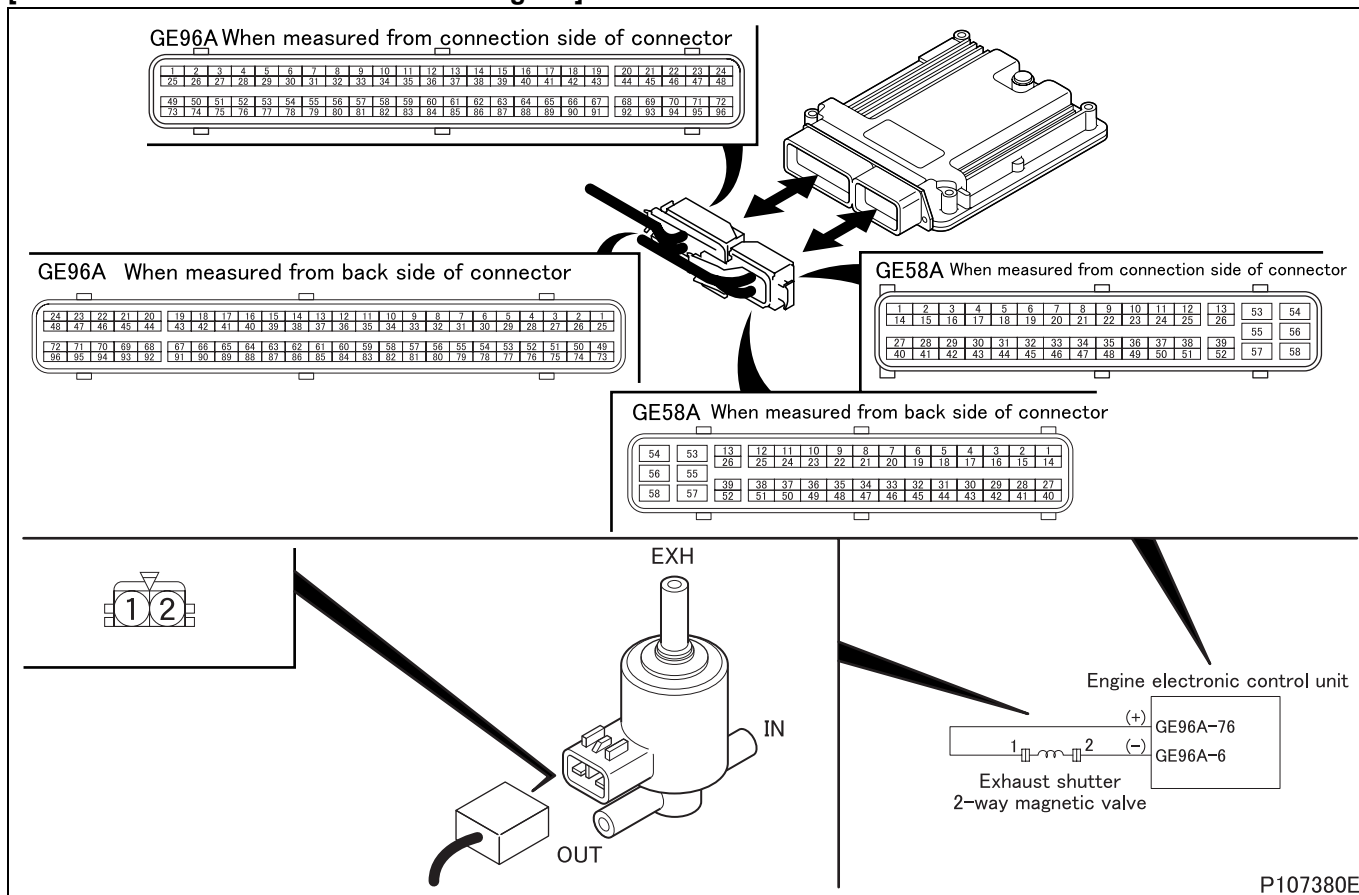
[Electronic Control Unit Connection Diagram]

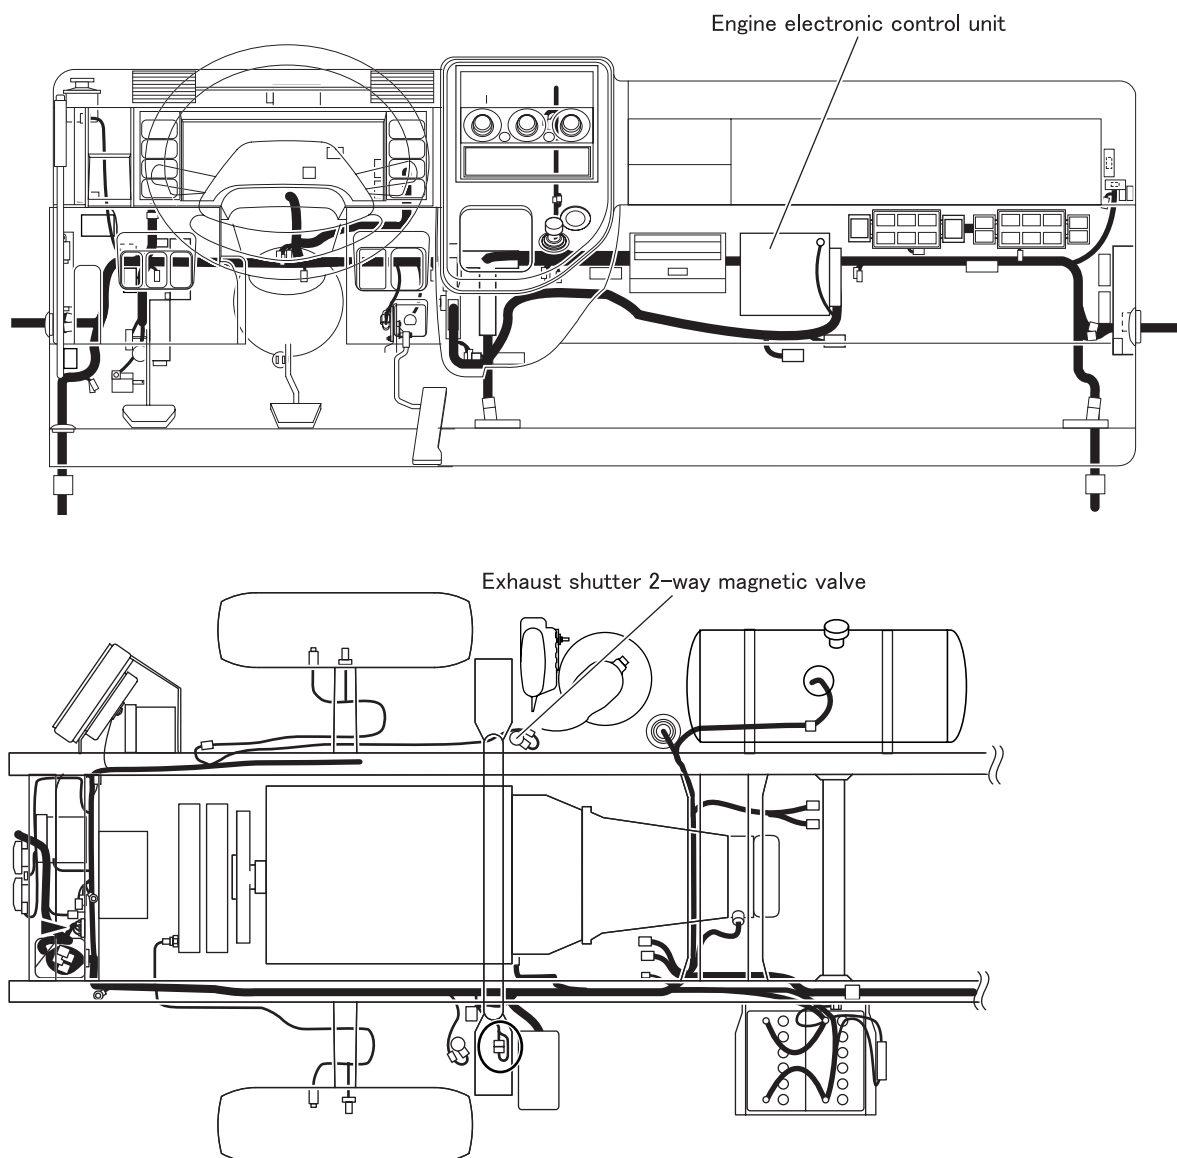
P107381E

## [Parts Identification and Location]

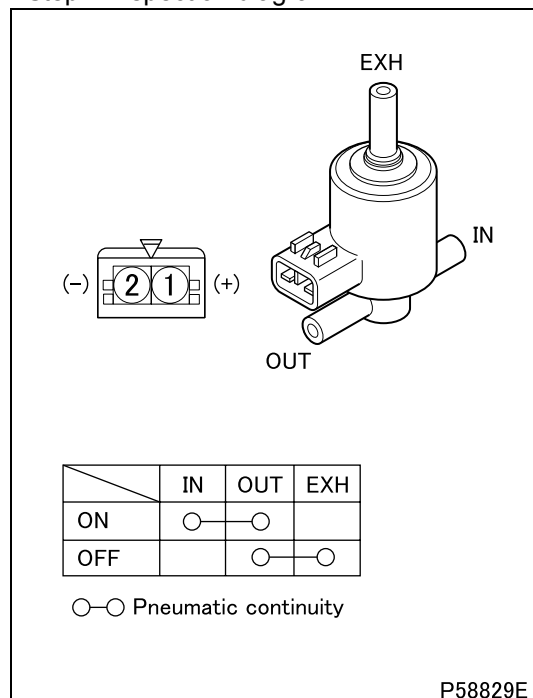
<Step 4 inspection diagram>

| | | NO | Replacement of 2-way magnetic valve | |

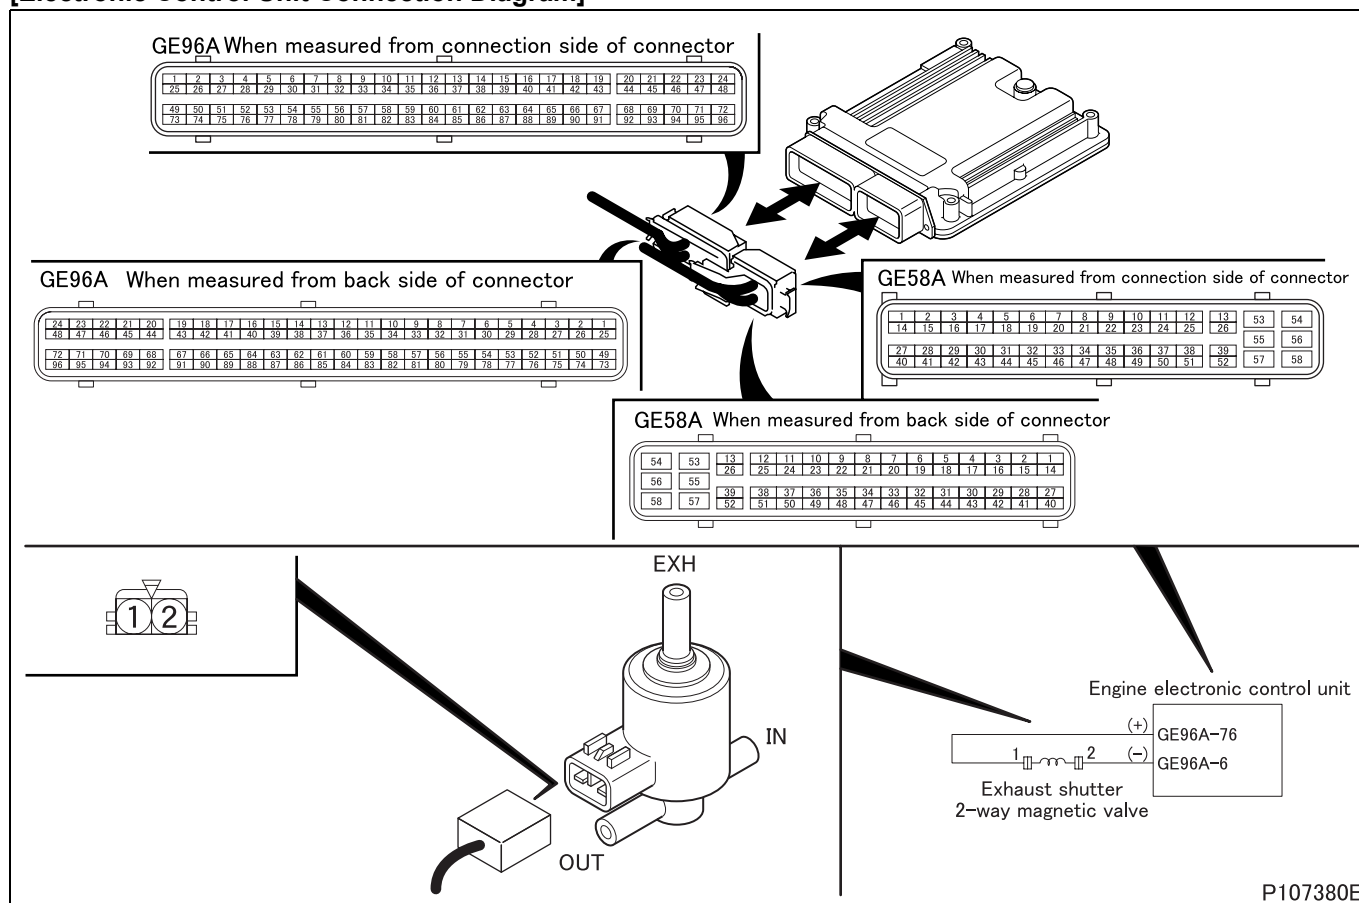
P107380E

## [Electronic Control Unit Connection Diagram]

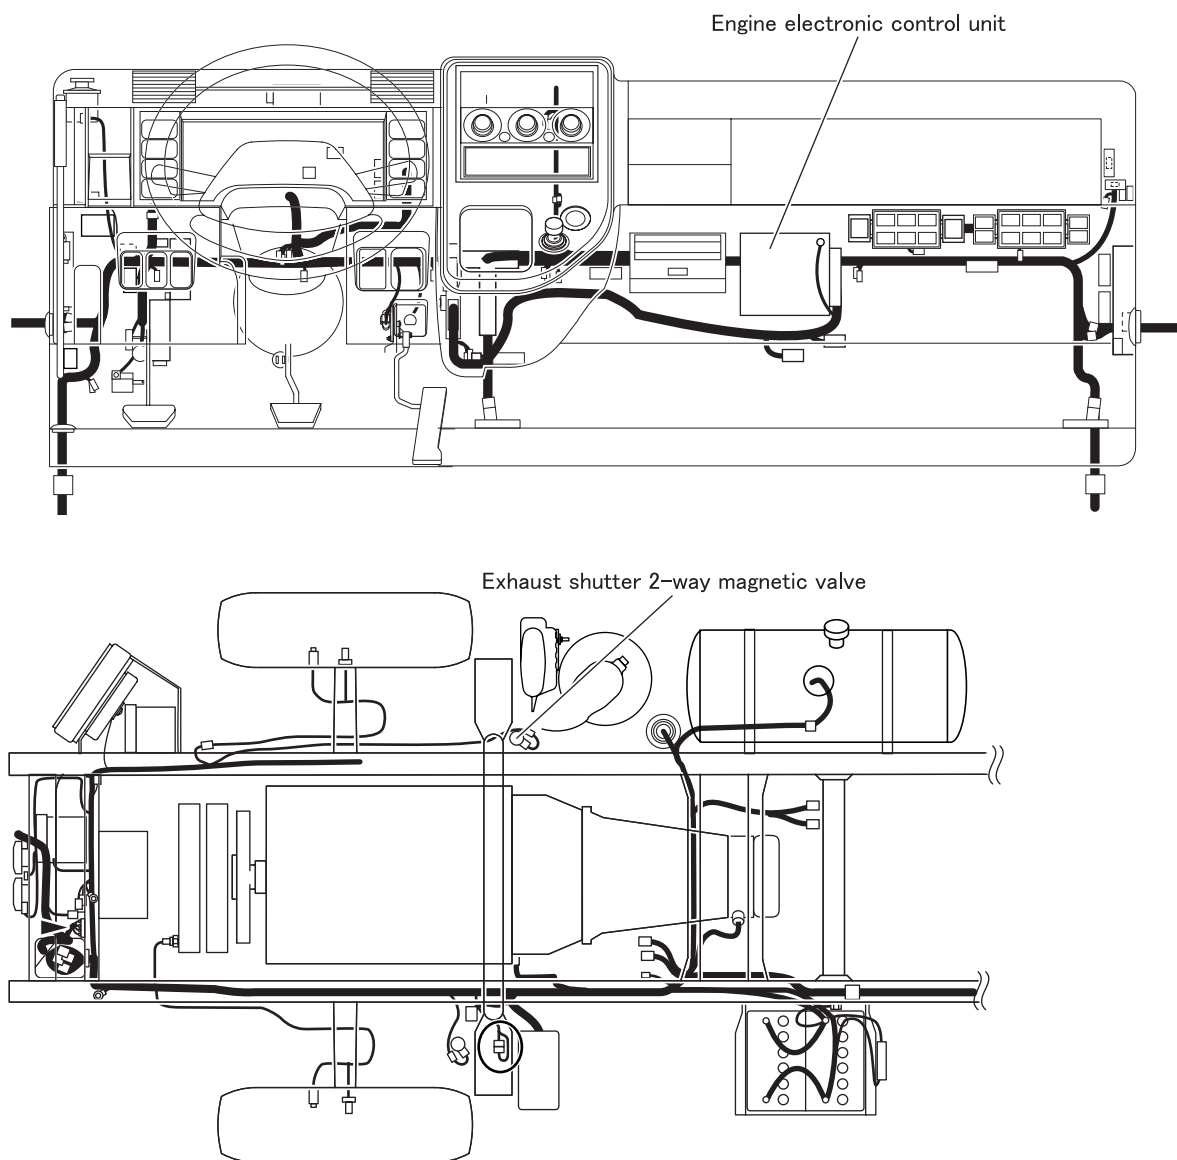
P107381E

## [Parts Identification and Location]

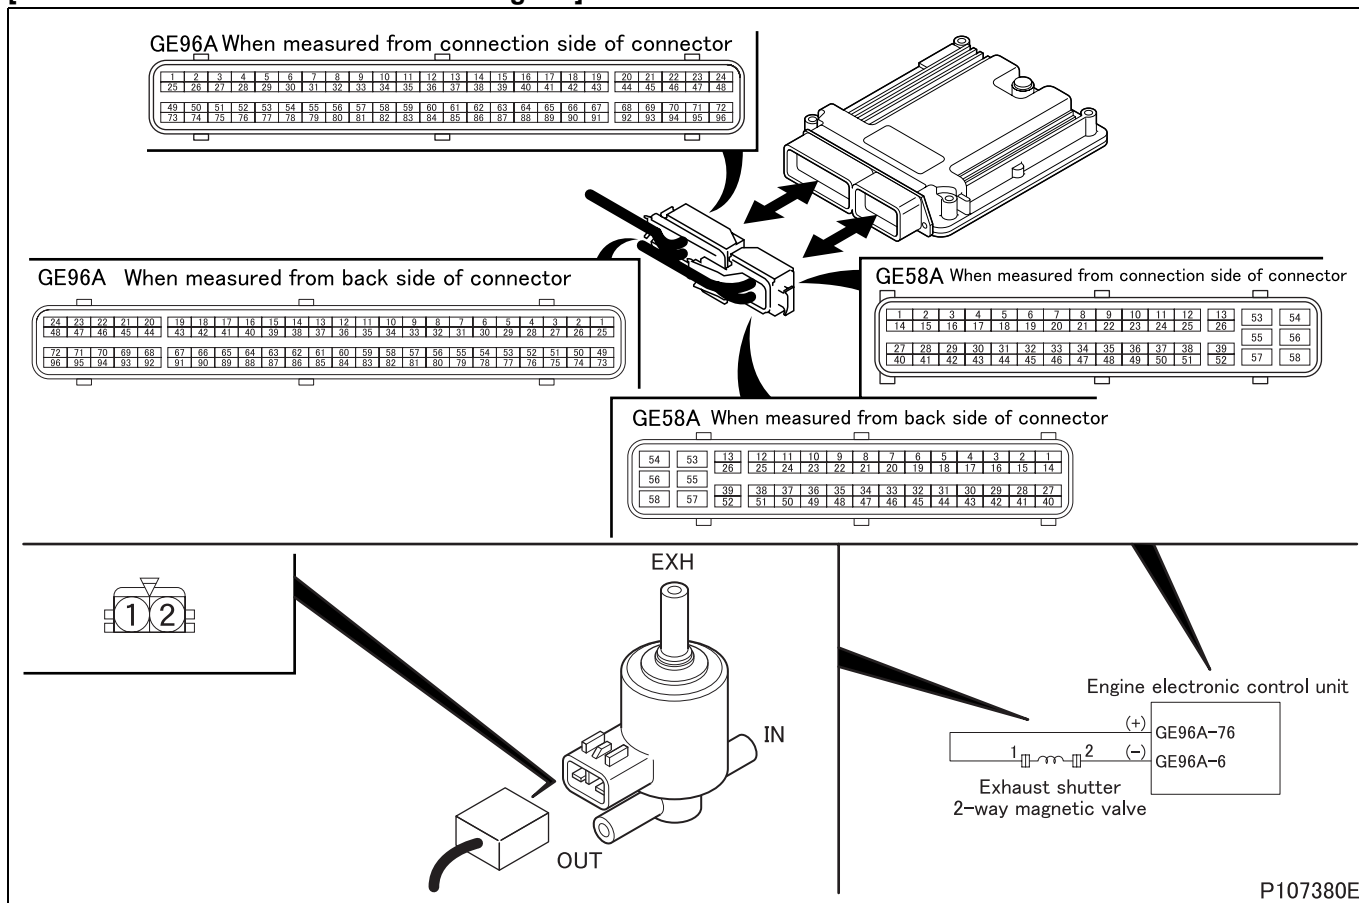
P107380E

## [Electronic Control Unit Connection Diagram]

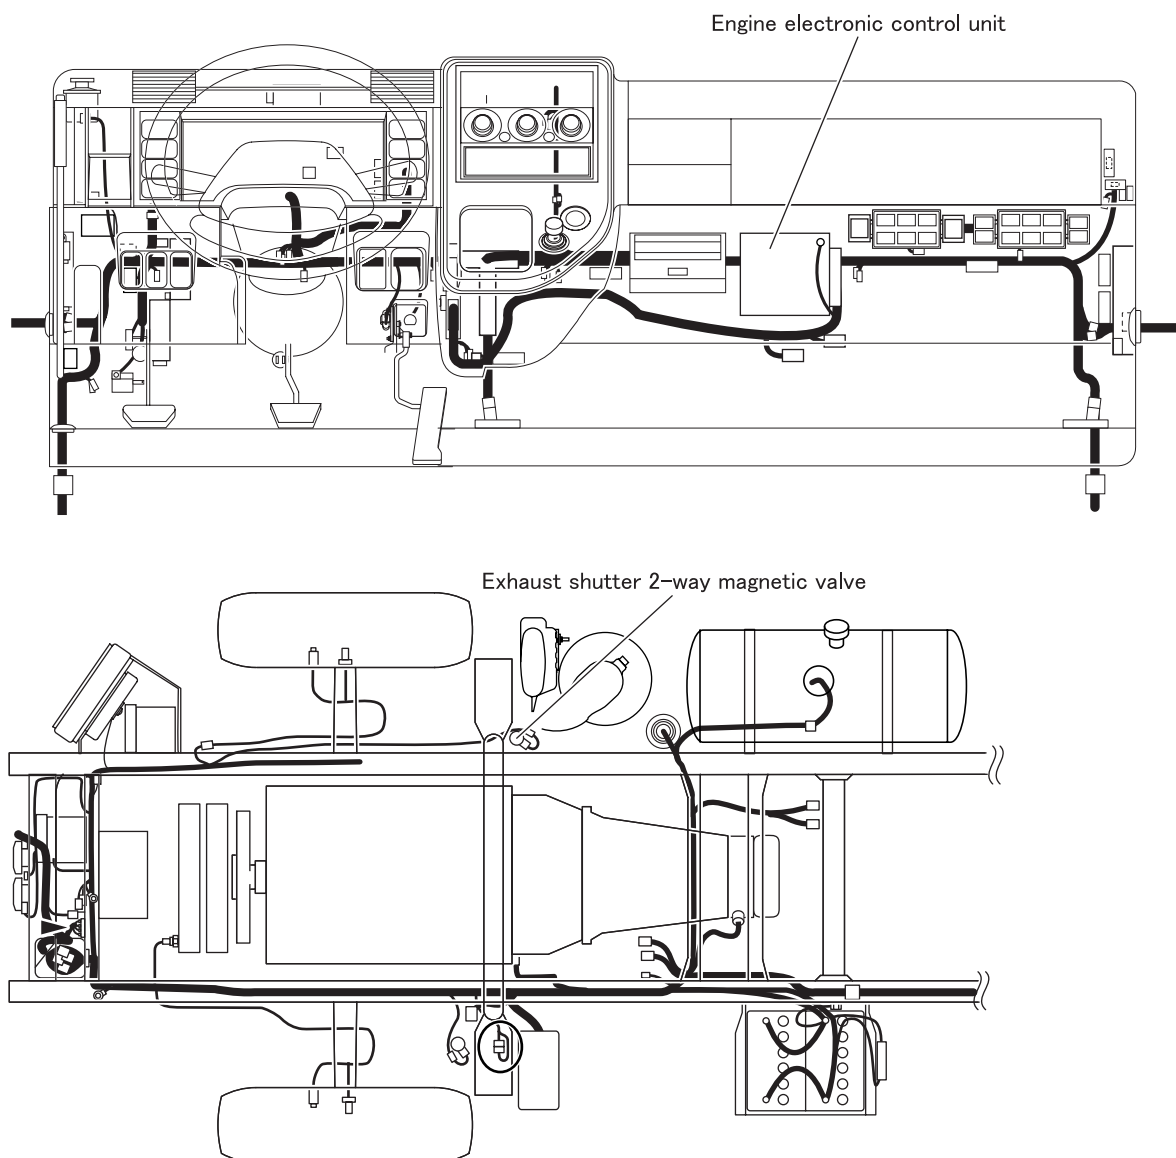
P107381E

## [Parts Identification and Location]

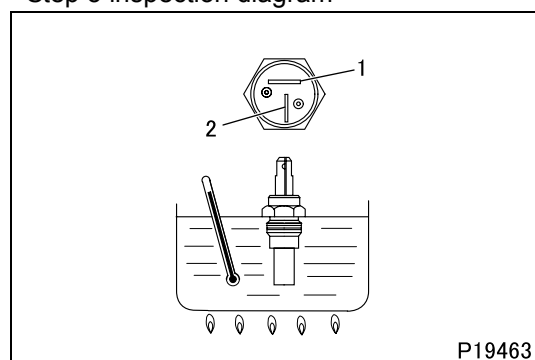
<Step 5 inspection diagram>

| NO | | Replacement of sensor | |

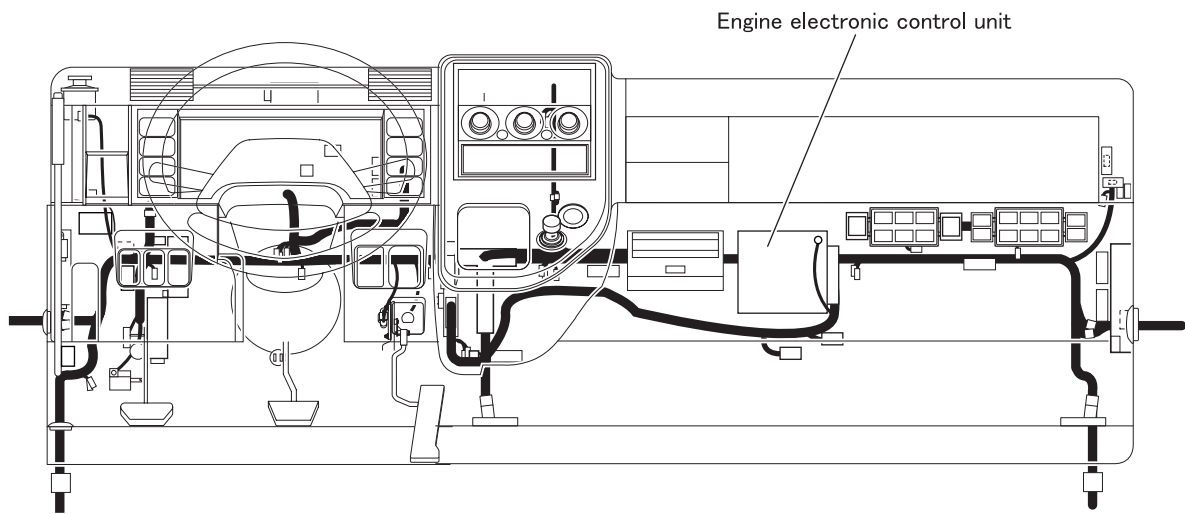
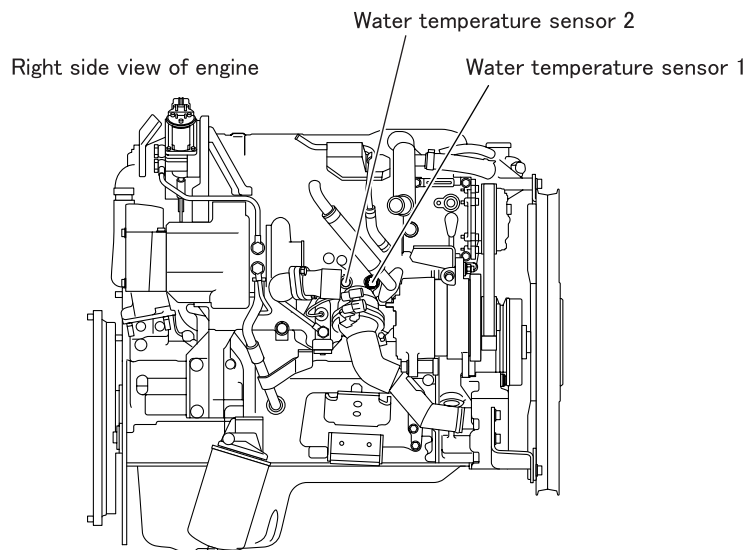
P103624E

## [Parts Identification and Location]

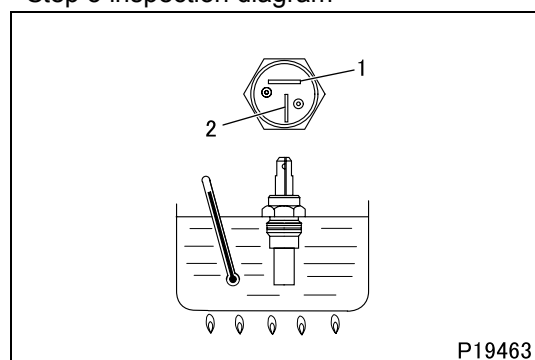
<Step 5 inspection diagram>

| | | NO | Replacement of sensor | |

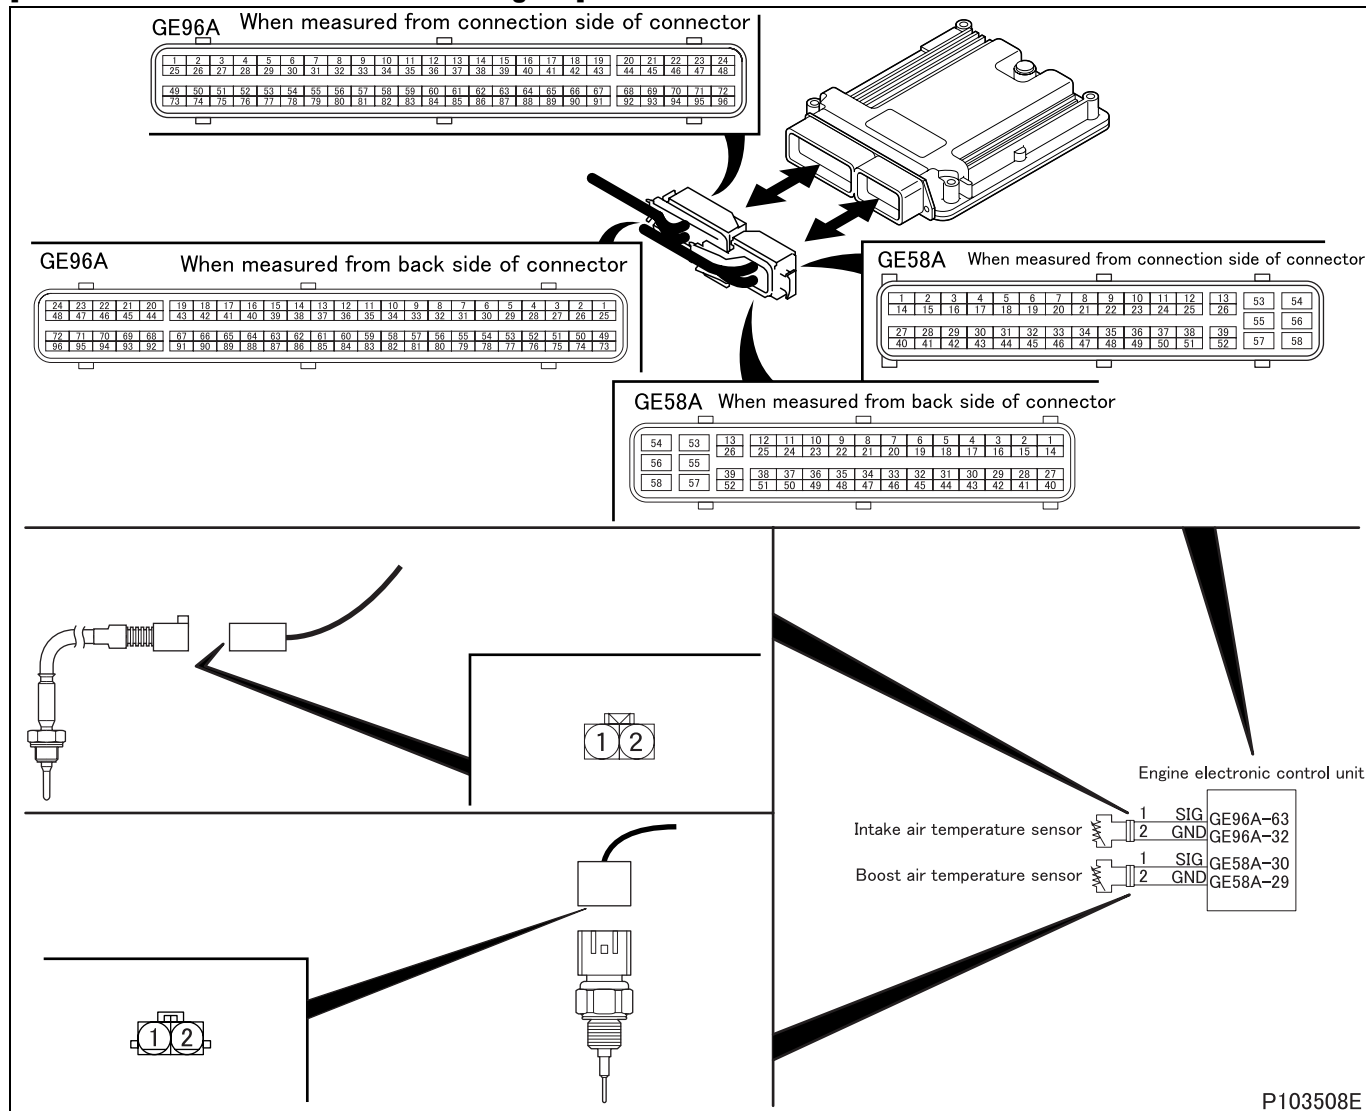
## [Electronic Control Unit Connection Diagram]

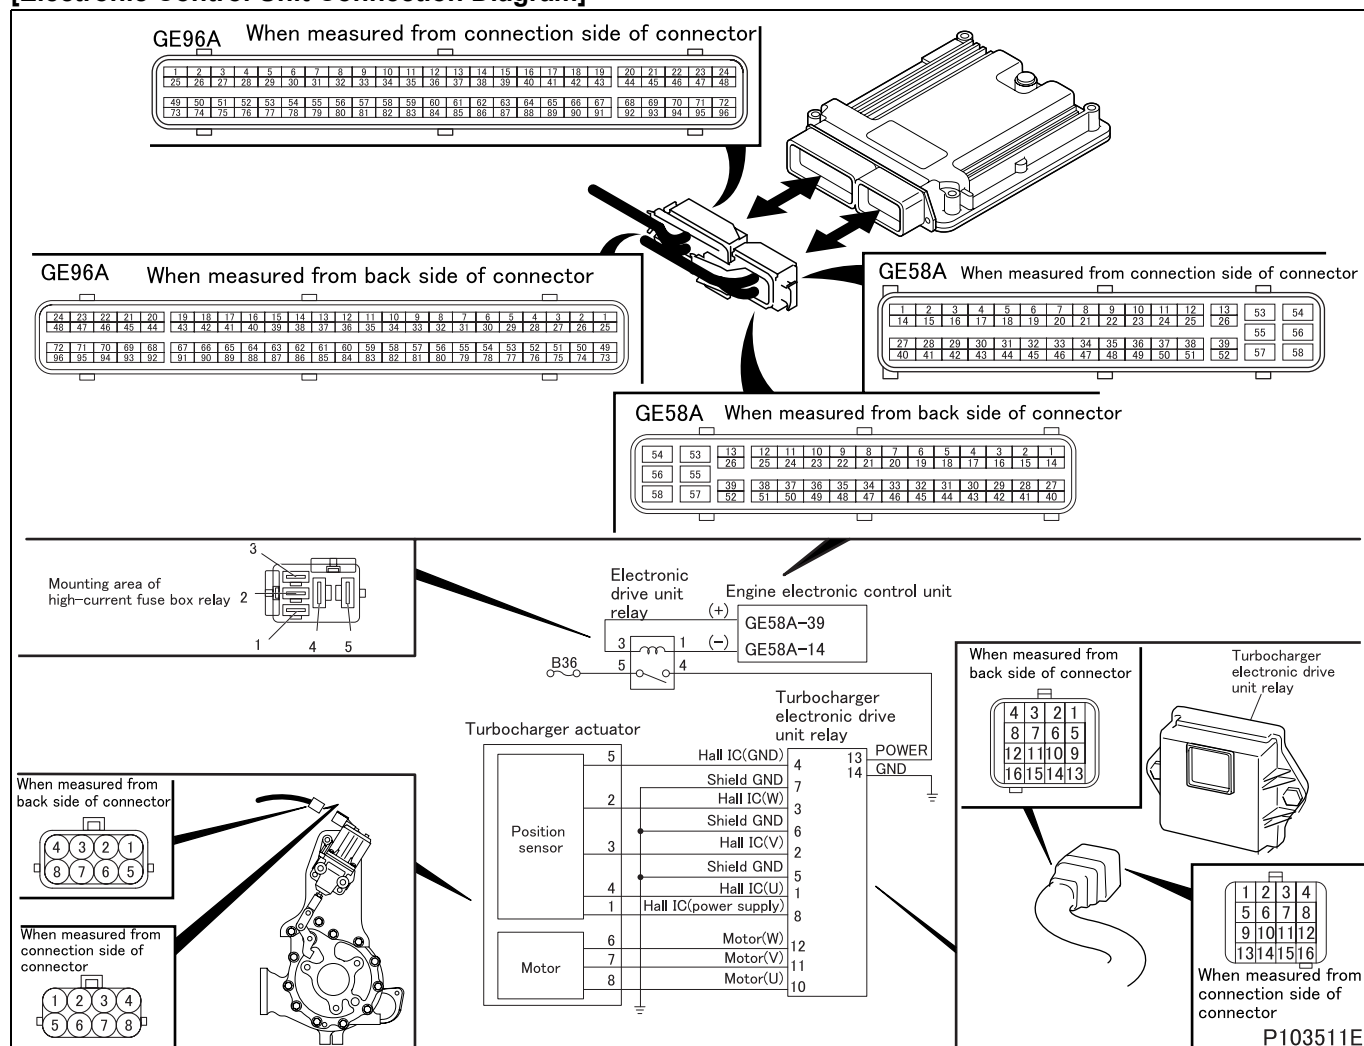
P103511E

## [Electronic Control Unit Connection Diagram]
