# FE.FG

## SERVICE MANUAL 2008 Model FOREWORD

This Service Manual contains maintenance and repair methods for the Mitsubishi Fuso Truck FE. FG Series. Read this manual carefully as an aid in providing correct, efficient maintenance. Please note that the information and specifications contained within this manual may change without notice. This is due to product modifications and continued vehicle improvements that are made throughout the model years. Should you encounter any discrepancy in the information provided, please do not hesitate to contact your nearest Mitsubishi Fuso Dealer or Mitsubishi Fuso Truck of America, Inc.

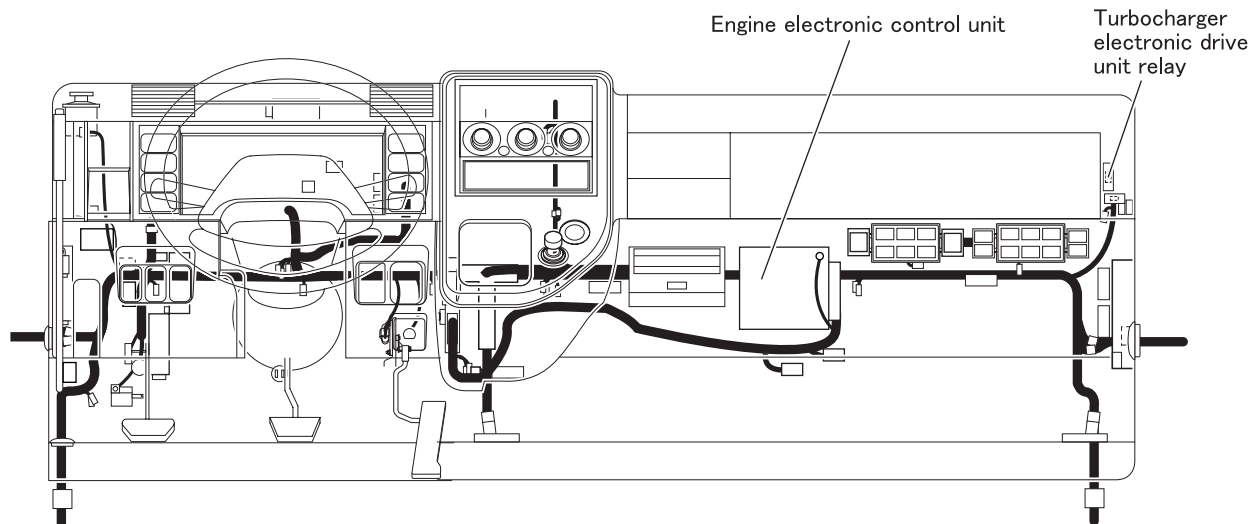
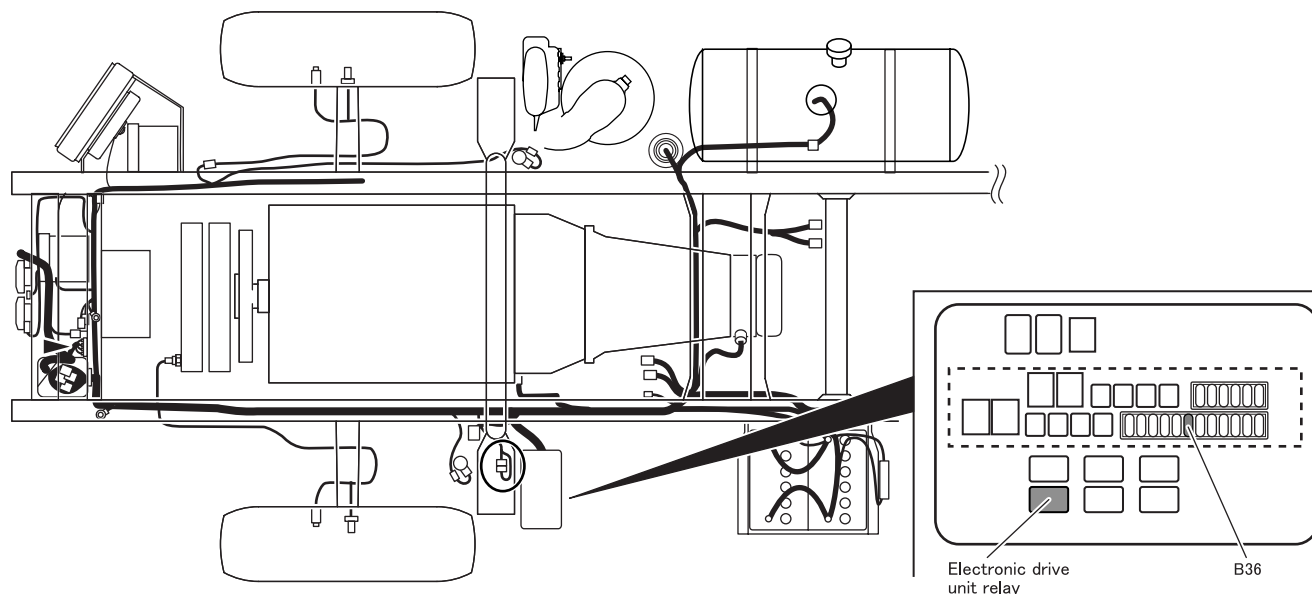
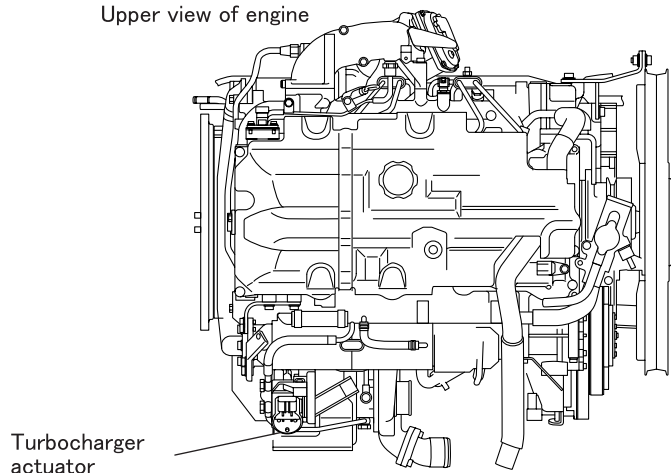
[Parts Identification and Location]

Upper view of engine

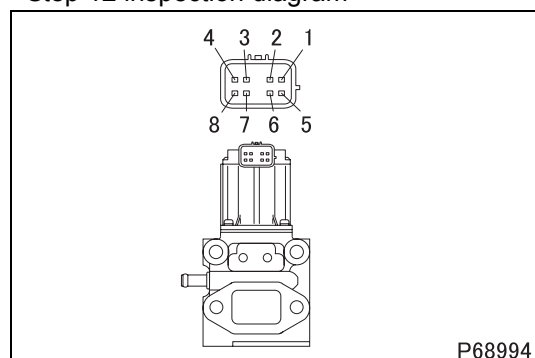
<Step 12 inspection diagram>

| | | NO | Replacement of turbocharger actuator |

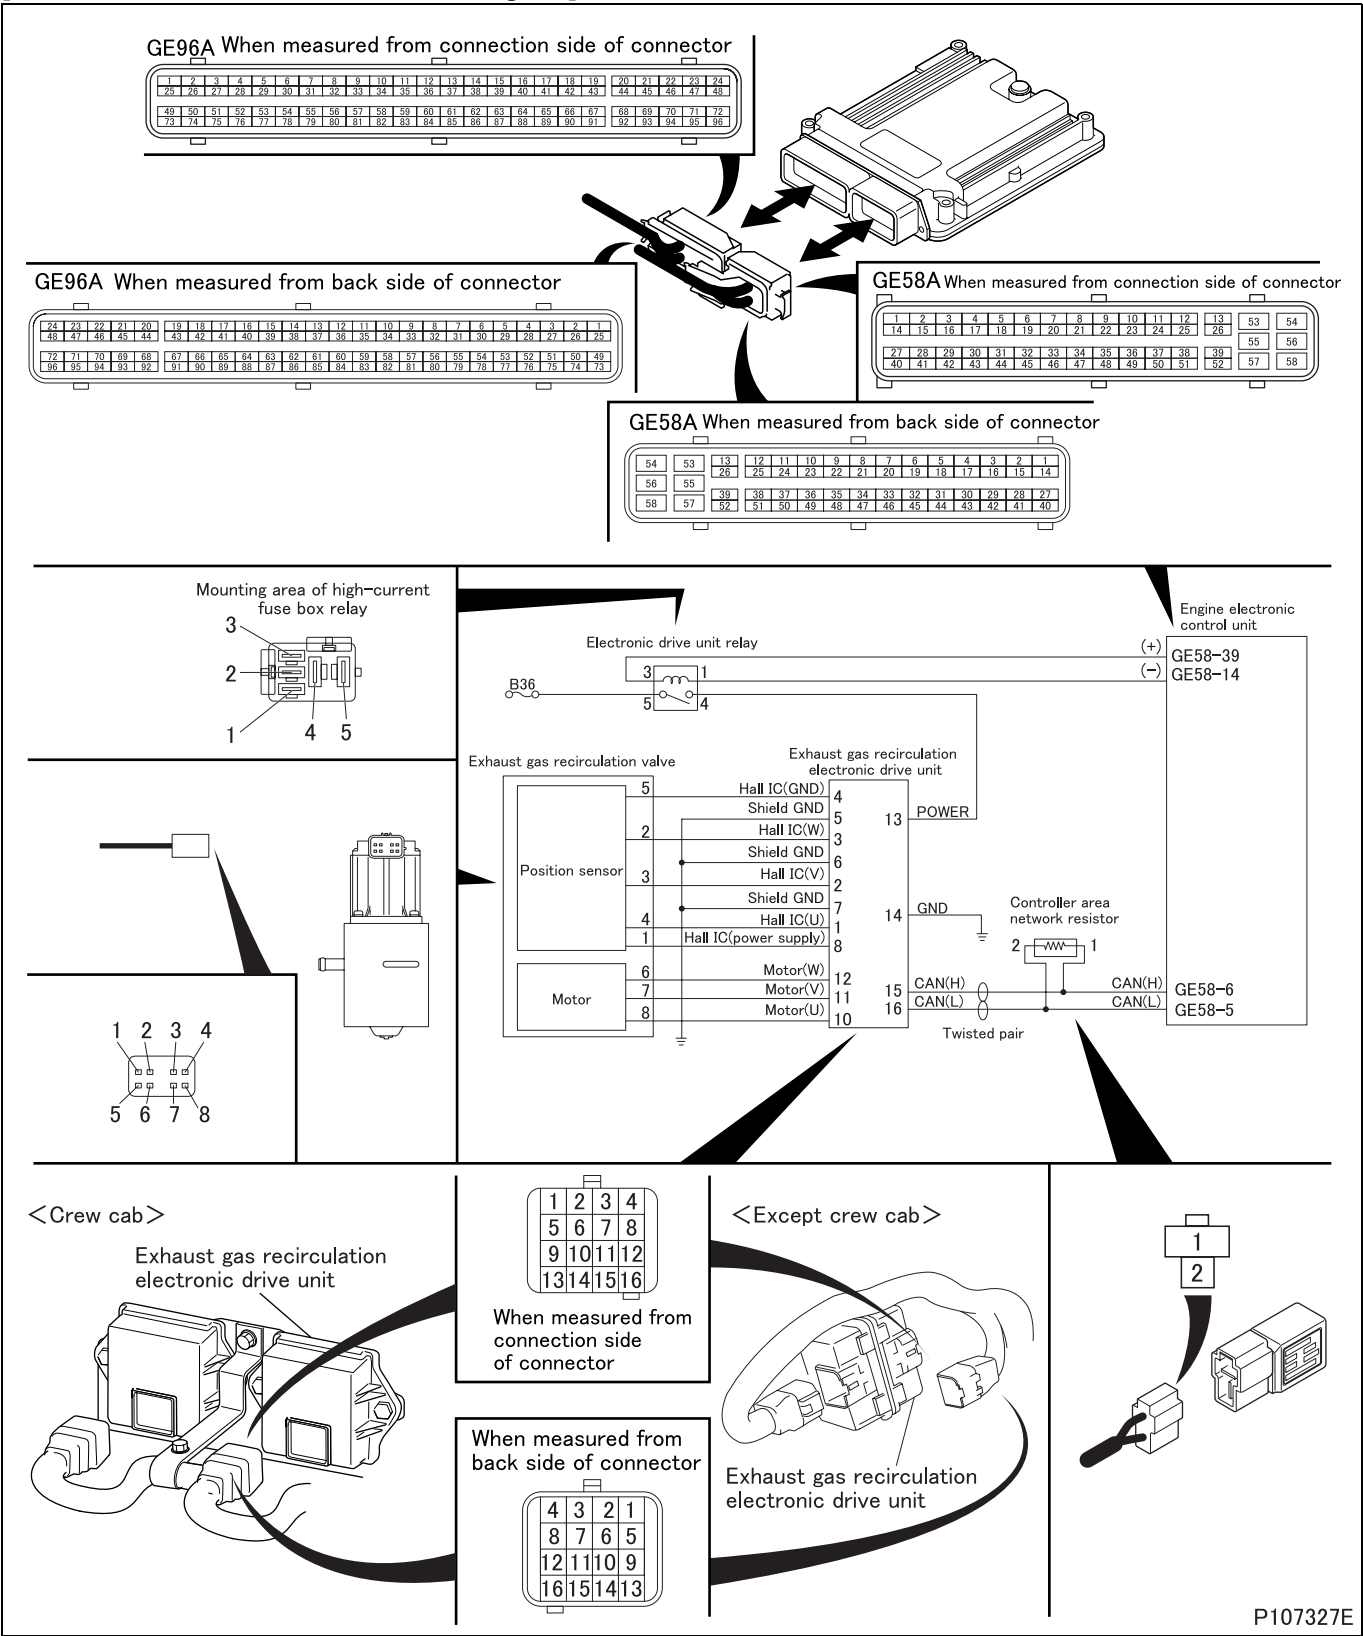
## [Electronic Control Unit Connection Diagram]

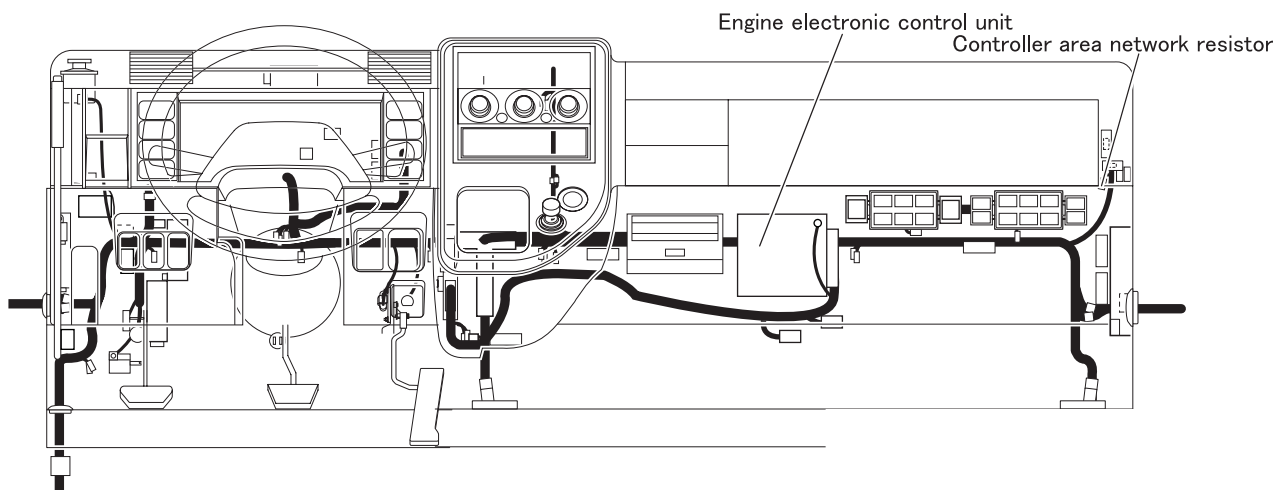
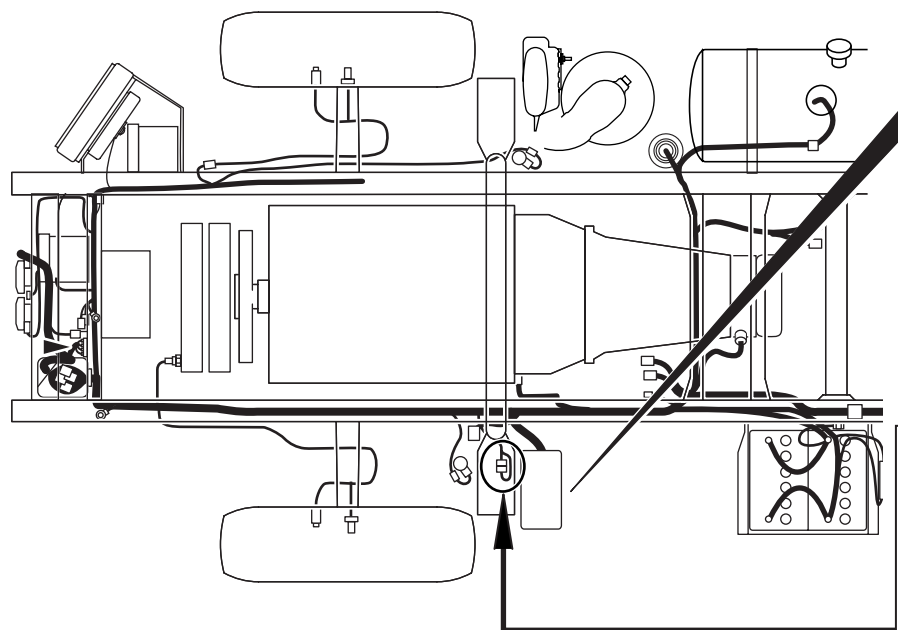
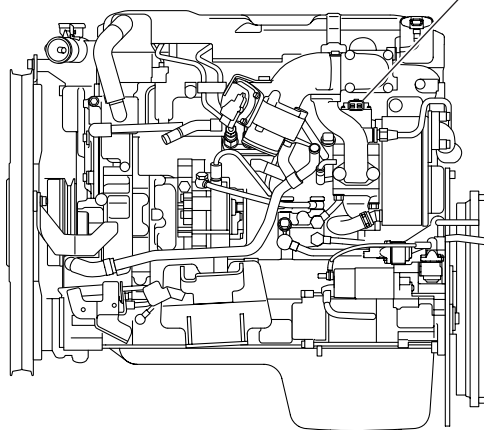
[Parts Identification and Location]

Left side view of engine

Exhaust gas recirculation valve

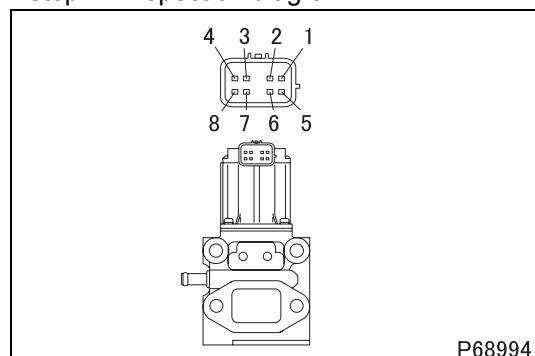
<Step 12 inspection diagram>

| | | NO | Replacement of turbocharger actuator |

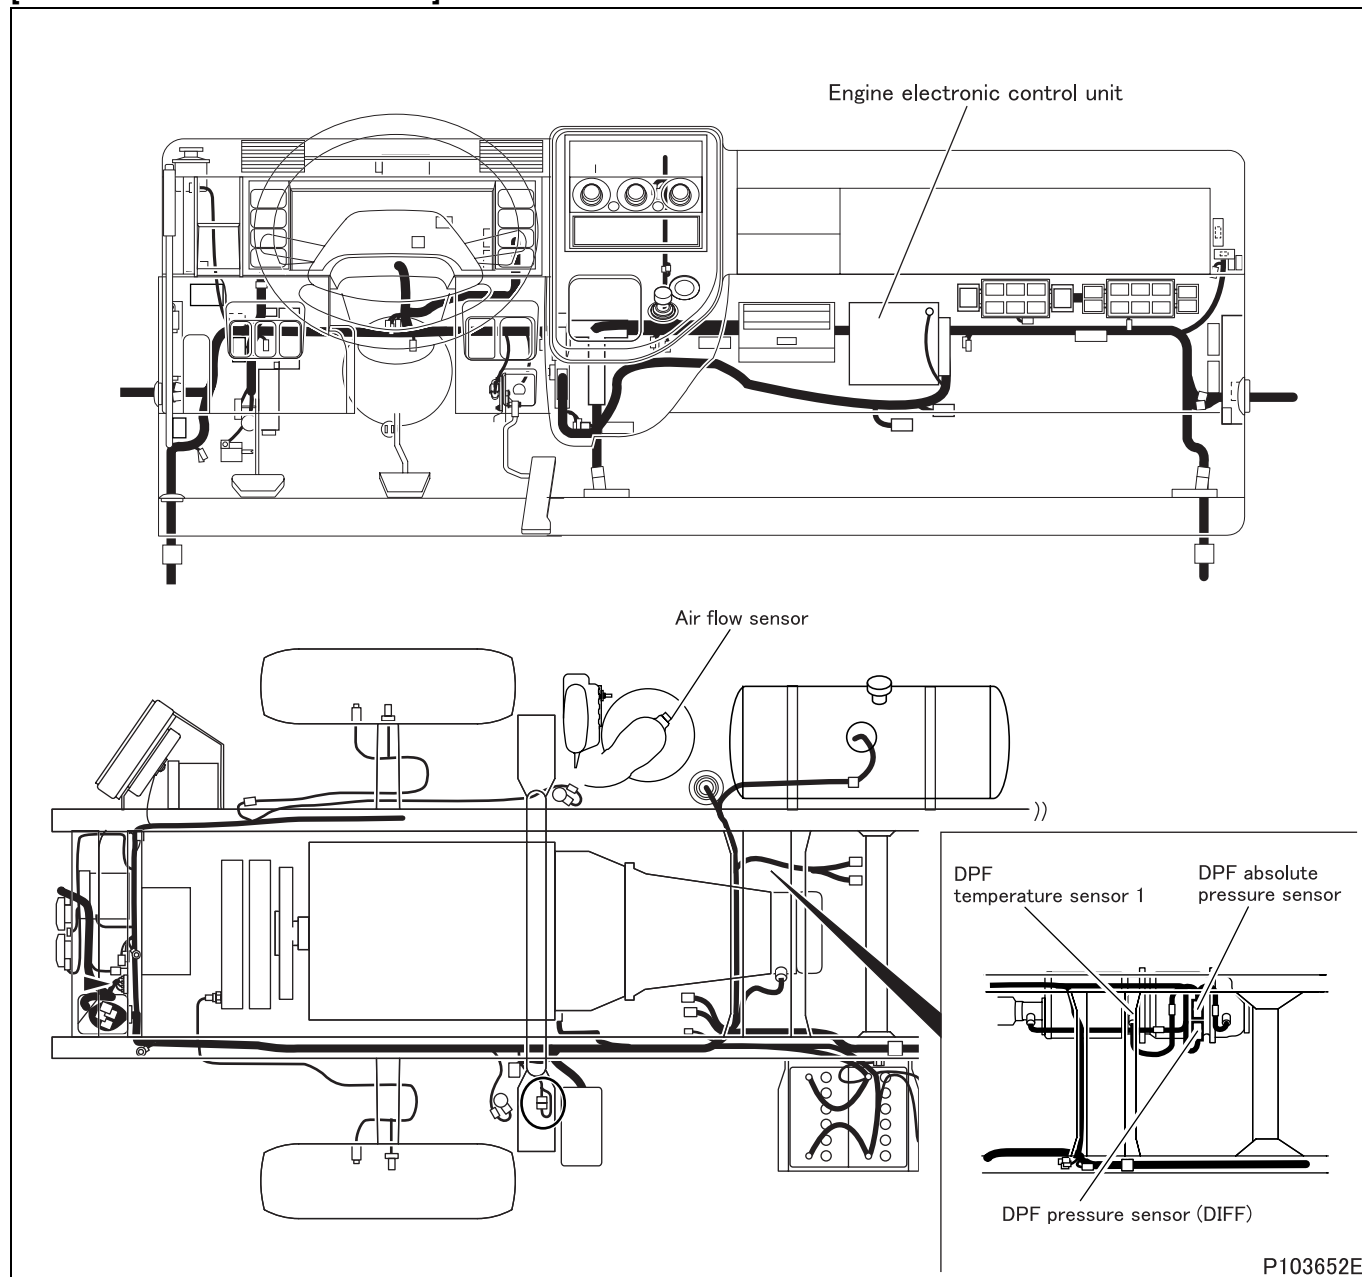
## [Parts Identification and Location]

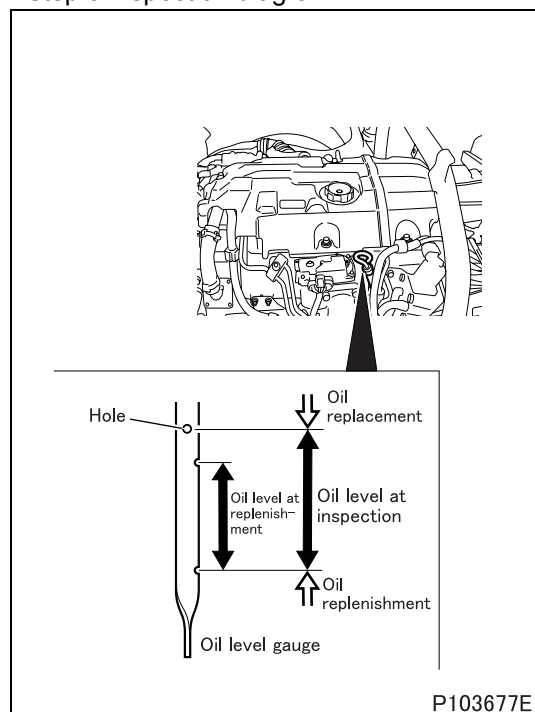
<Step 3 inspection diagram>

| Step 3 | Inspection items | | Inspection of oil level |
| | Inspection condition | | Engine stopped |

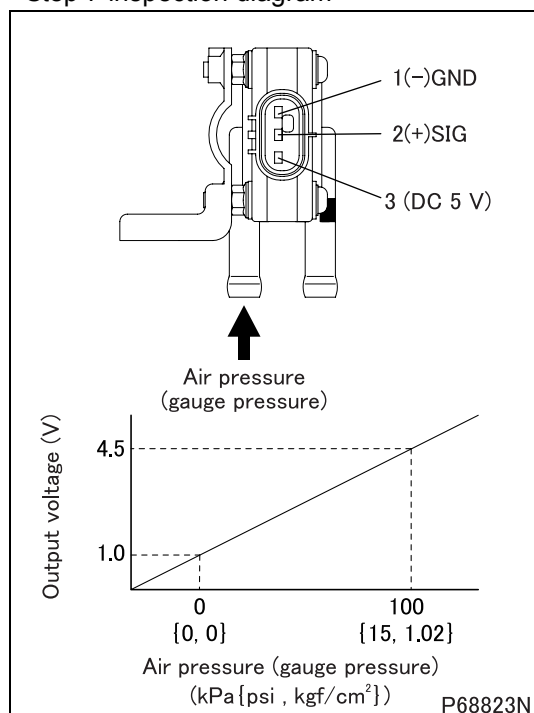
<Step 7 inspection diagram>

| | Inspection condition | | <ul style="list-style-type: none"> <li>Apply voltage DC 5 V across terminals No. 3 (+) and 1 (–).</li> <li>Gradually increase applied air pressure.</li> </ul> | |

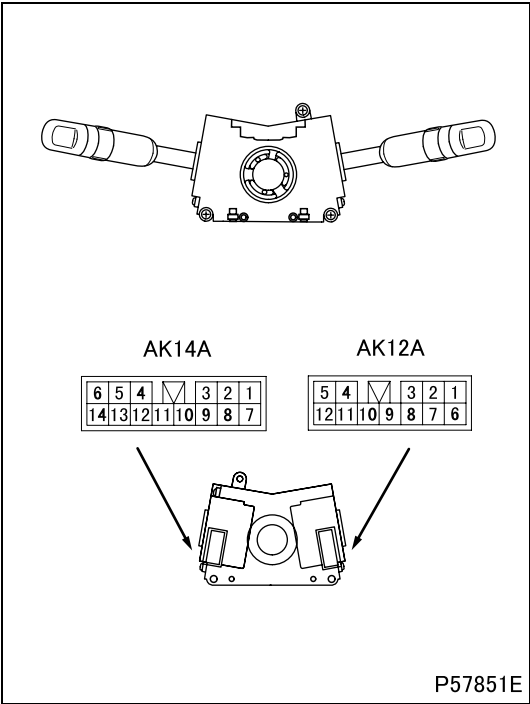
## #001 Inspection of combination switch

AK14A connector connection table

- For other inspections than shown above, see Electrical.
- If there is any abnormality, replace the switch.

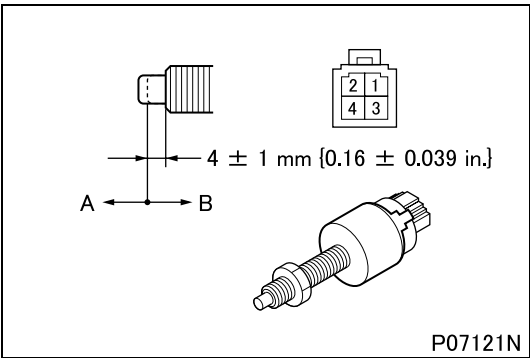
## #031 Inspection of clutch switch

| Switch position | Terminals with continuity |

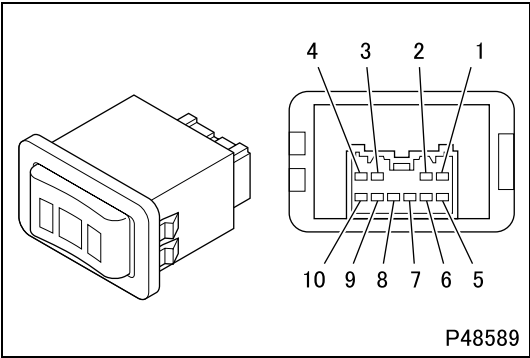
## #089 Inspection of DPF cleaning switch

| Switch position | Terminals with continuity | Night lighting |
| ON | 1 - 7 | |

- If there is any abnormality, replace the switch.

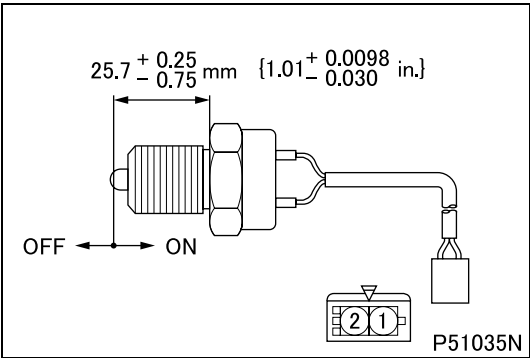
## #163 Inspection of torque limit switch

| Switch position | Terminals with continuity |
| ON | 1 - 2 |

- If there is any abnormality, replace the switch.

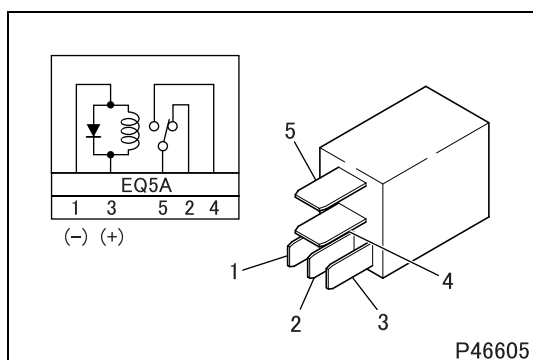
## #201 Inspection of relay (normally open 5-pin)

- Check continuity and operating condition of the relay. Replace the relay if necessary.

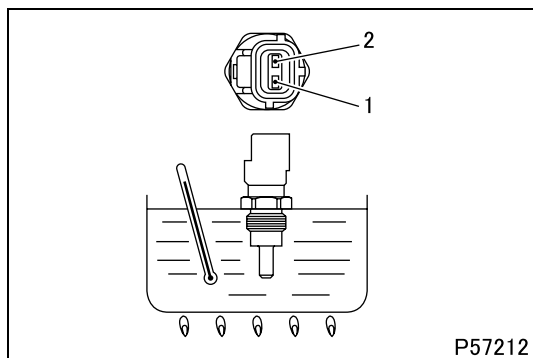
## #262 Inspection of water temperature sensor

### <Water temperature sensor 1>

| | 110°C {230°F} | 147.1 ± 2 Ω |

- If the measurement is out of specification, replace the sensor.

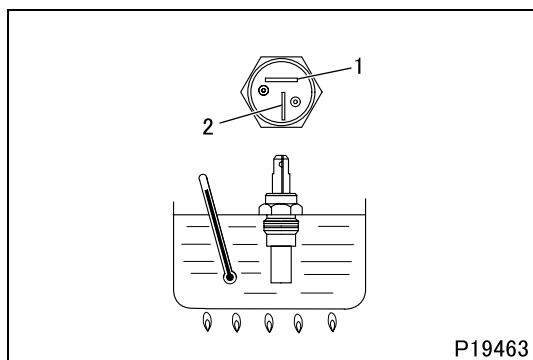
### <Water temperature sensor 2>

- Place the water temperature sensor in a container filled with engine oil.
- Heat the oil to each of the specified temperatures. Stir the oil well while doing so.
- Measure the resistance between terminals 2 and the body.

| | 80°C {176°F} | 300 Ω |

- If the measurement is out of specification, replace the sensor.

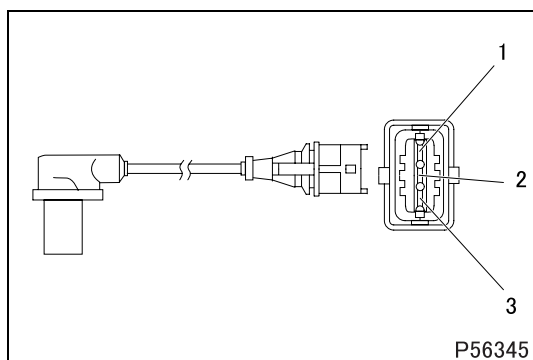
## #263 Inspection of engine speed sensor

- Measure the resistance between terminals 1 and 2.

- If the measurement is out of specification, replace the sensor.

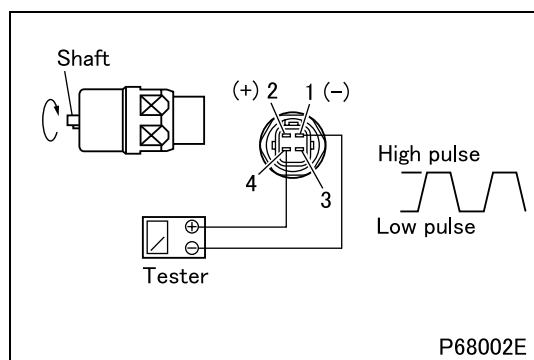
## #265 Inspection of vehicle speed sensor

- With the DC 12 V applied to terminals 1 and 2, slowly turn the shaft of the vehicle speed sensor.
- Measure the maximum voltage (high pulse voltage) and minimum voltage (low pulse voltage) occurring at each specified pair of terminals.

| Terminals | Inspection condition | Standard value |
|---|---|---|
| | High pulse voltage | $8 \pm 1$ V |

- If any measurement is out of specification, replace the sensor.

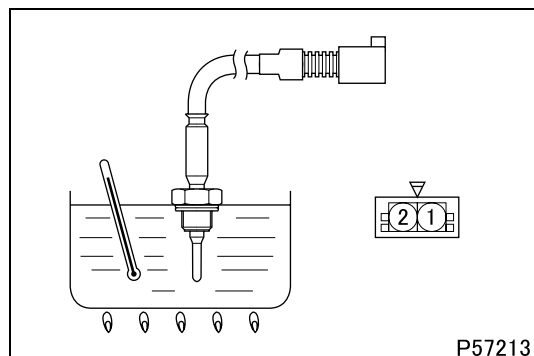
## #305 Inspection of air temperature sensor

### <Intake air temperature sensor>

| | 150°C {302°F} | $160.4^{+10.3}_{-9.6}$ Ω |

- If either measurement is out of specification, replace the sensor.

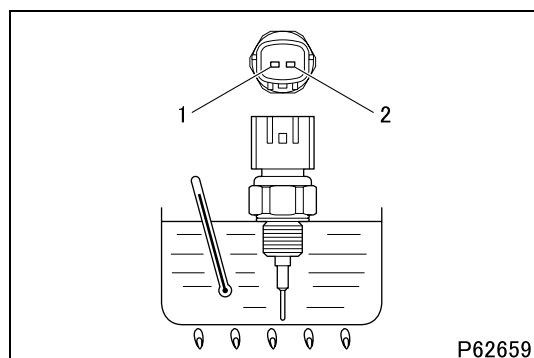
### <Boost air temperature sensor>

- The boost air temperature sensor may output false signals if its tip is contaminated. Clean it if necessary. (See Gr15.)
- Place the sensor in a container filled with engine oil.
- Heat the oil to each of the specified temperatures. Stir the oil well while doing so.
- Measure the resistance between terminals 1 and 2.

- If the measurement is out of specification, replace the sensor.

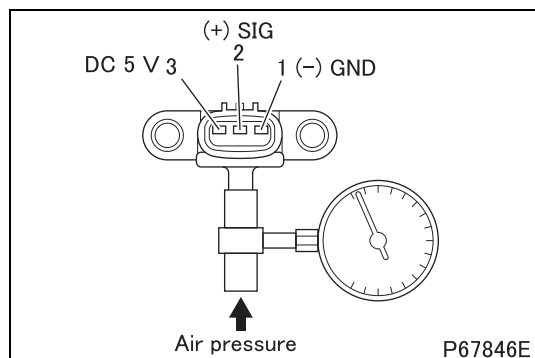
**#318 Inspection of boost pressure sensor**

- Apply DC 5 V to terminals 3 and 1.
- Apply air pressure. Gradually increase it and, while doing so, measure the output voltage occurring at terminals 2 and 1.

- If any measurement is out of specification, replace the sensor.

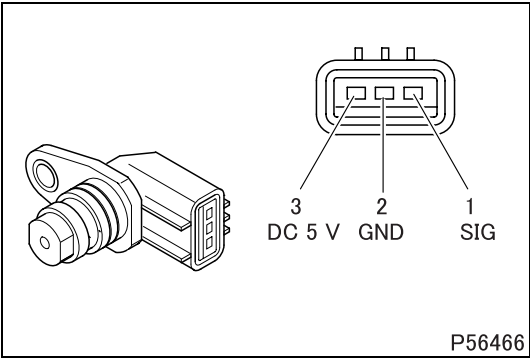
## #320 Inspection of cylinder recognition sensor

- Measure the resistance between terminals 2 and 3.

| Standard value | 200 to 1800 $\Omega$ |

- If the measurement is out of specification, replace the sensor.

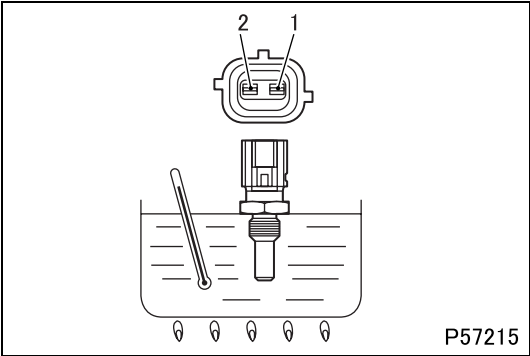
## #323 Inspection of fuel temperature sensor

- Measure the resistance between terminals 1 and 2.

| | 110°C {230°F} | 0.1417 $\pm$ 0.0018 k $\Omega$ |

- If any measurement is out of specification, replace the sensor.

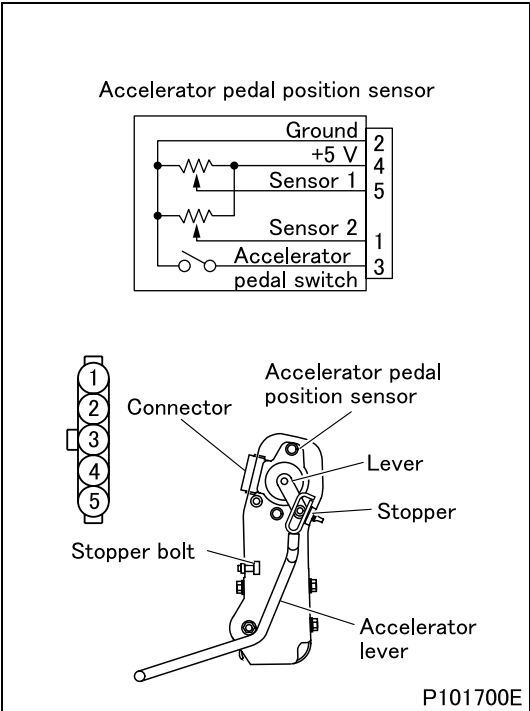
## #324 Inspection of accelerator pedal position sensor

**C:** Position in which accelerator lever is touching stopper bolt

- If any output voltage is out of specification, make an adjustment.
- If any output voltage is still out of specification when you have made an adjustment, replace the sensor.

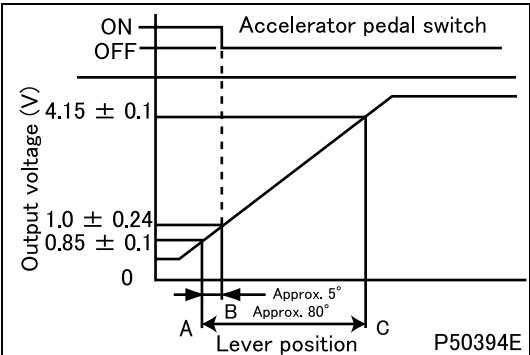
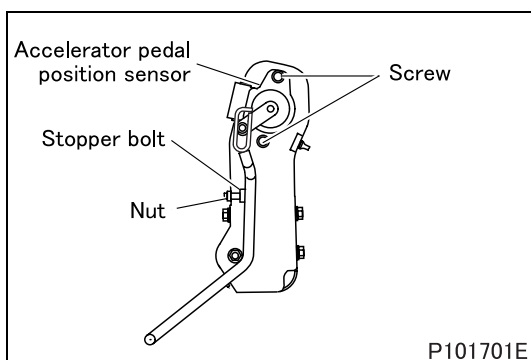
### [Adjustment]

- To adjust the output voltage for the idling position A, loosen the screws and move the accelerator pedal position sensor. Tighten the screws after making the adjustment.
- To adjust the output voltage for the full load position C, loosen the nut and make the adjustment using the stopper bolt. After making the adjustment, lock the stopper bolt in position with the nut.

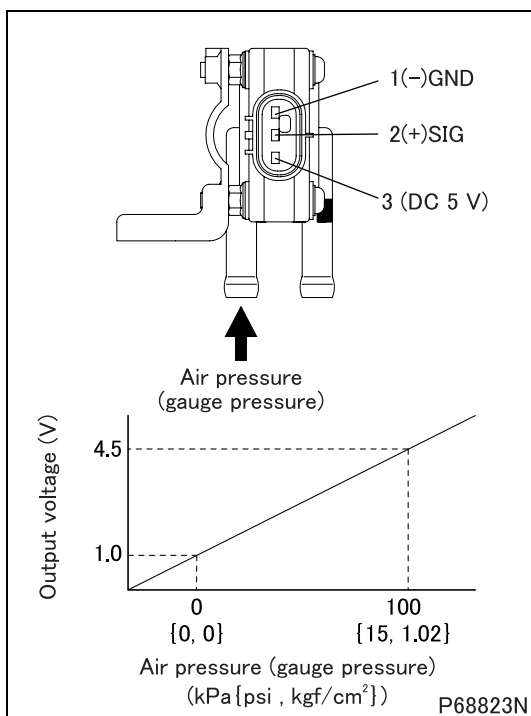
### #334 Inspection of DPF pressure sensor

#### <DPF pressure sensor (DIFF)>

| | $100 \pm 3.5 \text{ kPa}$ { $15 \pm 0.5 \text{ psi}$ ,<br>$1.02 \pm 0.04 \text{ kgf/cm}^2$ } | 4.5 V |

- If the measurement is out of specification, replace the sensor.

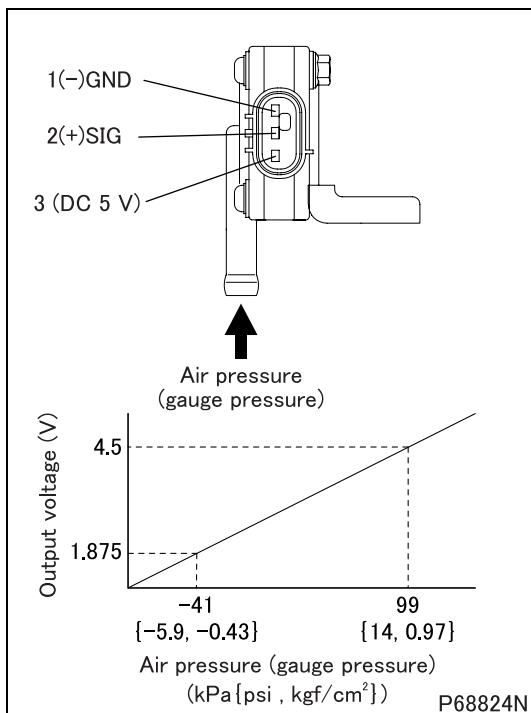
#### <DPF absolute pressure sensor>

- Apply DC 5 V to terminals 3 and 1.
- Apply air pressure (gauge pressure) and measure the output voltage occurring at terminals 2 and 1 (left figure).

- If the measurement is out of specification, replace the sensor.

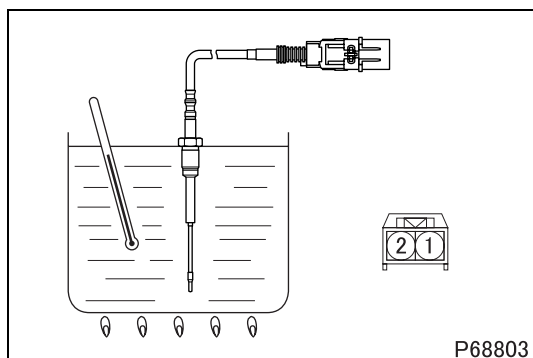
## #336 DPF temperature sensor

### <DPF temperature sensor 1>

| | 200°C {392°F} | 6.896 <sup>+2.064</sup> <sub>-1.252</sub> kΩ |

- If the measurement is out of specification, replace the sensor.

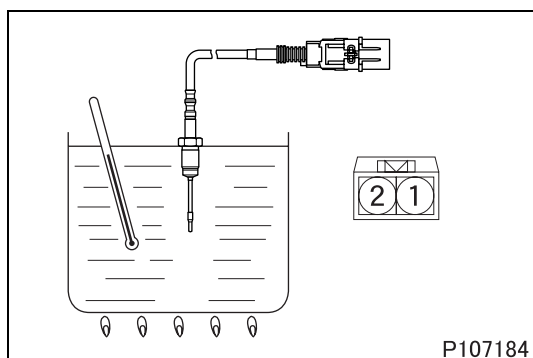
### <DPF temperature sensor 2>

- The DPF temperature sensor 2 may output false signals if its tip is contaminated. Clean it if necessary. (See Gr15.)
- Place the sensor in a container filled with engine oil.
- Heat the oil to each of the specified temperatures. Stir the oil well while doing so.
- Measure the resistance between terminals 1 and 2.

| | 200°C {392°F} | 6.896 <sup>+2.064</sup> <sub>-1.252</sub> kΩ |

- If the measurement is out of specification, replace the sensor.

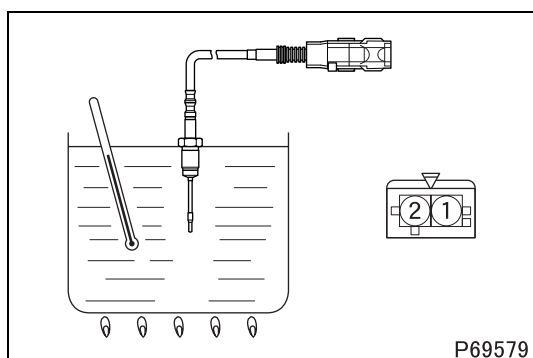
## #338 Inspection of catalytic temperature sensor

- The catalytic temperature sensor may output false signals if its tip is contaminated. Clean it if necessary. (See Gr15.)
- Place the sensor in a container filled with engine oil.
- Heat the oil to each of the specified temperatures. Stir the oil well while doing so.
- Measure the resistance between terminals 1 and 2.

| | 200°C {392°F} | 6.896 <sup>+2.064</sup> <sub>-1.252</sub> kΩ |

- If the measurement is out of specification, replace the sensor.

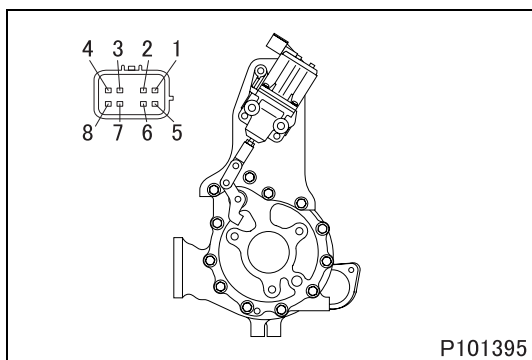
### #514 Inspection of turbocharger actuator

- Perform the following checks. If there is any abnormality, replace the turbocharger actuator.

#### (2) Position sensor

- The sensor cannot easily be inspected, so you must evaluate it indirectly by inspection of system harnesses and related parts.
- If there is no abnormality in any related part but the system is abnormal, replace the turbocharger actuator.

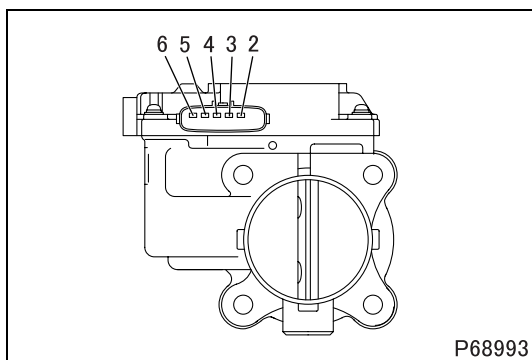
### #529 Inspection of intake throttle

- Perform the following checks. If there is any abnormality, replace the intake throttle.

#### (2) Position sensor

- The sensor cannot easily be inspected, so you must evaluate it indirectly by inspection of system harnesses and related parts.
- If there is no abnormality in any related part but the system is abnormal, replace the intake throttle.

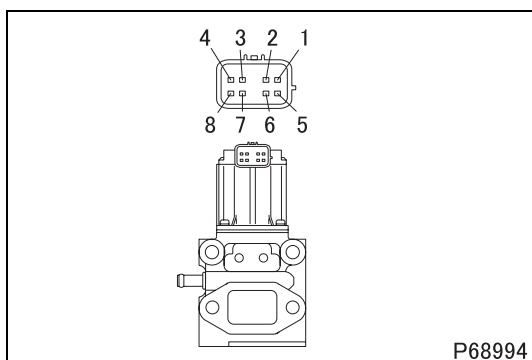
### #530 Inspection of EGR valve

- Perform the following checks. If there is any abnormality, replace the EGR valve.

- The sensor cannot easily be inspected, so you must evaluate it indirectly by inspection of system harnesses and related parts.
- If there is no abnormality in any related part but the system is abnormal, replace the EGR valve.

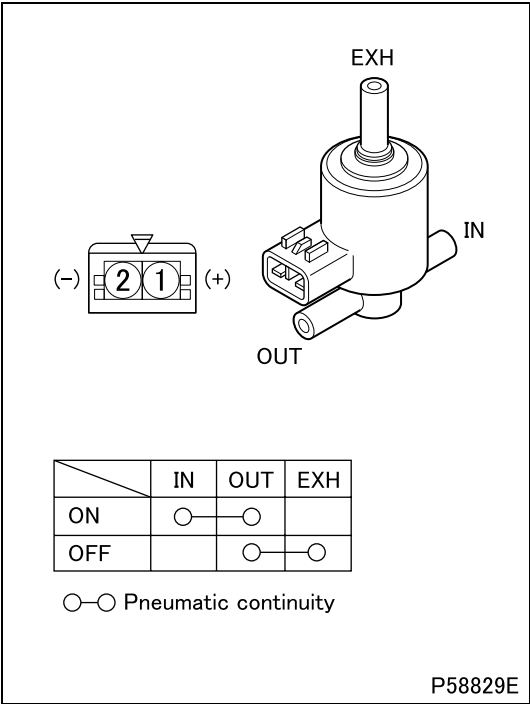
## #565 Inspection of exhaust shutter 2-way magnetic valve

- Perform the following checks. If there is any abnormality, replace the exhaust shutter 2-way magnetic valve.

### (2) Check of continuity and airtightness

- Vacuum pressure applied during check:  
-100 kPa {-15 psi, -10 kgf/cm<sup>2</sup>}

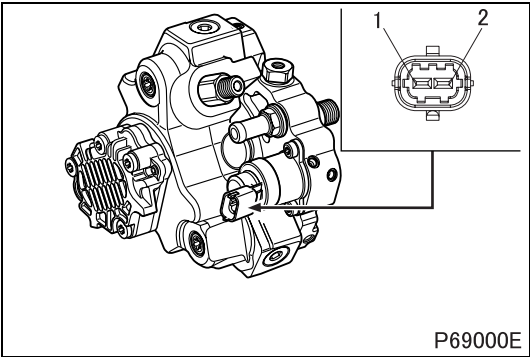
## #574 Inspection of MPROP (rail pressure control valve)

- Measure the resistance between terminals 1 and 2.

| Standard value | 2.6 to 3.15 Ω |

- If the measurement is out of specification, replace the supply pump.

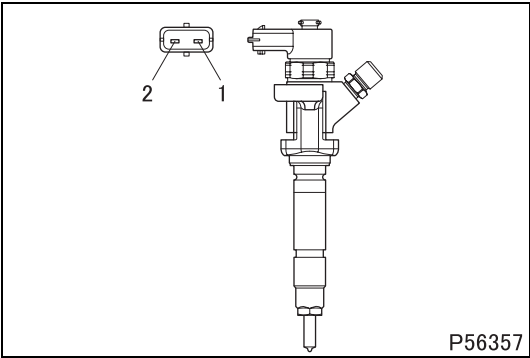
## #582 Inspection of injector magnetic valve

- Measure the resistance between terminals 1 and 2.

- If the measurement is out of specification, replace the injector.
- If an injector is replaced with a new one, the injector correction data must be written in the engine electronic control unit.
- For storing of data in the engine electronic control unit, contact your nearest MITSUBISHI FUSO dealer or MITSUBISHI FUSO TRUCK OF AMERICA, Inc.

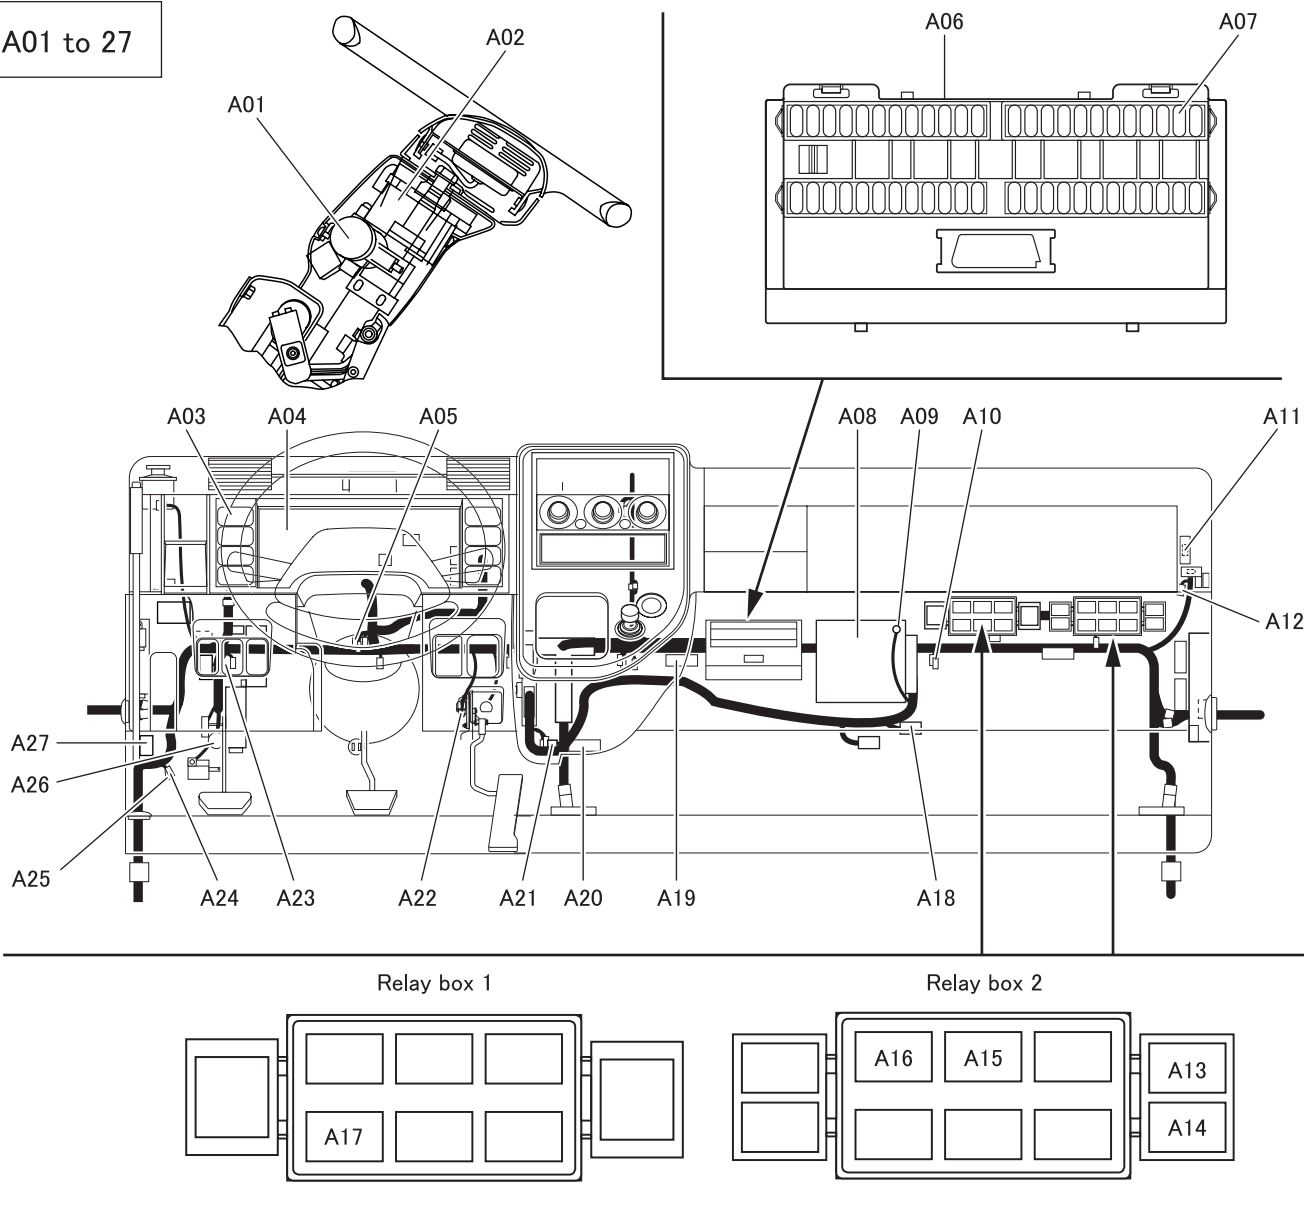
A01 to 27

- A01 Starter switch
- A02 Combination switch
- A03 DPF cleaning switch
- A04 Meter cluster
- A05 Diode
- A06 Fuse box
- A07 Diagnosis switch
- A08 Engine ECU
- A09 Ground
- A10 Diode
- A11 Turbocharger EDU
- A12 Controller area network resistor
- A13 Engine start relay <M/T>
- A14 T/M neutral relay <M/T>
- A15 Glow drive relay
- A16 ABS exhaust brake cut relay
- A17 Safety relay
- A18 Joint connector (J/C-2)

- A19 Joint connector (J/C-1)
- A20 Joint connector (J/C-M1)
- A21 Diode
- A22 Accelerator pedal position sensor
- A23 Joint connector (J/C-040) <A/T>
- A24 Controller area network resistor
- A25 Joint connector (J/C-040)
- A26 Clutch switch <M/T>
- A27 Diagnostic connector

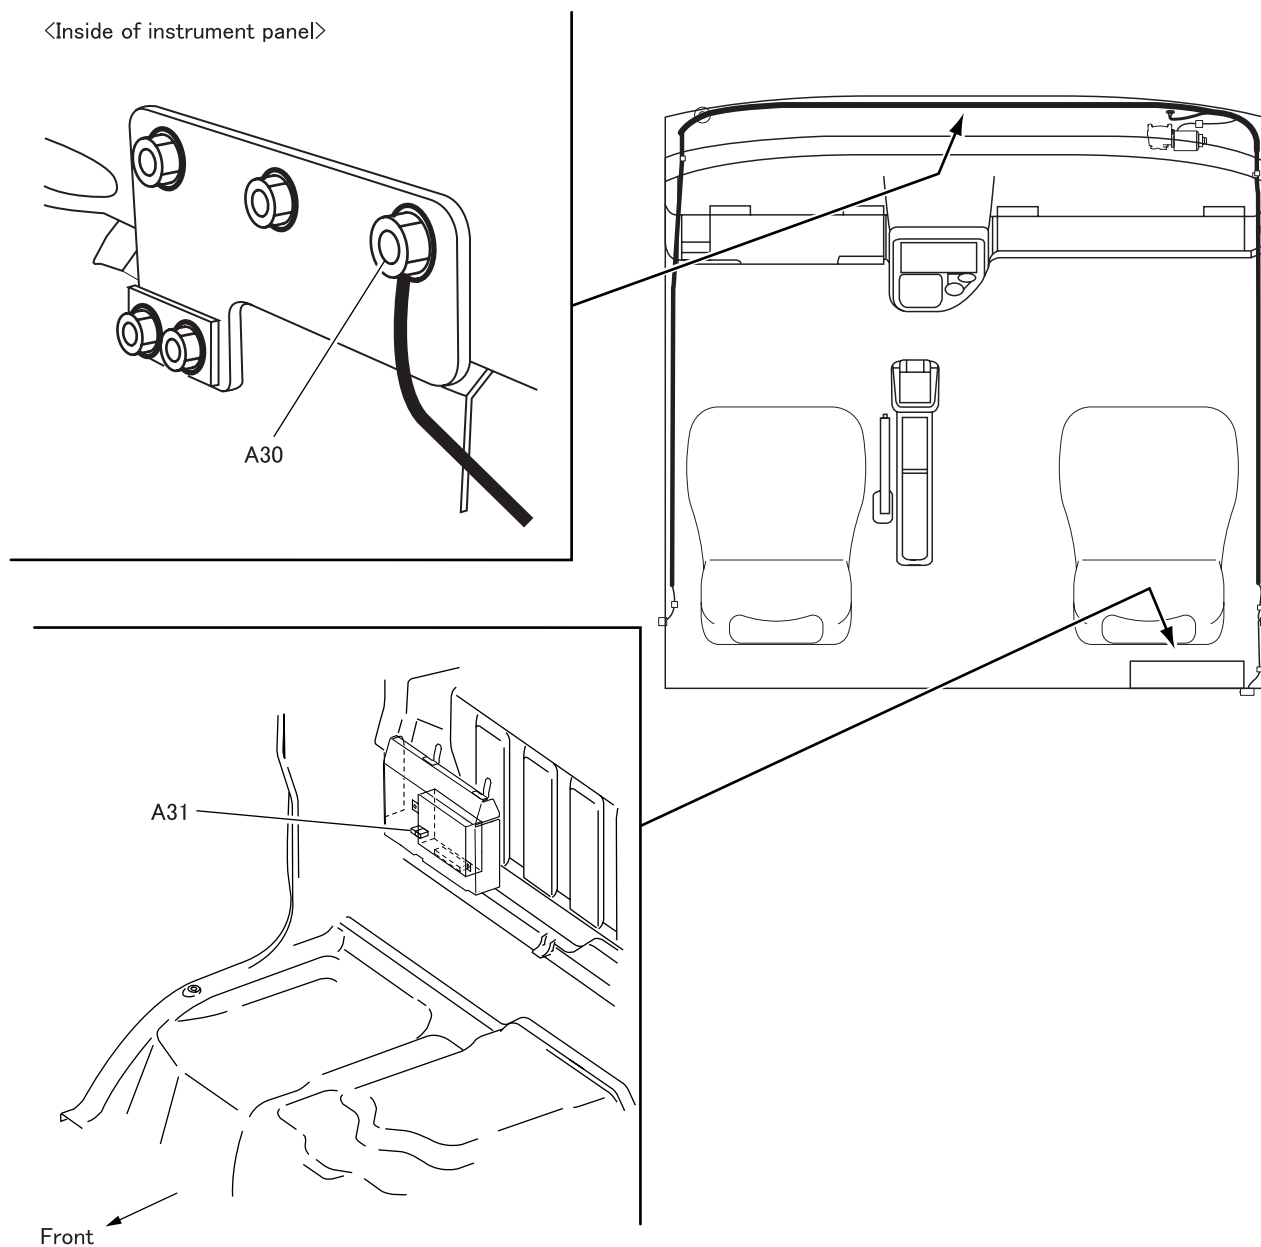
## A30-31

&lt;Inside of instrument panel&gt;

A30 Ground  
A31 Controller area network resistor

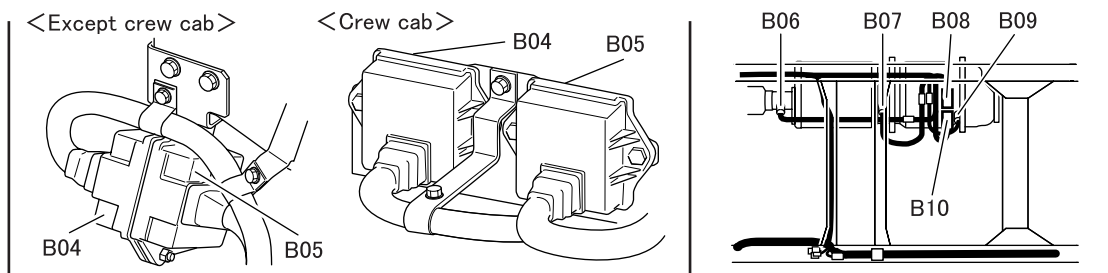
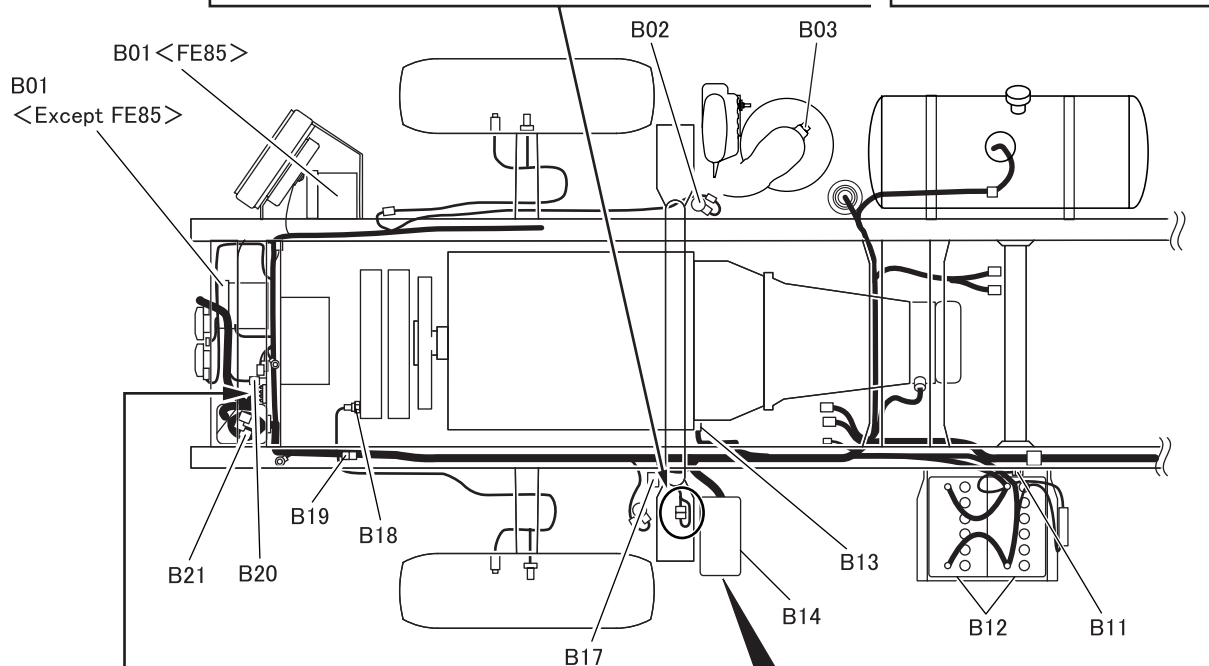
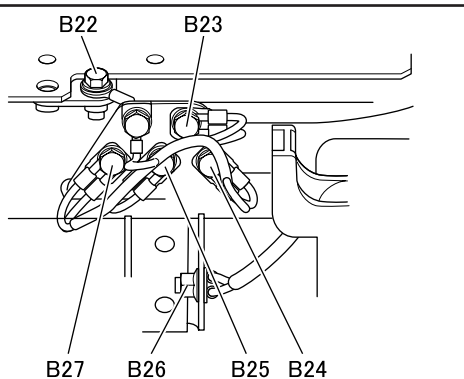
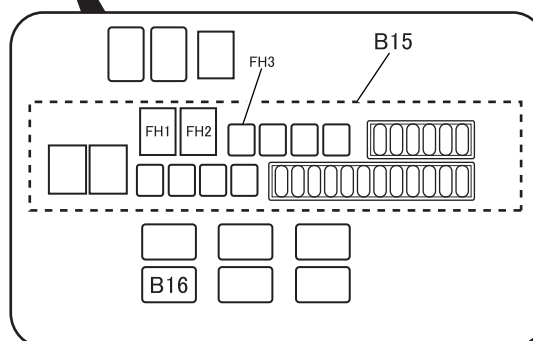
B01 to 27

- B01 Hydraulic unit (ECU)
- B02 Exhaust shutter 2-way magnetic valve
- B03 Air flow sensor
- B04 Throttle EDU
- B05 EGR EDU
- B06 Catalytic temperature sensor
- B07 DPF temperature sensor 1
- B08 DPF absolute pressure sensor
- B09 DPF temperature sensor 2
- B10 DPF pressure sensor (DIFF)
- B11 Ground
- B12 Battery
- B13 Ground
- B14 High-current fuse box
- B15 High-current fuse, fuse
- B16 EDU relay
- B17 Glow ECU <FE83>

- B18 Intake air temperature sensor
- B19 Connection of chassis harness and engine harness
- B20 Connection of cab harness and engine harness
- B21 Connection of chassis harness and cab harness  
<In connector box>
- B22 Ground
- B23 Ground
- B24 Ground
- B25 Ground
- B26 Ground
- B27 Ground

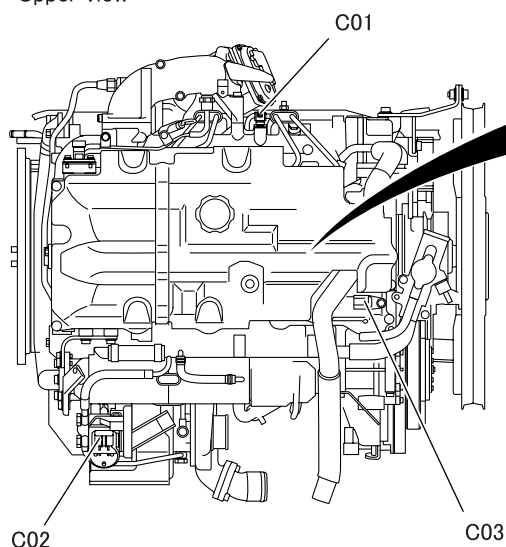
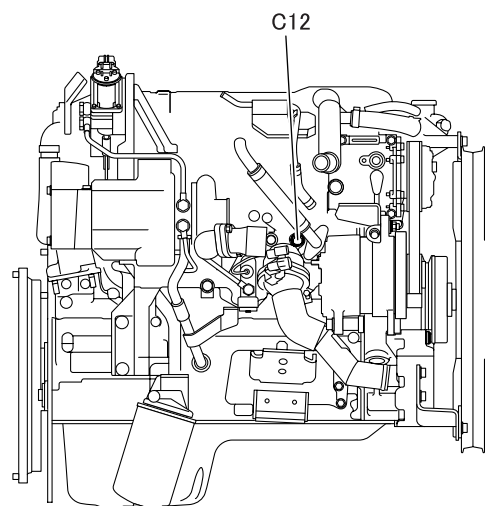
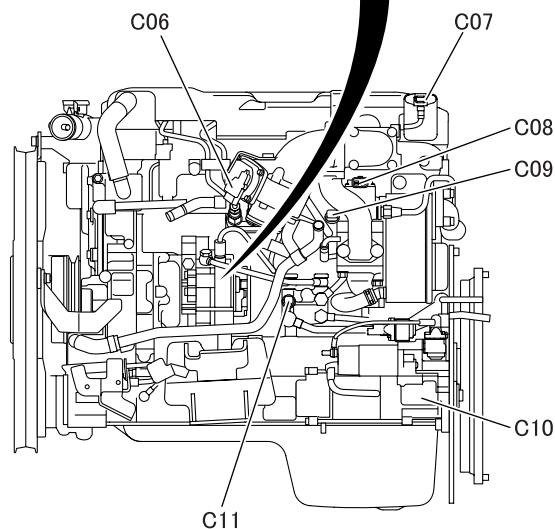
## C01 to 12

Upper view

Right side view

Left side view

- C01 Boost air temperature sensor
- C02 Turbocharger actuator
- C03 Cylinder recognition sensor
- C04 Injector magnetic valve
- C05 MPROP (Rail pressure control valve)
- C06 Throttle actuator (Building into motor, position sensor)
- C07 Boost pressure sensor
- C08 EGR valve (Building into motor, position sensor)
- C09 Common rail pressure sensor
- C10 Starter
- C11 Fuel temperature sensor
- C12 Water temperature sensor (Connects to engine ECU)
