# FE.FG

## SERVICE MANUAL 2008 Model FOREWORD

This Service Manual contains maintenance and repair methods for the Mitsubishi Fuso Truck FE. FG Series. Read this manual carefully as an aid in providing correct, efficient maintenance. Please note that the information and specifications contained within this manual may change without notice. This is due to product modifications and continued vehicle improvements that are made throughout the model years. Should you encounter any discrepancy in the information provided, please do not hesitate to contact your nearest Mitsubishi Fuso Dealer or Mitsubishi Fuso Truck of America, Inc.

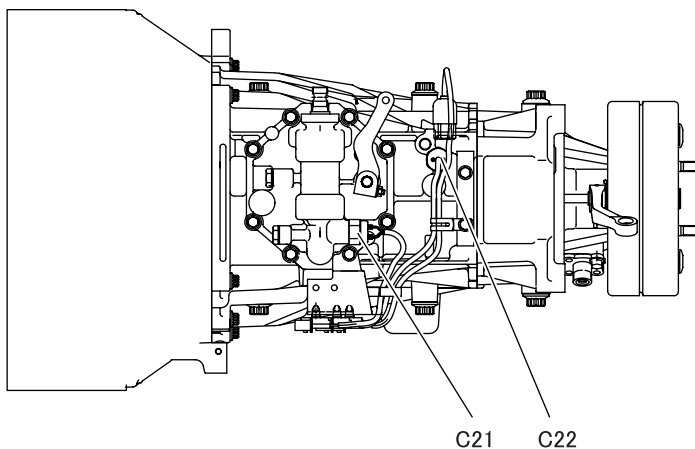
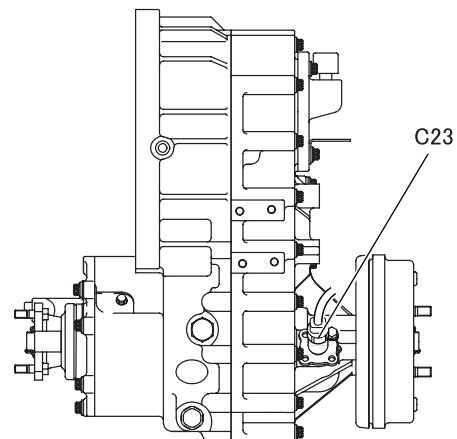
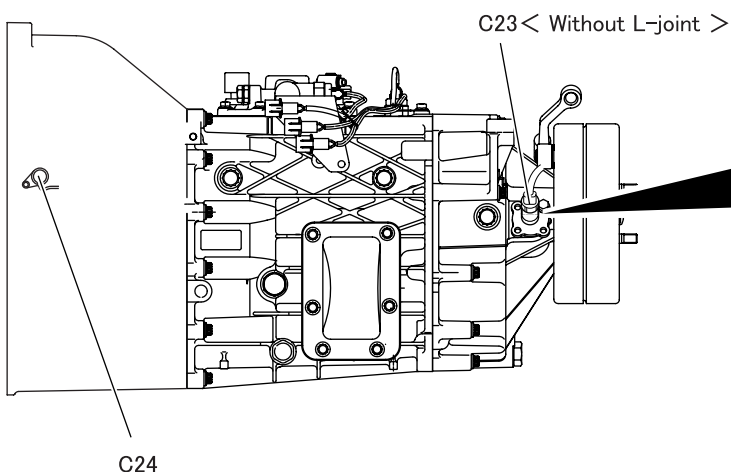
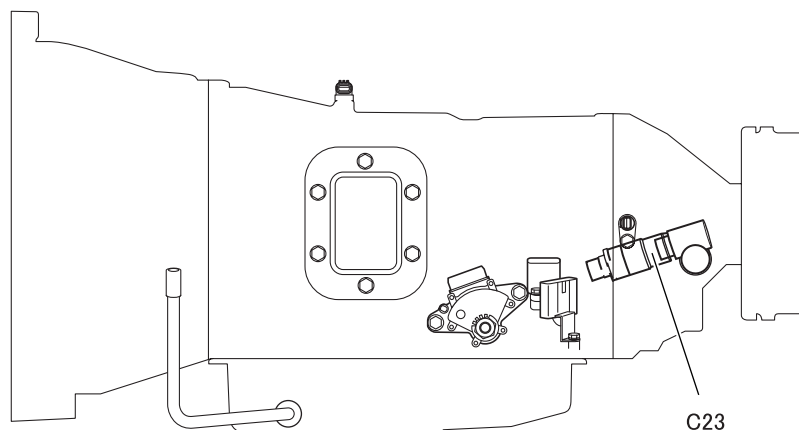
< Transfer (FG) >

- C21 Transmission neutral switch
- C22 Torque limit switch
- C23 Vehicle speed sensor
- C24 Engine speed sensor

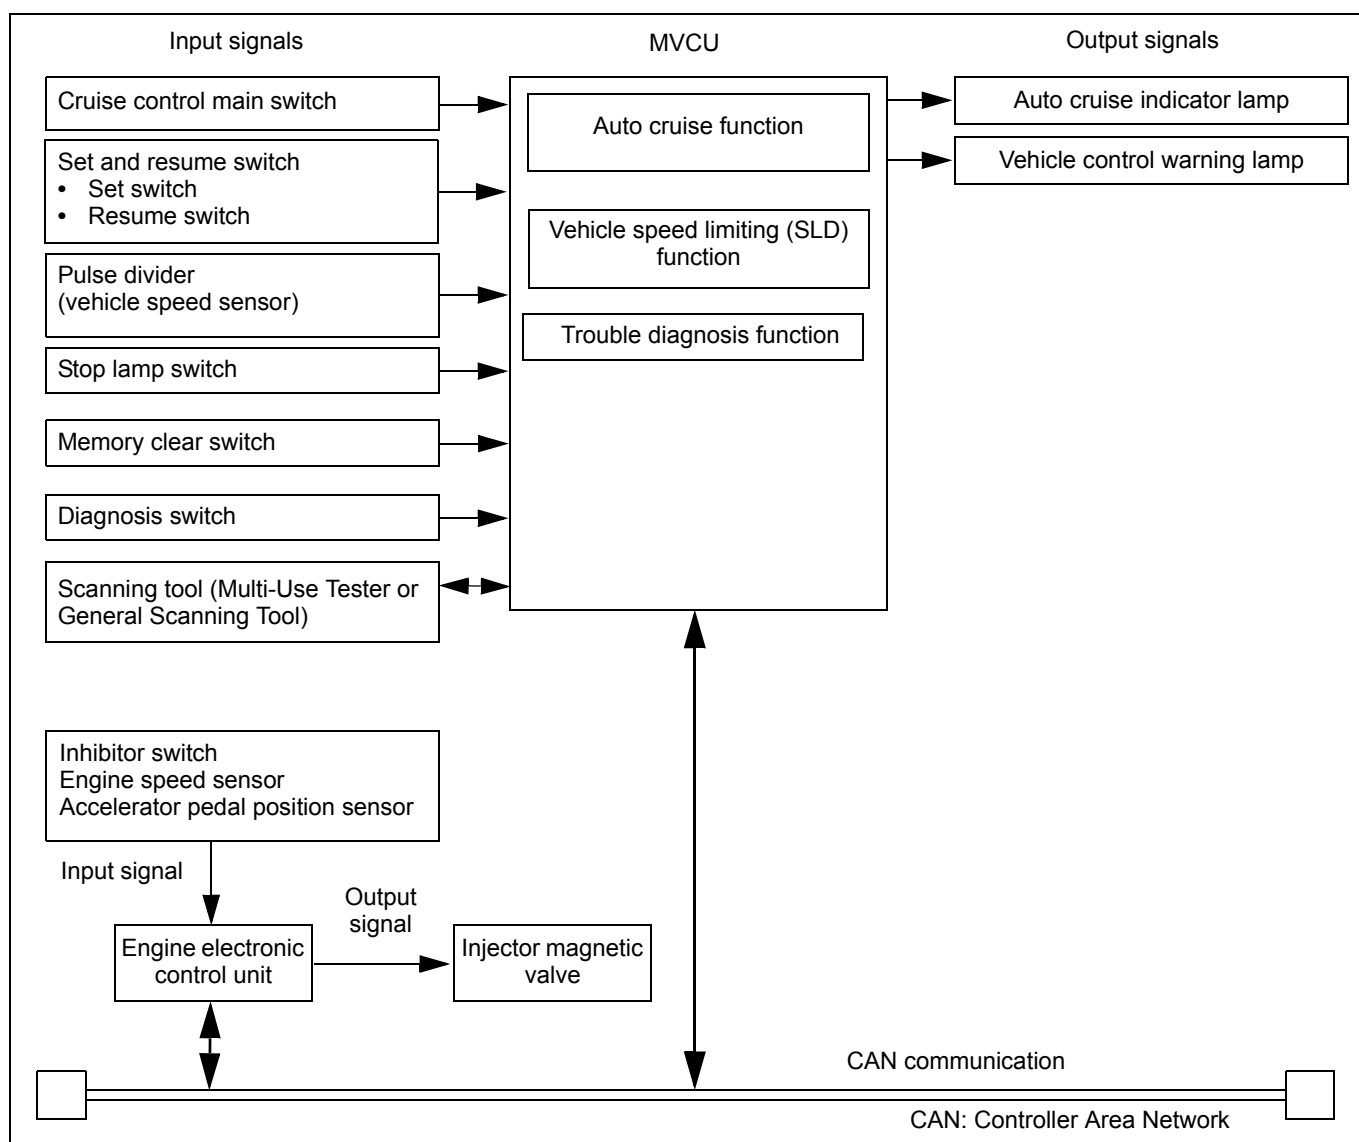
### 2.1 System block diagram

| Part name | Function/operation |

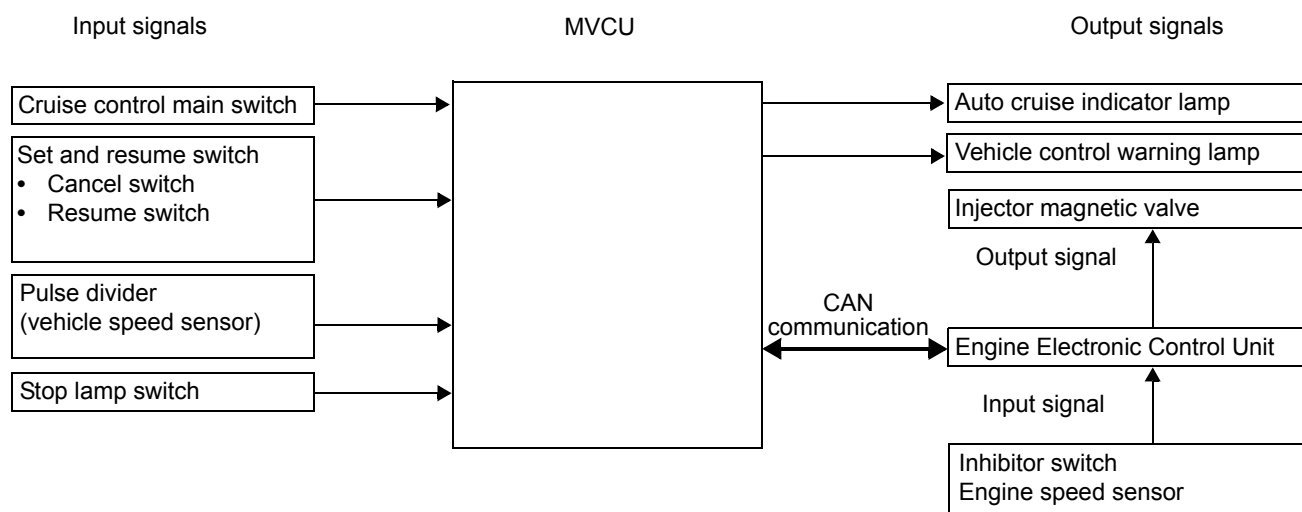
## 2.2 Auto cruise function

- In the auto cruise function, the target vehicle speed is set using the main switch, set switch and resume switch, and the MVCU maintains the set speed by controlling the engine.

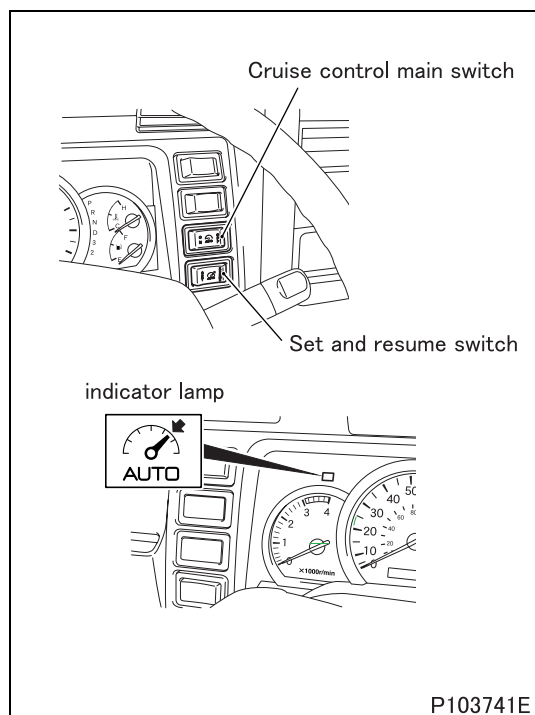
## (1) Setting the auto cruise function

- The operation of the auto cruise function using the set and resume switch is as follows:

- To activate the auto cruise function, the following conditions should be met:
  - Shift lever is in 4th or higher gear position.
  - Vehicle speed is increased to approx. 40 km/h {25 MPH} or higher.
  - The cruise control main switch is in ON position.
  - The brake pedals are released.

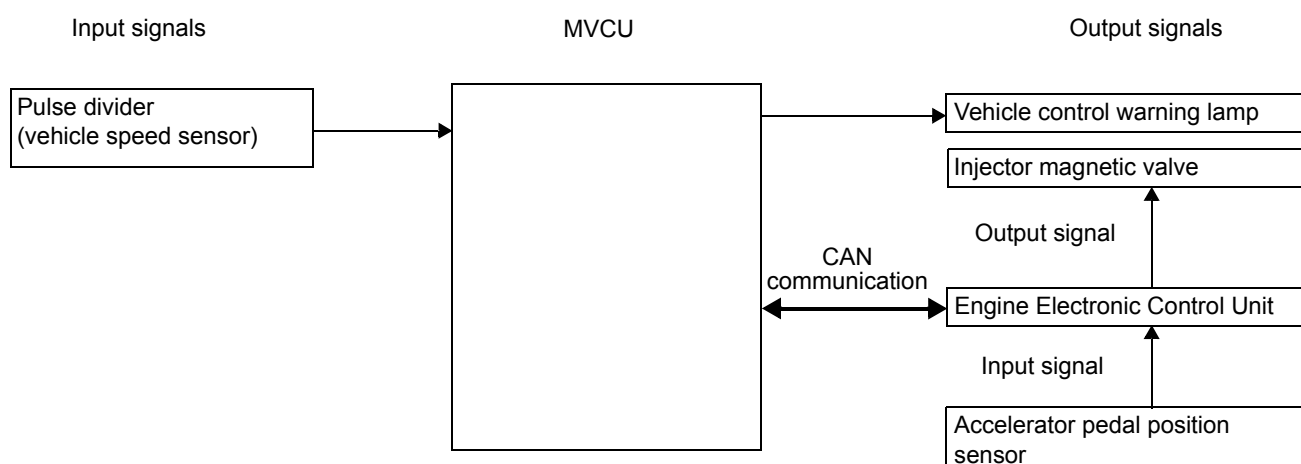
## 2.3 Vehicle speed limiting (SLD) function

- The vehicle speed limiting (SLD) function is designed to send output signals to the engine ECU to restrict the maximum vehicle speed to a preset speed limit regardless of the accelerator pedal operation when the vehicle speed reaches the speed limit on flat or uphill road.

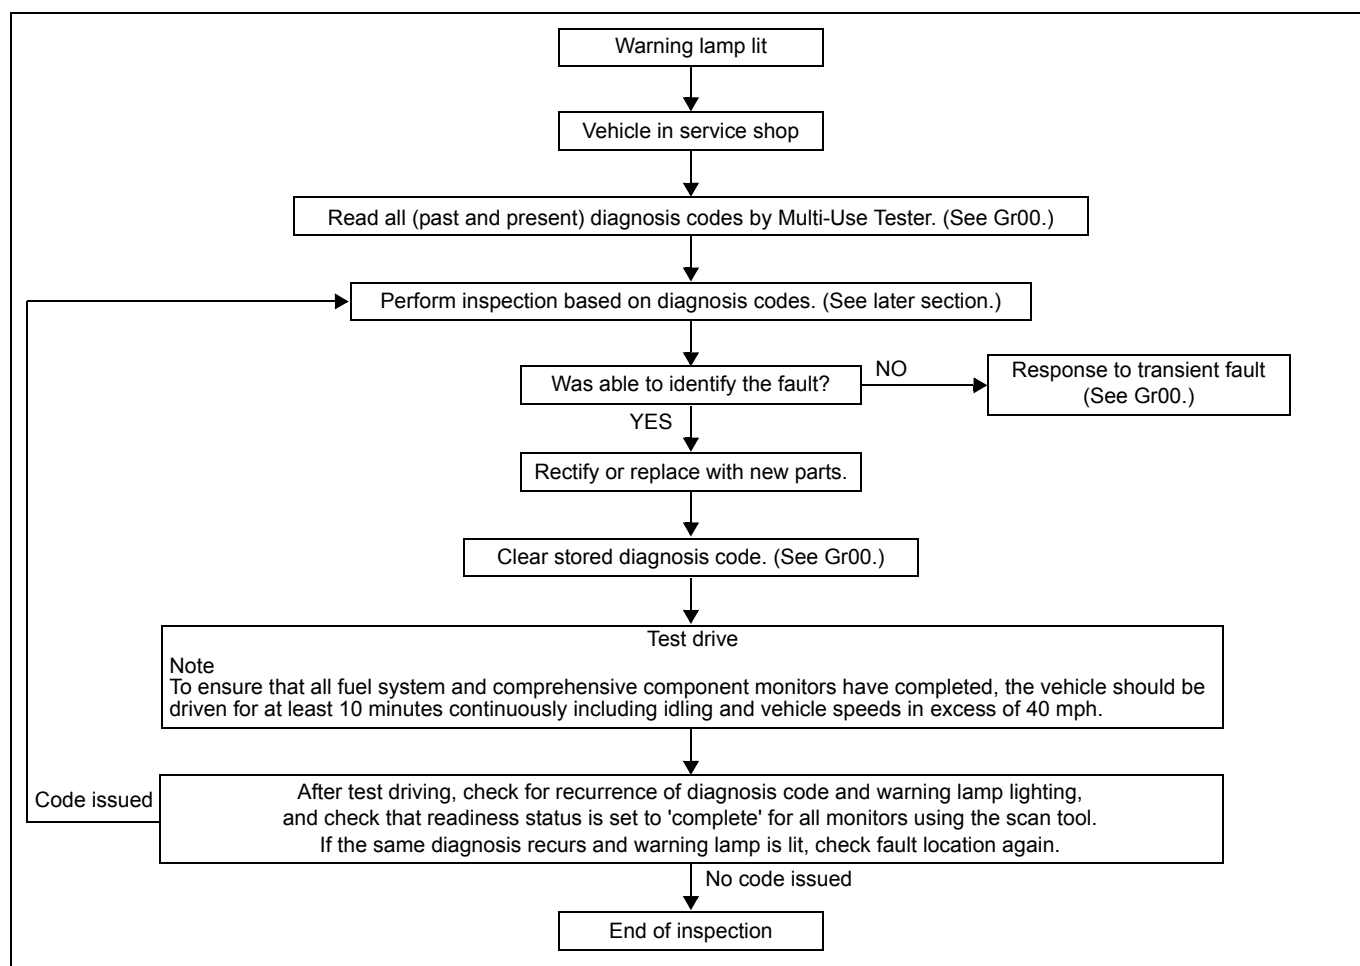
## 1. Diagnosis Procedure

- Perform the inspection in accordance with the following flowchart.

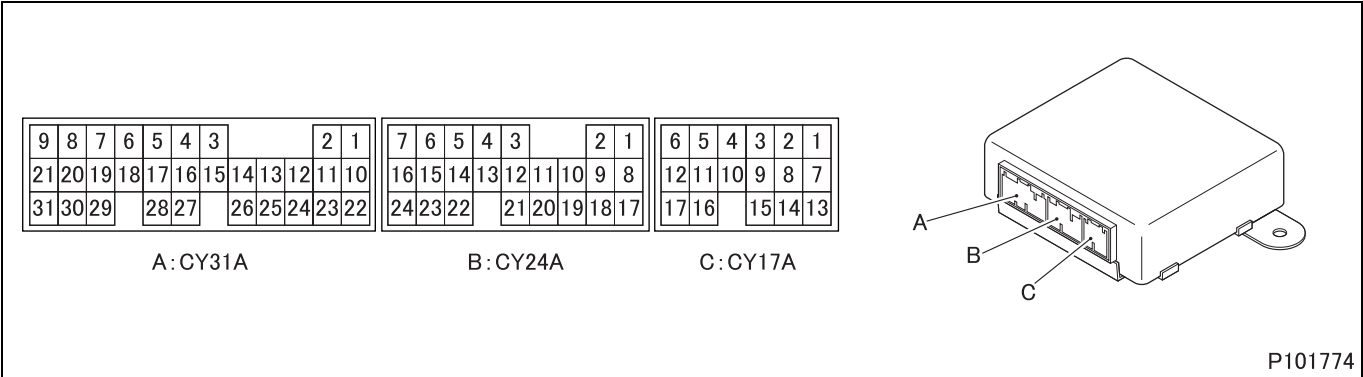
### 7.1 Electronic control unit connector terminal arrangement

- These inspections aid troubleshooting by enabling you to check whether electronic control unit signals are being correctly transmitted via the vehicle harness and connectors.  
The white-on-black numbers (**01**, **02** and so on) correspond to the similarly printed reference numbers in section “3. Inspection Based on Diagnosis Codes”.

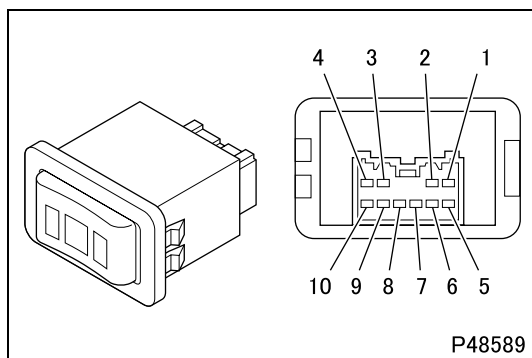
## #007 Cruise control main switch inspection

- Replace the switch if found abnormality.

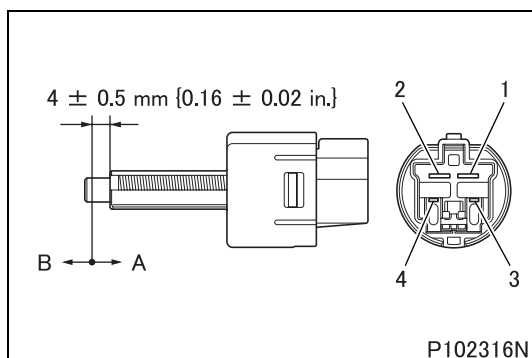
## #042 Stop lamp switch

- Replace the switch if found abnormality.

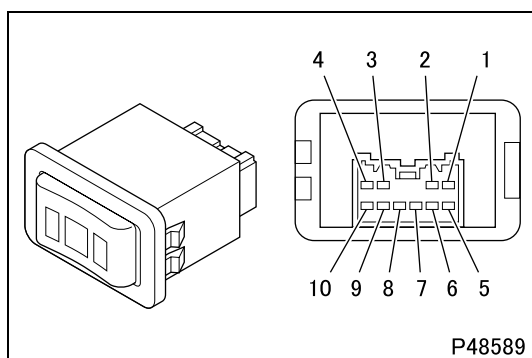
## #099 Set and resume switch inspection

- Replace the switch if found abnormality.

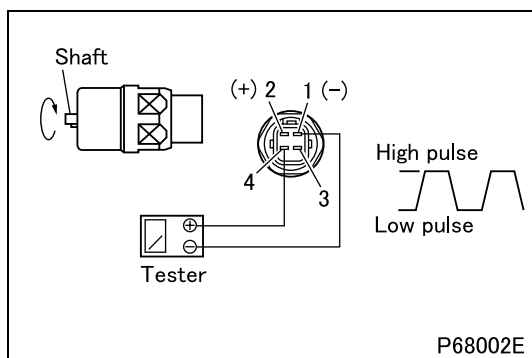
## #265 Vehicle speed sensor inspection

- Slowly rotate the shaft of the vehicle speed sensor with battery voltage applied between terminals 1 and 2 of the sensor.
- Measure maximum voltage (high pulse voltage) and minimum voltage (low pulse voltage) appearing between terminals 1 and 4 of the sensor.

- If the measurements deviate from the specified standard values, replace the sensor.

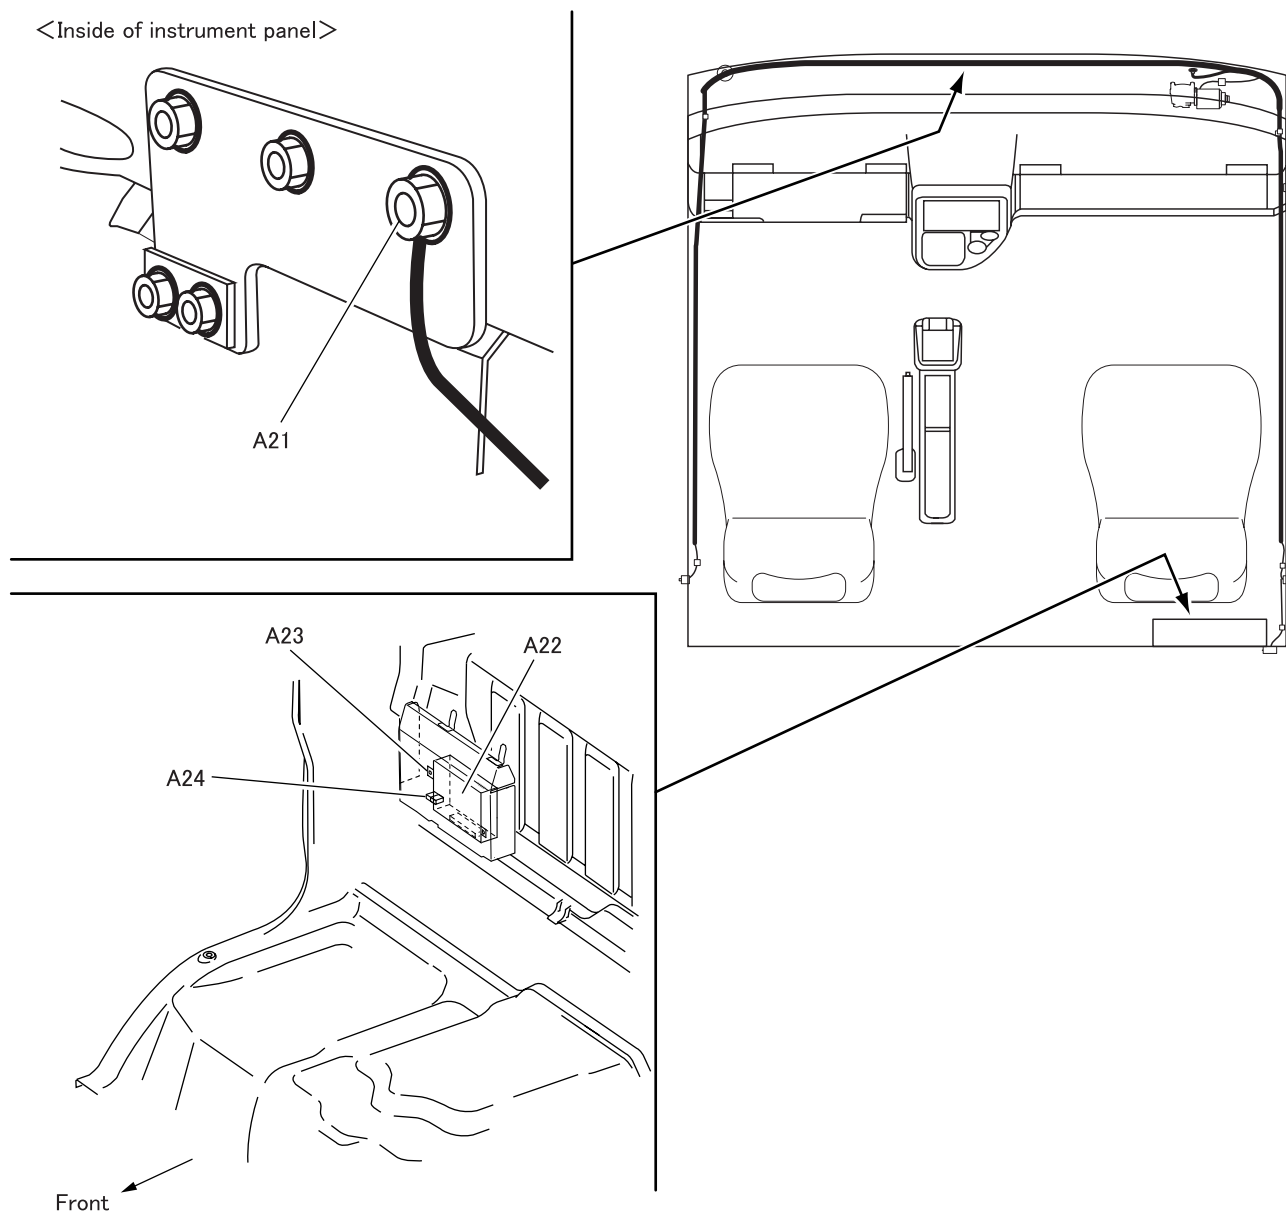
## A21 to 24

- A21 Ground
- A22 MVCU
- A23 Ground
- A24 Resistor unit

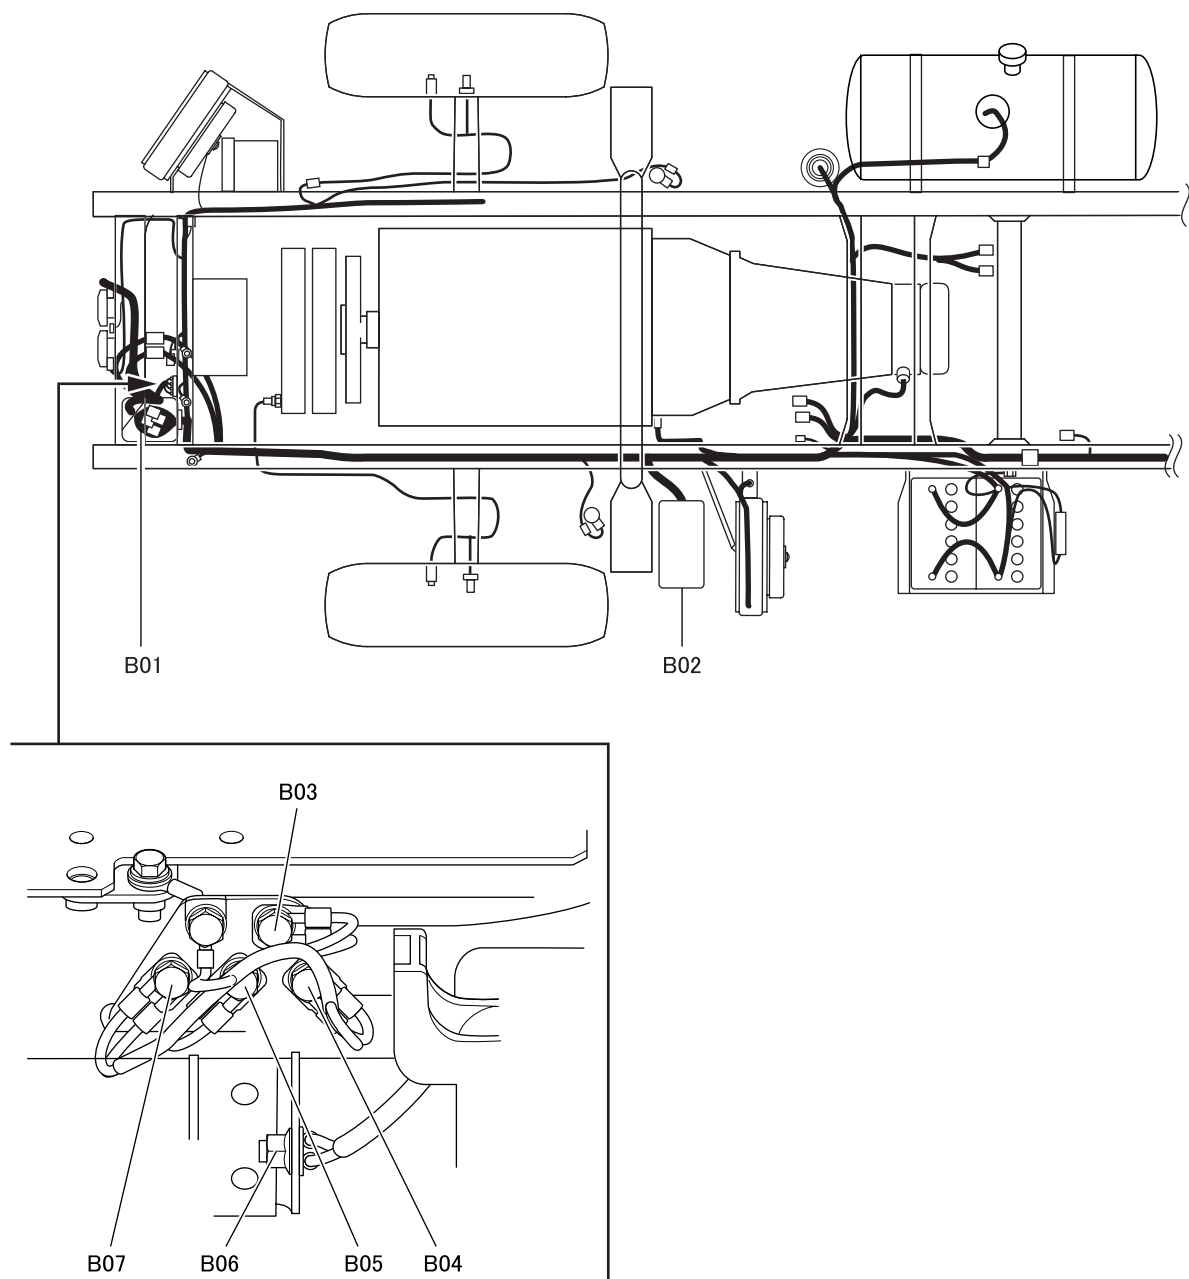
B01 to 07

- B01 Connection of chassis harness and cab harness <In connector box>
- B02 High-current fuse box
- B03 Ground
- B04 Ground
- B05 Ground
- B06 Ground
- B07 Ground

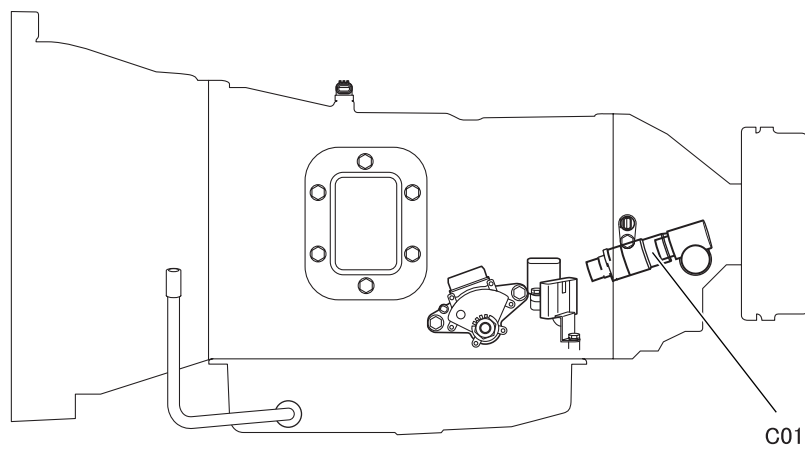
C01 Vehicle speed sensor

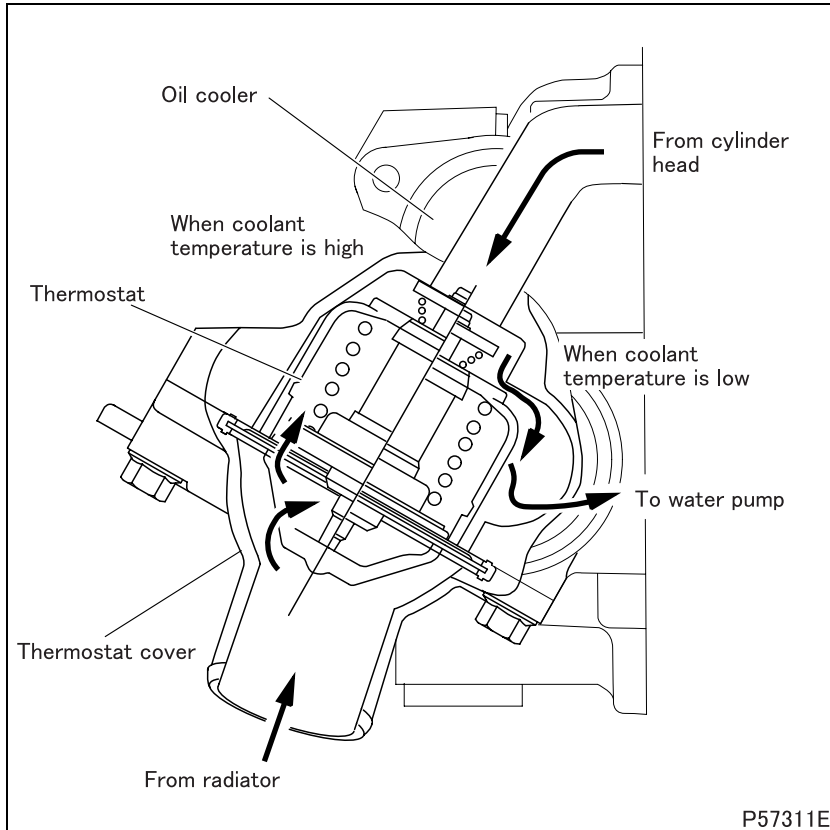
## 2. Thermostat

- It is a bottom bypass type that uses a wax-filled pellet as its flow-regulating element. When the wax is heated, it melts from solid to liquid, changing its total volume. This allows the valve to open or close in accordance with the coolant temperature, regulating and adjusting the flow of coolant to the radiator and to the cylinder head (bypassing the radiator).

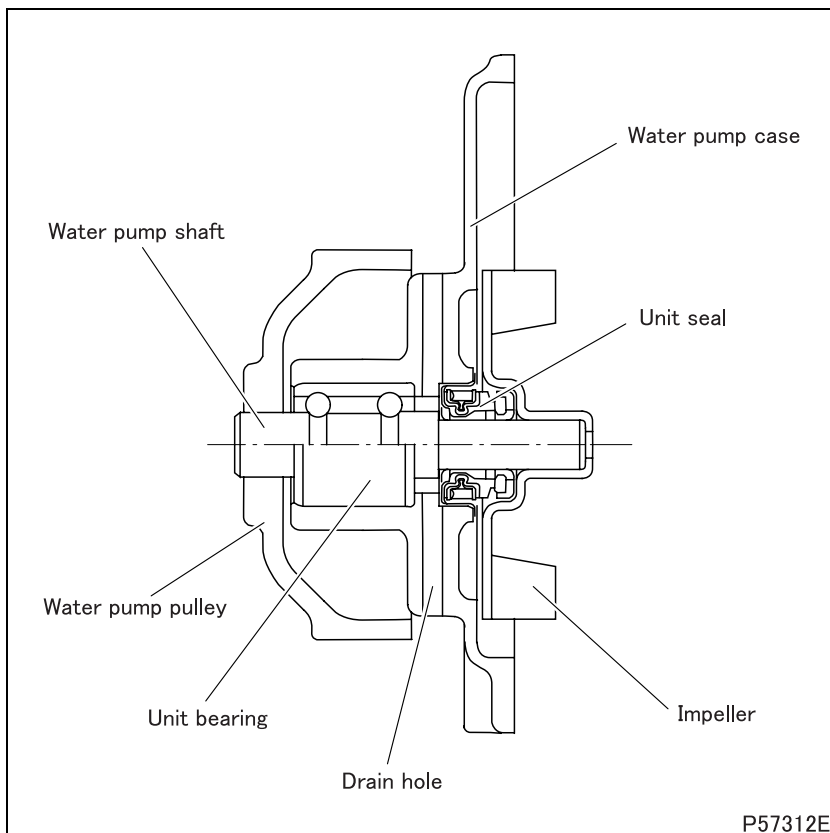
## 3. Water Pump

- The water pump has a drain hole to prevent coolant from entering the unit bearing in the case of defect of the unit seal.

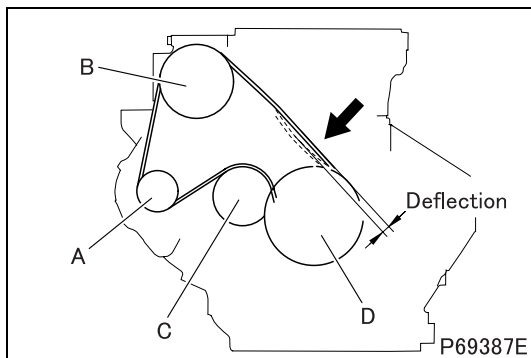
#### 1.1 Measurement by belt tension gauge

- Press each belt at a central portion between pulleys with a force of approximately 98 N {72 lbs, 10 kgf} as shown in the illustration and measure the amount of deflection of the belt.

A: Alternator pulley  
B: Air conditioner compressor pulley  
C: Water pump pulley  
D: Fan pulley

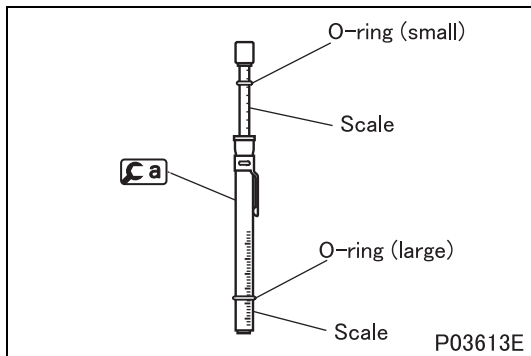
- Place the small O-ring on **Ca** at the scale mark corresponding to 98 N {72 lbs, 10 kgf} (press force).
- Place the large O-ring on **Ca** at the scale mark corresponding to the maximum permissible deflection value specified for the belt.

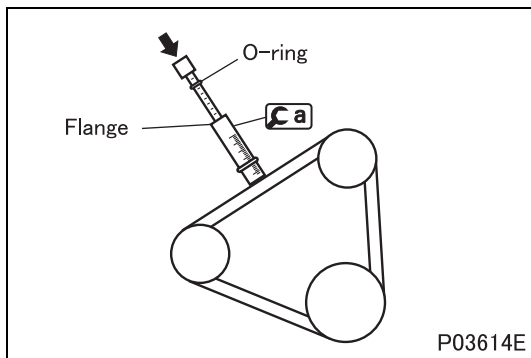
- Place **Ca** at a central portion between pulleys of the belt and push the handle (indicated by the arrow in the illustration) until the O-ring touches the flange.

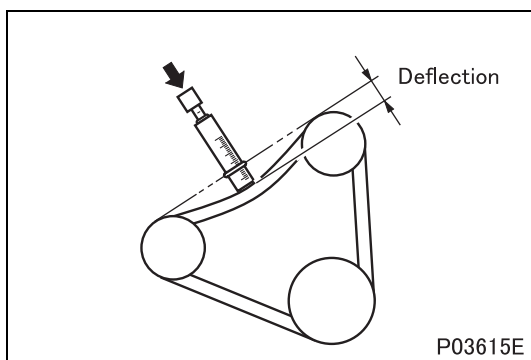
- Measure the amount of deflection of the belt.
- If the measured value deviates from the standard value range, adjust the tension of the belt as follows.

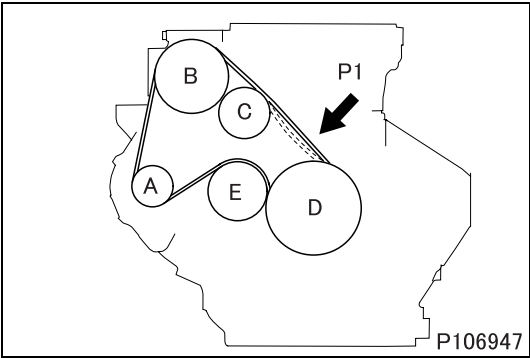
## 1.2 Measurement using sonic belt tension gauge

- Direct the sensor microphone of **[C b]** to the position shown in the drawing and measure the belt tension.
  - A: Alternator pulley
  - B: Compressor pulley (air conditioner)
  - C: Tension pulley
  - D: Fan pulley
  - E: Water pump pulley
  - P1: Measuring point on the belt

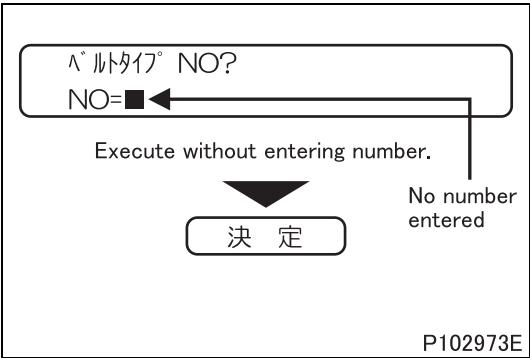
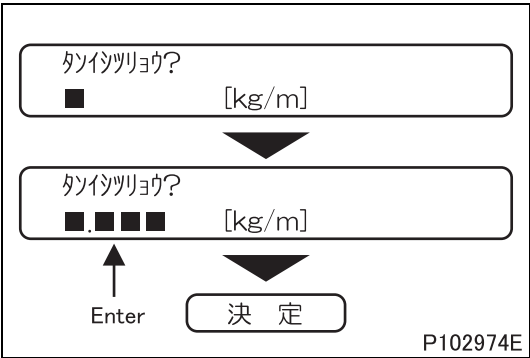
- Turn on **[C b]** and set the sensitivity of its sensor microphone.
  - ON (低: means "low"): Measuring in noisy environment, or outdoors in heavy wind
  - ON (高: means "high"): Measuring in silent environment, or measuring a hard-to-vibrate belt

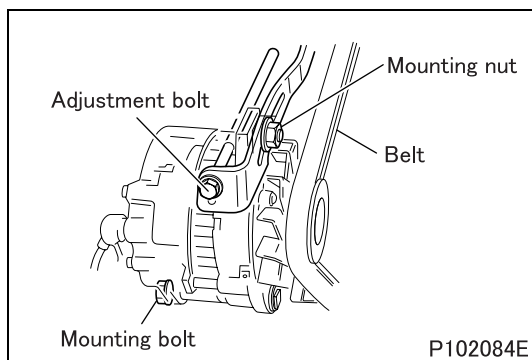
### (1) Vehicles with air conditioner

- Loosen the alternator mounting nuts (2 locations) and adjust the tension of the belt by tightening or loosening the adjustment bolt.
- After the adjustment is completed, retighten the mounting nuts firmly.

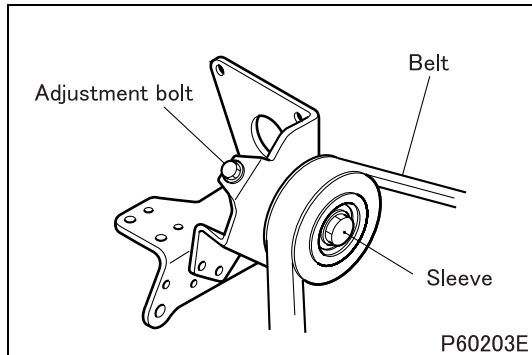
### (2) Vehicles without air conditioner

- Loosen the tension pulley mounting sleeve and turn in or out the adjustment bolt to adjust the tension of the belt.
- After the adjustment is completed, retighten the mounting sleeve firmly.

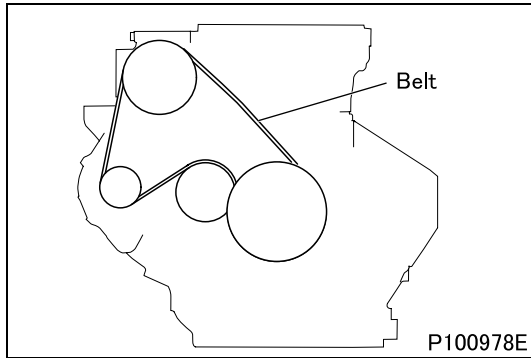
## 2. Inspection of Cracks or Damage of the Belt

- Visually check the belts for possible cracks and damage.
- If any faults are found, replace the belts.

| Belt condition | Remaining service life (reference) |

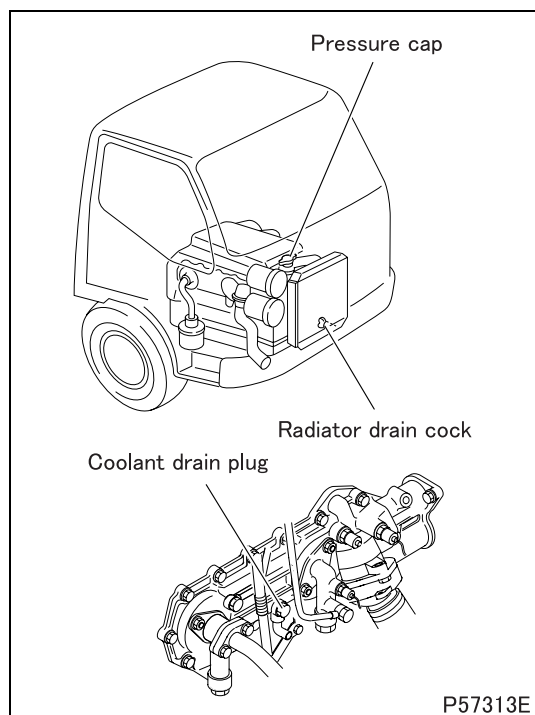
### 3.1 Draining of coolant

- Before draining the coolant, loosen the pressure cap to reduce the pressure in the cooling system. Remember to drain the coolant out of the reservoir tank as well.

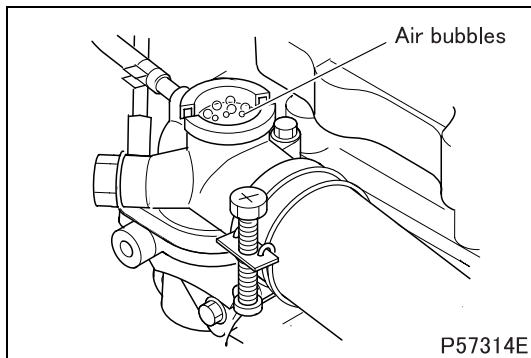
- Run the engine until the coolant temperature rises to approximately 90°C {195°F}.
- If air bubbles appear continuously through the filler port, there is air or exhaust gas penetrating into the cooling system.
- Presence of air in coolant can be an indication of loose cylinder head bolts, loose water pump mounting bolts, loose hose connections, and/or a damaged hose.
- Presence of exhaust gas in coolant can be an indication of a damaged cylinder head gasket and/or cracks in the cylinder head.

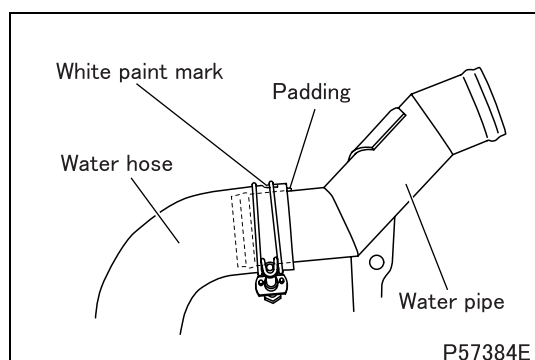
### ■ Installation: Water hose

- Install the water hose with the white mark on its end aligned with the padding on the water pipe.

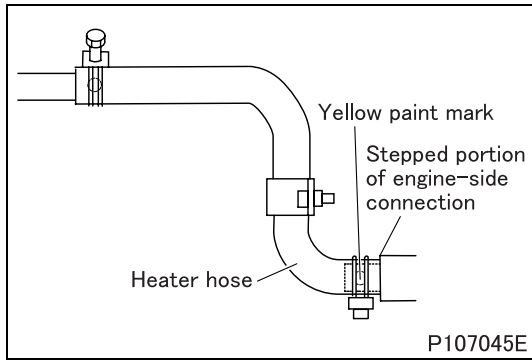
#### ■ Installation: Heater hose

- To install the heater hose with a yellow paint mark to the engine-side connection, slide the hose over the connection until it seats to the stepped portion.

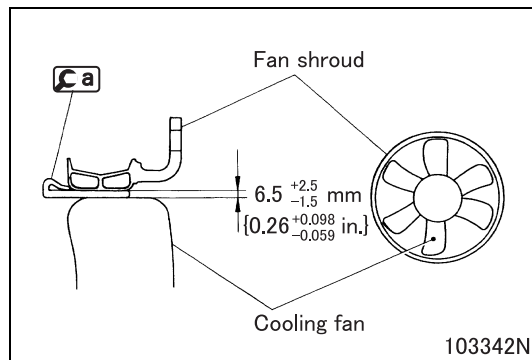
**■ Installation: Fan shroud**

- Using **Ca**, adjust the clearance between the fan shroud and cooling fan blades to the dimension shown in the illustration.

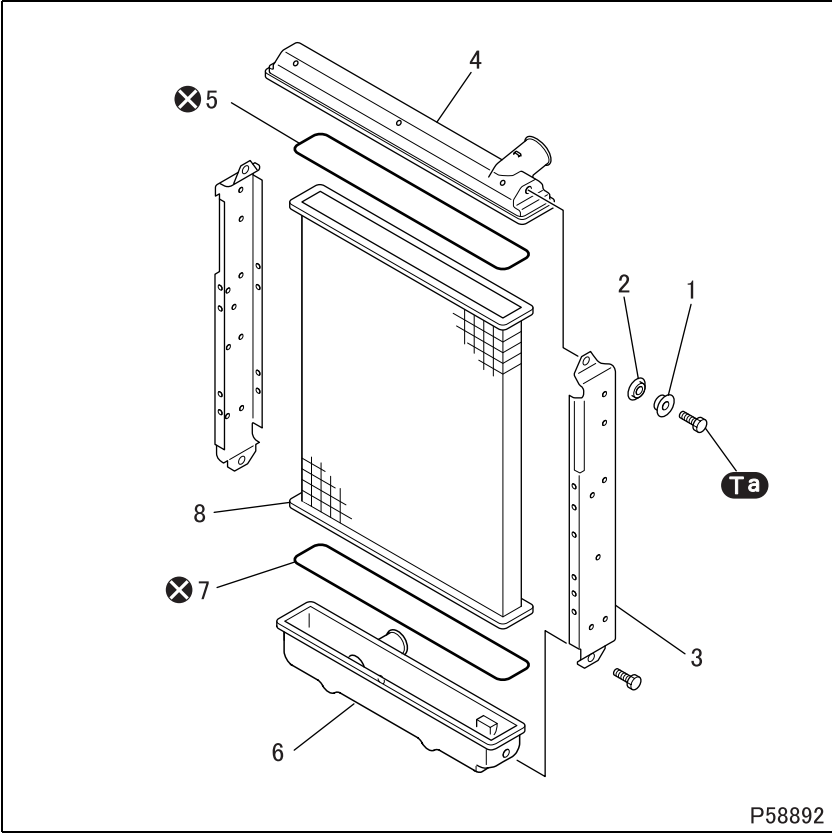
### ● Disassembly sequence

- 1 Pipe
- 2 Bush
- 3 Side member
- 4 Upper tank
- 5 Packing
- 6 Lower tank
- 7 Packing
- 8 Core

- Do not disassemble the radiator unless defects are evident.
- Handle the upper tank and lower tank carefully, as they are made of plastic and may crack under impact.
- Check the number of paint marks put near the upper tank and lower tank mounting tabs. The number of paint marks corresponds to the number of times the tabs have been unbent and re-clinched. If the core has already two paint marks, replace it with a new one.

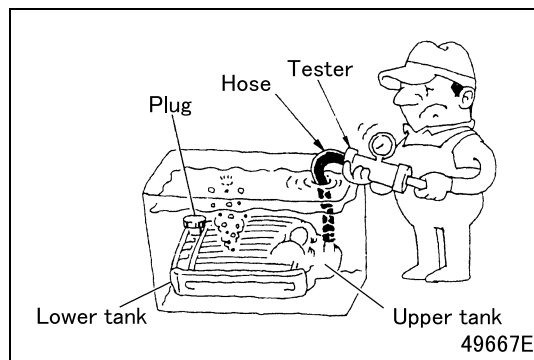
#### ■ Inspection: Radiator air leakage

- Connect a hose and radiator cap tester to the upper tank.
- Plug the lower tank and put the entire radiator into a tank filled with water.
- If air leakage is found, repair or replace the radiator.
- Apply a specified air pressure using radiator cap tester, and check for any air leakage.

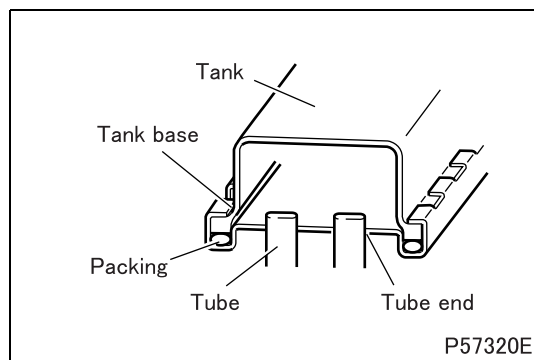
- Replace the following parts according to the area of leakage.

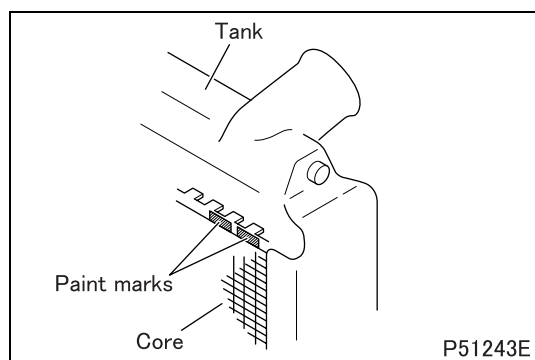
- The core may have paint marks that indicate the number of times the upper tank and lower tank mounting tabs have been unbent and re-clinched. Replace the core if it has already two paint marks.
- One paint mark is made every time the tabs are unbent and re-clinched. Upper tank paint marks should be counted separately from lower tank paint marks.

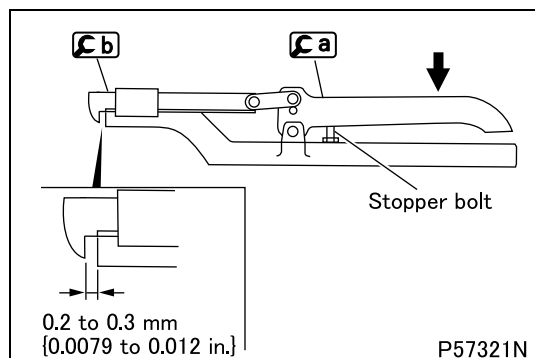
## ■ Removal: Upper tank and lower tank

- Attach **Cb** onto **Ca**.
- Using the stopper bolt on **Ca**, adjust the jaw span of **Cb** to the dimension indicated in the illustration.

- Make sure to adjust the stopper bolt before using the tools. Failure to do so may cause damage to **Cb**.

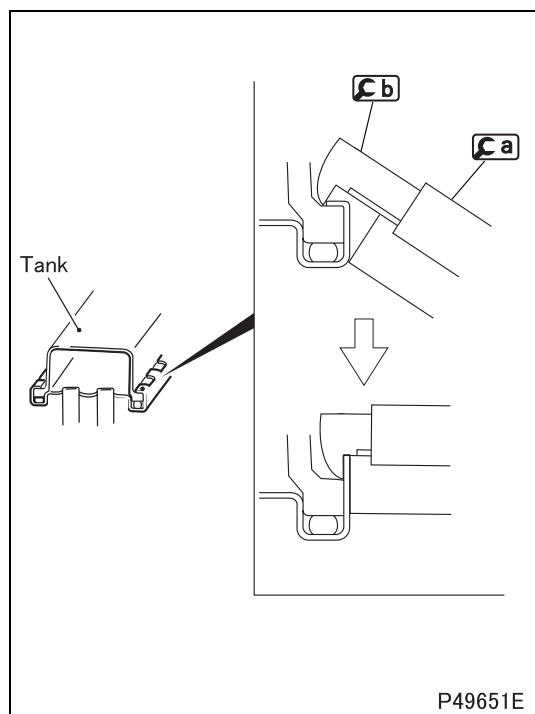
- Using **Cb**, undo the tabs that are holding the tank in place.
- Once each tab is unbent, grip **Ca** more tightly to straighten it out completely.
- Undo all the tabs on the entire periphery of the tank, then remove the tank using the inlet hose fitting as a grip.

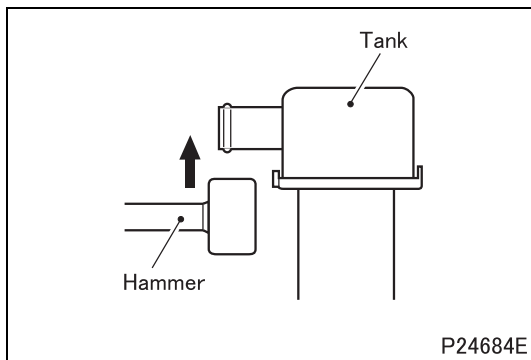
- If the tank does not come off easily, tap it lightly with a soft-face hammer (rubber or plastic hammer) to loosen it.

- Handle the tanks carefully, as they are made of plastic and may crack easily under impact.

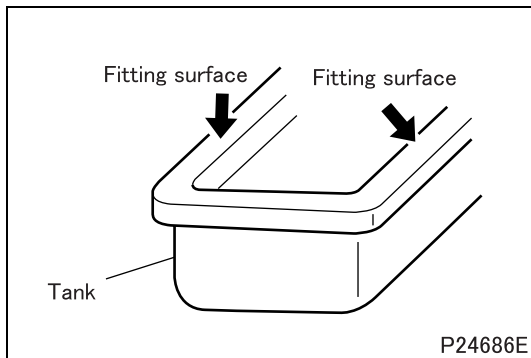
#### ■ Inspection: Core fitting surfaces of tank

- Inspect the core fitting surfaces of the tank for any dirt or damage. If necessary, clean them thoroughly.
- Replace the tank(s) if defective.

- Carry out the inspection with your bare hands to avoid putting foreign matter on the fitting surfaces.

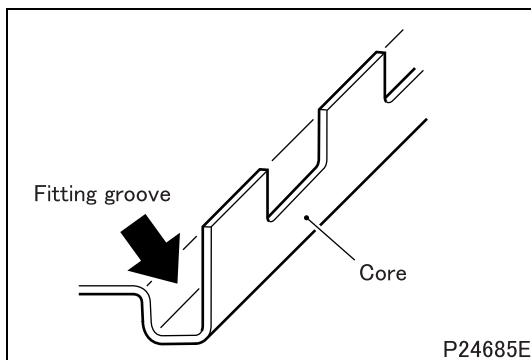
#### ■ Inspection: Tank fitting groove of core

- Check the tank fitting groove of the core for any foreign matter or cracks.
- If foreign matter is found on the groove surfaces, lightly scrub it off with a No.1000 sandpaper taking care not to damage the surfaces, or blow it off with compressed air.
- If a crack is found on the groove surfaces, repair the crack or replace the core.

- Installing a packing and tank on the core without removing foreign matter from the groove surfaces can lead to coolant leakage. Make sure to inspect the entire groove surfaces extremely carefully. Even one strand of hair is enough to cause leakage.

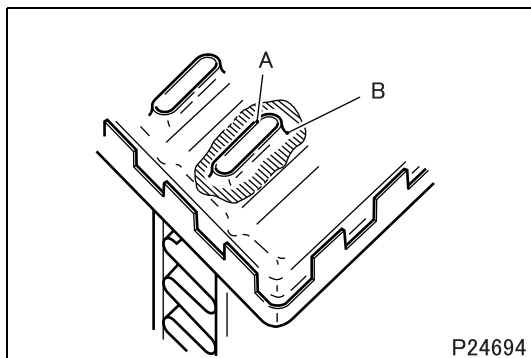
#### Repair of core

- Scrub both ends A of a leaky tube as well as the surrounding areas B of each end with a stainless wire brush. Continue scrubbing until the aluminum layer becomes exposed.

- The following core repair procedure involves tungsten inert gas arc welding (TIG arc welding). Only personnel competent for doing this type of welding should carry out the job.
- Dry the core completely before performing welding. Welding wet parts could be extremely dangerous.

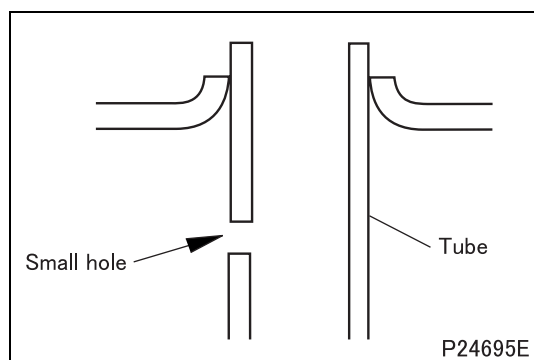
- Drill a small hole in the tube to let the air out when both ends of the tube are welded closed.

**Failure to drill an air release hole in the tube may cause pinholes to form in the welds.**

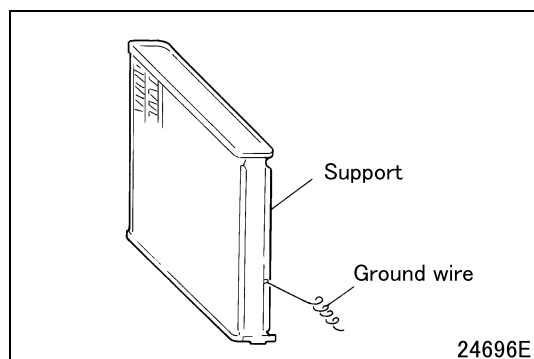
- Connect one of the support edges of the core to ground with a wire.

- **Inadequate connection of the ground wire can cause a short circuit to a part of the core, which may cause the part to melt.**

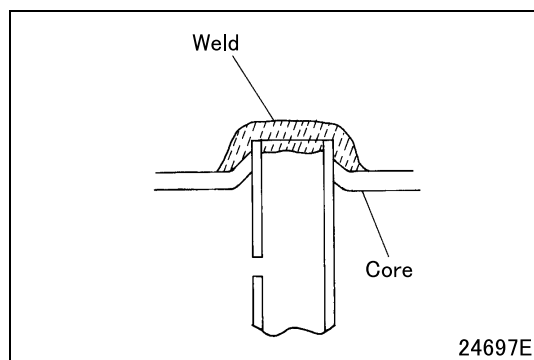
- Close both ends of the tube by TIG arc welding.  
Welding conditions
  - Welding rod: A4043  
(diameter approximately 2 mm { $\phi 0.079$  in.})
  - Welding current: AC80A
- After the welding is completed, check for the following defects. If any of these defects are spotted, repair the defect or replace the core.
  - Undercuts
  - Cracks in weld bead
  - Cracks in base metal

- **Make sure that welds are proper. Any defect in welding can lead to recurrence of leakage.**

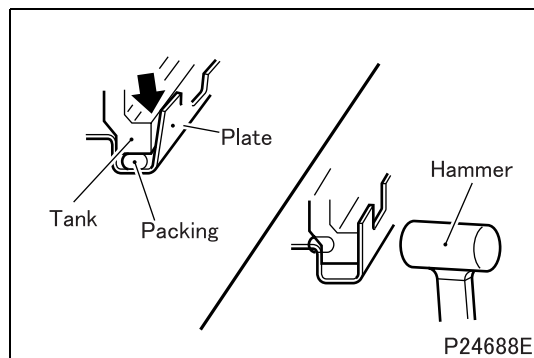
### ■ Installation: Upper tank and lower tank

- If there is a gap between the tank and core's tank holding plate when the tank is placed in position, lightly tap the plate with a rubber or plastic hammer to eliminate the gap.

- **When installing the tank and packing, use your bare hands to avoid putting foreign matter on the parts.**

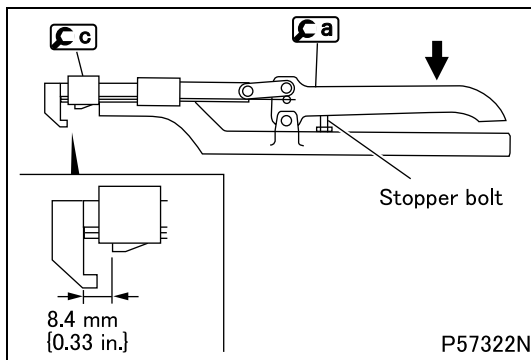
- Attach **c** onto **a**.
- Using the stopper bolt on **a**, adjust the jaw span of **c** to the dimension indicated in the illustration.

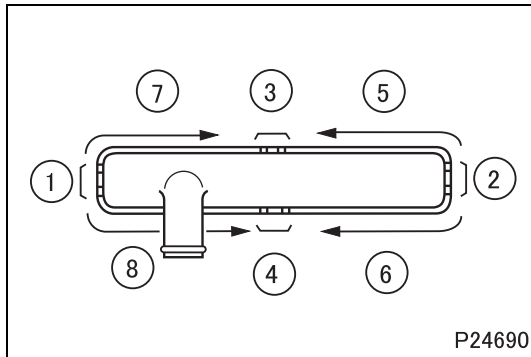
- Bend and clinch the tabs of the core over the brim of the tank in the sequence indicated in the illustration.  
1 to 4: Clinch the two tabs at the center on each side of the tank.  
5 to 8: Clinch the rest of the tabs in the order indicated by the arrows.

- The tabs on sides 1 and 2 cannot be clinched using **c**. Use a pair of pliers with the noses wrapped with vinyl tape to clinch these tabs.

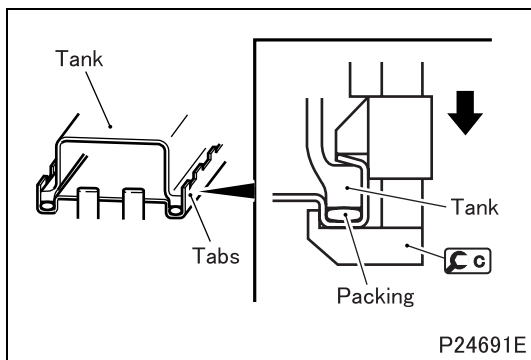
- After clinching all the tabs, check for leakage.

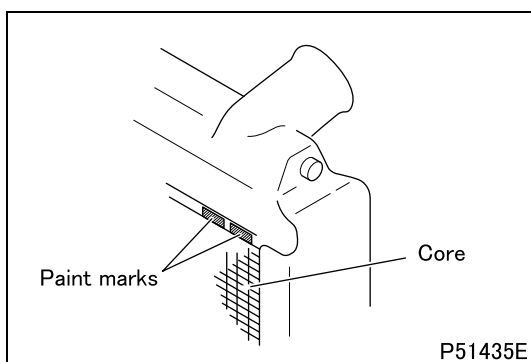
- Put a paint mark on a clearly visible area of the core to indicate the number of times the tabs have been unbent and re-clinched.

- One paint mark should be made for each of the upper and lower tanks every time the tabs for it are unbent and re-clinched.

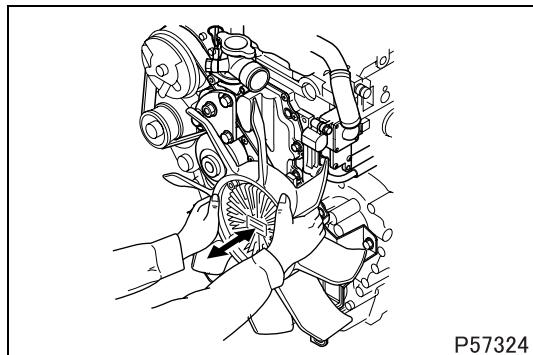
#### ■ Inspection: Automatic cooling fan coupling

- Make an inspection of the following points. Replace the automatic cooling fan coupling if defective.

- the hydraulic oil sealed inside the coupling is not leaking;
- the coupling does not make any abnormal noise or rotate unevenly due to defects in the inside bearing when rotated manually; and
- the automatic cooling fan coupling does not move too much when pushed and pulled in the axial directions when the engine is cold.
