# FE.FG

## SERVICE MANUAL 2008 Model FOREWORD

This Service Manual contains maintenance and repair methods for the Mitsubishi Fuso Truck FE. FG Series. Read this manual carefully as an aid in providing correct, efficient maintenance. Please note that the information and specifications contained within this manual may change without notice. This is due to product modifications and continued vehicle improvements that are made throughout the model years. Should you encounter any discrepancy in the information provided, please do not hesitate to contact your nearest Mitsubishi Fuso Dealer or Mitsubishi Fuso Truck of America, Inc.

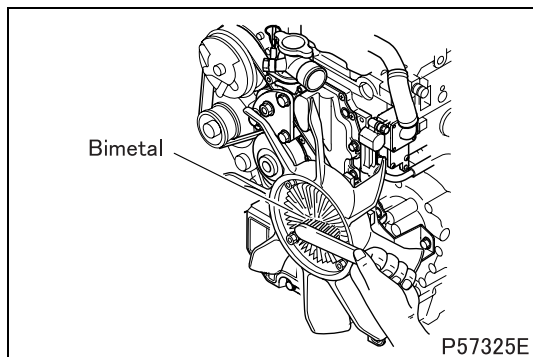
#### ■ Cleaning: Automatic cooling fan coupling

- When removing foreign matter from the bimetal, be careful not to press too hard against the bimetal.

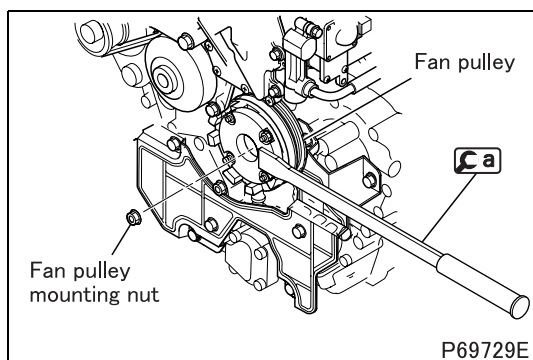
### ■ Installation: Fan pulley

- Put **Ca** in position on the studs of the fan pulley and fix the tool by using nuts.
- Tighten the fan pulley mounting nut to the specified torque while holding **Ca**.

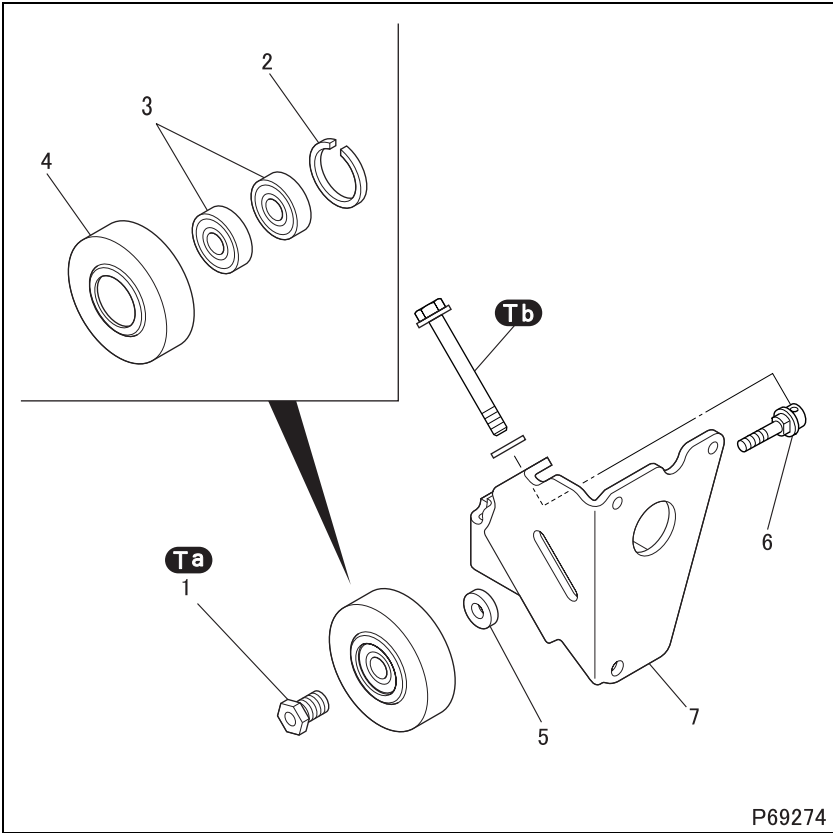
● Disassembly sequence

- 1 Sleeve
- 2 Snap ring
- 3 Bearing
- 4 Tension pulley
- 5 Spacer
- 6 Shaft
- 7 Tension pulley bracket

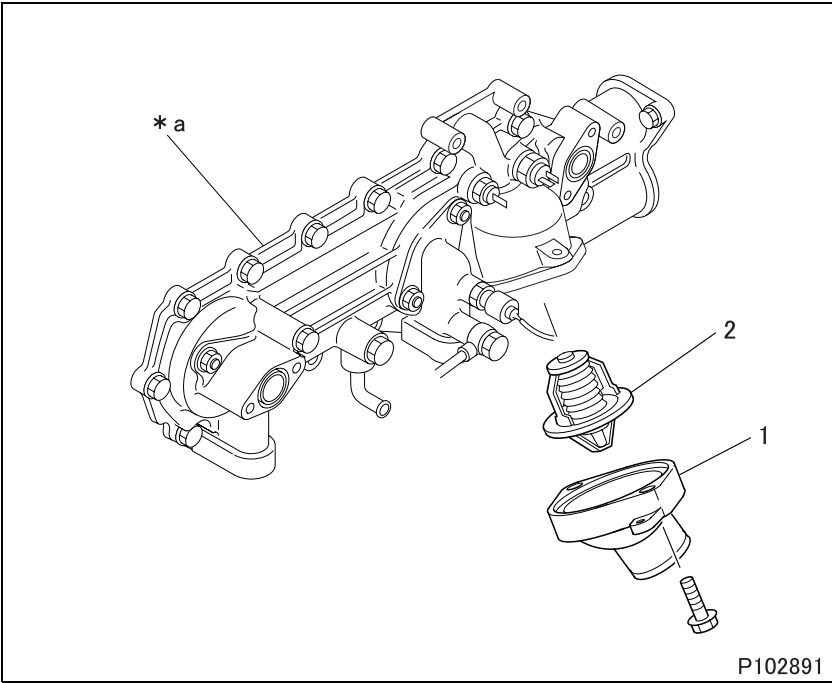
## ● Disassembly sequence

- 1 Thermostat cover
- 2 Thermostat

| Location | Maintenance item | Standard value | Limit | Remedy |
|---|---|---|---|---|
| 2 | Thermostat | Valve opening temperature | $82 \pm 2^{\circ}\text{C}$ { $180 \pm 3.6^{\circ}\text{F}$ } | Replace |
| | | Valve lift / temperature | 10 {0.39} or more / $95^{\circ}\text{C}$ { $205^{\circ}\text{F}$ } | |

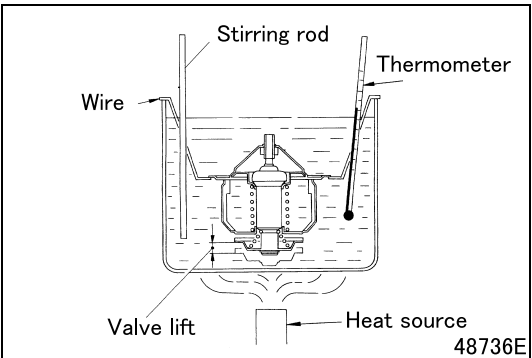
### ■ Inspection: Thermostat

- Stir the water using a stirring rod to maintain an even water temperature in the container, then conduct the tests indicated below.
- If the measured values deviate from the standard value ranges, replace the thermostat.

- Heat the water to a temperature slightly higher than the valve opening temperature. Maintain this temperature for five minutes and measure the valve lift.

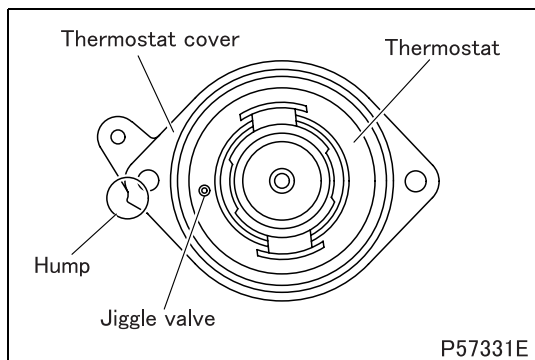
**■ Installation: Thermostat**

- Mount the thermostat on the thermostat cover in the illustrated direction.

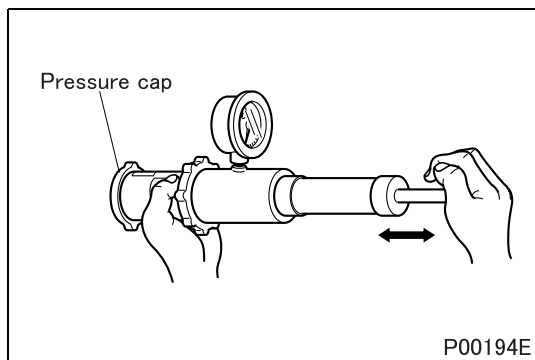
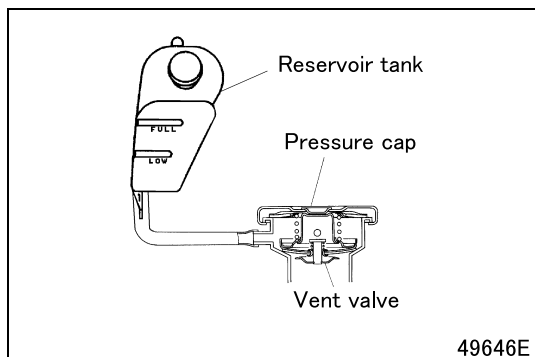
### ■ Inspection: Pressure cap

#### (1) Pressure valve opening pressure

- Replace the pressure cap if the measured value deviates from the standard value range.

- Before starting the inspection, check the level of coolant in the reservoir tank.
- Run the engine at full speed. Stop the engine when the level of coolant in the reservoir tank noticeably rises.
- Wait until the coolant temperature drops to the ambient temperature. Then, check if the coolant in the reservoir tank has returned to the same level as that confirmed before the engine was started.
- If the coolant has failed to return to its original level, the vent valve is defective. In this case, replace the pressure cap.

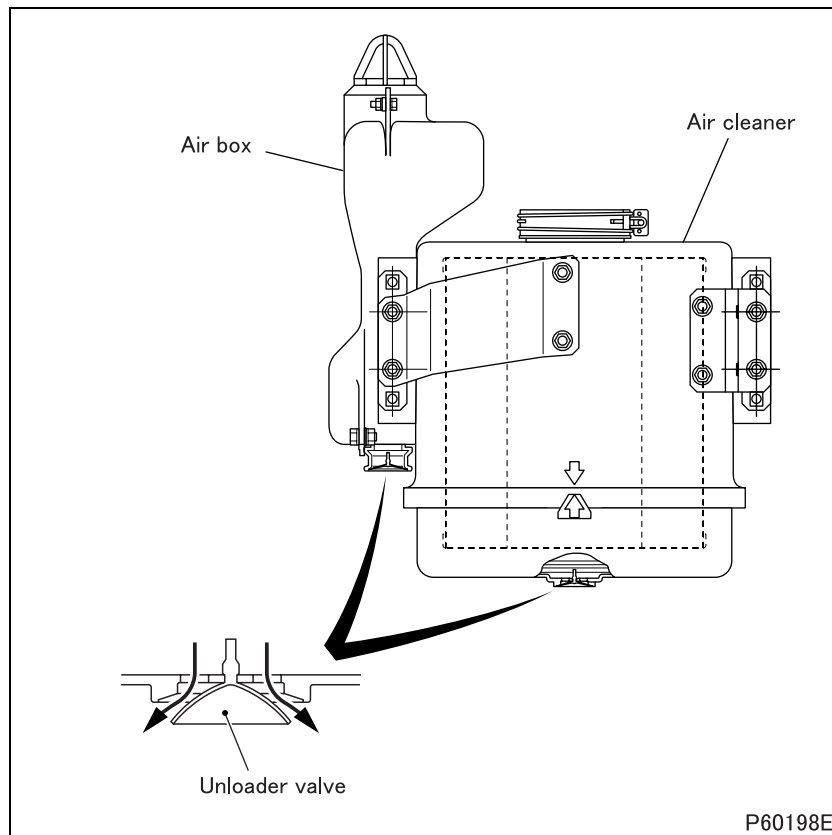
### 1. Air Cleaner

- The air cleaner is a single element type.
- When the engine slows down below the predetermined speed, the level of vacuum changes and causes the unloader valve to vibrate. Vibration of the unloader valve allows the air cleaner to automatically discharge any water and dust that has accumulated in its inside.

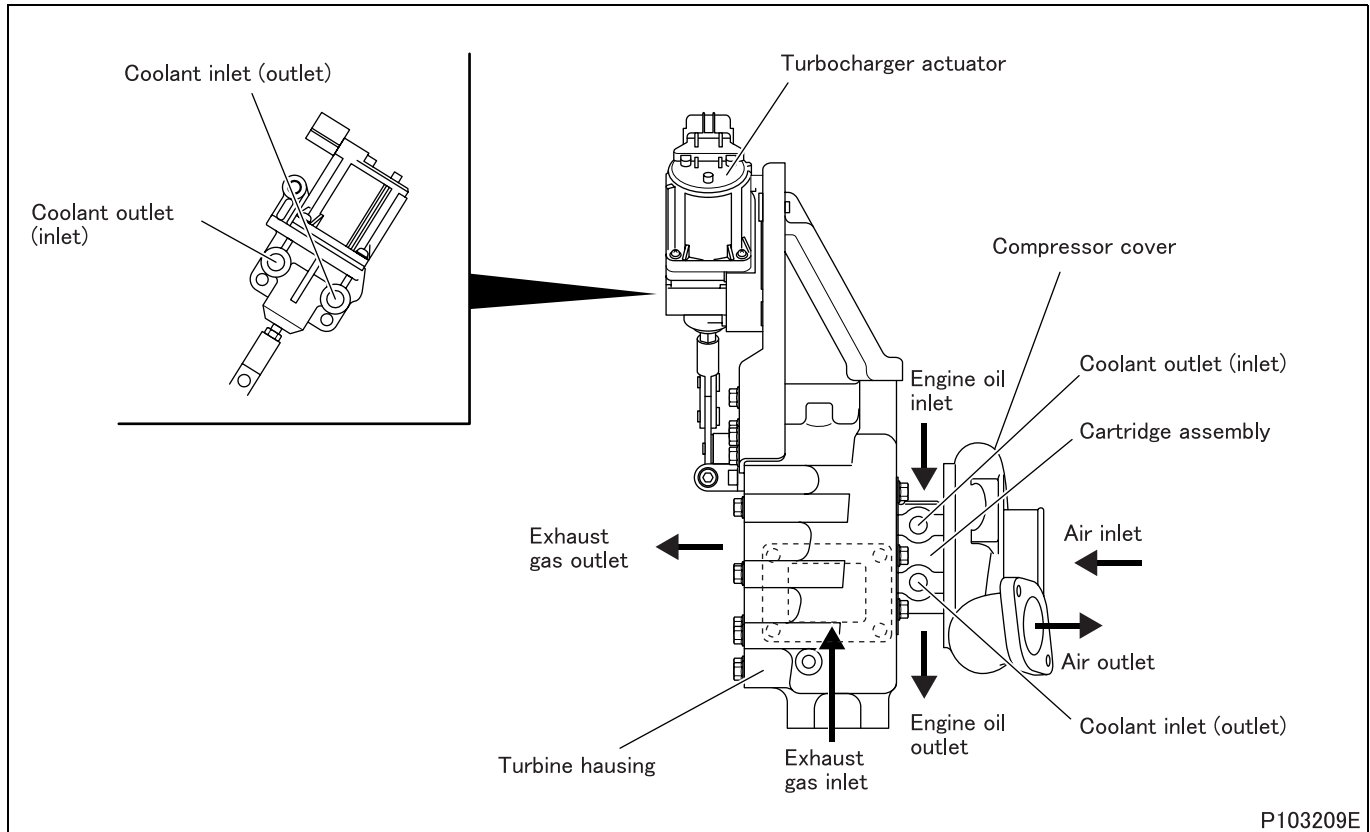
## 2. Turbocharger

- TD05 model is equipped with turbocharger, which is a variable nozzle vane type turbocharger with adjustable, heat-resistive alloy turbine vanes provided at the turbine exhaust gas inlet port.

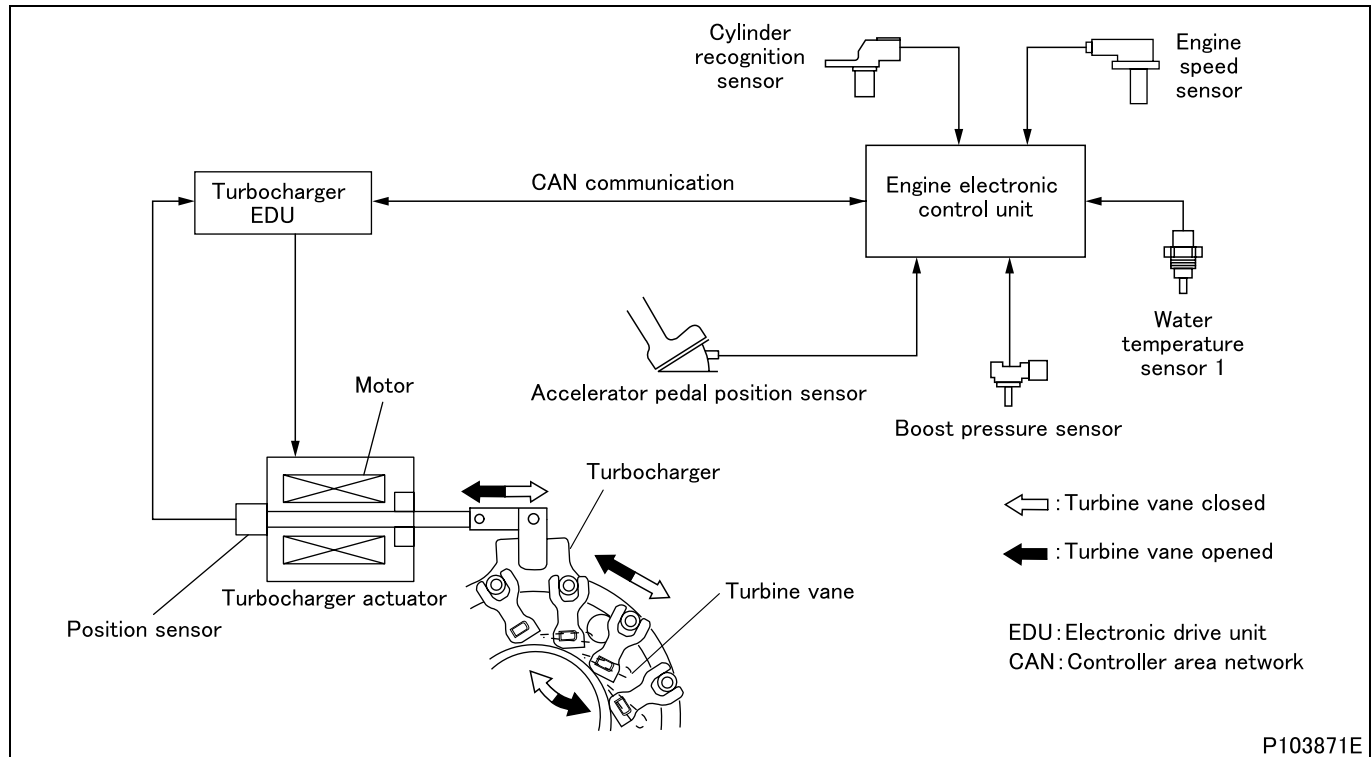
- In the turbocharger control system, various engine-related information (engine speed, coolant temperature, accelerator position) and driving status are collected by the relevant sensors and are sent to the engine electronic control unit and turbocharger electronic drive unit which then control the engine based on the information received.
- The turbocharger actuator controls the opening of turbine vanes according to control signals to ensure low fuel consumption and high torque operation over the entire speed range.

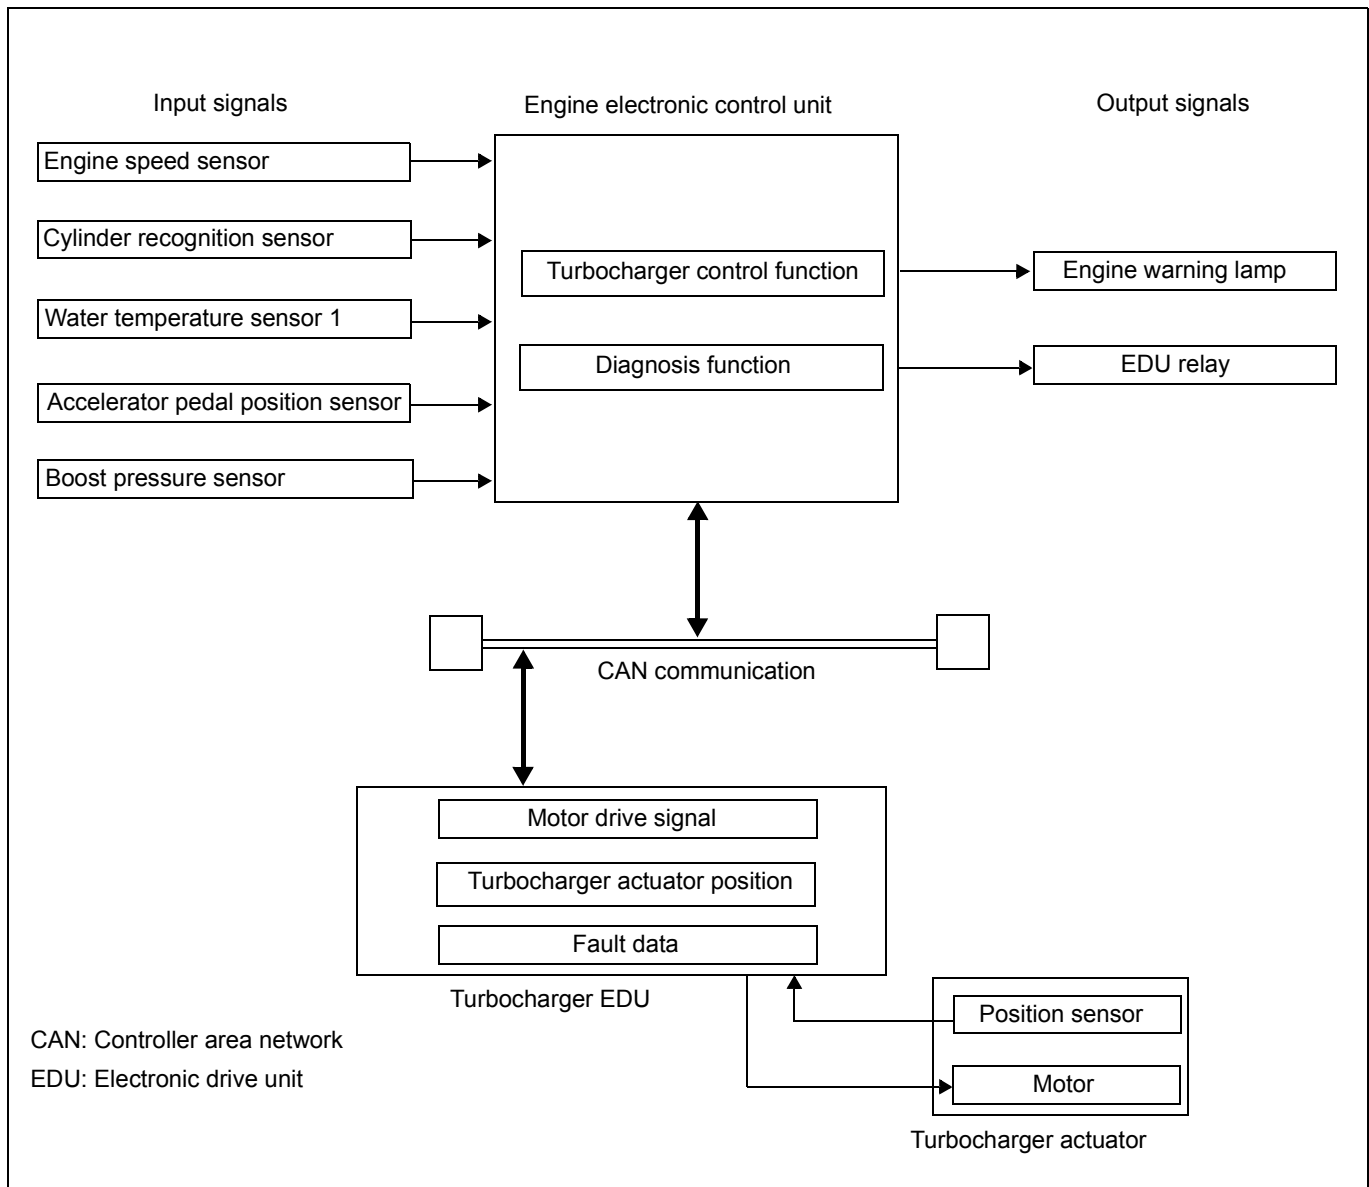
#### (1) System block diagram

### 3.2 Electronic control system

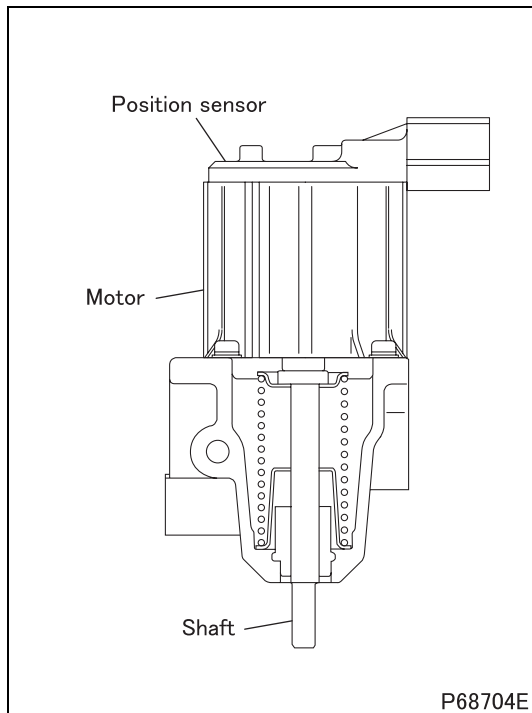
### (2.1) Turbocharger actuator

- In response to command signals from the turbocharger electronic drive unit, the turbocharger actuator moves the shaft up and down by means of its DC motor to open and close the turbine vanes.

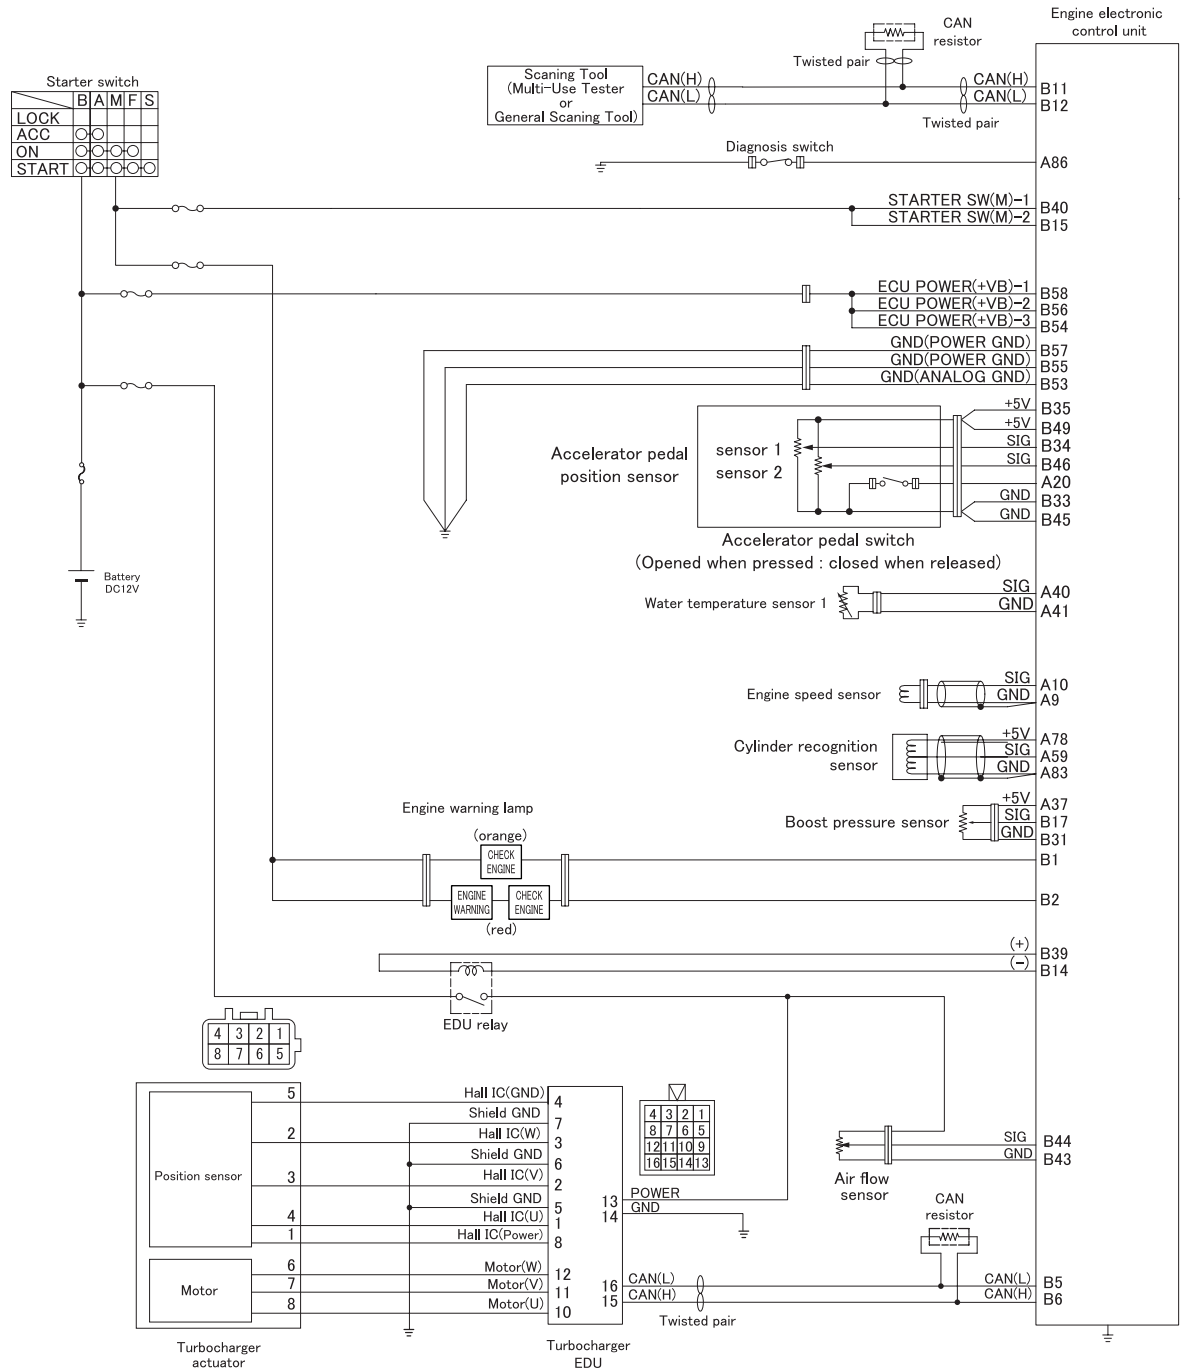
### 3.3 Electronic control unit wiring diagram

CAN : controller area network  
EDU : electronic drive unit

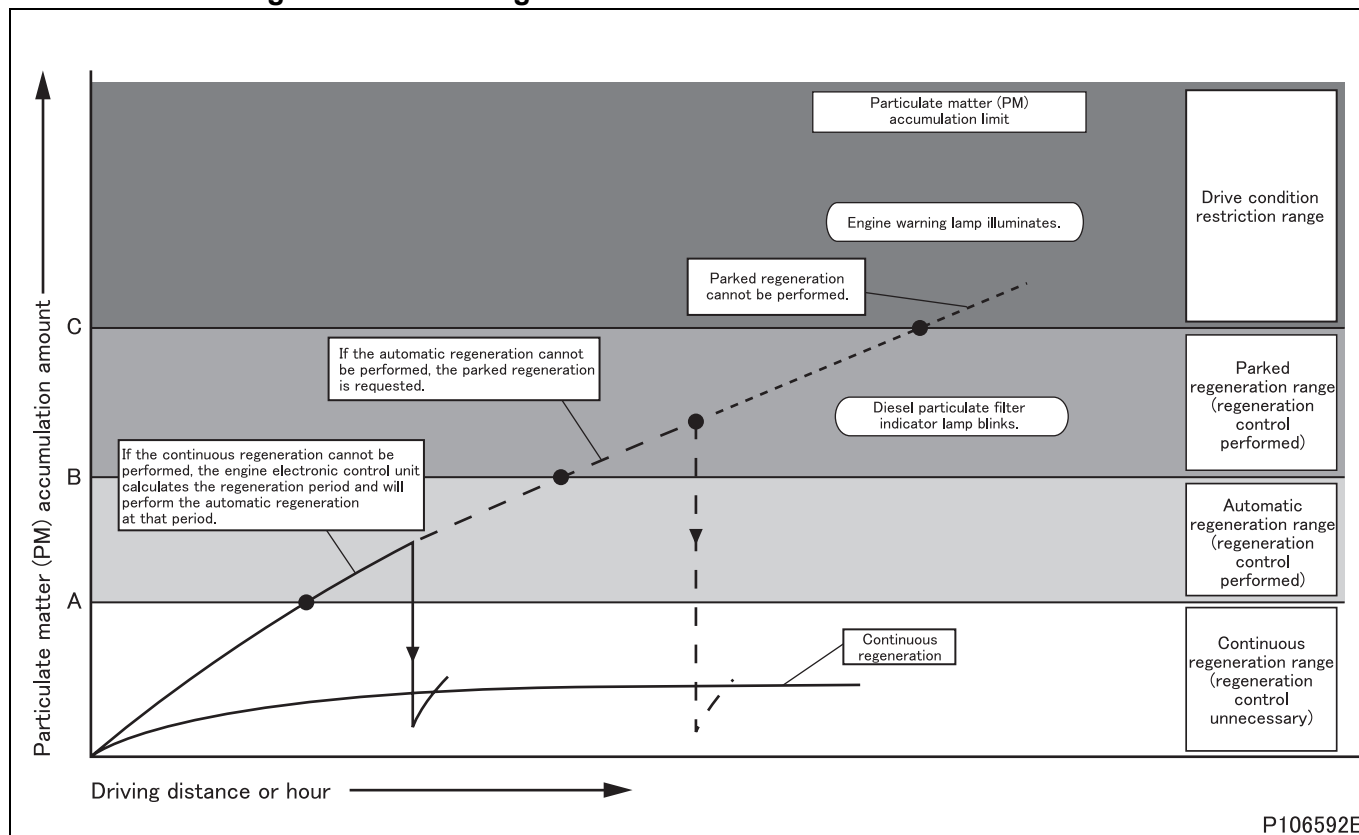
## 4.2 Continuous regeneration and regeneration control

- The above diagram shows the relations between the driving distance or hours and the particulate matter accumulation amount, and the range of each diesel particulate filter regeneration operation.
- The particulate matter accumulation amount increases as the driving distance or hours increase. However, by conducting the regeneration operation that matches the vehicle operating condition and the particulate matter accumulation amount, the particulate matter accumulation amount is reduced to keep the performance of the diesel particulate filter.
- The regeneration is divided into two types – the continuous regeneration utilizing exhaust gas during normal driving operation and the automatic or parked regeneration which uses exhaust gas created by the regeneration control.

- When the particulate matter accumulation level is between A and B on the diagram, the engine electronic control unit decides the regeneration period and the automatic regeneration will be performed at an appropriate period. During regeneration, the unburnt fuel (HC) supplied by the post injection is oxidized by the front oxidation catalyst, and the oxidation heat from that reaction burns the particulate matter accumulated in the ceramic filter.

- When the particulate matter accumulation level is between B and C on the diagram, the engine electronic control unit makes the diesel particulate filter indicator lamp blink. If the diesel particulate filter cleaning switch is turned on by the driver when the following conditions are met, the parked regeneration will take place.

- When the particulate matter accumulation level exceeds C on the diagram, the engine warning lamp illuminates and some restrictions are applied to the driving conditions.
- Under this restriction, parked regeneration will not take place even if the diesel particulate filter cleaning switch is turned on.

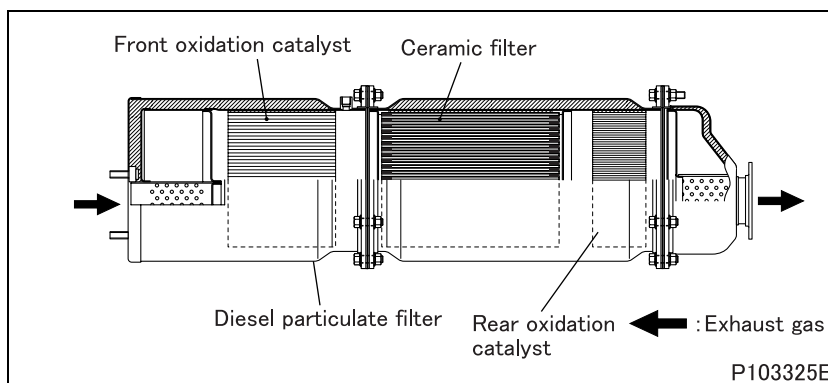
## 4.3 Diesel particulate filter unit

- Diesel particulate filter unit consists of the front oxidation catalyst, ceramic filter and rear oxidation catalyst.

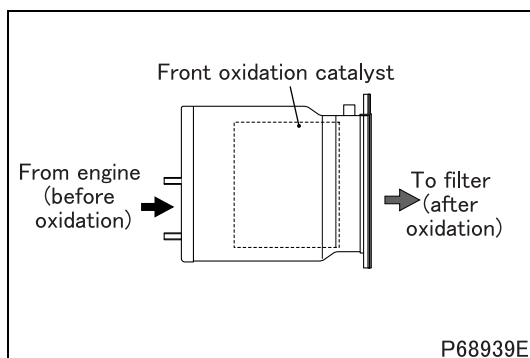
### (1) Front oxidation catalyst

- In normal driving condition, unburnt fuel (HC) and part of the particulate matter in the exhaust gas from the engine is purified by this catalyst.
- During filter regeneration, the unburnt fuel (HC) supplied by the post injection is oxidized by the front oxidation catalyst, and the oxidation heat raises exhaust gas temperature.

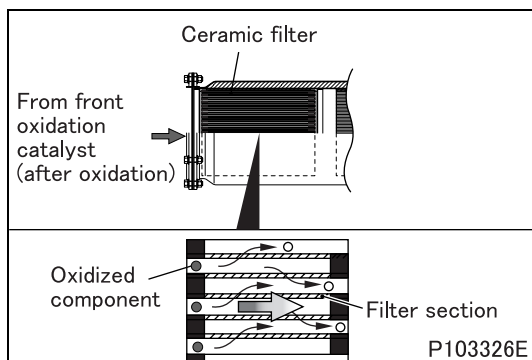
## (2) Ceramic filter

- The ceramic filter is an aggregate of thin tubes, and these tubes are closed at either end alternatively. During normal operation, particulate matter is trapped when the exhaust gas enters a tube and passes through the wall of the tube (filter section) to the adjacent tube.
- During regeneration, the particulate matter accumulated in the filter is cleared by burning at high temperature. This, however, cannot remove the calcium (ash) contained in the engine oil and the ash will accumulate in the filter. The excessively accumulated ash may cause early clogging of the ceramic filter. Therefore, the ceramic filter must be cleaned periodically.

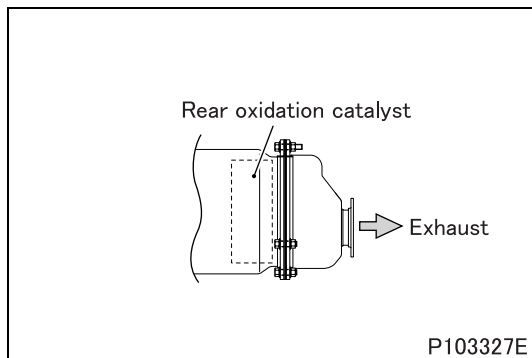
- The rear oxidation catalyst oxidize and remove the components (HC and CO) which remain untreated through the diesel particulate filter.

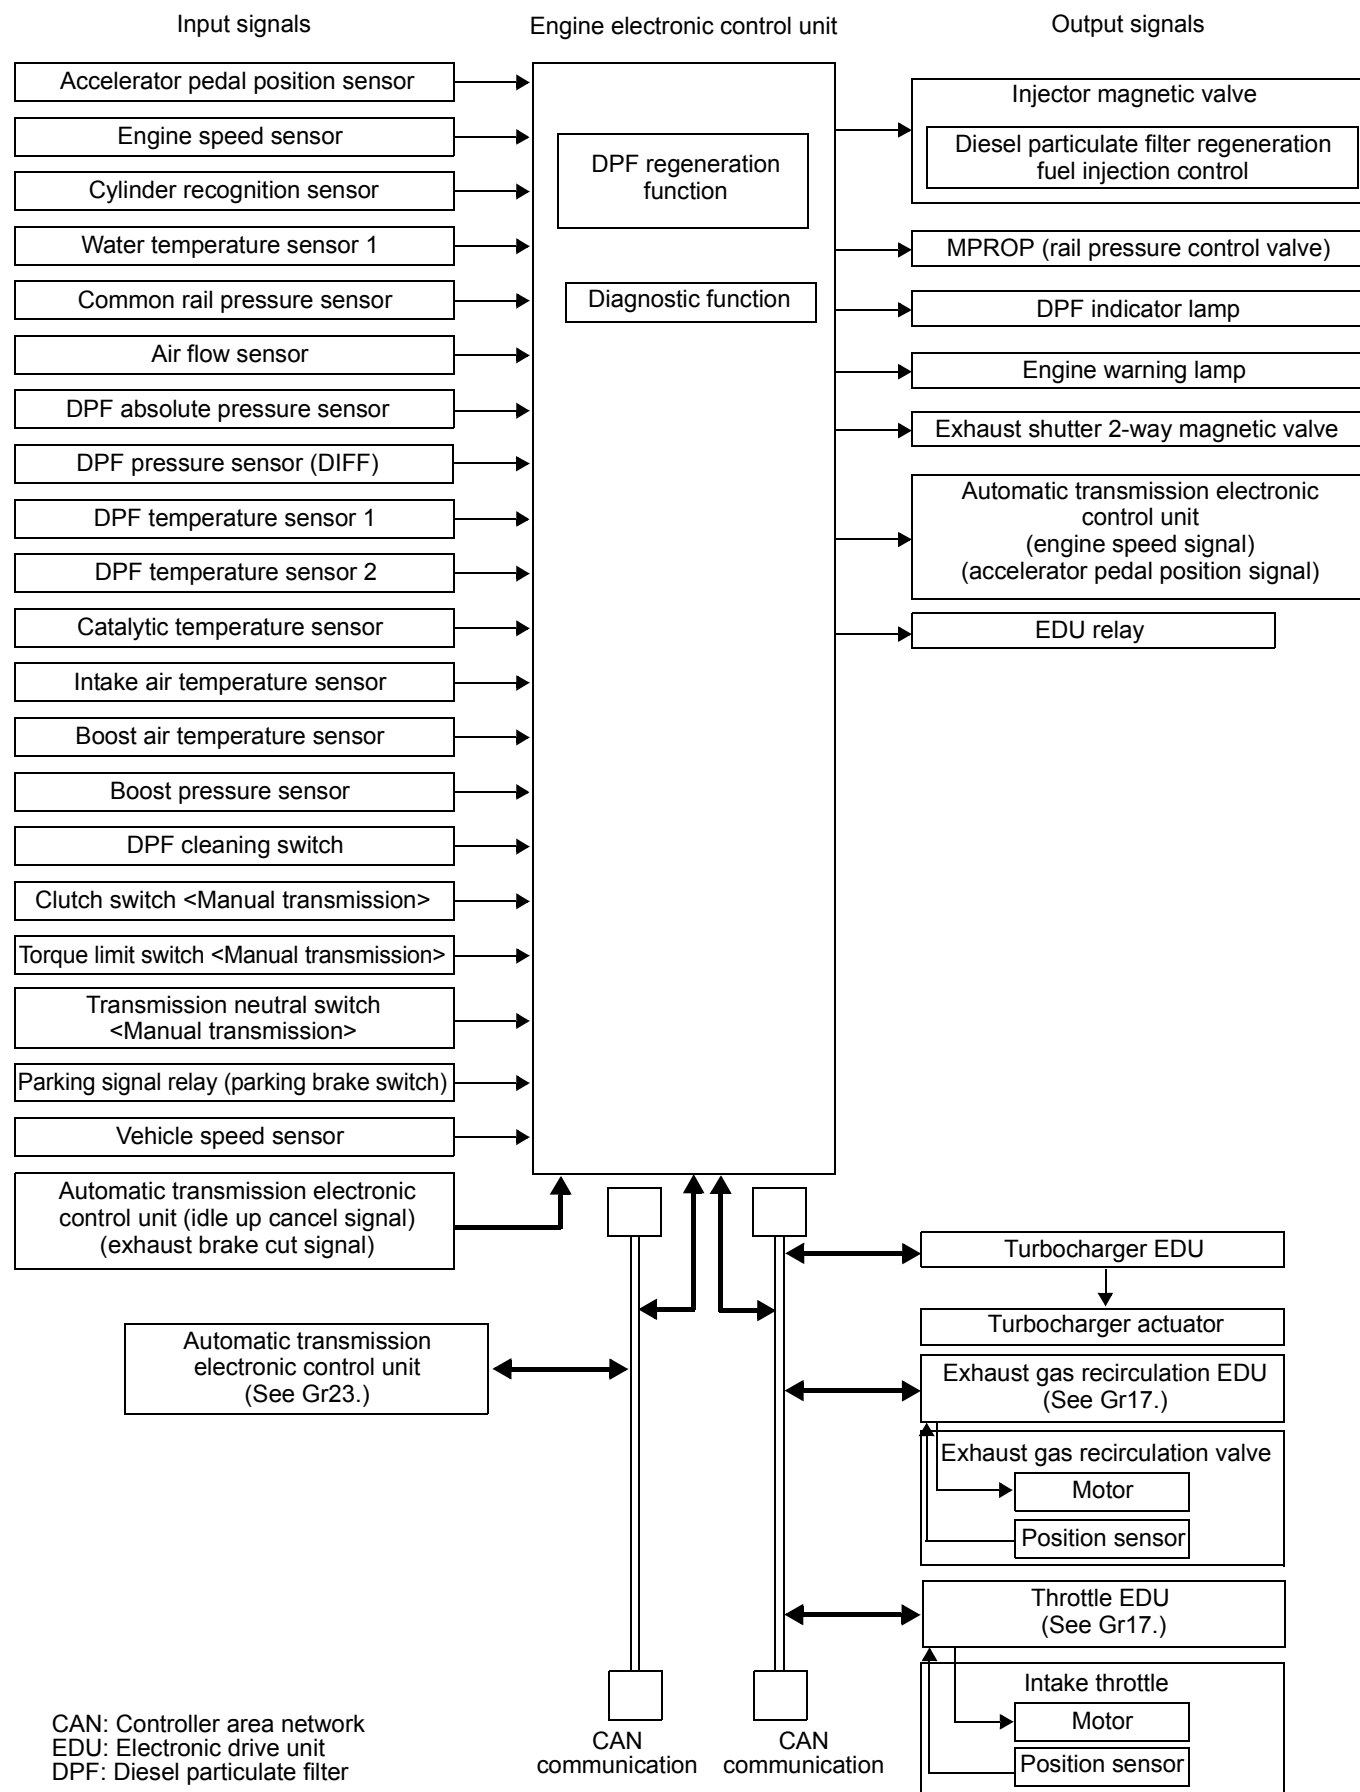
### (1) System block diagram

## 4.4 Electronic control system

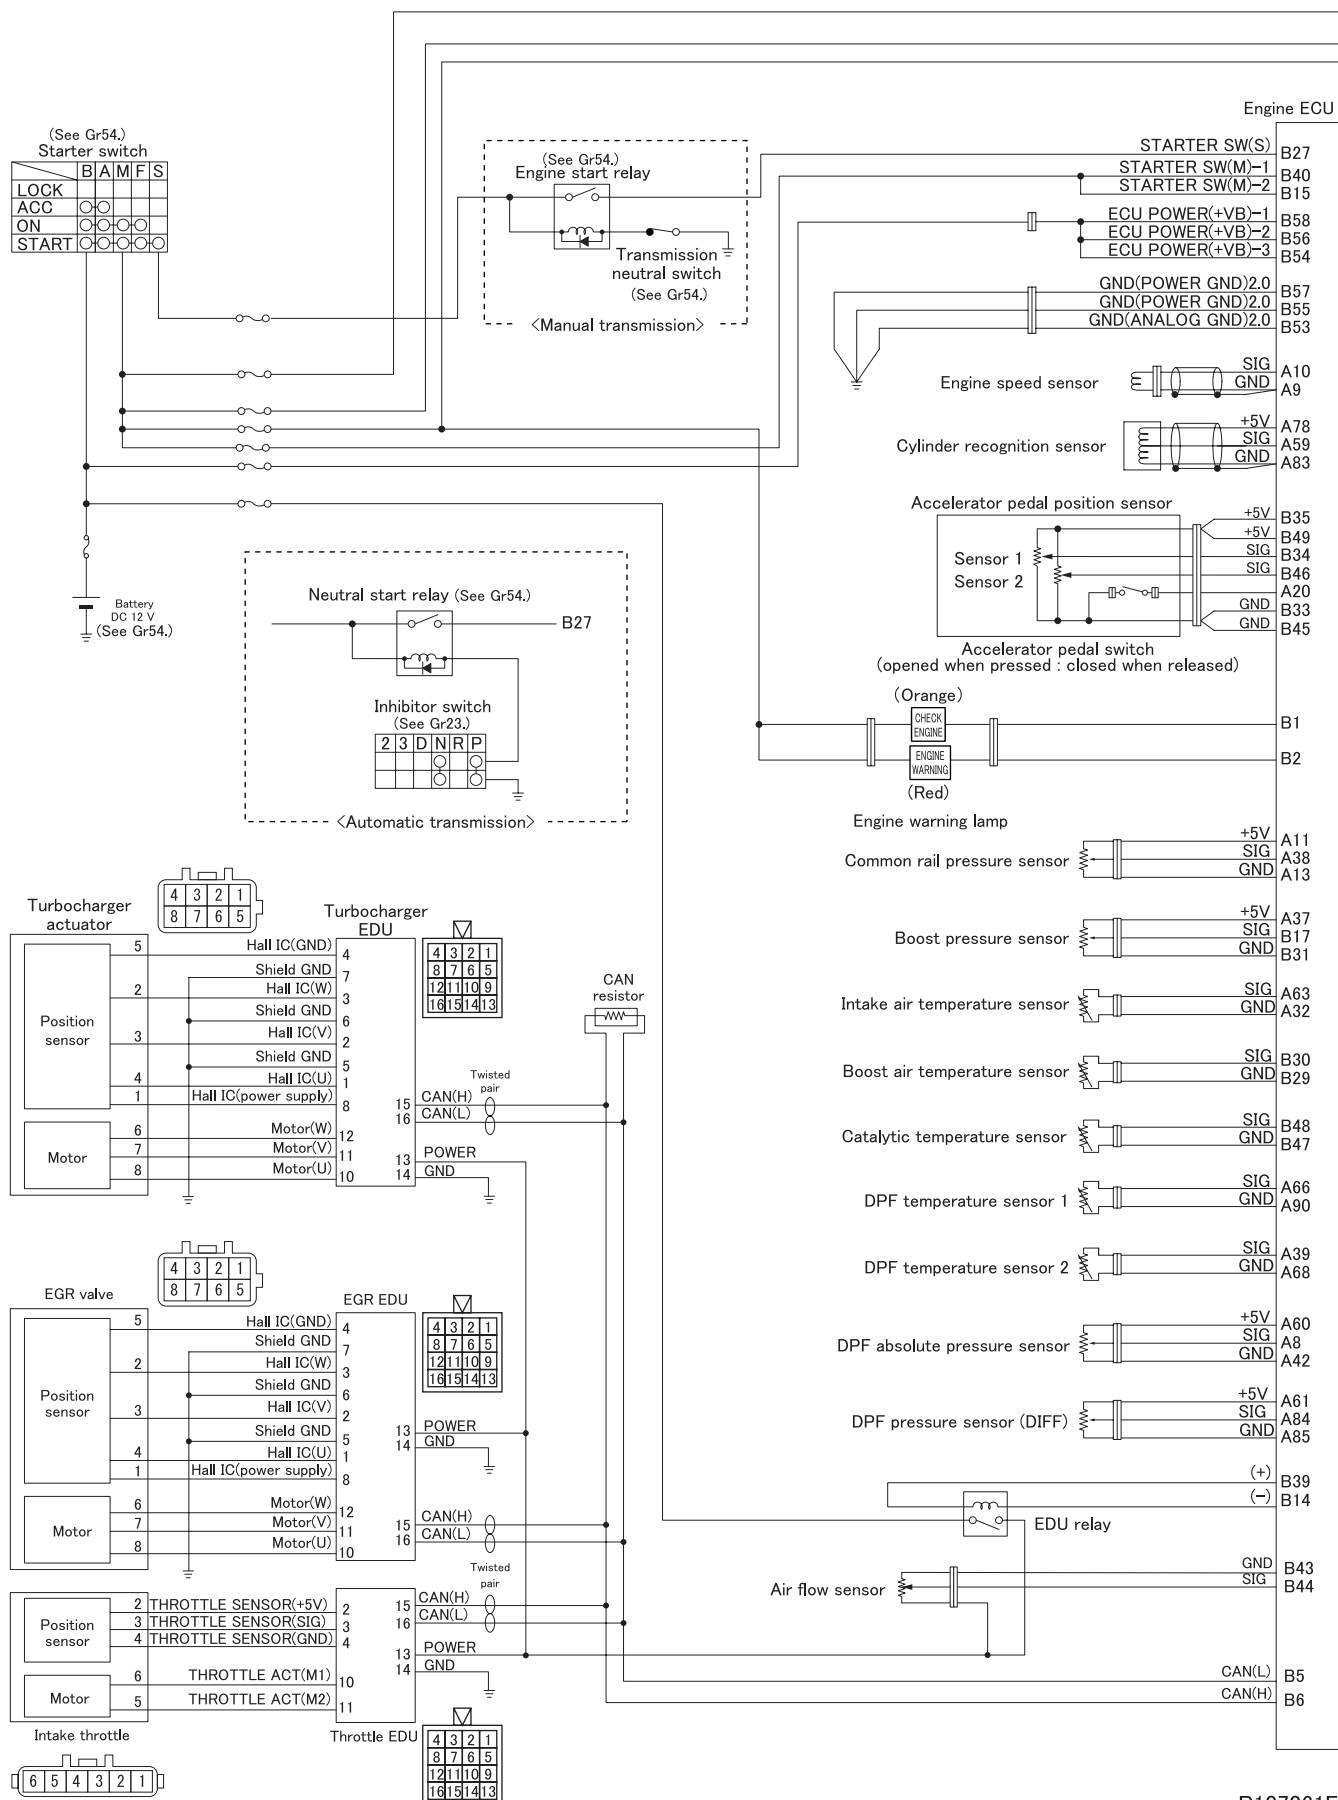
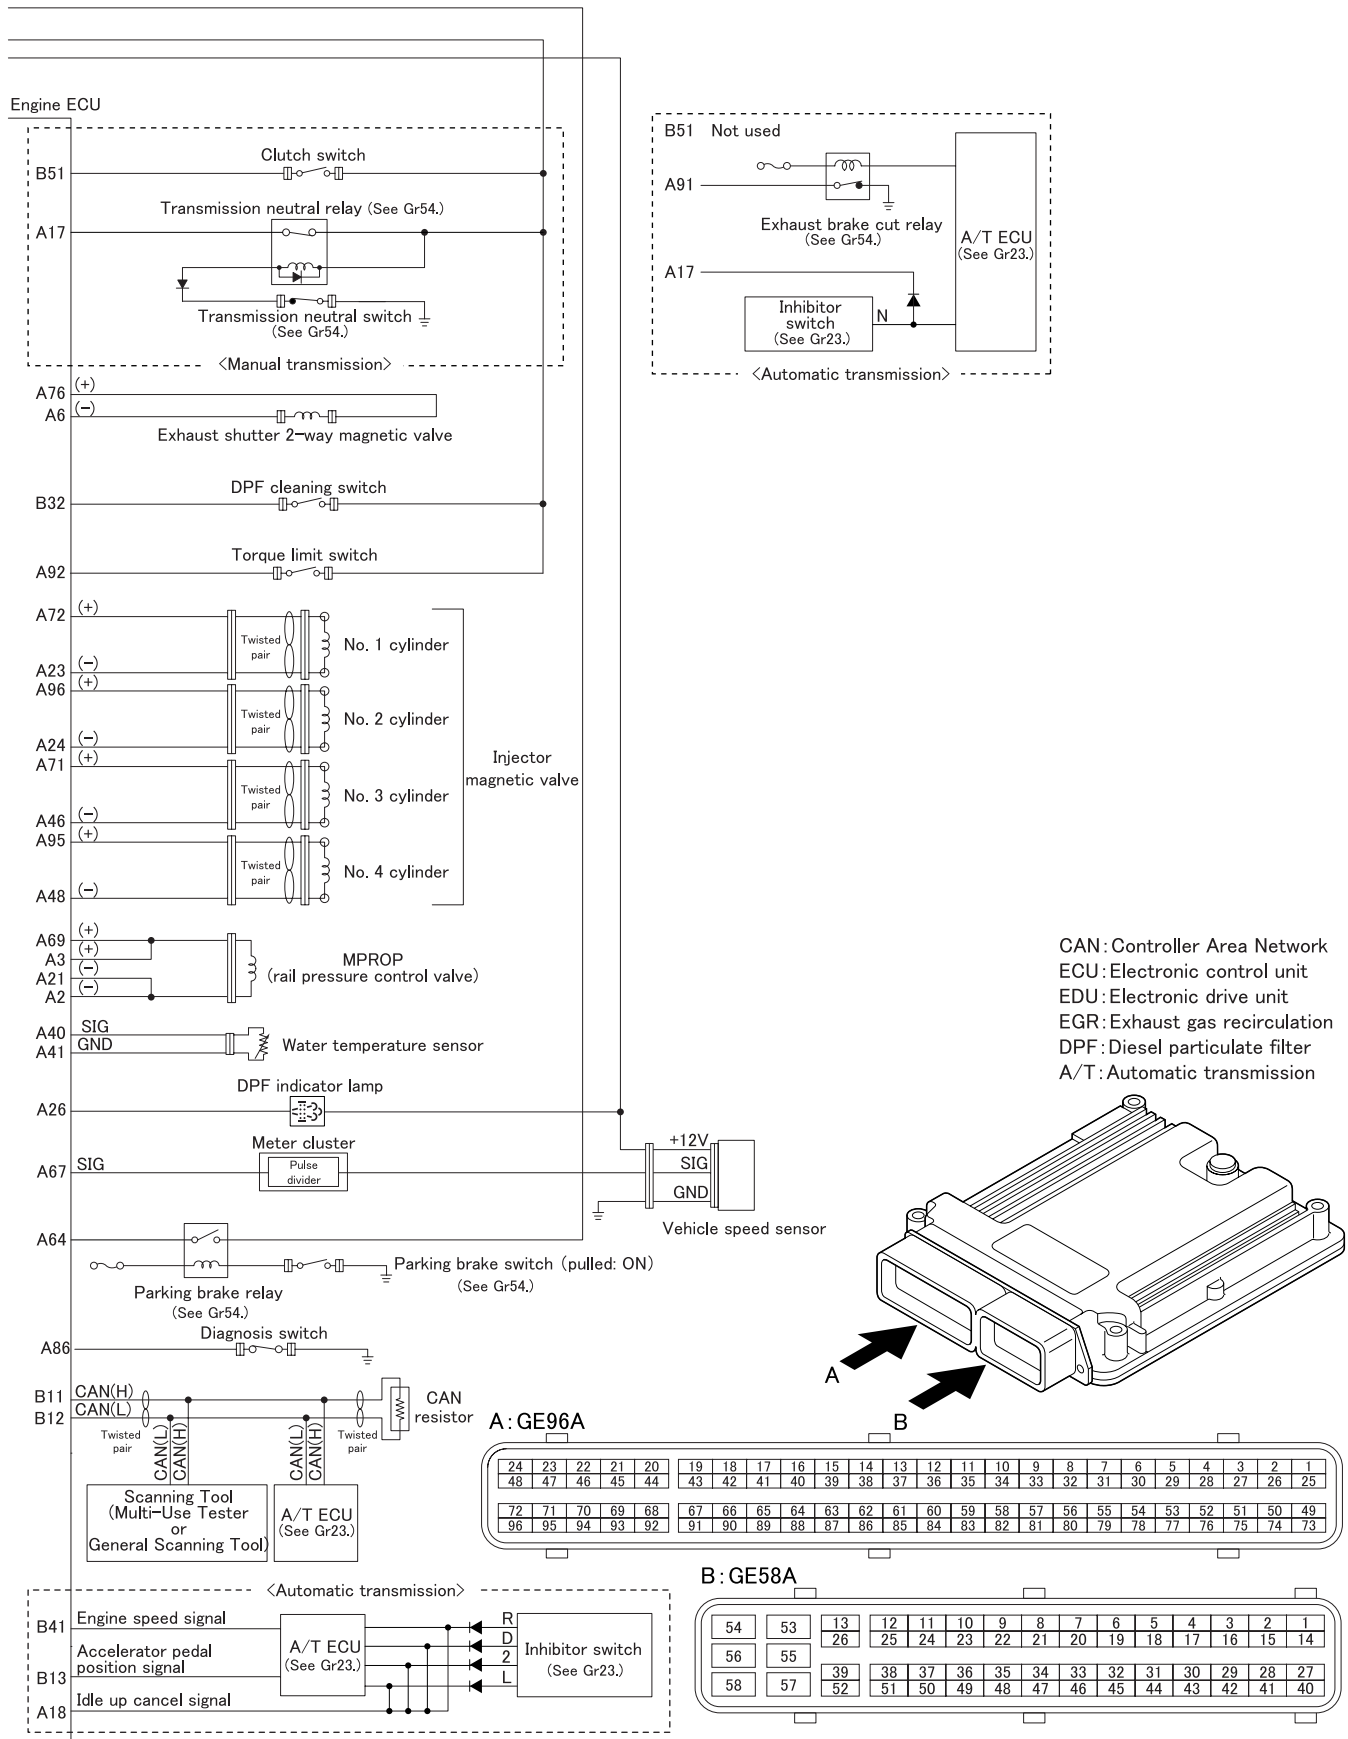
## 4.5 Electronic control unit wiring diagram

See Gr13EA for control concerning engine electronic control unit.

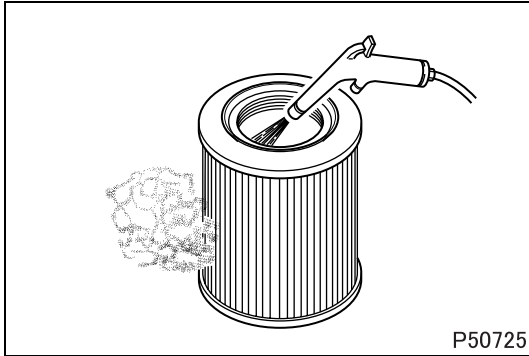
### ■ Cleaning: Filter element

- Blow a jet of compressed air at a pressure not higher than 685 kPa {100 psi, 7 kgf/cm<sup>2</sup>} against the inside surfaces of the element.
- Move the compressed air jet up and down along all pleats of the filter paper element.

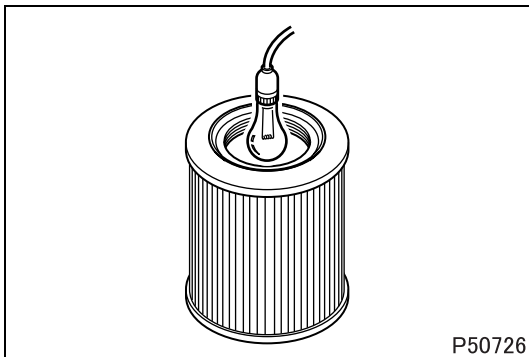
### ■ Inspection: Element

- Shine some electric light inside the element.
- Replace the element if thin spots or broken parts are evident in the filter paper, or if the packing at the top of the element is damaged.

Also replace the element if the dust on the element is damp with oily smoke or soot, regardless of the replacement schedule.

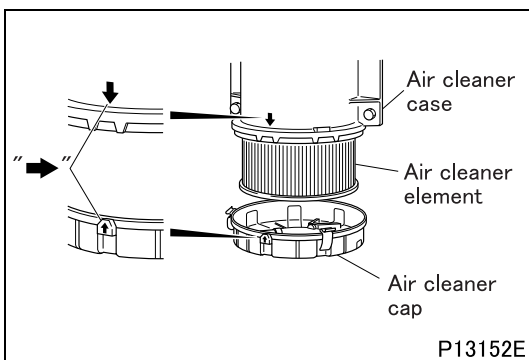
### ■ Installation: Air cleaner cap

➡ : Alignment mark

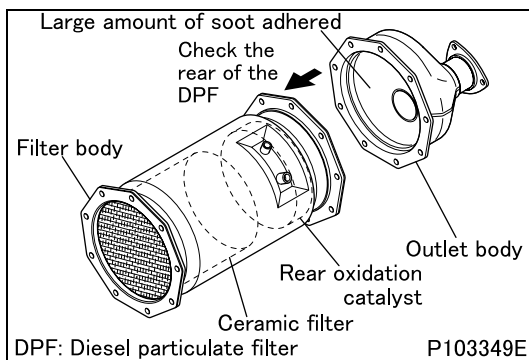
## (3) Visual inspection

- Disassemble the diesel particulate filter and check the following.
  - Check if a large amount of soot adheres inside the outlet body.
  - Check the rear oxidation catalyst behind the ceramic filter for damage.
- If a large amount of soot adheres inside the outlet body or if a damage is found on the rear oxidation catalyst, engine-related fault may be suspected. Replace the diesel particulate filter.

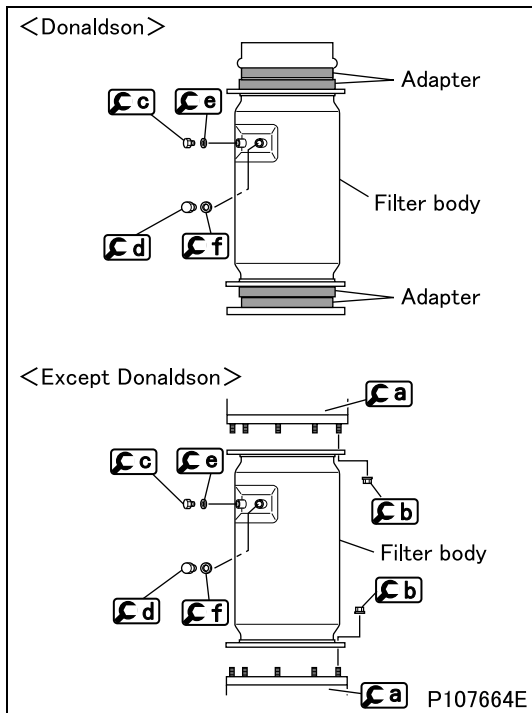
#### (4) Cleaning

- Fit the adapter to the filter body. <Donaldson>
- Fit **a** to the filter body with **b** and tighten **b** to the specified torque (43 N·m {32 ft.lbs, 4.4 kgf·m}). <Except Donaldson>
- Fit **c** and **e** to the sensor mounting hole on the filter body and tighten them to the specified torque (30 N·m {22 ft.lbs, 3.1 kgf·m}).
- Fit **d** and **f** to the sensor mounting hole on the filter body and tighten them to the specified torque (40 N·m {30 ft.lbs, 4.1 kgf·m}).

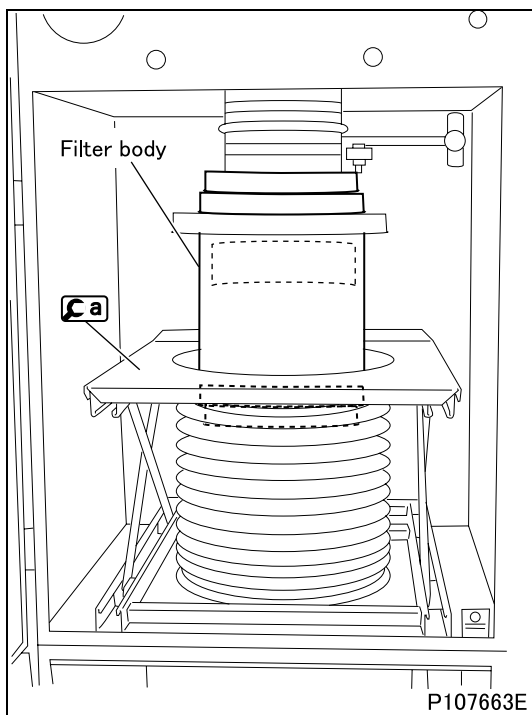
- Set the filter body in **a** with its rear oxidation catalyst side upward.
- Be sure to fit **a** and the filter body with no air leaks between them.
- Set the air pressure (refer to its instruction manual).
- Set the timer to about 15 minutes (refer to its instruction manual) and perform cleaning.
- For the handling procedure of **a**, refer to its instruction manual.

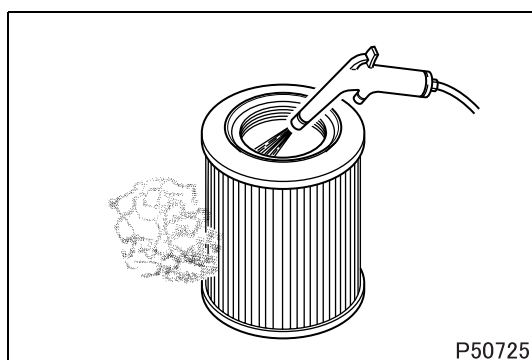
#### ■ Cleaning: Filter element

- Blow a jet of compressed air at a pressure not higher than 685 kPa {100 psi, 7 kgf/cm<sup>2</sup>} against the inside surfaces of the element.
- Move the compressed air jet up and down along all pleats of the filter paper element.

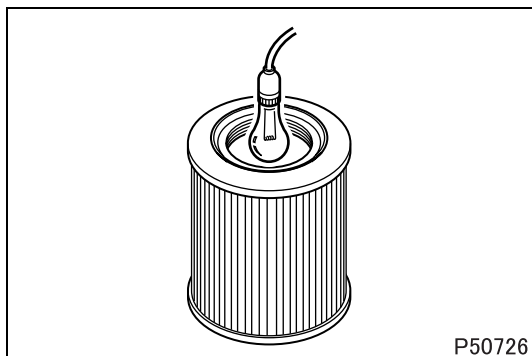
### ■ Inspection: Element

- Shine some electric light inside the element.
- Replace the element if thin spots or broken parts are evident in the filter paper, or if the packing at the top of the element is damaged.

Also replace the element if the dust on the element is damp with oily smoke or soot, regardless of the replacement schedule.

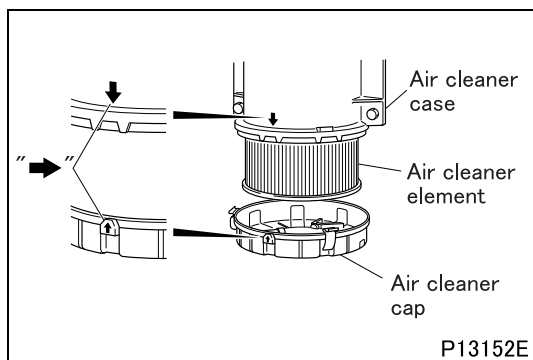
### ■ Installation: Air cleaner cap

➡ : Alignment mark
