# FE.FG

## SERVICE MANUAL 2008 Model FOREWORD

This Service Manual contains maintenance and repair methods for the Mitsubishi Fuso Truck FE. FG Series. Read this manual carefully as an aid in providing correct, efficient maintenance. Please note that the information and specifications contained within this manual may change without notice. This is due to product modifications and continued vehicle improvements that are made throughout the model years. Should you encounter any discrepancy in the information provided, please do not hesitate to contact your nearest Mitsubishi Fuso Dealer or Mitsubishi Fuso Truck of America, Inc.

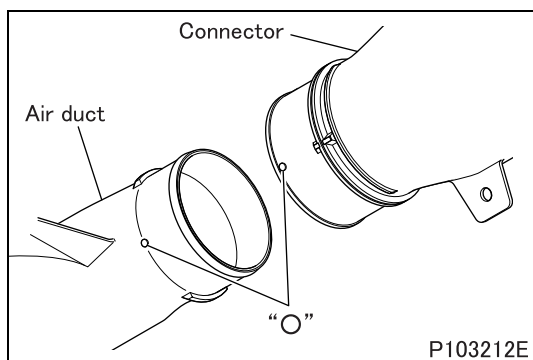
### ■ Installation: Air duct

- Align the marks “○” on air duct and push it in until it hits stopper.

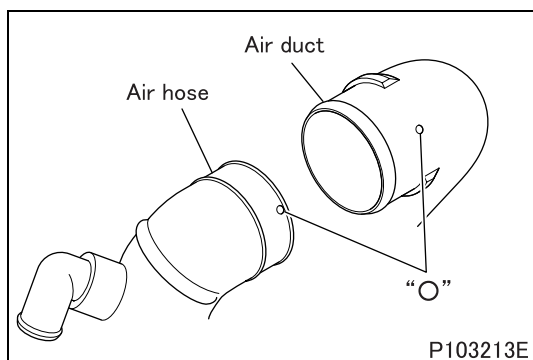
### ■ Installation: Air hose

- Align the marks “○” on air hose and push it in until it hits stopper.

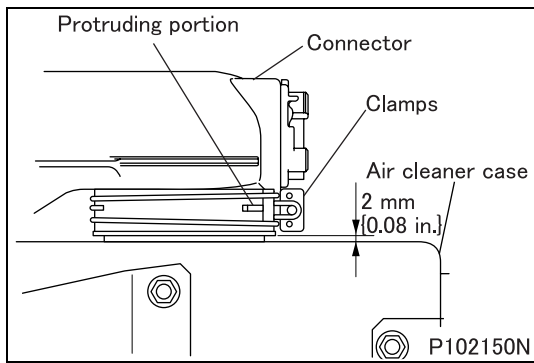
**■ Installation: Connector**

- The protruding portion of the connector is put between clamps.
- Installation is such that the space between the connector and the air cleaner case measures the amount shown in the figure.

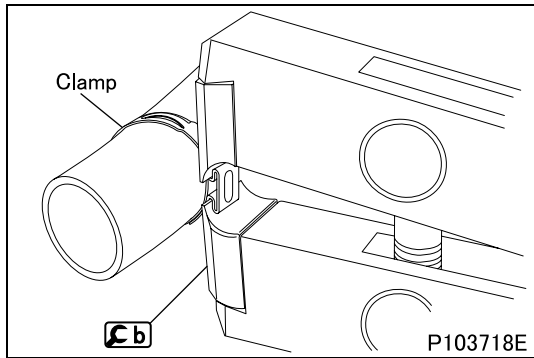
**■ Installation: Clamp**

- Pinch the projecting part of the clamp with

and tighten to the specified torque.

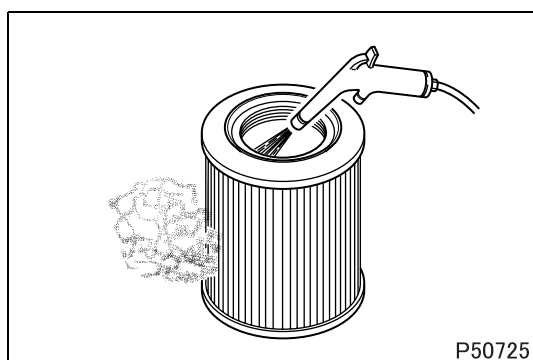
#### ■ Cleaning: Filter element

- Blow a jet of compressed air at a pressure not higher than 685 kPa {100 psi, 7 kgf/cm<sup>2</sup>} against the inside surfaces of the element.
- Move the compressed air jet up and down along all pleats of the filter paper element.

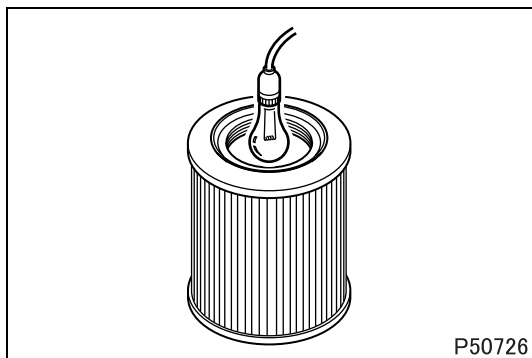
### ■ Inspection: Element

- Shine some electric light inside the element.
- Replace the element if thin spots or broken parts are evident in the filter paper, or if the packing at the top of the element is damaged.

Also replace the element if the dust on the element is damp with oily smoke or soot, regardless of the replacement schedule.

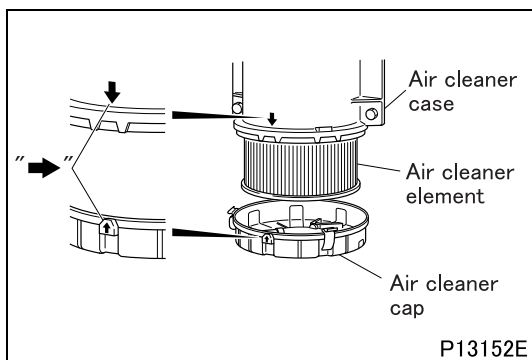
### ■ Installation: Air cleaner cap

➡ : Alignment mark

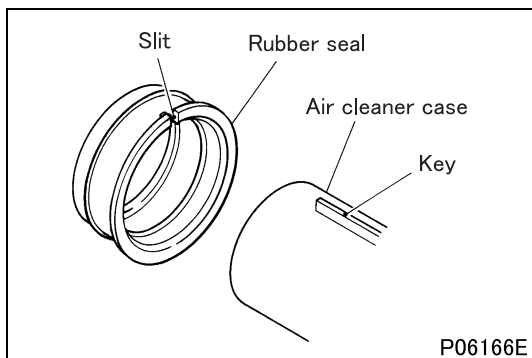
### ■ Installation: Rubber seal

- Align slit of rubber seal with key of air cleaner case.

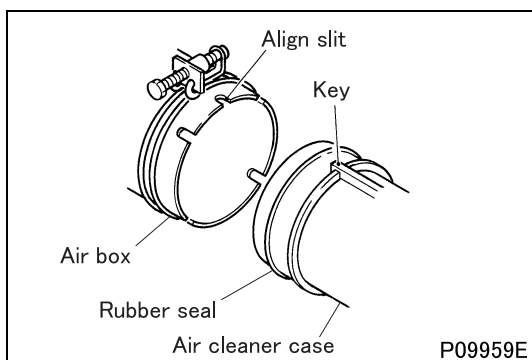
### ■ Installation: Air box

- Align slit of air box with key of air cleaner case.

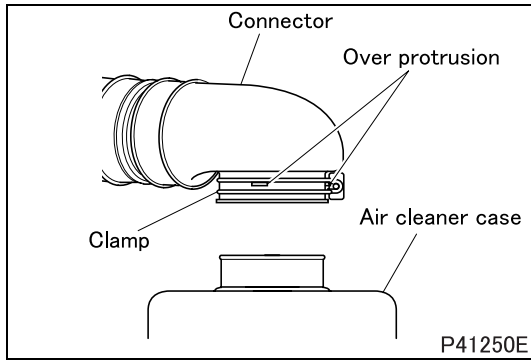
#### ■ Installation: Connector

- Fit clamp over protrusions of connector.
- Push air duct in until it hits air cleaner case.

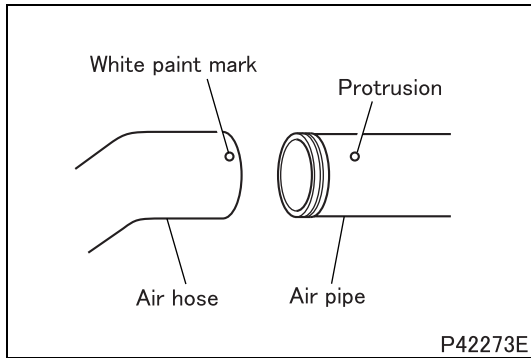
#### ■ Installation of connector

- Align paint mark on connector with protrusion on air pipe, and push in the Air hose.

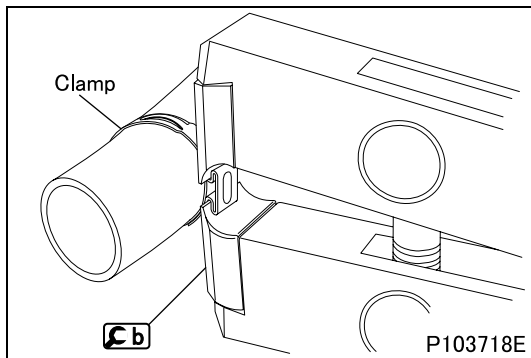
#### ■ Installation: Clamp

- Pinch the projecting part of the clamp with

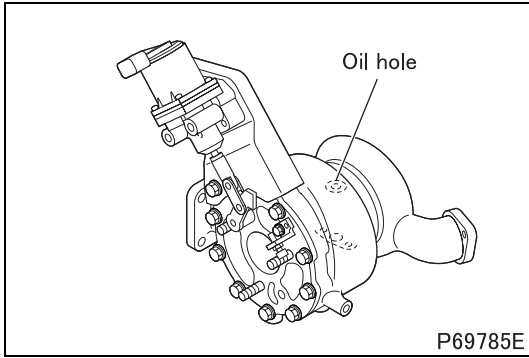
### ■ Installation: Turbocharger

- Before installing the turbocharger assembly, pour engine oil into the oil hole to ensure smooth operation of the internal parts.

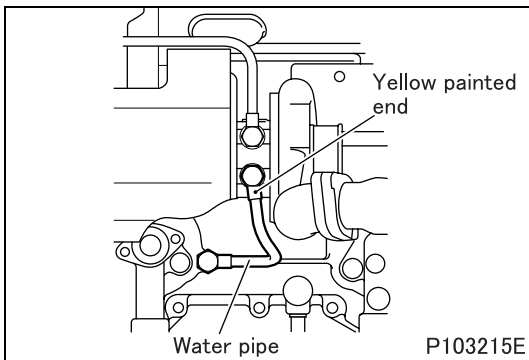
### ■ Installation: Water pipe

- Install the water pipe with its yellow painted end toward the turbocharger.

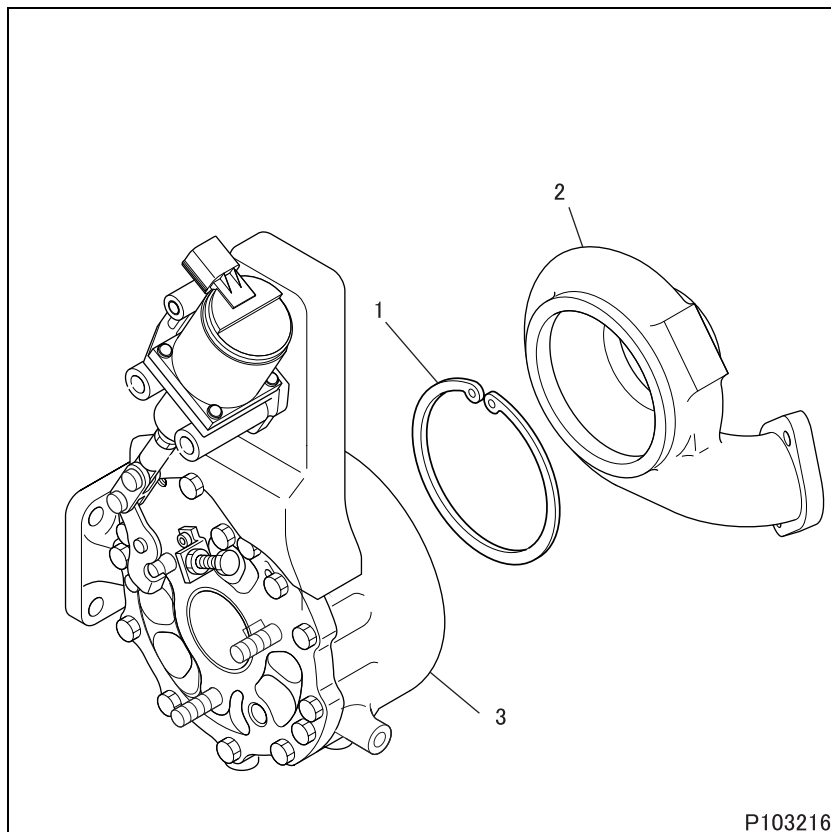
### ● Removal sequence

- 1 Snap ring
- 2 Compressor cover
- 3 Turbine assembly

- Do not attempt to disassemble the turbine assembly because it is of a unit construction.
- Do not unseal and try to adjust the turbine assembly. It should be replaced as an assembly if any failure is found.

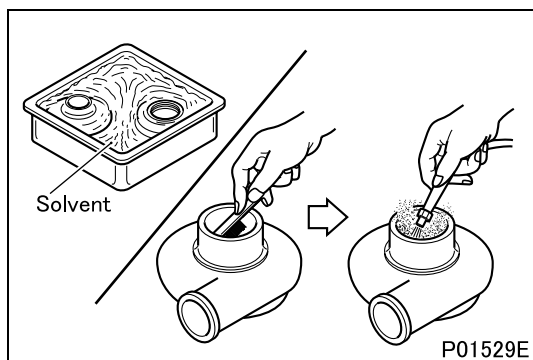
### ■ Cleaning

- Before cleaning, visually check the disassembled parts for scorchs, abrasion and other marks that may be difficult to see after cleaning. Replace any part that appears defective.
- Immerse the disassembled parts in a non-flammable solvent (a 5 to 10 aqueous solution of Oil Clean from New Hope Co., Ltd.). Take out the parts and blow them dry with compressed air. Remove any hard deposits with a stiff brush or plastic scraper.

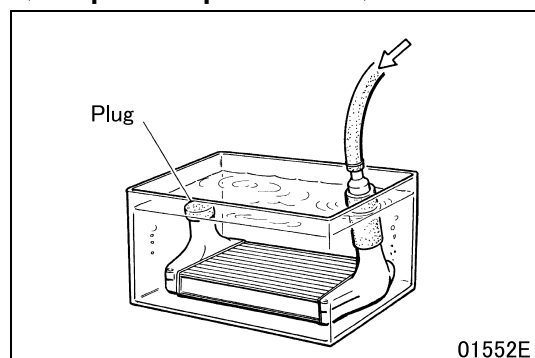
#### ■ Inspection: Intercooler

- Plug one of the air ports on the intercooler and connect an air source to the other port. Place the intercooler in a tank of water and apply air pressure of the specified level (200 kPa {29 psi, 2.0 kgf/cm<sup>2</sup>}) to the intercooler and retain the pressure for 30 seconds.
- Replace the intercooler if any air leakage is evident.

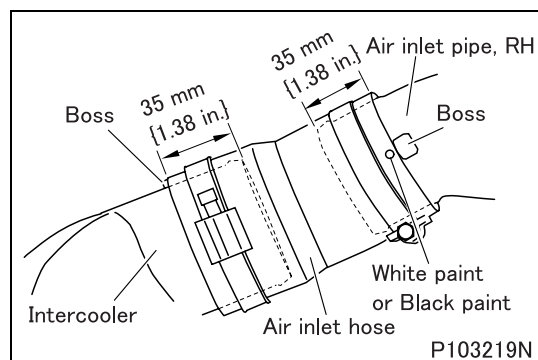
#### ■ Installation: Air inlet hose

- Connect the air inlet hose to the RH air inlet pipe with the white paint on the hose aligned with the boss on the pipe.
- Connect the air inlet hoses to the intercooler, RH air inlet pipe and turbocharger coupler to the dimensions indicated in the illustrations.

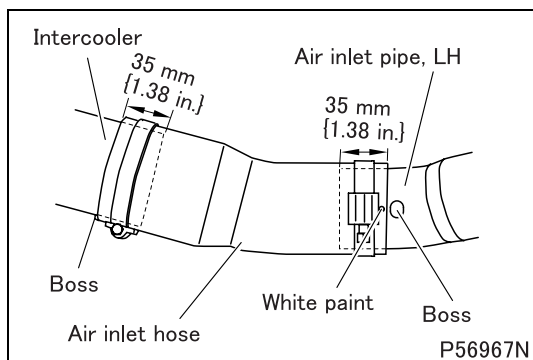
- Connect the air inlet hose to the LH air inlet pipe with the white paint on the hose aligned with the boss on the pipe.
- Connect the air inlet hoses to the intercooler, LH air inlet pipe and air inlet duct to the dimensions indicated in the illustrations.

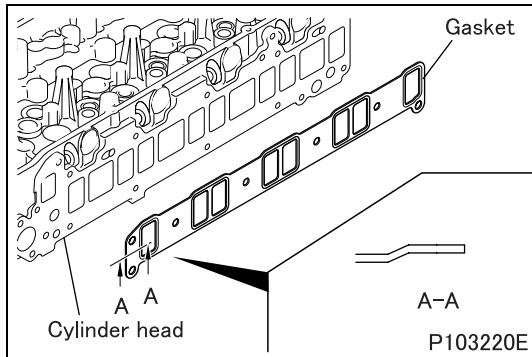
### ■ Installation: Gasket

- Install the gasket on the cylinder head in the illustrated direction.

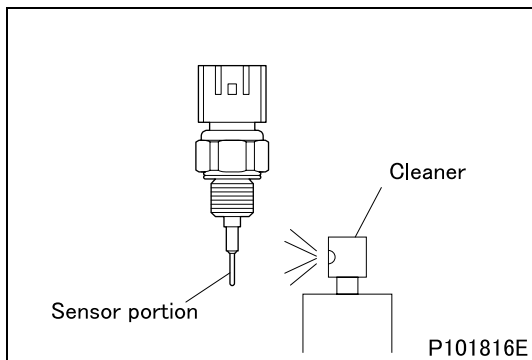
### ■ Inspection: Boost air temperature sensor

- Check that the sensor portion is free of soot, oily substance, etc.
- If not, clean the sensor portion as follows.
- Spray a cleaner on the sensor portion from 2 or 3 cm {0.79 or 1.18 in.} away.  
Recommended cleaners:  
Nonchlorinated solvent
- In 20 to 30 seconds after spraying, wipe the sensor portion clear of the sprayed cleaner using a soft waste cloth the like.

If the sensor portion is fouled excessively, the positive crankcase ventilation (PCV) may be faulty. Inspect the PCV valve and filter to locate the cause and remove it.

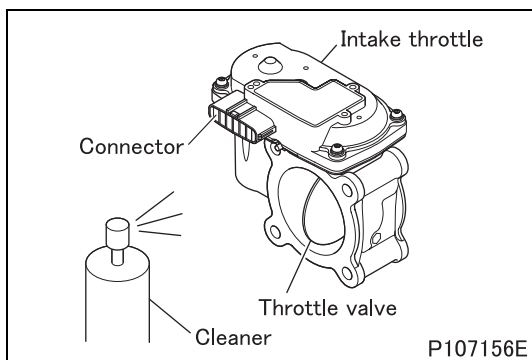
### ■ Inspection: Intake throttle

- Check that the throttle valve is free of soot, oily substance, etc.
- If not, clean the throttle valve as follows.
- Spray a cleaner on the throttle valve from 2 or 3 cm {0.79 or 1.18 in.} away.  
Recommended cleaners:  
Nonchlorinated solvent
- In 20 to 30 seconds after spraying, wipe the throttle valve clear of the sprayed cleaner using a soft waste cloth the like.

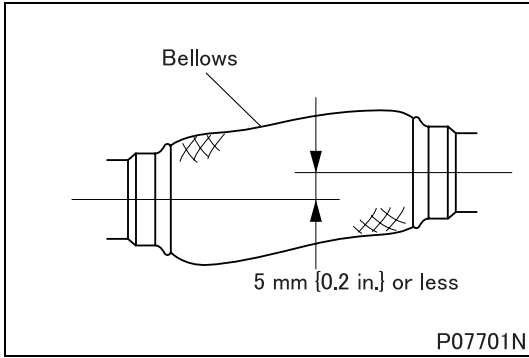
### ■ Installation: Front pipe

- Install the front pipe so that the amounts of offset in both vertical and horizontal directions between the pipes in front of and behind the bellows are smaller than the dimension indicated in the illustration.

- The bellows on the front pipe have the purpose of reducing the level of noise from the vehicle. It is not intended for compensating for misalignment that may result from improper installation of the front pipe. Install the front pipe properly to avoid excessive tension or other stress on the bellows.

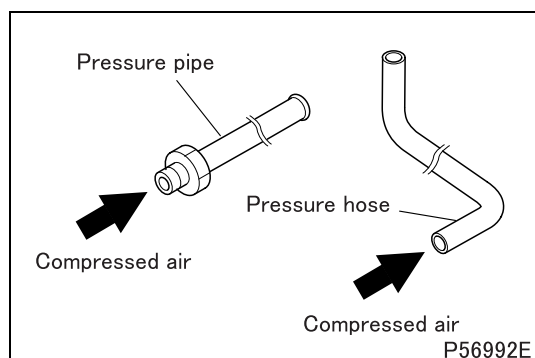
#### ■ Inspection: Pressure pipe and hose

- Check the pressure pipe and hose for clogging by blowing compressed air into the pipe and hose.

- Inspection must be performed on an individual pressure pipe or hose.
- If compressed air is blown into the pressure pipe or hose with diesel particulate filter pressure sensor still installed, the sensor may become damaged.

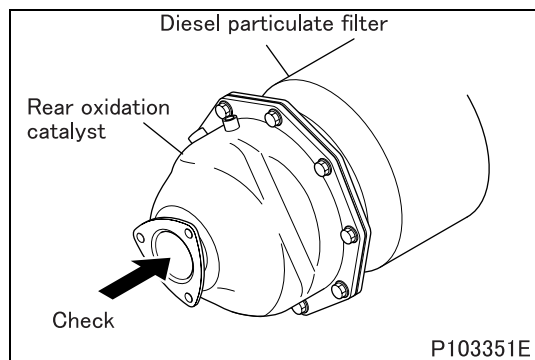
#### ■ Inspection: Diesel particulate filter

- Check the inside of the rear oxidation catalyst and the diesel particulate filter for adhesion of soot.
- If a large amount of soot is adhered, replace the ceramic filter as it may be damaged.

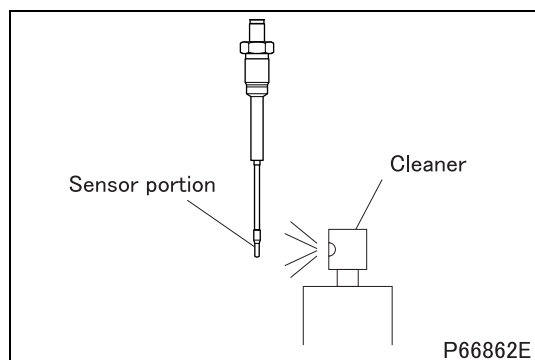
#### ■ Inspection: Temperature sensor

- Check that the sensor portion is free of soot, oily substance, etc.
- If not, clean the sensor portion as follows.
- Spray a cleaner on the sensor portion from 2 or 3 cm {0.79 or 1.18 in.} away.  
Recommended cleaners:  
Nonchlorinated solvent
- In 20 to 30 seconds after spraying, wipe the sensor portion clear of the sprayed cleaner using a soft waste cloth the like.

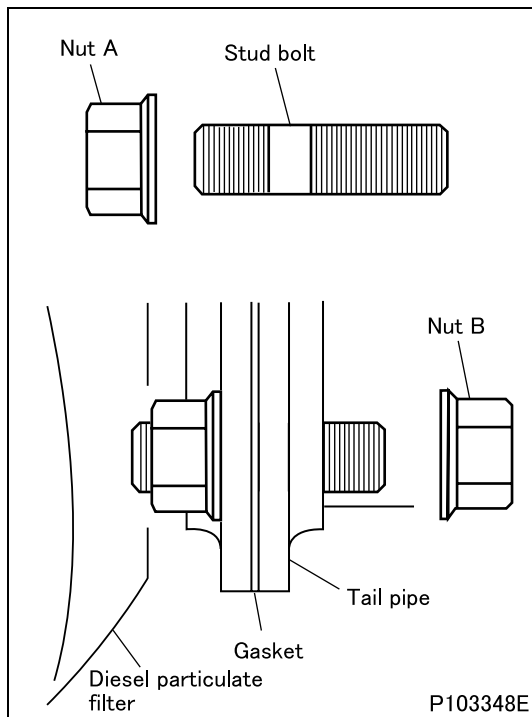
### ■ Installation: Tail pipe

- Install nut A to the shorter thread end of a stud bolt. Tighten the nut fully.
- From the diesel particulate filter side, insert the assembled stud bolt and nut A into the bolt hole. Fit the gasket and the tail pipe and tighten nut B to the specified torque.

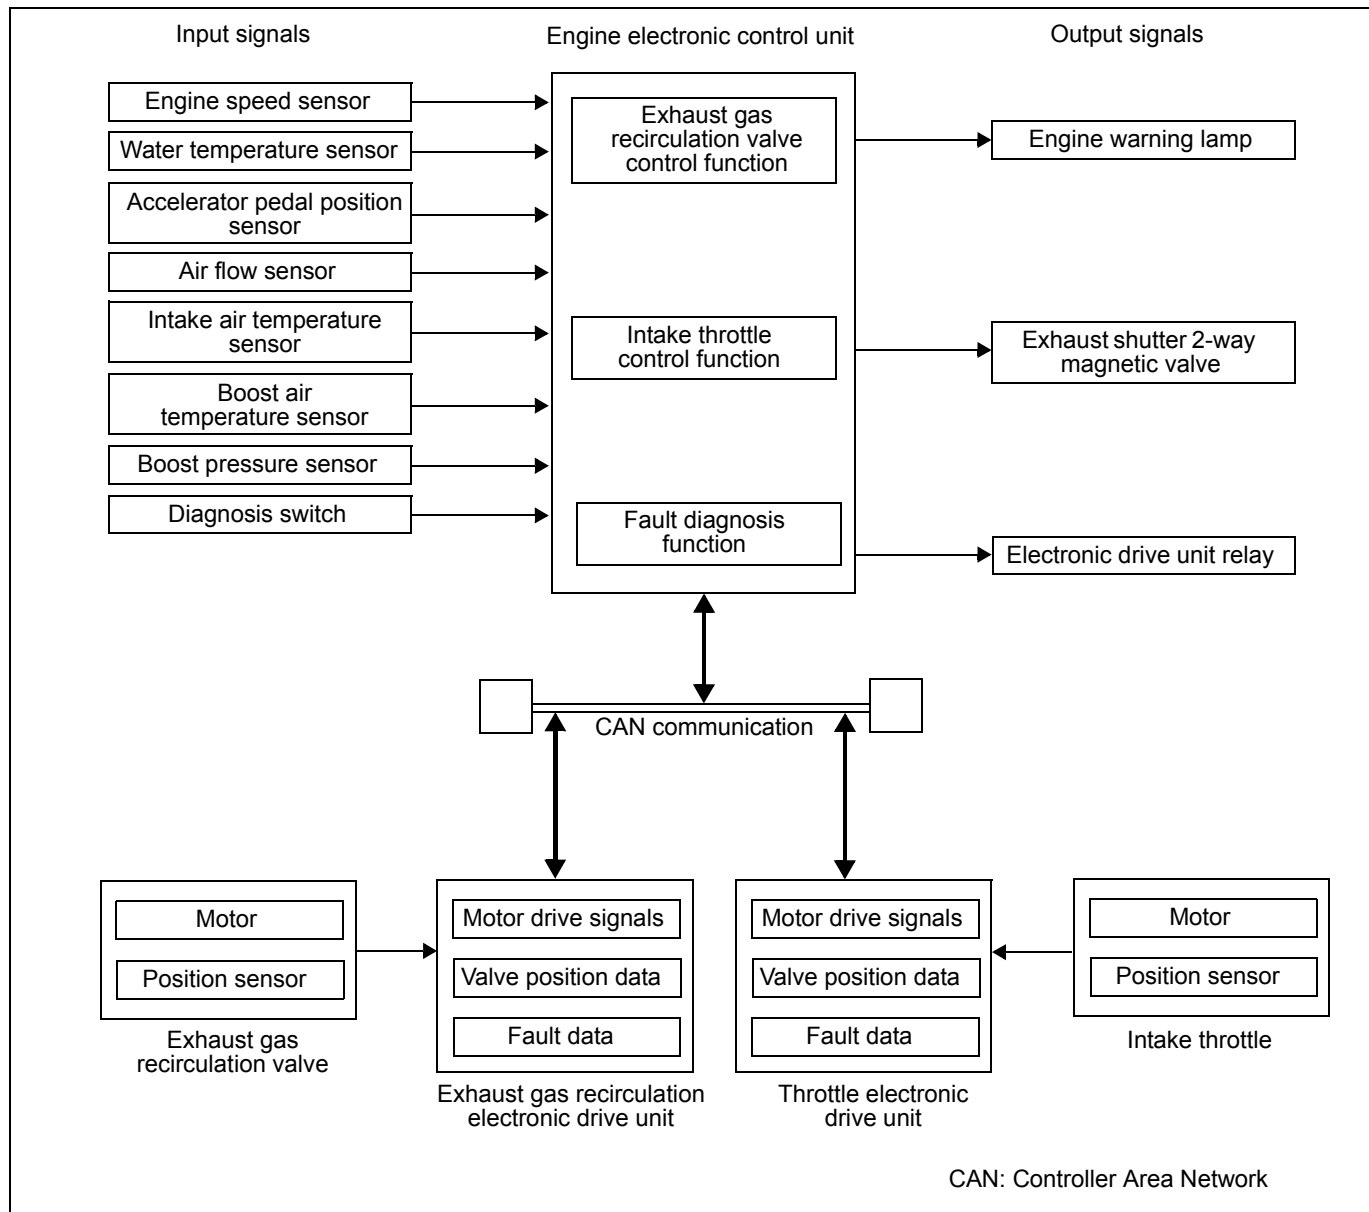
### (1) System block diagram

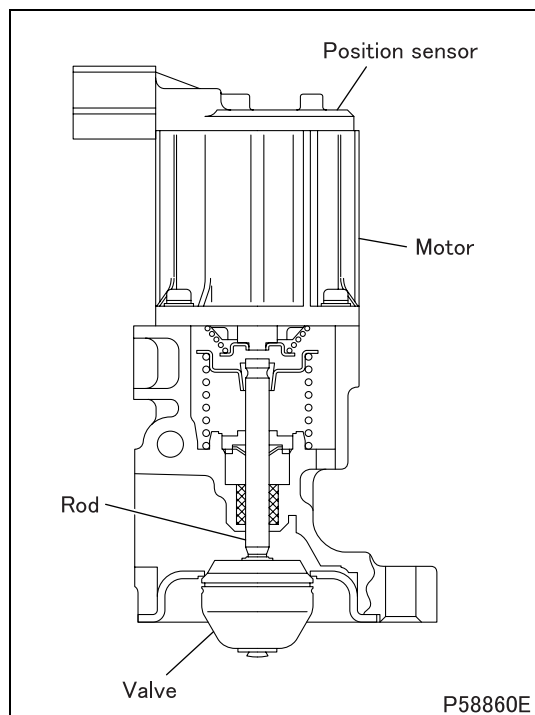
### (2.1) Exhaust gas recirculation valve

- A motor in the exhaust gas recirculation valve is driven by control signals from the exhaust gas recirculation electronic drive unit. Via a rod, the motor's operation opens and closes the valve.

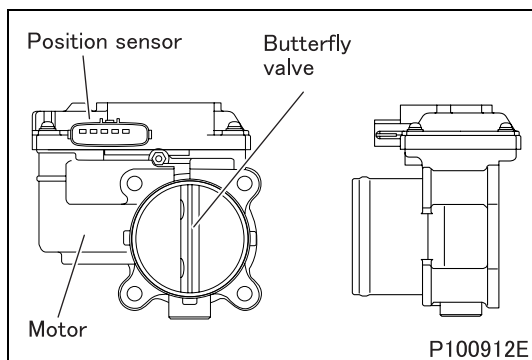
### (3.1) Intake throttle

- In accordance with signals from the throttle electronic drive unit, the motor opens and closes the butterfly valve, thereby adjusting the intake air amount such that the effectiveness of exhaust gas recirculation is maximized.

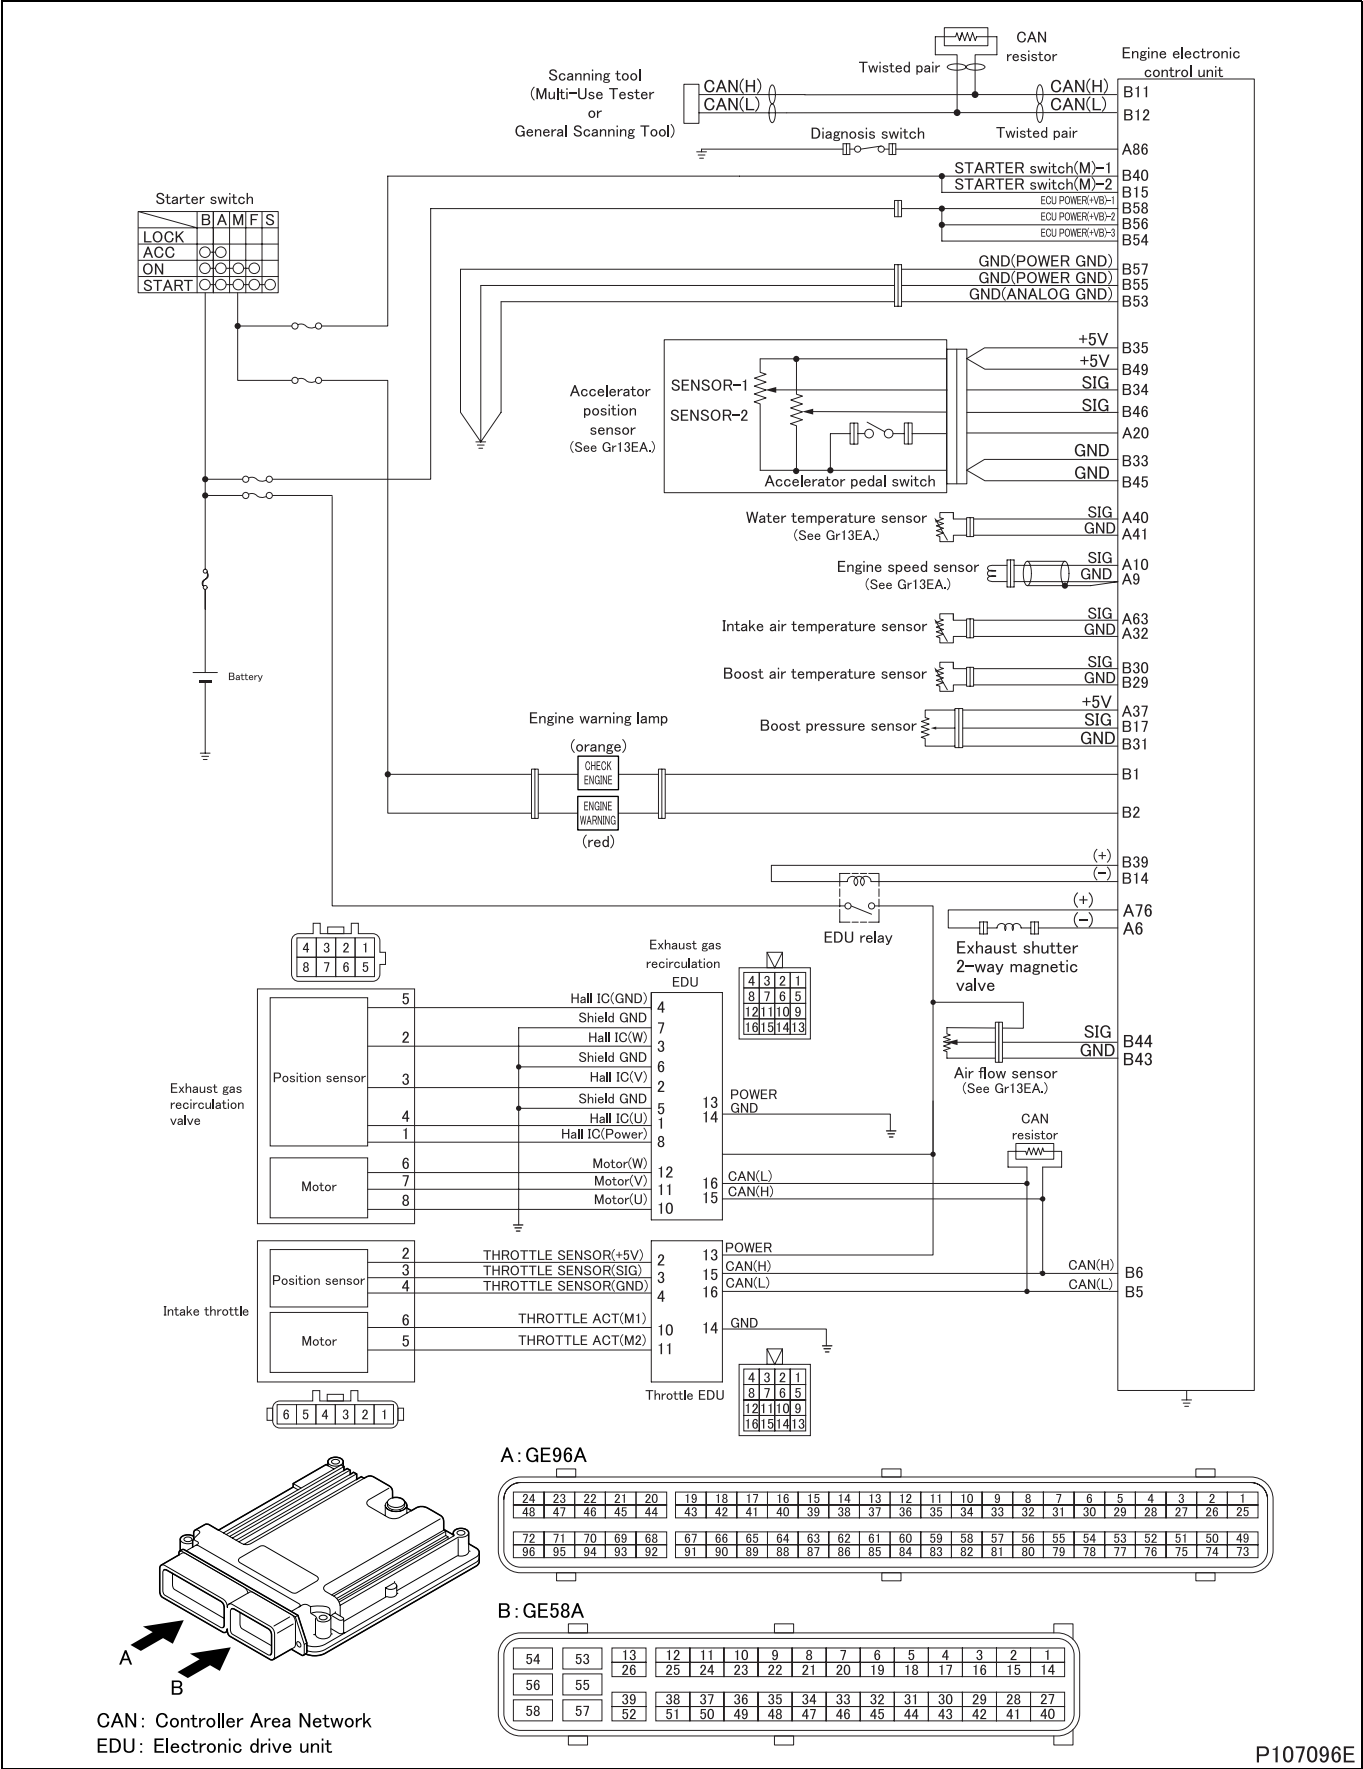
## 1.3 Electronic control unit connection diagram

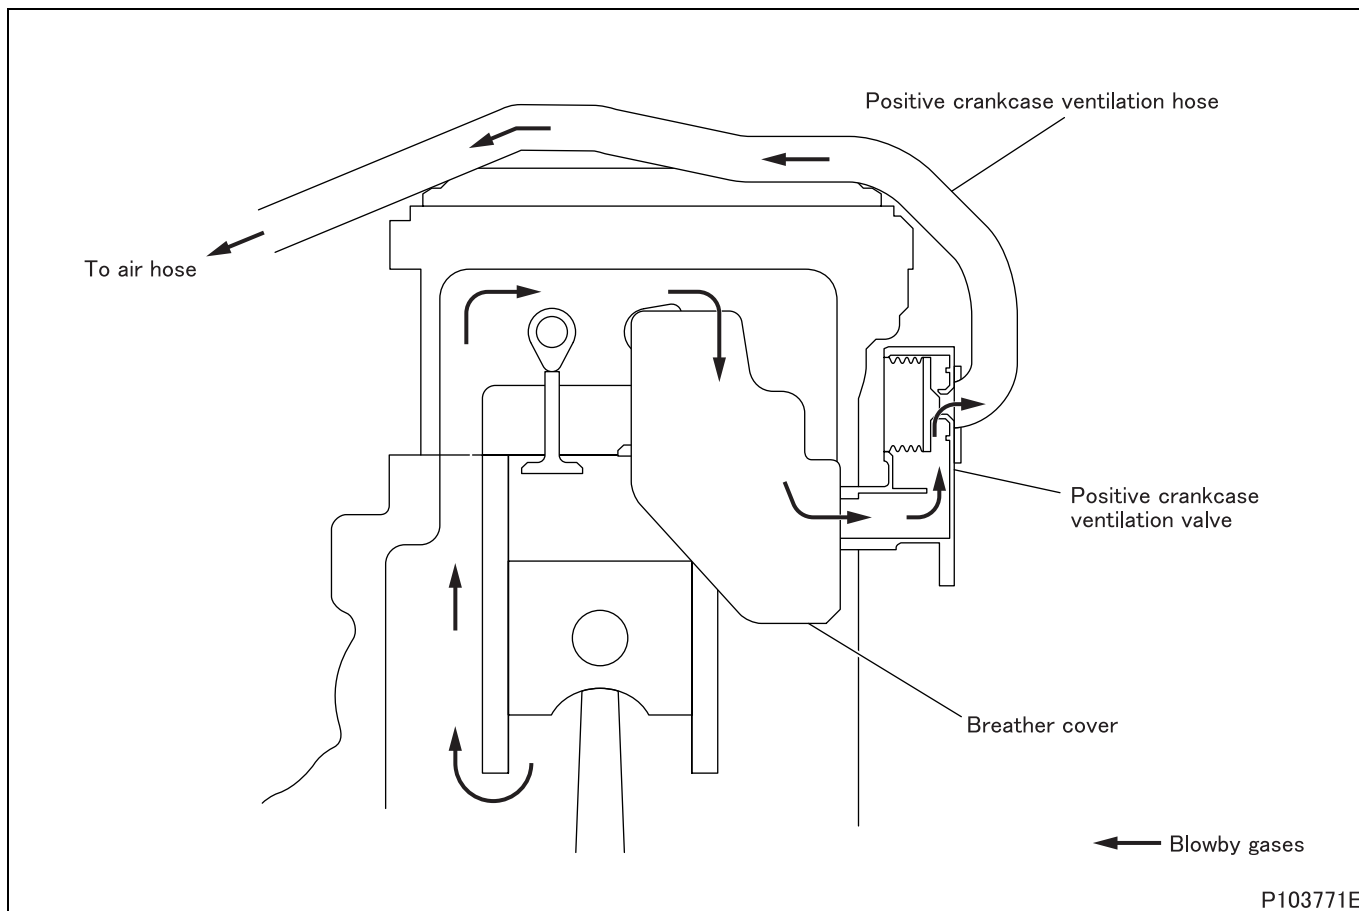
## 2. Crankcase Emission Control System

- The crankcase emission control system returns blowby gases to an air duct to prevent them from being released to the outside air.
- The positive crankcase ventilation valve keeps constant the pressure inside the crankcase.

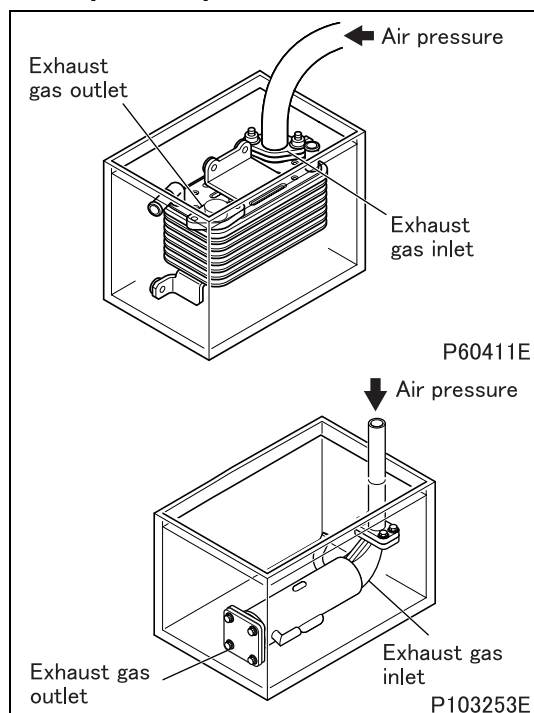
### ■ Inspection: Exhaust gas recirculation cooler

- Perform the following inspection. If any abnormality is found, replace the exhaust gas recirculation cooler.

- Fit a cover over the exhaust gas outlet of the exhaust gas recirculation cooler, and connect a hose to the exhaust gas inlet. Then, submerge the exhaust gas recirculation cooler in a container of water. Make sure the coolant passage is full of water.
- Apply specified air pressure through the hose. Check that air does not leak from any part of the exhaust gas recirculation cooler.

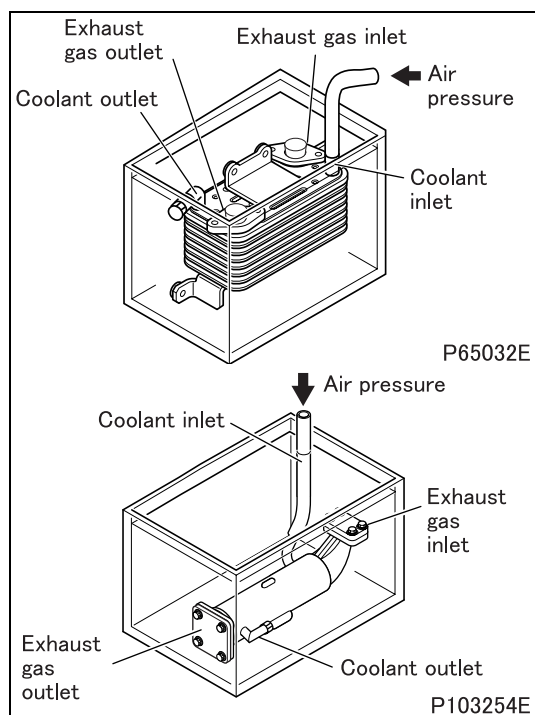
## (2) Coolant passage side

- Fit covers over the exhaust gas recirculation cooler's exhaust gas inlet, exhaust gas outlet, and coolant outlet, and connect a hose to the coolant inlet. Then, submerge the exhaust gas recirculation cooler in a container of water.
- Apply specified air pressure through the hose. Check that air does not leak from any part of the exhaust gas recirculation cooler.

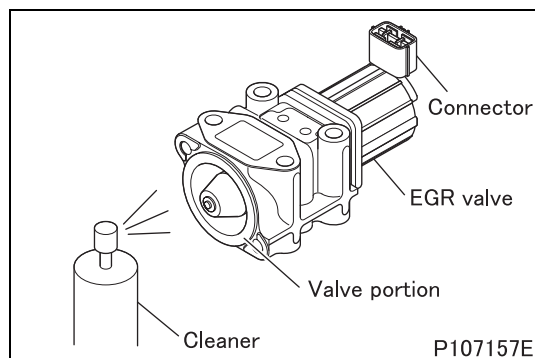
## ■ Inspection: Exhaust gas recirculation valve

- Check that the valve portion is free of soot, oily substance, etc.
- If not, clean the valve portion as follows.
- Spray a cleaner on the valve portion from 2 or 3 cm {0.79 or 1.18 in.} away.  
Recommended cleaners:  
Nonchlorinated solvent
- In 20 to 30 seconds after spraying, wipe the valve portion clear of the sprayed cleaner using a soft waste cloth the like.

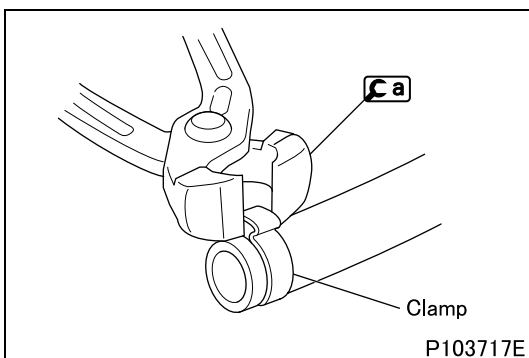
#### ■ Removal: Clamp

- To remove the clamp, cut the clamp using **Ca**.

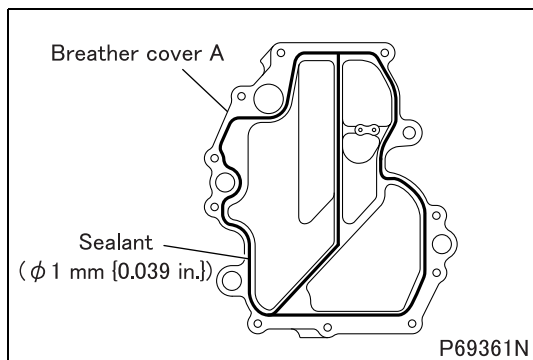
### ■ Installation: Breather cover A

- Clean the sealant application surfaces of each part.
- Apply a bead of sealant to the breather cover A evenly and without any breaks as shown in the illustration.
- Install the lower crankcase within three minutes of applying the sealant to the upper crankcase, being careful not to dislodge the sealant.

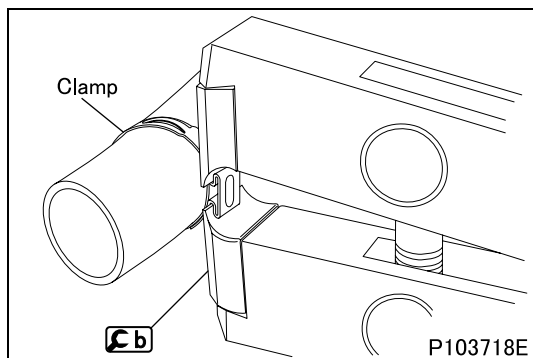
### ■ Installation: Clamp

- Pinch the projecting part of the clamp with

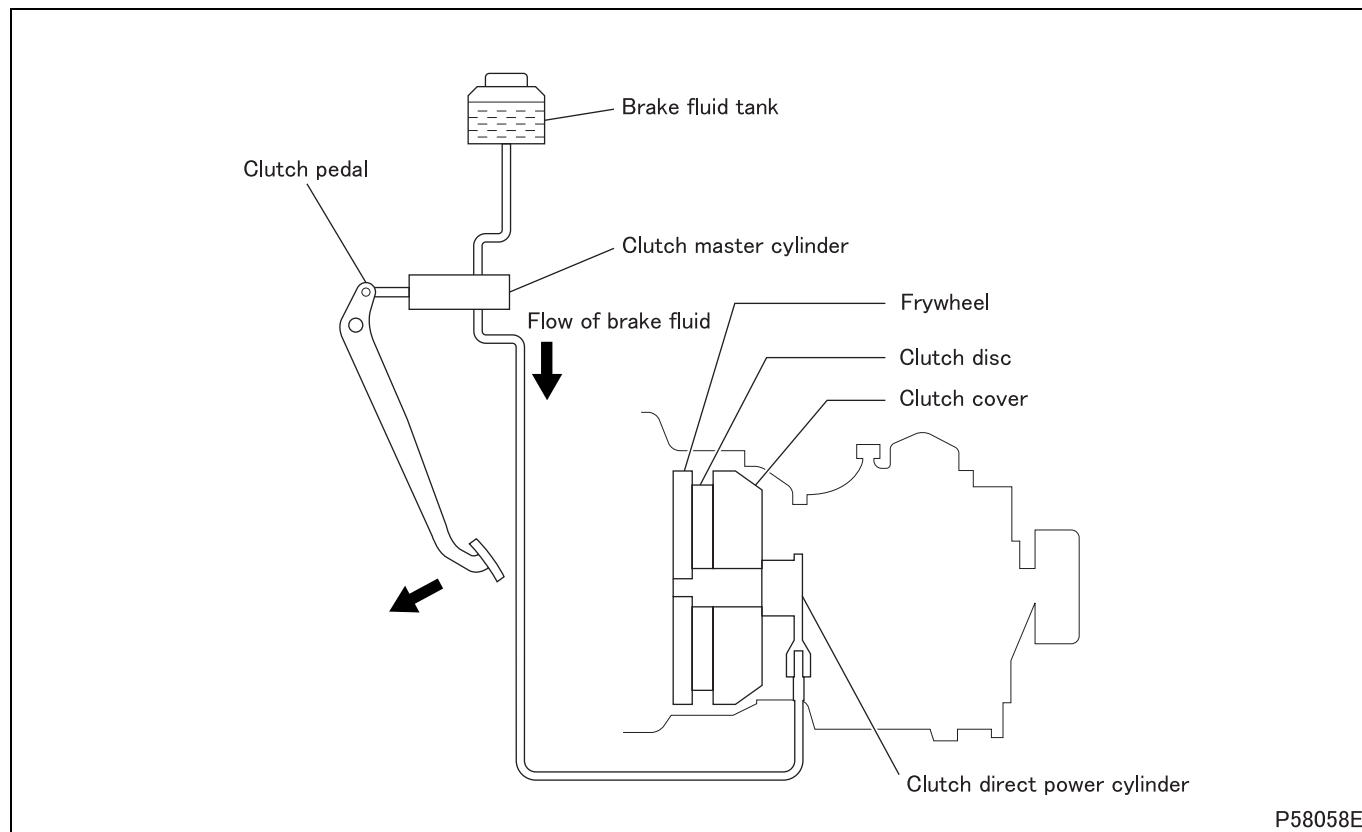
## 1. Clutch Control

- Fluid pressure is used to control the clutch operation.
- When the clutch pedal is pressed, the boosted force is then applied to the clutch master cylinder. This pressurizes the brake fluid inside the clutch master cylinder, pushing the clutch direct power cylinder and disengaging the clutch.

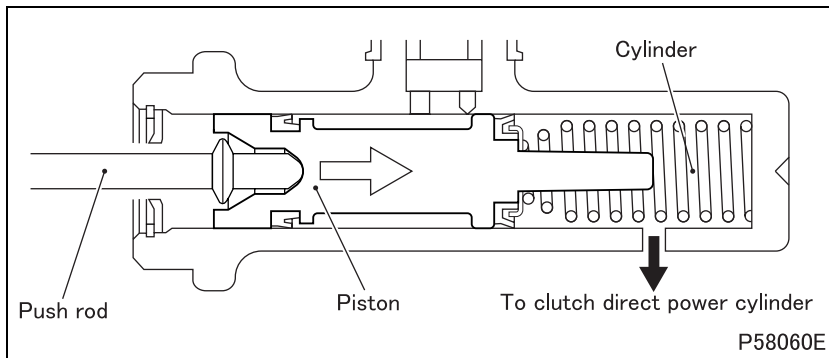
### 2.1 When clutch pedal is pressed

- The piston is pushed to the right by the push rod, pressurizing the brake fluid in the cylinder.
- This brake fluid pressure is transmitted to the clutch direct power cylinder.

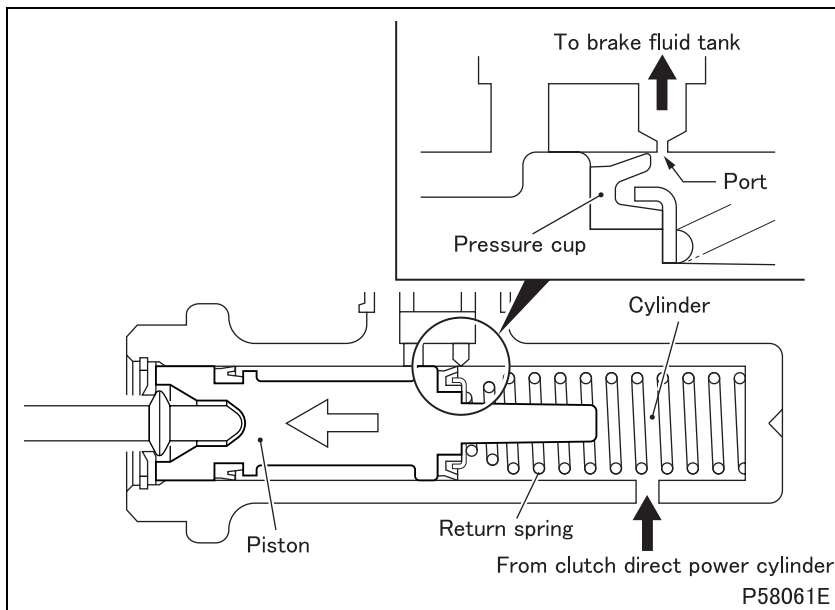
## 2.2 When clutch pedal is released

- The piston is pushed back to the left by the combined force of oil pressure from the clutch direct power cylinder and the return spring.
- This opens up the port that has been blocked by the pressure cup, connecting the cylinder to the brake fluid tank. This allows the oil pressure to completely drain to the tank.

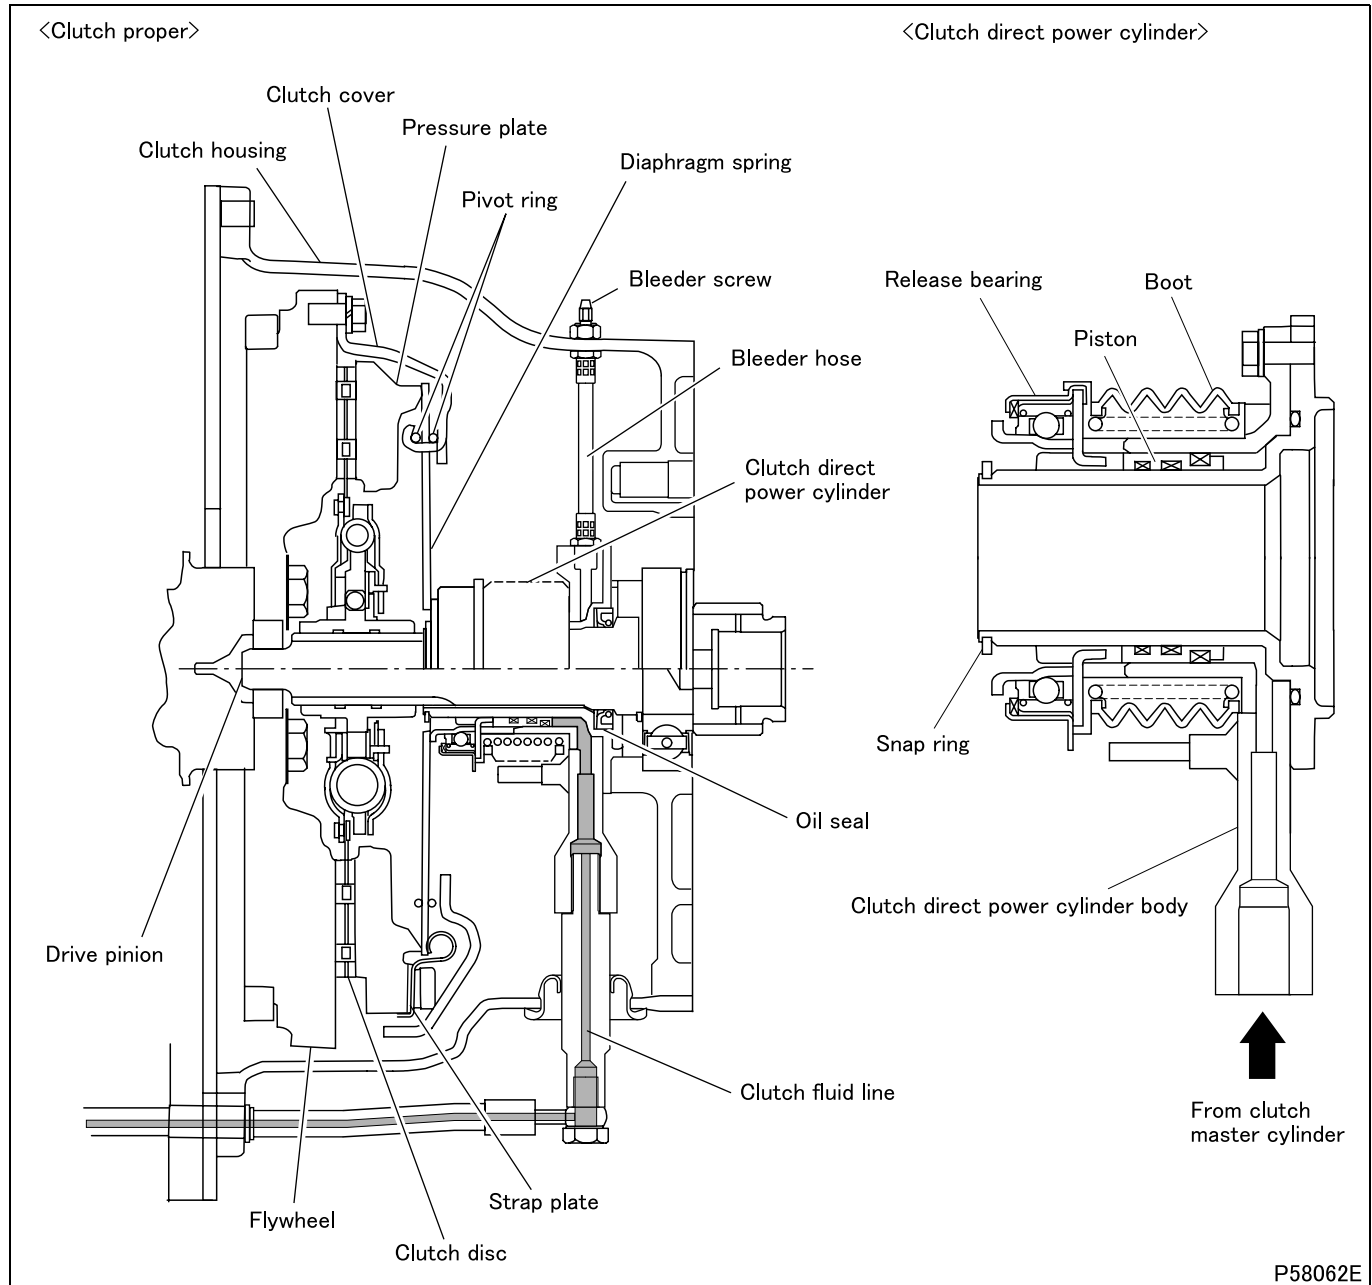
## 3. Clutch Proper and Clutch Direct Power Cylinder

- Clutch engagement and disengagement are controlled by the brake fluid pressure from the clutch master cylinder acting on the piston of the clutch direct power cylinder, and are achieved by the operation of the piston and the release bearing.

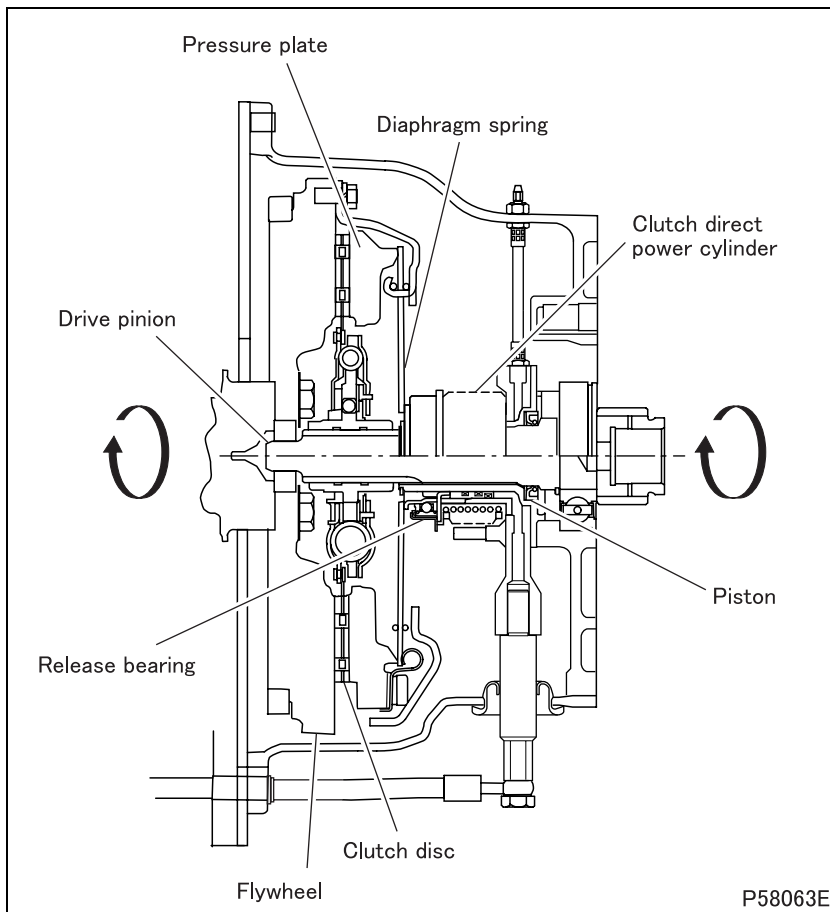
### 3.1 When clutch pedal is released

- There is no brake fluid pressure acting on the clutch direct power cylinder. The piston and release bearing remain in their home positions.
- The force of the diaphragm spring acts on the pressure plate, which in turn keeps the clutch disc pressed against the flywheel.
- Pressed against the flywheel, the clutch disc rotates together with the flywheel and transmits the engine power to the transmission drive pinion.

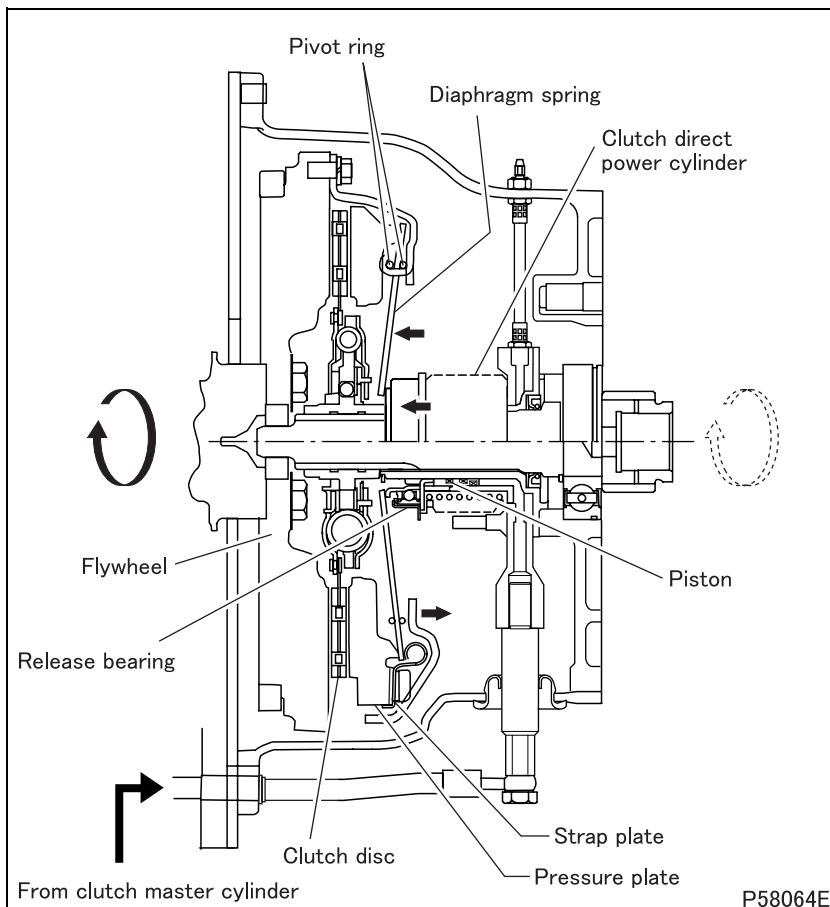
### 3.2 When clutch pedal is pressed

- Brake fluid pressure from the clutch master cylinder moves the piston in the clutch direct power cylinder.
- As it moves, the piston pushes the release bearing, which in turn pushes the diaphragm spring.
- The diaphragm spring pivots around the pivot ring. This movement, via the strap plate, causes the pressure plate to retract from the flywheel. As a result, the clutch disc separates from the flywheel, cutting off the transmission of engine power to the transmission.

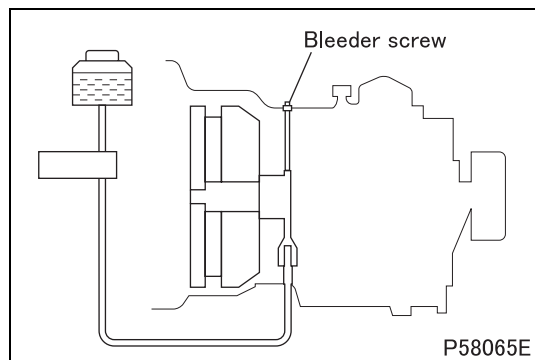
#### 1.1 Work before replacement

- Install one end of a vinyl pipe onto the bleeder screw. Place the loose end into a container.

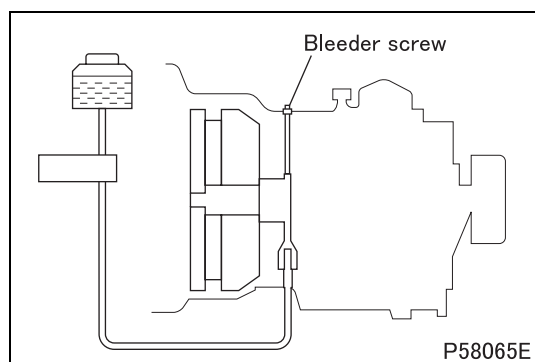
### 2.1 Work before air bleeding

- Install one end of a vinyl pipe onto the bleeder screw. Place the loose end into a container.

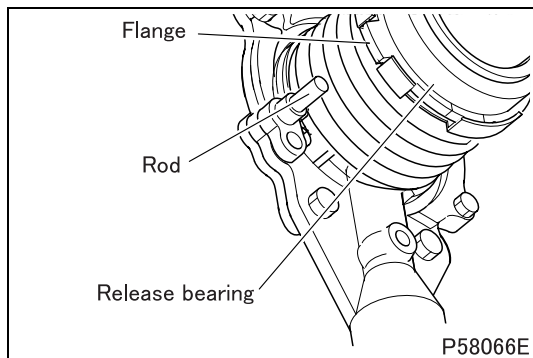
## 3. Inspection of Clutch Disc Wear Limit

- Remove the grommet from the clutch housing and make sure that the rod of the clutch direct power cylinder does not reach the flange of the release bearing.
- If the rod reaches the flange, replace the clutch disc.
