# FE.FG

## SERVICE MANUAL 2008 Model FOREWORD

This Service Manual contains maintenance and repair methods for the Mitsubishi Fuso Truck FE. FG Series. Read this manual carefully as an aid in providing correct, efficient maintenance. Please note that the information and specifications contained within this manual may change without notice. This is due to product modifications and continued vehicle improvements that are made throughout the model years. Should you encounter any discrepancy in the information provided, please do not hesitate to contact your nearest Mitsubishi Fuso Dealer or Mitsubishi Fuso Truck of America, Inc.

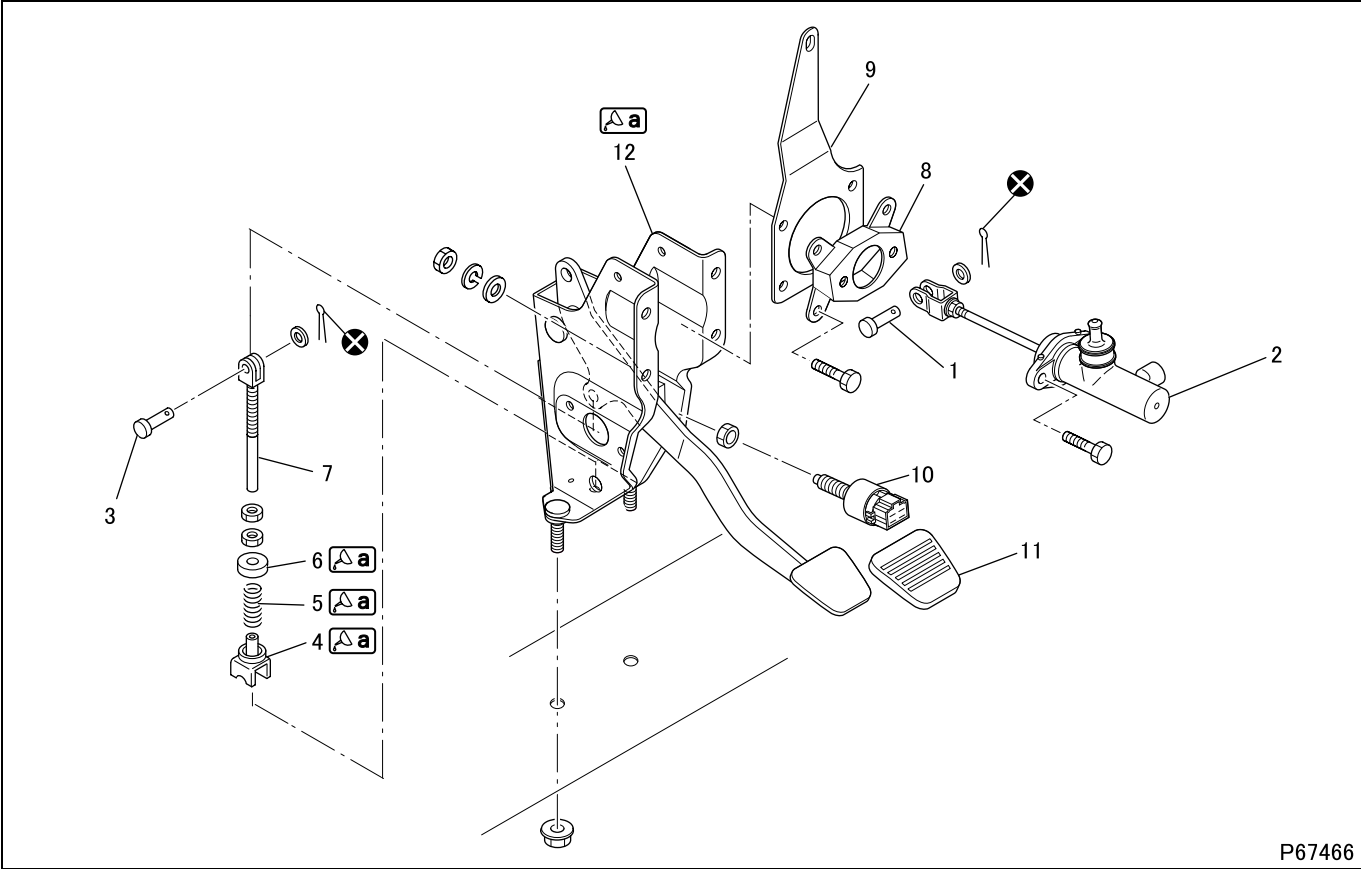
P67466

| Location | Maintenance item | Standard value | Limit | Remedy |
|---|---|---|---|---|
| 5 | Return spring load (installed length: 35.6 {1.40}) | 225 N<br>{51 lbs., 23.1 kgf} | 205 N<br>{46 lbs., 20.8 kgf} | Replace |
| 12 | Clutch pedal free play | 0.2 to 4.0<br>{0.0079 to 0.16} | — | Replace |

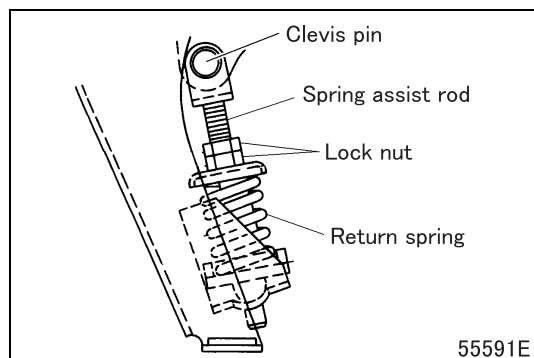
#### ■ Removal: Spring assist rod

- Loosen the lock nut to release the load on the return spring. Then, remove the clevis pin and remove the spring assist rod.

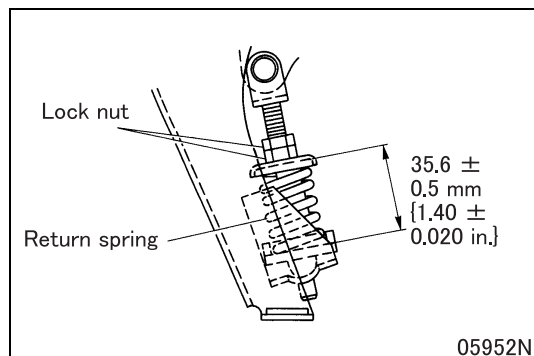
#### ■ Adjustment: Return spring

- Tighten the lock nut such that the return spring is set to the illustrated length.

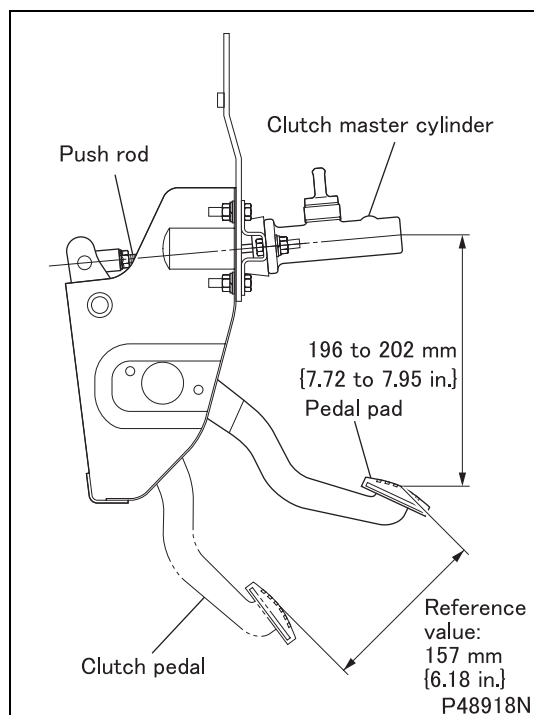
#### ■ Adjustment: Clutch pedal

- Adjust the push rod of the clutch master cylinder such that the distance between the center of the clutch pedal pad and the center of the clutch master cylinder is set to the value indicated in the drawing.

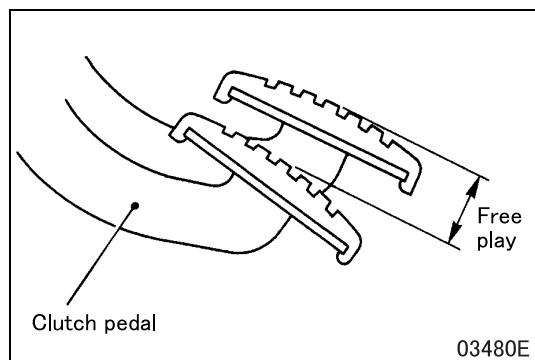
## ■ Inspection: Clutch pedal free play

- After installing the clutch master cylinder, check the clutch pedal free play as follows.
- Using a finger, press the clutch pedal pad in the center until resistance is felt. Measure the distance that the pedal has traveled.

- **Do not press the clutch pedal pad until a second resistance is felt (which is the point at which the clutch master cylinder's push rod contacts the piston).**

- If the measured distance does not conform to the standard value, replace the clutch pedal.

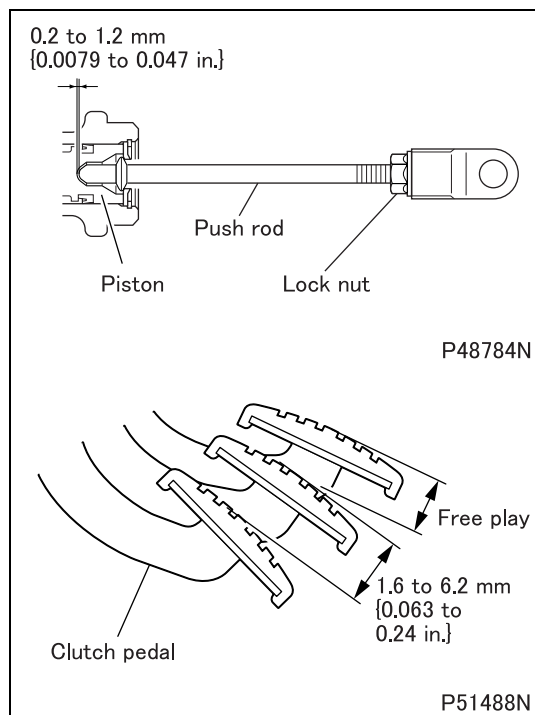
## ■ Adjustment: Clearance between clutch master cylinder's push rod and piston

- Adjust the clearance between the clutch master cylinder's push rod and piston by using the clutch pedal as follows.
- Using a finger, press the clutch pedal in the center.
- Set the pedal travel, from the point at which the first resistance is felt to the point at which the second resistance is felt, to the illustrated value. (This distance corresponds to the clearance between the push rod and the piston.) This is done by turning the push rod in or out.
- With the pedal travel set to the illustrated value, the push rod-to-piston clearance should conform to the standard value.
- After the adjustment, tighten the lock nut to the specified torque.

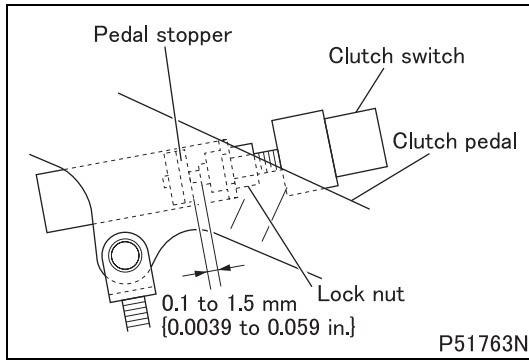
■ **Adjustment: Clearance between clutch switch (for exhaust brake) and pedal**

- With the clutch pedal adjusted as above, set the clearance between the end of the threaded portion of the clutch switch and the pedal stopper to the value indicated in the drawing. Tighten the locknut.

- **Do not allow the threaded end of the clutch switch to come into contact with the clutch pedal stopper during the adjustment operation.**

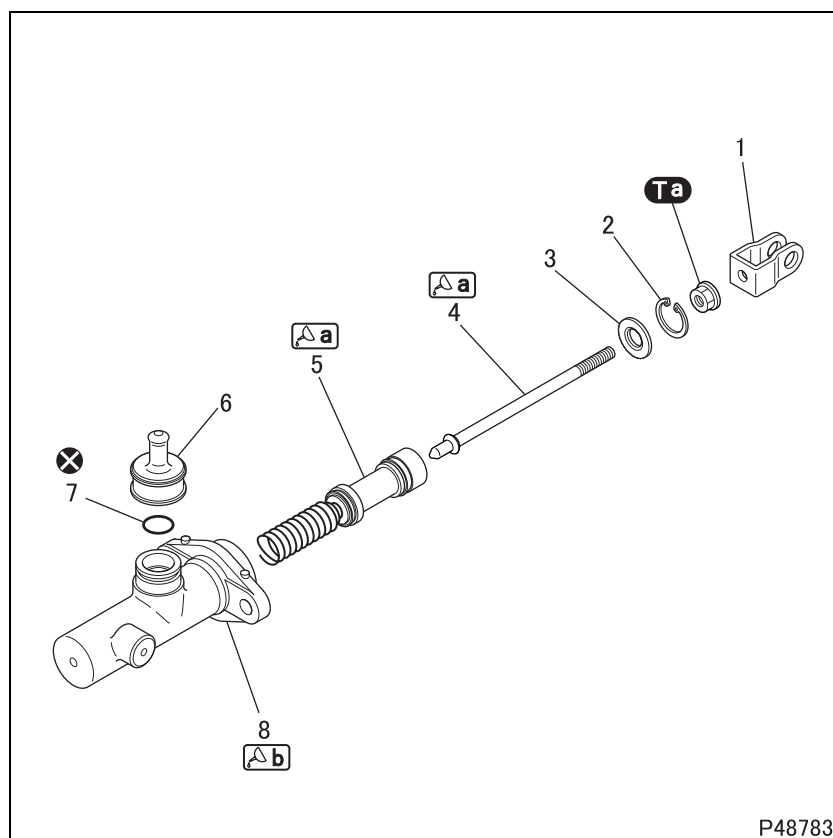
## Disassembly sequence

- 1 Clevis
- 2 Circlip
- 3 Stop plate
- 4 Push rod
- 5 Piston
- 6 Union collar
- 7 O-ring
- 8 Cylinder body

| Location | Maintenance item | Standard value | Limit | Remedy |
|---|---|---|---|---|
| 5, 8 | Clearance between piston and cylinder body | 0.02 to 0.1<br>{0.00079 to 0.0039} | 0.2<br>{0.0079} | Replace |

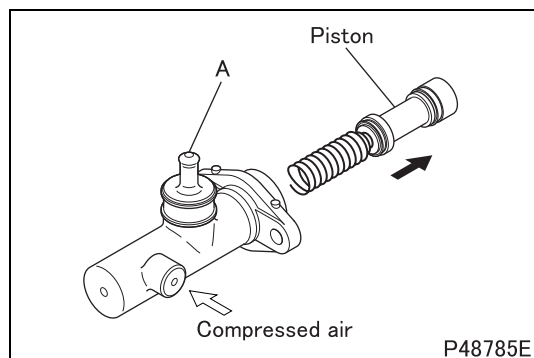
### Removal: Piston

- With opening A blocked, feed compressed air gradually starting from 0 kPa {0 psi, 0 kgf/cm<sup>2</sup>} to remove the piston.

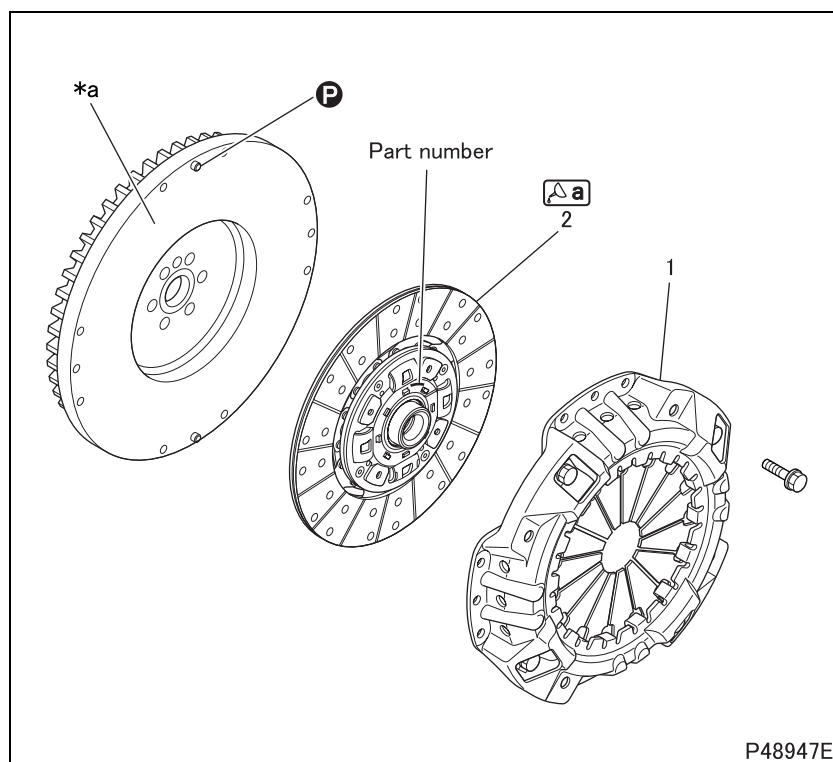
## ● Removal sequence

- 1 Clutch cover
- 2 Clutch disc

| Location | Maintenance item | | Standard value | Limit | Remedy |
|---|---|---|---|---|---|
| 1 | Pressure plate flatness | | — | 0.05<br>{0.0020} | Replace |
| 2 | Clutch disc | Depth from facing surface to rivet | 1.8 to 2.4<br>{0.071 to 0.094} | 0.2<br>{0.0079} | Replace |

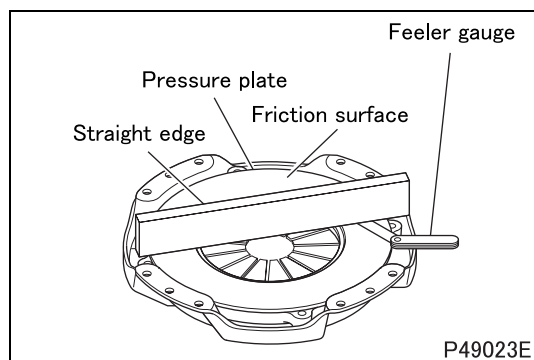
#### ■ Inspection: Clutch cover

##### (1) Pressure plate flatness

- Place a straight edge across the friction surface of the pressure plate. Using a feeler gauge, measure the clearance between the gauge and the surface in several locations selected randomly.
- Obtain the flatness of the pressure plate by subtracting the smallest clearance measured from the greatest clearance measured.
- If the flatness is equal to or exceeds the specified limit, replace the clutch cover.

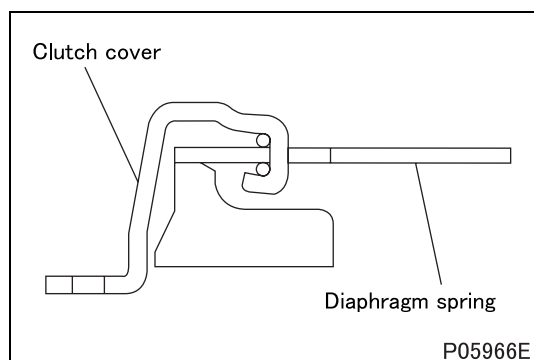
## (2) Inspection of diaphragm spring

- Inspect the diaphragm spring for play.
- If the spring has play, the clutch cover needs to be replaced.

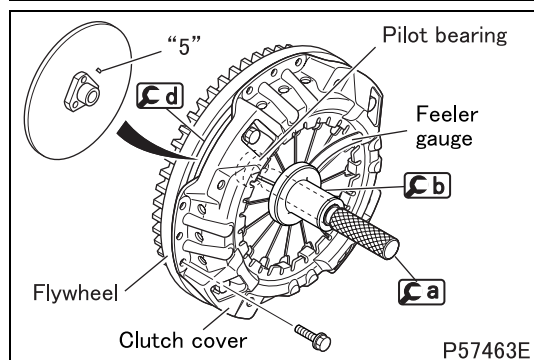
## (3) Installed height of diaphragm spring

- Using **C a**, install **C c** (in place of the clutch disc) and the clutch cover.
- Install **C b** and check for unevenness in height of the fingers using a feeler gauge.
- If the unevenness exceeds the limit, replace the clutch cover.

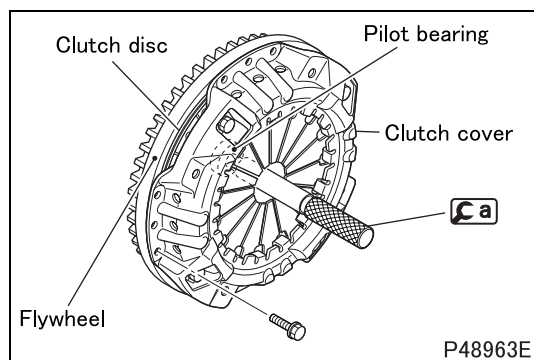
## ■ Installation: Clutch disc

- Insert **C a** into the flywheel pilot bearing to support the clutch disc.
- Install the clutch cover by tightening the bolts diagonally and gradually.

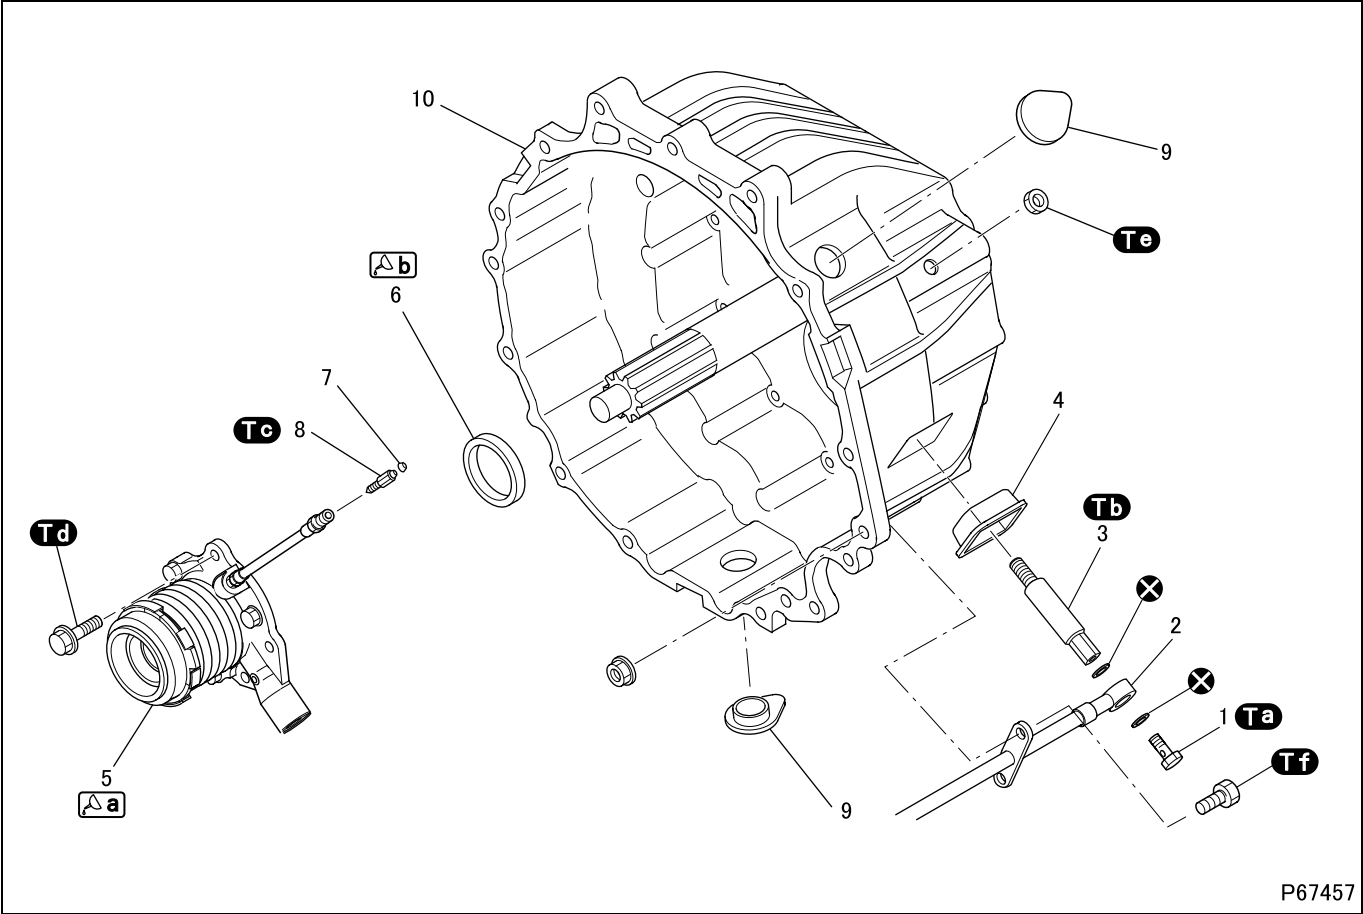
P67457

- When handling the clutch direct power cylinder, be careful not to smear it with mineral oil such as engine oil and transmission oil. The smeared cylinder can cause brake fluid leakage.

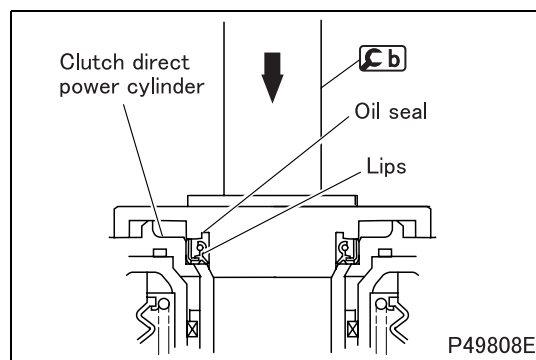
### ■ Installation: Oil seal

- Apply grease onto the oil seal lips. Then, install the oil seal onto the clutch direct power cylinder making sure that the seal faces as shown in the drawing.

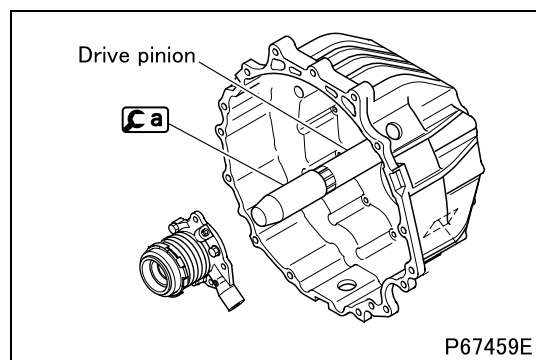
### ■ Installation: Clutch direct power cylinder

- After cleaning the sealant application surfaces, apply sealant as required.
- Install

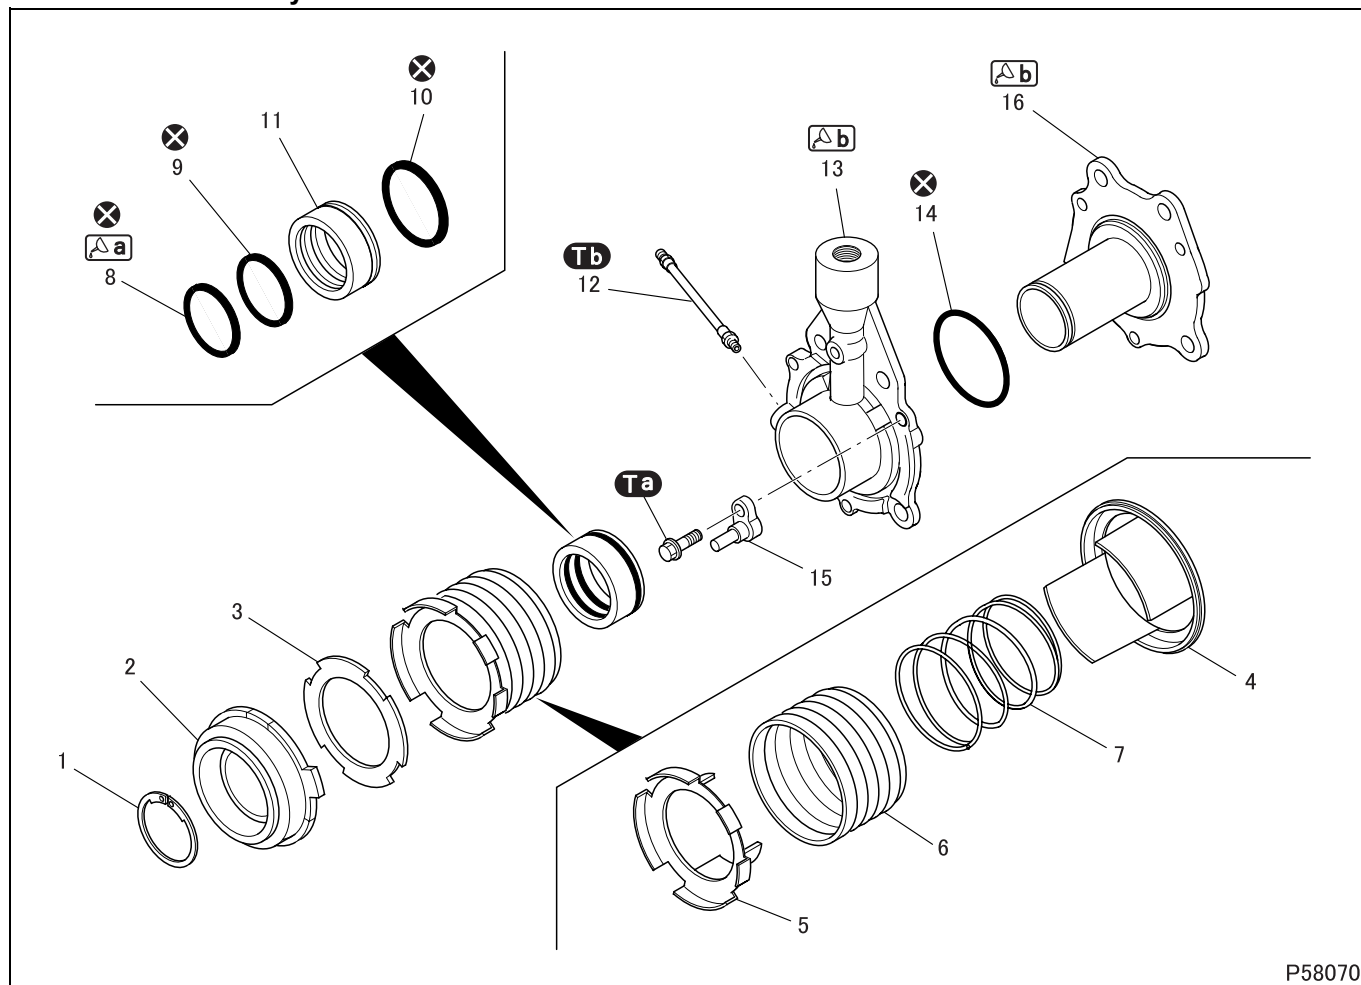
P58070

- Remove the bleeder only when cylinder body A is being replaced. Because removing the bleeder may cause the thread deformation of the cylinder body A. Therefore you must replace the cylinder body A when removing the bleeder once. Reusing the body causes oil leak.

- Install the piston correctly: It needs to be faced as shown in the drawing, and the cups should not be dislodged. An incorrectly installed piston causes brake fluid leakage and clutch drag.

- Install the front inner cup, rear inner cup, and outer cup correctly, facing them in the illustrated directions. Incorrectly installed cups cause brake fluid leakage and clutch drag.
- Do not apply grease onto the rear inner cup or the outer cup. Otherwise, brake fluid will leak.
- Apply only a thin coat of grease to the front inner cup. Greasing it too much can cause brake fluid leakage.

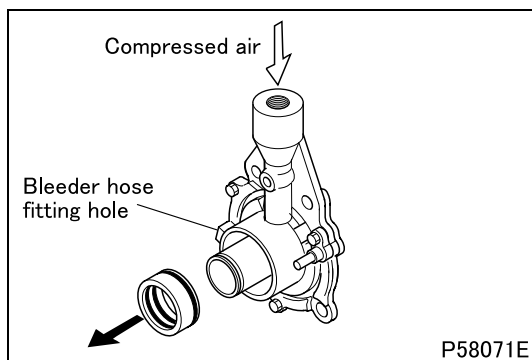
**■ Removal: Piston**

- With the bleeder hose fitting hole of cylinder body A blocked, feed compressed air gradually starting from 0 kPa {0 psi, 0 kgf/cm<sup>2</sup>} to remove the piston.

- Do not apply compressed air suddenly at high pressure, or the piston will fly out with full force.

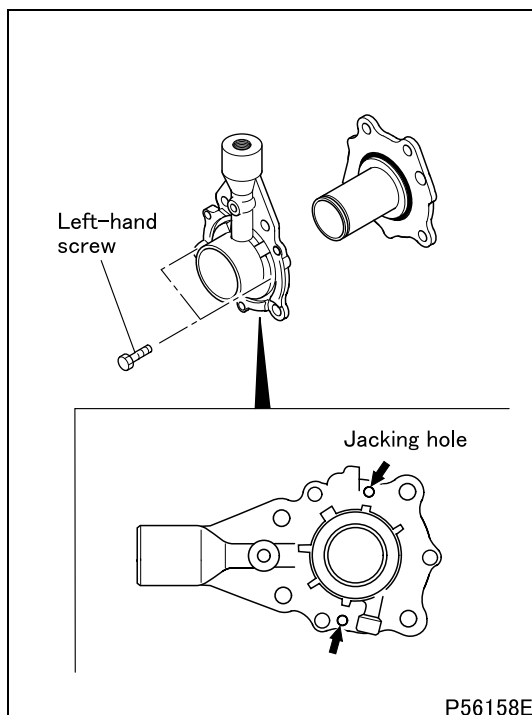
**■ Removal: Cylinder body A**

- Install left-hand screws (M8 × 1.25 mm) evenly into the jacking holes on cylinder body A and remove the body.

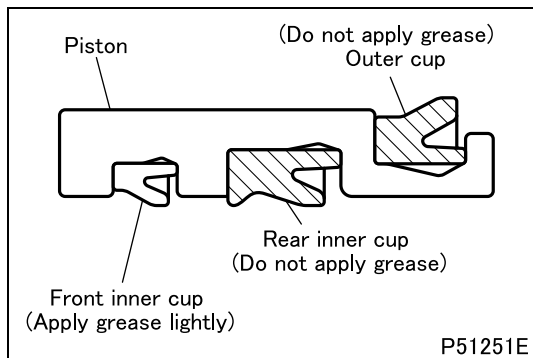
### ■ Installation: Front inner cup, rear inner cup and outer cup

- Install the front inner cup, rear inner cup, and outer cup onto the piston, facing them in the illustrated directions.

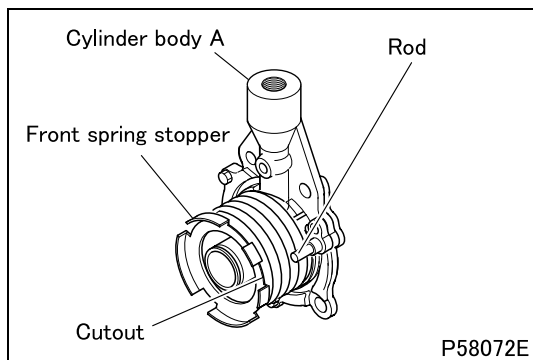
### ■ Installation: Front spring stopper

- Install the front spring stopper onto cylinder body A such that its cutout aligns with the rod on the body and that it faces in the illustrated direction.

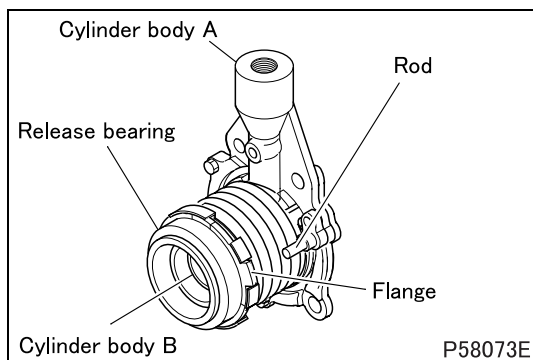
### ■ Installation: Release bearing

- Install the release bearing onto cylinder body B such that its flange aligns with the rod on cylinder body A and that it faces in the illustrated direction.

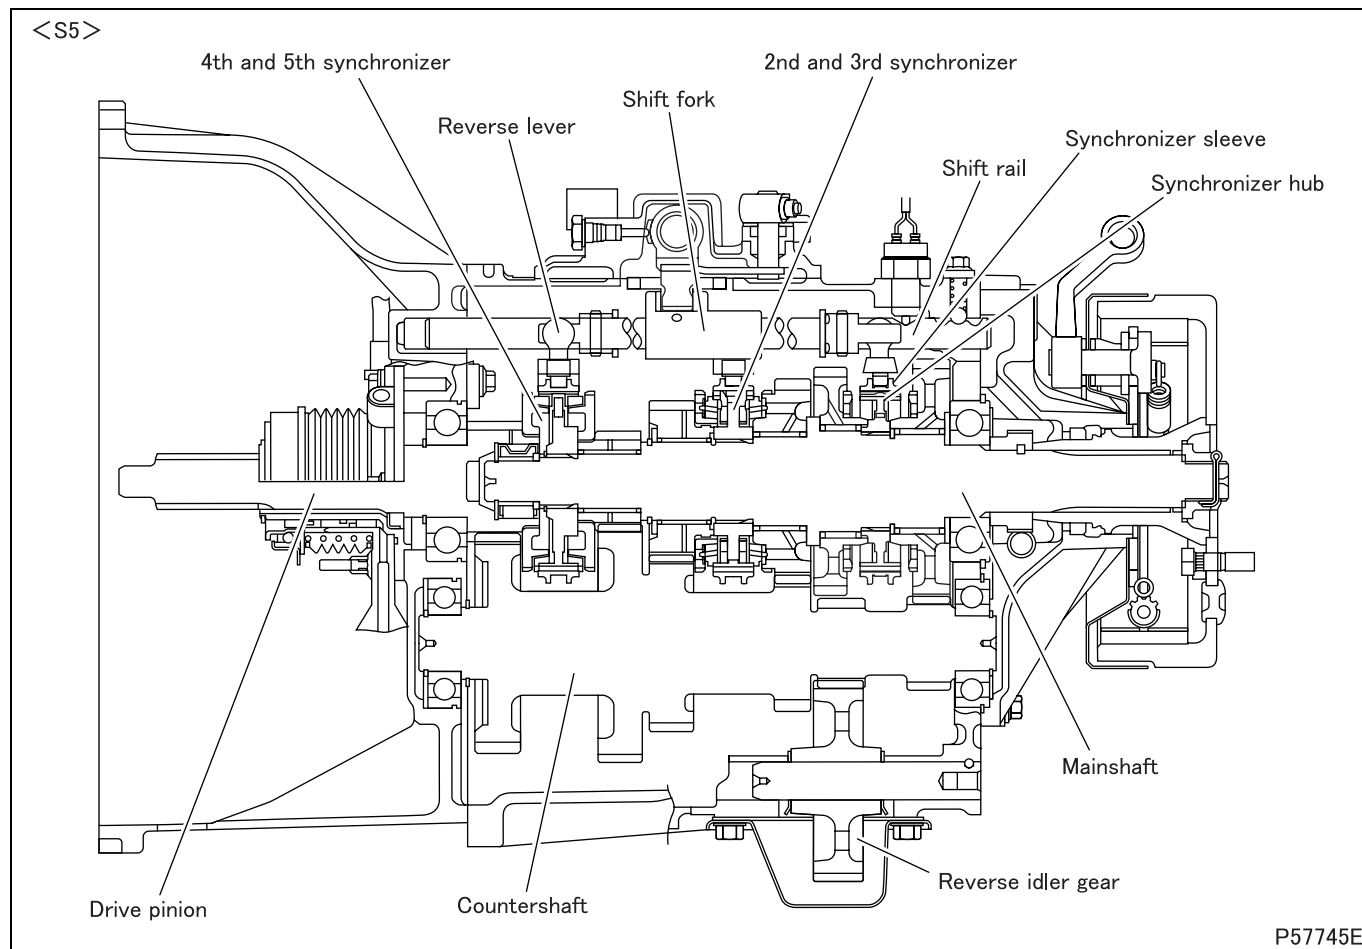
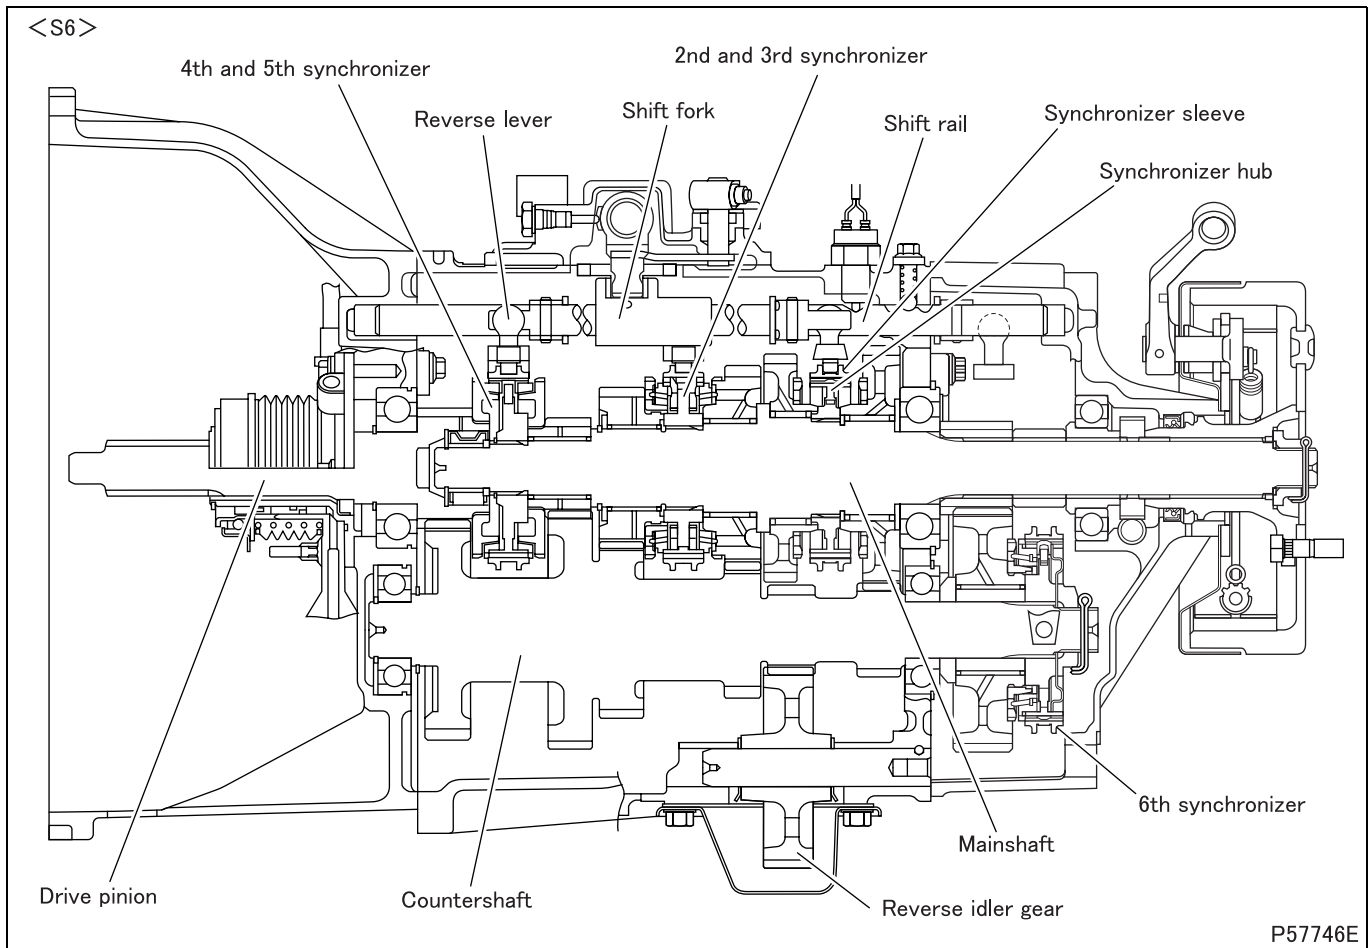
- The transmission changes revolution and torque generated by the engine into those that match the vehicle's power requirement (driving force). The power requirement (driving force) is increased or decreased by making a selection from several sets of engaged gears.
- The transmission uses an interlock mechanism to avoid double engagement.

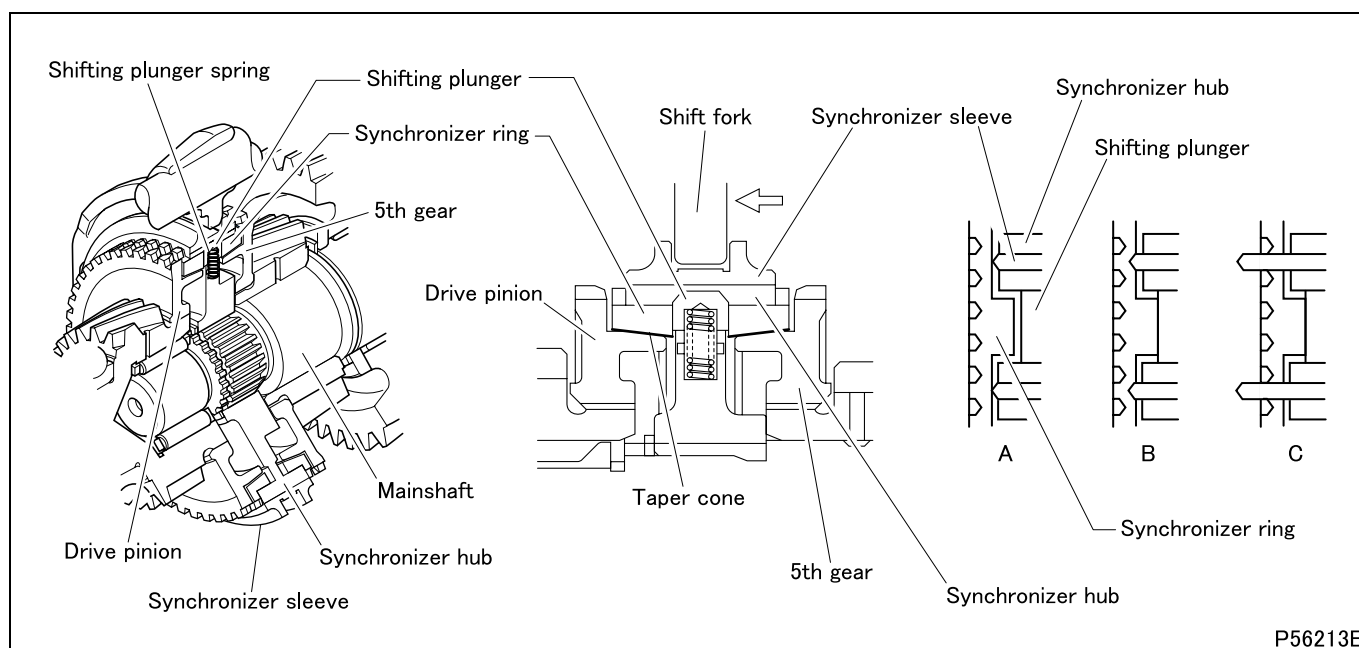
The following descriptions are for 4th gear of 4th and 5th synchronizer assembly.

- The inside of the synchronizer hub engages the spline of the mainshaft and rotates with it. The outside of the synchronizer hub has a spline that engages the synchronizer sleeve and three grooves.

- Shifting plungers are inserted into these grooves. When the gear shift is in neutral, the shifting plungers engage grooves in the synchronizer sleeve and are pressed against the inside of the synchronizer sleeve by shifting plunger springs.

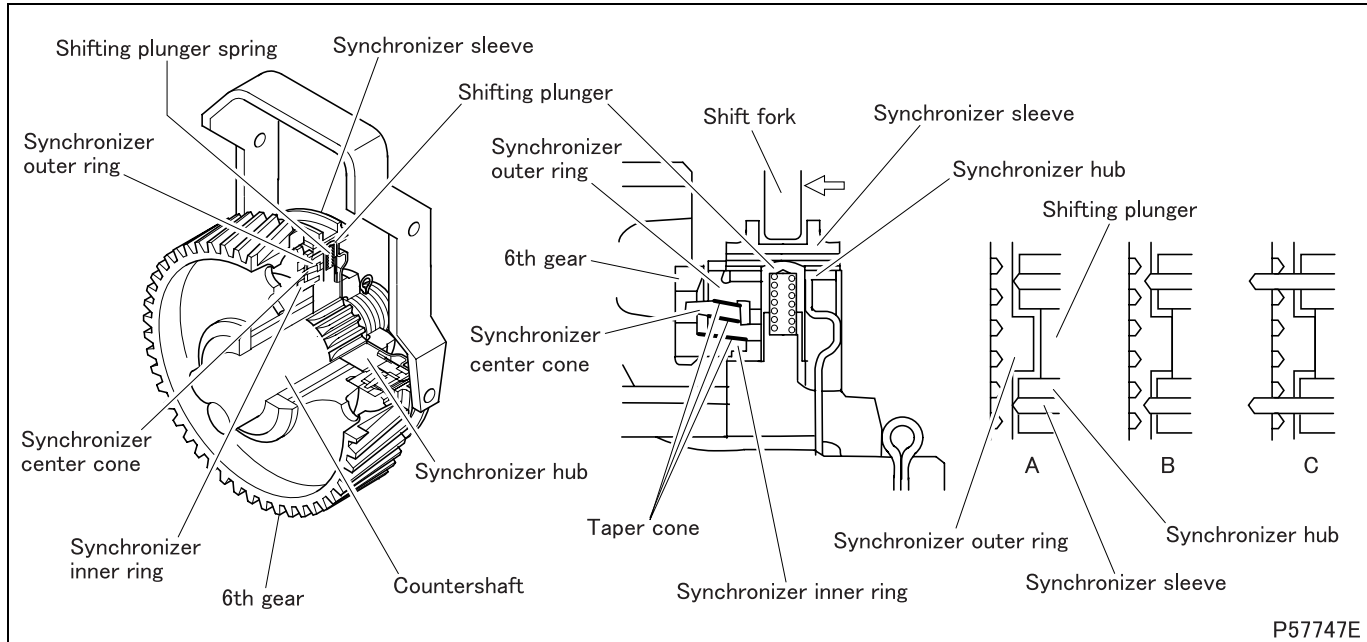
P57747E

The following descriptions are for 6th gear of 6th synchronizer assembly.

- The synchromesh structure and operation of the triple cone type are basically the same as for the single cone type. The synchronizer ring is divided into three parts (synchronizer inner ring, synchronizer center cone and synchronizer outer ring) and the center cone (both the inside and outside surfaces are tapered) and the inner ring (both the inside and outside surfaces are tapered) are sandwiched between the outer ring and the taper cone of each gear to shorten the time required for synchronization with cone clutches at three locations.

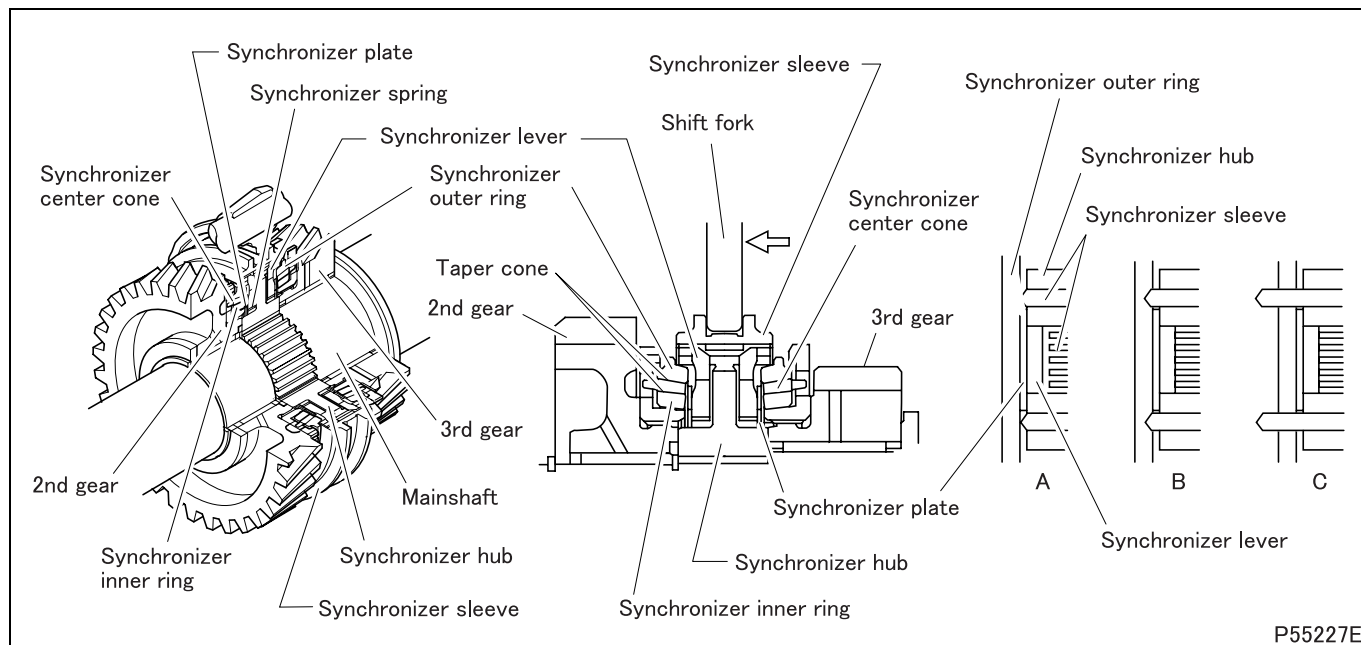
The following descriptions are for 2nd gear of 2nd and 3rd synchronizer assembly.

- The synchronizer ring consists of three elements (synchronizer inner ring, synchronizer center cone and synchronizer outer ring). When a gear is selected, the center cone (having taper cone surfaces on both inner and outer surfaces) and the inner ring (having taper cone surfaces on both inner and outer surfaces) are sandwiched between the outer ring and the taper cone portion of the gear. Since cone clutch actions occur at three places, the mechanism can complete synchronization in a short time.

- Six protrusions on the outside of the synchronizer center cone fit into corresponding gear holes. As in the taper cone of the single cone type, the center cone and the gear are installed as if integrated.

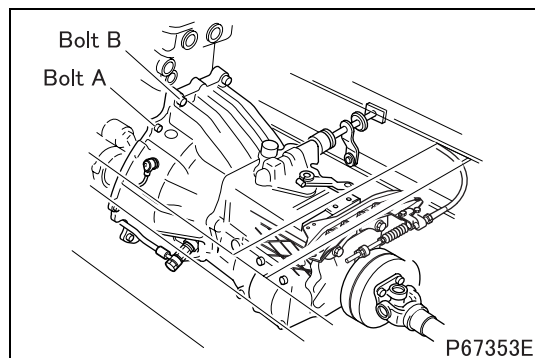
- Check the transmission mounting bolts for looseness.
- Retighten any loose bolt to the specified torque.

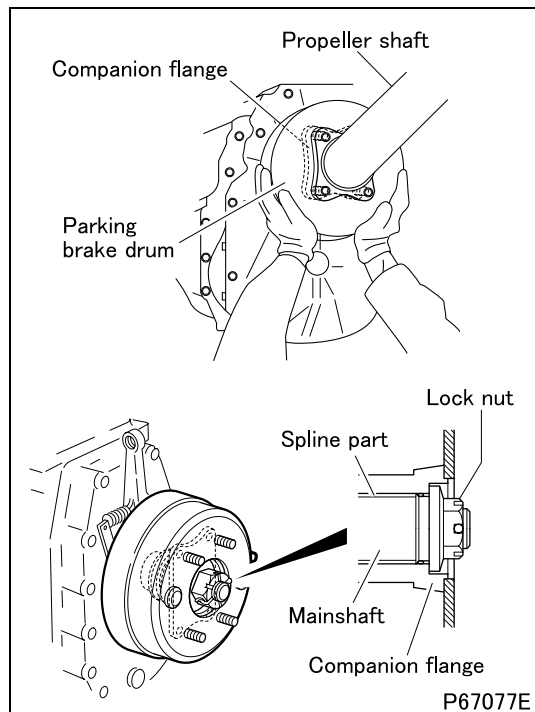
### 3. Inspection of Play in Companion Flange and Looseness in Lock Nut

- Move the parking brake drum in axial and vertical directions to check for excessive play between the companion flange and main shaft.
- If excessive play is detected, remove the propeller shaft, then check the lock nut for looseness and the splines on companion flange and main shaft for abnormalities. If any part is found defective, replace the part. (See "REAR COVER <S5> AND PARKING BRAKE" or "EXTENSION HOUSING <S6> AND PARKING BRAKE" section.)

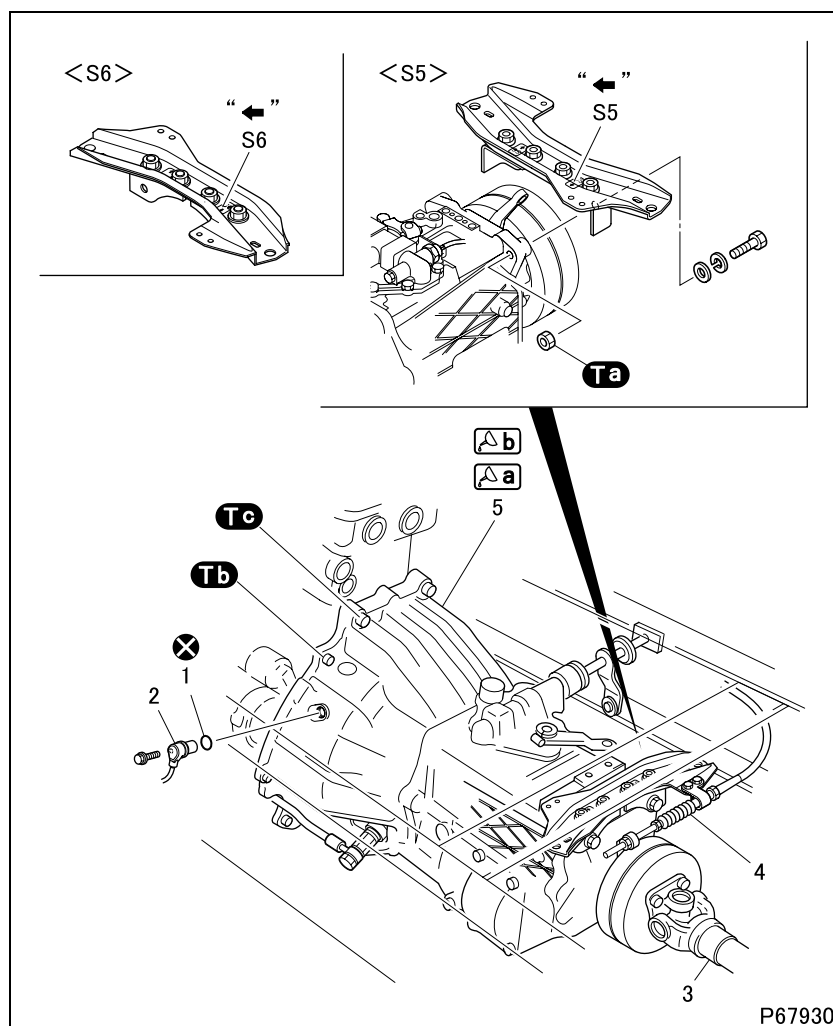
## ● Removal sequence

- 1 O-ring
- 2 Engine speed sensor
- 3 Propeller shaft
- 4 Parking brake cable
- 5 Transmission

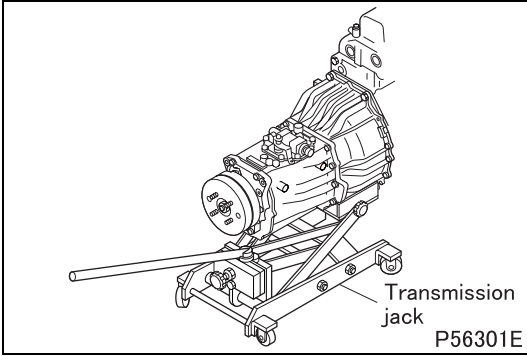
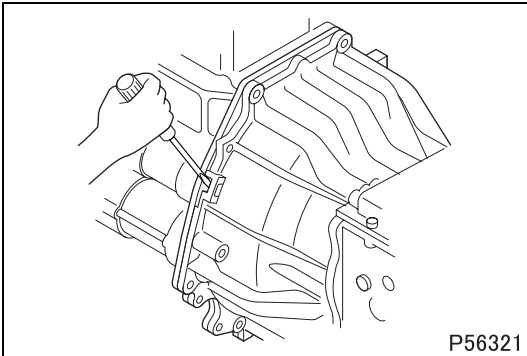
### ■ Removal: Transmission

- Support the transmission on the transmission jack and remove transmission mounting bolts.

- **Make sure that you pull the transmission out in a straight line. If you seesaw the transmission violently, you will damage the spline that connects the drive pinion and the clutch.**

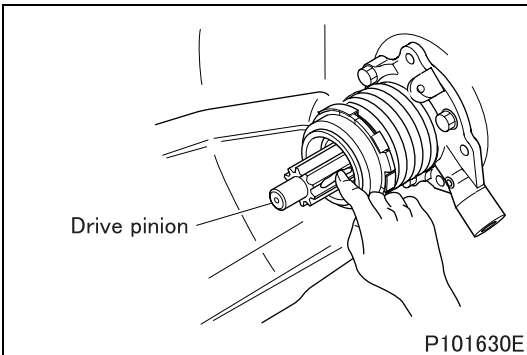
### ■ Installation: Transmission

- Check the spline of the drive pinion for rust.
- If rust is found, remove it using a wire brush.
- Rub grease evenly onto the clutch disc sliding surface of the drive pinion using your hand.

- **Make sure that you apply only the necessary amount of grease because too much grease would drip and cause clutch slip.**

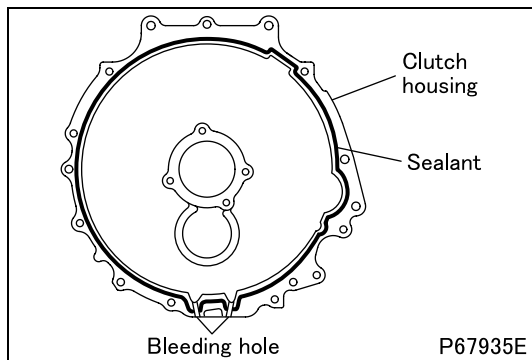
## <Case of using nozzle gun>

- Clean the mating surfaces of each part.
- Apply sealant on the width center of the mating surfaces so that the diameter of the applied sealant is the same as the diameter of the nozzle. The line of applying sealant is illustrated.

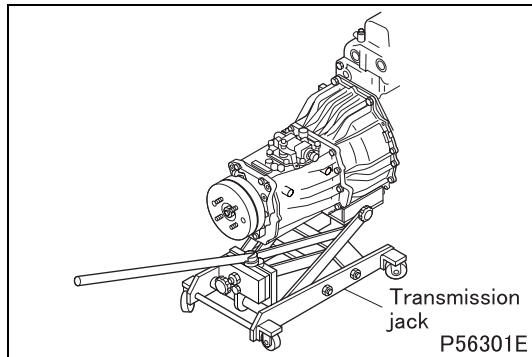
- Support the transmission on the transmission jack, and insert the transmission into the pilot bearing of the flywheel paying attention to the drive pinion spline.
- Tighten transmission mounting bolts to the specified torque.

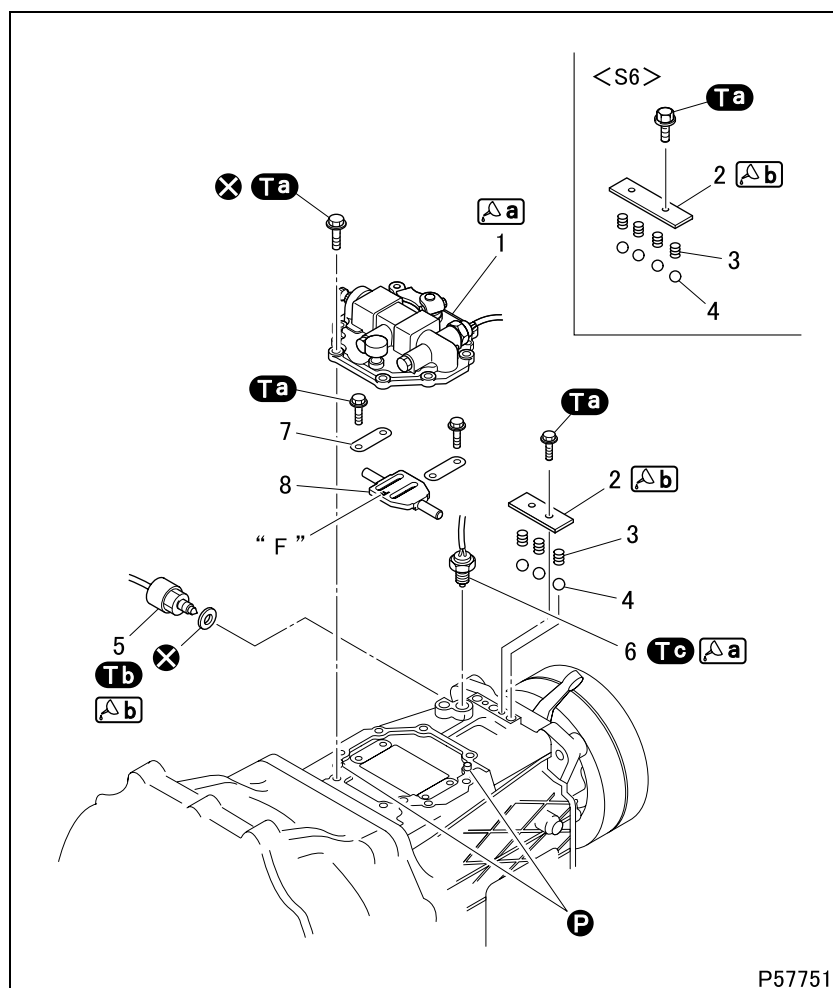
## ● Removal sequence

- 1 Gear shifter upper  
(See later section.)
- 2 Poppet spring plate
- 3 Poppet spring
- 4 Steel ball
- 5 Backup lamp switch
- 6 Torque limit switch
- 7 Plate
- 8 Interlock plate

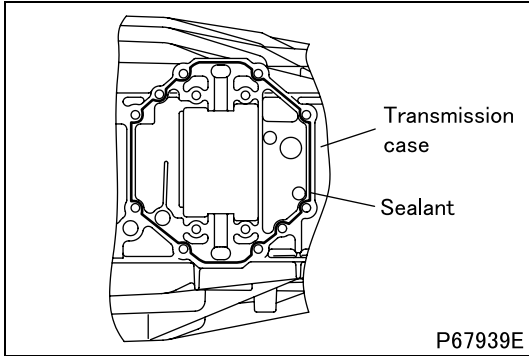
**<Case of using nozzle gun>**

- Clean the mating surfaces of each part.
- Apply sealant on the width center of the mating surfaces so that the diameter of the applied sealant is the same as the diameter of the nozzle. The line of applying sealant is illustrated.

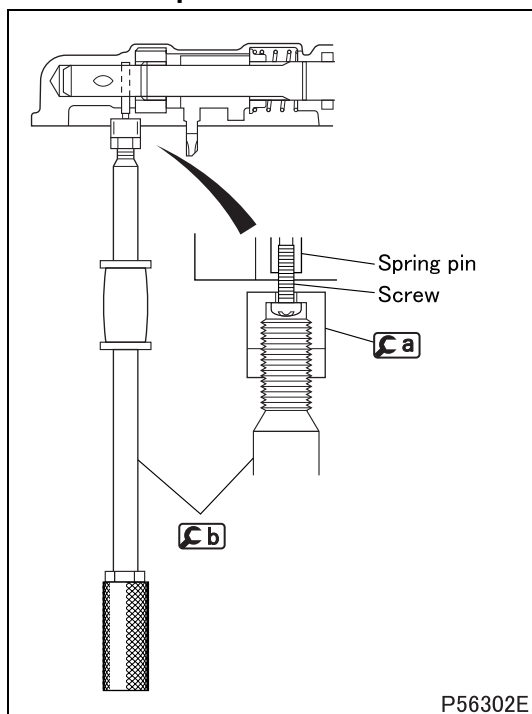
### ■ Removal: Spring pin

- Tap the spring pin using an M4 tap.
- Insert **a** spring pin puller with an M4 screw of appropriate length into the spring pin, and remove the spring pin using **b** reverse shaft puller.

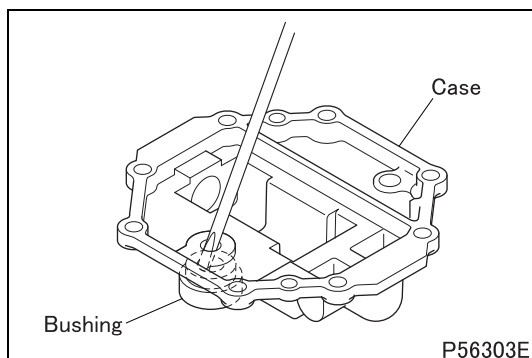
### ■ Removal: Bushing

- Remove the bushing using a screwdriver.

- Be careful not to damage the selector lever case.

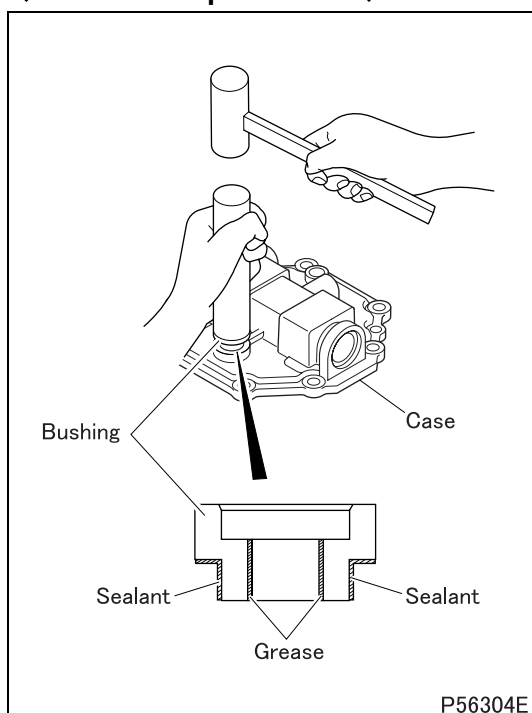
### ■ Installation: Bushing

- Clean the bushing and bushing mounting surface of the selector lever case.
- Apply grease to the inner surface of the bushing and sealant to its outer surface.

- Do not allow sealant to adhere to the inner surface of the bushing.
- Mount the bushing by evenly tapping it using a round bar of outer diameter of approximately 30 mm {1.18 in.}.

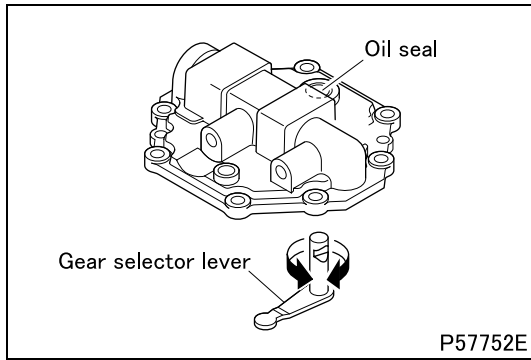
**■ Installation: Gear selector lever**

- Turn the gear selector lever when installing it in order to avoid damage to the oil seal lip.

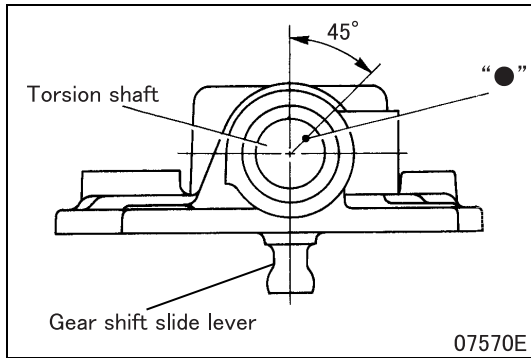
**■ Installation: Torsion shaft**

- Install the torsion shaft so that the angle the punch mark "●" at the tip of the torsion shaft forms with the gear shift slide lever is as illustrated.

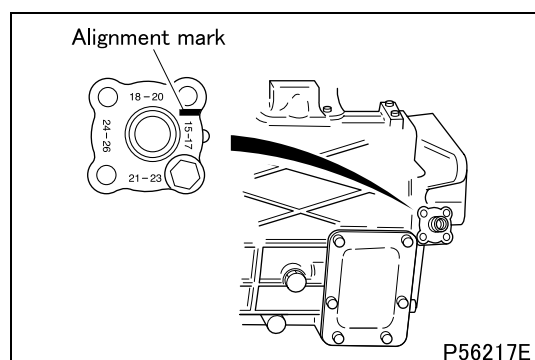
#### ■ Alignment marks: Speedometer gear bushing

- The installed direction of the speedometer gear bushing is determined by the number of the speedometer gear teeth.
- Put alignment marks to prevent misassembly.
