# FE.FG

## SERVICE MANUAL 2008 Model FOREWORD

This Service Manual contains maintenance and repair methods for the Mitsubishi Fuso Truck FE. FG Series. Read this manual carefully as an aid in providing correct, efficient maintenance. Please note that the information and specifications contained within this manual may change without notice. This is due to product modifications and continued vehicle improvements that are made throughout the model years. Should you encounter any discrepancy in the information provided, please do not hesitate to contact your nearest Mitsubishi Fuso Dealer or Mitsubishi Fuso Truck of America, Inc.

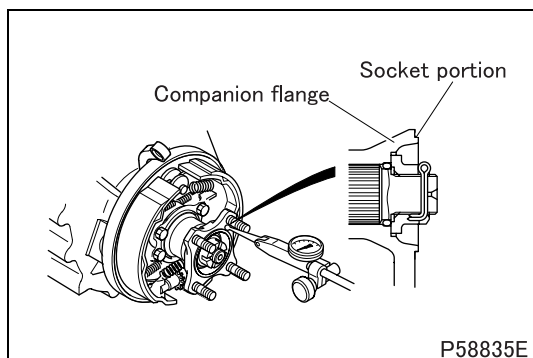
### ■ Inspection: Runout at socket portion of companion flange

- After removing the parking brake drum, measure runouts of the companion flange at its socket portion.
- If the measurement exceeds the specified limit, replace the companion flange.

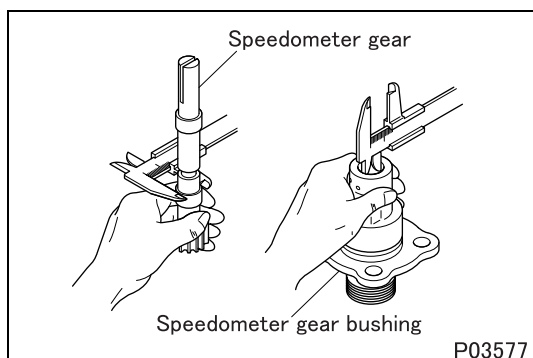
### ■ Inspection: Clearance between speedometer gear and speedometer gear bushing

- If the measured value exceeds the limit, replace defective parts.

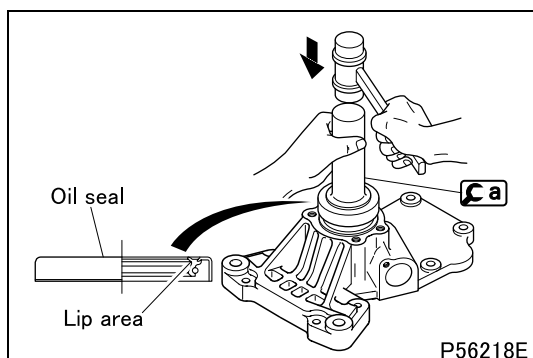
### ■ Installation: Oil seal

- Apply grease to the lip area of the oil seal, and install it in the illustrated direction.

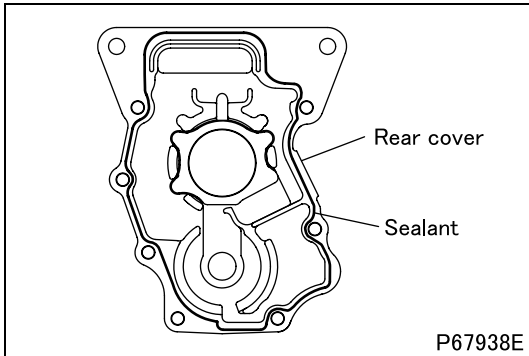
#### <Case of using nozzle gun>

- Clean the mating surfaces of each part.
- Apply sealant on the width center of the mating surfaces so that the diameter of the applied sealant is the same as the diameter of the nozzle. The line of applying sealant is illustrated.

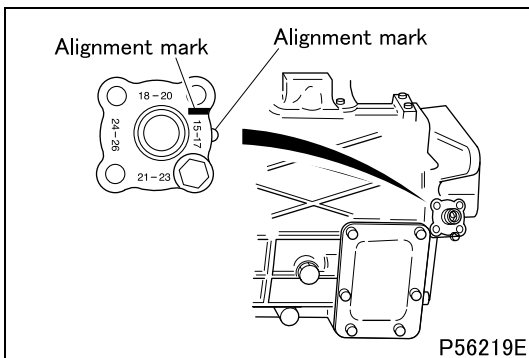
### ■ Installation: Speedometer gear bushing

- When replacing the speedometer gear bushing, align the alignment mark of the old part with that of the rear cover to install.

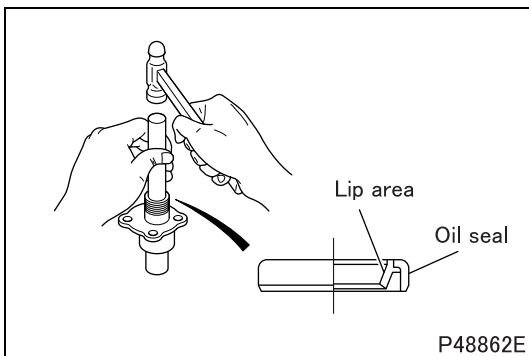
### ■ Installation: Oil seal

- Apply grease to the lip area of the oil seal.
- Install the oil seal evenly in the illustrated direction using a round bar of outer diameter of approx. 14 mm {0.55 in.}.

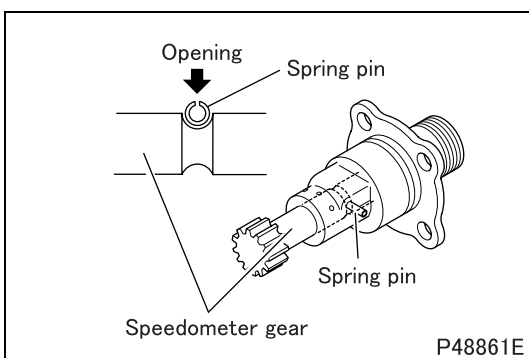
### ■ Installation: Spring pin

- Install the spring pin in the illustrated direction to prevent the speedometer gear from slipping off.

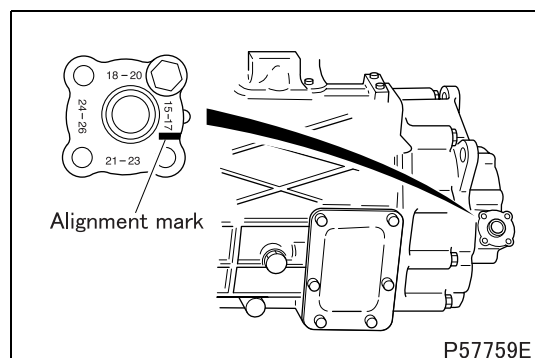
#### ■ Alignment marks: Speedometer gear bushing

- The installed direction of the speedometer gear bushing is determined by the number of the speedometer gear teeth.
- Put alignment marks to prevent misassembly.

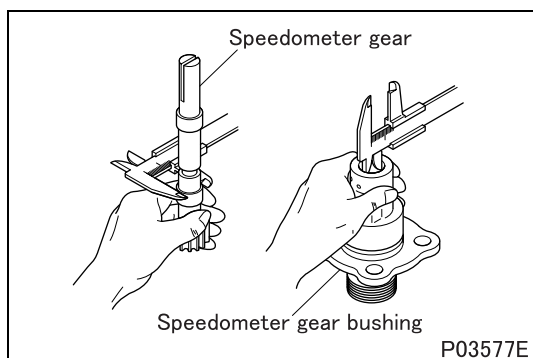
### ■ Inspection: Clearance between speedometer gear and speedometer gear bushing

- If the measured value exceeds the limit, replace defective parts.

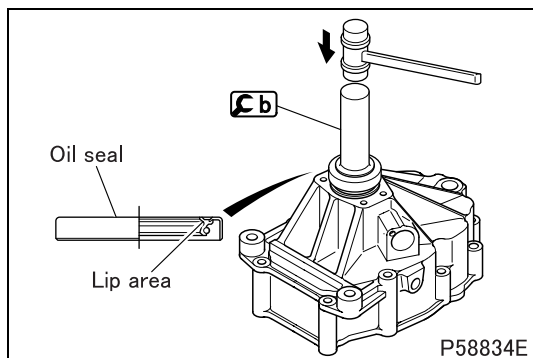
### ■ Installation: Oil seal

- Apply grease to the lip area of the oil seal, and install it on the extension housing in the illustrated direction.

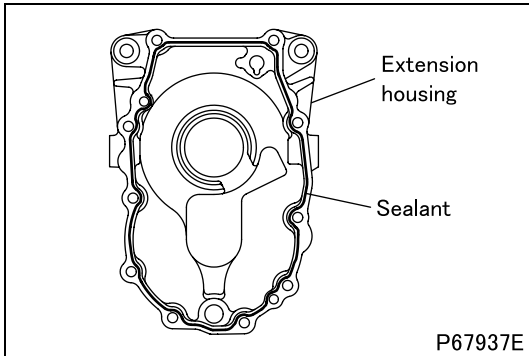
#### <Case of using nozzle gun>

- Clean the mating surfaces of each part.
- Apply sealant on the width center of the mating surfaces so that the diameter of the applied sealant is the same as the diameter of the nozzle. The line of applying sealant is illustrated.

#### <Case of using spatula, etc.>

- Clean the mating surfaces of each part.
- Apply sealant evenly on the entire mating surfaces.

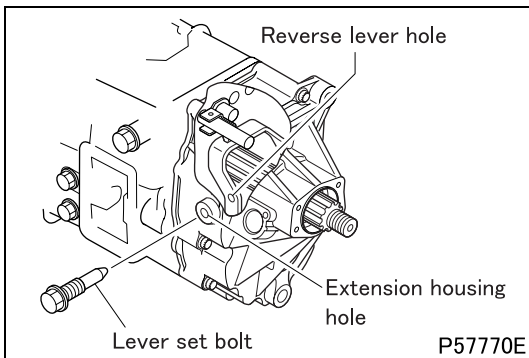
### ■ Installation: Lever set bolt

- Apply sealant to the thread areas of the lever set bolts to install them onto the extension housing holes and reverse lever hole.

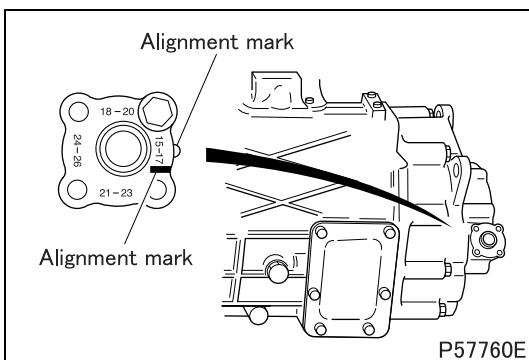
### ■ Installation: Speedometer gear bushing

- When replacing the speedometer gear bushing, align the alignment mark of the old part with that of the rear cover to install.

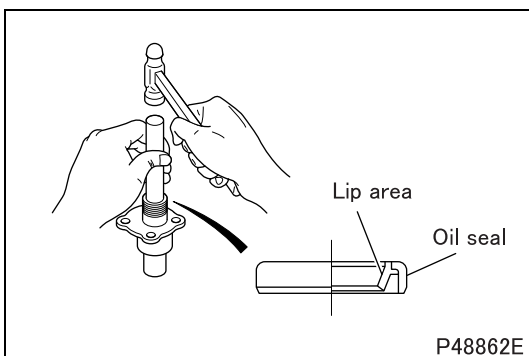
### ■ Installation: Oil seal

- Apply grease to the lip area of the oil seal.
- Install the oil seal evenly in the illustrated direction using a round bar of outer diameter of approx. 14 mm {0.55 in.}.

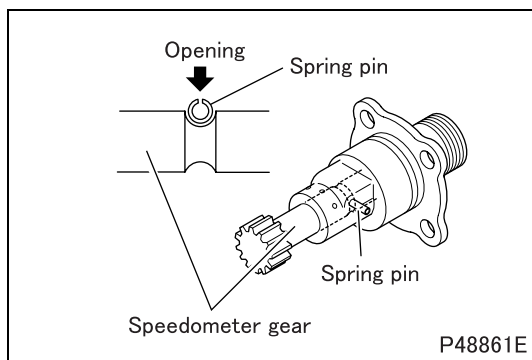
## ■ Installation: Spring pin

- Install the spring pin in the illustrated direction to prevent the speedometer gear from slipping off.

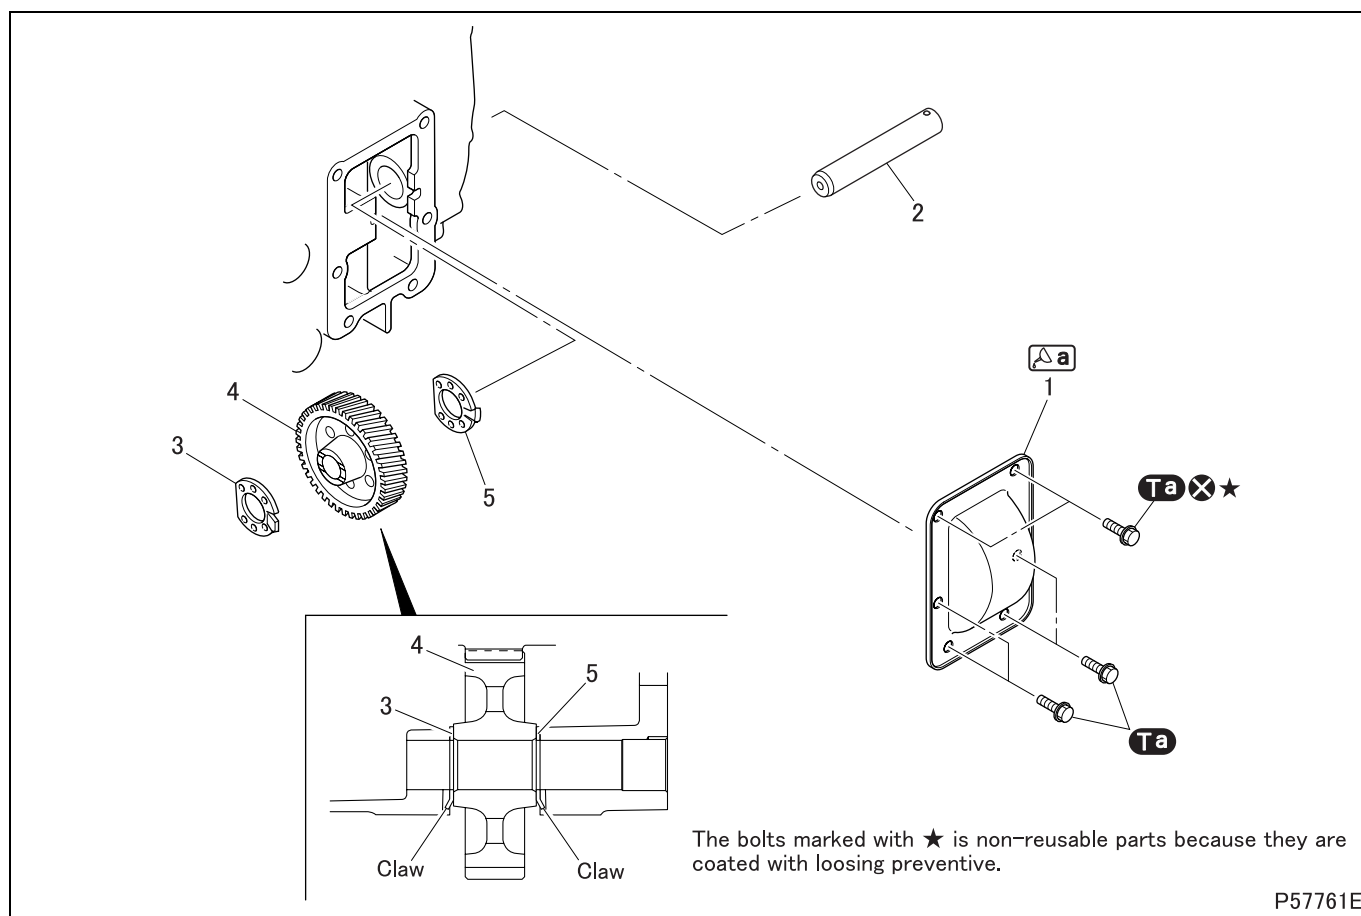
## ● Disassembly sequence

- 1 Power take-off cover
- 2 Reverse idler gear shaft
- 3 Side washer
- 4 Reverse idler gear

| Location | Maintenance item | Standard value | Limit | Remedy |
|---|---|---|---|---|
| 2, 4 | Play of reverse idler gear in diameter direction | 0.045 to 0.107<br>{0.0018 to 0.0042} | 0.4 {0.016} | Replace |

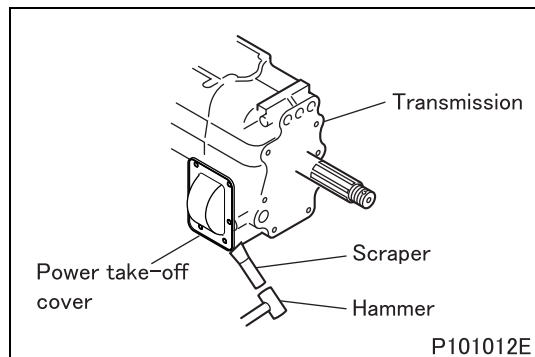
#### ■ Removal: Power take-off cover

- Insert a scraper from the lower right or lower left of the power take-off cover to remove the power take-off cover.

- Be careful that prying the scraper halfway could deform the power take-off cover or damage the transmission case.

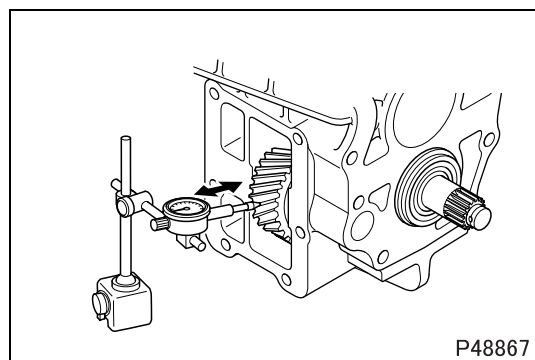
#### ■ Inspection: Play of reverse idler gear in diameter direction

- If the measured value exceeds the limit, replace defective parts.
- Check the play again after assembly and make sure it does not exceed the limit.

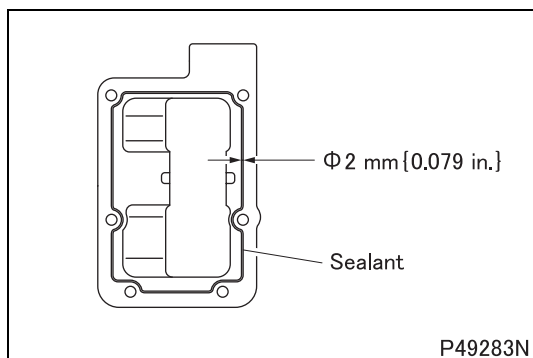
### ■ Installation: Power take-off cover

- Clean the seal surface of each part.
- Apply the sealant to the transmission case mounting surface of the power take-off cover evenly and without breaks.
- Install the power take-off cover within three minutes after applying the sealant. Be sure not to allow the sealant to be displaced.

- Do not start the engine within one hour after installing the power take-off cover.
  - When loosening or removing power take-off cover mounting bolts, be sure to reapply the sealant.
-

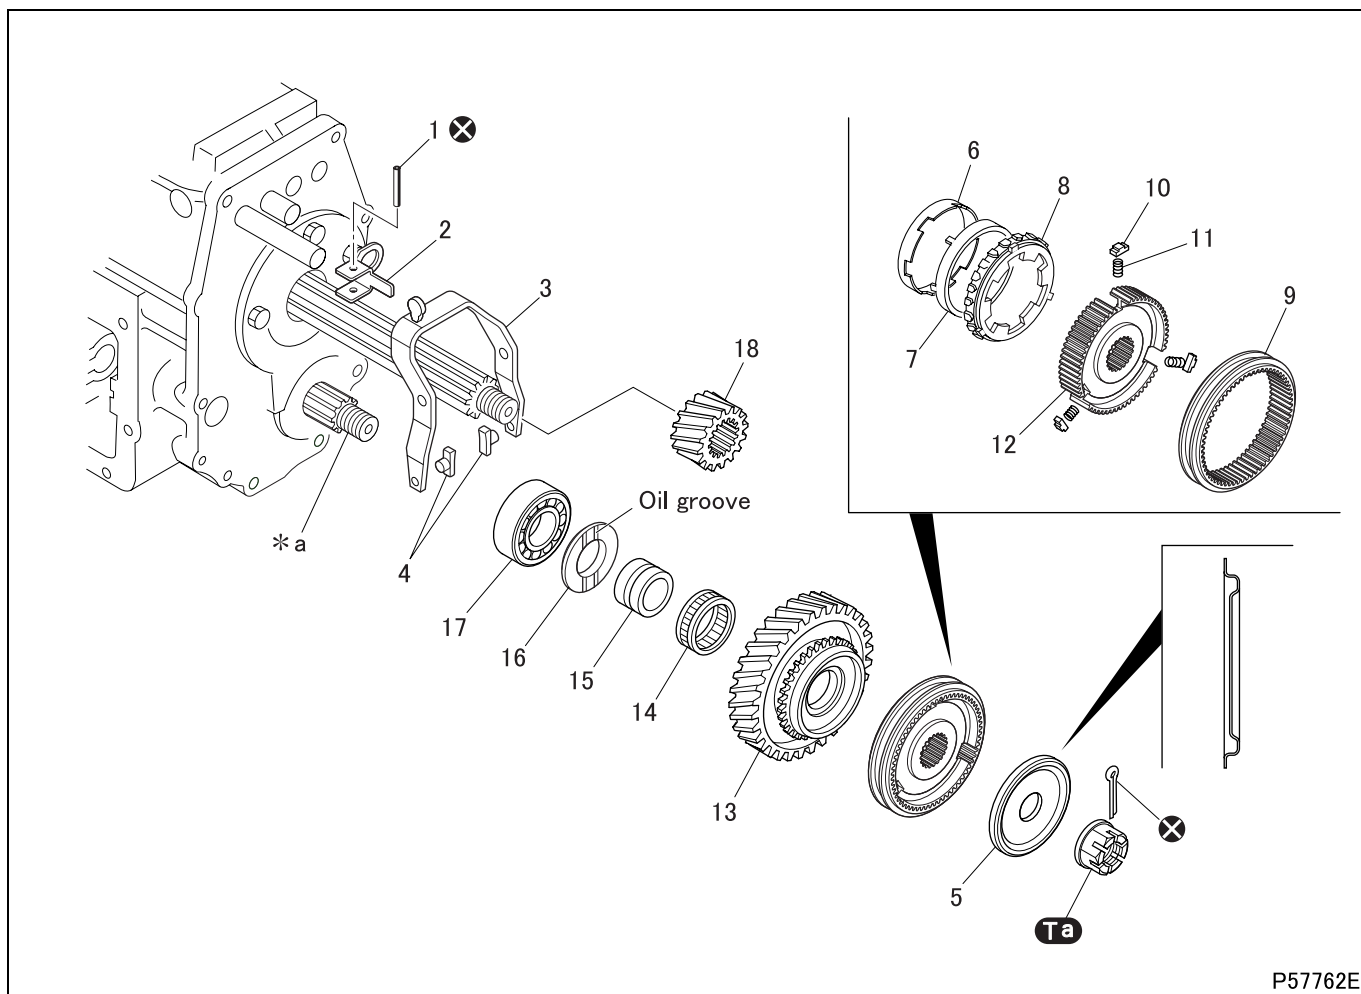
### ● Disassembly sequence

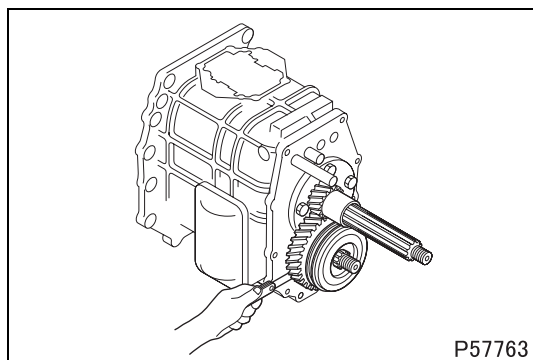
#### ■ Inspection: End play of countershaft 6th gear

- If the measured value exceeds the limit, replace defective parts.

| Location | Maintenance item | Standard value | Limit | Remedy |
|---|---|---|---|---|
| 13 | End play of countershaft 6th gear | 0.25 to 0.35<br>{0.0098 to 0.014} | 0.7 {0.028} | Replace |

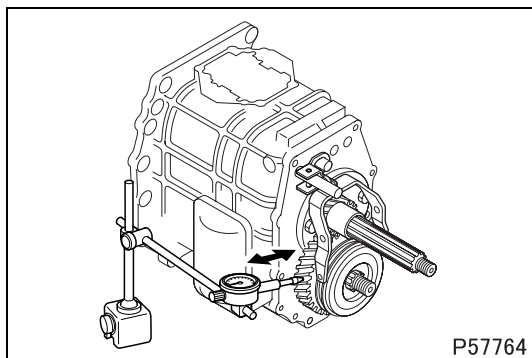
### ■ Inspection: Play of countershaft 6th gear in diameter direction

- If the measured value exceeds the limit, replace defective parts.

| Location | Maintenance item | Standard value | Limit | Remedy |
|---|---|---|---|---|
| 13 to 15 | Play of countershaft 6th gear in diameter direction | 0.08 to 0.14<br>{0.0031 to 0.0055} | 0.2 {0.0079} | Replace |

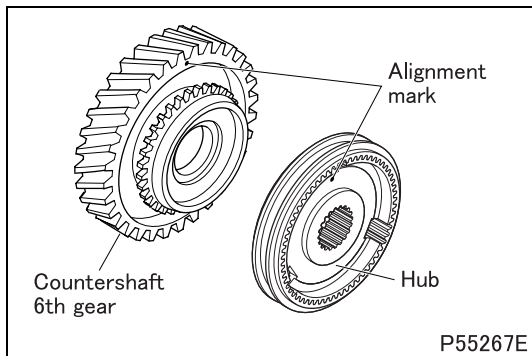
### ■ Alignment marks: Synchronizer hub and countershaft 6th gear

- Put alignment marks on the synchronizer hub and countershaft 6th gear, each at one location before disassembly.
- Put alignment marks on the synchronizer inner ring, center cone, outer ring and sleeve, each at one location, aligning with the alignment mark put on the synchronizer hub before disassembly.

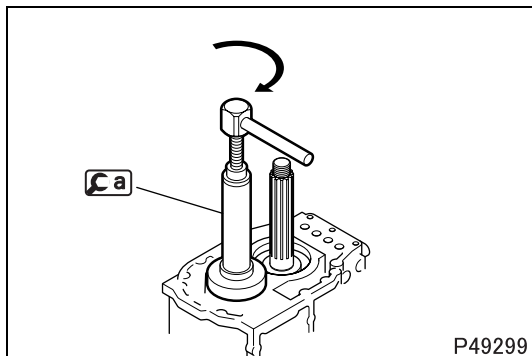
### ■ Removal: Countershaft 6th gear sleeve, thrust washer and countershaft rear bearing

- Remove the countershaft rear bearing together with the sleeve and washer.

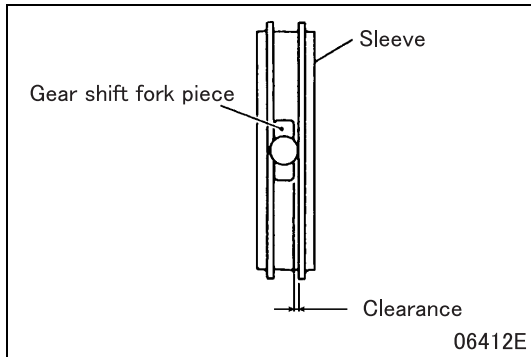
#### ■ Inspection: Clearance between gear shift fork piece and synchronizer sleeve of mainshaft

- If the measured value exceeds the limit, replace defective parts.

| Location | Maintenance item | Standard value | Limit | Remedy |
|---|---|---|---|---|
| 4, 9 | Clearance between 6th gear shift fork piece and synchronizer sleeve | 0.3 to 0.6<br>{0.012 to 0.024} | 1.0 {0.039} | Replace |

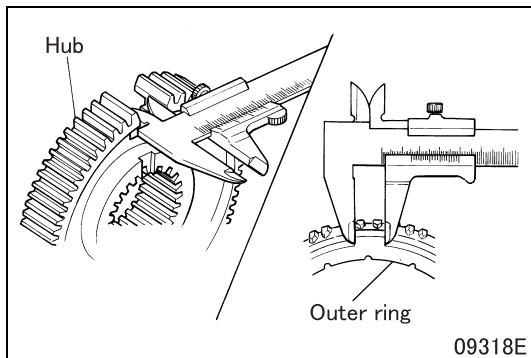
#### ■ Inspection: Clearance between synchronizer outer ring and synchronizer hub

- If the measured value exceeds the limit, replace defective parts.

| Location | Maintenance item | Standard value | Limit | Remedy |
|---|---|---|---|---|
| 8, 12 | Clearance between protrusion of synchronizer outer ring and synchronizer hub groove | 3.0 to 3.3<br>{0.12 to 0.13} | 4.0 {0.16} | Replace |

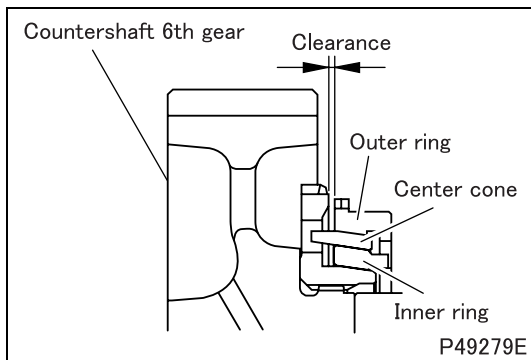
#### ■ Inspection: Clearance between synchronizer outer ring and countershaft 6th gear

- When measuring the clearance, press each synchronizer ring and center cone evenly against the gear and measure all around the circumference.
- If the measured value is less than the limit, replace defective parts.

| Location | Maintenance item | Standard value | Limit | Remedy |
|---|---|---|---|---|
| 8, 13 | Clearance between synchronizer outer ring and countershaft 6th gear | 0.96 to 1.54<br>{0.038 to 0.061} | 0.5 {0.020} | Replace |

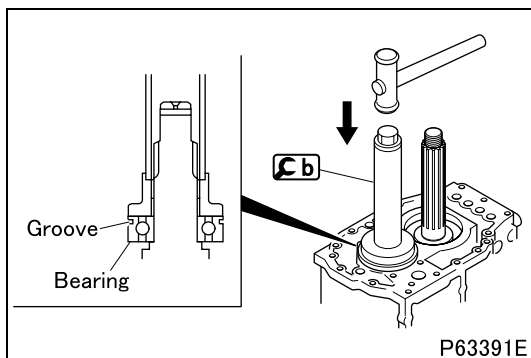
#### ■ Installation: Countershaft rear bearing

- Install the countershaft rear bearing on the countershaft in the illustrated direction.

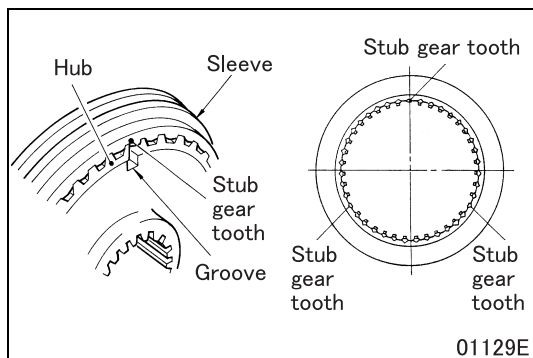
### ■ Installation: Synchronizer sleeve and synchronizer hub

- When replacing the synchronizer sleeve or synchronizer hub with a new one, align the three keyways of the synchronizer hub with three locations of the stub gear tooth of the synchronizer sleeve to install.

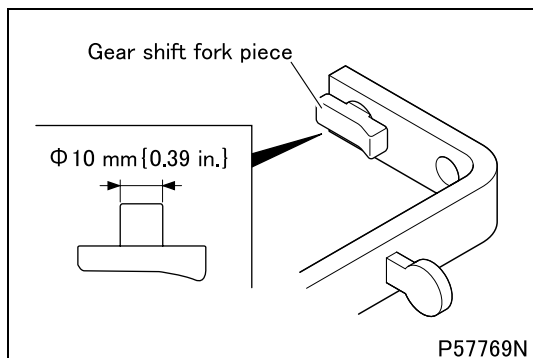
### ■ Installation: Gear shift fork piece

- Install the gear shift fork piece on the reverse lever as shown in the illustration after checking that its shaft diameter is appropriate.

- Never fail to check the shaft diameter of the gear shift fork piece. Installation of any gear shift fork piece with a smaller diameter shaft is possible but not permitted.

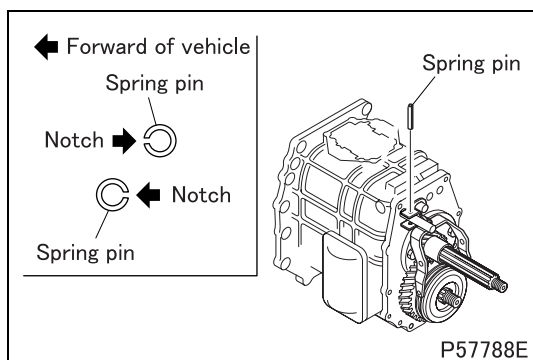
### ■ Installation: Spring pin

- Install the spring pin in the illustrated direction (the spring pin notch to be positioned forward or rearward of the vehicle). When installing the spring pin, leave 0 to 0.5 mm {0 to 0.020 in.} outside from the transmission shift rail.

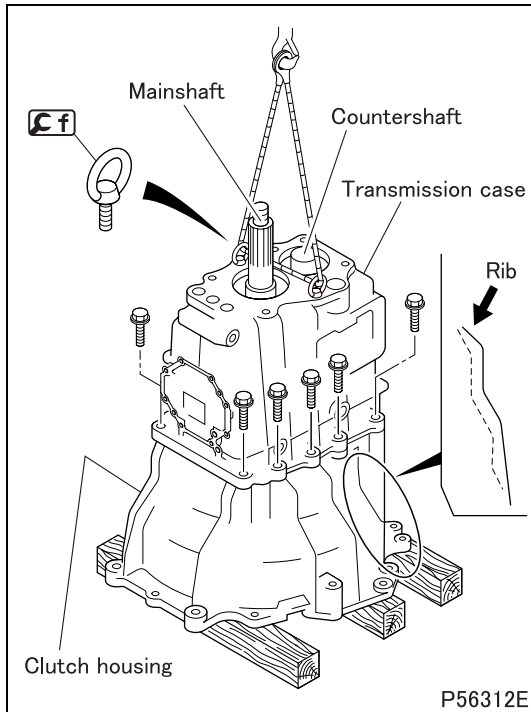
## ■ Removal: Transmission case

- Install **f** on the transmission case and make preparations for lifting it up with a crane.
- After removing the bolts, lift up the transmission case while hitting the rear ends of the countershaft and mainshaft and the rear ribs of the clutch housing with a plastic hammer to remove the transmission case.

- Be sure to hit the ribs as illustrated because hitting other areas may break the clutch housing.

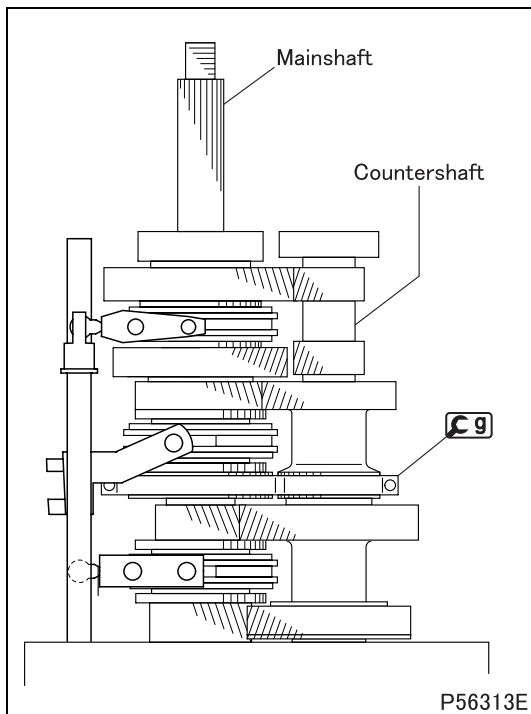
## ■ Removal: Shift rail and shift fork, countershaft, drive pinion and mainshaft

- Secure the countershaft and the 2nd gear area of the mainshaft with **g** for safety. Be sure to tighten the steel lifting band adequately enough to prevent it from coming undone, but not excessively.

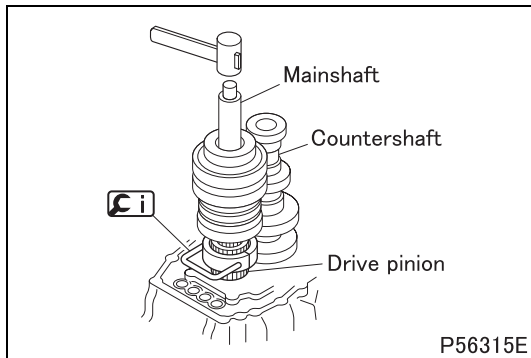
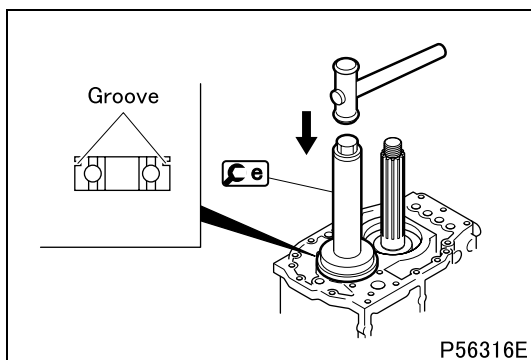
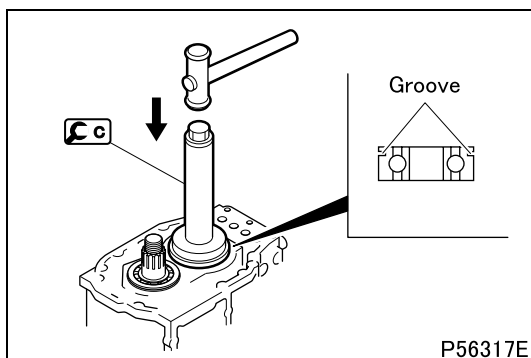
- Leave the countershaft and mainshaft secured with **(Ch)**.
- Install **(Ch)** on the mainshaft and make preparations for lifting it up with a crane.
- Secure the shift rail and shift fork with a rubber band to prevent it from coming undone from the mainshaft.
- Put a piece of wood on the clutch housing and lift it up while hitting it with a plastic hammer to remove.

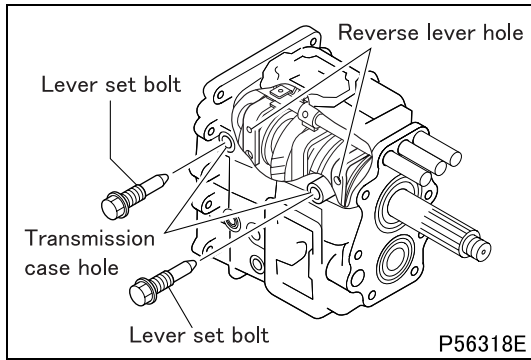
## ■ Installation: Lever set bolt

- Apply sealant to the thread areas of the lever set bolts to install them onto the transmission case holes and reverse lever hole.

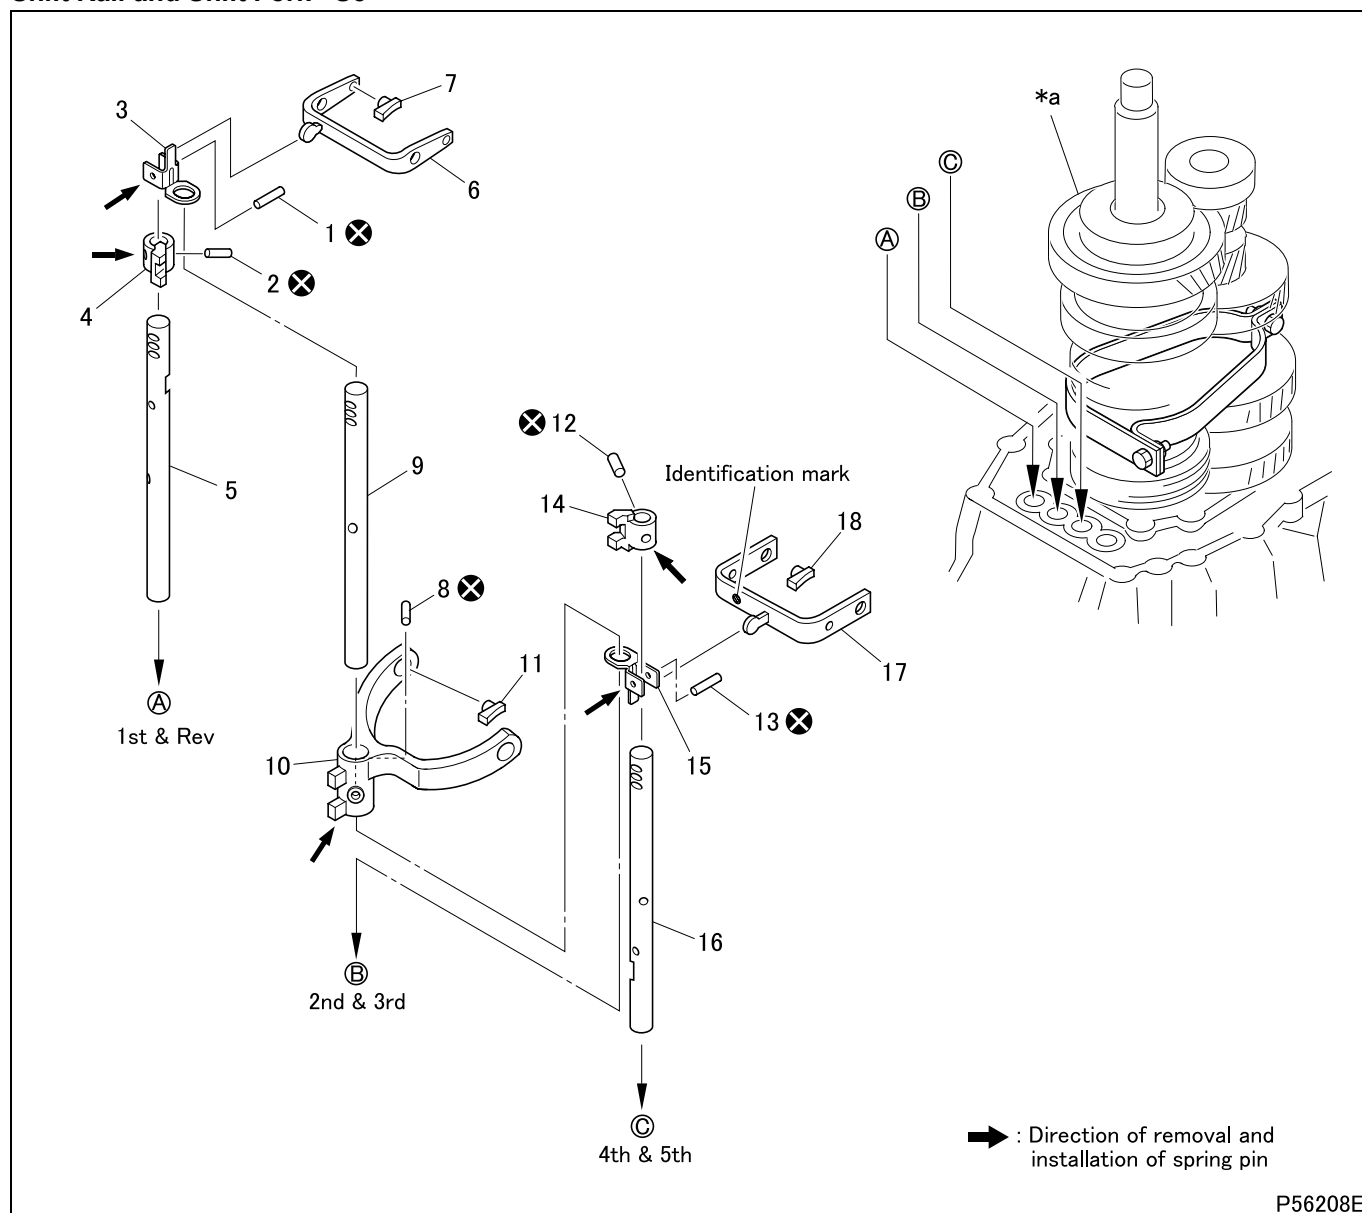
P56208E

### ● Disassembly sequence

| Location | Maintenance item | Standard value | Limit | Remedy |
|---|---|---|---|---|
| 5, 9, 16 | Bend of shift rail | 0.04 {0.0016} or less | 0.05 {0.0020} | Correct or replace |
| 7, 11, 18, *a | Clearance between gear shift fork piece and synchronizer sleeve | 0.3 to 0.6 {0.012 to 0.024} | 1.0 {0.039} | Replace |

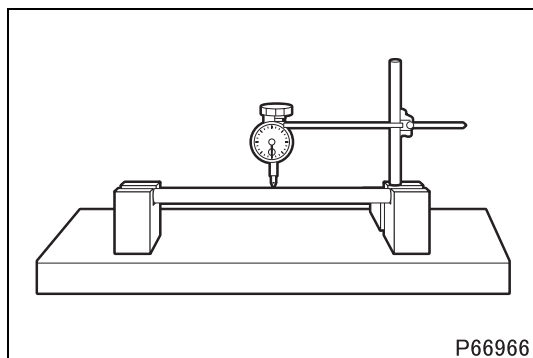
**■ Inspection: Bend of shift rail**

- Measure the extent of bending at the middle of each of shift rail.
- If any measured value exceeds the limit, correct or replace the shift rail.

- Give each of the shift rails one complete turn and read the dial gauge at that time. The extent of bending is half of the reading.

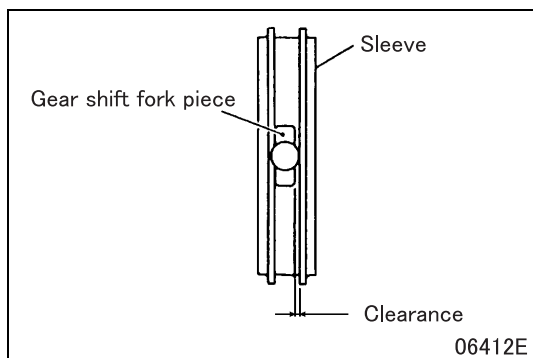
**■ Inspection: Clearance between gear shift fork piece and synchronizer sleeve of mainshaft**

- If the measured value exceeds the limit, replace defective parts.

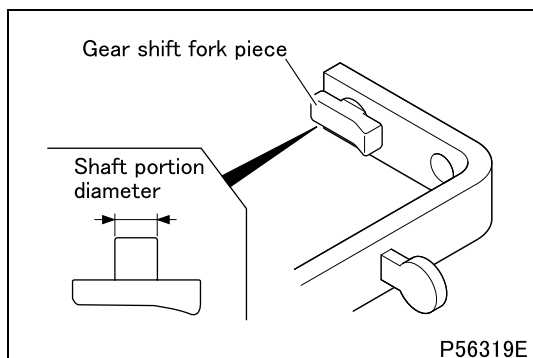
**■ Installation: Gear shift fork piece**

- Install the gear shift fork piece on the reverse lever as shown in the illustration after checking that its shaft diameter is appropriate.

- Never fail to check the shaft diameter of the gear shift fork piece. Installation of any gear shift fork piece with a smaller diameter shaft is possible but not permitted.

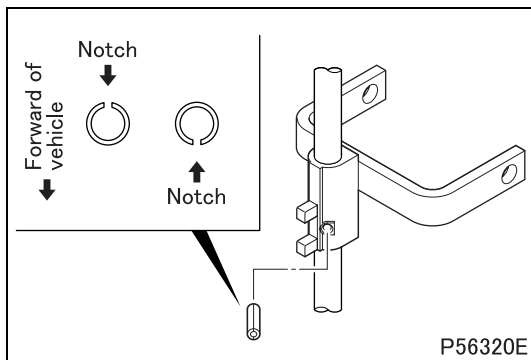
## ■ Installation: Spring pin

- Install the spring pin in the illustrated direction (the spring pin notch to be positioned forward or rearward of the vehicle). When installing the spring pin, leave 0 to 0.5 mm {0 to 0.020 in.} outside from each shift rail or each shift rail jaw.

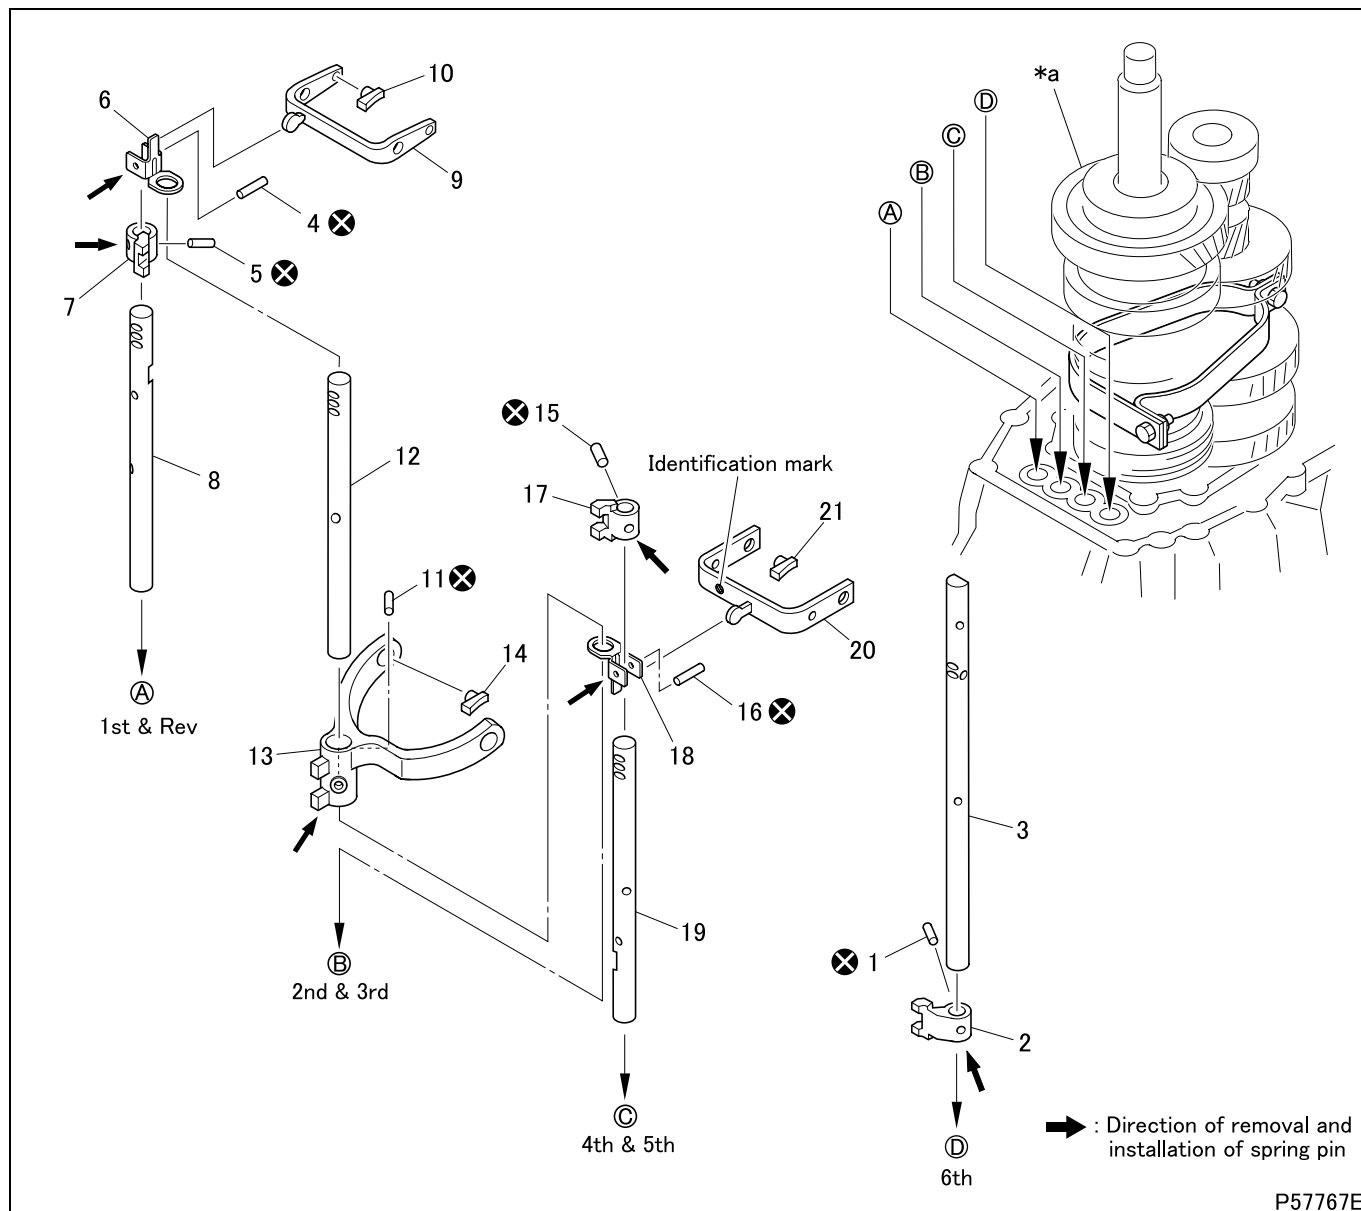
## Shift Rail and Shift Fork <S6>

### ● Disassembly sequence

| Location | Maintenance item | Standard value | Limit | Remedy |
|---|---|---|---|---|
| 3, 8, 12, 19 | Bend of shift rail | 0.04 {0.0016} or less | 0.05 {0.0020} | Correct or replace |
| 10, 14, 21, *a | Clearance between gear shift fork piece and synchronizer sleeve | 0.3 to 0.6 {0.012 to 0.024} | 1.0 {0.039} | Replace |

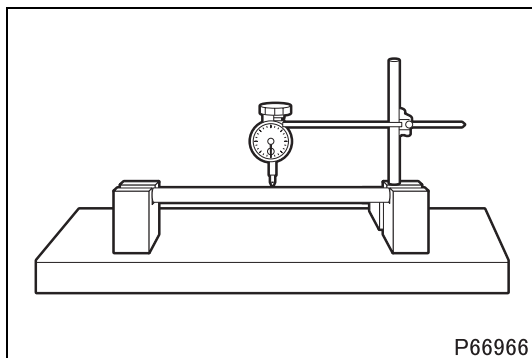
#### ■ Inspection: Bend of shift rail

- Measure the extent of bending at the middle of each of shift rail.
- If any measured value exceeds the limit, correct or replace the faulty shift rails.

- Give each of the shift rails one complete turn and read the dial gauge at that time. The extent of bending is half of the reading.

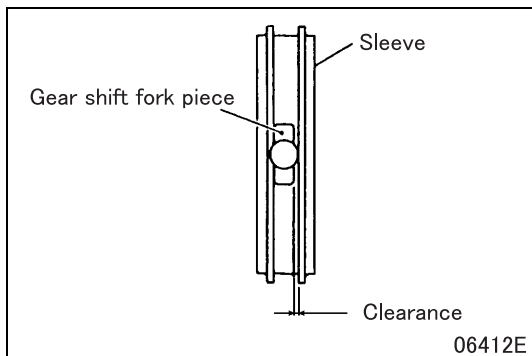
#### ■ Inspection: Clearance between gear shift fork piece and synchronizer sleeve of mainshaft

- If the measured value exceeds the limit, replace defective parts.

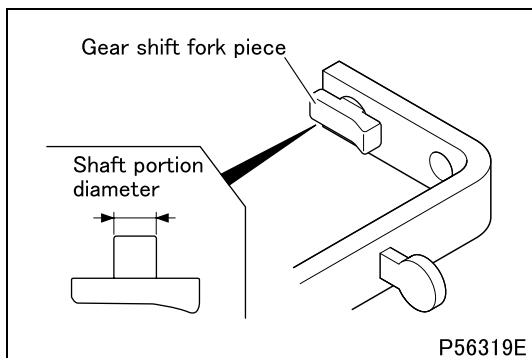
#### ■ Installation: Gear shift fork piece

- Install the gear shift fork piece on the reverse lever as shown in the illustration after checking that its shaft diameter is appropriate.

- Never fail to check the shaft diameter of the gear shift fork piece. Installation of any gear shift fork piece with a smaller diameter shaft is possible but not permitted.

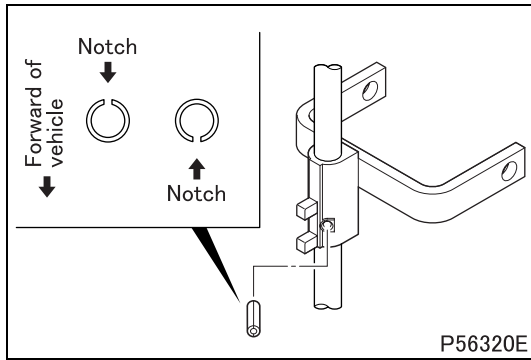
## ■ Installation: Spring pin

- Install the spring pin in the illustrated direction (the spring pin notch to be positioned forward or rearward of the vehicle). When installing the spring pin, leave 0 to 0.5 mm {0 to 0.020 in.} outside from each shift rail or each shift rail jaw.

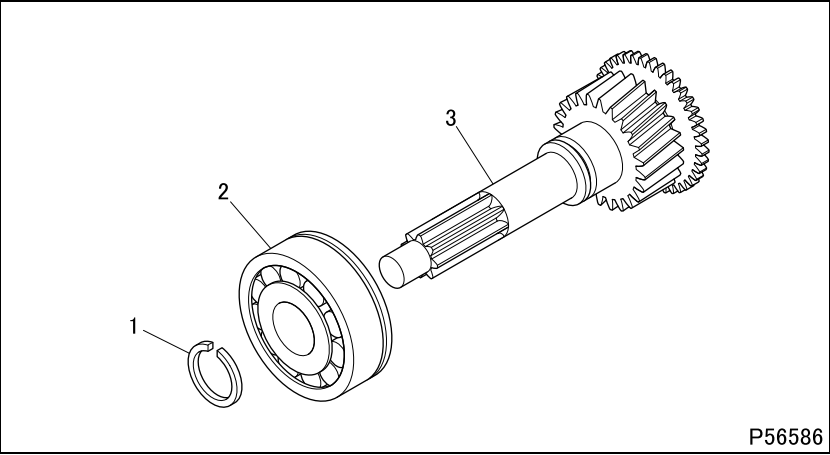
● Disassembly sequence

- 1 Snap ring
- 2 Drive pinion bearing
- 3 Drive pinion

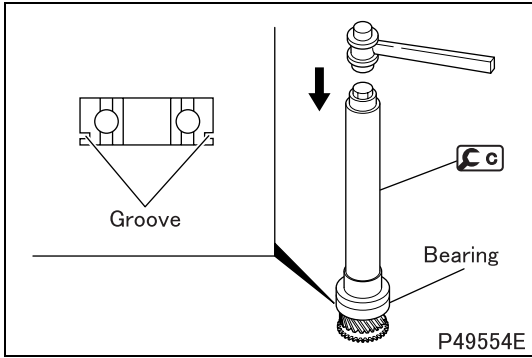
**■ Installation: Drive pinion bearing**

- Install the drive pinion bearing on the drive pinion in the illustrated direction.

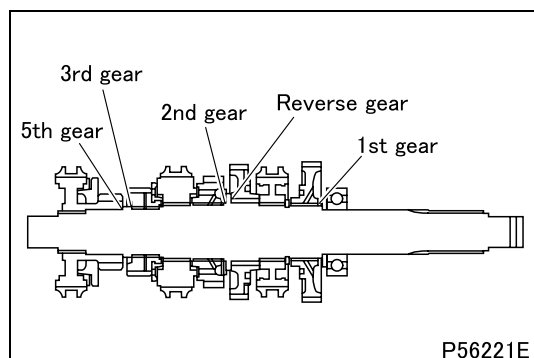
### ■ Inspection: End play of gears

- If the measured value exceeds the limit, replace defective parts.

| Location | Maintenance item | | Standard value | Limit | Remedy |
|---|---|---|---|---|---|
| - | End play | 1st gear | 0.15 to 0.46<br>{0.0059 to 0.018} | 0.7 {0.028} | Replace |

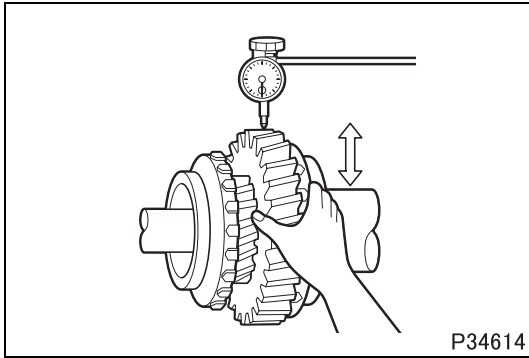
## ■ Inspection: Play of gears in diameter direction

- If the measured value exceeds the limit, replace defective parts.

| Location | Maintenance item | | Standard value | Limit | Remedy |
|---|---|---|---|---|---|
| - | Play in the diameter direction | 1st gear | 0.02 to 0.05<br>{0.0079 to 0.0020} | 0.12<br>{0.0047} | Replace |

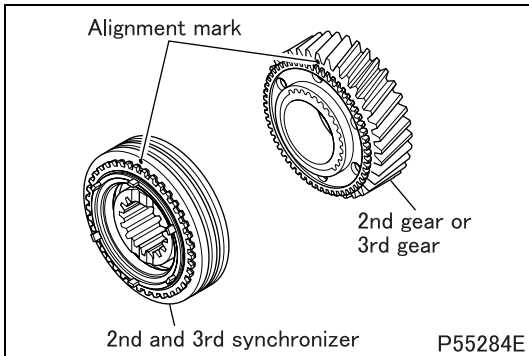
## ■ Alignment marks: 2nd gear, 2nd and 3rd synchronizer and 3rd gear

- Put alignment marks on the synchronizer sleeve of the 2nd and 3rd synchronizer, 2nd gear and 3rd gear, each at one location before disassembly.

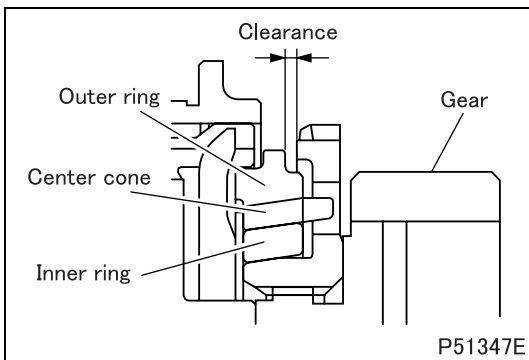
## ■ Inspection: Clearance between synchronizer outer ring of 2nd and 3rd synchronizer and 2nd gear or 3rd gear

- When measuring the clearance, press each ring and the center cone evenly against the gear and measure all around the circumference.
- If the measured value is less than the limit, replace defective parts.

| Location | Maintenance item | | Standard value | Limit | Remedy |
|---|---|---|---|---|---|
| 17, 20 | Clearance between 3rd gear and synchronizer outer ring of 2nd and 3rd synchronizer | | 1.16 to 1.74<br>{0.046 to 0.069} | 0.7 {0.028} | Replace |
| 20, 21 | Clearance between synchronizer outer ring of 2nd and 3rd synchronizer and 2nd gear | | 1.16 to 1.74<br>{0.046 to 0.069} | 0.7 {0.028} | Replace |

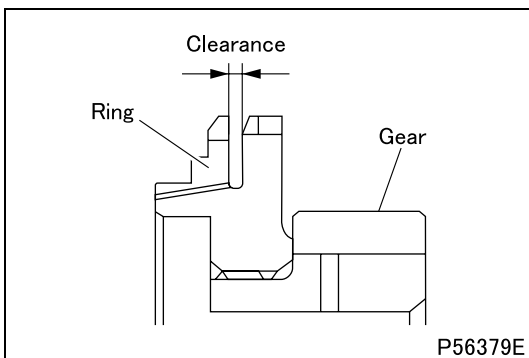
## ■ Inspection: Clearance between synchronizer ring of 4th and 5th synchronizer and 5th gear or drive pinion

- When measuring the clearance, press each ring evenly against the gear and measure all around the circumference.
- If the measured value is less than the limit, replace defective parts.

| Location | Maintenance item | | Standard value | Limit | Remedy |
|---|---|---|---|---|---|
| 12, 13 | Clearance between synchronizer ring of 4th and 5th synchronizer and 5th gear | | 1.23 to 1.47<br>{0.048 to 0.058} | 0.5 {0.020} | Replace |
| 12, *a | Clearance between synchronizer ring of 4th and 5th synchronizer and drive pinion | | 1.23 to 1.47<br>{0.048 to 0.058} | 0.5 {0.020} | Replace |

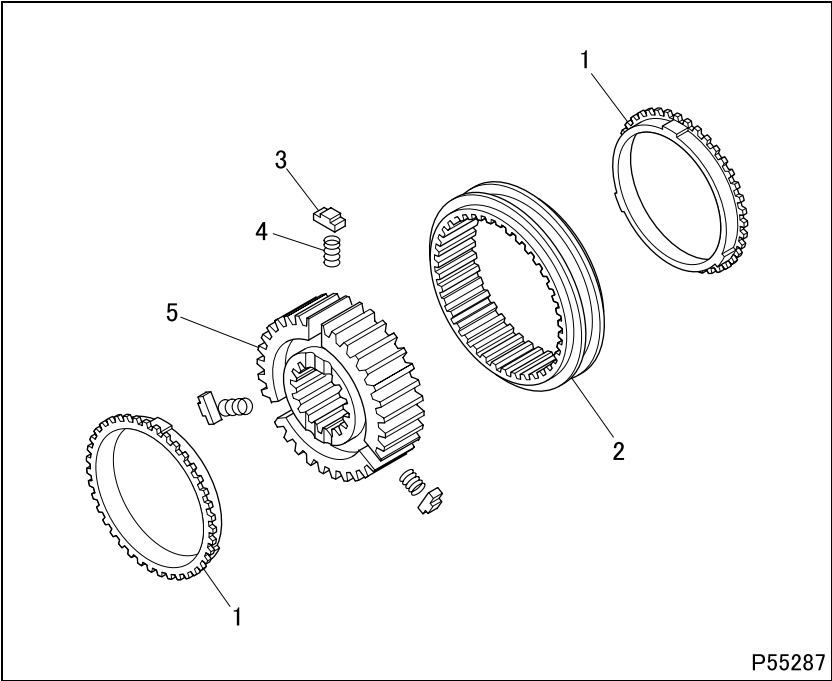
## 4th and 5th Synchronizer

- 1 Synchronizer ring
- 2 Synchronizer sleeve
- 3 Shifting plunger
- 4 Shifting plunger spring
- 5 Synchronizer hub

| Location | Maintenance item | Standard value | Limit | Remedy |
|---|---|---|---|---|
| 1, 5 | Clearance between protrusions of synchronizer ring and synchronizer hub groove | 3.0 to 3.3 {0.12 to 0.13} | 4.0 {0.16} | Replace |

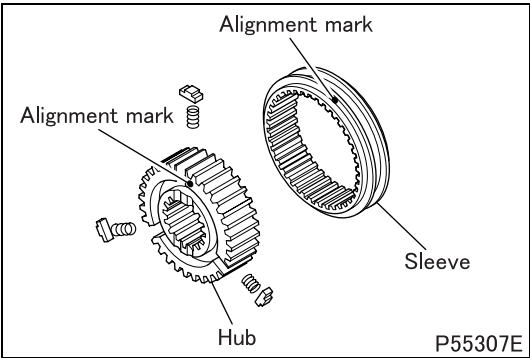
### ■ Alignment marks: Synchronizer sleeve and synchronizer hub

- Put alignment marks on the synchronizer ring and synchronizer hub, each at one location before disassembly.

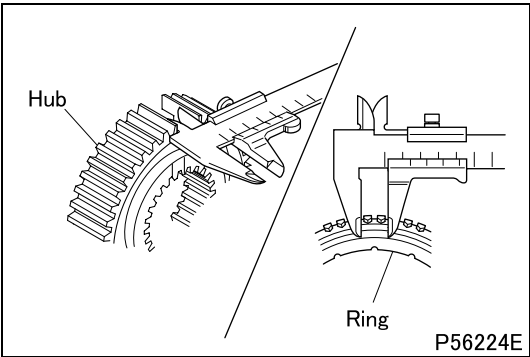
### ■ Inspection: Clearance between synchronizer ring or synchronizer outer ring and synchronizer hub

- If the measured value exceeds the limit, replace defective parts.

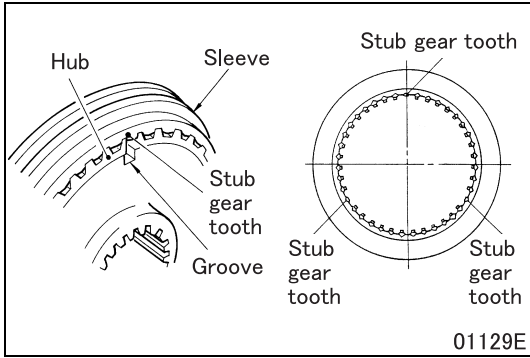
### ■ Installation: Synchronizer sleeve and synchronizer hub

- When replacing the synchronizer sleeve or synchronizer hub with a new one, align the three keyways of the synchronizer hub with three locations of the stub gear tooth of the synchronizer sleeve to install.

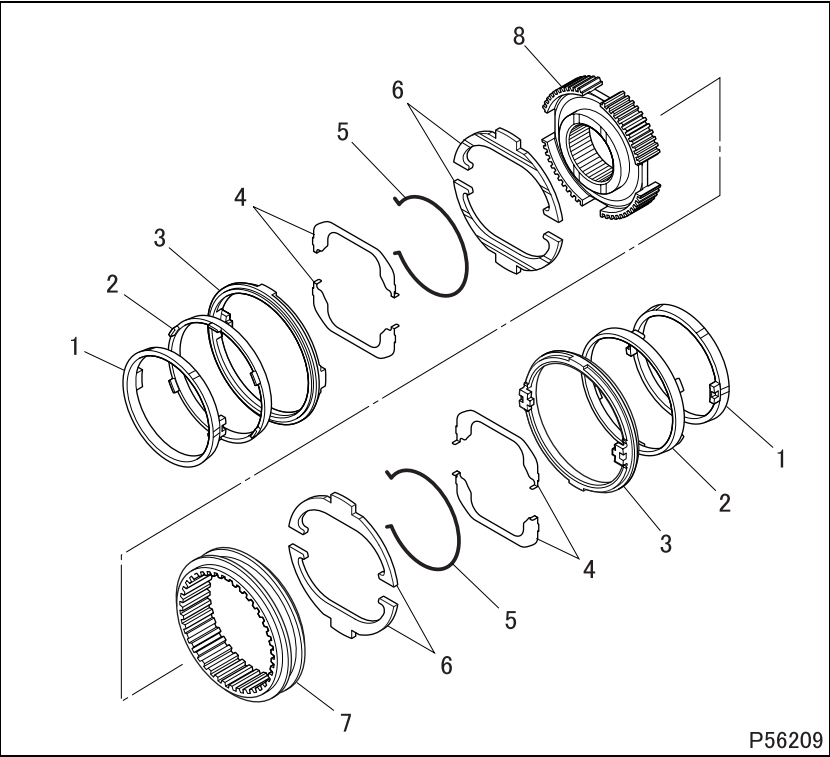
## 2nd and 3rd Synchronizer

- 1 Synchronizer inner ring
- 2 Synchronizer center cone
- 3 Synchronizer outer ring
- 4 Synchronizer plate
- 5 Synchronizer spring
- 6 Synchronizer lever
- 7 Synchronizer sleeve
- 8 Synchronizer hub

| Location | Maintenance item | Standard value | Limit | Remedy |
|---|---|---|---|---|
| 3 | Width of claws of synchronizer outer ring | 13.8 to 14.0<br>{0.54 to 0.55} | 13 {0.51} | Replace |

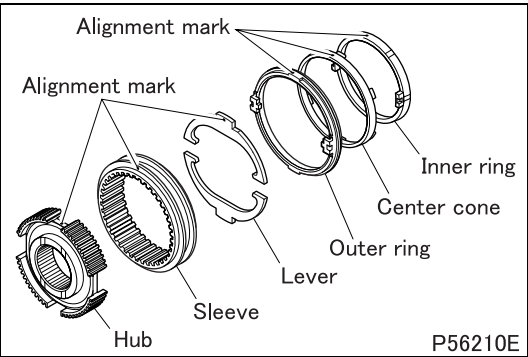
### ■ Alignment marks: Synchronizer inner ring, center cone, outer ring, lever and hub

- Put alignment marks on the synchronizer inner ring, center cone, outer ring, lever and hub, each at one location, aligning with the alignment mark put on the synchronizer sleeve before disassembly.

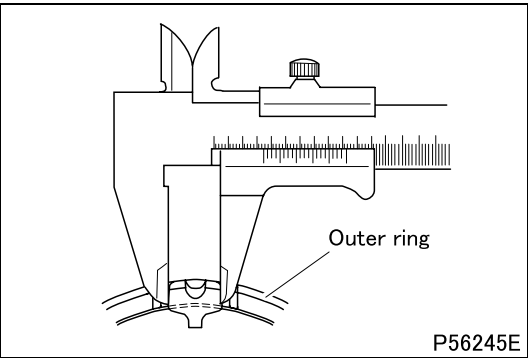
### ■ Inspection: Width of claws of synchronizer outer ring

- If the measured value exceeds the limit, replace defective parts.
