# FE.FG

## SERVICE MANUAL 2008 Model FOREWORD

This Service Manual contains maintenance and repair methods for the Mitsubishi Fuso Truck FE. FG Series. Read this manual carefully as an aid in providing correct, efficient maintenance. Please note that the information and specifications contained within this manual may change without notice. This is due to product modifications and continued vehicle improvements that are made throughout the model years. Should you encounter any discrepancy in the information provided, please do not hesitate to contact your nearest Mitsubishi Fuso Dealer or Mitsubishi Fuso Truck of America, Inc.

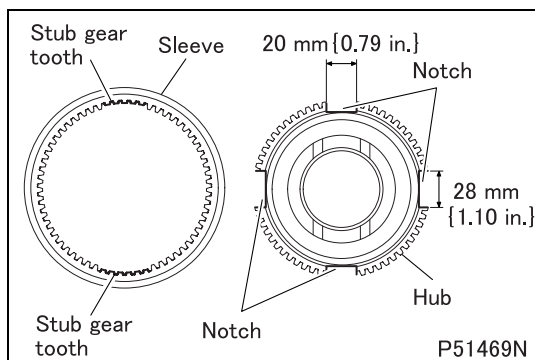
### ■ Installation: Synchronizer sleeve and synchronizer hub

- When replacing the synchronizer sleeve or synchronizer hub with a new one, align the stub gear tooth (2 locations) of the synchronizer sleeve and the notch (2 locations) of the synchronizer hub to install.
- Install the stub gear teeth, aligning with the notches with narrow width (20 mm {0.79 in.}) of the synchronizer hub.

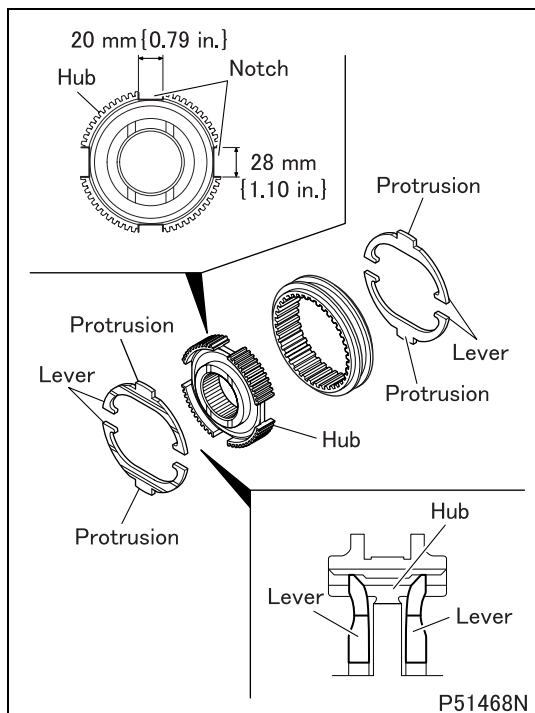
### ■ Installation: Synchronizer lever

- Install the synchronizer lever on the synchronizer hub in the illustrated direction.
- To install the synchronizer lever, install its protrusions on the notches with narrow width (20 mm {0.79 in.}) of the synchronizer hub.

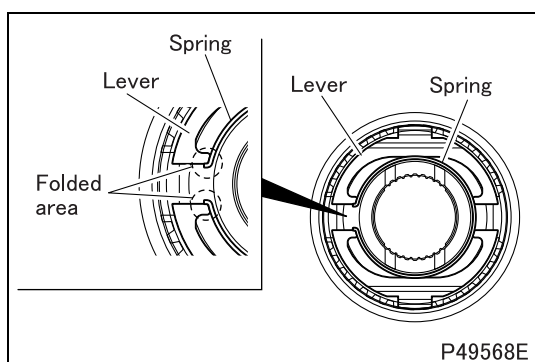
### ■ Installation: Synchronizer spring

- Hang the folded area on the synchronizer lever to install the synchronizer spring.

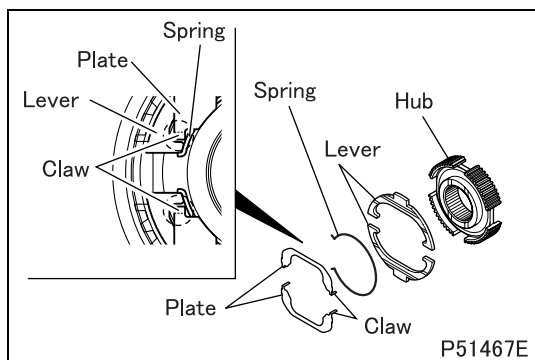
### ■ Installation: Synchronizer plate

- Install the synchronizer plate facing the claws toward the synchronizer hub so that it may be inserted between the synchronizer lever and synchronizer spring.

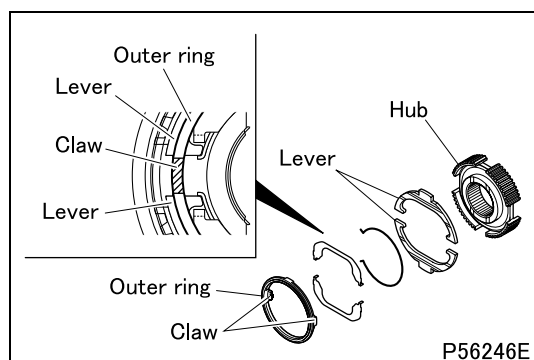
## ■ Installation: Synchronizer outer ring

- Install the synchronizer ring facing the claws toward the synchronizer hub so that it may be inserted between the two synchronizer levers.

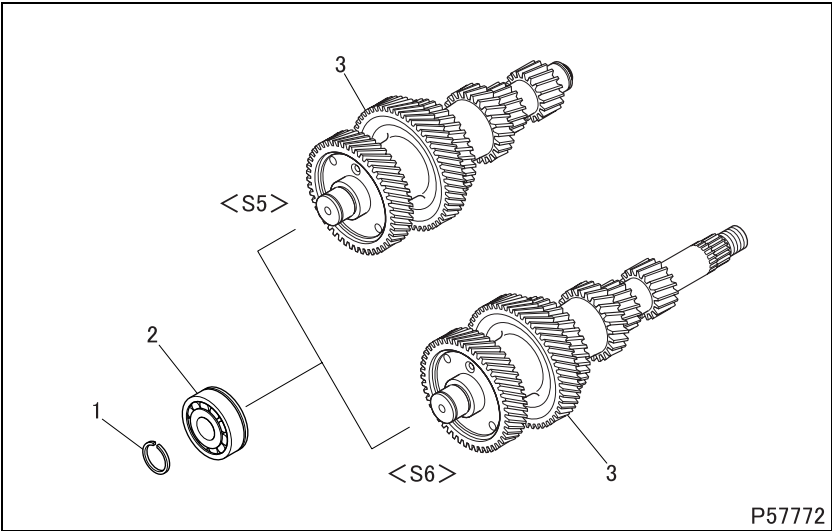
## ● Disassembly sequence

- 1 Snap ring
- 2 Countershaft front bearing
- 3 Countershaft gear

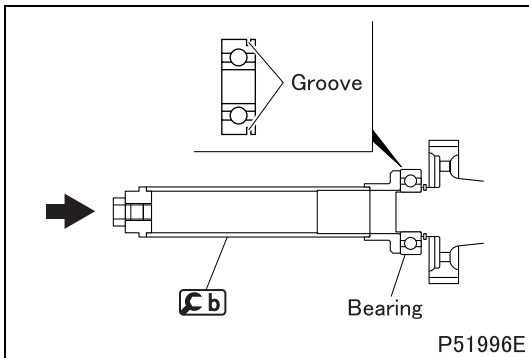
**■ Installation: Countershaft front bearing**

- Install the countershaft front bearing on the countershaft in the illustrated direction.

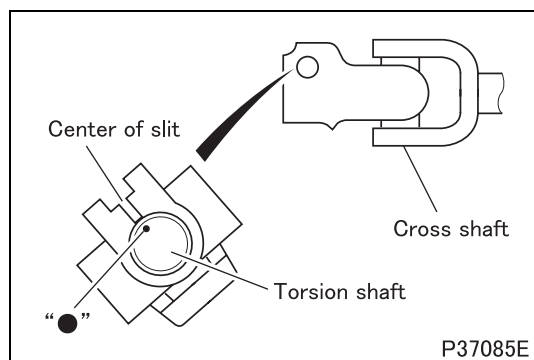
#### ■ Installation: Cross shaft

Insert the cross shaft so that the punch mark “●” of the torsion shaft on the transmission is positioned at the center of the slit of the cross shaft.

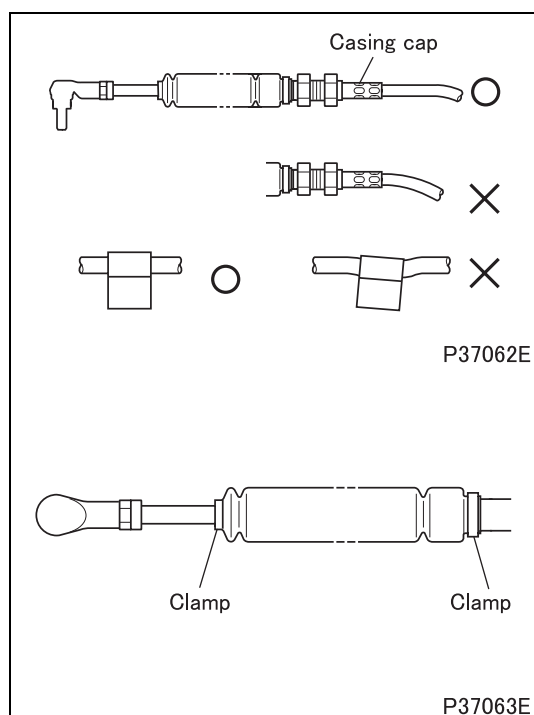
#### ■ Installation: Shift cable and select cable

- Install the casing cap portion as a straight line.
- The radius of the cable bend shall be 200 mm {7.87 in.} or more.
- Make sure that there is no obstruction in movement of the cable.
- Install the clamp at right angles to the cable.
- Do not twist clamps at either ends of the boot.
- Check for the identification mark on the shift cable.
- The twist angle of ball joints at both ends of the cables shall be 15 degrees or less.
- Make sure that the ball joints face the correct direction. Installing them in the wrong direction can remarkably reduce durability of the cables.

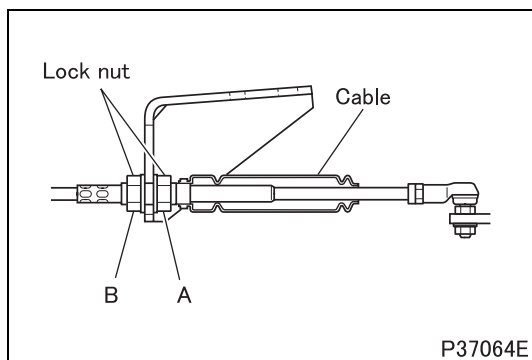
- Connect the shift cable and select cable with each clamp temporarily tightened.
- Permanently tighten the lock nuts and each clamp of the cables in this order with no excessive force applied to the shift cable and select cable.

- When tightening lock nuts, tighten B without moving A on the transmission.

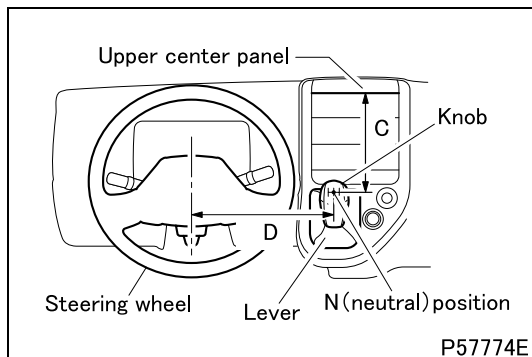
- Make sure when operating the gear shift lever that it shifts and selects smoothly each position.
- Adjust the gear shift lever with the lock nut on the transmission and turn buckle or clevis on the gear shift lever.

Fore-and-aft direction C: Distance from the upper center panel

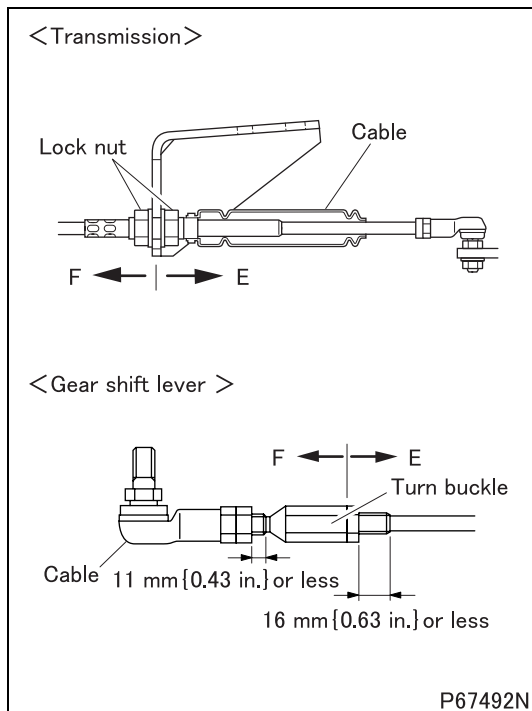
| | Shift cable | Select cable |

- When adjusting cable length, do not move the torsion shaft and gear selector lever from the neutral position.
- When adjusting the select position, align N (neutral) position of the transmission with N (neutral) position of the gear shift lever.

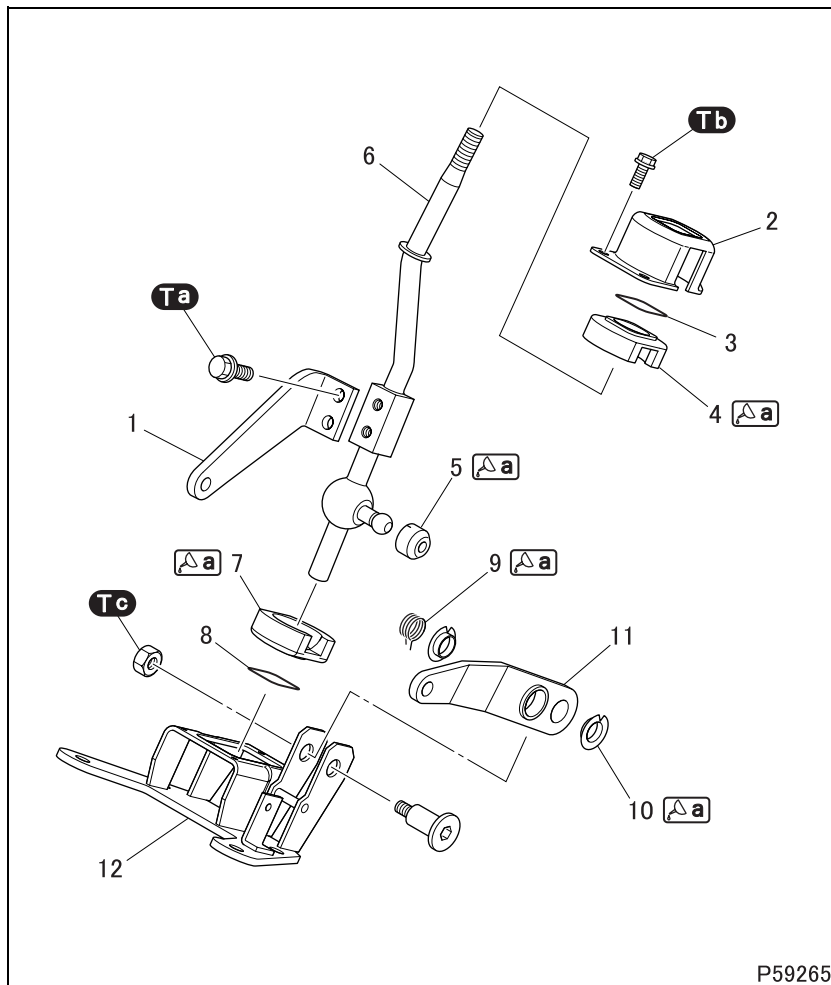
## Gear Shift Lever

- 1 Shift lever
- 2 Lever support
- 3 Insulator
- 4 Case
- 5 Bushing
- 6 Shift rod
- 7 Case
- 8 Insulator
- 9 Return spring
- 10 Shift bushing
- 11 Selector lever
- 12 Plate

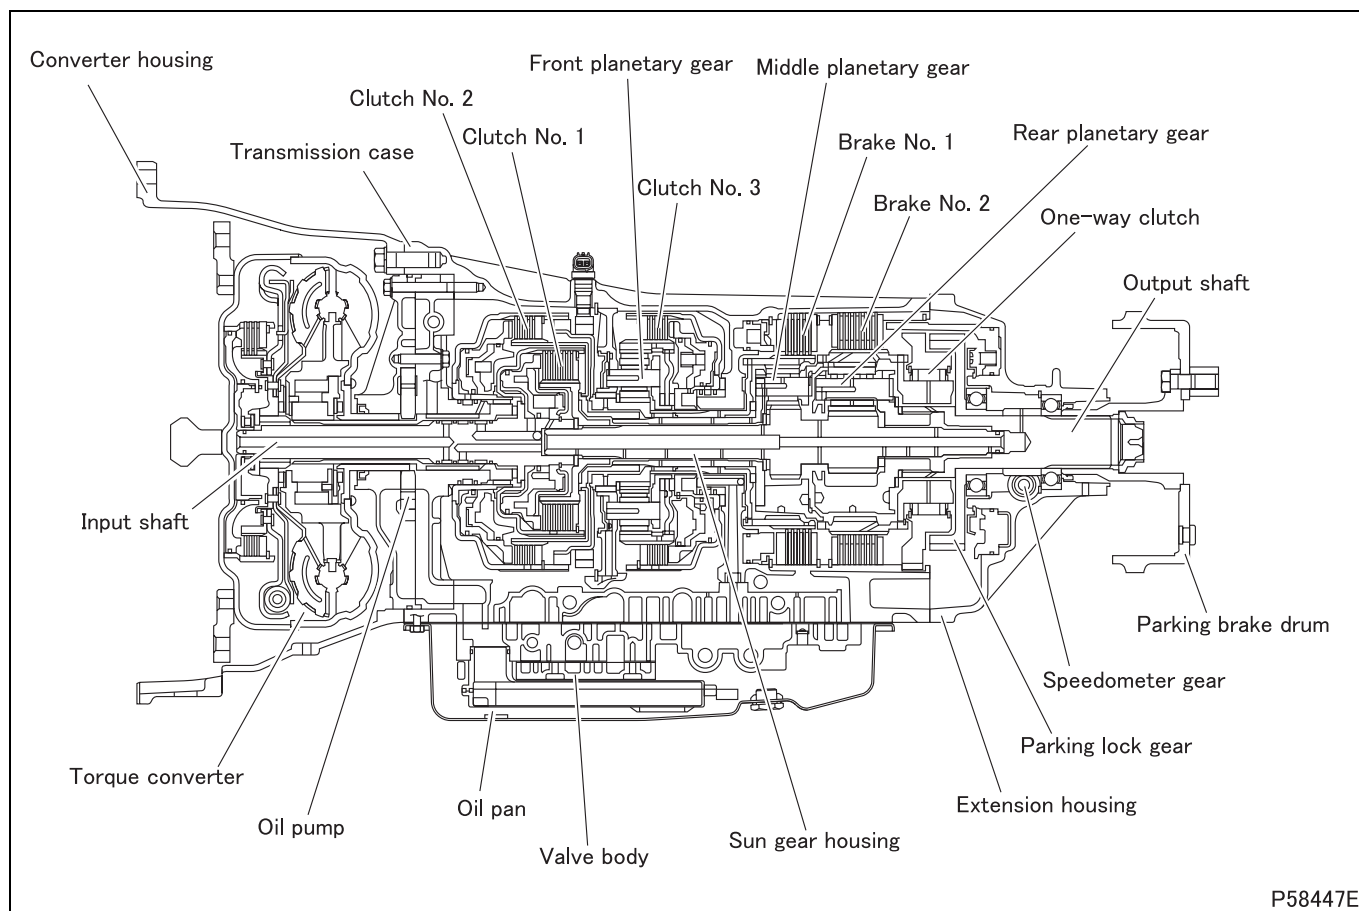
## 1.1 Automatic transmission

- The automatic transmission combines a torque converter (this has a lockup mechanism) and a fully automatic 6-speed gear system.

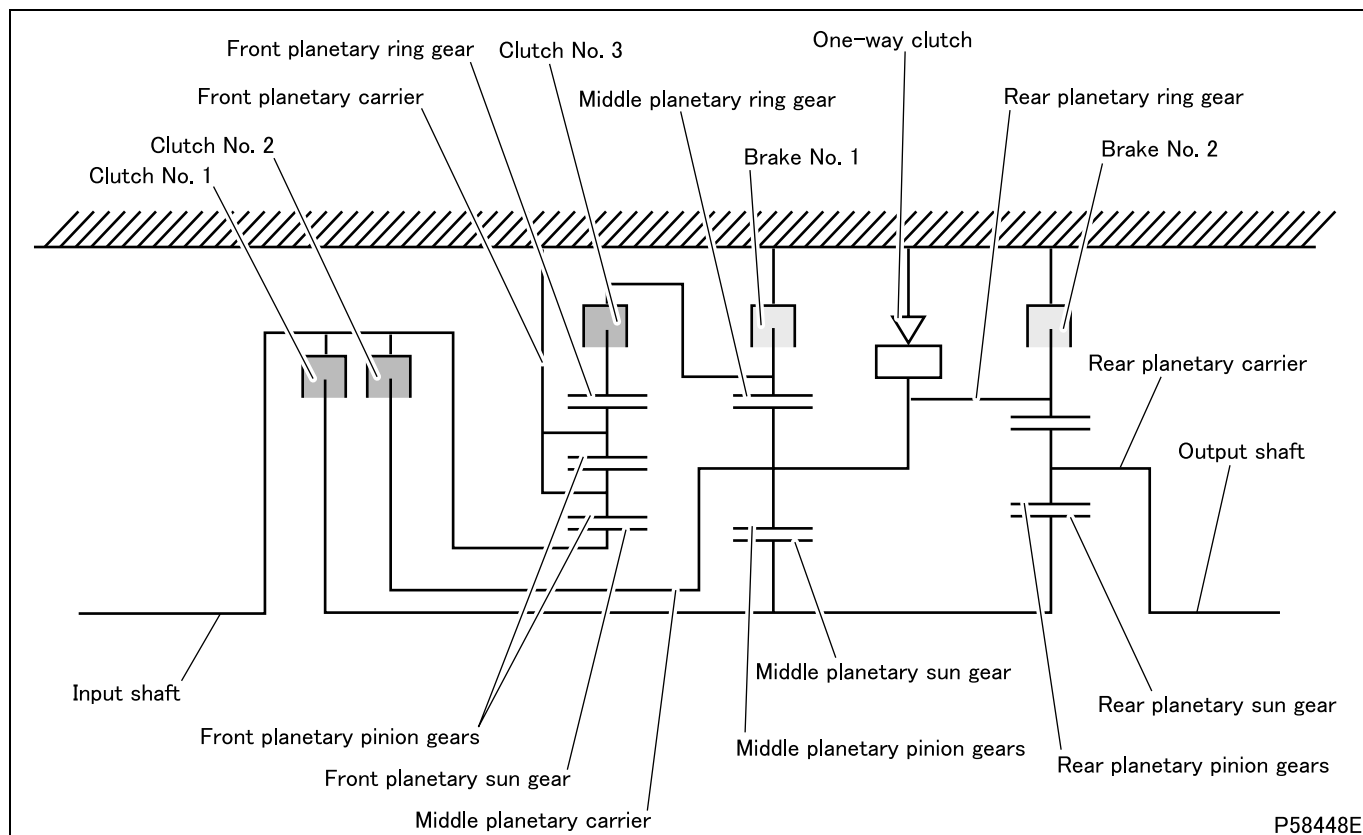
## 1.3 Transmission

### (1) Functions of clutches and brakes

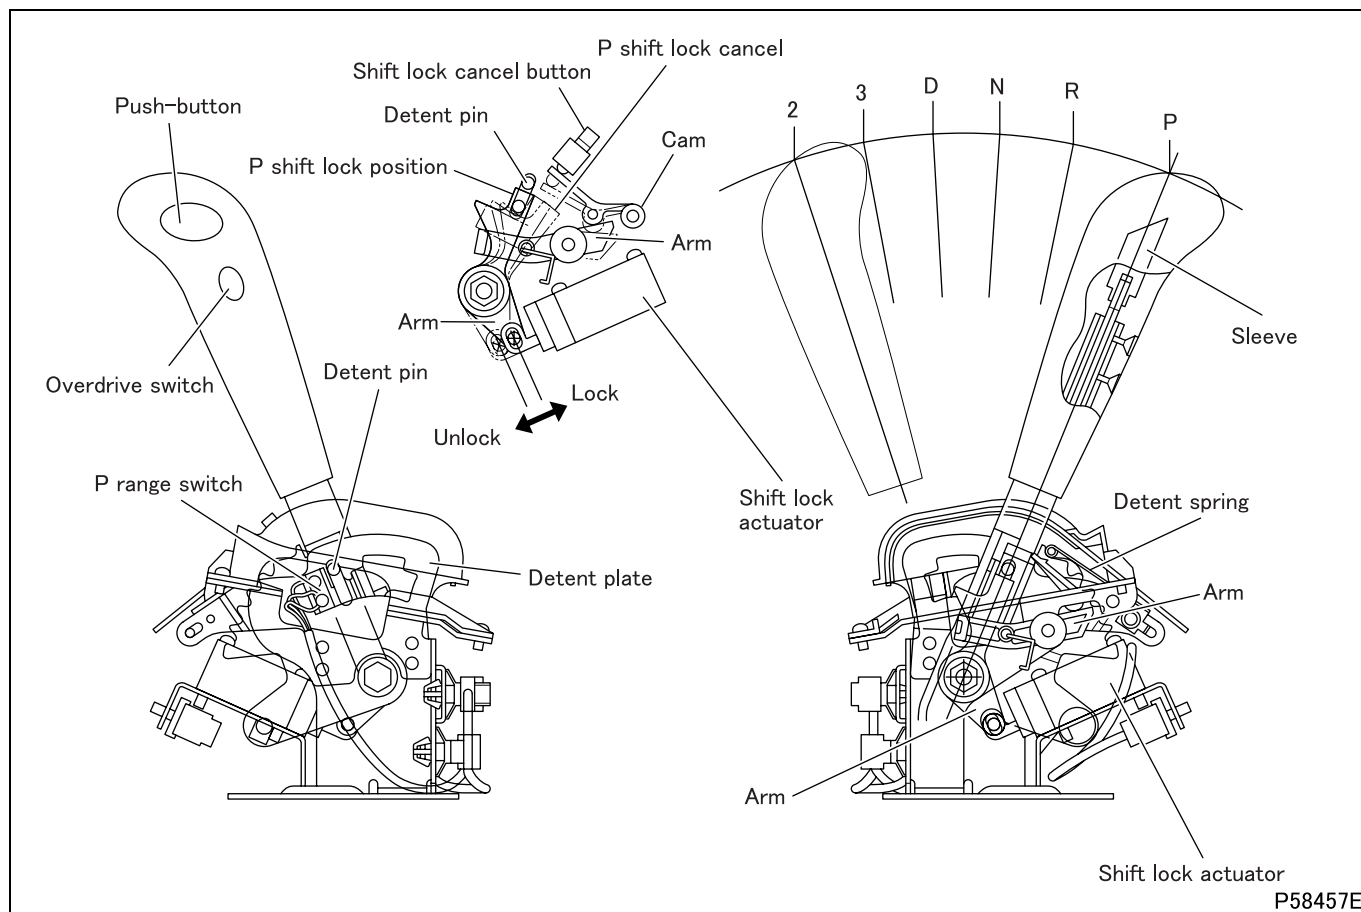
## 1.4 Range selector lever

- The P range switch indicates whether the P range is selected. It is used for the key interlock function.
- The shift lock actuator is used in control of the P shift lock function.
- The shift lock cancel button cancels the P shift lock function in a way that bypasses the shift lock actuator. It is used in the event of a fault.

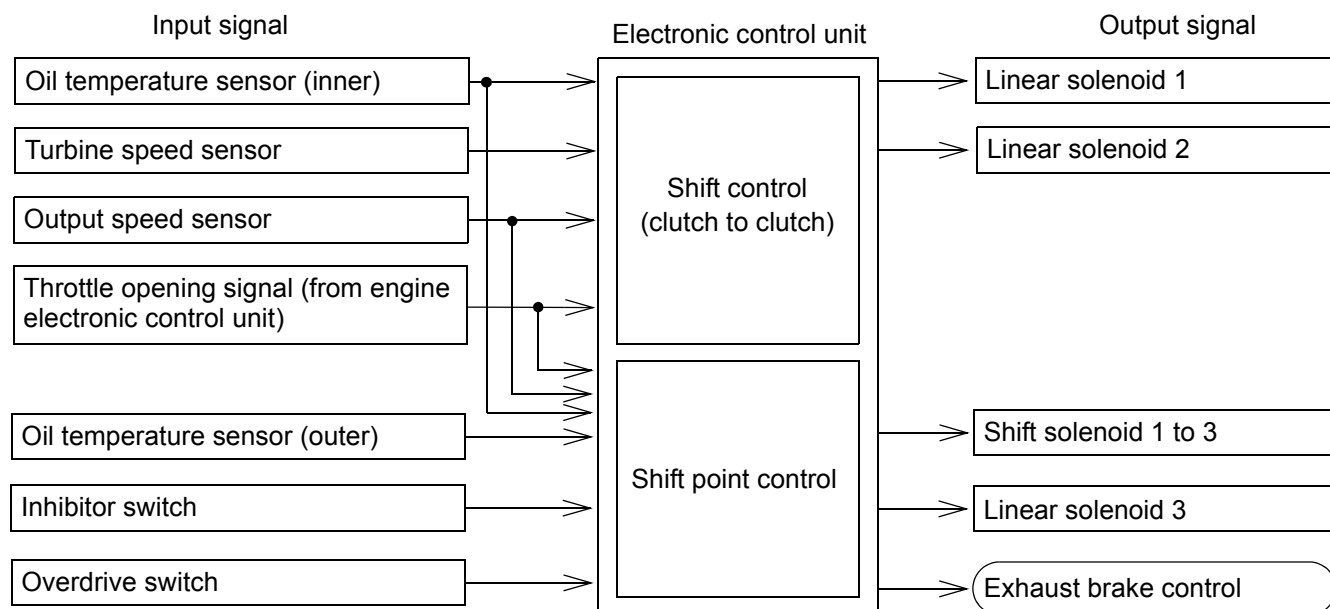
## 2.2 Shift control and shift point control

- For automatic selection of the optimal gear, the throttle opening signal and the output speed sensor signals (which correspond to the vehicle speed) cause the automatic transmission electronic control unit to issue relevant signals in accordance with a predetermined shift map to shift solenoid 1-3 and linear solenoid 1 and 2, which are mounted on the valve body.
- Clutch selection for shift control is performed by means of clutch-to-clutch control, whereby one clutch is disengaged as another is engaged.

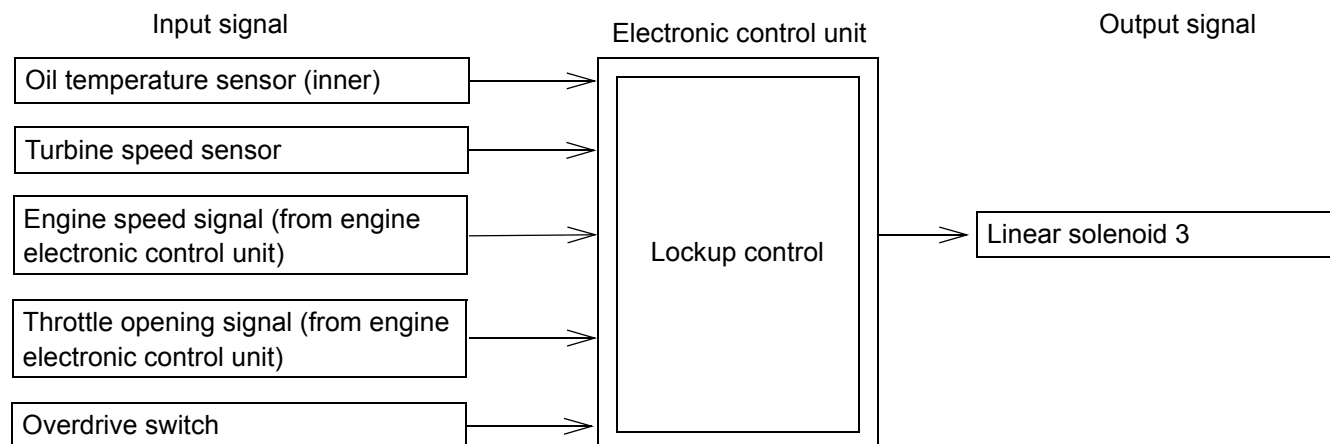
### 2.3 Lockup control

- Lockup control enables slippage in the torque converter to be eliminated for increased transmission efficiency. The throttle opening signal and the output speed sensor signals (which correspond to the vehicle speed) cause the automatic transmission electronic control unit to issue relevant signals in accordance with a predetermined shift map to linear solenoid 3 (this is mounted on the valve body) for lockup ON-OFF-slip selection.

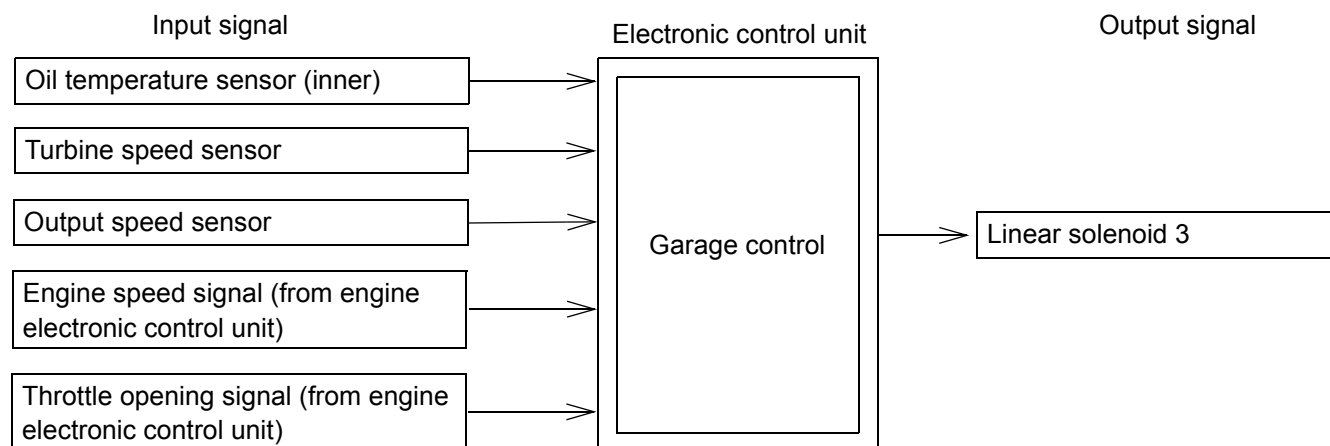
### 2.4 Garage control

- When the inhibitor switch signal changes from N to a driving range (D or R), a signal is issued by the automatic transmission electronic control unit to linear solenoid 3 (this is mounted on the valve body) to realize a forward or reverse gear.

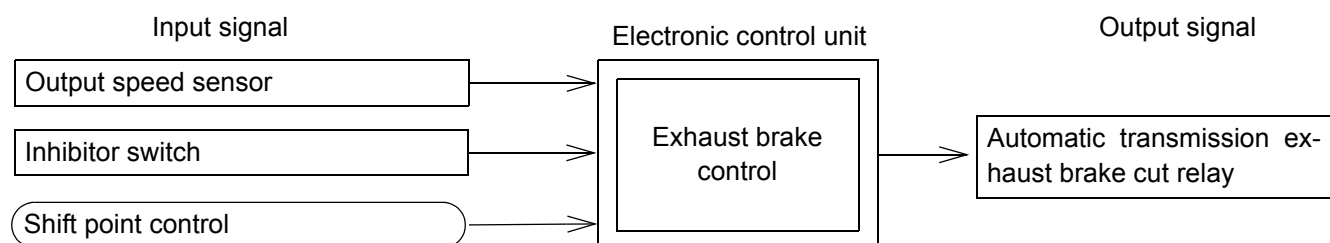
### 2.5 Exhaust brake control

- The exhaust brake is released under any of the following conditions.
  - Range selector lever is in P or N
  - Low speed driving
  - During automatic transmission shifting
  - ATF temperature is high

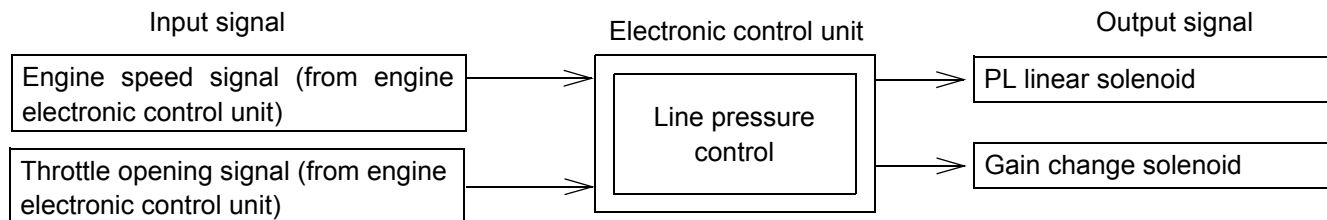
## 2.6 Line pressure control

- The line pressure control optimizes the automatic transmission line pressure in accordance with the throttle opening signal and engine speed signal.

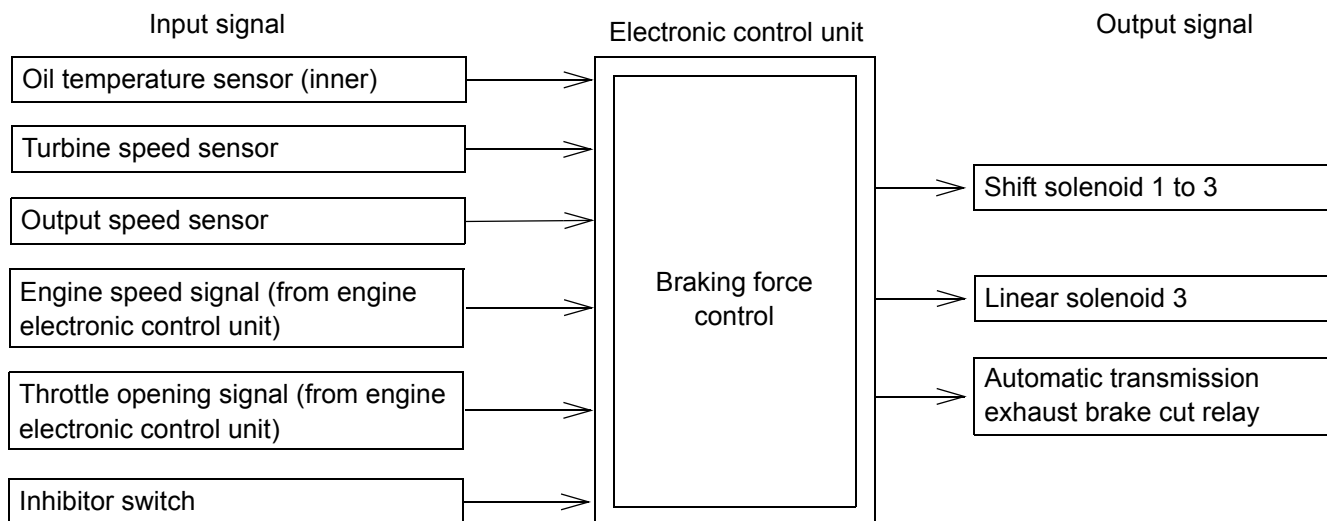
## 2.7 Braking force control

- If the accelerator pedal is released when the vehicle speed is higher than a certain level, a gear is selected in accordance with the road grade and cargo weight to realize optimal engine braking.

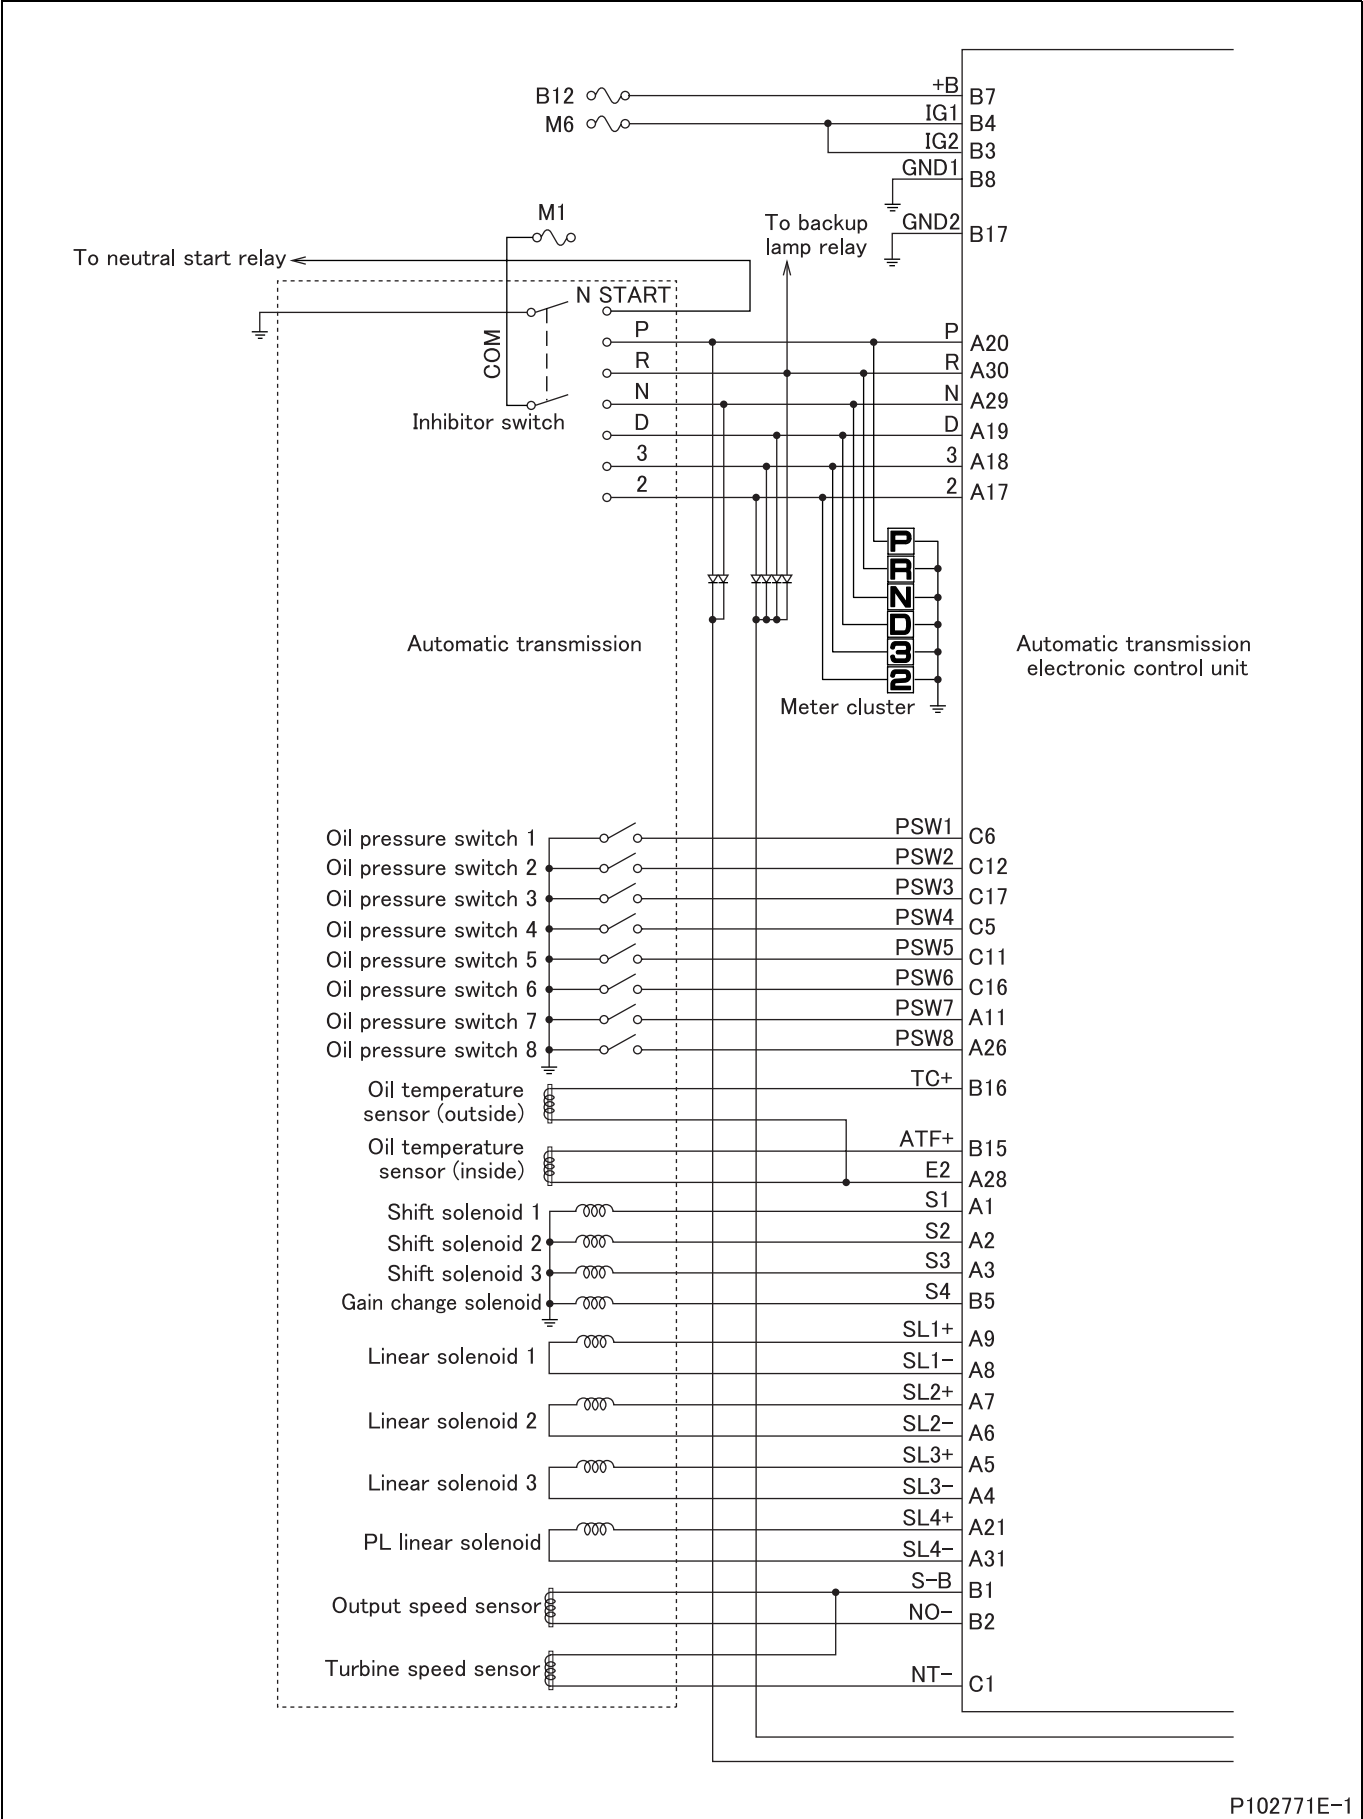
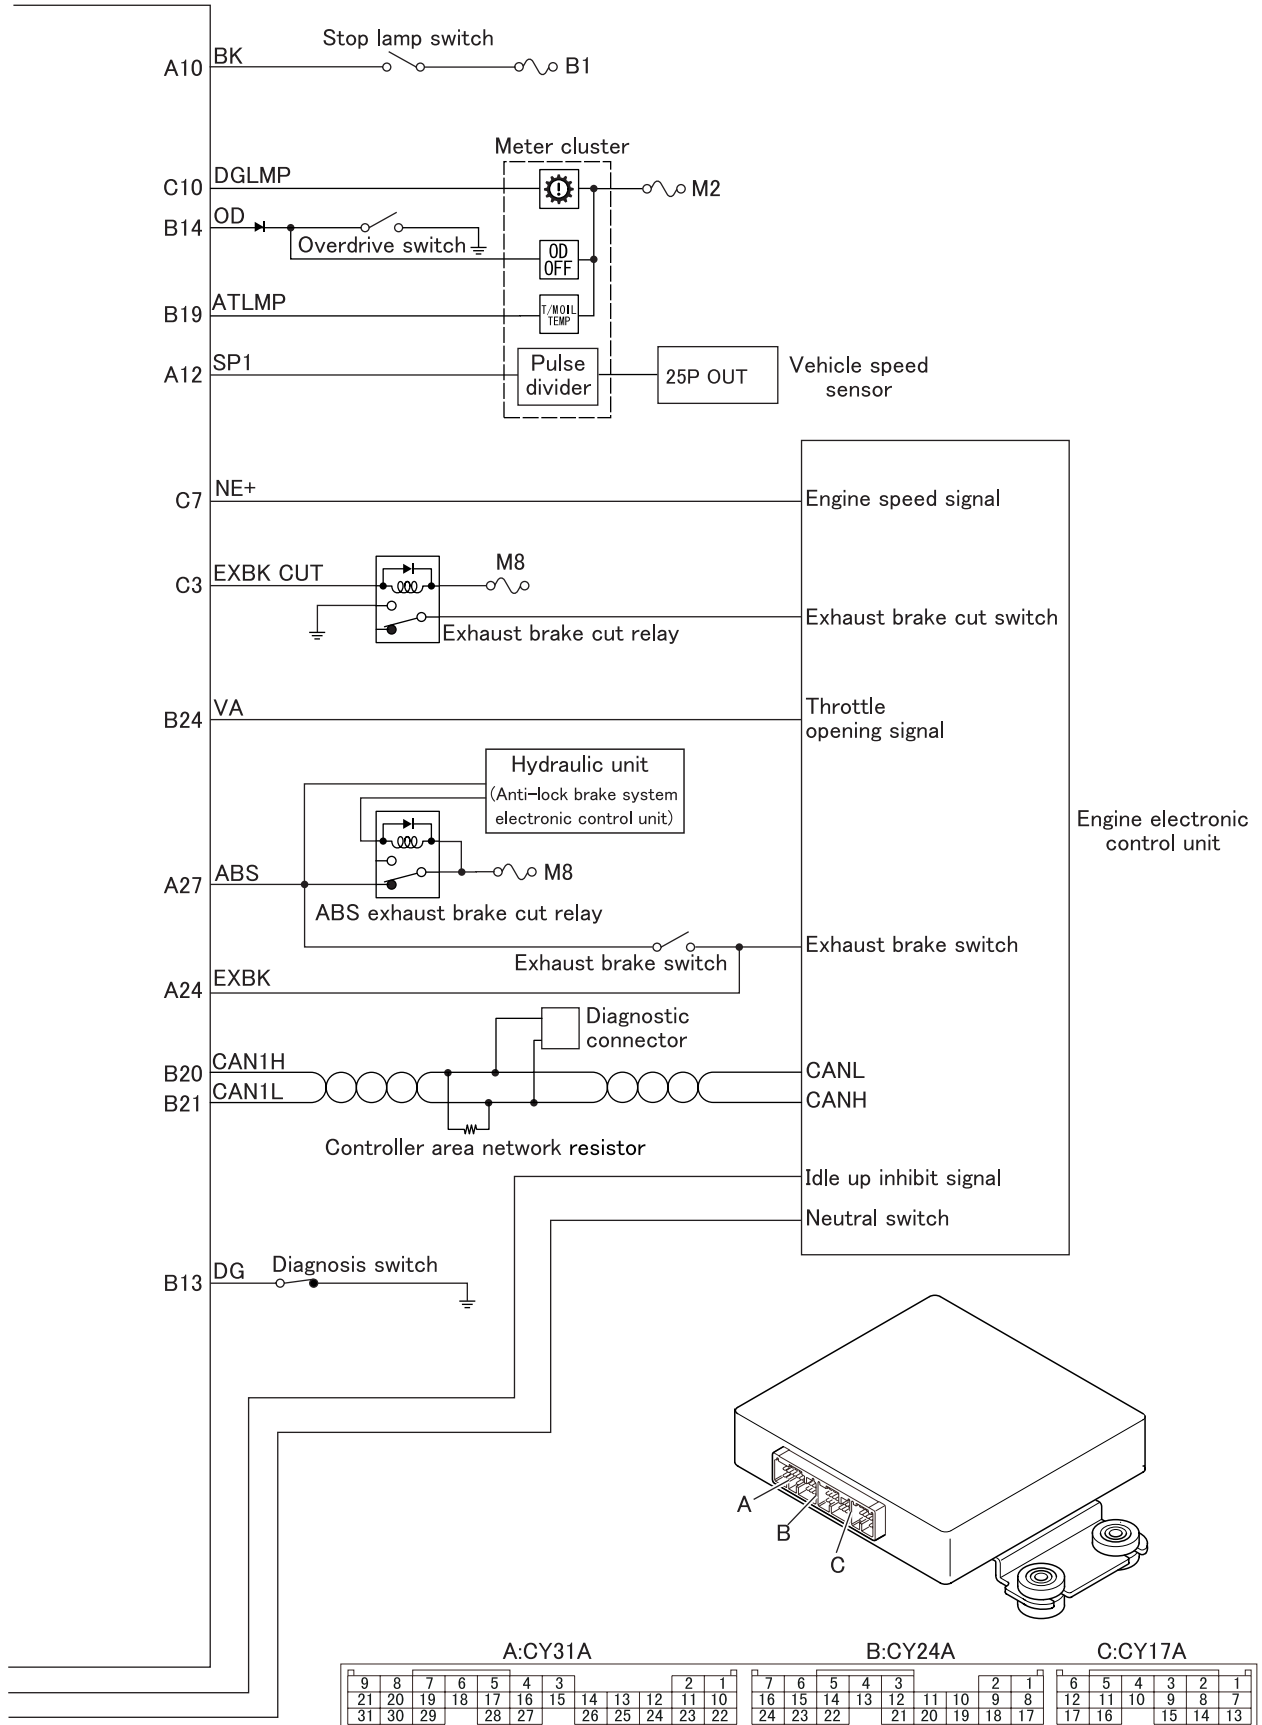
P102771E-2

## 3. Electronic Control Unit Connection Diagram

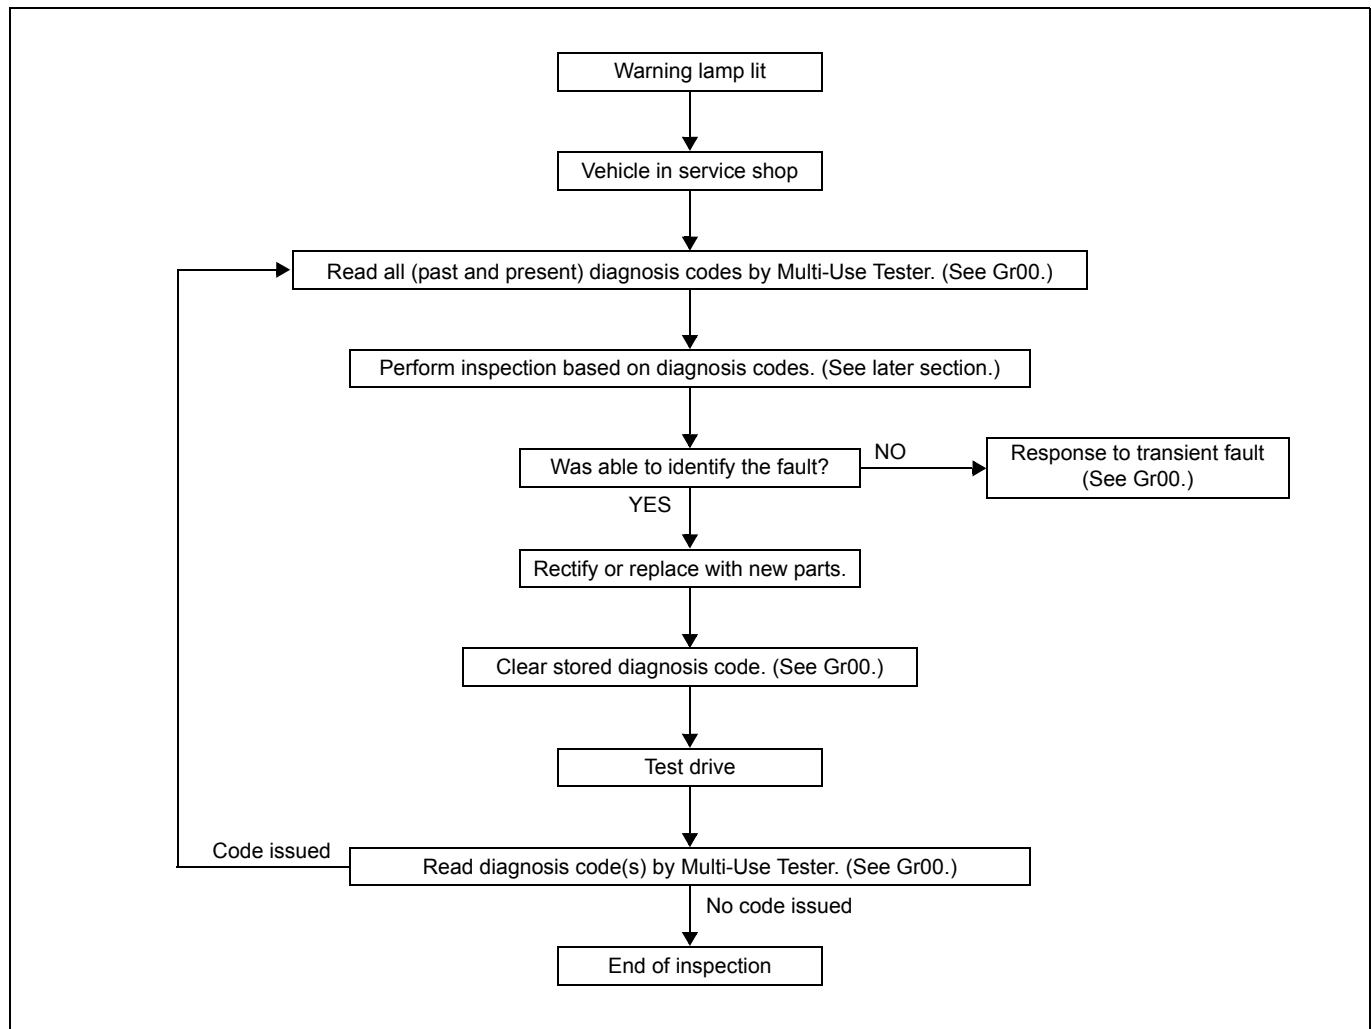
- Perform the inspection in accordance with the following flowchart.

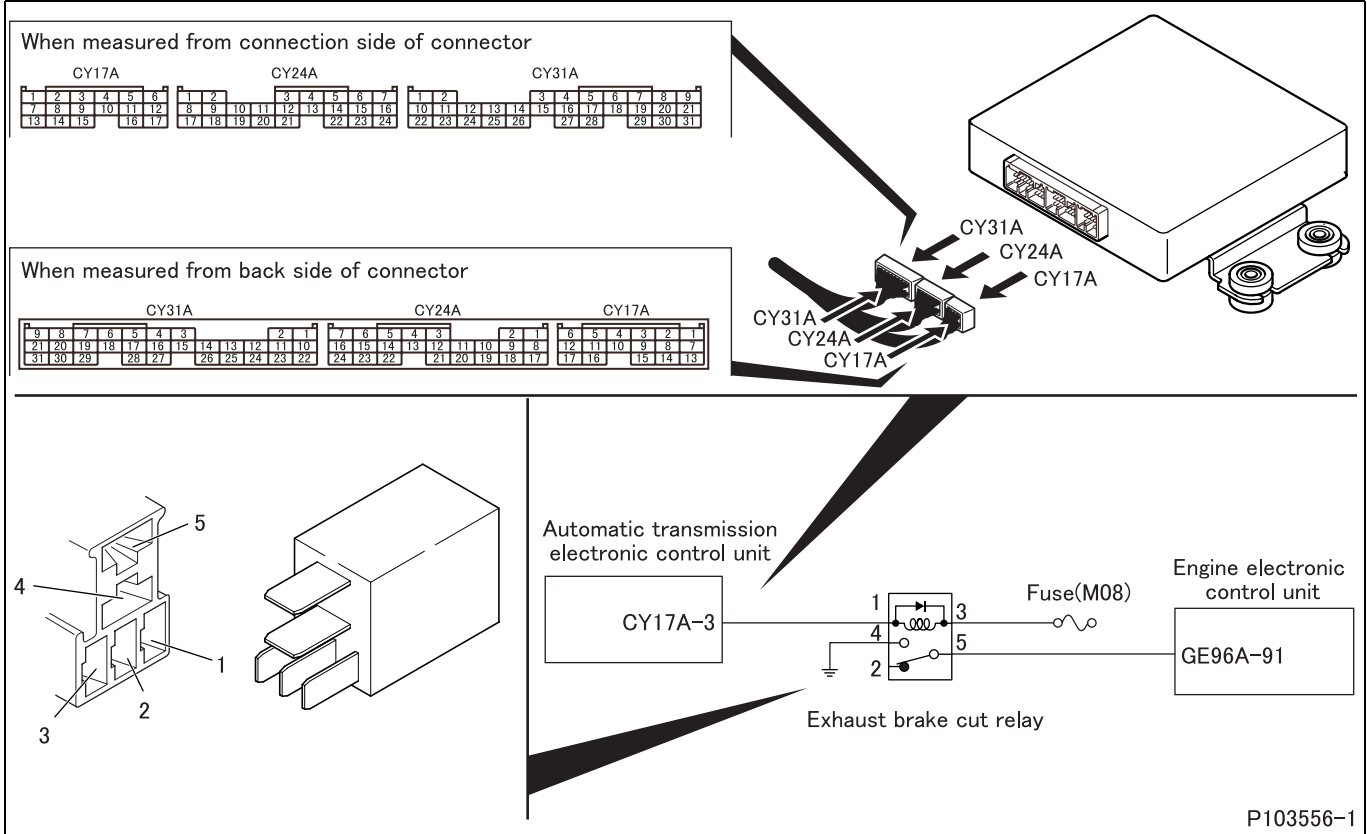
# [Electronic Control Unit Connection Diagram]

- Open-circuit or short-circuit of harness between electronic control unit and automatic transmission exhaust brake cut relay
- Malfunction of each connector
- Malfunction of automatic transmission exhaust brake cut relay
- Defective electronic control unit

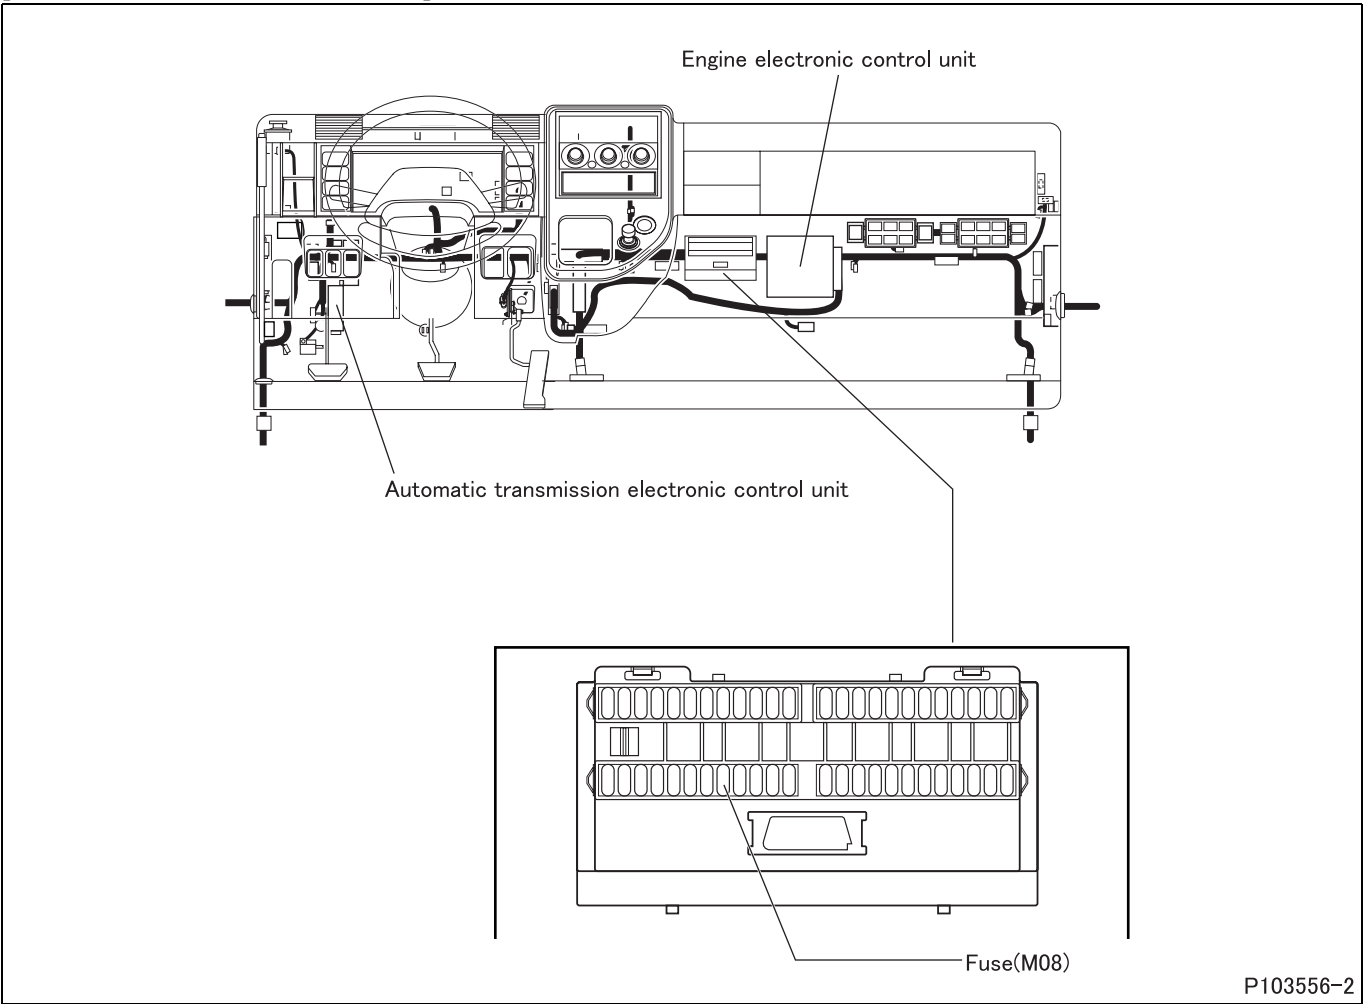
## [Parts Identification and Location]

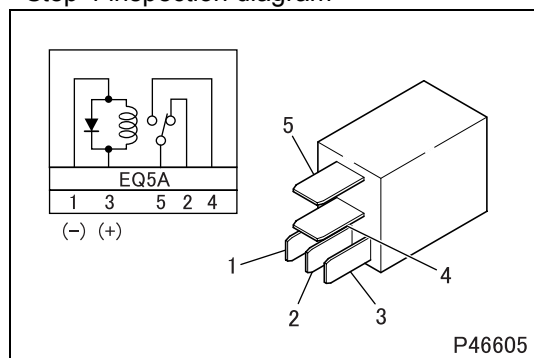
<Step 4 inspection diagram>

| | Inspection condition | | Apply battery voltage across connector terminals No. 3 (+) and 1 (–). | |

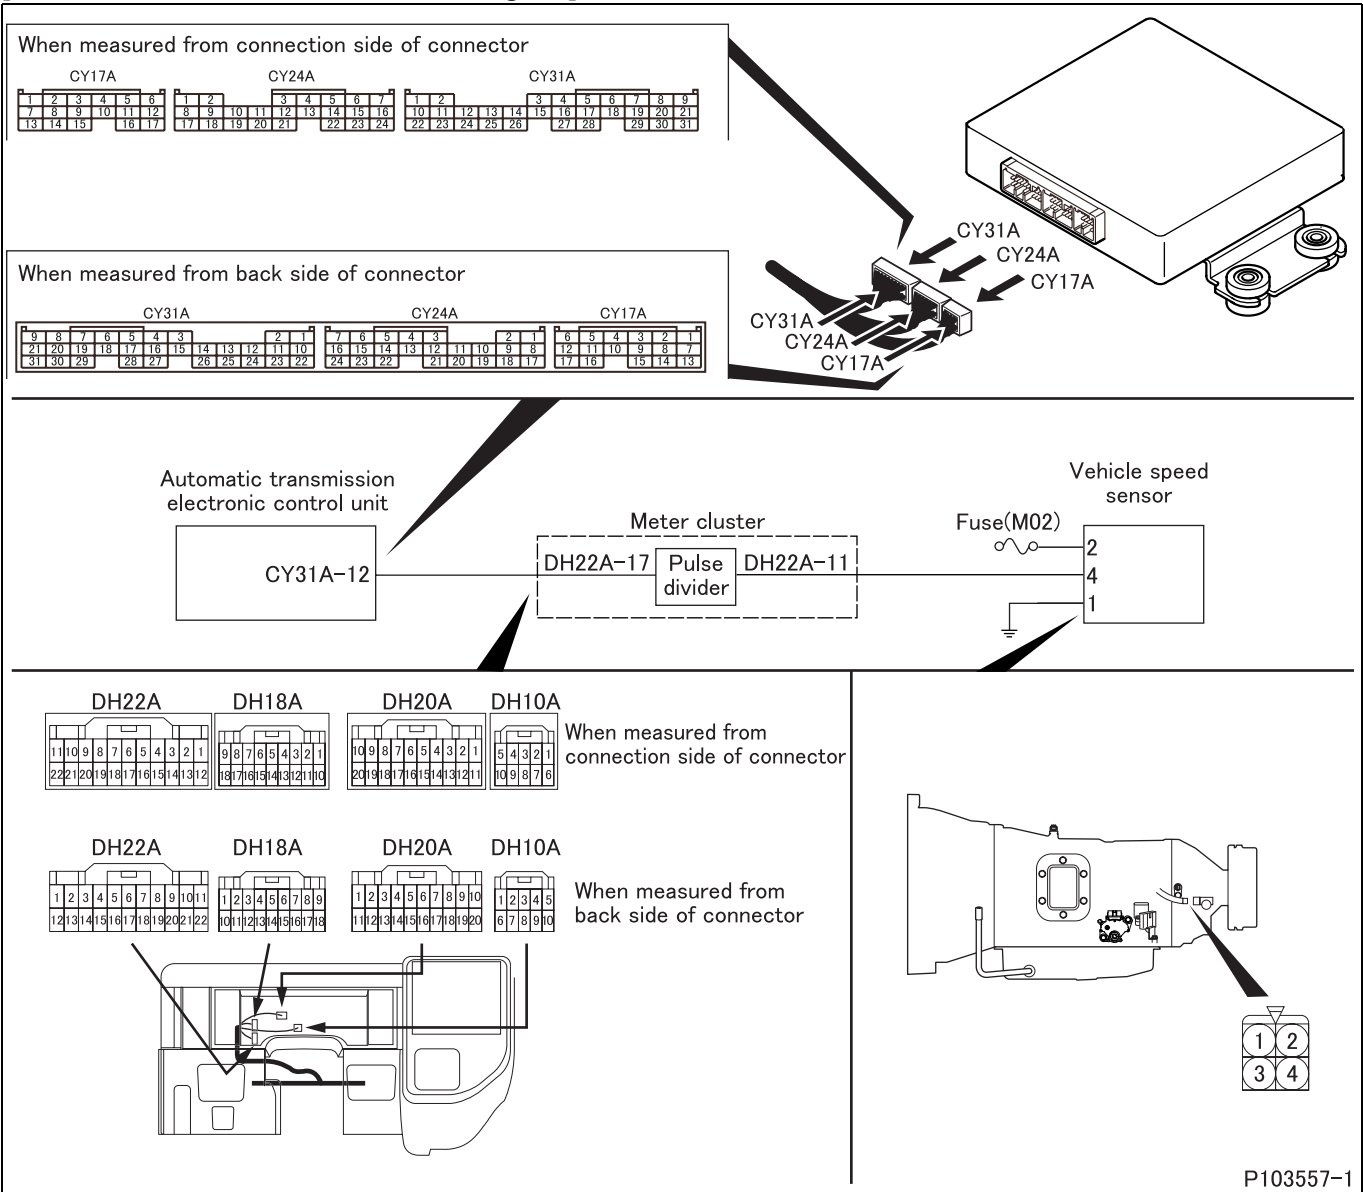
## [Electronic Control Unit Connection Diagram]
