# FE.FG

## SERVICE MANUAL 2008 Model FOREWORD

This Service Manual contains maintenance and repair methods for the Mitsubishi Fuso Truck FE. FG Series. Read this manual carefully as an aid in providing correct, efficient maintenance. Please note that the information and specifications contained within this manual may change without notice. This is due to product modifications and continued vehicle improvements that are made throughout the model years. Should you encounter any discrepancy in the information provided, please do not hesitate to contact your nearest Mitsubishi Fuso Dealer or Mitsubishi Fuso Truck of America, Inc.

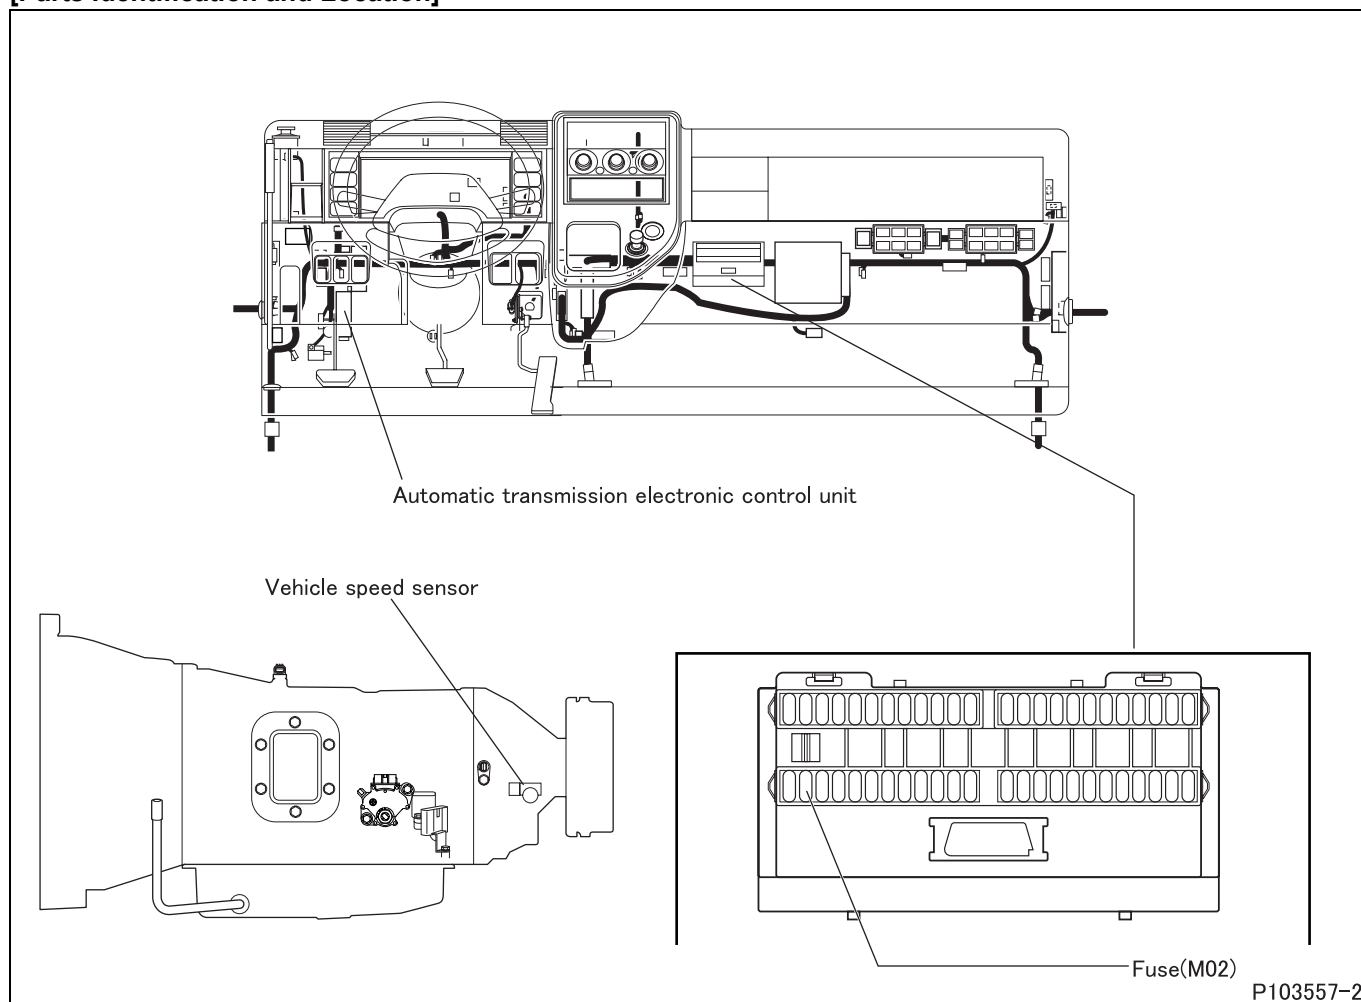
## [Parts Identification and Location]

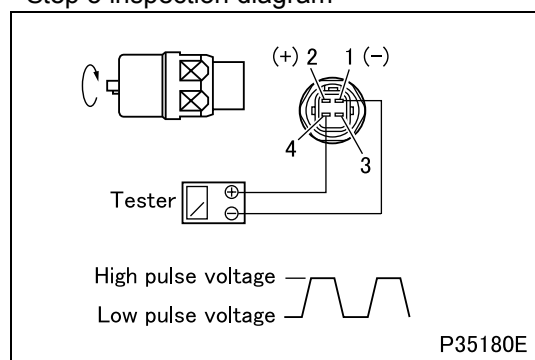
<Step 5 inspection diagram>

| | Inspection condition | | <ul style="list-style-type: none"> <li>Measure from back side of harness connector with electronic control unit connected to harness.</li> <li>Slowly turn the wheel using chassis dynamometer or the like.</li> <li>Starter switch: ON</li> </ul> |

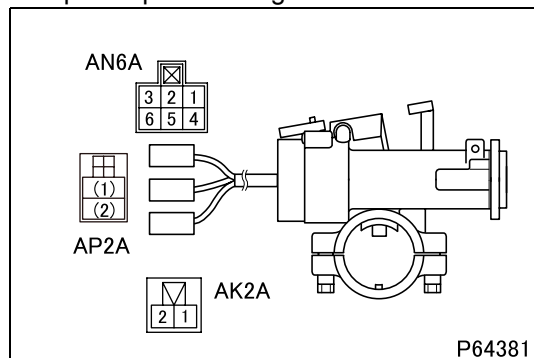
<Step 7 inspection diagram>

| | Maintenance item | | Check circuit between battery terminal (+) and electronic control unit connector (CY24A) terminal No. 3, 4. | |

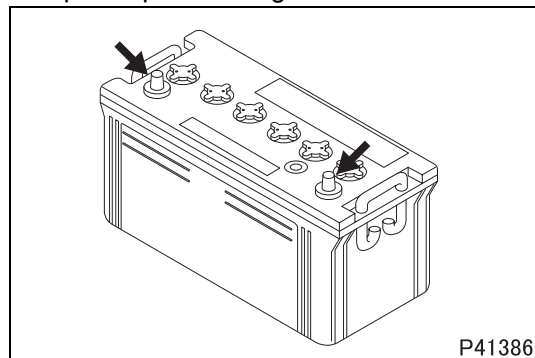
<Step 4 inspection diagram>

| | Maintenance item | | Check circuit between battery terminal (+) and electronic control unit connector (CY24A) terminal No. 7. | |

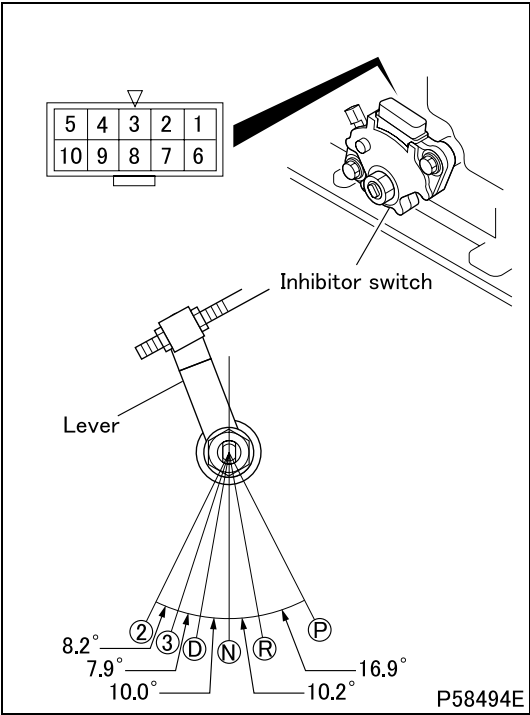
<Step 5 inspection diagram>

| | Maintenance item | | <p>&lt;P&gt;</p> <ul style="list-style-type: none"> <li>Check circuit between switch connector terminal No. 5 and electronic control unit connector (CY31A) terminal No. 20</li> </ul> <p>&lt;R&gt;</p> <ul style="list-style-type: none"> <li>Check circuit between switch connector terminal No. 9 and electronic control unit connector (CY31A) terminal No. 30</li> </ul> <p>&lt;N&gt;</p> <ul style="list-style-type: none"> <li>Check circuit between switch connector terminal No. 1 and electronic control unit connector (CY31A) terminal No. 29</li> </ul> <p>&lt;D&gt;</p> <ul style="list-style-type: none"> <li>Check circuit between switch connector terminal No. 8 and electronic control unit connector (CY31A) terminal No. 19</li> </ul> <p>&lt;3&gt;</p> <ul style="list-style-type: none"> <li>Check circuit between switch connector terminal No. 2 and electronic control unit connector (CY31A) terminal No. 18</li> </ul> <p>&lt;2&gt;</p> <ul style="list-style-type: none"> <li>Check circuit between switch connector terminal No. 7 and electronic control unit connector (CY31A) terminal No. 17</li> </ul> |

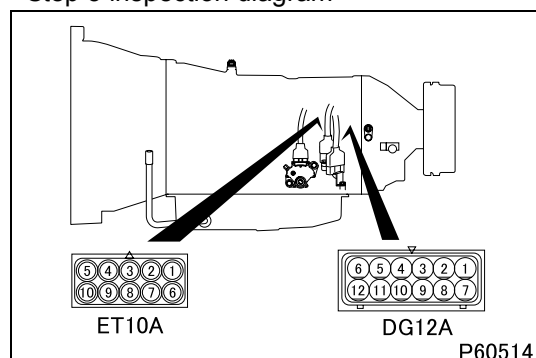
<Step 5 inspection diagram>

| | Maintenance item | | Check circuit between connector (ET10A) terminal No. 3 and electronic control unit connector (CY24A) terminal No. 15. | |

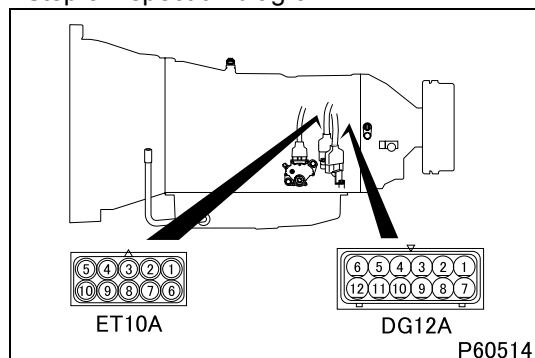
<Step 5 inspection diagram>

| | Maintenance item | | Check circuit between connector (ET10A) terminal No. 3 and electronic control unit connector (CY24A) terminal No. 15. | |

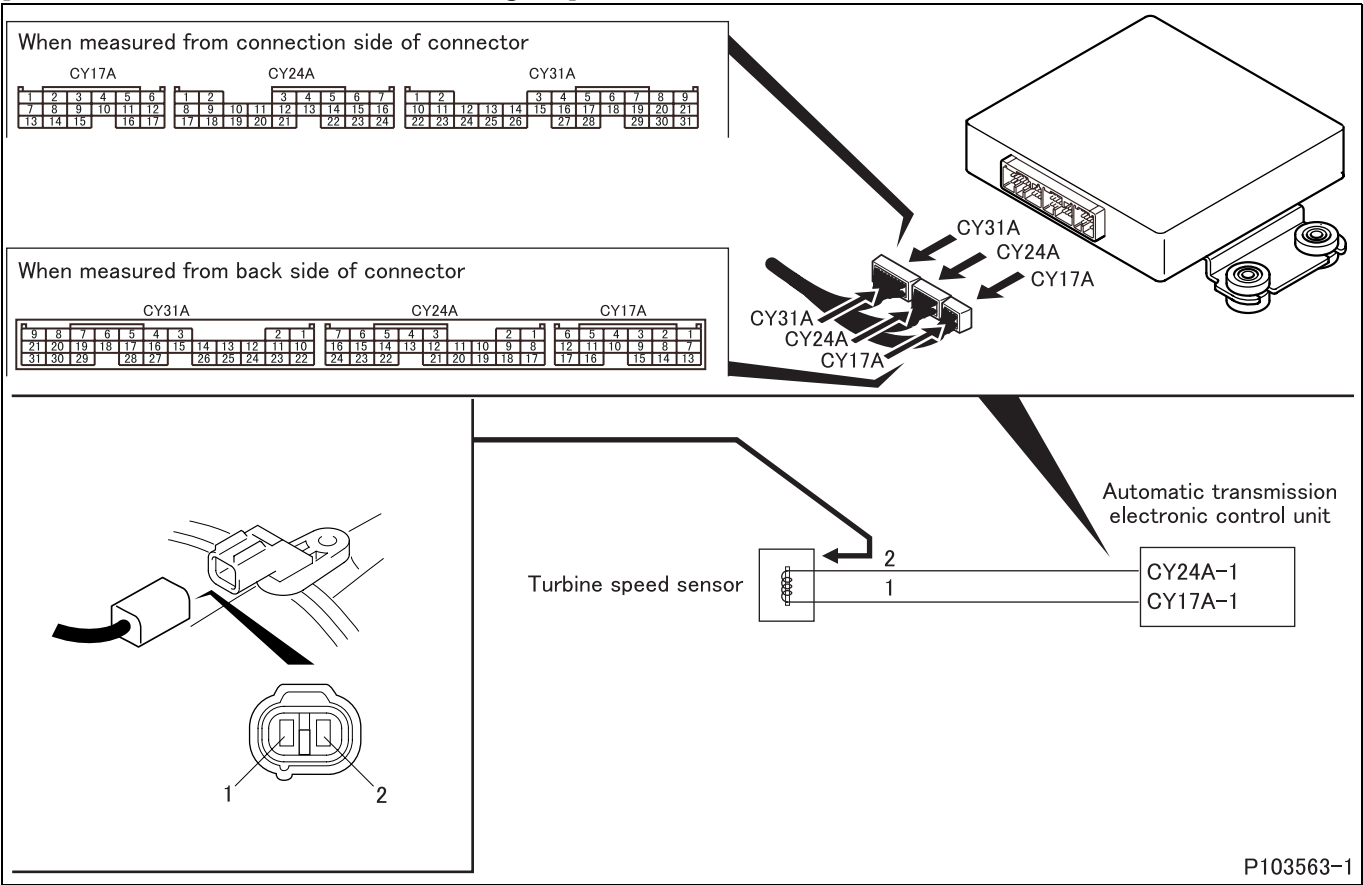
P103563-1

## [Electronic Control Unit Connection Diagram]

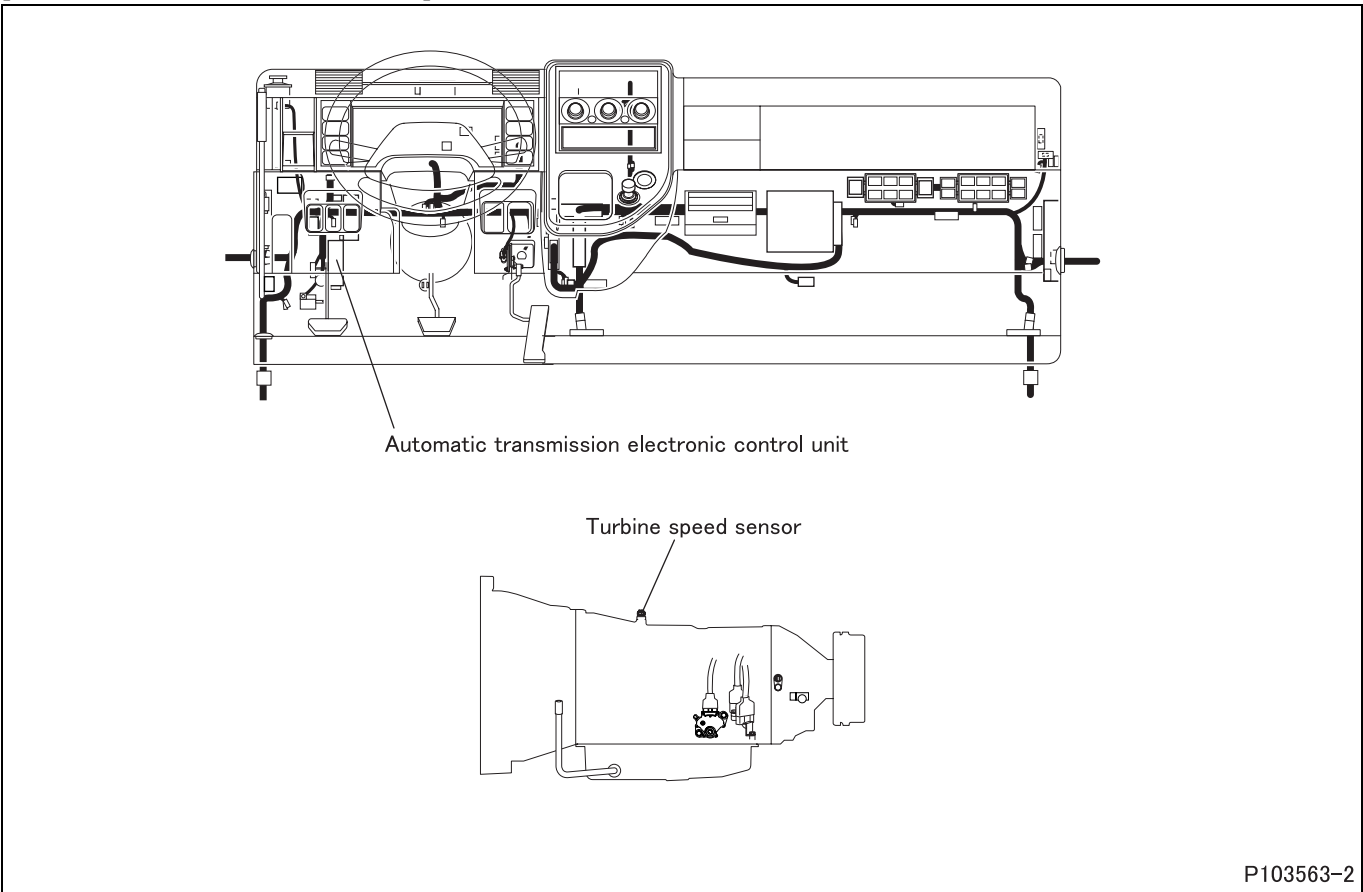
P103563-2

## [Parts Identification and Location]

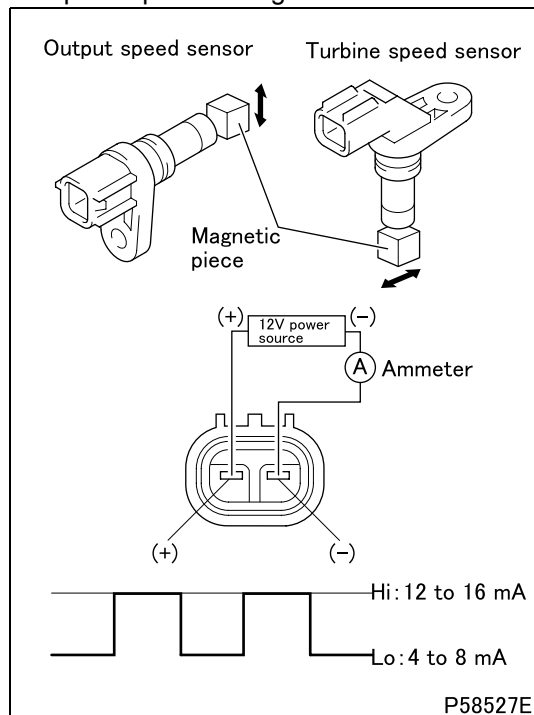
<Step 4 inspection diagram>

| | Inspection condition | | <ul style="list-style-type: none"><li>• Wire sensor as illustrated.</li><li>• Move magnetic piece at sensor tip in illustrated direction. (Distance between sensor and magnetic piece: Within 5 mm [0.20 in.])</li></ul> | |

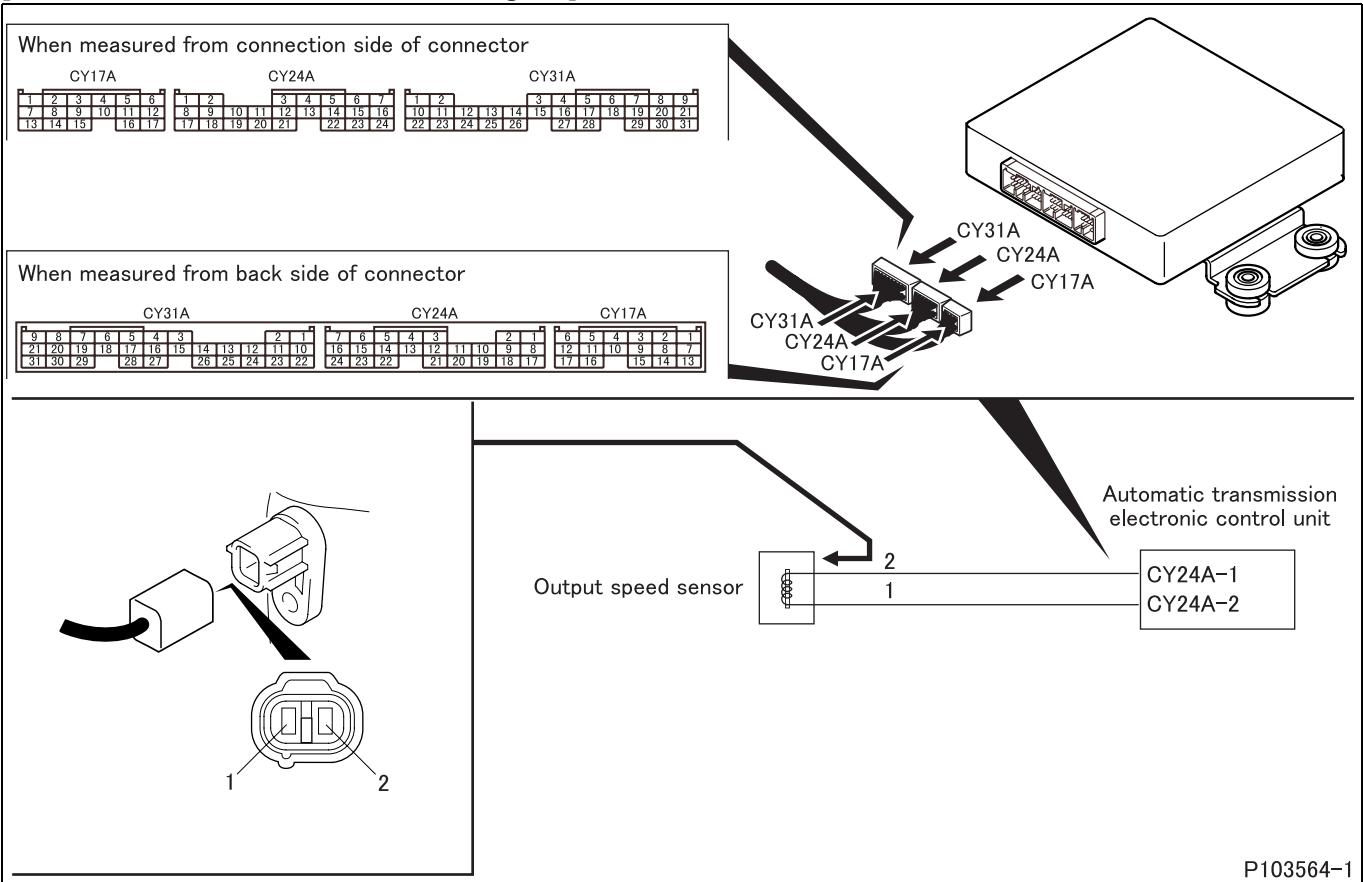
P103564-1

## [Electronic Control Unit Connection Diagram]

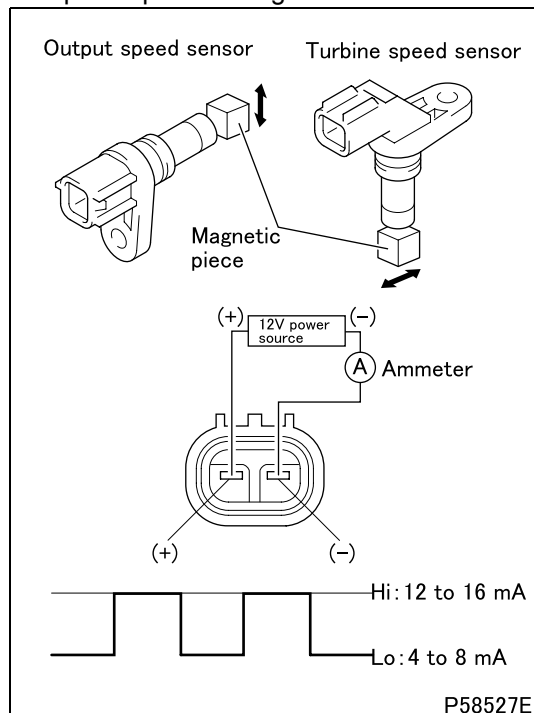
<Step 4 inspection diagram>

| | Inspection condition | | <ul style="list-style-type: none"> <li>• Wire sensor as illustrated.</li> <li>• Move magnetic piece at sensor tip in illustrated direction. (Distance between sensor and magnetic piece: Within 5 mm [0.20 in.])</li> </ul> |

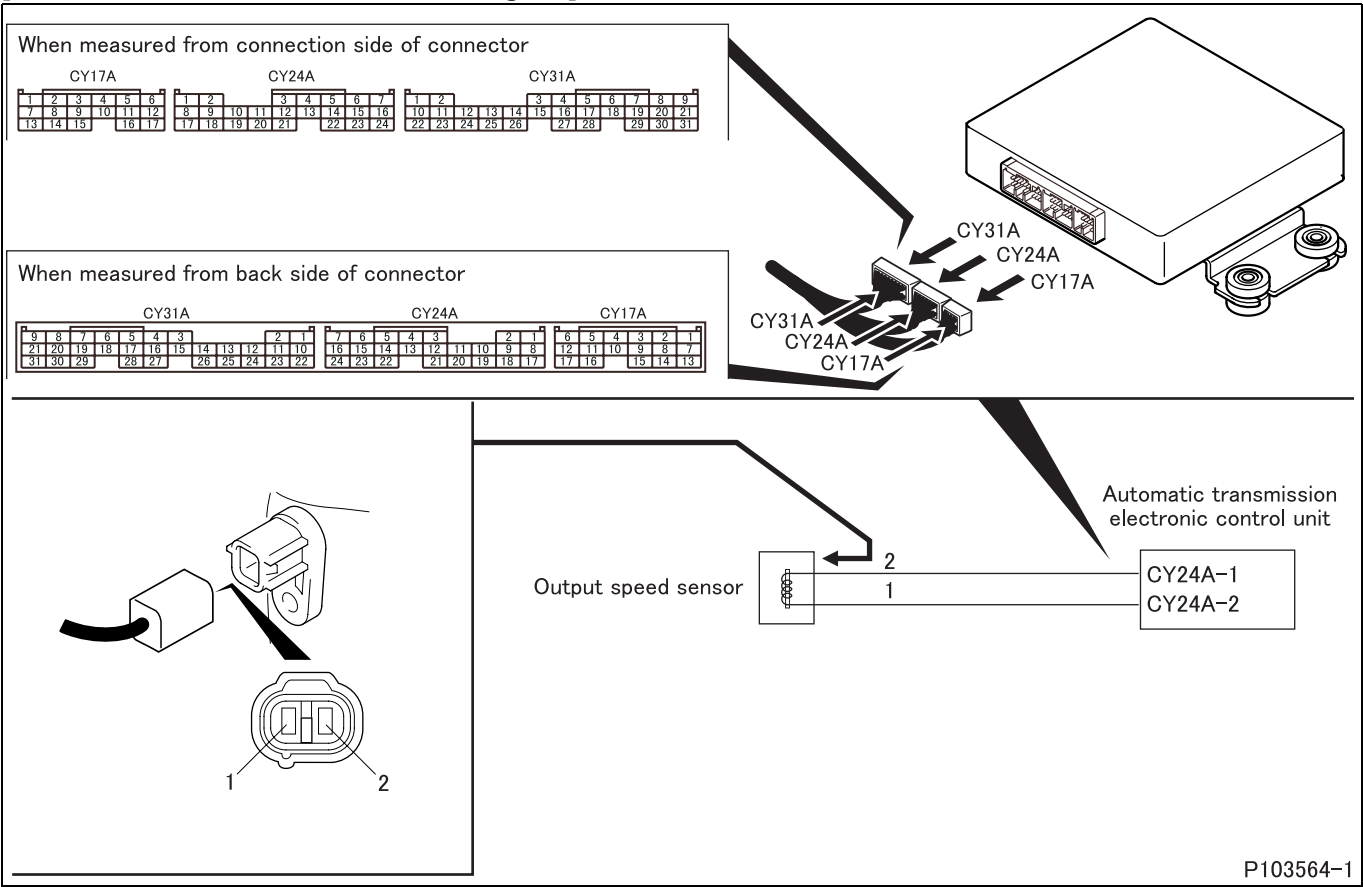
## [Electronic Control Unit Connection Diagram]

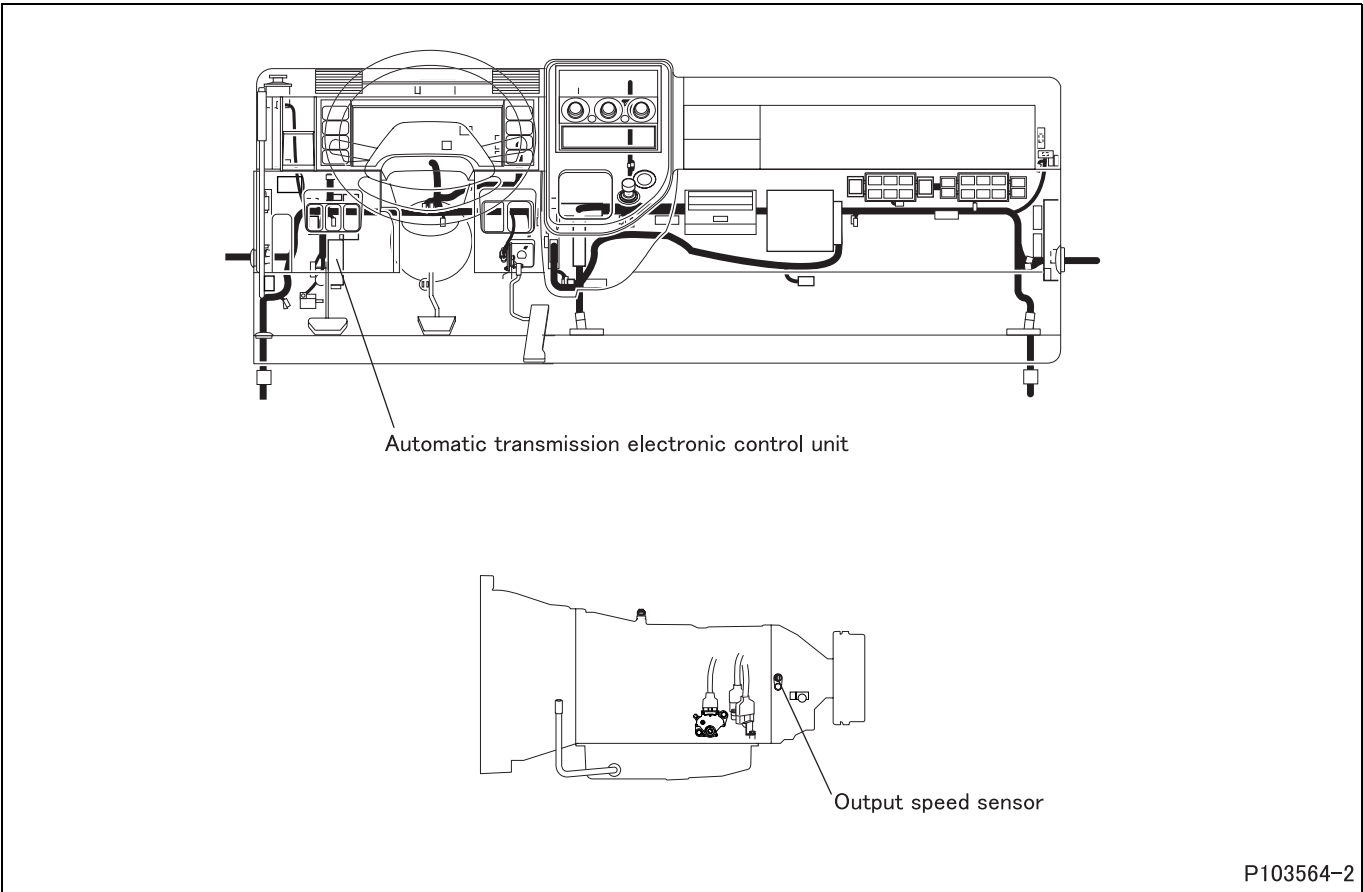
## [Parts Identification and Location]

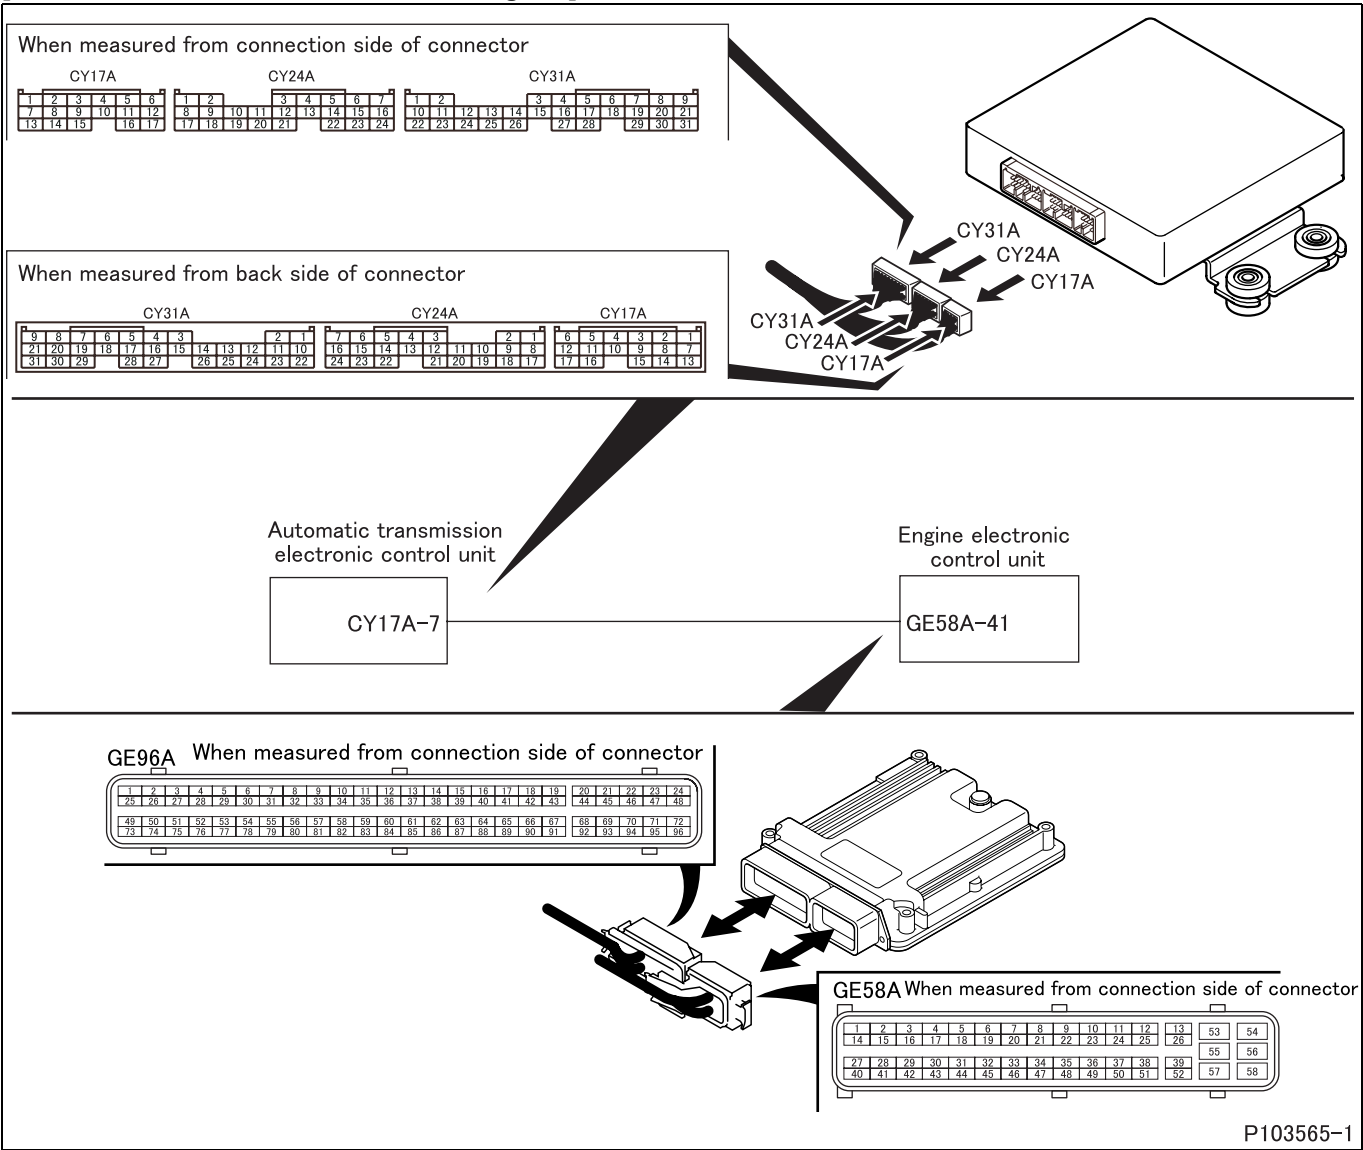
## [Electronic Control Unit Connection Diagram]

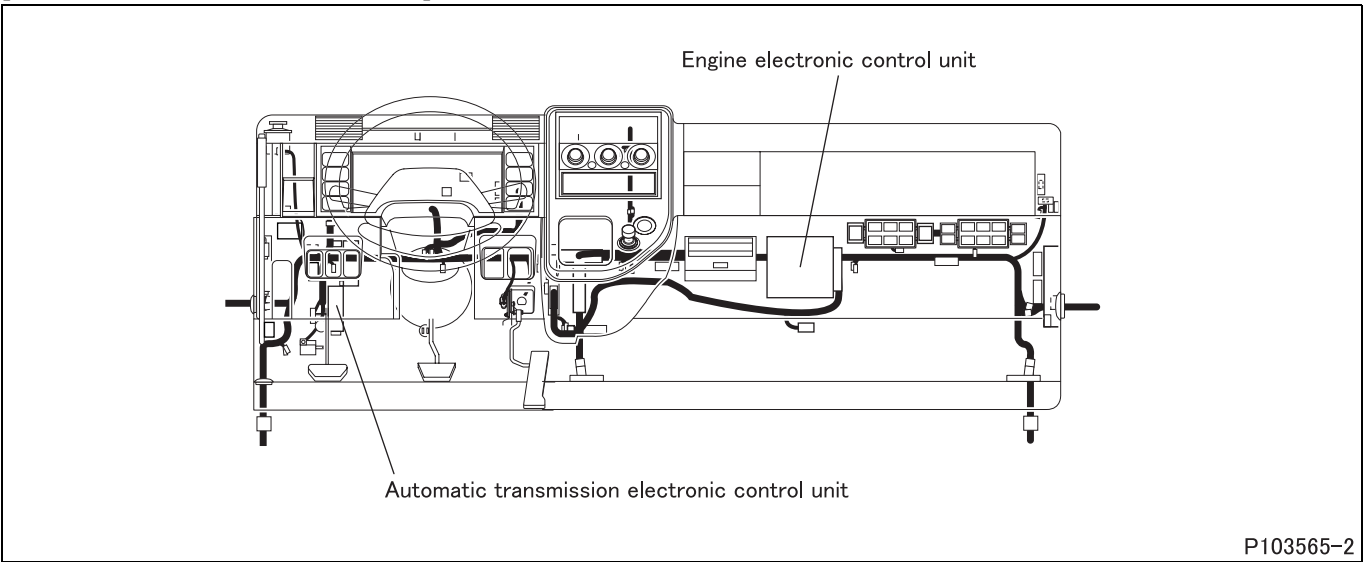
## [Parts Identification and Location]

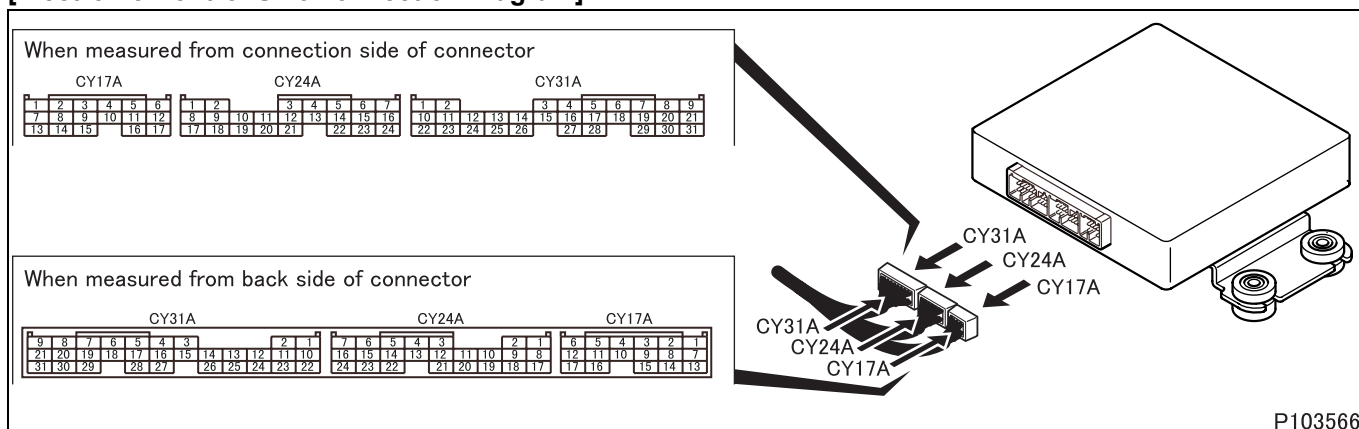
**[Electronic Control Unit Connection Diagram]**

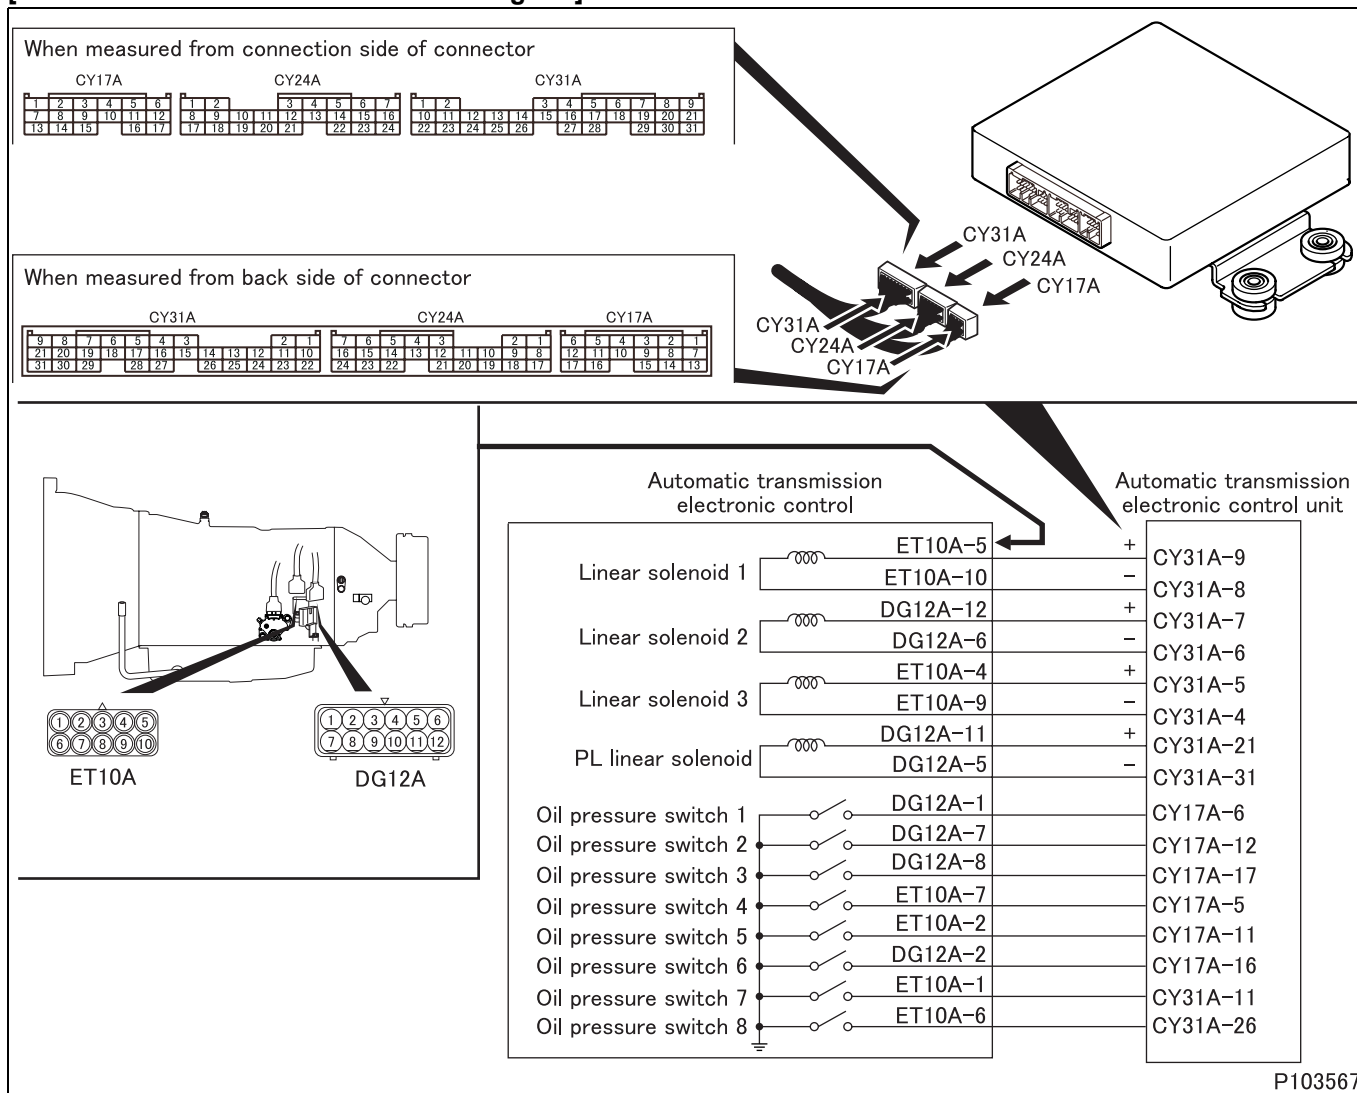
P103567

# [Electronic Control Unit Connection Diagram]

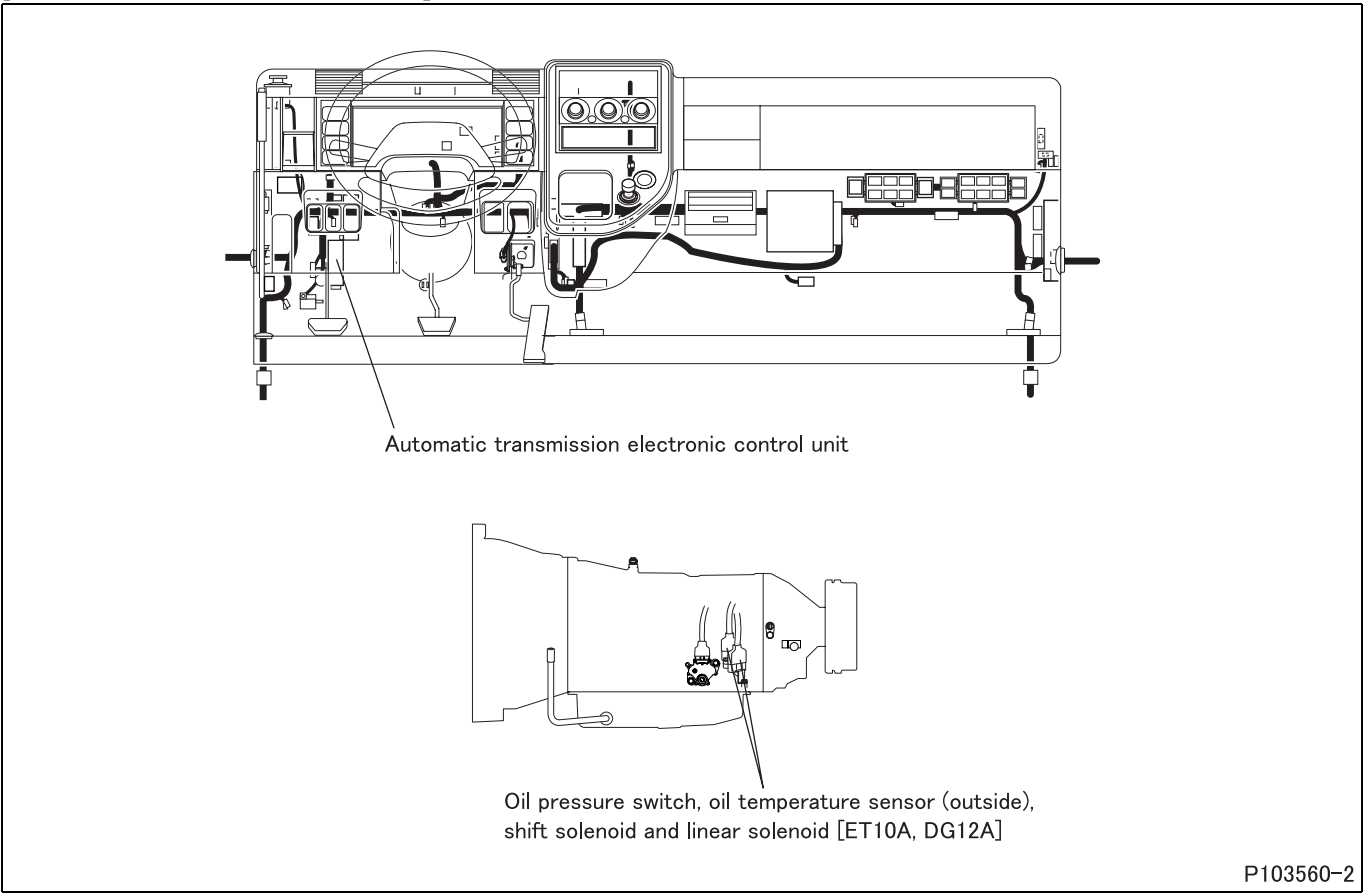
P103560-2

## [Parts Identification and Location]

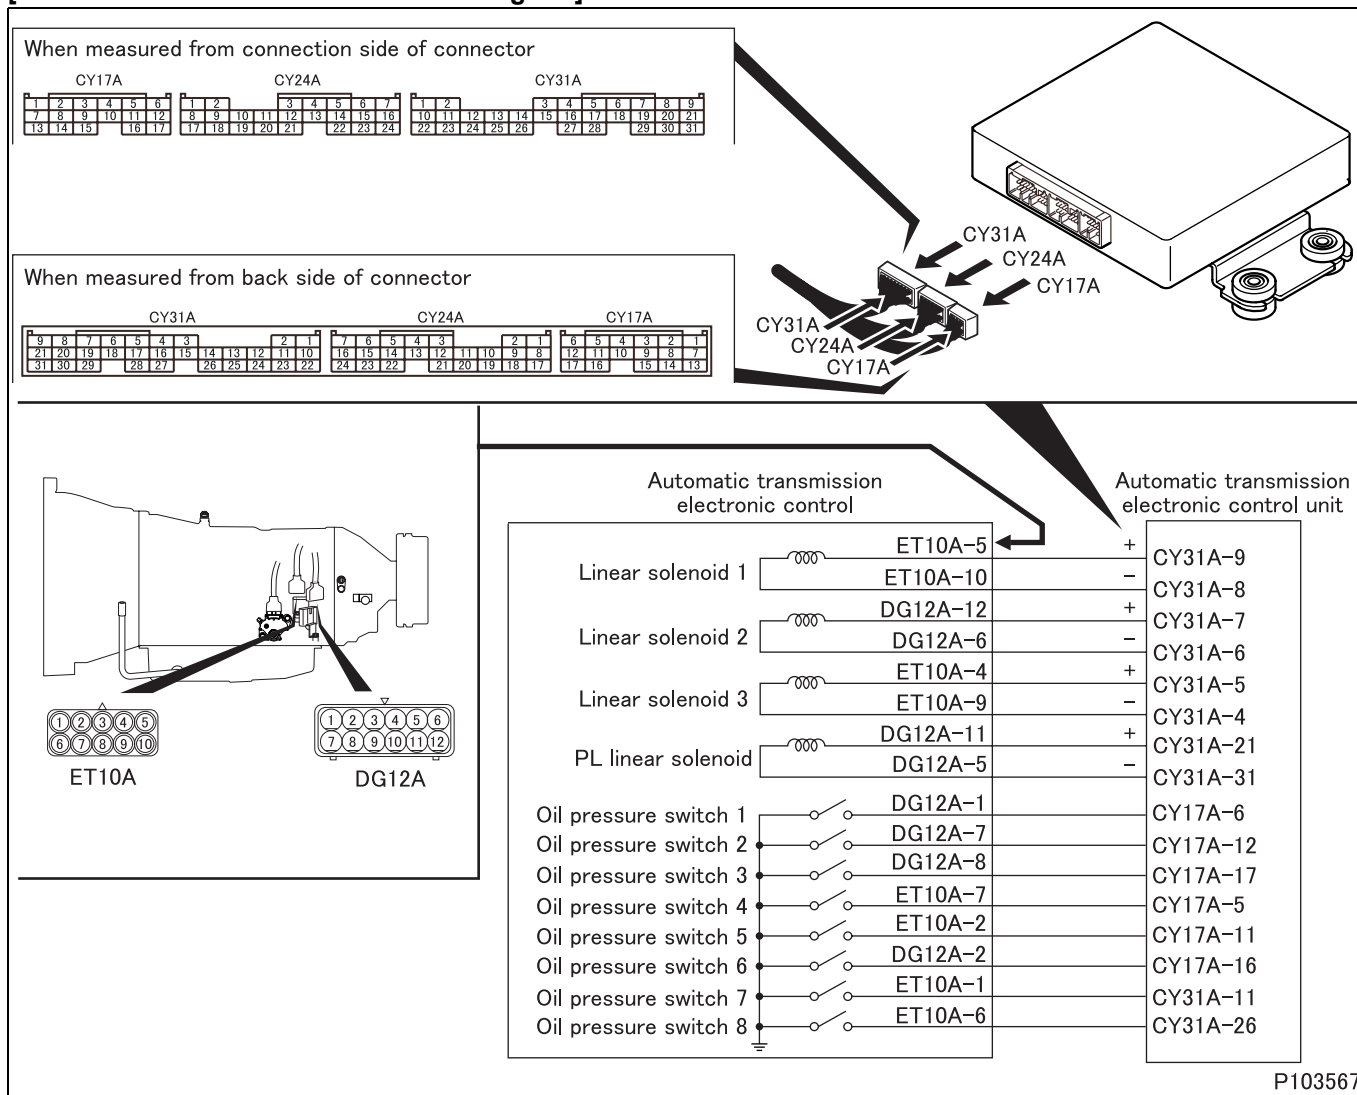
P103567

# [Electronic Control Unit Connection Diagram]

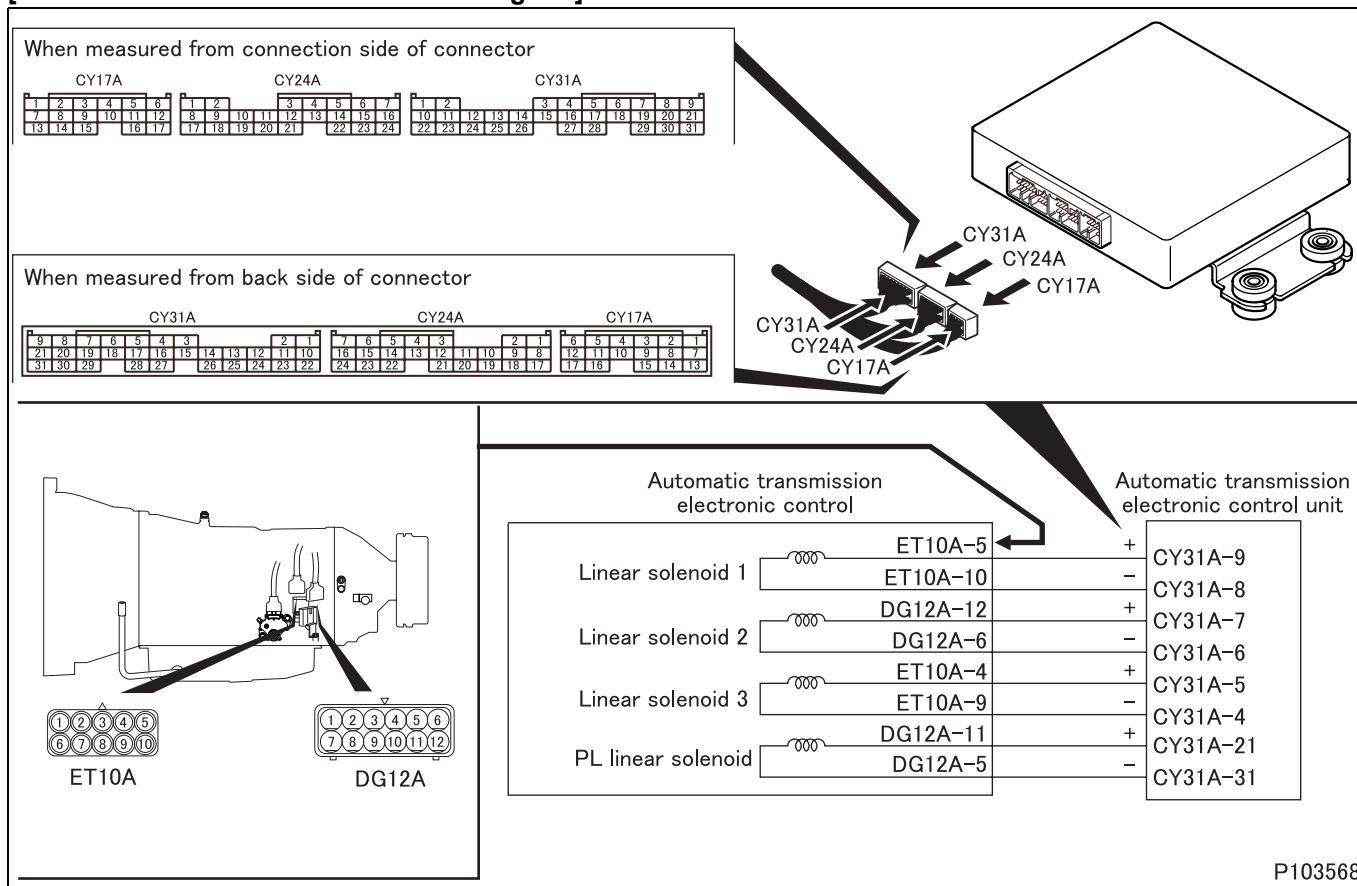
P103568

# [Electronic Control Unit Connection Diagram]

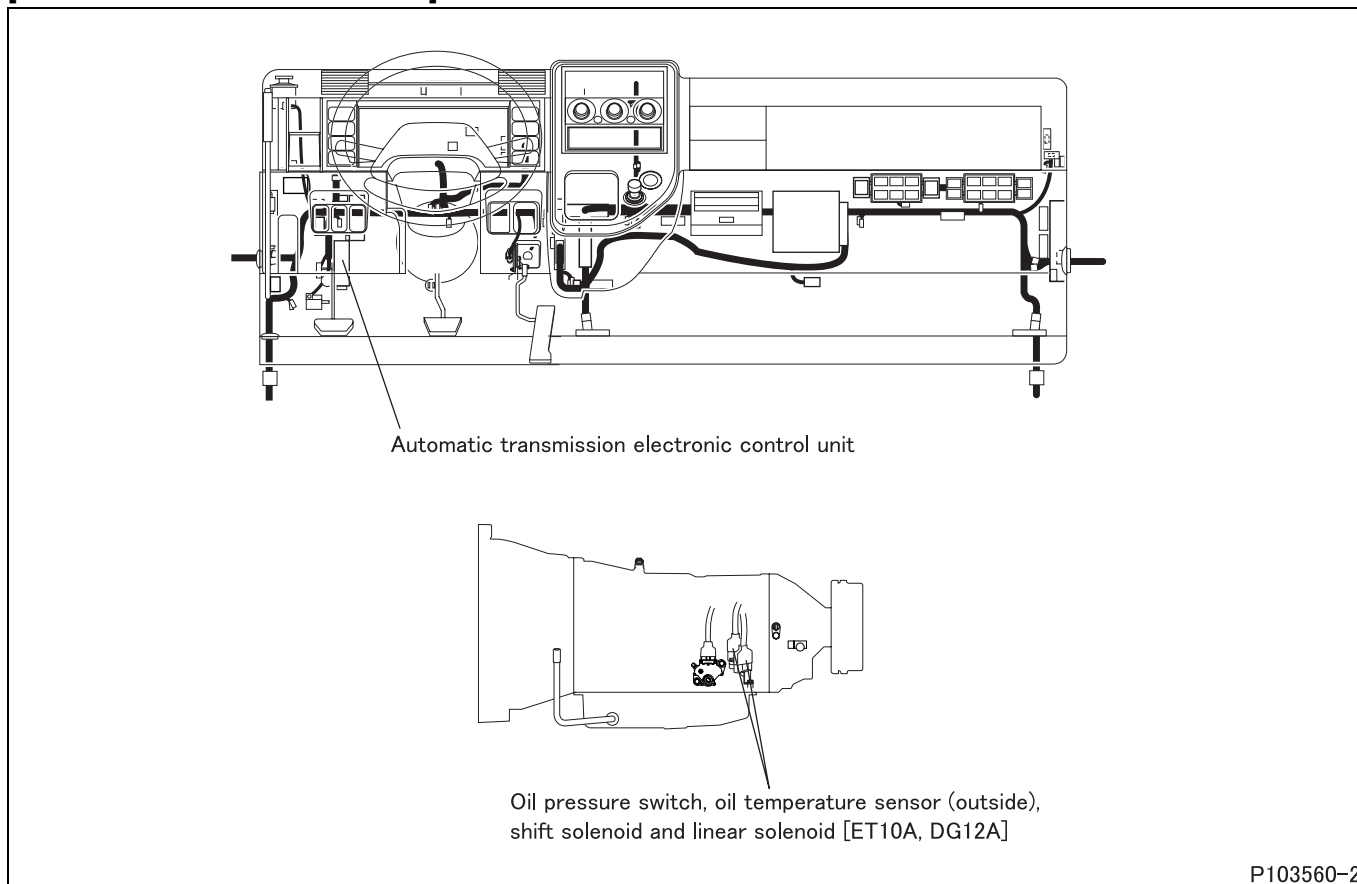
P103560-2

## [Parts Identification and Location]

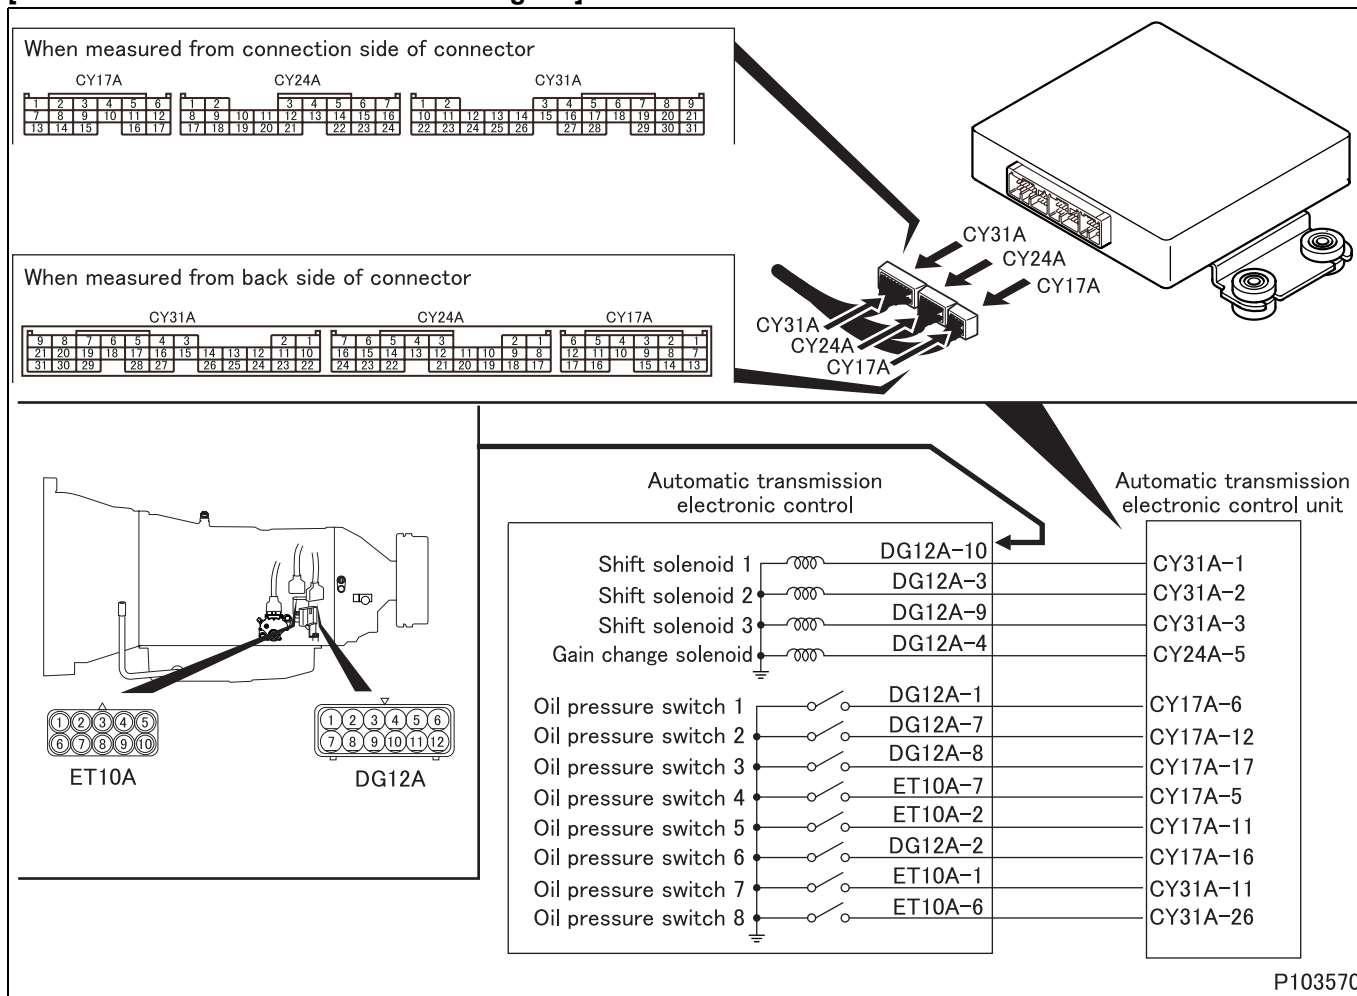
# [Electronic Control Unit Connection Diagram]

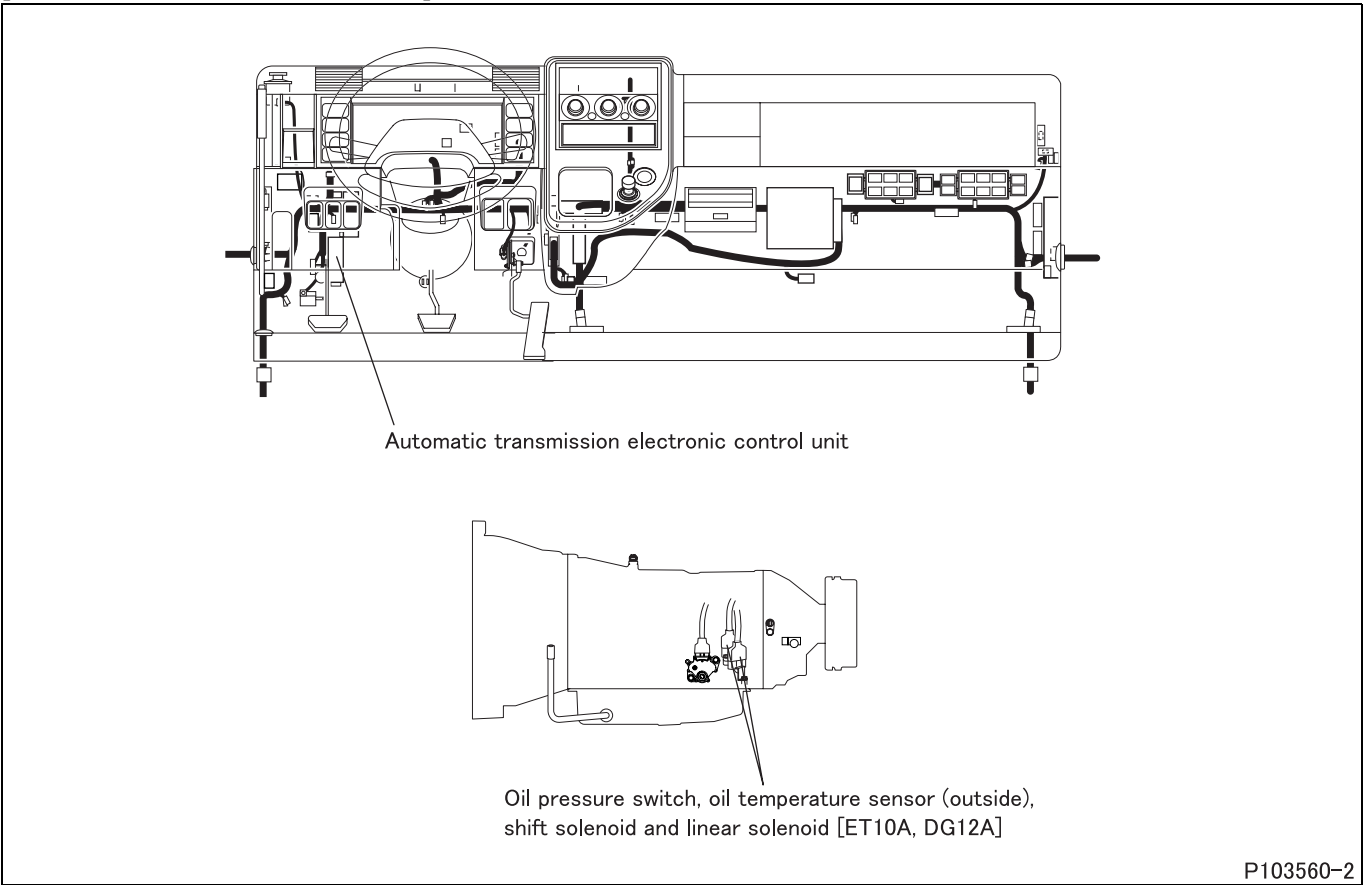
P103560-2

## [Parts Identification and Location]
