# FE.FG

## SERVICE MANUAL 2008 Model FOREWORD

This Service Manual contains maintenance and repair methods for the Mitsubishi Fuso Truck FE. FG Series. Read this manual carefully as an aid in providing correct, efficient maintenance. Please note that the information and specifications contained within this manual may change without notice. This is due to product modifications and continued vehicle improvements that are made throughout the model years. Should you encounter any discrepancy in the information provided, please do not hesitate to contact your nearest Mitsubishi Fuso Dealer or Mitsubishi Fuso Truck of America, Inc.

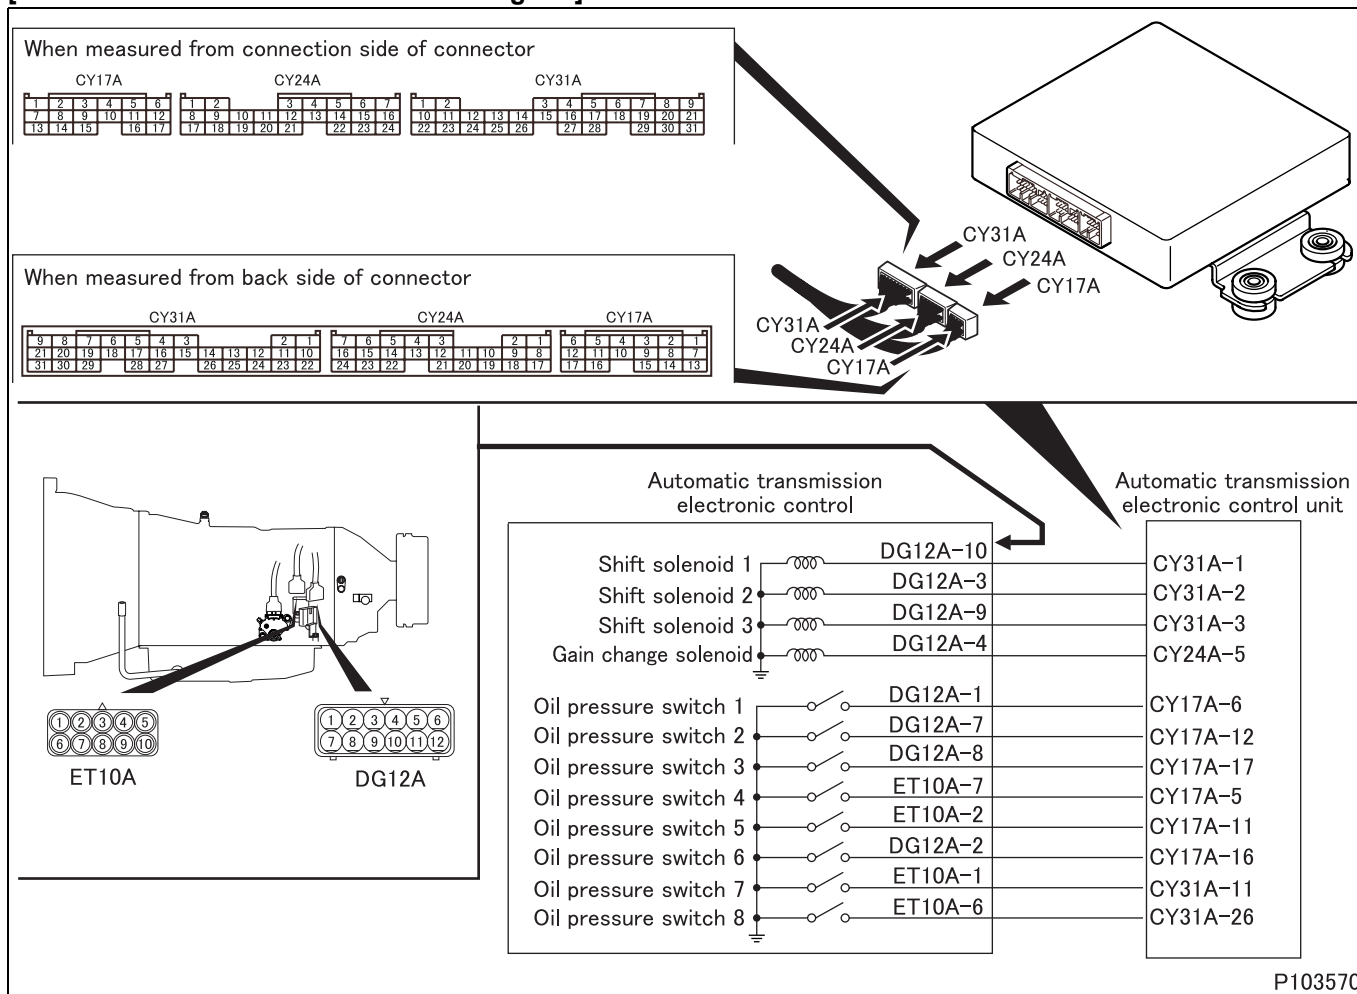
# [Electronic Control Unit Connection Diagram]

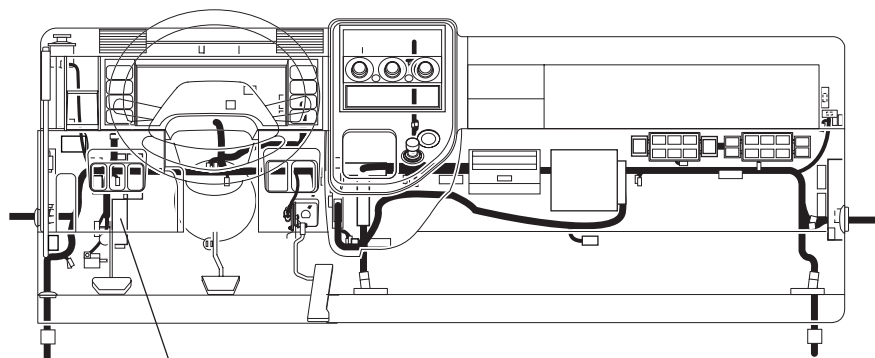
Automatic transmission electronic control unit

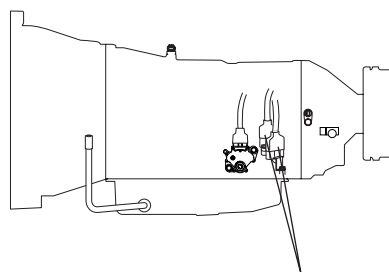
Oil pressure switch, oil temperature sensor (outside), shift solenoid and linear solenoid [ET10A, DG12A]

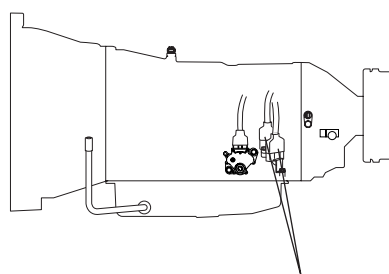
Oil pressure switch, oil temperature sensor (outside),  
shift solenoid and linear solenoid [ET10A, DG12A]

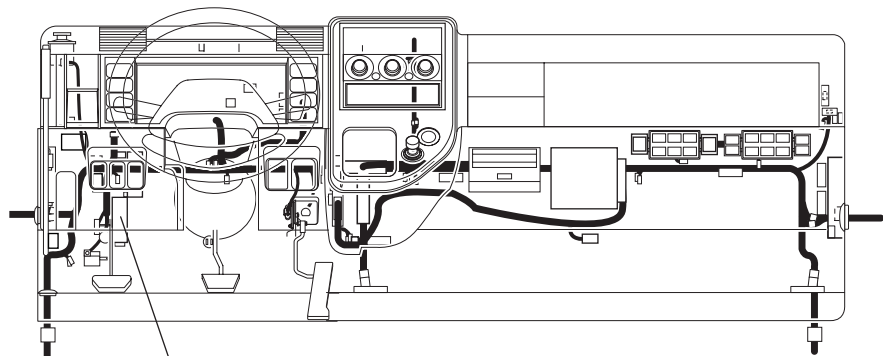
Automatic transmission electronic control unit

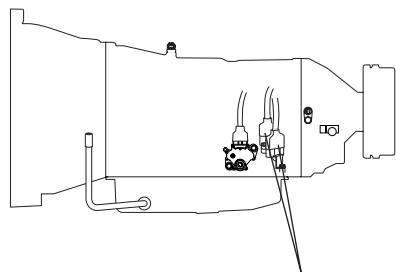
Oil pressure switch, oil temperature sensor (outside),  
shift solenoid and linear solenoid [ET10A, DG12A]

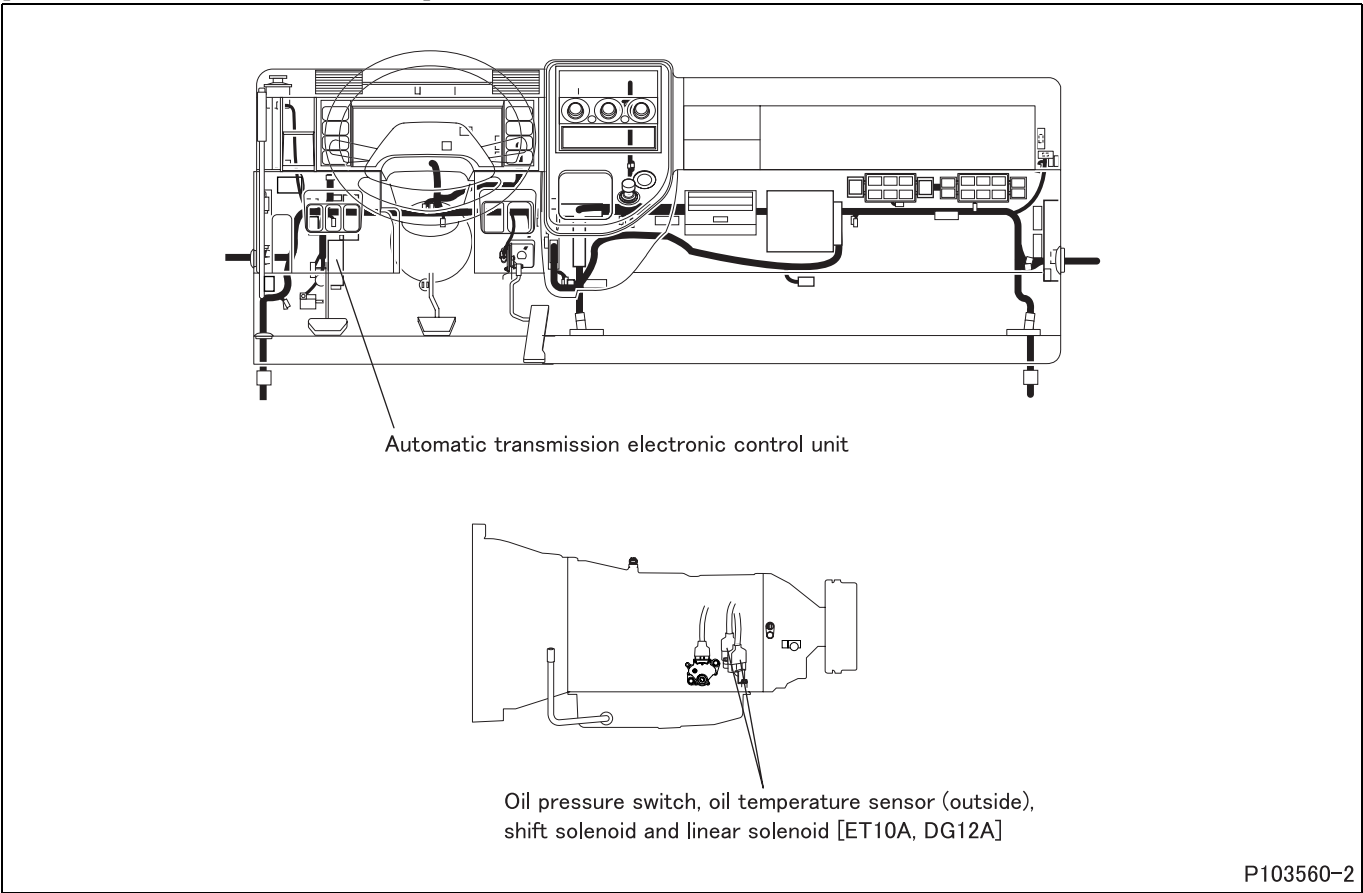
P103560-2

## [Parts Identification and Location]

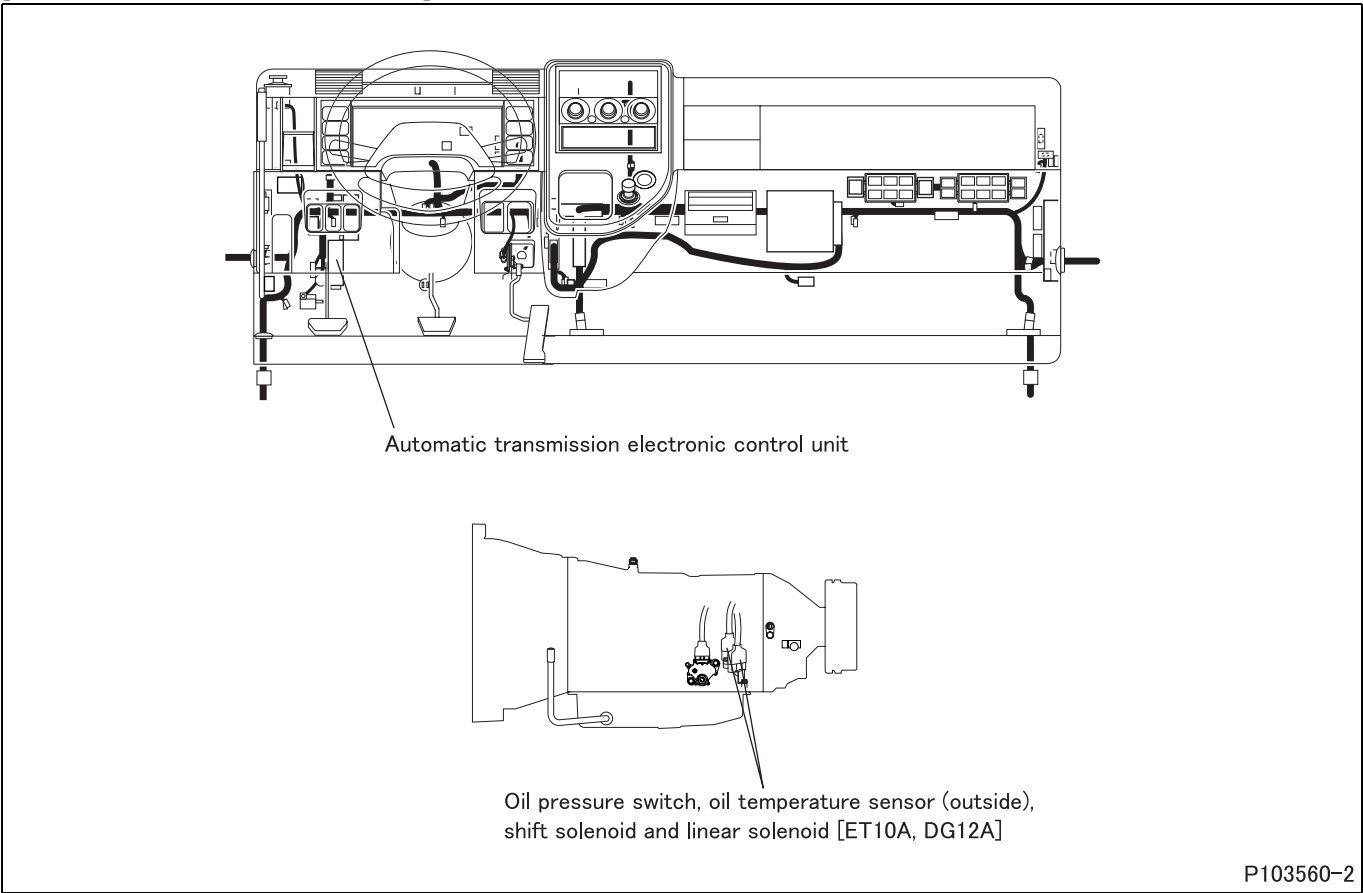
## [Parts Identification and Location]

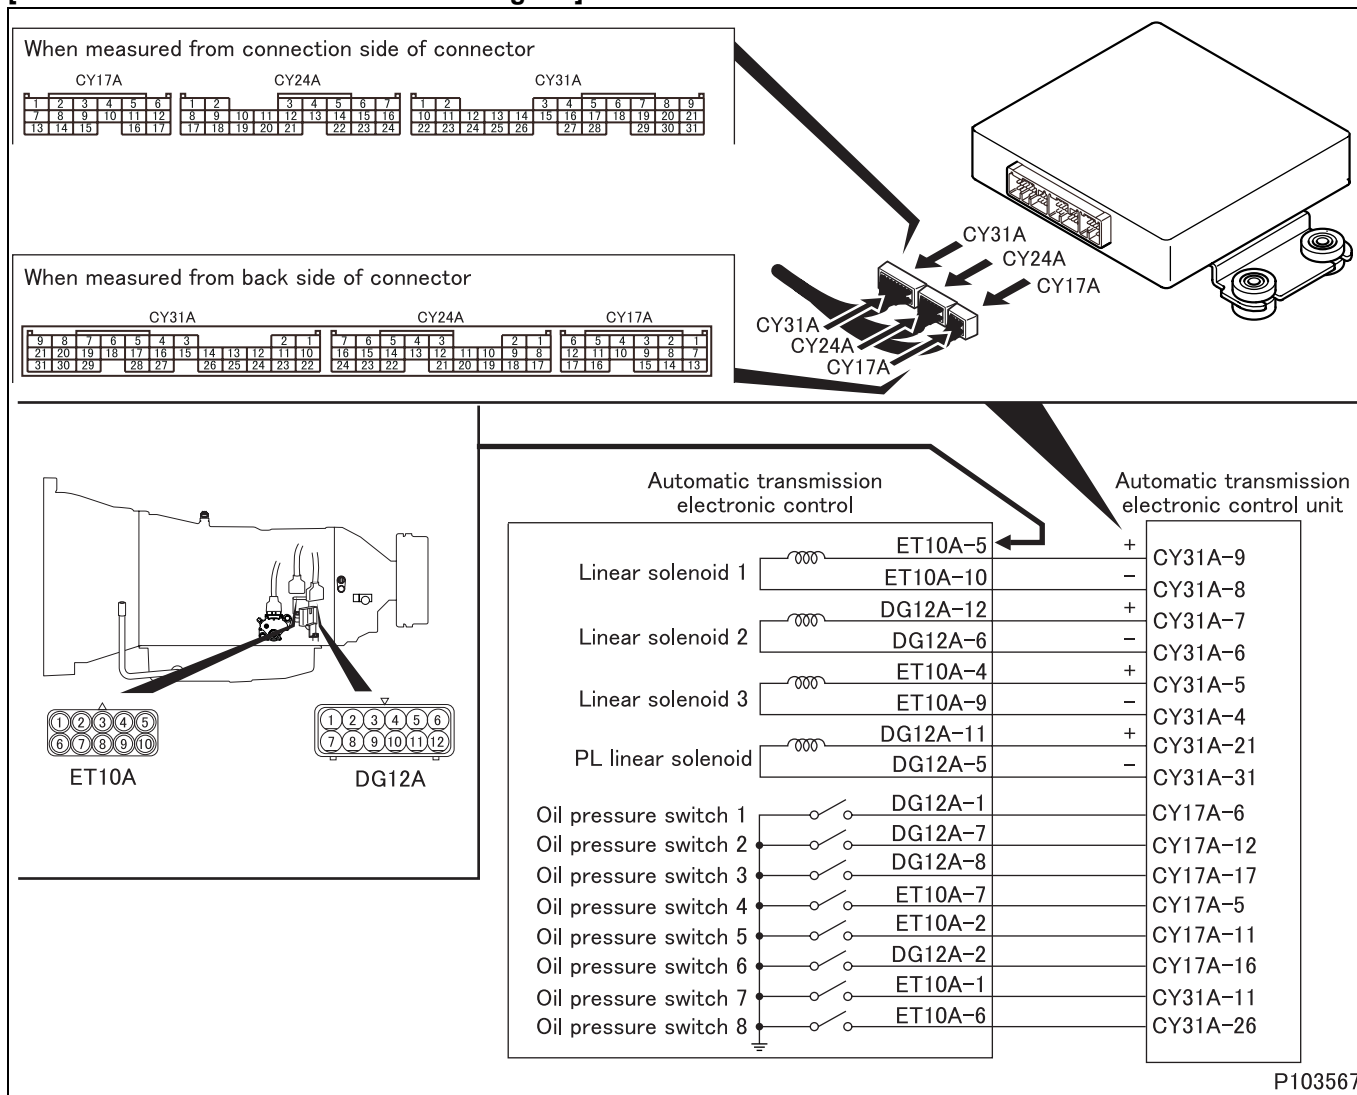
P103567

# [Electronic Control Unit Connection Diagram]

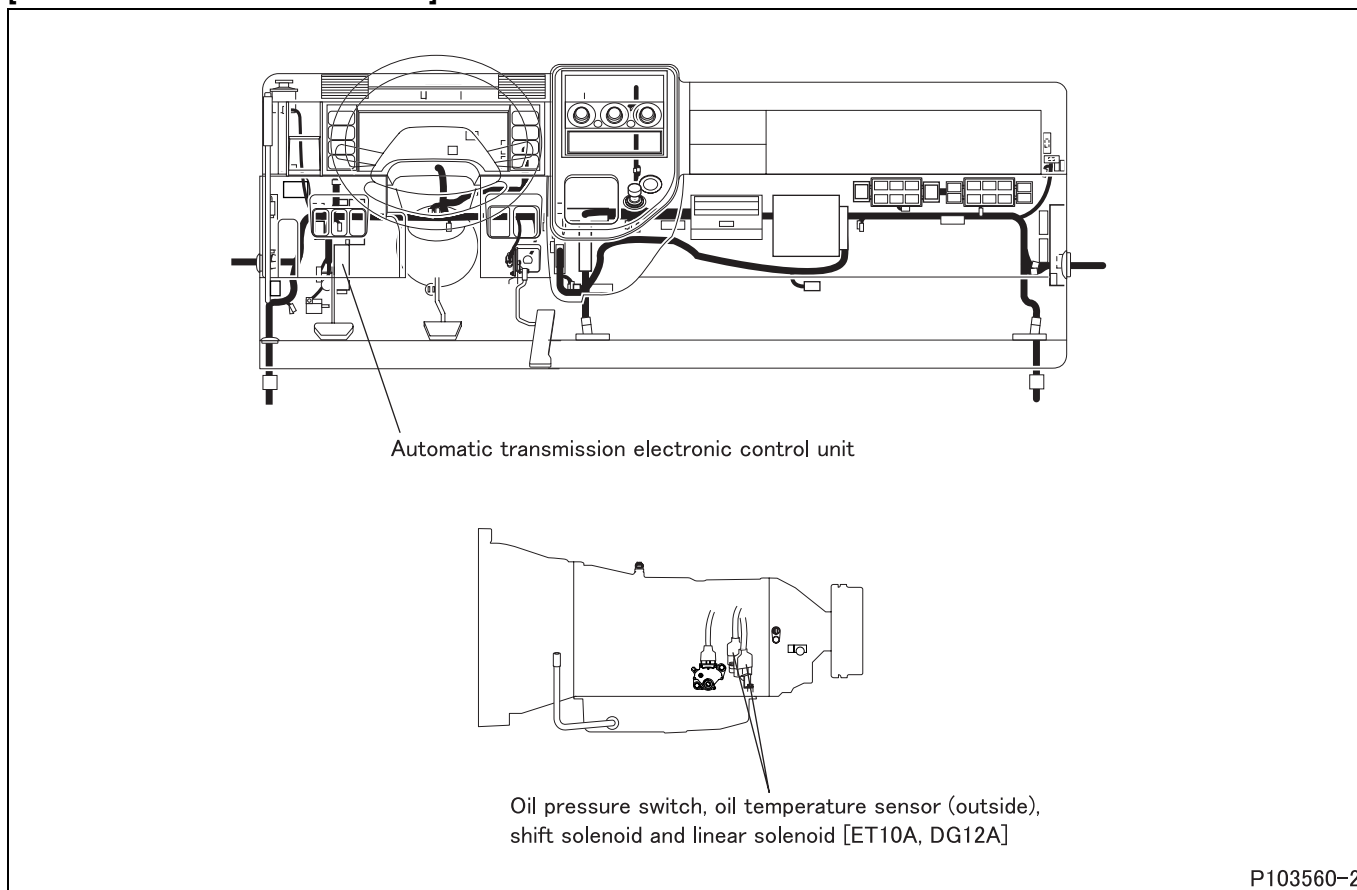
P103560-2

## [Parts Identification and Location]

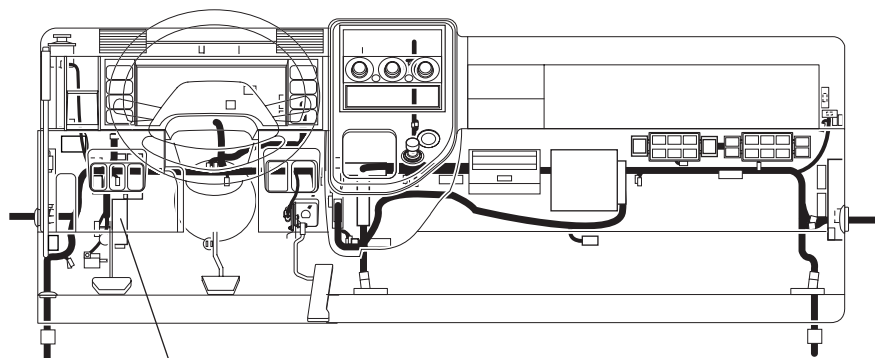
## [Parts Identification and Location]

Automatic transmission electronic control unit

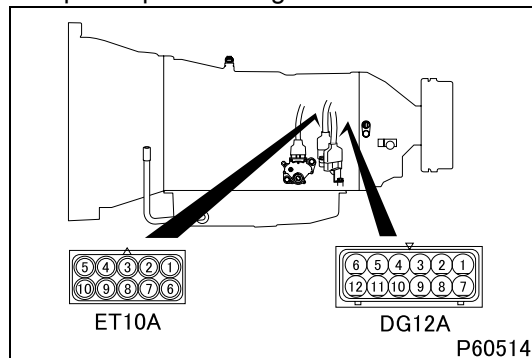
<Step 5 inspection diagram>

| | Maintenance item | | Check circuit between connector (DG12A) terminal No. 1 and electronic control unit connector (CY17A) terminal No. 6. | |

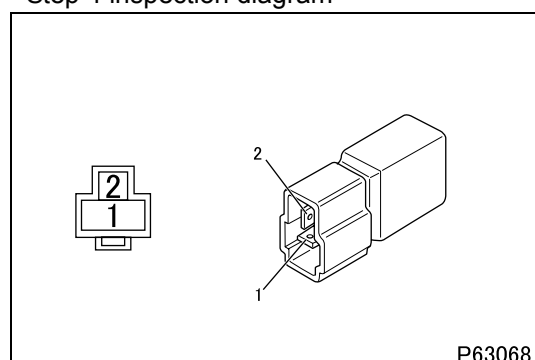
<Step 4 inspection diagram>

| | Maintenance item | | Check circuit between controller area network resistor connector terminal No. 1 and electronic control unit connector (CY24A) terminal No. 20. | |

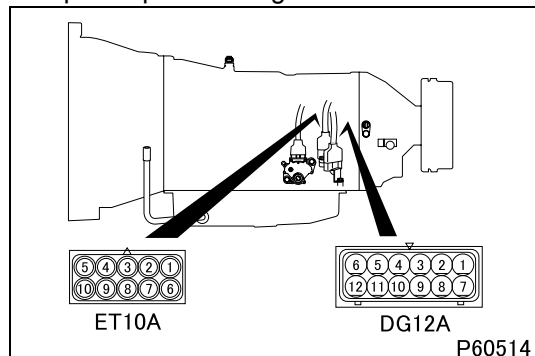
<Step 5 inspection diagram>

| | Maintenance item | | Check circuit between connector (DG12A) terminal No. 8 and electronic control unit connector (CY17A) terminal No. 17. | |

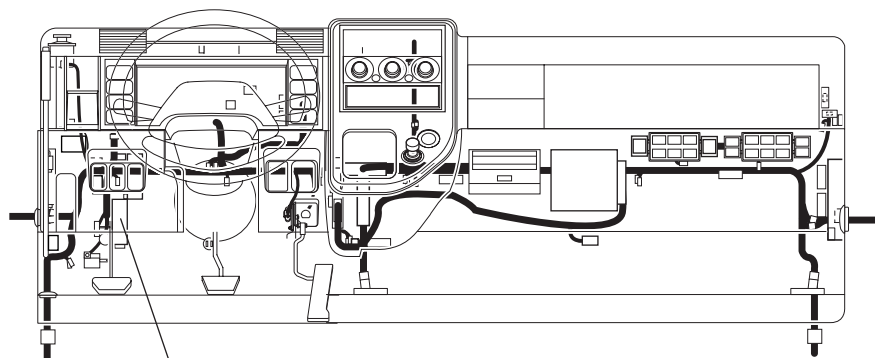
## [Parts Identification and Location]

Automatic transmission electronic control unit

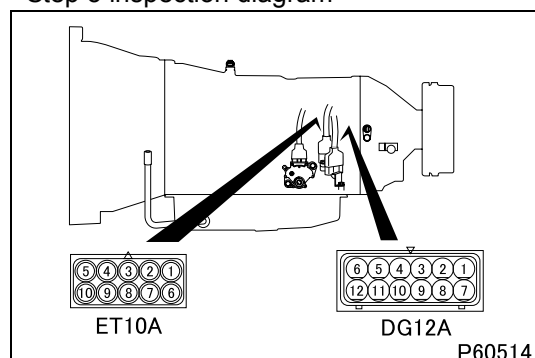
<Step 5 inspection diagram>

| | Maintenance item | | Check circuit between connector (ET10A) terminal No. 7 and electronic control unit connector (CY17A) terminal No. 5. |

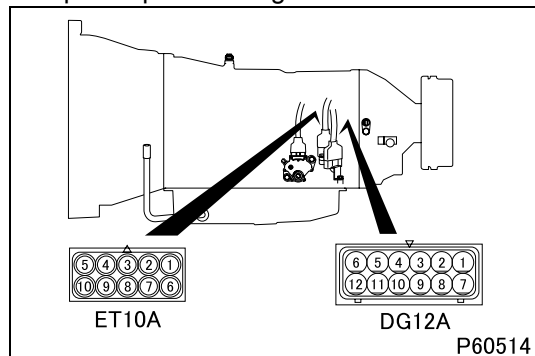
<Step 5 inspection diagram>

| | Maintenance item | | Check circuit between connector (DG12A) terminal No. 9 and electronic control unit connector (CY31A) terminal No. 3. | |

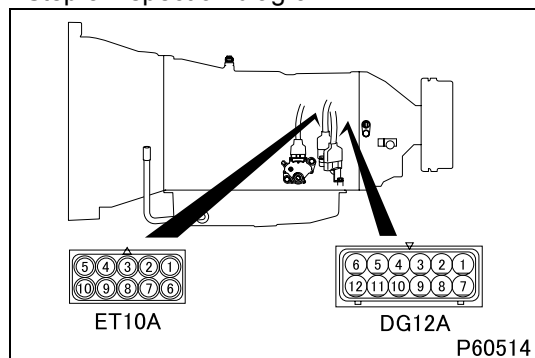
<Step 5 inspection diagram>

| | Maintenance item | | Check circuit between connector (DG12A) terminal No. 4 and electronic control unit connector (CY24A) terminal No. 5. | |

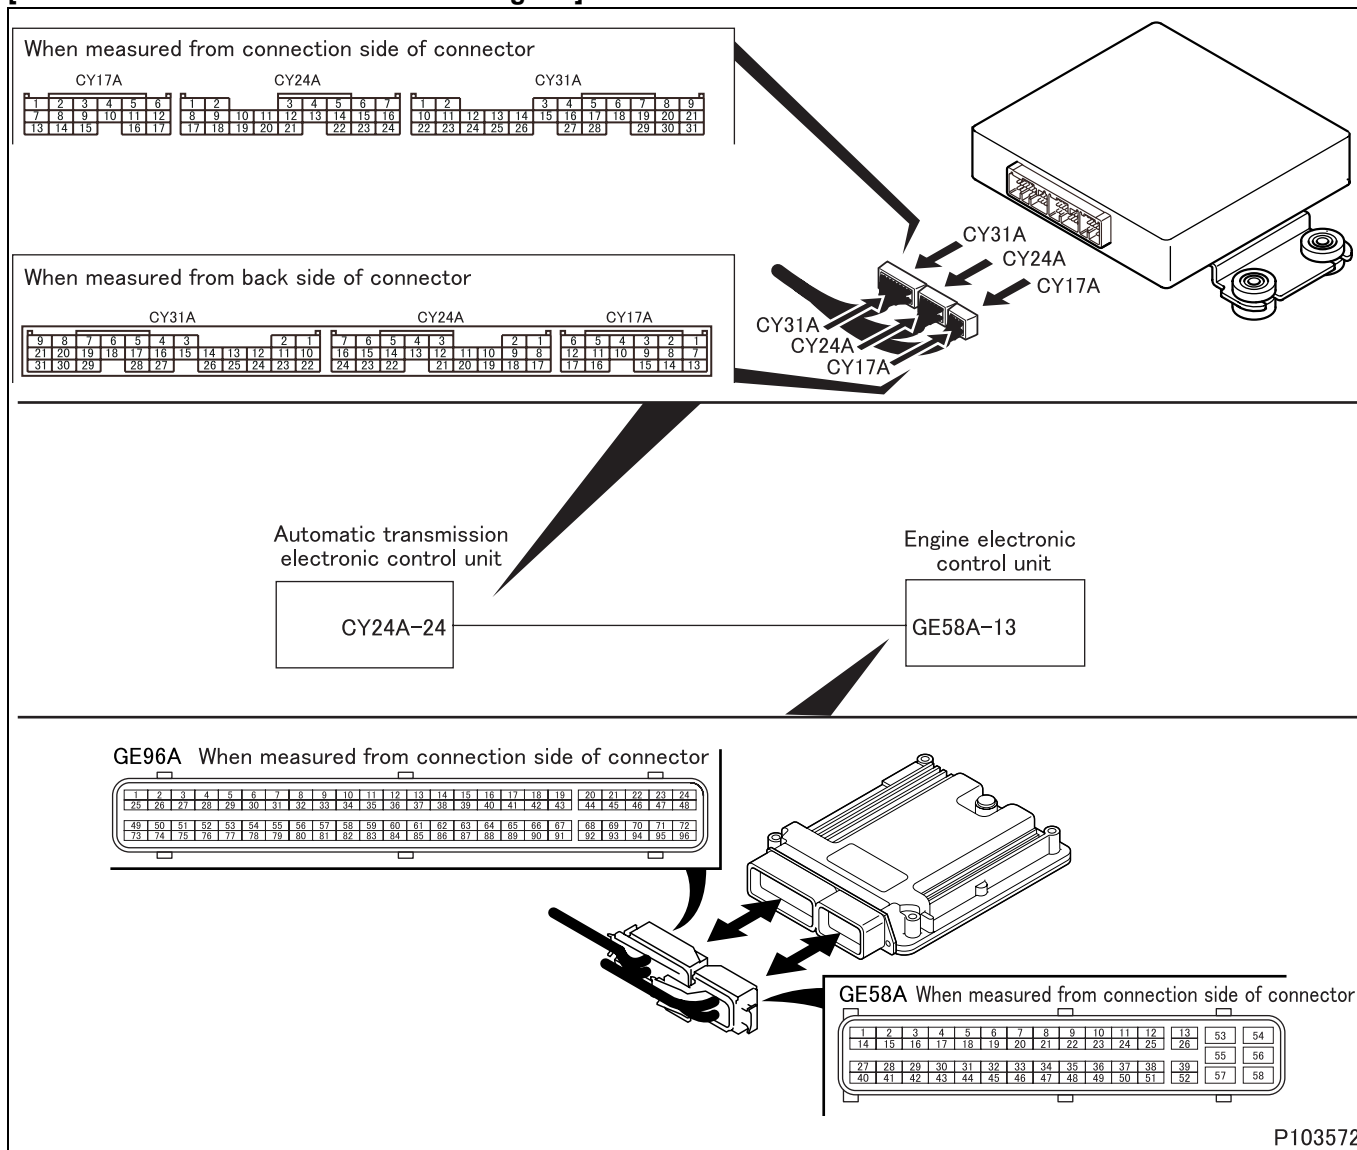
P103572

# [Electronic Control Unit Connection Diagram]

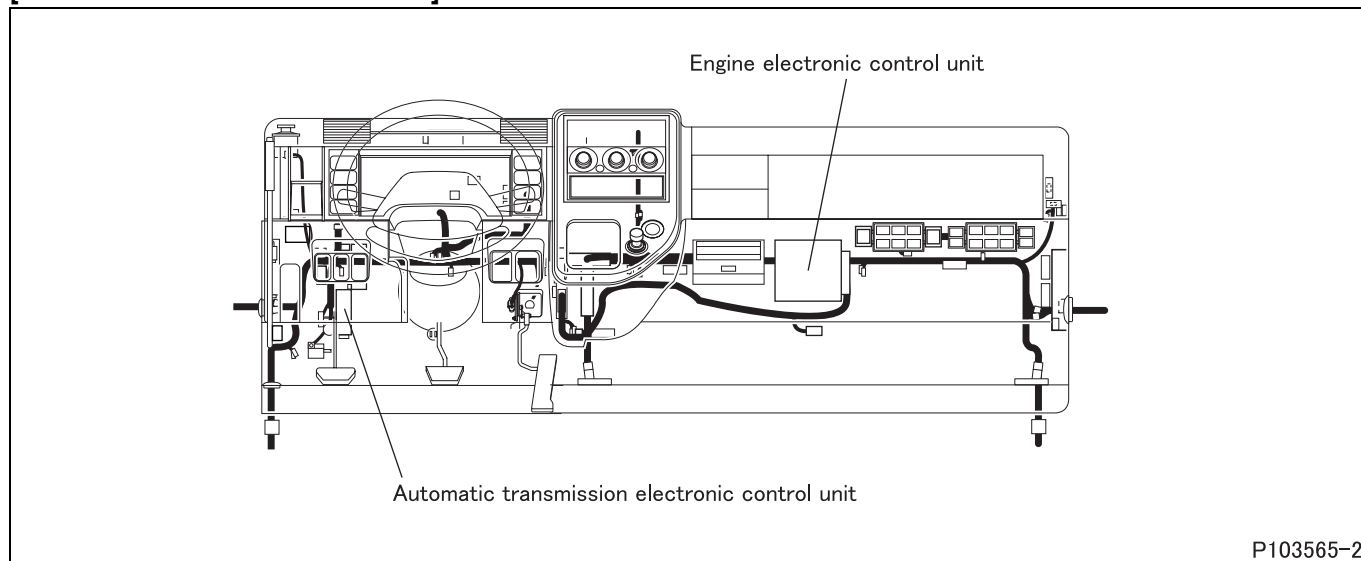
## [Parts Identification and Location]

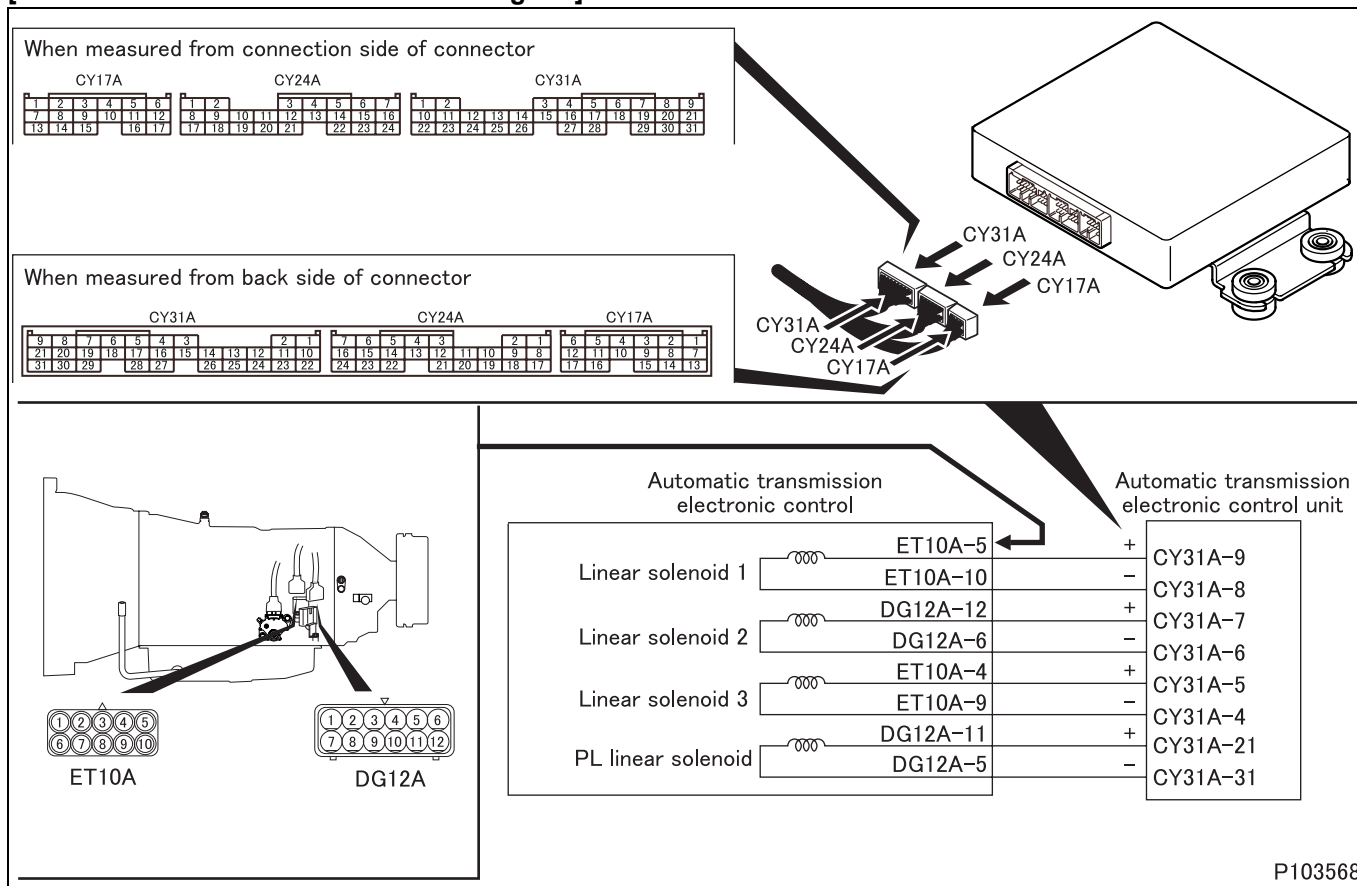
P103568

# [Electronic Control Unit Connection Diagram]

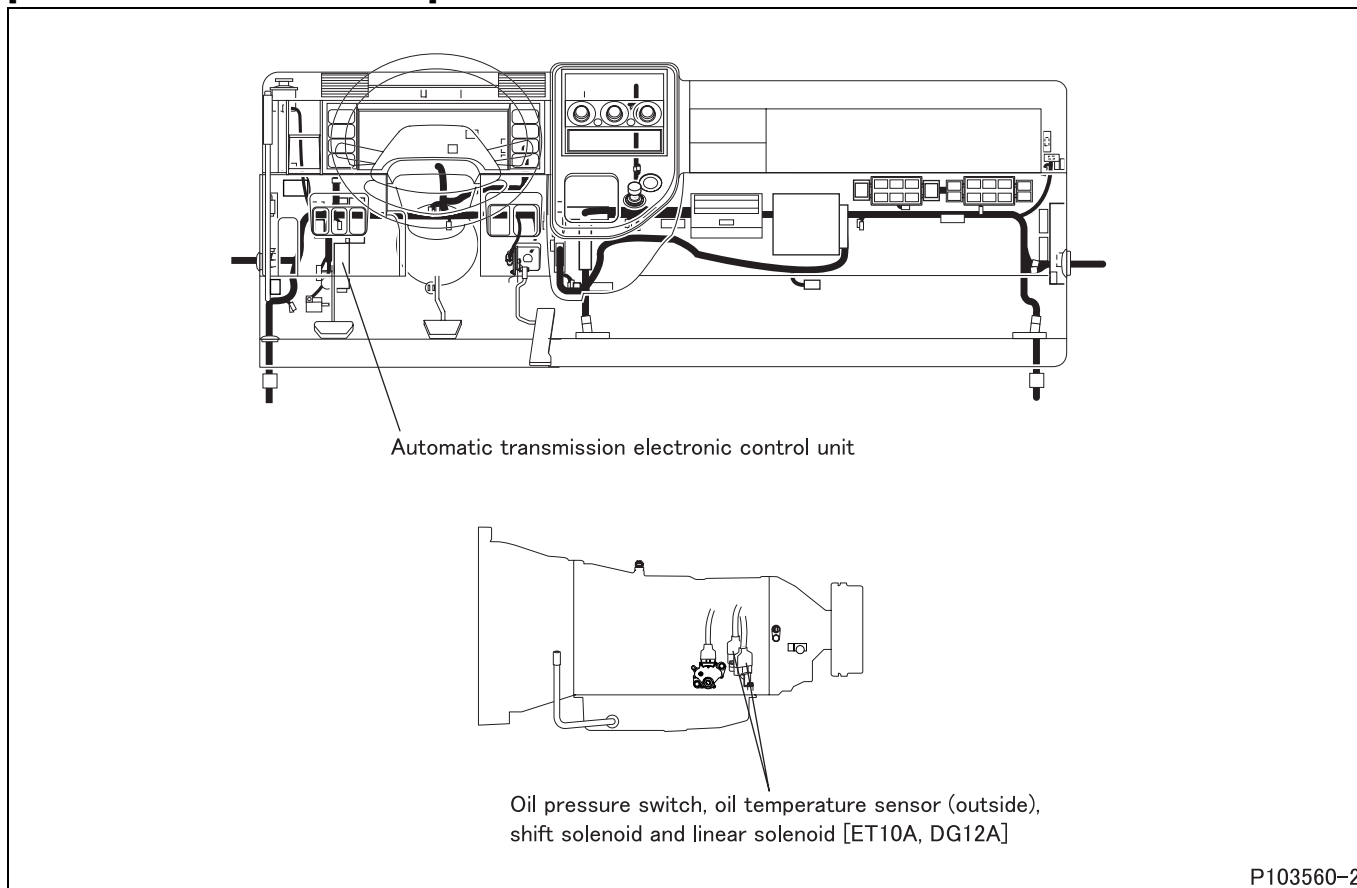
P103560-2

# [Parts Identification and Location]

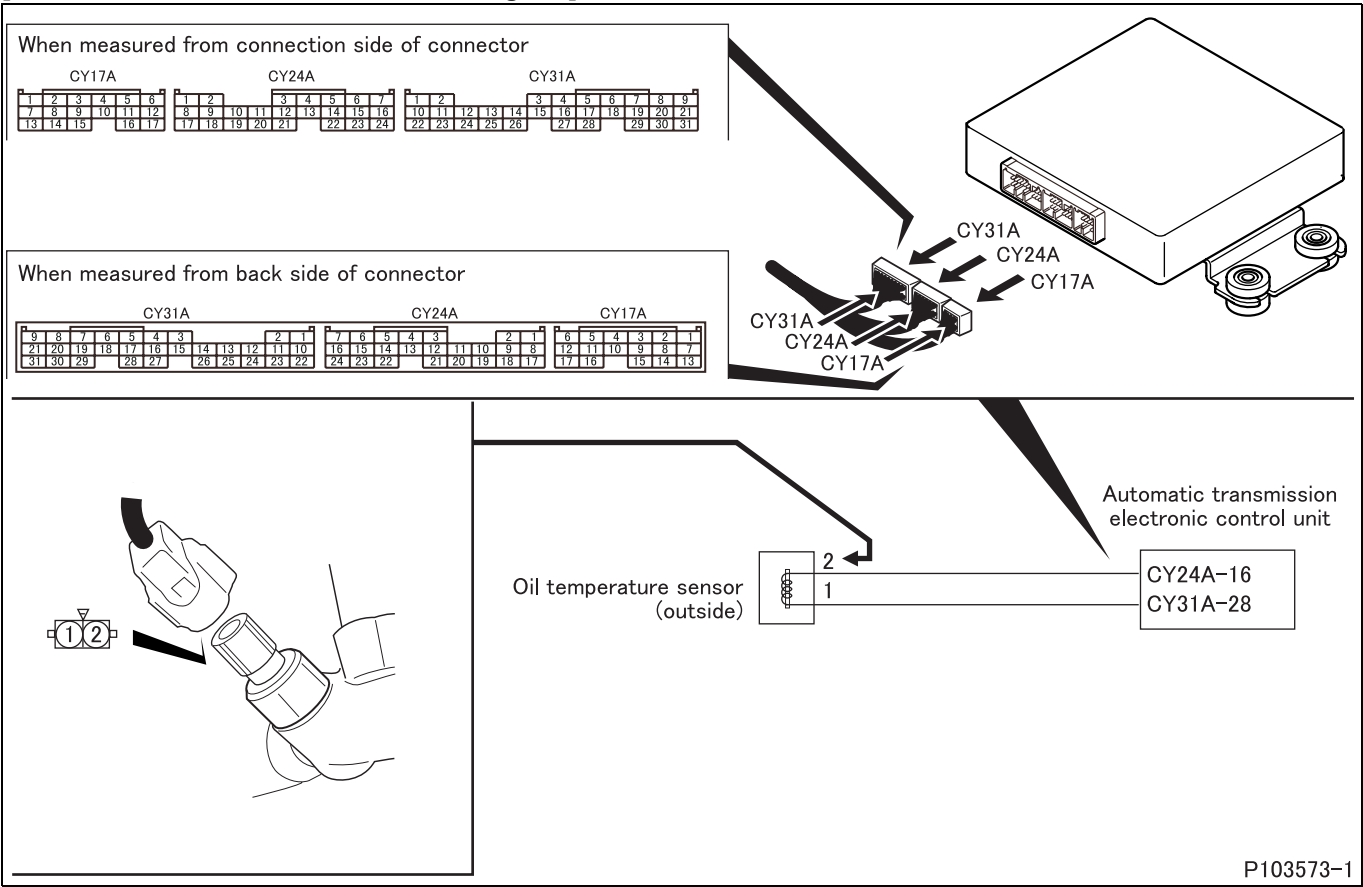
P103573-1

## [Electronic Control Unit Connection Diagram]

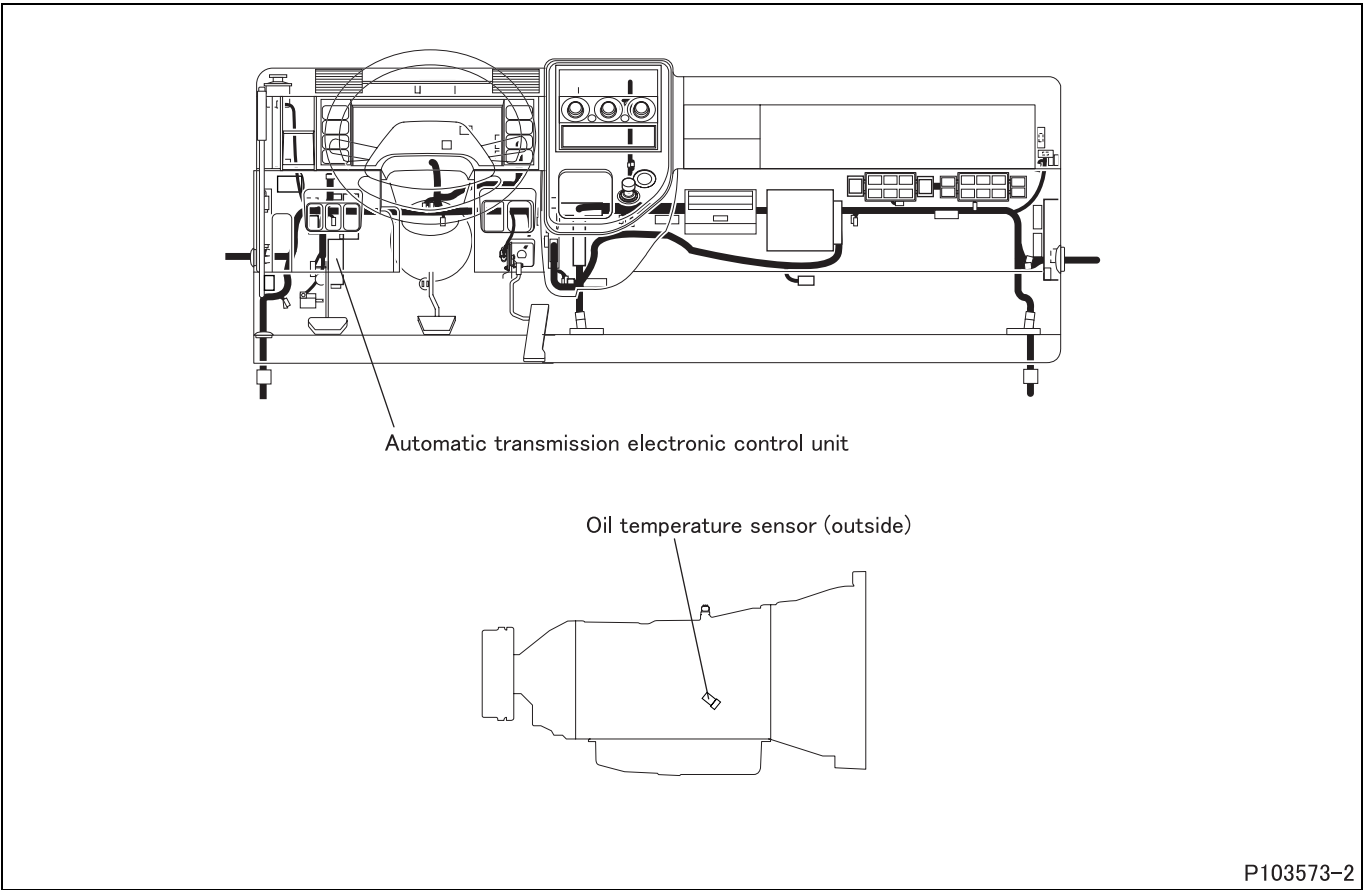
P103573-2

## [Parts Identification and Location]

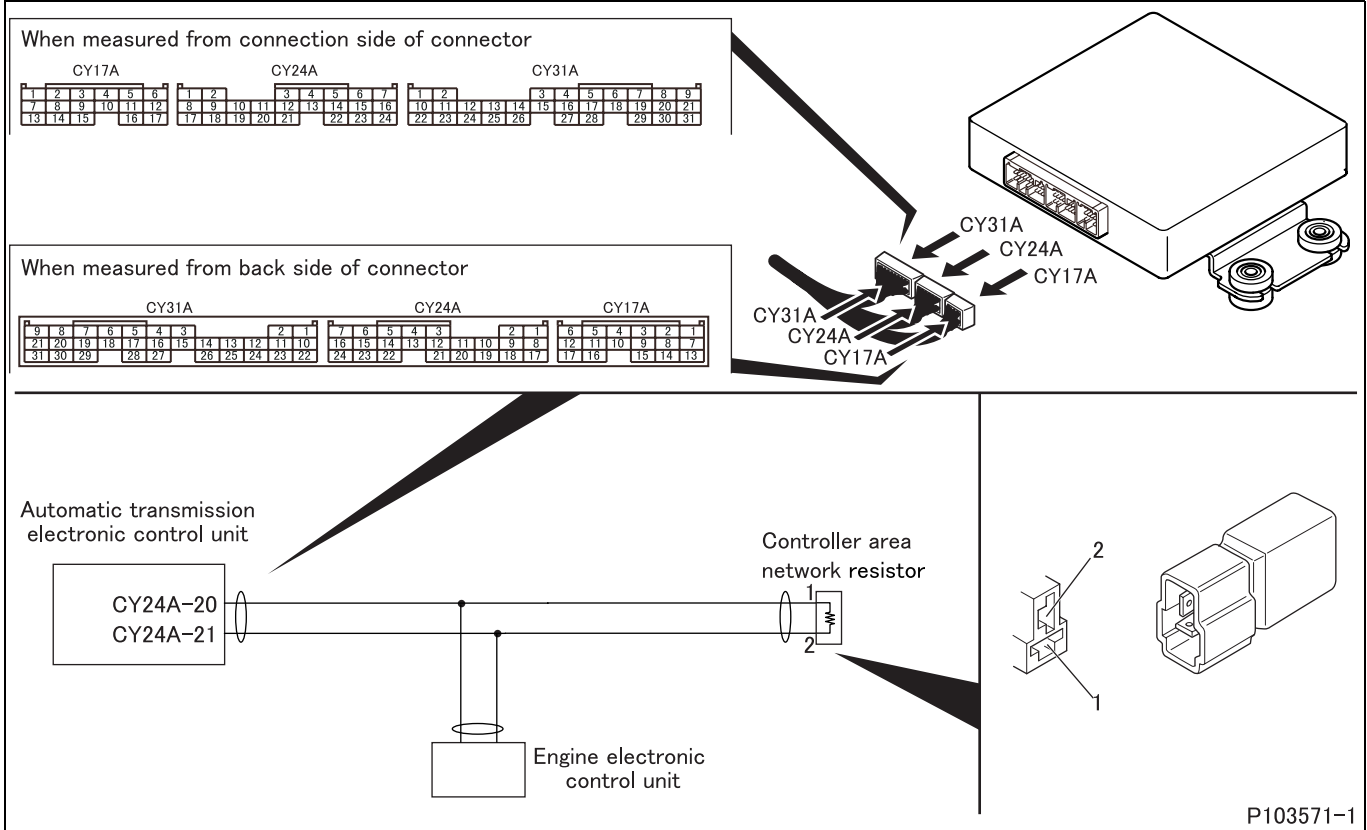
P103571-1

# [Electronic Control Unit Connection Diagram]

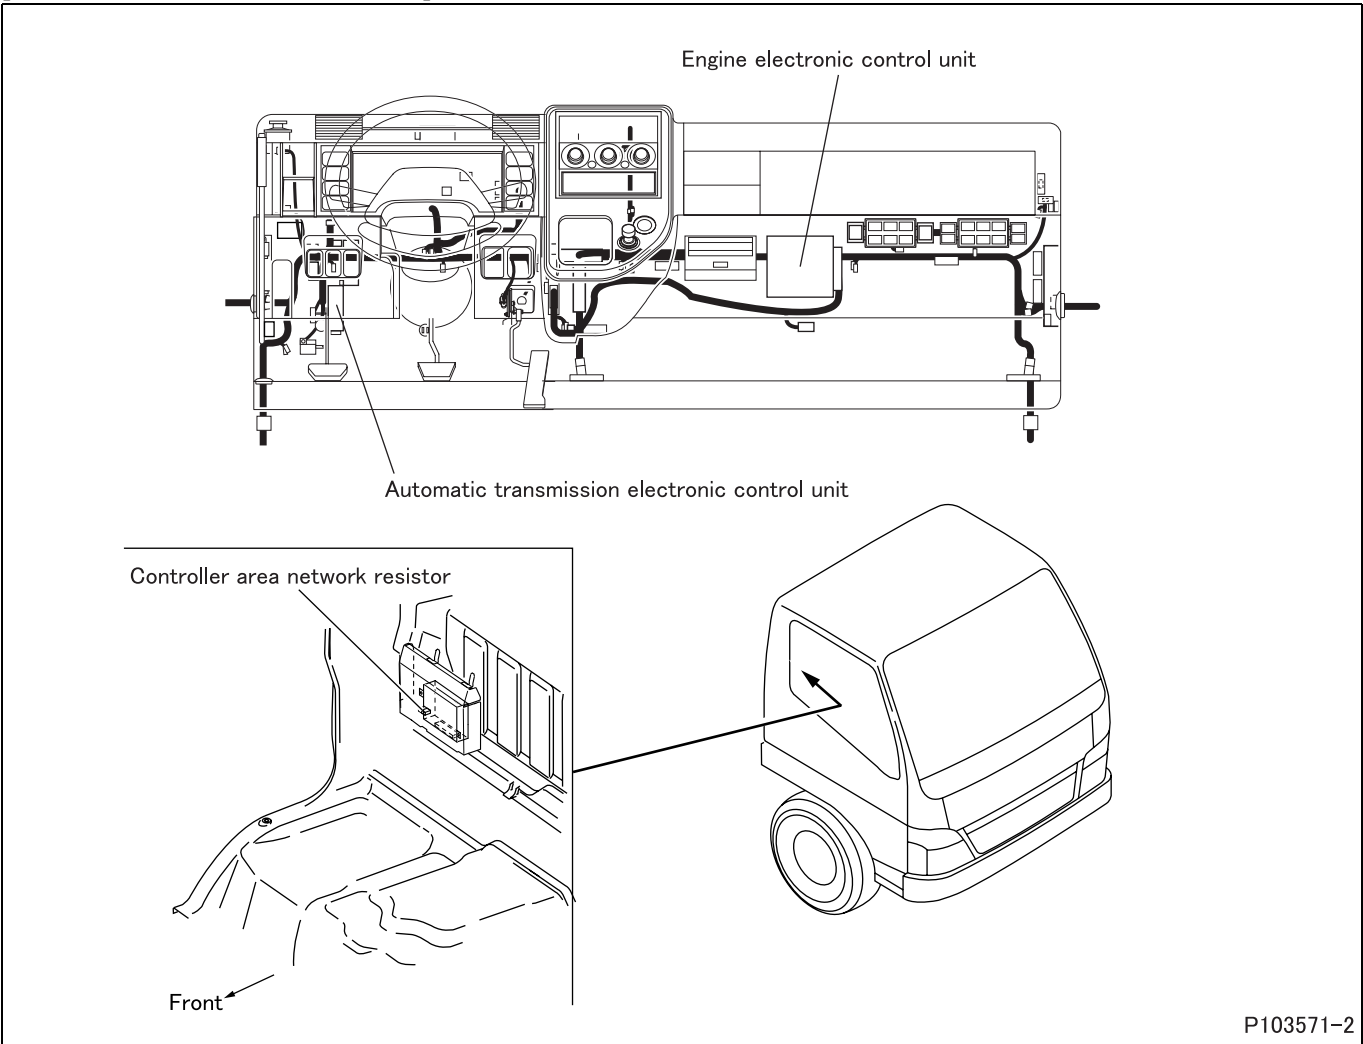
P103571-2

## [Parts Identification and Location]

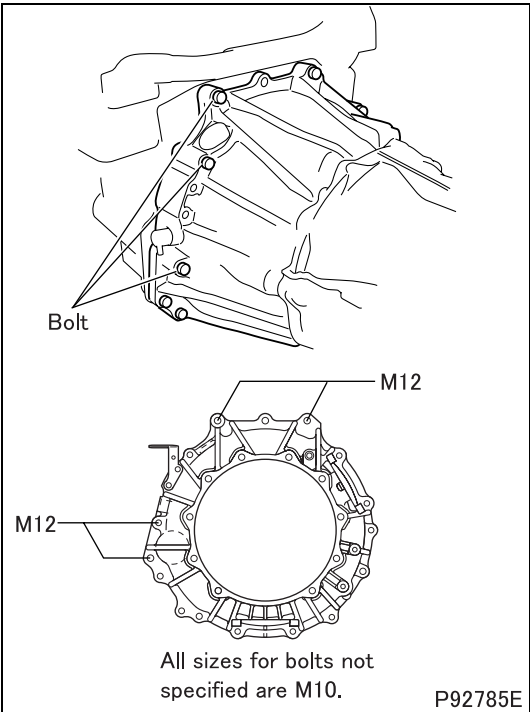
- Check the automatic transmission mounting bolts for looseness.
- Retighten any loose bolt to the specified torque.

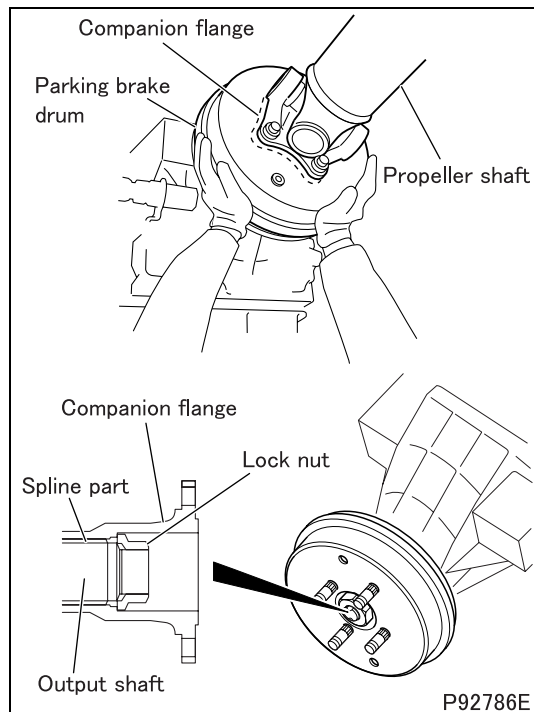
### 3. Inspection of Play in Companion Flange and Looseness in Lock Nut

- Move the parking brake drum or companion flange in axial and vertical directions to check for excessive play between the companion flange and output shaft.
- If excessive play is detected, remove the propeller shaft, then check the lock nut for looseness and the splines on companion flange and output shaft for abnormalities.
- If found loose, tighten the lock nut to the specified torque, then crimp it at two places. (See "PARKING BRAKE".)
- If the companion flange is found defective, replace the part. (See "PARKING BRAKE" section.)
- If the companion flange is not found defective, the output shaft may be defective, replace automatic transmission.

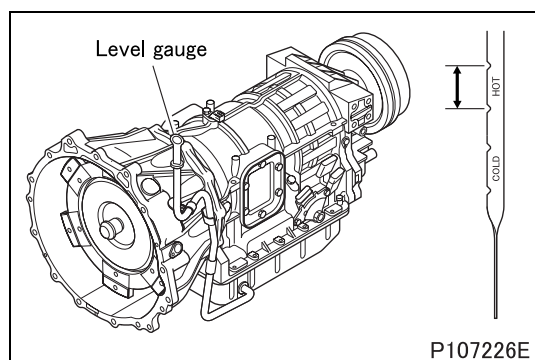
## 4.2 Inspection of automatic transmission fluid level

- Drive the vehicle until the automatic transmission fluid is adequately warm (70 to 80°C {160 to 175°F}).
- Stop the vehicle on a level surface, securely apply the parking brake, and apply chocks to the wheels.
- With the engine idling, slowly move the range selector lever from the P position to each position through L then back to the P position to ensure that the hydraulic circuit is filled with automatic transmission fluid.
- Remove all dirt from the top of the filler tube.
- With the engine still idling, withdraw the level gauge, wipe the ATF off it, and re-insert it. Then, withdraw the level gauge again and check the automatic transmission fluid level.
- The automatic transmission fluid level is acceptable if the level on the level gauge is within the HOT range.

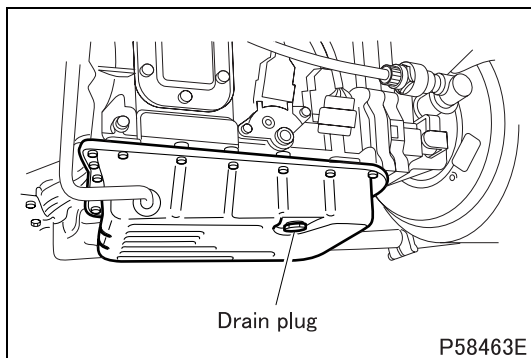
### 5.1 Draining

- Place a container under the transmission oil pan. Remove the drain plug near the front of the oil pan and allow the automatic transmission fluid to drain out.
- At the same time, check whether the drained automatic transmission fluid is dirty and whether it contains metallic particles. Note that the automatic transmission fluid will drain out more quickly if you warm it by allowing the engine to warm up.

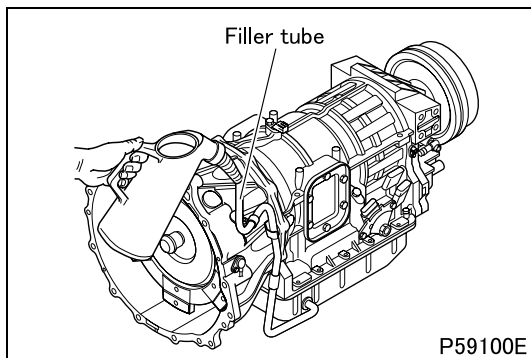
### 5.2 Filling

- Make ready the new automatic transmission fluid.
- Fit the oil pan drain plug and gasket in their original conditions.
- Supply new automatic transmission fluid through the filler tube in a quantity equivalent to that of the automatic transmission fluid that drained out.

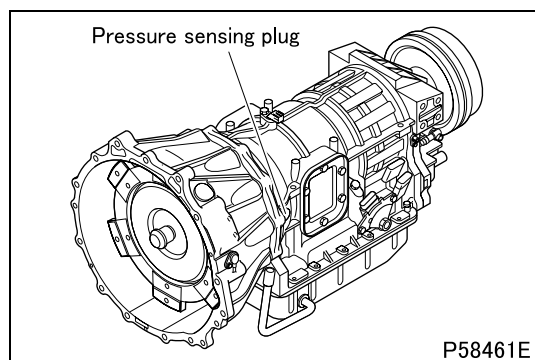
- Apply chocks to the front and rear wheels from both sides and apply the parking brake to hold the vehicle in place.
- The line pressure test should be performed by two people. One person moves away from the vehicle and checks the condition of the tires and wheel chocks. The other person performs the test.
- Remove the pressure sensing plug and fit the oil pressure gauge.
- Start the engine. Allow it to warm up until the automatic transmission fluid reaches a temperature of 50 to 80°C {120 to 175°F}. Check the idling speed.
- Press the brake pedal firmly with your left foot. While holding down the brake pedal, shift to the D range. Then, measure the oil pressure while the engine is idling.

- Fully press the accelerator pedal. Quickly measure the oil pressure at the stall speed.

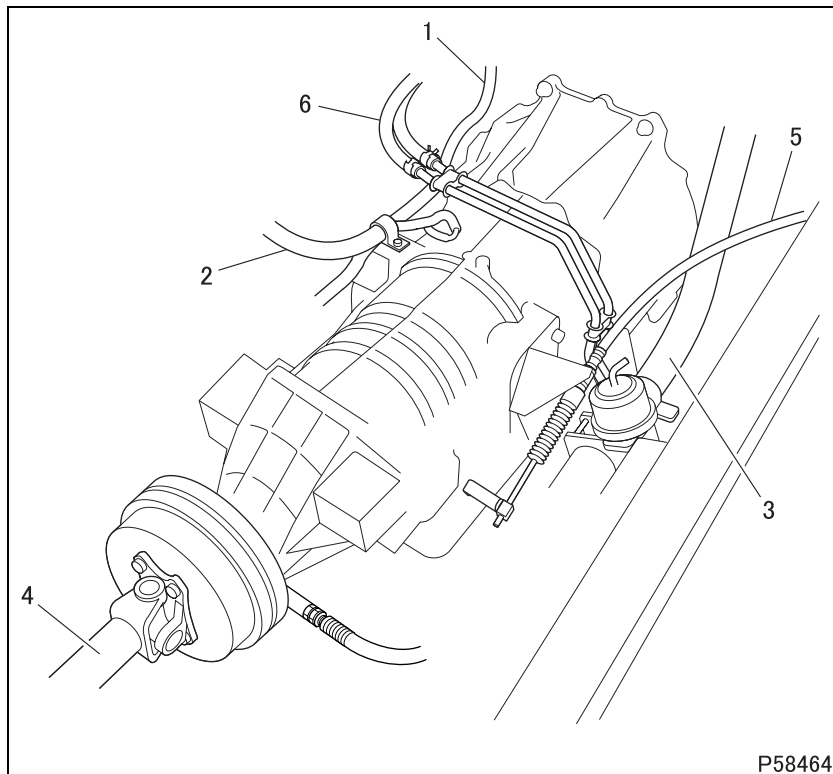
### ● Removal sequence

- 1 Filler tube
- 2 Electrical harness
- 3 Exhaust pipe
- 4 Propeller shaft (See Gr25.)
- 5 Selector cable (See later section.)
- 6 Oil cooler hose (See later section.)

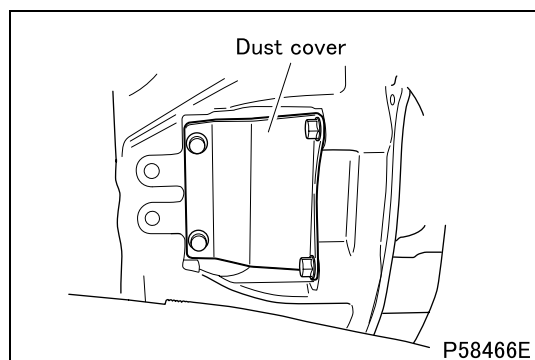
### ■ Removal: Automatic transmission

- Remove the dust cover.
