# FE.FG

## SERVICE MANUAL 2008 Model FOREWORD

This Service Manual contains maintenance and repair methods for the Mitsubishi Fuso Truck FE. FG Series. Read this manual carefully as an aid in providing correct, efficient maintenance. Please note that the information and specifications contained within this manual may change without notice. This is due to product modifications and continued vehicle improvements that are made throughout the model years. Should you encounter any discrepancy in the information provided, please do not hesitate to contact your nearest Mitsubishi Fuso Dealer or Mitsubishi Fuso Truck of America, Inc.

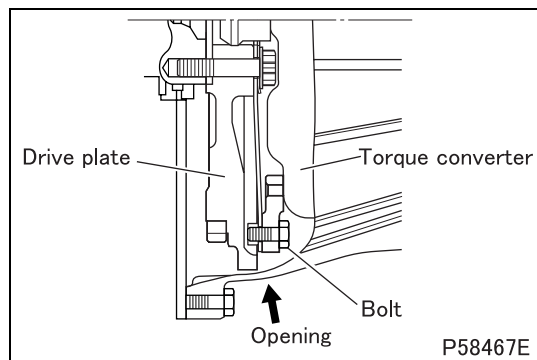
- Crank the engine to bring one of the bolts to the opening.
- Remove the bolt that is accessible through the opening. Also remove all of the rest of the six bolts, cranking the engine to bring each one to the opening in turn.

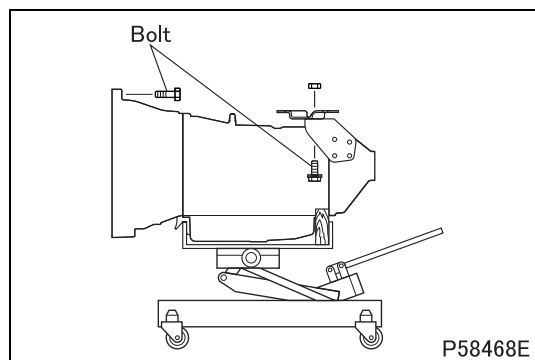
- Support the automatic transmission with a jack and remove each of the bolts.
- Move the automatic transmission rearward to remove it.

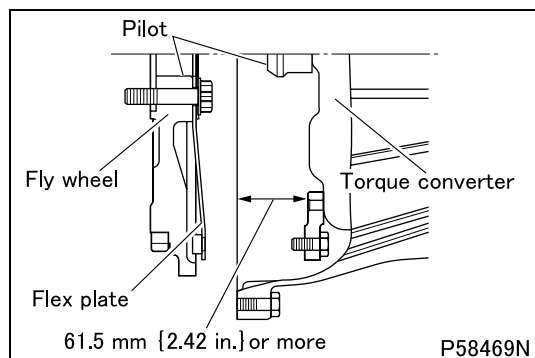
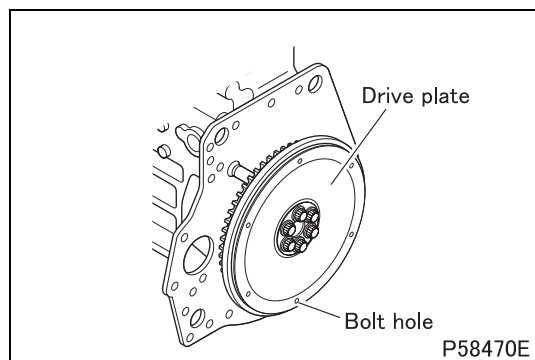
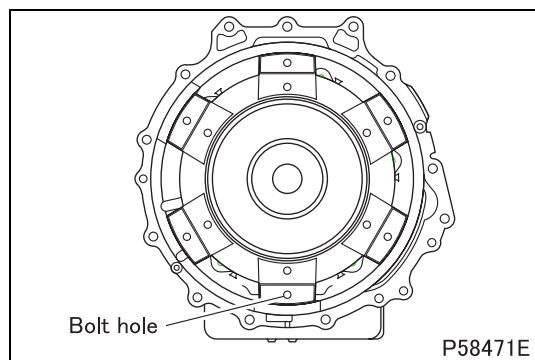
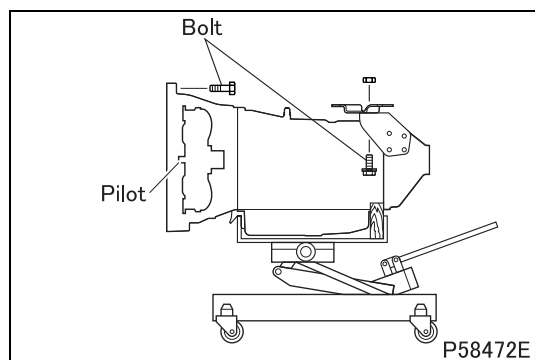
## ■ Installation: Automatic transmission

- Make sure the torque converter is correctly installed on the automatic transmission. With the torque converter correctly installed, the dimension from the drive plate surface to the case mounting surface is as shown in the diagram.
- Apply grease to the pilot.

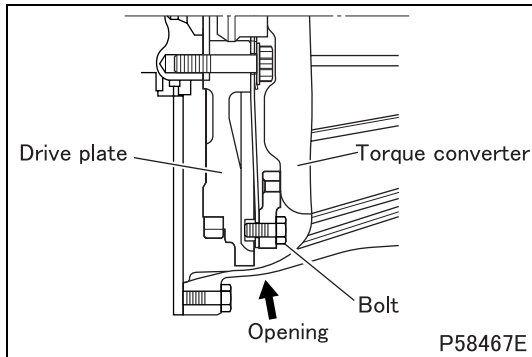
- Through the opening, align the holes for one of the bolts that join the drive plate and the torque converter and fit the bolt.
- Fit all of the rest of the six bolts, cranking the engine to bring the holes to the opening for each one. Next, tighten each bolt to specification, cranking the engine to bring each bolt to the opening in turn.

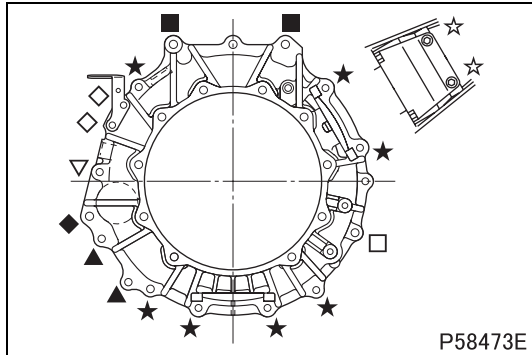
- With the dust cover and bracket mounted using the same bolts, tighten to torque all of the bolts that join the automatic transmission and engine.
- ▲: M10 × 1.25 - 55  
 ★: M10 × 1.25 - 80  
 □: M10 × 1.25 - 95  
 ◇: M10 × 1.5 - 20 (for bracket)  
 ◆: M12 × 1.75 - 45  
 ■: M12 × 1.75 - 60  
 ▽: M12 × 1.75 - 100
- Tighten the dust cover's remaining mounting bolts (marked ☆) to the specified torque to retain the dust cover.

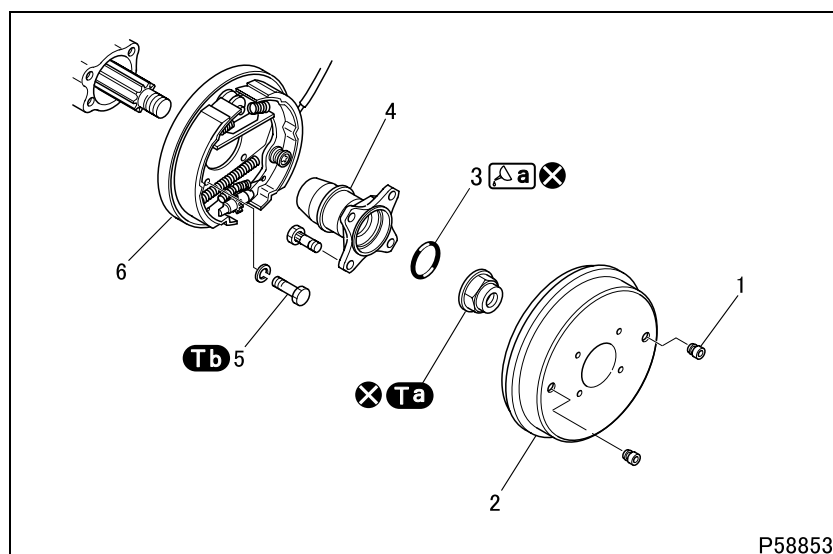
## ● Removal sequence

- 1 Dust plug
- 2 Parking brake drum
- 3 O-ring
- 4 Companion flange
- 5 Reamer bolt
- 6 Parking brake (See Gr36.)

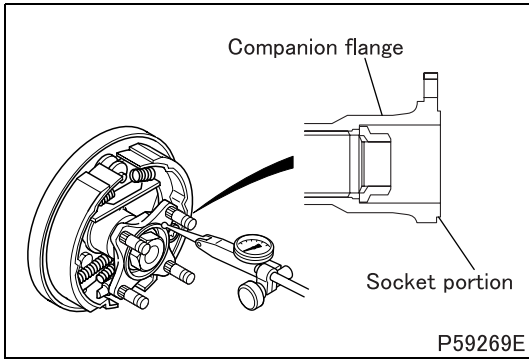
- **Inspection: Runout of socket portion of companion flange**
  - If the measured value exceeds the limit, replace the companion flange.

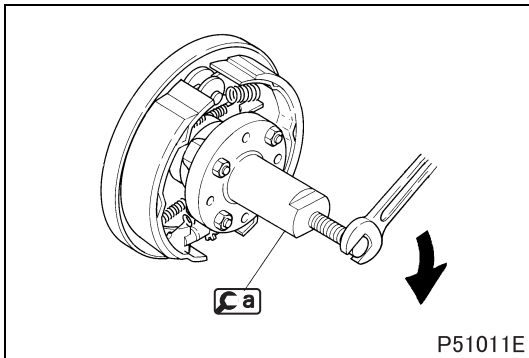
- **Removal: Companion flange**
  - Attach the special tool **Ca** to the companion flange with propeller shaft mounting nut. Using **Ca**, remove the companion flange.

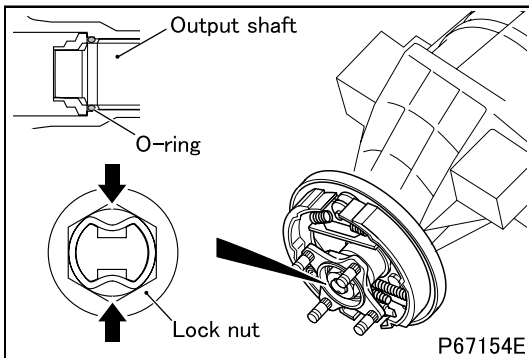
- **Inspection: Companion flange**
  - After installing O-ring to output shaft and tightening the lock nut to the specified torque, crimp the lock nut at two places.
  - After installing the companion flange, check the companion flange for excessive play and looseness. (See "ON-VEHICLE INSPECTION AND ADJUSTMENT.")

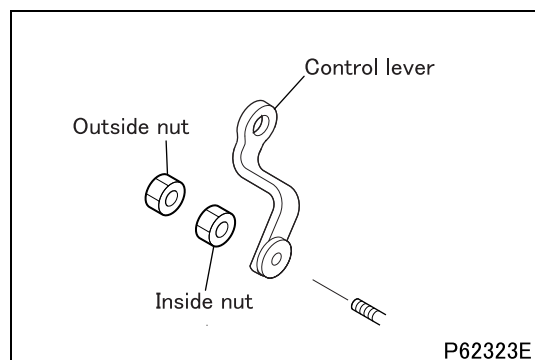
### ■ Installation: Control lever

- Tighten inside nut to the specified torque and then tighten outside nut to the specified torque with holding the inside nut by spanner.

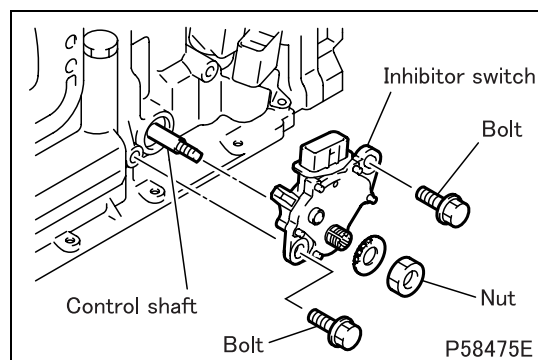
### ■ Installation: Inhibitor switch

- Position the inhibitor switch onto the control shaft.
- Loosely tighten the bolts (× 2).
- Tighten the nut to the specified torque.

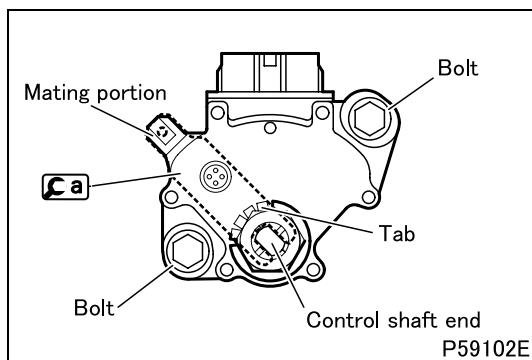
- Loosen the two bolts to enable the special tool **Ca** to be installed such that one end of the tool with a pin engages with the mating portion of the inhibitor switch while the other end of the tool engages with the end of the control shaft.
- While holding the inhibitor switch with one hand, tighten the two bolts to the specified torque.
- Stake the nut by bending over two of the tabs on the inhibitor switch.

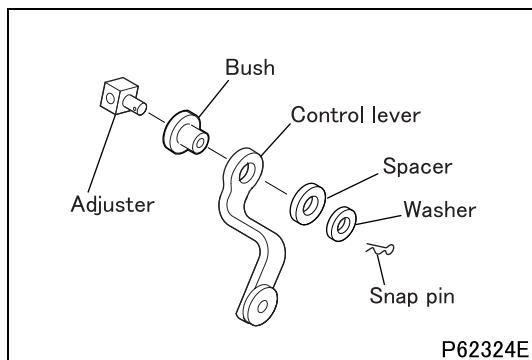
## ■ Installation: Adjuster

- Check if the adjuster turns smoothly to the control lever after mounting the adjuster to the control lever with the snap pin.
- When if the adjuster does not turn smoothly, replace the adjuster, plane washer, snap pin and control lever.
- Check the abrasion and damage of the brush and the spacer. This damage means dust, breakage, loosen, bend, twist, and so on.

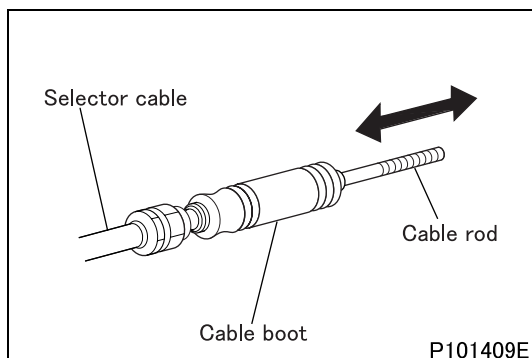
## ■ Installation: Selector cable

- When the selector cable stroke is not smooth, replace selector cable.
- Check the damage of the cable boot and the cable rod. Replace the selector cable if necessary. This damage means dust, breakage, loosen, bend, twist, and so on.

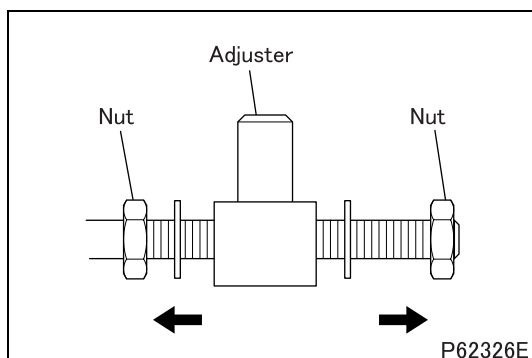
- Loosen the nuts to the both ends of thread.

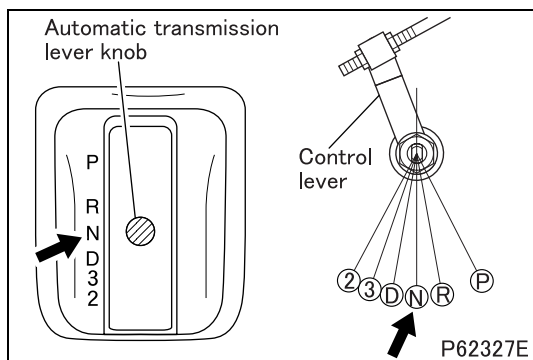
- Place the automatic transmission lever knob inside the cab in the N position. Also, place the control lever on the automatic transmission main body side in the N position.

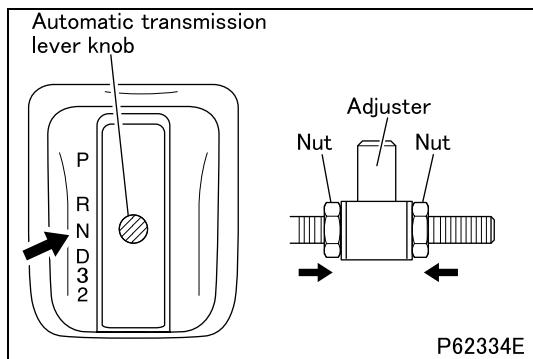
- Confirm that the automatic transmission lever knob inside the cab is in the N position, then tighten the nuts to the specified torque.

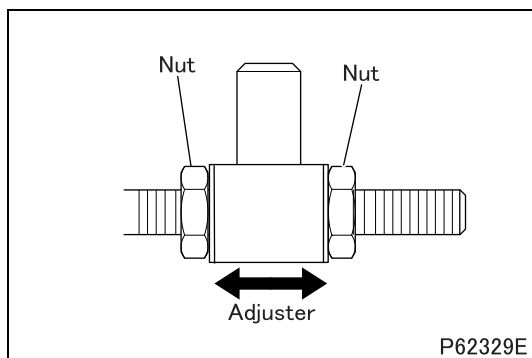
- Loosen each nut and then adjust the adjuster position in accordance with the procedure in "■ **Installation: Selector cable**".
- If the control lever is shifted toward "2" position, move the adjuster toward the selector cable end. If the lever is shifted toward "P" position, move the adjuster in the opposite direction.
- After adjustment, recheck the operate performance of range selector lever to confirm that there is no abnormality.
- If the abnormality has not solved by the adjustment, check the indicator lamp-related circuit in the meter cluster (See Gr54.) and P range switch.

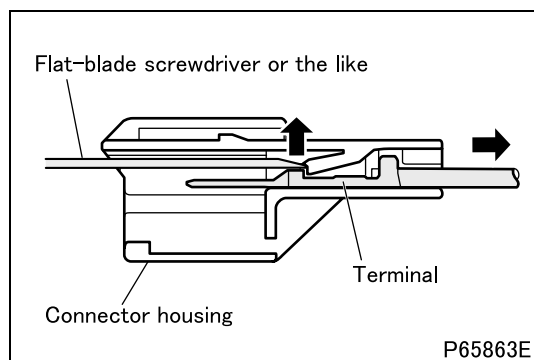
#### ■ Removal: Connector housing

- Use a flat-blade screwdriver or the like to free the terminal in the connector, then remove the connector housing.

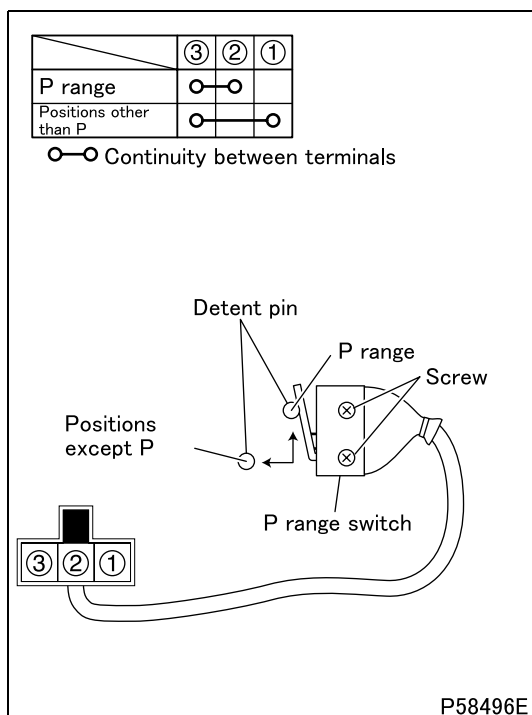
### ■ Installation: P range switch

- Tighten the screws to the specified torque with the P range switch positioned such that the continuity of the P range switch is as shown in the illustration.

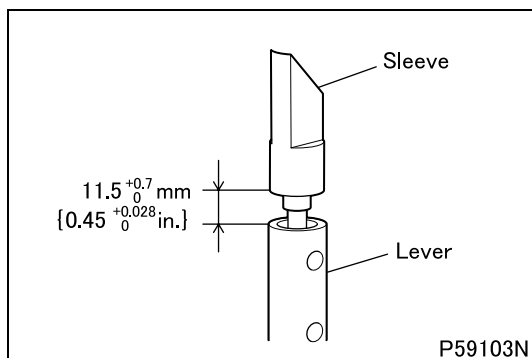
### ■ Installation: Sleeve

- Turn the sleeve to install it such that the dimension between the sleeve and the end of the lever is as shown in the illustration when the lever is in the R position.
- Install the sleeve with its tapered part on the same side as the push-button.

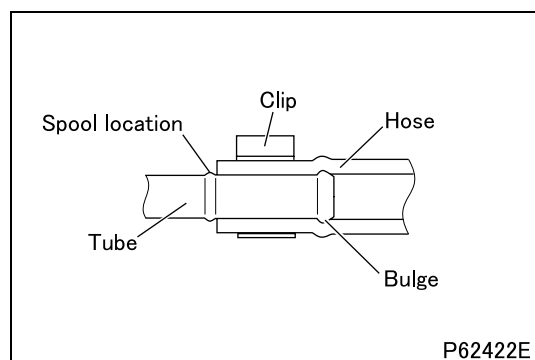
- Fit the oil cooler hose all the way to the spool at the end of the oil cooler tube.
- Fasten the hose with the clip avoiding the bulge.

- Install the oil cooler hose without forced bend and twist.
- When installing the oil cooler hose, do not apply oil to its joints.

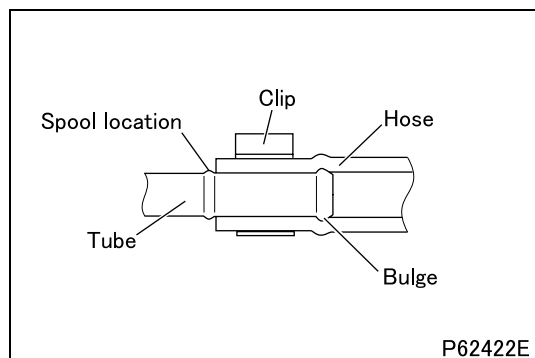
- Fit the oil cooler hose all the way to the spool at the end of the oil cooler tube.
- Fasten the hose with the clip avoiding the bulge.

- Install the oil cooler hose without forced bend and twist.
- When installing the oil cooler hose, do not apply oil to its joints.

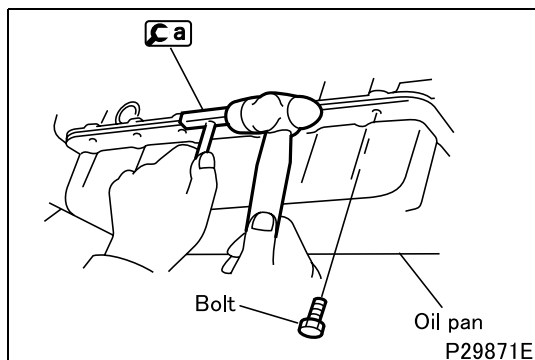
- Remove the bolts, leaving one bolt (not tightened) in every third hole to prevent the oil pan from falling.
- Remove the oil pan using the special tool **C a** as illustrated. Insert the special tool at one corner of the oil pan.

- Do not deform the oil pan when tapping in the special tool **C a**.
- Oil remains in the oil pan. Do not tip the oil pan when removing it.

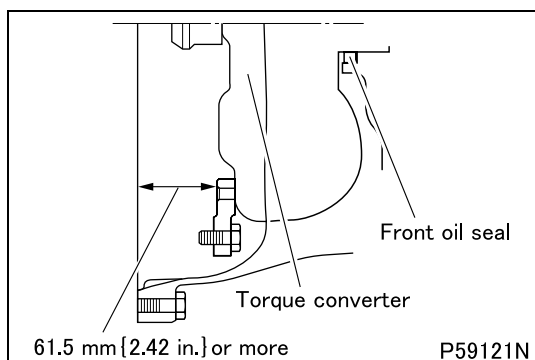
- If the torque converter is replaced and the replacement is new, fill it with fresh automatic transmission fluid up to the specified level.
- Apply automatic transmission fluid to the front oil seal, then install the torque converter on the oil pump.

- Do not damage the oil seal when installing the torque converter.
- Measure the dimension from the torque converter housing to the torque converter's set block. Confirm that the torque converter is correctly positioned.

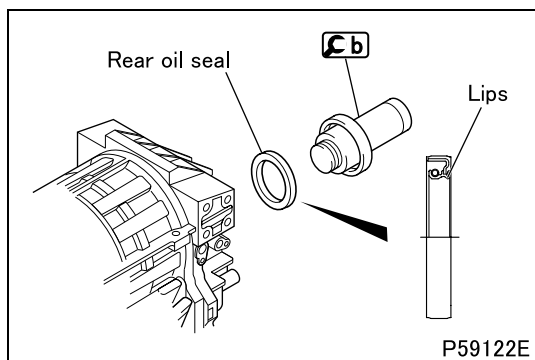
- Install the rear oil seal evenly throughout its periphery.
- Be careful not to deform or otherwise damage the rear oil seal.

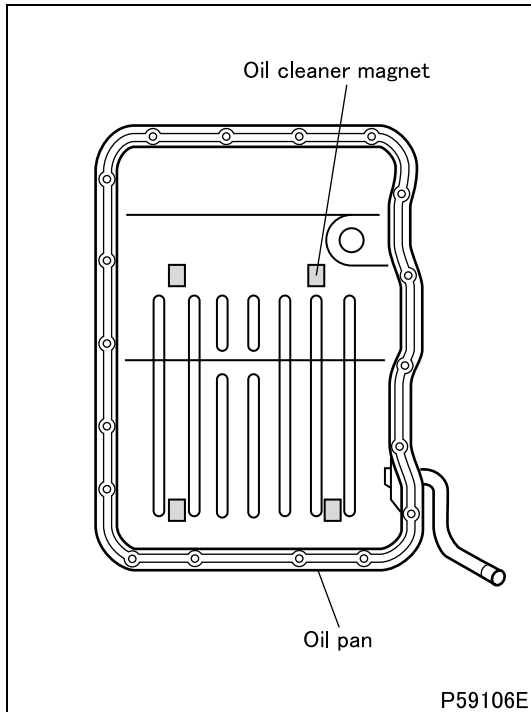
- Remove any gasket that may be remaining on the mating faces of the automatic transmission main body and the oil pan.
- Clean the oil cleaner magnet and install it onto the oil pan.
- Install new gasket onto the oil pan, then install them onto the automatic transmission main body.
- Tighten the bolts evenly in several steps, in each step tightening individual bolts a little in a set sequence to the specified torque.

- Ensure that the mating faces of the oil pan and the automatic transmission main body are free from automatic transmission fluid spill.
- After installing the oil pan, do not operate the automatic transmission for at least one hour.

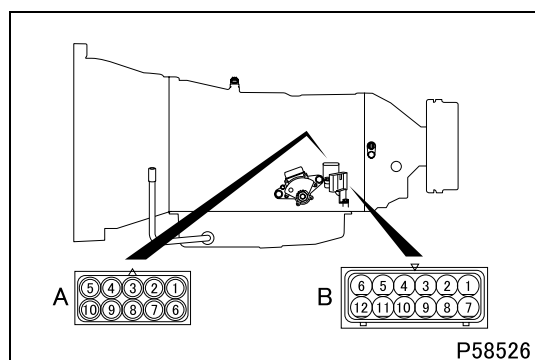
## #140 Inspection of oil pressure switch

- Measure the resistance between the indicated terminals.

- If any measured value is out of specification, replace automatic transmission.

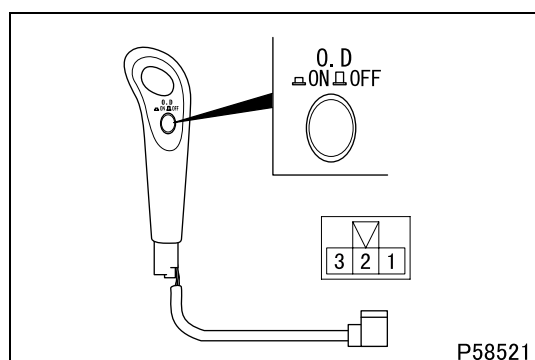
## #150 Inspection of overdrive switch

- If there is any abnormality, replace the knob.

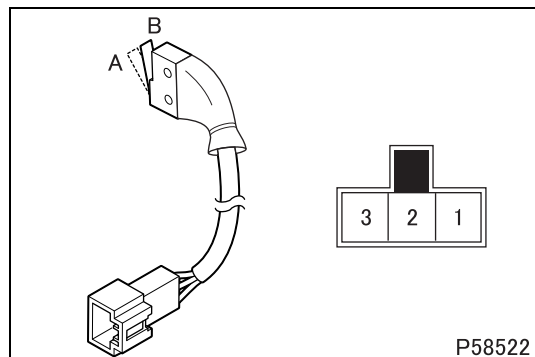
## #151 Inspection of P range switch

- If there is any abnormality, replace the P range switch.

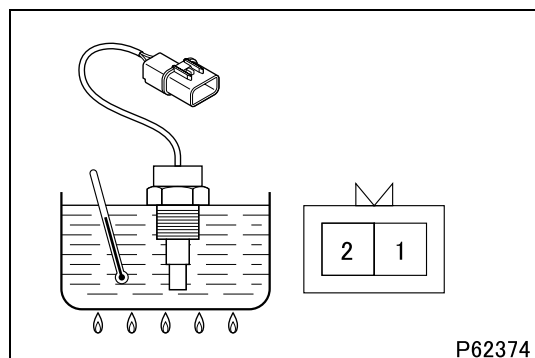
## #153 Inspection of ATF thermo switch

- Place the ATF thermo switch in a container filled with automatic transmission fluid and use a heater to raise the temperature of the fluid.
- Measure the temperature of the fluid at which continuity becomes established between terminals 1 and 2 and check that the measurement is within the standard value range.

| Standard value<br>(ON to OFF temperature) | 90°C {195°F} or higher |

- If any of the above measurements is not within the standard value range, replace the ATF thermo switch.

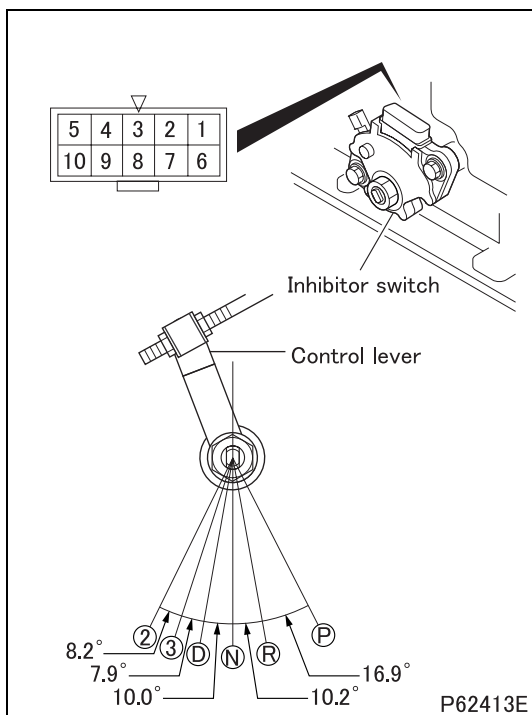
### #159 Inspection of Inhibitor switch

- After installing the inhibitor switch to the automatic transmission and connecting the control lever, check the continuity in the following conditions.

- If there is any abnormality, replace the inhibitor switch.

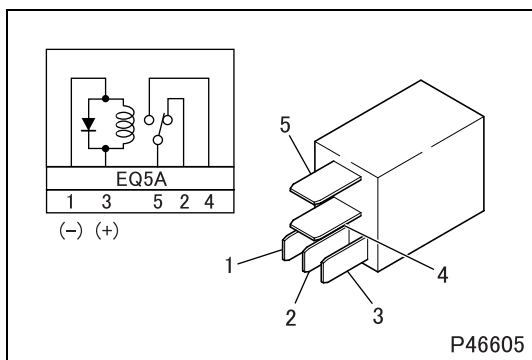
### #201 Inspection of relay (normally open, 5-pin type)

- Perform a continuity check and an operation check. If there is any abnormality, replace the relay.

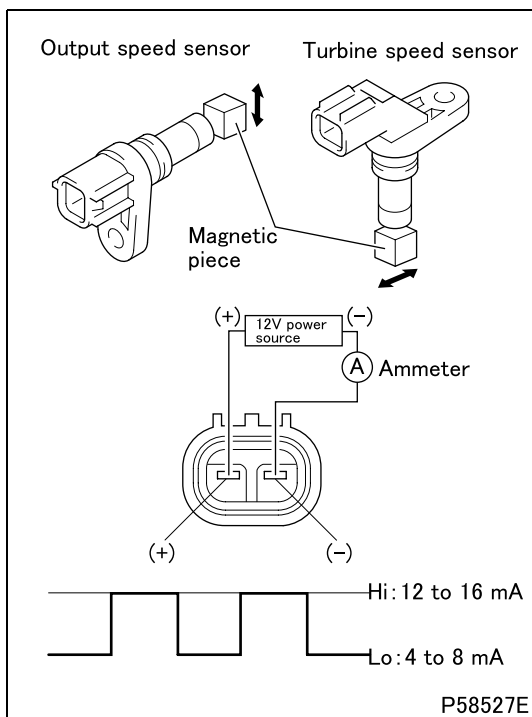
### #293 Inspection of speed sensors

- Connect the speed sensor to the power source and an ammeter as illustrated.
- While moving a magnetic piece (metal that attaches to magnet) in the illustrated directions near the end of the speed sensor, read the ammeter. (Distance between sensor and magnetic piece: 5 mm {0.20 in.} or less)

- If the measured value does not conform to the standard value, replace the speed sensor.

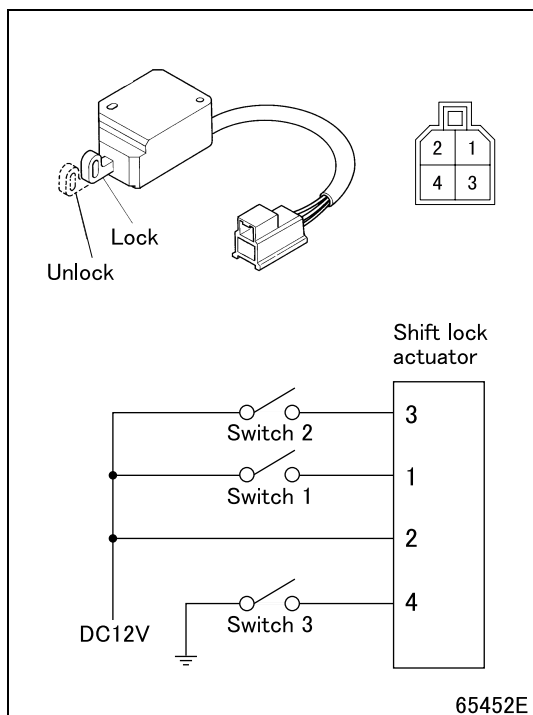
### #535 Inspection of shift lock actuator

- Wire the shift lock actuator as illustrated.
- Check the lever position with each combination of switch conditions shown in the following table.

- If there is any abnormality, replace the shift lock actuator.

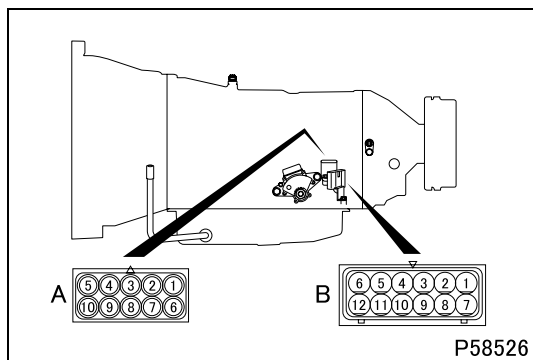
### #585 Inspection of solenoids

- Measure the resistance between the indicated terminals.

- If any measured value is out of specification, replace automatic transmission.

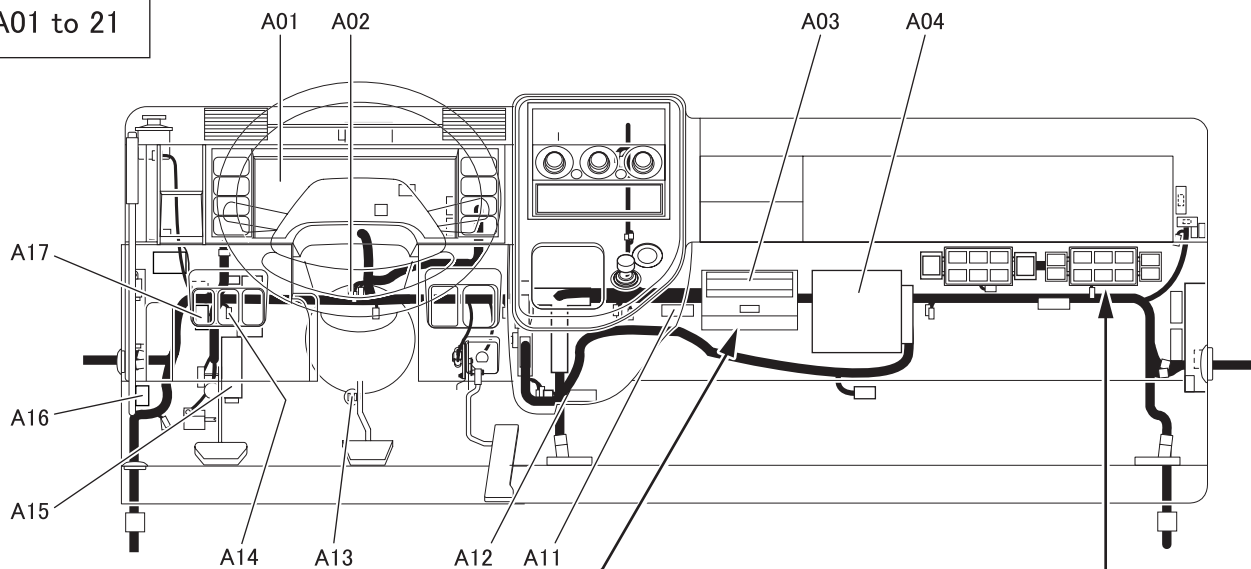
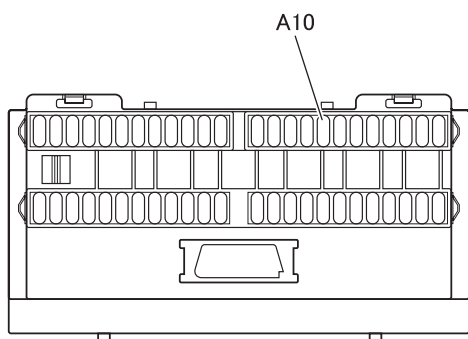
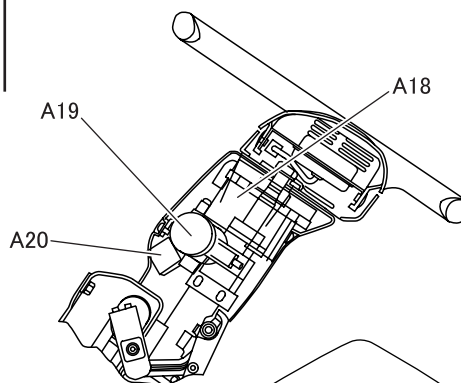
A01 to 21

- A01 Meter cluster
- A02 Diode
- A03 Fuse box
- A04 Engine ECU
- A05 Exhaust brake cut relay
- A06 ABS exhaust brake cut relay
- A07 Over drive switch
- A08 Shift lock actuator
- A09 P range switch
- A10 Diagnosis switch
- A11 Joint connector (J/C-1)
- A12 Joint connector (J/C-M1)
- A13 Stop lamp switch
- A14 Joint connector (J/C-040)
- A15 A/T ECU
- A16 Diagnostic connector
- A17 Key interlock control unit
- A18 Combination switch
- A19 Starter switch
- A20 Key interlock solenoid
- A21 Controller area network resistor

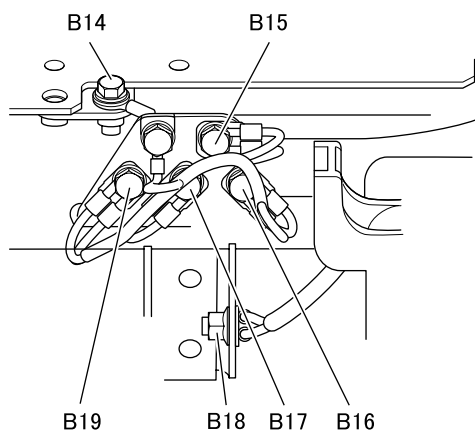
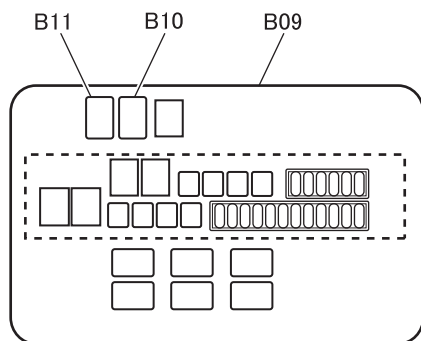
## B01 to 19

- B01 Exhaust shutter 3-way magnetic valve
- B02 Back buzzer
- B03 Rear combination lamp
- B04 Connection of chassis harness and rear chassis harness
- B05 Ground
- B06 Battery
- B07 ATF thermo switch
- B08 ATF cooler fan motor
- B09 High-current fuse box
- B10 Backup lamp relay
- B11 ATF cooler fan motor relay
- B12 Ground
- B13 Connection of chassis harness and cab harness  
<In connector box>
- B14 Ground
- B15 Ground
- B16 Ground
- B17 Ground
- B18 Ground
- B19 Ground

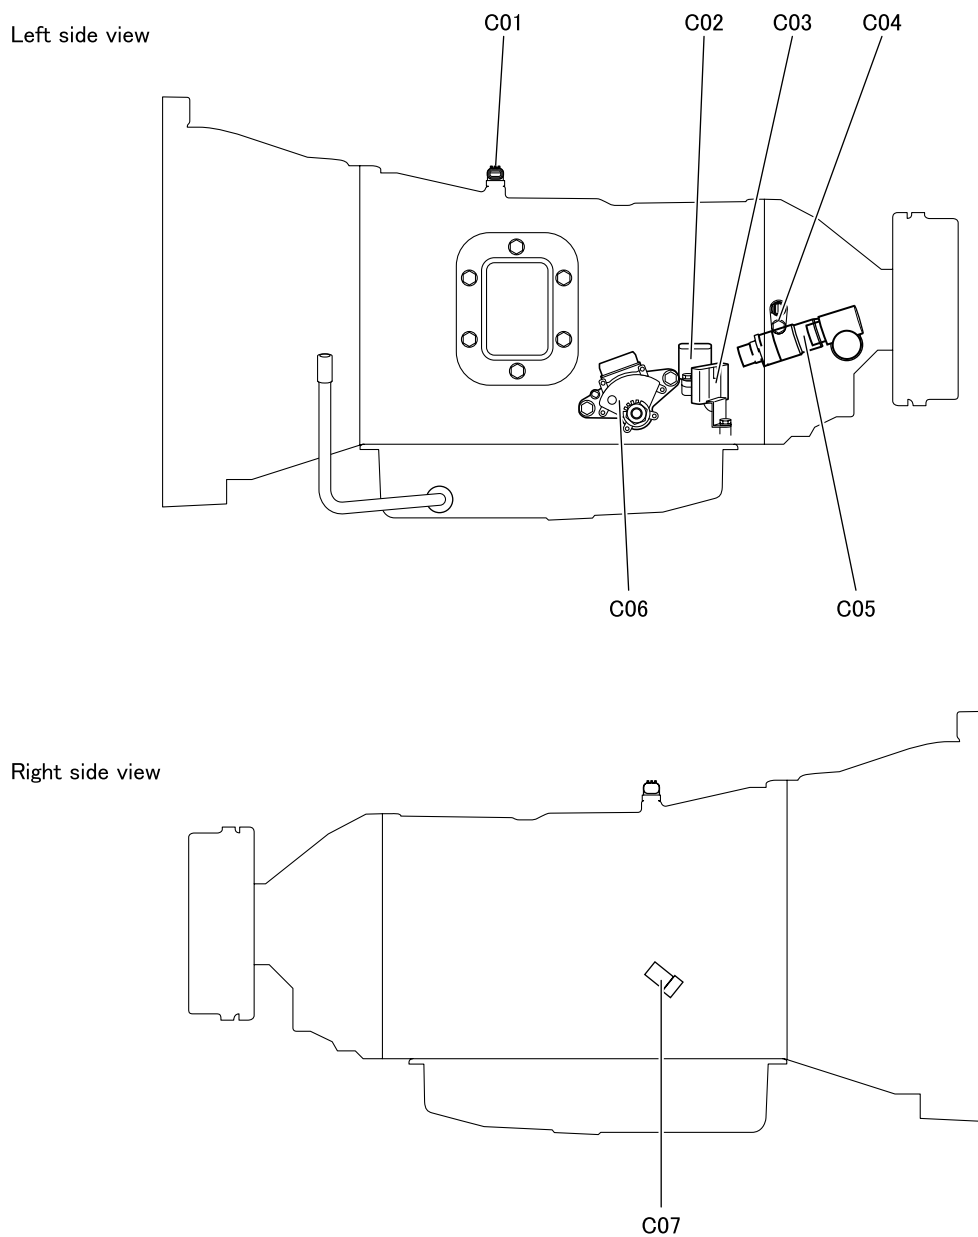
C01 to 07

- C01 Turbine speed sensor
- C02 Connector (Oil pressure switches, Oil temperature sensor (inside), Solenoids) [ET10A]
- C03 Connector (Oil pressure switches, Solenoids) [DG12A]
- C04 Output speed sensor
- C05 Vehicle speed sensor
- C06 Inhibitor switch
- C07 Oil temperature sensor (outside)

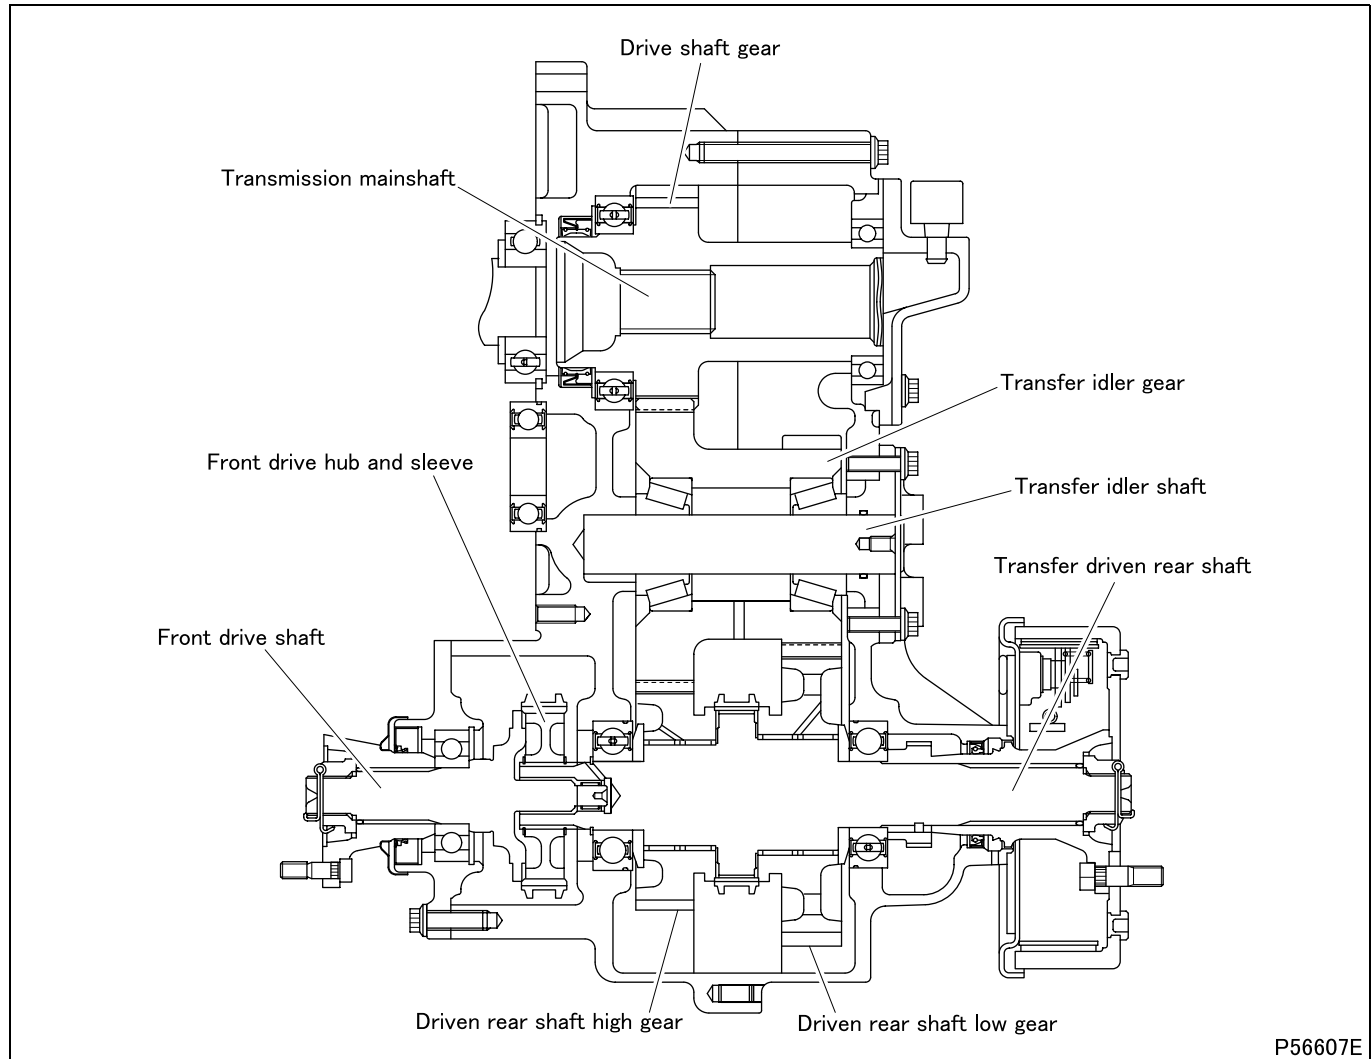
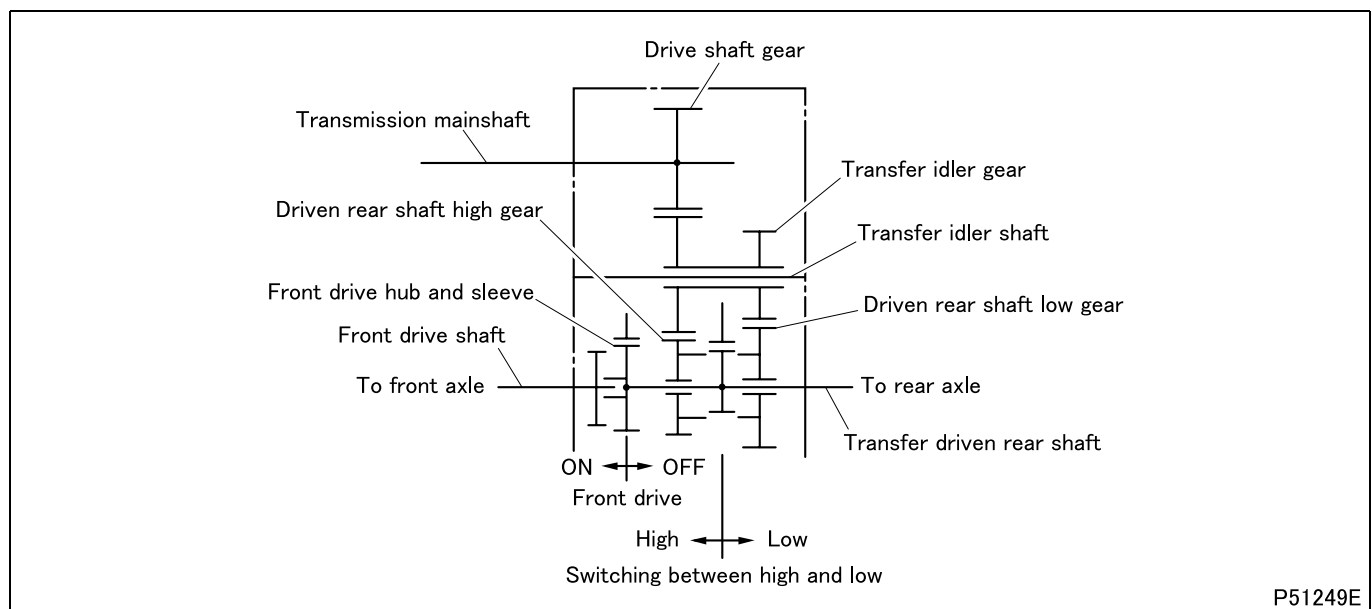
- The transfer has two functions of distribution of all-wheel drive and a sub transmission with a reduction gear.
- The transfer is of a three-shaft constant-mesh type.
- The switch of a driver seat enables switching between engagement and disengagement of the front drive.
- The transfer control lever in the cab enables switching between the high and low range.

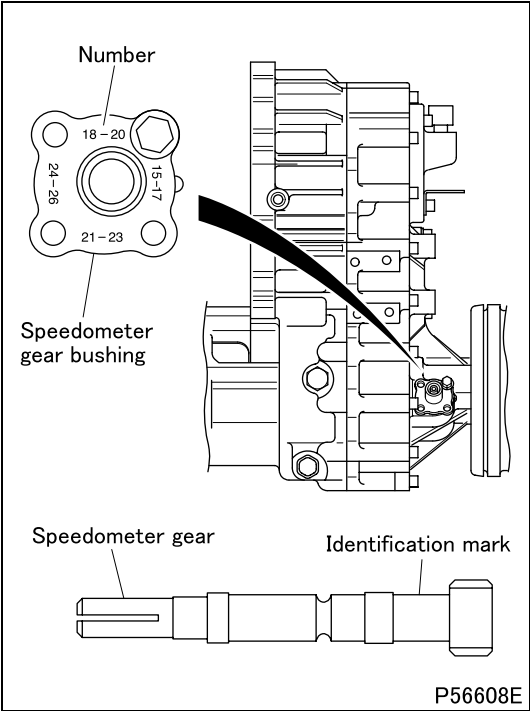
- The speedometer gear bushing is eccentric, and displacing the installed position allows it to correspond to the different number of teeth of the speedometer gear.
- The numbers marked on the front at four locations show the range of the number of teeth of the corresponding speedometer gear.  
“15-17”: Number of teeth 15 to 17.
- An identification mark showing the number of teeth is marked on the speedometer gear.

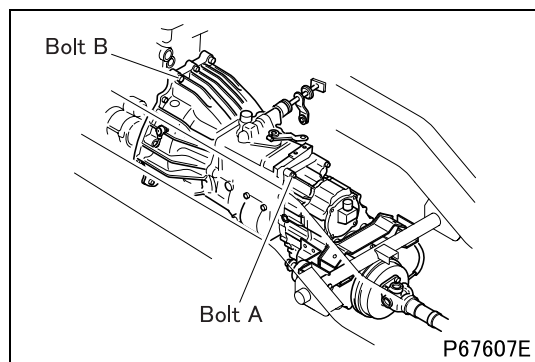
- Check the transmission and transfer mounting bolts for looseness.
- Retighten any loose bolt to the specified torque.

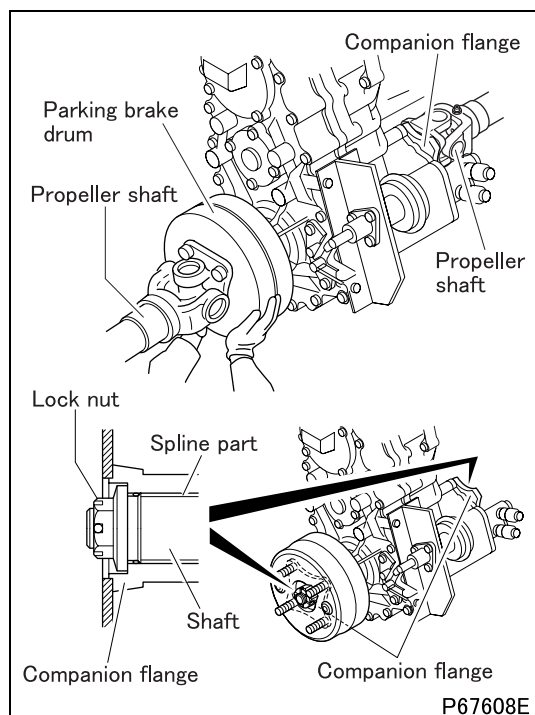
- Check for looseness in the propeller shaft mounting bolts. (See Gr25.)
- Move the parking brake drum (on the rear drive side) and the companion flange (on the front drive side) in axial and vertical directions to check for excessive play between the companion flange and the shaft.
- If excessive play is detected, remove the propeller shaft, then check the lock nut for looseness and the splines on companion flange and shaft for abnormalities. If any part is found defective, replace the part. (See FRONT DRIVE and REAR DRIVE sections.)

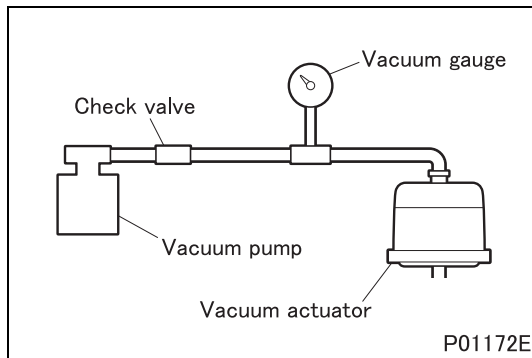
### ■ Inspection: Vacuum actuator

- Pipe the vacuum pump, check valve and vacuum gauge, apply negative pressure of 66.7 kPa {19.7 in.Hg, 500 mmHg} to the vacuum actuator, and stop the vacuum pump. After 15 seconds, measure the negative pressure with the vacuum gauge.
- If the measured value deviates from the standard value, replace the vacuum actuator.

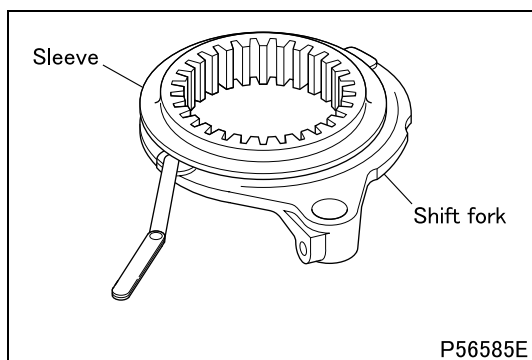
### ■ Inspection: Clearance between front drive shift fork and synchronizer sleeve

- If the measured value exceeds the limit, replace defective parts.

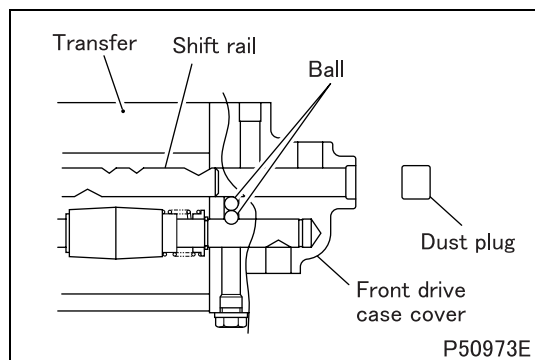
## ■ Installation: Interlock ball

- Install the front drive case cover on the transfer.
- Push in the high and low shift rail to the illustrated position (until the hole in which the balls enter is visible from the dust plug hole), and roll in the interlock balls from the dust plug to install.

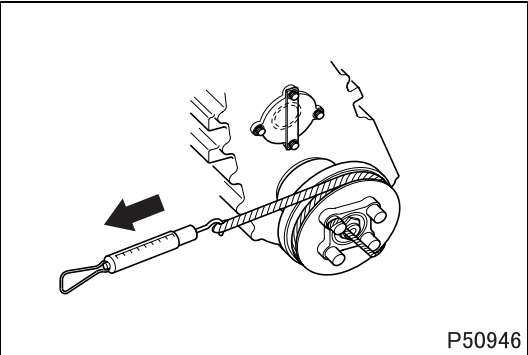
#### ■ Inspection: Startup torque of idler gear bearing

- Measure the tangential force at the outer diameter of the parking brake drum using a spring balance.

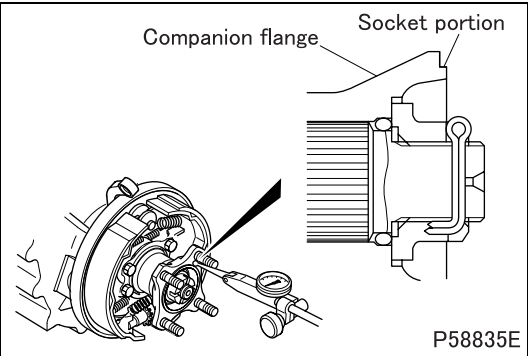
#### ■ Inspection: Runout at socket portion of companion flange

- After removing the parking brake drum, measure runouts of the companion flange at its socket portion.
- If the measurement exceeds the specified limit, replace the companion flange.

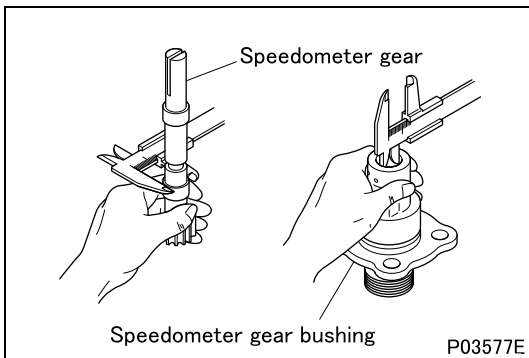
### ■ Inspection: Clearance between speedometer gear and speedometer gear bushing

- If the clearance exceeds the limit, replace defective parts.

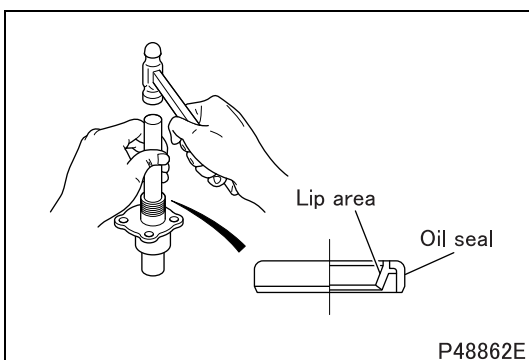
</div> <div>P49383</div> | A              | B                          | C | φ103<br>{φ4.06} | φ100<br>{φ3.94} | φ15<br>{φ0.59} | MH062677 | Installation of rear oil seal slinger |
| A | B | C | | | | | | | |
| φ103<br>{φ4.06} | φ100<br>{φ3.94} | φ15<br>{φ0.59} | | | | | | | |

### ■ Installation: Speedometer gear bushing

- When replacing the speedometer gear bushing, align the alignment mark of the old part with that of the transfer to install.

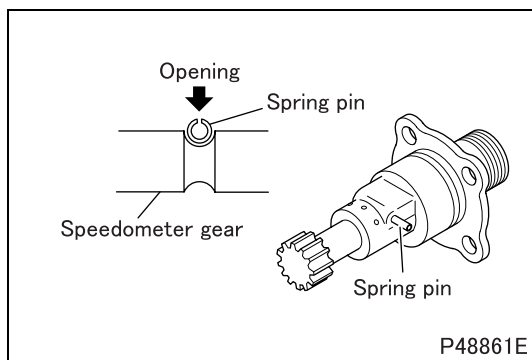
## ■ Installation: Spring pin

- Install the spring pin in the speedometer gear bushing in the illustrated direction.

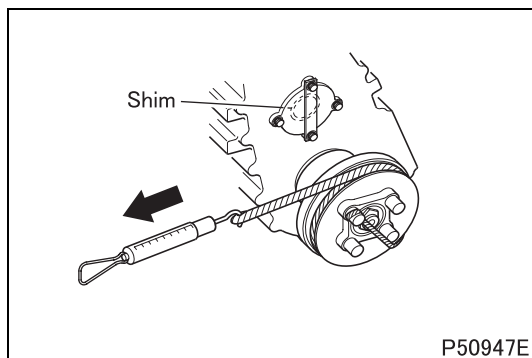
## ■ Inspection: Starting torque of pinion bearing

- Measure the tangential force at the outer diameter of the parking brake drum using a spring balance.
- If the tangential force meets the specified value, the startup torque becomes the standard value.
- If the measured value deviates from the standard value, adjust by changing thickness of the shim.  
Kinds of shim: 0.10, 0.15, 0.20, 0.50 mm {0.0039, 0.0059, 0.0079, 0.020 in.}

| Location | Maintenance item | | Standard value | Limit | Remedy |
|---|---|---|---|---|---|
| – | Startup torque of idler gear bearing (measure with tangential force at outer diameter position of parking brake drum) | | 0 to 2 N·m<br>{0 to 1.5 ft.lbs,<br>0 to 0.2 kgf·m}<br>Tangential force:<br>0 to 26.9 N<br>{0 to 20 ft.lbs,<br>0 to 2.7 kgf} | – | Adjust or replace |

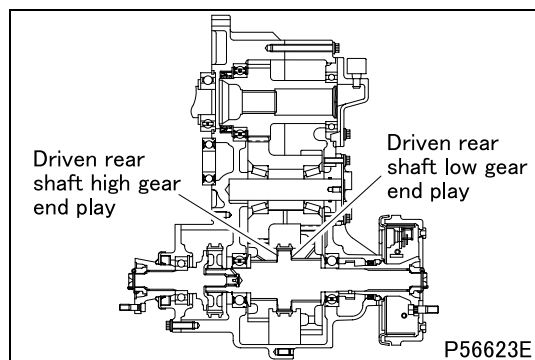
#### ■ Inspection: End play of gears

- Measure the end play using feeler gauge from the actuator bracket mounting face side.
- If the measured value exceeds the limit, replace defective parts.
- Check the play again after assembly and make sure it does not exceed the limit.

| Location | Maintenance item | | Standard value | Limit | Remedy |
|---|---|---|---|---|---|
| – | End play | Driven rear shaft low gear | 0.25 to 0.40<br>{0.0098 to 0.016} | 0.6 {0.024} | Replace |

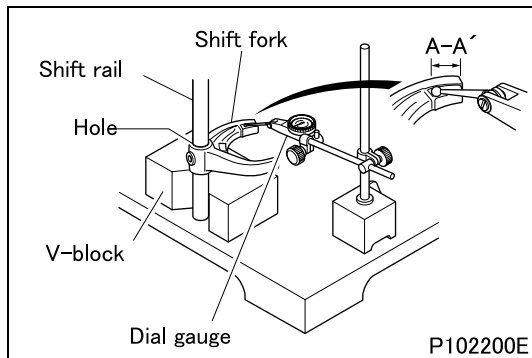
### ■ Inspection: Tilt of high and low shift fork claws

- Measure the tilt (difference between A and A') of claw A-A' against the high and low shift rail hole of high and low shift fork with pressing the rail to V-block and standing it vertically.
- If the measurement exceeds the limit, replace the high and low shift fork.

| Location | Maintenance item | | Standard value | Limit | Remedy |
|---|---|---|---|---|---|
| 9 | Tilt of high and low shift fork claws | | 0 to 0.1 {0 to 0.0039} | 0.2 {0.0079} | Replace |

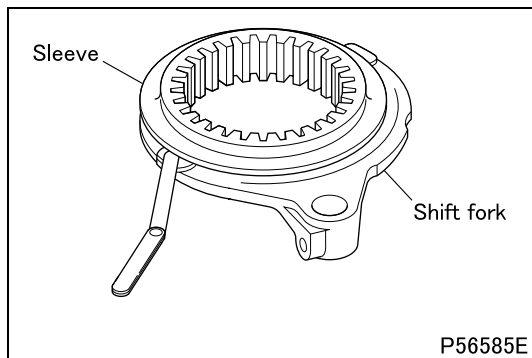
### ■ Inspection: Clearance between high and low shift fork and synchronizer sleeve of transfer driven rear shaft

- Measure clearance between the shift fork claws and synchronizer sleeve groove.
- If the measured value exceeds the limit, replace defective parts.

| Location | Maintenance item | | Standard value | Limit | Remedy |
|---|---|---|---|---|---|
| 9, 14 | Clearance between high and low shift fork and synchronizer sleeve of transfer driven rear shaft | | 0.3 to 0.5<br>{0.012 to 0.020} | 1.0 {0.039} | Replace |

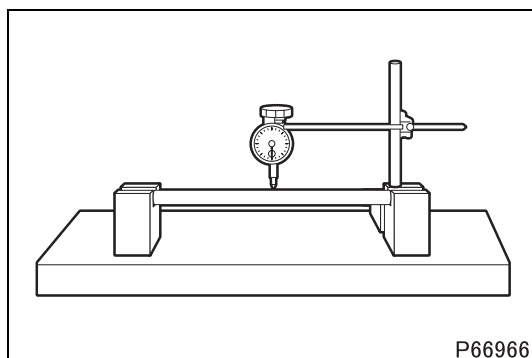
### ■ Inspection: Bend of high and low shift rail

- Measure the extent of bending at the middle of the high and low shift rail.
- While rotating the high and low shift rail by one revolution, read how much the dial gauge needle will move. A half of the reading observed represents the bend, if any, of the shaft.
- If measurement exceeds the limit, correct or replace the high and low shift rail.

| Location | Maintenance item | | Standard value | Limit | Remedy |
|---|---|---|---|---|---|
| 10, 13 | Bend of high and low shift rail | | 0 to 0.02 {0 to 0.00079} | 0.03<br>{0.0012} | Replace |

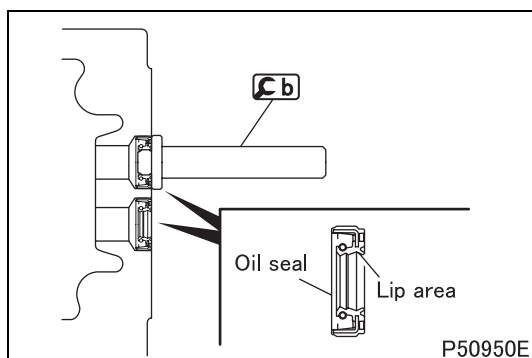
### ■ Installation: Oil seal

- Apply grease to the lip area of the oil seal and install it on the transfer cover in the illustrated direction.

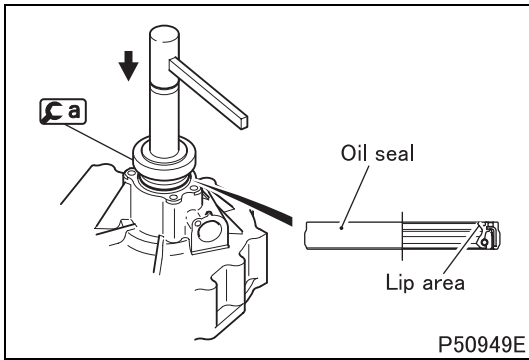
#### ■ Installation: Oil seal

- Apply grease to the lip area of the oil seal and install it on the transfer cover in the illustrated direction.
