# FE.FG

## SERVICE MANUAL 2008 Model FOREWORD

This Service Manual contains maintenance and repair methods for the Mitsubishi Fuso Truck FE. FG Series. Read this manual carefully as an aid in providing correct, efficient maintenance. Please note that the information and specifications contained within this manual may change without notice. This is due to product modifications and continued vehicle improvements that are made throughout the model years. Should you encounter any discrepancy in the information provided, please do not hesitate to contact your nearest Mitsubishi Fuso Dealer or Mitsubishi Fuso Truck of America, Inc.

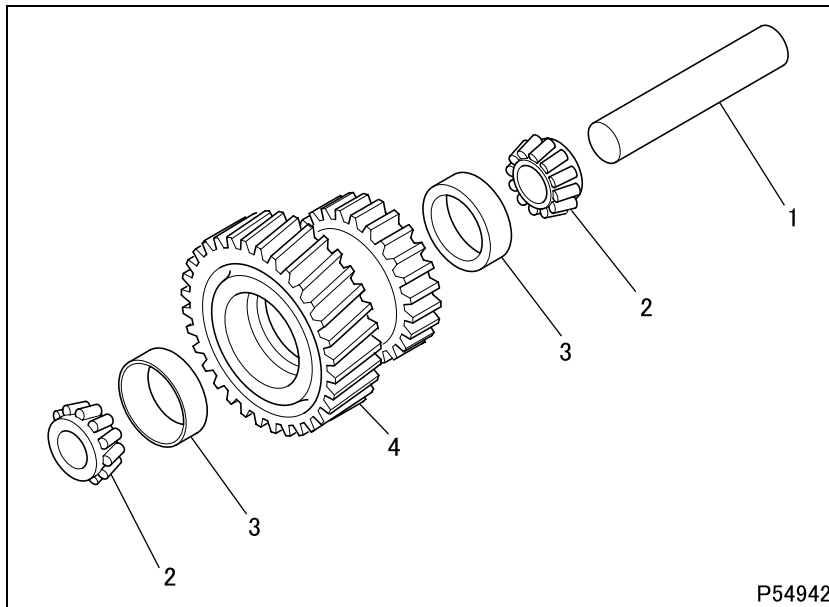
## Transfer Idler Gear

### ● Disassembly sequence

- 1 Transfer idler shaft
- 2 Bearing inner race
- 3 Bearing outer race
- 4 Transfer idler gear

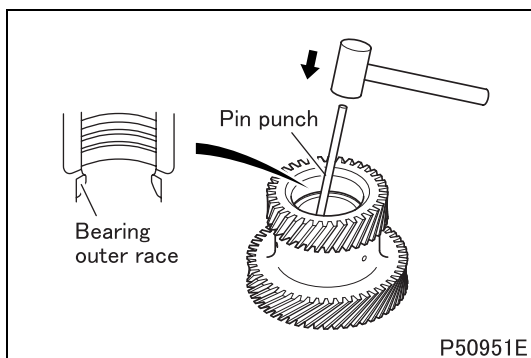
### ■ Removal: Bearing outer race

- Evenly tap the bearing outer race to take it out from the transfer idler gear.

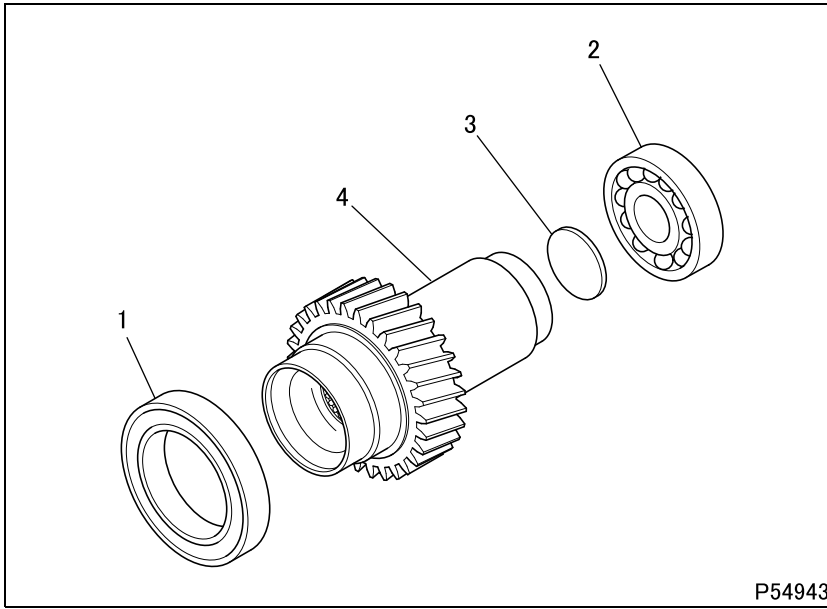
**Transfer Drive Gear**

**● Disassembly sequence**

- 1 Bearing
- 2 Bearing
- 3 Plug
- 4 Transfer drive gear

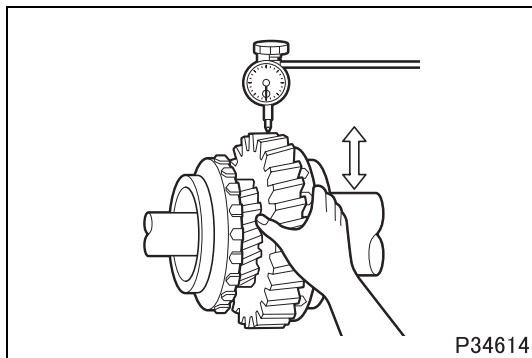
#### ■ Inspection: Play of driven rear shaft gears in diameter direction

- If the measured value exceeds the limit, replace defective parts.
- Check the play again after assembly and make sure it does not exceed the limit.

| Location | Maintenance item | Standard value | Limit | Remedy |
|---|---|---|---|---|
| – | Play of transfer driven rear shaft in diameter direction | 0.02 to 0.06<br>{0.00079 to 0.0024} | 0.12<br>{0.0047} | Replace |

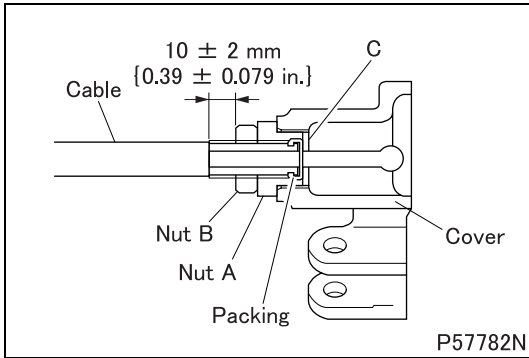
### ■ Installation: Transfer control cable

- Install the cable in the shift rail cover being careful not to let the packing project from surface C in the cover, and then tighten nut A to the specified torque.
- Tighten nut B to the specified torque and to the dimension indicated in the illustration.

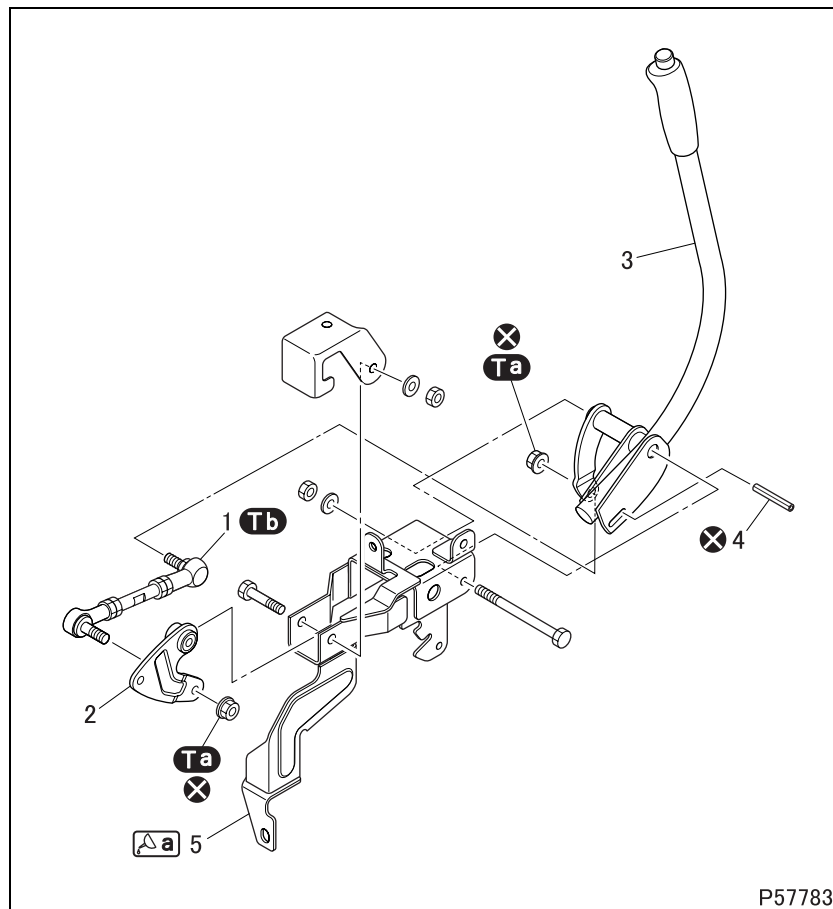
## Transfer Control Lever

### ● Disassembly sequence

- 1 Rod
- 2 Lever
- 3 Transfer lever
- 4 Spring pin
- 5 Transfer control bracket

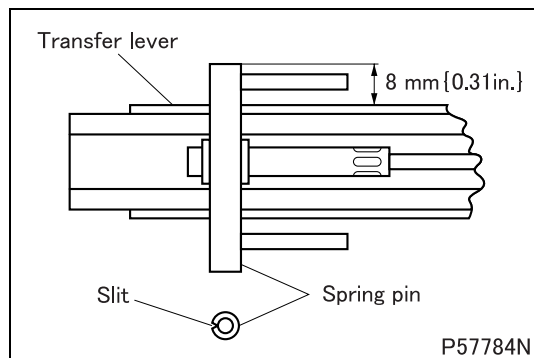
### ■ Installation: Spring pin

- Install the spring pin so that the protruding distance from the transfer lever and the slit direction of the spring pin are as illustrated.

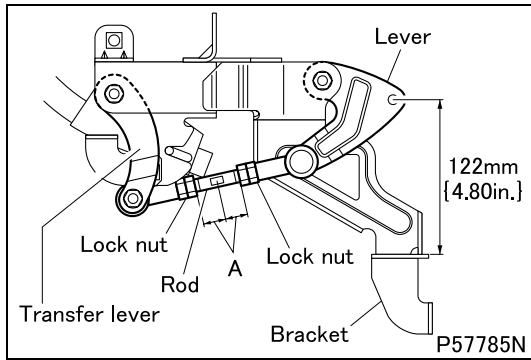
#### ■ Installation: Rod

- Install the rod on the lever and transfer lever.
- Loosen the lock nuts on the rod and turn the rod until the distance between the lever and transfer control bracket is as indicated in the illustration. Make sure that distance A in the illustration does not exceed 32.3 mm {1.27 in.}.
- Tighten the lock nuts after the above adjustment.

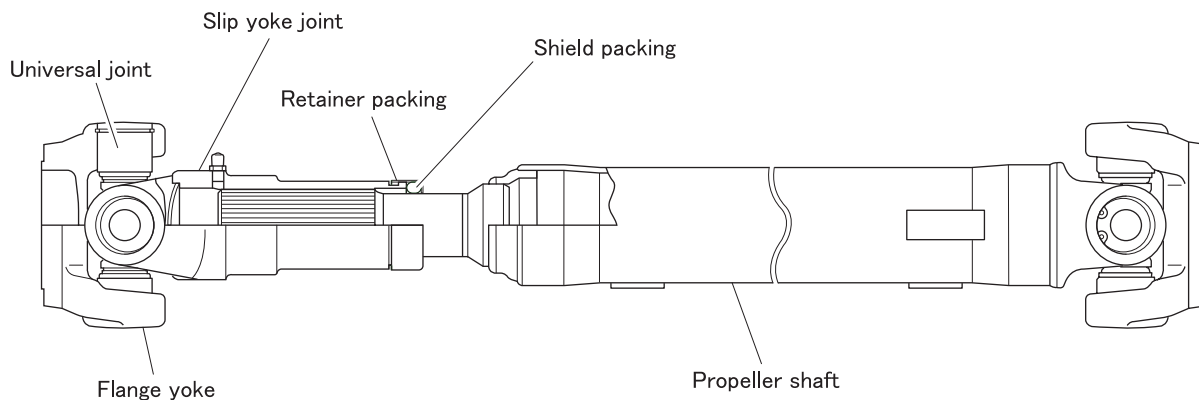
P48635E

<Except double Cardan type>

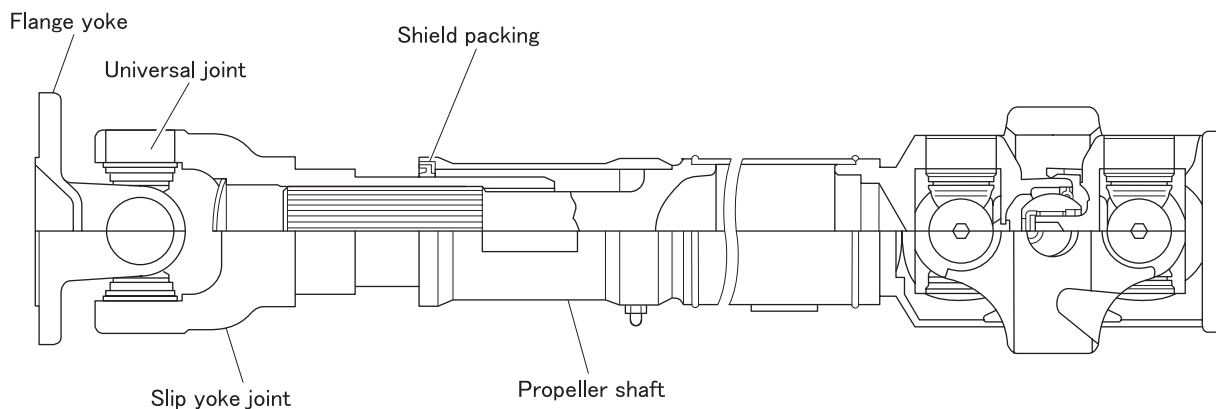
P48633E

<Double Cardan type>

- Propeller shafts used with FG front axles are of double Cardan type suited for suppressing vibrations caused by angle changes in universal joint.

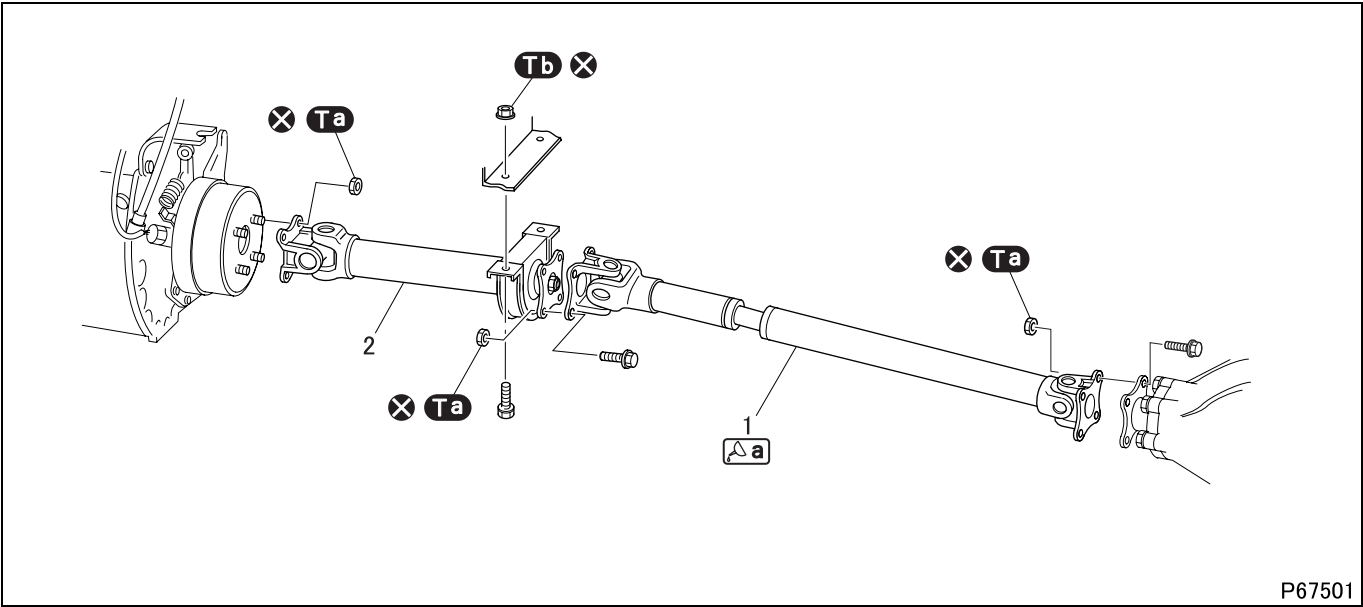
REMOVAL AND INSTALLATION OF PROPELLER SHAFT <BETWEEN T/M (OR T/F) AND REAR AXLE>

Shown above is a tandem propeller shaft for FE. The illustration applies to other propeller shafts.

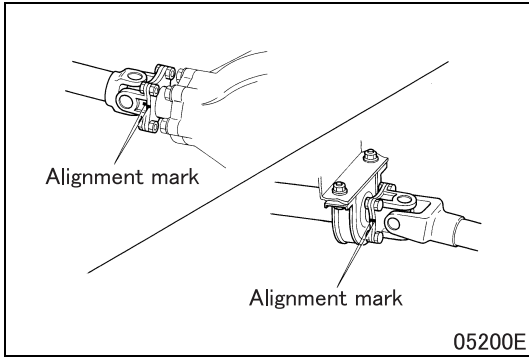
**■ Alignment mark: Propeller shaft**

- Be sure to make alignment marks before removal.

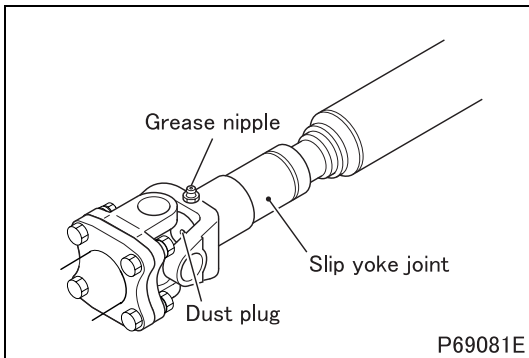
**■ Lubrication: Propeller shaft**

- Fill grease through grease nipple until clean grease overflows from the hole in dust plug of slip yoke joint.

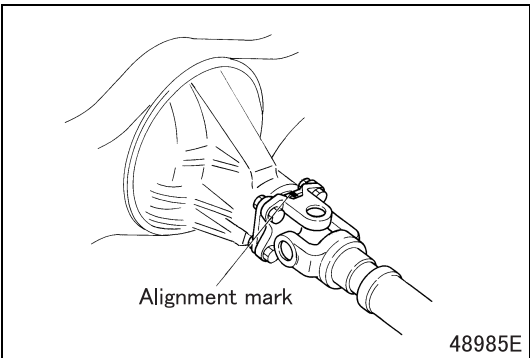
#### ■ Alignment mark: Propeller shaft

- Be sure to make alignment marks before removal.

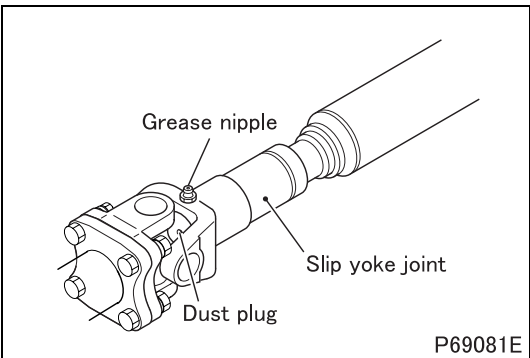
#### ■ Lubrication: Propeller shaft

- Fill grease through grease nipple until clean grease overflows from the hole in dust plug of slip yoke joint.

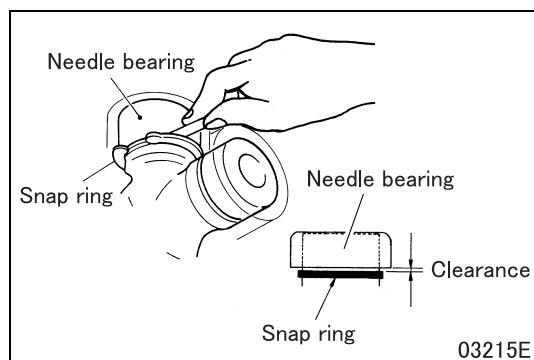
### ■ Inspection: Axial clearance of spider

- Press down on the needle bearing, and measure clearances between snap ring and flange yoke, slip yoke joint and propeller shaft.
- If measured value exceeds the standard value, change snap ring thickness for adjustment.  
To adjust, use snap rings for both ends with the same thickness. Select optimal combination of snap rings from the table below if necessary.

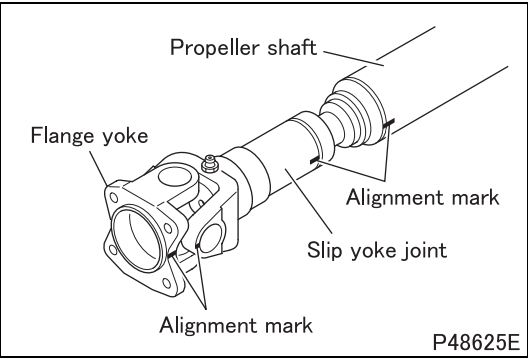
## ■ Alignment mark: Propeller shaft

- To prevent assembly of wrong parts, make alignment marks on flange yoke, slip yoke joint and propeller shaft.

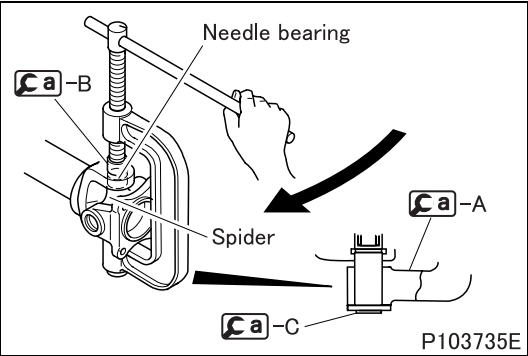
## ■ Removal: Needle bearing

- Fit **Ca**-C into **Ca**-A from outside.
- Applying **Ca**-B to spider, screw **Ca**-A to force out spider and remove needle bearing.

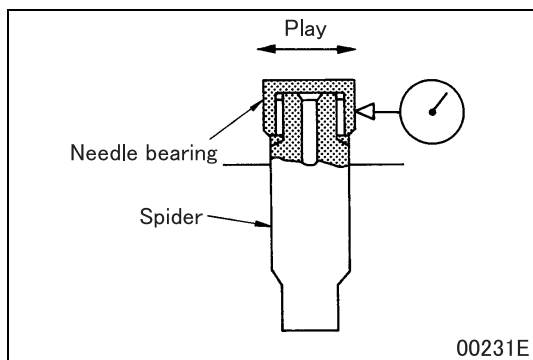
### ■ Inspection: Clearance between needle bearing and spider

- If the measurement exceeds the limit, replace with the universal joint spider kit.

| Location | Maintenance item | Standard value | Limit | Remedy |
|---|---|---|---|---|
| 2, 5, 6 | Play between needle bearing and spider | 0.02 to 0.05<br>{0.00079 to 0.0020} | 0.1 {0.0039} | Replace |

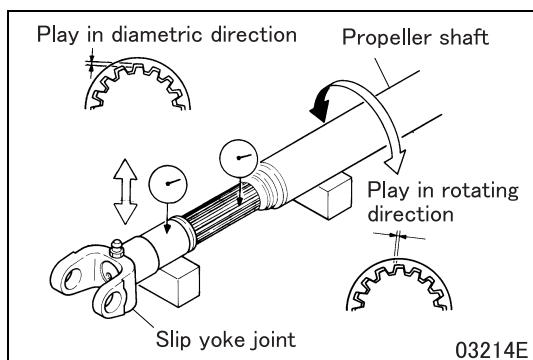
### ■ Inspection: Play between slip yoke joint and propeller shaft spline

- Check the following, and if the measurement is higher than the limit, replace the faulty part.

- (1) Play of spline in rotating direction
- (2) Play of spline in diametric direction

| Location | Maintenance item | Standard value | Limit | Remedy |
|---|---|---|---|---|
| 8, 11 | Play in rotating direction between slip yoke joint and propeller shaft spline | 0.01 to 0.09<br>{0.00039 to 0.0035} | 0.3 {0.012} | Replace |
| | Play in diametric direction between slip yoke joint and propeller shaft spline | 0.02 to 0.16<br>{0.00079 to 0.0063} | 0.3 {0.012} | Replace |

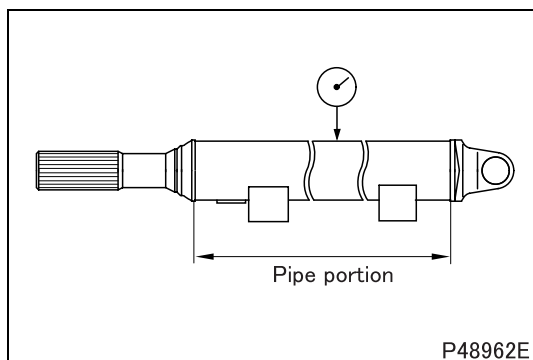
### ■ Inspection: Bend of propeller shaft

- Measure bend of propeller shaft at the center of its pipe portion.
- If the measurement is higher than the limit, correct the bend with a press or replace the propeller shaft.

- To measure the bend of propeller shaft, turn it fully once and read the dial gauge indicator. The bend is one half of the indicated value.
- Check the propeller shaft for cracks in the welded area after correcting the bend using a press. If cracking is found, replace the shaft.

| Location | Maintenance item | Standard value | Limit | Remedy |
|---|---|---|---|---|
| 11 | Bend of propeller shaft | – | 0.4 {0.016} | Correct or replace |

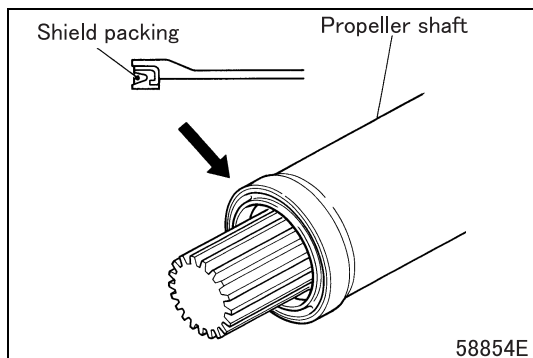
### ■ Installation: Shield packing

- Install shield packing flush onto propeller shaft in the illustrated direction.

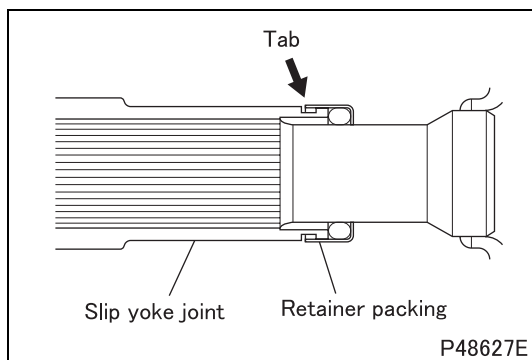
## ■ Installation: Retainer packing <Except double Cardan type>

- Hold retainer packing against slip yoke joint and crimp tabs (at eight places).

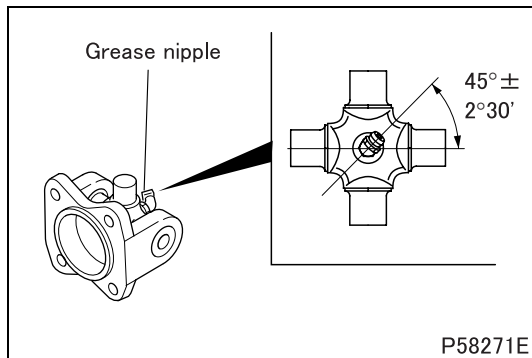
## ■ Installation: Grease nipple

- Install the grease nipple on the spider at an angle conforming to the indication in the illustration.

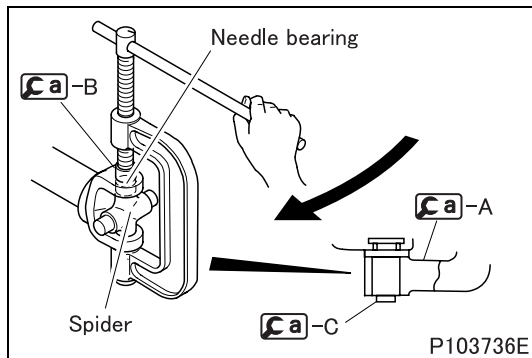
## ■ Installation: Needle bearing

- Fit Ca-C into Ca-A from inside.
- Operating Ca-A, install needle bearing into place.

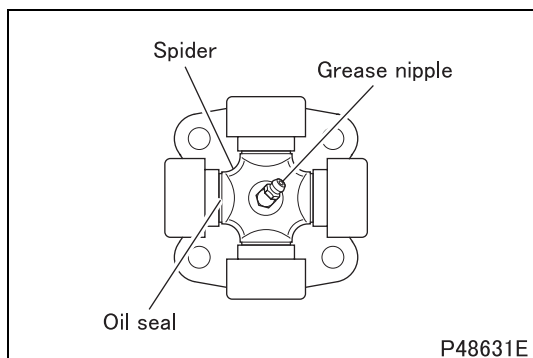
### ■ Lubrication: Grease nipple

- Fill grease through grease nipple until clean grease overflows from all of the four oil seals of spider.
- If grease does not overflow from all of the four oil seals or rust, water and dirt come out with grease, replace the spider with the spider kit.

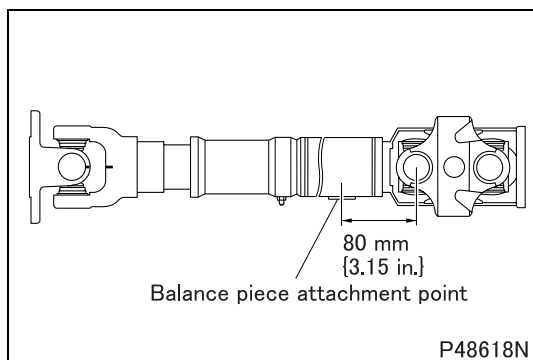
### ■ Inspection: Propeller shaft

- Attach appropriate balance pieces at the illustrated points so that the amount of unbalance comes within the specified standard value.
- Maximum balance piece allowance for one point is 100 g {3.53 oz.}.
- Use a combination that keeps the number of balance pieces to a minimum.

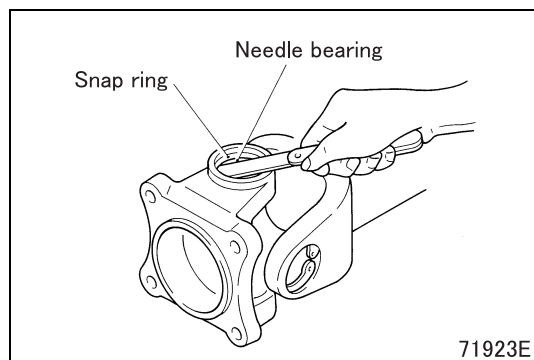
### ■ Inspection: Axial clearance of spider

- Press down on the needle bearing, and measure clearance between snap ring and needle bearing.
- If measured value exceeds the standard value, change snap ring thickness for adjustment.  
To adjust, use snap rings for both ends with the same thickness. Select optimal combination of snap rings from the table below if necessary.

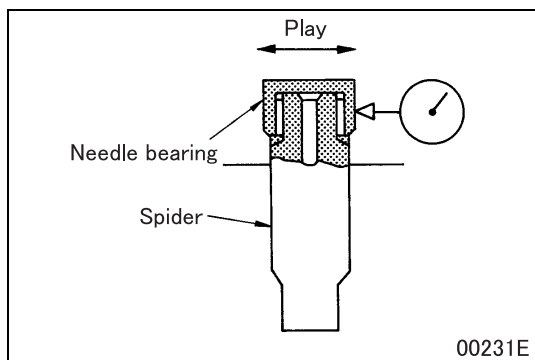
### ■ Inspection: Clearance between needle bearing and spider

- If the measurement is higher than the limit, replace with the universal joint spider kit.

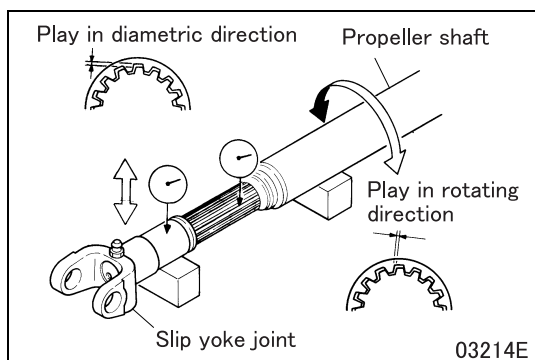
### ■ Inspection: Play between slip yoke joint and propeller shaft spline

- Check the following, and if the measurement is higher than the limit, replace the faulty part.

- (1) Play of spline in rotating direction
- (2) Play of spline in diametric direction

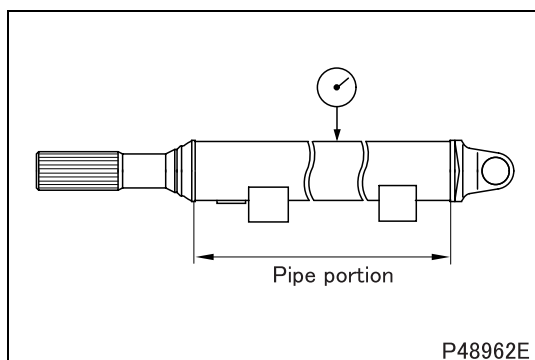
### ■ Inspection: Bend of propeller shaft

- Measure bend of propeller shaft at the center of its pipe portion.
- If the measurement is higher than the limit, correct the bend with a press or replace the propeller shaft.

- To measure the bend of propeller shaft, turn it fully once and read the dial gauge indicator. The bend is one half of the indicated value.
- Check the propeller shaft for cracks in the welded area after correcting the bend using a press. If cracking is found, replace the shaft.

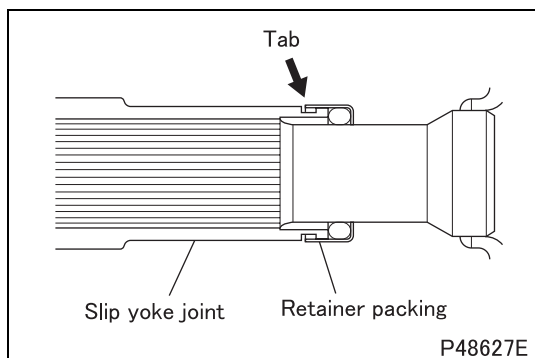
### ■ Installation: Retainer packing

- Hold retainer packing against slip yoke joint and caulk tabs (at eight places).

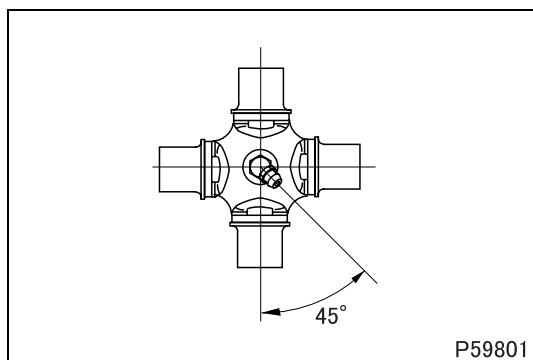
## ■ Installation: Spider

- Install the grease nipple on the spider at an angle conforming to the indication in the illustration.

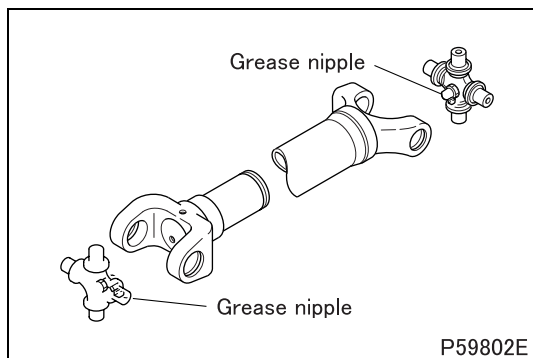
- Install the spiders on the both ends of propeller shaft so that the direction of grease nipples must be the same.

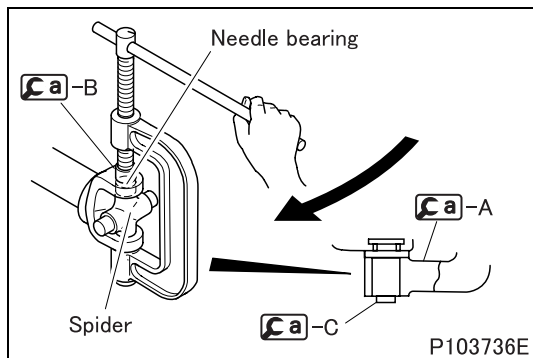
## ■ Installation: Needle bearing

- Fit **ca**-C into **ca**-A from inside.
- Operating **ca**-A, install needle bearing into place.

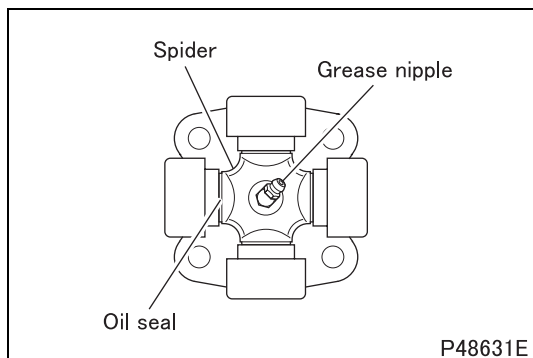
## ■ Lubrication: Grease nipple

- Fill grease through grease nipple until clean grease overflows from all of the four oil seals of spider.
- If grease does not overflow from all of the four oil seals or rust, water and dirt come out with grease, replace the spider with the spider kit.

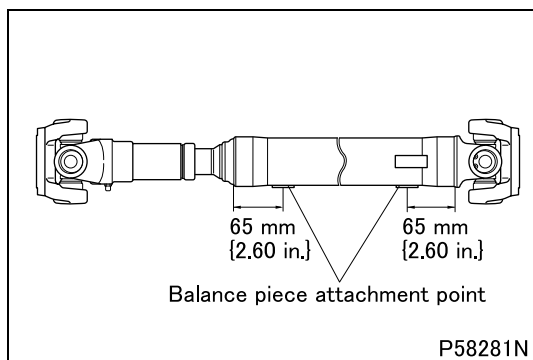
### ■ Inspection: Propeller shaft

- Attach appropriate balance pieces at the illustrated points so that the amount of unbalance comes within the specified standard value.
- Maximum balance piece allowance for one point is 100 g {3.53 oz.}.
- Use a combination that keeps the number of balance pieces to a minimum.

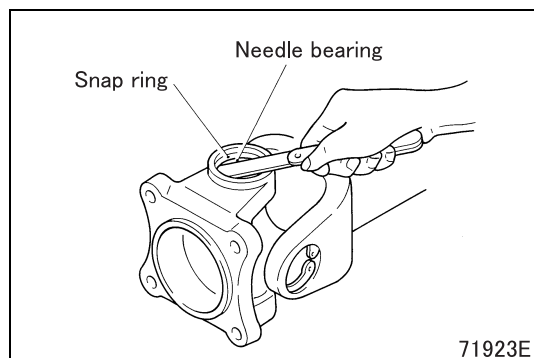
### ■ Inspection: Axial clearance of spider

- Press down on the needle bearing, and measure clearance between snap ring and needle bearing.
- If measured value exceeds the standard value, change snap ring thickness for adjustment.  
To adjust, use snap rings for both ends with the same thickness. Select optimal combination of snap rings from the table below if necessary.

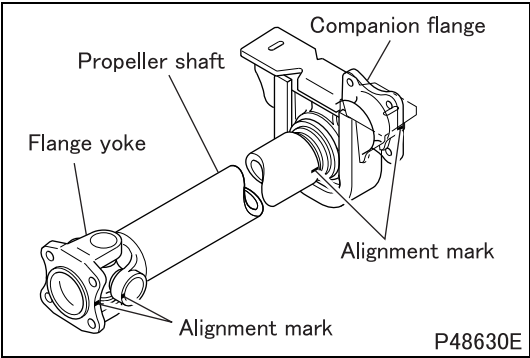
## ■ Alignment mark: Propeller shaft

- To prevent assembly of wrong parts, make alignment marks on flange yoke, companion flange and propeller shaft.

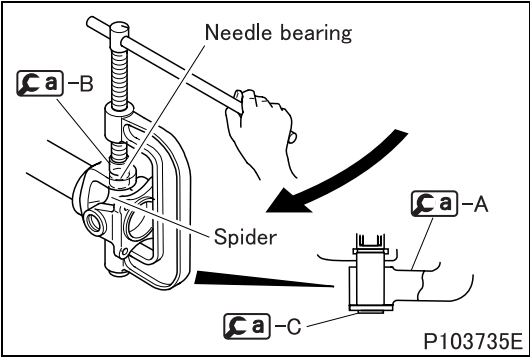
## ■ Removal: Needle bearing

- Fit **Ca**-C into **Ca**-A from outside.
- Applying **Ca**-B to spider, operate **Ca**-A to force out spider and remove needle bearing.

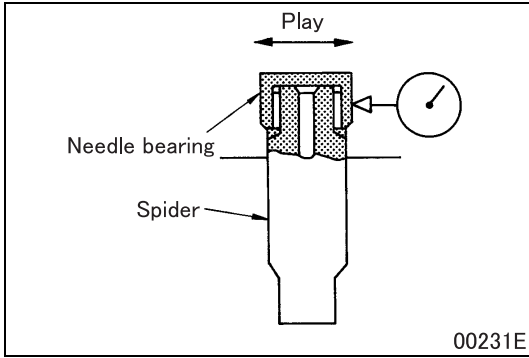
#### ■ Inspection: Clearance between needle bearing and spider

- If the measurement is higher than the limit, replace with the universal joint spider kit.

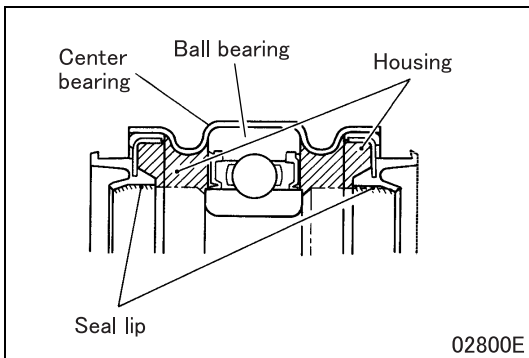
#### ■ Inspection: Center bearing

- Check at every 50,000 km {31070 mile} or each official vehicle inspection. If excessive grease outflow is evident, pack grease in center bearing housing up to 70 to 100% (20 to 29 g {0.71 to 1.02 oz.}) of space capacity.
- Apply grease to seal lips.

- The ball bearing portion of center bearing is provided with oil seal and requires no supply of grease.

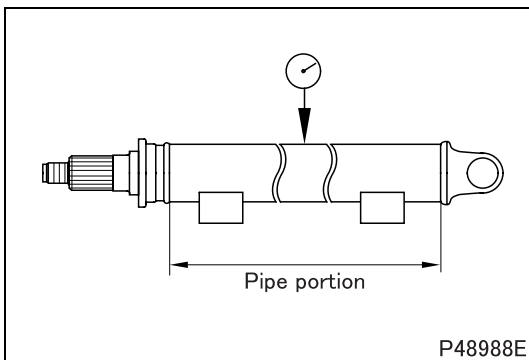
#### ■ Inspection: Bend of propeller shaft

- Measure end of propeller shaft at the center of its pipe portion.
- If the measurement is higher than the limit, correct the bend with a press or replace propeller shaft.

- To measure the bend of propeller shaft, turn it fully once and read the dial gauge indicator. The bend is one half of the indicated value.
- Check propeller shaft for cracks in welded area after correcting the bend with a press. If cracking is found, replace propeller shaft.

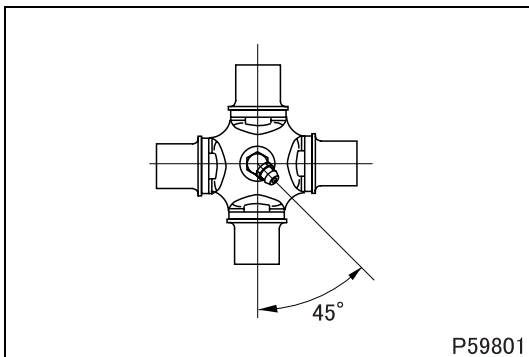
#### ■ Inspection: Grease nipple

- Install the grease nipple on the spider at an angle conforming to the indication in the illustration.

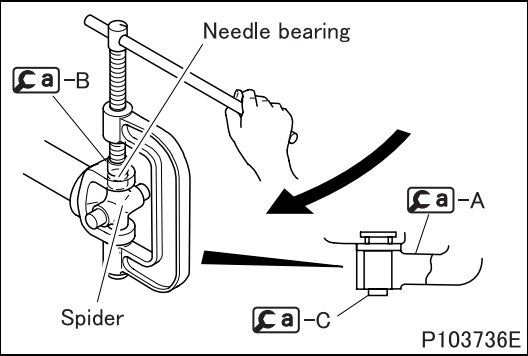
## ■ Installation: Needle bearing

- Fit Ca-C into Ca-A from inside.
- Operating Ca-A, install needle bearing into place.

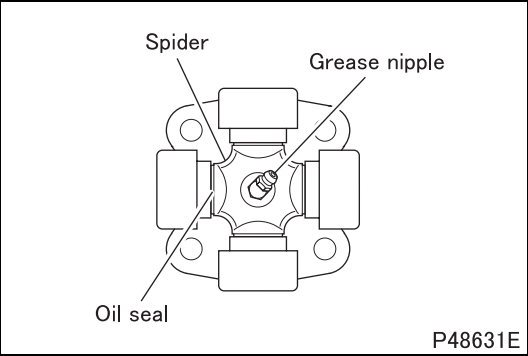
## ■ Lubrication: Grease nipple

- Fill grease through grease nipple until grease overflows from oil seal of spider.

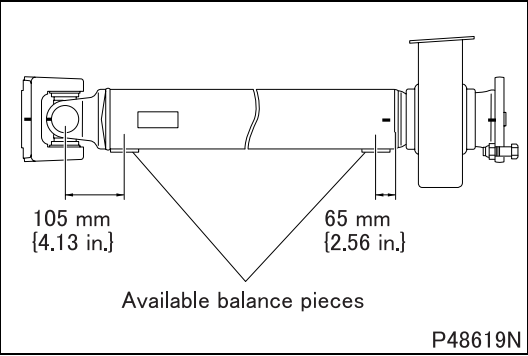
## ■ Inspection: Propeller shaft

- Attach appropriate balance pieces at the illustrated points so that the amount of unbalance comes within the standard value.
- Maximum balance piece allowance for one point is 100 g {3.53 oz.}.
- Use a combination that keeps the number of balance pieces to a minimum.

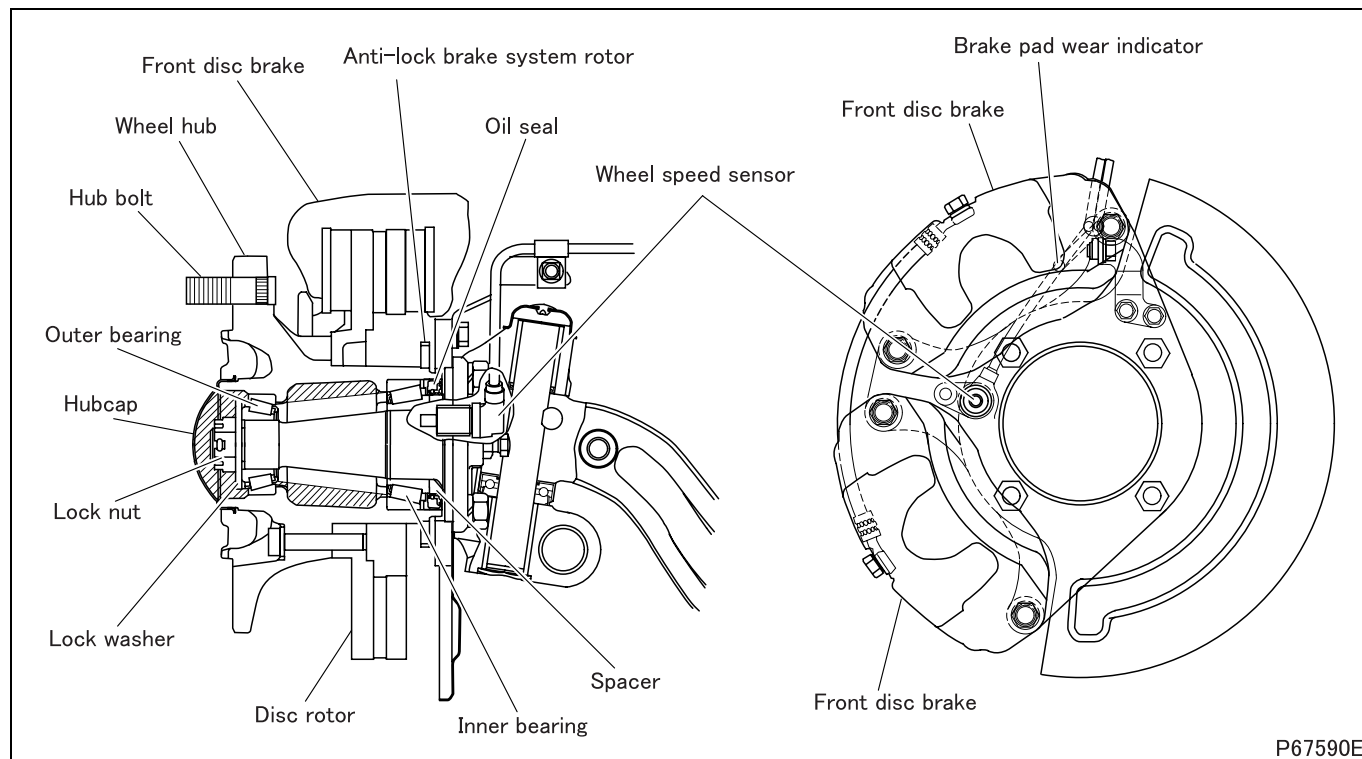
## 1. Wheel Hub and Rotor

- The brake pad wear indicator is installed on the right wheels or on both the right and left wheels.

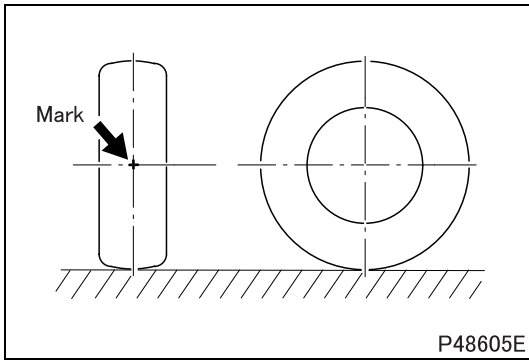
## 1.1 Inspection and adjustment of toe-in

- Direct the front wheels exactly to forward running position.
- Put a mark to each tire of right and left at the height of front wheel axis and in the middle of tire width.

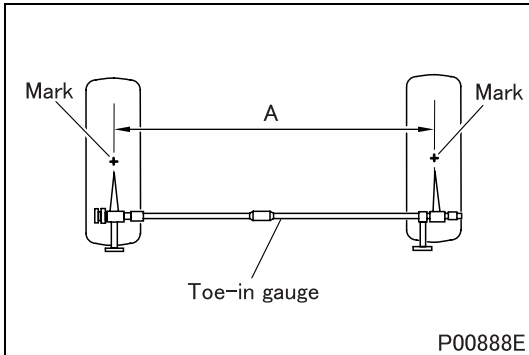
- Align the two points of the toe-in gauge with respective marks and measure distance A between the marks.

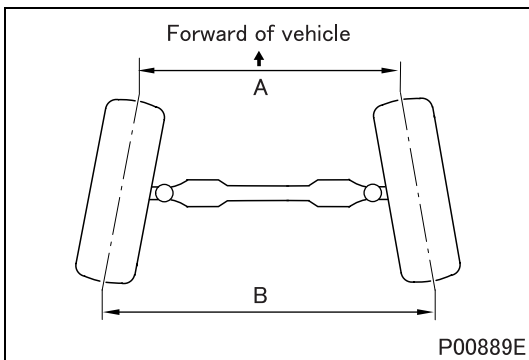
- Push the vehicle to roll the tires 180 degrees.
- Measure distance B between the marks that have moved to the rear of the vehicle.
- If toe-in (difference between A and B) deviates from the standard value, adjust.

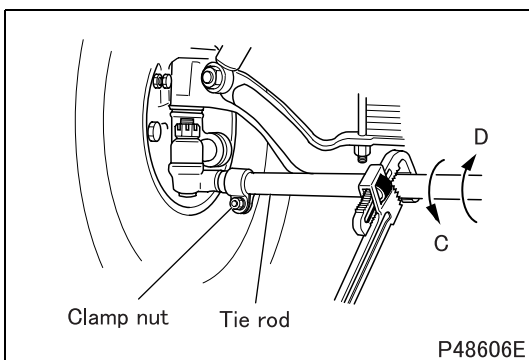
- Loosen the clamp nuts on the right and left.
- Turn the tie rod with a pipe wrench to adjust the toe-in.  
C: When adjusting to the toe-out direction  
D: When adjusting to the toe-in direction
- After adjustment, tighten the clamp nut to the specified torque.

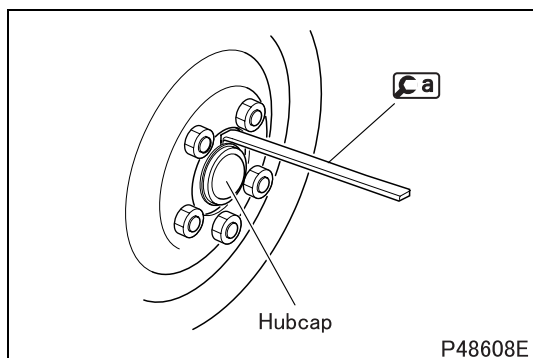
## 1.2 Inspection of camber

- Direct the front wheels exactly to forward running position.
- Remove the hubcap using **a**.

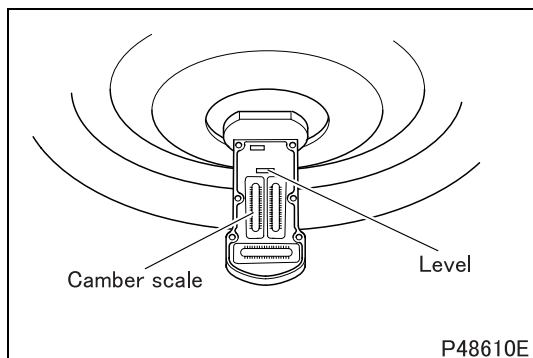
- Wipe off grease from the knuckle end, attach **b** and tighten it to the specified torque.
- Attach the camber/caster/kingpin gauge.
- Place the level in order to have bubble stay in the middle.
- Read center of bubble on camber scale to find the camber. Do the same way for the right and left front tires.
- If the measured value deviates from the standard value, disassemble the front axle for service.

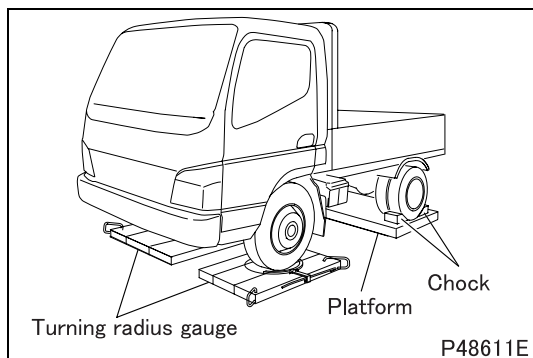
## 1.3 Inspection of caster and kingpin inclination angle

- Prepare a platform with the same height as the turning radius gauge and place it under the rear wheels so that the vehicle may be placed level.
- Apply chocks to the rear wheels.
- Keep the turning radius gauge locked.
- Jack up the vehicle, and set the right and left front wheels so that respective ground contact area centers of two wheels and turn table centers may meet.

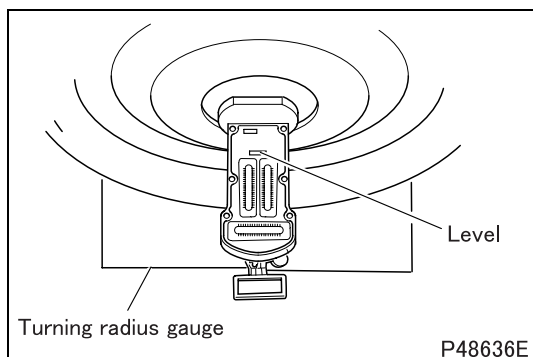
- Unfasten locking of the turning radius gauge, and set the scale to 0 degrees.
- In the same manner as in case of measuring camber in Section 1.2, attach the camber/caster/kingpin gauge, and set the level so that the bubble comes in the middle.

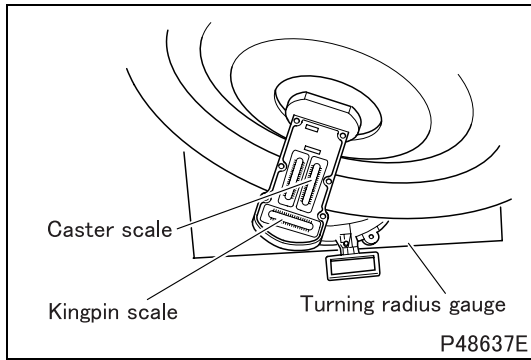
- Apply brake, and with brake applied to the front wheels, turn steering wheel slowly from the point of 0 degrees on the turning radius gauge, until the direction is changed by 20 degrees each to the right side in case of the right front wheel and to the left in case of the left front wheel.

- **Pay attention to the kingpin scale because it has scales for right and left: align the right kingpin scale in case of the right front wheel, and left kingpin scale in case of the left front wheel.**

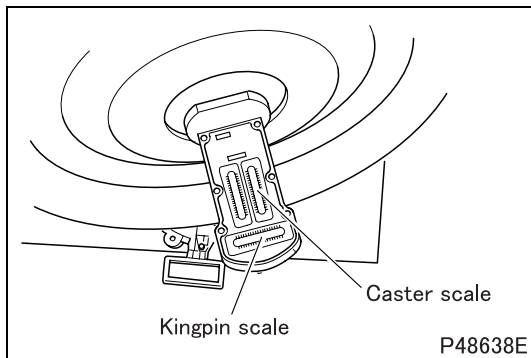
- Reverse this position, turn the steering wheel slowly until the direction of the front wheels changes by 20 degrees in the opposite direction.
- Read the center of bubbles at this position at the caster scale and kingpin scale to find caster and kingpin inclination angles.
- If the measured value deviates from the standard value, disassemble the front axle for service.

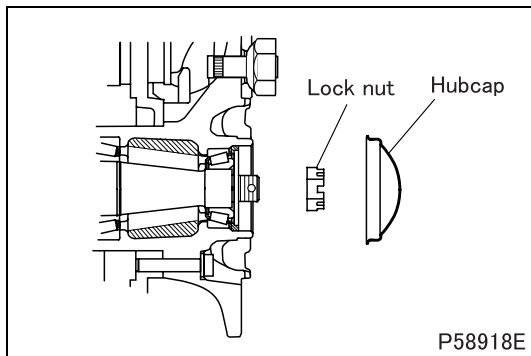
- After inspection, install the lock nut and measure the starting torque of the wheel hub bearing. If the starting torque deviates from the standard value, check the wheel bearings and perform expedient adjustment.
- Fill the specified amount of grease into wheel hub by using nozzle so that the outer bearing is covered with the grease and then install a new hubcap.

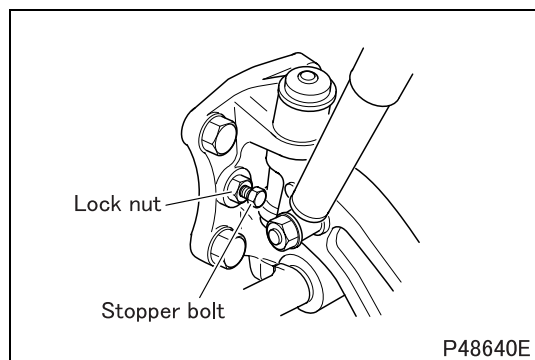
- Set the turning radius gauge and a platform on the vehicle in the same manner as in case of caster and kingpin inclination angle measurement performed in Section 1.3.
- Turn the steering wheel right or left completely from the position where the turning radius gauge is set to 0 degrees, and read the scale of the turning radius gauge to measure the steering angle.
- If the measured value deviates from the standard value, adjust with the knuckle stopper bolt and tighten the lock nut to the specified torque.

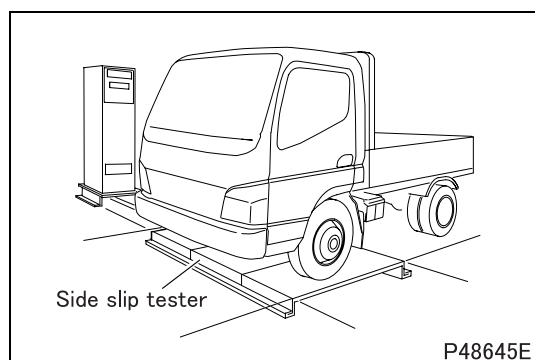
- Set the front wheels exactly to forward running position.
- Move the vehicle forward past the side slip tester as slowly as possible to inspect side slip.

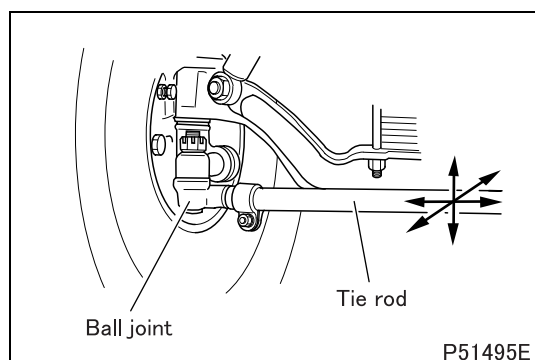
#### (1) Play of tie rod end ball joint

- Hold the tie rod section of the tie rod with the vehicle kept stationary, and move it in the back-and-forth, up-and-down and right-and-left directions to check for play at ball joints of the tie rod end.

- If feeling play with your hand, replace the tie rod end of the tie rod.

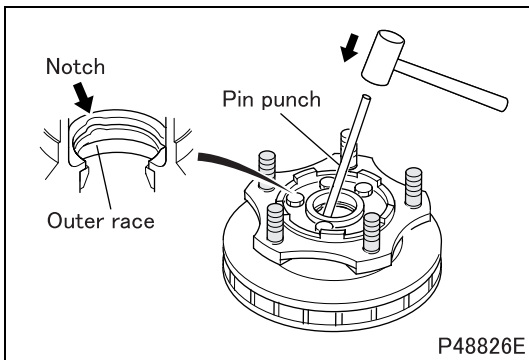
### ■ Removal: Inner bearing outer race

- Drive out the inner bearing outer race by tapping evenly at three indented parts in the wheel hub.

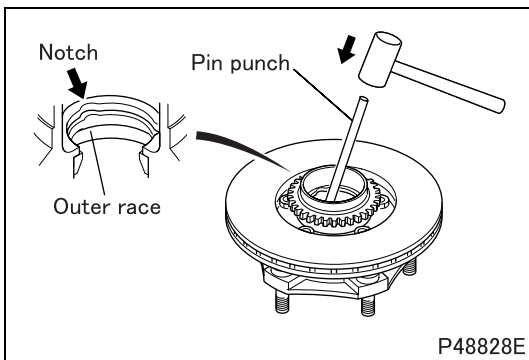
### ■ Removal: Outer bearing outer race

- Drive out the outer bearing outer race by tapping evenly at three indented parts in the wheel hub.

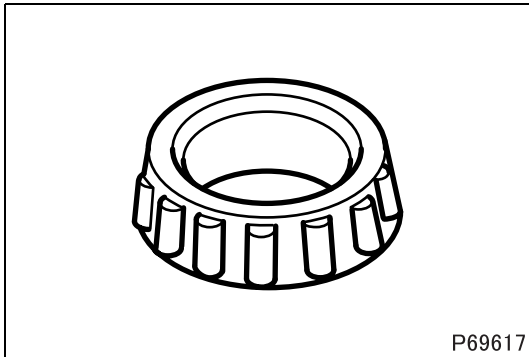
### ■ Inspection: Outer bearing inner race

- Inspect the outer bearing inner race after cleaning the bearing to remove grease completely.
- If any damage, wear, or poor rotating condition is evident in the inner race, replace it with a new one.
- The inner race and outer race should be replaced as a set.

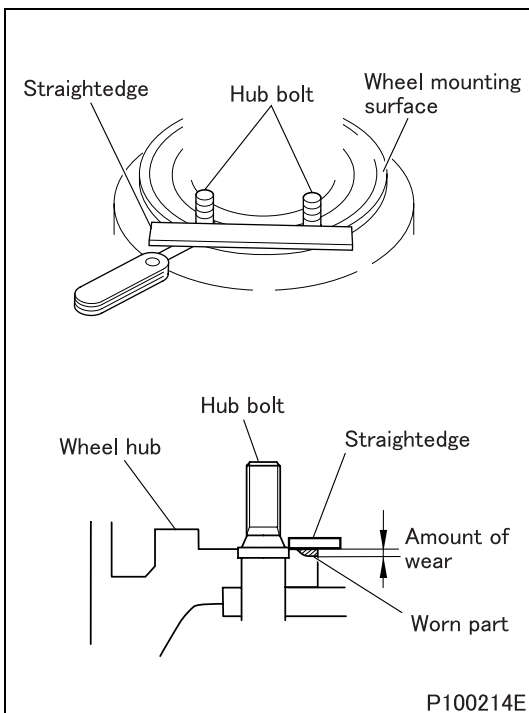
### ■ Inspection: Wheel hub

- Check the disc wheel mounting surface of the wheel hub by watching and touching. If there is damage or crack on it, replace the wheel hub.
- Make sure that there is not rust, dust, paint or foreign body on the disc wheel mounting surface of the wheel hub to prevent the wheel nut to loosen.
- If any abnormality is found, remove it with sandpaper.

- Using feeler gauges to measure the amount of wear at the outer periphery of the wheel hub.  
Measure the amount of wear in the area of every hub bolt.
- If the amount of wear at any point exceeds the following standard value, inspect the crack check of wheel hub.  
Wear standard value: 0.8 mm

- Check if there is not crack on the entire rounded corner on the root of flange of the wheel hub by magnetic particle or liquid penetrant testing. If crack is found, replace the wheel hub.
- If crack is found on the wheel hub bolt, replace it.
- If there is crack or stepped wear on the wheel hub mounting surface of wheel disc, replace it. (See Gr31.)

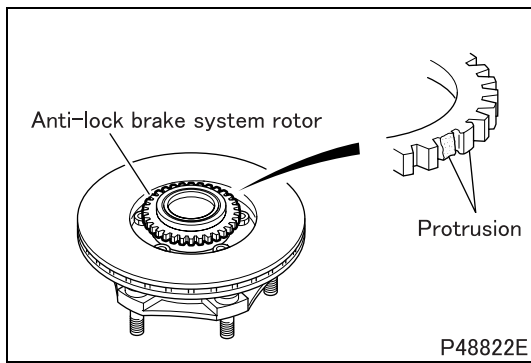
### ■ Inspection: Anti-lock brake system rotor

- Check protrusions of the anti-lock brake system rotor for chipping and flattening.
- If any abnormality is found, replace the anti-lock brake system rotor.

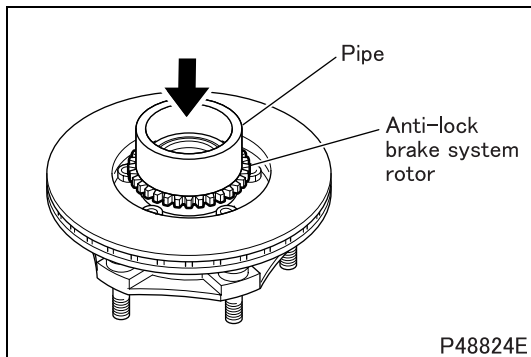
#### [Installation]

- Warm the anti-lock brake system rotor to approximately 150°C.
- Install the anti-lock brake system rotor and wheel hub evenly using a pipe so as not to allow them to tilt.

- Handling the warmed rotor by bare hands may burn.

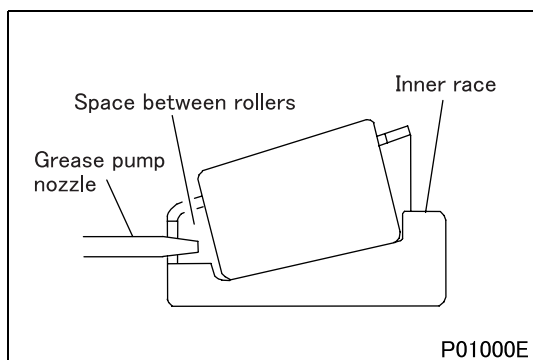
### ■ Installation: Packing grease in inner bearing inner race

- Insert the grease pump nozzle into the space between rollers of the inner bearing inner race to pack grease sufficiently.

- Follow the same procedure as for packing the inner bearing inner race with grease.  
(See “■ Installation: Packing grease in inner bearing inner race”.)

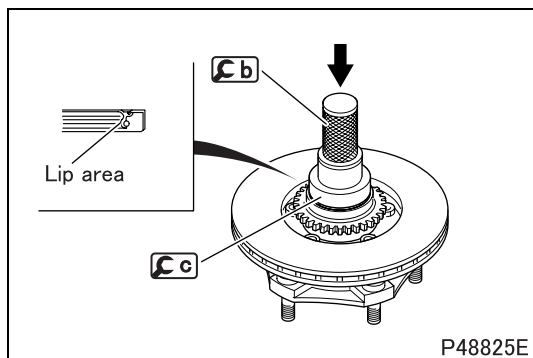
### ■ Installation: Oil seal

- Apply grease to the lip area of the oil seal and install it on the wheel hub in the illustrated direction.

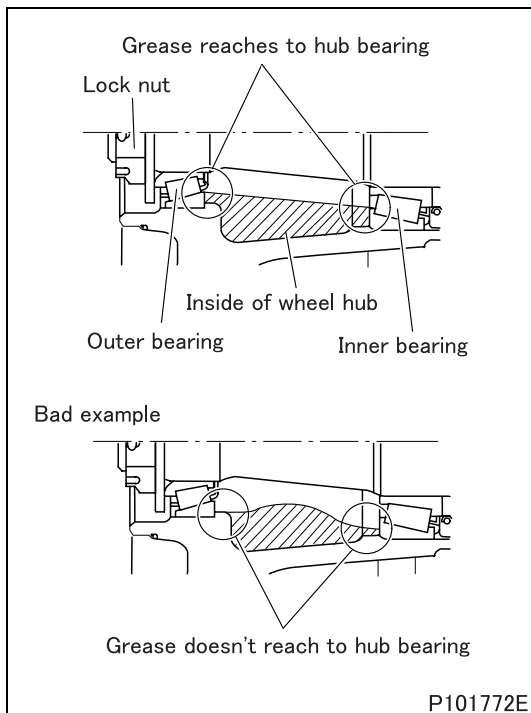
#### ■ Installation: Packing grease inside of wheel hub

- Apply specified amount of grease to inside A of wheel hub so that the grease reaches inner bearing and outer bearing as illustrated.
- After installing lock nut, insert grease pump nozzle into outside B of wheel hub and fill specified amount of grease so as to make a grease wall outside of the outer bearing.

- Applying grease as illustrated in the “bad example” causes the wheel hub bearing to seize.

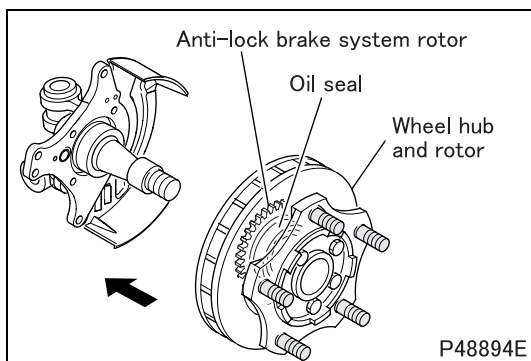
#### ■ Installation: Wheel hub and rotor

- Slowly install the wheel hub and rotor assembly so as not to cause damage to the oil seal and anti-lock brake system rotor.

- If the anti-lock brake system rotor is damaged, wheel speed sensor signals become abnormal, causing the anti-lock brake system to malfunction.
