# FE.FG

## SERVICE MANUAL 2008 Model FOREWORD

This Service Manual contains maintenance and repair methods for the Mitsubishi Fuso Truck FE. FG Series. Read this manual carefully as an aid in providing correct, efficient maintenance. Please note that the information and specifications contained within this manual may change without notice. This is due to product modifications and continued vehicle improvements that are made throughout the model years. Should you encounter any discrepancy in the information provided, please do not hesitate to contact your nearest Mitsubishi Fuso Dealer or Mitsubishi Fuso Truck of America, Inc.

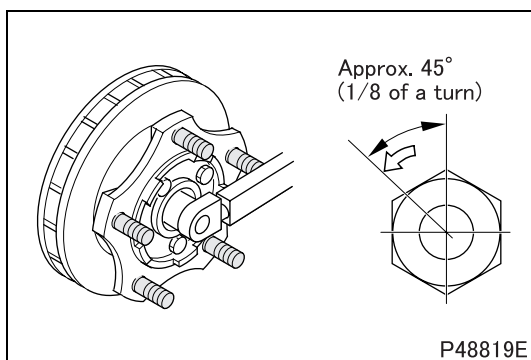
#### ■ Adjustment: Starting torque of wheel hub bearing

- Tighten the lock nut to the specified torque (primary tightening) while turning the wheel hub and rotor, and then loosen it completely.
- Smooth operation of the outer bearing and inner bearing by turning the wheel hub and rotor several times, and then tighten the lock nut to the specified torque (secondary tightening).
- Return the lock nut by approximately 45 degrees (1/8 of a turn) and secure it with a split pin. If pin holes do not align, align them in the course of loosening. Make sure that there is no play in the axial direction.

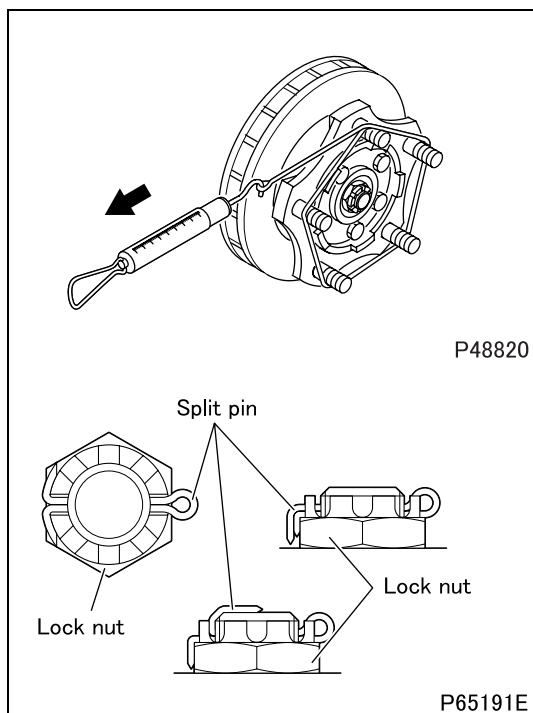
- After installing the lock nut, perform the following inspection.
- Measure the tangential force at the hub bolt position using a spring balance.
- If the tangential force is within the specified value, the starting torque conforms to the standard value. When the measured value is the specified value, install the split pin following either of method in the illustration.
- If the measured value deviates from the specified value, repeat adjustment because the adjustment of the lock nut may be insufficient.
- If the result is found to be abnormal, replace the outer and inner bearings.

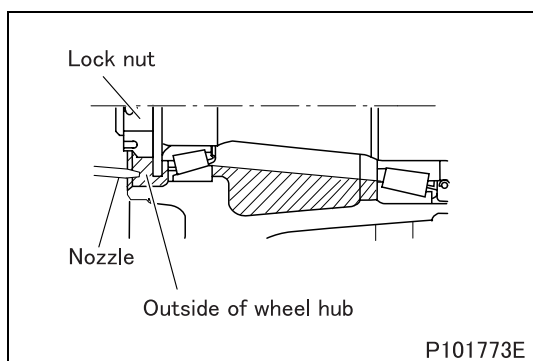
## ■ Installation: Packing grease outside of wheel hub

- After installing lock nut, insert grease pump nozzle into outside of wheel hub and fill specified amount of grease so as to make a grease wall outside of the outer bearing.

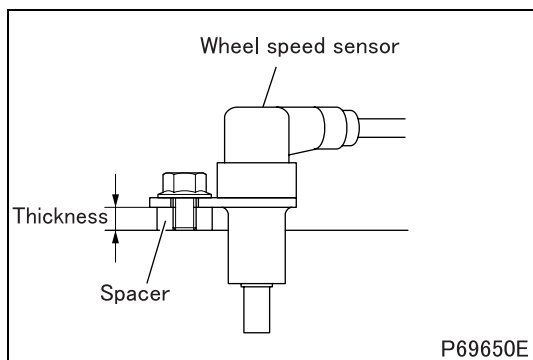
## ■ Installation: Spacer

- Install a spacer and wheel speed sensor in the position shown in the illustration.  
Thickness of spacer: 16.0 mm <FE (Except FE85)>  
14.5 mm <FE85>

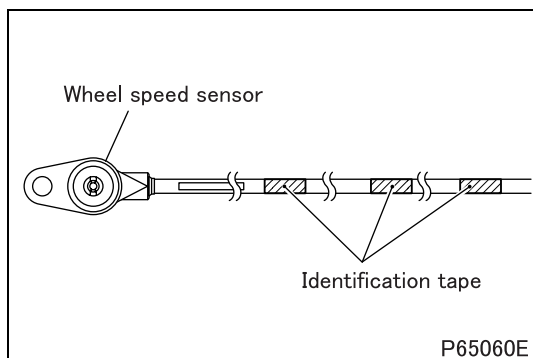
## ■ Installation: Wheel speed sensor

- Using clips, secure in place the wheel speed sensor harness at the identification tape portions, ensuring that the harness is free of kinks, slack and/or interference with other parts.

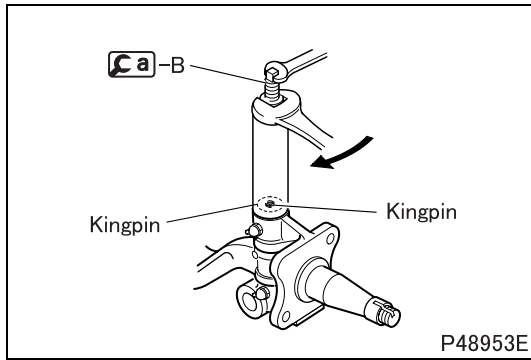
### ■ Removal: Kingpin

- Screw **Ca**-B into the kingpin threads to remove the kingpin.

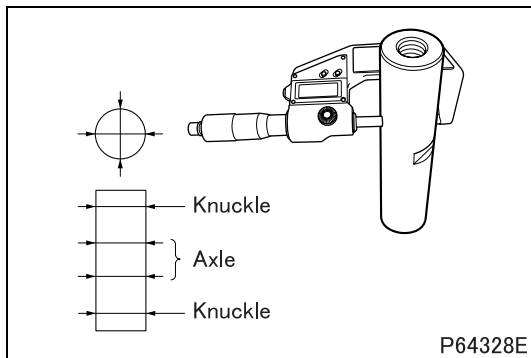
### ■ Inspection: Outer diameter of kingpin

- Take measurement at a total of four levels on the kingpin: two levels for the axle fitting portion and one level each for the upper and lower knuckle fitting portions.
- If the measured value is under the limit, replace the kingpin with a new one.

| Location | Maintenance item | | Standard value | Limit | Remedy |
|---|---|---|---|---|---|
| 7 | Outer diameter of kingpin | | 27.947 to 27.980<br>{1.100 to 1.102} | 27.9<br>{1.098} | Replace |

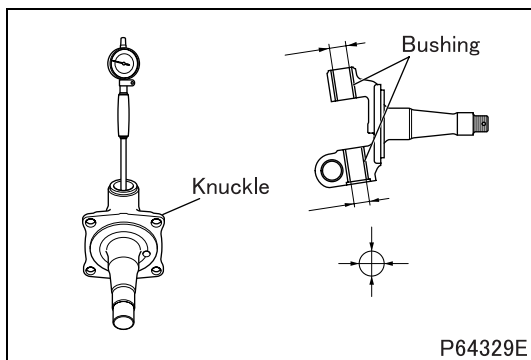
### ■ Inspection: Clearance between kingpin and bushing

- Measure the inner diameter of the upper and lower bushings using a cylinder gauge and calculate the clearance deducting the outer diameter of the kingpin from the inner diameter of the bushing.  
If the clearance exceeds the limit, replace the bushings with new ones.

| Location | Maintenance item | | Standard value | Limit | Remedy |
|---|---|---|---|---|---|
| 7, 11 | Clearance between kingpin and bushing | | 0.020 to 0.086<br>{0.00079 to 0.0034} | 0.15<br>{0.0059} | Replace |

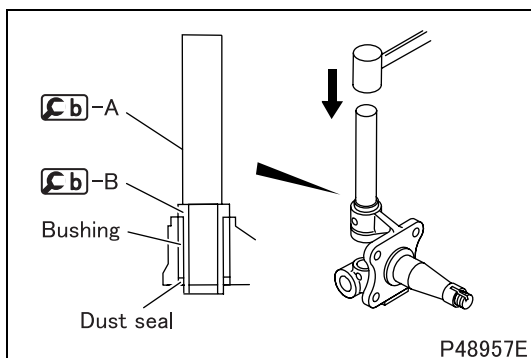
### Replacement of bushing

- Remove the bushing and the dust seal at the same time using **Cb**.

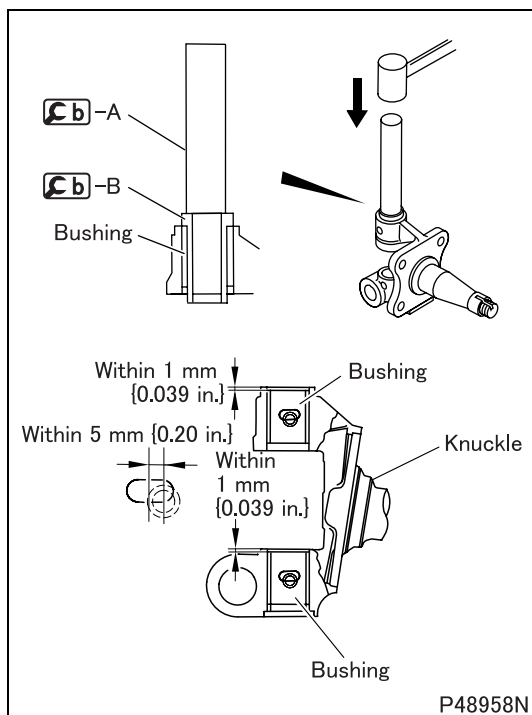
- Install the bushing using

so that a step height between the bushing and knuckle is within 1 mm {0.039 in.}.
- The oil hole of the bushing must not deviate from the screw hole of the knuckle more than 5 mm {0.20 in.}.

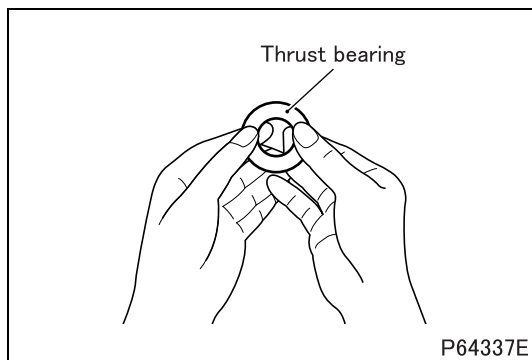
- Inspect the aspect and smooth turning of the thrust bearing. If any crack, damage, or un-smooth turning is found, replace the thrust bearing with a new one.

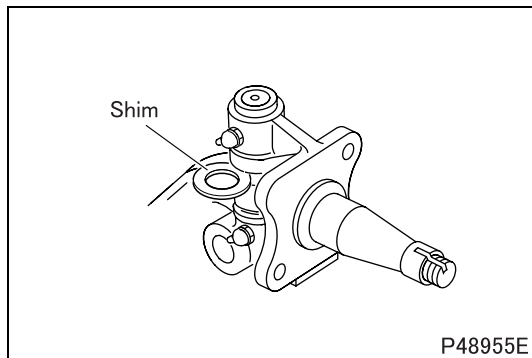
## ■ Installation: Knuckle

- After temporarily assembling the thrust bearing, knuckle and kingpin into the front axle, move the knuckle several times to smooth its operation.
- Measure clearance between the front axle top face and the knuckle bottom.

- If the measured value exceeds the limit, adjust with a kingpin shim.  
Thickness of kingpin shims available  
0.10, 0.15, 0.20, 0.30, 0.40, 0.50, 0.60, 0.70 mm  
{0.0039, 0.0059, 0.0079, 0.012, 0.016, 0.020, 0.023, 0.028 in.}  
(Eight thickness)

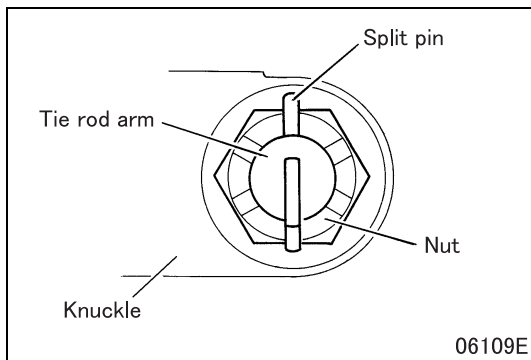
- Polish the entire tapered surfaces of the tie rod arm and knuckle evenly by means of sand paper #120 or above until sand paper score is visible on polished surfaces. (This does not apply to new replacement parts.)
- Clean the tapered surfaces and thread areas of the tie rod arm and knuckle.

- Apply grease to the thread area of the tie rod arm and install it.

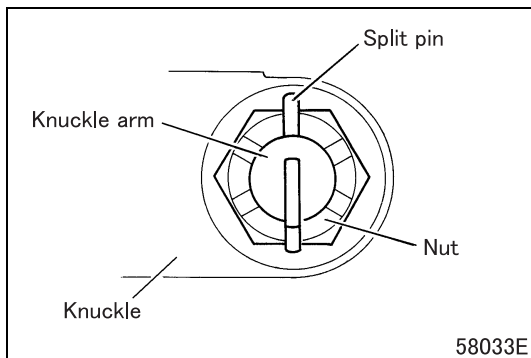
- Clean tapered surfaces and thread areas of the knuckle arm and knuckle.
- Tighten the nut to the specified torque. Be sure to align pin holes in the course of tightening and insert the split pin as illustrated.

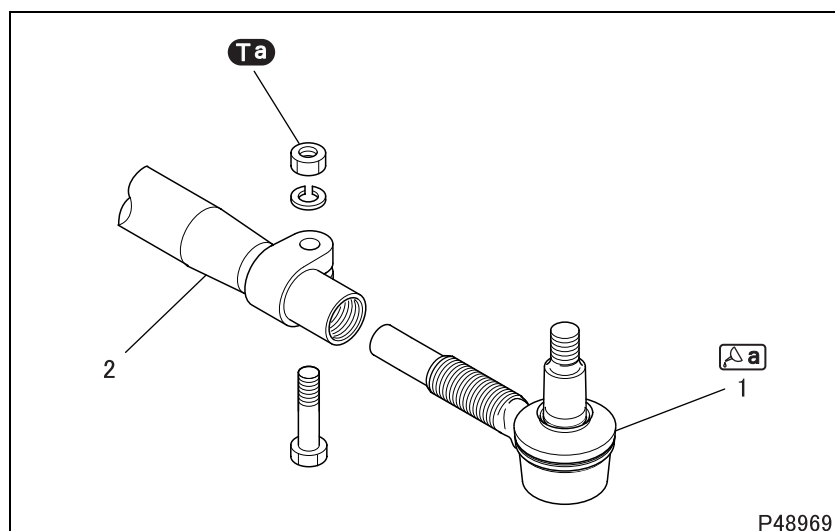
# TIE ROD

- 1 Tie rod end
- 2 Tie rod

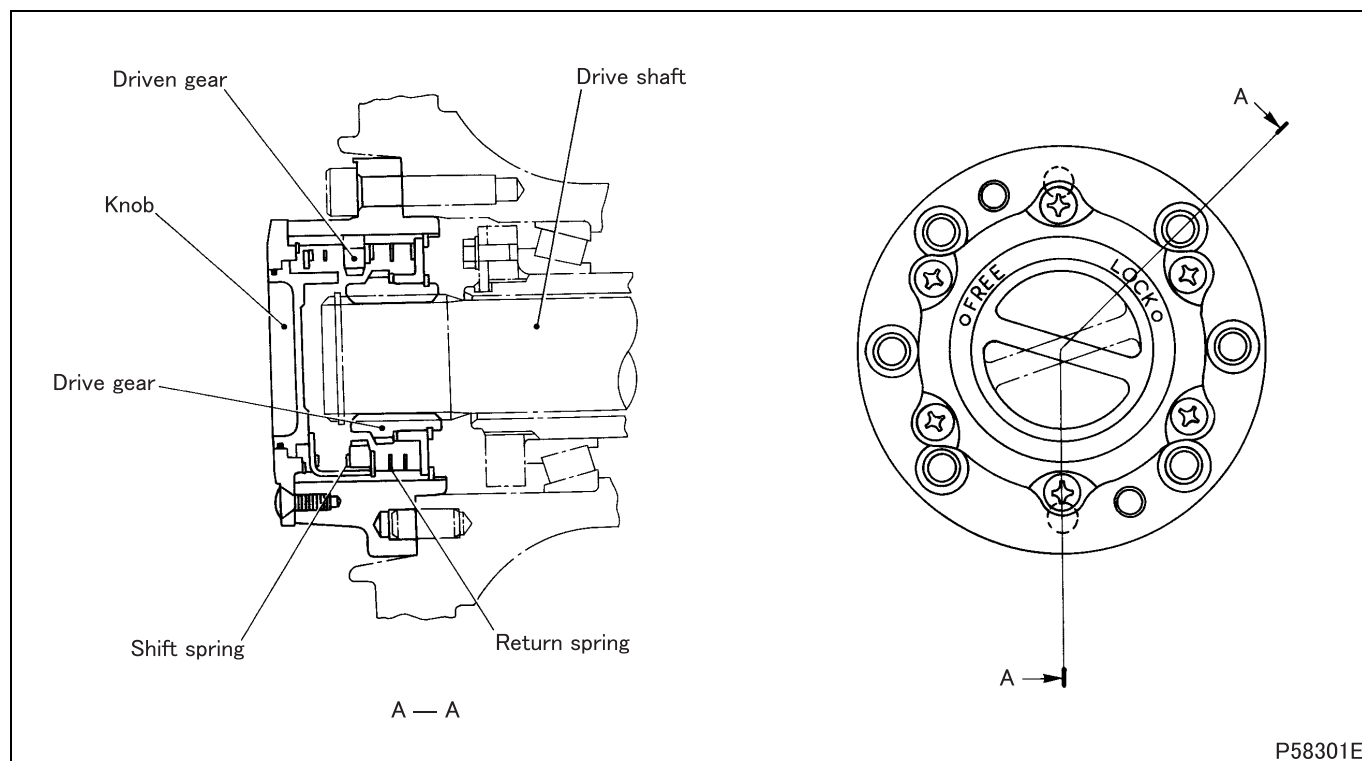
## 2. Free Wheel Hub

- In the case of a four-wheel drive vehicle, even when it is running in rear-wheel drive only, the drive shaft, differential, propeller shaft, and driving parts of the transfer front drive shaft continue to run due to transmission of rotation from the wheels. This subjects the vehicle drive to a load, and it causes loss of driving power. Now, with a free wheel hub, transmission of rotation from the front wheels to the drive shaft is cut, reducing driving loss when running in rear-wheel drive only. This improves fuel efficiency and reduces vibration and noise.
- With a free wheel hub, FREE (cutting of driving power) ↔ LOCK (transmission of driving power) is made easily by manual operation.

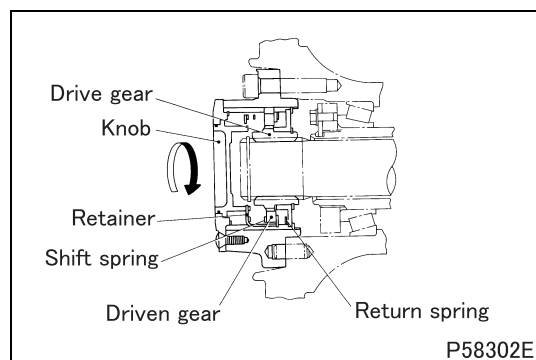
#### ● From FREE to LOCK

When knob is turned to LOCK, retainer shifts to the inside along with the shape of the knob, pressing return spring. At this instance, driven gear, being pressed by shift spring, engages with drive gear at the spline, and transmits the driving power.

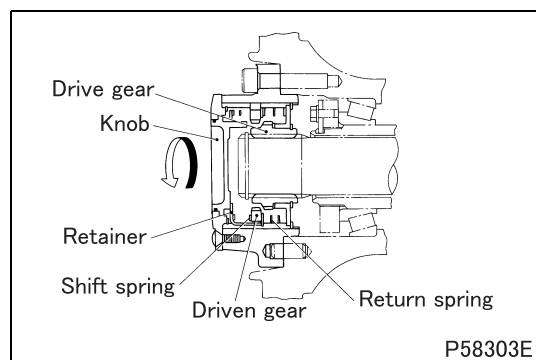
#### ● From LOCK to FREE

When knob is turned to FREE, the action is the reverse of FREE to LOCK, and the driving power is disengaged.

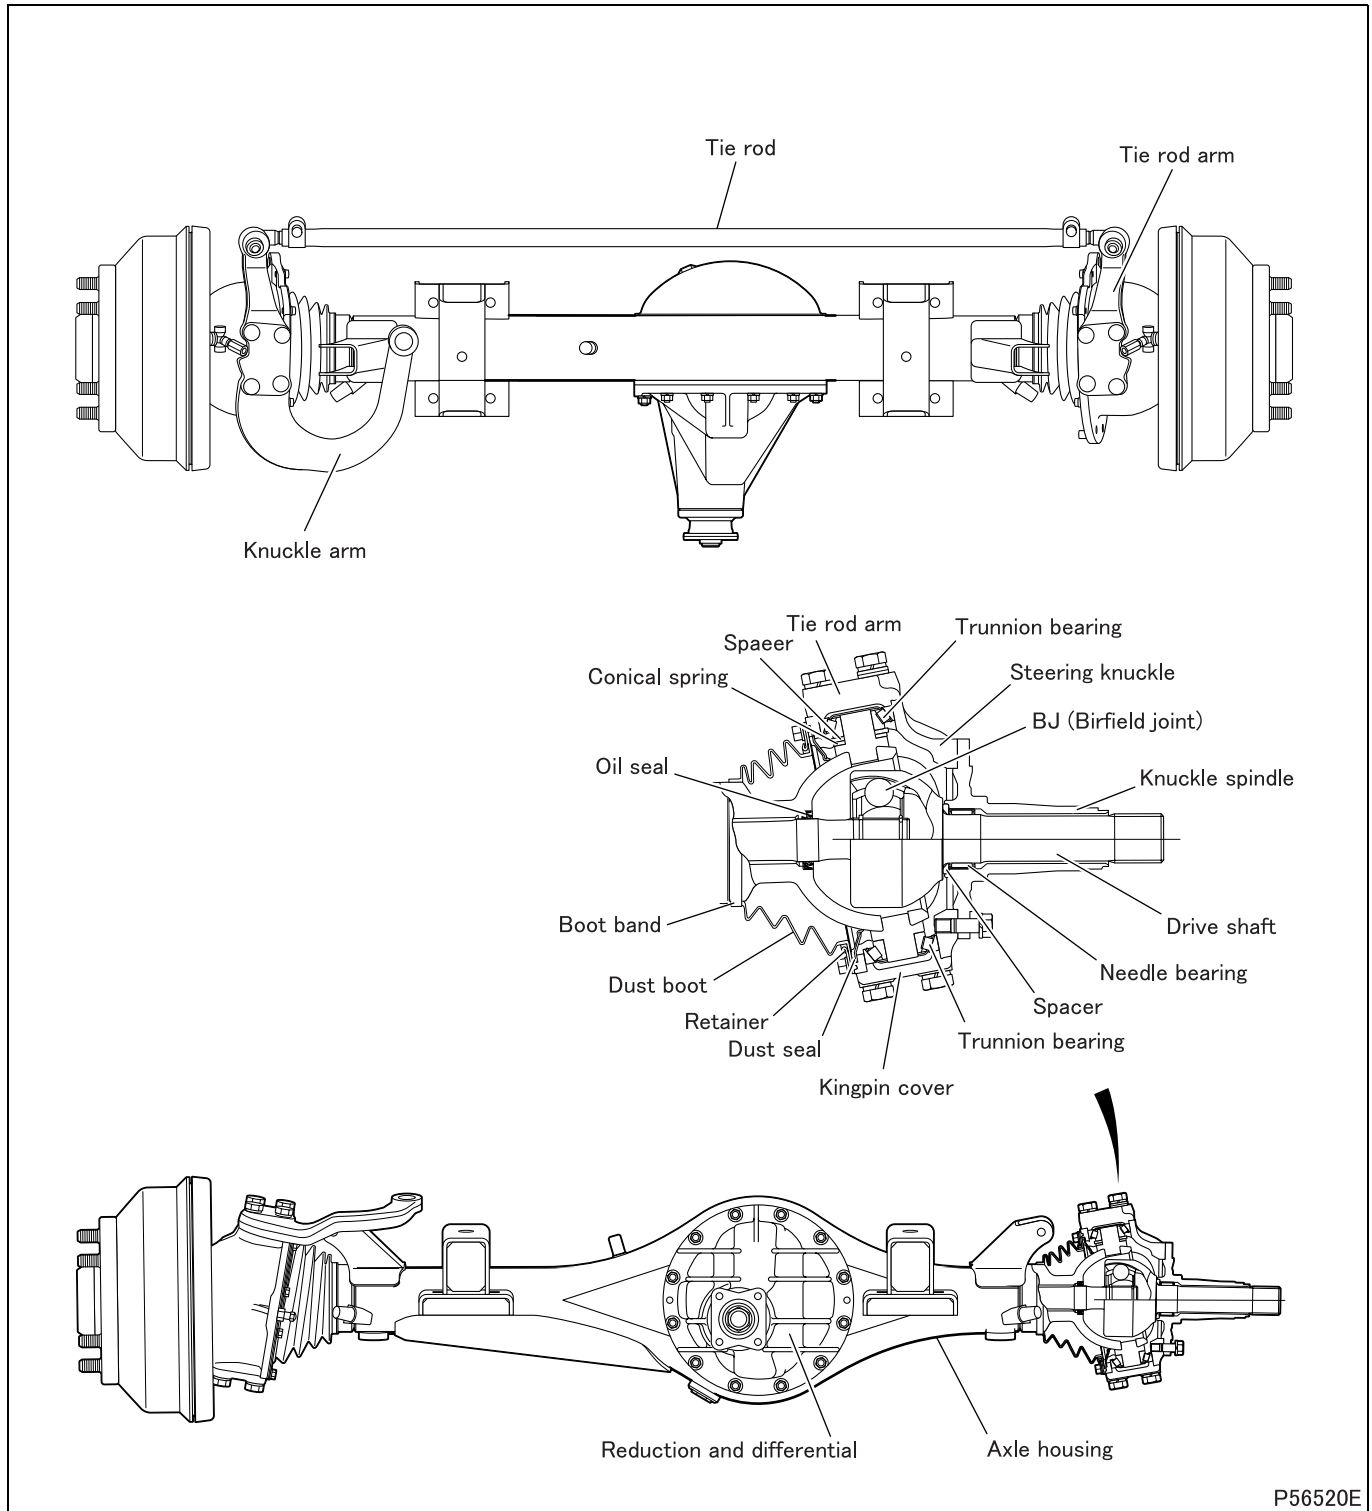
## 3. Drive Shaft and Steering Knuckle, Axle Housing

- The drive shaft must transfer power according to rotation speed fluctuations caused by change of steering angle when a vehicle is steered. Therefore, a constant velocity universal joint, which eliminates rotation speed fluctuations between the drive shaft and the driven shaft and transfers power evenly, is used for the Birfield joint of the drive shaft.

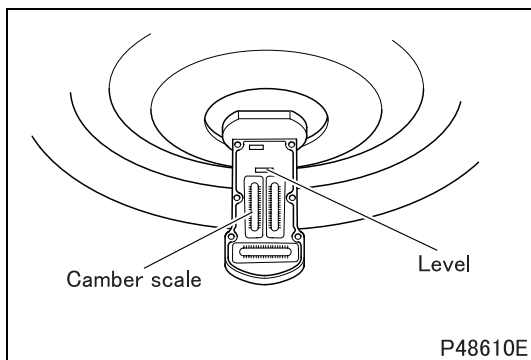
## 1.2 Inspection of camber

- Direct the front wheels exactly to forward running position.
- Remove the free wheel hub.
- Install **Ca** on the drive shaft tip.
- Install the camber/caster/kingpin gauge.

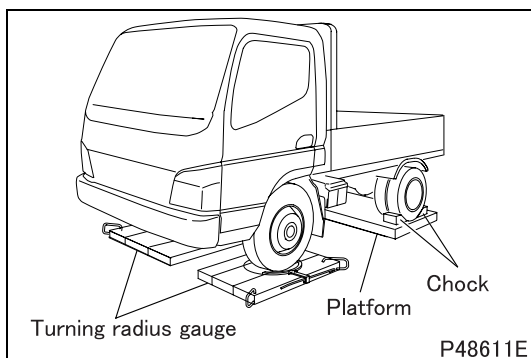
- Place the level in order to have bubble stay in the middle.
- Read center of bubble on camber scale to find the camber. Do the same way for the right and left front tires.
- If the measured value deviates from the standard value, disassemble the front axle for service.

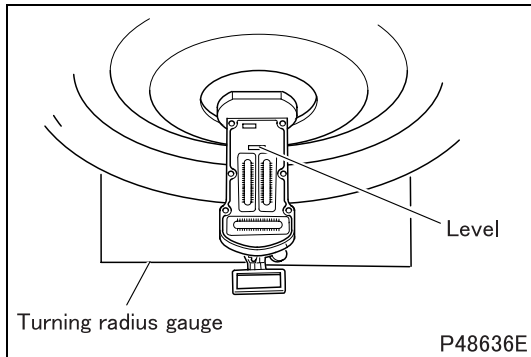
## 1.3 Inspection of caster and kingpin inclination angle

- Prepare a platform with the same height as the turning radius gauge and place it under the rear wheels so that the vehicle may be placed level.
- Apply chocks to the rear wheels.
- Keep the turning radius gauge locked.
- Jack up the vehicle, and set the right and left front wheels so that respective ground contact area centers of two wheels and turntable centers may meet.

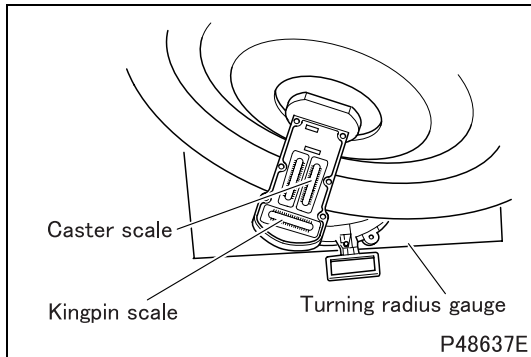
- Unfasten locking of the turning radius gauge, and set the scale to 0 degrees.
- In the same manner as in case of measuring camber in Section 1.2, attach the camber/caster/kingpin gauge, and set the level so that the bubble comes in the middle.

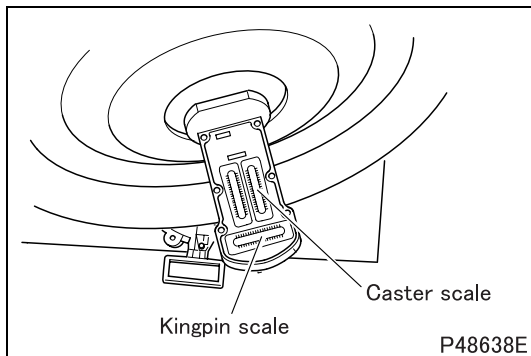
- Apply brake, and with brake applied to the front wheels, turn steering wheel slowly from the point of 0 degrees on the turning radius gauge, until the direction is changed by 20 degrees each to the right side in case of the right front wheel and to the left in case of the left front wheel.

- **Pay attention to the kingpin scale because it has scales for right and left: align the right kingpin scale in case of the right front wheel, and left kingpin scale in case of the left front wheel.**

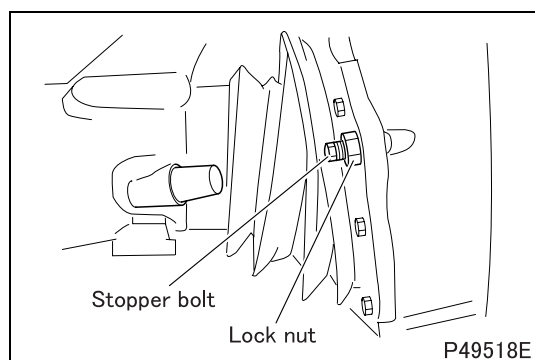
- Set the turning radius gauge and a platform on the vehicle in the same manner as in case of caster and kingpin inclination angle measurement performed in Section 1.3.
- Turn the steering wheel right or left completely from the position where the turning radius gauge is set to 0 degrees, and measure the steering angle, reading the scale of the turning radius gauge.
- If the measured value deviates from the standard value, adjust with the knuckle stopper bolt and tighten the lock nut to the specified torque.

| Mark | Parts to be tightened | Tightening torque | Remarks |
|---|---|---|---|
| – | Lock nut (knuckle stopper bolt tightening) | $96 \pm 12$ { $71 \pm 9$ , $9.75 \pm 1.25$ } | – |

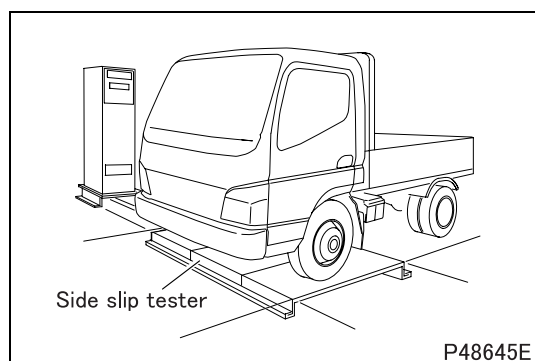
## 3. Inspection of Side Slip

- Set the front wheels exactly to forward running position.
- Move the vehicle forward past the side slip tester as slowly as possible to inspect side slip.

- Pay attention to the following when moving over the side slip tester.
  - Be sure to hold steering exactly at the forward running position, and make no turn.
  - Do not apply brake.
  - Keep the speed constant.
- If the measured value deviates from the standard value, inspect and adjust wheel alignment.

| Location | Maintenance item | Standard value | Limit | Remedy |
|---|---|---|---|---|
| – | Side slip amount (per 1 m {3.3 ft}) | 3 {0.12} or less | – | Adjust |

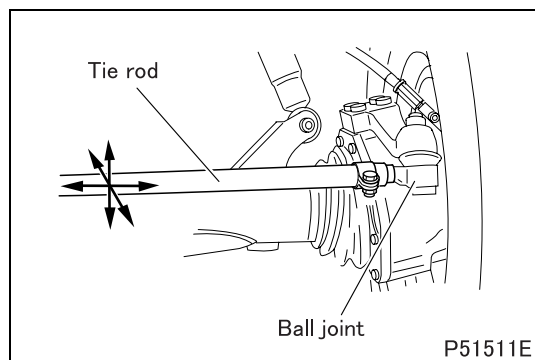
## 4. Inspection of Tie Rod End Ball Joint

- Hold the tie rod section of the tie rod with the vehicle kept stationary, and move it in the back-and-forth, up-and-down and right-and-left directions to check for play at ball joints of the tie rod end.

- If there is play, replace the tie rod end of the tie rod.

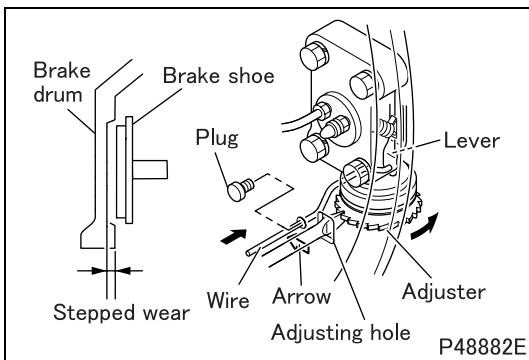
### ■ Removal: Wheel hub and brake drum

- If the brake drum has stepped wear and the wear prevents the wheel hub and brake drum from being removed, the removal can still be effected by taking the following procedure.
  - Insert a wire of approx.  $\phi 2$  mm {0.079 in.} into the hole from which the plug has been removed, and lift up the adjust lever of the wheel cylinder.
  - Turn the adjuster from the adjust hole in the opposite direction to the arrow on the backing plate to increase the clearance between the brake drum and the brake shoe. Then, remove the wheel hub and brake drum.

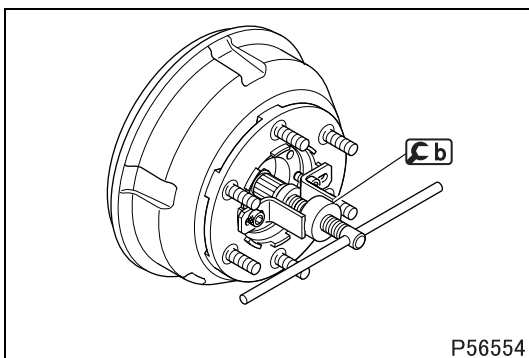
- Install **Cb** using free wheel hub mounting bolts to remove the wheel hub and brake drum.

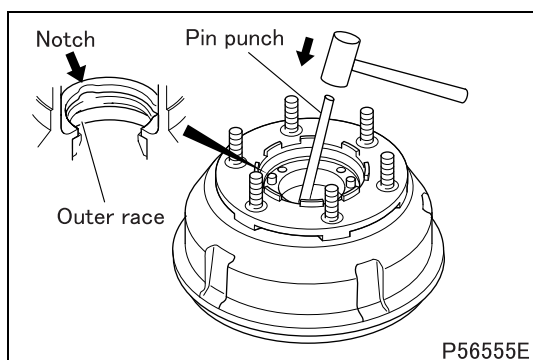
## ■ Removal: Inner bearing outer race

- Drive out the inner bearing outer race by tapping evenly at three indented parts in the wheel hub.

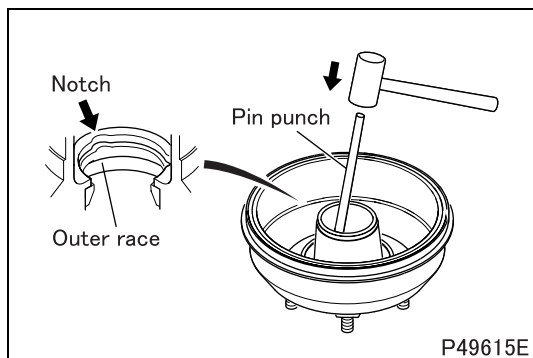
## ■ Removal: Outer bearing outer race

- Drive out the outer bearing outer race by tapping evenly at three indented parts in the wheel hub.

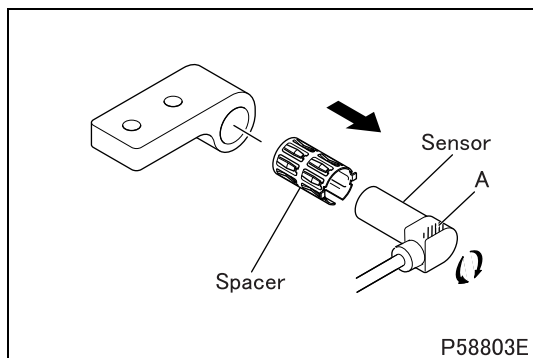
## ■ Removal: Wheel speed sensor

- Hold shaded section A of wheel speed sensor with pliers, and remove the sensor by twisting it slightly in left and right directions.

- When removing the wheel speed sensor, never apply a force to it such as tapping it with a hammer, prying it with a screwdriver and pulling the harness, as doing so causes the wire to be broken.
- If the wheel speed sensor pulls out lightly, replace the spring spacer.

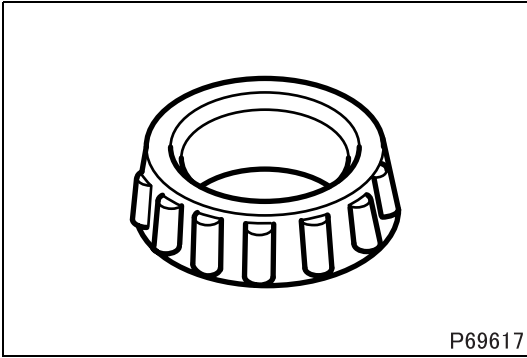
### ■ Inspection: Outer bearing inner race

- Inspect the outer bearing inner race after cleaning the bearing to remove grease completely.
- If any damage, wear, or poor rotating condition is evident in the inner race, replace it with a new one.
- The inner race and outer race should be replaced as a set.

- Inspect the inner bearing inner race in the same manner as for the outer bearing inner race.  
(See “■ Inspection: Outer bearing inner race”.)

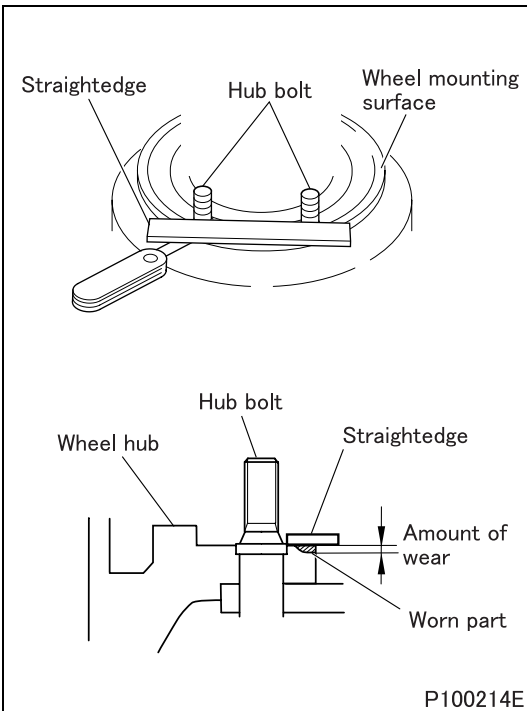
### ■ Inspection: Wheel hub

- Check the disc wheel mounting surface of the wheel hub by watching and touching. If there is damage or crack on it, replace the wheel hub.
- Make sure that there is not rust, dust, paint or foreign body on the disc wheel mounting surface of the wheel hub to prevent the wheel nut to loosen.
- If any abnormality is found, remove it with sandpaper.

- Using feeler gauges to measure the amount of wear at the outer periphery of the wheel hub.  
Measure the amount of wear in the area of every hub bolt.
- If the amount of wear at any point exceeds the following standard value, inspect the crack check of wheel hub.  
Wear standard value: 0.8 mm

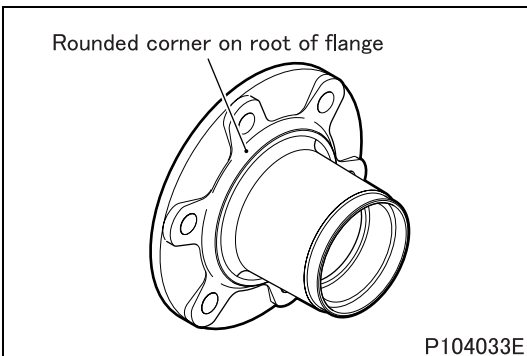
- Check if there is not crack on the entire rounded corner on the root of flange of the wheel hub by magnetic particle or liquid penetrant testing. If crack is found, replace the wheel hub.
- If crack is found on the wheel hub bolt, replace it.
- If there is crack or stepped wear on the wheel hub mounting surface of wheel disc, replace it. (See Gr31.)

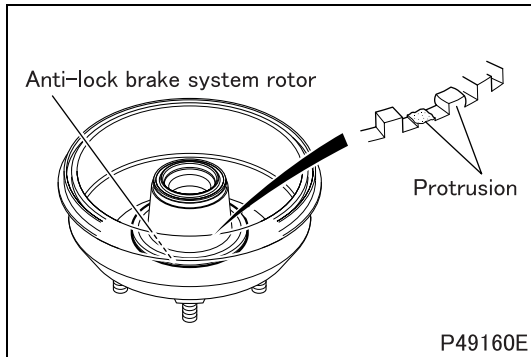
## ■ Inspection: Anti-lock brake system rotor

- Check protrusions of the anti-lock brake system rotor for chipping and flattening.
- If any abnormality is found, replace the anti-lock brake system rotor.

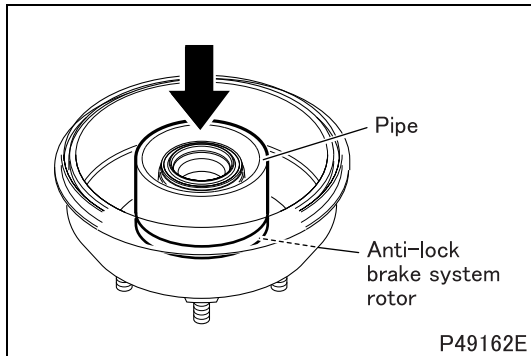
- Warm the anti-lock brake system rotor to approximately 150°C {302°F}.
- Install the anti-lock brake system rotor and wheel hub evenly using a pipe so as not to allow them to tilt.

- Handling the warmed rotor by bare hand causes scald.

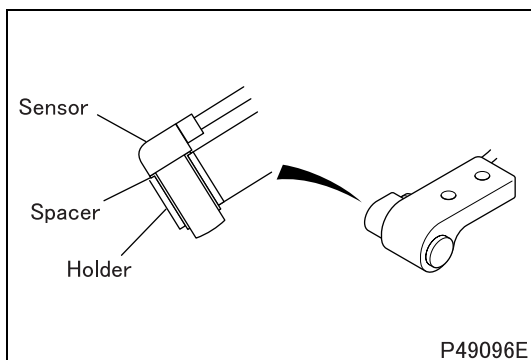
## ■ Installation: Wheel speed sensor

- Install the wheel speed sensor so that it securely contacts the sensor holder together with the spring spacer.

- When installing the wheel speed sensor, never apply a force to it such as tapping it with a hammer, prying it with a screwdriver and pulling the harness, as doing so causes the wire to be broken.

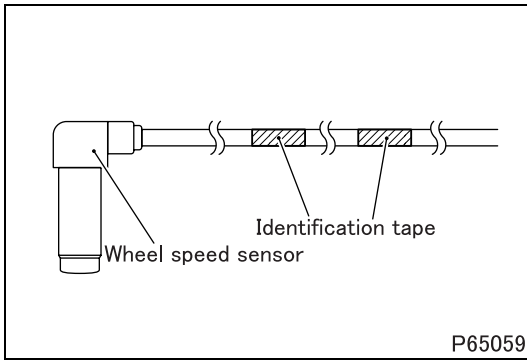
- Using clips, secure in place the wheel speed sensor harness at the identification tape portions, ensuring that the harness is free of kinks, slack and/or interference with other parts.

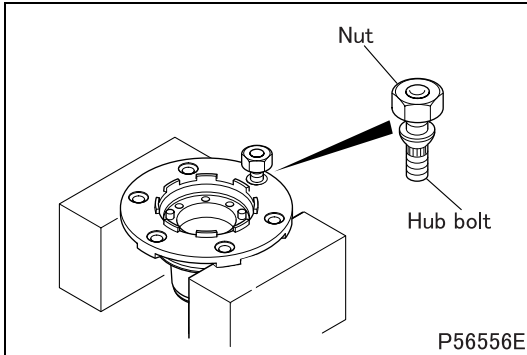
#### ■ Installation: Hub bolt

- Screw the nut into the hub bolt until just before they become flush.
- Drive the hub bolt into the wheel hub vertically by hitting the end face of the nut.

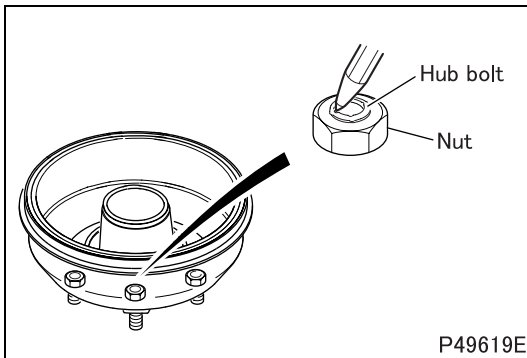
- Assemble the brake drum and wheel hub with the hub bolt. After tightening the nut to the specified torque, caulk it with a punch.

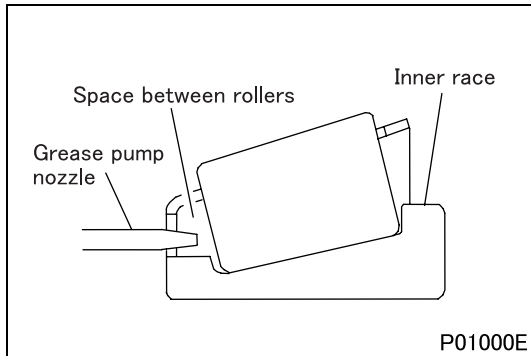
## ■ Installation: Packing grease in inner bearing inner race

- Insert the grease pump nozzle into the space between rollers of the inner bearing inner race to pack grease sufficiently.

- Follow the same procedure as for packing the inner bearing inner race with grease.

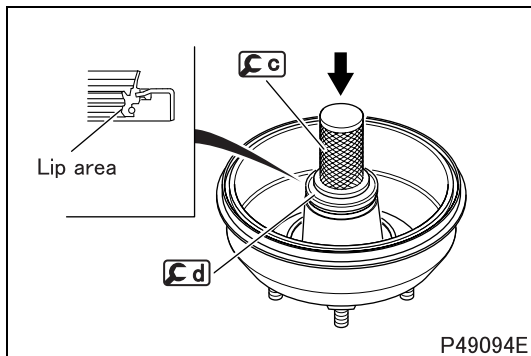
## ■ Installation: Oil seal

- Apply grease to the lip area of the oil seal and install it on the wheel hub in the illustrated direction.

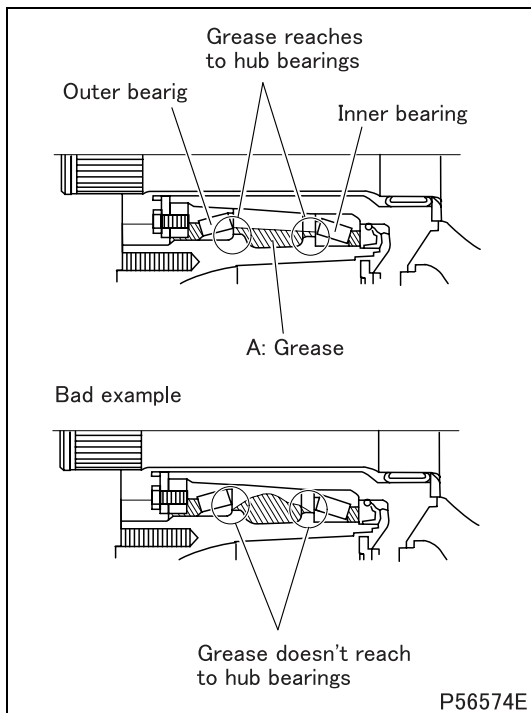
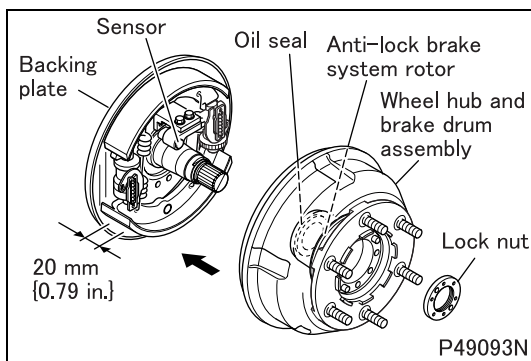
### ■ Installation: Packing grease inside of wheel hub

- Apply specified amount of grease to inside A of wheel hub so that the grease reaches to inner bearing and outer bearing as illustrated.

- Applying grease as illustrated in the “bad example” causes the wheel hub bearing to seize.

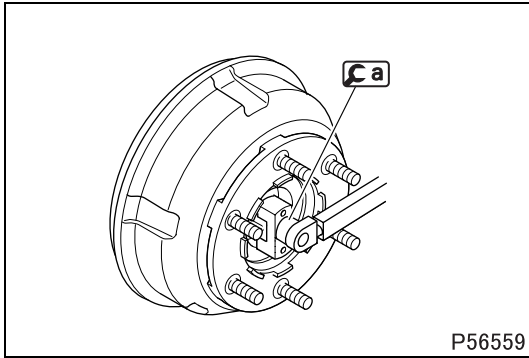
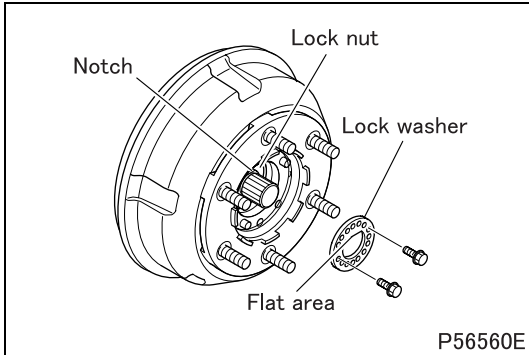
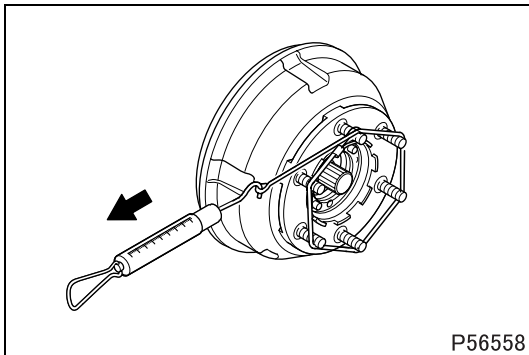
- Tighten the lock nut to the specified torque (primary tightening) while turning the wheel hub and brake drum assembly, and then loosen it completely.
- Smooth operation of the outer bearing and inner bearing by turning the wheel hub and brake drum assembly several times, and then tighten the lock nut to the specified torque (secondary tightening).
- Insert the flat area of the lock washer, aligning it with the notch of the knuckle spindle, and mount two bolts diagonally to the lock nut.
- If the lock nut does not align with a screw hole of the lock washer, align by loosening the lock nut. Make sure that there is no play in the axial direction.

- Make sure that there is no drag in the brake lining and brake drum.
- If any abnormality is found, adjust the brake shoe clearance.
- Measure the tangential force at the hub bolt position using a spring balancer.

- If the tangential force is within the specified value, the starting torque conforms to the standard value. If the measured value deviates from the specified value, repeat adjustment because the adjustment of the lock nut may be insufficient.
- If the result is found to be abnormal, replace the outer and inner bearings.

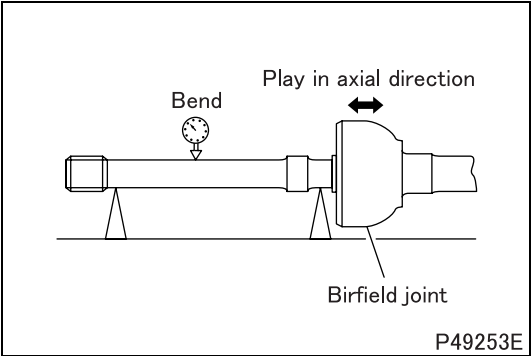
#### ■ Inspection: Drive shaft

- Carry out the following inspections. If any abnormality is found, replace the drive shaft.

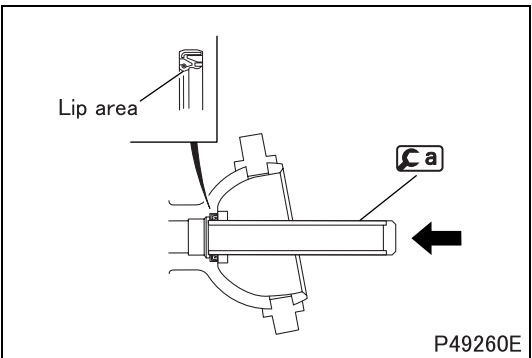
#### ■ Installation: Oil seal

- Apply grease to the lip area of the oil seal and install it on the axle housing in the illustrated direction.

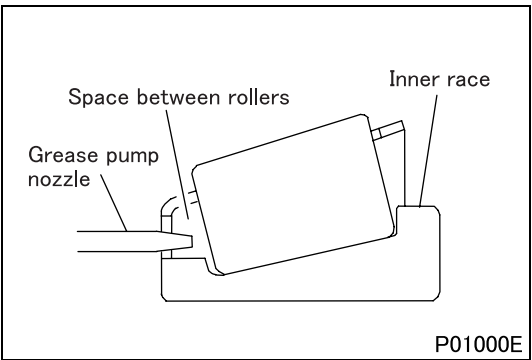
#### ■ Installation: Packing grease in trunnion bearing inner race

- Insert the grease pump nozzle into the space between rollers of the trunnion bearing inner race to pack grease sufficiently.

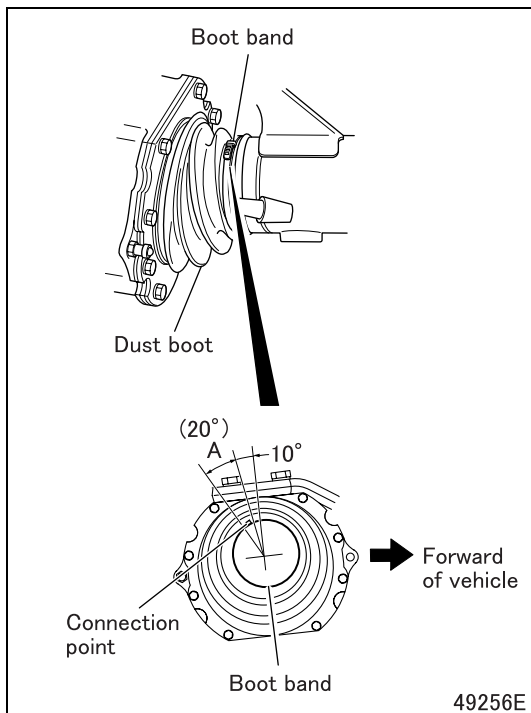
#### ■ Installation: Boot band

- Install the boot band within illustrated range A.

- When installing the boot band, do not tighten the dust boot excessively so as not to allow the dust boot to stick out of the mating surface remarkably.

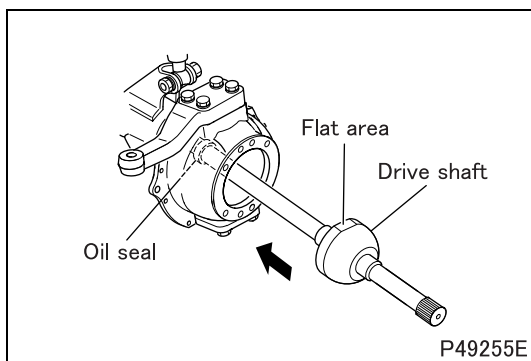
#### ■ Installation: Drive shaft

- Install the drive shaft with the flat area of the Birfield joint of the drive shaft placed in a vertical direction.
- Slowly install the drive shaft to avoid damage to the oil seal.

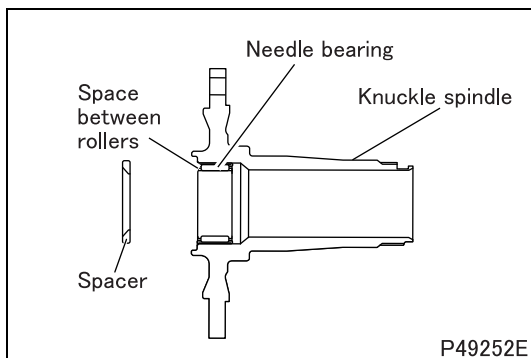
#### ■ Installation: Spacer and needle bearing

- Pack grease sufficiently in the space between rollers of the needle bearing, and install the needle bearing so that it is flush with the end face of the knuckle spindle.

- Do not drive in the needle bearing excessively.

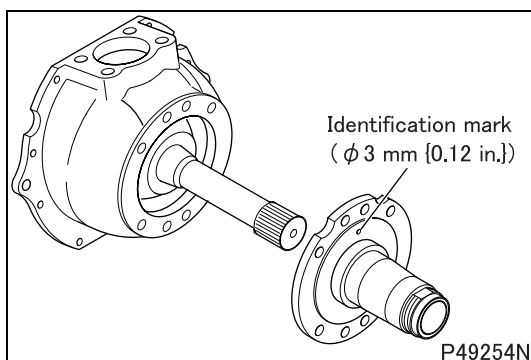
#### ■ Installation: Knuckle spindle

- Install the knuckle spindle on the steering knuckle in the illustrated direction.

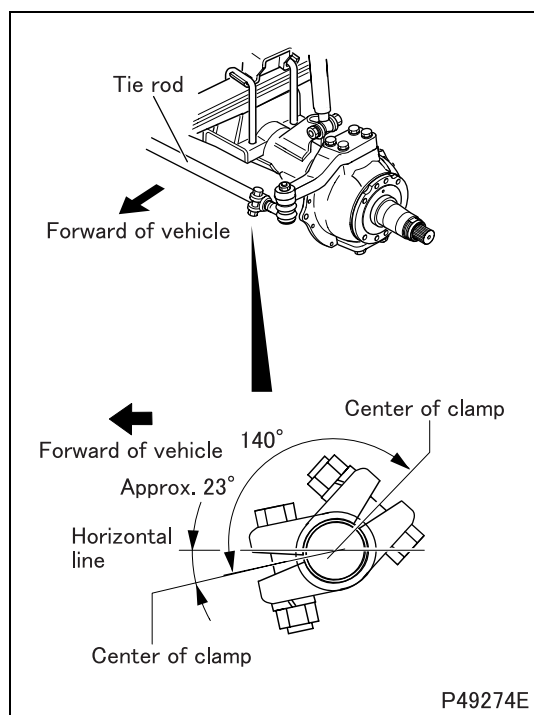
## ■ Installation: Tie rod

- When installing the tie rod, make sure that the center of the tie rod clamp is within the illustrated range.
- If it is out of the illustrated range, change the center position by loosening the clamp.

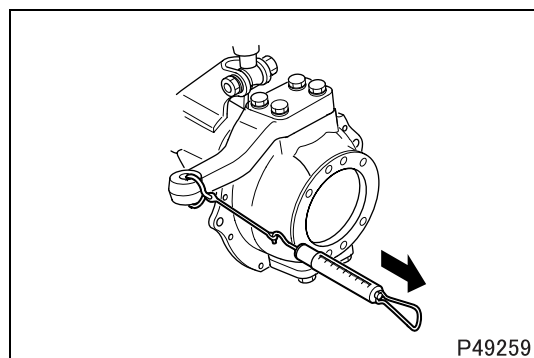
## ■ Inspection: Starting torque of steering knuckle

- If the tangential force is within the specified value, the starting torque conforms to the standard value.  
If the measured value deviates from the specified value, adjust.
- Perform measurement again after adjustment. If any fault is found, replace the trunnion bearing.

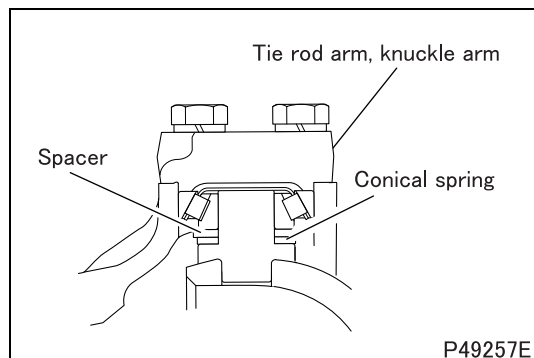
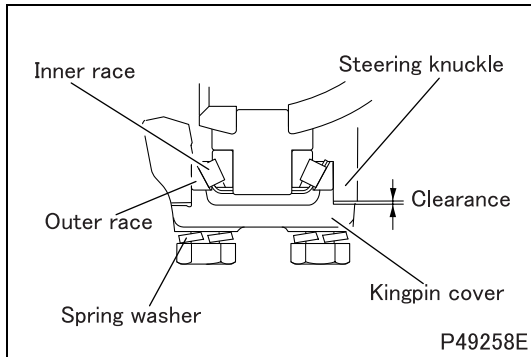
- Insert the conical spring and spacer ( $t = 3.2 \text{ mm}$  {0.13 in.}) as illustrated and assemble the tie rod arm and knuckle arm as illustrated. Then, temporarily tighten them with bolts.

- Install the kingpin cover on the steering knuckle and tighten bolts to such extent that no tension is applied to the spring washers.
- Lift up the kingpin cover by hand until it securely contacts the trunnion bearing outer race and trunnion bearing inner race.
- Measure clearance between the steering knuckle and kingpin cover and select a spacer.  
When clearance is 0.6 mm {0.024 in.} or more: Spacer of 3.2 mm {0.13 in.}  
When clearance is less than 0.6 mm {0.024 in.}: Spacer of 3.6 mm {0.14 in.}
- Install the selected spacer and tighten bolts to the specified torque.

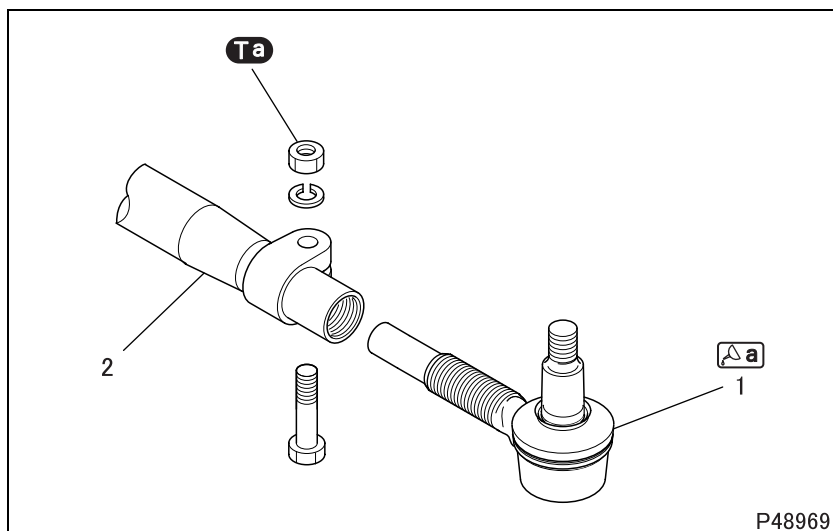
- 1 Tie rod end
- 2 Tie rod

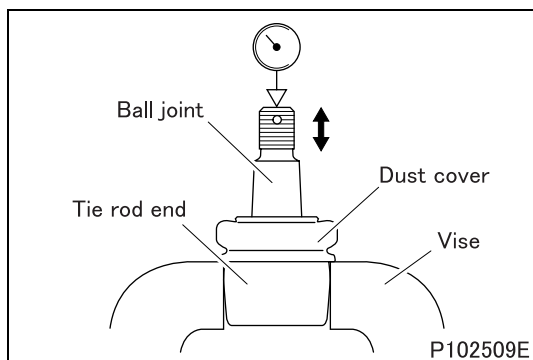
## ■ Inspection: Tie rod end

- Take care not to deform or damage the dust cover when fixing it with a vise.

- The position of the ball joint with applying no load is adjusted to standard position.
- Measure each play of the ball joint with applying the specified push and pull load from the standard position.

- Total each play and if the total deviates from standard value, replace the tie rod end.

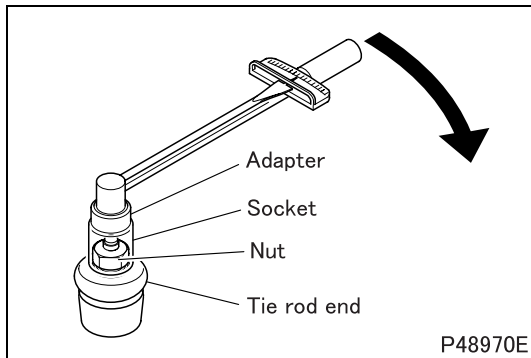
## (2) Rotation torque

- Install the tie rod mounting nut on the tie rod end.
- Install the socket, adapter and torque wrench to measure the rotation torque.
- If the measured value deviates from the standard value, replace the tie rod end.

- Check the dust cover for wear, cracks and other damage. These abnormalities may cause water infiltration to the ball joint and wear out it at early stage.
- If any abnormality is found in the dust cover, replace the tie rod end.

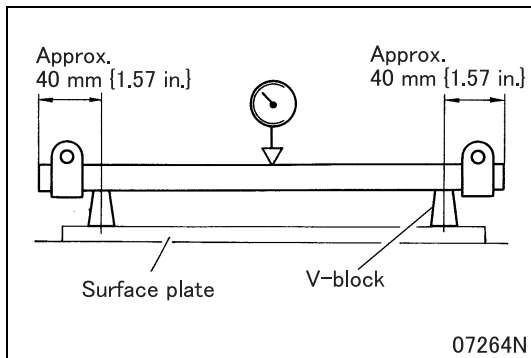
## ■ Inspection: Bend of tie rod

- Measure the bend of the tie rod at its center.

- Give the tie rod one complete turn and read the dial gauge at this time. The bend is one half of the reading.
- If the measured value exceeds the standard value, correct or replace the tie rod.

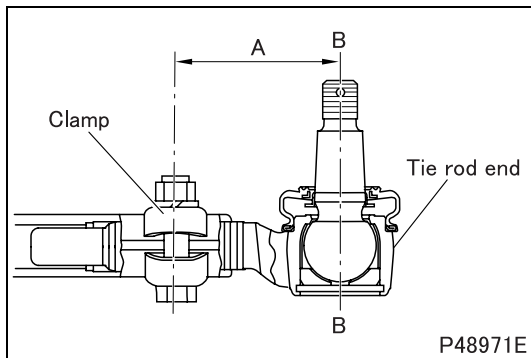
## ■ Installation: Tie rod end

- Screw in the tie rod end so that difference of dimension A between the tie rod end and the clamp is within 1.5 mm {0.059 in.} between right and left.  
A: Approximately 74 mm {2.91 in.}

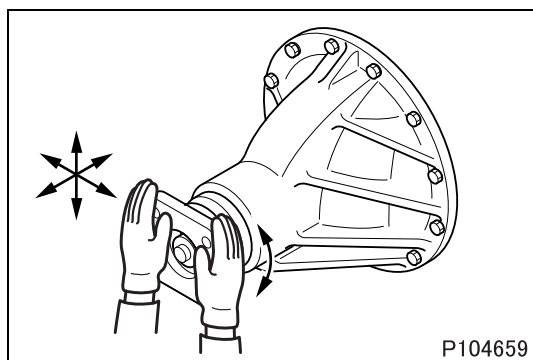
#### ■ Inspection: Play at companion flange

- Move the companion flange in the back-and-forth, up-and-down, right-and-left and rotation direction to check for play.
- If there is play in either of directions, replace the following all parts.
  - Front bearing and rear bearing
  - Pinion spacer
  - Reduction gear set (reduction pinion and reduction gear)
  - Companion flange

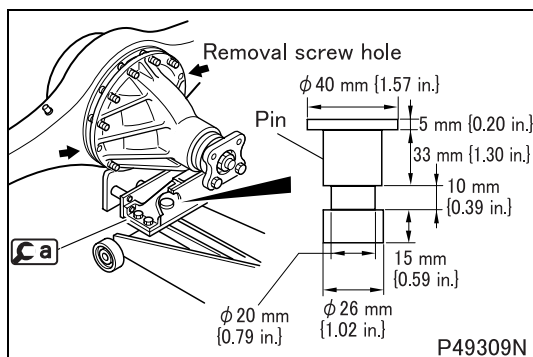
#### ■ Removal: Reduction and differential

on it. Fabricate the pin as illustrated, insert and fix it with bolts that have fixed the saucer.
- Screw two M10 × 1.25 mm bolts evenly into the reduction and differential removal screw holes (as shown in illustration) to remove the reduction and differential.
