# FE.FG

## SERVICE MANUAL 2008 Model FOREWORD

This Service Manual contains maintenance and repair methods for the Mitsubishi Fuso Truck FE. FG Series. Read this manual carefully as an aid in providing correct, efficient maintenance. Please note that the information and specifications contained within this manual may change without notice. This is due to product modifications and continued vehicle improvements that are made throughout the model years. Should you encounter any discrepancy in the information provided, please do not hesitate to contact your nearest Mitsubishi Fuso Dealer or Mitsubishi Fuso Truck of America, Inc.

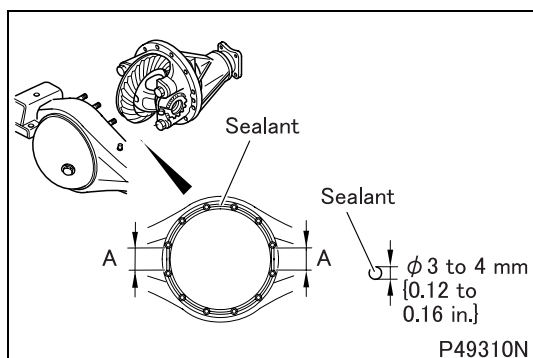
#### ■ Installation: Reduction and differential

- Clean a seal surface of each part.
- Apply sealant to the reduction and differential mounting surface of the axle housing evenly and without breaks. Apply sealant in a straight line direction for illustrated position A.

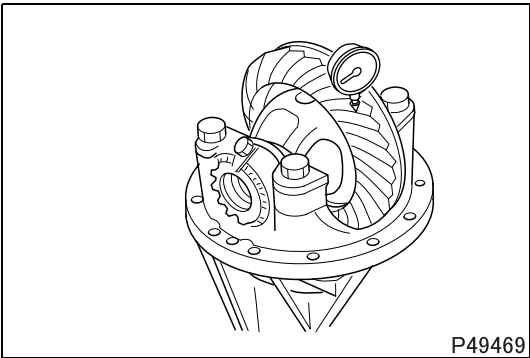
### ■ Inspection: Backlash between reduction gear and reduction pinion

- If backlash is found faulty, the tightening amount of the side bearing nut is probably inappropriate.

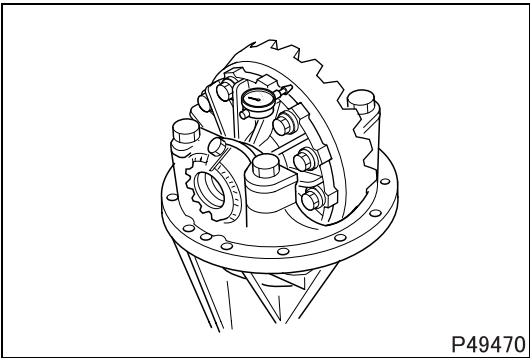
### ■ Inspection: Wobble at back face of reduction gear

- Measure wobble at the illustrated position of the reduction gear.

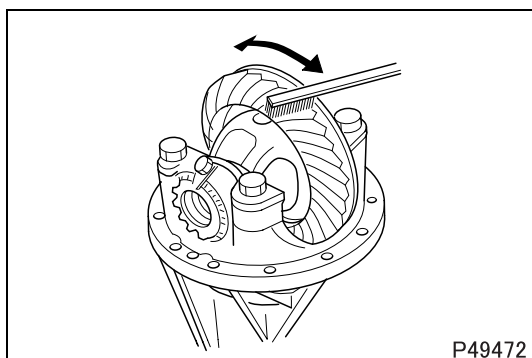
#### ■ Inspection: Tooth contact of reduction gear

- Apply red lead to three to four teeth at three equally spaced points of the reduction gear.
- Turn the reduction gear several times to check for tooth contact.

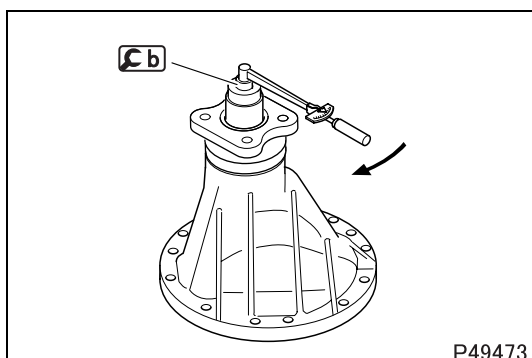
#### ■ Inspection: Starting torque of pinion bearing

- After removing the differential, measure the starting torque of the pinion bearing.

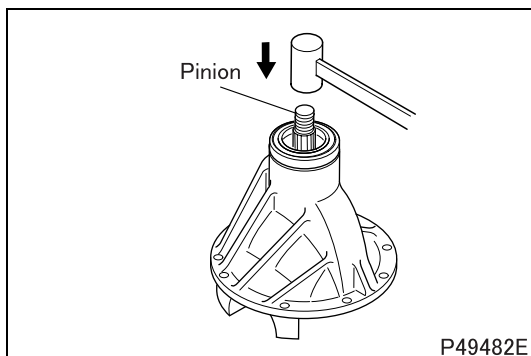
## ■ Removal: Reduction pinion

- Tap the reduction pinion with a plastic hammer and hold the reduction pinion with your hand to prevent it from falling.

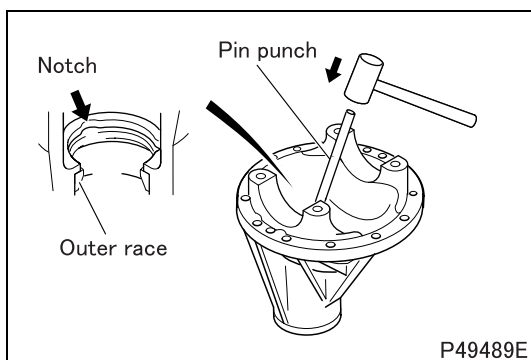
## ■ Removal: Front bearing outer race

- Drive out the front bearing outer race by tapping evenly at three indented parts in the differential carrier.

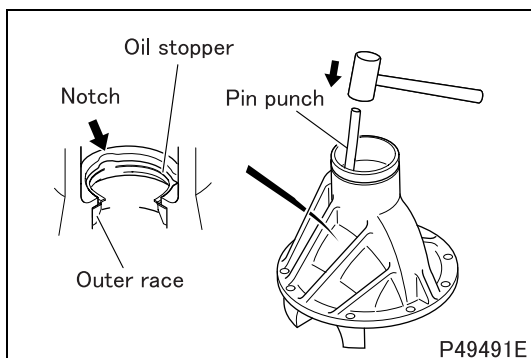
## ■ Removal: Rear bearing outer race

- Drive out the rear bearing outer race, together with the oil stopper, by tapping evenly at three indented parts in the differential carrier.

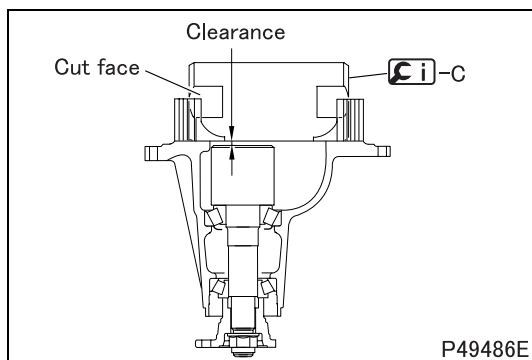
- Set **C i -C** in the illustrated direction and measure clearance as illustrated.
- Select shims so that clearance becomes 1.5 mm {0.059 in.}.  
Thickness of shims available  
0.30 and 1.38 to 1.65 mm {0.012 and 0.054 to 0.065 in.} (10 thickness in 0.03 mm {0.012 in.} increments)

- If using a shim of 0.30 mm {0.012 in.} in thickness in combination with a shim of other thickness for installing rear bearing shims, install a shim of 0.30 mm {0.012 in.} in thickness on the rear bearing inner race to prevent wear-out.

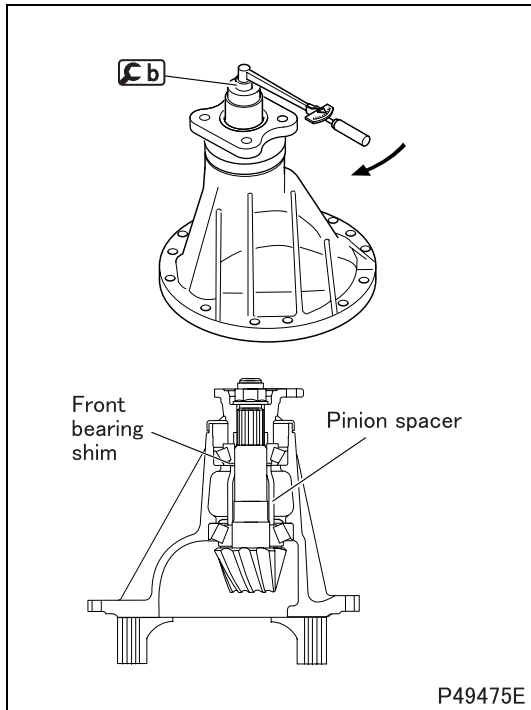
#### ■ Inspection: Starting torque of pinion bearing

- After installing front bearing shims, measure the starting torque of the pinion bearing with no oil seal assembled.
- If the measured value deviates from the standard value, adjust by changing a pinion spacer and front bearing shims.  
 Thickness of pinion spacers available  
 64.07, 64.40 mm {2.52, 2.54 in.} (painted in white)  
 Thickness of front bearing shims available  
 0.03 and 2.00 to 2.33 mm {0.0012 and 0.079 to 0.092 in.} (12 thickness in 0.03 mm {0.012 in.} increments)

- Select a pinion spacer so that the number of front bearing shims becomes as least as possible.

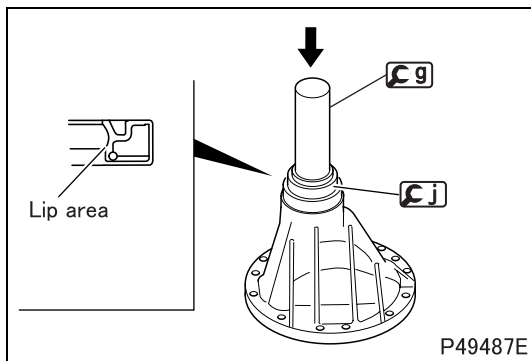
#### ■ Installation: Oil seal

- Apply grease to the lip area of the oil seal and install it on the differential carrier in the illustrated direction.

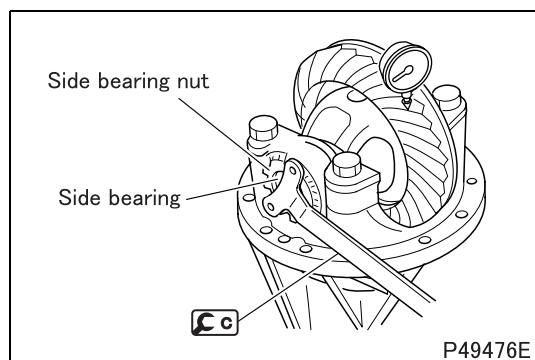
### ■ Adjustment: Backlash between reduction gear and reduction pinion

- Tighten the side bearing nut for adjustment to such extent that no preload is applied to the side bearing.

- When one side bearing nut is loosened, be sure to tighten the other one the same amount to prevent the side bearing preload from changing.

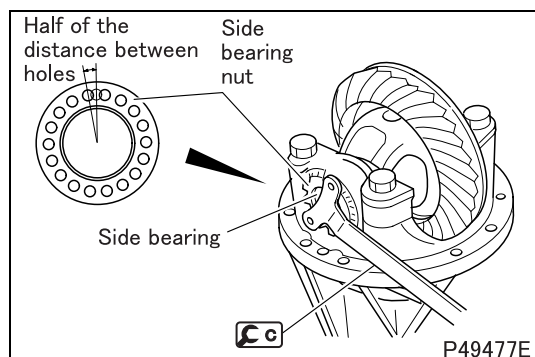
### ■ Adjustment: Side bearing preload

- After adjusting backlash between the reduction gear and reduction pinion, further tighten both of the side bearing nuts within the range of backlash to provide preload to the side bearing.
- The tightening amount of preload must be limited to the distance between two holes for combination of right and left sides.

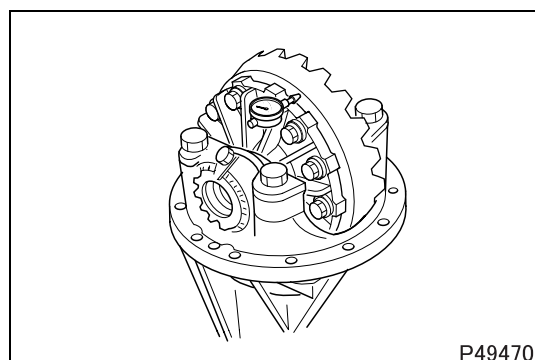
### ■ Inspection: Wobble at back face of reduction gear

- Measure wobble at the illustrated position of the reduction gear.
- If the measured value deviates from the standard value, replace the reduction gear and reduction pinion of the differential as a set.

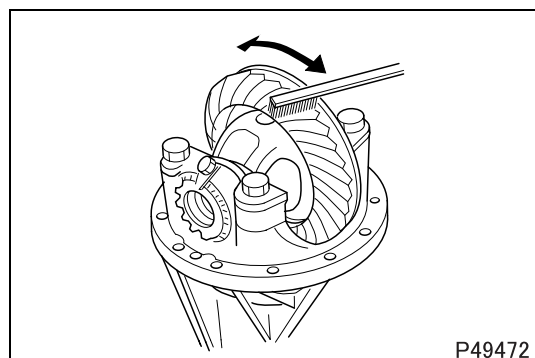
### ■ Inspection: Tooth contact of reduction gear

- Apply red lead to three to four teeth at three equally spaced points of the reduction gear.
- Turn the reduction gear several times to check for tooth contact.
- Adjust tooth contact if it is remarkably offset.

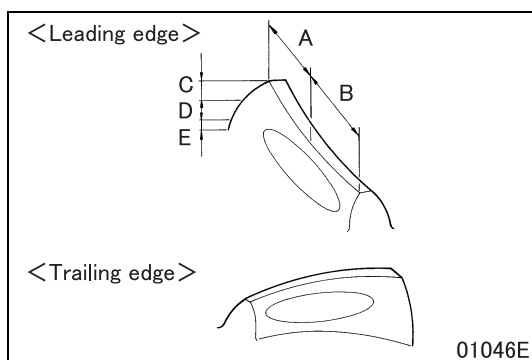
### ● Correct tooth contact at no load

- A: Heel
- B: Toe
- C: Face
- D: Flank
- E: Clearance

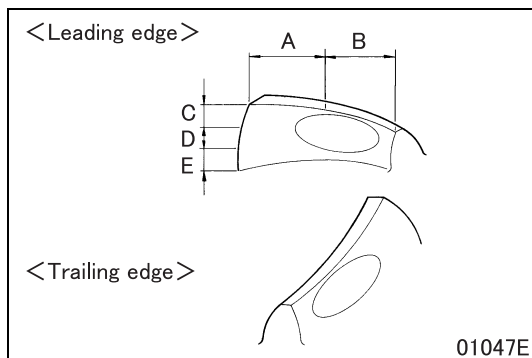
#### <Reduction pinion>

- A: Heel
- B: Toe
- C: Face
- D: Flank
- E: Clearance

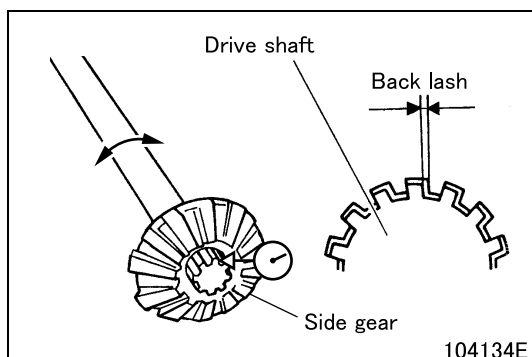
## ■ Inspection: Backlash between side gear and spline of drive shaft

- If the measured value exceeds the limit, replace defective parts.

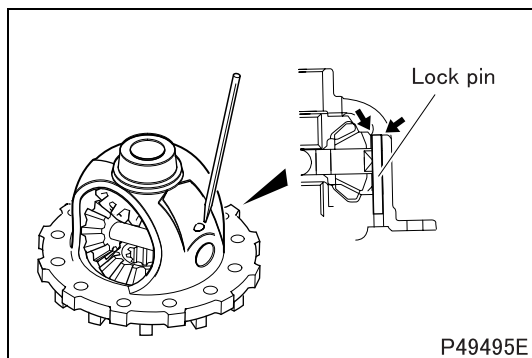
## ■ Installation: Lock pin

- After installing the lock pin, caulk it with a punch (two locations).

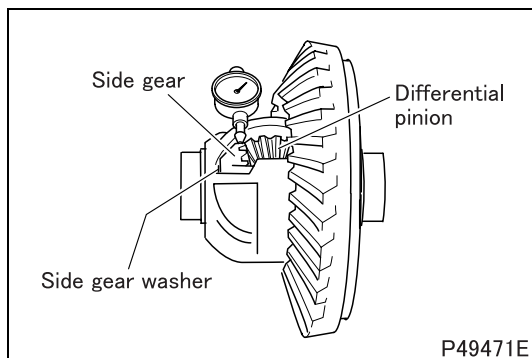
## ■ Inspection: Backlash between differential pinion and side gear

- If the measured value deviates from the standard value, adjust by changing thickness of the side gear washer.

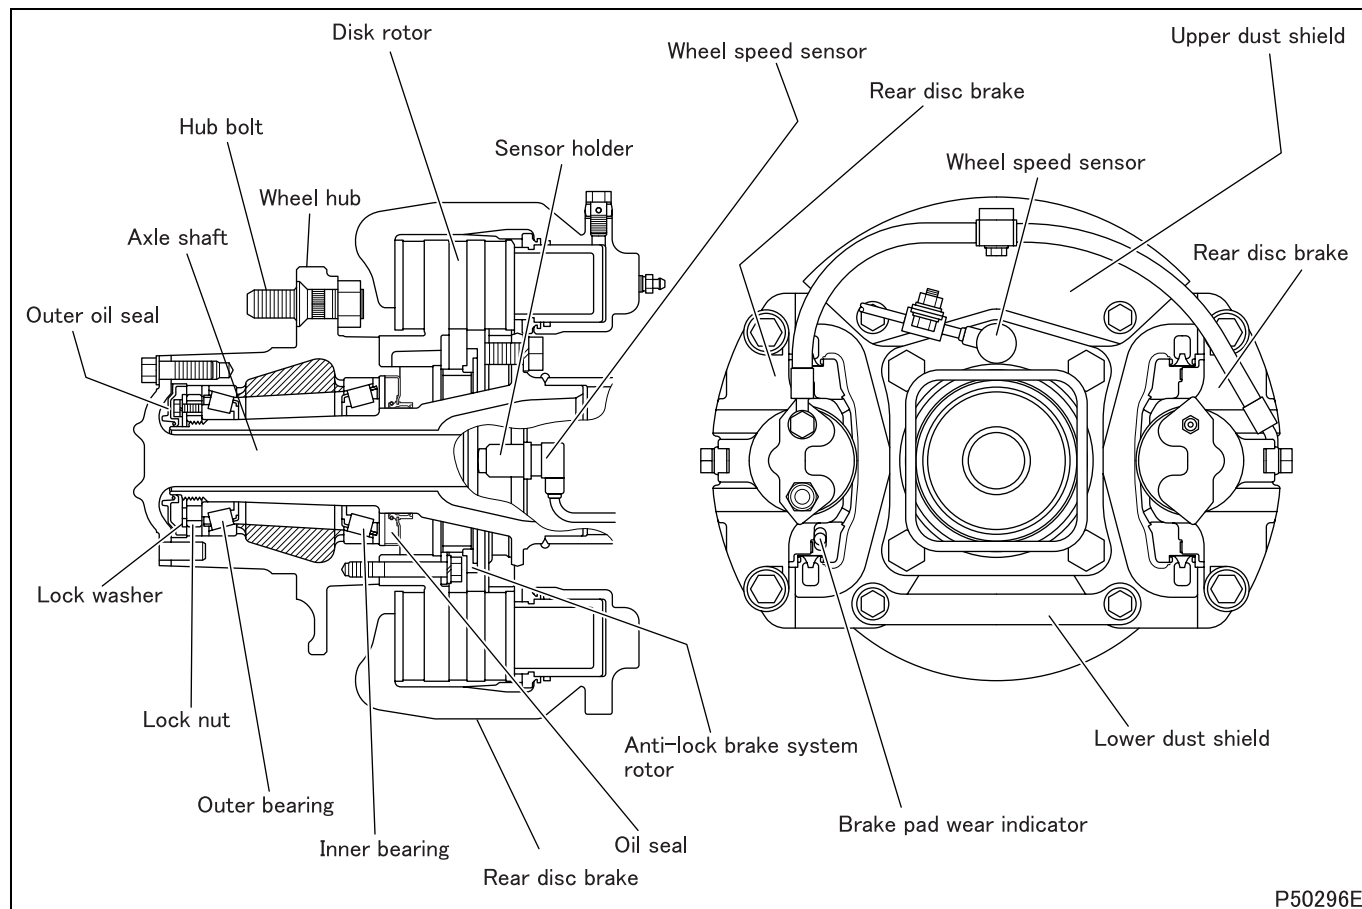
## 1. Wheel Hub and Rotor

- The brake pad wear indicator is installed only on the right wheels.

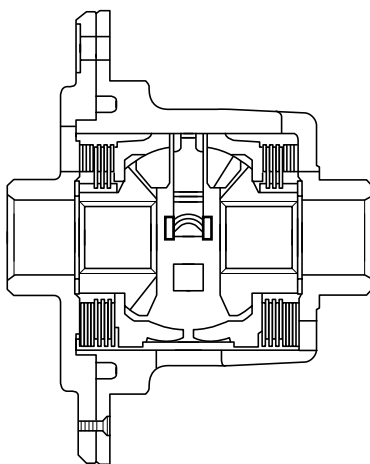
Limited slip differential

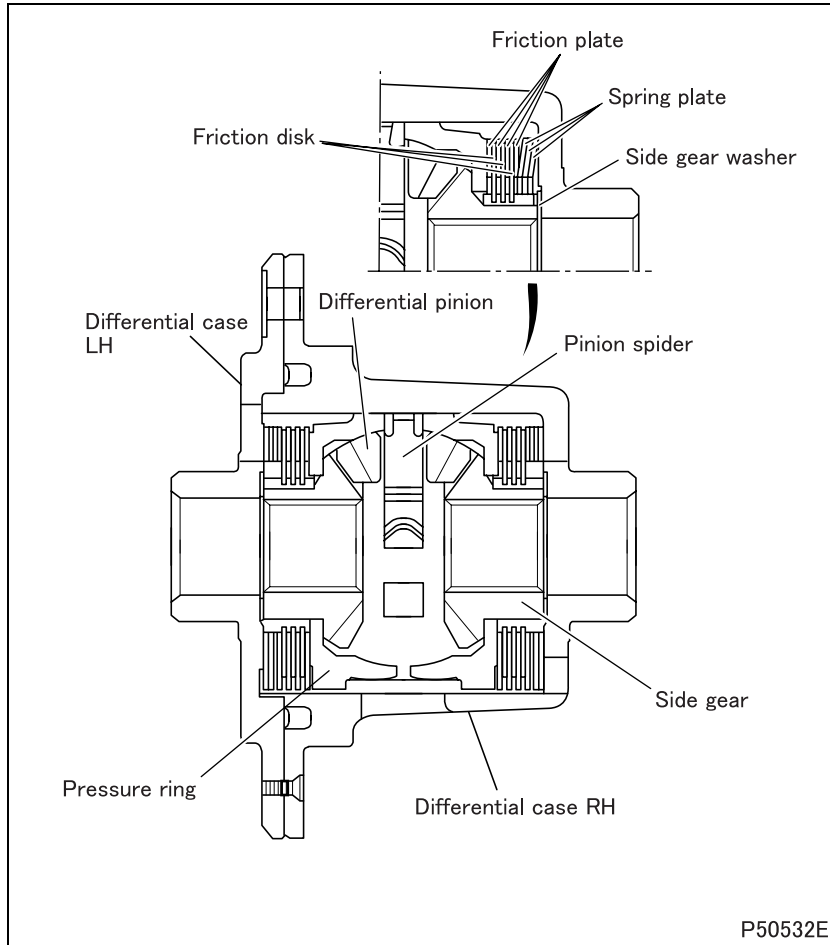
## 4. Limited Slip Differential

- The friction discs and spring discs, which are fitted in the side gears, and the friction plates, which are fitted in the differential case RH, are pushed against the pressure rings by the spring plates.
- The pressure rings fit in the groove inside the differential case RH and always rotate at the same speed.

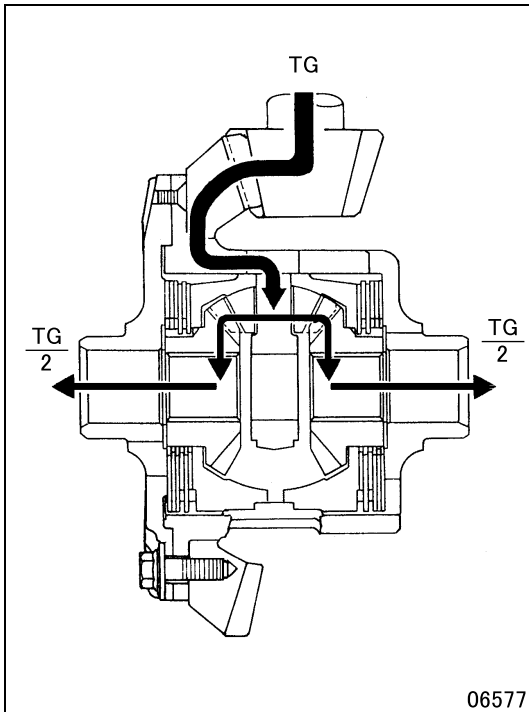
#### 4.2 Operation during straight driving

- During straight driving, the right and left axle shafts rotate at the same speed, and no friction torque generates.

TG: input torque

- When one wheel spins, a difference in the revolution speed generates between the side gear and the differential case, LH and RH, which causes the friction discs, spring discs and friction plates to revolve relatively to each other. This relative revolution produces a friction torque between the friction discs and friction plates.

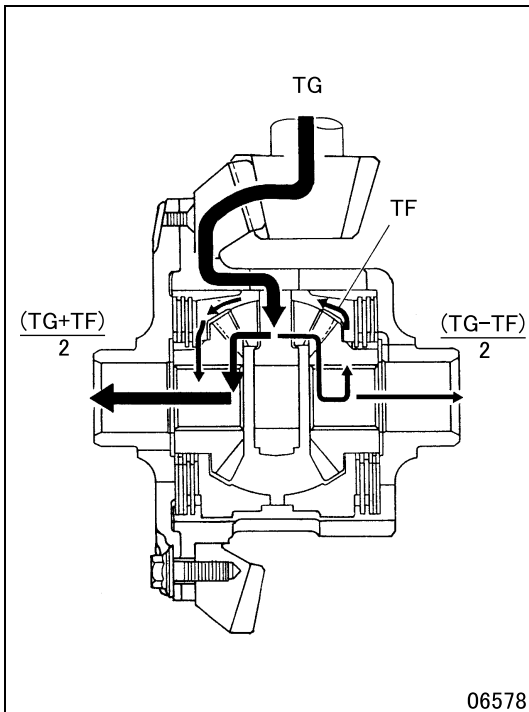
#### 4.3 Operation when there is a difference in rotation speed between right and left wheels

- If one wheel is on a slippery surface such as mud and the other wheel is not, the differential function becomes effective due to a difference in surface resistance. In this state, friction torque TF is generated and this torque works in such a manner as to reduce the difference in rotations between right and left wheels. That is, the faster axle shaft is forced to slow down, and the slower axle shaft is forced to turn faster.

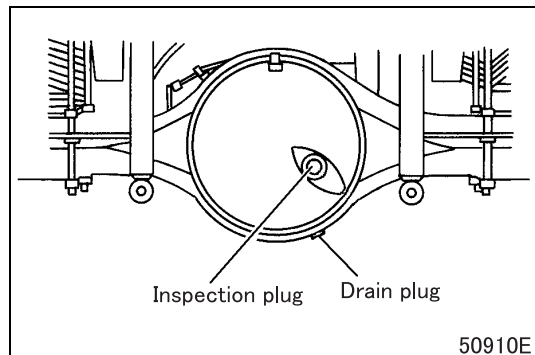
- The oil temperature is high immediately after the vehicle has stopped, so take care not to scald yourself.

- When draining gear oil, check for oil quality, metal chips and metal powder.
- If an abnormally large amount of metal chips and metal powder is found, disassemble the assembly for service, as abnormalities may be caused inside.

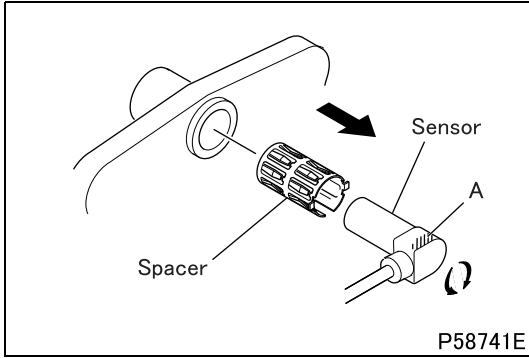
### ■ Removal: Wheel speed sensor

- Hold shaded section A of wheel speed sensor with pliers, and remove the sensor by twisting it slightly in left and right direction.

- When removing the wheel speed sensor, never apply a force to it such as tapping it with a hammer, prying it with a screwdriver and pulling the harness, as doing so causes the wire to be broken.
- If the wheel speed sensor pulls out lightly, replace the spring spacer.

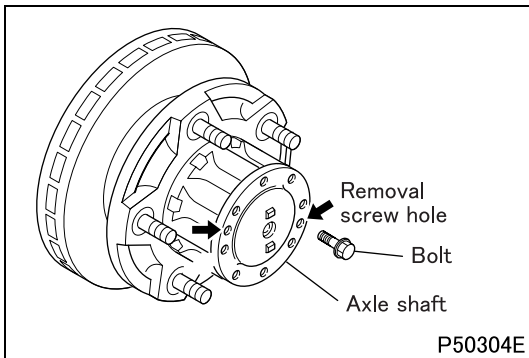
### ■ Removal: Axle shaft

- Screw two axle shaft mounting bolts evenly into the axle shaft removal screw holes to remove the axle shaft.

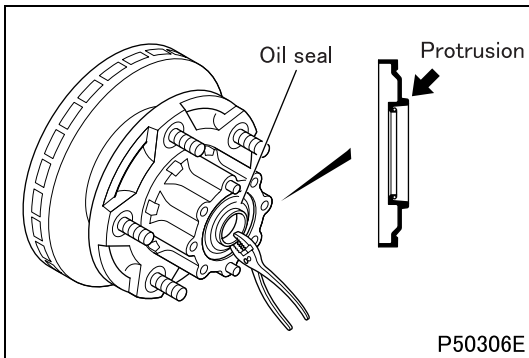
### ■ Removal: Outer oil seal

- To remove the outer oil seal, pull protrusions on the outer periphery of the outer oil seal evenly around the whole circumference with pliers.

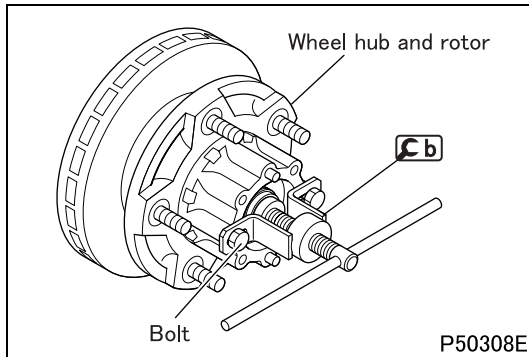
## ■ Removal: Wheel hub and rotor

- Install **C b** using axle shaft mounting bolts and remove the wheel hub and rotor assembly.

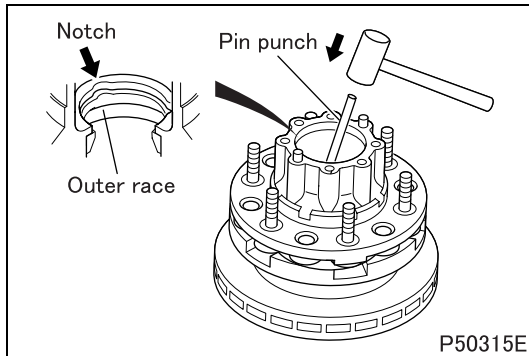
## ■ Removal: Inner bearing outer race

- Drive out the inner bearing outer race by tapping evenly at three indented parts in the wheel hub.

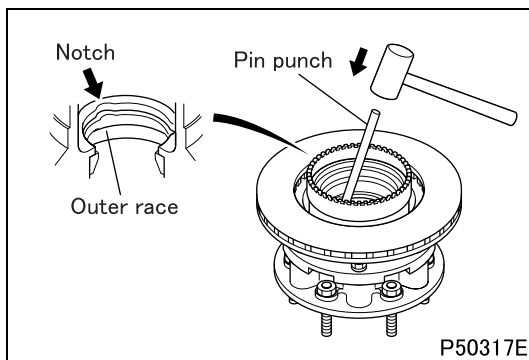
## ■ Removal: Outer bearing outer race

- Drive out the outer bearing outer race by tapping evenly at three indented parts in the wheel hub.

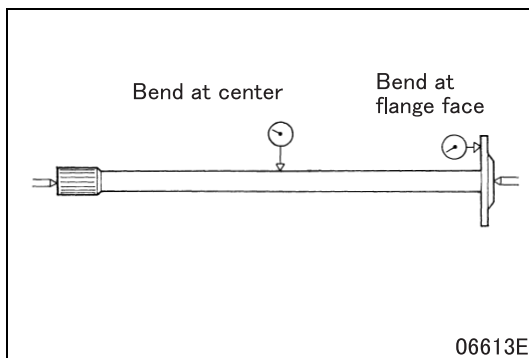
## ■ Inspection: Axle shaft

- Measure the bend of the axle shaft at its center.

- Give the axle shaft one complete turn and read the dial gauge at this time. The bend is one half of the reading.
- If the measured value exceeds the limit, replace the axle shaft.
- Measure the bend of the flange face of the axle shaft.
- If the measured value exceeds the limit, replace the axle shaft.

| Location | Maintenance item | | Standard value | Limit | Remedy |
|---|---|---|---|---|---|
| 12 | Axle shaft | Bend | 1 {0.039} or less | 2 {0.079} | Replace |

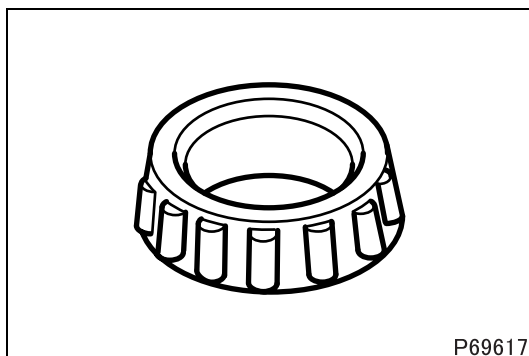
## ■ Inspection: Outer bearing inner race

- Inspect the outer bearing inner race after cleaning the bearing to remove grease completely.
- If any damage, wear, or poor rotating condition is evident in the inner race, replace it with a new one.
- The inner race and outer race should be replaced as a set.

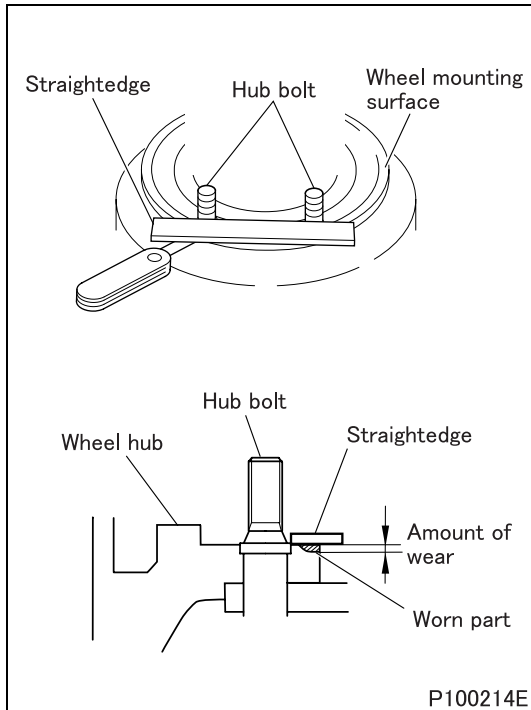
## ■ Inspection: Wheel hub

- Check the disc wheel mounting surface of the wheel hub by watching and touching. If there is damage or crack on it, replace the wheel hub.
- Make sure that there is not rust, dust, paint or foreign body on the disc wheel mounting surface of the wheel hub to prevent the wheel nut to loosen.
- If any abnormality is found, remove it with sandpaper.

- Using feeler gauges to measure the amount of wear at the outer periphery of the wheel hub.  
Measure the amount of wear in the area of every hub bolt.
- If the amount of wear at any point exceeds the following standard value, inspect the crack check of wheel hub.  
Wear standard value: 0.8 mm

- Check if there is not crack on the entire rounded corner on the root of flange of the wheel hub by magnetic particle or liquid penetrant testing. If crack is found, replace the wheel hub.
- If crack is found on the wheel hub bolt, replace it.
- If there is crack or stepped wear on the wheel hub mounting surface of wheel disc, replace it. (See Gr31.)

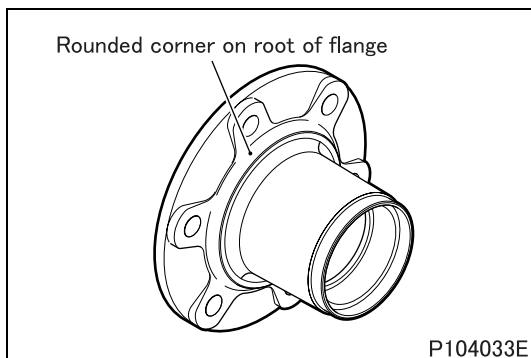
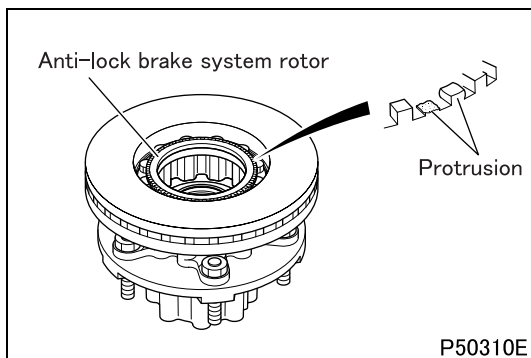
## ■ Inspection: Anti-lock brake system rotor

- Remove any debris on the anti-lock brake system rotors and check protrusions of the anti-lock brake system rotor for chipping and flattening.
- If any abnormality is found, replace the anti-lock brake system rotor.

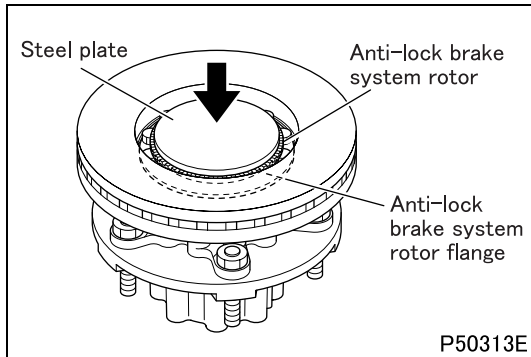
## [Installation]

- Warm the anti-lock brake system rotor to approximately 150°C.
- Install the anti-lock brake system rotor and anti-lock brake system rotor flange evenly using a steel plate so as not to allow them to tilt.

- Handling the warmed rotor by bare hand causes scald.

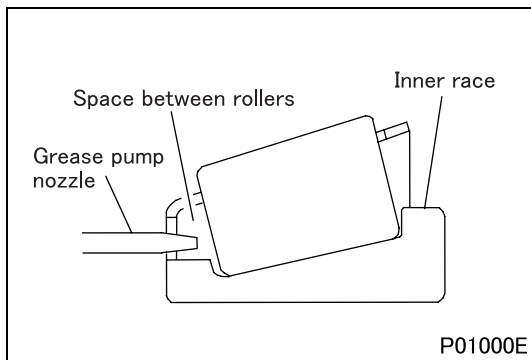
## ■ Installation: Packing grease in inner bearing inner race

- Insert the grease pump nozzle into the space between rollers of the inner bearing inner race to pack grease sufficiently.

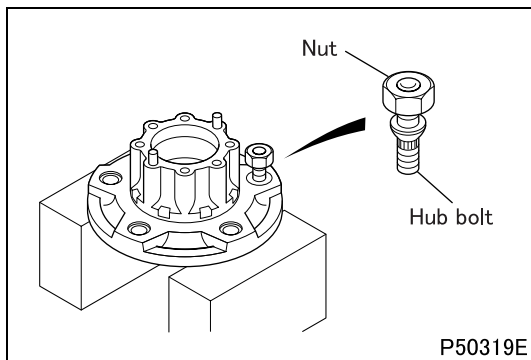
## ■ Installation: Hub bolt

- Screw the nut into the hub bolt until just before they become flush.
- Drive the hub bolt into the wheel hub vertically by hitting the end face of the nut with a brass punch or the like.

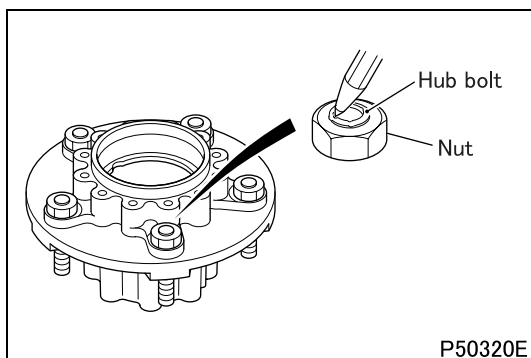
- After tightening the nut to the specified torque, caulk it with a punch.

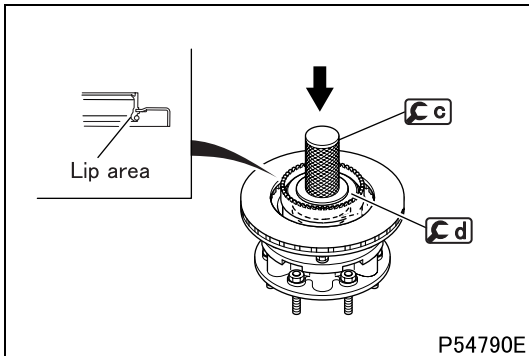
#### ■ Installation: Oil seal

- Apply grease to the lip area of the oil seal and install it on the wheel hub in the illustrated direction.

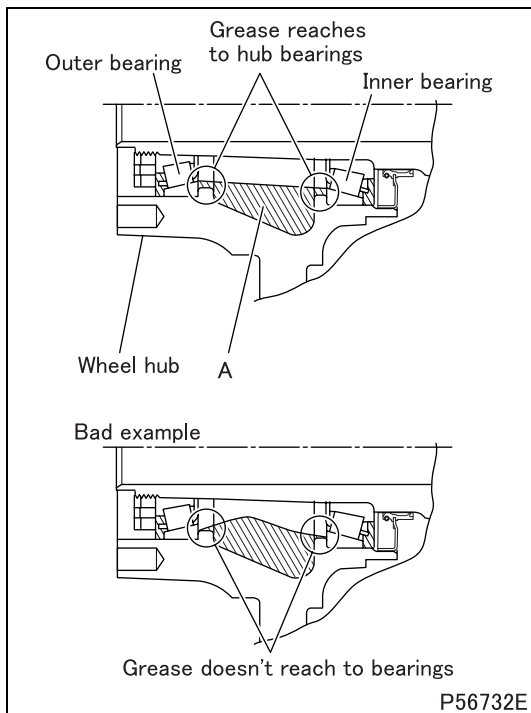
## ■ Installation: Packing grease in wheel hub

- Apply specified amount of grease to inside A of wheel hub so that the grease reaches to inner bearing and outer bearing as illustrated.

- Applying grease as illustrated in the “bad example” causes the wheel hub bearing to seize.

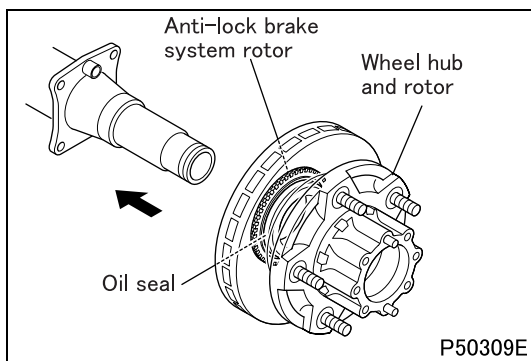
## ■ Installation: Wheel hub and rotor

- Slowly install the wheel hub and rotor assembly so as not to cause damage to the oil seal and anti-lock brake system rotor.

- If the anti-lock brake system rotor is damaged, wheel speed sensor signals become abnormal, causing the anti-lock brake system to malfunction.

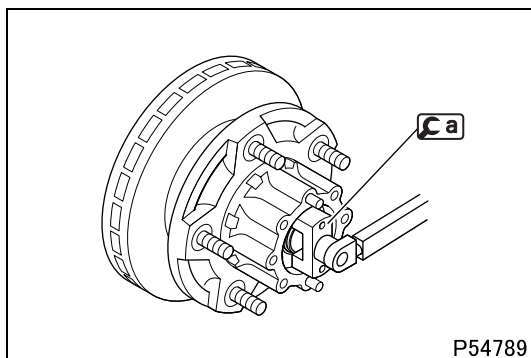
### [Adjustment]

- Tighten the lock nut to the specified torque (primary tightening) while turning the wheel hub and rotor, and then loosen it completely.
- Smooth operation of the outer bearing and inner bearing by turning the wheel hub and rotor several times, and then tighten the lock nut to the specified torque (secondary tightening).

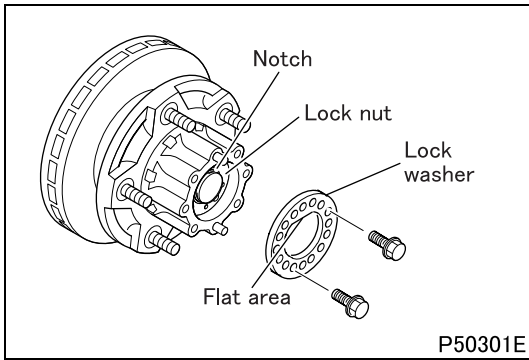
- Insert the flat area of the lock washer, aligning it with the notch of the axle housing, and mount two bolts diagonally to the lock nut.
- If the lock nut does not align with a screw hole of the lock washer, align by loosening the lock nut. Make sure that there is no play in the axial direction.

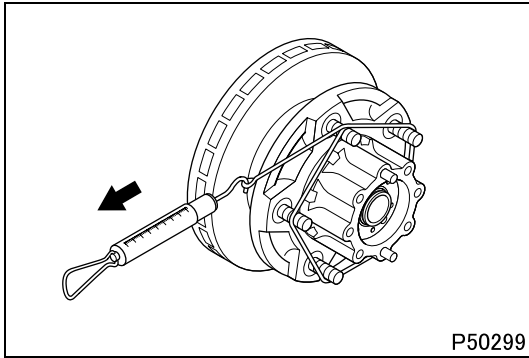
#### [Inspection]

- After installing the lock washer, carry out the following inspections.
- Measure the tangential force at the hub bolt position using a spring balancer.
- If the tangential force is within the specified value, the starting torque conforms to the standard value. If the measured value deviates from the specified value, repeat adjustment because the adjustment of the lock nut may be insufficient.
- If the result is found to be abnormal, replace the outer and inner bearings.

| Location | Maintenance item | | Standard value | Limit | Remedy |
|---|---|---|---|---|---|
| – | Starting torque of wheel hub bearing (tangential force at hub bolt position with oil seal assembled) | | 2.0 to 3.9 N·m<br>{1.4 to 2.9 ft.lbs,<br>0.2 to 0.4 kgf·m}<br>(tangential force: 18 to 32 N<br>{4.0 to 7.2 lbs,<br>1.8 to 3.3 kgf}) | – | Adjust or replace |

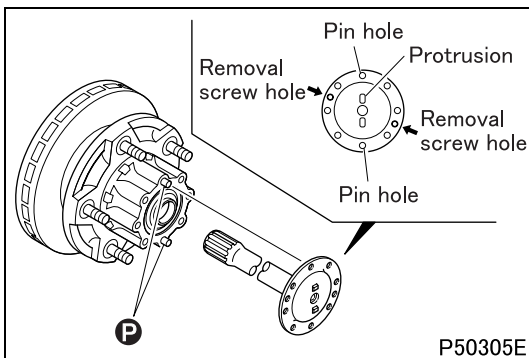
#### ■ Installation: Axle shaft

- Align the pin hole of the locating pin with that of the axle shaft to install the axle shaft.

- A pin hole is not necessarily located at the position of a protrusion on the axle shaft flange face as illustrated. The second hole from a removal screw hole clockwise is a pin hole.

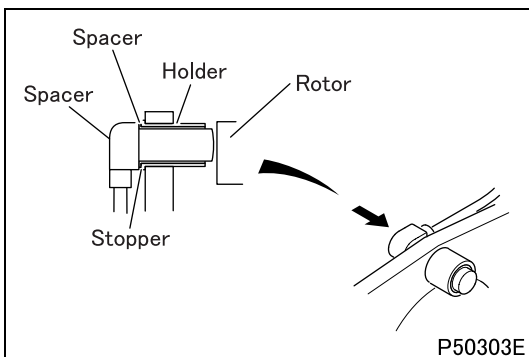
#### ■ Installation: Wheel speed sensor

- Install the wheel speed sensor so that it securely contacts the sensor holder together with the spring spacer.

- When installing the wheel speed sensor, never apply a force to it such as tapping it with a hammer, prying it with a screwdriver and pulling the harness, as doing so causes the wire to be broken.

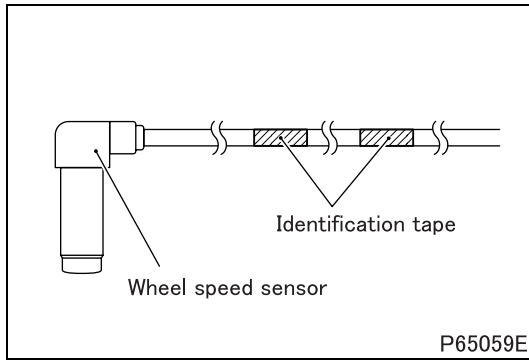
- Using clips, secure in place the wheel speed sensor harness at the identification tape portions, ensuring that the harness is free of kinks, slack and/or interference with other parts.

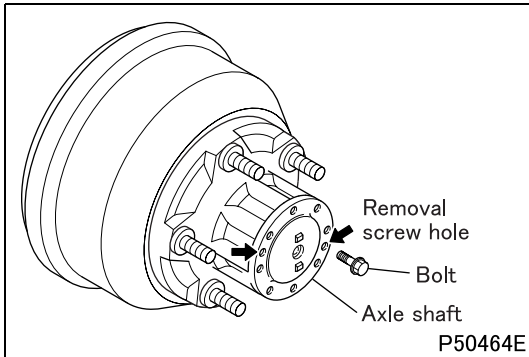
### ■ Removal: Axle shaft

- Screw two axle shaft mounting bolts evenly into the axle shaft removal screw holes to remove the axle shaft.

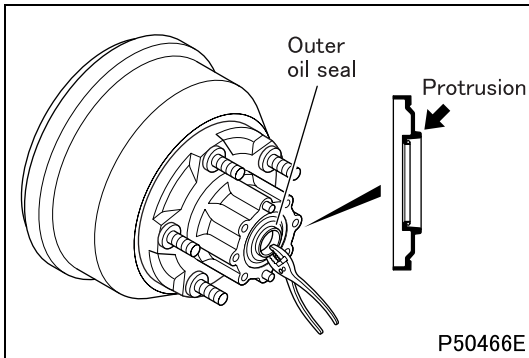
### ■ Removal: Outer oil seal

- To remove the outer oil seal, pull protrusions on the outer periphery of the outer oil seal evenly around the whole circumference with pliers.

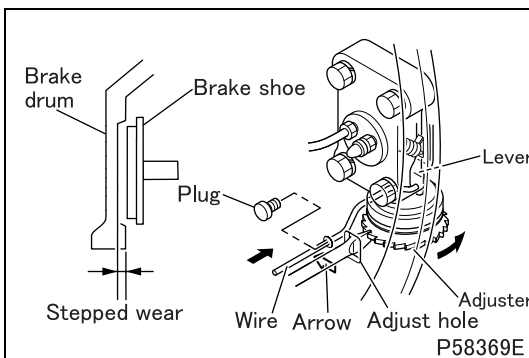
### ■ Removal: Wheel hub and brake drum

- If the brake drum has stepped wear and the wear prevents the wheel hub and brake drum assembly from being removed, the removal can still be effected by taking the following procedure.
- Insert a wire of approx.  $\phi 2$  mm {0.079 in.} into the hole from which the plug has been removed, and lift up the adjust lever of the wheel cylinder.
- Turn the adjuster from the adjust hole in the opposite direction to the arrow on the backing plate to increase the clearance between the brake drum and the brake shoe. Then, remove the wheel hub and brake drum assembly.

- Correct or replace the brake drum if any fault is found.

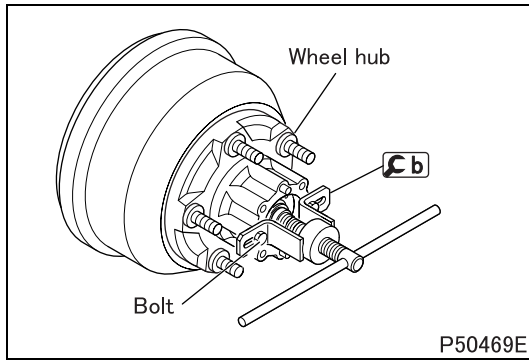
- Install **C b** using axle shaft mounting bolts to remove the wheel hub and brake drum assembly.

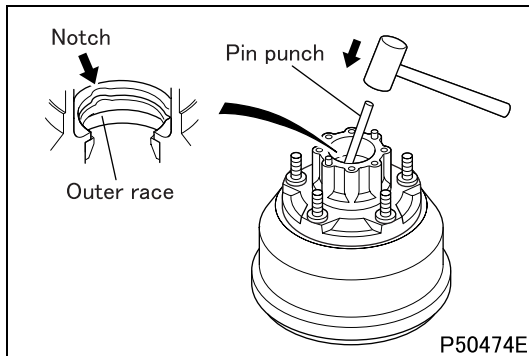
#### ■ Removal: Inner bearing outer race

- Drive out the inner bearing outer race by tapping evenly at three or four indented parts in the wheel hub.

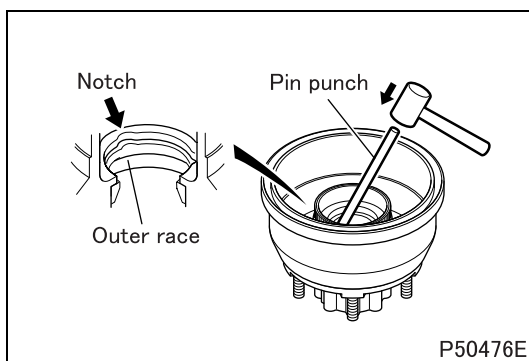
#### ■ Removal: Outer bearing outer race

- Drive out the outer bearing outer race by tapping evenly at three or four indented parts in the wheel hub.

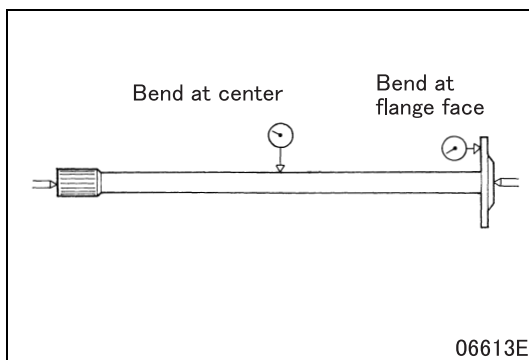
#### ■ Inspection: Axle shaft

- Measure the bend of the axle shaft at its center.

- If the measured value exceeds the limit, replace the axle shaft.
- Measure the bend of the flange face of the axle shaft.
- If the measured value exceeds the limit, replace the axle shaft.

### ◆ Installation procedure ◆

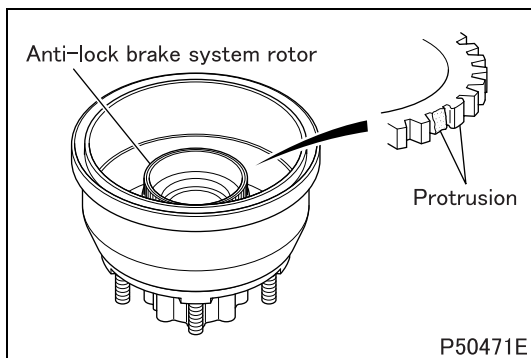
## ■ Inspection: Anti-lock brake system rotor

- Remove any debris on the anti-lock brake system rotor and check protrusions of the anti-lock brake system rotor for chipping and flattening.
- If any abnormality is found, replace the anti-lock brake system rotor.

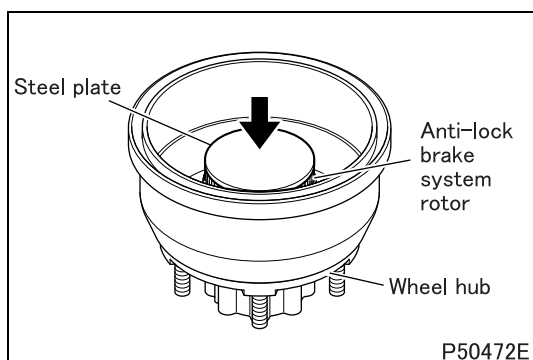
### [Installation]

- Warm the anti-lock brake system rotor to approximately 150°C.
- Install the anti-lock brake system rotor and anti-lock brake system rotor flange evenly using a steel plate so as not to allow them to tilt.

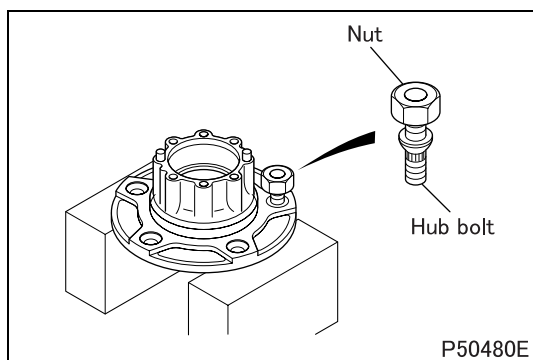
### ■ Installation: Hub bolt

- Screw the nut into the hub bolt until just before they become flush.
- Drive the hub bolt into the wheel hub vertically by hitting the end face of the nut with a brass punch or the like.

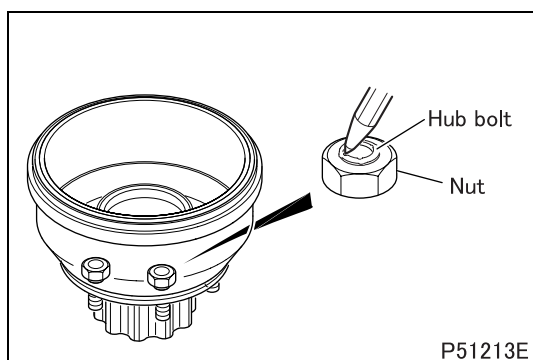
- Assemble the brake drum and wheel hub with the hub bolt. After tightening the nut to the specified torque, crimp it with a punch.

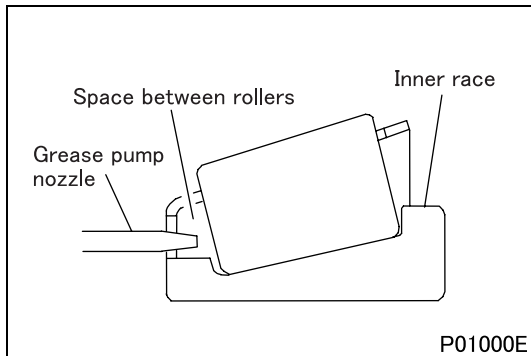
## ■ Installation: Packing grease in inner bearing inner race

- Insert the grease pump nozzle into the space between rollers of the inner bearing inner race to pack grease sufficiently.

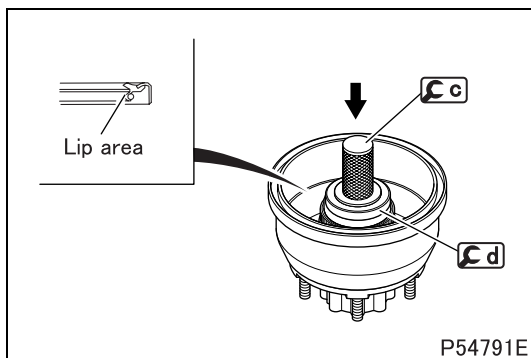
## ■ Installation: Oil seal

- Apply grease to the lip area of the oil seal and install it on the wheel hub in the illustrated direction.

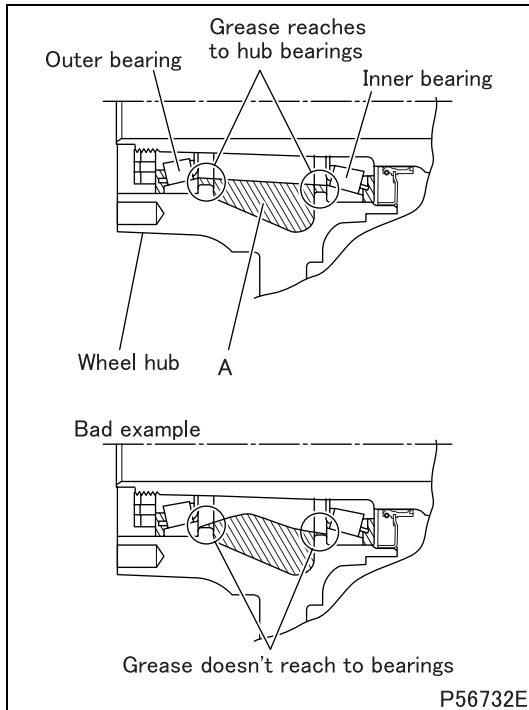
#### ■ Installation: Parking grease in wheel hub

- Apply specified amount of grease to inside A of wheel hub so that the grease reaches inner bearing and outer bearing as illustrated.

- Applying grease as illustrated in the “bad example” causes the wheel hub bearing to seize.

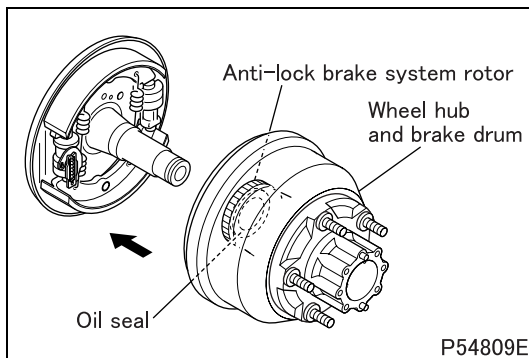
#### ■ Installation: Wheel hub and brake drum

- Slowly install the wheel hub and brake drum assembly so as not to cause damage to the oil seal and anti-lock brake system rotor.

- If the anti-lock brake system rotor is damaged, wheel speed sensor signals become abnormal, causing the anti-lock brake system to malfunction.

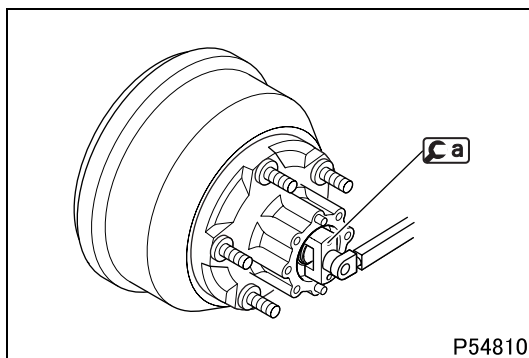
#### [Adjustment]

- Tighten the lock nut to the specified torque (primary tightening) while turning the wheel hub and brake drum, and then loosen it completely.
- Smooth operation of the outer bearing and inner bearing by turning the wheel hub and brake drum several times, and then tighten the lock nut to the specified torque (secondary tightening).

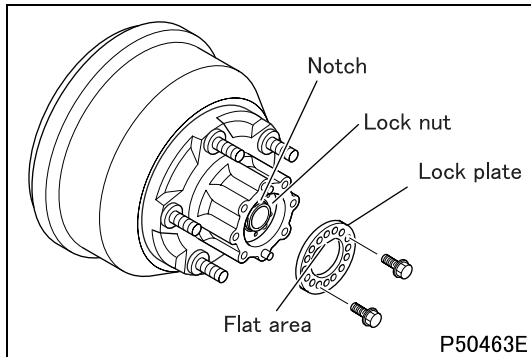
- Insert the flat area of the lock washer, aligning it with the notch of the axle housing, and mount two bolts diagonally to the lock nut.
- If the lock nut does not align with a screw hole of the lock washer, align by loosening the lock nut. Make sure that there is no play in the axial direction.

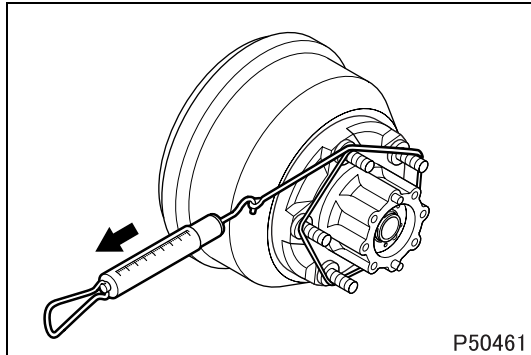
## [Inspection]

- After installing the lock washer, carry out the following inspections.
- Make sure that there is no drag in the brake lining and brake drum.
- If any abnormality is found, adjust the brake shoe clearance.
- Measure the tangential force at the hub bolt position using a spring balancer.
- If the tangential force is within the specified value, the starting torque conforms to the standard value. If the measured value deviates from the specified value, repeat adjustment, because the adjustment of the lock nut may be insufficient.
- If the result is found to be abnormal, replace the outer and inner bearings.

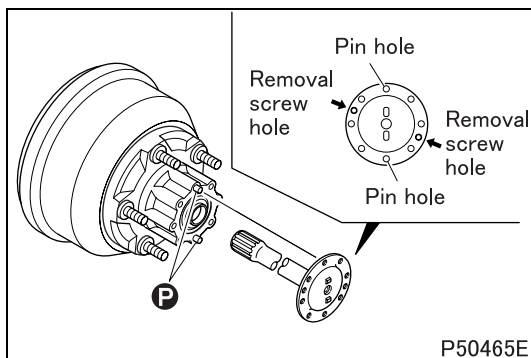
## ■ Installation: Axle shaft

- Align the pin hole of the locating pin with that of the axle shaft to install the axle shaft.

- **A pin hole is not necessarily located at the position of a protrusion on the axle shaft flange face. The second hole from a removal screw hole clockwise is a pin hole.**

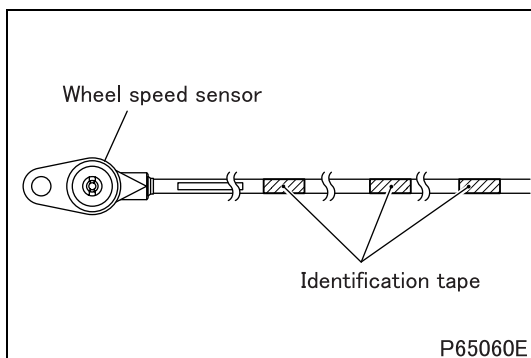
## ■ Installation: Wheel speed sensor

- Using clips, secure in place the wheel speed sensor harness at the identification tape portions, ensuring that the harness is free of kinks, slack and/or interference with other parts.

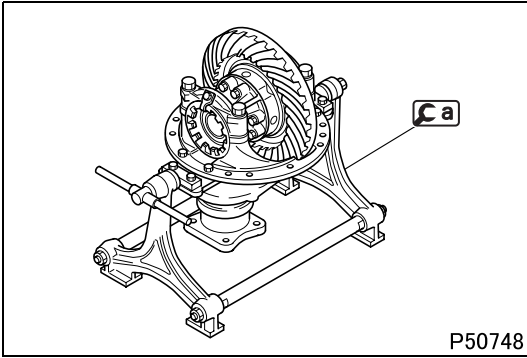
## ■ Preparatory work: Installation of differential working base assembly

- Install the reduction and differential on **Ca**.

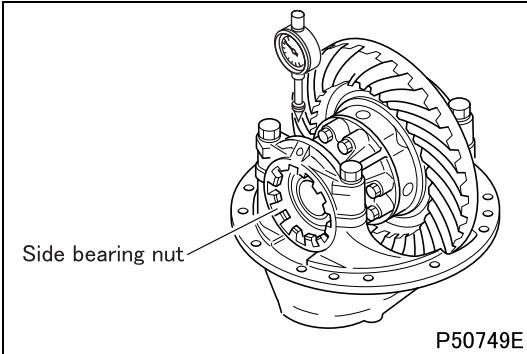
## ■ Inspection: Backlash between reduction gear and reduction pinion

- If backlash is found faulty, the tightening amount of the side bearing nut is probably inappropriate.

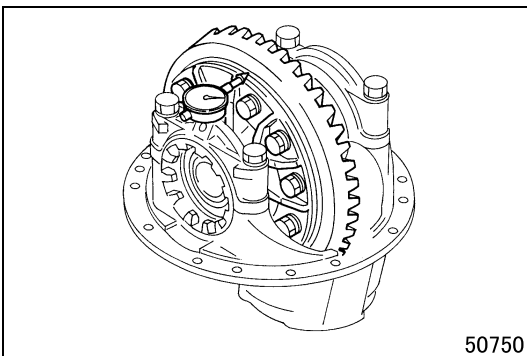
## ■ Inspection: Wobble at back face of reduction gear

- Measure wobble at the illustrated position of the reduction gear.

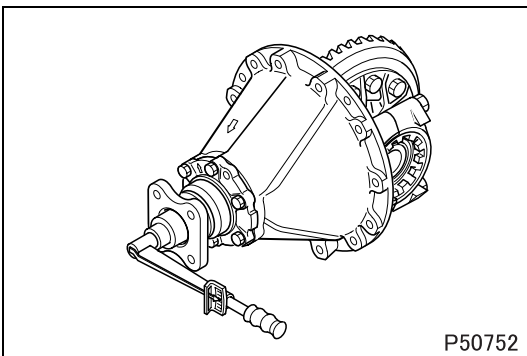
## ■ Inspection: Starting torque of side bearing

- Measure starting torque of the pinion assembly using a torque wrench and calculate the starting torque of the side bearing using the following formula.

(Total starting torque – Pinion bearing starting torque (See later section.)) × Final ratio = Side bearing starting torque

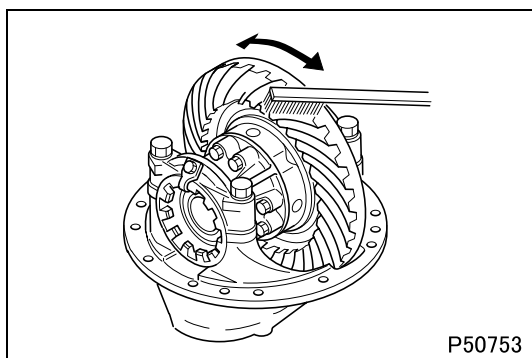
## ■ Inspection: Tooth contact of reduction gear

- Apply red lead to three to four teeth at three equally spaced points of the reduction gear.
- Turn the reduction gear several times to check for tooth contact.
