# FE.FG

## SERVICE MANUAL 2008 Model FOREWORD

This Service Manual contains maintenance and repair methods for the Mitsubishi Fuso Truck FE. FG Series. Read this manual carefully as an aid in providing correct, efficient maintenance. Please note that the information and specifications contained within this manual may change without notice. This is due to product modifications and continued vehicle improvements that are made throughout the model years. Should you encounter any discrepancy in the information provided, please do not hesitate to contact your nearest Mitsubishi Fuso Dealer or Mitsubishi Fuso Truck of America, Inc.

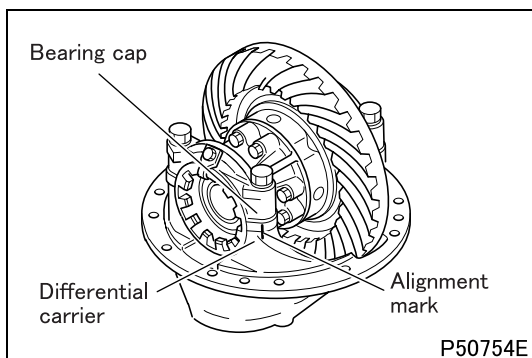
## ■ Alignment marks: Bearing cap and differential carrier

- Put alignment marks on the bearing cap and differential carrier for correct identification of right and left parts.

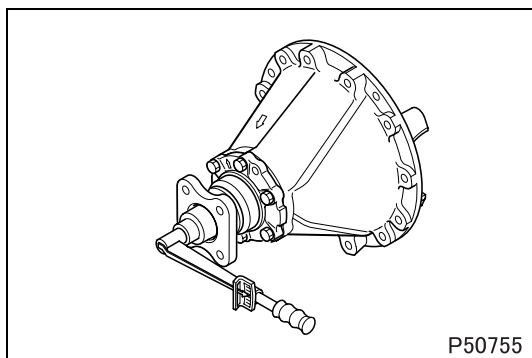
## ■ Inspection: Starting torque of pinion bearing

- After removing the differential, measure the starting torque of the pinion bearing.

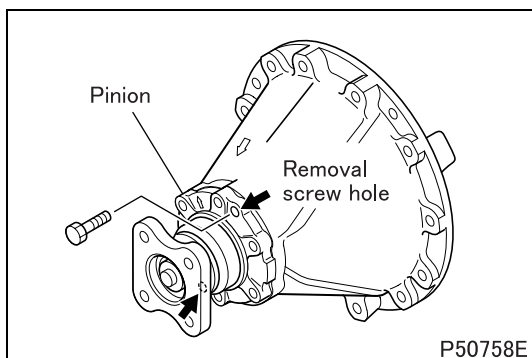
## ■ Removal: Pinion

- Screw two bolts evenly into the pinion removal screw holes to remove the pinion.

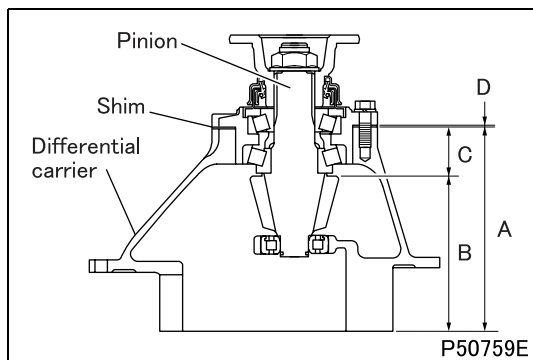
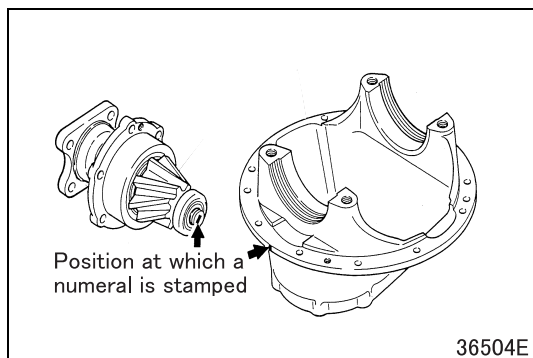
### ■ Adjustment: Reduction pinion

- Perform the following steps to adjust A, B and C within the specified dimensions.
- Calculate shim thickness D by using the following formula based on the machining error data stamped on pinion assembly and differential carrier.
- Formula:

- Select a shim based on shim thickness D.  
 Thickness of shims available  
 0.1 mm {0.0039 in.}, 0.2 mm {0.0079 in.} (two thickness)

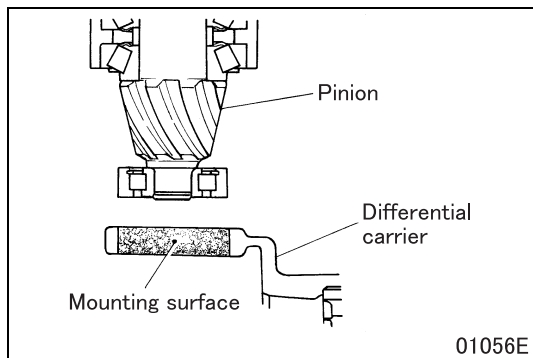
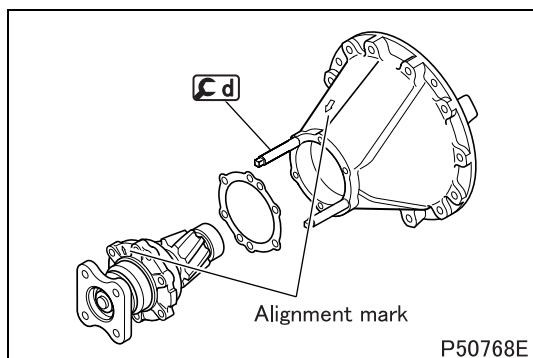
### ■ Installation: Reduction pinion

- Apply sealant to the pilot bearing mounting surface of the differential carrier.

- Leave for 30 minutes to 2 hours after installation to let the sealant harden.
- Wait at least three hours or, if feasible 24 hours, before running the vehicle to let the sealant harden.

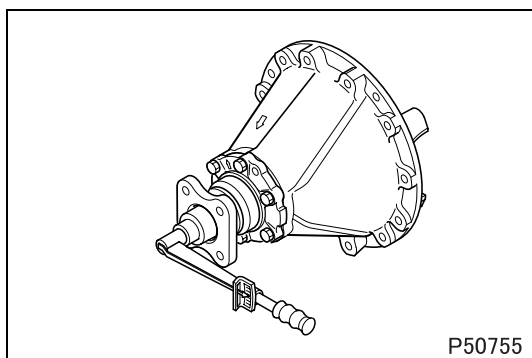
## ■ Inspection: Starting torque of pinion bearing

- After installing the pinion, measure the starting torque of the pinion bearing.
- If the measured value deviates from the standard value, adjust.

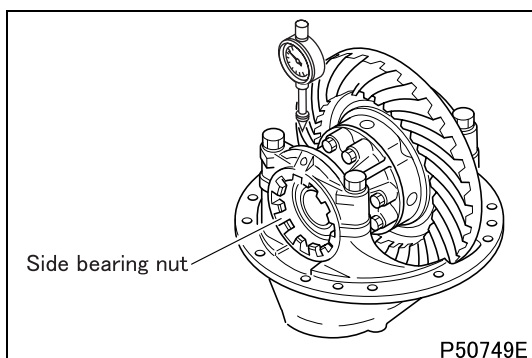
## ■ Adjustment: Backlash between reduction gear and reduction pinion

- Adjust backlash with the side bearing nut, using care not to allow the side bearing starting torque to change.

- When one side bearing nut is loosened, be sure to tighten the other one the same amount to prevent the side bearing starting torque from changing.

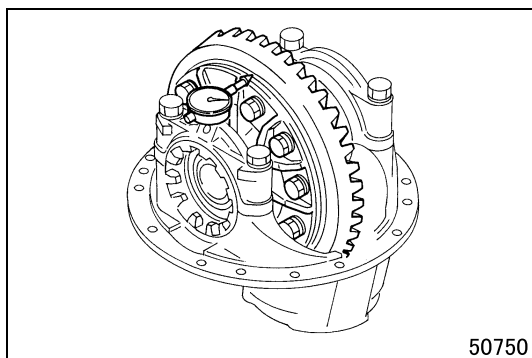
## ■ Inspection: Wobble at back face of reduction gear

- Measure wobble at the illustrated position of the reduction gear.
- If the measured value deviates from the standard value, replace the reduction gear and reduction pinion of the differential as a set.

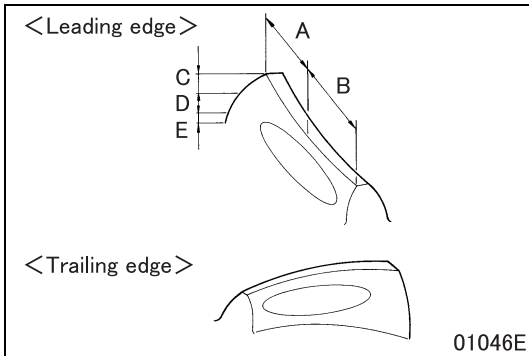
### ■ Inspection: Tooth contact of reduction gear

- Apply red lead to three to four teeth at three equally spaced points of the reduction gear.
- Turn the reduction gear several times to check for tooth contact.
- Adjust tooth contact if it is remarkably offset.

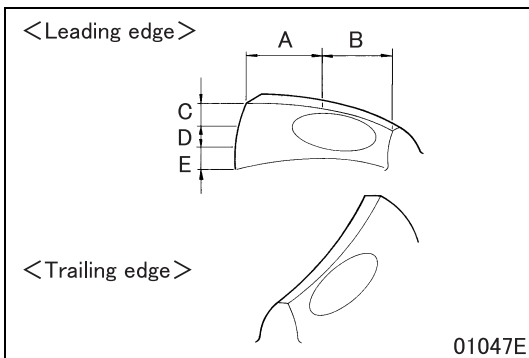
#### <Reduction Pinion>

- A: Heel  
B: Toe  
C: Face  
D: Flank  
E: Clearance

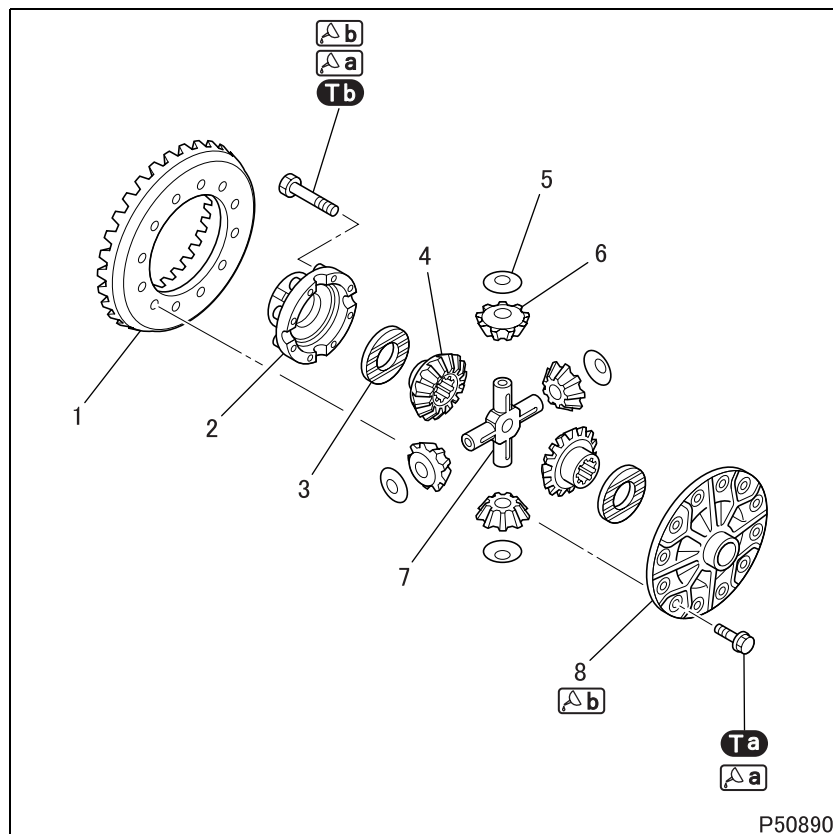
### ● Disassembly sequence

- 1 Reduction gear
- 2 Differential case RH
- 3 Side gear washer
- 4 Side gear
- 5 Pinion washer
- 6 Differential pinion
- 7 Pinion spider
- 8 Differential case LH

- Be sure to replace the differential case RH and the differential case LH as a differential case set.
- Be sure to replace the side gear and the differential pinion as a side gear set.

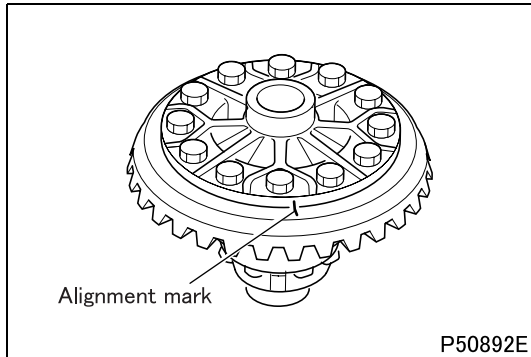
#### ■ Alignment marks: Reduction gear and differential case LH

- Put alignment marks on the reduction gear and differential case LH.

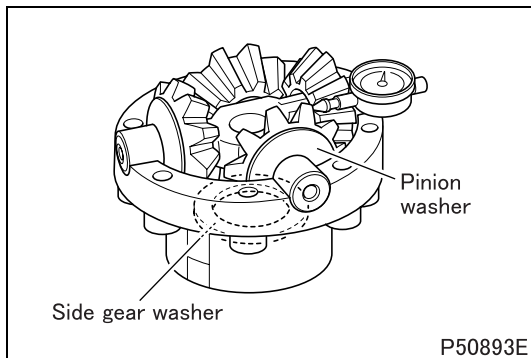
#### ■ Inspection: Backlash between side gear and differential pinion

- If backlash is found faulty, thickness of the side gear washer and pinion washer is probably inappropriate.

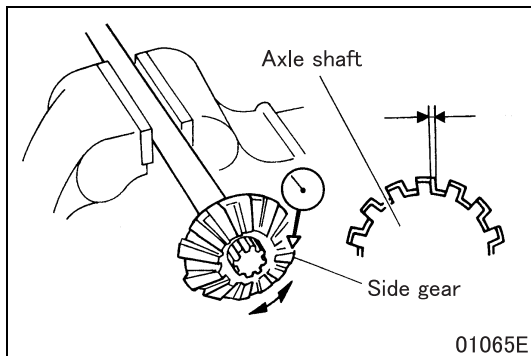
#### ■ Inspection: Backlash between side gear and axle shaft

- If the measured value exceeds the limit, replace defective parts.

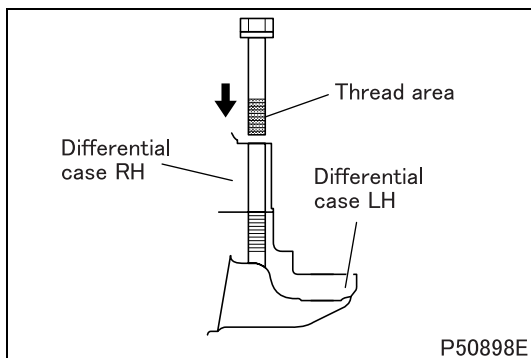
#### ■ Installation: Differential case RH and differential case LH

- Apply rust preventive to the entire surface of the bolt. After applying it, blow off the excess rust preventive on the bolt by compressed air.
- Apply thread lock cement to the bolt threads.
- Tighten the bolt to the specified torque.

- Make sure to apply rust preventive when tightening the bolt to the specified torque.
- Wait at least one hour after installation before actually running the vehicle to let the thread lock cement harden.
- Wait at least four hours after installation before operating the vehicle at full torque to let the thread lock cement harden.

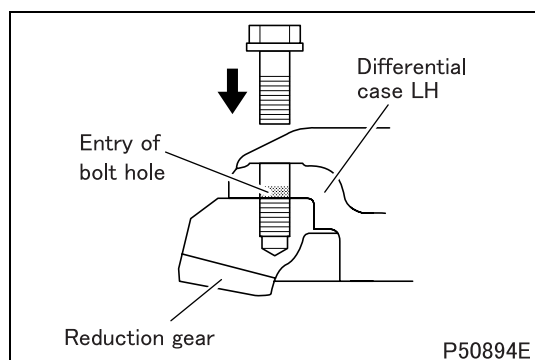
## ■ Installation: Reduction gear and differential case LH

- Apply rust preventive to the entire surface of the bolt. After applying it, blow off the excess rust preventive on the bolt by compressed air.
- Apply thread lock cement at the entry of bolt holes on differential case LH.
- Tighten the bolt to the specified torque.

- **Make sure to apply rust preventive when tightening the bolt to the specified torque.**
- **Wait at least one hour after installation before actually running the vehicle to let the thread lock cement harden.**
- **Wait at least four hours after installation before operating the vehicle at full torque to let the thread lock cement harden.**

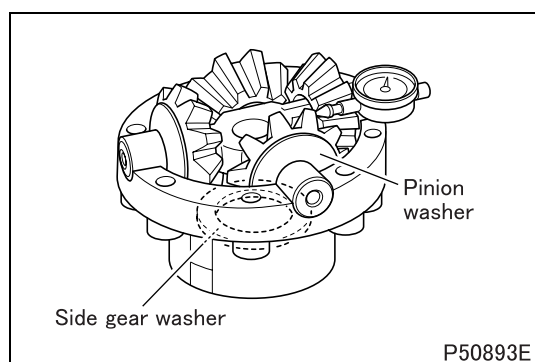
## ■ Inspection: Backlash between side gear and differential pinion

- If the measured value deviates from the standard value, replace the side gear washer and pinion washer.  
Thickness of side gear washers available  
3.0 mm {0.11 in.} (one thickness)  
Thickness of pinion washers available  
1.6 mm {0.063 in.} (one thickness)

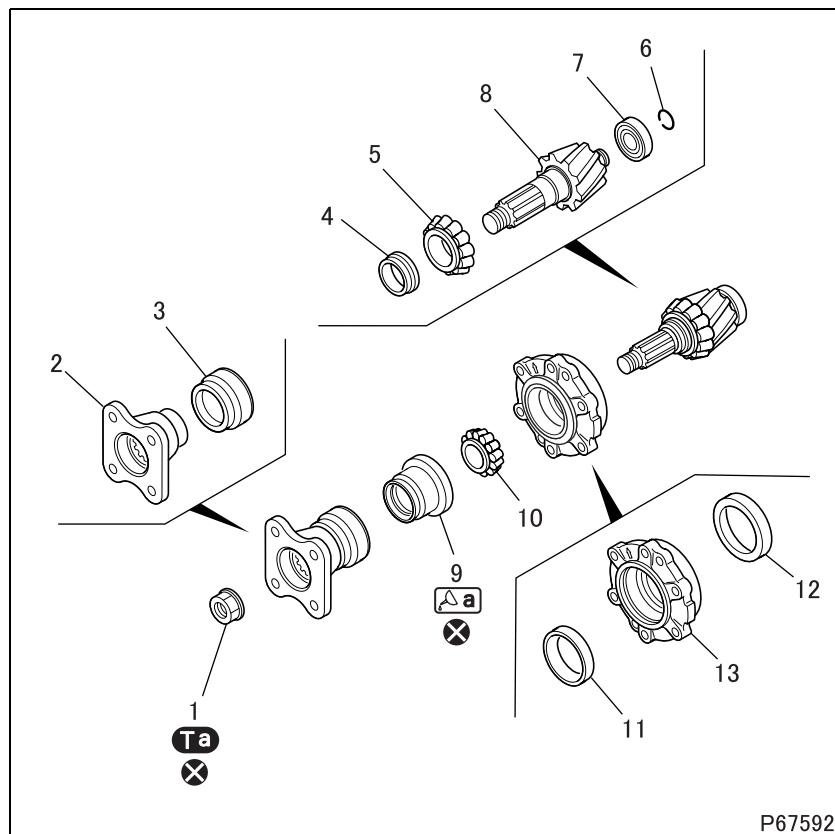
### ● Disassembly sequence

- 1 Lock nut
- 2 Companion flange
- 3 Dust cover
- 4 Collar
- 5 Rear bearing inner race
- 6 Lock ring
- 7 Pinion pilot bearing
- 8 Reduction pinion
- 9 Oil seal
- 10 Front bearing inner race
- 11 Front bearing outer race
- 12 Rear bearing outer race
- 13 Bearing retainer

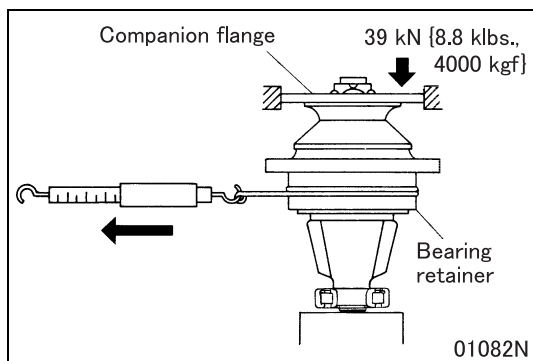
### ■ Inspection: Starting torque of pinion bearing

- Apply the specified load to the companion flange or tighten the lock nut to the specified torque.
- Measure the tangential force at outer periphery point of the bearing retainer using a spring balancer.

- If the measured tangential force is within the specified value, the starting torque conforms to the standard value.

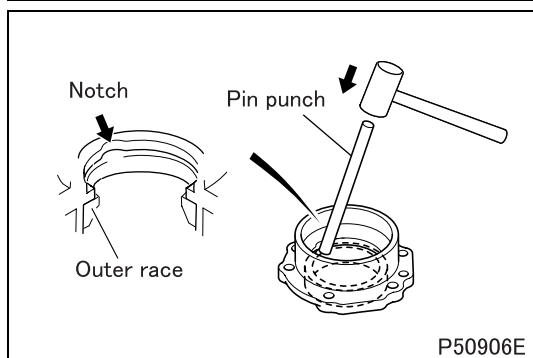
### ■ Removal: Front bearing outer race

- Drive out the front bearing outer race by tapping evenly at three indented parts in the bearing retainer.

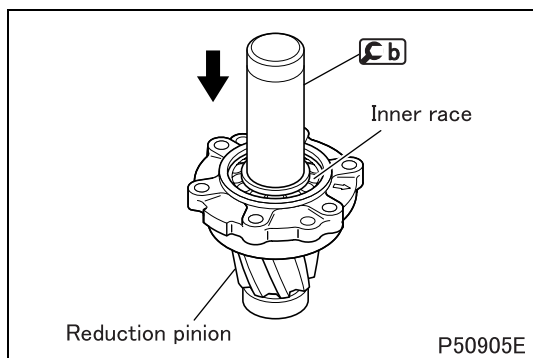
## ■ Installation: Front bearing inner race

- Install the front bearing inner race with the pinion assembled into the bearing retainer.

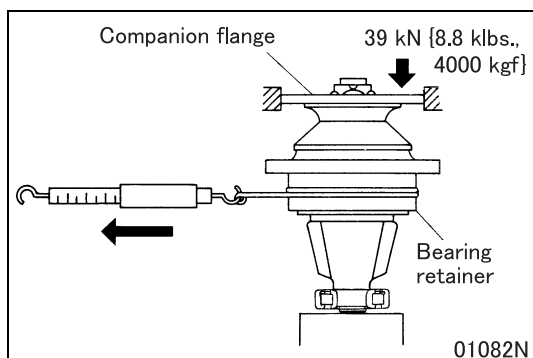
## ■ Inspection: Starting torque of pinion bearing

- Apply the specified load to the companion flange or tighten the lock nut to the specified torque.
- Measure the tangential force at outer periphery point of the bearing retainer using a spring balance.

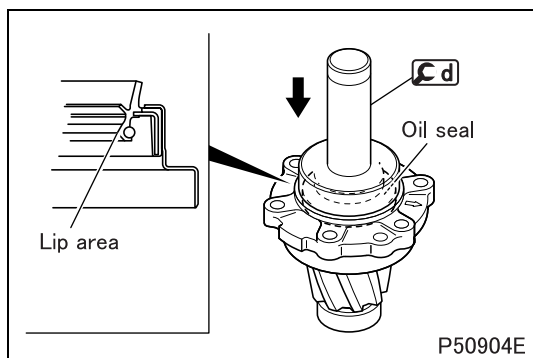
## ■ Installation: Oil seal

- Apply grease to the lip area of the oil seal and install it on the bearing retainer in the illustrated direction.

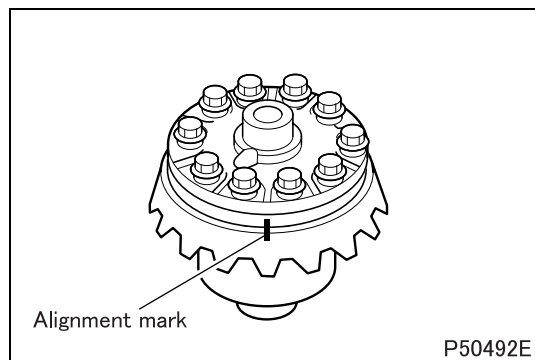
#### ■ Alignment marks: Reduction gear and limited slip differential

- Put alignment marks on the reduction gear and limited slip differential.

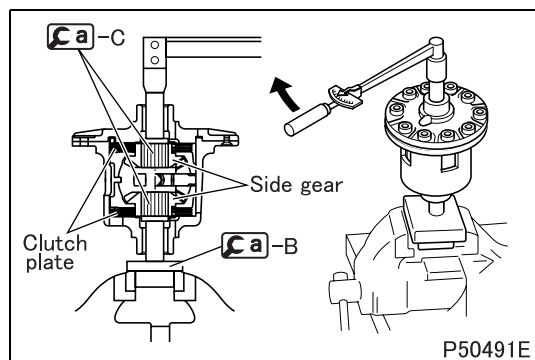
#### ■ Inspection: Rotation torque of LSD clutch plate

- After removing the reduction gear, carry out the following inspection.
- Measure the rotation torque to check for the friction force of the clutch plate.

- For measurement of rotation torque, rotate the side gears to sufficiently smooth their operation and measure the value during their rotation.

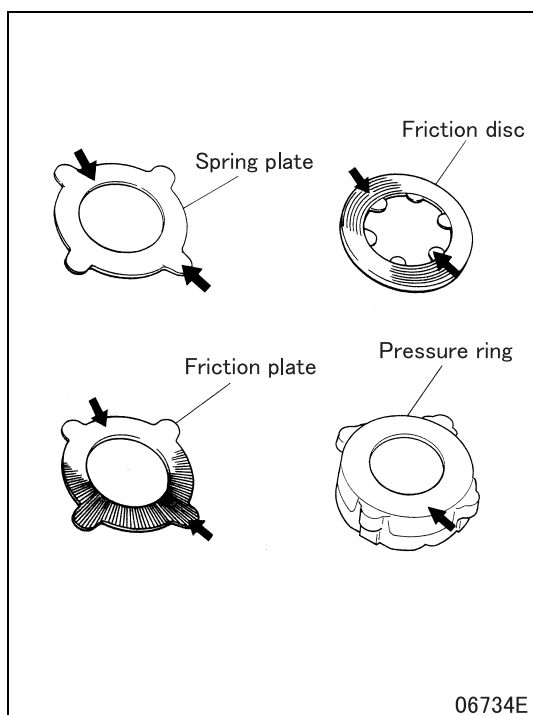
## ■ Inspection: Limited slip differential

### (1) Inspection of contacting and sliding surfaces

- If heat discoloration and remarkable wear are found on friction surfaces and sliding surfaces of the spring plates, spring discs, friction discs and friction plates, replace defective parts.

- **Strong contact on the inner periphery of friction surfaces is caused by the spring force of each plate and disc. Do not mistake that it is caused by abnormal wear.**

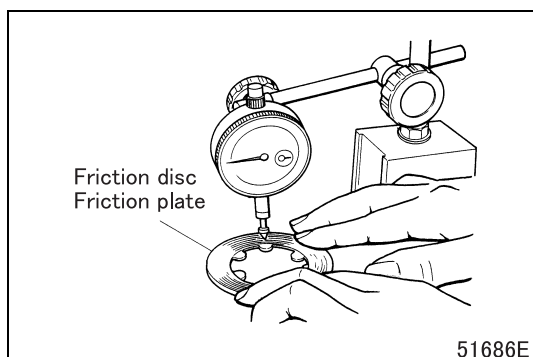
### (2) Inspection of distortion

- Apply a dial gauge to the friction disc and friction plate on a surface plate and measure their distortion (flatness) while turning them. If the measured value exceeds the limit, replace.

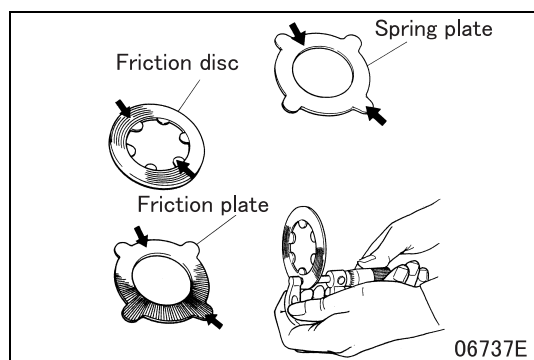
## (3) Inspection of thickness

- Measure thickness of the friction surfaces and protrusions ◀ of the spring plate, friction disc and friction plate, and find the difference. If it exceeds the limit, replace defective parts.

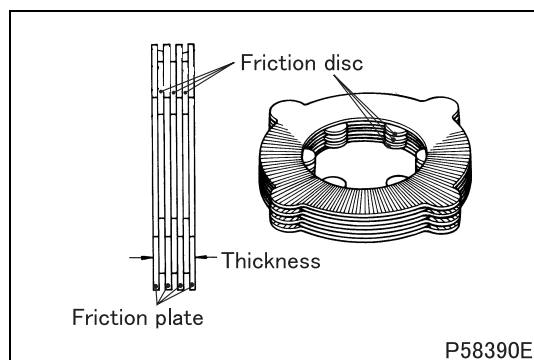
- Before assembling the limited slip differential, adjust the dimensional difference (friction force of clutch plate) in the axial direction and the clearance in the side gear axial direction, when assembling integral parts of the differential cases LH and RH, in the following procedure.

- Pile friction discs and friction plates as illustrated and measure thickness with a micrometer. Select the combination so that the difference in thickness between the right and left combination falls within the range of the standard value.

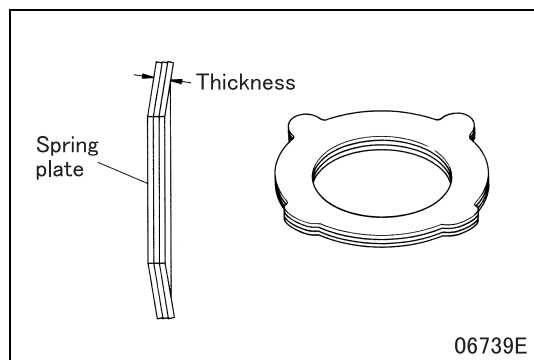
- Pile a spring plate and a spring disc as illustrated and measure thickness with a micrometer. Select the combination so that the difference in thickness between the right and left combination is as small as possible.

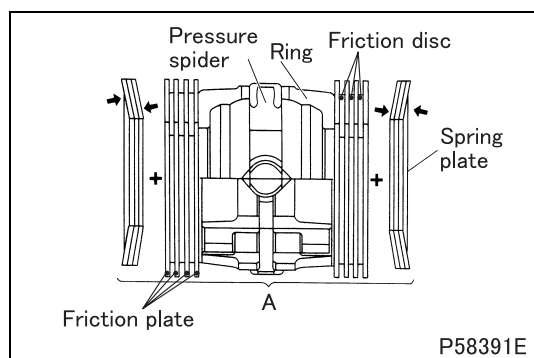
- Assemble the pressure rings, pinion spiders, friction discs, friction plates, spring plates and spring discs and measure overall width A with a micrometer.

- Measure the overall width with the V-shaped groove of the pressure ring pressed against the pinion spider from both sides to obtain secure contact.

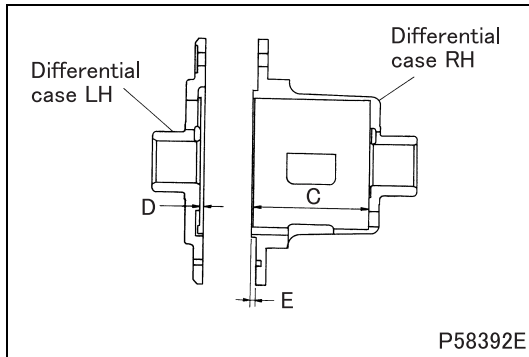
- Find dimension B between spring plate contact faces when the differential cases LH and RH are combined.  
 $B = C + D - E$

- If overall width A measured in the previous item and the clearance (B-A) between the differential cases LH and RH deviate from the standard value, adjust by changing a friction plate.

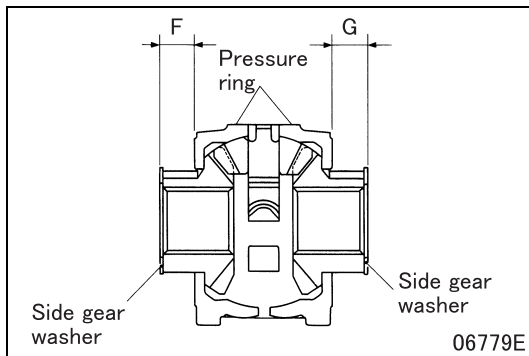
- After installing the side gear washers as illustrated, make sure that the difference between F and G dimensions from the back face of the pressure rings to the end face of the side gear washers falls within the range of the standard value.

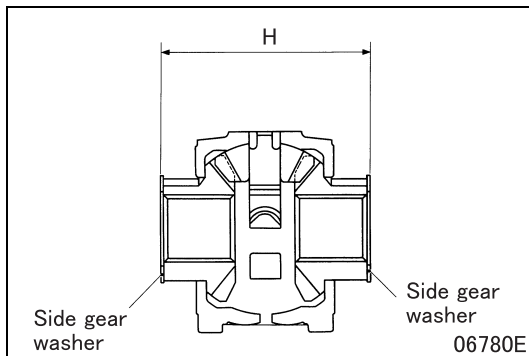
- Measure overall width H.

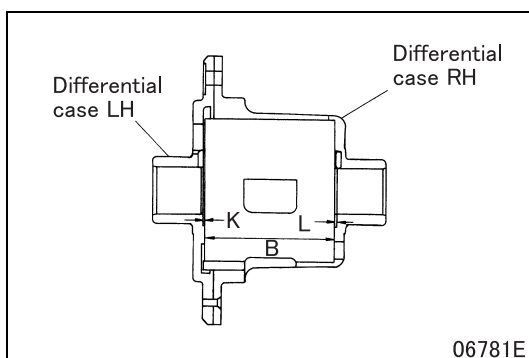
- Find dimension J between side gear washer contact faces when the differential cases LH and RH are combined.

$$J = B + K + L$$

- For dimension B, refer to the difference between spring plate contact surfaces found in the previous item when the differential cases LH and RH are combined.

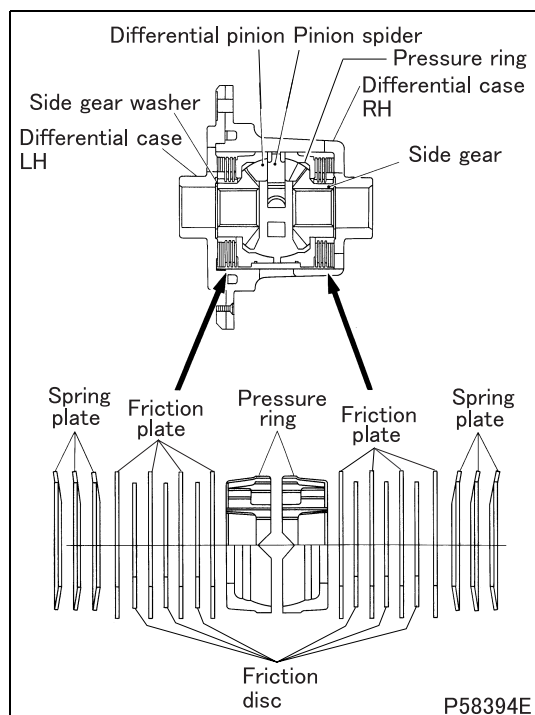
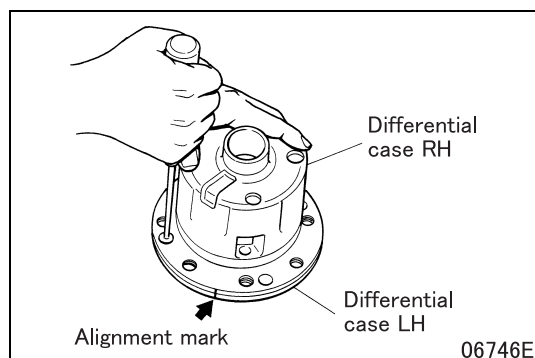
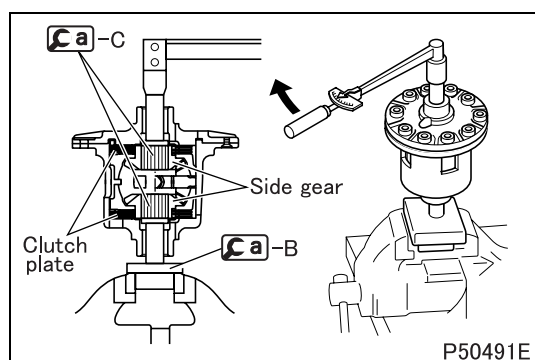
### ■ Assembly: LSD (Limited Slip Differential)

- Assemble each part into the differential case RH in the illustrated direction.

- If the differential cases LH and RH do not contact positively each other even after screws have been tightened fully, improperly assembled side gear washers and spring plates are suspected. In that case, reassemble these parts.

- For measurement of rotation torque, rotate the side gears to sufficiently smooth their operation and measure the value during their rotation.
- If the measured value deviates from the standard value, replace defective parts of the internal components.

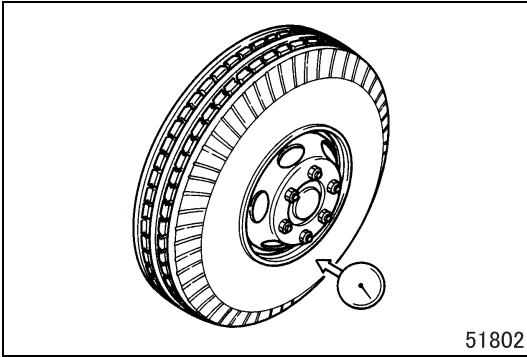
### ■ Inspection: Tire

- Measure the tire for lateral runout (sideway deflection).
- If the measured value is equal to or exceeds the standard value, correct as follows.

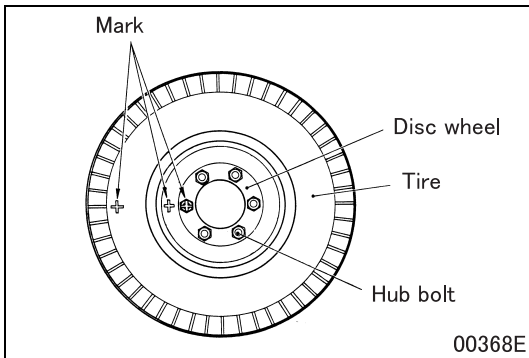
### ■ Correction: Tire

- Mark the tire, disc wheel, and one of the hub bolts in the illustrated locations.
- Remove the tire from the disc wheel.

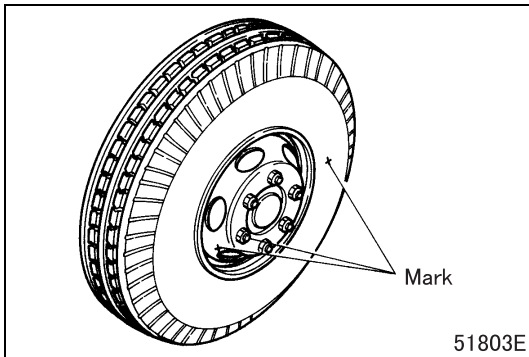
- Measure the disc wheel for lateral runout.
- If the disc wheel's maximum runout is located near the mark on the wheel, install the tire such that the mark on the tire is 180° away from the mark on the disc wheel.
- Measure the tire again for lateral runout.
- If the measured value still does not conform to the standard value, replace the tire.

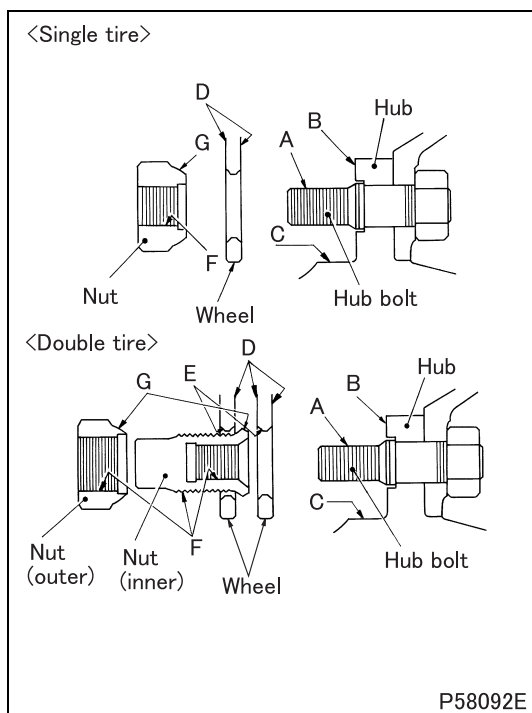
### ■ Installation: Tire

- To prevent hardware and parts from becoming loose and/or damaged, thoroughly clean the following areas, removing rust, dirt, paint and foreign matter, before installing the tire.

- A: Threaded portion of hub bolt
- B: Wheel mounting surface of hub
- C: Wheel alignment area of hub
- D: Mating surfaces of disc wheel
- E: Wheel nut mounting surface of disc wheel
- F: Threaded portion of wheel nut
- G: Spherical portion of wheel nut

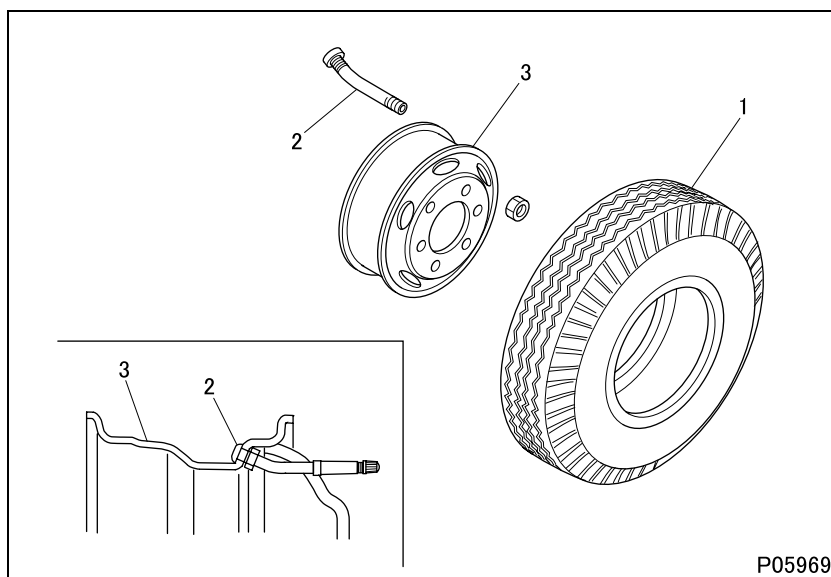
### ● Disassembly sequence

- 1 Tire
- 2 Air valve
- 3 Disc wheel

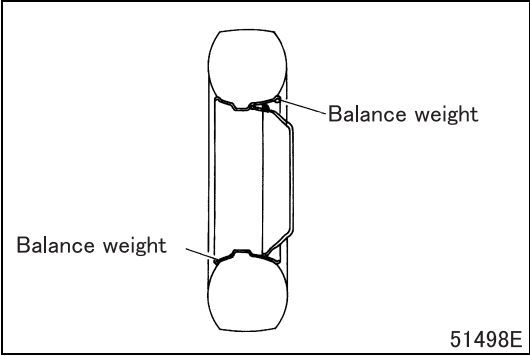
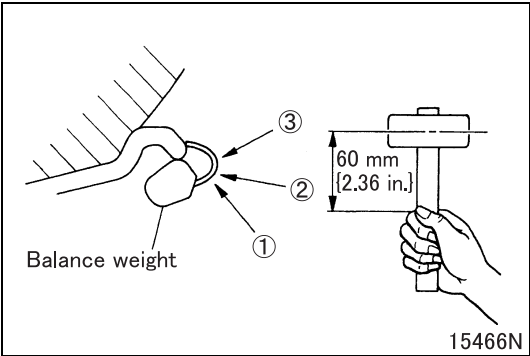
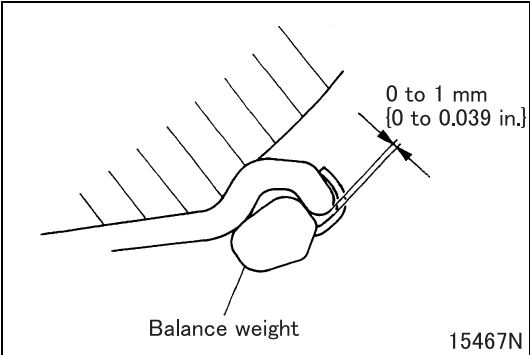
### ■ Installation: Balance weight

- Install balance weights onto the front and back sides of the disc of the tires listed in the table below. Ensure that the static unbalance of the tire being balanced remains within the standard value.

- Use a 1-pound resin hammer to drive balance weights into position.
- To install a balance weight, tap the clip of the weight in the center at 1, 2 and 3 in that order.
- Leave a clearance of approx. 0 to 1 mm {0 to 0.039 in.} between the clip and the disc wheel. Ensure that the balance weight is not loose after installation.
- Do not use a balance weight that has been improperly tapped or dropped to the floor during installation attempt.
- When 2 weights are being installed, these weights should be as much equal to each other as possible in weight. Also remember that the center point between the weights will become the support point for a balancer.

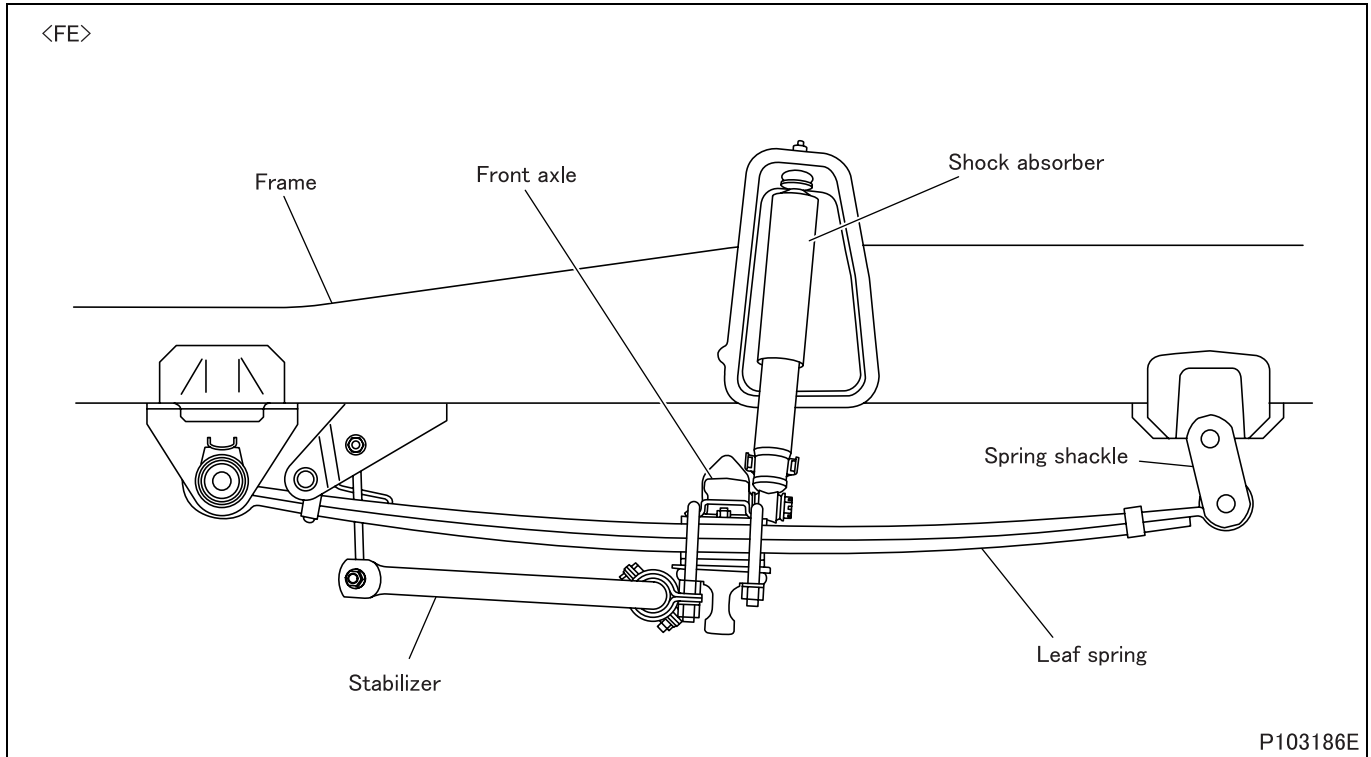
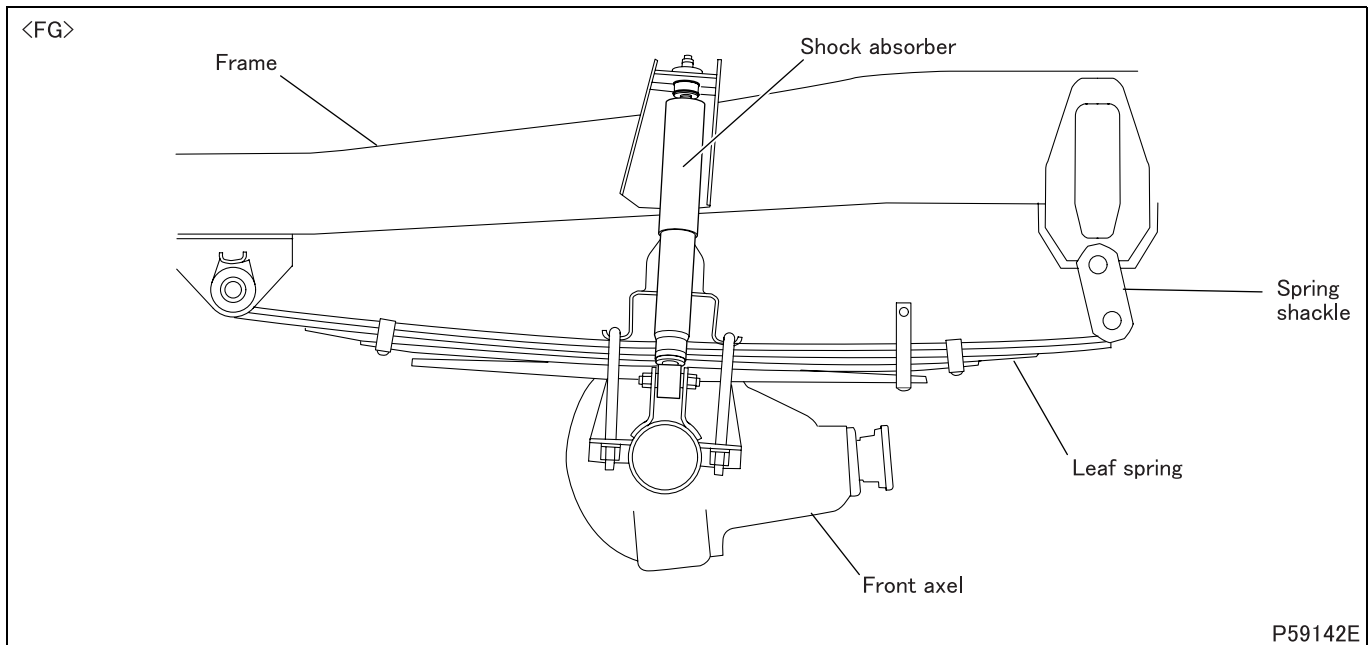
## 1. Front Suspension Elements

- The front suspensions shown above both use a spring shackle connected to the rear end of the leaf spring (shackle-link type suspension).
- The stabilizer prevents the vehicle from pitching, keeping it parallel with the ground.

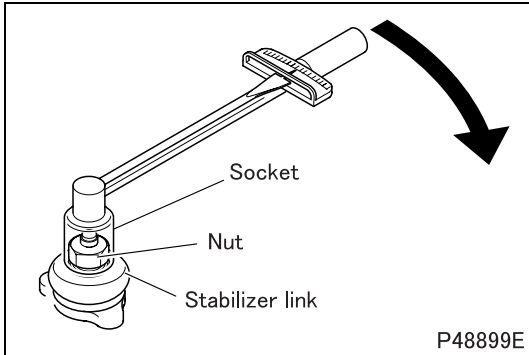
### ■ Inspection: Stabilizer link

#### (1) Starting torque

- Install a nut onto the stabilizer link.
- Install a socket and a torque wrench onto the nut. Measure the starting torque of the stabilizer link.
- If the measured value does not conform to the standard value, replace the stabilizer link.

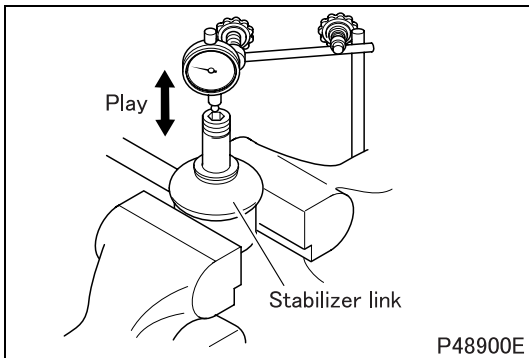
#### (2) Play

- If the measured value does not conform to the standard value, replace the stabilizer link.

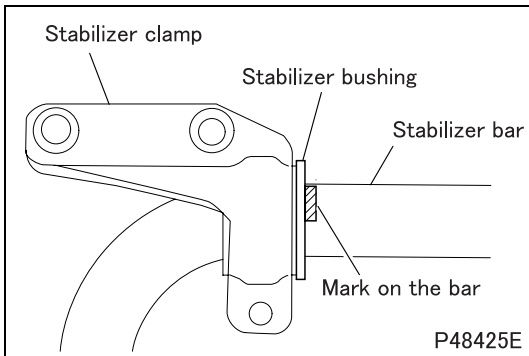
### ■ Installation: Stabilizer clamp and bushing

- Position the stabilizer bushing onto the stabilizer bar such that the end of the bushing aligns with the mark on the bar. Clamp them in place with the stabilizer clamp.

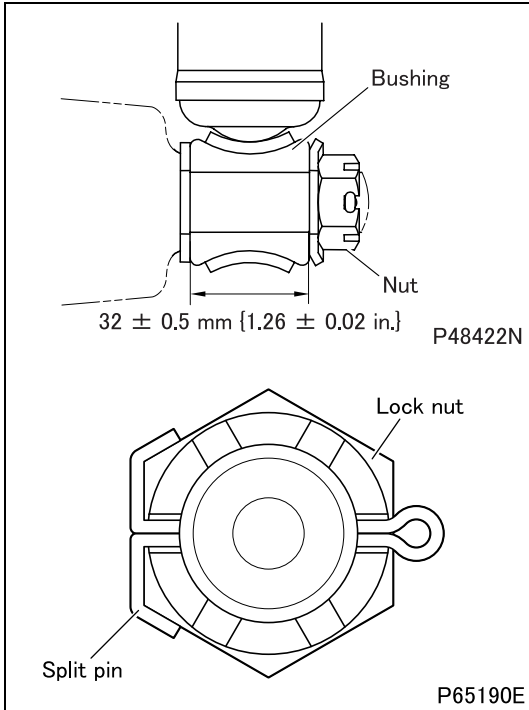
### ■ Installation: Rubber bushing

- Tighten the nut until the rubber bushing is squeezed to the illustrated dimension.
- Install the split pin as shown in the illustration.

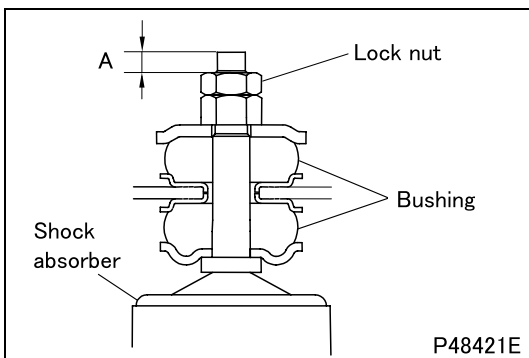
### ■ Installation: Rubber bushing

- Tighten the nuts until dimension A in the illustration becomes equal to the following value.  
A:  $4.7 \text{ mm}$  { $0.19 \text{ in.}$ }

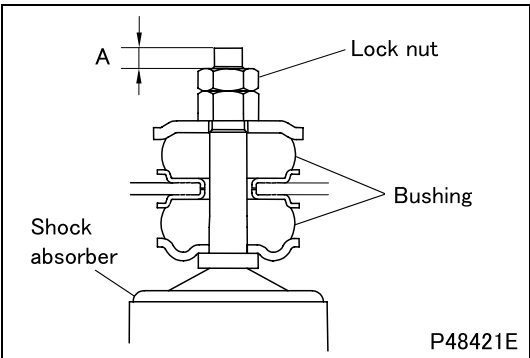
### ■ Installation: Rubber bushing

- Tighten the nuts until dimension A in the illustration becomes equal to the following value.  
A: 4.2 mm {0.17 in.}

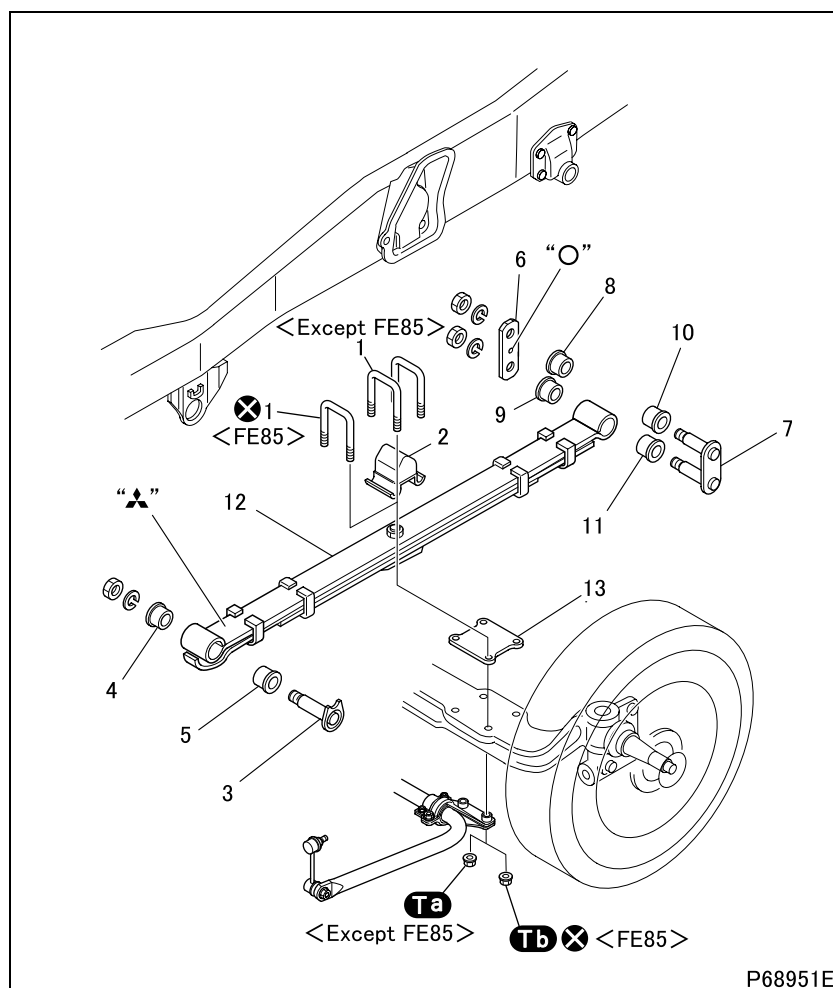
## ● Removal sequence

- 1 U-bolt
- 2 Front axle bumper
- 3 Spring pin
- 4 Rubber bushing
- 5 Rubber bushing
- 6 Shackle plate
- 7 Spring shackle
- 8 Rubber bushing
- 9 Rubber bushing
- 10 Rubber bushing
- 11 Rubber bushing
- 12 Leaf spring (See later section.)
- 13 Spacer

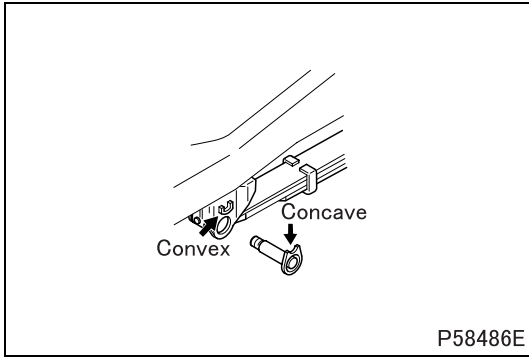
### ■ Installation: Spring pin

- Install the spring pin such that the concave on the pin engages with the convex on the frame.

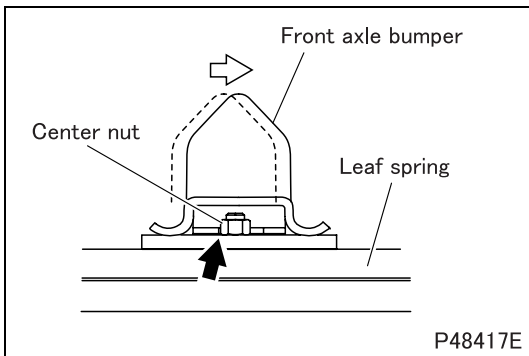
### ■ Installation: Front axle bumper

- With the unloaded vehicle, slide the front axle bumper on the leaf spring to the rear of the vehicle until it is against the center nut of the leaf spring. Then, install the bumper using U-bolts.

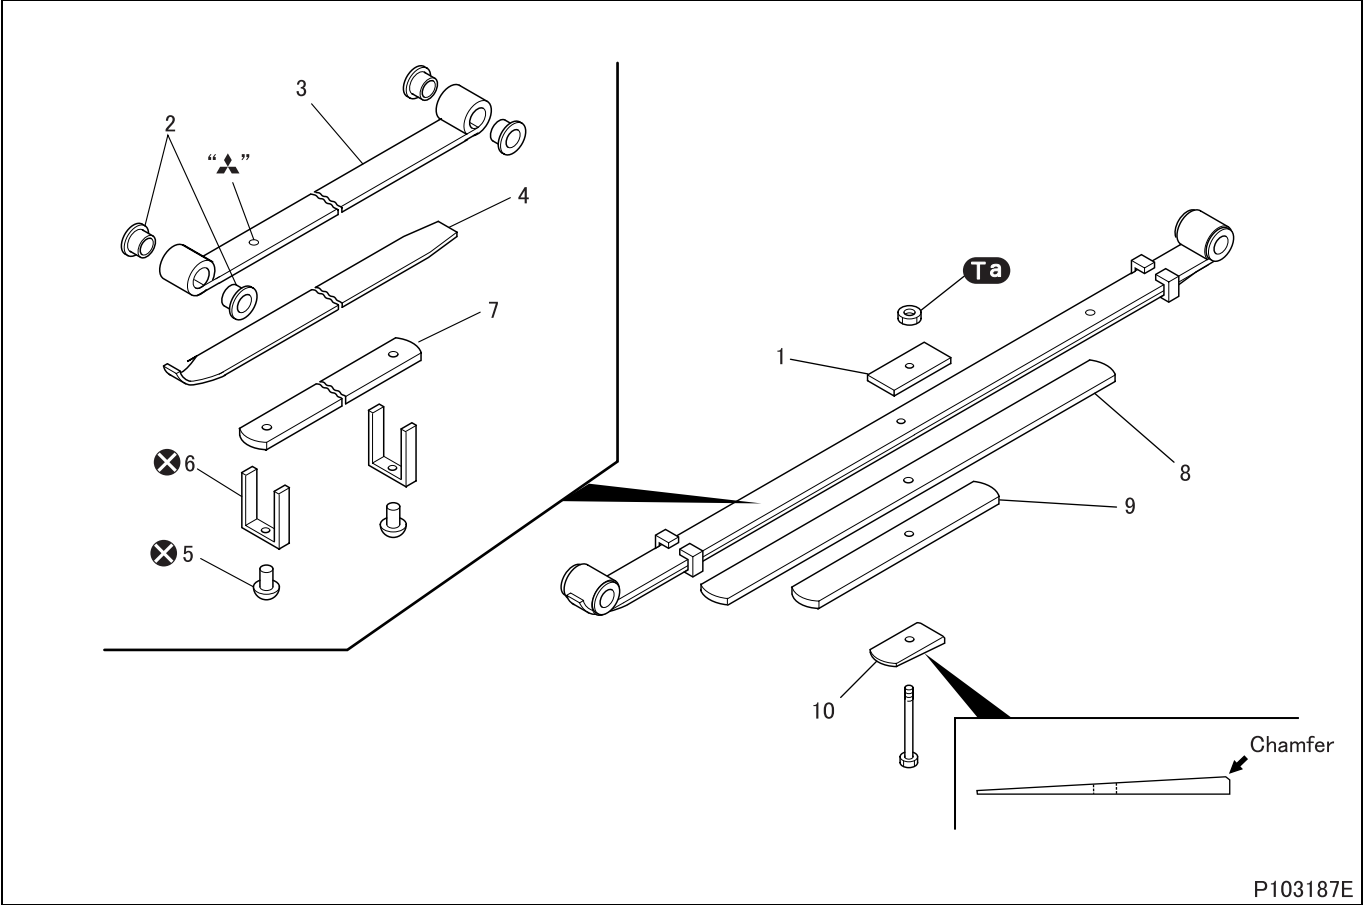
## Leaf Spring

- The above schematic is only an example. Details may differ depending on vehicle models, such as the number of spring leaves, spacers, and the parts used.

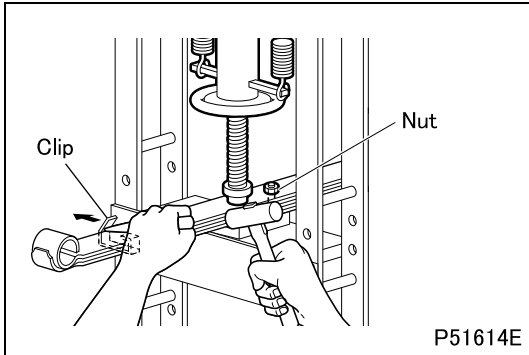
### ■ Compression: Leaf spring

- Using a press, compress the leaf spring as illustrated for subsequent operations.
- Using a chisel or the like, open the bent ends of the clip.

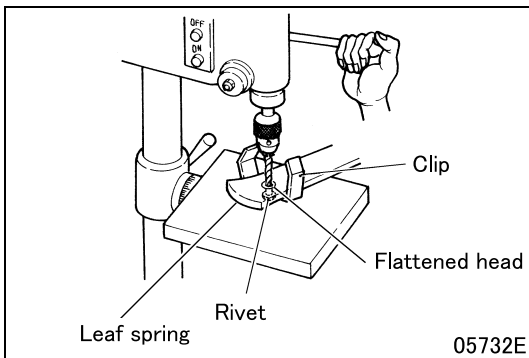
### ■ Removal: Clip

- Using a drill press, break the flattened head of the rivet and remove the clip from the leaf spring (No. 3).

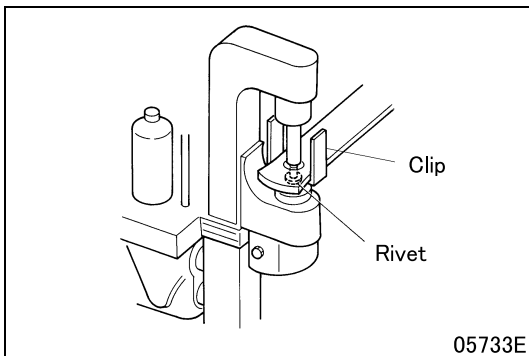
### ■ Installation: Clip

- Using a riveting machine, rivet a clip onto the leaf spring.

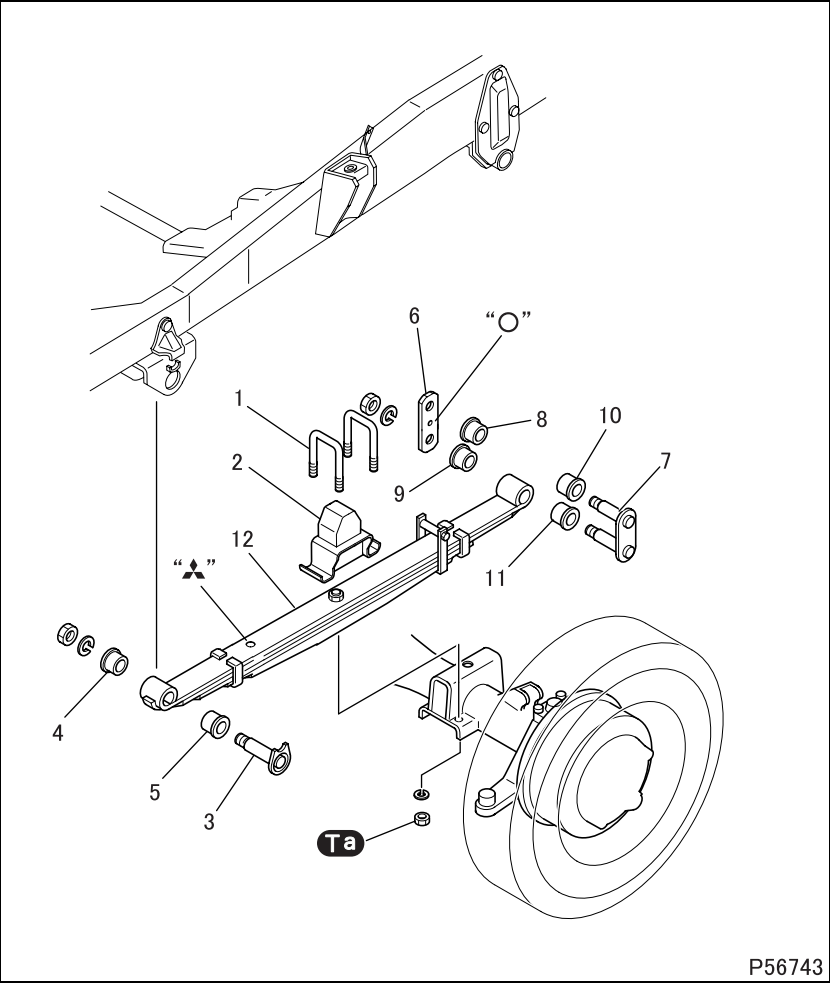
### ● Removal sequence

- 1 U-bolt
- 2 Front spring pad
- 3 Spring pin
- 4 Rubber bushing
- 5 Rubber bushing
- 6 Shackle plate
- 7 Spring shackle
- 8 Rubber bushing
- 9 Rubber bushing
- 10 Rubber bushing
- 11 Rubber bushing
- 12 Leaf spring (See later section.)

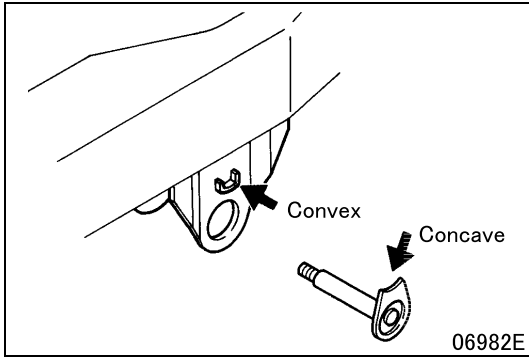
**■ Installation: Spring pin**

- Install the spring pin such that the concave on the pin engages with the convex on the frame.

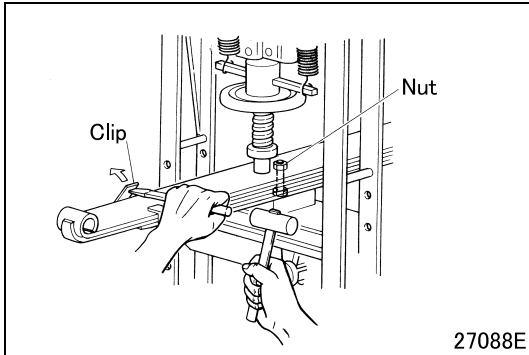
### ■ Compression: Leaf spring

- Using a press, compress the leaf spring as illustrated for subsequent operations.
- Using a chisel or the like, open the bent ends of the clip.
