# FE.FG

## SERVICE MANUAL 2008 Model FOREWORD

This Service Manual contains maintenance and repair methods for the Mitsubishi Fuso Truck FE. FG Series. Read this manual carefully as an aid in providing correct, efficient maintenance. Please note that the information and specifications contained within this manual may change without notice. This is due to product modifications and continued vehicle improvements that are made throughout the model years. Should you encounter any discrepancy in the information provided, please do not hesitate to contact your nearest Mitsubishi Fuso Dealer or Mitsubishi Fuso Truck of America, Inc.

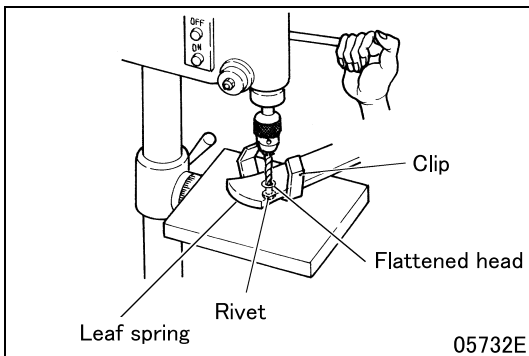
### ■ Removal: Clip

- Using a drill press, break the flattened head of the rivet and remove the clip from the leaf spring (No. 3 or 4).

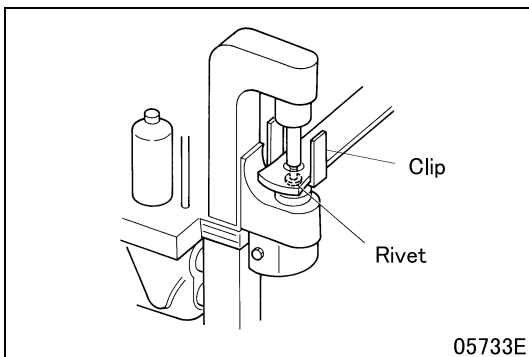
### ■ Installation: Clip

- Using a riveting machine, rivet a clip onto the leaf spring.

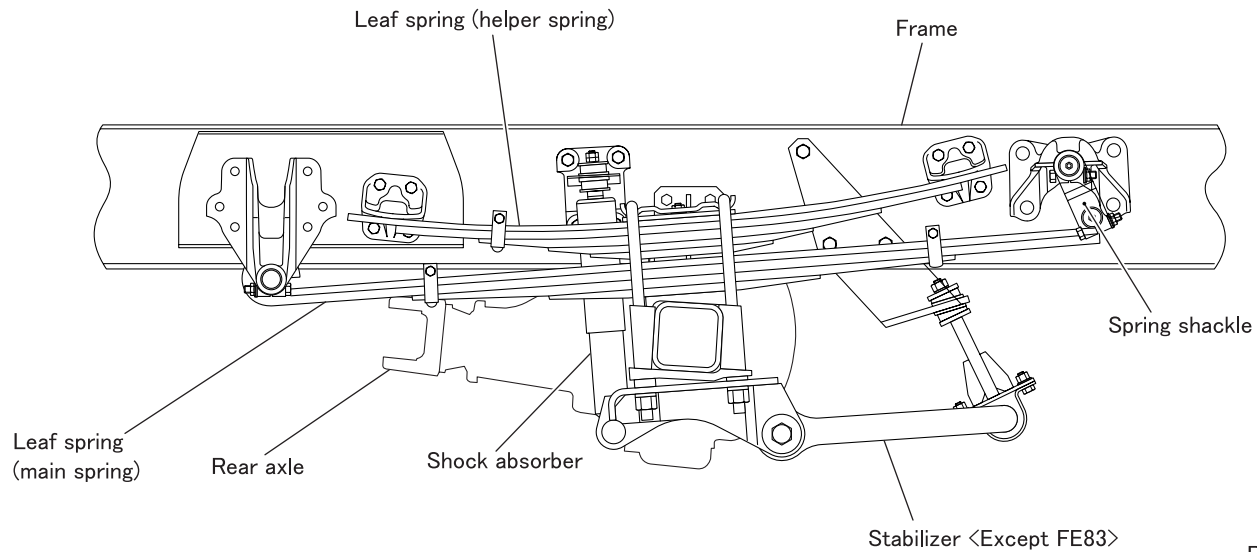
P103188E

<FE (except FE84DHW)>

- The rear suspensions shown above both use a spring shackle connected to the rear end of the leaf spring (shackle-link type suspension).
- The above schematics are only examples. Details may differ depending on vehicle models, such as the number of spring leaves, the shape of spring shackle, and the location of shock absorber.

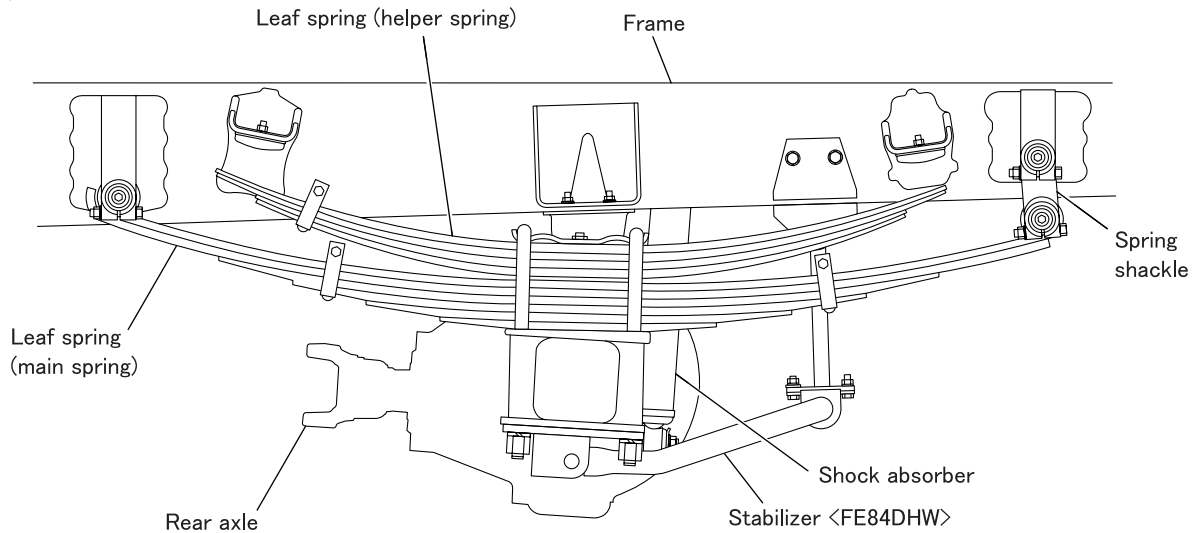
P103189E

<FE84DHW, FG>

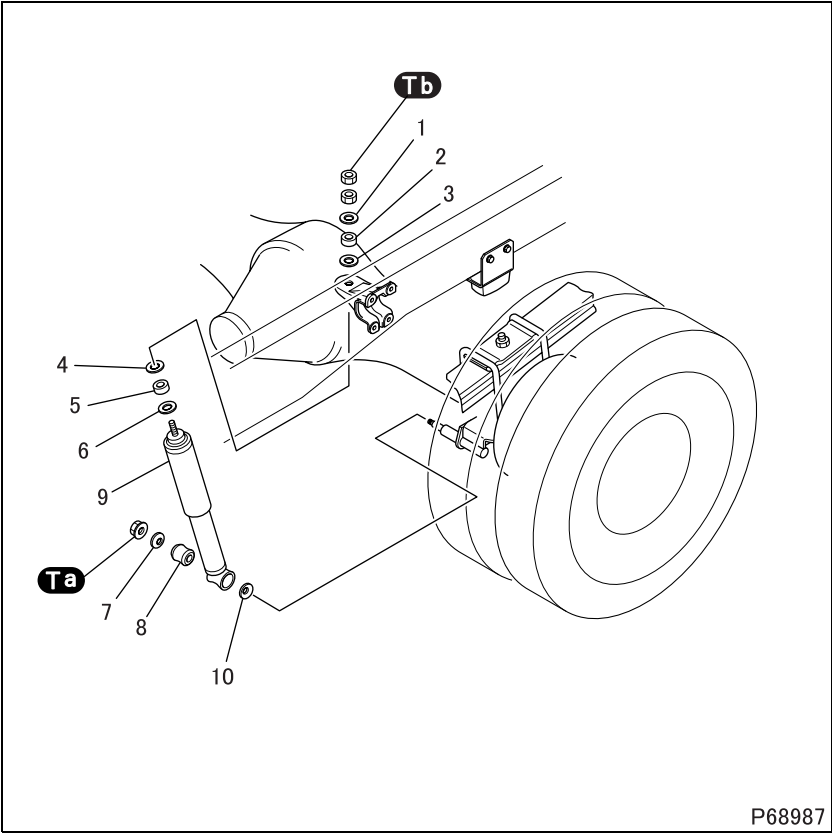
- 1 Washer
- 2 Rubber bushing
- 3 Washer
- 4 Washer
- 5 Rubber bushing
- 6 Washer
- 7 Washer
- 8 Rubber bushing
- 9 Shock absorber
- 10 Washer

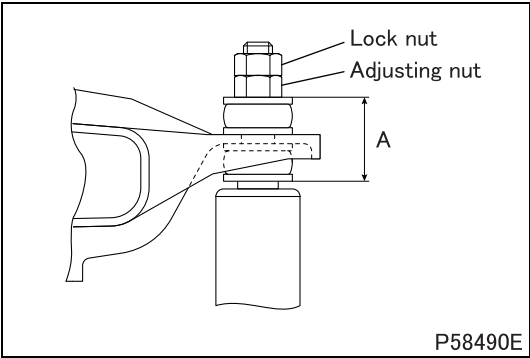
### ■ Installation: Shock absorber

- Tighten the adjusting nut until the part A in the illustration becomes the following dimension.  
A: 48 mm {1.89 in.}
- Tighten the lock nut to the specified torque.

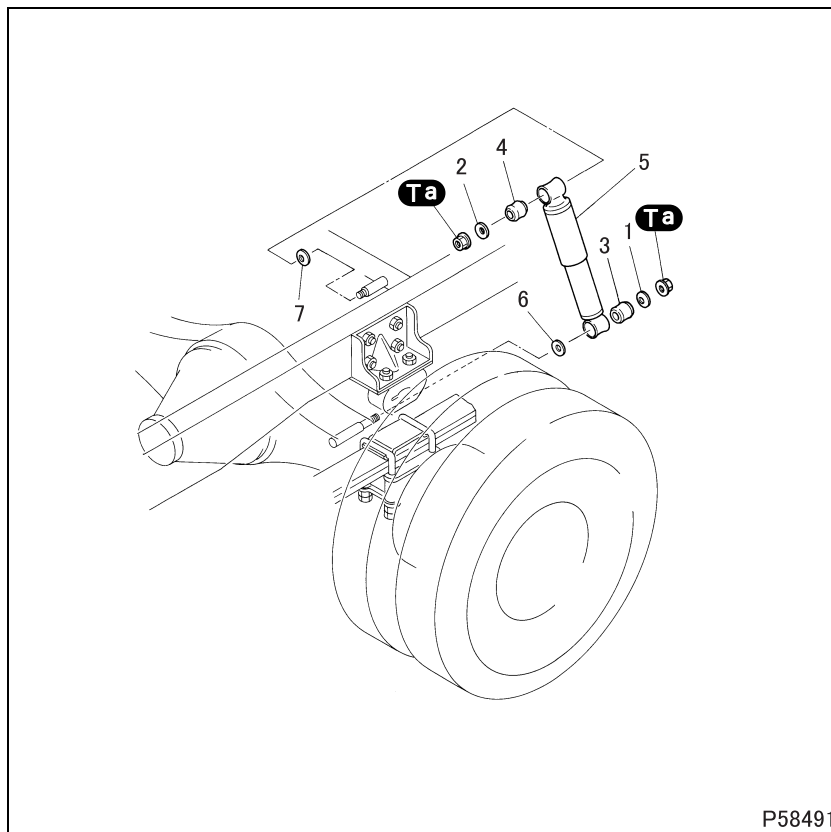
- 1 Washer
- 2 Washer
- 3 Rubber bushing
- 4 Rubber bushing
- 5 Shock absorber
- 6 Washer
- 7 Washer

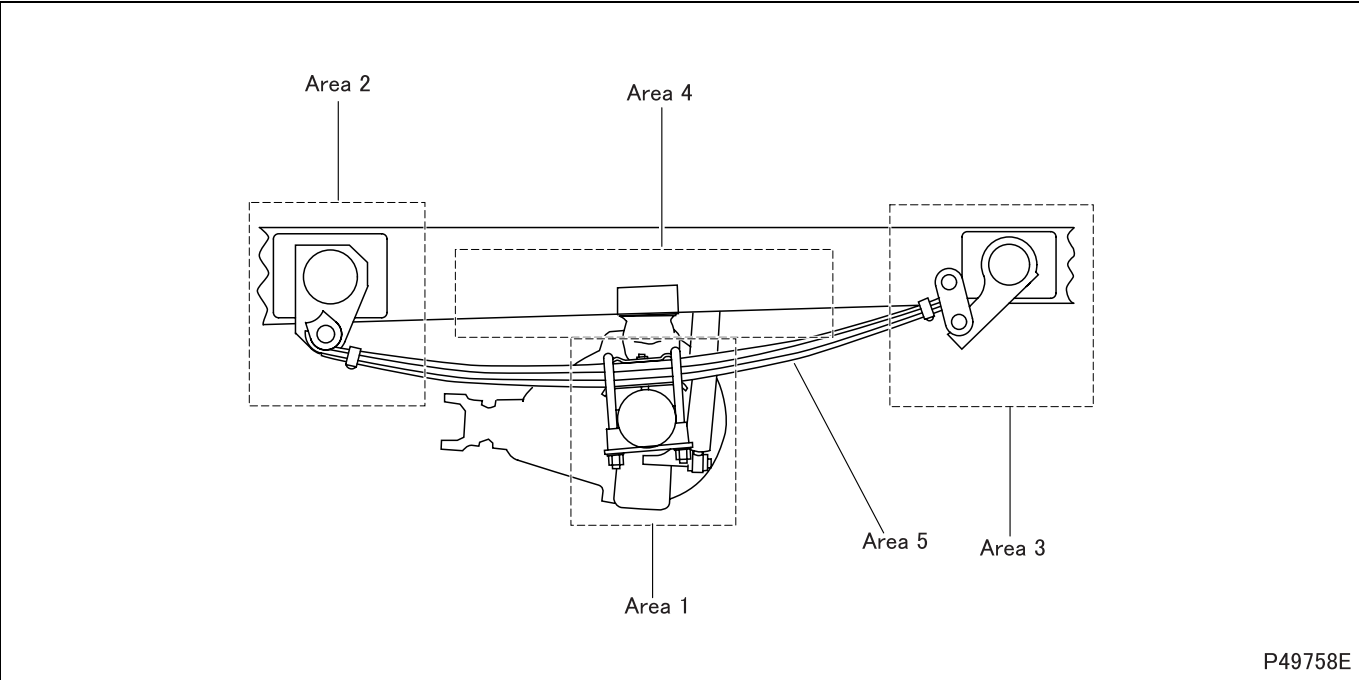
- This section divides the leaf spring in 5 areas and describes removal and installation procedures for each area. For information on specific components, refer to the corresponding area descriptions.

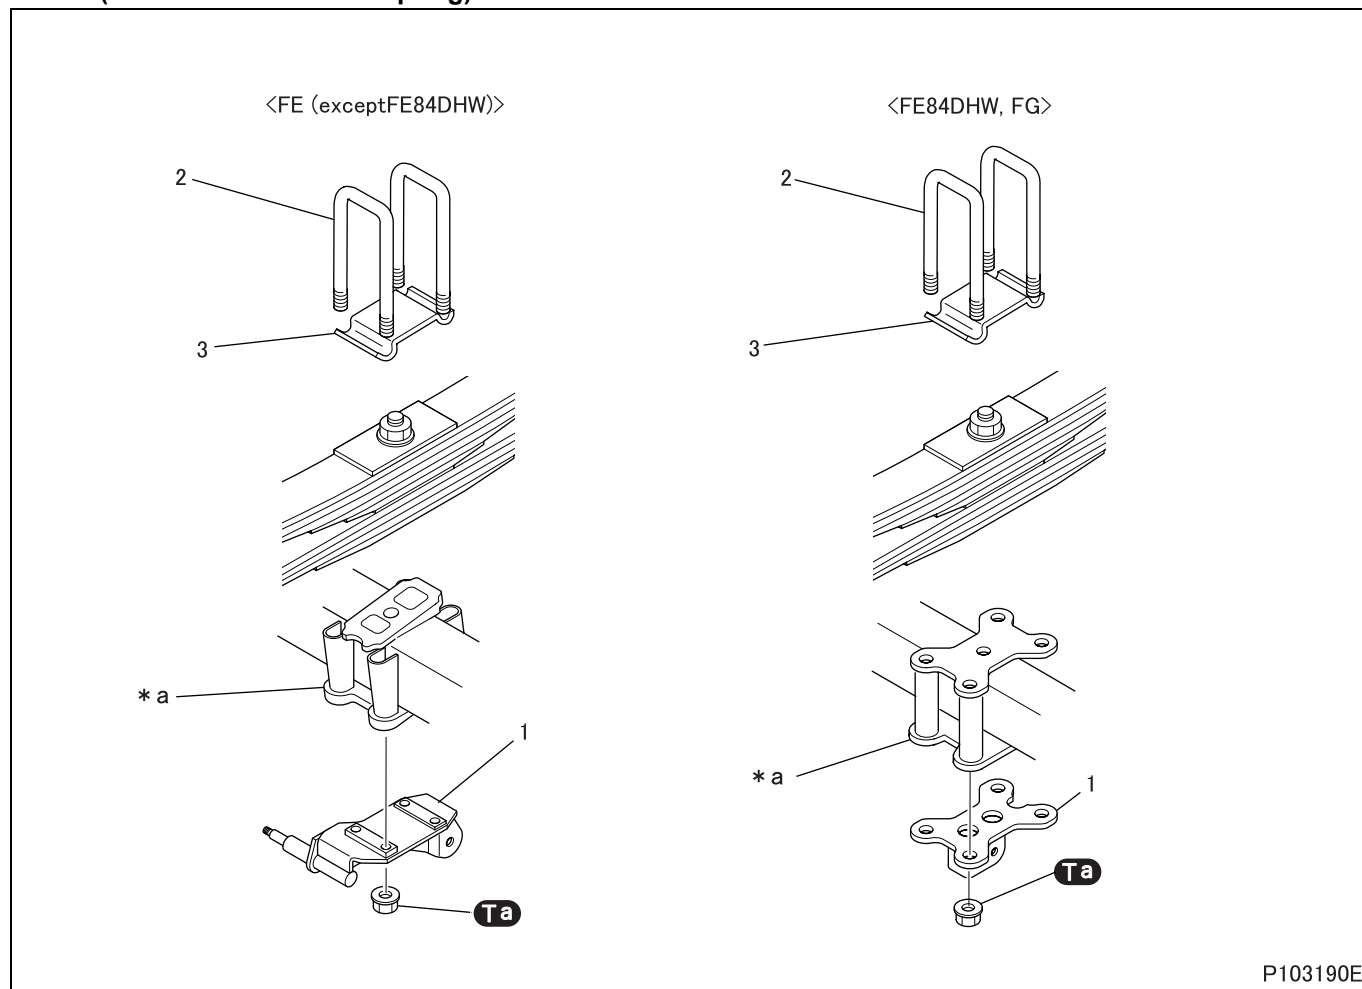
- 1 Stabilizer bracket lower  
<FE>
- 2 U-bolt

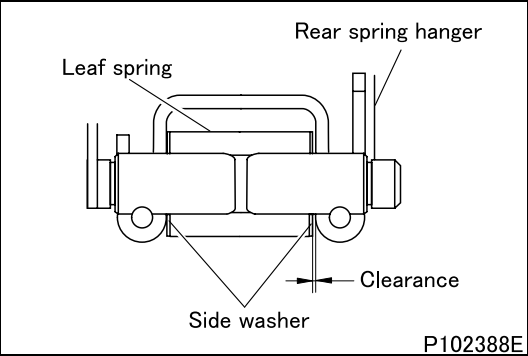
### ■ Inspection: Clearance between rear spring hanger and leaf spring

- Measure the spring-to-hanger clearance using feeler gauge. If the measured value is equal to or exceeds the limit, adjust by means of side washers.

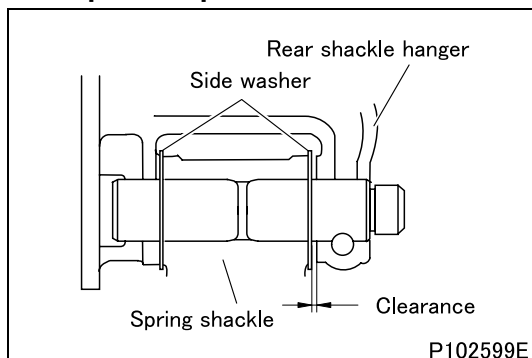
### ■ Inspection: Clearance between spring shackle and rear shackle hanger

- Measure the spring-to-hanger clearance using feeler gauge. If the measured value is equal to or exceeds the limit, adjust by means of side washers.

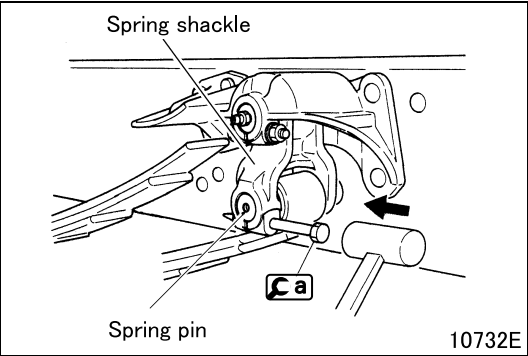
### ■ Inspection: Clearance between spring shackle and leaf spring

- Measure the spring-to-shackle clearance using feeler gauge. If the measured value is equal to or exceeds the limit, adjust by means of side washers.

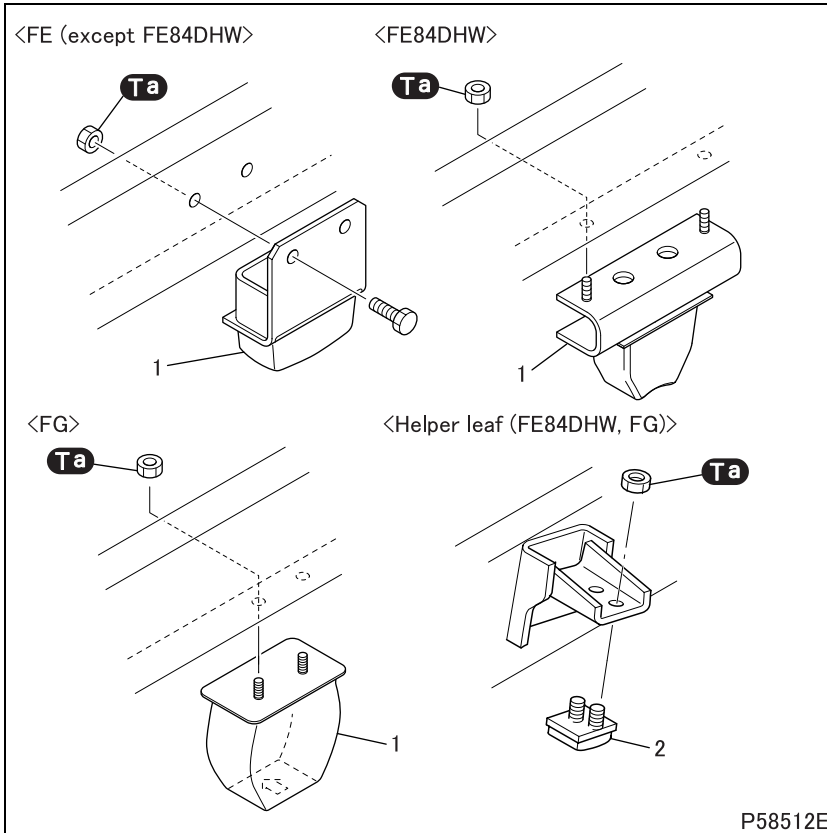
- 1 Helper rubber
- 2 Helper spring stopper

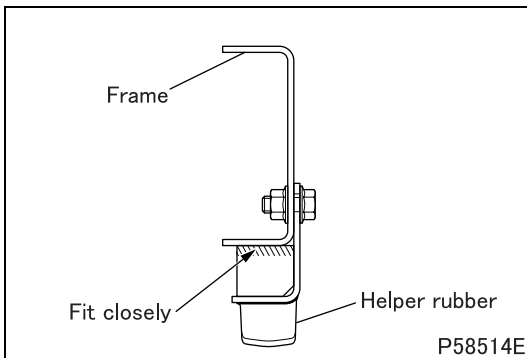
### ■ Installation: Helper rubber <FE (except FE84DHW)>

- Fit helper rubber to the lower face of frame closely as illustrated, then tighten installation bolt and nut.

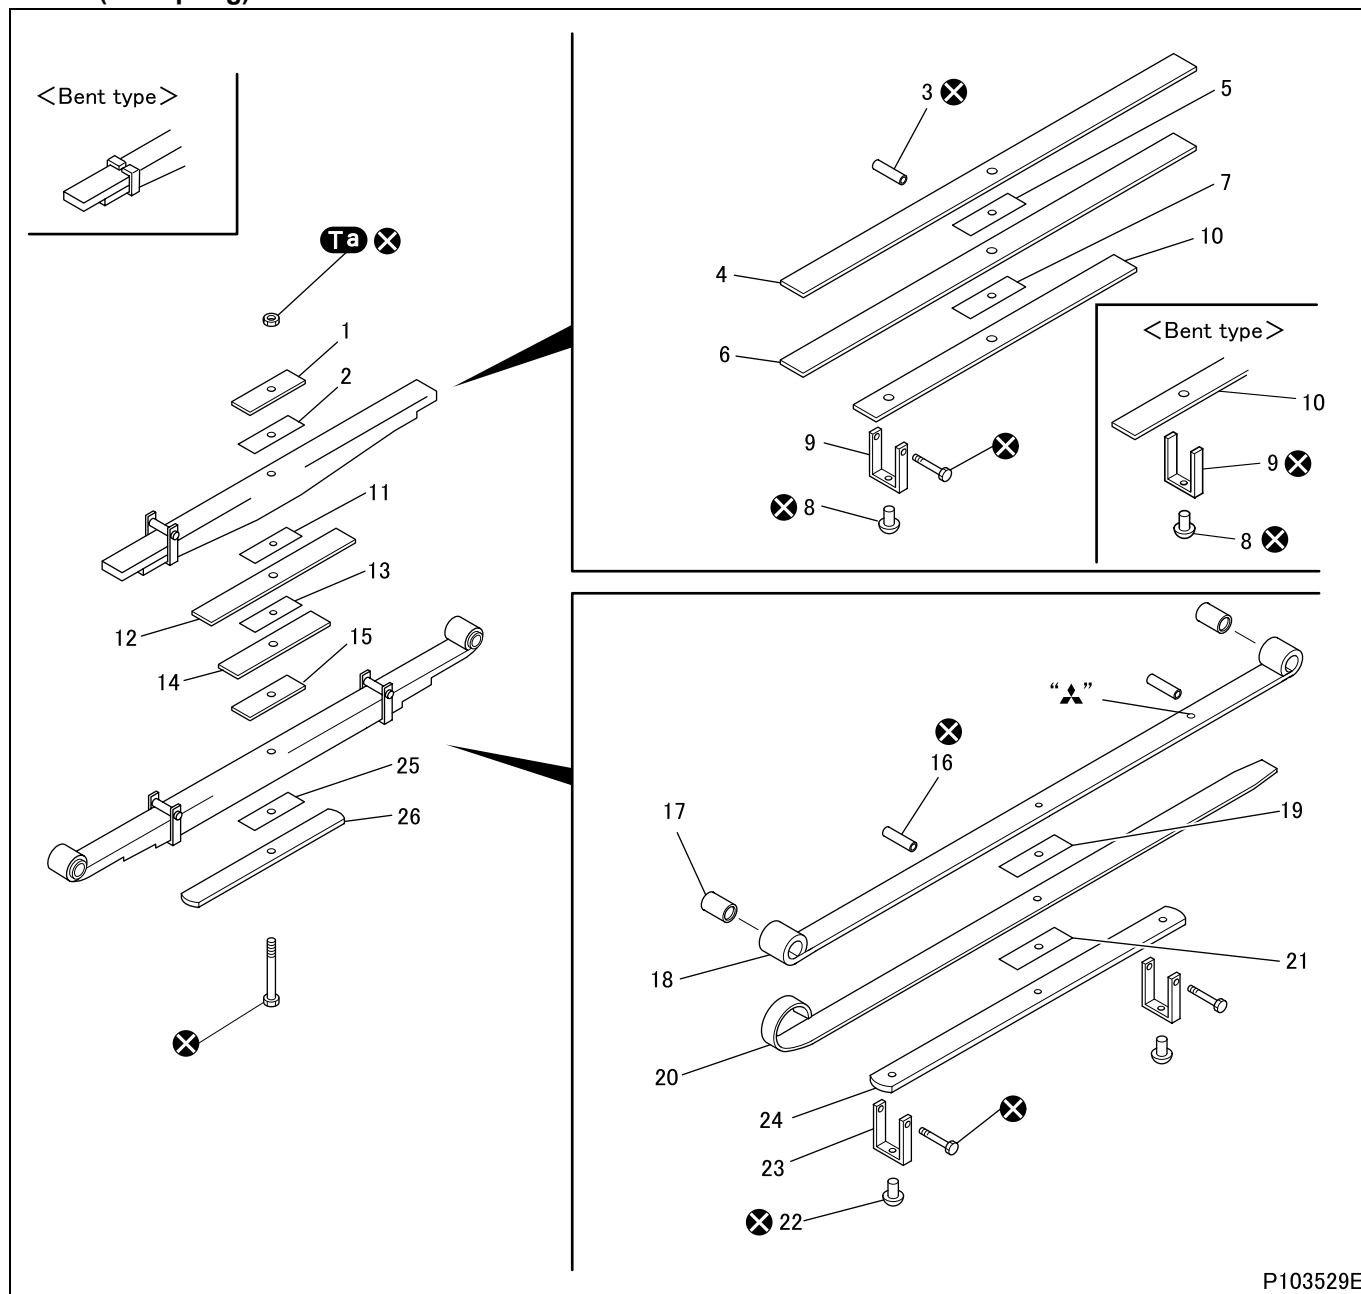
• The above schematic is only an example. Details may differ depending on vehicle models, such as the number of spring leaves, spacers, and the parts used.

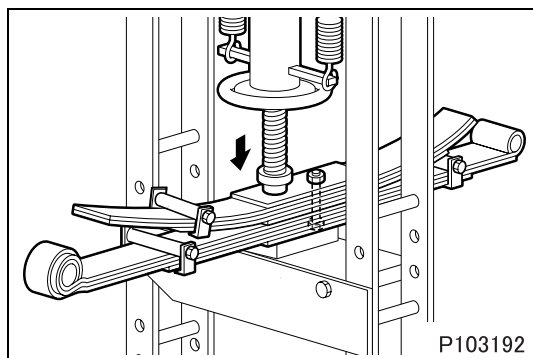
### ■ Compression: Leaf spring

- Using a press, compress the leaf spring as illustrated for subsequent operations.
- Using a chisel or the like, open the bent ends of the clip. <Bent type>

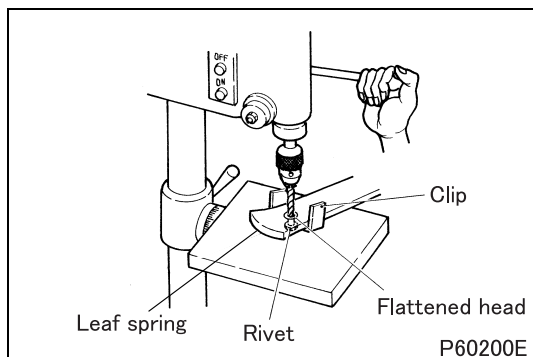
### ■ Removal: Clip

- Using a drill press, break the flattened head of the rivet and remove the clip from the leaf spring.

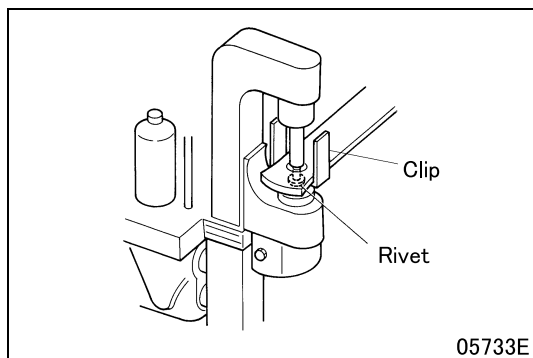
## ■ Installation: Clip

- Using a riveting machine, rivet a clip onto the leaf spring.

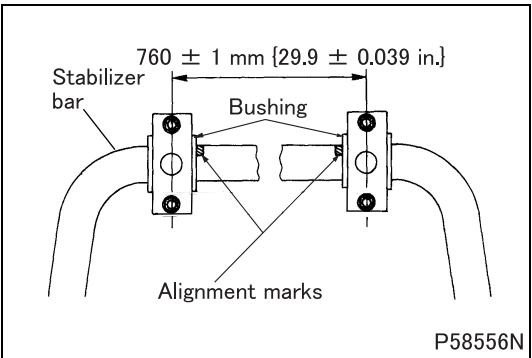
### ■ Installation: Stabilizer bushing

- Mount stabilizer bushings with their end surfaces aligned with marks on stabilizer bar.

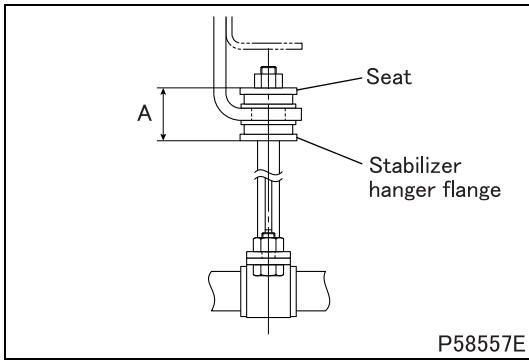
#### ■ Installation: Stabilizer hanger

- Tighten the mounting nut until the part A in the illustration becomes the following dimension.  
A: 48.4 mm {1.89 in.}

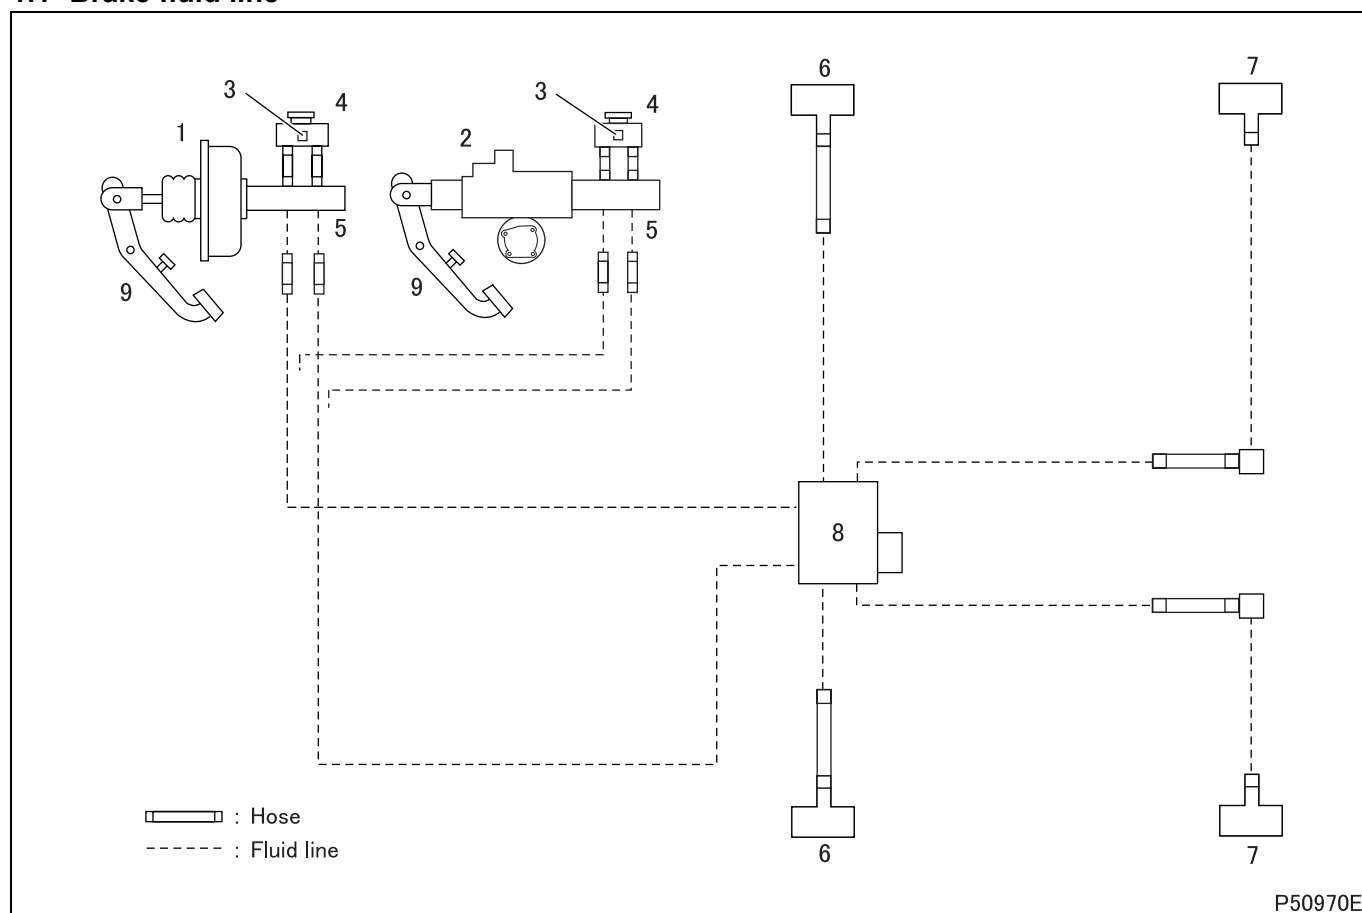
### 1.1 Brake fluid line

- The brake system incorporating the vacuum booster uses vacuum to provide servo-assisted braking to all wheels of the vehicle onto which it is mounted. <Except FE85>
- The brake system incorporating the hydraulic booster uses the power steering oil pump pressure to provide servo-assisted braking to all wheels of the vehicle onto which it is mounted. <FE85>

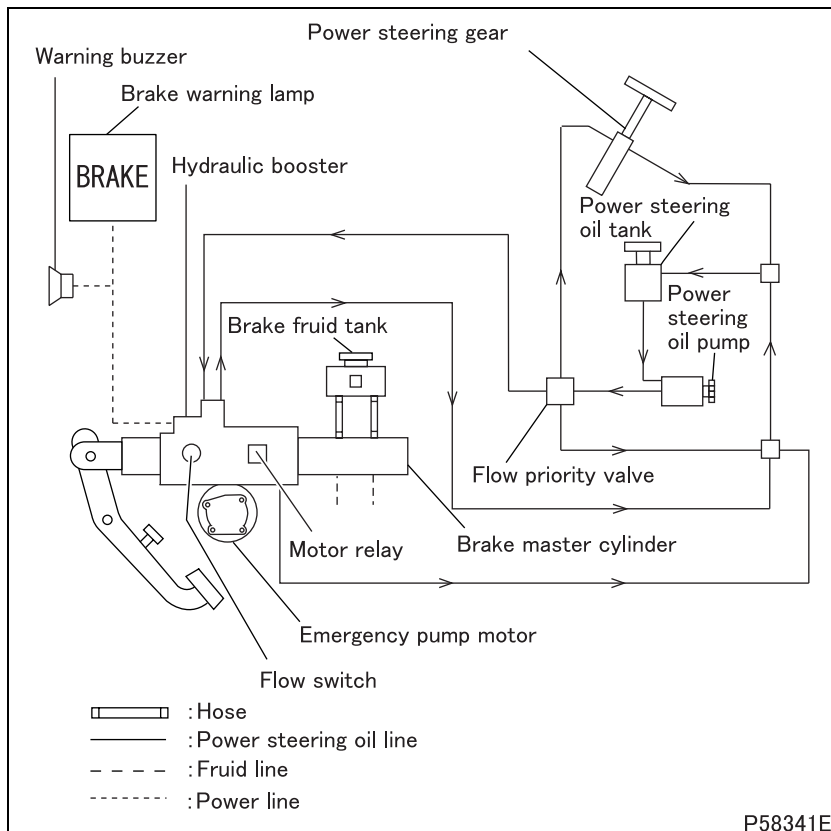
## 1.3 Hydraulic booster line <FE85>

- The stepping force applied on the brake pedal is boosted by the hydraulic booster which operates on the pressure provided by the power steering oil pump.
- When brakes are applied hard while the steering wheel is turned, the associated steering shock is dampened by the flow priority valve in the system.
- When engine stall, power steering oil pump failure, or oil leakage from the power steering line causes oil pressure to drop, the flow switch detects this. This causes the motor relay to switch over, providing power to the emergency pump motor which then turns to generate emergency oil pressure.

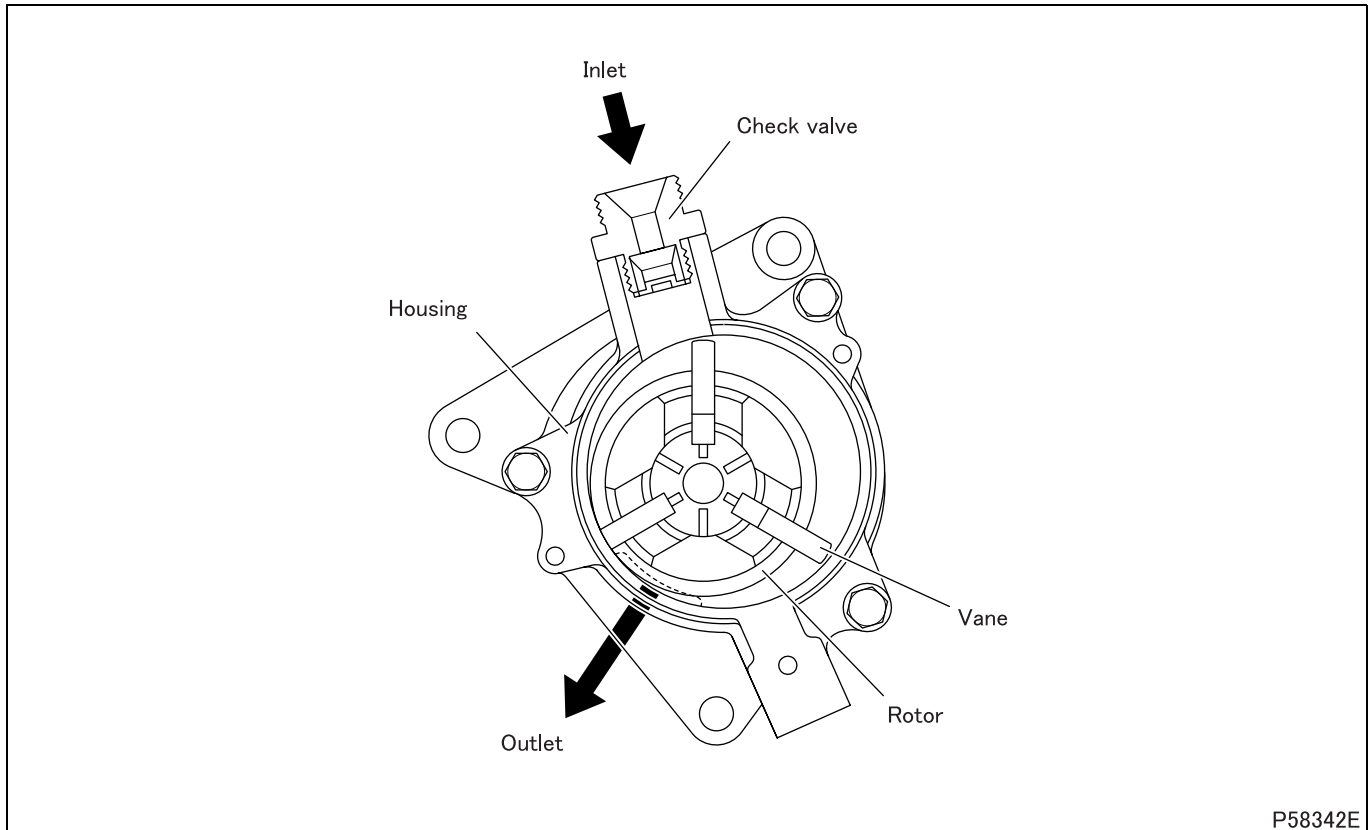
## 2. Vacuum Pump

- The vacuum pump is mounted onto the timing gear case, and is driven by the idler gear.
- The check valve is provided to ensure that no air or engine oil flow from the vacuum pump back to the vacuum tank when the engine is stationary.

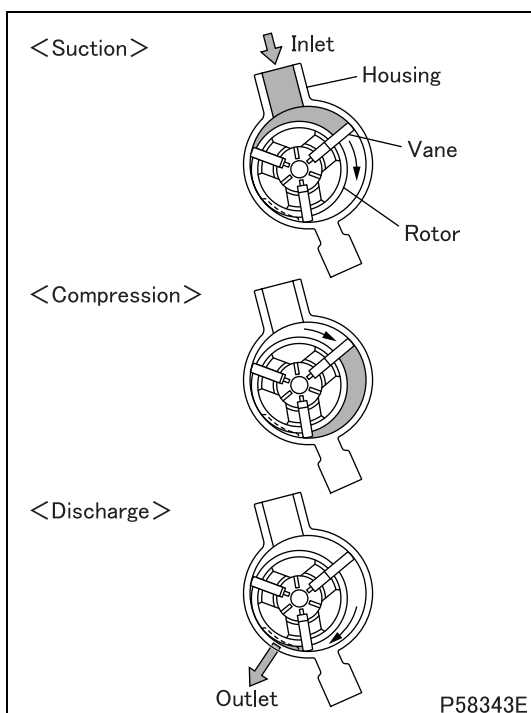
### 2.1 Operation

- A rotor with 3 movable vanes is housed in a cylindrical housing. As the rotor rotates, the vanes are pressed against the inner face of the housing by centrifugal force.
- The rotor is eccentrically mounted relative to the housing. As the rotor rotates, air in the vacuum tank is sucked through the pump inlet and then compressed before being discharged through the outlet. The suction-compression-discharge cycle is repeated to generate vacuum in the vacuum tank.
- The inside of the housing is lubricated and cooled by engine oil. After lubrication/cooling, the engine oil together with the compressed air is returned through the pump outlet and into the oil pan.

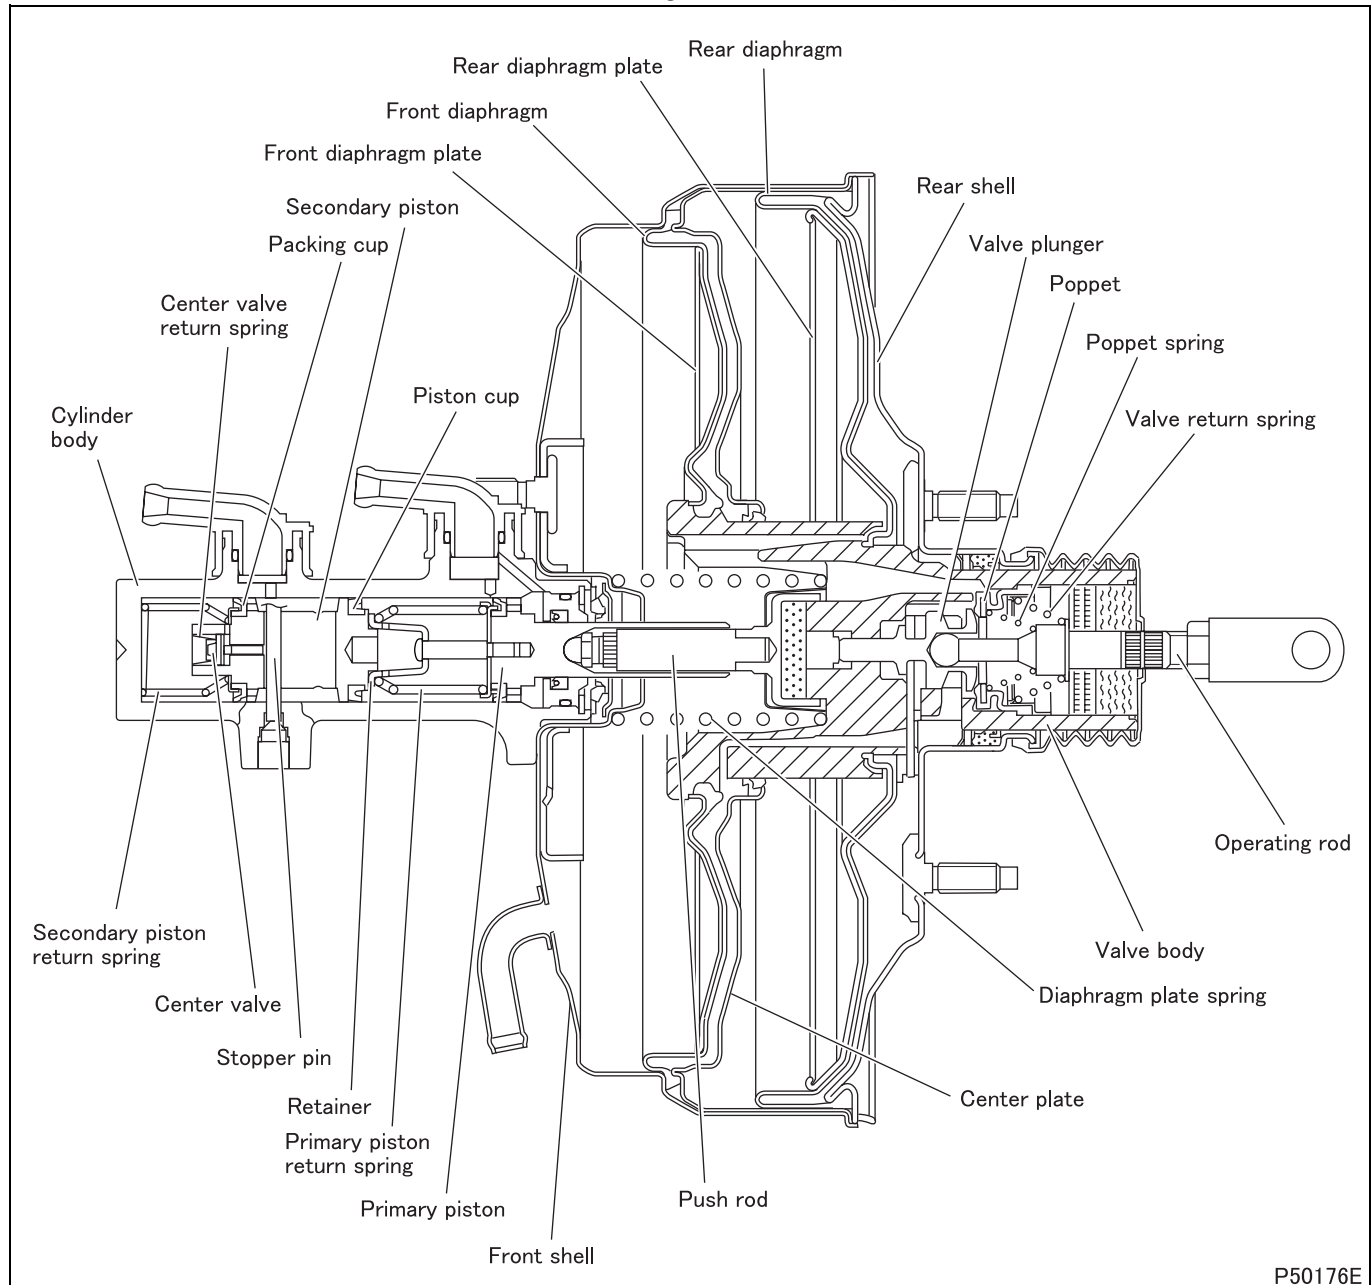
## 3. Vacuum Booster and Brake Master Cylinder <Except FE85>

- The vacuum booster magnifies the stepping force applied onto the brake pedal (therefore reduces the operator's pedal effort) through the utilization of pressure difference between the vacuum it generates and the atmospheric pressure. The system is of a tandem type and has 2 vacuum chambers, achieving size reduction while offering a great capacity for highly efficient boosting performance.
- The brake master cylinder serves both the front and rear brake systems that are independent of each other. Should fluid leakage occur in either the front or rear brake system, stopping power can still be provided by whichever system is intact.

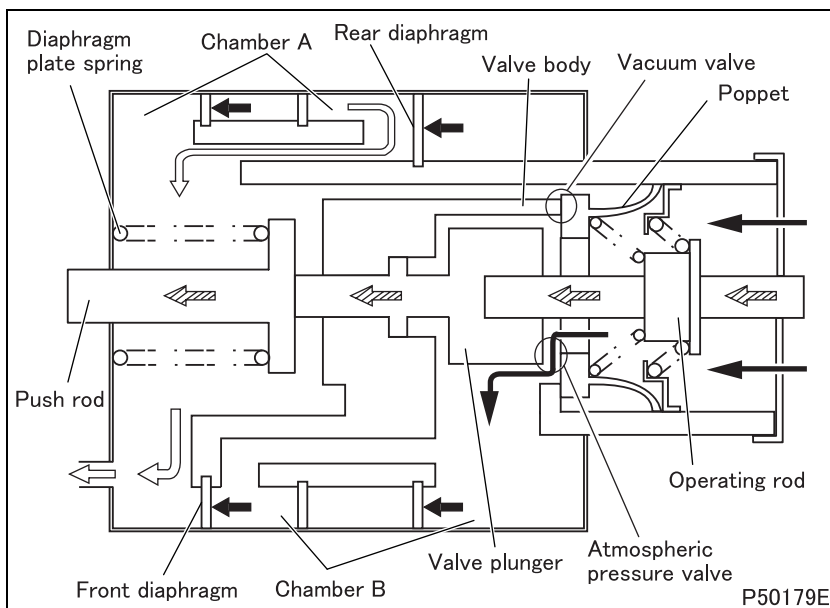
- As the brake pedal is pressed, the stepping force acts on the operating rod. This seats the poppet onto the valve body, closing the vacuum valve and cutting off vacuum supply into chamber B. As the brake pedal is pressed further, the valve plunger separates from the poppet. This opens the atmospheric pressure valve, allowing outside air into chamber B. There is now a pressure difference between chambers A and B.

- The stepping force, boosted as a result of the pressure difference between chambers A and B, overcomes the force of the diaphragm plate spring, pushing the front and rear diaphragms and the push rod to operate the brake master cylinder.

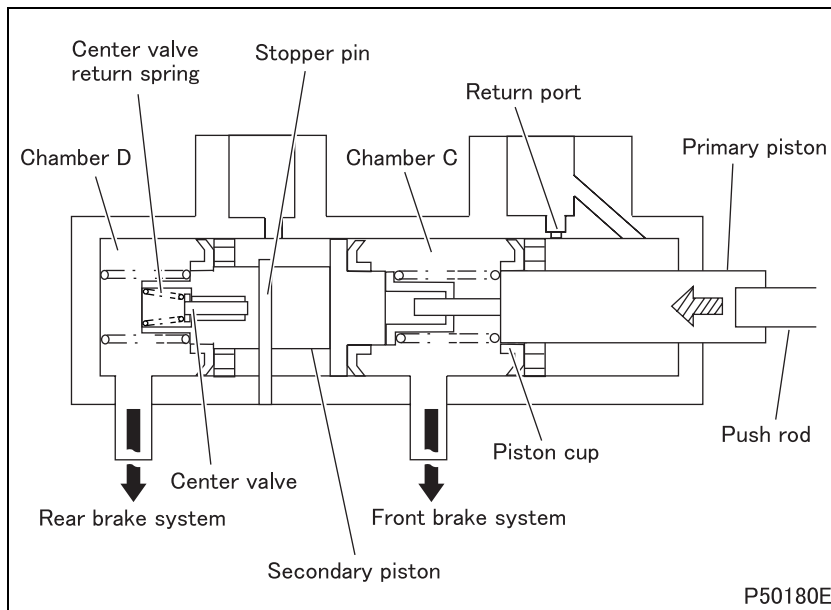
## (2) Brake master cylinder operation

- As the push rod pushes the primary piston, the return port is closed by the piston cup. Fluid pressure now builds up in chamber C.
- The pressure buildup is sent to the front brake system and at the same time pushes the secondary piston.
- The center valve in front of the secondary piston separates from the stopper pin. The center valve return spring now closes the center valve, seating it onto the secondary piston.
- Fluid pressure now builds up in chamber D in front of the secondary piston, and the pressure is sent to the rear brake system.

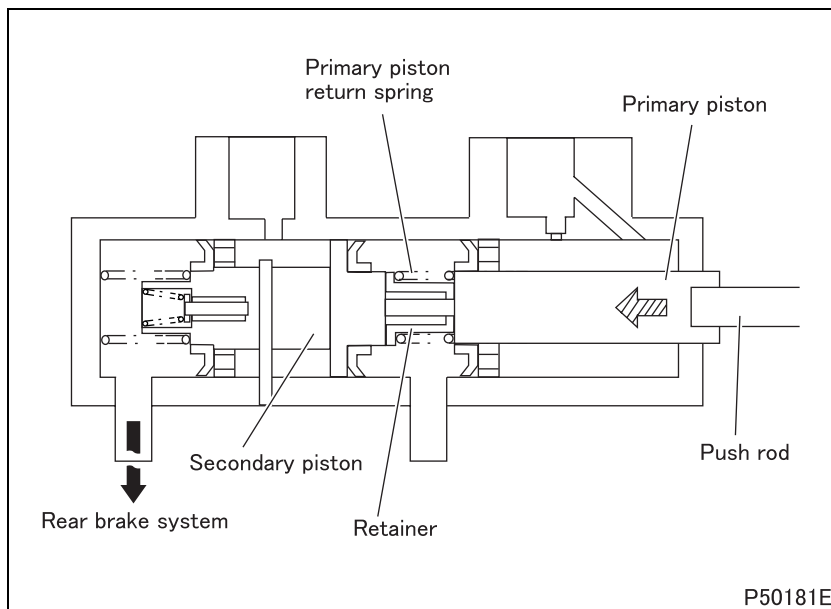
## 3.2 Fluid leakage in front brake system

- As the brake pedal is pressed, the push rod moves to push the primary piston. As there is fluid leakage in the front brake system, no fluid pressure builds up in that system.
- As the brake pedal is pressed further, the primary piston overcomes the force of the primary piston return spring and, via the retainer, pushes the secondary piston. Fluid pressure is now sent to the rear brake system.

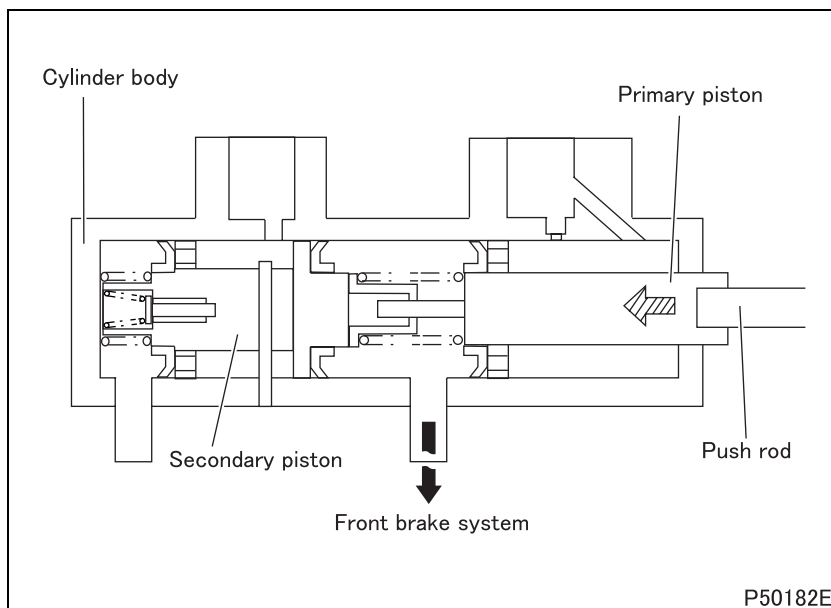
## 3.3 Fluid leakage in rear brake system

- As the brake pedal is pressed, the push rod moves to push the primary and secondary pistons. As there is fluid leakage in the rear brake system, no pressure builds up in that system.
- As the brake pedal is pressed further, the tip of the secondary piston contacts the cylinder body while the primary piston continues to be pushed. Fluid pressure builds up further in the front brake system.

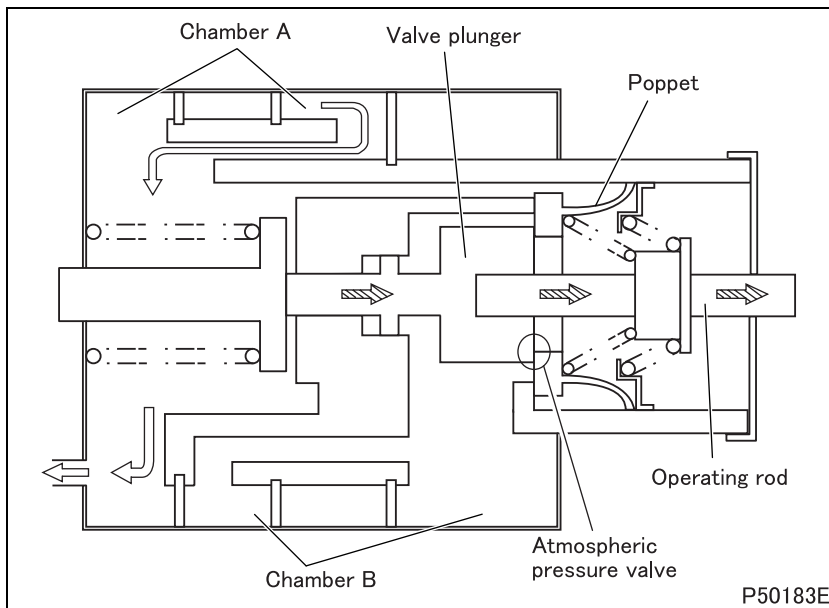
- With the brake pedal pressed, chamber A is filled with vacuum generated by the vacuum pump while chamber B is open to the atmosphere. When the brake pedal is released, the stepping force no longer acts on the operating rod. This causes the valve plunger to seat on the poppet, closing the atmospheric pressure valve and cutting off air flow into chamber B.

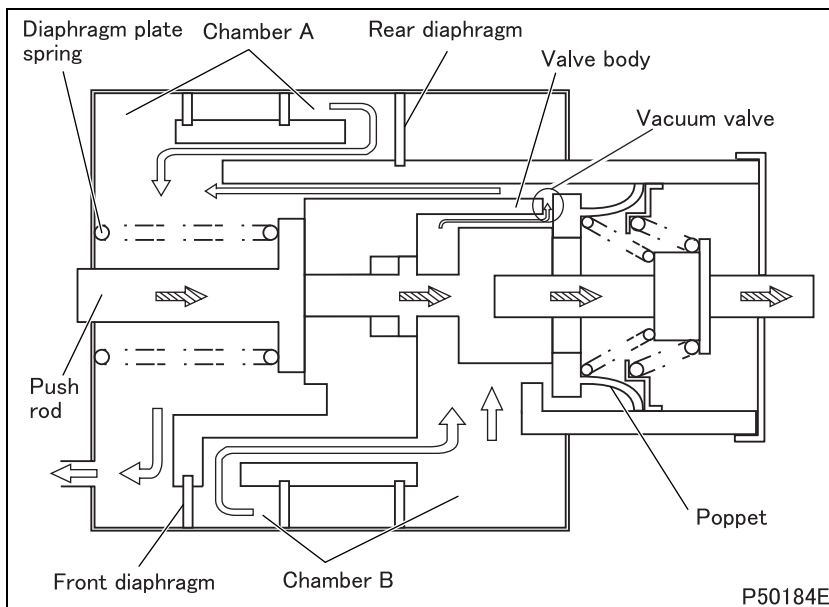
- In further progression, the poppet separates from the valve body. This opens the vacuum valve, allowing vacuum from the vacuum pump to flow into chamber B. As there is now no pressure difference between chambers A and B, the diaphragm plate spring pushes back the front and rear diaphragms and also the push rod to their original positions.

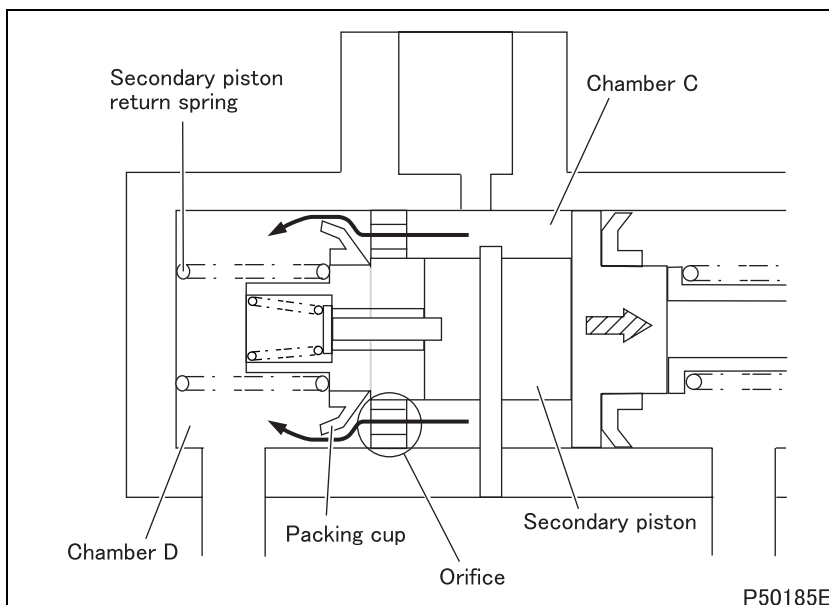
- As the push rod returns to its original position, the secondary piston immediately starts to be pushed back by the force of the secondary piston return spring. The speed of return is gradual as there is no difference between chambers C and D in fluid pressure supplied by the brake master cylinder.
- As the secondary piston starts to return to its original position, the pressure in chamber D becomes lower than the pressure in chamber C. The pressure difference causes the packing cup to buckle, allowing the fluid pressure in chamber C to flow through the orifices and into chamber D.

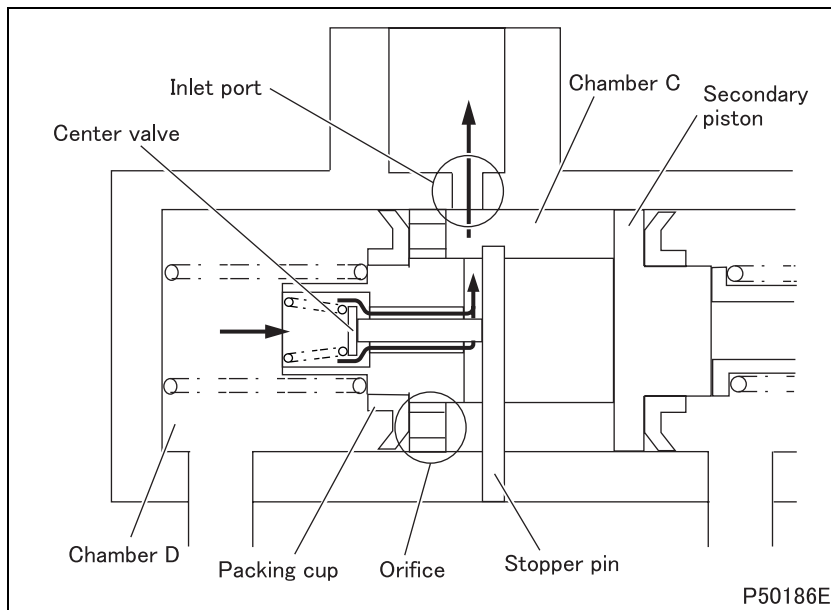
- With the secondary piston back in its original position, there is no difference in fluid pressure between chambers C and D. The packing cup restores its original shape, blocking the orifices. The liquid pressure in the brake line now flows through the center valve, which has been open since hitting the stopper pin. The liquid pressure then returns through the inlet port to the brake fluid tank.

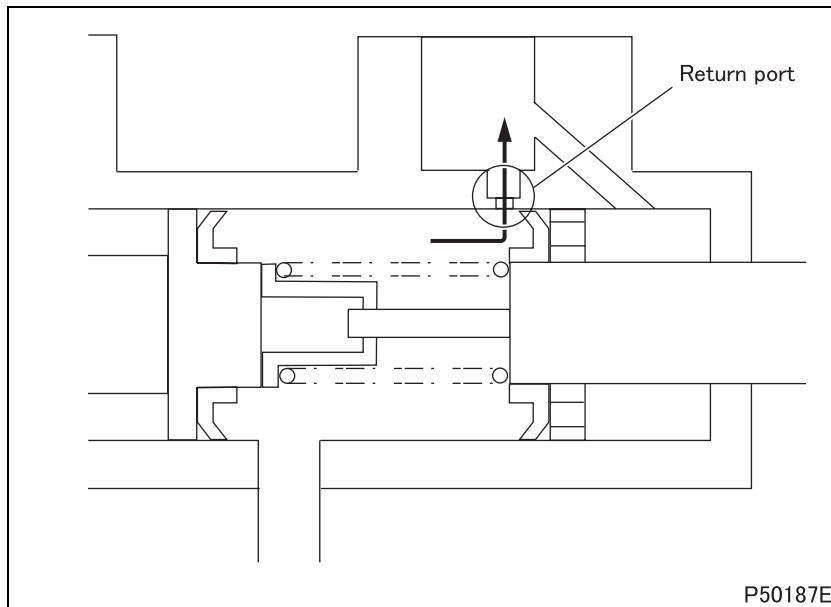
- The fluid pressure in the primary (front) brake line returns through the return port to the brake fluid tank.
