# FE.FG

## SERVICE MANUAL 2008 Model FOREWORD

This Service Manual contains maintenance and repair methods for the Mitsubishi Fuso Truck FE. FG Series. Read this manual carefully as an aid in providing correct, efficient maintenance. Please note that the information and specifications contained within this manual may change without notice. This is due to product modifications and continued vehicle improvements that are made throughout the model years. Should you encounter any discrepancy in the information provided, please do not hesitate to contact your nearest Mitsubishi Fuso Dealer or Mitsubishi Fuso Truck of America, Inc.

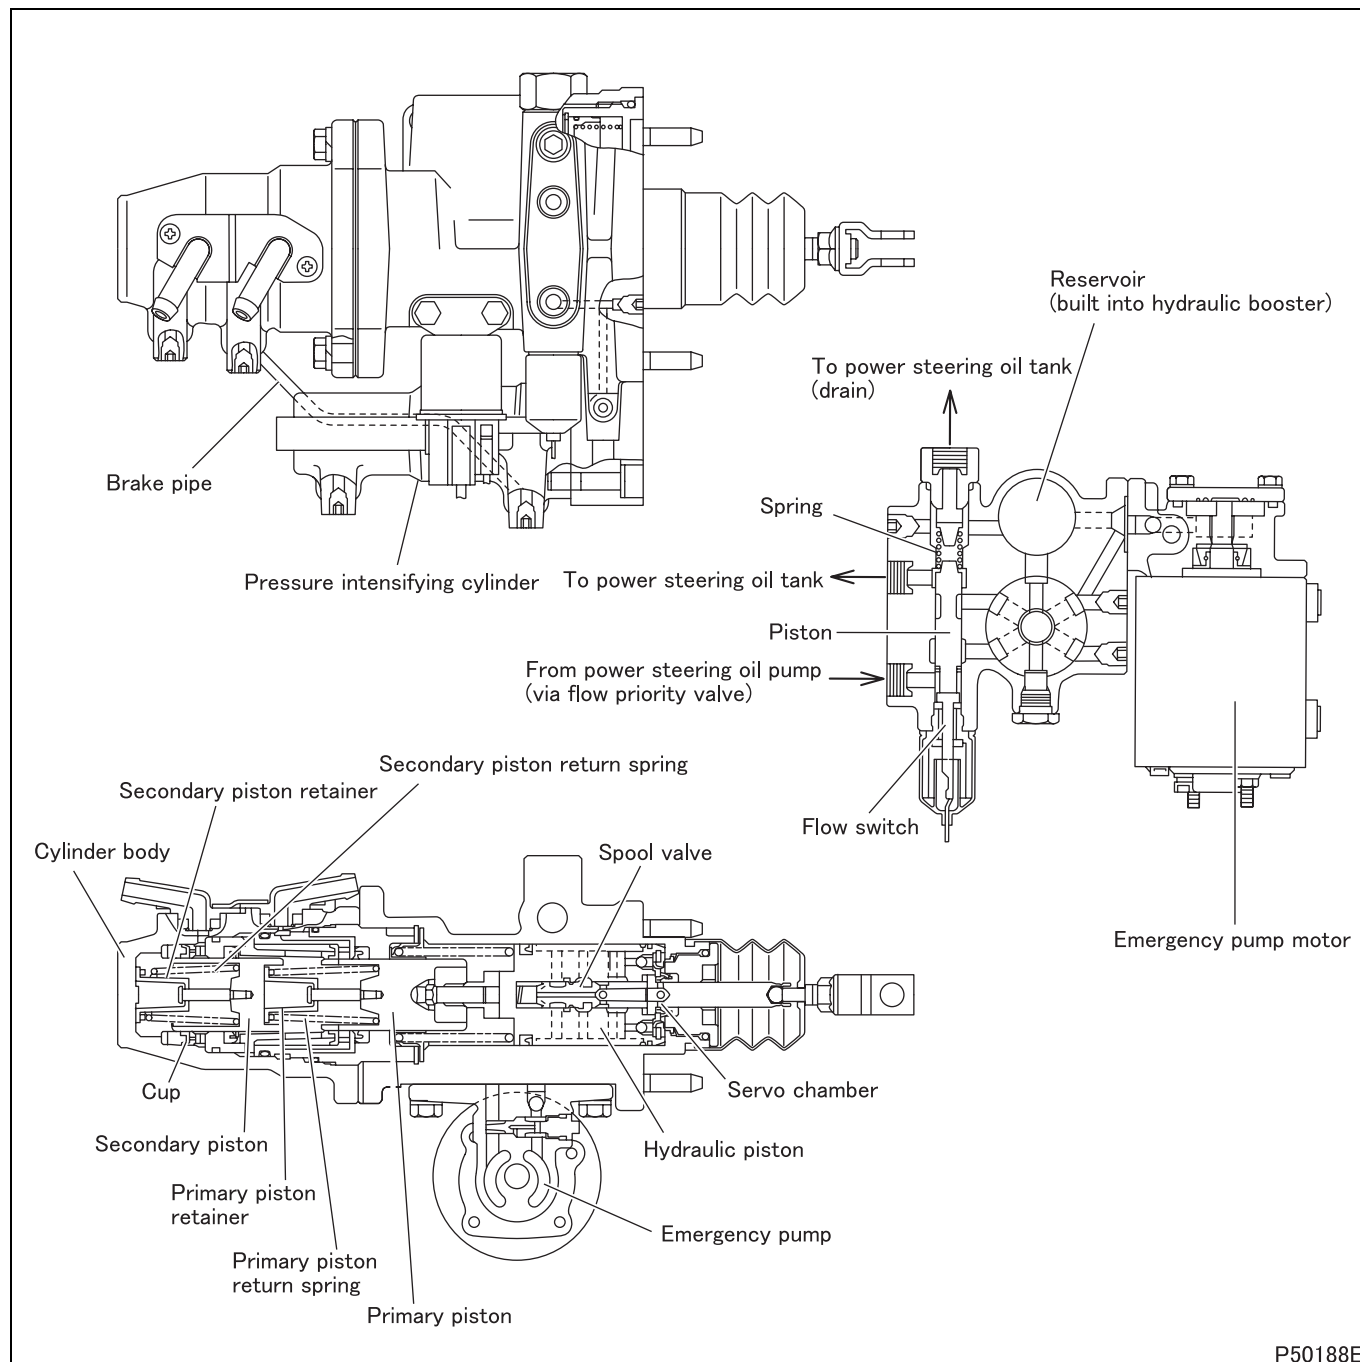
P50188E

- The hydraulic booster magnifies the stepping force applied onto the brake pedal (therefore reduces the operator's pedal effort) through the utilization (via the flow priority valve) of the steering pump pressure.

- The brake master cylinder serves both the front and rear brake systems that are independent of each other. Should fluid leakage occur in either the front or rear brake system, stopping power can still be provided by whichever system is intact.

- The spool valve is connected to the brake pedal, and generates oil pressure proportional to the pedal stepping force.
- The hydraulic piston, which is connected to the brake master cylinder, operates to store oil supplied via the spool valve into the servo chamber for pressure boost.

- Should oil pressure is lost, the piston is pushed to the left by the force of the spring, blocking oil flow from the power steering oil pump and to the power steering oil tank. At the same time, the flow switch is turned ON, providing power to the emergency pump motor. The emergency pump generates oil pressure for the hydraulic booster to continue to operate.

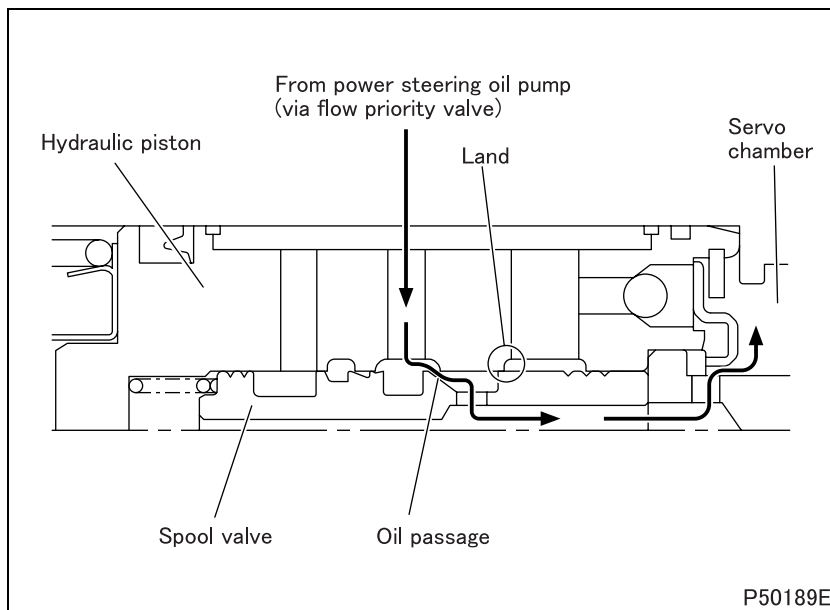
- As the brake pedal is pressed, the spool valve moves to the left, closing the land.
- Oil pressure from the flow priority valve builds up.
- The high pressure oil flows through the oil passage and into the servo chamber.
- The hydraulic piston is pushed to the left.
- The pistons in the brake master cylinder are moved, supplying pressure for brake application.

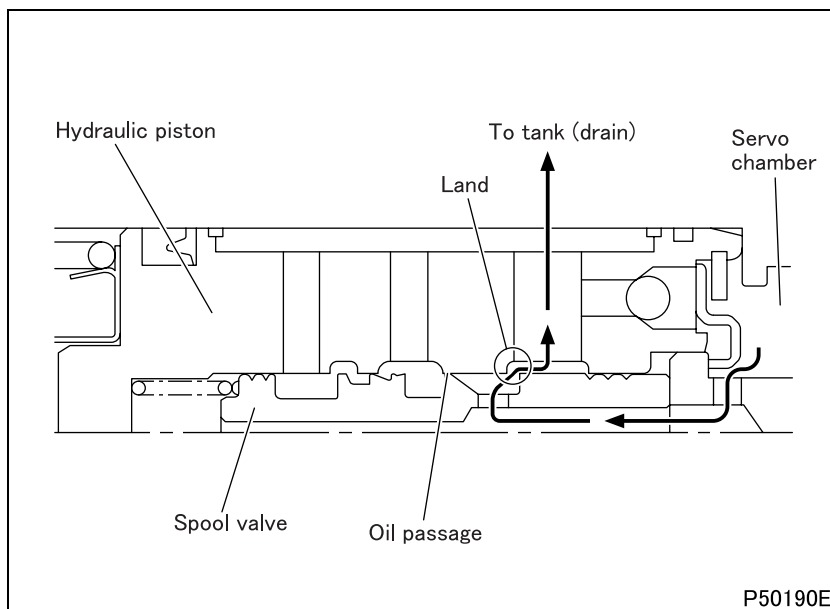
- As the brake pedal is released, the spool valve moves to the right. This opens the land while the oil passage is closed.
- Oil pressure from the flow priority valve drops.
- The oil in the servo chamber drains to the tank as well as to the reservoir.
- The hydraulic piston returns to its original position.
- Pressure acting on the pistons in the brake master cylinder is released.

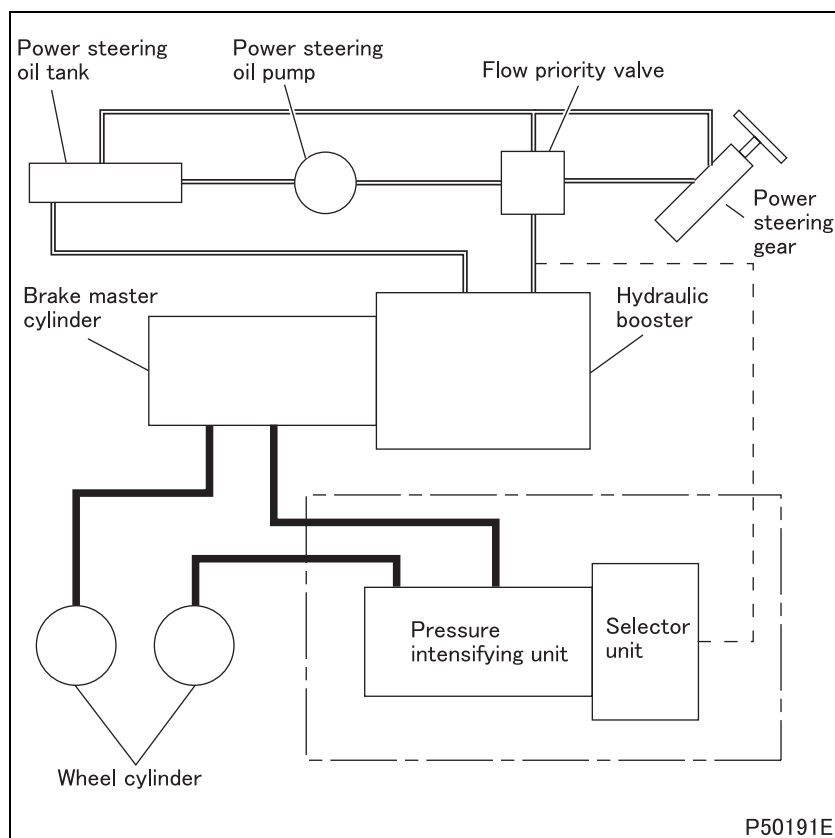
## 4.2 Pressure intensifying cylinder system

- The pressure intensifying cylinder system is attached onto the hydraulic booster which operates on the power steering oil pump pressure.
- Should the pump fail, pressing the brake pedal causes the system to boost the fluid pressure from the brake master cylinder and send it to the wheel cylinders.

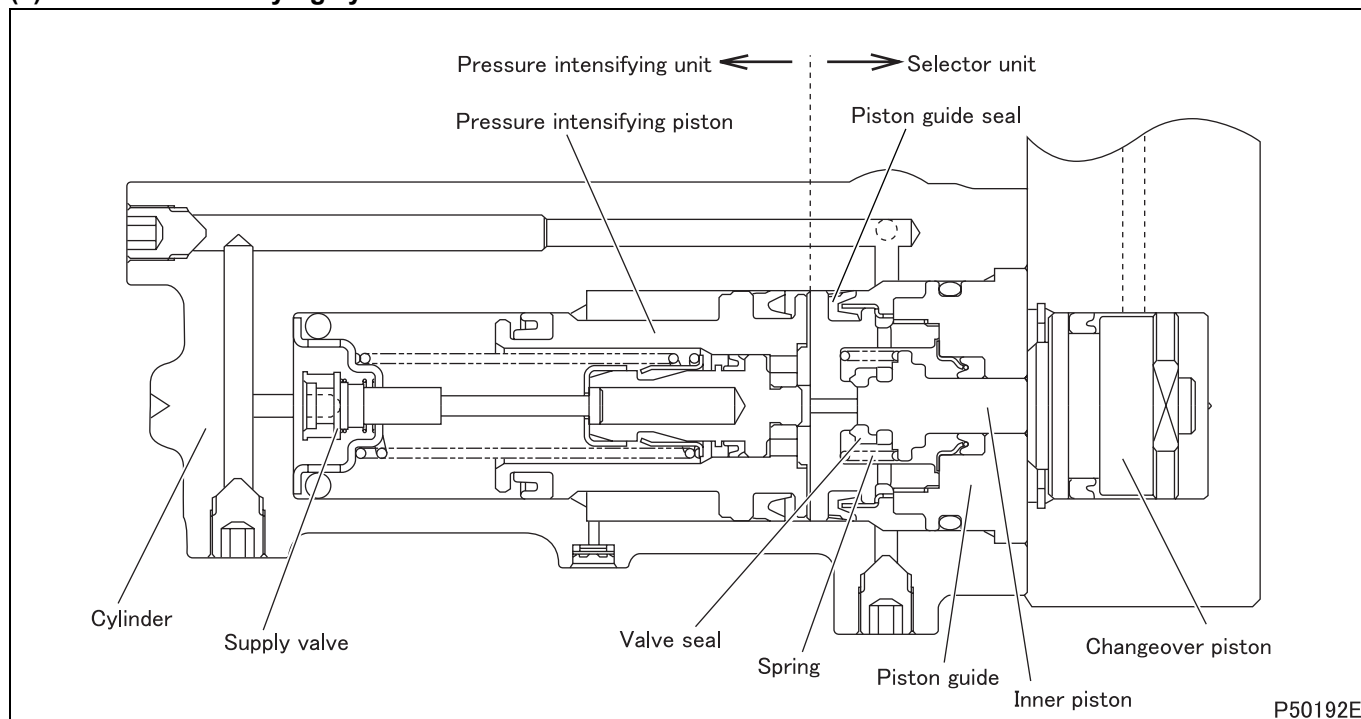
### (1) Pressure intensifying cylinder

- Should the power steering pump fail to discharge oil, the selector unit detects this. The unit also ensures that pressure not be intensified when the power steering pump is functioning normally.
- Should the power steering pump fail, the pressure intensifying unit comes into action, boosting the fluid pressure from the brake master cylinder before sending it to the wheel cylinders.

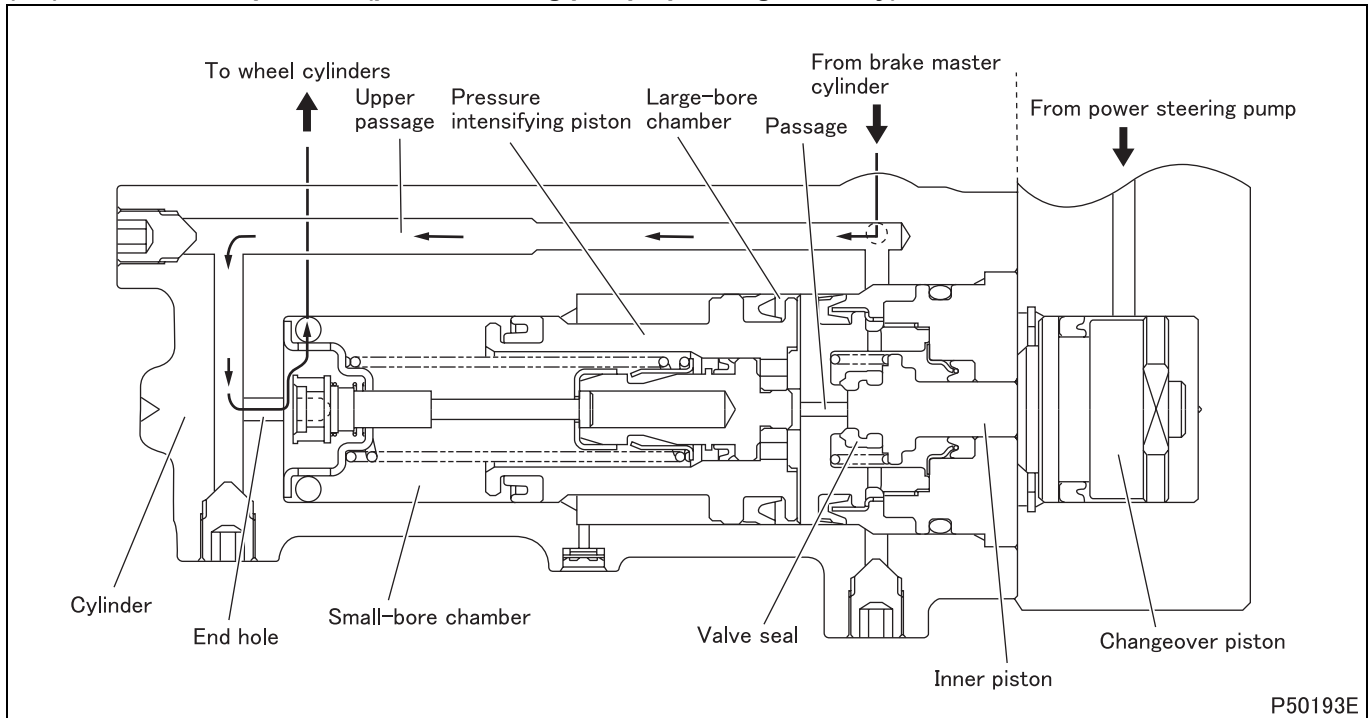
### (1.1) When not in operation (power steering pump operating normally)

- Power steering oil pump pressure pushes the changeover piston, which then moves the inner piston. As a result, the passage to the large-bore chamber is blocked by the valve seal. Fluid pressure from the brake master cylinder flows through the upper passage, the end hole, the small-bore chamber, and into the wheel cylinders. As fluid pressure acts only on the small-bore end of the pressure intensifying piston, the piston remains in the same position.

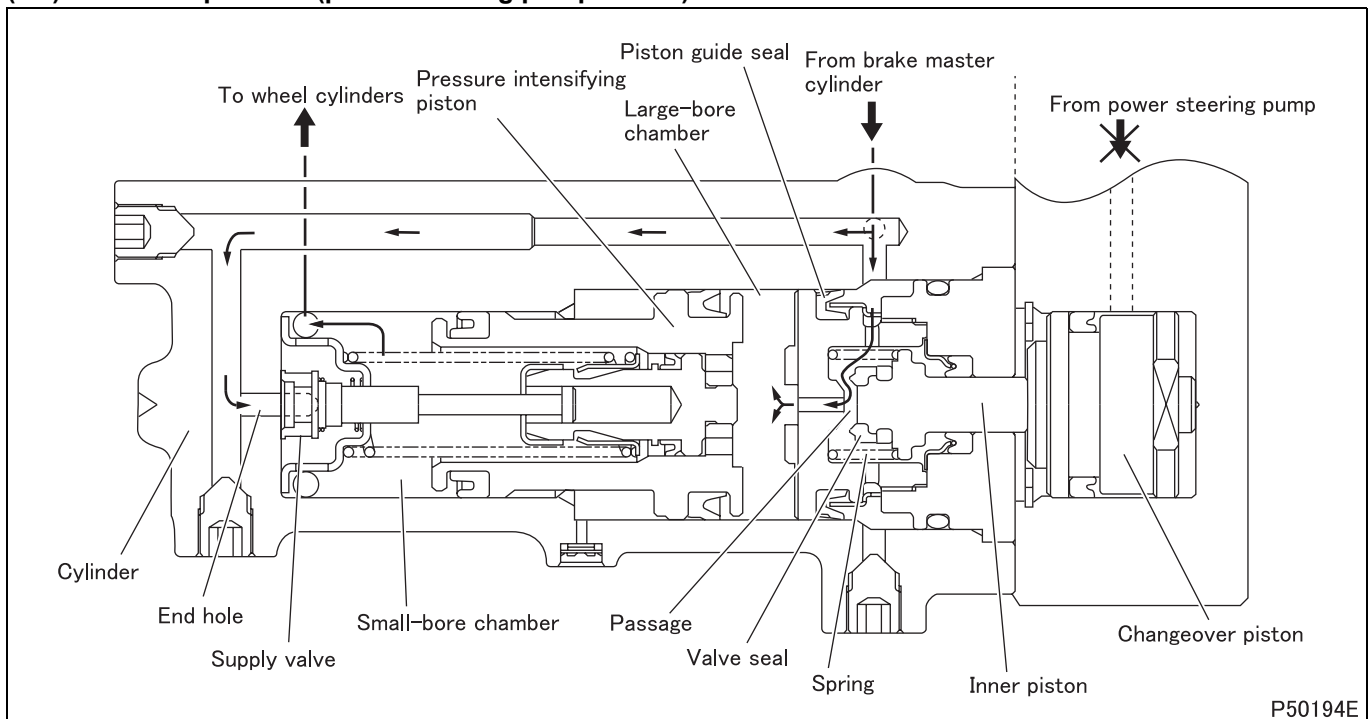
### (1.2) When in operation (power steering pump failure)

- When the power steering oil pump fails to discharge oil, the spring at the end of the inner piston pushes back the inner and changeover pistons. This opens up the passage through the valve seal into the large-bore chamber.
- Fluid pressure from the brake master cylinder flows into both the large- and small-bore chambers. As the large-bore end of the pressure intensifying piston has a larger area than the small-bore end, the piston moves to the left. As a result, the end hole is blocked by the supply valve.

- The brake master cylinder continues to supply fluid into the pressure intensifying cylinder, which in turn sends the increasing pressure to the wheel cylinders.
- When the brake pedal is released, pressure fluid in the large-bore chamber flows through the valve seal, the back of the piston guide seal, and to the brake master cylinder.

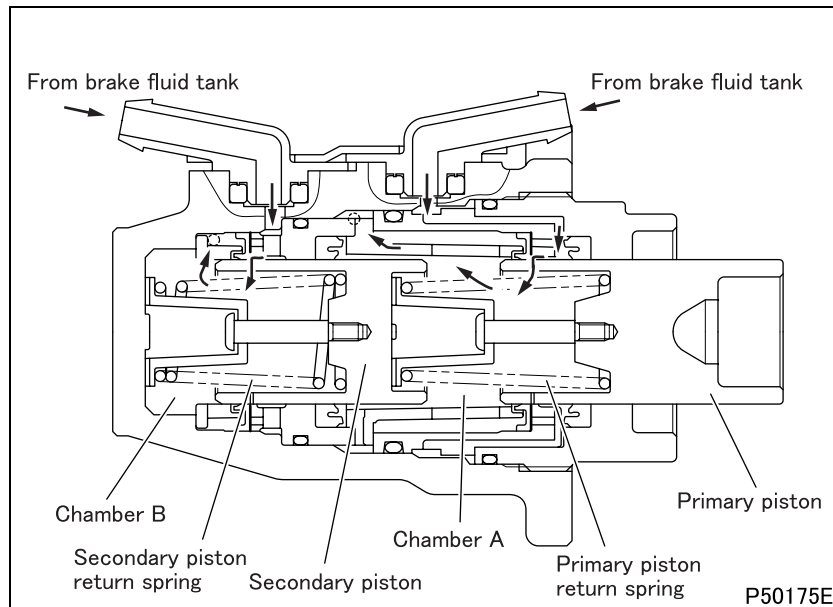
### (1) When not in operation

- With the brake pedal released, the primary and secondary pistons are held to the right by the forces of the primary and secondary piston return springs respectively.
- Chambers A and B are open to the brake fluid tank.

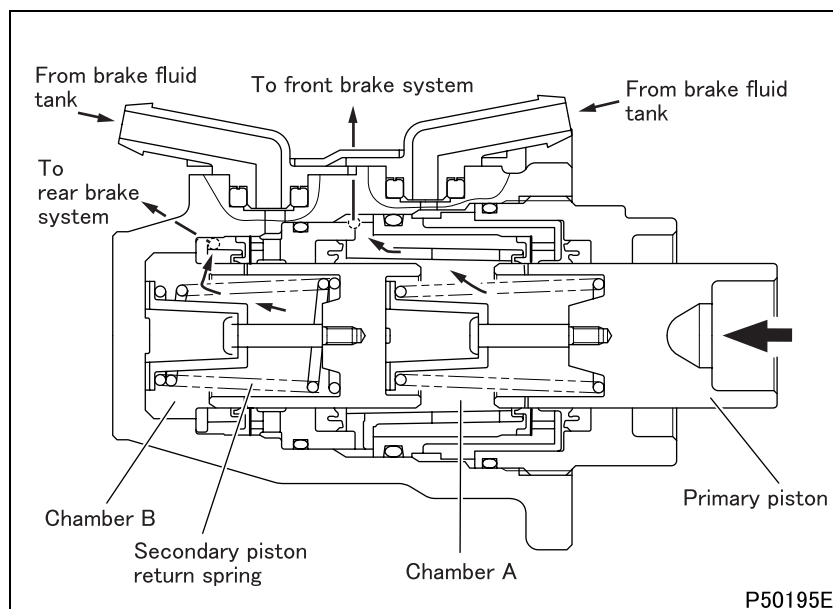
### (2) When brake pedal is pressed

- As the brake pedal is pressed, the primary piston is pushed via the push rod.
- The secondary piston return spring is compressed, and the passages from chambers A and B to the brake fluid tank are blocked.
- As the brake pedal is pressed further, the primary piston is pushed. Fluid pressure builds up in chambers A and B, and is sent to the front and rear brake systems respectively.
- When fluid leakage occurs in either the front or rear brake system, the master cylinder operates basically in the same manner as the master cylinder with the vacuum booster.

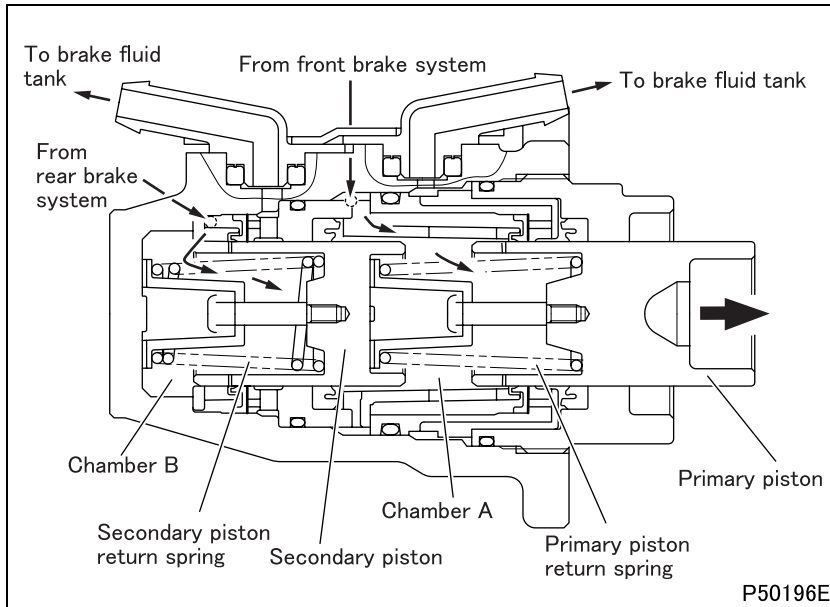
### (3) When brake pedal is released

- As the brake pedal is released and the push rod returns to the original position, the primary piston return spring pushes back the primary piston. Chamber A restores the original volume and the pressure in the chamber drops accordingly.
- The secondary piston return spring pushes back the secondary piston. Chamber B restores the original volume and pressure.
- Chambers A and B open up to the brake fluid tank.
- Pressure fluid in the front and rear brake lines flows back into chambers A and B.

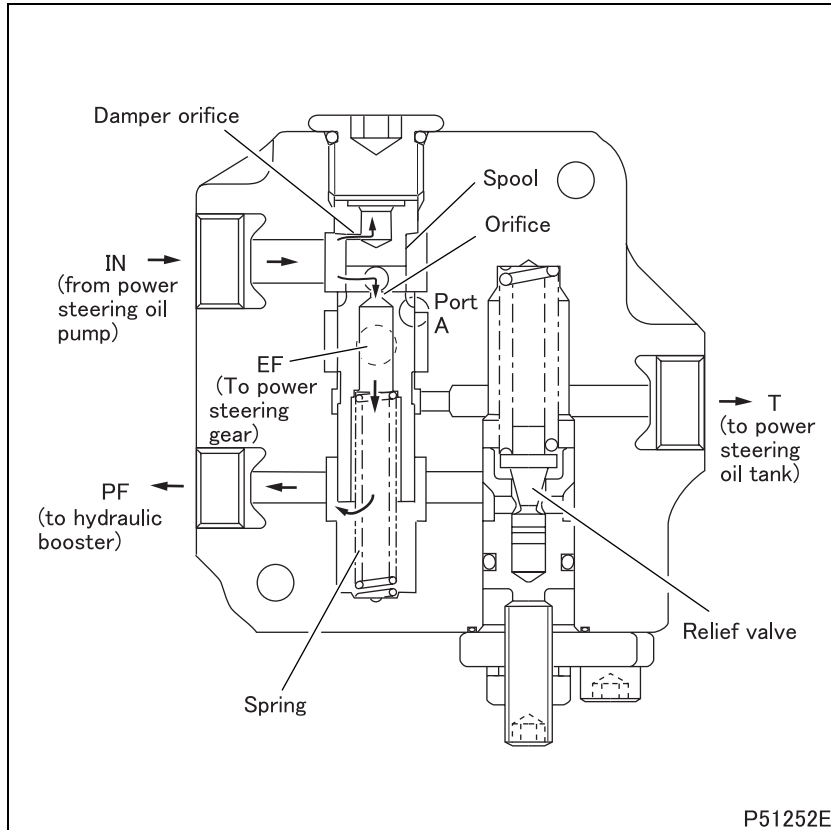
## 5. Flow Priority Valve <FE85>

- When brakes are applied hard while the steering wheel is turned, the flow priority valve dampens the associated steering shock by appropriately distributing the flow from the power steering oil pump between the hydraulic booster and the power steering gear.

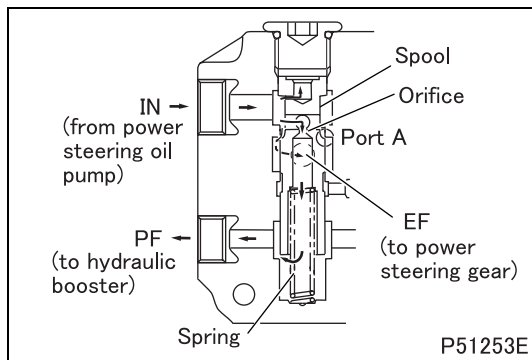
### 5.1 When pump output is at or below regulated flow rate

- The power steering oil pump output flows through the orifice and to the hydraulic booster.
- The pressure difference across the orifice acts on the spool which is then pushed down against the spring. However, port A remains blocked by the spool. As a result, the full flow from the pump is directed to PF.

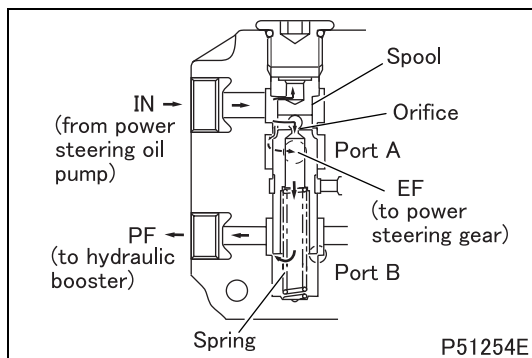
### 5.2 When pump output exceeds regulated flow rate

- When the pump output exceeds the regulated flow rate, the pressure difference across the orifice becomes greater and acts on the spool such that the spool is pushed down against the spring until port A opens. Excess flow is directed through port A and into EF.
- In this state, if the hydraulic booster is operated and a greater flow is demanded by PF line (PF pressure > EF pressure), the spool moves to reduce the opening of port A so that the required pressure and the regulated flow rate are both achieved.

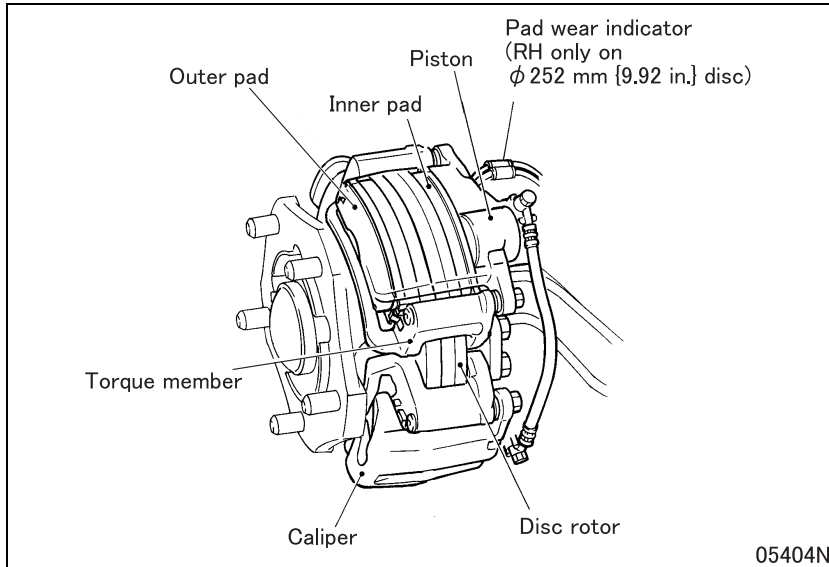
## 6. Front Disc Brake <FE>

- The front disc brake uses a twin floating-type calipers.
- The caliper houses one each of cylinder and piston. Stopping power is generated by squeezing the disc rotor between the pads, with the outer pad pressed against the disc rotor by reaction.
- The inner pad is equipped with wear indicator which serves to indicate replacement timing for both the inner and outer pads.
- The front disc brake is equipped with a self-adjusting mechanism to compensate for pad wear and maintain the correct clearances between the disc rotor and the inner and outer pads. The adjustment is made each time braking is performed.

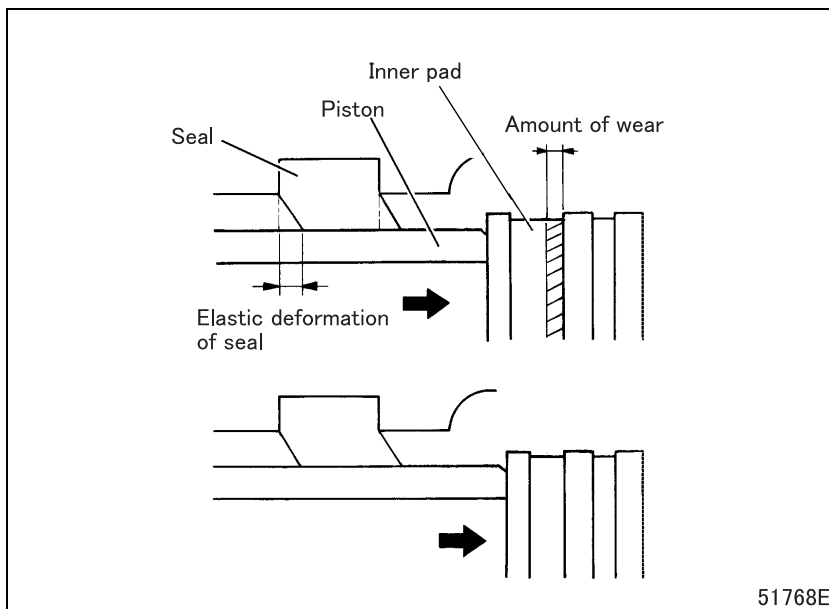
##### (1.1) When brake pedal is pressed

- The piston extends in excess of the seal's elastic deformation by the amount of inner pad wear (shown hatched).

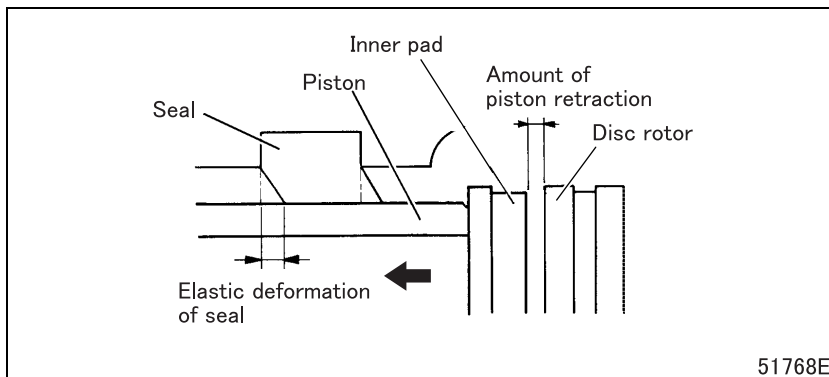
##### (1.2) When brake pedal is released

- The piston retracts as much as the amount of the seal's elastic deformation, thus maintaining the correct clearance between the disc rotor and the inner pad.

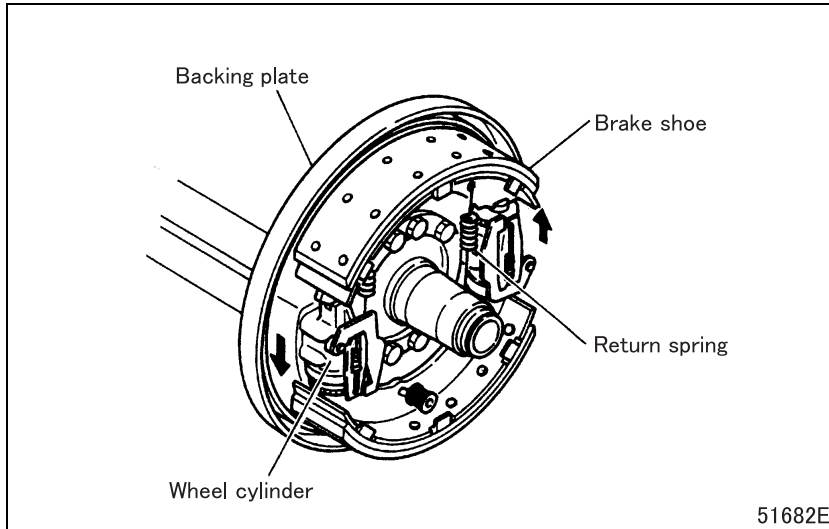
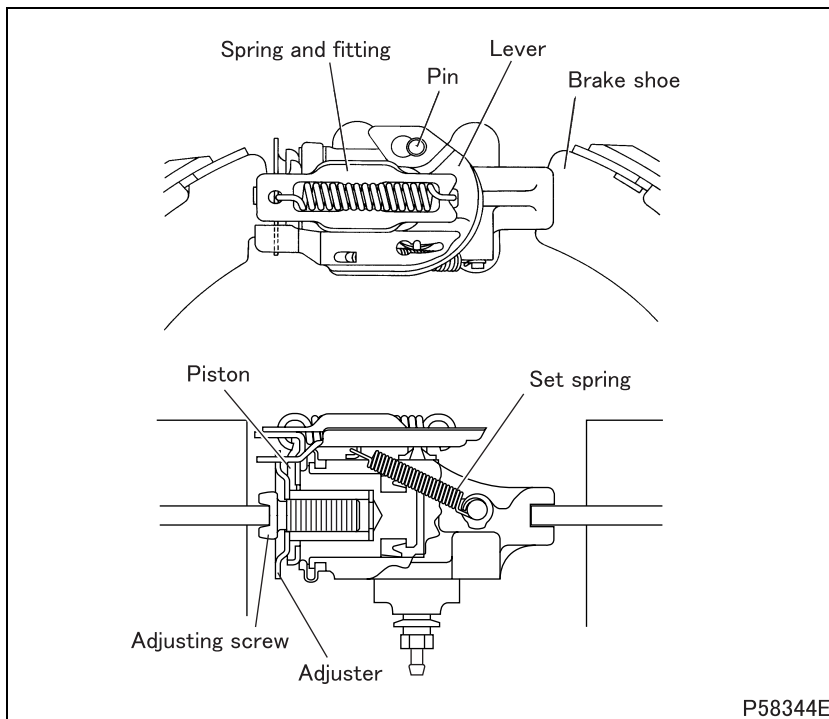
## 7. Front Drum Brake <FG>

- The front drum brake is of a 2-leading type.
- Single-acting wheel cylinders activate brake shoes, both as a leading shoe, in forward-travel braking. By self-boosting effect, the 2-leading shoe brake generates a great stopping power.

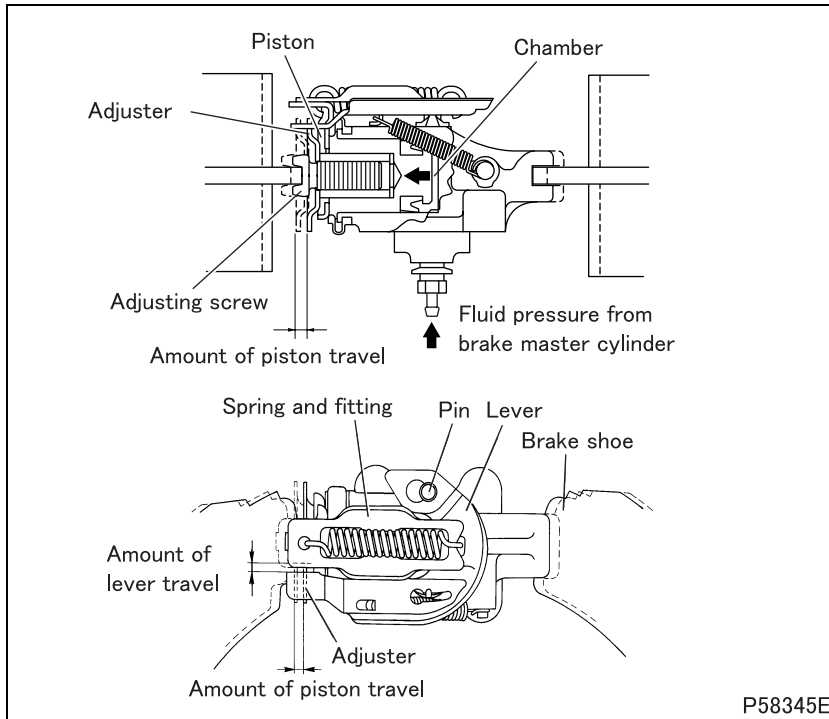
### 7.1 Wheel cylinder

- The wheel cylinder is equipped with a self-adjusting mechanism to compensate for lining wear and maintain the correct clearance between the lining and the drum. The adjustment is made each time braking is performed.

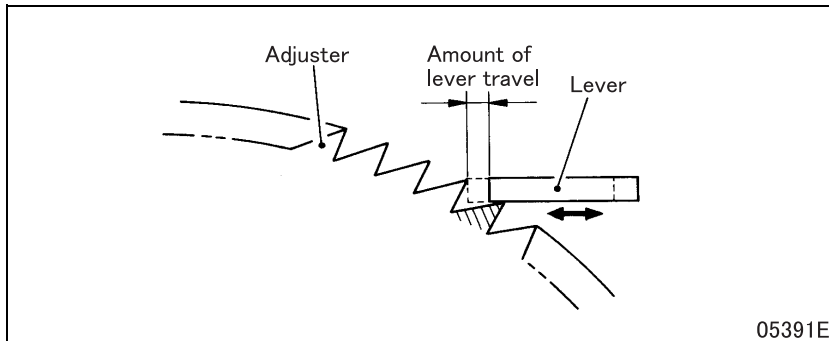
## 7.2 Self-adjusting mechanism

- When the brake pedal is pressed, fluid pressure from the brake master cylinder enters into chamber and pushes the piston, which then extends the spring and fitting. The lever, which is connected to the spring and fitting, pivots about the pin.

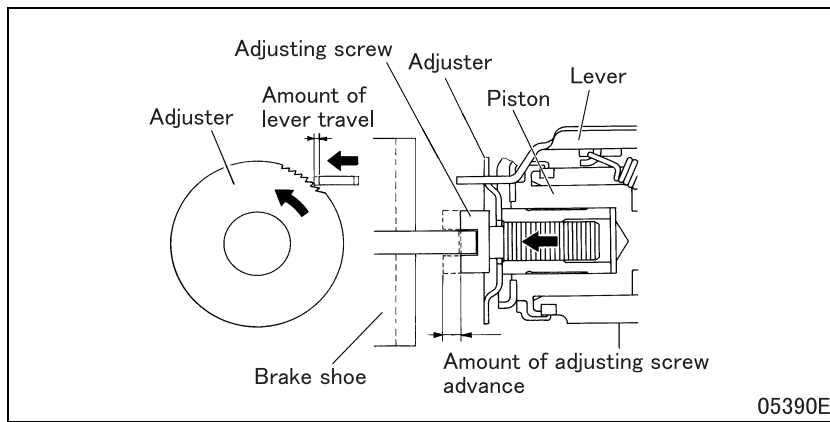
- When the brake drum-to-lining clearance is correct, the amount of lever travel when the brake pedal is pressed is not enough to turn the adjuster which therefore remains in the same place.

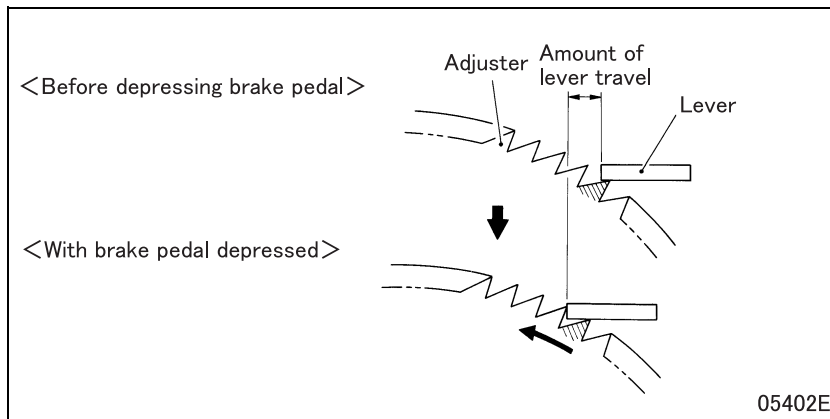
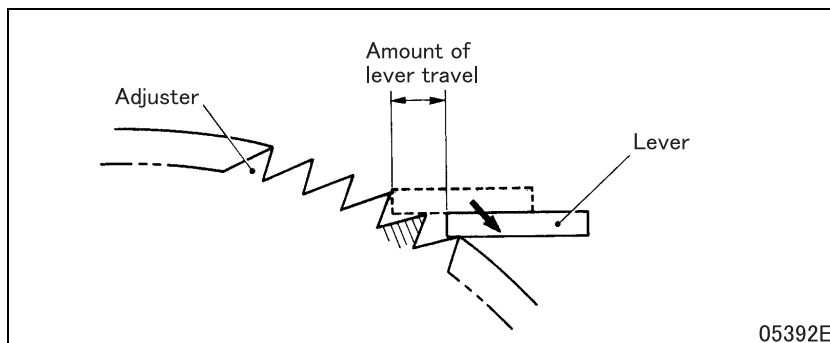
- As the brake drum-to-lining clearance grows, the amount of piston travel, and therefore the amount of lever travel, becomes greater.
- When the lever travels far enough to turn the adjuster, the threads on the adjuster causes the adjusting screw to advance. As a result, the brake shoe extends.

- As the brake pedal is released, the adjuster remains in the new position while the lever retracts by one tooth. The brake drum-to-lining clearance is now correctly adjusted.

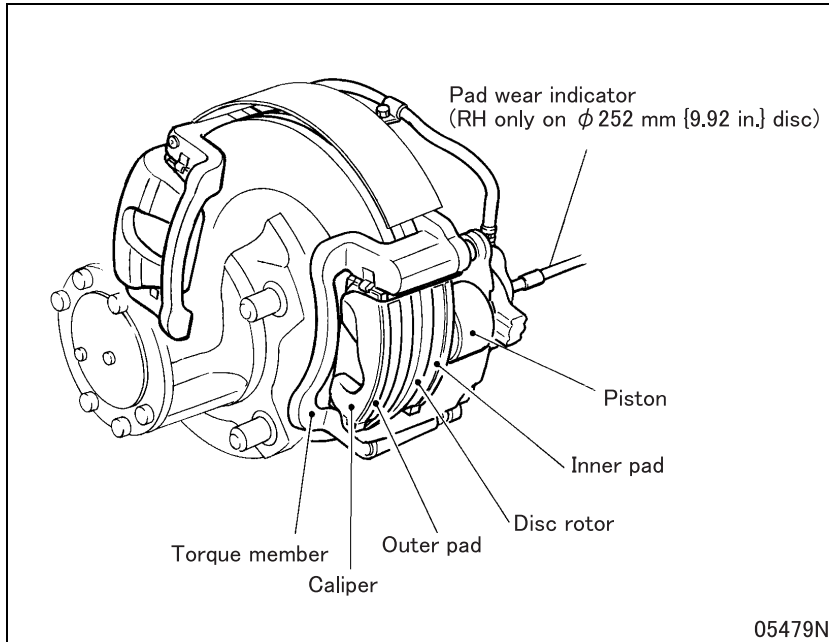
## 8. Rear Disc Brake <FE>

- The rear disc brake uses a twin floating-type calipers.
- The caliper houses one each of cylinder and piston. Stopping power is generated by squeezing the disc rotor between the pads, with the outer pad pressed against the disc rotor by reaction.
- The inner pad is equipped with wear indicator which serves to indicate replacement timing for both the inner and outer pads.
- The rear disc brake is equipped with a self-adjusting mechanism to compensate for pad wear and maintain the correct clearances between the disc rotor and the inner and outer pads. The adjustment is made each time braking is performed.
- The self-adjusting mechanism operates in the same manner as that of the front disc brake.

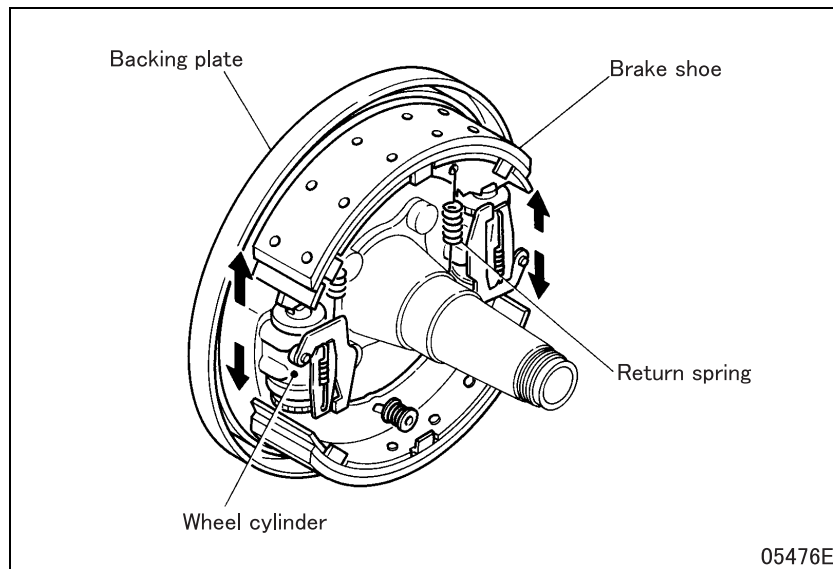
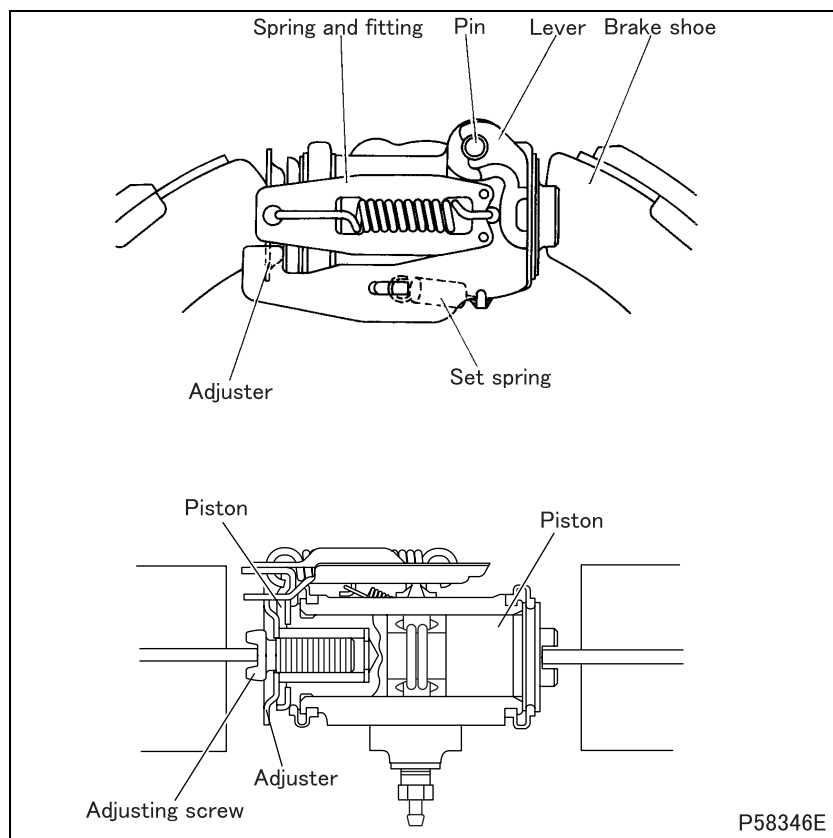
## 9. Rear Drum Brake <FG>

- The rear drum brake is of a dual 2-leading type.
- Double-acting wheel cylinders activate brake shoes, both as a leading shoe, in forward- and rearward-travel braking. By self-boosting effect, the dual 2-leading shoe brake generates a great stopping power.

- The wheel cylinder is equipped with a self-adjusting mechanism to compensate for lining wear and maintain the correct clearance between the lining and the drum. The adjustment is made each time braking is performed.
- The self-adjusting mechanism operates in the same manner as that of the front drum brake.

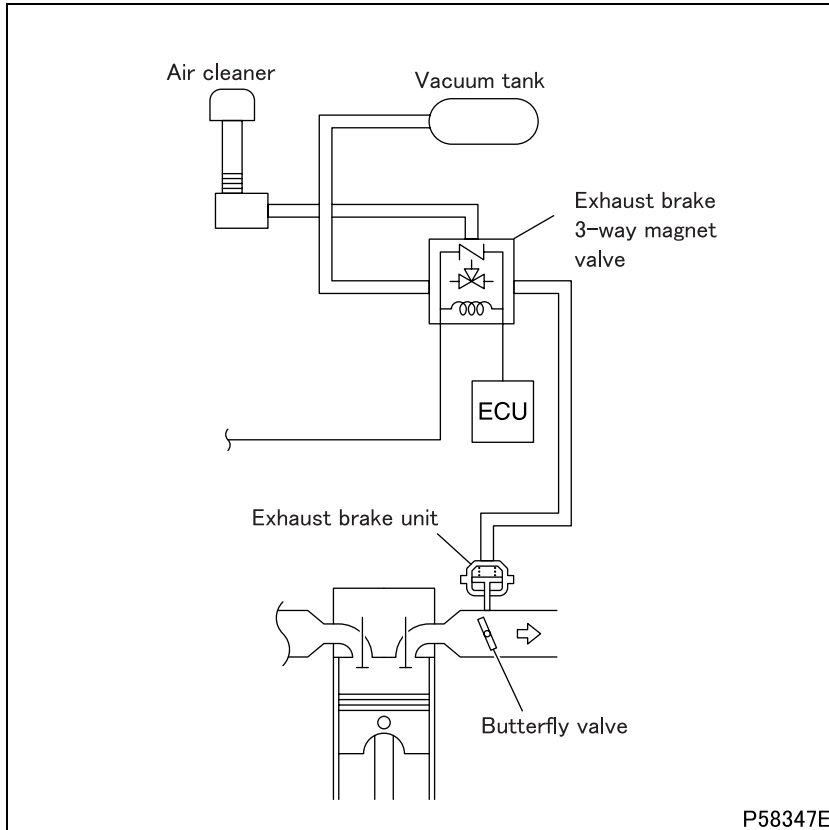
## 10. Exhaust Brake System <FE>

- The exhaust brake system provides stopping power by closing the exhaust piping. Specifically, pressure builds up in the blocked exhaust piping, which then is used to resist the pistons as they move to discharge exhaust in the exhaust stroke.
- The exhaust brake system supplements the foot brake. It is equipped with the exhaust brake unit incorporating a butterfly valve.
- When the exhaust brake switch is turned ON, the excitation winding within the exhaust brake 3-way magnet valve is magnetized. This closes the atmospheric pressure valve while opening the vacuum valve. Vacuum in the vacuum tank acts on the exhaust brake unit, closing the butterfly valve and bringing the exhaust braking in operation.

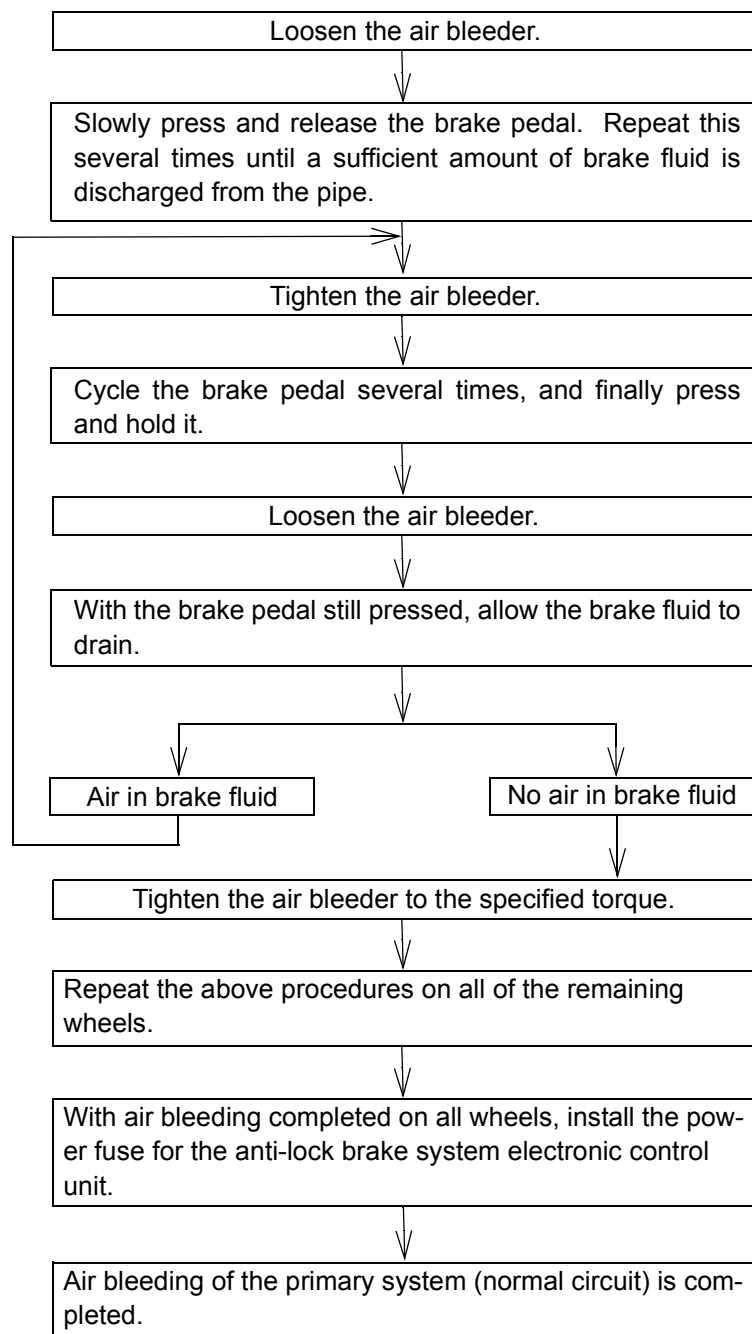
- If air has entered into the secondary brake system (anti-lock brake system operating circuit), bleed air from the secondary system after completing the air bleeding of the primary system (normal circuit).
- Normally, during air bleeding or hydraulic unit replacement operation, air cannot enter into the secondary system (anti-lock brake system operating circuit) which is filled with brake fluid and is closed off. Therefore, only the primary system (anti-lock brake system operating circuit) needs to be bled of air.

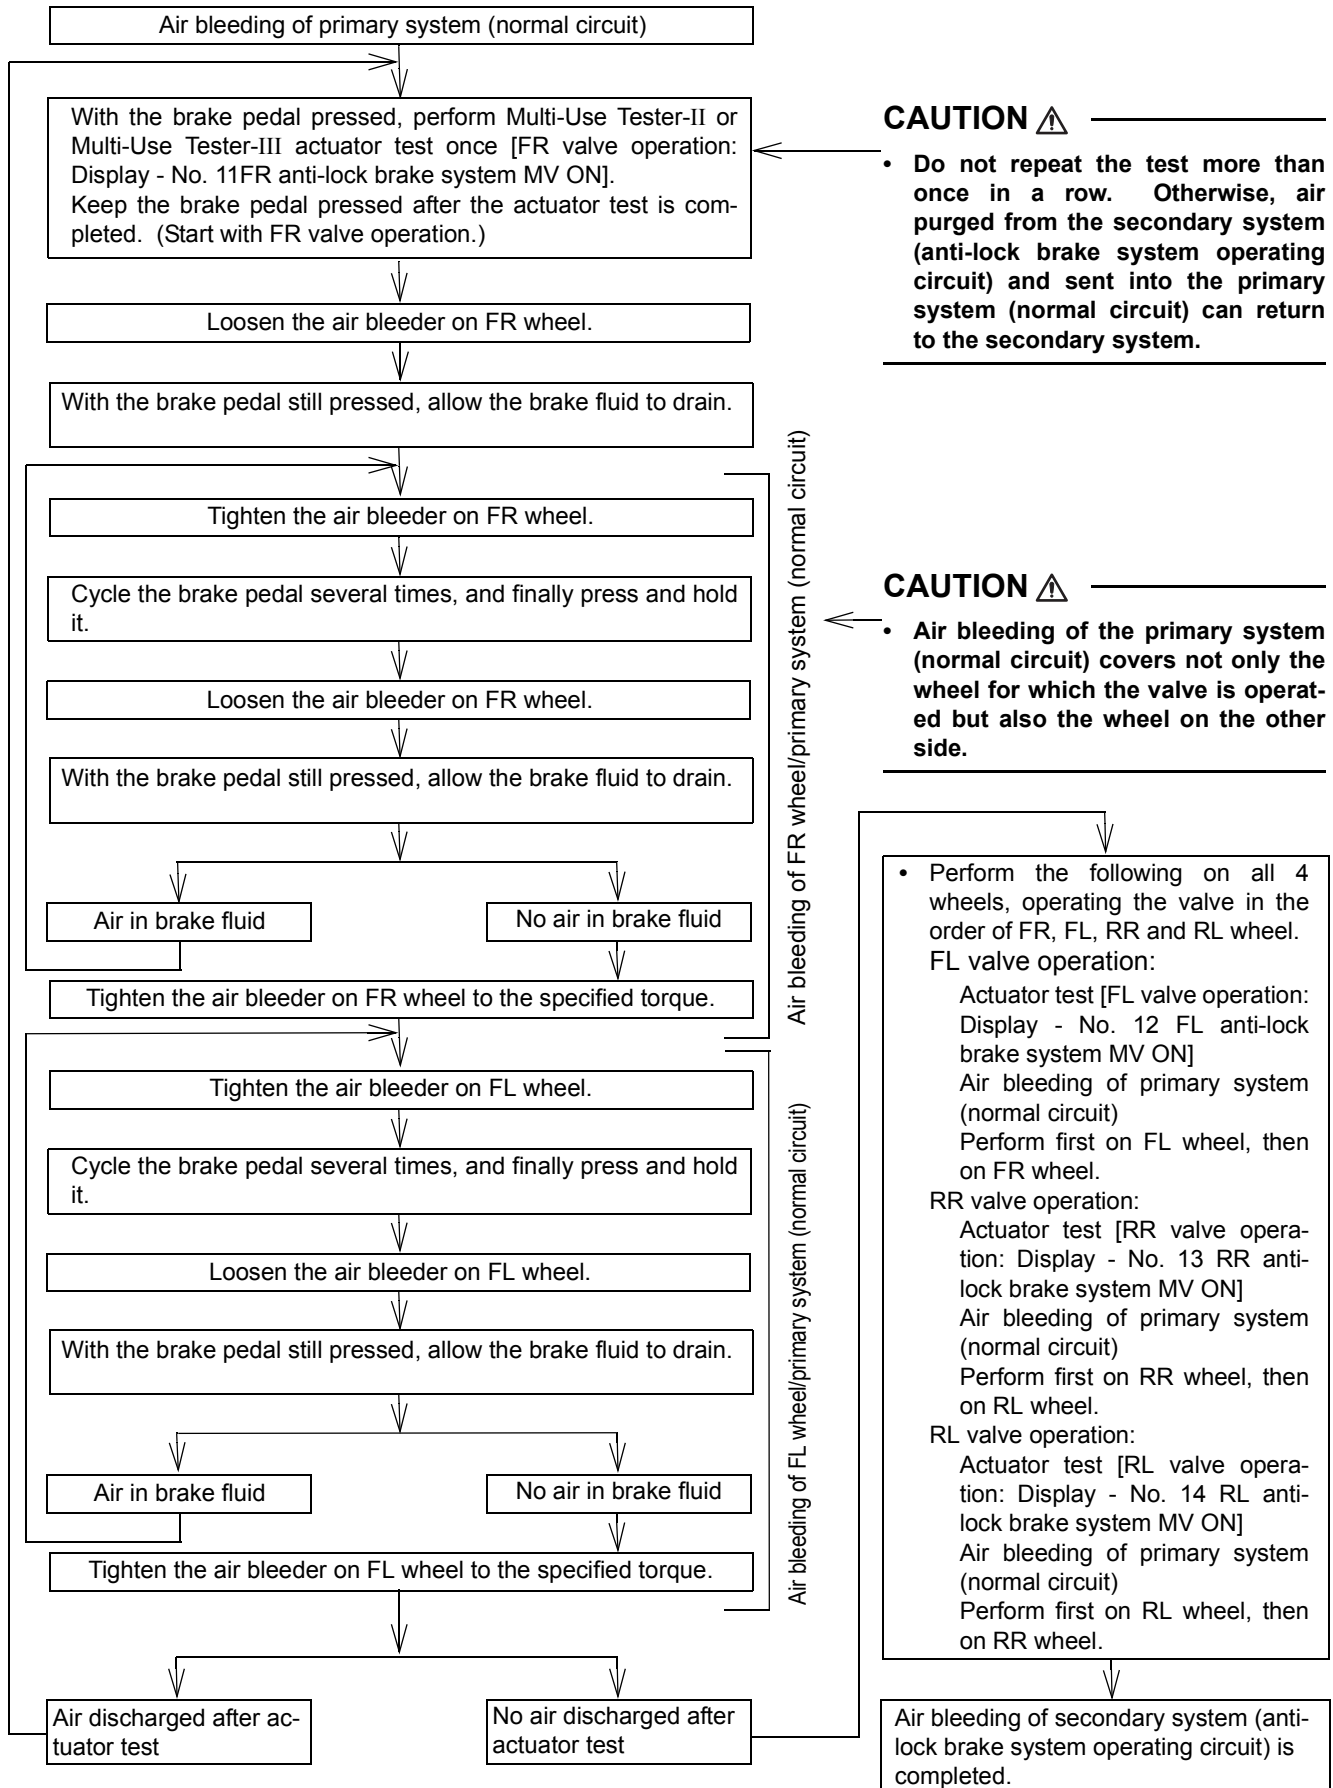
## (2) Air bleeding of secondary brake system (anti-lock brake system operating circuit)

- If the anti-lock brake system system is operated with air still remaining in the primary brake system (normal circuit), air can enter into the secondary brake system (anti-lock brake system operating circuit).
- If air has entered into the secondary system (anti-lock brake system operating circuit), that air can also flow into the primary system (normal circuit) when the anti-lock brake system system is operated, possibly causing the brake pedal stroke to extend.
- Multi-Use Tester-II or Multi-Use Tester-III actuator test (anti-lock brake system operating mode) is performed as part of the air bleeding procedures.

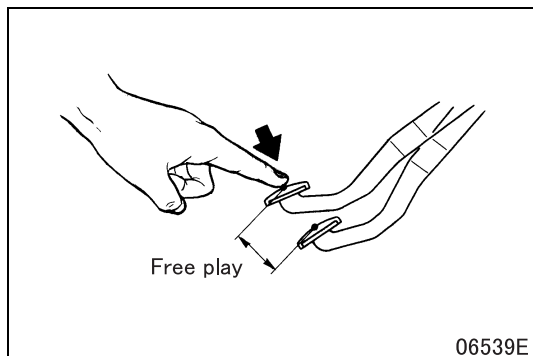
| Location | Maintenance item | Standard value | Limit | Remedy |
|---|---|---|---|---|
| – | Pedal free play | 0.1 to 3 {0.0034 to 0.12} | – | Adjust |

- With the engine stationary, ensure that the pedal play conforms to the standard value.
- If the measured value does not conform to the standard value, adjust the installed height of the brake pedal.
