# FE.FG

## SERVICE MANUAL 2008 Model FOREWORD

This Service Manual contains maintenance and repair methods for the Mitsubishi Fuso Truck FE. FG Series. Read this manual carefully as an aid in providing correct, efficient maintenance. Please note that the information and specifications contained within this manual may change without notice. This is due to product modifications and continued vehicle improvements that are made throughout the model years. Should you encounter any discrepancy in the information provided, please do not hesitate to contact your nearest Mitsubishi Fuso Dealer or Mitsubishi Fuso Truck of America, Inc.

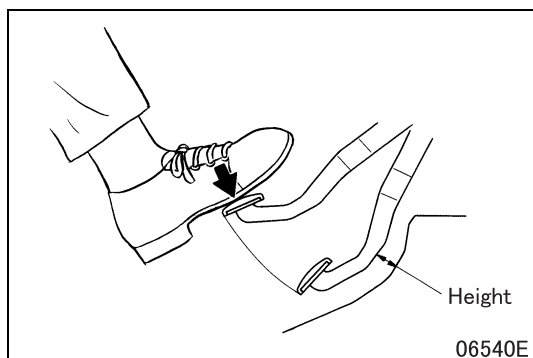
| Location | Maintenance item | Standard value | Limit | Remedy |
|---|---|---|---|---|
| – | Brake pedal height from floor (when pressed with a force of 490 N {110 lbs, 50 kgf}) | 20 {0.79} or above | – | Adjust |

- With the engine running at idle, press the brake pedal with a force of 490 N {110 lbs, 50 kgf} and measure the brake pedal height from the floor.
- If the measured value does not conform to the standard value, adjust the installed height of the brake pedal.

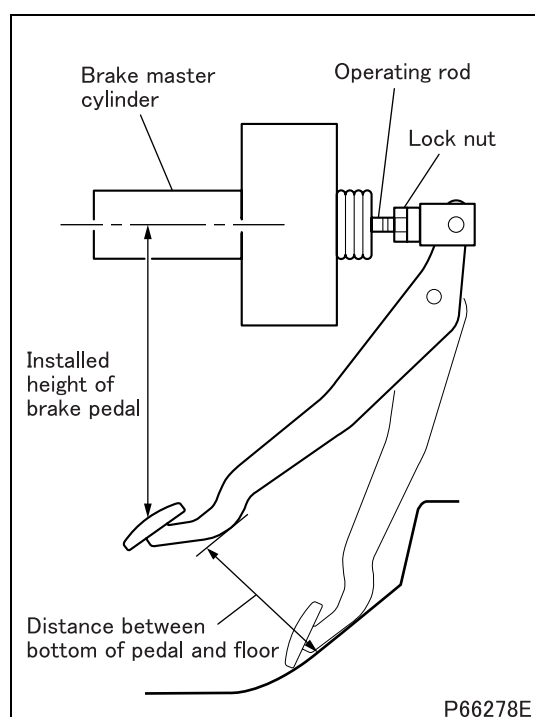
### 5.1 Inspection of pedal stroke

- With the brake pedal released, measure the distance between the bottom of pedal and the floor. If the measurement conforms to the standard value, the pedal full stroke is correctly adjusted.
- If the above measurement does not conform to the standard value, adjust the installed height of the brake pedal.

- After loosening the lock nut, turn the operating rod of the vacuum booster/hydraulic booster until the distance from the pedal pad center to the axis of brake master cylinder conforms to the standard value.
- Tighten the lock nut to the specified torque.
- With the lock nut correctly tightened, adjust the stop lamp switch and inspect the brake pedal play.

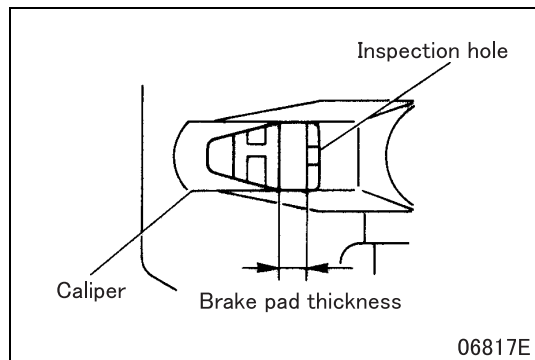
- When a brake pad has worn down to a thickness of approximately 4 mm {0.16 in.}, the pad wear indicator contacts the disc rotor. This breaks the circuit, illuminating the disc brake warning lamp on the meter cluster to tell the operator that the brake pads need replacement.

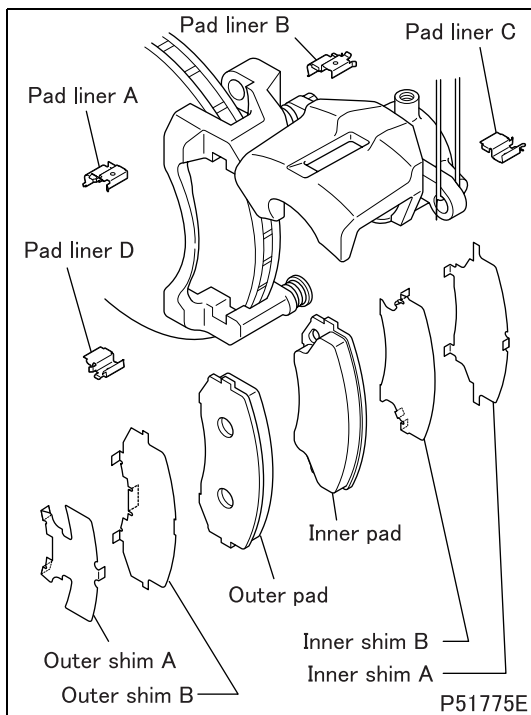
### <φ235 mm {9.25 in.} disc>

- Inspect the piston for fluid leakage. Inspect the piston boots for damage. Faulty parts must be replaced.
- Remove the following parts. Installation follows the removal procedure in reverse. When installing shims onto the pads, be sure to face them in the illustrated directions.

- The inner pad on RH wheel and the inner pad on LH wheel are both equipped with a pad wear indicator.

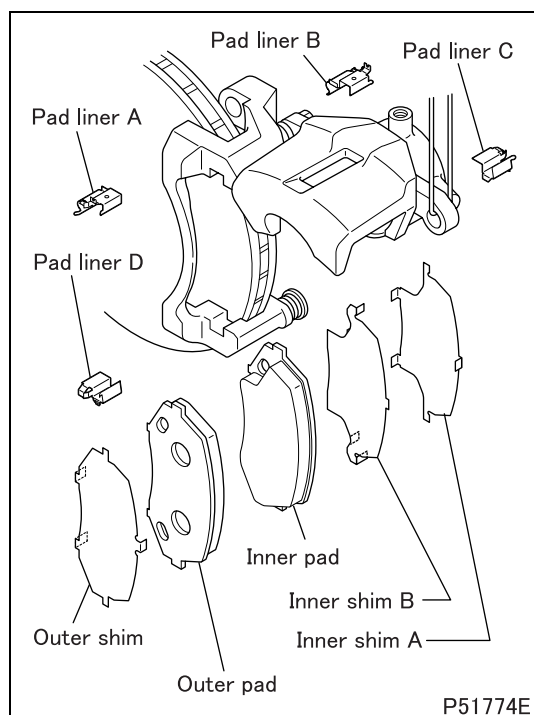
<φ252 mm {9.92 in.} disc>

- The inner pad on RH wheel and the inner pad on LH wheel are both equipped with a pad wear indicator.

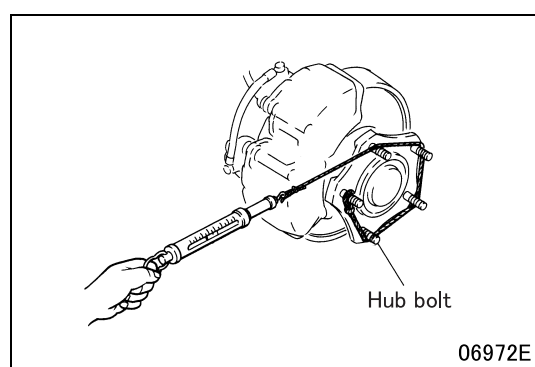
- Ensure that the starting torque of the wheel hub bearings conforms to the standard value.
- Using a spring balance, measure the tangential force at the hub bolts.
- The tangential force is calculated by the following formula.  
Tangential force = Dragging torque / (hub bolt P.C.D. / 2)
- If the measured tangential force conforms to the specified value, this means that the drag torque of the disc brake conforms to the standard value.
- If the measured value does not conform to the specified torque, check the sliding portions of the piston and piston seal.

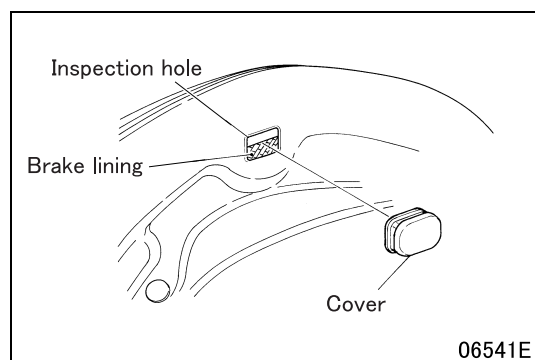
| Location | Maintenance item | Standard value | Limit | Remedy |
|---|---|---|---|---|
| - | Brake lining thickness | - | 4.0 {0.16} | Replace |

- Remove the cover from the backing plate. Through the inspection hole, check the thickness of the brake lining.
- If the measured value is equal to or less than the limit, replace all of the brake linings or shoes on the same axle.
- After the inspection, be sure to install the cover.

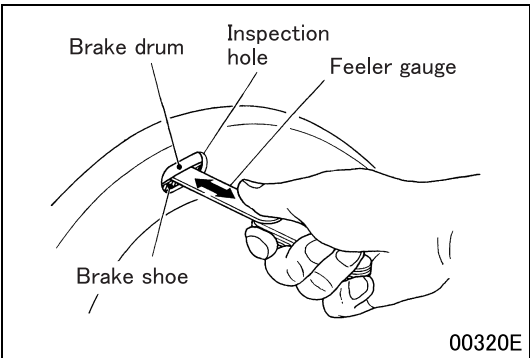
- Cycle the brake pedal a couple of times to bring the brake shoes to conditions appropriate for the inspection.
- Through the inspection hole, insert a feeler gauge between the brake drum and lining. The gauge should be able to be inserted and out with slight resistance.
- If the clearance does not conform to the standard value, perform the following adjustment.

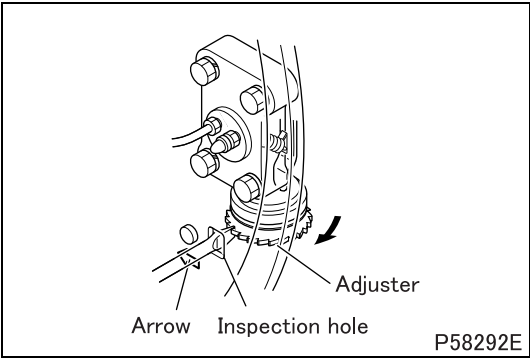
- Jack up the wheel being adjusted. Ensure that the wheel hub bearings are not loose.
- With a 0.3 mm {0.012 in.} feeler gauge inserted through the inspection hole, adjust the drum-to-lining clearance in the following manners such that the gauge can be inserted and out with slight resistance.
- If the feeler gauge can be inserted and out with no resistance, turn the adjuster through the inspection hole in the direction of the arrow on the backing plate.

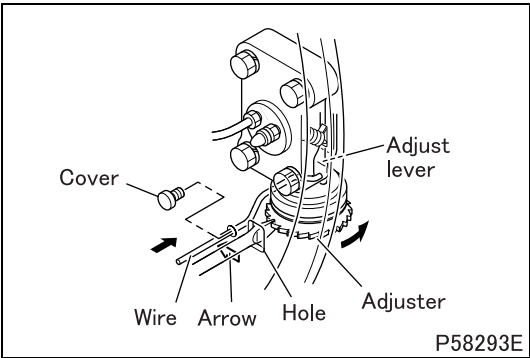
- If the clearance is too small to insert the feeler gauge or there is considerable resistance when inserting the gauge, remove the cover and insert a  $\phi 2$  mm {0.079 in.} wire through the hole to lift the adjust lever for the wheel cylinder. Then, through the inspection hole turn the adjuster in the direction opposite to the arrow on the backing plate to increase the clearance between the brake drum and shoe.
- Then, cycle the brake pedal a couple of times. This will automatically bring the brake drum-to-shoe clearance to 0.2 mm {0.0079 in.}.
- Insert a 0.2 mm {0.0079 in.} feeler gauge between the brake drum and lining. It should be able to be inserted and out with slight resistance.
- Check the disc brake for normal operation. If faulty, disassemble and inspect the wheel cylinders.

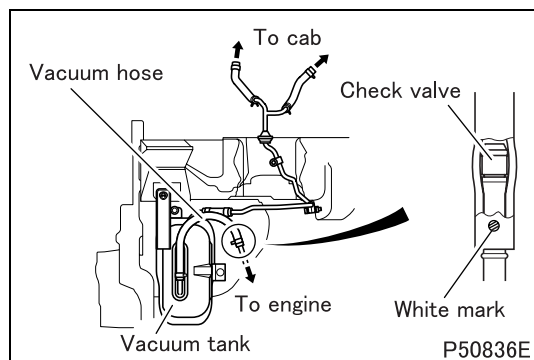
## 10. Inspection of Check Valve in Vacuum Line Hose

- Be careful not to allow moisture into the check valve.
  - During the inspection, ensure that the check valve opens as well as closes correctly.
  - Do not attempt to remove the check valve from the vacuum hose.
- 
- Perform the following inspections. If the check valve does not pass both inspections, replace the check valve complete with the vacuum hose.
    - Blow into the hose. The check valve should close, preventing the breath from passing it.
    - Suck on the hose. The check valve should open, allowing air to pass.

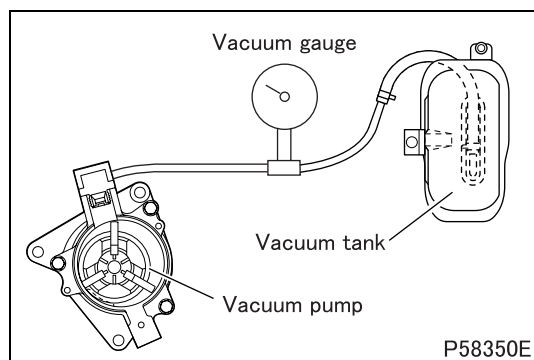
- Install a vacuum gauge between the vacuum tank and the vacuum pump.
- Start the engine and measure the time taken to reach the specified degree of vacuum.
- If the measured time does not conform to the standard value, disassemble and service the vacuum pump.

| Location | Maintenance item | | Standard value | Limit | Remedy |
|---|---|---|---|---|---|
| - | Time to reach vacuum of 80 kPa {23.6 in.Hg, 600 mmHg} | At 1500 rpm | Within 20 sec. | - | Replace |
| | | At 3000 rpm | Within 12 sec. | - | |

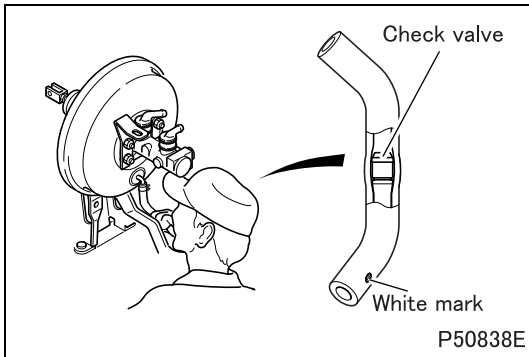
- Start the engine and charge the vacuum tank with vacuum.
- Stop the engine, and immediately remove the clamp fixing the vacuum hose onto the vacuum pipe, and hold the hose in the mouth.
- Blow into the hose. The check valve should close, preventing the breath from passing it.
- Suck on the hose while pressing the brake pedal. The check valve should immediately open, allowing air to pass.
- If any fault is encountered during the above inspections, replace the check valve complete with the vacuum hose.

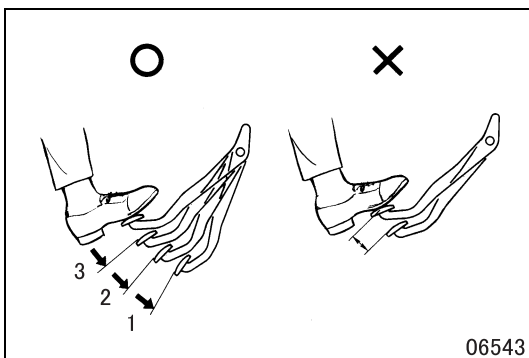
- Start the engine and run it for 1 to 2 minutes. Stop the engine.
- Press the brake pedal repetitively with the normal stepping force.
- The pedal stroke should become smaller each time the pedal is pressed.

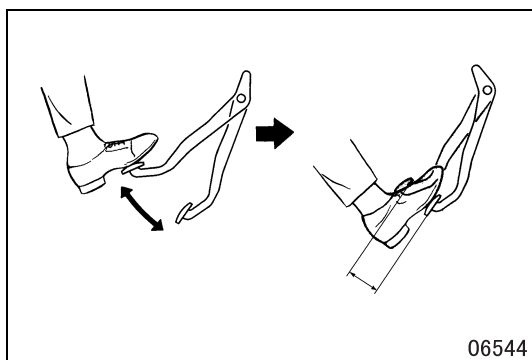
- With the engine stationary, press the brake pedal several times.
- With the brake pedal pressed, start the engine. The pedal should sink slightly.

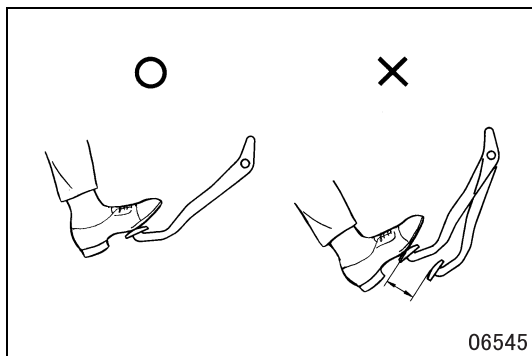
- With the engine running and the brake pedal pressed, stop the engine.
- The brake pedal should maintain the same height for approximately 30 seconds.

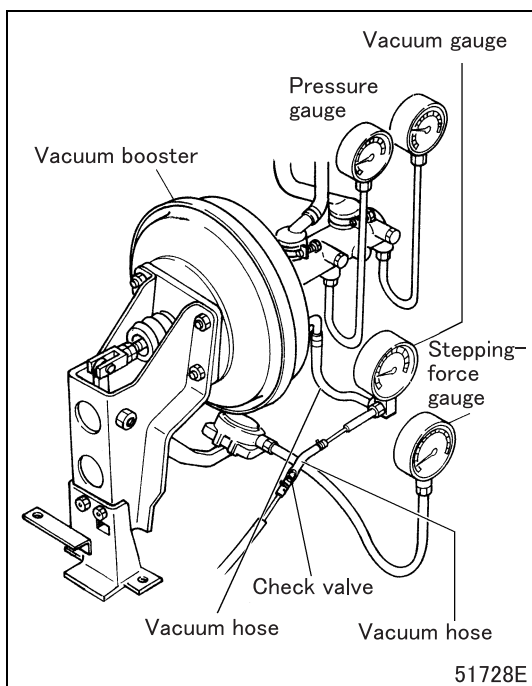
- Inspect the check valve in the vacuum hose for normal operation.
- Remove the vacuum hose from the vacuum booster and connect it to the vacuum gauge.
- Connect another hose (not equipped with a check valve) onto the vacuum booster and the vacuum gauge.
- Install 2 pressure gauges and 1 stepping-force gauge as illustrated. Bleed the pressure gauges of air.
- Perform the following checks. If any fault is encountered during these checks, inspect the vacuum booster.

- Start the engine. When the reading on the vacuum gauge has reached 67 kPa {19.8 in.Hg, 500 mmHg}, stop the engine.
- The vacuum lost in approximately 15 seconds of the engine stop should conform to the standard value.

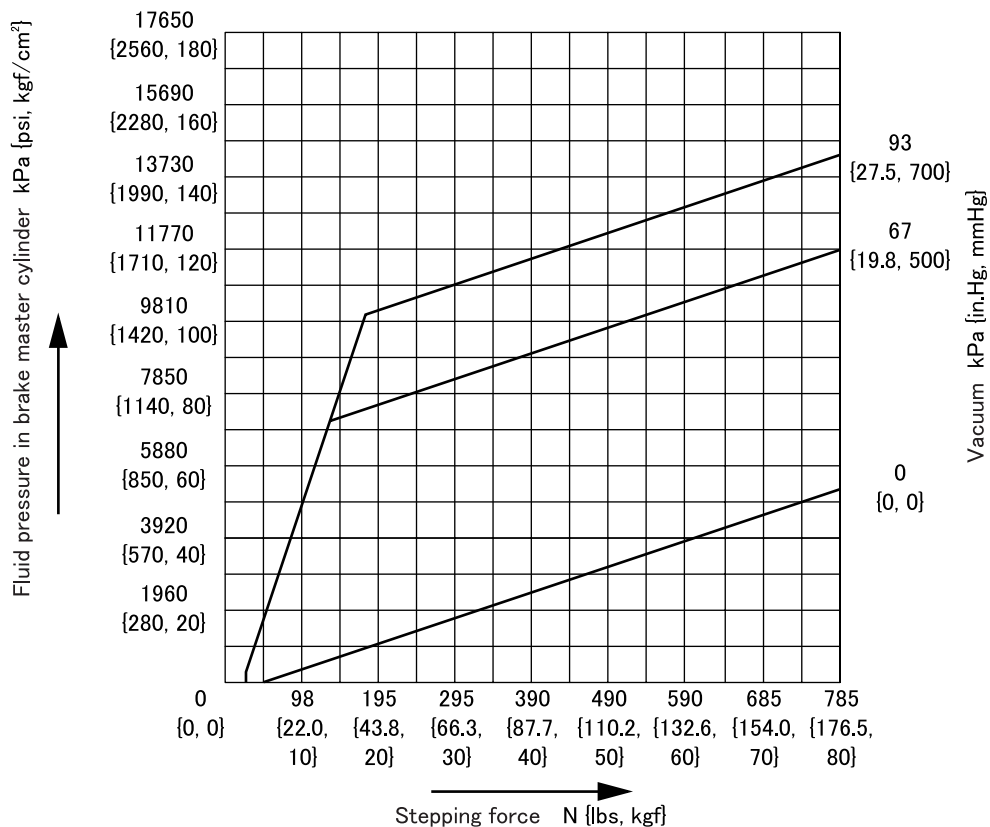
**(2.3) Vacuum booster performance graph**

<  $\phi 8 + \phi 9$  inch vacuum booster,  $\phi 30.16$  mm {1.19 in.} brake master cylinder >

| Location | Maintenance item | | Standard value | Limit | Remedy |
|---|---|---|---|---|---|
| – | Fluid pressure at vacuum of 67 kPa {19.8 in.Hg, 500 mmHg} | φ8 + φ9 inch vacuum booster, φ30.16 mm {1.19 in.} brake master cylinder | 4830 kPa {700 psi, 49.3 kgf/cm <sup>2</sup> }<br>(pedal pressed with a force of 98 N {22.0 lbs, 10 kgf}) | – | Replace |

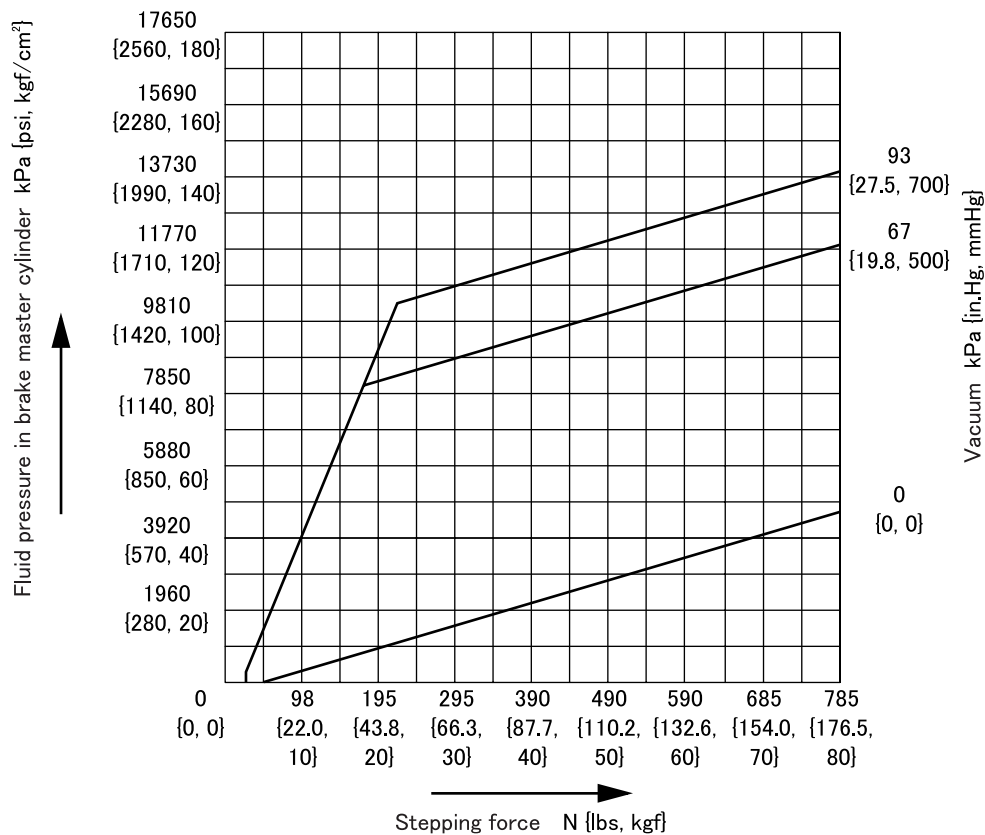
<  $\phi 9 + \phi 10$  inch vacuum booster,  $\phi 30.75$  mm {1.25 in.} brake master cylinder >

| Location | Maintenance item | | Standard value | Limit | Remedy |
|---|---|---|---|---|---|
| | | φ9 + φ10 inch vacuum booster, φ31.75 mm {1.25 in.} brake master cylinder | 315 kPa {46 psi, 3.2 kgf/cm <sup>2</sup> }<br>(pedal pressed with a force of 98 N {22.0 lbs, 10 kgf}) | – | |
| | | | 1550 kPa {225 psi, 15.8 kgf/cm <sup>2</sup> }<br>(pedal pressed with a force of 295 N {66.3 lbs, 30 kgf}) | – | |

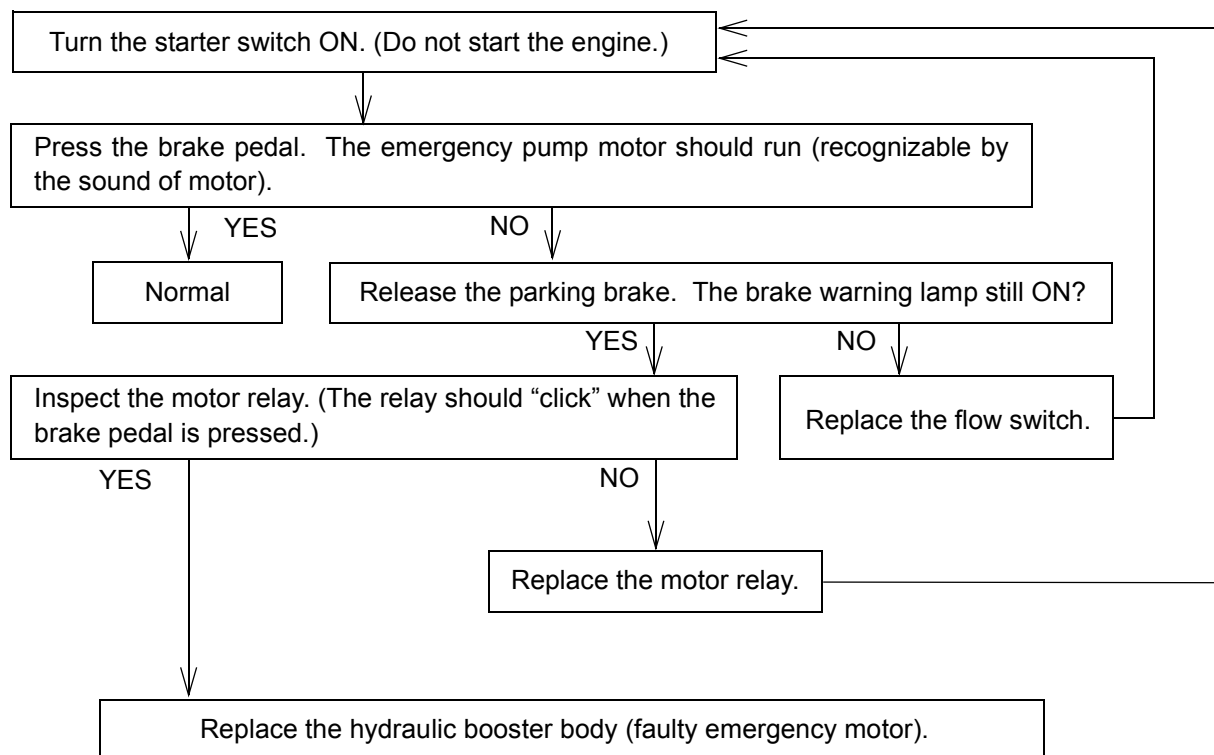
- Inspect in accordance with the following flow chart.
- Before inspection, park the vehicle on a flat surface, apply the parking brake firmly, and chock the wheels.

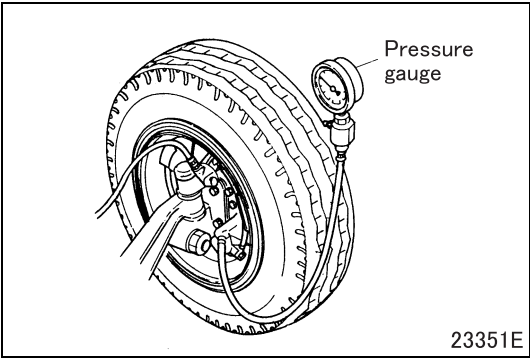
- Install a stepping-force gauge onto the brake pedal. Remove an air bleeder from the front wheel brake, and install a pressure gauge. Bleed the gauge of air.
- Carry out performance test on the power steering system. Ensure that the system pressure is to specification.
- After confirming that the electric equipment has passed the inspection described above, press the brake pedal with varying forces. The reading of the front wheel brake fluid pressure should follow the pressure line of the graph.

- If any fault is observed during these checks, replace the hydraulic booster.

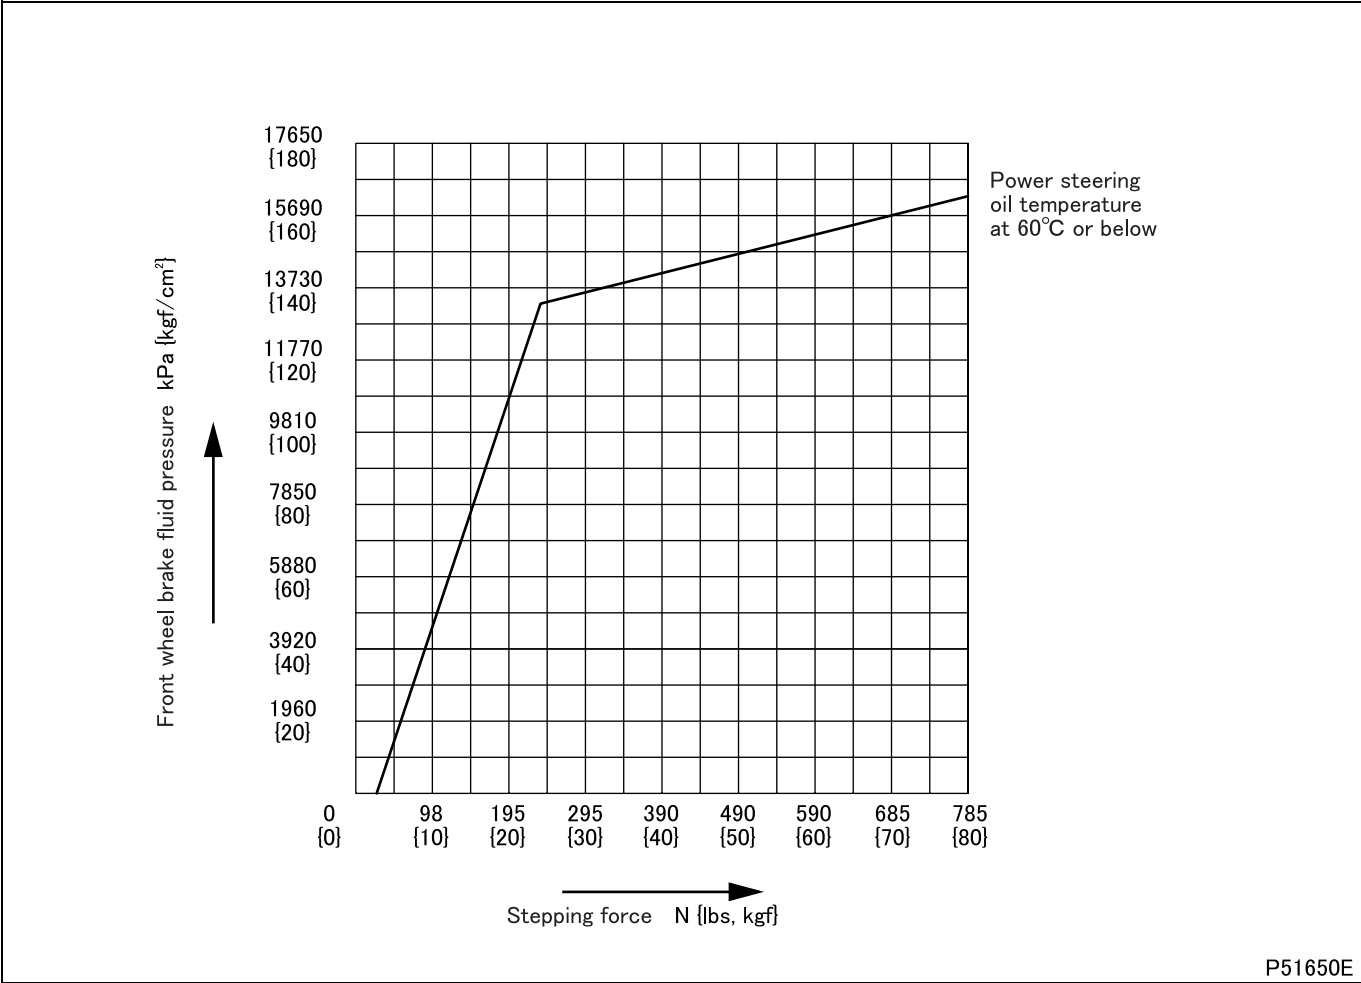
## 13.3 Hydraulic booster performance graph

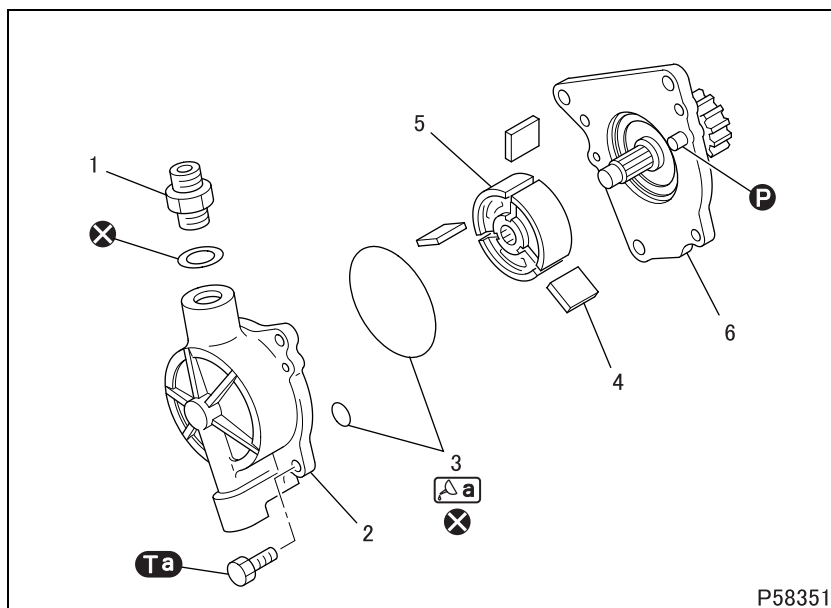
- 1 Check valve
- 2 Housing
- 3 O-ring
- 4 Vane
- 5 Rotor
- 6 Bracket

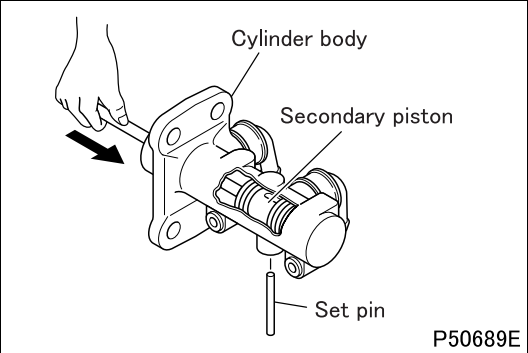
■ Removal: Secondary piston

- Position the cylinder body such that the set pin faces down. Using a rod or the like, compress the secondary piston to ease out the set pin.

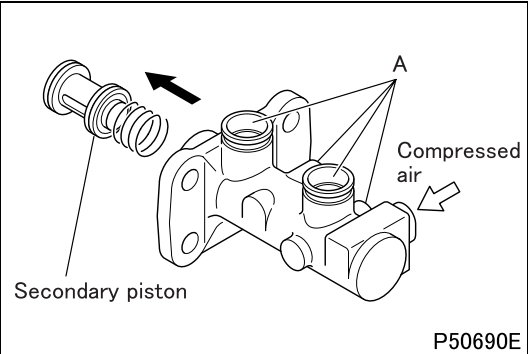
- With ports A blocked, feed compressed air in the direction of the arrow, gradually increasing pressure from 0 kPa {0 kgf/cm<sup>2</sup>}, to remove the secondary piston.

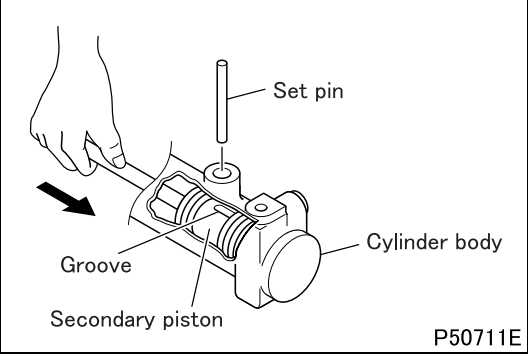
■ Installation: Secondary piston

- Position the cylinder body such that the set pin hole faces up. Using a rod or the like, insert the secondary piston into the cylinder body while at the same time trying to insert the set pin.

- If necessary, rotate the secondary piston to align the groove on the piston with the set pin hole.

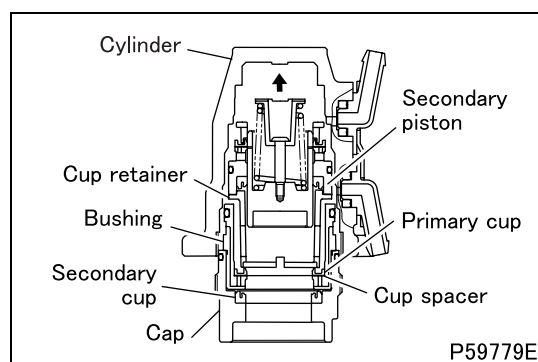
### ■ Installation: Cap, secondary cup, cup spacer, primary cup, bushing, cup retainer, secondary cup and primary piston

- With the end of the cylinder facing upward, insert each assembled part slowly.

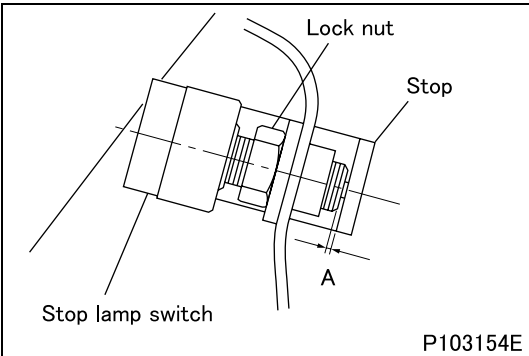
### ■ Installation: Stop lamp switch

- Set the distance A between the threaded end of the stop lamp switch and the stop for the brake pedal & pedal support to the illustrated value. Then, fix the assembly with the lock nut.  
A: 0.5 to 1.5 mm {0.020 to 0.059 in.} <Without auto cruise>  
1.5 ± 0.5 mm {0.059 ± 0.020 in.} <With auto cruise>

- To prevent brake drag, ensure that the threaded end of the stop lamp switch does not interfere with the stop for the brake pedal.

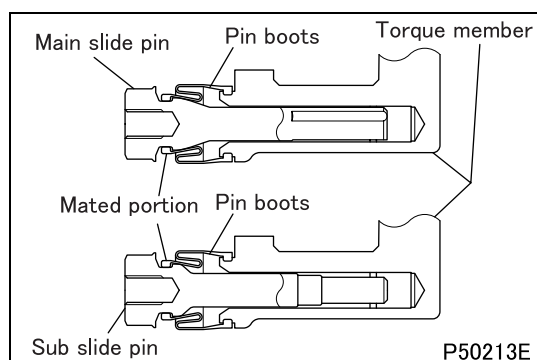
**■ Installation: Main slide pin, sub slide pin, pin boots, and torque member**

- On the torque member, apply grease onto the grooves and guide holes for the pin boots.
- Apply grease onto the outer peripheries of the main and sub slide pins. Apply grease onto the surfaces of the pin boots that are to be mated with the slide pins. Then, assemble these onto the torque member.
- Ensure that the seals on the pin boots are correctly attached onto the mated pin-boots portions.

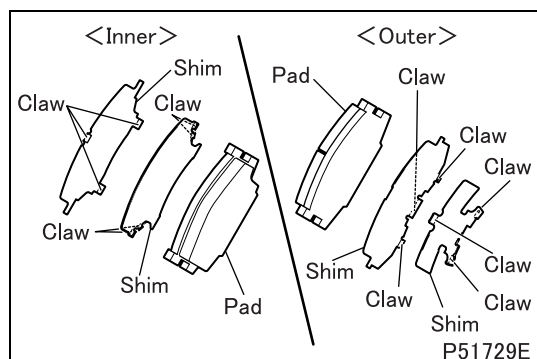
**■ Installation: Shims**

- Position shims such that they face the illustrated directions before installing them onto the pads.

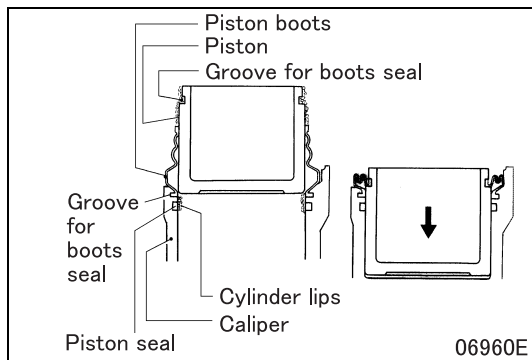
## ■ Installation: Piston boots, piston, and piston seal

- Apply brake fluid onto the outer periphery of the piston. Then, insert the piston boots over the piston.
- On the piston seal, spread the grease, already applied on it, evenly over the seal. Then, install the seal into the groove on the caliper.
- Apply grease evenly along the inner periphery of the cylinder lips on the caliper.
- Install the caliper-end seal of the piston boots into the groove on the caliper.
- Press fit the piston further into the boots. Ensure that the piston-end seal of the piston boots is engaged in the groove on the piston.

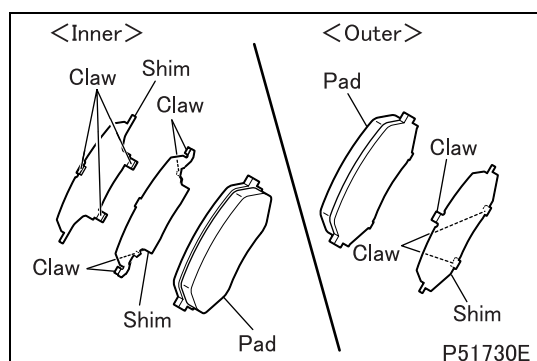
**■ Installation: Shims**

- Position shims such that they face the illustrated directions before installing them onto the pads.

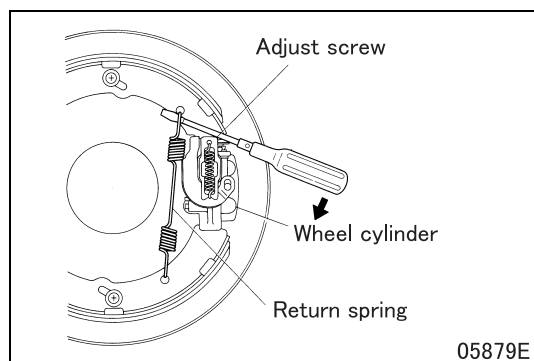
**■ Removal: Return spring**

- Using a flat-head screwdriver, remove the return spring. To do this, rest the screwdriver on the wheel cylinder adjust screw. Then, with the adjust screw as a fulcrum, engage the screwdriver with the spring hook and pry away the spring.

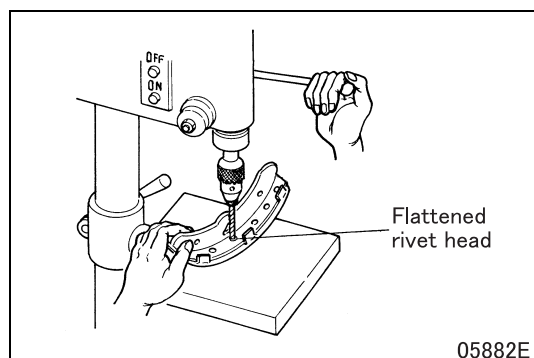
**■ Removal: Brake lining**

- Using a drilling machine, break the flattened rivet heads on the brake shoe side to release the brake lining.

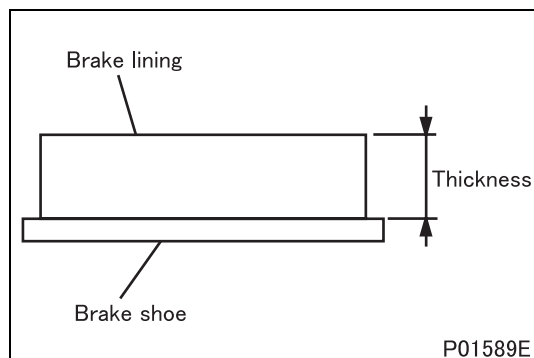
### ■ Inspection: Brake shoe

- Measure the thickness of the brake lining. If the measured value is less than the limit, replace all of the brake linings on the same axle.

- Brake linings used on the same axle should be in the same size and have the same identification mark. Otherwise, braking performance can be different from left to right.

| Location | Maintenance item | Standard value | Limit | Remedy |
|---|---|---|---|---|
| 7 | Brake lining thickness | 8.8 {0.35} | 4.0 {0.16} | Replace |

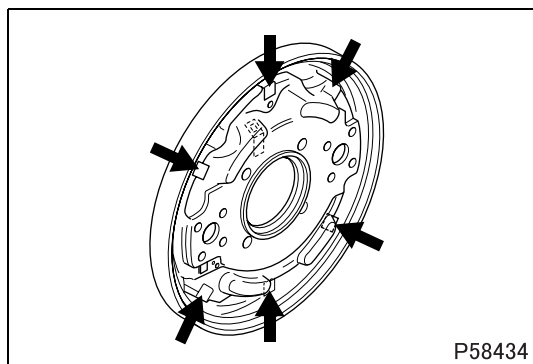
### ■ Installation: Backing plate

- Grease the backing plate at the illustrated locations.

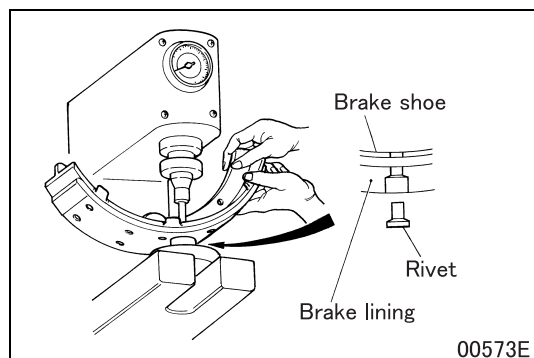
### ■ Installation: Brake lining

- Using cleaning fluid, clean the surface of the brake shoe to which the brake lining is to be mounted. Dry the brake shoe.
- Insert rivets from the lining to the shoe. Stake them, starting from the center of the shoe and moving towards the ends. Ensure that the shoe-to-lining clearances conform to the following specifications.
  - Around the rivets: 0.05 {0.0020 in.} mm or less
  - Along the shoe/lining sides: 0.4 mm {0.016 in.} or less
  - Along the shoe/lining ends: 0.2 mm {0.0078 in.} or less
- Stake the rivets with a force of 17650 ± 980 N {38920 ± 2160 lbs, 1800 ± 100 kgf}.

- Replace all of the brake linings on the same axle and the brake linings should be in the same size and have the same identification mark. Otherwise, braking performance can be different from left to right.

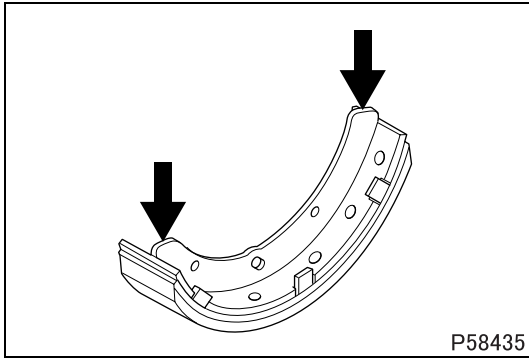
**■ Installation: Brake shoe**

- Grease the brake shoe at the illustrated locations.

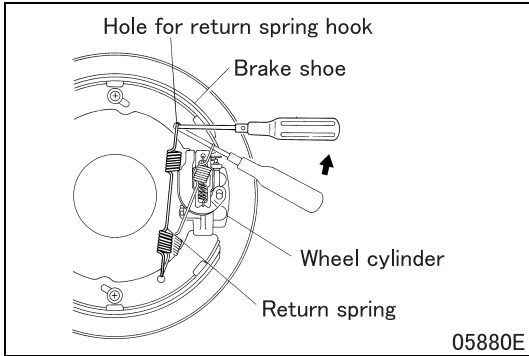
**■ Installation: Return spring**

- Hook the end of the return spring that has a smaller number of coils onto the brake shoe on the adjust screw side of the wheel cylinder.
- Engage a small Phillips screwdriver into the return spring hook. Then, using the screwdriver insert the spring hook into the hook hole in the brake shoe and attach the hook onto the shoe.

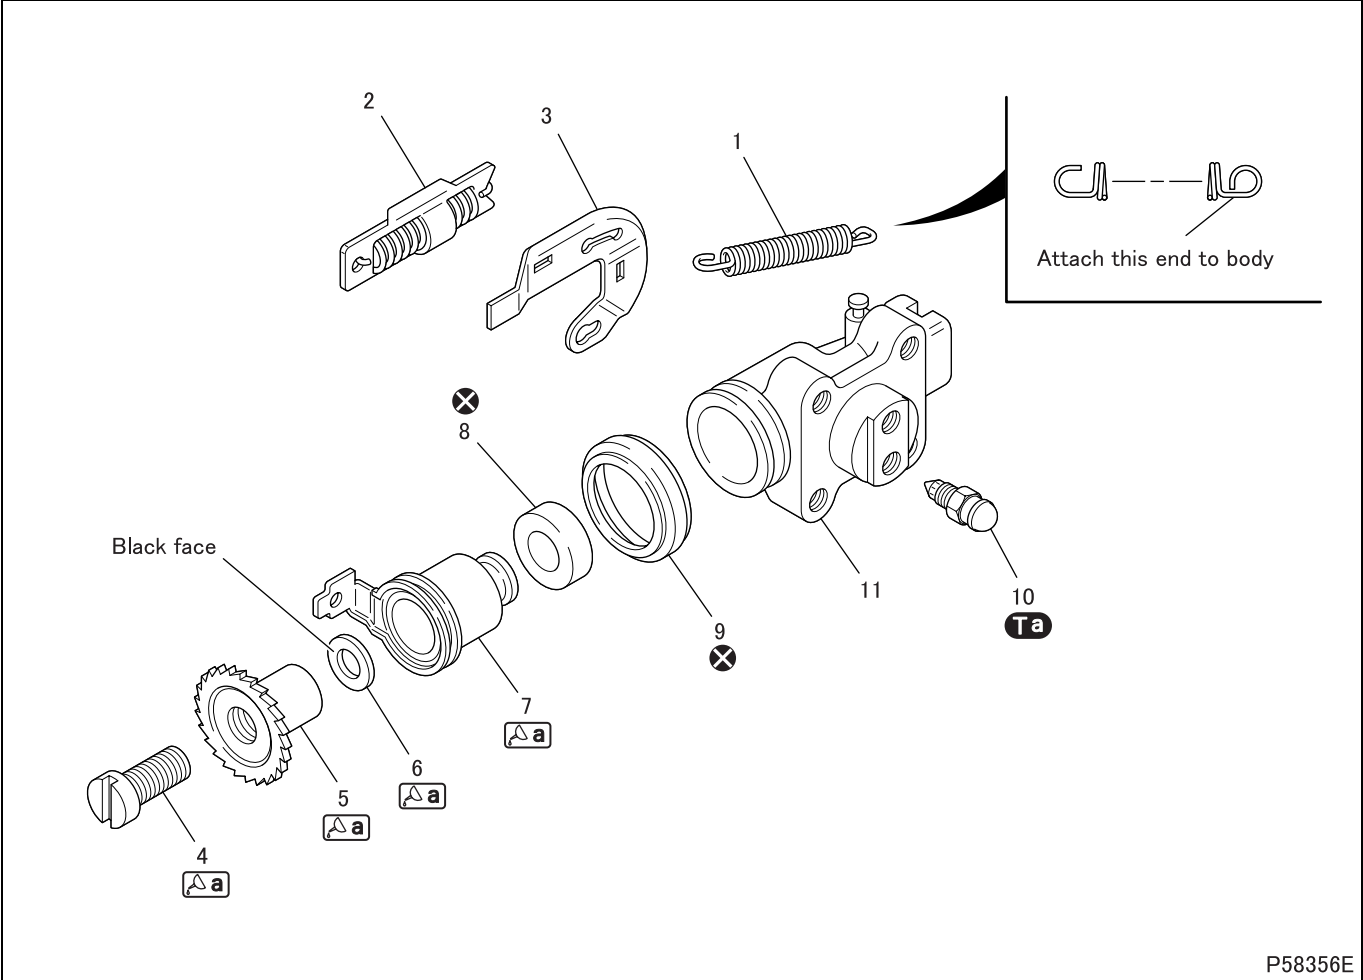
P58356E

## Wheel Cylinder

| Location | Maintenance item | Standard value | Limit | Remedy |
|---|---|---|---|---|
| 8, 11 | Piston-to-body clearance | 0.02 to 0.08<br>{0.00079 to 0.031} | 0.2 {0.0079} | Replace |

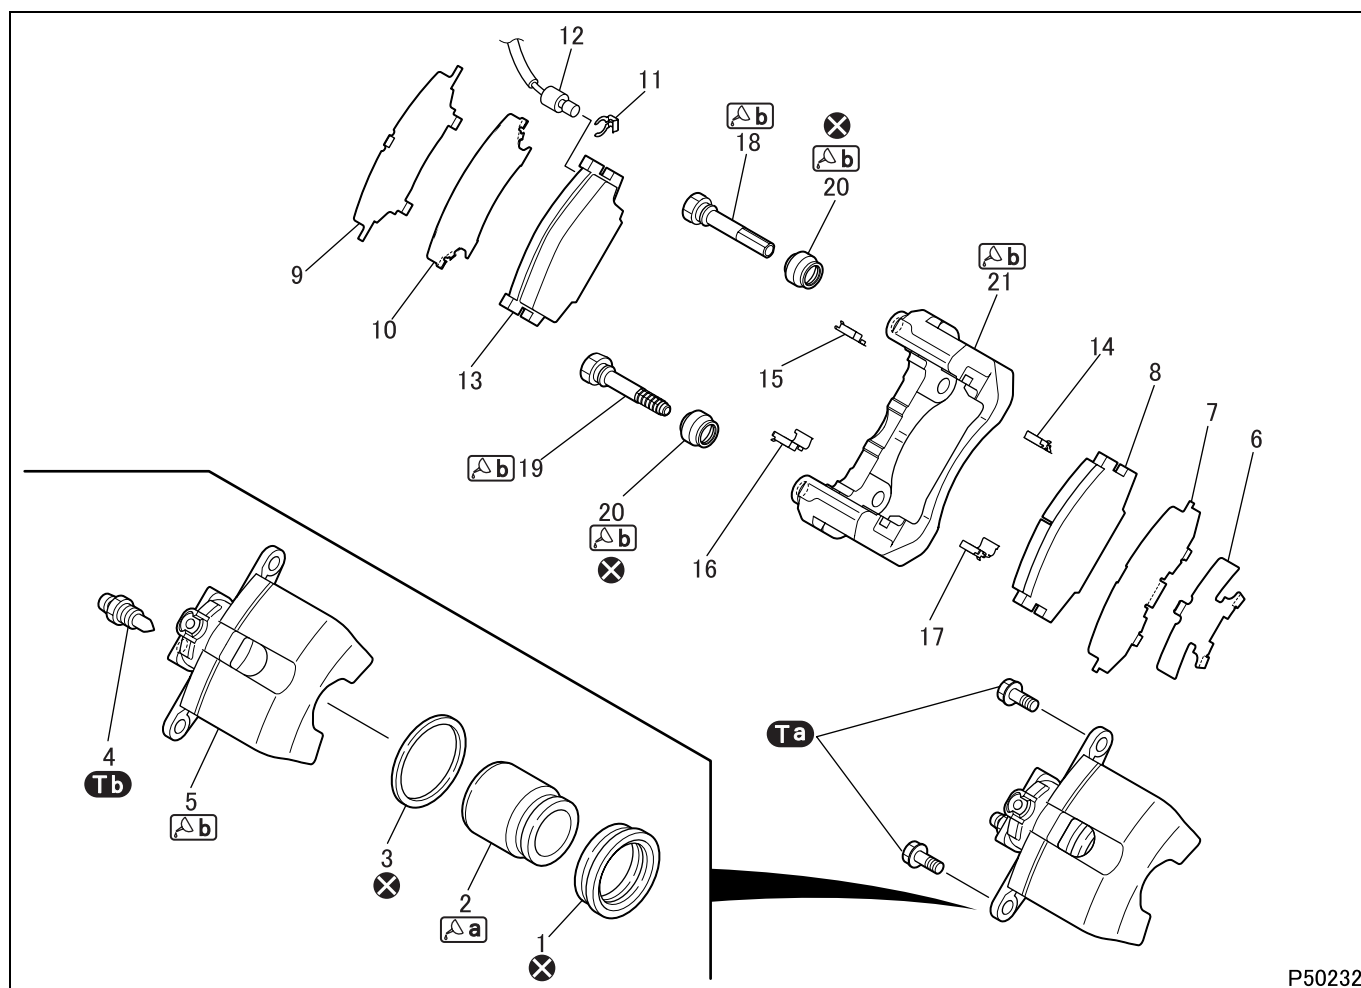
P50232

# REAR DISC BRAKE <φ235 mm {9.25 in.} DISC>

| Location | Maintenance item | Standard value | Limit | Remedy |
|---|---|---|---|---|
| 8, 13 | Thickness of outer/inner pad | 14 {0.55} | 4 {0.16} | Replace |

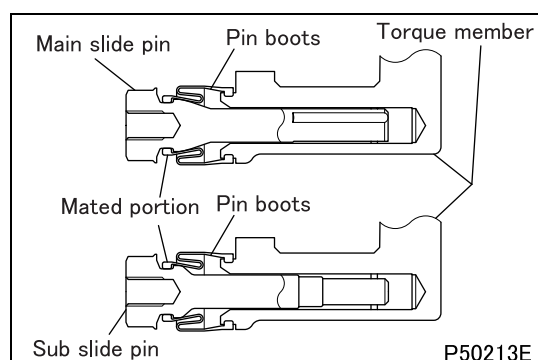
### ■ Installation: Main slide pin, sub slide pin, pin boots, and torque member

- On the torque member, apply grease onto the grooves and guide holes for the pin boots.
- Apply grease onto the outer peripheries of the main and sub slide pins. Apply grease onto the surfaces of the pin boots that are to be mated with the slide pins. Then, assemble these onto the torque member.
- Ensure that the seals on the pin boots are correctly attached onto the mated pin-boots portions.

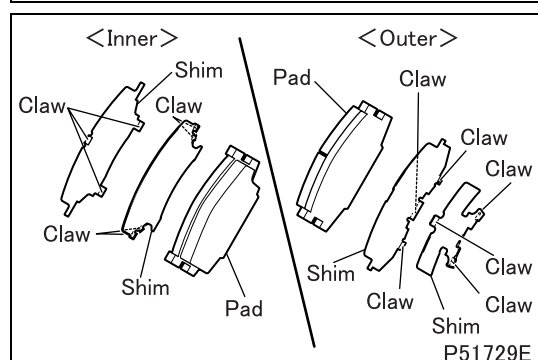
### ■ Installation: Shims

- Position shims such that they face the illustrated directions before installing them onto the pads.

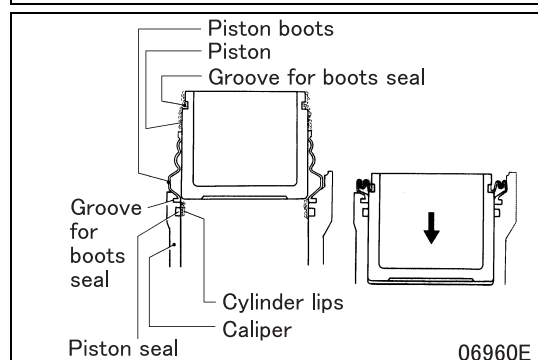
### ■ Installation: Piston boots, piston, and piston seal

- Apply brake fluid onto the outer periphery of the piston. Then, insert the piston boots over the piston.
- On the piston seal, spread the grease, already applied on it, evenly over the seal. Then, install the seal into the groove on the caliper.
- Apply grease evenly along the inner periphery of the cylinder lips on the caliper.
- Install the caliper-end seal of the piston boots into the groove on the caliper.
- Press fit the piston further into the boots. Ensure that the piston-end seal of the piston boots is engaged in the groove on the piston.

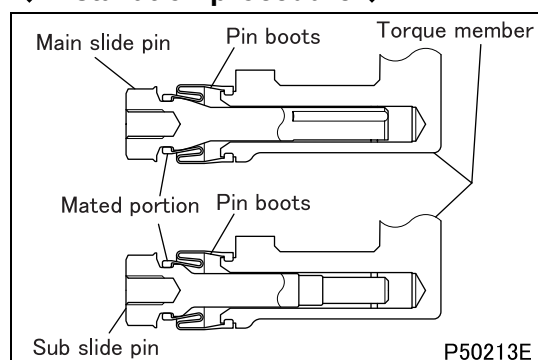
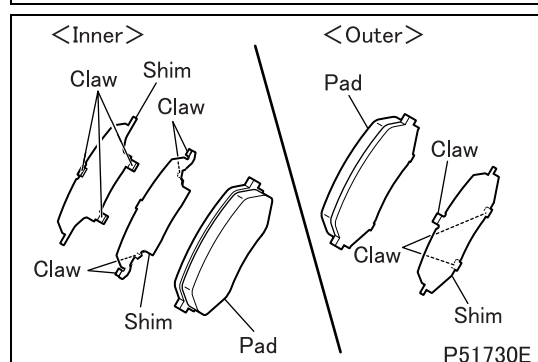
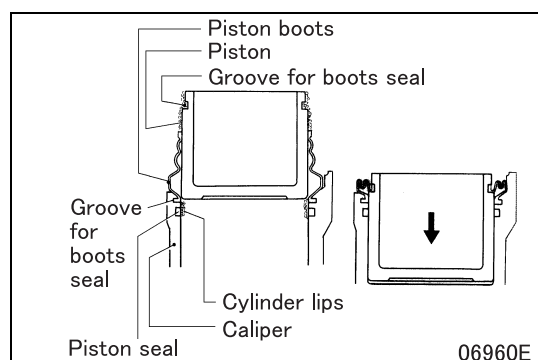
### ■ Installation: Main slide pin, sub slide pin, pin boots, and torque member

- On the torque member, apply grease onto the grooves and guide holes for the pin boots.
- Apply grease onto the outer peripheries of the main and sub slide pins. Apply grease onto the surfaces of the pin boots that are to be mated with the slide pins. Then, assemble these onto the torque member.
- Ensure that the seals on the pin boots are correctly attached onto the mated pin-boots portions.

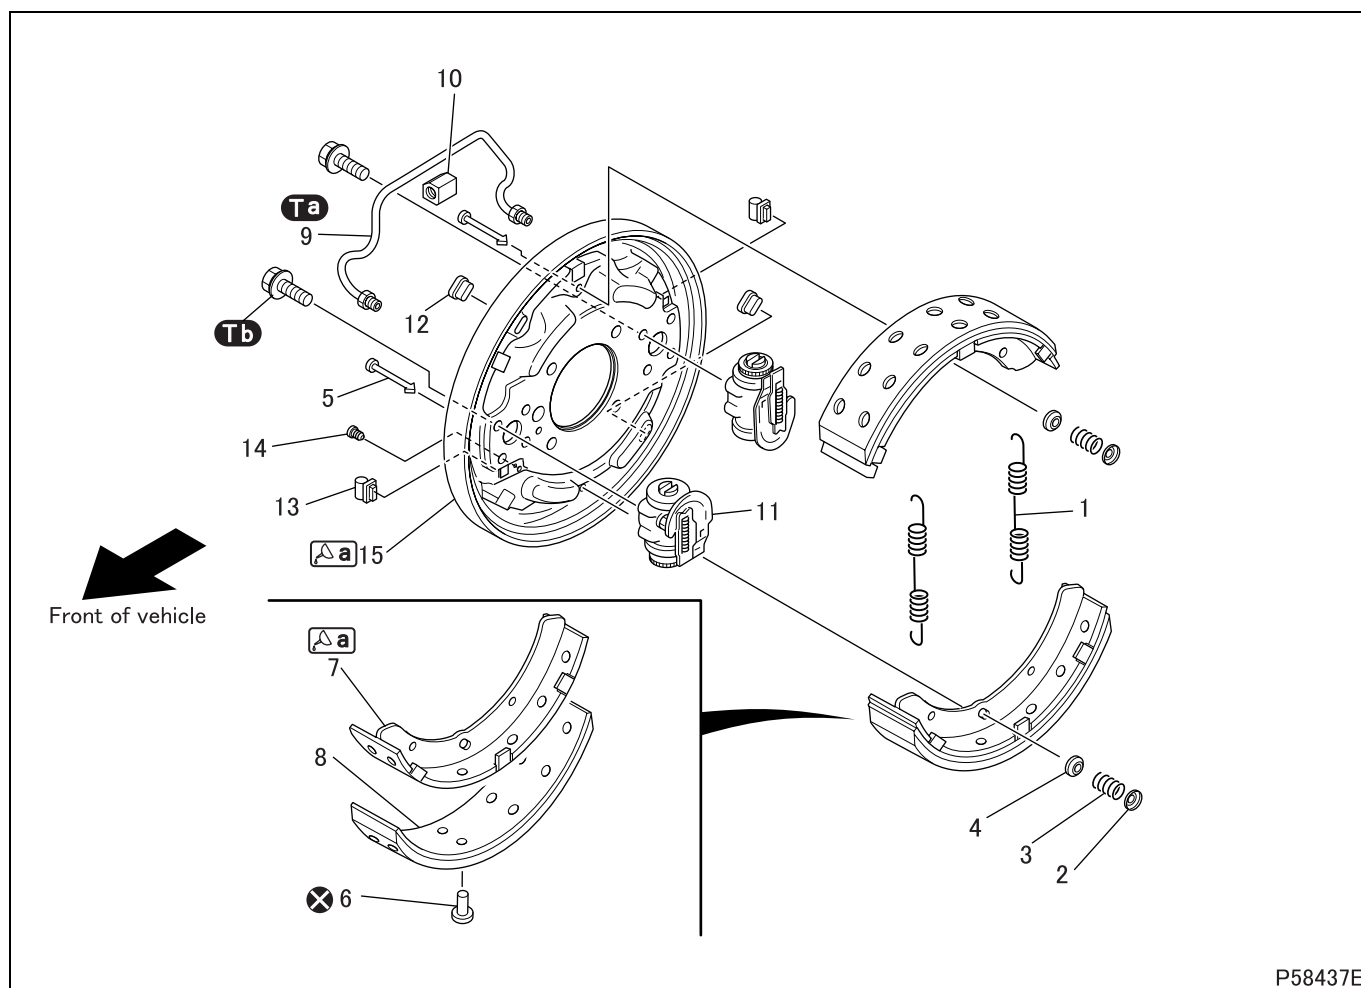
P58437E

# REAR DRUM BRAKE

| Location | Maintenance item | Standard value | Limit | Remedy |
|---|---|---|---|---|
| 8 | Brake lining thickness | 8.8 {0.35} | 4.0 {0.16} | Replace |

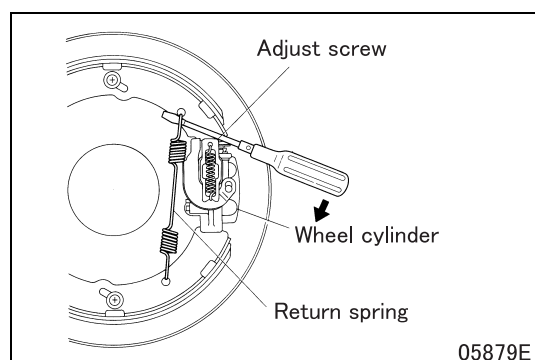
#### ■ Removal: Return spring

- Using a flat-head screwdriver, remove the return spring. To do this, rest the screwdriver on the wheel cylinder adjust screw. Then, with the adjust screw as a fulcrum, engage the screwdriver with the spring hook and pry away the spring.

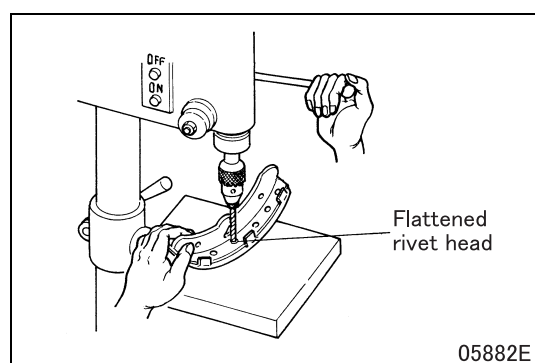
#### ■ Removal: Brake lining

- Using a drilling machine, break the flattened rivet heads on the brake shoe side to release the brake lining.

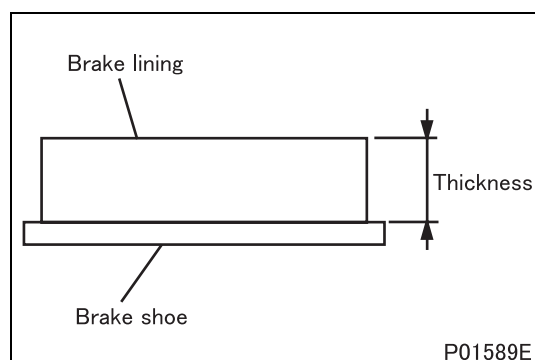
#### ■ Inspection: Brake shoe

- Measure the thickness of the brake lining. If the measured value is less than the limit, replace all of the brake linings on the same axle.

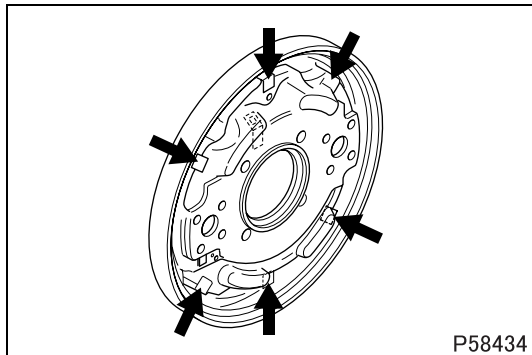
### ■ Installation: Backing plate

- Grease the backing plate at the illustrated locations.
