# FE.FG

## SERVICE MANUAL 2008 Model FOREWORD

This Service Manual contains maintenance and repair methods for the Mitsubishi Fuso Truck FE. FG Series. Read this manual carefully as an aid in providing correct, efficient maintenance. Please note that the information and specifications contained within this manual may change without notice. This is due to product modifications and continued vehicle improvements that are made throughout the model years. Should you encounter any discrepancy in the information provided, please do not hesitate to contact your nearest Mitsubishi Fuso Dealer or Mitsubishi Fuso Truck of America, Inc.

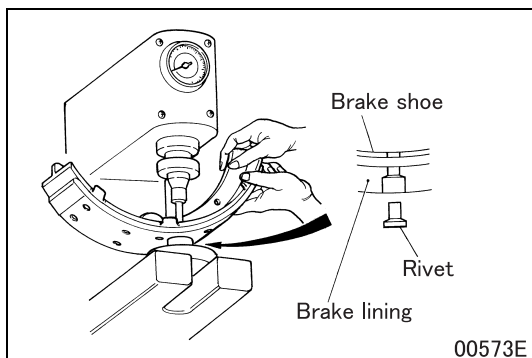
### ■ Installation: Brake lining

- Using cleaning fluid, clean the surface of the brake shoe to which the brake lining is to be mounted. Dry the brake shoe.
- Insert rivets from the lining to the shoe. Stake them, starting from the center of the shoe and moving towards the ends. Ensure that the shoe-to-lining clearances conform to the following specifications.
  - Around the rivets: 0.05 mm {0.0020 in.} or less
  - Along the shoe/lining sides: 0.4 mm {0.016 in.} or less
  - Along the shoe/lining ends: 0.5 mm {0.020 in.} or less
- Stake the rivets with a force of  $21 \pm 1.0$  kN {4720  $\pm$  225 lbs, 2100  $\pm$  100 kgf}.

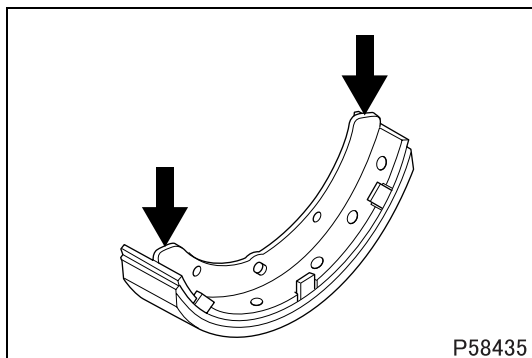
### ■ Installation: Brake shoe

- Grease the brake shoe at the illustrated locations.

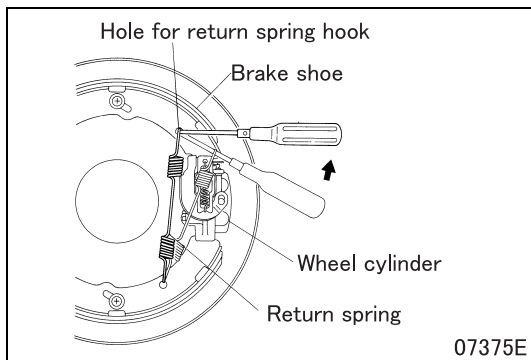
#### ■ Installation: Return spring

- Hook the end of the return spring that has a smaller number of coils onto the brake shoe on the adjust screw side of the wheel cylinder.
- Engage a small Phillips screwdriver into the return spring hook. Then, using the screwdriver insert the spring hook into the hook hole in the brake shoe and attach the hook onto the shoe.

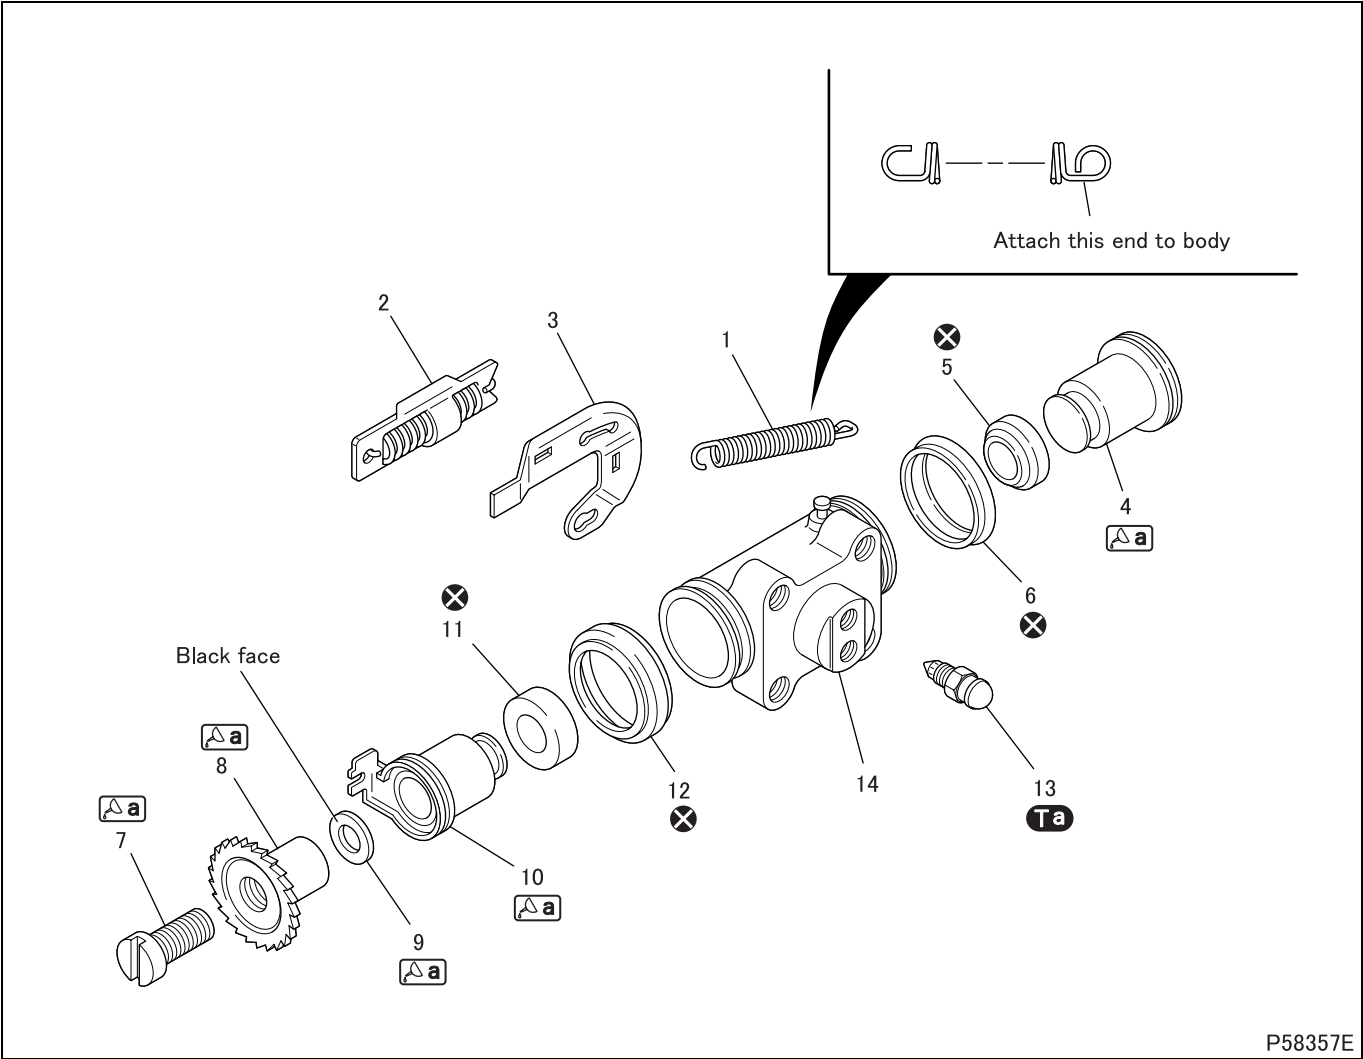
## Wheel Cylinder

- 1 Spring
- 2 Spring & fitting
- 3 Lever
- 4 Piston
- 5 Piston cup
- 6 Boots
- 7 Adjust screw
- 8 Adjuster
- 9 Washer
- 10 Piston
- 11 Piston cup
- 12 Boots
- 13 Air bleeder
- 14 Body

| Location | Maintenance item | Standard value | Limit | Remedy |
|---|---|---|---|---|
| 4, 10, 14 | Piston-to-body clearance | 0.02 to 0.08<br>{0.00079 to 0.031} | 0.2 {0.0079} | Replace |

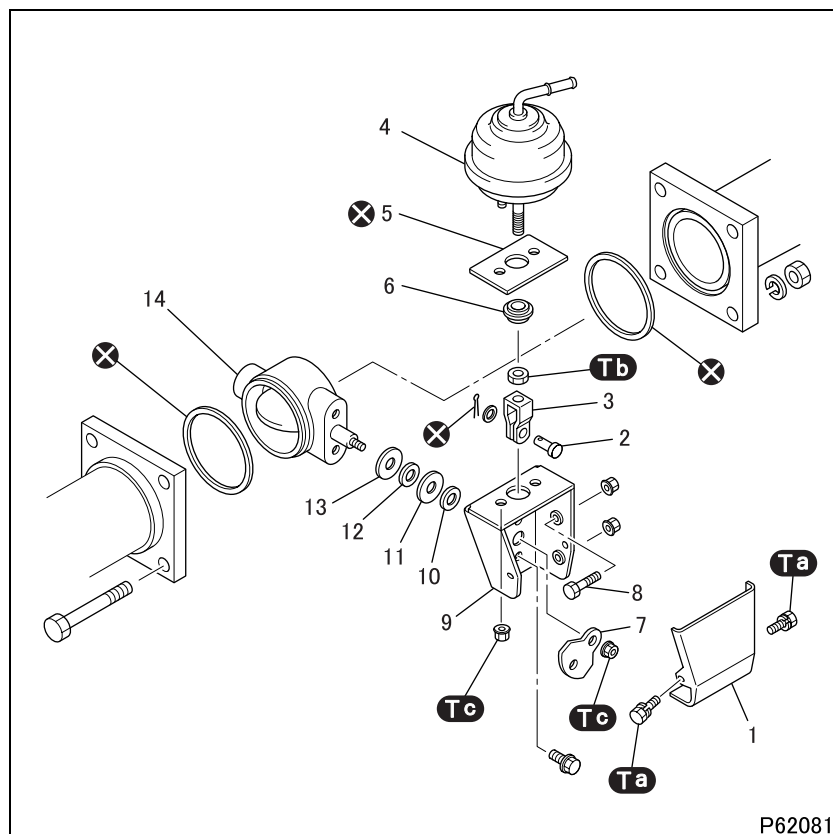
## Exhaust Brake Unit

- 1 Cover
- 2 Clevis pin
- 3 Clevis
- 4 Power chamber
- 5 Gasket
- 6 Bearing
- 7 Lever
- 8 Adjust bolt
- 9 Bracket
- 10 Seal ring A
- 11 Seal ring B
- 12 Seal ring A
- 13 Seal ring B
- 14 Valve

| Location | Maintenance item | Standard value | Limit | Remedy |
|---|---|---|---|---|
| 4 | Air-tightness of power chamber (at 15 sec. after vacuum of 67 kPa {19.8 in.Hg, 500 mmHg} is achieved in chamber) | 63 kPa {18.6 in.Hg, 475 mmHg} or above | — | Replace |

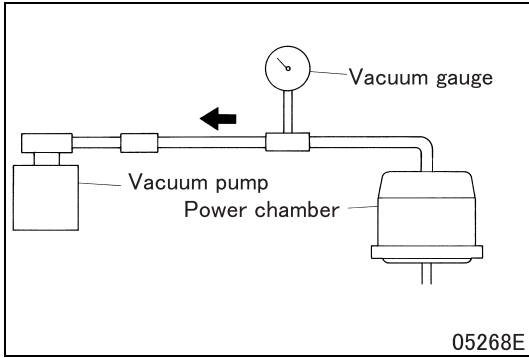
### ■ Inspection: Power chamber air-tightness

- Connect the components with piping as illustrated. When a vacuum of 67 kPa {19.8 in.Hg, 500 mmHg} or above is applied to the power chamber, stop the vacuum pump.
- Fifteen seconds later, the reading on the vacuum gauge should conform to the standard value.
- If not, replace the power chamber.

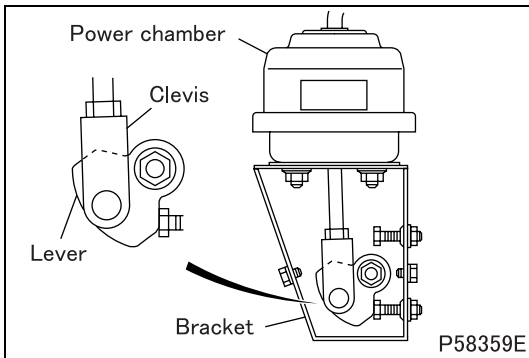
### ■ Adjustment: Clevis

- Assemble the power chamber onto the bracket. Then, adjust the location of the clevis such that the hole in the clevis is aligned by half with the hole in the lever.

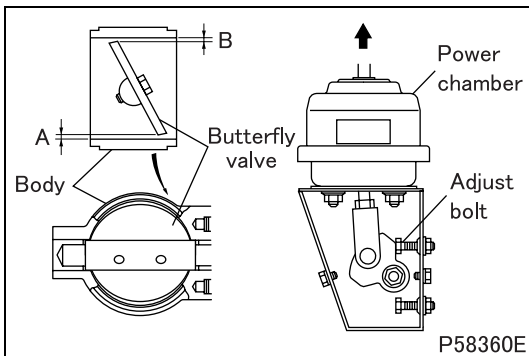
### ■ Adjustment: Butterfly valve

- Adjust the butterfly valve to the full open position using the adjust bolt.

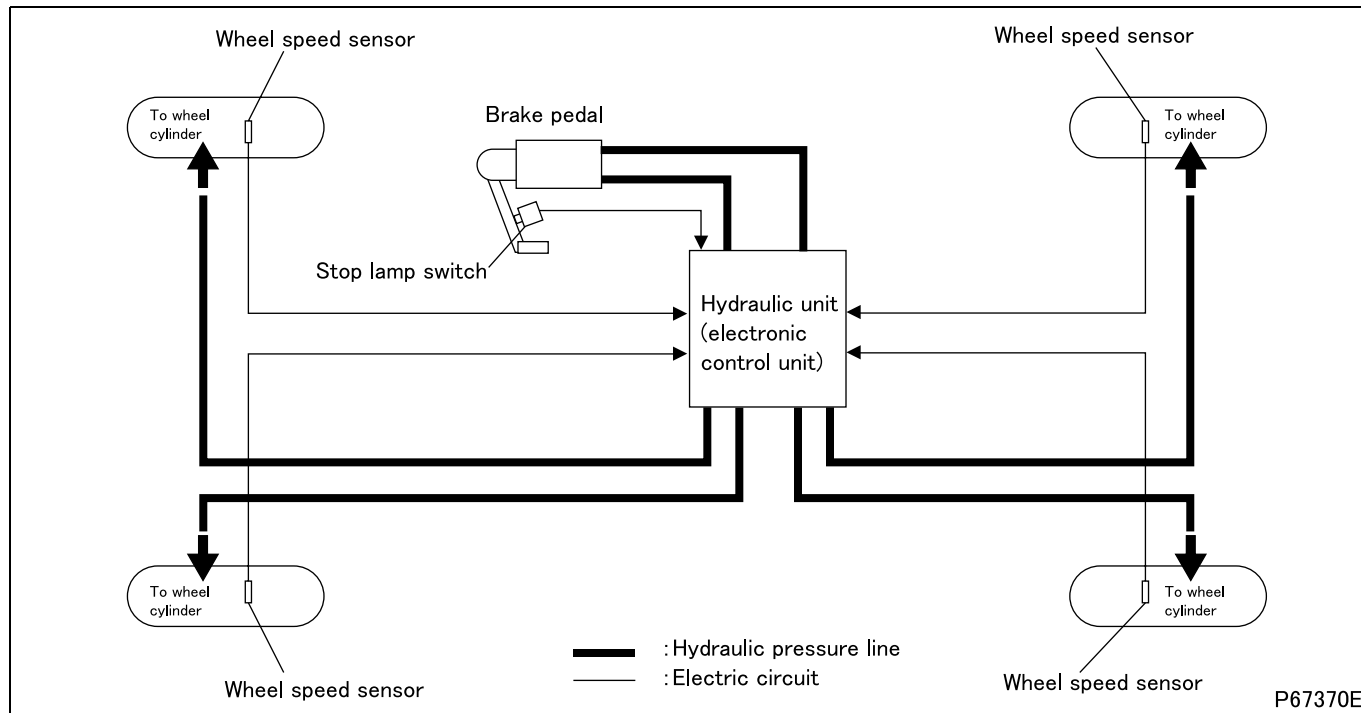
- The anti-lock brake system (ABS) prevents wheel lock-up and resultant skid when braking hard or on slippery roads, thus maintain vehicle stability and steerability.

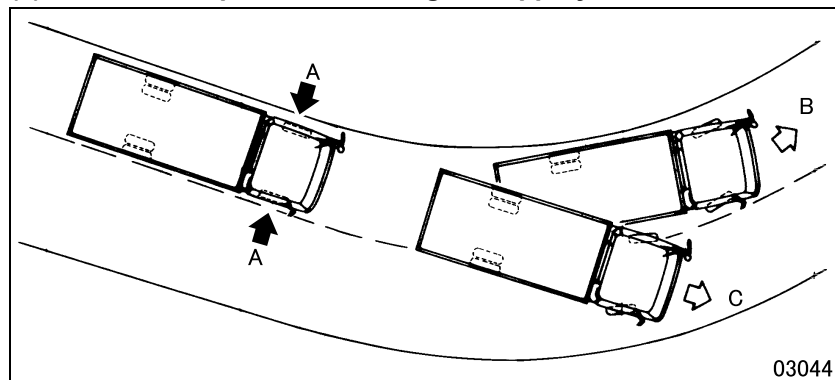
#### (1) Wheel lock-up when cornering on slippery road

- If wheel lock-up occurs during braking on a slippery curve, steering control will be lost. If this happens, the vehicle may deviate, while skidding, from the intended course no matter how the driver maneuvers the steering wheel.  
A: Application of brakes (wheel lock-up)  
B: Intended course  
C: Go out of course

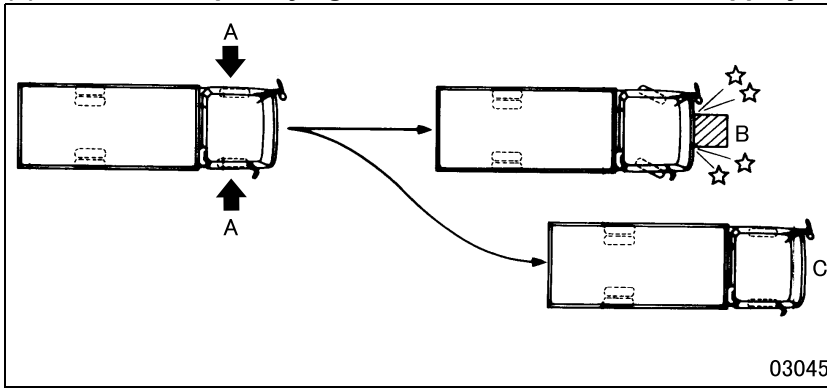
## (2) Wheel lock-up in trying to avoid obstacle ahead on slippery straight road

- If wheel lock-up occurs during hard braking on a slippery straight road in trying to avoid an obstacle ahead, steering control will be lost. If this happens, the vehicle will not be able to avoid the obstacle no matter how the driver maneuvers the steering wheel.
- A: Application of brakes (wheel lock-up)  
 B: Obstacle  
 C: Intended course

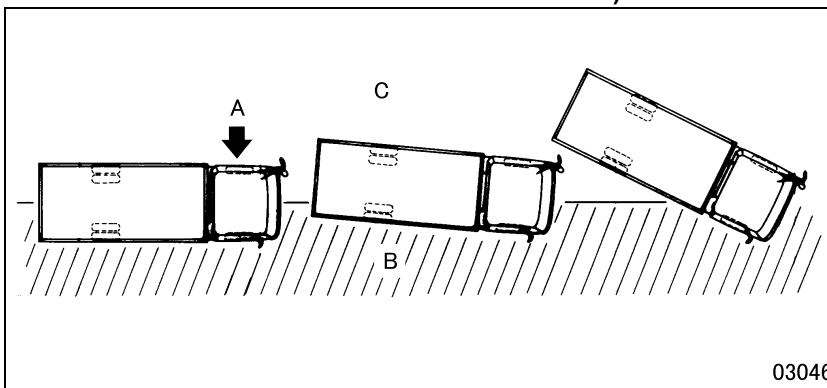
## (3) Split $\mu$ (Wheel lock-up on asymmetrical road surface, with higher friction of coefficient on one side and lower friction of coefficient on the other side)

- If the front and rear wheels on one side of the vehicle are on the side of the road that has a lower friction of coefficient and therefore is more slippery than the other side of the road, these wheels are more likely to lock up and slip than the wheels on the other side of the vehicle. When the brakes are applied under such conditions, the braking efficiency will be different between the right and left sides of the vehicle and the vehicle will lose stability. Braking hard under such conditions can even cause the vehicle to spin.
- A: Application of brakes (wheel lock-up)  
 B: Less slippery road surface  
 C: More slippery road surface
- As mentioned above, the system prevents wheel lock-up by providing controlled braking force to each wheel. This prevents wheel slip and skid and ensures steering control and vehicle stability even during hard braking.

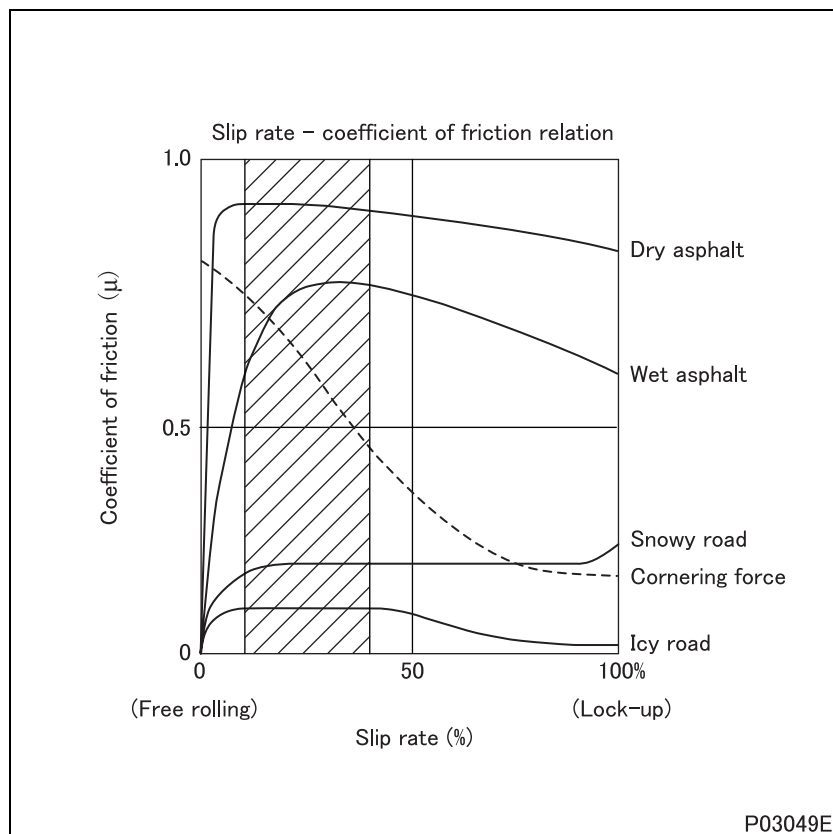
- The graph shows the variation in the tire's coefficient of friction from free rolling to lock-up. As the brake pedal is slowly pressed, the tires continue to rotate but start slipping.

- As the stepping force on the brake pedal increases, the tires will stop rotating and the vehicle will just skid. This is wheel lock-up.
- As the graph shows, the coefficient of friction peaks within the hatched area.

- On vehicles equipped with anti-lock brake system, the hydraulic control unit (electronic control unit) controls the braking force so that it falls within the hatched area. This will ensure that the tires do not lock up but have the maximum coefficient of friction, thus achieving efficient braking performance.

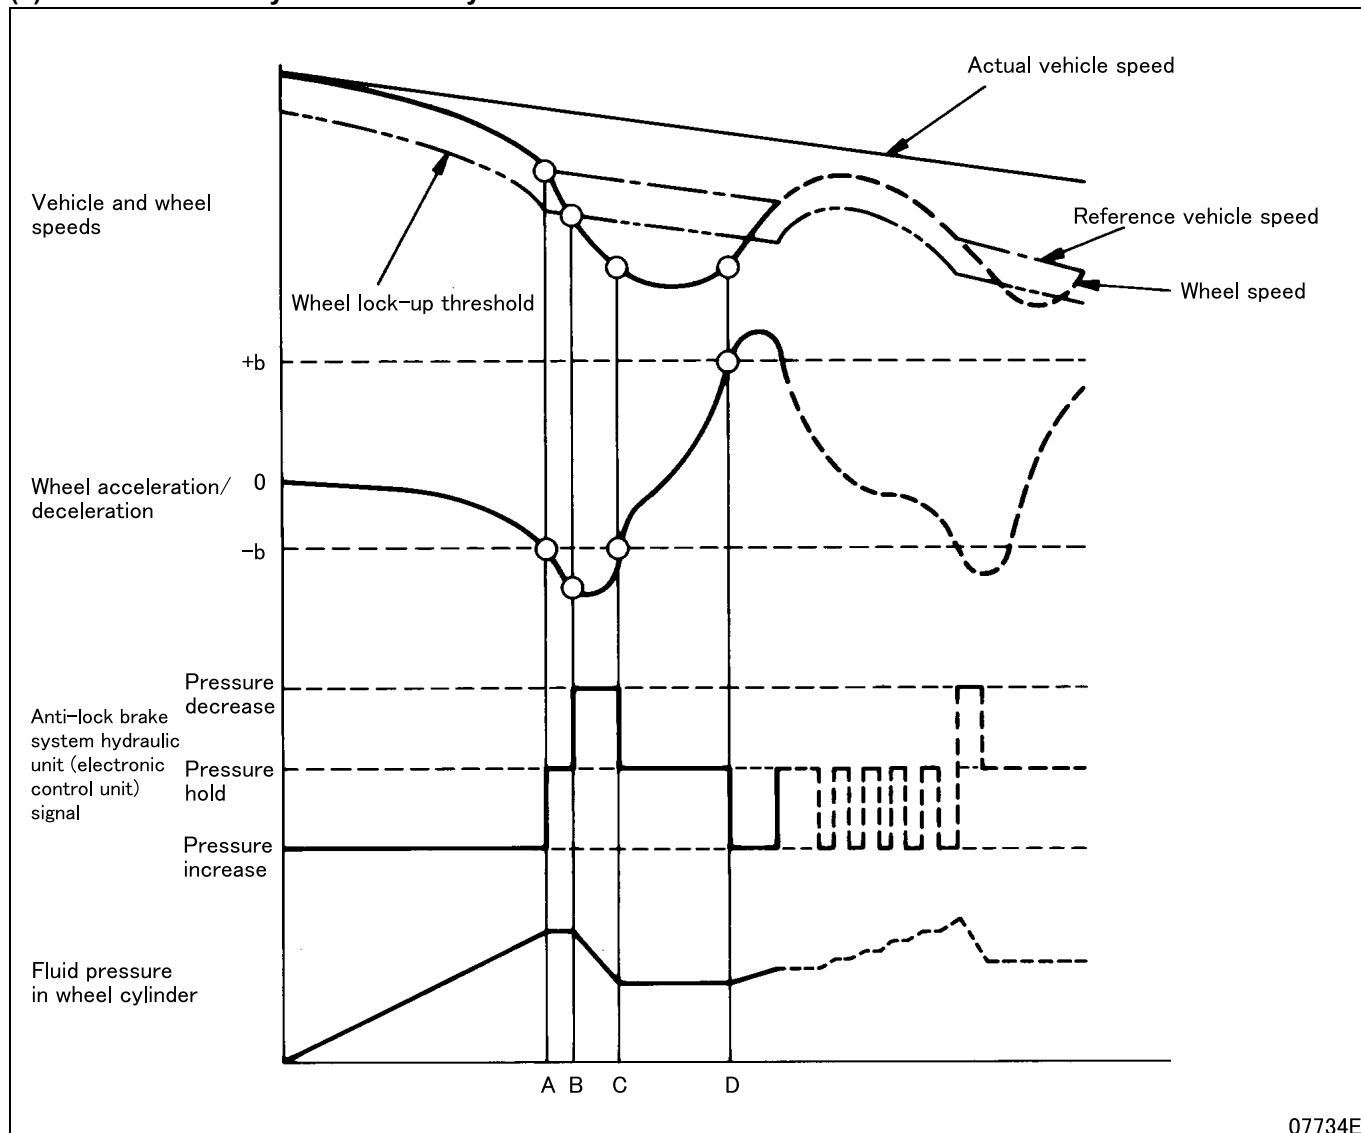
07734E

## (1) Anti-lock brake system control cycle

- The above chart shows the typical control cycle of anti-lock brake system following the application of brakes, detailing in time series the variation in wheel speed, wheel speed acceleration/deceleration and fluid pressure in the wheel cylinder.

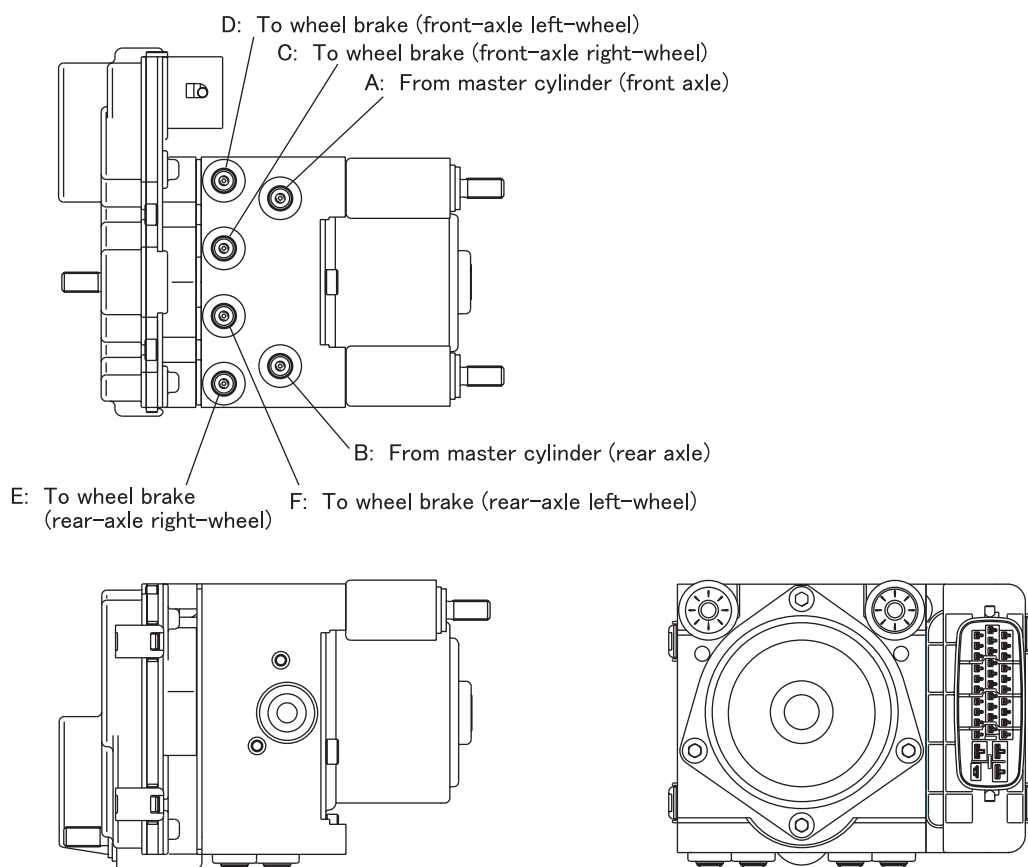
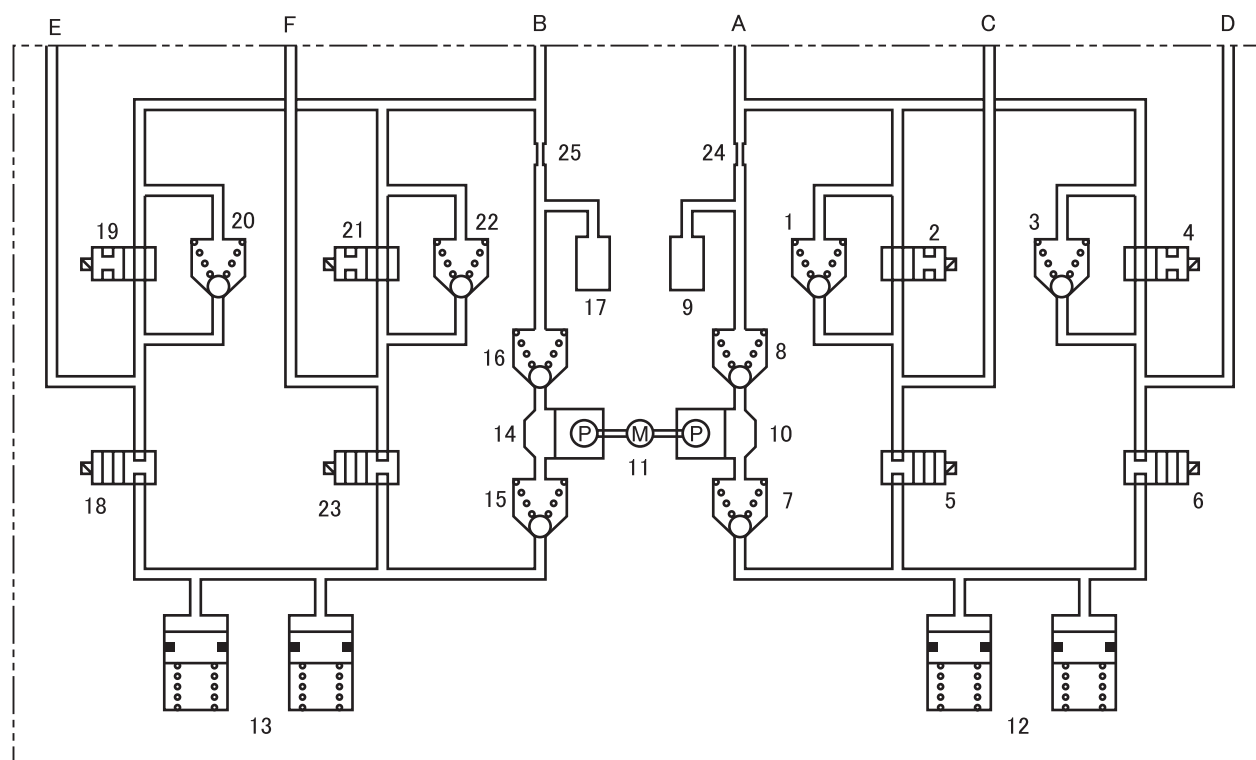
P78478E

### (1) Schematic circuit diagram

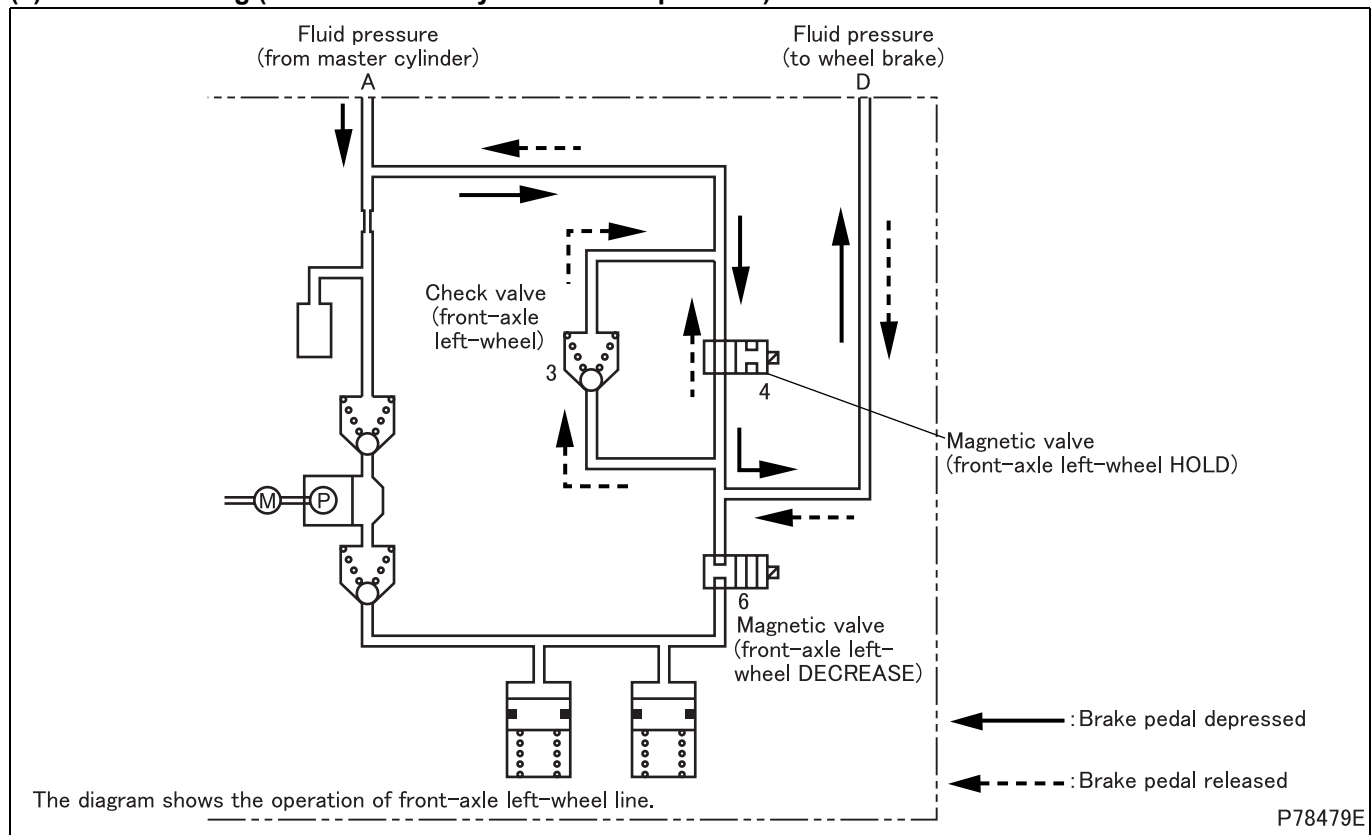
## (2) Normal braking (anti-lock brake system not in operation)

- When the brake pedal is pressed and there is no imminent wheel lock-up, the hydraulic unit (electronic control unit) will not send any control signal to the magnetic valve (front-axle left-wheel DECREASE) or to the magnetic valve (front-axle left-wheel HOLD). The former valve remains closed while the latter valve stays open.
- Pressure fluid A from the brake master cylinder flows past the magnetic valve (front-axle left-wheel DECREASE) and to the wheel brake D.
- When the brake pedal is released, pressure fluid A from the brake master cylinder drops. Pressure fluid from the wheel brake D now flows past the magnetic valve (front-axle left-wheel HOLD) and the check valve (front-axle left-wheel) and returns to the brake master cylinder.

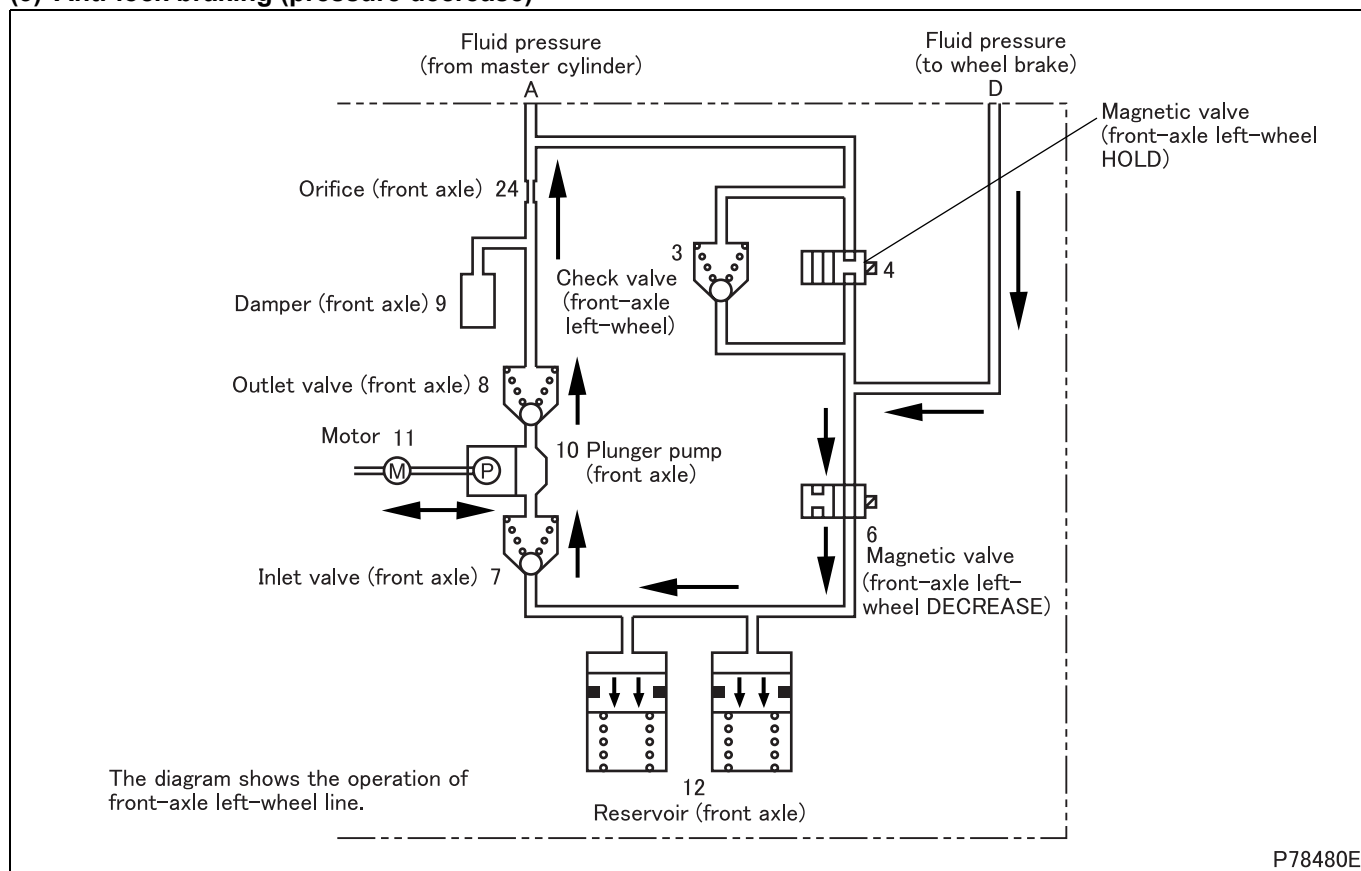
**(3) Anti-lock braking (pressure decrease)**

- When the brake pedal is pressed and there is imminent wheel lock-up, the hydraulic unit (electronic control unit) sends control signal to the magnetic valve (front-axle left-wheel DECREASE) and the magnetic valve (front-axle left-wheel HOLD). The former valve will open while the latter valve will close.

- Pressure fluid from the wheel brake D now flows past the magnetic valve (front-axle left-wheel DECREASE) and to the reservoirs. The line pressure will drop.

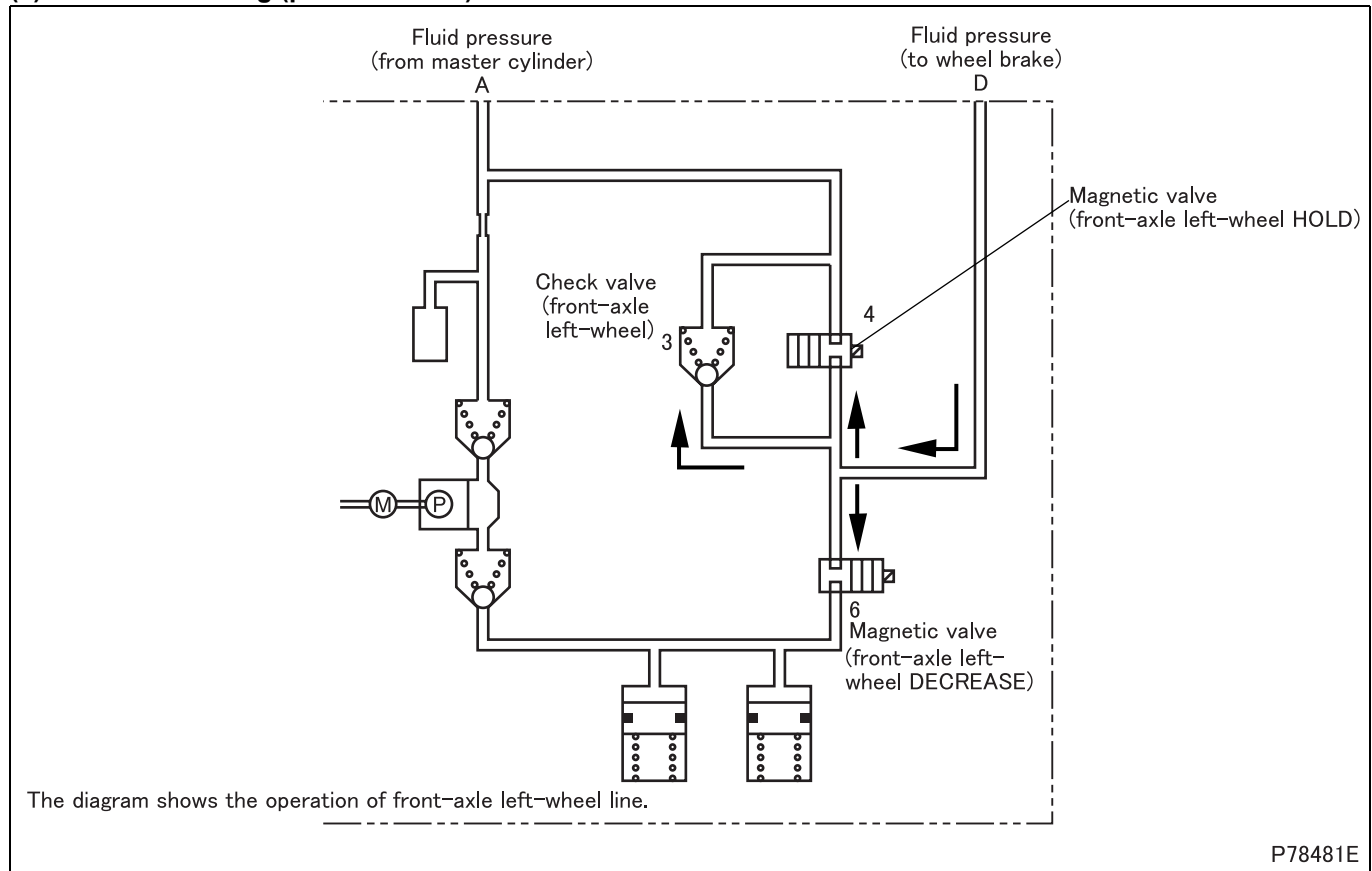
## (4) Anti-lock braking (pressure hold)

- When it becomes necessary to hold the fluid pressure D in the wheel brake at the same level as part of anti-lock brake system control, the hydraulic unit (electronic control unit) sends "HOLD" signal to the magnetic valve (front-axle left-wheel HOLD). As a result, both of the magnetic valve (front-axle left-wheel HOLD) and the magnetic valve (front-axle left-wheel DECREASE) will be closed, which holds the fluid pressure in the wheel brake at the current level.
- The check valve (front-axle left-wheel) remains closed by the fluid pressure A from the brake master cylinder.

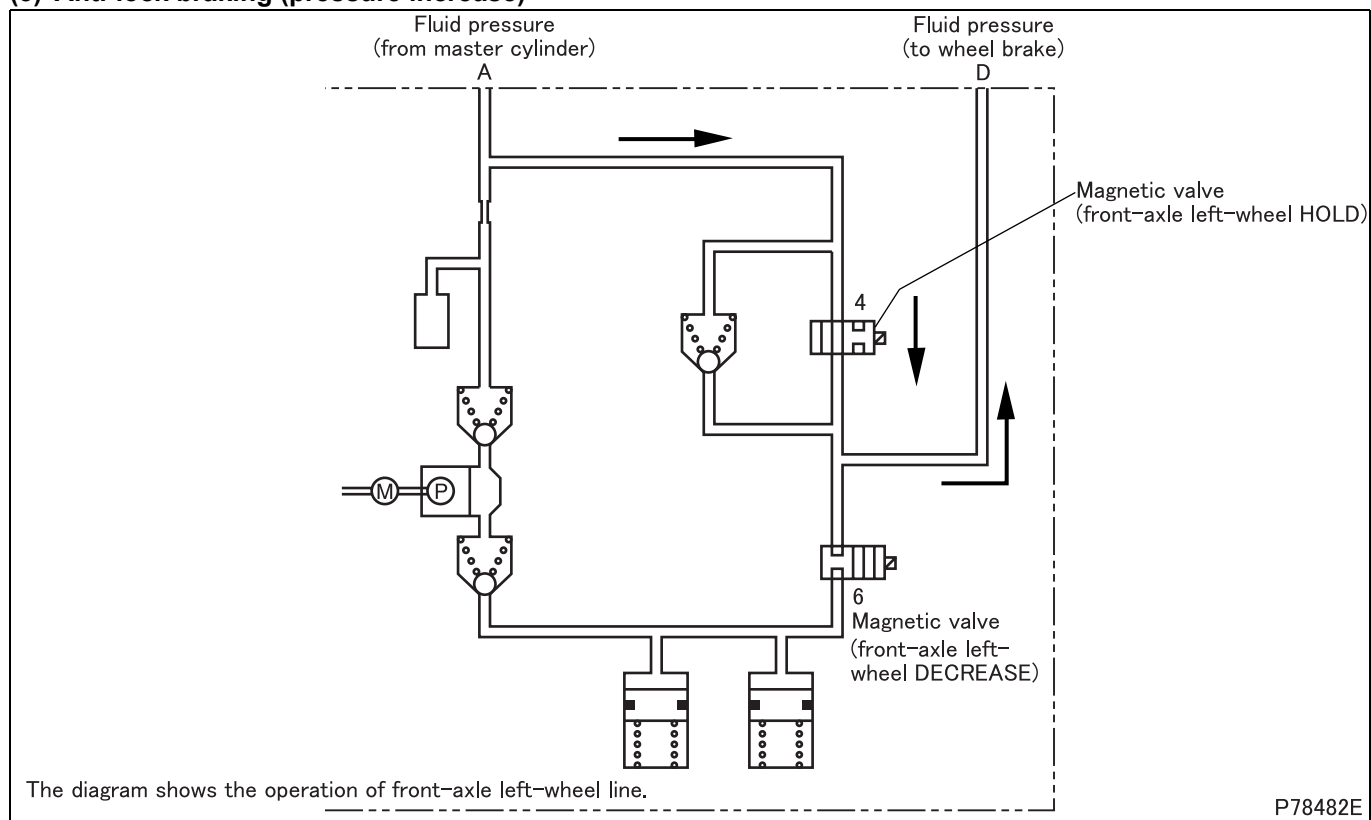
**(5) Anti-lock braking (pressure increase)**

- When it becomes necessary to increase the fluid pressure D in the wheel brake, control signal from the hydraulic unit (electronic control unit) to the magnetic valve (front-axle left-wheel HOLD) and to the magnetic valve (front-axle left-wheel DECREASE) will be cut off.
- As a result, the magnetic valve (front-axle left-wheel HOLD) will open while the magnetic valve (front-axle left-wheel DECREASE) will close. Both valves are now in their normal-braking positions. Fluid pressure A being generated by the depression of the brake pedal is now applied to the wheel brake to increase the braking force.

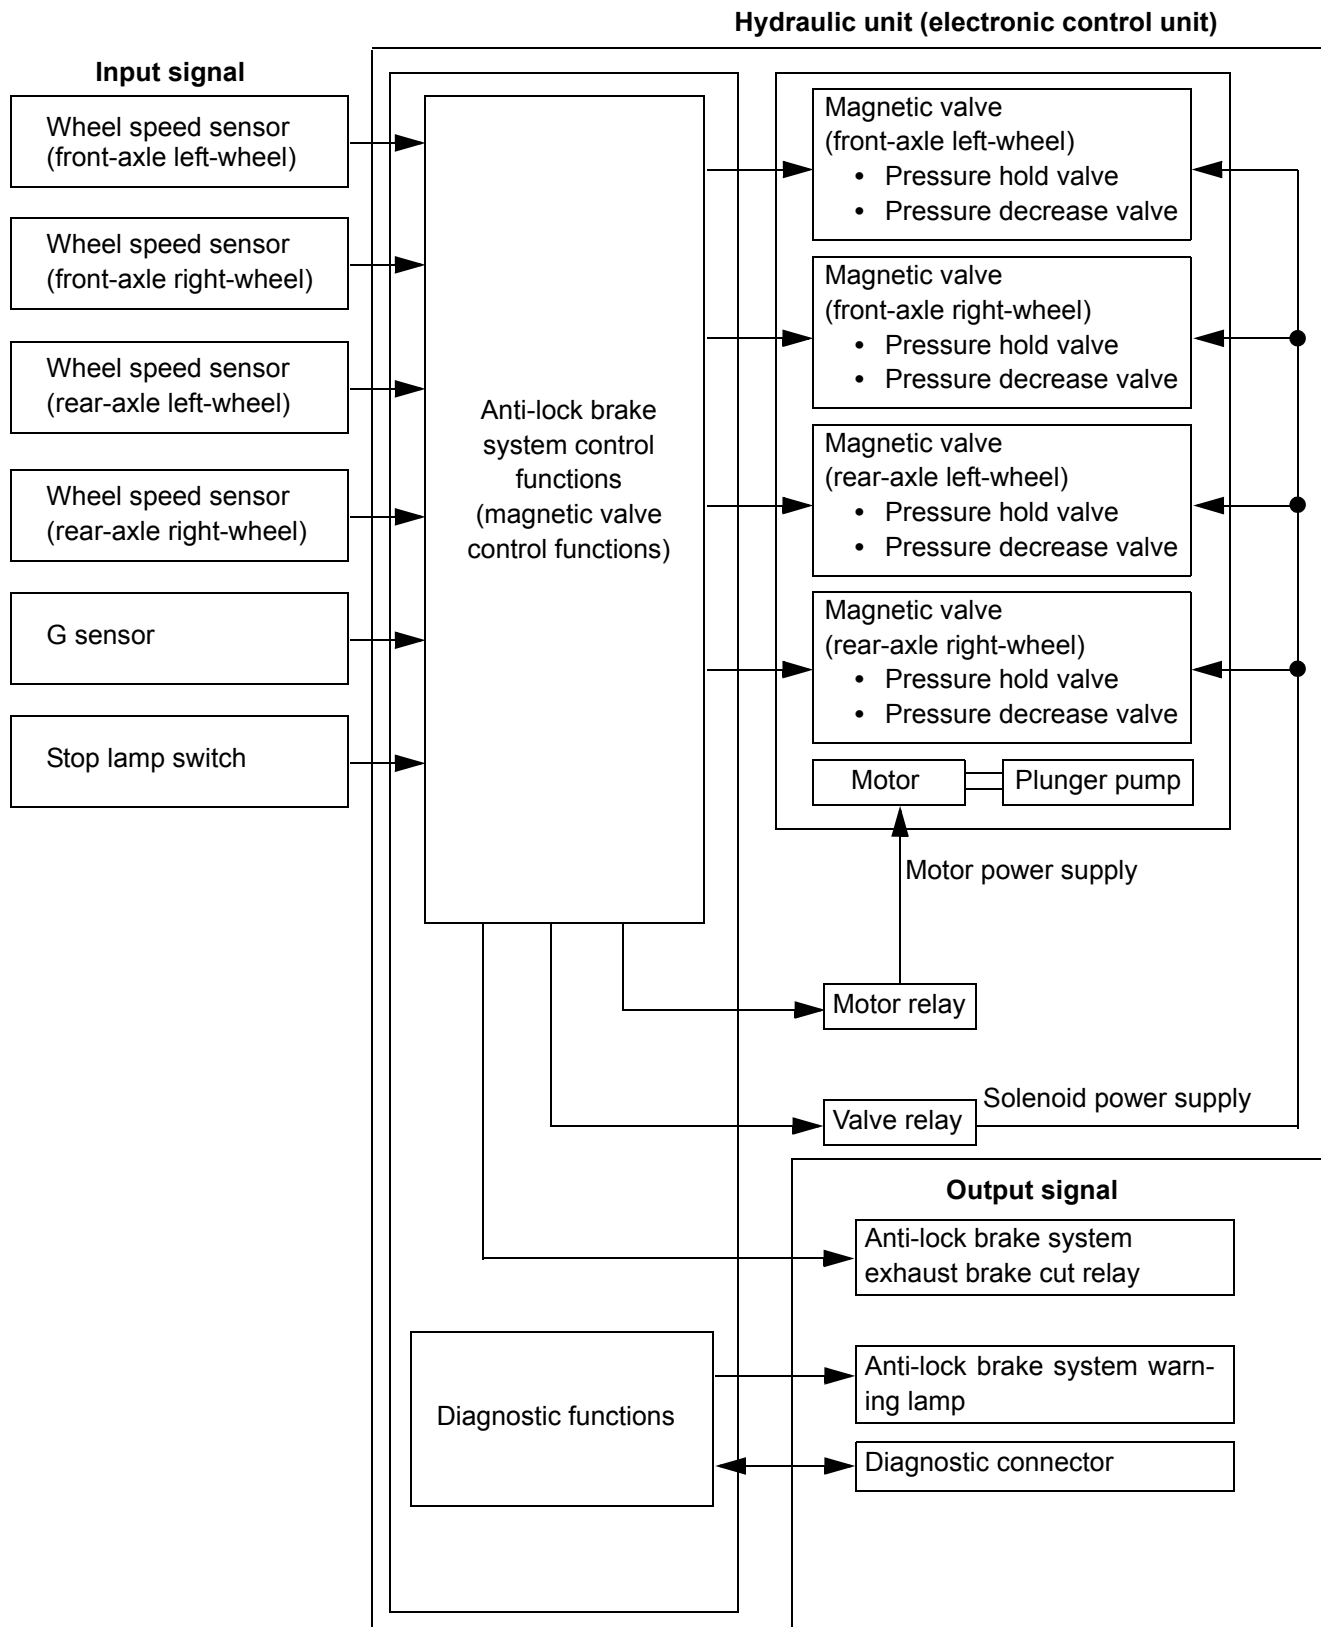
### 2.1 Block diagram

| Part | Primary function or operation |
|---|---|
| Wheel speed sensor | Senses wheel speed |

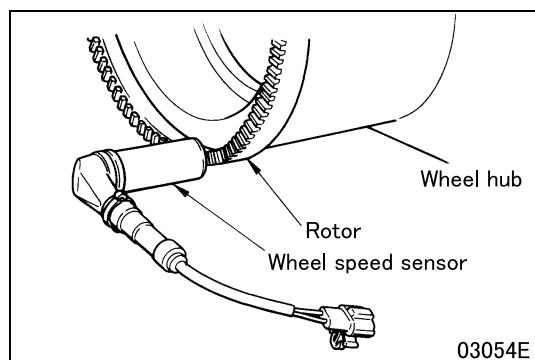
### (3) Wheel speed sensor

- Each wheel speed sensor detects wheel speed and sends this as a signal to the hydraulic unit (electronic control unit). The sensor is essentially a magnetic pickup unit, consisting of a permanent magnet core and a coil of wire wound around the core.
- A rotor is fitted onto the wheel hub. This rotor, like a ring gear, has a set of evenly-spaced teeth directly facing the sensor. As the wheel rotates, these teeth pass through the magnetic flux of the sensor, inducing potential difference in the coil which is then sent as a signal (alternating voltage proportional to the wheel speed) to the hydraulic unit (electronic control unit).

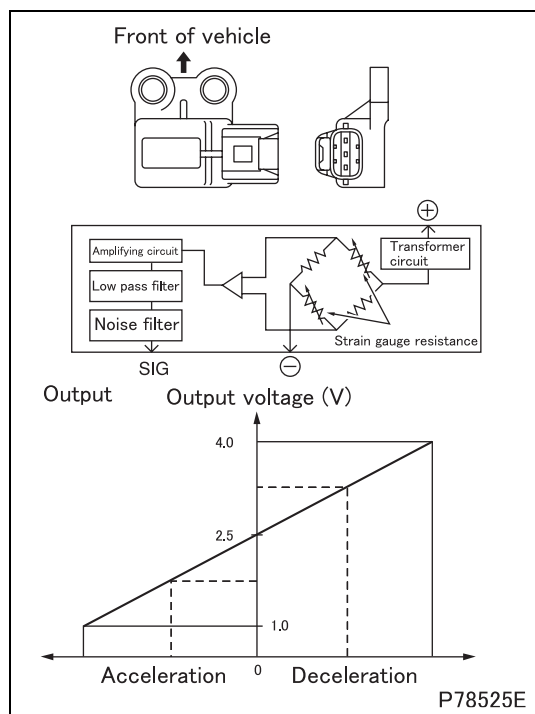
### (4) G sensor

- On slippery roads, trucks can experience wheel lock-up due to the inertia of the powertrain. This makes it difficult for anti-lock brake system to perform controlled braking.
- To avoid this, in addition to the wheel speed sensors, a G sensor is also used to detect acceleration/deceleration and assist anti-lock brake system control.
- The G sensor is a semiconductor-type strain gauge. It detects acceleration or deceleration by converting acceleration/deceleration inertia into resistance and further converting this into voltage.

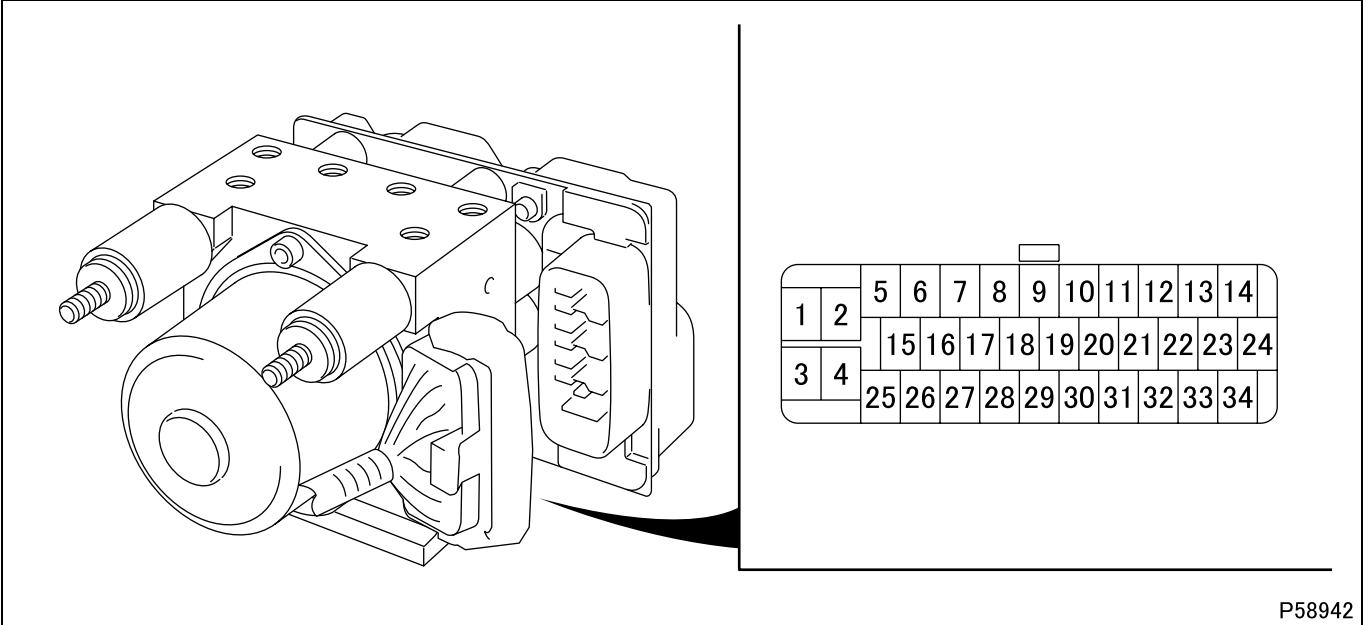
## 6. Inspection at Hydraulic Unit (Electronic Control Unit) Connector

- This inspection is intended to aid troubleshooting by verifying whether or not hydraulic unit (electronic control unit) signals are correctly transmitted via the vehicle harness and connector.  
The **01**, **02** ... in the table below is a cross reference to the electronic control unit connector inspection items listed in the table in “3. Diagnosis Based on Diagnosis Codes” of this manual.

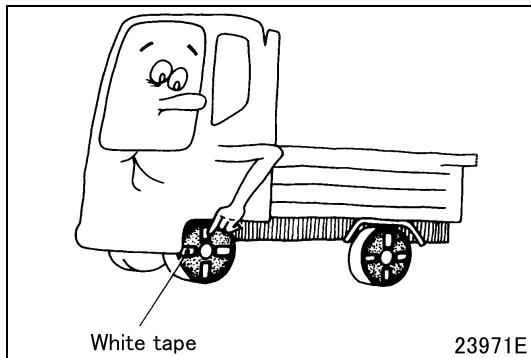
- The vehicle being tested should be in the unloaded state.
- Apply white tapes onto the walls of front and rear tires to aid the observation of wheel rotation.
- Turn the starter switch from LOCK to ON. The warning lamp should come on and, in several seconds, go out.
- Drive the vehicle at 20 to 30 km/h {12 to 19 mph} and apply the brakes hard. The wheels should not lock up.

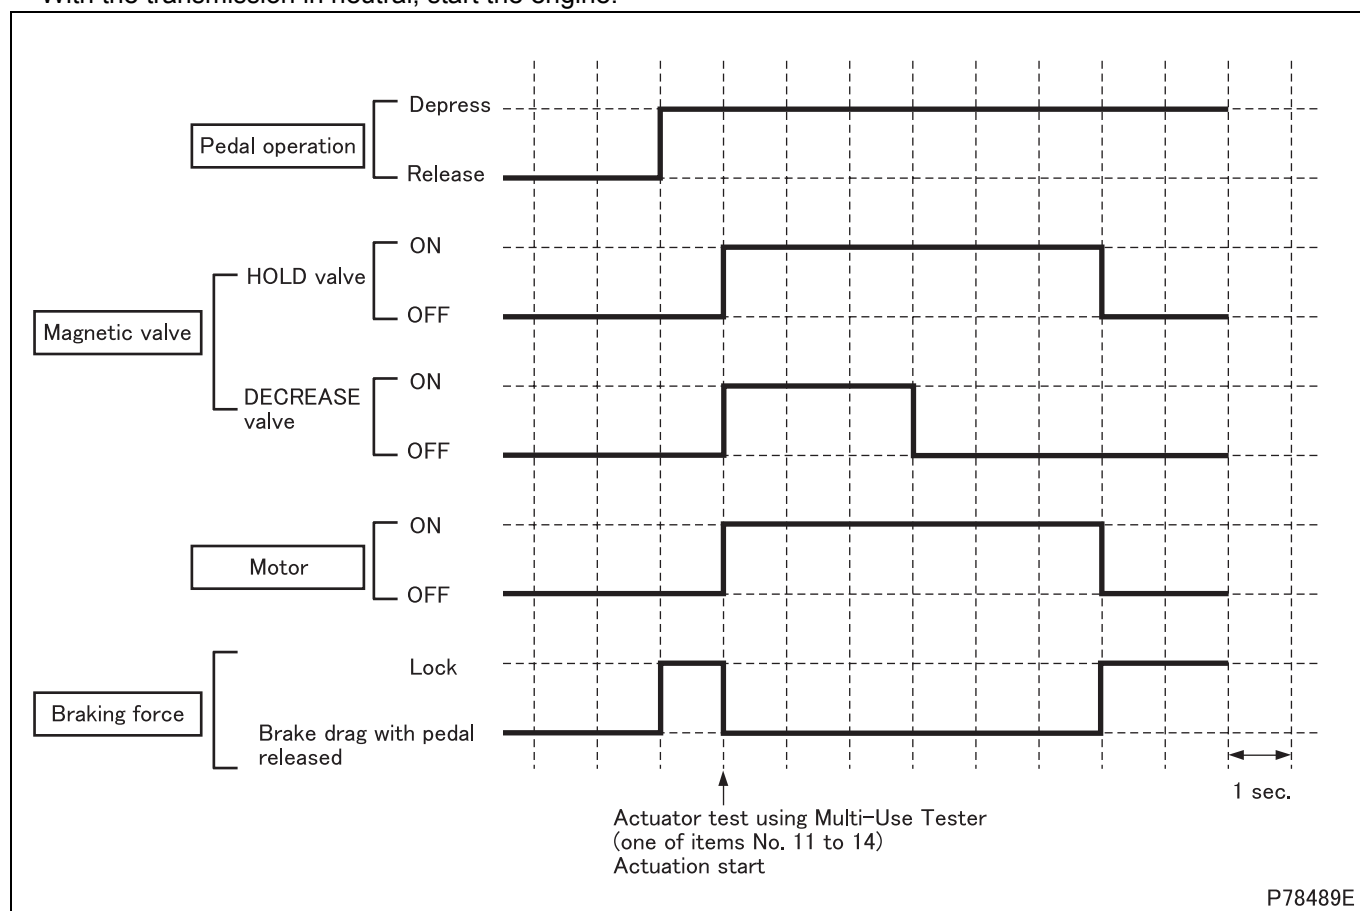
### 2.1 Inspection using Multi-Use Tester

- The hydraulic unit (electronic control unit) cannot be inspected for operation during control effected by the electronic control unit at the time of a fault which will cause a diagnosis code to occur. The inspection should be performed after system recovery from the control through troubleshooting.
- Jack up the vehicle and support it on rigid racks, or place the vehicle on the rollers of a brake tester.
- Apply the parking brake when testing the front brake. Apply chokes to the front wheels when testing the rear brake.
- During inspection, keep the brake tester rollers and the tires dry.
- With the parking brake released, feel the brake drag of each wheel. When the brake tester is used, read the brake drag indicated in the tester.
- Connect the Multi-Use Tester. (See Gr00.)
- With the transmission in neutral, start the engine.

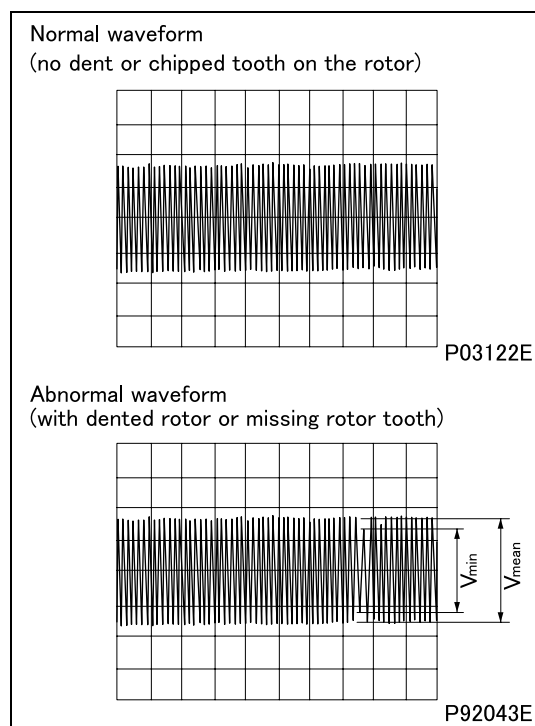
- Jack up the wheel under inspection. Disconnect the wheel speed sensor connector.
- Connect the oscilloscope terminals to the disconnected connector. Rotate the wheel at a certain speed and check oscilloscopic waveform for dented rotor or missing rotor tooth.
- If any wave is evidently smaller in width than others, there should be a dented rotor or missing rotor tooth. The standard wave width is as calculated below.

- If there is a wave more than 20% smaller in width than others, visually examine the rotor for the defect and replace if necessary. (See Gr26, 27).
