# FE.FG

## SERVICE MANUAL 2008 Model FOREWORD

This Service Manual contains maintenance and repair methods for the Mitsubishi Fuso Truck FE. FG Series. Read this manual carefully as an aid in providing correct, efficient maintenance. Please note that the information and specifications contained within this manual may change without notice. This is due to product modifications and continued vehicle improvements that are made throughout the model years. Should you encounter any discrepancy in the information provided, please do not hesitate to contact your nearest Mitsubishi Fuso Dealer or Mitsubishi Fuso Truck of America, Inc.

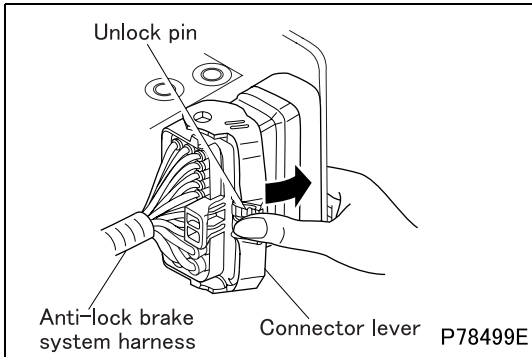
### ■ Removal: Hydraulic unit connector

- While holding the connector, push the unlock pin on the connector lever with finger and unlock.
- With the connector unlocked, push the connector lever in the direction of the arrow.

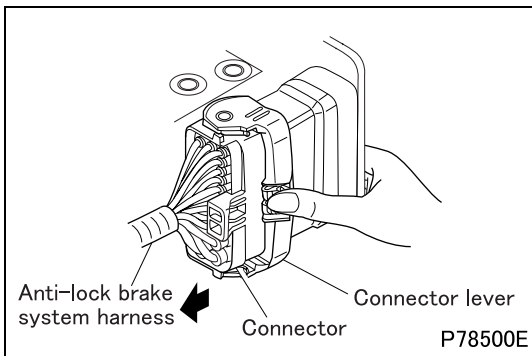
- With the connector lever fully pushed back, remove it together with the anti-lock brake system harness while holding the connector.

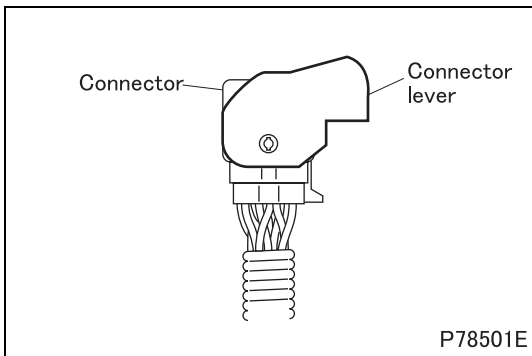
### ■ Installation: Hydraulic unit connector

- Ensure that the connector terminals are clean and free from foreign matter.
- Set the connector lever to the illustrated position.

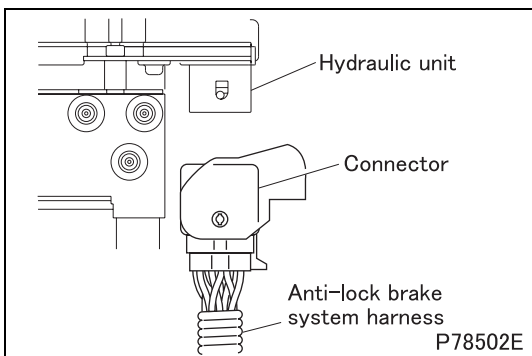
- Insert the anti-lock brake system harness connector straight into the other connector half on the hydraulic unit.

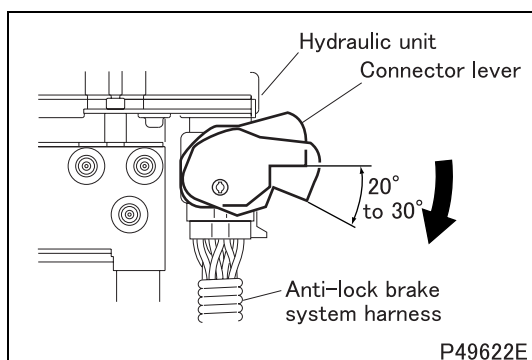
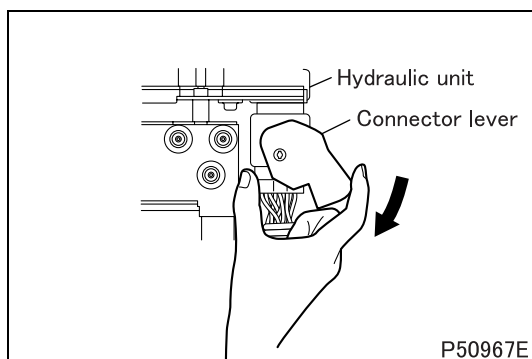
- Check that the connector lever can be turned with a small force to the specified angle in the direction of the arrow.

- In order to lock the connector lever, turn the lever in the direction of the arrow until it clicks by applying force to the central portion while holding the connector body.
- If the connector is not completely connected, the anti-lock brake system (ABS) warning lamp may be illuminated. If the lamp is illuminated, connector installation steps must be performed again from the beginning.

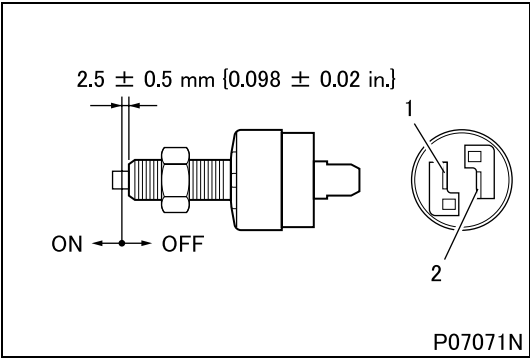
## #042 Inspection of stop lamp switch

- If faulty, replace the switch.

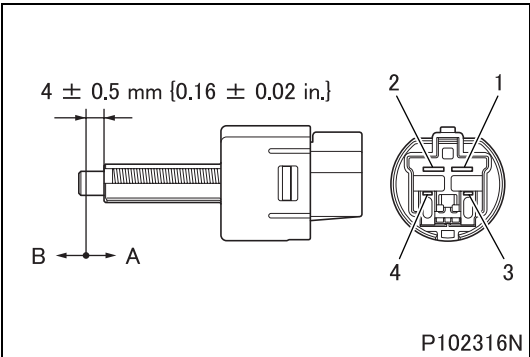
### <Type (2)>

- If faulty, replace the switch.

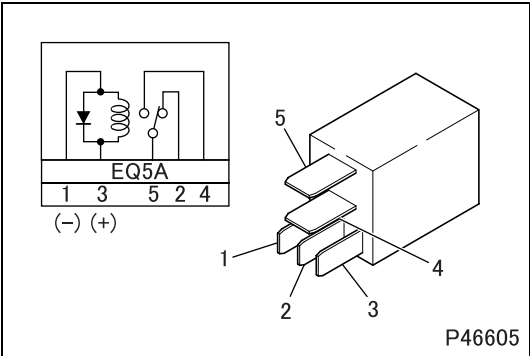
## #201 Inspection of relay (normally open 5-pin relay)

- Check the relay for continuity and normal operation. If faulty, replace the relay.

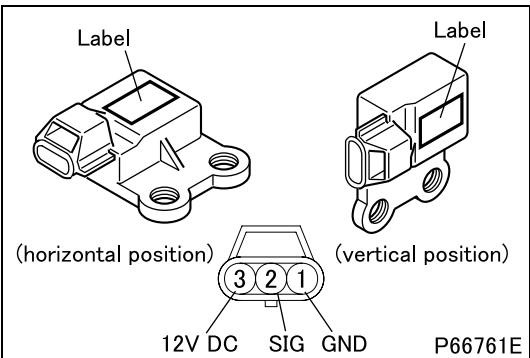
## #327 Inspection of G sensor

- Apply a 12V DC across terminals 3 and 1 of the G sensor.
- Measure the G sensor output voltage between terminals 2 and 1 for both when the sensor is in a horizontal position and when it is in a vertical position.

- If any of the measurements is not within the standard value range, replace the sensor.

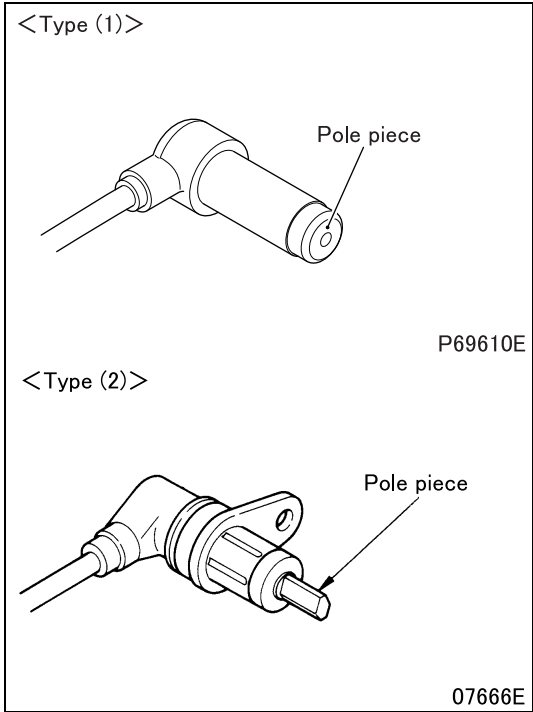
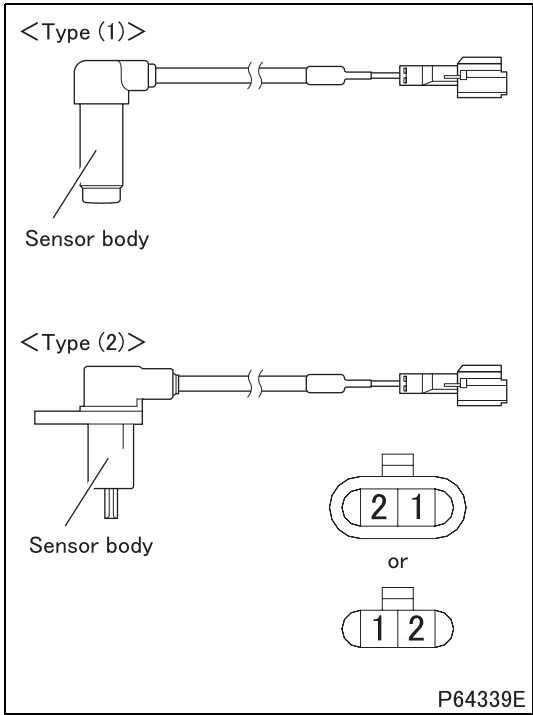
#329 Inspection of wheel speed sensor

- Carry out the following checks. If faulty, replace the wheel speed sensor.

- The pole piece is magnetized by the magnet housed in the wheel speed sensor. Be careful not to allow metal parts to stick onto the pole piece.

| Standard value | Type (1) | $1.4 \pm 0.2 \text{ k}\Omega$ |

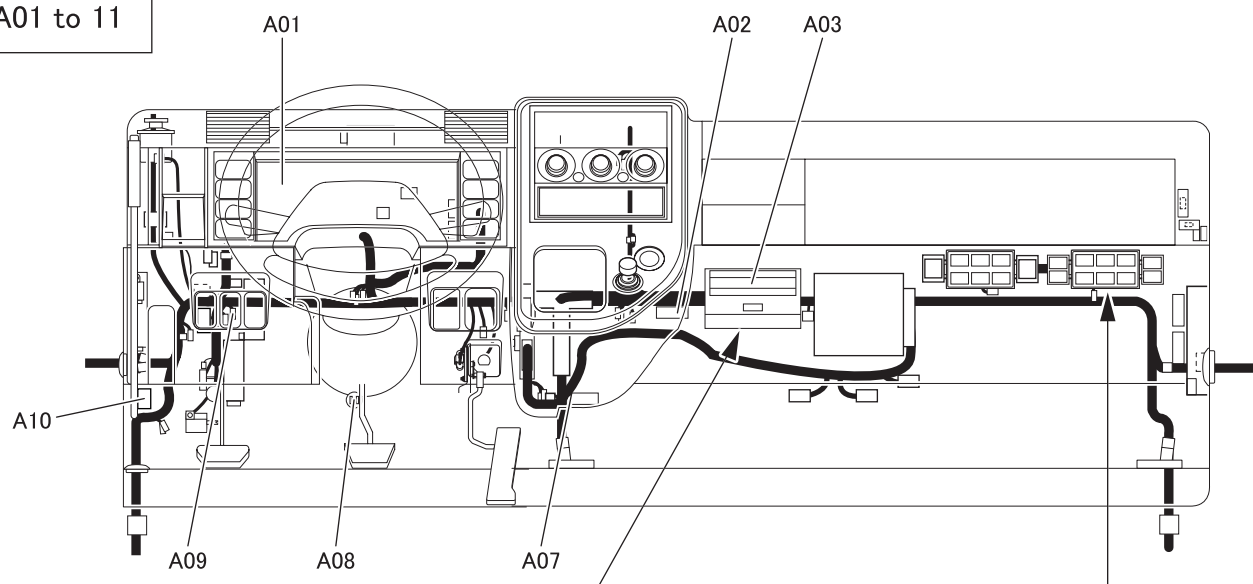
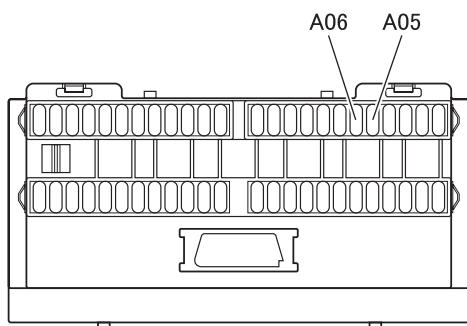
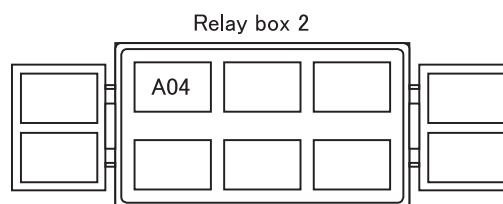
A01 to 11

- A01 Meter cluster
- A02 Joint connector (J/C-1)
- A03 Fuse box
- A04 ABS exhaust brake cut relay
- A05 Memory clear switch
- A06 Diagnosis switch
- A07 Joint connector (J/C-M1)
- A08 Stop lamp switch
- A09 G sensor <FG>
- A10 Diagnostic connector
- A11 Starter switch

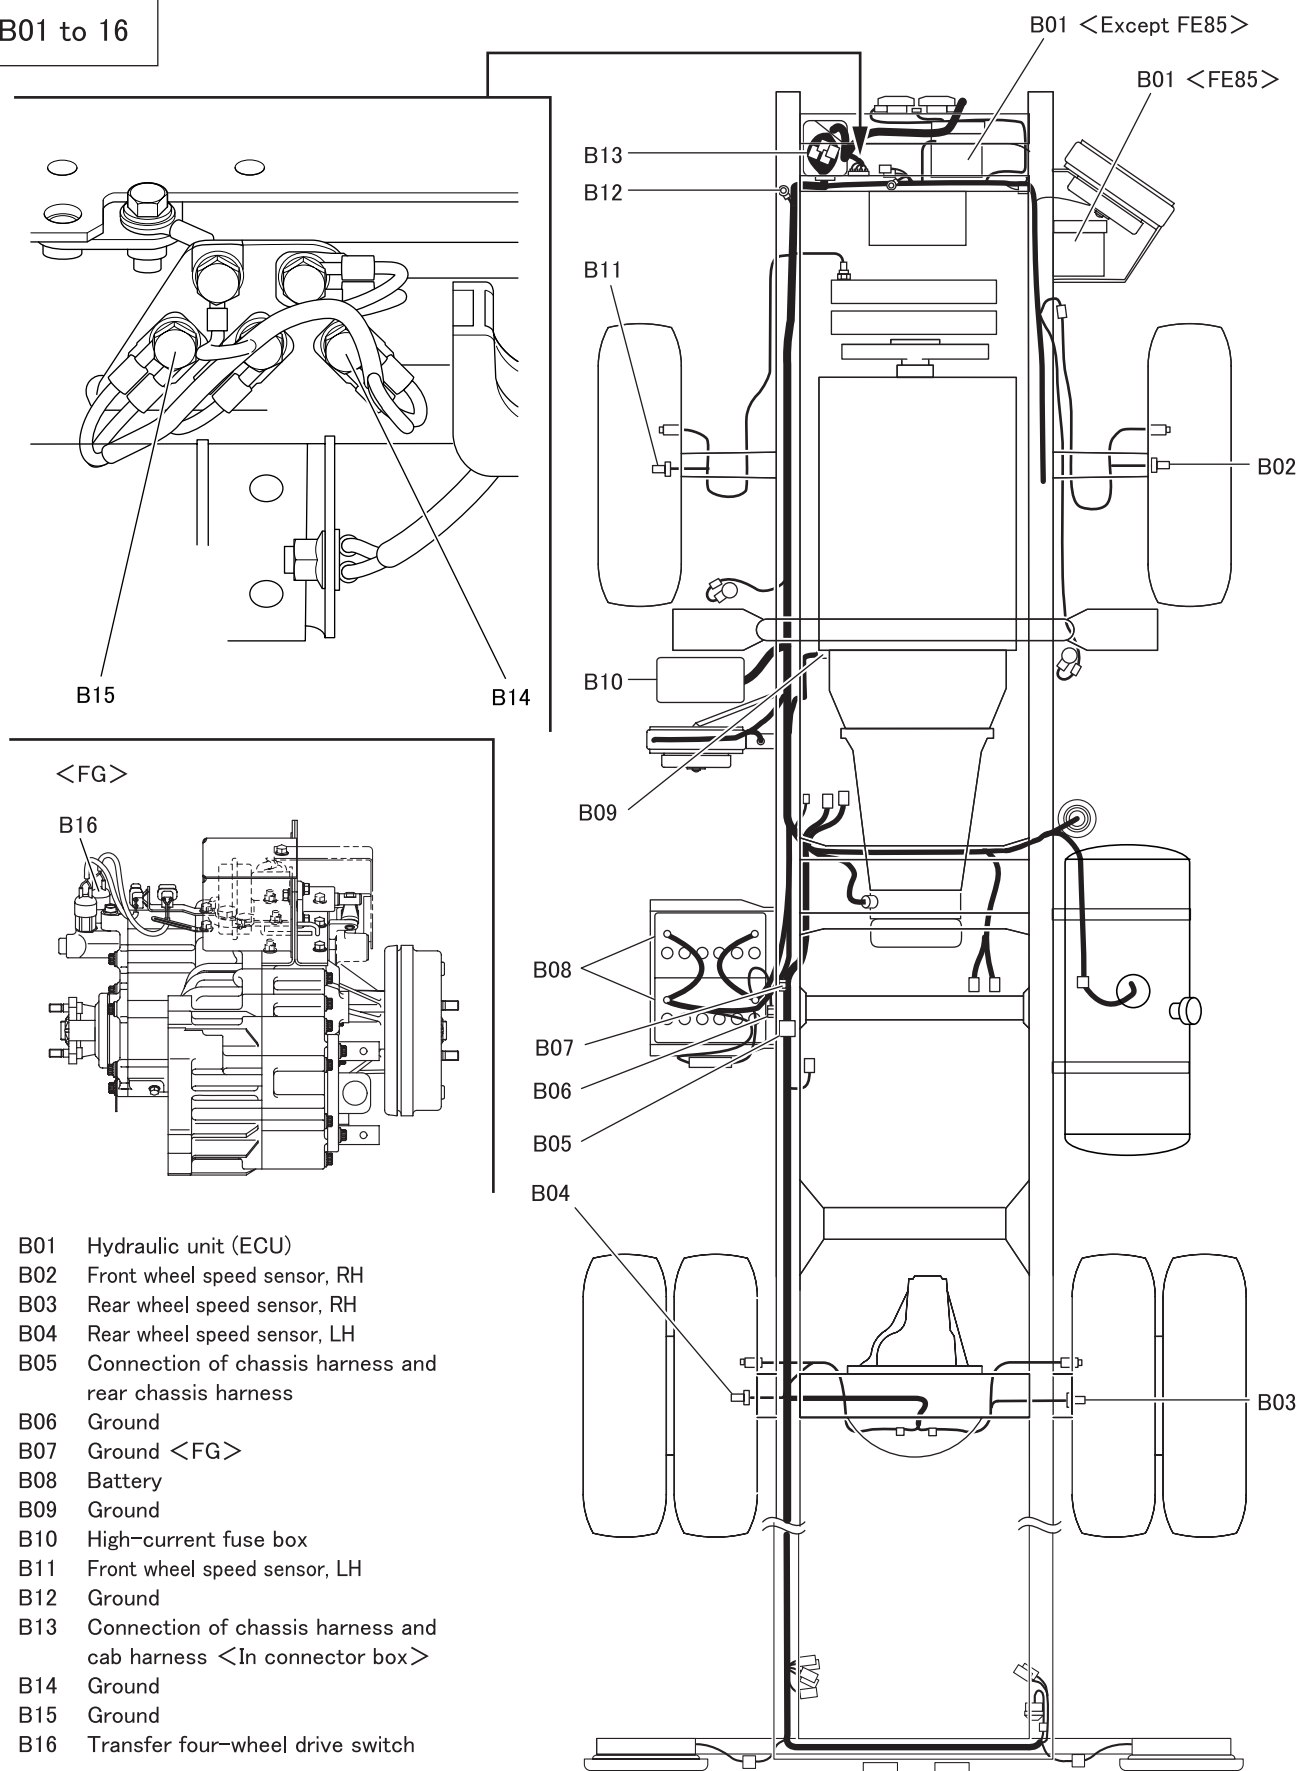
## B01 to 16

- B01 Hydraulic unit (ECU)
- B02 Front wheel speed sensor, RH
- B03 Rear wheel speed sensor, RH
- B04 Rear wheel speed sensor, LH
- B05 Connection of chassis harness and rear chassis harness
- B06 Ground
- B07 Ground <FG>
- B08 Battery
- B09 Ground
- B10 High-current fuse box
- B11 Front wheel speed sensor, LH
- B12 Ground
- B13 Connection of chassis harness and cab harness <In connector box>
- B14 Ground
- B15 Ground
- B16 Transfer four-wheel drive switch

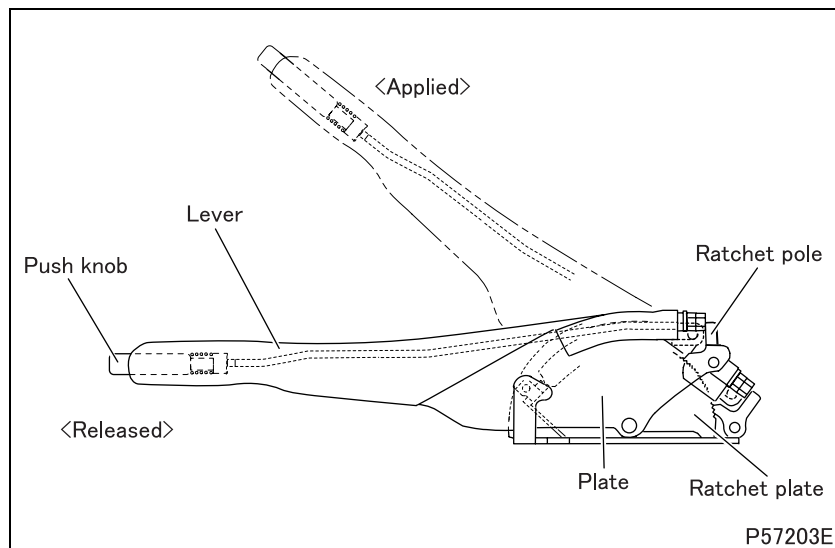
## 2. Parking Brake Lever

- Pulling the parking brake lever makes the parking brake work, at which point the ratchet pole engages with the ratchet plate and the lever is locked.
- To release the parking brake lever, slightly pull it up while pushing the release knob. This disengages the ratchet pole from the ratchet plate, allowing the parking brake lever to return to the released position.

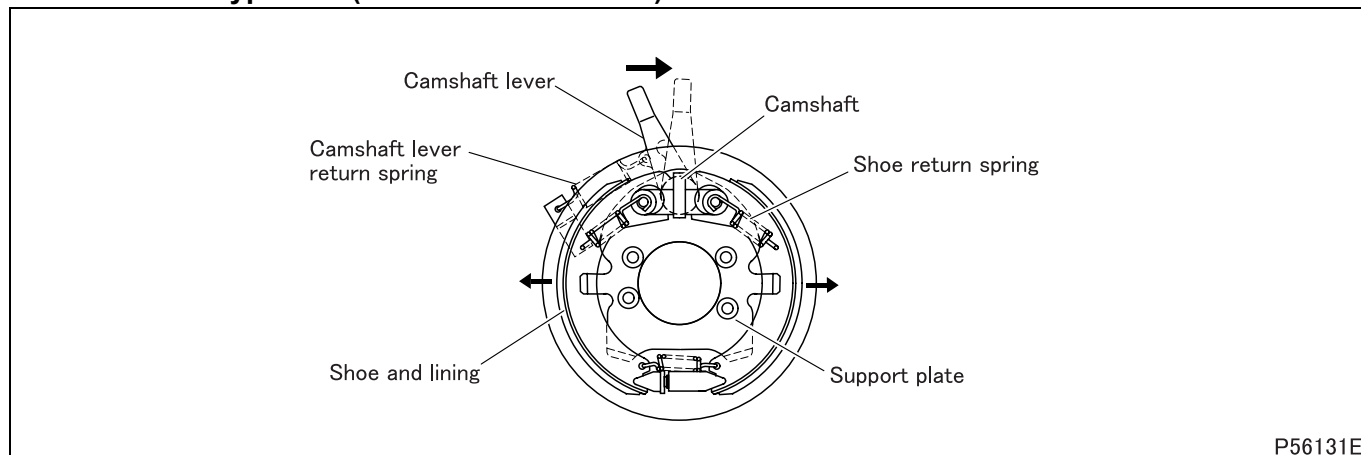
### 3.1 Duo servo type <FE (manual transmission)>

- The camshaft lever, which is used to actuate the shoes/linings, is built into the parking brake unit. Pulling the parking brake lever actuates the camshaft lever via the parking brake cable.
- Actuation of the camshaft lever causes the camshaft to rotate, which expands both shoes/linings onto the brake drum. In this case, both shoes/drums function as a leading shoe.
- As the parking brake lever (camshaft lever) is released, the forces of shoe and camshaft lever return springs restore the components to their home positions. This releases the parking brake.

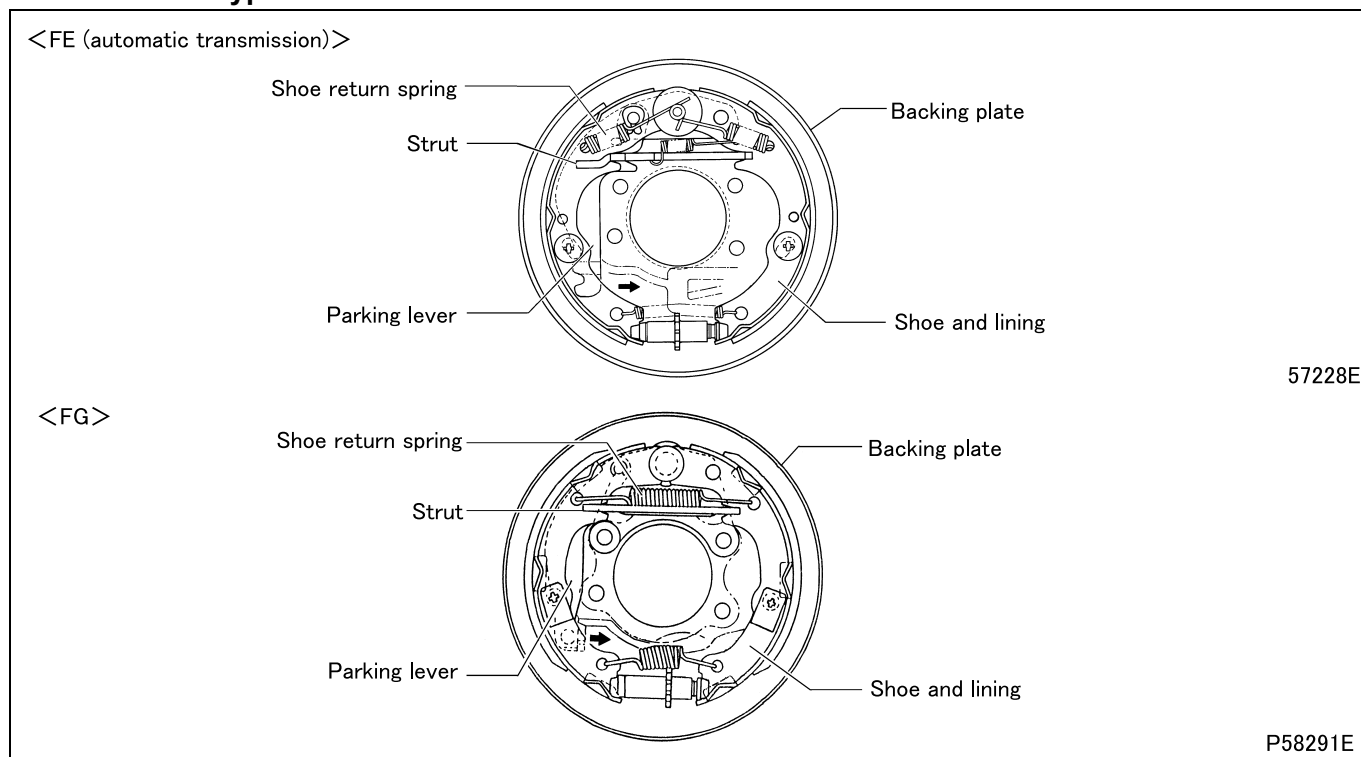
### 3.2 Duo servo type

- The parking lever that actuates the shoe and lining is a built-in component of the parking brake body. Pulling the parking brake lever pulls the parking brake cable, which in turn pulls the parking lever.
- When the parking lever is pulled, one shoe and lining is forced to expand with the medium of strut. At the same time, the parking lever directly expands the other shoe and lining. Thus, each shoe and lining assembly works as a leading shoe.
- When the parking brake lever (parking lever) is returned to the released position, the repercussive force of the shoe return spring releases the brake.

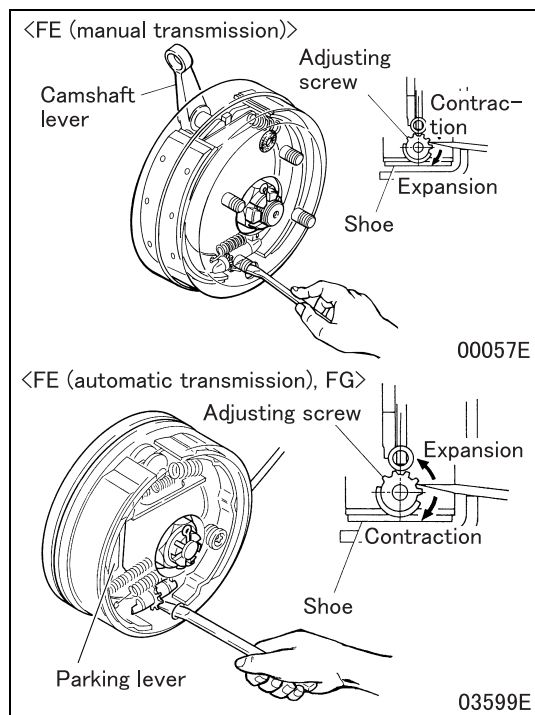
- Chock the front wheels and raise the rear wheels with a jack before adjusting the shoe clearance.
- Operate the parking brake lever to release the parking brake. (The parking lever or camshaft lever is released from locking.)
- Using a standard screwdriver inserted through the shoe adjusting hole in the parking brake drum, turn the adjusting screw in the C direction (expansion) shown to bring the shoe into close contact with the brake drum.
- Turn the adjusting screw 8 notches in the B direction (contraction) shown from the position where the shoe is in close contact with the drum. The shoe clearance should be adjusted to the standard value.

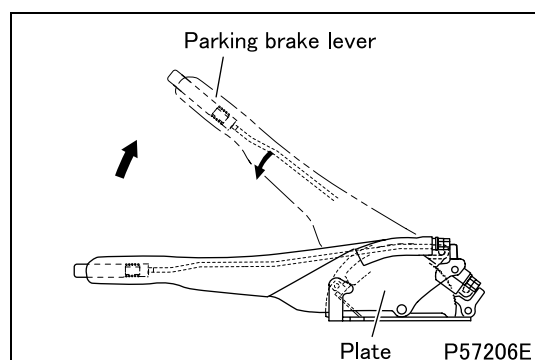
#### [Inspection]

- Pull the parking brake lever from the released position with an operating physical force of 300N {67 lbs, 31 kgf} and count the number of cleared notches.
- If the count of notches deviates from the specified range of standard values, adjust the length of the parking brake cable.
- If the count of notches (pulling stroke) is still out of the specified range after cable length adjustment, check the parking brake shoe clearance.

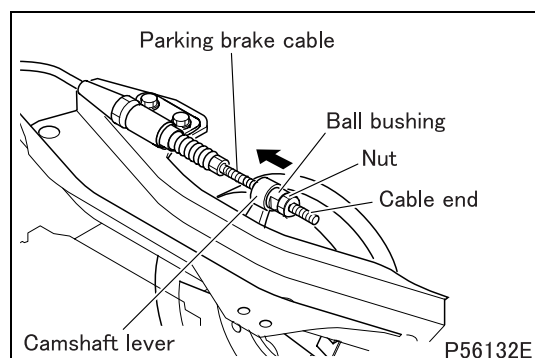
#### [Adjustment]

- Do not rotate the ball bushing so much as to cause the camshaft lever to move.

- Pull the parking brake lever 3 times with a force of 500 N {110 lbs, 51 kgf}.
- This operation causes the cable to extend. Rotate the ball bushing again until it contacts the camshaft lever. Then, pull the parking brake lever with a force of 45 to 50 N {10 to 11 lbs, 4.6 to 5.1 kgf}. The camshaft lever should not move more than 1mm {0.039 in.}.

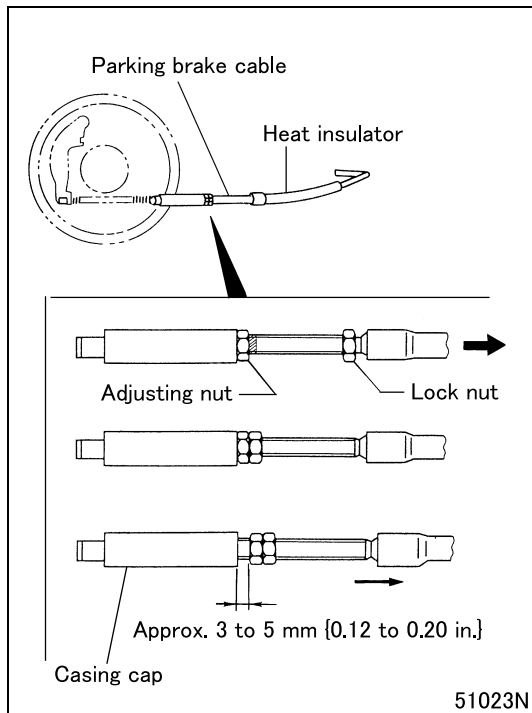
## <FE (automatic transmission), FG>

- Pull the outer cable of the parking brake cable with a force of 60 to 100 N {13 to 22 lbs, 6.1 to 10 kgf} to zero the parking brake shoe clearance.

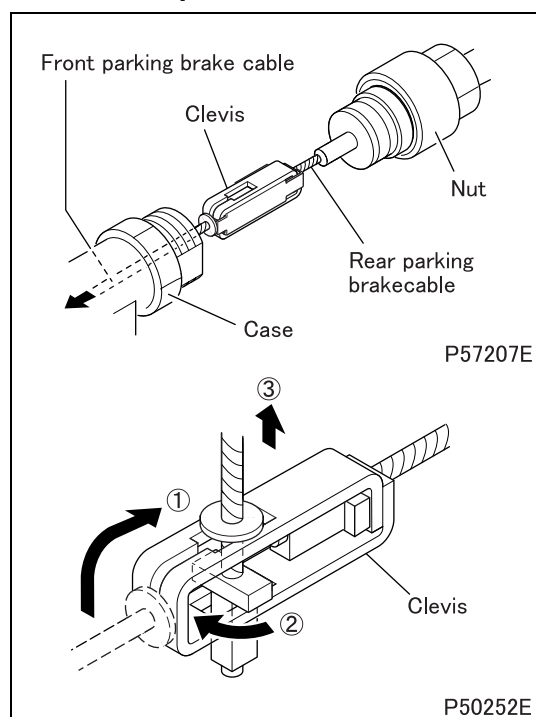
#### ■ Removal: Front parking brake cable <FE (automatic transmission), FG>

- Loosen the nut connecting the front and rear parking brake cables, then separate the front parking brake cable case from the rear parking brake cable.
- Remove the cap and pull out the clevis from the front parking brake cable case and remove it at the steps of 1, 2 and 3 in that order as shown.

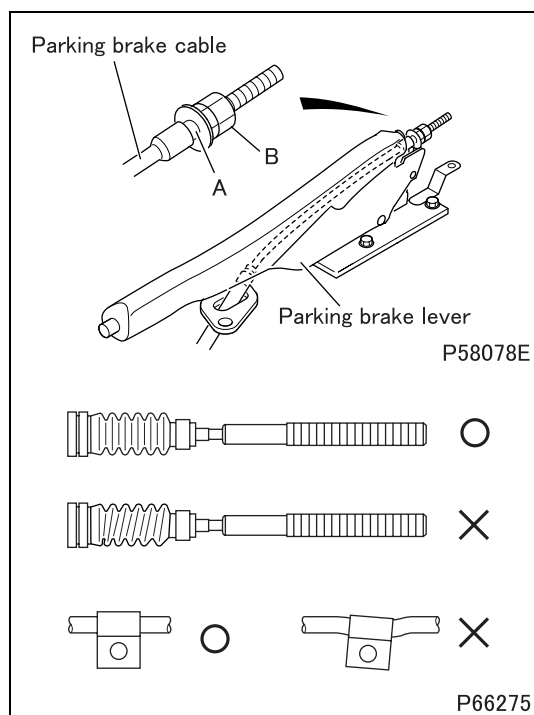
### ■ Installation: Front parking brake cable or parking brake cable

- Connect the front parking brake cable to the rear parking brake cable by following the removal procedure in reverse. <FE (automatic transmission), FG>
- Attach the parking brake cable to the parking brake lever by fully tightening nut A, then tightening nut B to the specified torque.

- Cable bending radius must be at least 100 mm.
- The cable must not be bent at clamped portions.
- There must not be torsion in the boot.
- Avoid any interference with other components when routing the cable.

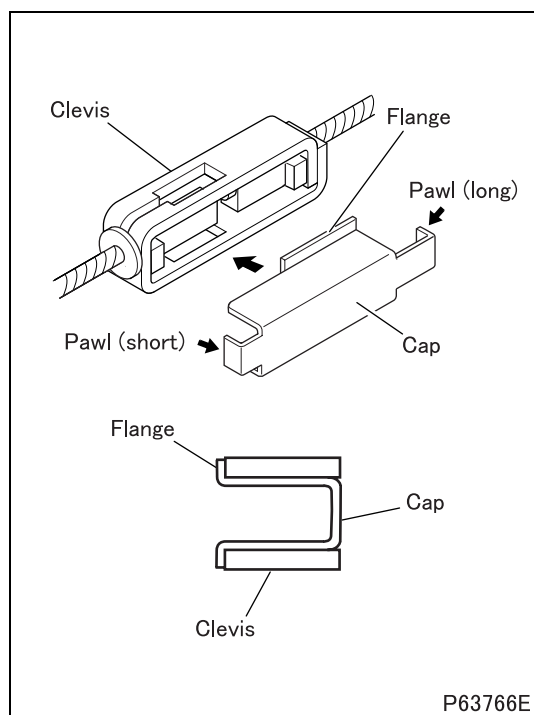
### ■ Installation: Cap <FE (automatic transmission), FG>

- Attach the cap to the clevis of the rear parking brake cable from the direction shown in the illustration.
- Fit the cap into the clevis all the way so that the flange of the cap comes out at the other side of the clevis.

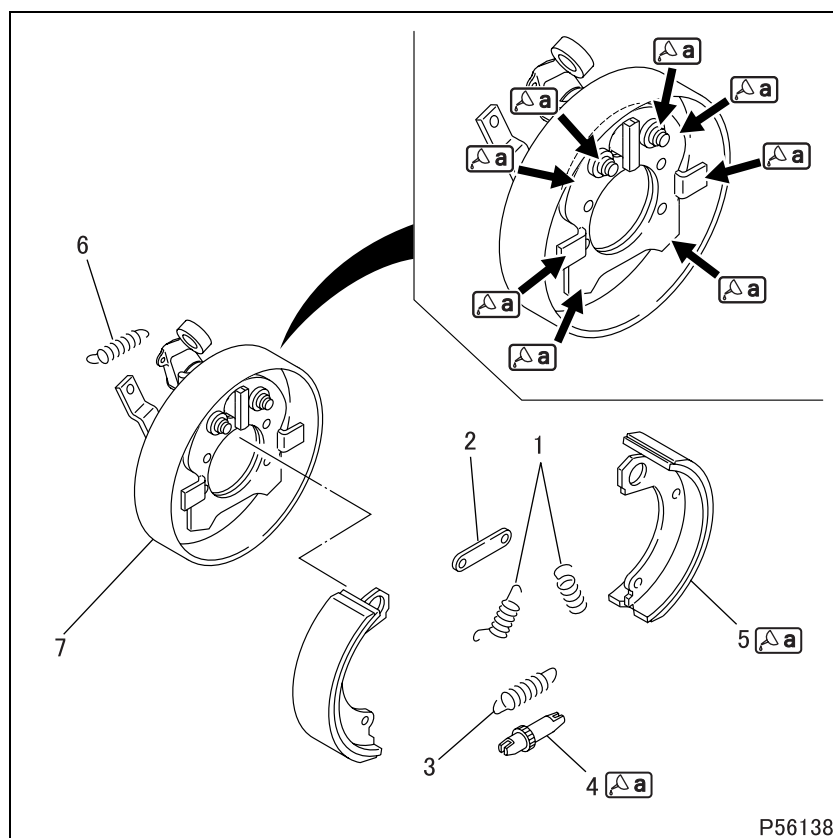
# PARKING BRAKE <FE (MANUAL TRANSMISSION)>

- 1 Shoe return spring
- 2 Anchor pin brace
- 3 Adjust wheel return spring
- 4 Adjust screw
- 5 Shoe & lining
- 6 Camshaft lever return spring
- 7 Support plate & dust cover

| Location | Maintenance item | Standard value | Limit | Remedy |
|---|---|---|---|---|
| 1 | Shoe return spring installed load (installed length: 57.5 {2.26}) | 145 ± 15 N<br>{33 ± 3.3 lbs,<br>15 ± 1.5 kgf} | 115 N<br>{26 lbs,<br>12 kgf} | Replace |
| 3 | Adjust wheel return spring installed load (installed length: 59 {2.32}) | 78 ± 7.8 N<br>{18 ± 1.8 lbs, 8 ± 0.8 kgf} | 63 N<br>{14 lbs,<br>6.4 kgf} | Replace |
| 5 | Brake lining thickness | 4.0 {0.16} | 1.4<br>{0.055} | Replace |
| 6 | Cam shaft lever return spring installed load (installed length: 85 {3.35}) | 62 ± 5.9 N<br>{14 ± 1.3 lbs,<br>6.3 ± 0.6 kgf} | 49 N<br>{11 lbs,<br>5.0 kgf} | Replace |

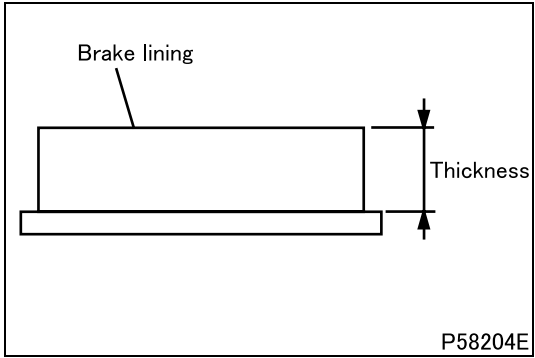
**■ Inspection: Brake lining thickness of shoe and lining**

- If the measured value is lower than the limit, replace the shoe and lining.

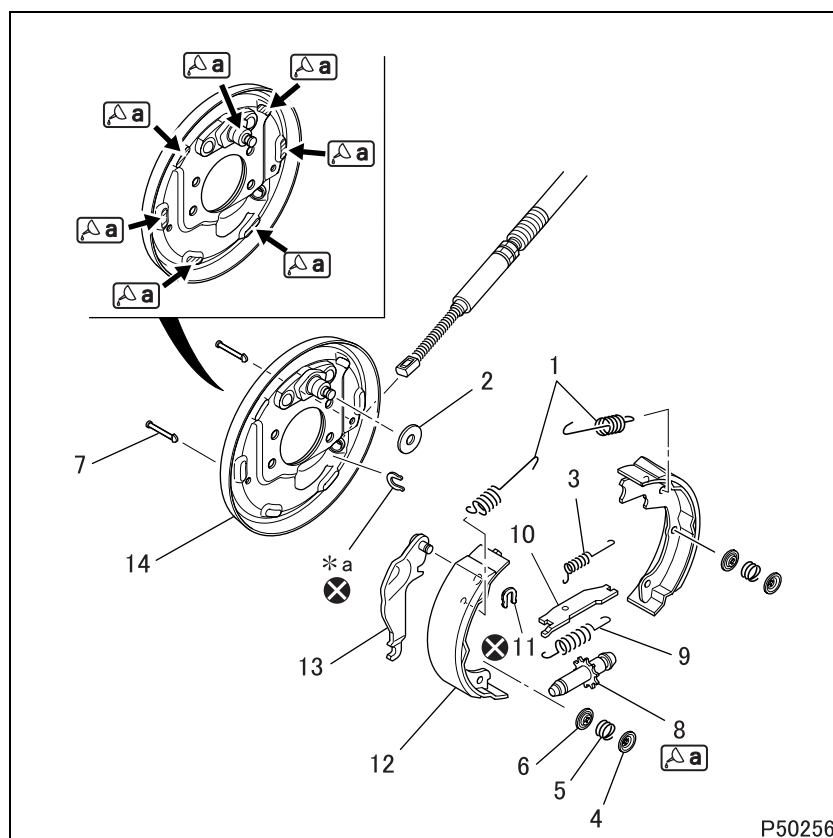
# PARKING BRAKE <FE (AUTOMATIC TRANSMISSION)>

- 1 Shoe return spring
- 2 Washer
- 3 Strut spring
- 4 Shoe holddown cup
- 5 Shoe holddown spring
- 6 Shoe holddown cup
- 7 Shoe holddown pin
- 8 Adjuster
- 9 Adjuster spring
- 10 Strut
- 11 Retainer
- 12 Shoe and lining
- 13 Parking lever
- 14 Backing plate

| Location | Maintenance item | Standard value | Limit | Remedy |
|---|---|---|---|---|
| 1 | Installed load of shoe return spring<br>(installed length: 67.1 {2.64}) | 58.8 ± 5.9 N<br>{13 ± 1.3 lbs,<br>6.0 ± 0.6 kgf} | 49 N<br>{11 lbs,<br>5.0 kgf} | Replace |
| 3 | Installed load of strut spring (installed length: 49 {1.93}) | 29.4 ± 2.9 N<br>{6.6 ± 0.7 lbs,<br>3.0 ± 0.3 kgf} | 26 N<br>{5.8 lbs,<br>2.7 kgf} | Replace |
| 5 | Installed load of shoe holddown spring<br>(installed length: 15.5 {0.61}) | 78.5 ± 7.9 N<br>{18 ± 1.8 lbs,<br>8.0 ± 0.8 kgf} | 71 N<br>{16 lbs,<br>7.2 kgf} | Replace |
| 9 | Installed load of adjuster spring (installed length: 78.2 {3.08}) | 58.8 ± 5.9 N<br>{13 ± 1.3 lbs,<br>6.0 ± 0.6 kgf} | 49 N<br>{11 lbs,<br>5.0 kgf} | Replace |
| 12 | Brake lining thickness of shoe and lining | 4.0 {0.16} | 1.4 {0.053} | Replace |

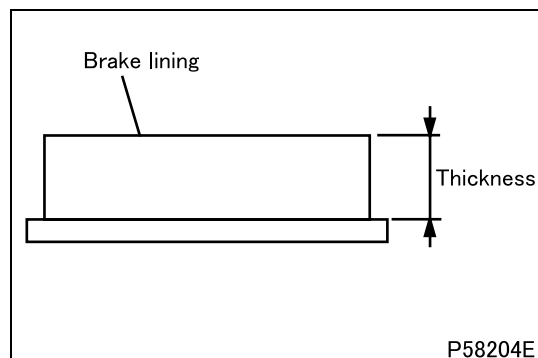
### ■ Inspection: Brake lining thickness of shoe and lining

- If the measured value is lower than the limit, replace the shoe and lining.

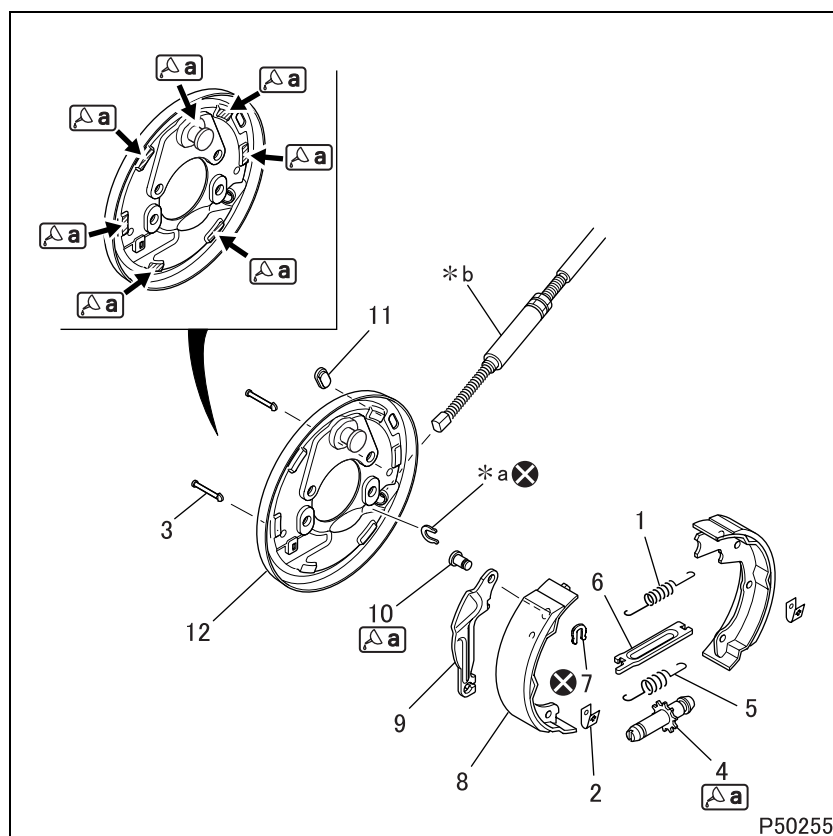
# PARKING BRAKE <FG>

- 1 Shoe return spring
- 2 Shoe holddown spring
- 3 Shoe holddown pin
- 4 Adjuster
- 5 Adjuster spring
- 6 Strut
- 7 Retainer
- 8 Shoe & lining
- 9 Parking lever
- 10 Brake lever pin
- 11 Plug
- 12 Backing plate

| Location | Maintenance item | Standard value | Limit | Remedy |
|---|---|---|---|---|
| 1 | Shoe return spring installed load (installed length: 109.4 {4.31}) | 145 ± 15 N<br>{32 ± 3.3 lbs,<br>14.6 ± 1.5 kgf} | 115 N<br>{26 lbs,<br>11.7 kgf} | Replace |
| 5 | Adjuster spring installed load (installed length: 72 {2.83}) | 50 ± 7.8 N<br>{11 ± 1.8 lbs,<br>5.1 ± 0.8 kgf} | 40 N<br>{9.0 lbs,<br>4.1 kgf} | Replace |
| 8 | Brake lining thickness | 5.3 {0.21} | 3.0 {0.12} | Replace |

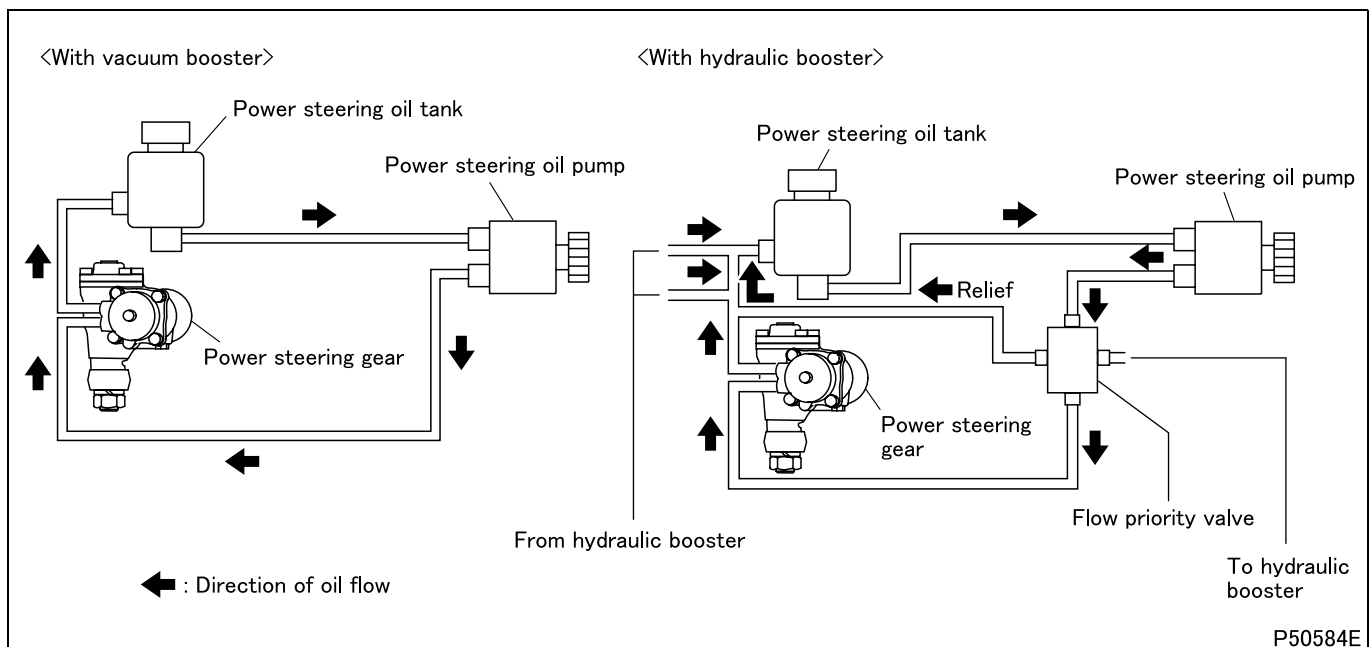
## 2. Oil Flow

- The power steering system with hydraulic booster is provided with a flow priority valve to reduce steering shock that occurs when the brakes are suddenly applied during steering wheel manipulation.

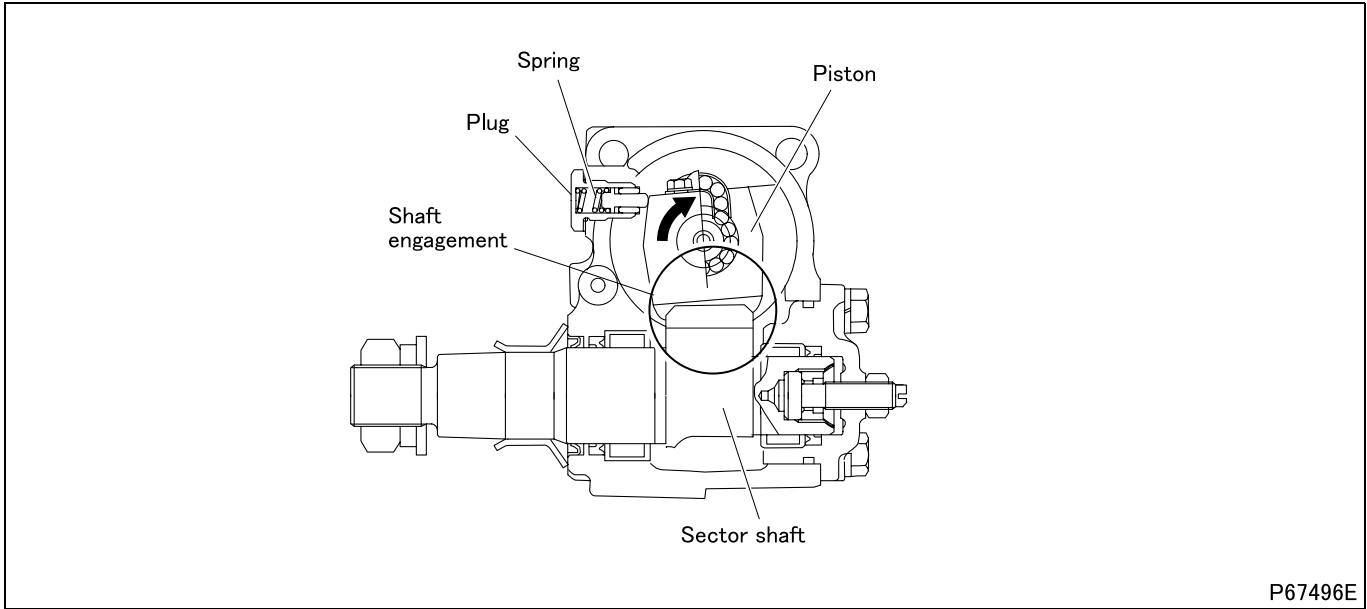
### 3. Power Steering Gear (Backlash Compensation Mechanism)

- The plug constantly presses the piston in the illustrated turning direction with the force of internal spring.
- This eliminates play between the piston and sector shaft where they are engaged to suppress backlash during straight travel, thus improving steerability.

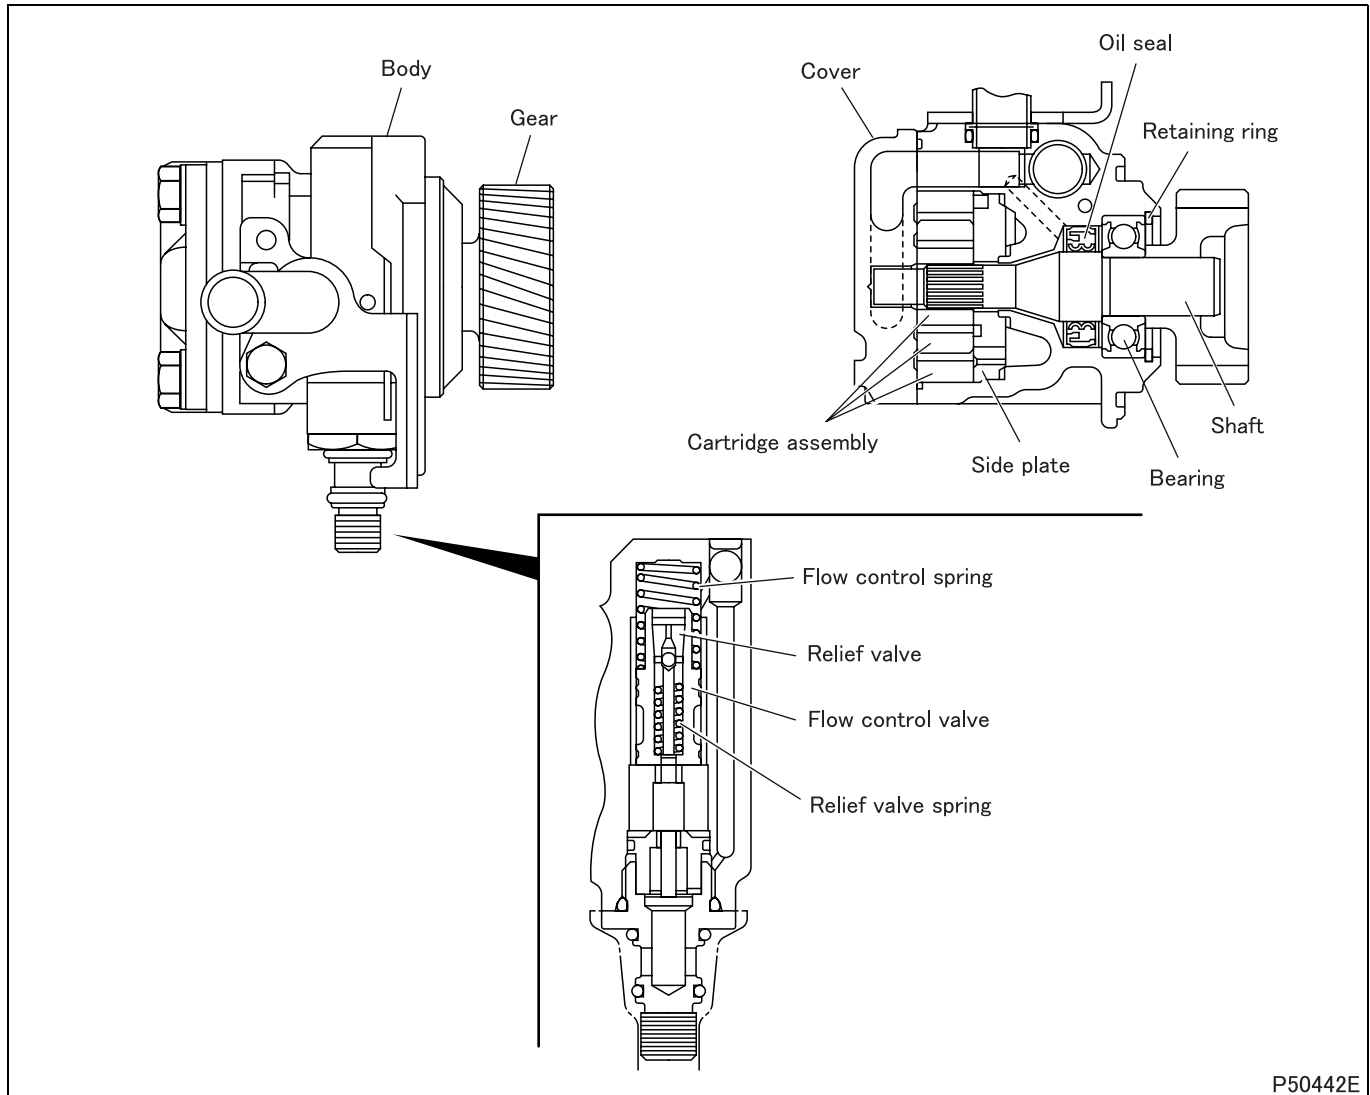
P50442E

## 4. Power Steering Oil Pump <KYB Product>

- The power steering oil pump is a hydraulic source pump with the vane in the rotor groove and is geared to the engine.
  - The power steering oil pump consists of a cartridge assembly that discharges oil, a flow control valve that controls the oil flow rate and a relief valve that prevents free oil pressure rise.
  - The flow control valve maintains constant the quantity of oil to the power steering gear during steering wheel manipulation.
- The relief valve is provided in the flow control valve to prevent oil pump pressure from rising beyond necessary level during stationary swing operation.

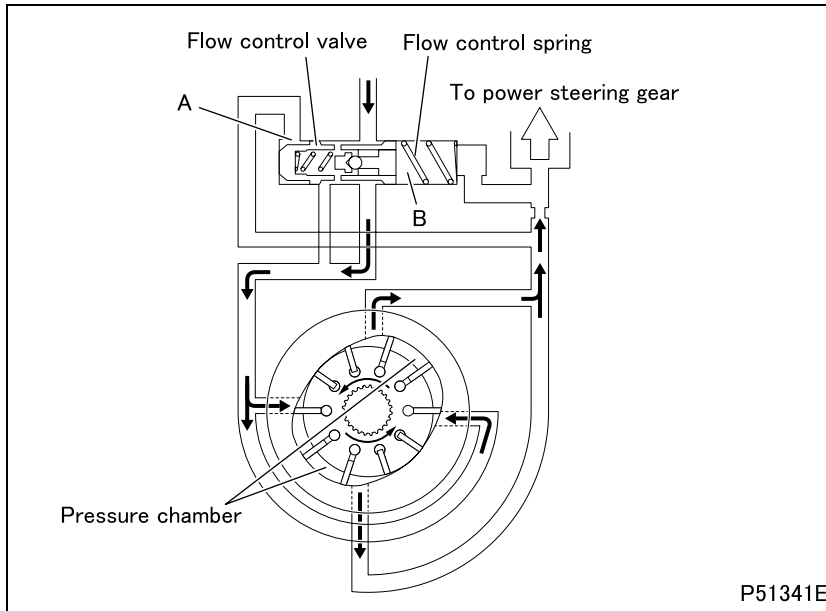
## 4.1 Flow control valve

#### (1.1) When not functioning (oil pump in operation at low speed)

- Oil pressure in the chamber A is weaker than the combined force of oil pressure in the chamber B and tension of the flow control spring, and the flow control valve remains stationary.

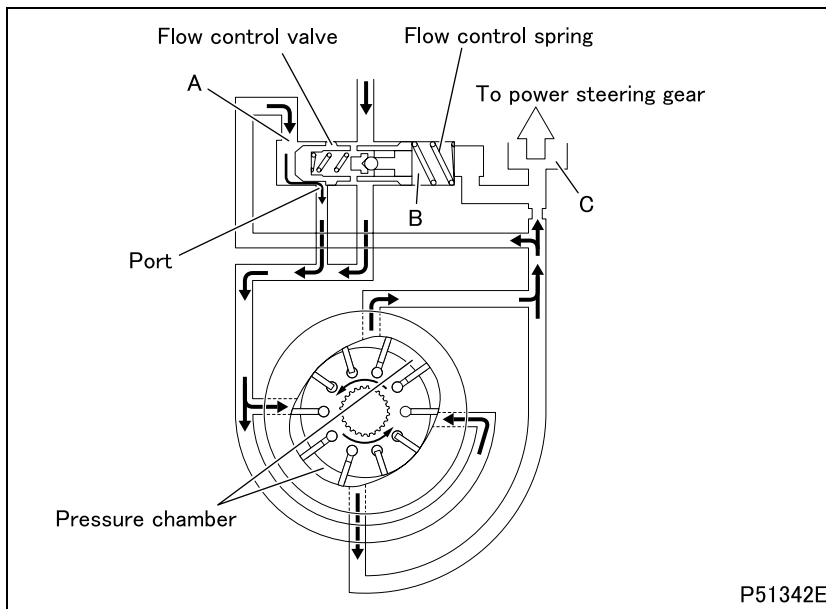
#### (1.2) When functioning (oil pump in operation at middle to high speeds)

- Oil pressure in the chamber A overcomes the combined force of oil pressure in the chamber B and tension of the flow control spring, and the flow control valve is shifted.
- Port is made open to release oil pressure, and the flow rate from the chamber C is maintained constant.

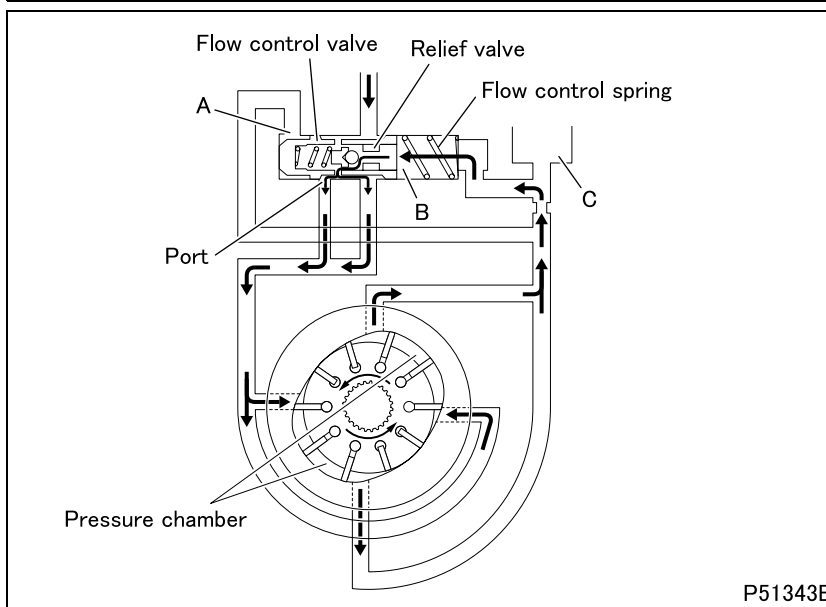
### (2) Operation of relief valve

- When the combined force of oil pressure in the chamber B and tension of the flow control spring overcomes oil pressure in the chamber A, the flow control valve is shifted. Further increased oil pressure in the chamber B pushes the relief valve to open port, thus preventing excessive oil pressure from going to the chamber C.

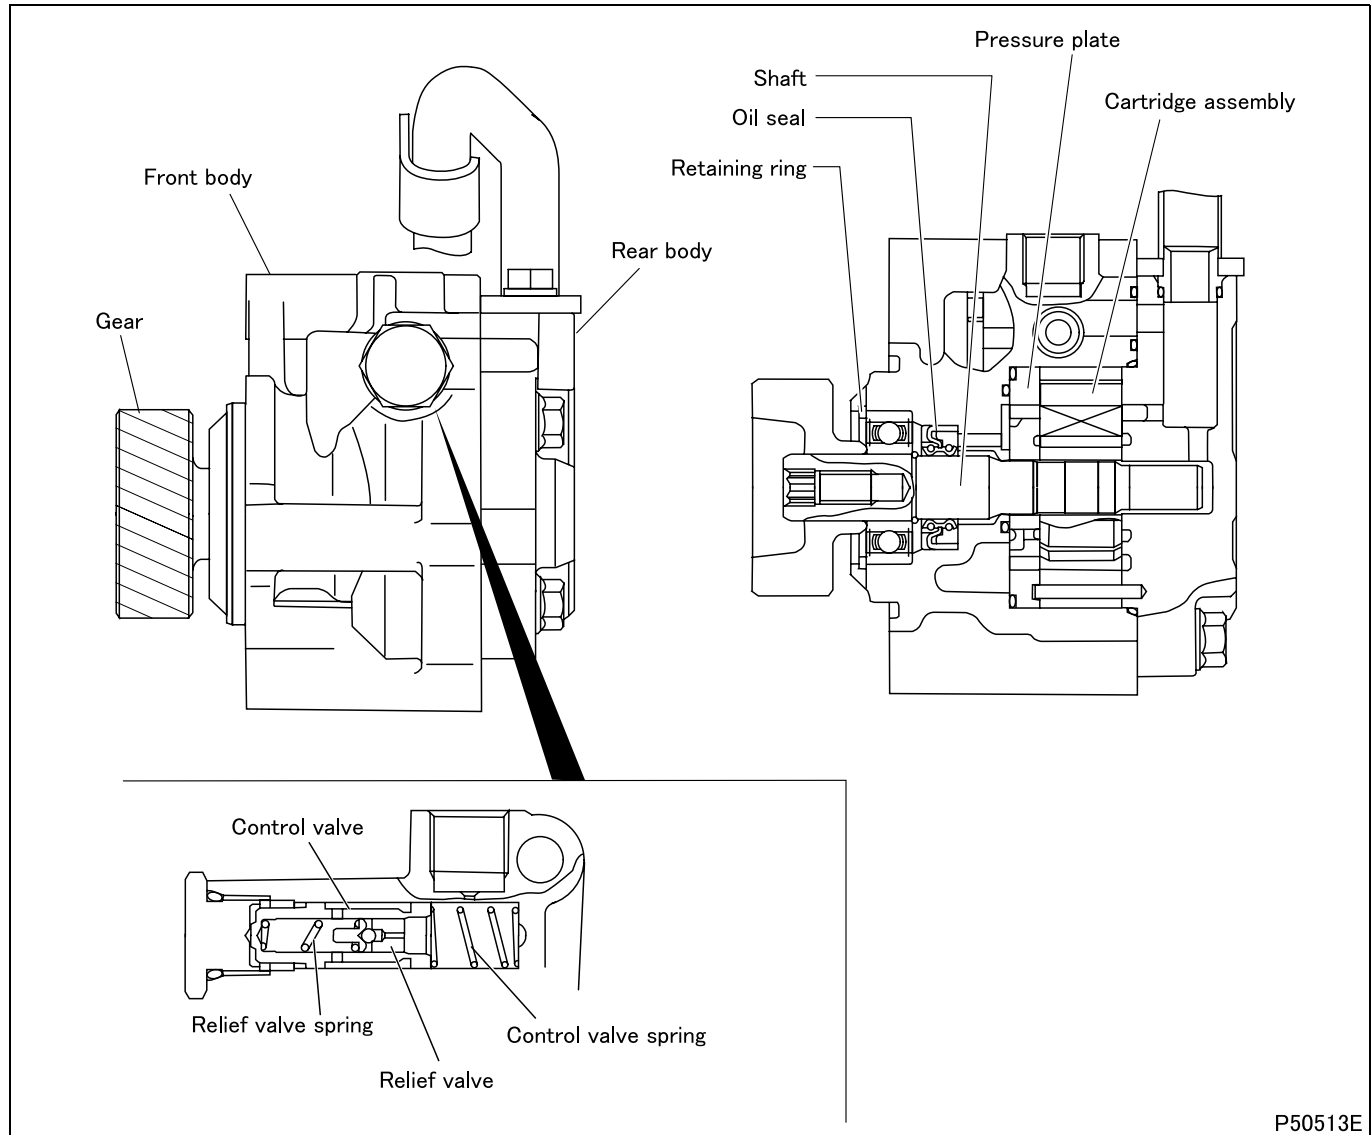
P50513E

## 5. Power Steering Oil Pump <Unisia JKC Steering Systems Product>

- The power steering oil pump is a hydraulic source pump with the vane in the rotor groove and is geared to the engine.
- The power steering oil pump consists of a cartridge assembly that discharges oil, a control valve that control the oil flow rate and a relief valve that prevents free oil pressure rise.
- The control valve maintains constant the quantity of oil to the power steering gear during steering wheel manipulation. The relief valve is provided in the control valve to prevent oil pump pressure from rising beyond necessary level during stationary swing operation.
