# FE.FG

## SERVICE MANUAL 2008 Model FOREWORD

This Service Manual contains maintenance and repair methods for the Mitsubishi Fuso Truck FE. FG Series. Read this manual carefully as an aid in providing correct, efficient maintenance. Please note that the information and specifications contained within this manual may change without notice. This is due to product modifications and continued vehicle improvements that are made throughout the model years. Should you encounter any discrepancy in the information provided, please do not hesitate to contact your nearest Mitsubishi Fuso Dealer or Mitsubishi Fuso Truck of America, Inc.

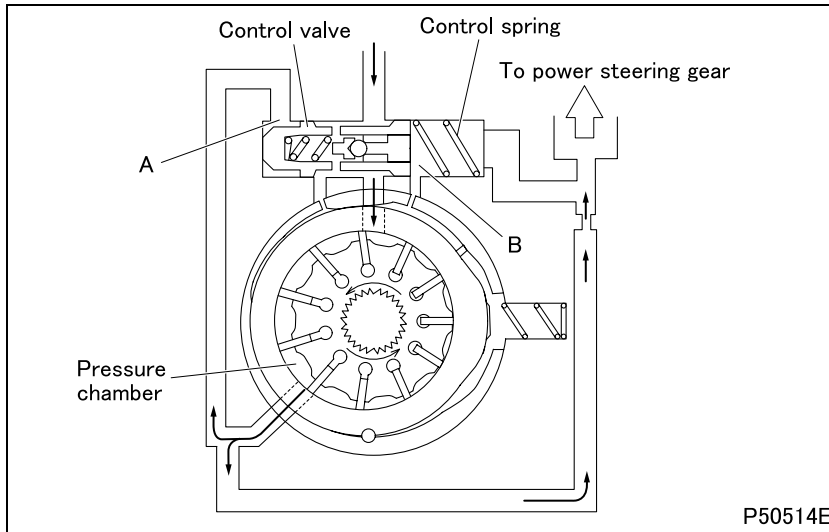
## 5.1 Control valve

#### (1.1) When not functioning (oil pump in operation at low speed)

- Oil pressure in the chamber A is weaker than the combined force of oil pressure in the chamber B and tension of the control spring, and the control valve remains stationary.

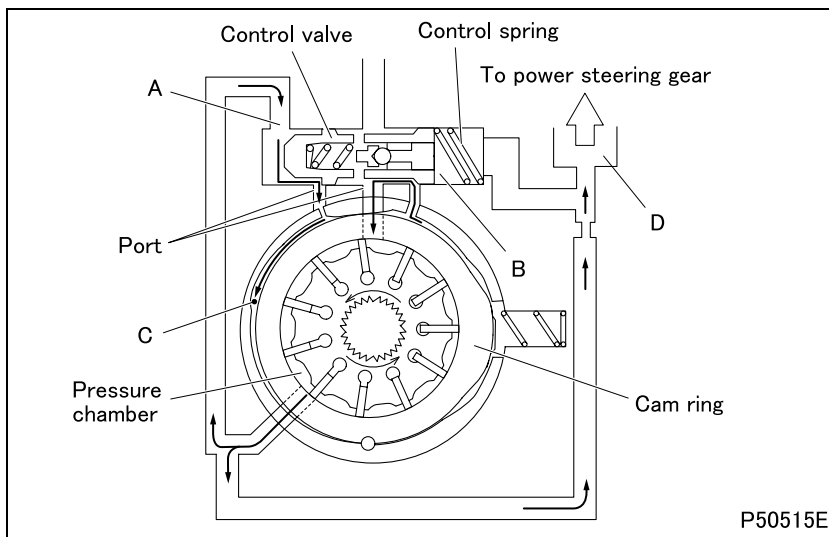
#### (1.2) When functioning (oil pump in operation at medium to high speeds)

- Oil pressure in the chamber A overcomes the combined force of oil pressure in the chamber B and tension of the control spring, and shifts the control valve.
- Port is made open to release oil pressure in the chamber A into the chamber C, and the cam ring is shifted to right.
- This reduces the pressure chamber in capacity to decrease oil pump output per revolution, thus maintaining constant the flow rate from the chamber D.

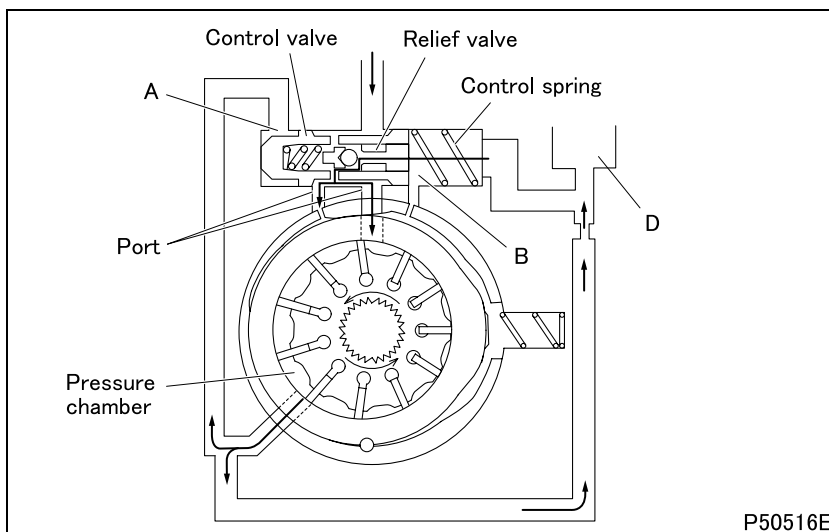
### (2) Operation of relief valve

- The combined force of oil pressure in the chamber B and tension of the control spring overcomes oil pressure in the chamber A, and the control valve is shifted.
- Increased oil pressure in the chamber B pushes the relief valve to open port, thus preventing excessive oil pressure from going to the chamber D.

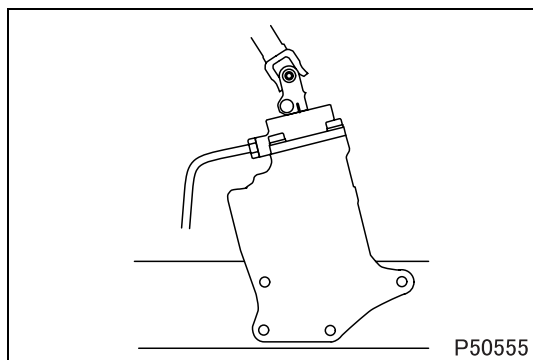
#### (1) Draining

- Jack up the front wheels.
- Clean the port areas of feed and return pipes to prevent ingress of dirt, dust, and other foreign matters inside the power steering gear.
- Loosen feed and return pipes connected to the power steering gear.
- Repeatedly turn the steering wheel fully left and right to drain the fluid from the power steering gear.
- After draining the fluid, tighten the feed and return pipes to specified torque.

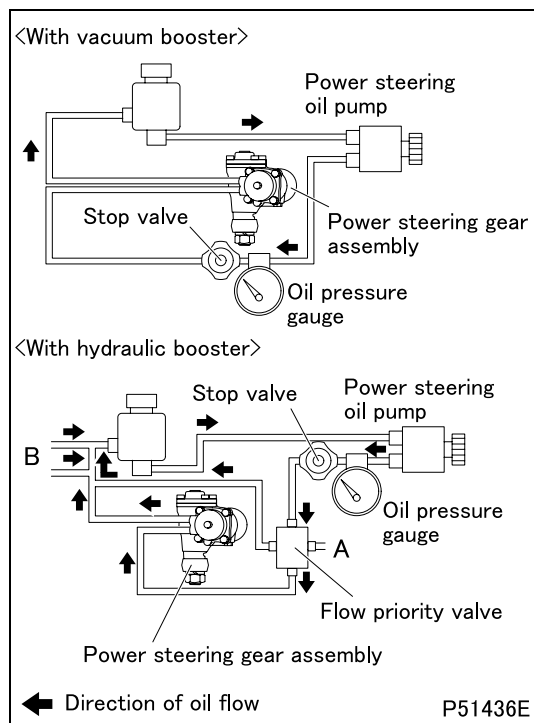
- Perform the tests with the following measuring conditions to verify normal operation of the power steering gear assembly and power steering oil pump.
  - A: To hydraulic booster
  - B: From hydraulic booster
- Install oil pressure gauge capable of measuring upward of 13.2 MPa {1910 psi, 135 kgf/cm<sup>2</sup>} and stop valve between power steering oil pump and power steering gear assembly <With vacuum booster> or flow priority valve <With hydraulic booster>, then bleed air.
- Start engine to idle.
- Turn steering wheel left and right several times to raise fluid temperature up to 50 to 60°C {122 to 140°F}.
- With the engine idling, fully open stop valve.

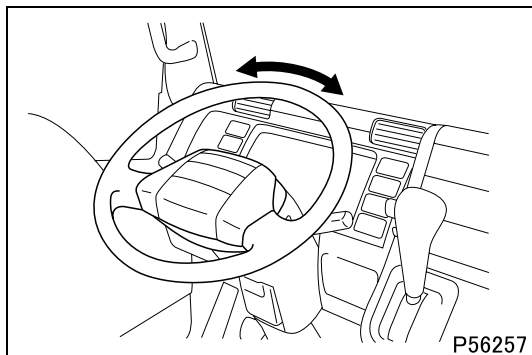
- With vehicle placed straight forward, start the engine and gently turn the steering wheel left and right to measure its peripheral play.
- If the play deviates from the standard value, check tightening points and the power steering gear.

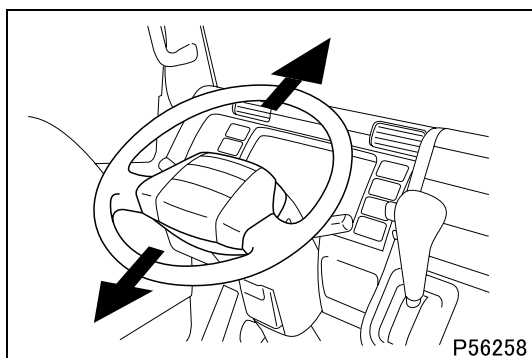
## 5. Steering Column Looseness

- Push and pull the steering wheel by hand to check the steering column for looseness.
- With the steering column tilted all the way forward, pull the steering wheel backward and check the steering column for looseness.
- If the steering column is loose, adjust the tilting and telescoping lever.

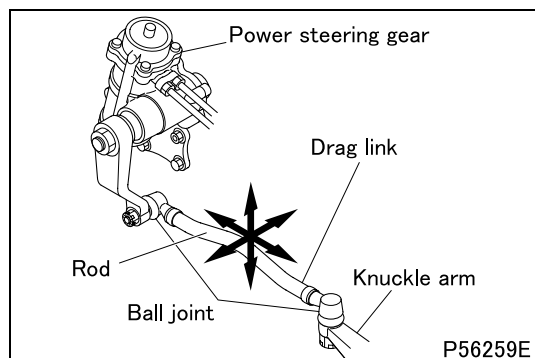
#### (1) Play of drag link ball joint

- With the vehicle in the stationary state, move the drag link by the rod in the forward, backward, vertical and lateral directions of the vehicle and check for play at the ball joints with the gear power steering gear and knuckle arm.
- If feeling play with your hand, replace the drag link.

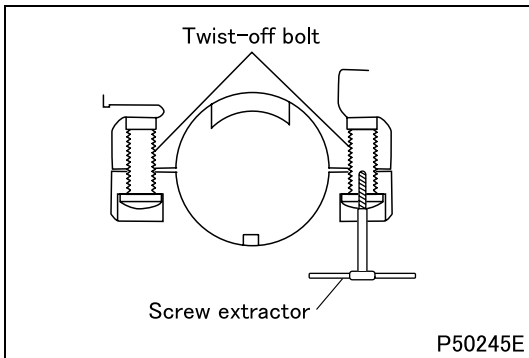
### ■ Removal: Starter switch

- Drill a hole of 5.5 to 6 mm {0.22 to 0.24 in.} in diameter to a depth of 10 to 15 mm {0.39 to 0.59 in.} in the twist-off bolt.
- Using the drilled hole, screw the screw extractor counterclockwise into the twist-off bolt and remove it.

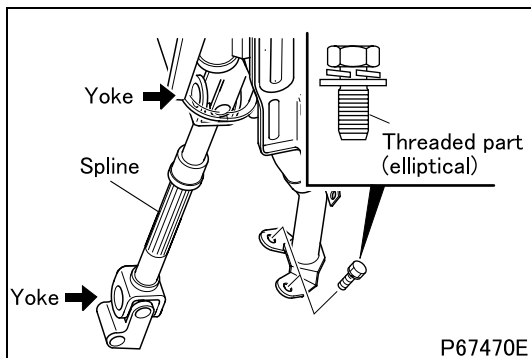
#### ■ Installation: Steering column

- If the spline is off the steering column, assemble them with the yokes facing in the same direction.
- Install the steering column using the illustrated bolts. The threaded portion of these bolts is elliptical for grounding the horn circuit properly.

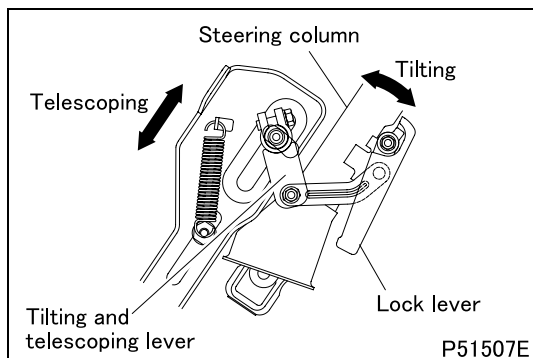
### ■ Inspection: Tilting and telescoping lever operating force

- Tilt the steering column all the way forward and telescope it to the mid-point of the movable range.
- Push the tilting and telescoping lever in and lock the steering column. In this state, check that the force required to operate the tilting and telescoping lever is 140 N {31 lbs, 14 kgf} or more.
- Push the steering column forward by hand to check that it is securely held.
- Adjust the installed position of the lock lever if necessary.

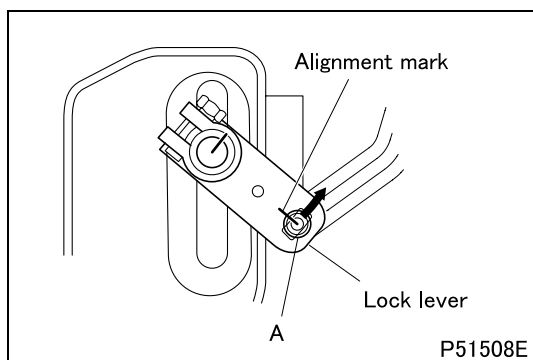
### ■ Adjustment: Lock lever

- Loosen nut A.
- Move the lock lever to relocate the nut A in the slot from the alignment mark in the arrow direction, then tighten the nut A in that position.

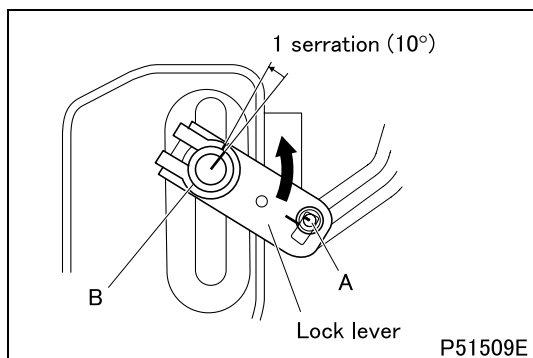
- If the nut A is already at the end of the slot in the lock lever and cannot be relocated, remove the lock lever and turn the nut B one serration (10°) from the alignment mark in the arrow direction, then reinstall the lock lever.
- Adjust the tightening position of the nut A so that the tilting and telescoping lever operating force becomes 140 N {31 lbs, 14 kgf} or more.

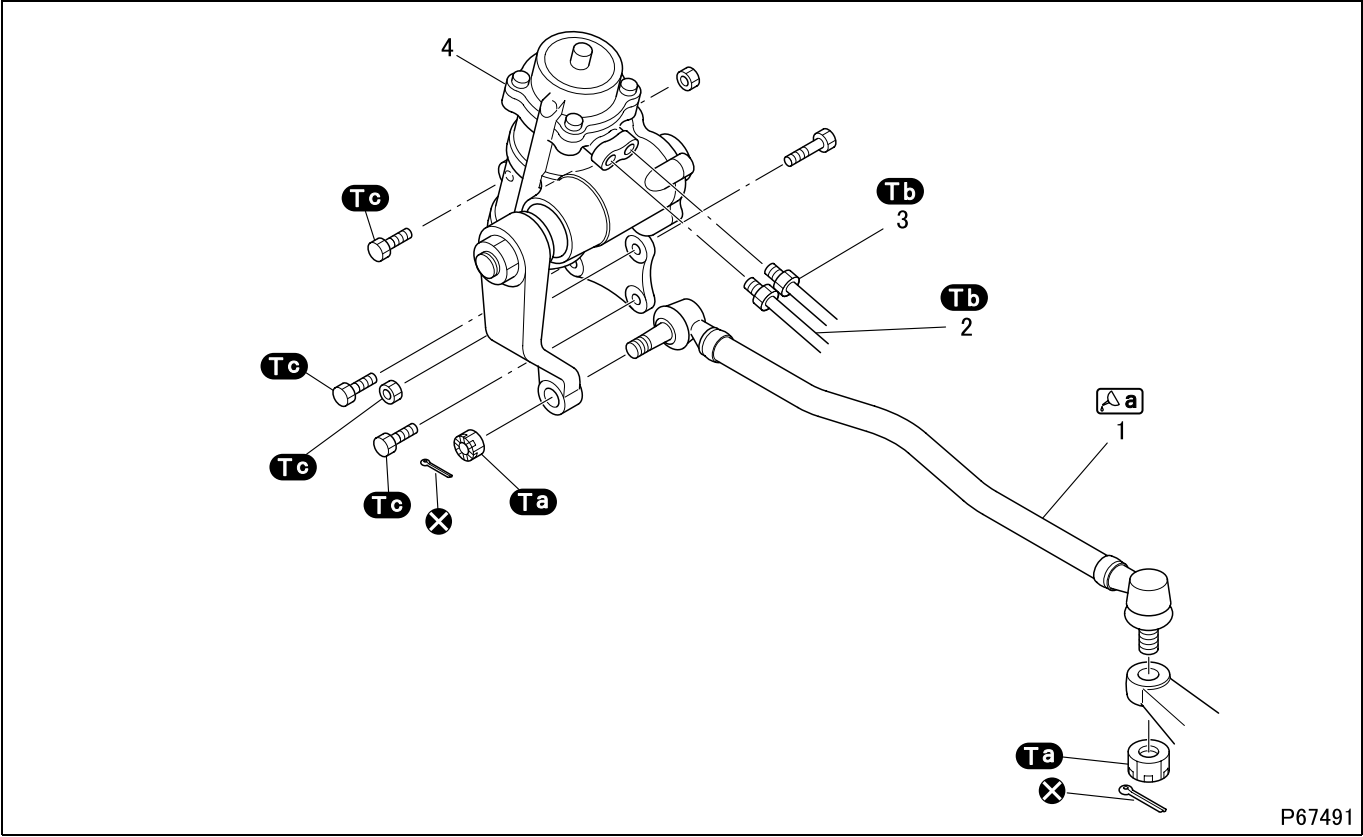
## ● Removal sequence

- 1 Drag link
  - 2 Feed pipe
  - 3 Return pipe
  - 4 Power steering gear assembly
- ⊗: Non-reusable parts

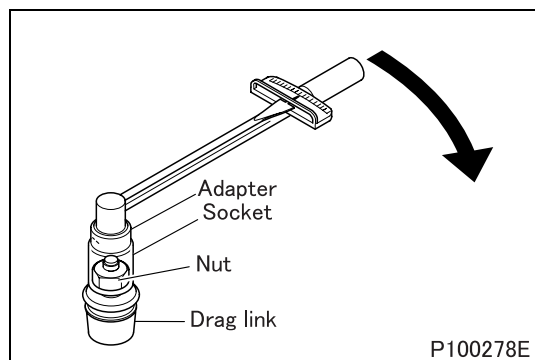
##### (2) Rotation torque

- Install the drag link mounting nut on the drag link.
- Install the socket, adapter and torque wrench to measure the rotation torque.
- If the measured value deviates from the standard value, replace the drag link.

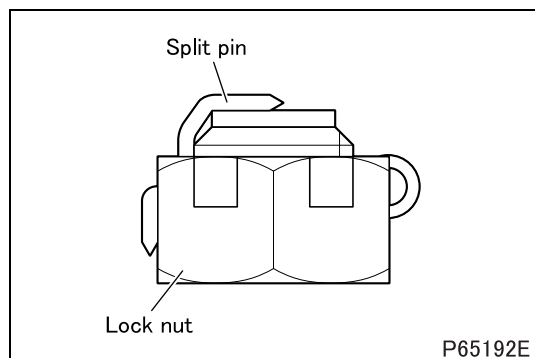
#### ■ Installation: Drag link

- Align a slot in the lock nut with the split pin hole in the ball joint by turning the lock nut in the tightening direction while checking the torque is within the specified range, then install the split pin as shown in the illustration.

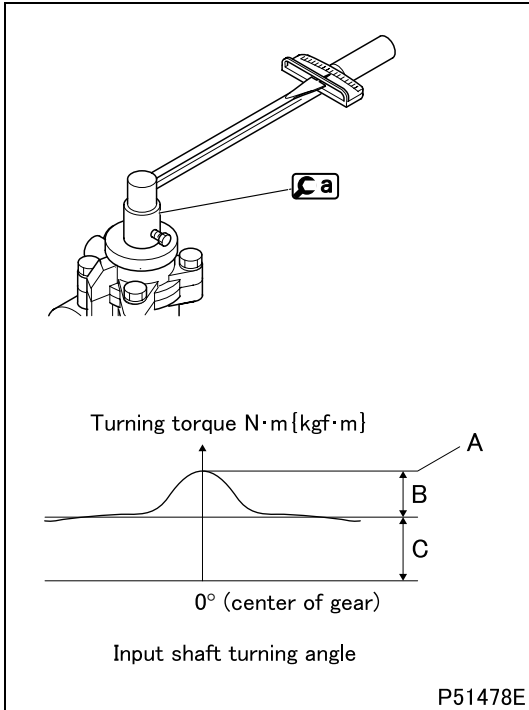
### ■ Inspection: Starting torque

- Using **a**, measure the starting torque of the power steering gear assembly for reference at the time of reassembly before removal.
  - A: Starting torque (= engagement torque + normal turning torque)
  - B: Engagement torque
  - C: Normal turning torque

- Using **a**, measure the starting torque of the power steering gear assembly in the same manner as the measurement before removal. If the measurement deviates from the standard value, adjust the power steering gear assembly for proper starting torque or replace.

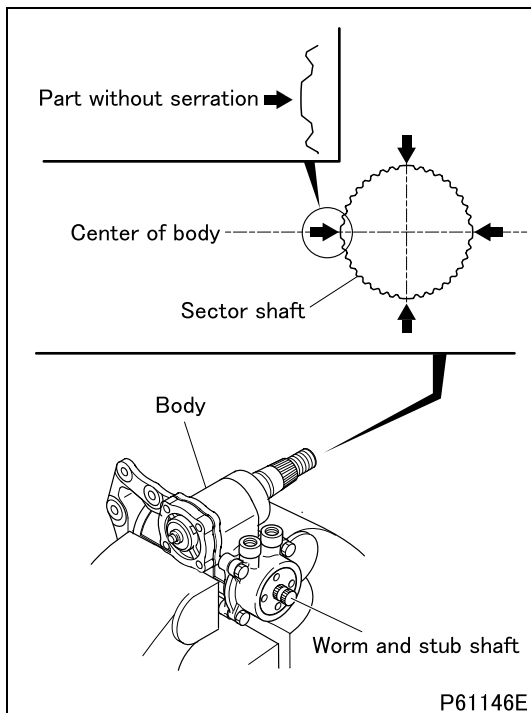
#### ■ Removal: Sector shaft

- Before removing, set the sector shaft in neutral position as follows.
- Turn the worm and stub shaft counterclockwise into the lock position, then back it up roughly 2.6 turns to bring the serration missing part of the serrated portion of the sector shaft into parallelism with the center of the body as shown.

- Loosen nut, and remove the sector shaft by tapping the shaft end with a plastic hammer.
- If the sector shaft is stuck, it should be out of neutral position. In such a case, do not attempt to force it out by hammering but redo the neutral positioning procedure.

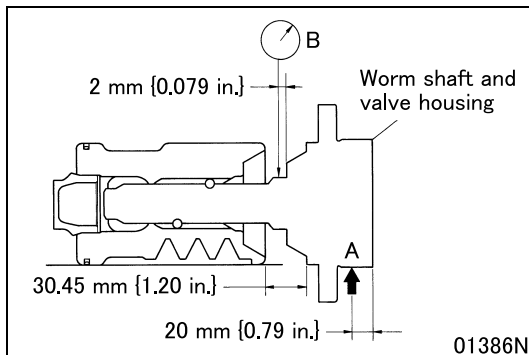
- Apply a force of 49 N {11 lbs, 5.0 kgf} to the illustrated point A and measure play B (play in the diametric direction) of the worm shaft and valve housing.
- If the measurement exceeds the limit, replace the faulty parts.

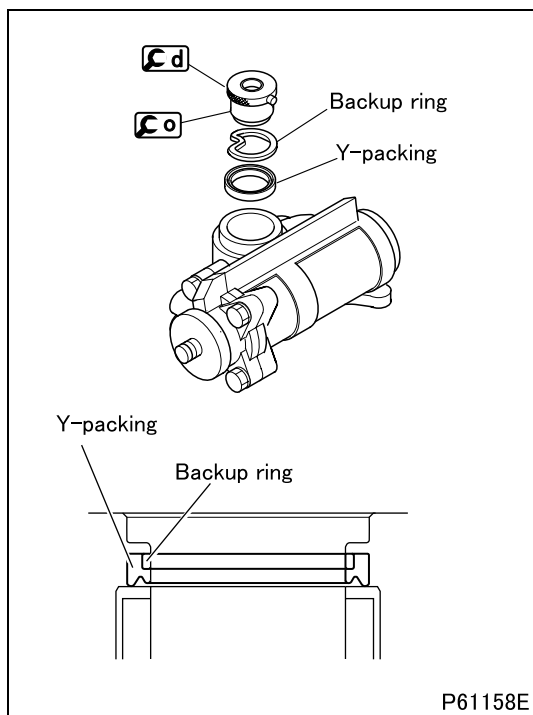
- Fill grease in the groove of Y-packing and install Y-packing in the illustrated direction.
- Install backup ring, formed as shown, using

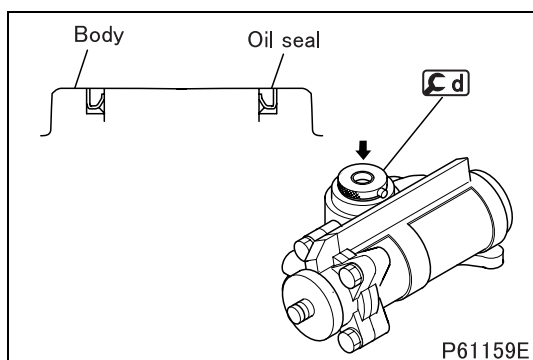
- Install the oil seal to the body in the illustrated direction.

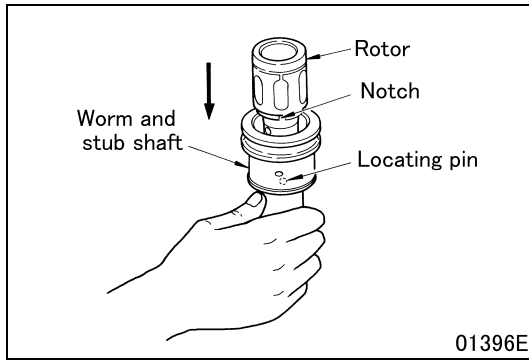
- Install the rotor aligning its notch with the locating pin of the worm and stub shaft.

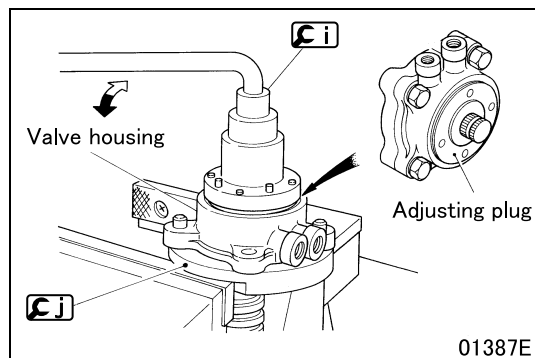
- Hold **Cj** with a vise and secure the valve housing to it.
- Tighten the adjusting plug to the specified torque using **Ci**, then back it up by approximately 180°.

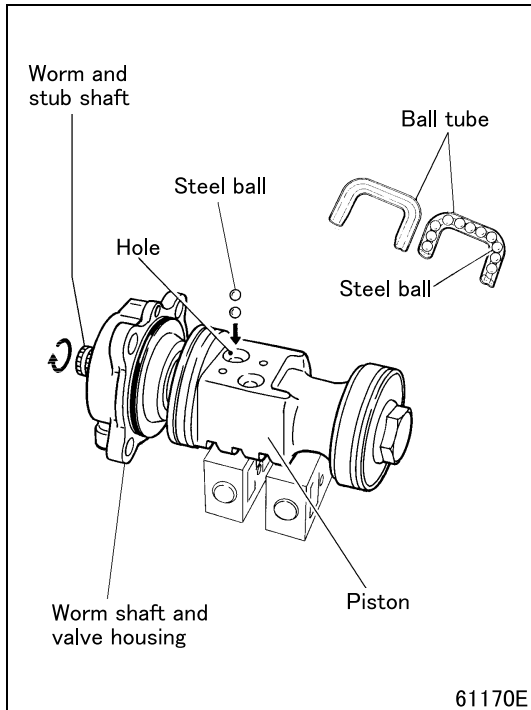
- Pack grease in one half of the ball tube, place 10 to 11 steel balls in it and put the other half upon it.
- Place the piston on a flat workbench, align the positions of the worm shaft and valve housing and piston ball race, then while turning the worm and stub shaft, let steel balls fall from the ball tube hole.
- Do not draw out the worm shaft and valve housing until its end passes over the ball tube hole during installation. Otherwise the steel balls will come out of the ball race.

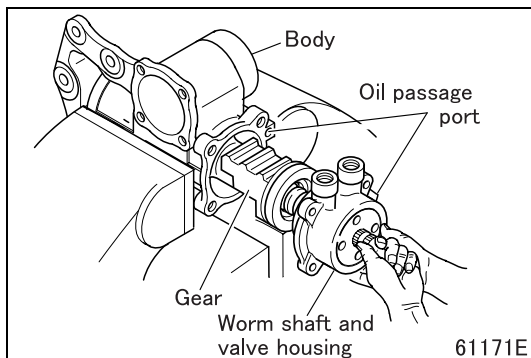
- Position the gear toothed portion of the worm shaft and valve housing in the illustrated direction so that it engages with the sector shaft.
- Install the worm shaft and valve housing to the body, lightly holding it with hand so that its gear portion does not turn out of position. When installing, align the oil passage ports of the worm shaft and valve housing and body.

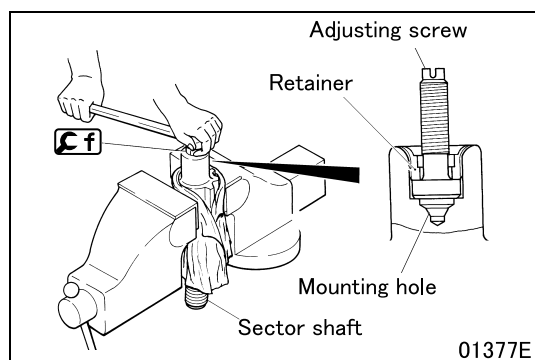
- Pack grease in the adjusting screw mounting hole on the sector shaft.
- Install the adjusting screw into the sector shaft.
- Using **Cf**, tighten the retainer into place in the sector shaft.
- Back up the retainer by 180°, retighten it to a torque of 39 N·m {29 ft.lbs, 4 kgf·m}, then back it up again by 20°.
- Check that the adjusting screw turns smoothly.

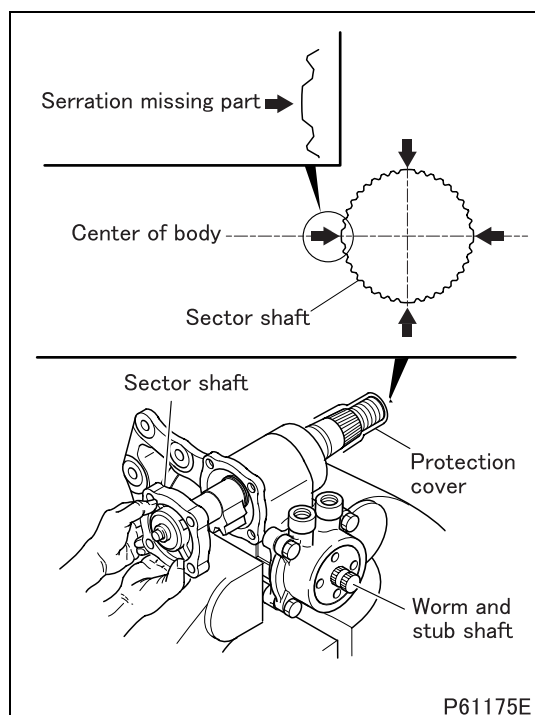
- Set the sector shaft in the neutral position and install it into the body.
- When installing the sector shaft, cover up its threaded end and serration portions for protection.
- Turn the worm and stub shaft to check that it makes roughly five turns lock to lock.
- If the number of turns is less, check engagement of the worm and stub shaft with the sector shaft, and correct if necessary.

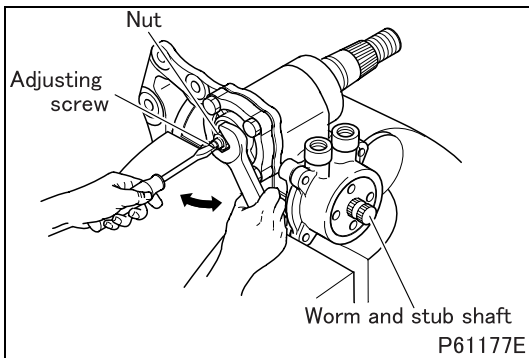
- Loosen nut.
- Rotating the worm and stub shaft approximately 1/4 turns left and right, make adjustment for proper starting torque with the adjusting screw.

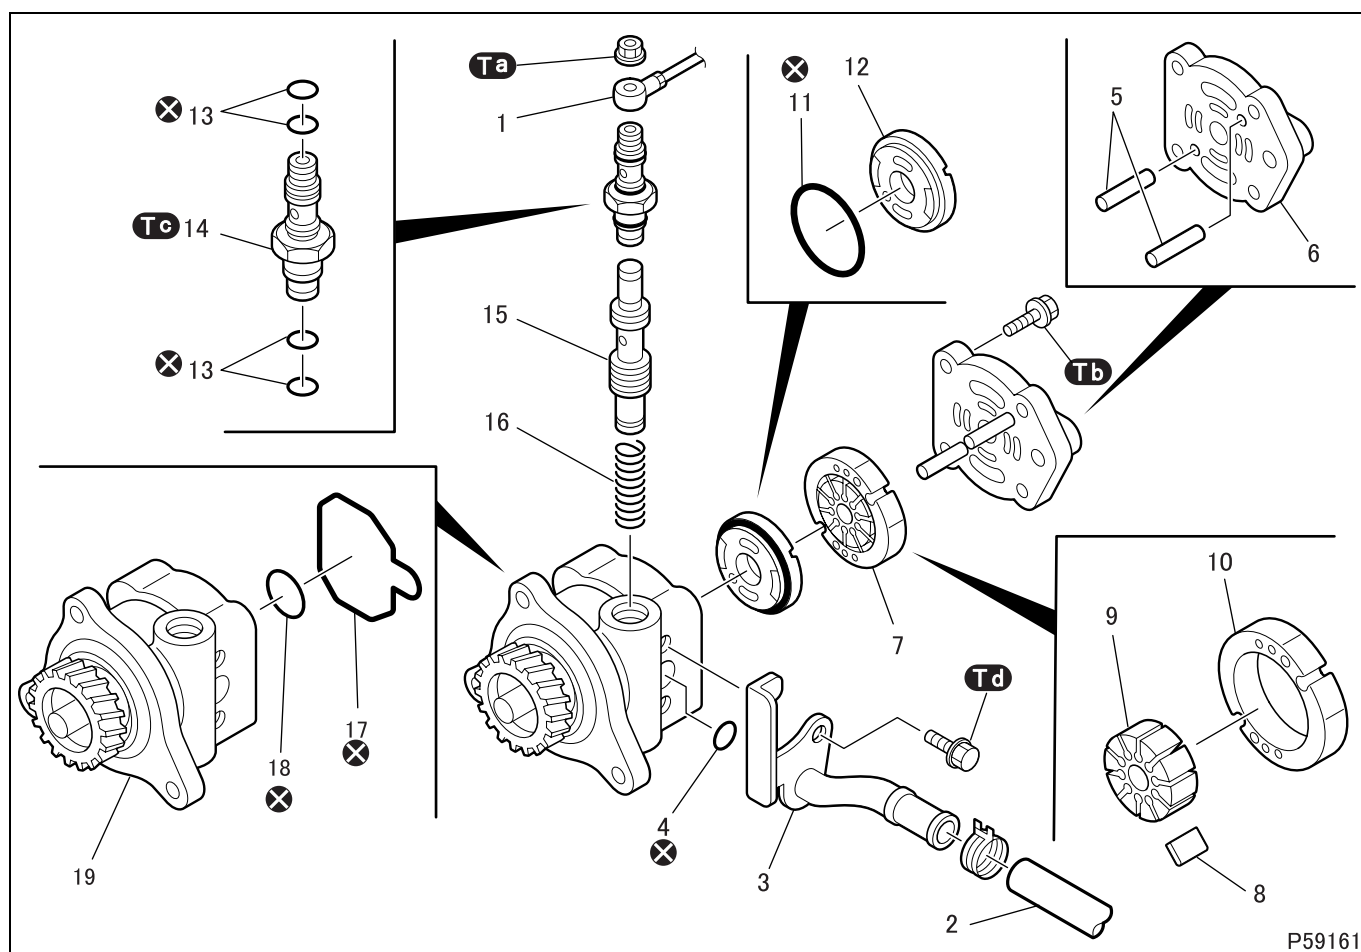
P59161

# POWER STEERING OIL PUMP <KYB Product>

| Location | Maintenance item | Standard value | Limit | Remedy |
|---|---|---|---|---|
| 6 | Stepped wear on rotor and vane contact surfaces of cover | – | 0.05<br>{0.0020} | Replace* |
| 8, 9 | Clearance between vane and rotor | 0.01 {0.00039} | 0.06<br>{0.0024} | Replace |
| 15, 19 | Clearance between flow control valve and body | 0.01 to 0.02<br>{0.00039 to 0.00079} | 0.03<br>{0.0012} | Replace* |
| 16 | Free length of flow control spring | 36.5 {1.44} | 33.5 {1.32} | Replace |

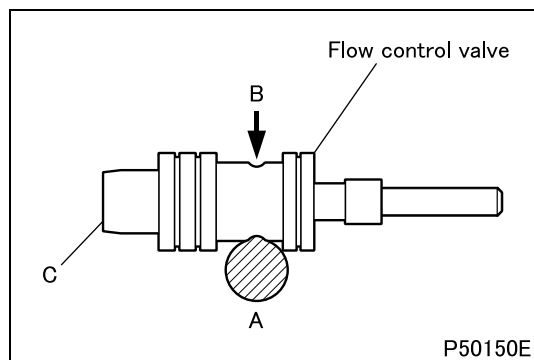
- Cover port A of the flow control valve with a finger.
- Apply air pressure (390 to 490 kPa {57 to 71 psi, 4.0 to 5.0 kgf/cm<sup>2</sup>}) to port B.
- Check for a leak of air from port C.
- If there is an air leakage, replace the power steering oil pump.

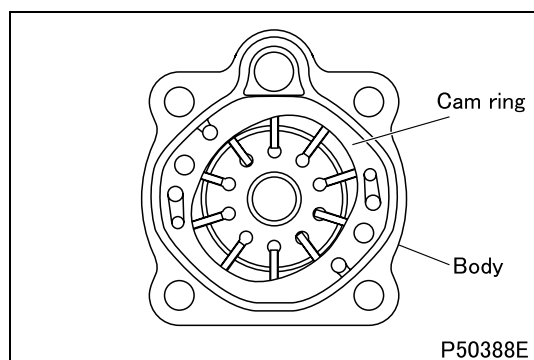
- Install the cam ring in the illustrated direction to the body.

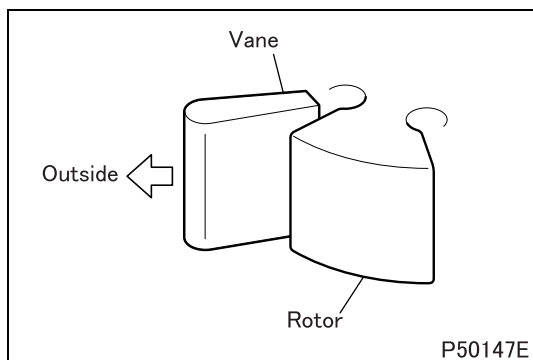
- Fit the vane into the rotor, with its round edge facing toward outside.

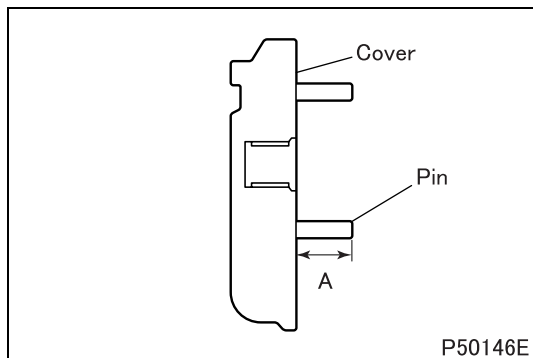
- Fit the pins into the cover so that they protrude to the illustrated length A from the cover.  
A: 18.1 mm {0.71 in.}

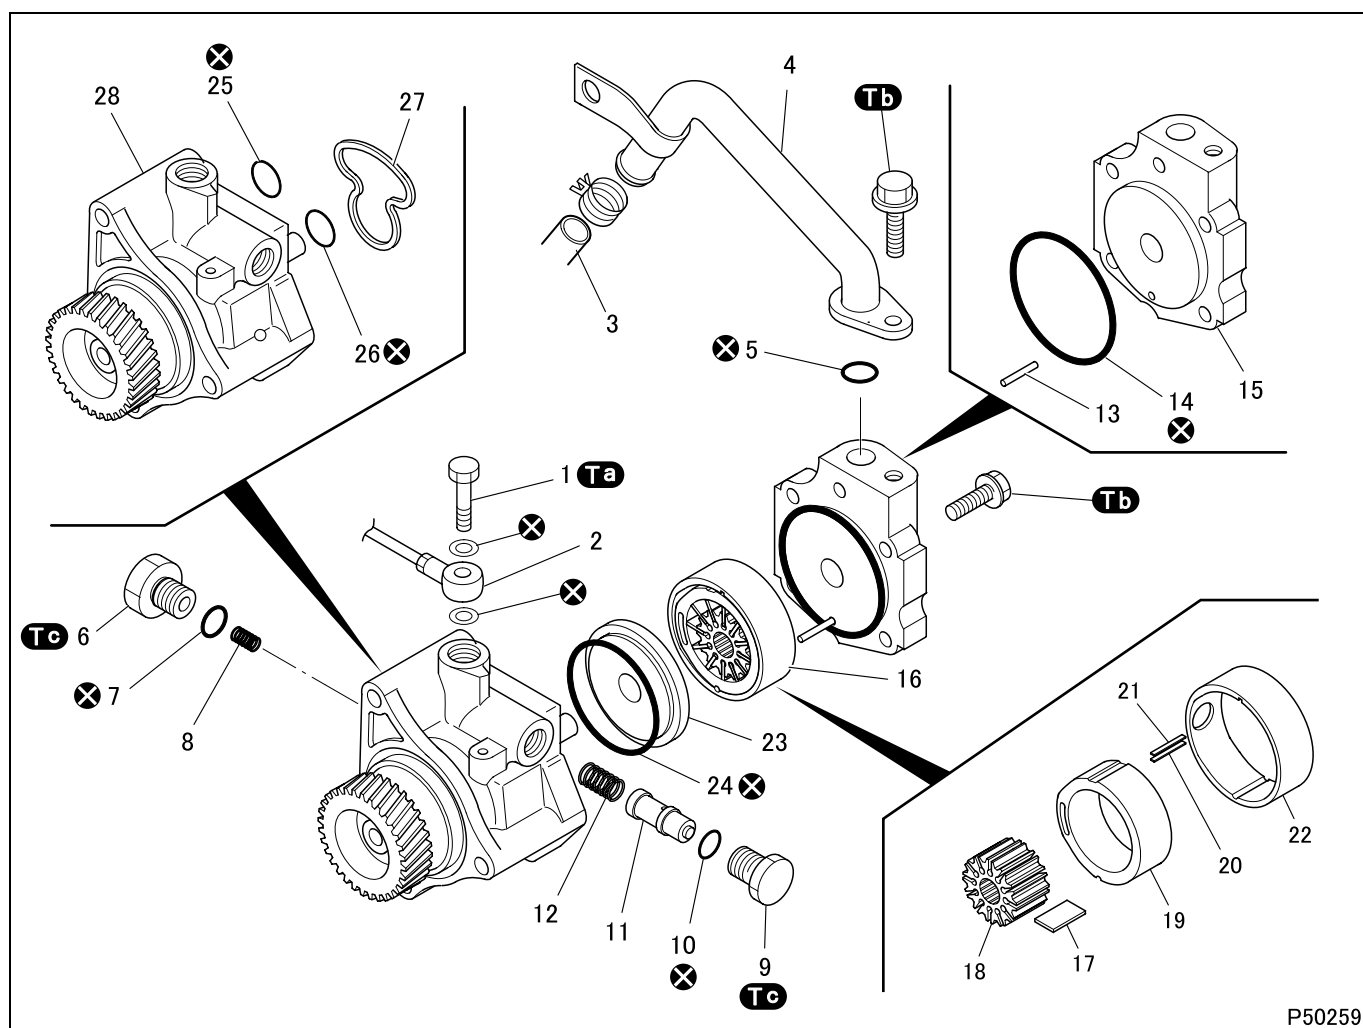
P50259

# POWER STEERING OIL PUMP <UNISIA JKC STEERING SYSTEMS Product>

| Location | Maintenance item | Standard value | Limit | Remedy |
|---|---|---|---|---|
| 11, 28 | Clearance between control valve and front body | 0.02 {0.00079} | 0.03 {0.0012} | Replace* |
| 17, 18 | Clearance between vane and rotor | 0.02 {0.00079} | 0.03 {0.0012} | Replace |

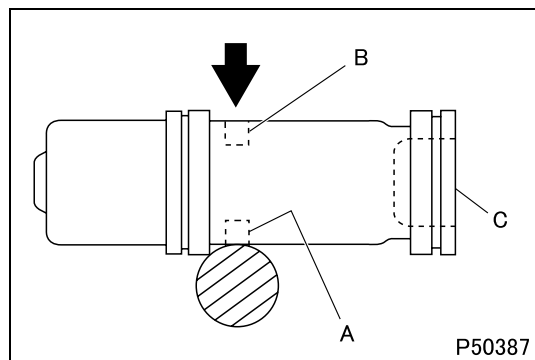
- Cover port A of the control valve with a finger.
- Apply air pressure (390 to 490 kPa {57 to 71 psi, 4.0 to 5.0 kgf/cm<sup>2</sup>}) to port B.
- Check for a leak of air from port C.
- If there is an air leakage, replace the control valve.

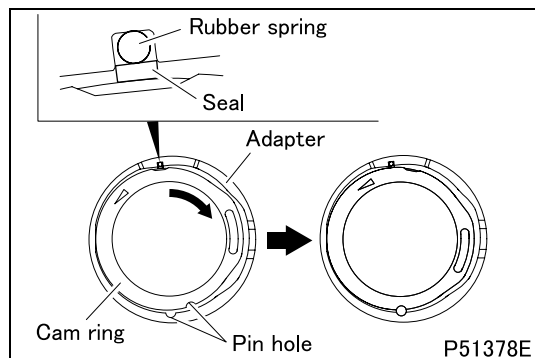
- Align the peripheral groove of the cam ring to the inner groove of the adapter, then fit the rubber spring (black) into the adapter and the seal (white) into the cam ring.
- Turn the cam ring clockwise to align pin holes.

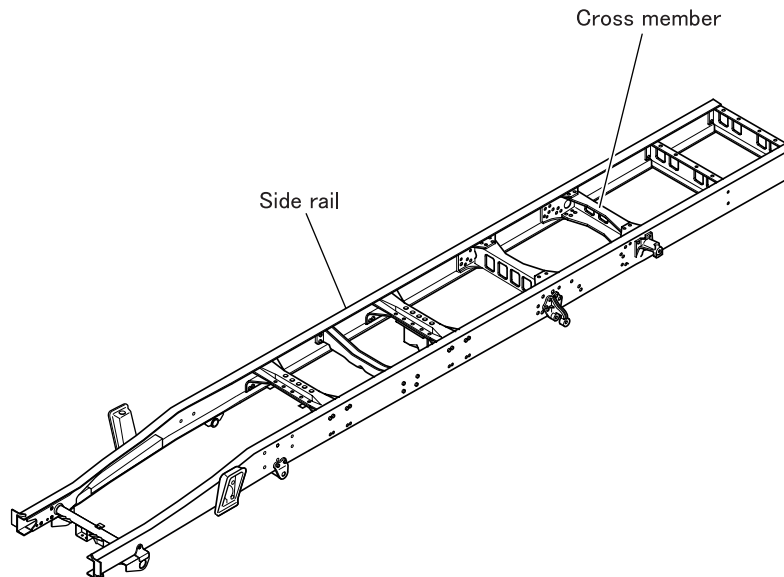
P67917E

- The frame has cross members fastened to the web of side rails (lateral linkage) so that stress on the joints is very small. This allows joint rivets to maintain tightness and ensures long-lasting high torsional stiffness.
- Unlike vertical linkage where cross members are fastened to the flange of side rails, no rivets appear on top of the frame, making the body mounting greatly easier.

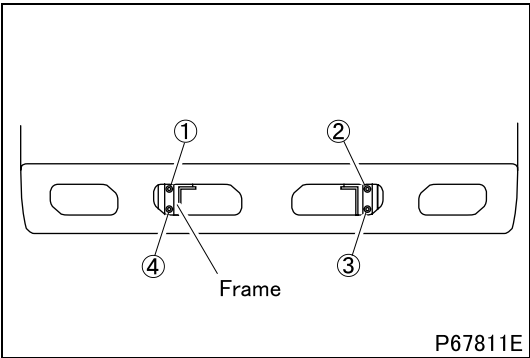
### ■ Installation: Bumper stay

- Install the bumper stay on the frame by tightening the bolts (four places) to the specified torque in the order of the numbers (1 to 4) indicated in the illustration.

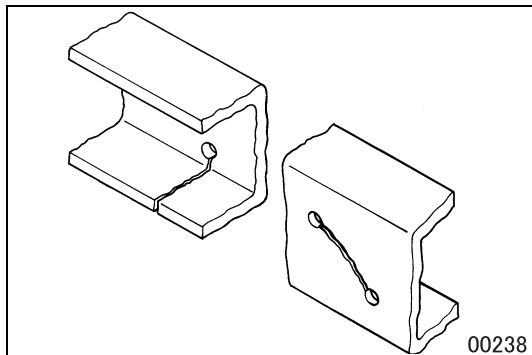
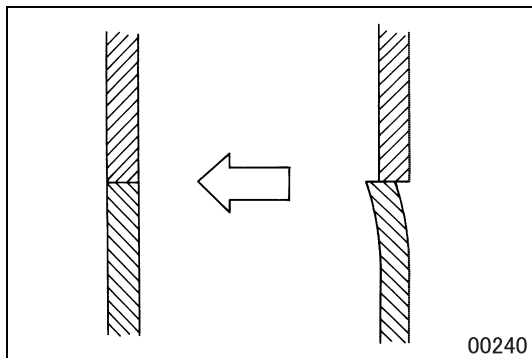
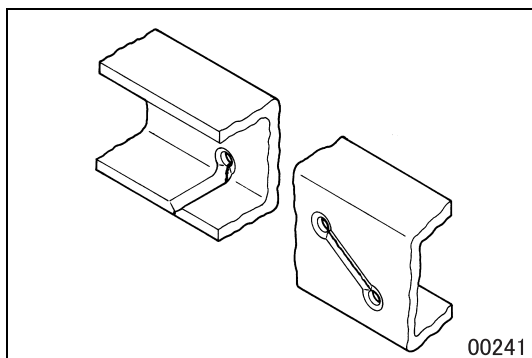
- With the vehicle unloaded, level the frame.
- Drill a hole, roughly twice the thickness of frame plate in diameter, 10 mm {0.39 in.} from the inside end of crack.

- If crack is within the frame plate, drill holes at both ends of the crack.

- If the edges of crack are uneven, make them even.

- Using a grinder, cut a 90° V-channel at the crack to a depth of approximately 2/3 of the frame plate thickness, then fill the channel with filler metal by welding.

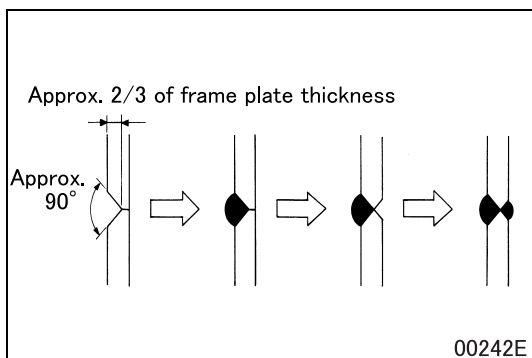
00242E

- Then, make a similar V-channel on the opposite side of the weld and fill it with filler metal by electric welding as well. At the same time, deposit metal to cover up the hole or holes at both ends of the crack by welding.

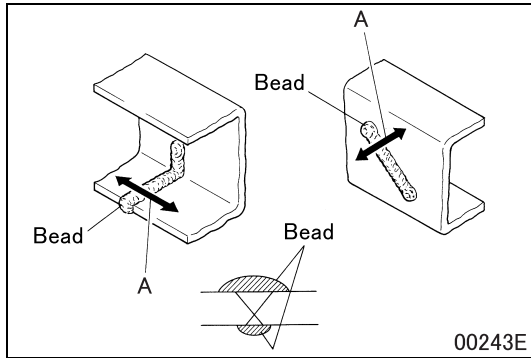
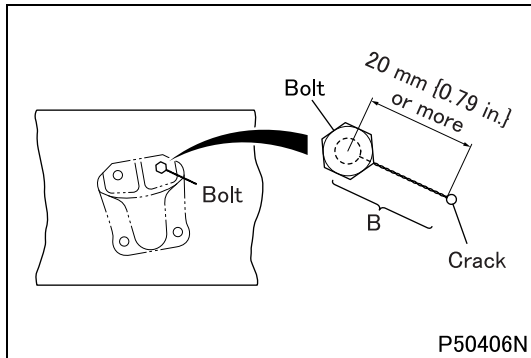
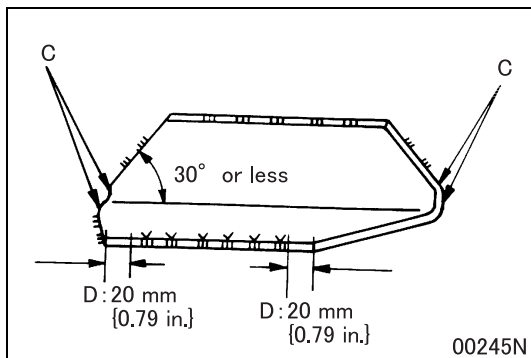
- In cold districts, heat the weld zone to approximately 200°C {390°F} after welding.
- After welding, run a grinder over the bead at right angles A to remove the hatched portion from the weld on each side of the plate.
- Finish the ground surfaces flat to a thickness equal to the original plate thickness.

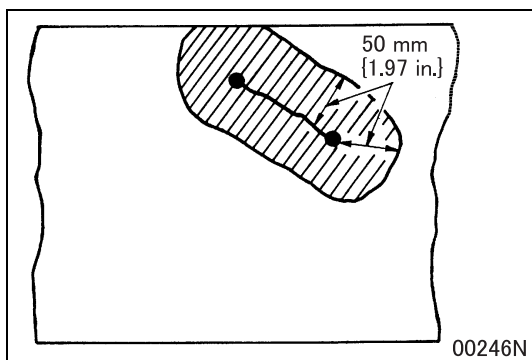
- To prevent the concentration of welding stress at both ends C of the reinforcement plate, cut the ends at a bevel of 30° or less for welding. Do not weld at points D.
- The reinforcement plate must have enough to cover the cracked area.

- **Reinforcement plate thickness:** Equal to frame plate thickness
- **Reinforcement plate material:** As specified below or equivalent

**SAPH440 (Hot rolled steel for automobiles), or  
SS400 (Rolled steel for general structures)**

- After welding, heat the hatched area to 600 to 700°C {1110 to 1292°F}.

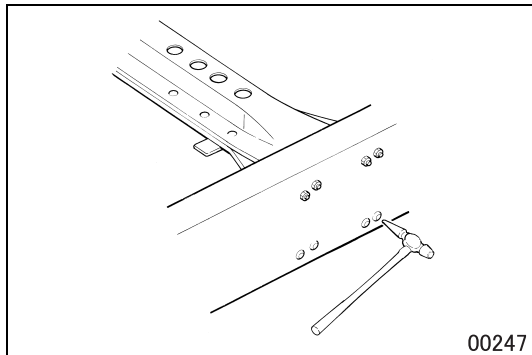
- Lightly tap the head of each rivet using an inspection hammer and feel or listen for the echo to determine if the rivet is loose.
- Rusting between rivet and frame plate is an indication of loosened rivet.

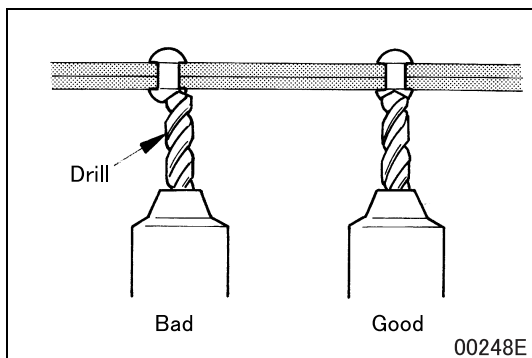
- To remove a loosened rivet, eliminate its head using a drill or grinder. When a drill is used, make a dent in the middle of the rivet's head and align the drill bit to the dent as shown.

- The rivet hole must be intact.

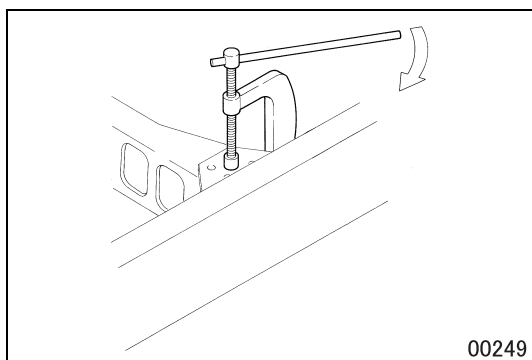
- Before rivetting, clamp the two plates closely together near the rivet hole using a C vice.
- Using a rivetting machine, drive the rivet (cold rivet) into the rivet hole.
- If rivetting is impracticable, ream the rivet hole, drive a reamer bolt in the hole, fully tighten the nut, then weld it in place. As the reamer bolt and nut, use a flange bolt and a flange nut.

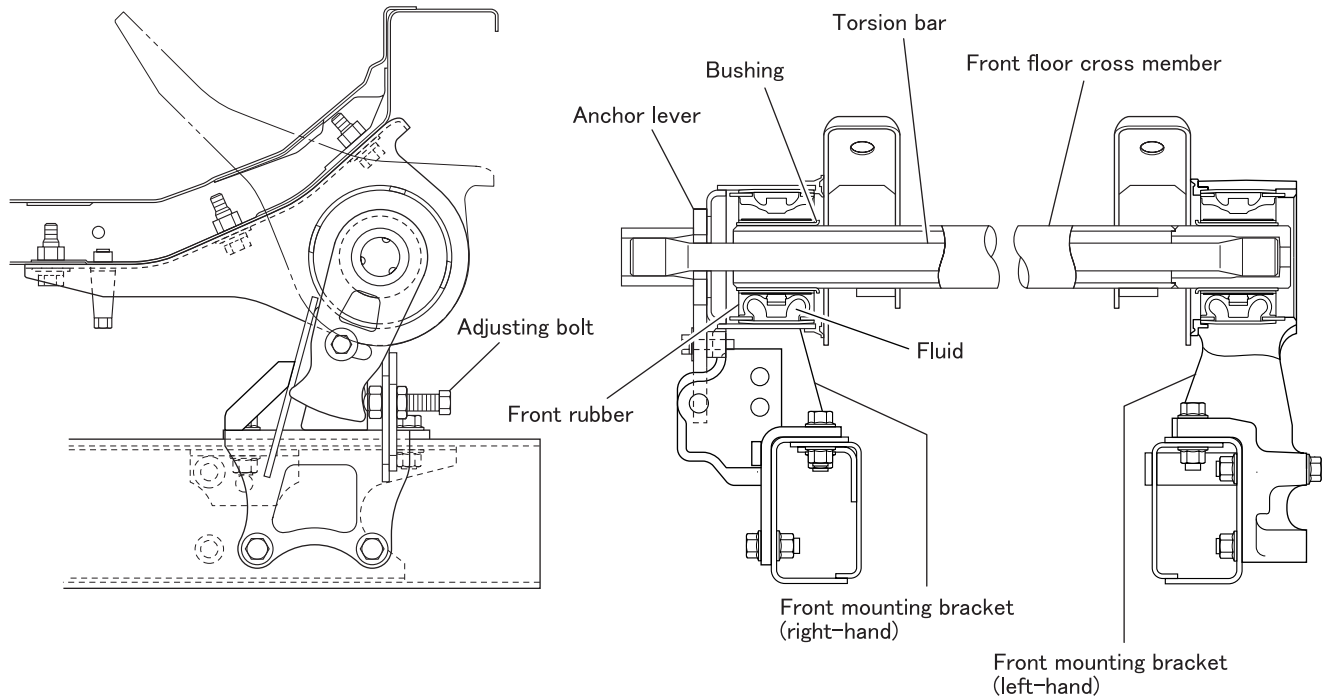
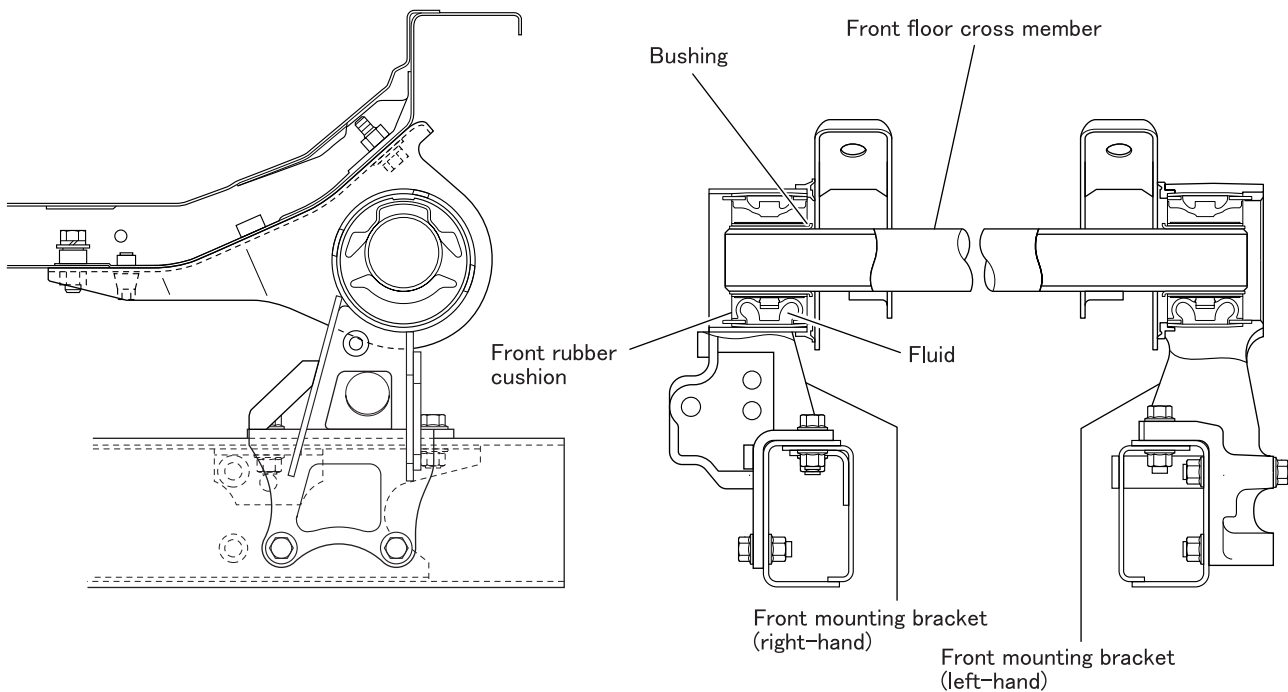
P58035E

- The operating physical force for the cab tilt system can be adjusted using the adjusting bolt of the front mounting bracket. <Except crew cab>
- The front rubber cushion reduces the vibration and noise of the cab.

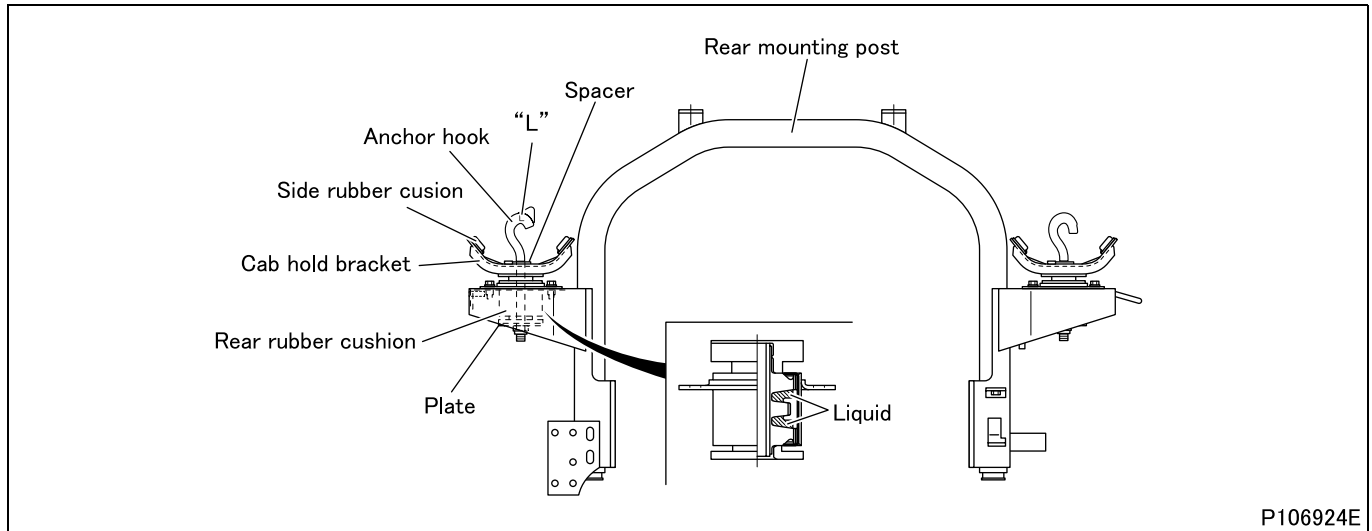
## 2. Rear Cab Mounting <Except Crew Cab>

- The operating physical force for the lock handle can be adjusted by increasing and decreasing the number of spacers provided between anchor hook and cab hold bracket.
- Rear mounting upper and lower rubber cushions reduce the vibration and noise of the cab.

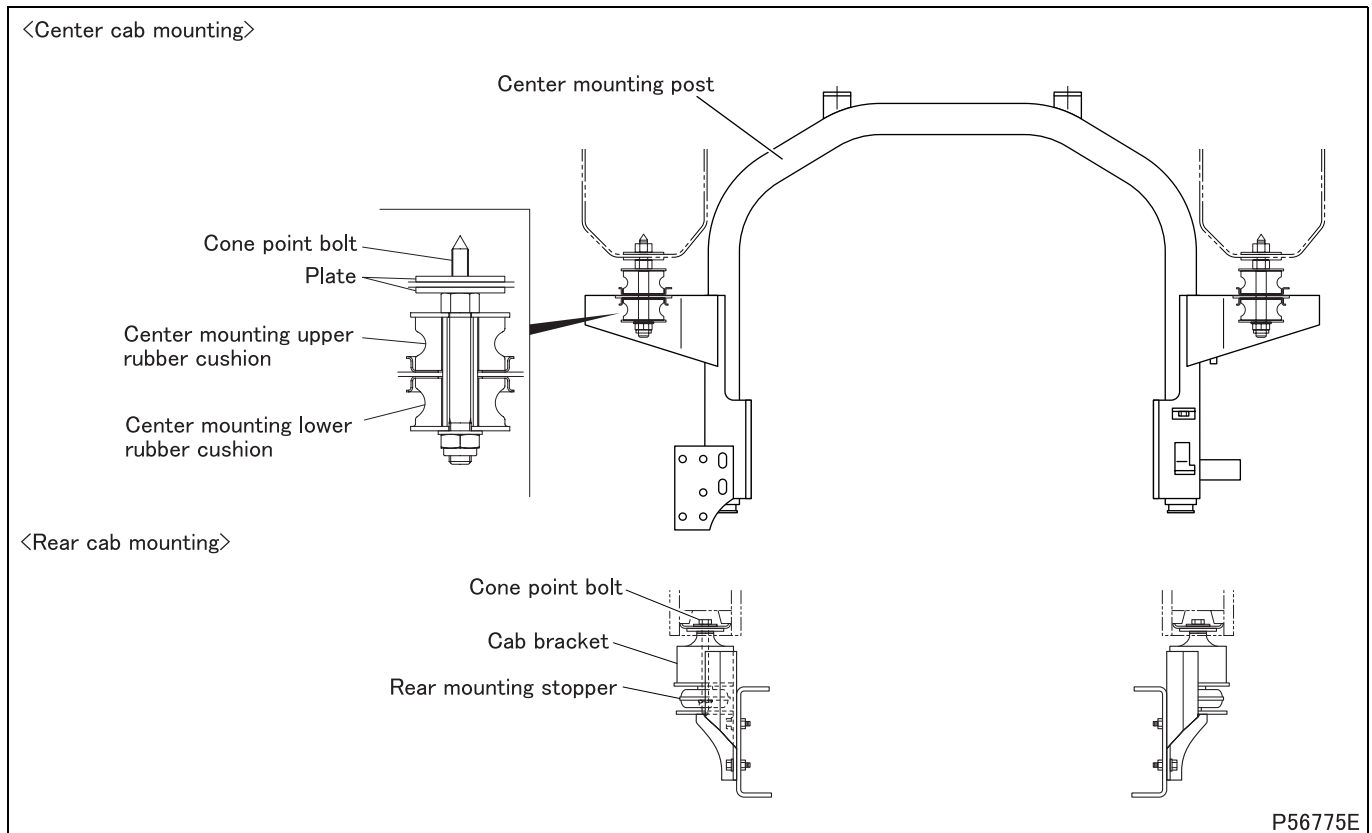
## 3. Center and Rear Cab Mountings <Crew Cab>

- Center mounting upper and lower rubber cushions reduce the vibration and noise of the cab.
