# FE.FG

## SERVICE MANUAL 2008 Model FOREWORD

This Service Manual contains maintenance and repair methods for the Mitsubishi Fuso Truck FE. FG Series. Read this manual carefully as an aid in providing correct, efficient maintenance. Please note that the information and specifications contained within this manual may change without notice. This is due to product modifications and continued vehicle improvements that are made throughout the model years. Should you encounter any discrepancy in the information provided, please do not hesitate to contact your nearest Mitsubishi Fuso Dealer or Mitsubishi Fuso Truck of America, Inc.

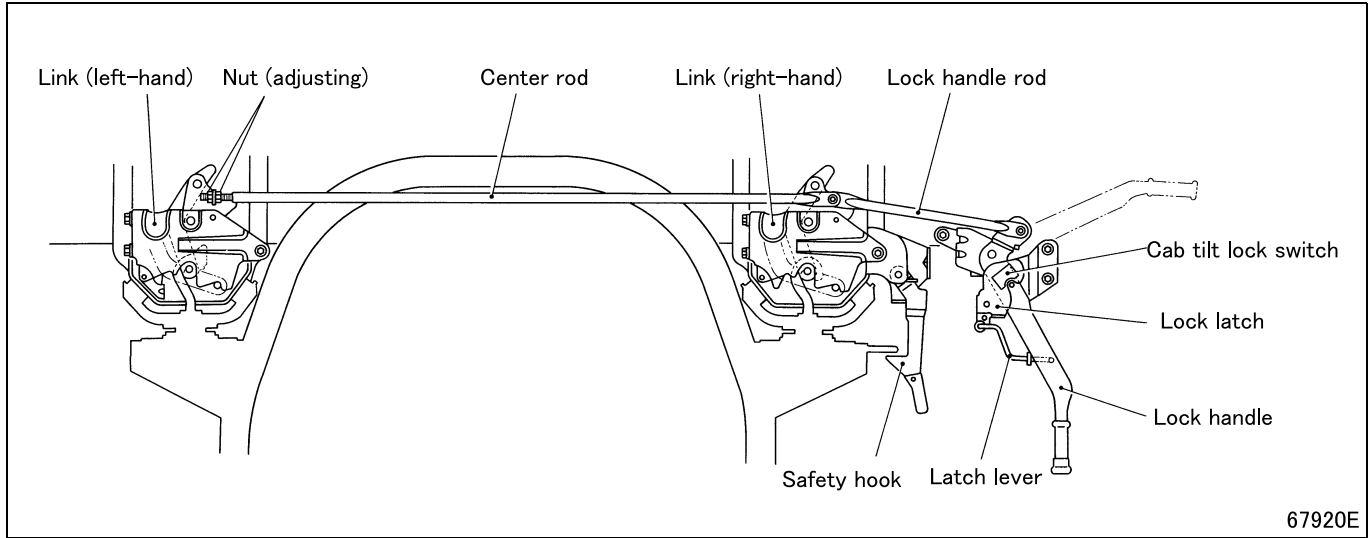
#### 4. Cab Tilt Link <Except Crew Cab>

- The length of center rod is adjustable with the adjusting nut.
- The cab tilt lock switch of the manual cab tilt system monitors the locking status of the lock handle.

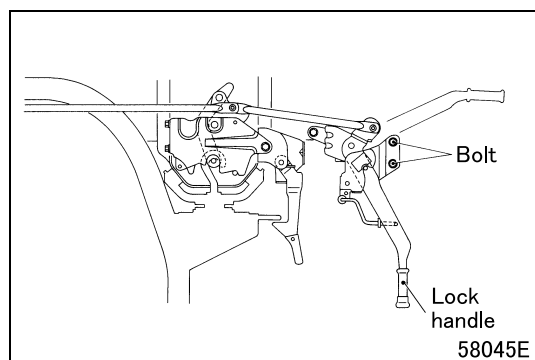
### 1.2 Adjustment of latch

- If the latch resists, loosen bolts and adjust the installed position of the lock handle using bolt slot.
- After adjustment, retighten the bolts.

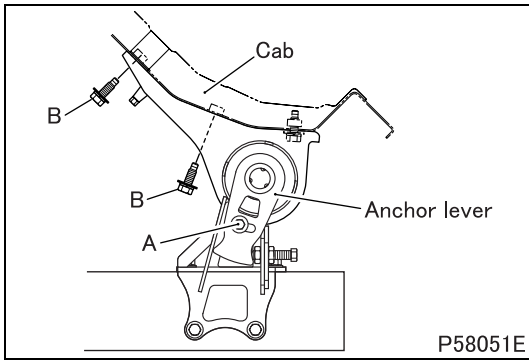
- Remove the bolt A, then detach the anchor lever.
- Remove the bolts B holding the cab in place.

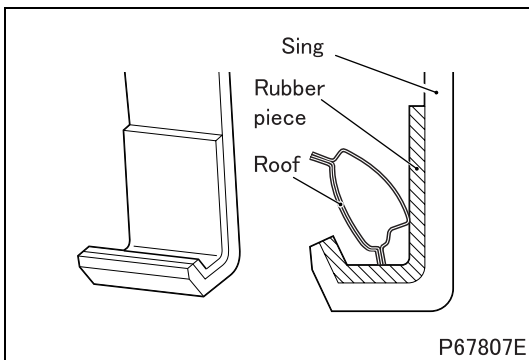
- Make available slings rigid enough to carry the weight of the cab.
- The hook portion of the sling must be lined with a rubber piece as shown to prevent deformation of the roof of the cab.

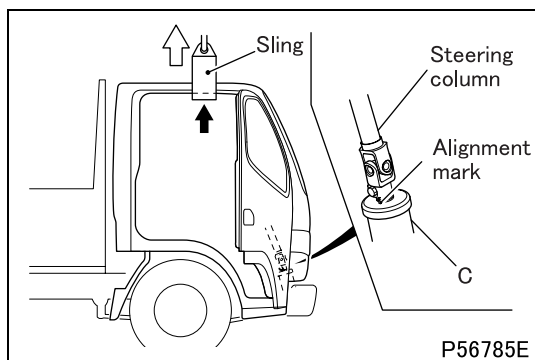
- Hook the slings on the cab roof as shown, then hoist the cab a little to see if it maintains level (balanced at the center of gravity).
- Provide alignment marks on the power steering gear C and steering column, then separate the steering column.
- To prevent the steering column from falling off, tie it securely to the cab using a rigid cord.
- Slowly and slightly hoist the cab straightly up to check that all cables, hoses and electric wiring have been disconnected before removing the cab.
- Lift off the cab straight.

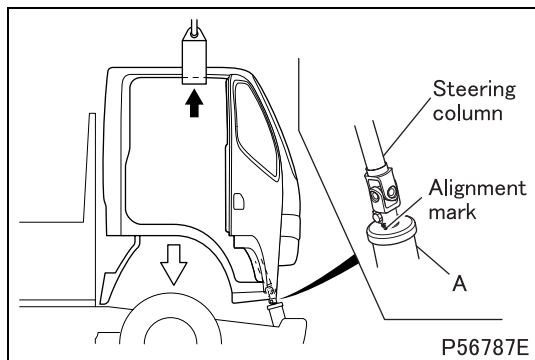
- Slowly lower the cab halfway.
- Join the power steering gear A and steering column together in accordance with the alignment marks.

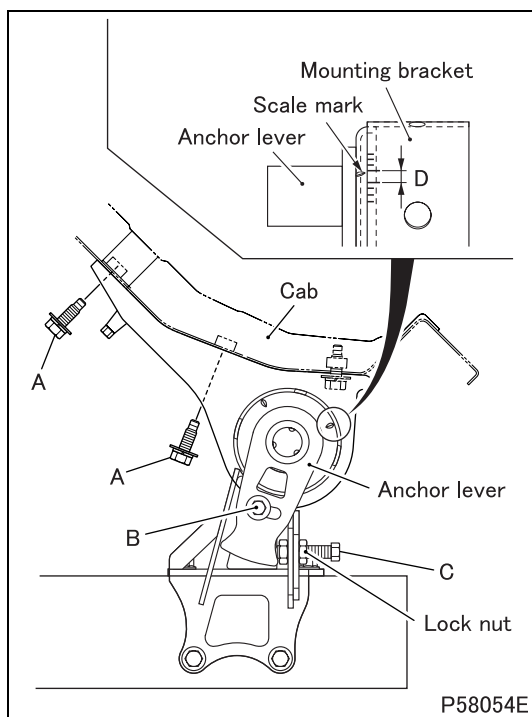
- Tighten the bolt A to specified torque.
- Align the graduated line of the anchor lever to the illustrated range of D (long division) of the scale graduated on the mounting bracket, then install the bolt B handtight.
- After contacting the bolt C with the anchor lever, tighten the bolt C by 10 mm {0.39 in.} (six and two third turns).
- Tighten the lock nut to specified torque.
- Tighten the handtight bolt B to specified torque.

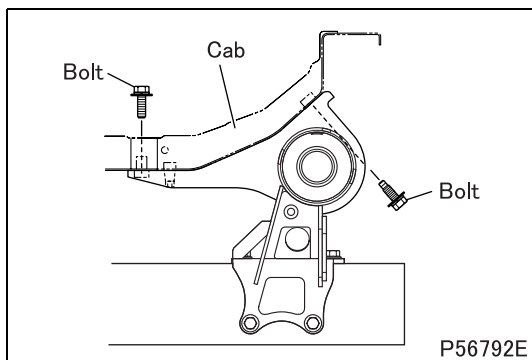
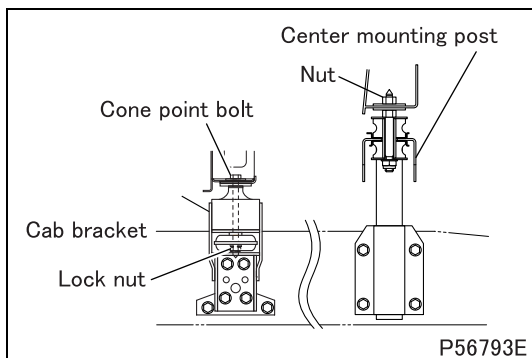
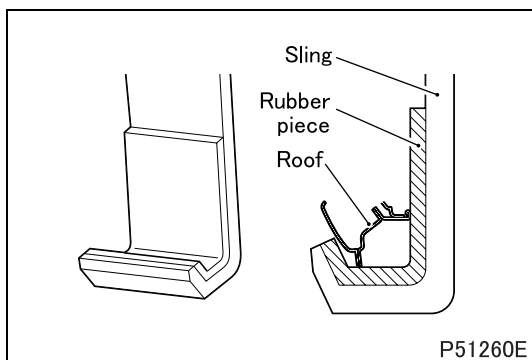
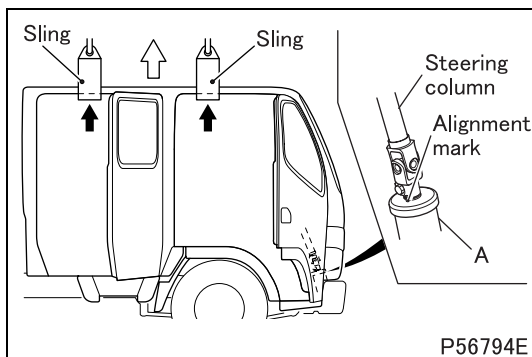
### ■ Removal: Cab

- Remove bolts from inside and outside the cab.
- Remove nuts from the center mounting post, then remove lock nut and cone point bolt from the cab bracket.
- Make available slings rigid enough to support the weight of the cab.
- Line the hook portion of each sling with a rubber piece to prevent deformation of the roof of the cab.
- Hook the slings at appropriate points on the roof of the cab, and lift the cab a little to see if it maintains level (balanced at the center of gravity).
- Provide alignment marks on the power steering gear A, then separate the steering column.
- Tie the steering column securely to the cab with a rigid cord not to fall off.
- Slowly and slightly hoist the cab straightly up to check that all cables, hoses and electric wiring have been disconnected before removing the cab.
- Slowly lift off the cab.

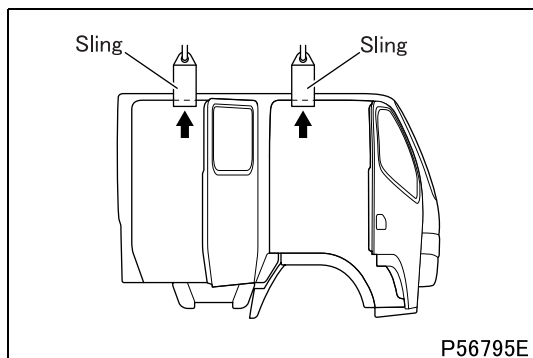
### ■ Installation: Cab

- Hook the slings at equilibrium center-of-gravity points on the roof of the cab.

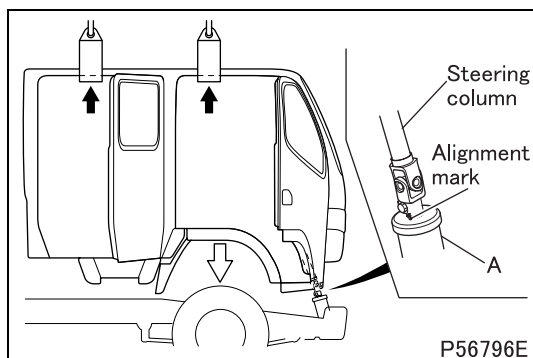
- Slowly lower the cab.
- Join the power steering gear A and steering column together in accordance with the alignment marks on them.

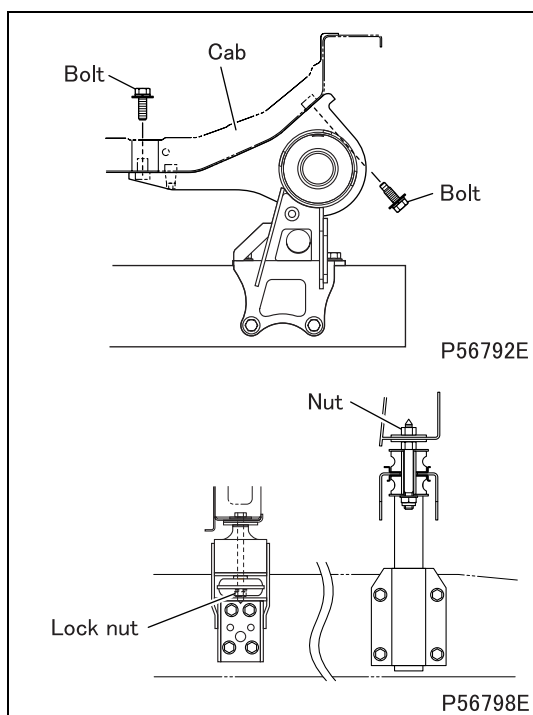
- Further lower the cab slowly into place. Then unhook the slings and tighten bolts, nuts and lock nuts to specified torques.

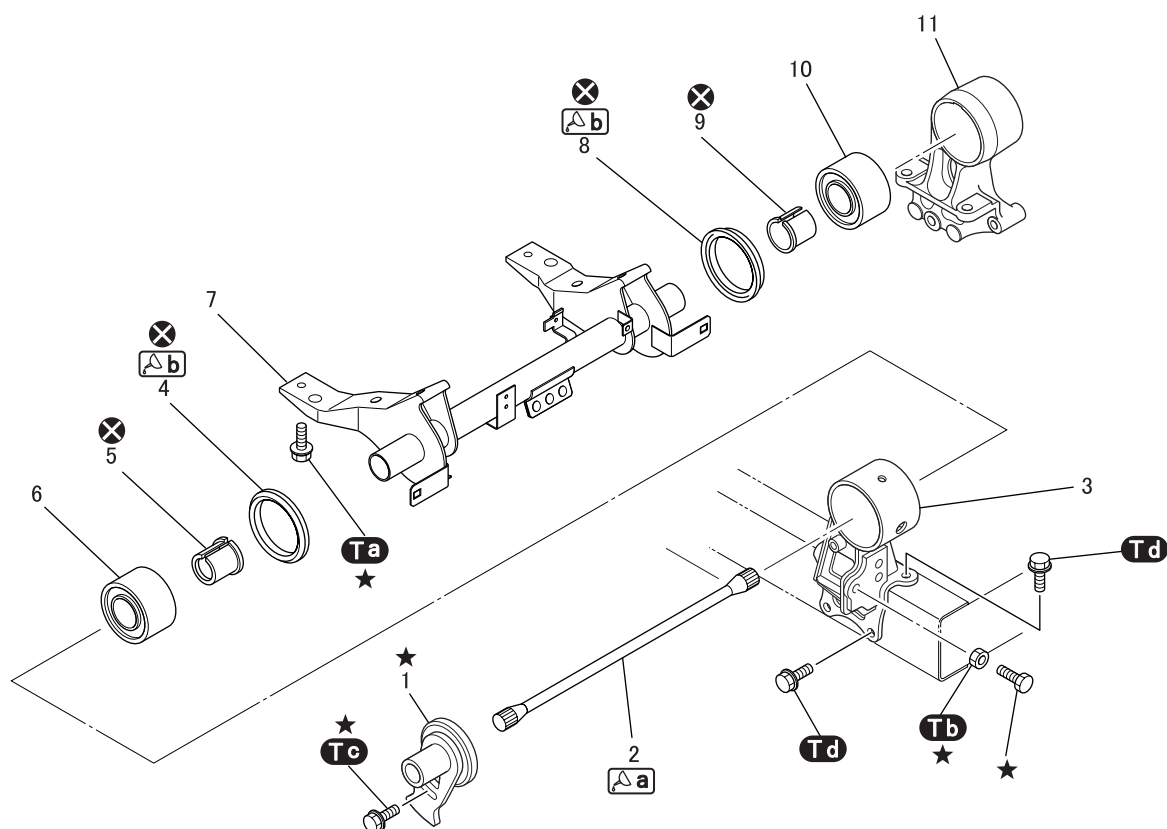
P103727E

Parts marked with ★ are to be installed while the cab assembly is mounted.  
Assemble them by reference to the removal and installation procedures for cab assembly.

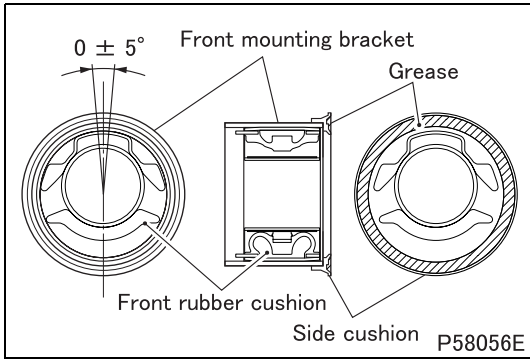
**■ Installation: Side rubber cushion and front rubber cushion**

- Fit the front rubber cushion to the front mounting bracket at an angle within the illustrated range.
- After installing the front rubber cushion, fit the side rubber cushion to it and fill grease in the side rubber cushion as shown.

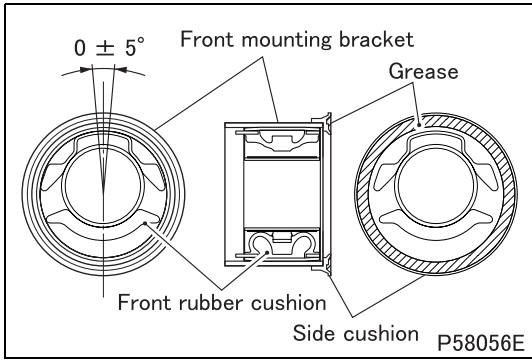
**■ Installation: Side rubber cushion and front rubber cushion**

- Fit the front rubber cushion to the front mounting bracket at an angle within the illustrated range.
- After installing the front rubber cushion, fit the side rubber cushion to it and fill grease in the side rubber cushion as shown.

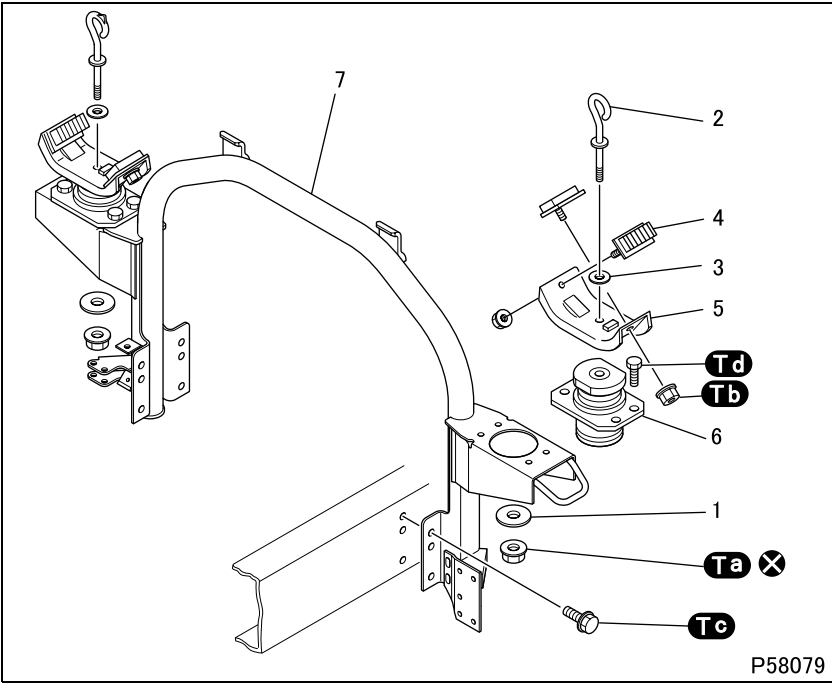
- 1 Plate
- 2 Anchor hook
- 3 Spacer
- 4 Side rubber cushion
- 5 Cab hold bracket
- 6 Rear lower rubber cushion
- 7 Rear mounting post

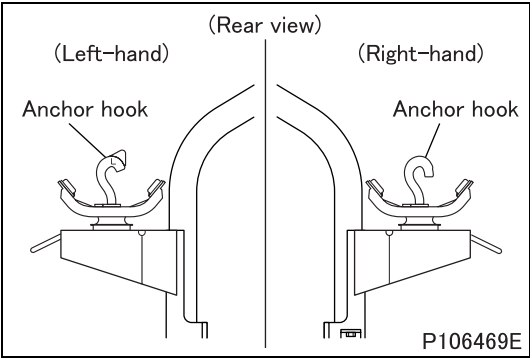
#### Installation: Anchor hook

- Fit the anchor hooks to the bracket as shown in the illustration.

- When the cab is tilted down with installing the anchor hooks in wrong direction, the links installed in the cab can not hook to the anchor hooks and it may damage both of the anchor hooks and the links.

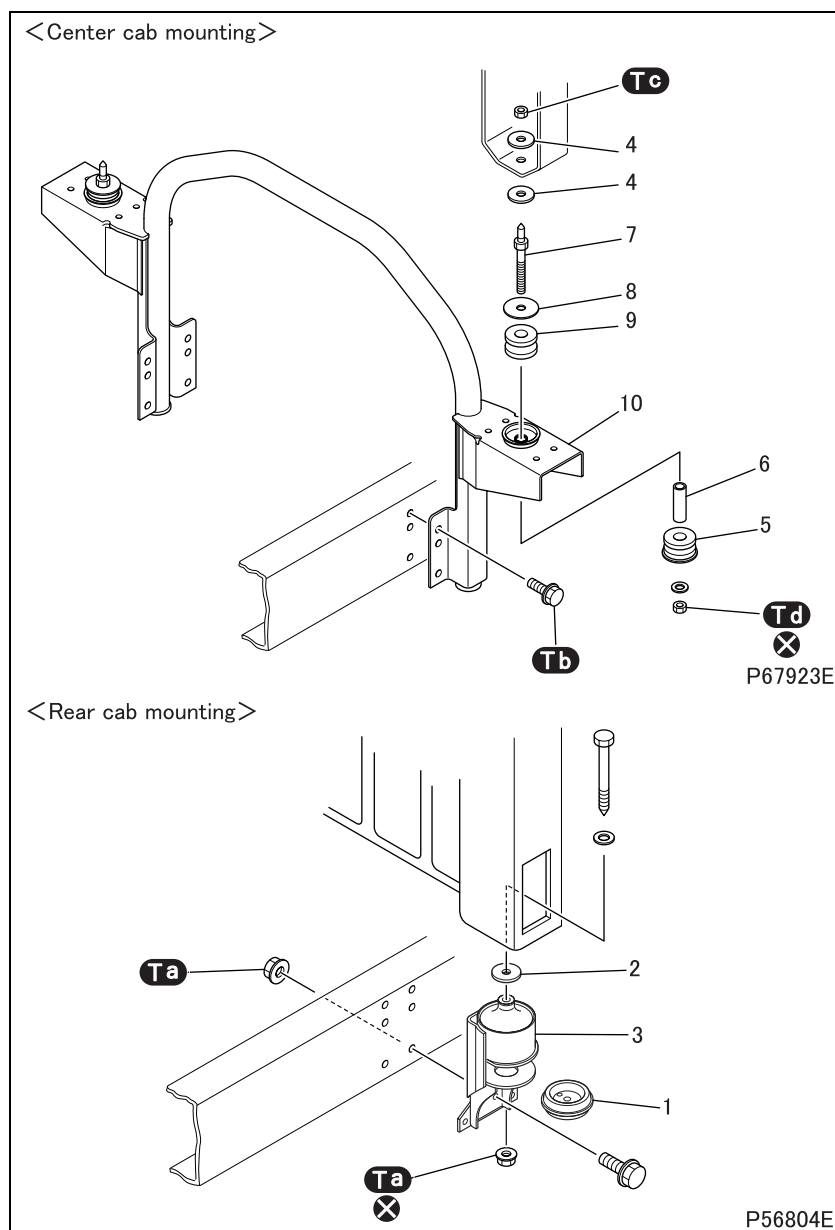
- 1 Rear mounting stopper
- 2 Plate
- 3 Cab bracket
- 4 Plate
- 5 Rear mounting lower rubber cushion
- 6 Pipe
- 7 Cone point bolt
- 8 Plate
- 9 Rear mounting upper rubber cushion
- 10 Rear mounting post

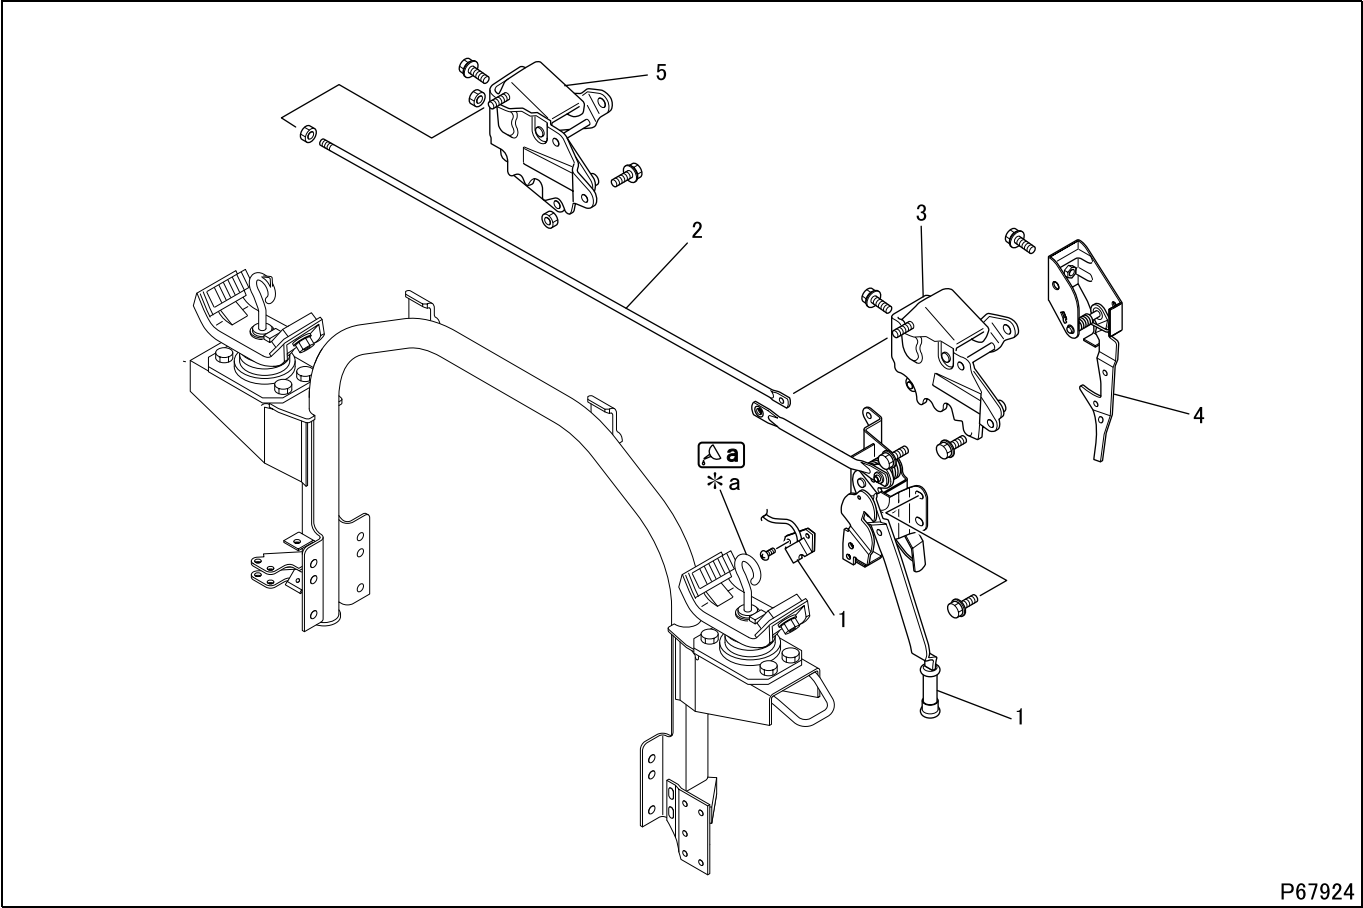
- 1 Lock handle
  - 2 Center rod
  - 3 Link (right-hand)
  - 4 Safety hook
  - 5 Link (left-hand)
- \*a: Anchor hook

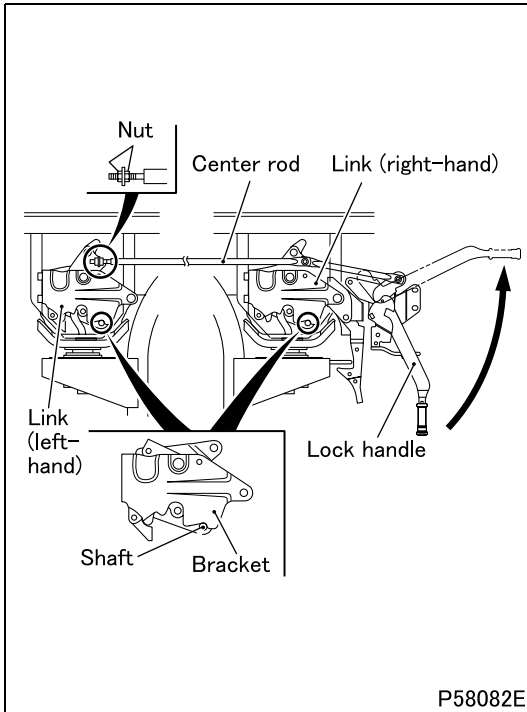
### ■ Installation: Center rod

- Operate the lock handle in the illustrated direction to unlock the left-hand and right-hand links.
- Adjust the center rod nut to bring the shafts of left-hand and right-hand links into contact with brackets.

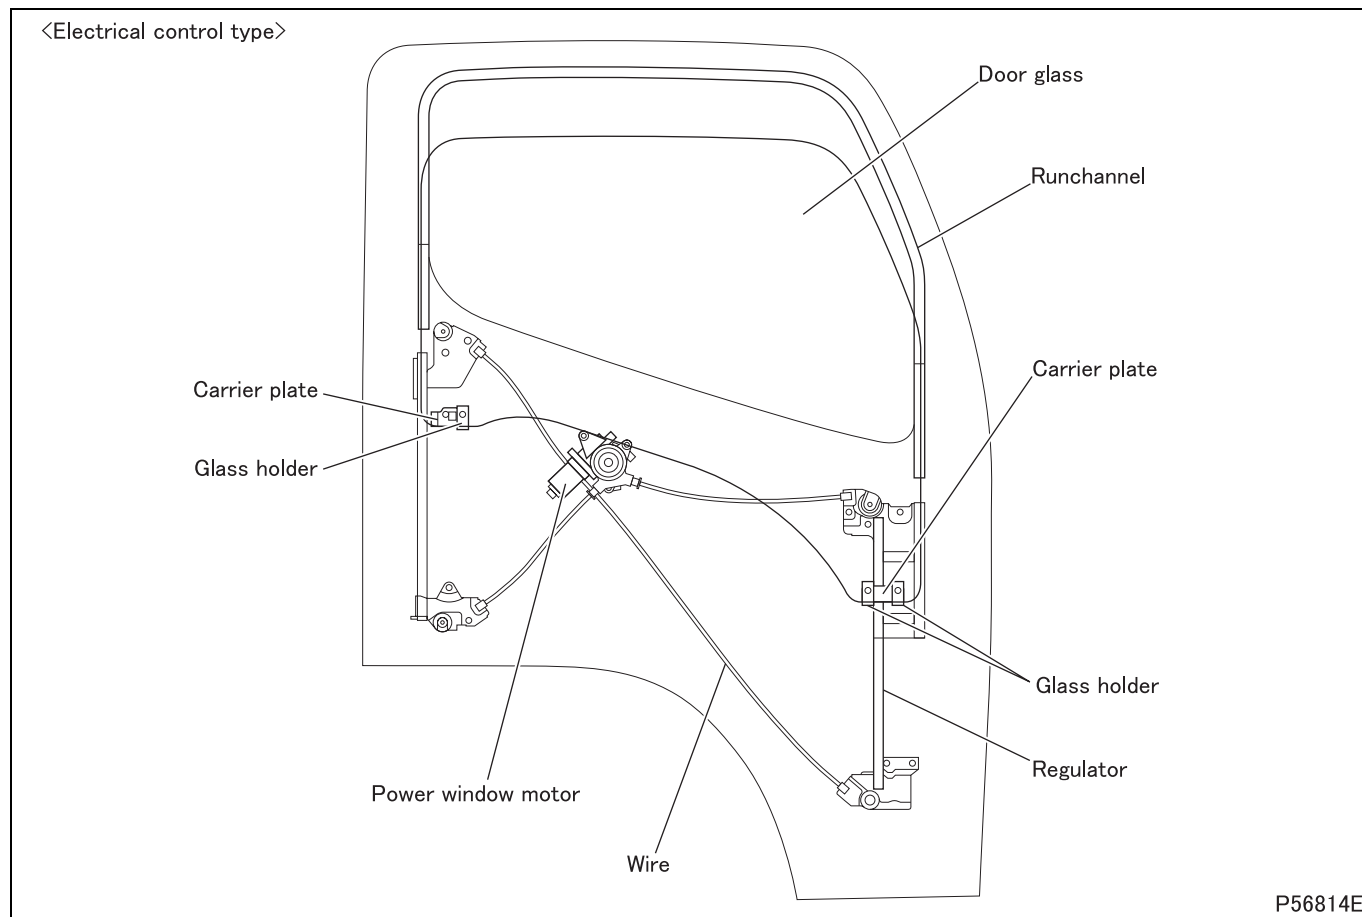
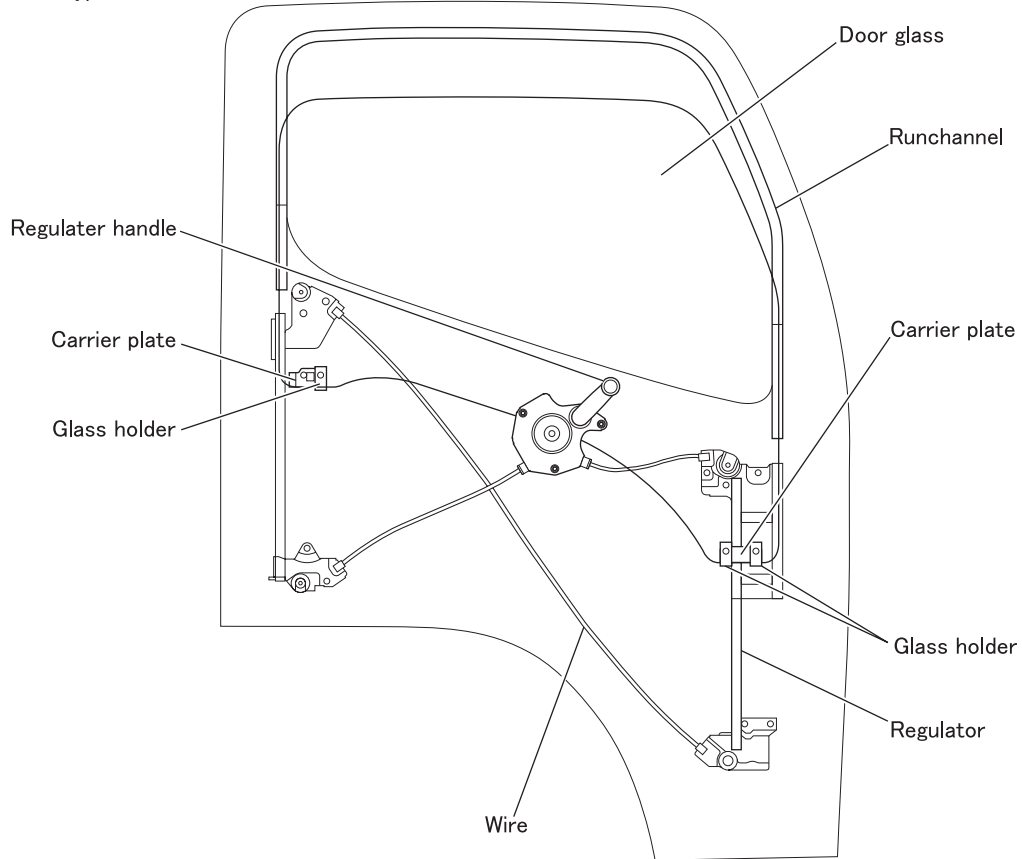
P56813E

- The door glass is secured to the carrier plate by the medium of glass holder.
- With the rotation of the power window motor <Electrical control type> or regulator handle <Manual control type>, the carrier plate is moved up and down by means of the wire to open and close the door glass.

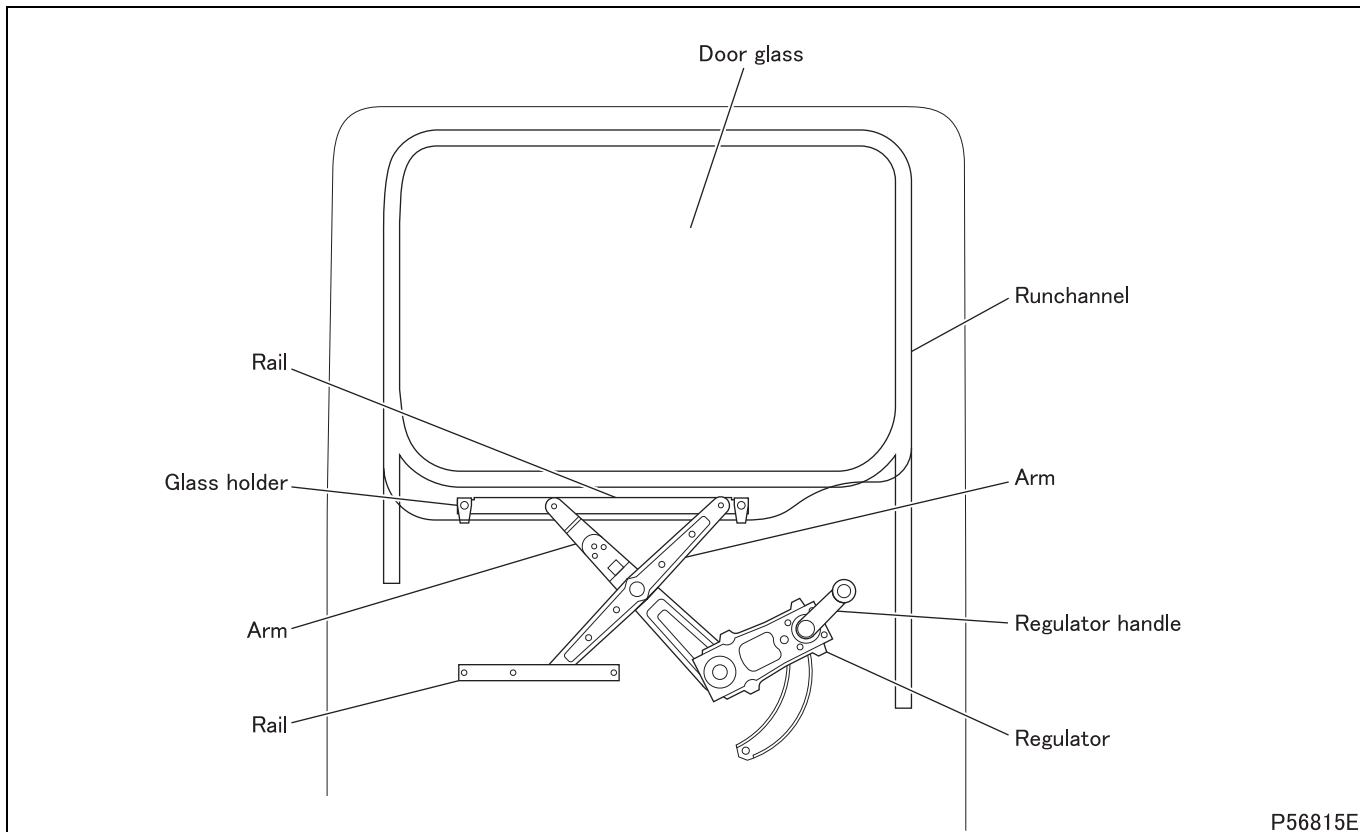
- The door glass is secured to the rail by the medium of glass holder.
- The rail is secured to the door panel, and the arms slide back and forth inside the rail.
- Turning the regulator handle moves the rail up and down by means of the regulator and arm to open and close the door glass.

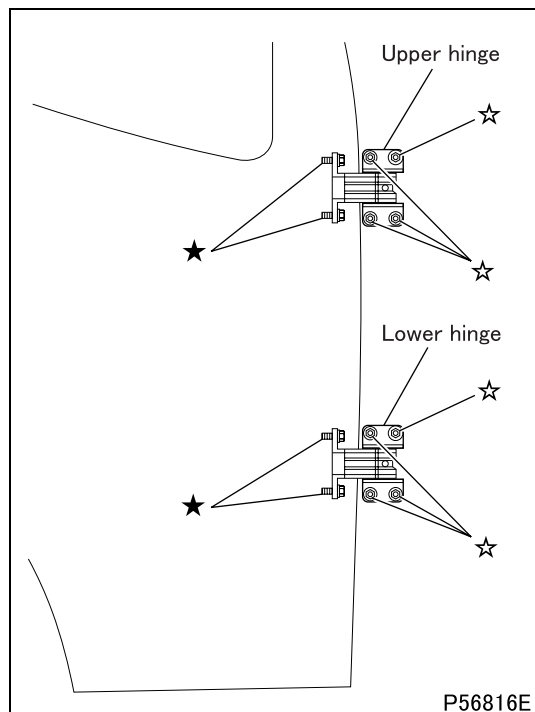
### 1.1 Adjustment of hinge positions

- Use ★ marked bolts to adjust gap.
- Use ☆ marked bolts to adjust flushness.

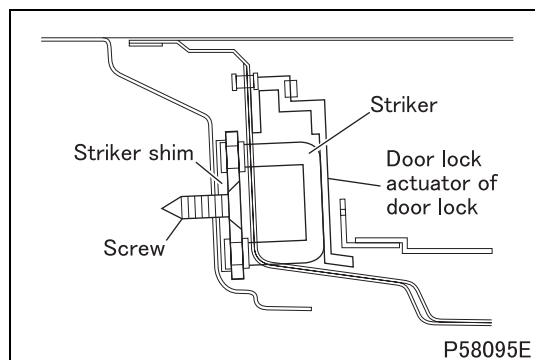
### 1.2 Adjustment of striker position

- Use mounting screw to make the adjustment.
- To adjust the engagement of the striker with the door lock actuator or door lock, change the number of striker shims as required.

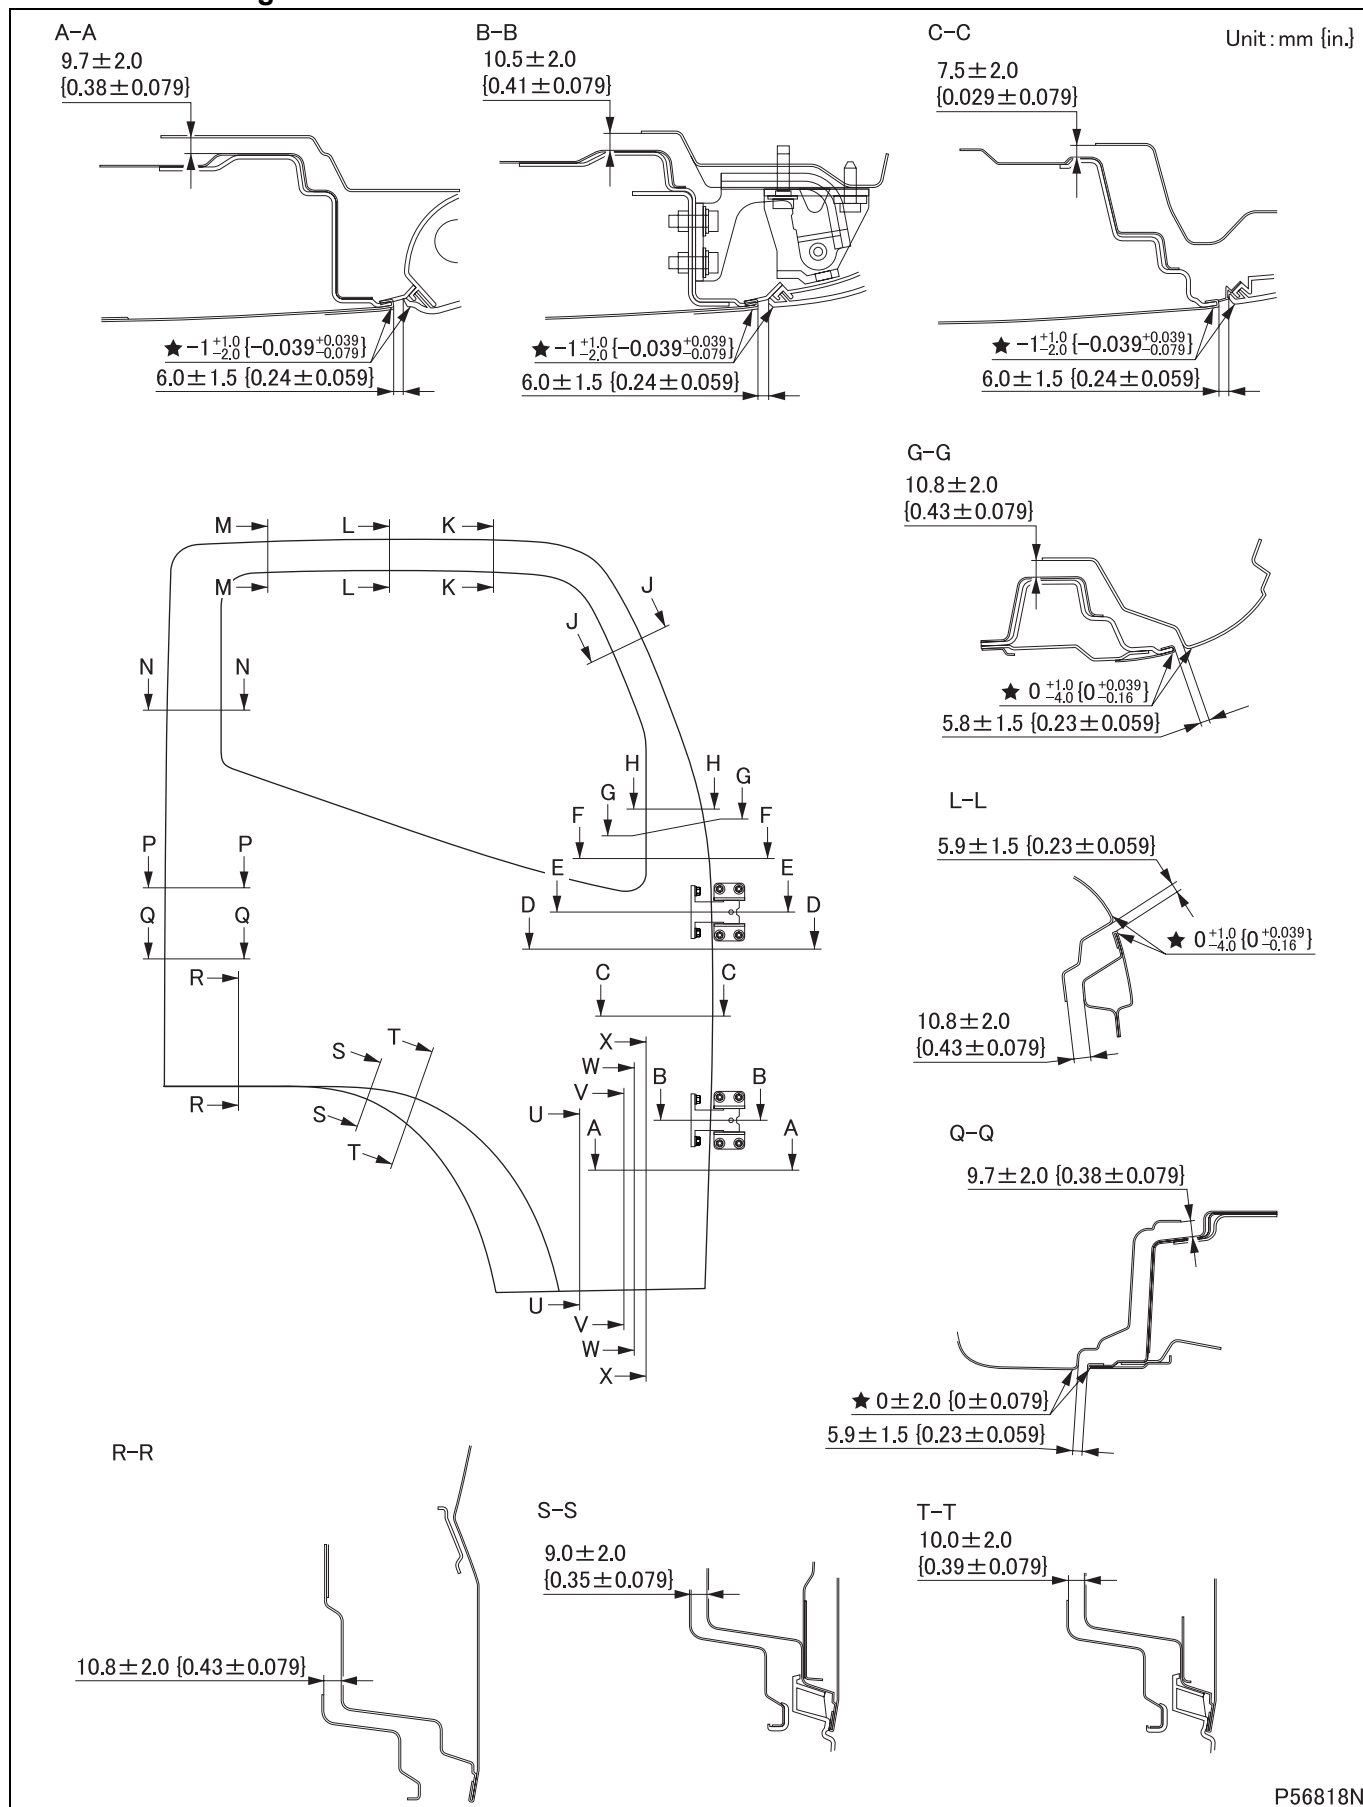
P56818N

### 1.3 Front door alignment dimensions

- Door alignment is adjusted by changing the positions of the upper and lower hinges and striker.
- Door alignment dimensions: See 1.3.

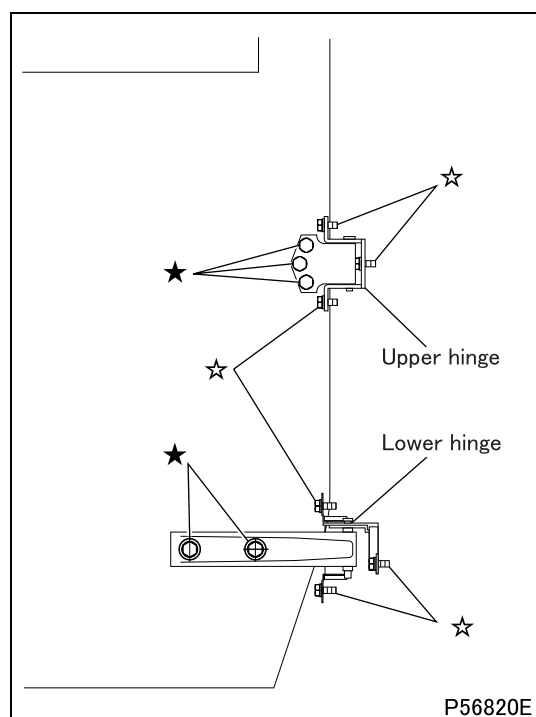
### 2.1 Adjustment of hinge positions

- Use ★ marked bolts to adjust gap.
- Use ☆ marked bolts to adjust flushness.

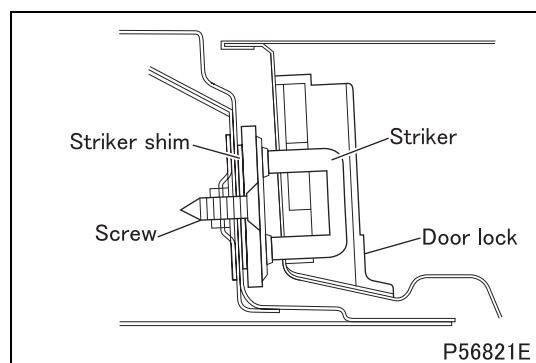
### 2.2 Adjustment of striker position

- Use mounting screw to make the adjustment.
- To adjust the engagement of the striker with the door lock, change the number of striker shims as required.

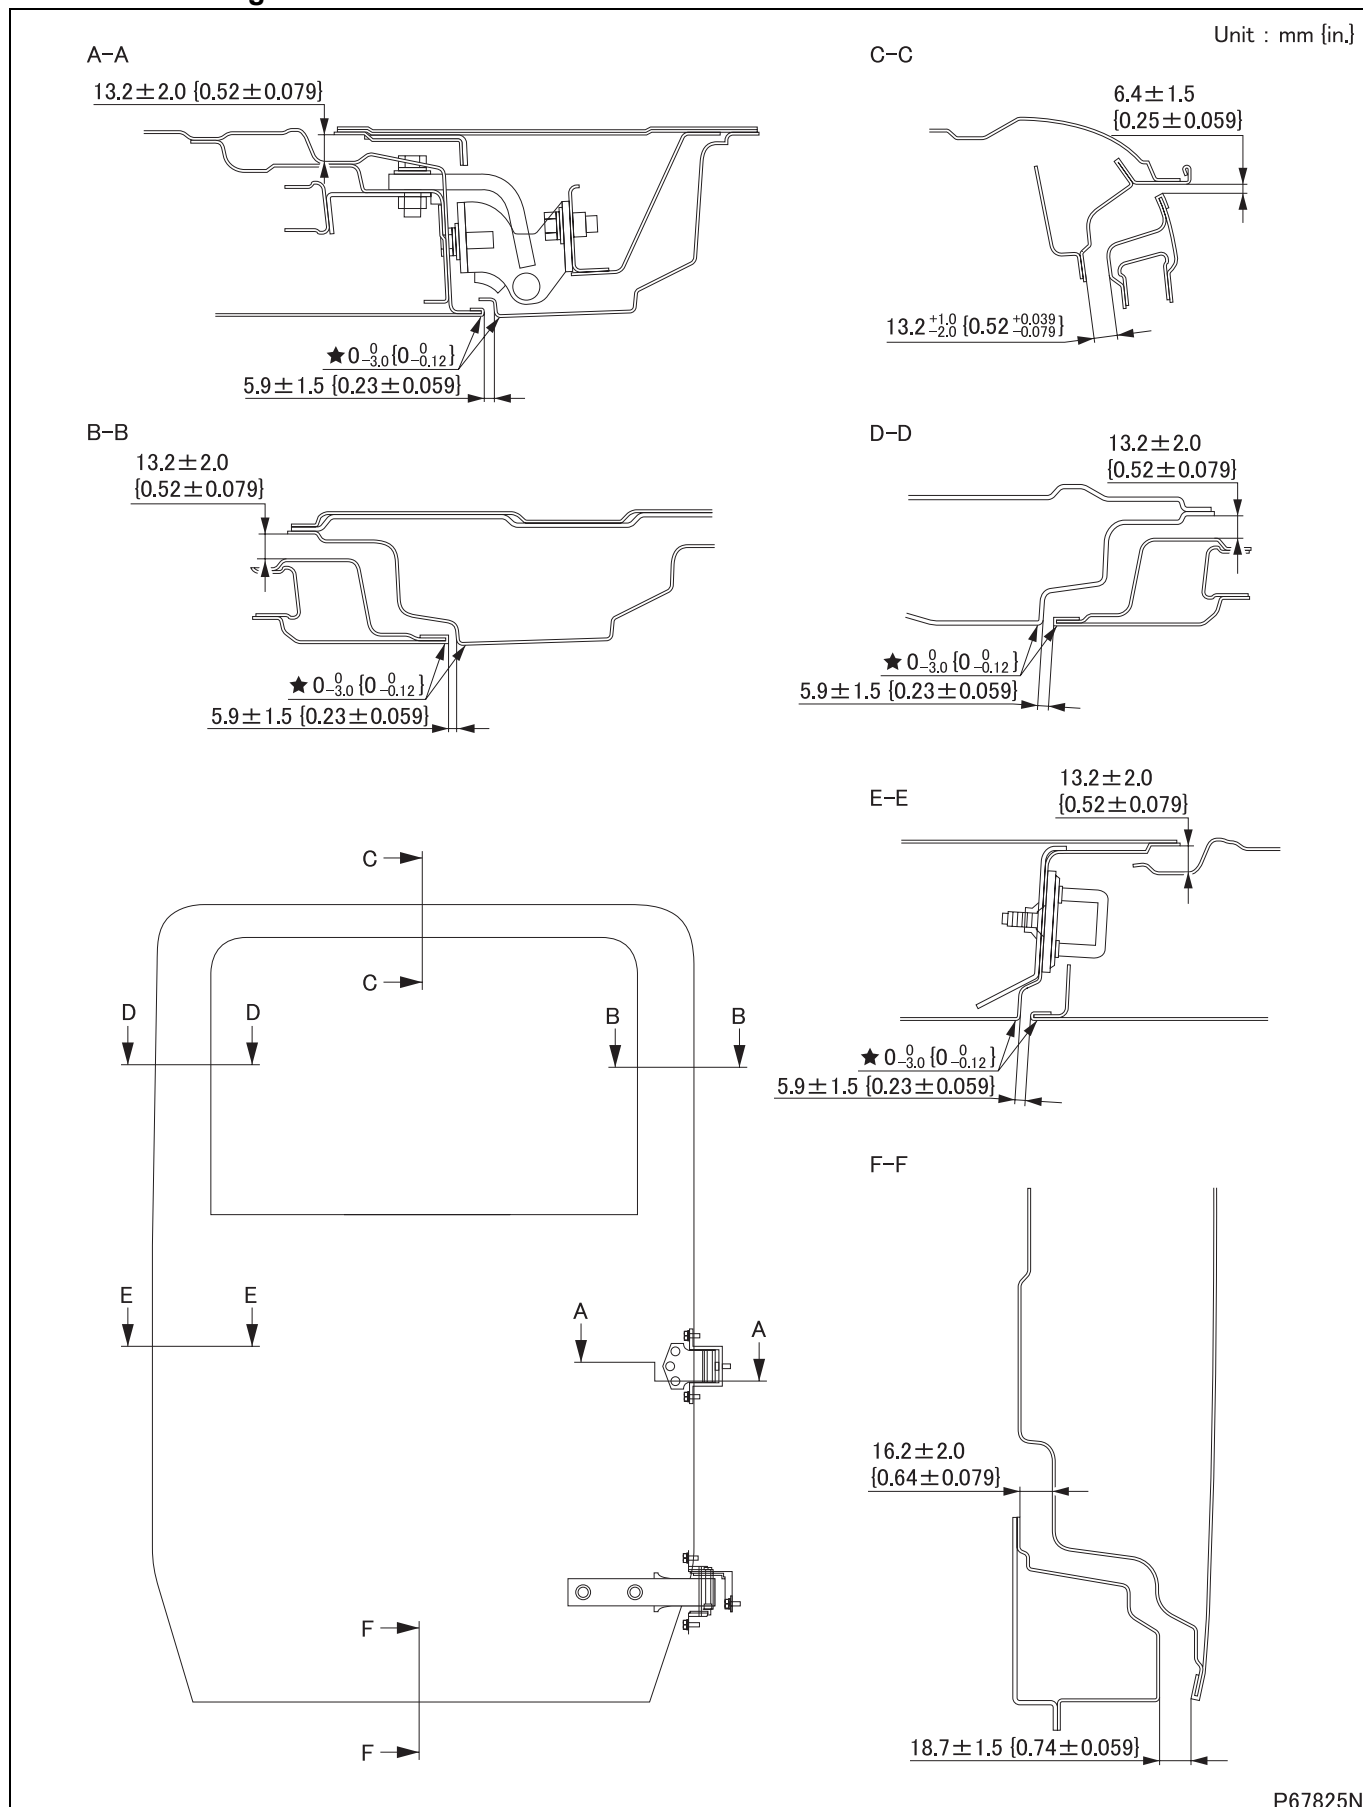
P67825N

## 2.3 Rear door alignment dimensions

★: Flushness dimension (+ for outside of cab; – for inside of cab)

Rear door alignment dimensions: See 2.3.

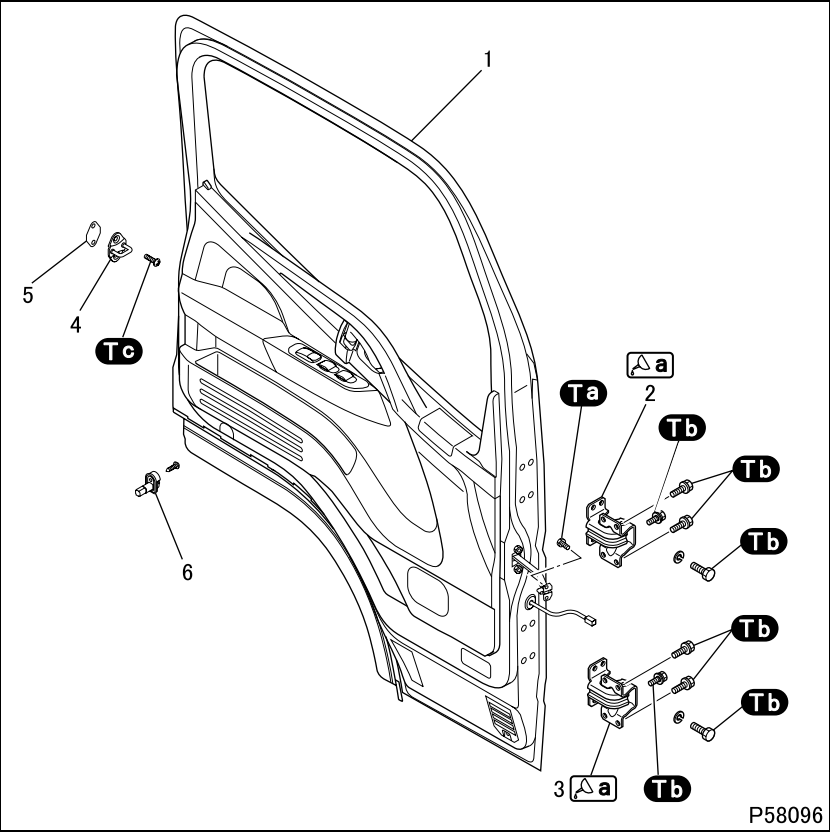
- 1 Door (See later section.)
- 2 Upper hinge
- 3 Lower hinge
- 4 Striker
- 5 Striker shim
- 6 Door switch

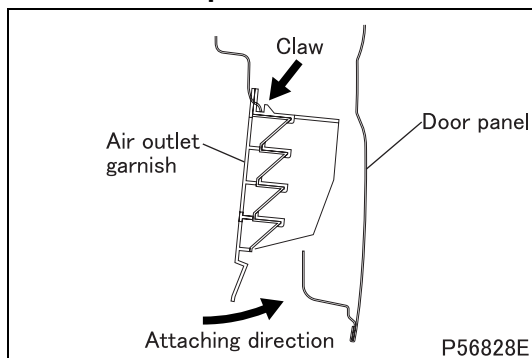
### ■ Installation: Air outlet garnish

- Attach the air outlet garnish to the door panel in the illustrated direction, with its claw fitted in the door panel.

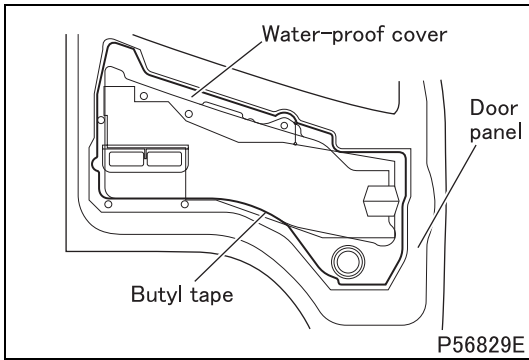
**■ Installation: Water-proof cover**

- Apply butyl tape to the door panel as shown, then attach the water-proof cover to the door panel.

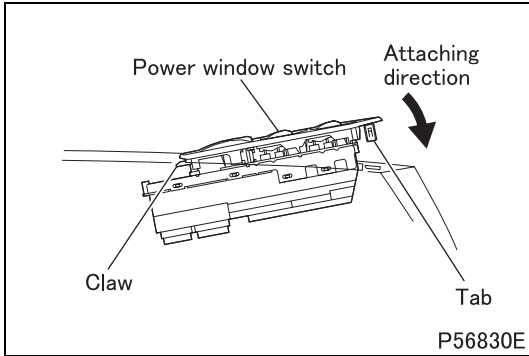
**■ Installation: Power window switch**

- To install the power window switch in position, fit claw first, then tab, in the lower door trim.

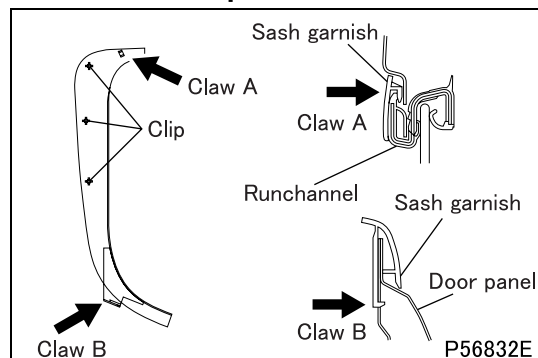
### ■ Removal: Sash garnish

- Disengage claw A on upper part of the sash garnish from the runchannel, then remove clips (3 places).
- Disengage claw B on the lower part of the sash garnish from the door panel.

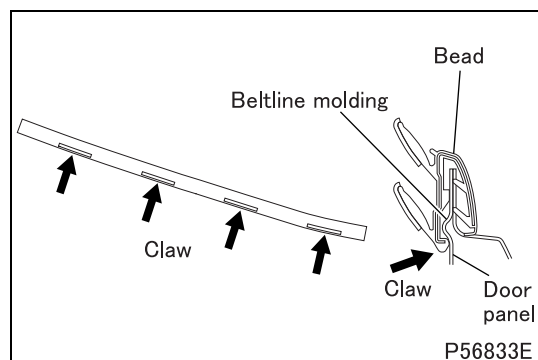
### ■ Removal: Beltline molding

- Disengage claws (4 places) and remove the beltline molding from the door panel bead.

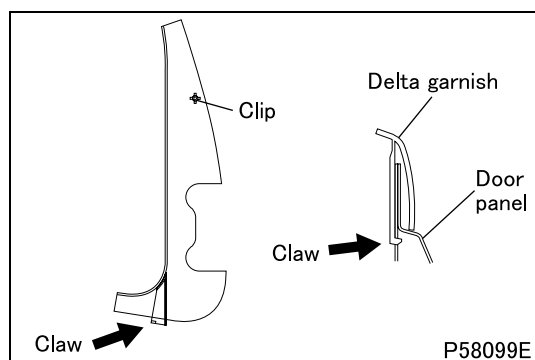
## ■ Removal: Delta garnish

- Disengage clip (1 place) first and then claw to remove the delta garnish from the door panel.

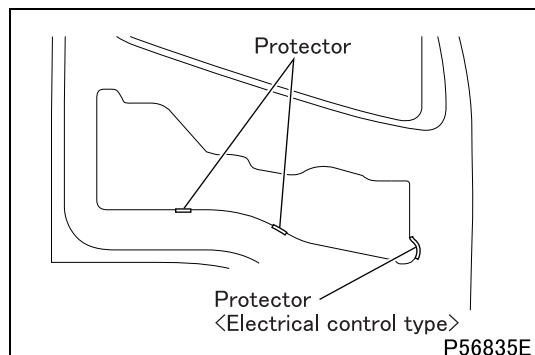
## ■ Installation: Protector

- Fit the protectors (three on electrical control type; two on manual control type) to the door panel in the illustrated positions.

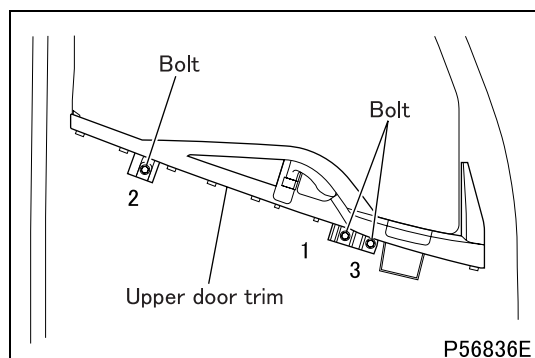
## ■ Installation: Upper door trim

- Tighten bolts to specified torque in numerical order (1 to 3) as shown to secure the upper door trim.

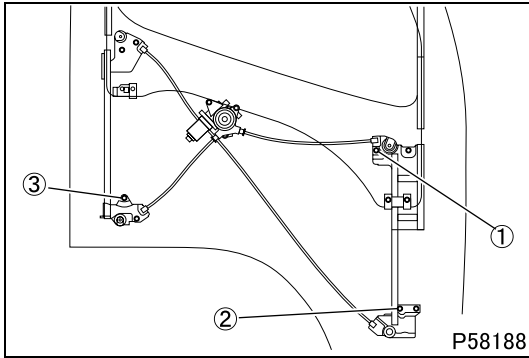
**■ Installation: Regulator and motor or manual regulator**

- Tighten bolts (3 places) to specified torque in numerical order (1 to 3) as shown, then tighten the remaining bolts and nuts to specified torque.

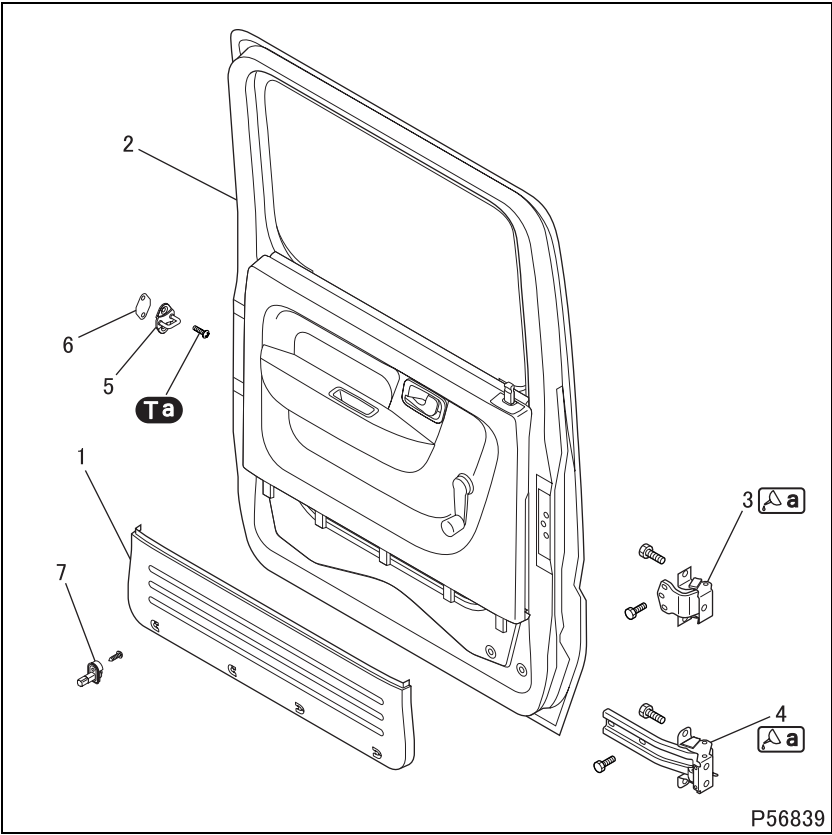
● Removal sequence

- 1 Lower door trim
- 2 Door
- 3 Upper hinge
- 4 Lower hinge
- 5 Striker
- 6 Strike shim
- 7 Door switch
