# FE.FG

## SERVICE MANUAL 2008 Model FOREWORD

This Service Manual contains maintenance and repair methods for the Mitsubishi Fuso Truck FE. FG Series. Read this manual carefully as an aid in providing correct, efficient maintenance. Please note that the information and specifications contained within this manual may change without notice. This is due to product modifications and continued vehicle improvements that are made throughout the model years. Should you encounter any discrepancy in the information provided, please do not hesitate to contact your nearest Mitsubishi Fuso Dealer or Mitsubishi Fuso Truck of America, Inc.

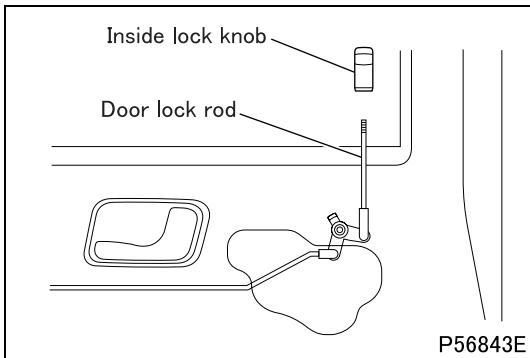
### ■ Installation: Inside lock knob

- Screw the inside lock knob all the way onto the door lock rod, then back it up 1 or 2 turns.

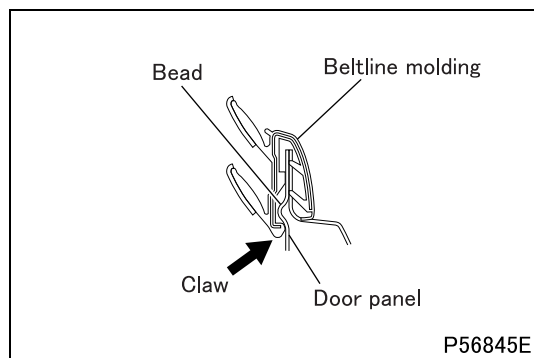
#### ■ Removal: Beltline molding

- Disengage claws (4 places) from the door panel bead to remove the beltline molding from the door panel.

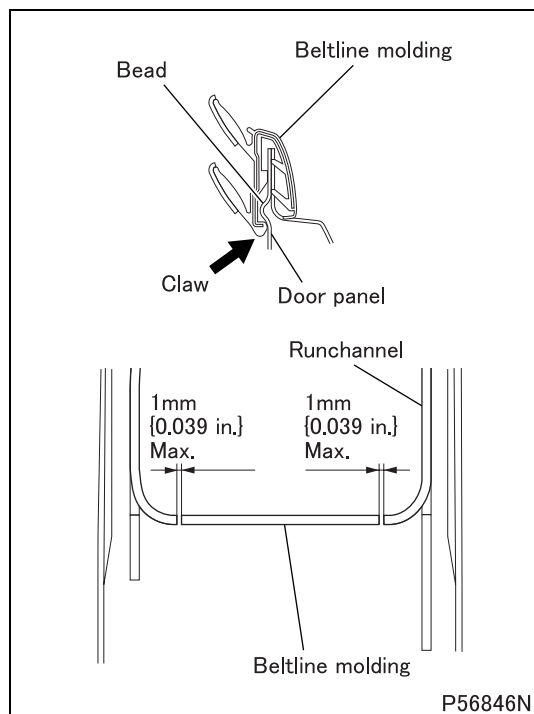
#### ■ Installation: Beltline molding

- Engage hooks (4 places) with the door panel bead to install the beltline molding to the door panel. Gaps between beltline molding and runchannel should be as shown.
- Make sure that the cover is tight at both ends of the belt line molding.

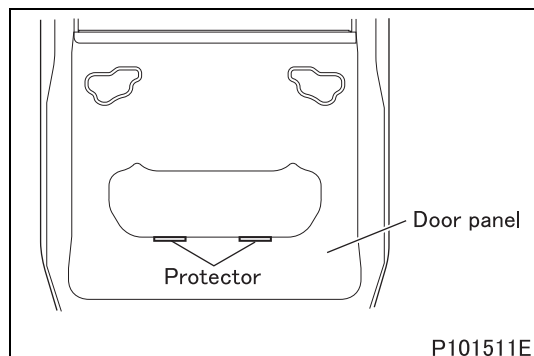
#### ■ Installation: Protector

- Fit the protectors to the door panel in the illustrated positions.

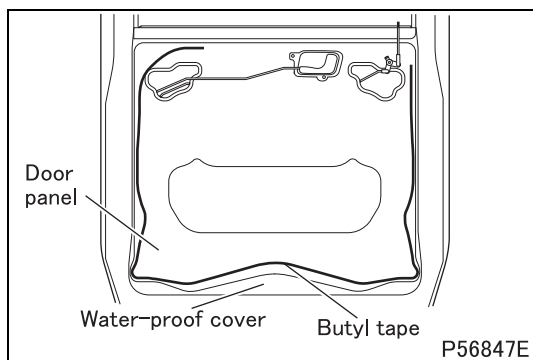
### ■ Installation: Water-proof cover

- Apply butyl tape to the door panel as shown, and attach the water-proof cover to the door panel.

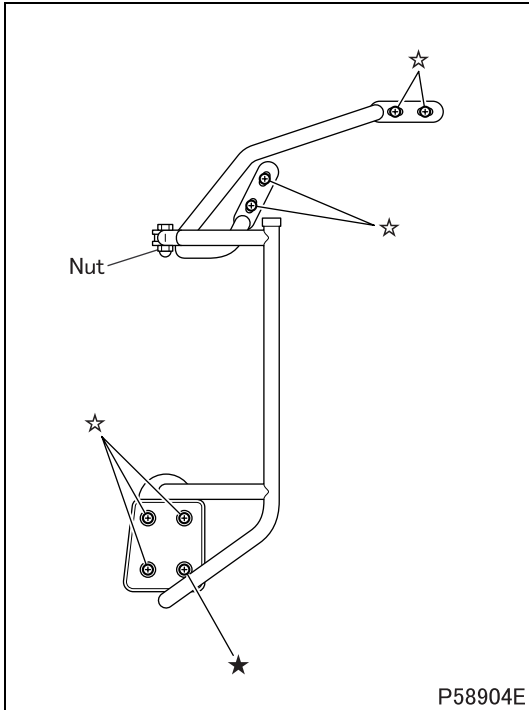
### ■ Installation: Mirror stay

- Install the one screw marked ★ and adjust the position of the mirror stay.
- Install all the remaining seven screws marked ★ to secure the mirror stay.
- Fasten the mirror stay nut to the specified torque.

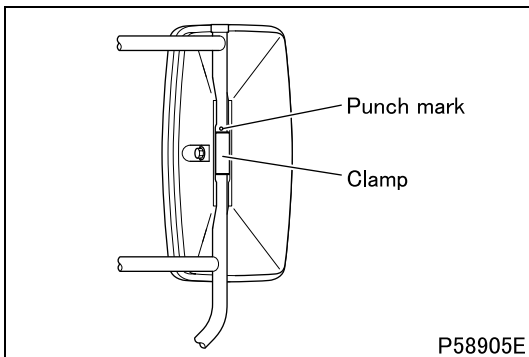
### ■ Installation: Mirror

- Adjust the height of the mirror by aligning the punch mark on the mirror stay with the clamp edge as shown in the illustration.

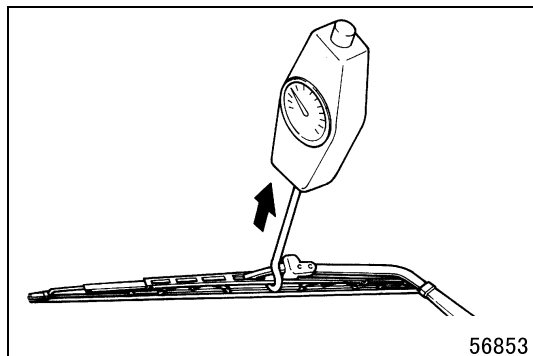
#### ■ Inspection: Wiper arm

- Measure the wiper arm force to press the blade against the windshield.
- If the measurement deviates from the standard value, replace the wiper arm.

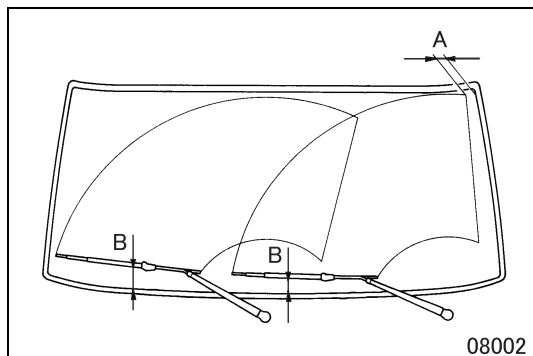
#### ■ Installation: Wiper arm and blade

- Install the wiper arm and blade so that the blades come to the illustrated points as much as A and B apart from the edge of weatherstrip.  
 A: 50 mm {1.97 in.}  
 B: 59 ± 5 mm {2.3 ± 0.20 in.}

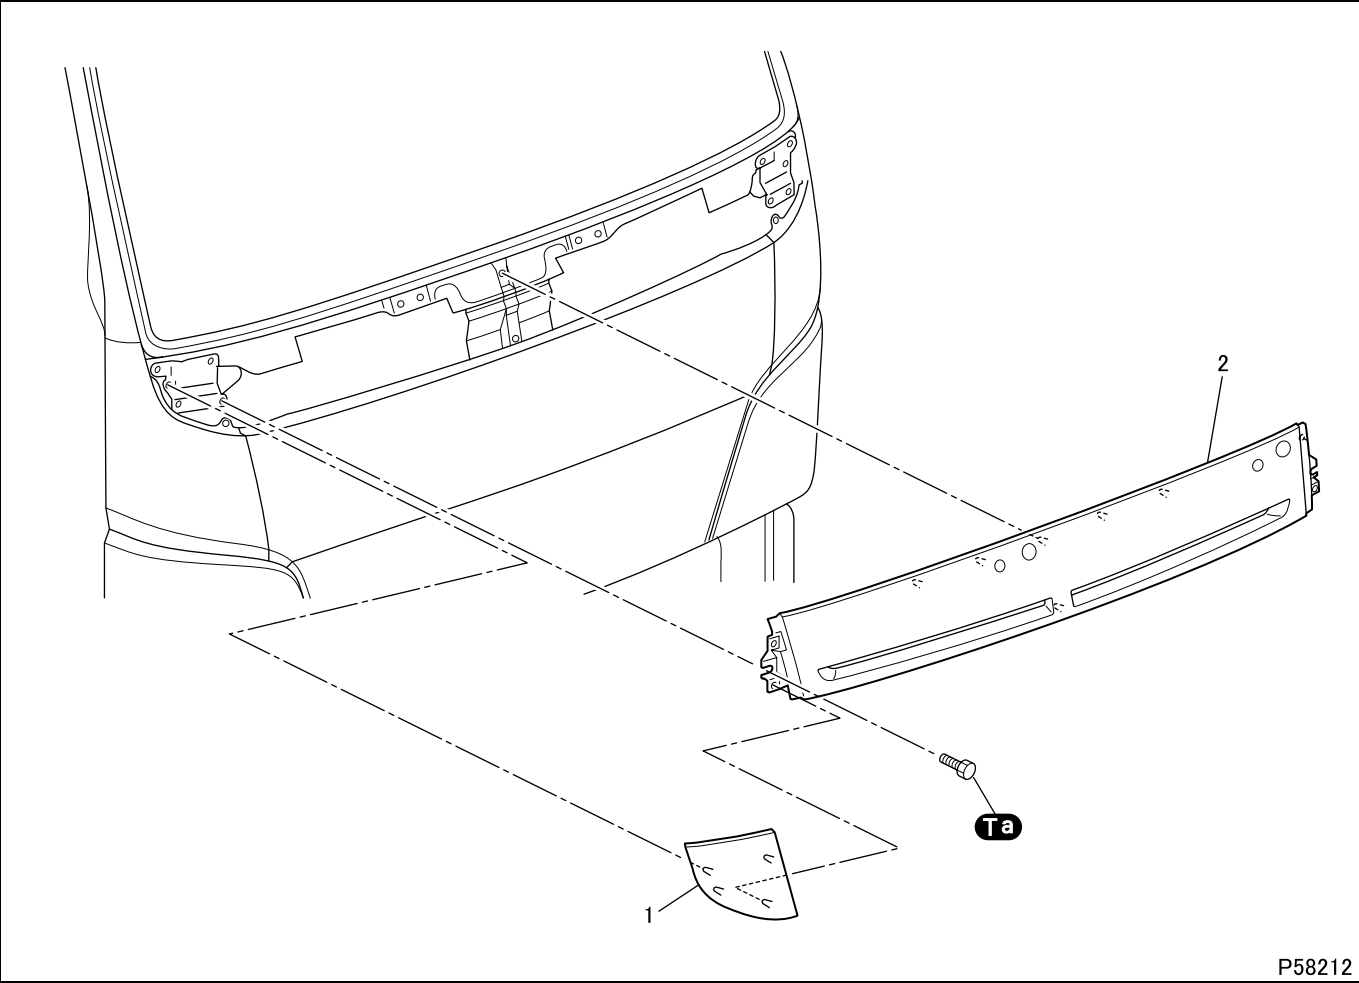
## ●Disassembly sequence

- 1 Front side cover
- 2 Front cover

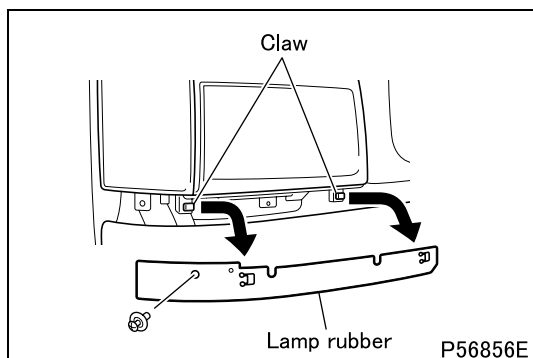
### ■ Removal: Lamp rubber

- Slide the lamp rubber sideways to disengage from the claws of the headlamp.

- Do not pull the lamp rubber to forcedly remove. It could be damaged.

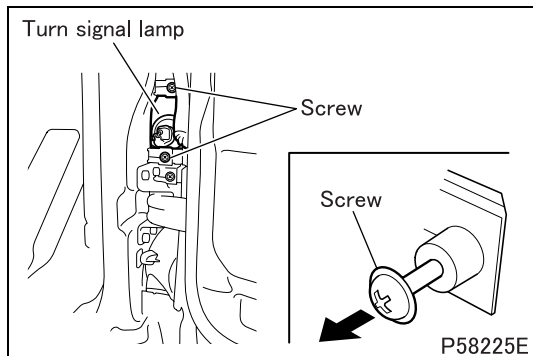
### ■ Removal: Turn signal lamp

- Open the door. Loosen screws securing the turn signal lamp from behind to such an extent that they freely turn.
- Draw out the loosened screws.

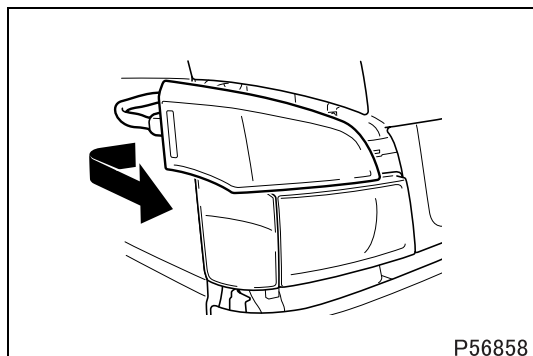
- Close the door. Move the turn signal lamp sideways to disengage its claws.
- Ascertain the disengagement of the claws, then pull out the turn signal lamp.

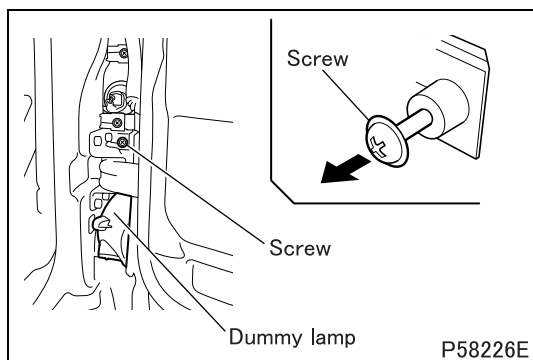
### ■ Removal: Dummy lamp

- Open the door. Loosen screw securing the dummy lens from behind to such an extent that it freely turn.
- Pull out the loosened screw.

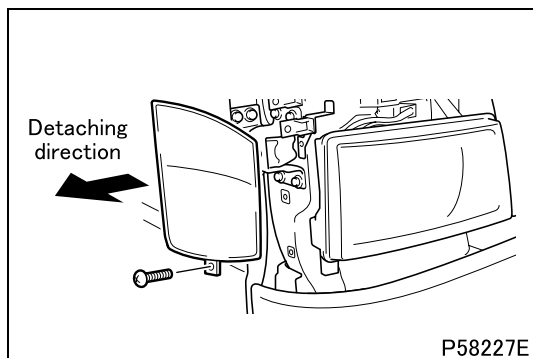
- Close the door, and remove the dummy lamp.

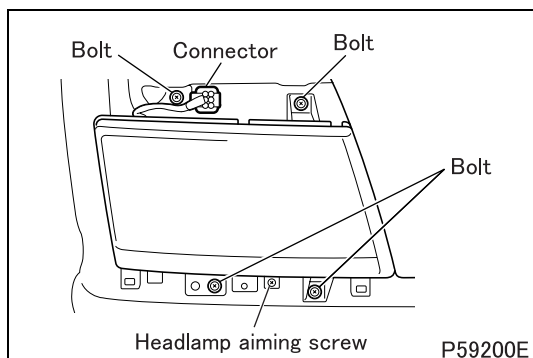
## ■ Removal: Headlamp

- The headlamp has aiming screw at the illustrated positions. Do not mistake them for mounting bolts.

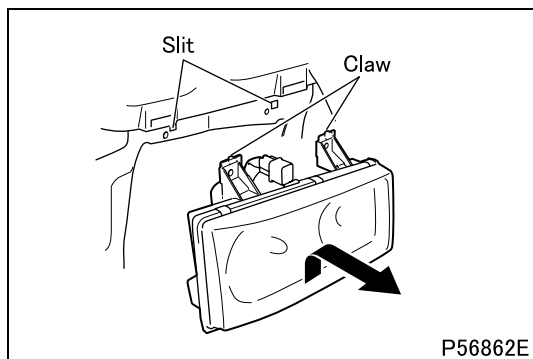
- Lift the headlamp a little to disengage its claws from the slits, then pull it out.

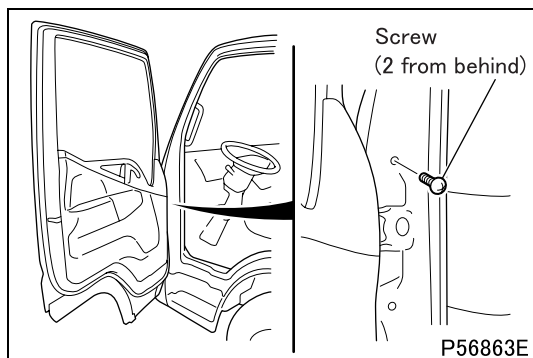
## ■ Removal: Front corner panel

- Open the door. Remove two screws securing the front corner panel from behind.
- Close the door. Remove three screws securing the front corner panel from front.
- Remove the front corner panel.

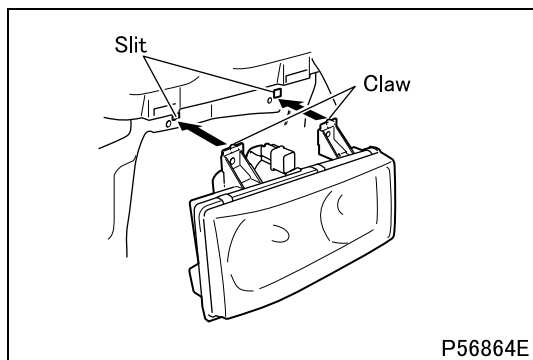
## ■ Installation: Headlamp

- Install the headlamp with its claws inserted in the slits.

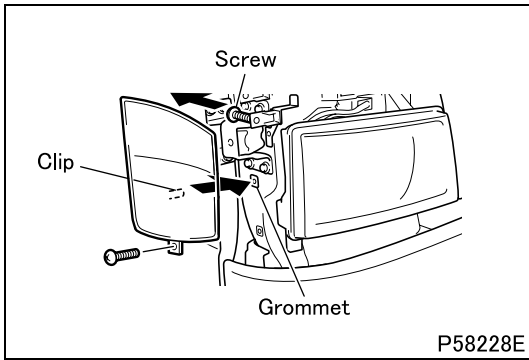
#### ■ Installation: Dummy lamp

- Check to see if the threaded portion of cab-side screw protrudes. If it does, move it out of the way in the illustrated direction.
- Insert the clip of the dummy lamp into the grommet.

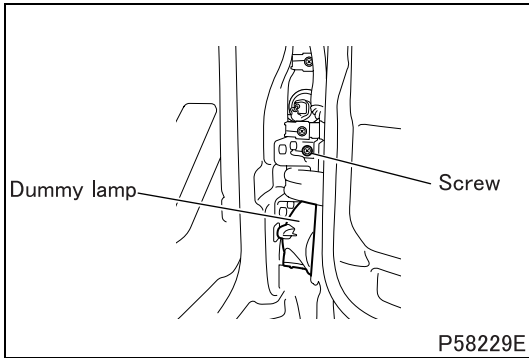
- Open the door. Tighten the screw securing the dummy lens from behind.

- **Do not overtighten the screw. Doing so may damage the dummy lamp.**

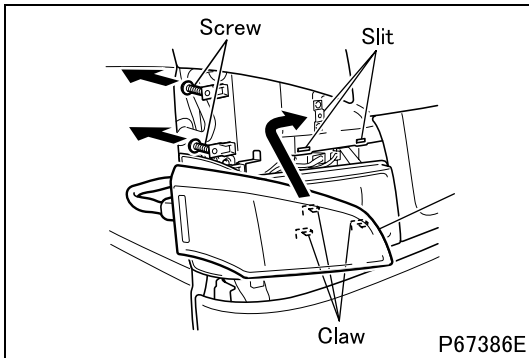
#### ■ Installation: Turn signal lamp

- Check to see if the threaded portions of screws protrude. If they protrude, move them out of the way in the illustrated direction.
- Put the claws of the turn signal lamp in the cab-side slits, then press-fit the lamp sideways into place.

- **Do not open the door when the turn signal lamp is not seated completely. Doing so may damage the turn signal lamp.**
- **Do not overtighten the screws. Doing so may damage the turn signal lamp.**

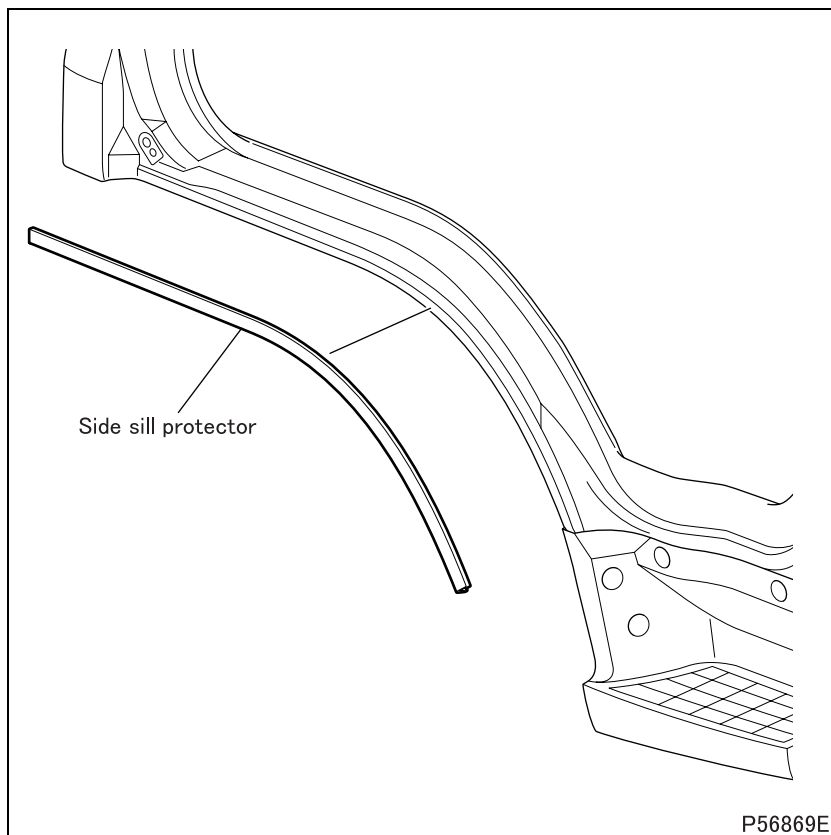
<FE>

- For details on removal and installation of the fender, see Gr43.
- Attach the side sill protector using double-coated adhesive tape.

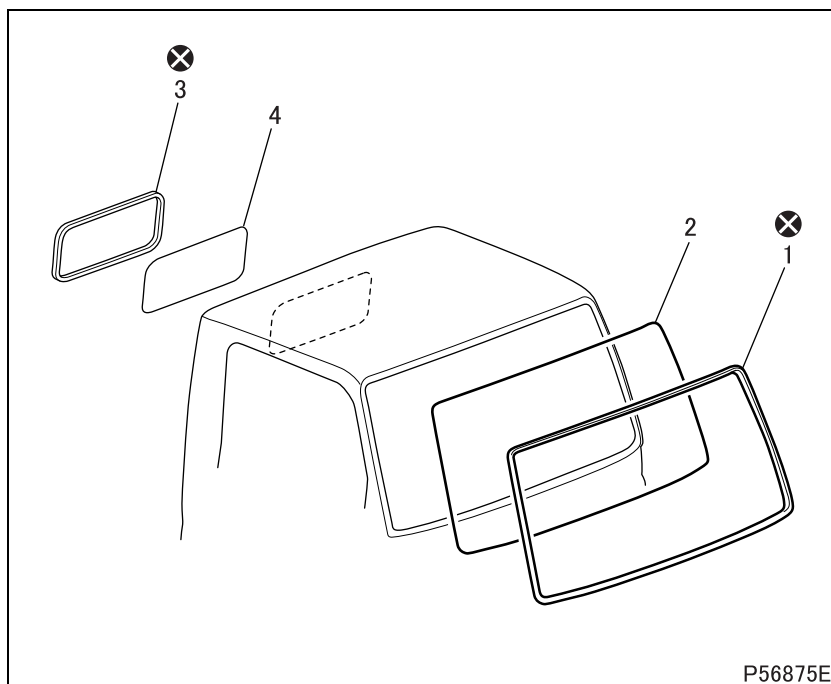
## ● Removal sequence

- 1 Windshield weatherstrip
- 2 Windshield glass
- 3 Rear window weatherstrip
- 4 Rear window glass

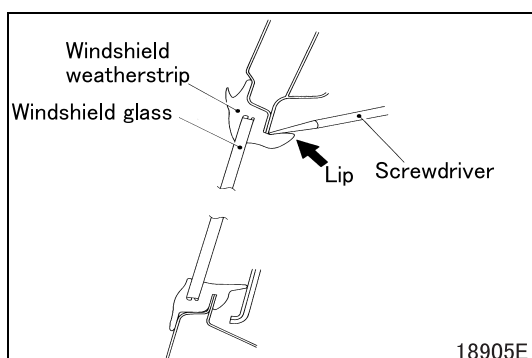
### ■ Removal: Windshield weatherstrip and windshield glass

- While prying up the lip of the weatherstrip with the tip of a screwdriver, push the windshield glass out from inside the cab.

- Be careful not to damage the painted surface of the cab. Damaged surface may form rust.

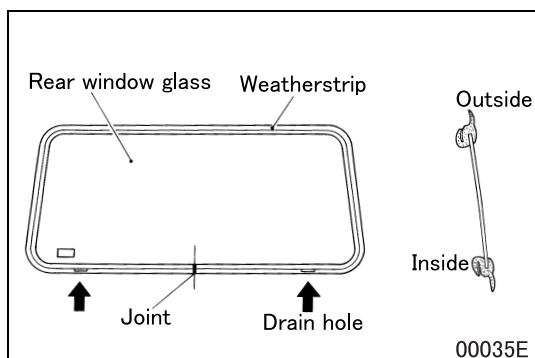
### ■ Installation: Rear window weatherstrip and rear window glass

- Fit the rear window weatherstrip round the rear window glass so that the joint of weatherstrip comes at the bottom center of the glass.
- Except for the point mentioned above, install the rear window glass in the same manner as the windshield glass.

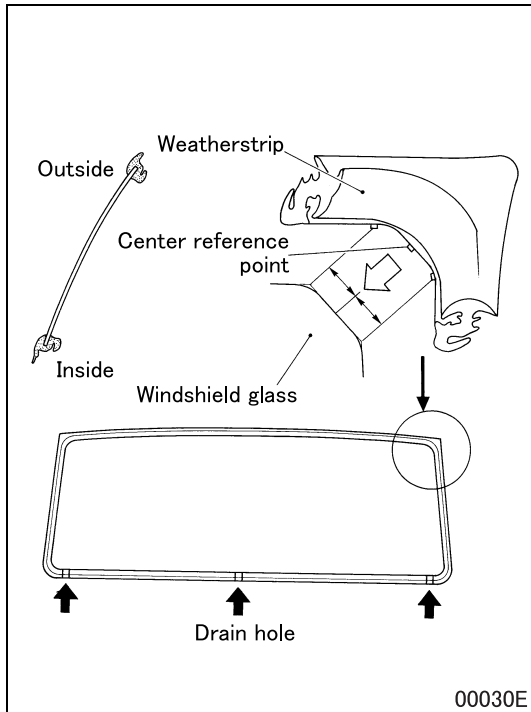
#### ■ Installation: Windshield weatherstrip and windshield glass

- Install the weatherstrip with its center reference point aligned with the center of the cut at each corner of the glass.

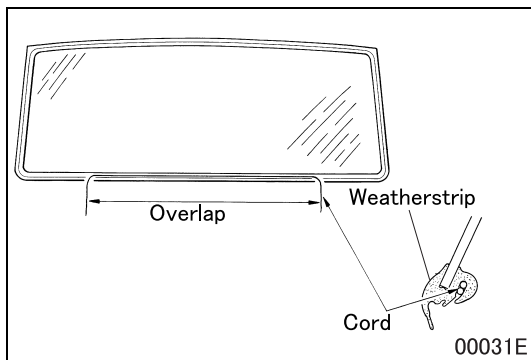
- Put a piece of strong cord in the cab flange fitting groove in the weatherstrip with its end portions overlapped.

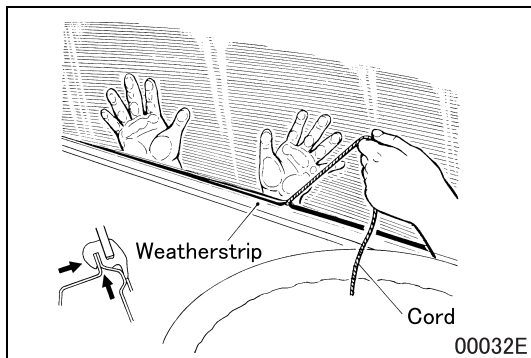
- With the glass strongly pushed from outside, pull out the cord by its ends from inside the cab to gradually fit the flange of the cab in the inner groove of the weatherstrip.

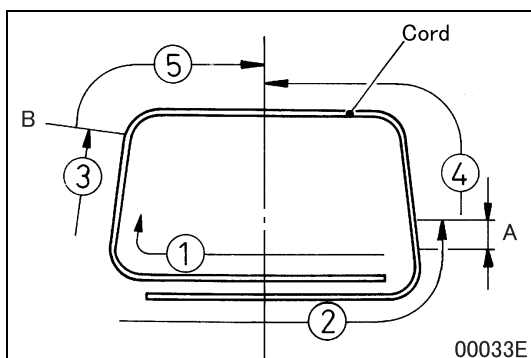
- Pull the cord in the numerical order of steps as shown. At the same time, while tapping with a rubber-headed mallet from outside the cab, settle the windshield glass in place in the weatherstrip.

A: Approx. 100 mm {3.9 in.} from the beginning of straight portion

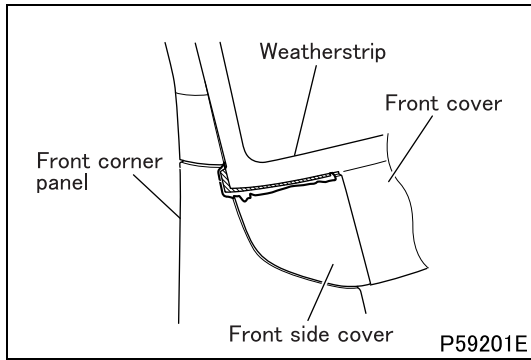
- To ensure watertightness, put the hatched part of the weatherstrip inside between the cab and the front cover, front side cover and front corner panel.

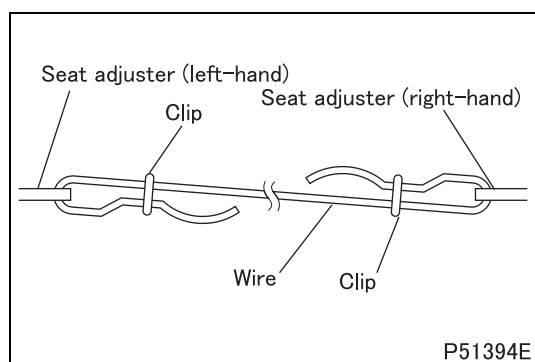
#### ■ Installation: Wire

- Install one end of the wire onto the seat adjuster (left-hand). Then, twist the wire a half turn before fitting the other end onto the seat adjuster (right-hand).

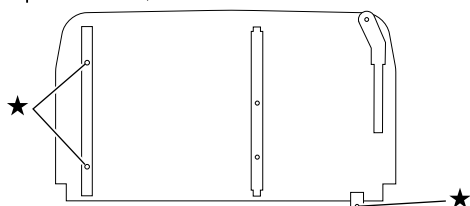
<Except crew cab>

Nuts shown with ★ should be removed from under the cab.

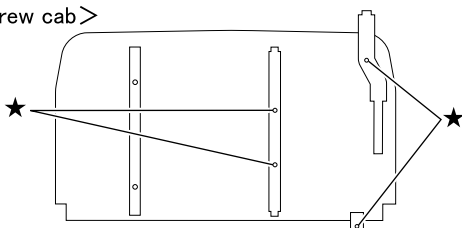
<Crew cab>

Nuts shown with ★ should be removed from under the engine inspection cover.

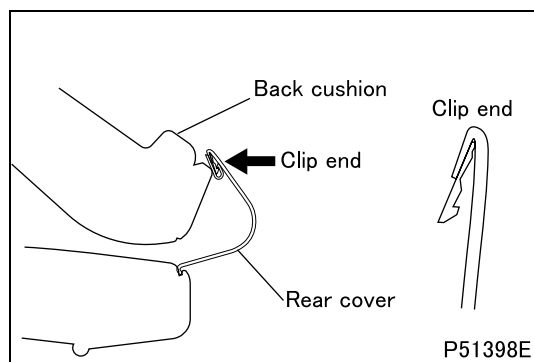
#### ■ Removal: Back cushions

- With the back cushion folded forward, disengage the clip end of the rear cover.

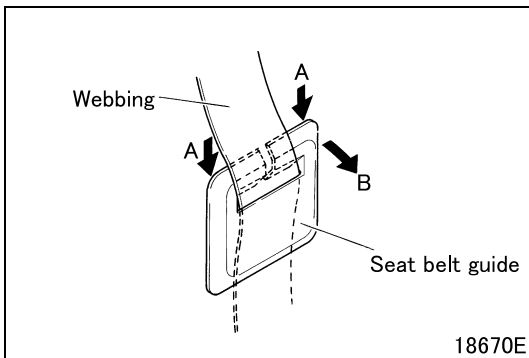
**■ Removal: Seat belt guide**

- To detach the seat belt guide, pull the top of the guide towards you in the direction of B while holding it down in the direction of A.

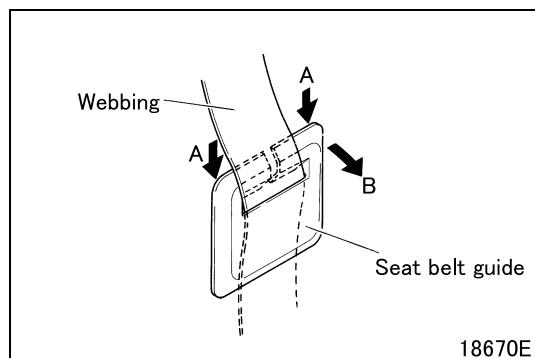
#### ■ Removal: Seat belt guide

- To detach the seat belt guide, pull the top of the guide towards you in the direction of B while holding it down in the direction of A.

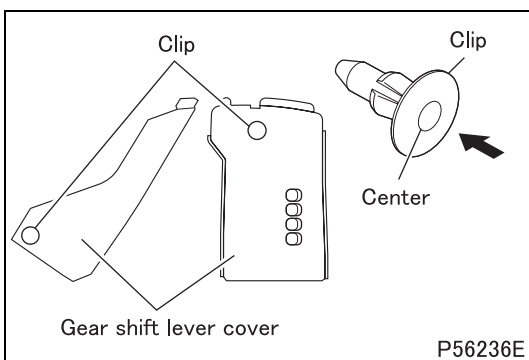
### ■ Removal: Gear shift lever cover

- Push the clips (× 3) in the center to disengage them from the gear shift lever cover.

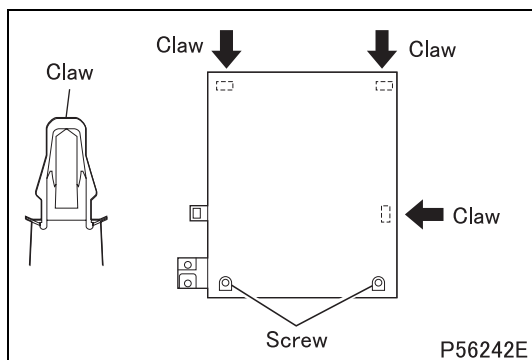
## ■ Removal: Lower center panel

- Remove the screws (× 4) from the lower center panel.
- Push the clips (× 2) in the center to disengage them from the lower center panel.

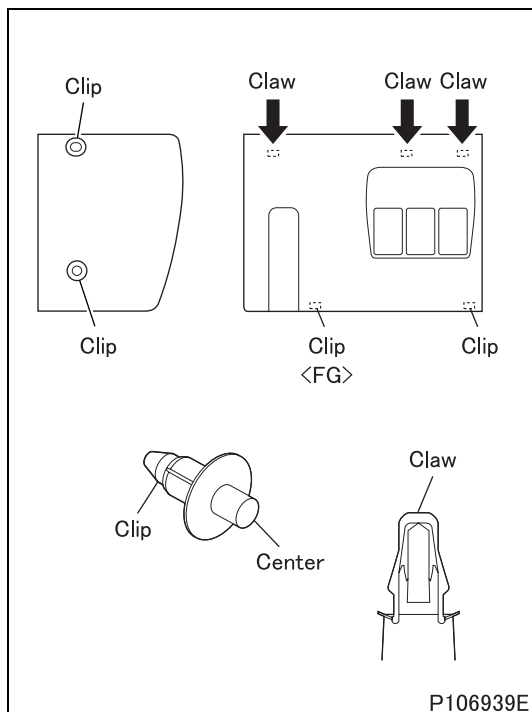
## ■ Removal: Driver panel

- Push the clips (× 3 <FE>, × 4 <FG>) in the center to disengage them from the driver panel.

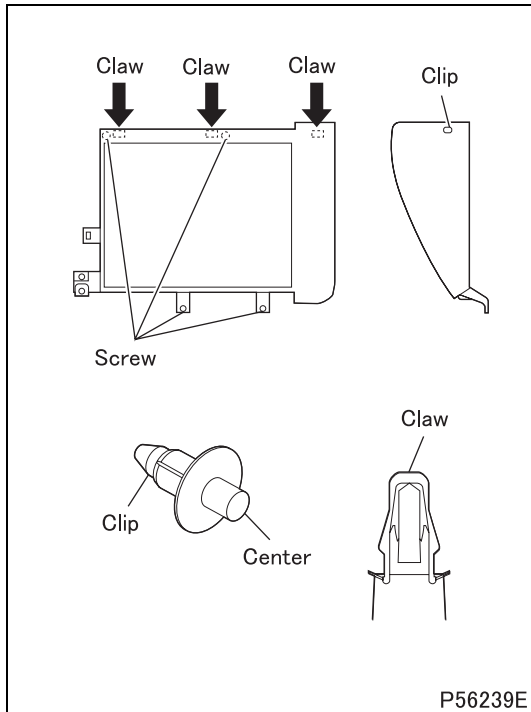
## ■ Installation: Driver panel

- Insert the clips (× 3 <FE>, × 4 <FG>) at the illustrated locations and push them in the center to engage into the driver panel.

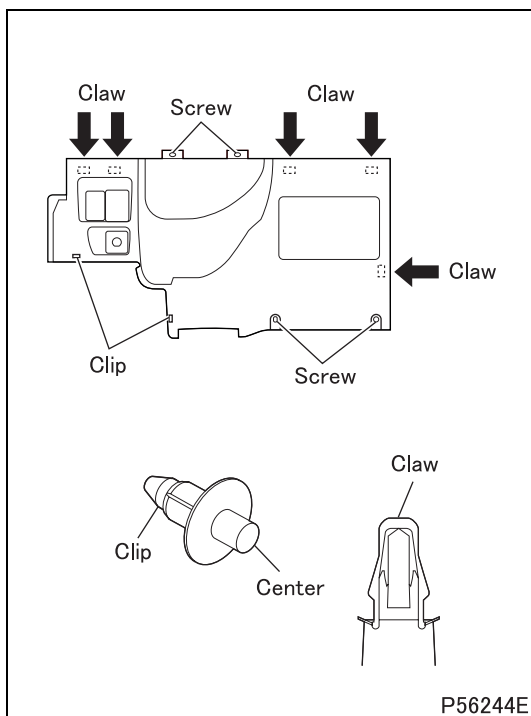
#### ■ Installation: Passenger panel A

- Insert the clip (× 1) at the illustrated location and push it in the center to engage into the passenger panel.
- Install the screws (× 4) to the passenger panel.

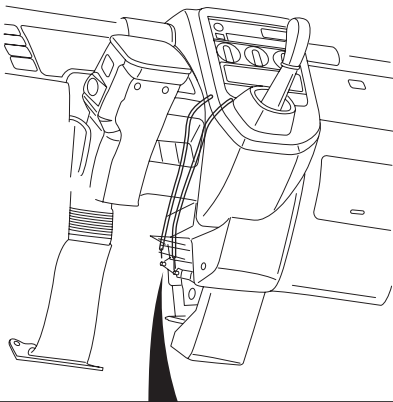
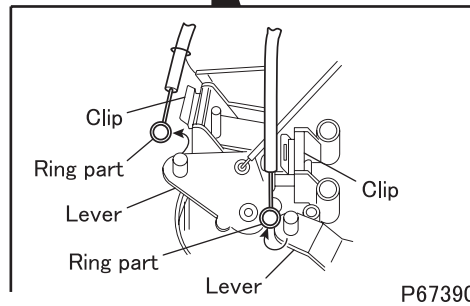
P67390E

### ■ Removal: Control cables

- Turn the temperature control knob of the heater controls to the MAX-COOL position.

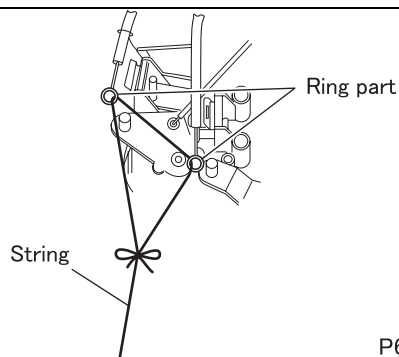
P67391E

- Before disconnecting the cables from the levers, put pairing marks on each cable and its lever.
- Disconnect the control cables from the heater unit.

- In order that the control cables can be pulled back at the time of installation, attach string to the ring parts of the cables as shown in the illustration.

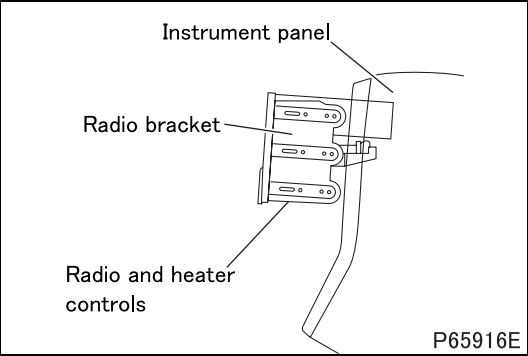
### ■ Removal: Radio bracket

- Pull out the radio bracket for radio and heater controls until it completely comes out of the instrument panel as shown in the illustration.

- Do not pull the bracket with a strong force. Pulling it strongly could give damage to the heater controls and control cables.

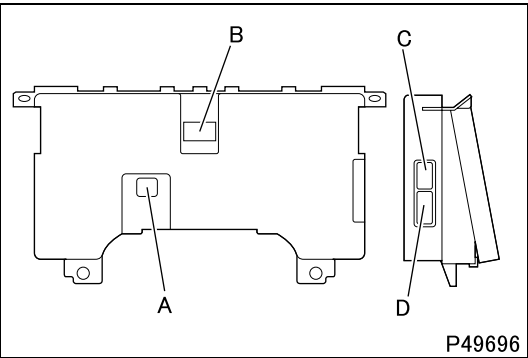
### ■ Removal: Meter cluster

- Disconnect the cab harness connectors A to D from the meter cluster and remove the meter cluster from the instrument panel. (The illustration shows the rear face of the meter cluster.)

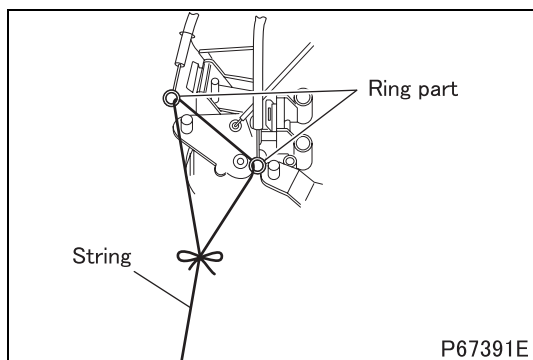
#### ■ Installation: Control cables

- Of the heater controls, turn the temperature control knob to the MAX-COOL position and also turn the mode selector knob to the face position.

- Pull out the control cables using the string that was attached to them at the time of removal.
- According to the pairing marks, reconnect the cables to the heater unit levers correctly. (See Gr55.)

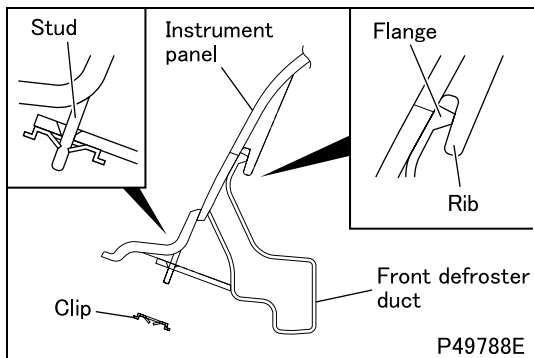
### ■ Installation: Front defroster duct

- Insert the front defroster duct flanges into the instrument panel ribs.
- Insert the instrument panel studs into the front defroster duct holes and clip them together.

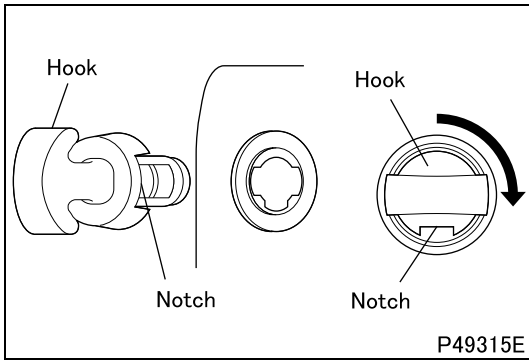
### ■ Removal: Hook

- Turn the hook 90° to disengage it.

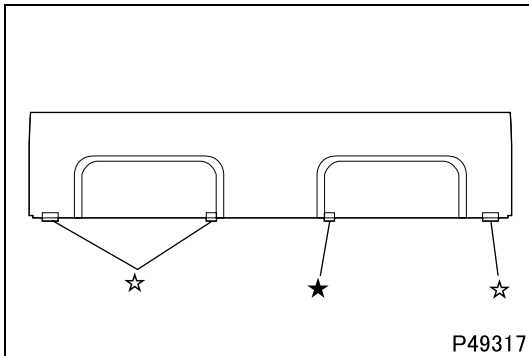
### ■ Installation: Lower rear trim

- Locate the lower rear trim correctly in position by installing a clip into the hole ★.
- Install 3 clips into the holes ★ to completely fix the lower rear trim in position.

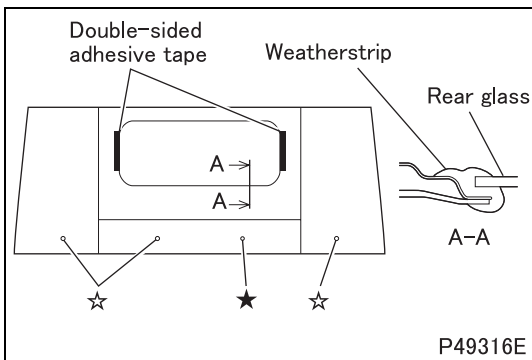
### ■ Installation: Upper rear trim

- Stick double-sided adhesive tapes onto the upper rear trim along the strips illustrated.
- Locate the upper rear trim correctly in position by installing a clip into the hole ★.
- Remove the backing strips from the double-sided adhesive tapes. Press the trim firmly on where the adhesive tapes are applied on the back. Then, install 3 clips at the places ★.
- Install the rear glass by inserting the rear glass weatherstrip over the upper rear trim.

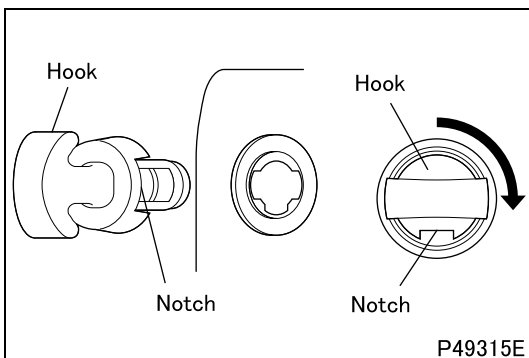
### ■ Installation: Hook

- With the notch facing in the illustrated direction, insert the hook into the lower rear trim.
- To engage the hook, turn it 90° until the notch faces downwards.

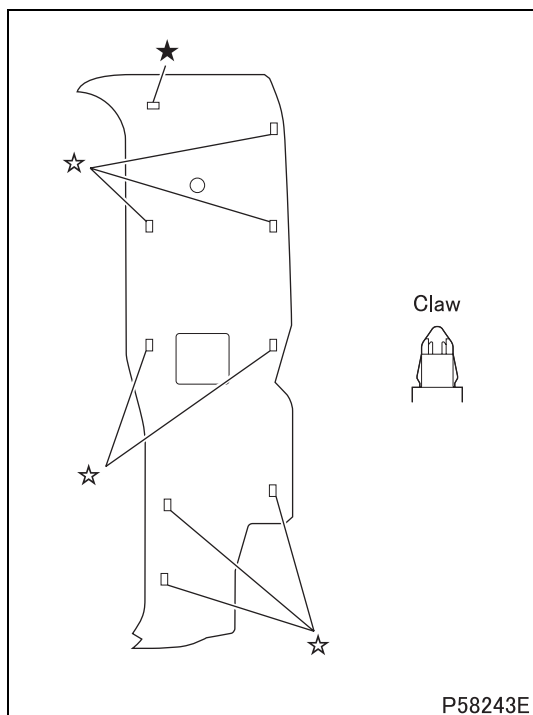
## ■ Installation: Rear pillar trim

- Locate the rear pillar trim correctly onto the cab by engaging the claw ★.
- Engage the claws ★ (× 8) onto the cab, from the front to the rear.

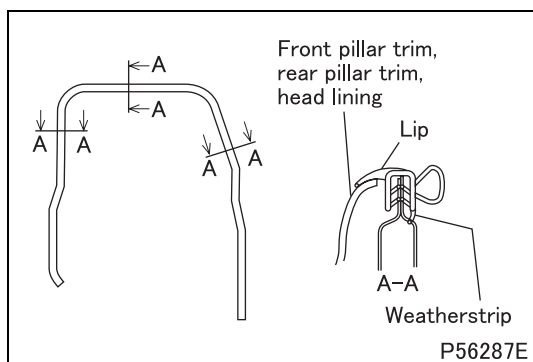
## ■ Installation: Weatherstrip

- Install the weatherstrip in such a manner that the lip of the strip holds down the front pillar trim, rear pillar trim, and head lining.

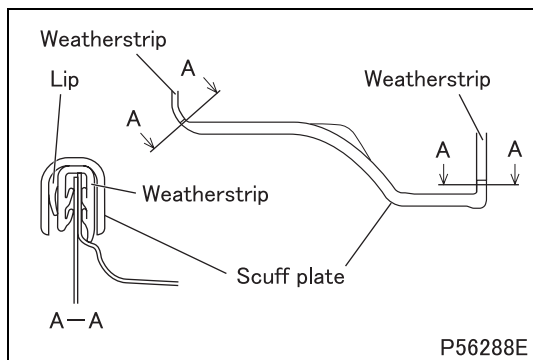
## ■ Installation: Scuff plate

- Install the scuff plate in such a manner that it holds down the lip of the weatherstrip.

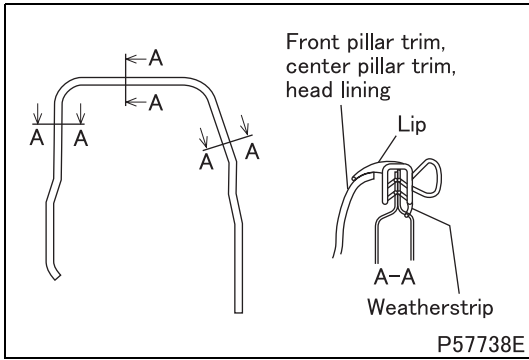
### ■ Installation: Weatherstrip

- Install the weatherstrip in such a manner that the lip of the strip holds down the front pillar trim, center pillar trim, and head lining.

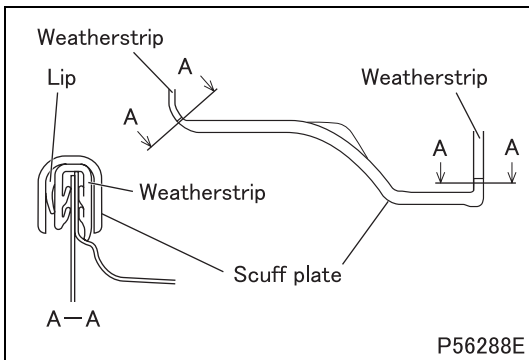
### ■ Installation: Scuff plate

- Install the scuff plate in such a manner that it holds down the lip of the weatherstrip.

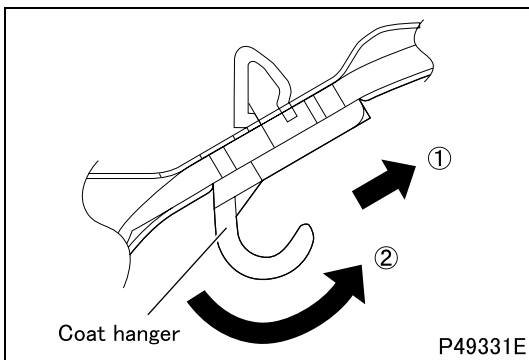
### ■ Removal: Coat hanger

- Remove the coat hanger from the head lining by pulling it in the direction of "2" while pressing it in the direction of "1".

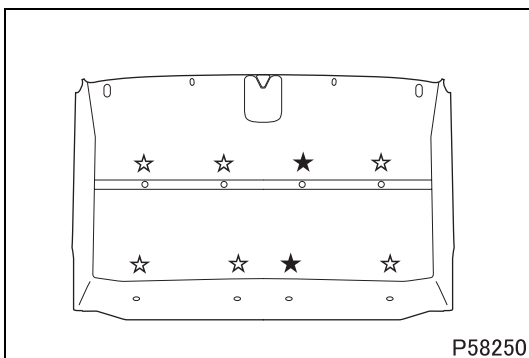
### ■ Installation: Head lining

- Locate the head lining correctly onto the cab by installing clips at the locations ★ (× 2). Install clips at the locations ☆ (× 6).

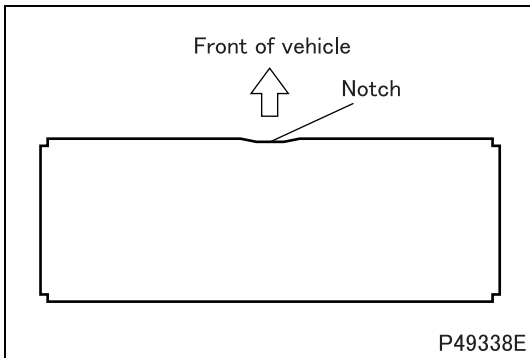
### ■ Installation: Center head lining

- On a standard-cab-width vehicle, install the center head lining with its edges directed as shown in the illustration.

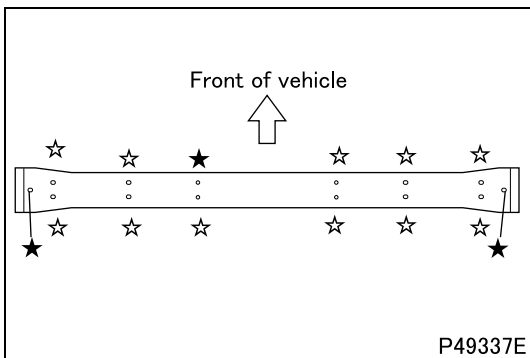
### ■ Installation: Rear roof garnish

- Locate the rear roof garnish correctly onto the cab by installing clips at the locations ★ (× 3). Install clips at the locations ★ (× 11).

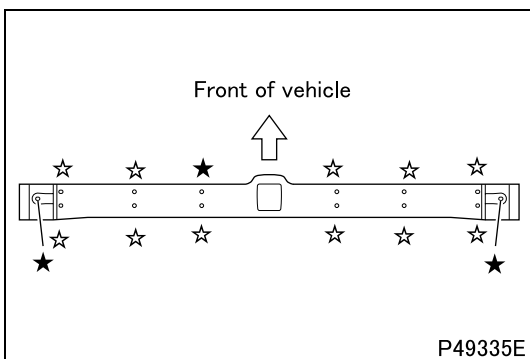
### ■ Installation: Center roof garnish

- Locate the center roof garnish correctly onto the cab by installing clips at the locations ★ (× 3). Install clips at the locations ★ (× 11).

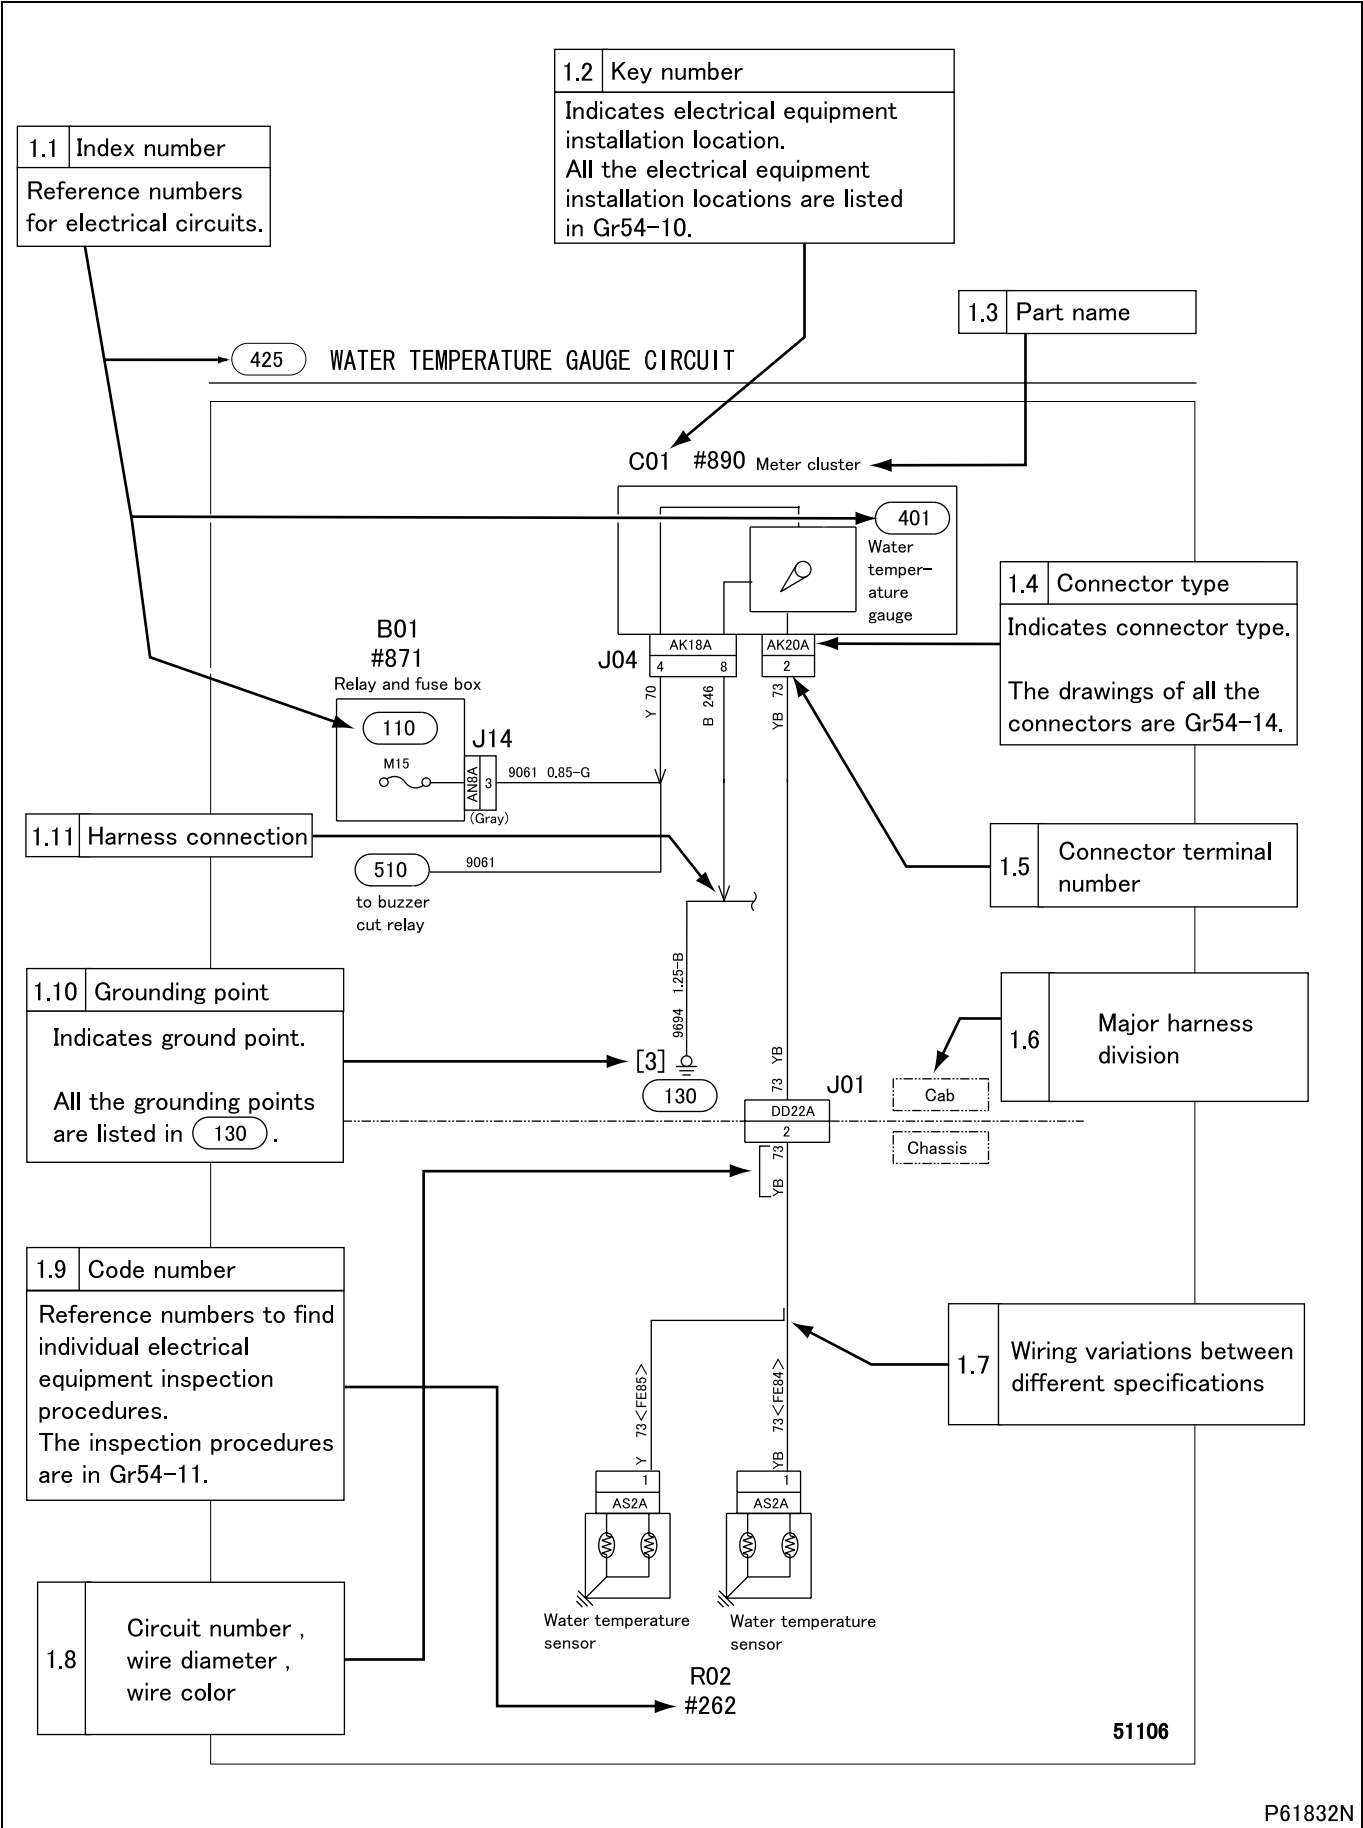
## HOW TO READ CIRCUITS (ELECTRICAL)

## 1.1 Index number: (100) to (999)

- Index numbers are used as reference numbers for electrical circuits. Each electrical circuit has been assigned its own index number.

- Key numbers indicate parts installation locations. The installation location of a part can be easily found using its key number shown in a circuit diagram.  
All of the electrical equipment installation locations are listed in Gr54-10.

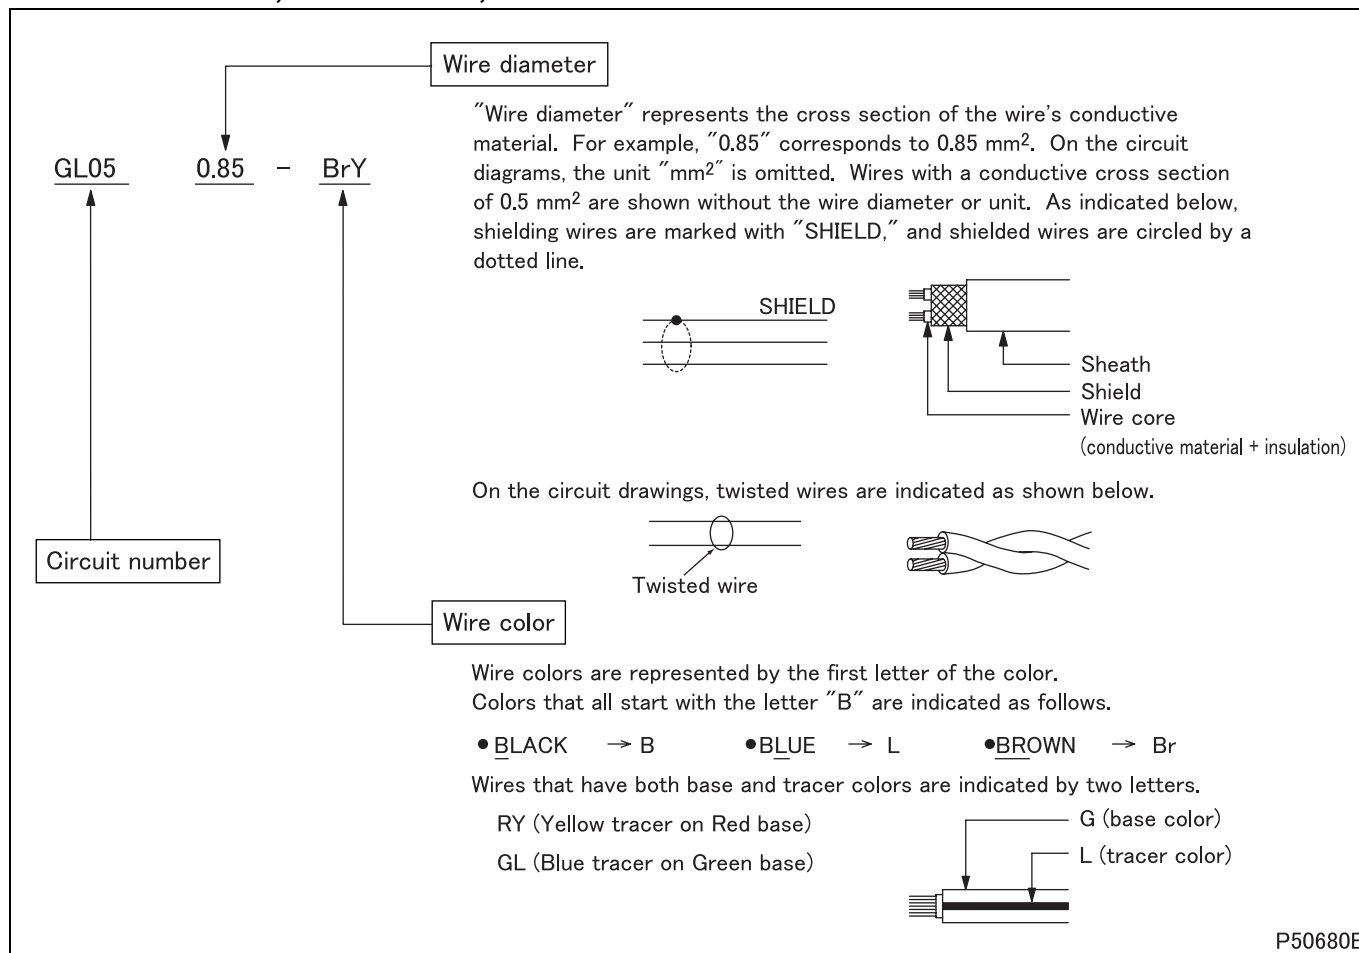
## 1.8 Circuit number, wire diameter, wire color

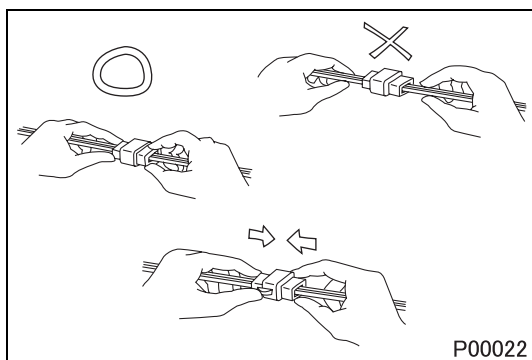
- When separating connectors, grasp the connectors themselves rather than the harnesses.
- To separate locking connectors, first push them in the direction of the arrows. To reconnect locking connectors, push them together until they click.

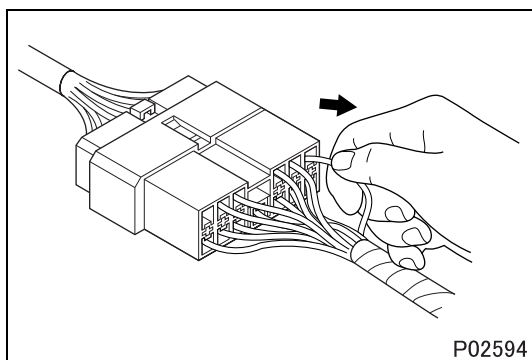
## (2) Checking for loose terminals

- If connector terminal retainers become damaged, male and female terminals may not mate with each other when the connector bodies are fitted together. To check for such terminals, gently pull each wire and see whether any terminals slip out of their connector housings.
