# FE.FG

## SERVICE MANUAL 2008 Model FOREWORD

This Service Manual contains maintenance and repair methods for the Mitsubishi Fuso Truck FE. FG Series. Read this manual carefully as an aid in providing correct, efficient maintenance. Please note that the information and specifications contained within this manual may change without notice. This is due to product modifications and continued vehicle improvements that are made throughout the model years. Should you encounter any discrepancy in the information provided, please do not hesitate to contact your nearest Mitsubishi Fuso Dealer or Mitsubishi Fuso Truck of America, Inc.

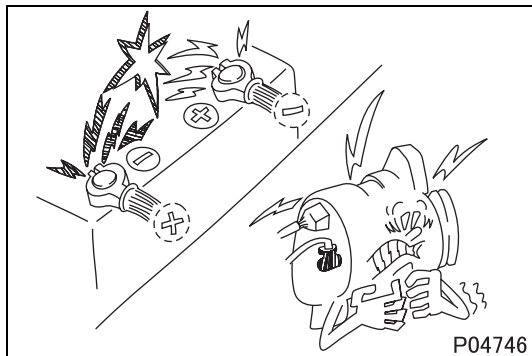
- When servicing alternators, observe the following precautions:
  - Never reverse the polarity of battery connections.  
If the polarity of the battery connections were to be reversed, a large current would flow from the battery to the alternator, damaging the diodes and regulator.

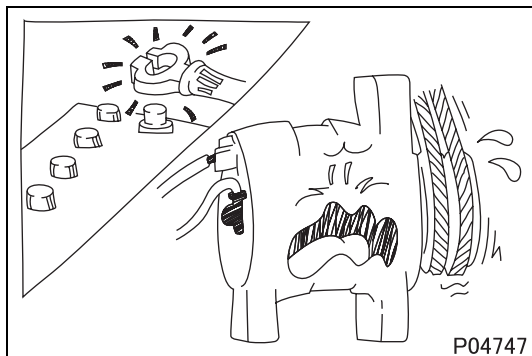
- Never disconnect the battery cables with the engine running.  
Disconnection of the battery cables during engine operation would cause a surge voltage, leading to deterioration of the diodes and regulator.

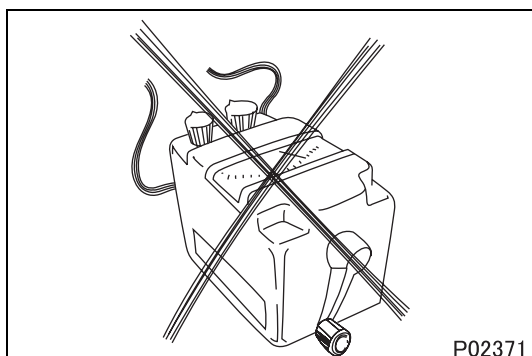
- Never perform inspections using a high-voltage multimeter.  
The use of a high-voltage multimeter could damage the diodes and regulator.

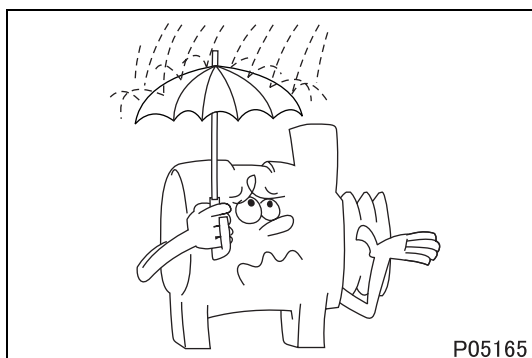
- Keep alternators dry.  
Water on alternators can cause internal short circuits and damage.

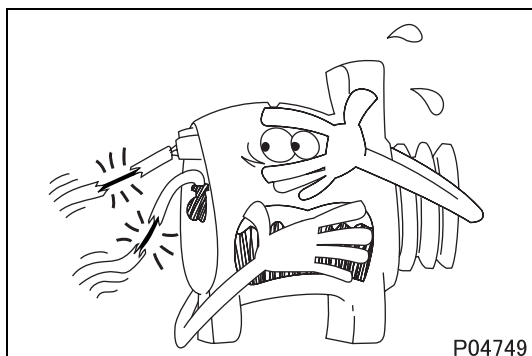
- Never operate an alternator with the B and L terminals short-circuited. Operation with the B and L terminals connected together would damage the diode trio.

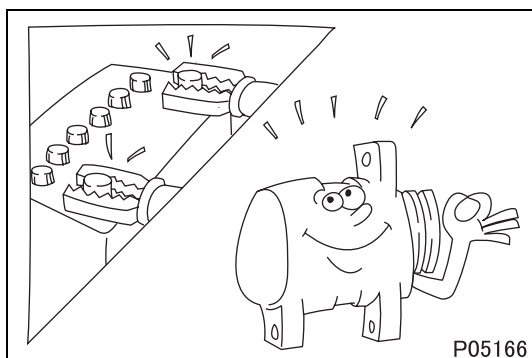
- Disconnect the battery cables (+) and (–) before quick-charging the battery with a quick charger. Unless the battery cables are disconnected, quick-charging can damage the diodes and regulator.

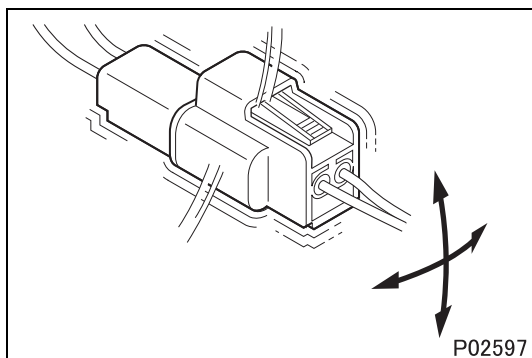
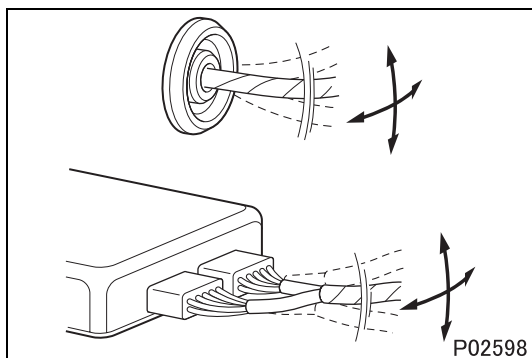
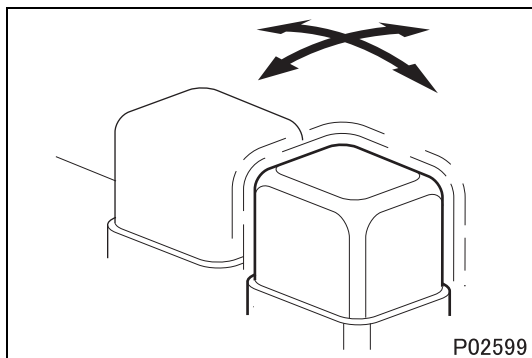
- An intermittent fault typically occurs only under certain operating conditions. Once these conditions have been identified, the cause of the intermittent fault can be ascertained easily. First, ask the customer about the vehicle operating conditions and weather conditions under which the fault occurs. Also ask about the frequency with which the fault occurs and about the fault symptoms. Then, reproduce the fault based on this information. In accordance with the conditions under which the fault occurs, determine whether the fault is caused by vibration, heat or other factors. If vibration is a possible factor, see if the fault can be reproduced by performing the following checks on individual connectors and other parts:

- Gently move connectors up and down and to left and right.
  - Gently move wiring harnesses up and down and to left and right.
  - Gently wiggle sensors and other devices by hand.

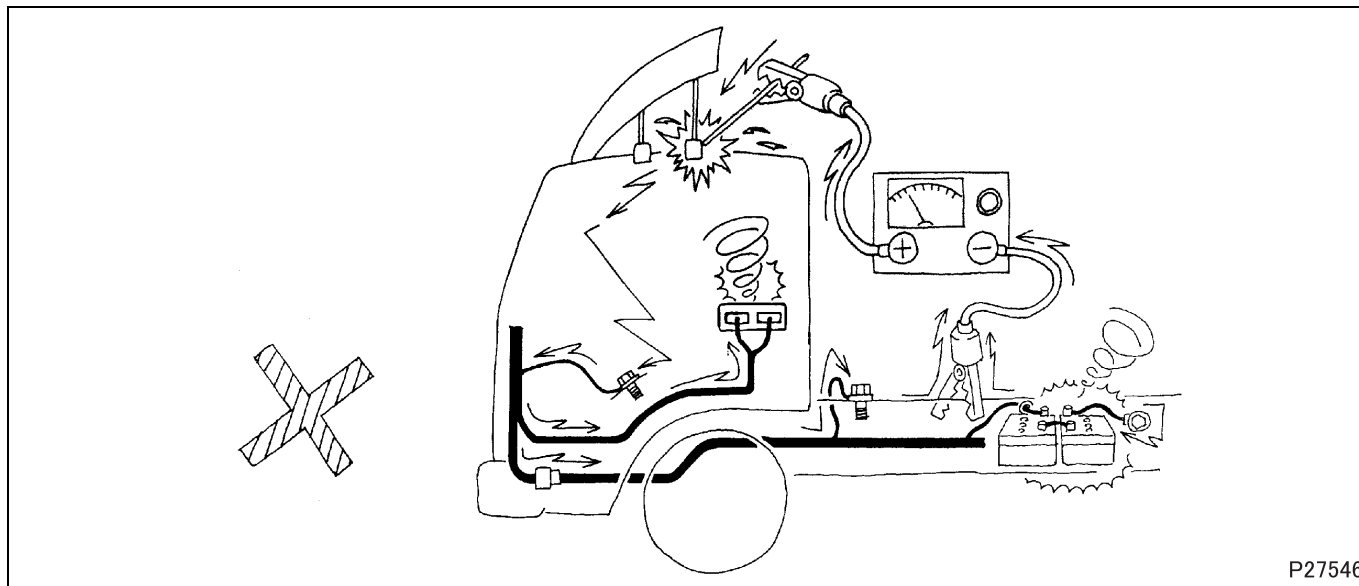
P27546

- When arc welding is performed, current from the welder flows to ground via the vehicle's metal parts. Unless appropriate steps are taken, this current can damage control units, other electrical devices and wiring harnesses. And any electrical device near the point on the vehicle to which the (–) cable of the welder is connected, might be largely damaged.

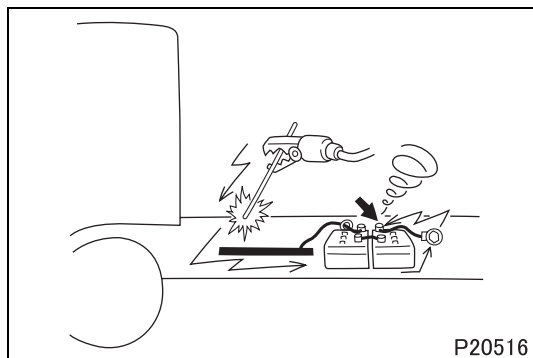
P20516

- Current flows backward as shown below.

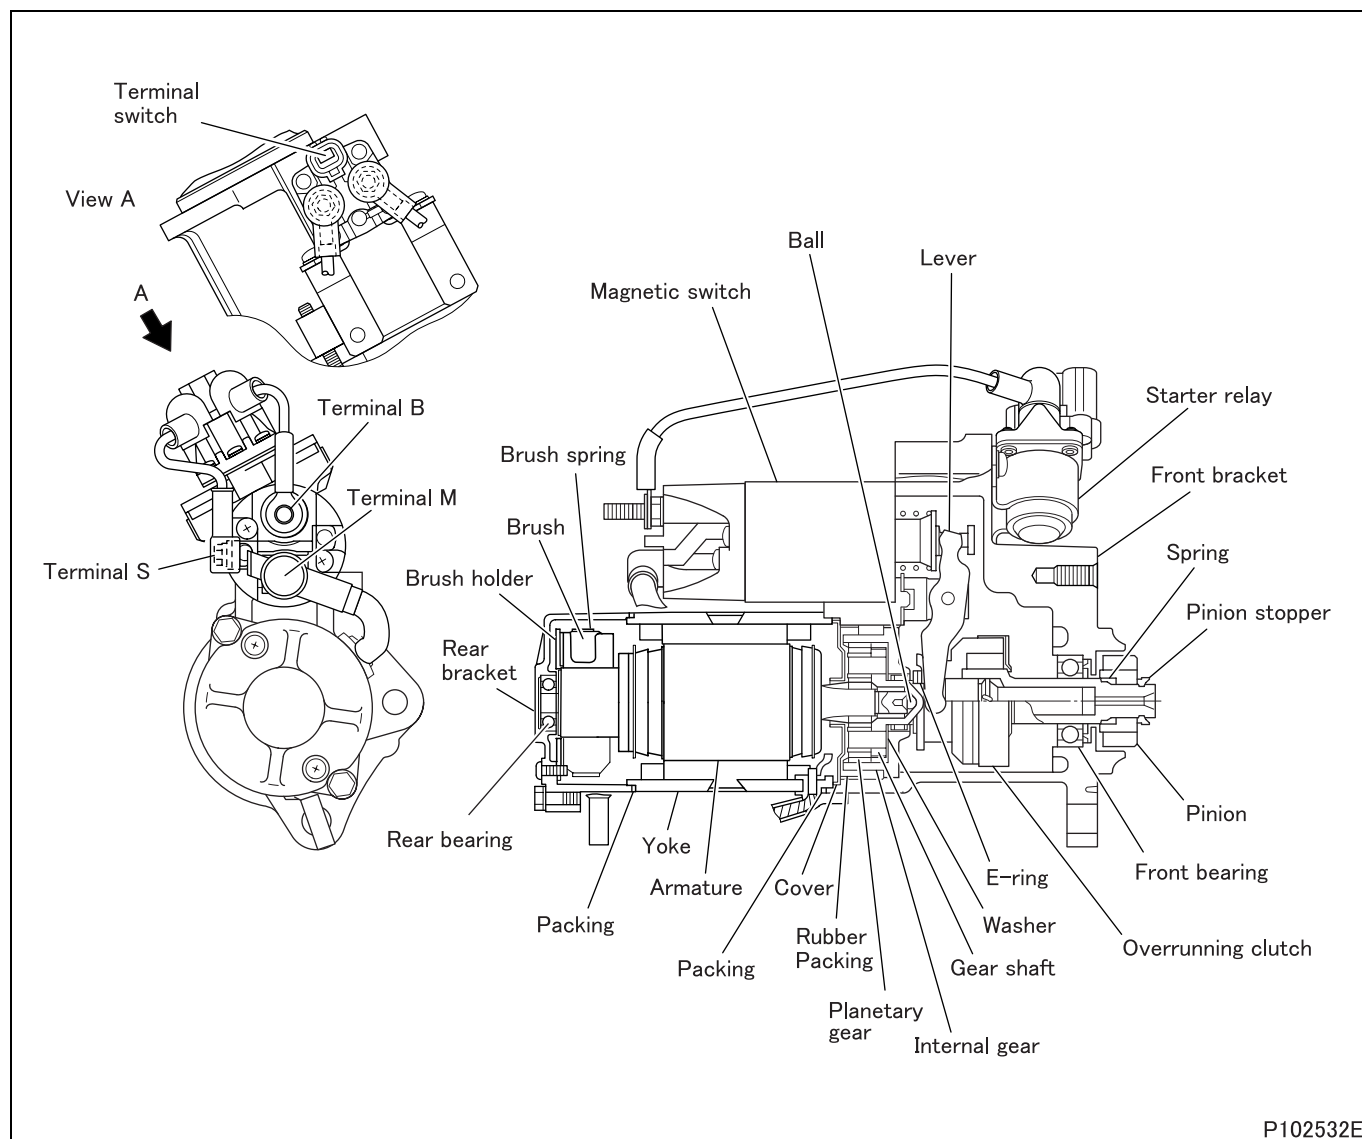
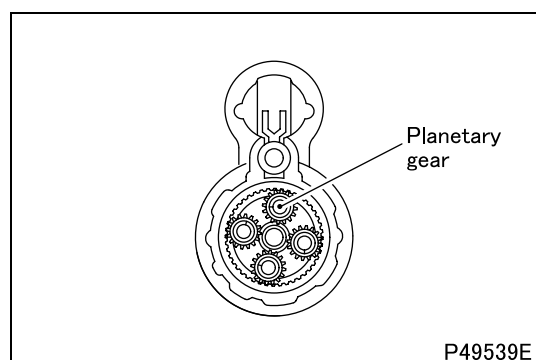
## 1. Starter

- This starter uses planetary gears as its reduction gearing mechanism.

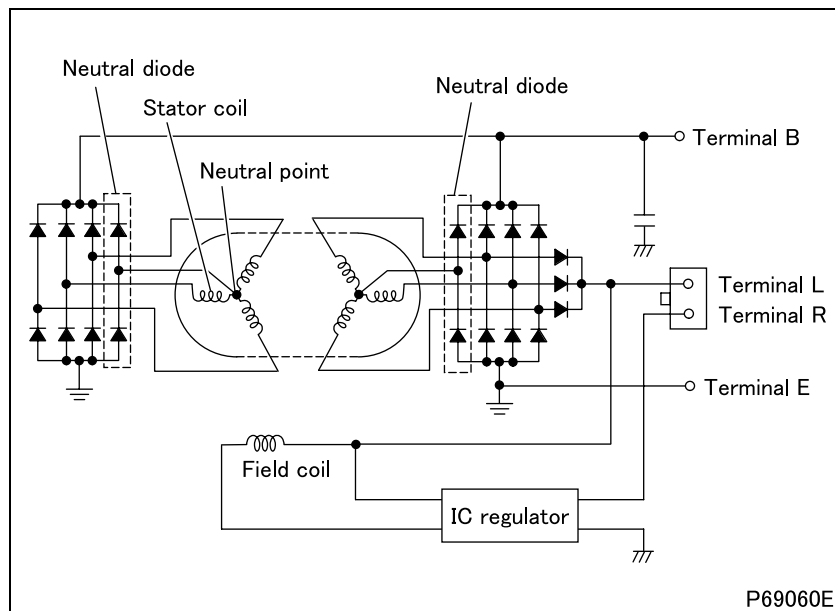
## 2.1 Alternator with neutral diodes

- The alternator is the same as the current alternator except that neutral diodes have been added.
- These neutral diodes enable this alternator to provide higher DC output during operation at high speeds than the alternator without neutral diodes.

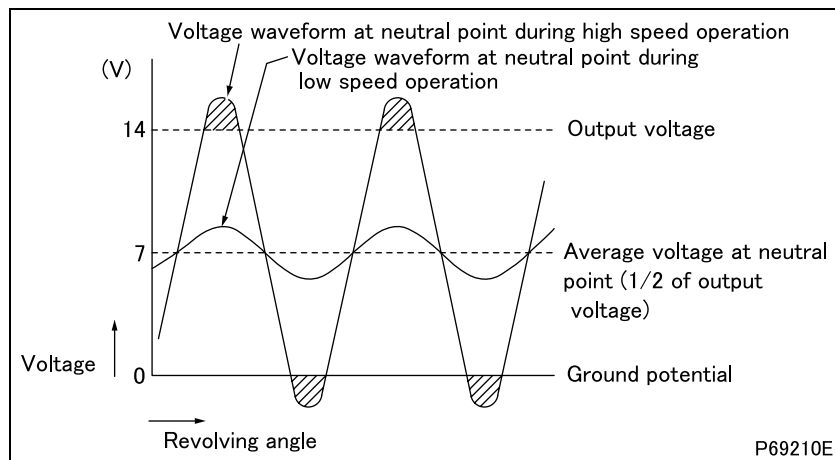
### (2) Variations of voltage at neutral point and operation of neutral diodes

- The potential at the neutral point varies up and down with the neutral point DC voltage ( $1/2$  of output voltage) as a center as shown.
- When the alternator is operated at high speeds, the voltage at the neutral point can increase to exceed the output voltage (14V) and decrease to become lower than the ground voltage (0V). To adjust these over-voltage and under-voltage (shaded portions of diagram) the current from the excess voltages is taken by neutral diodes and added to the DC output.

- When the voltage at neutral point is in the range from 0 to 14V, the other six diodes are operated. Neutral diodes are not operated.

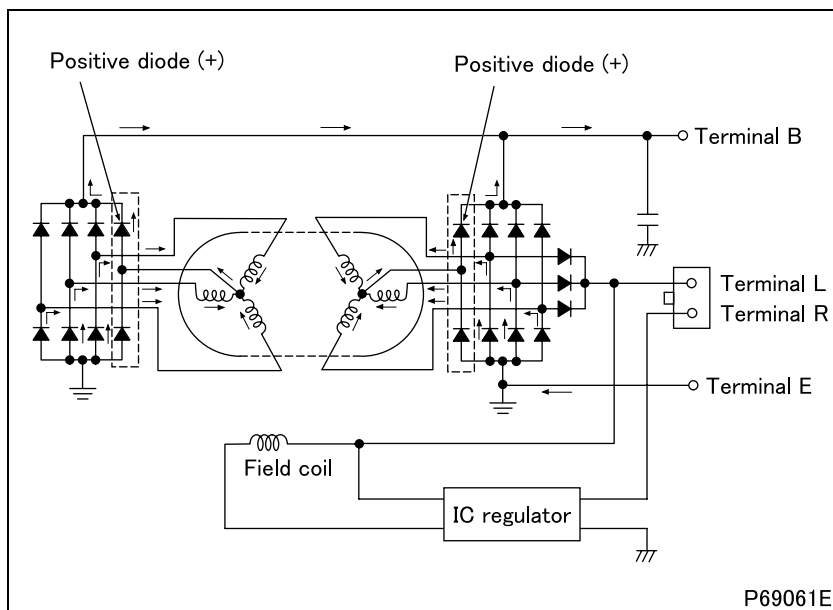
**(3) When the voltage at neutral point exceeds 14V**

- The positive diode (+) adds extra output to the DC output for supply to each electric equipment.

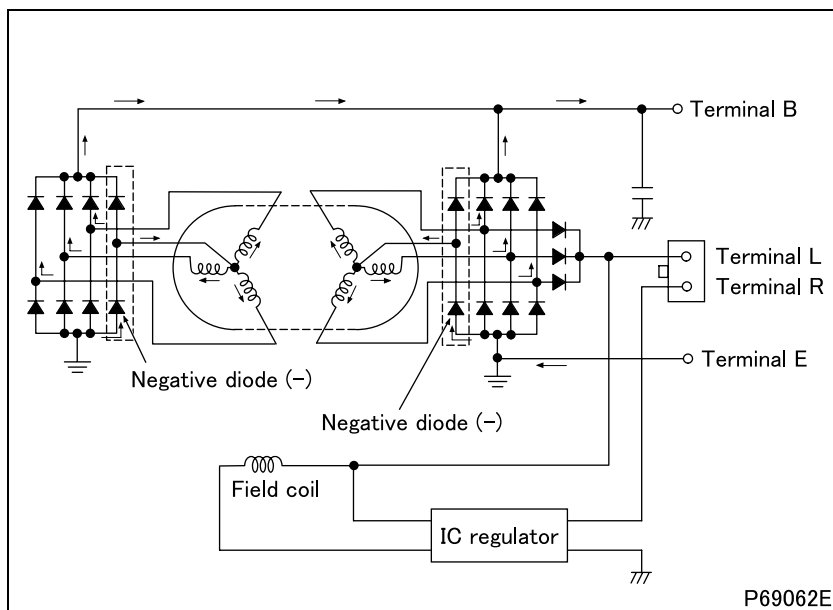
**(4) When the voltage at neutral point drops below 0V**

- The negative diode (-) supplies the output from neutral point through other three diodes.

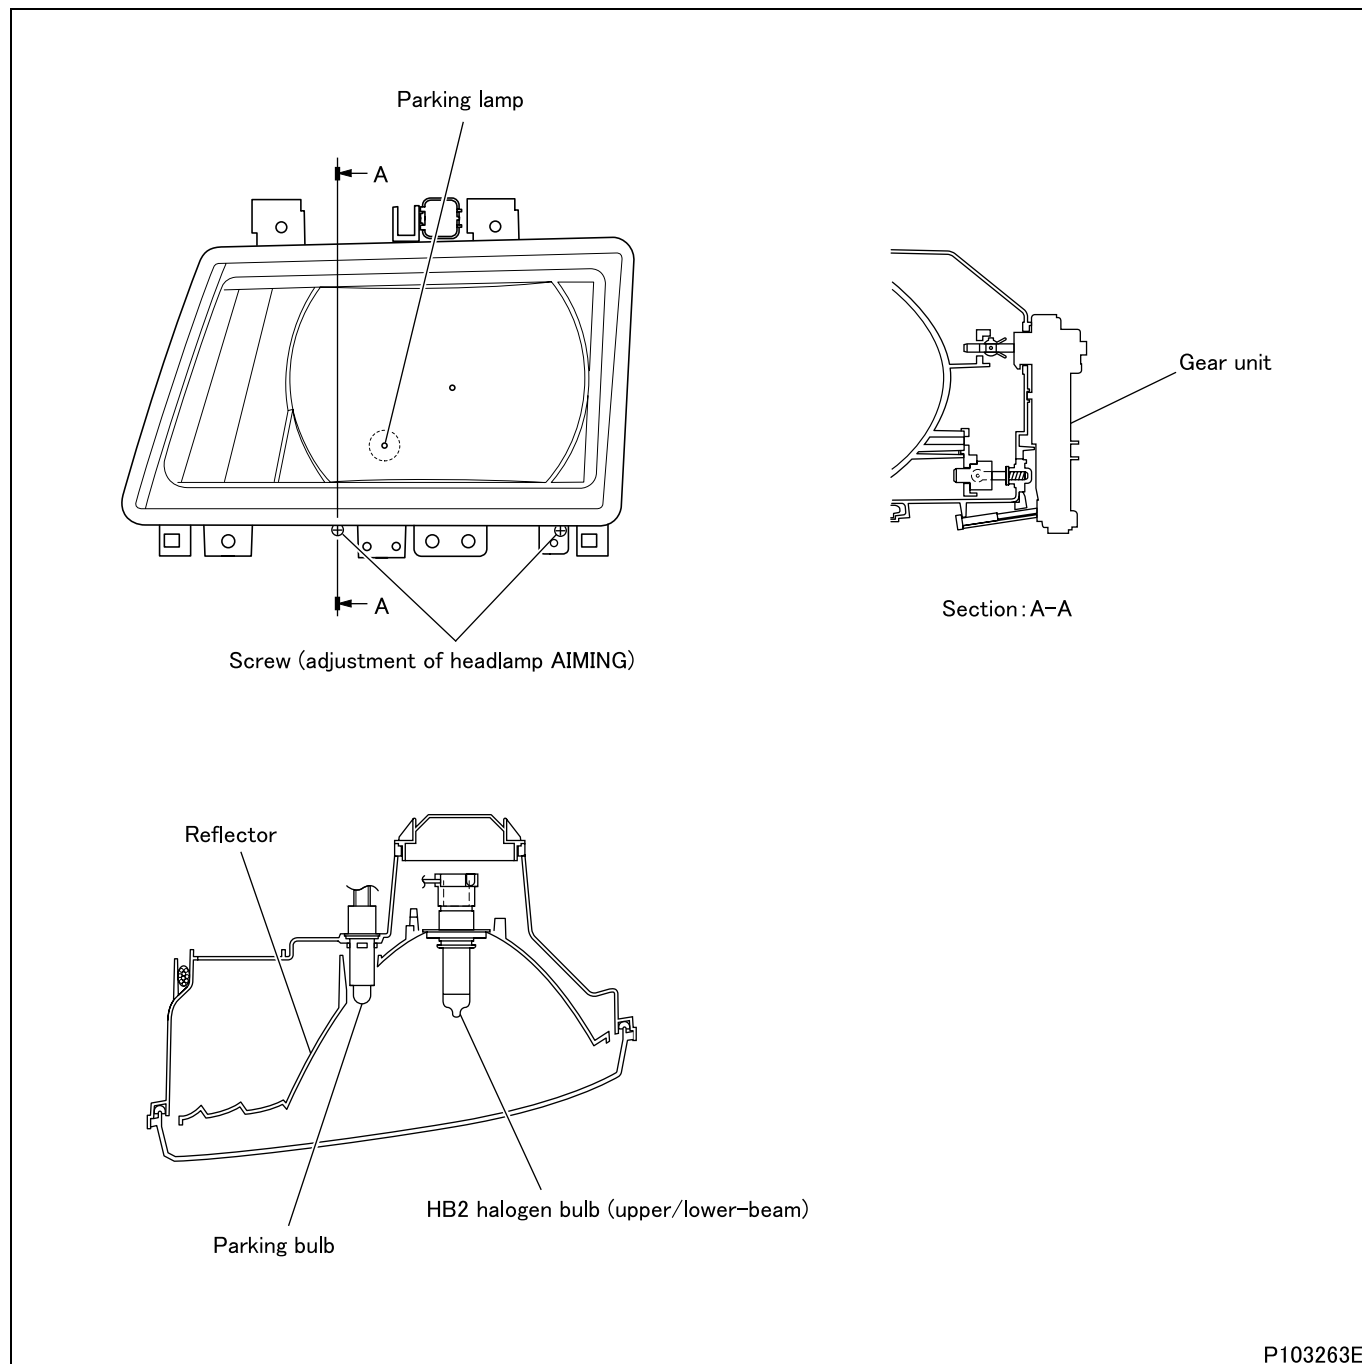
## 3. Headlamps

(Left headlamps are shown in this illustration)

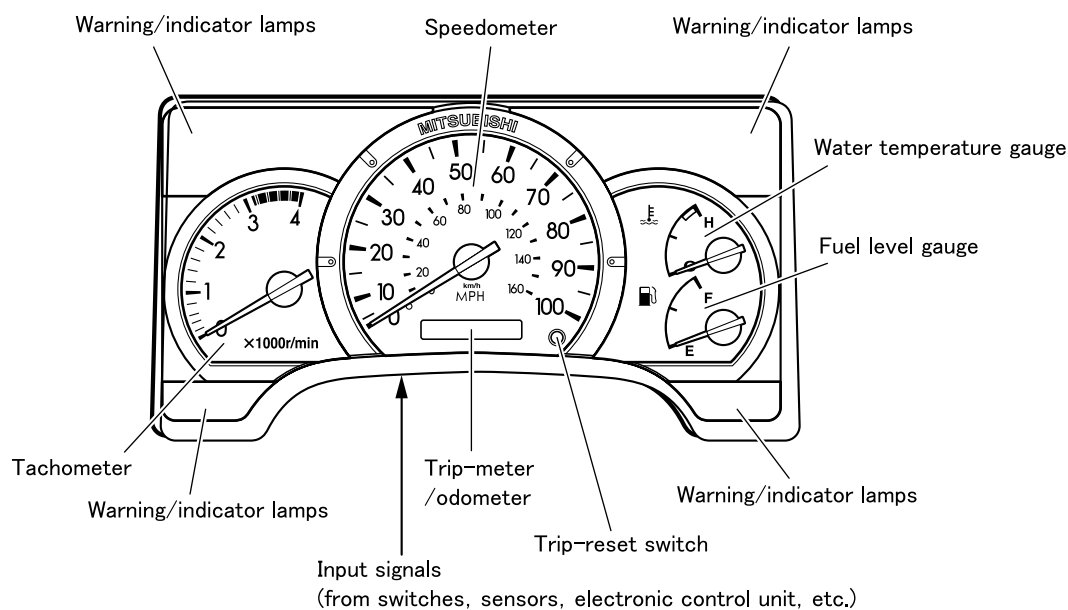
P64157E

<Manual transmission>

- The meter cluster incorporates a CPU, which contains the lighting and alarm control (LAC) function, learning function, and self-diagnosis function.

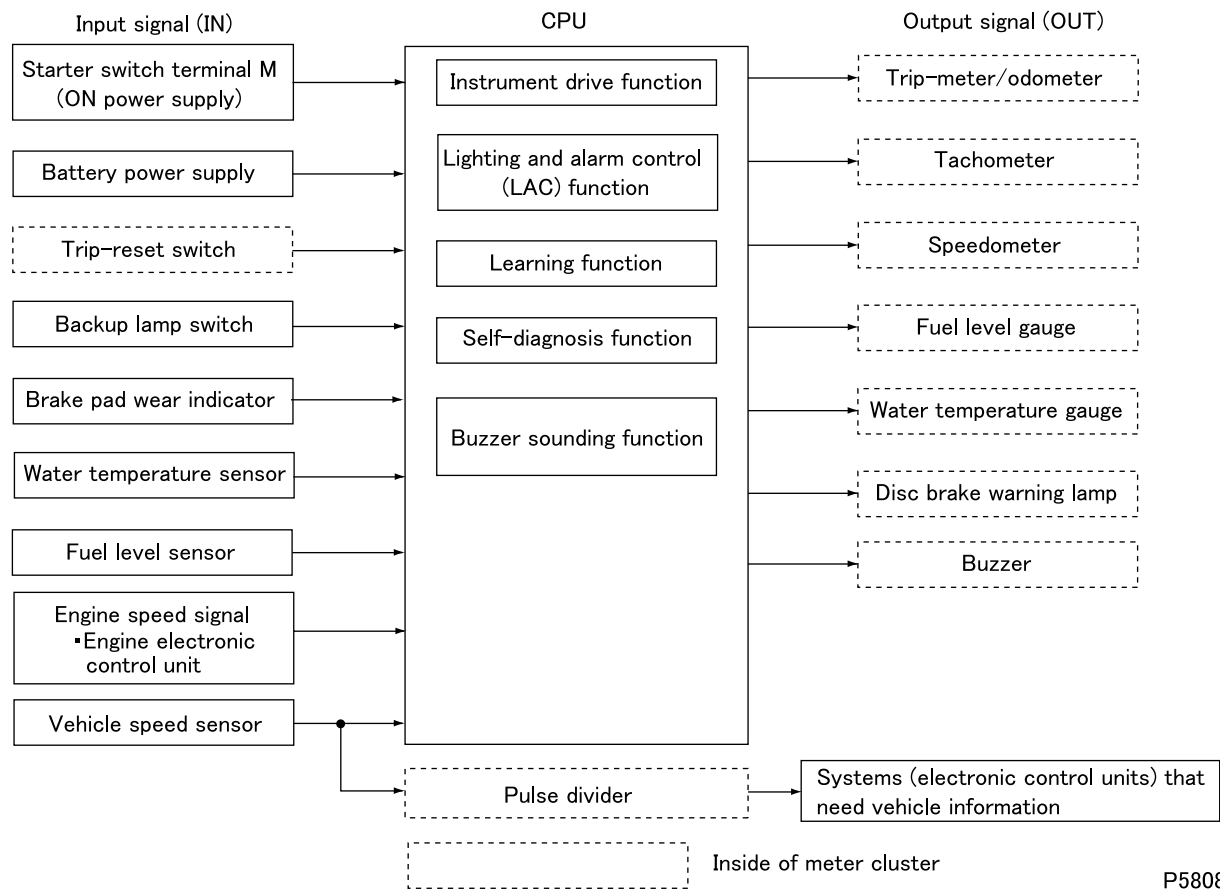
P58089E

## 4.1 Electronic control unit in the meter cluster system block diagram

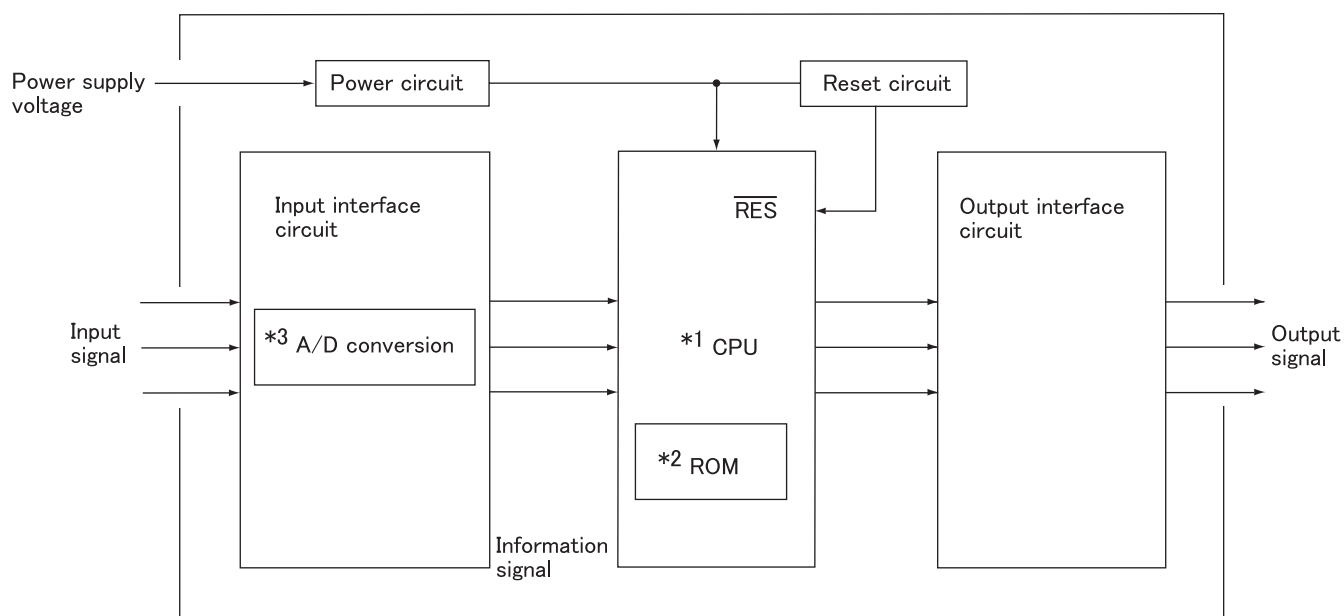
P57494E

### (1) Internal structure of LAC

- Internally, the LAC is essentially made up of the input interface circuit, \*<sup>1</sup>CPU, \*<sup>2</sup>ROM, and output interface circuit.
  - \*<sup>1</sup>CPU:  
An abbreviation for Central Processing Unit. It compares the input information and the information stored in the ROM, makes a decision and sends commands to the outputs.

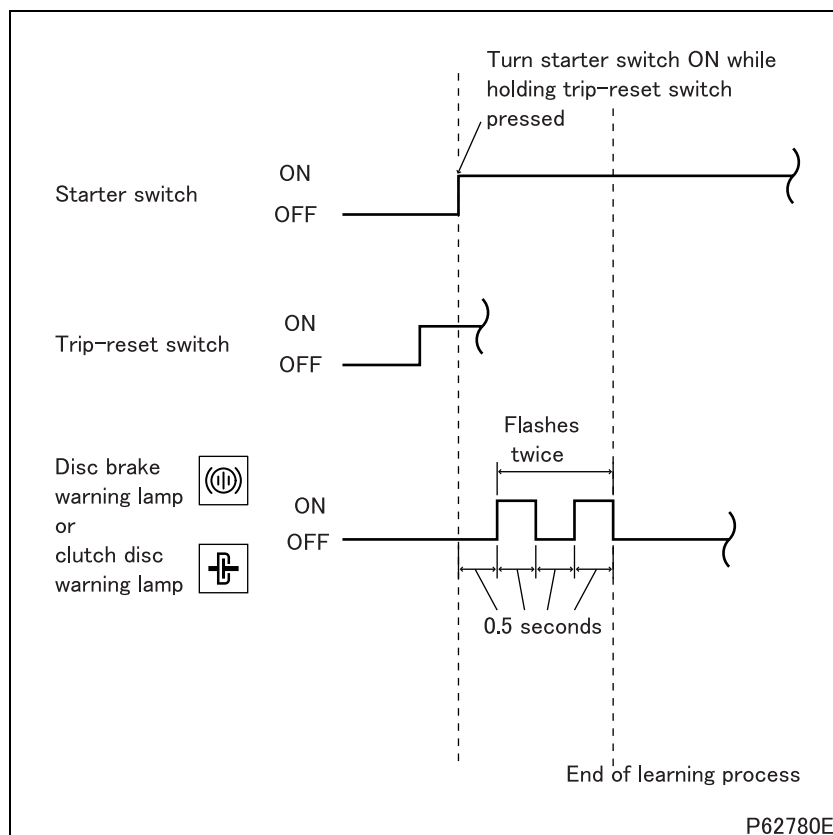
#### (2) Learning operation for odometer reading of less than 3 km

- Turn the starter switch to ON while holding the trip-reset switch pressed, then release the reset switch.
- After 0.5 seconds, the disc brake warning lamp or clutch disc warning lamp will flash twice, indicating completion of the learning process.
- If the vehicle is not equipped with the brake pad wear indicator or clutch disc wear indicator switch, the corresponding warning lamp does not flash.

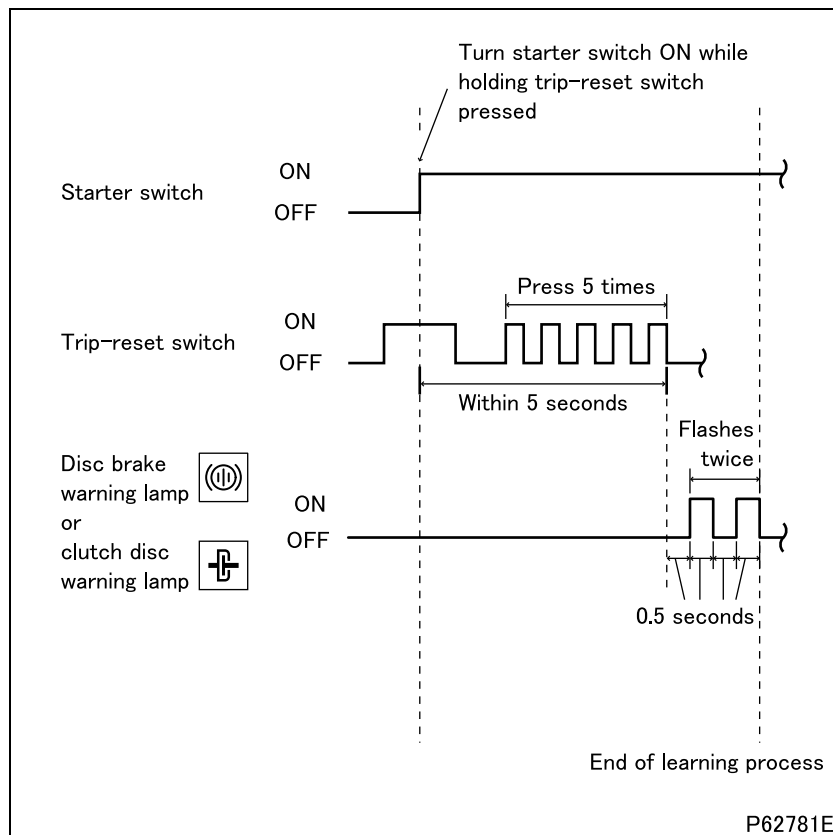
## (3) Learning operation for odometer reading of 3 km or more

- Turn the starter switch to ON while holding the trip-reset switch pressed, then release the reset switch.
- Within 5 seconds after turning the starter switch to ON, press again the trip-reset switch 5 times.
- After 0.5 seconds, the disc brake warning lamp or clutch disc warning lamp will flash twice, indicating completion of the learning process.
- If the vehicle is not equipped with the brake pad wear indicator or clutch disc wear indicator switch, the corresponding warning lamp does not flash.

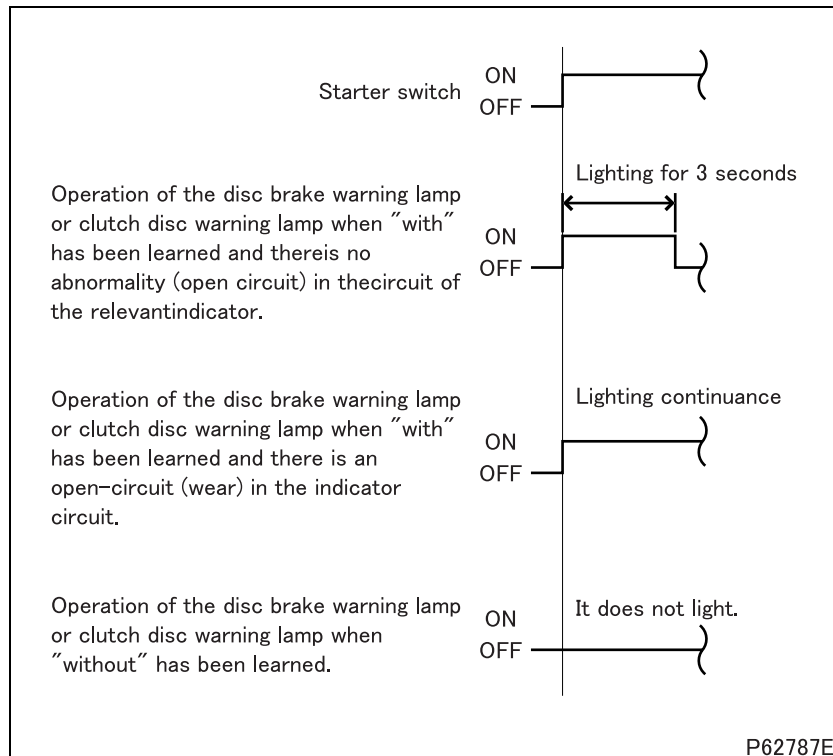
- After every learning operation, turn the starter switch to OFF and then to ON again to make sure that the indicator lamp for which "equipment" has been learnt illuminates.

- The open-circuit checking function checks that the indicator lamp(s) for which "equipment" has been learned illuminates normally when the starter switch is turned to ON.

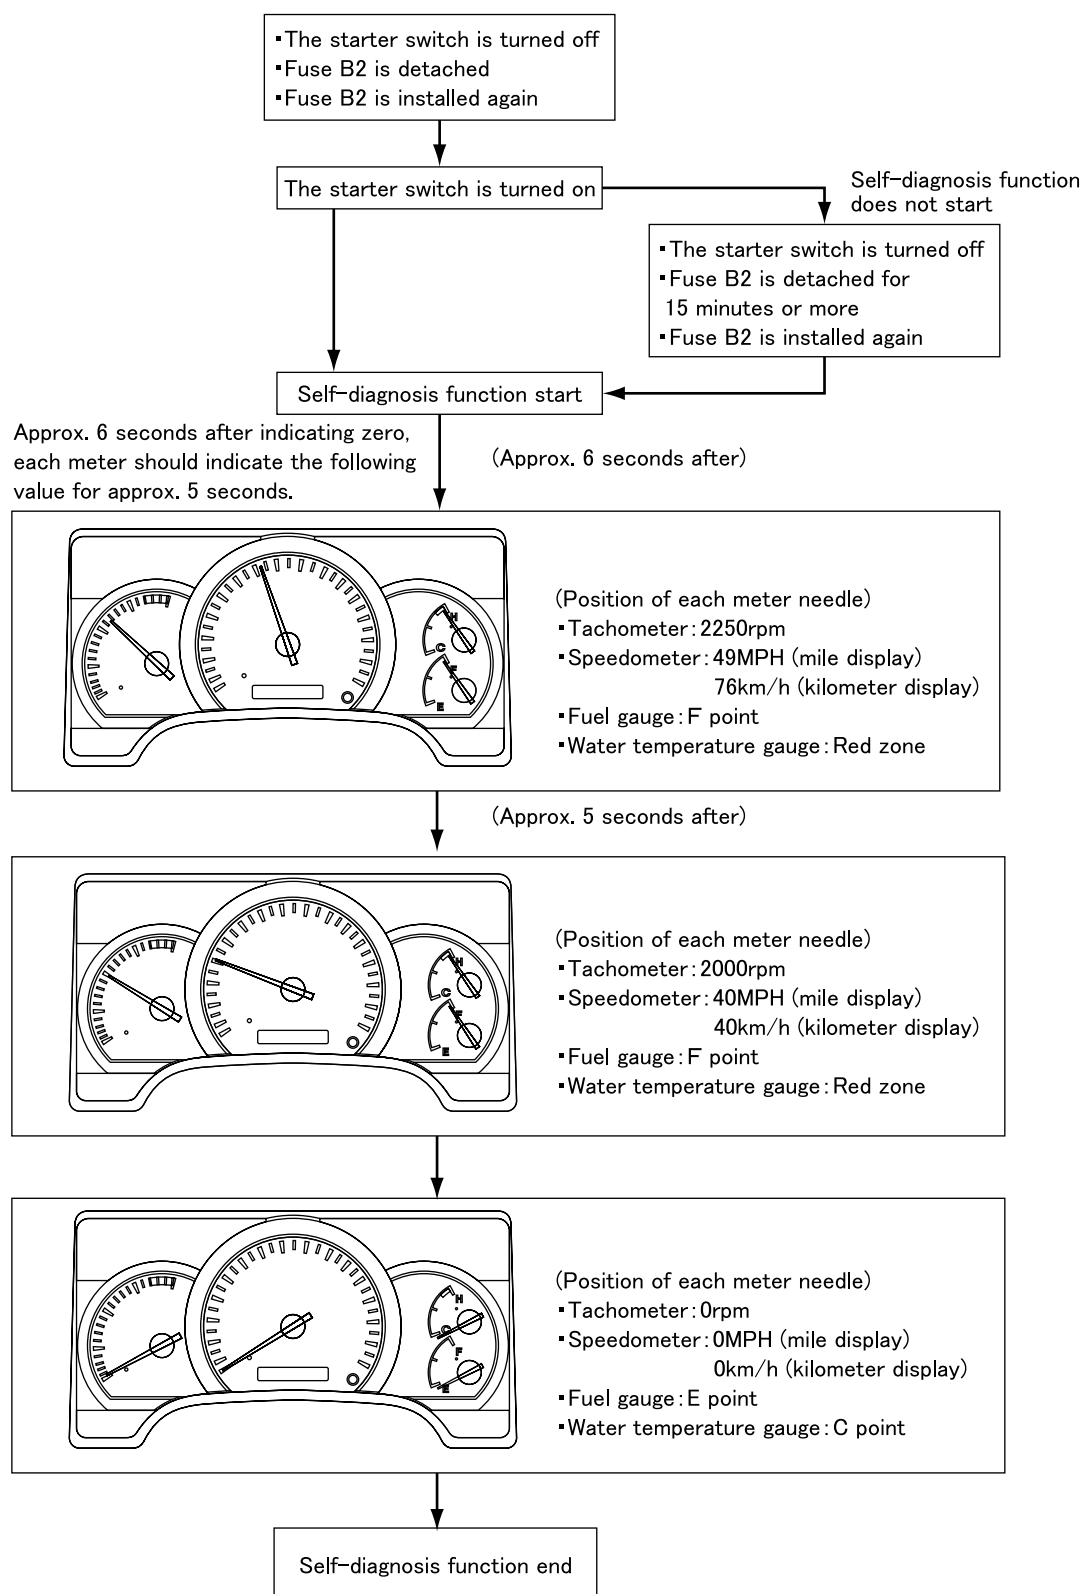
- This function is used to check meters in the meter cluster for normal operation when the meter cluster is replaced.

- If any meter does not function as follows, the meter cluster may be faulty.

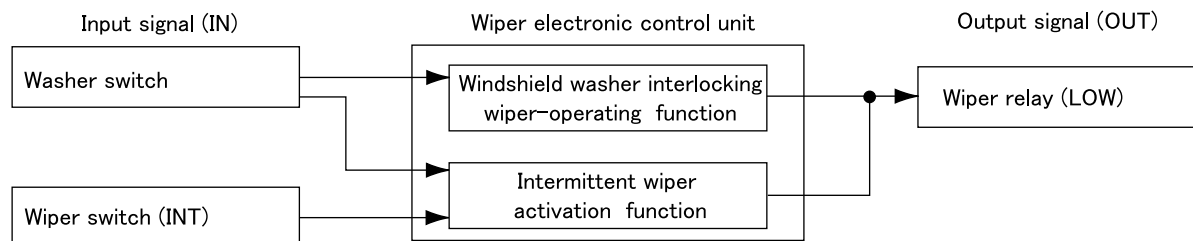
P58030E

- This wiper electronic control unit is an integrated control unit controlling the following functions.
  - Windshield washer interlocking wiper-operating function.
  - Intermittent wiper activation function.

#### (1) System function schematic

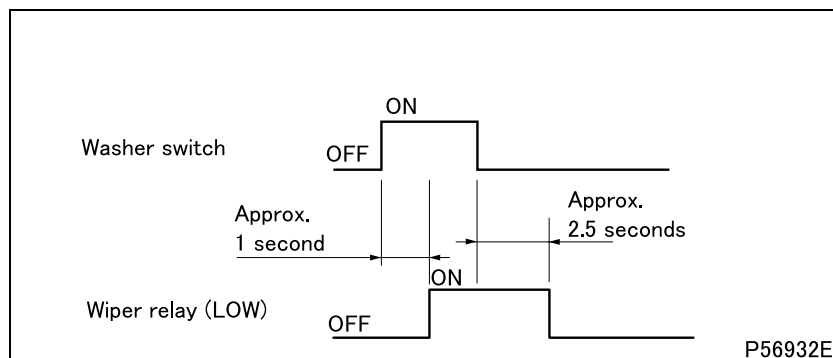
P56932E

### 6.2 Windshield washer interlocking wiper-operating function

- This function causes the windshield wipers to operate a few times at low speed when the windshield washer switch is turned ON.
- As shown in the drawing, the wiper electronic control unit introduces a short delay between detecting the ON condition of the wiper and washer switch (washer switch) and activating the wiper relay.

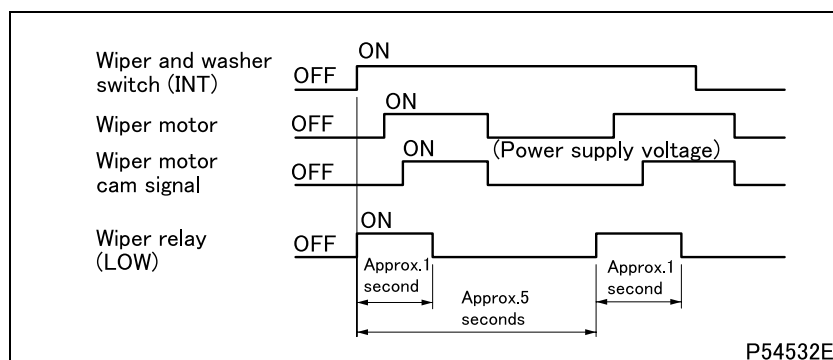
P54532E

### 6.3 Intermittent wiper activation function

- Wiper electronic control unit causes intermittent wiper operation to take place as shown in the drawing.

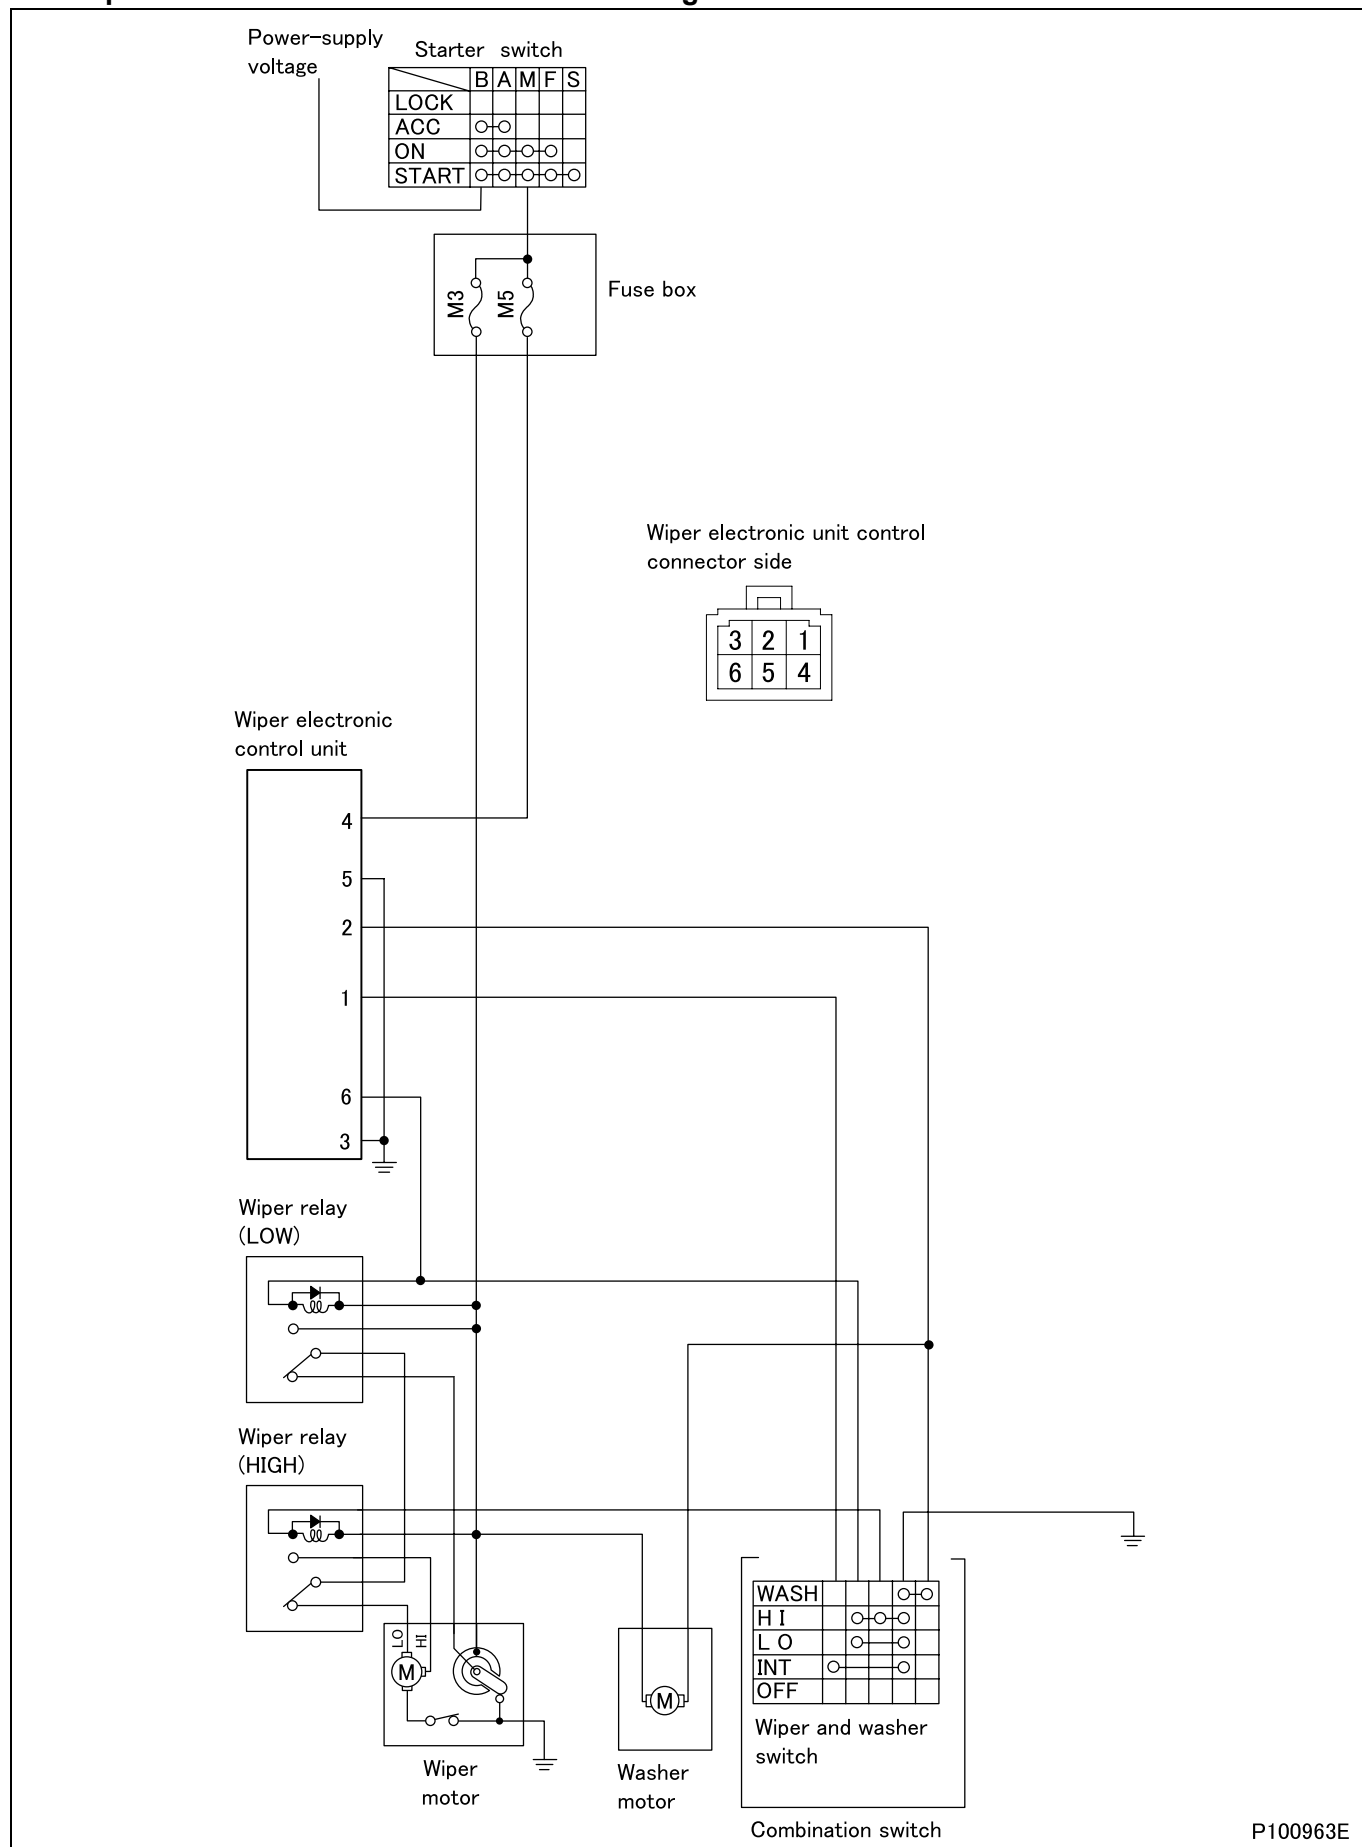
## 6.4 Wiper electronic control unit connection diagram

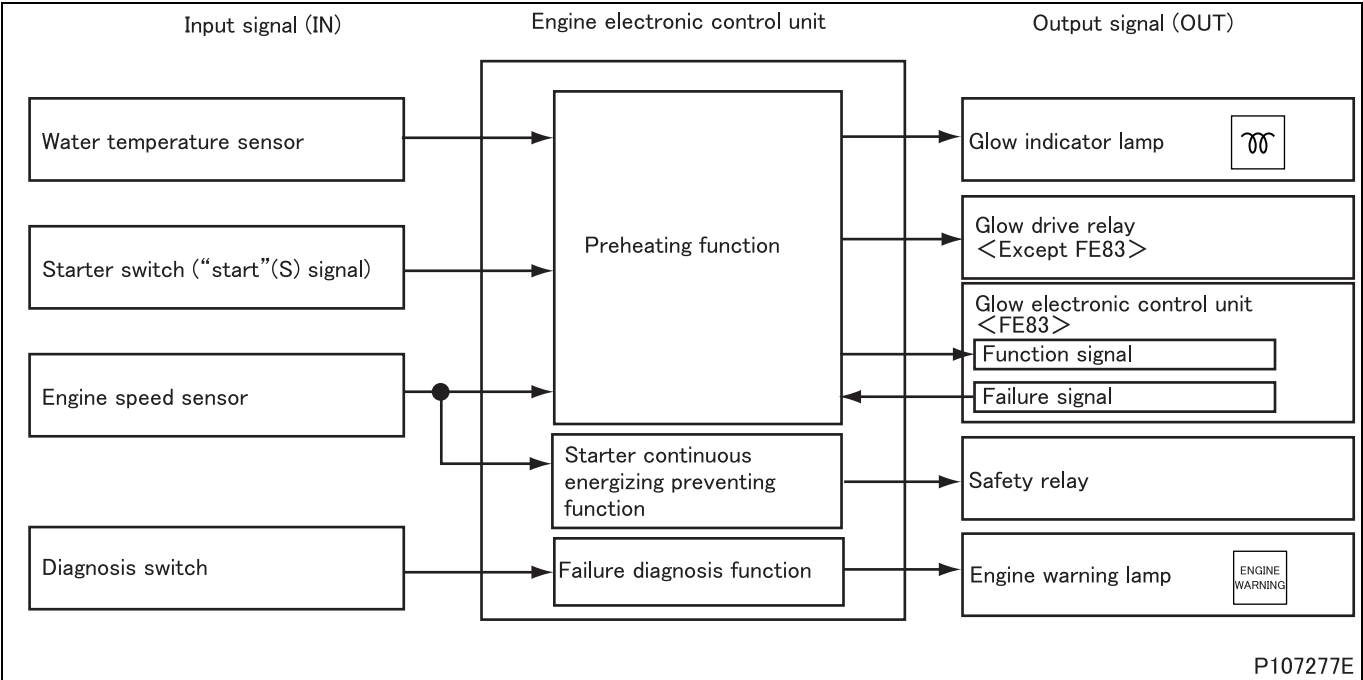
#### (1) System function schematic

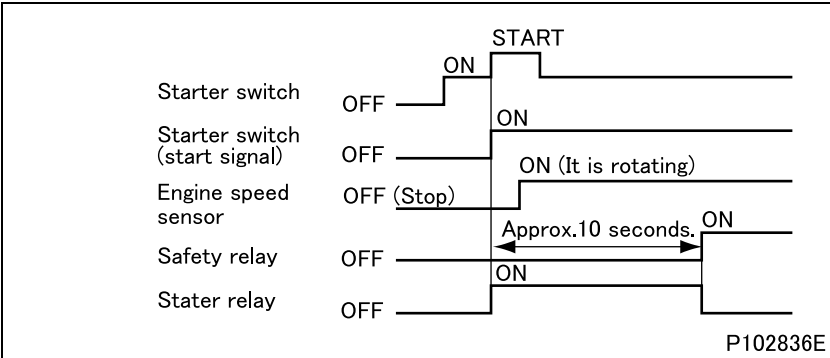
### 7.2 Starter continuous energizing preventing function

- This function is provided to prevent starter over-run.
- If the starter operates for longer than a predetermined period following engine startup, the Engine electronic control unit deems that it has been energized continuously for too long. The Engine electronic control unit then stops the flow of current to the starter and starter relay, thereby preventing the starter from seizing.

- If the engine electronic control unit determines, based on the engine speed signal it receives, that the engine has run at or above the specified speed for longer than the specified time period after start-up, the unit trips the safety relay open.

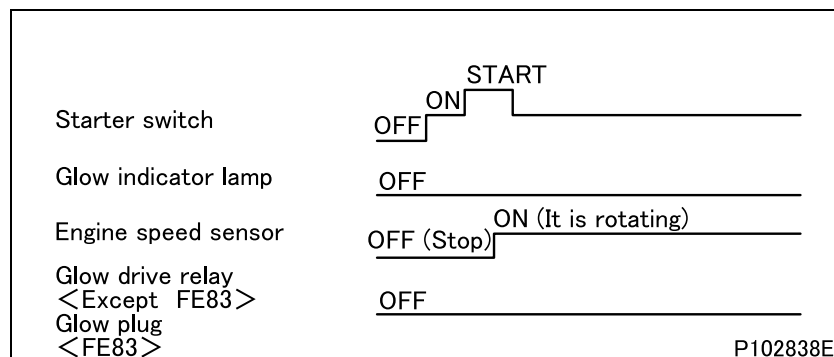
#### (1) Pre-glow and After-glow

The preheating is operated with a pre-glow before the engine starts and an after-glow after the engine starts. They are controlled by the starter switch (S terminal) signal, engine water temperature signal and the engine speed signal.

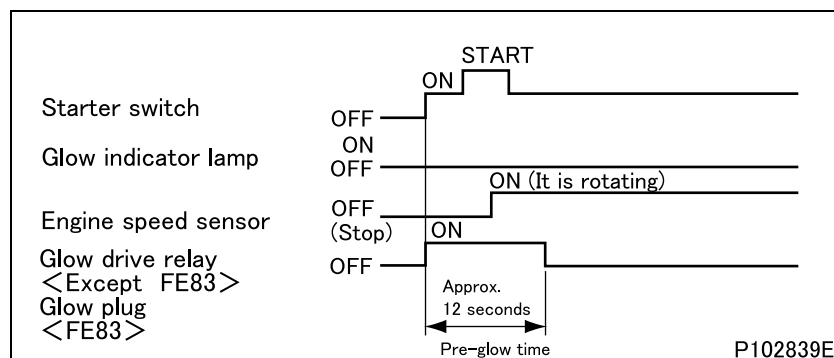
#### (2) Operation mode

- When the engine coolant temperature is 60°C {140°F} or more.
- When the engine coolant temperature is 0 to 60°C {32 to 140°F}.

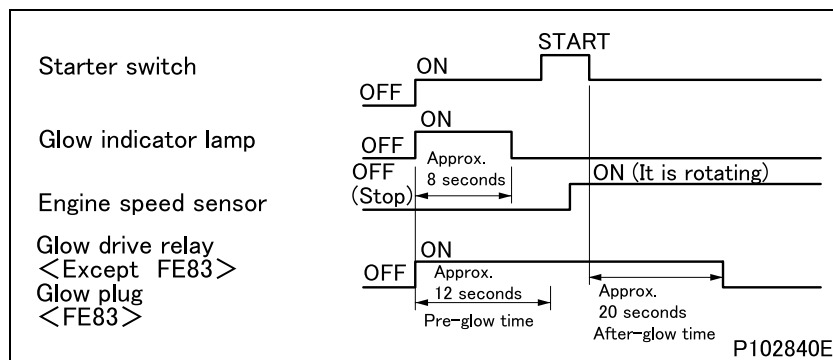
- When the engine coolant temperature is 0°C {32°F} or less.
