# FE.FG

## SERVICE MANUAL 2008 Model FOREWORD

This Service Manual contains maintenance and repair methods for the Mitsubishi Fuso Truck FE. FG Series. Read this manual carefully as an aid in providing correct, efficient maintenance. Please note that the information and specifications contained within this manual may change without notice. This is due to product modifications and continued vehicle improvements that are made throughout the model years. Should you encounter any discrepancy in the information provided, please do not hesitate to contact your nearest Mitsubishi Fuso Dealer or Mitsubishi Fuso Truck of America, Inc.

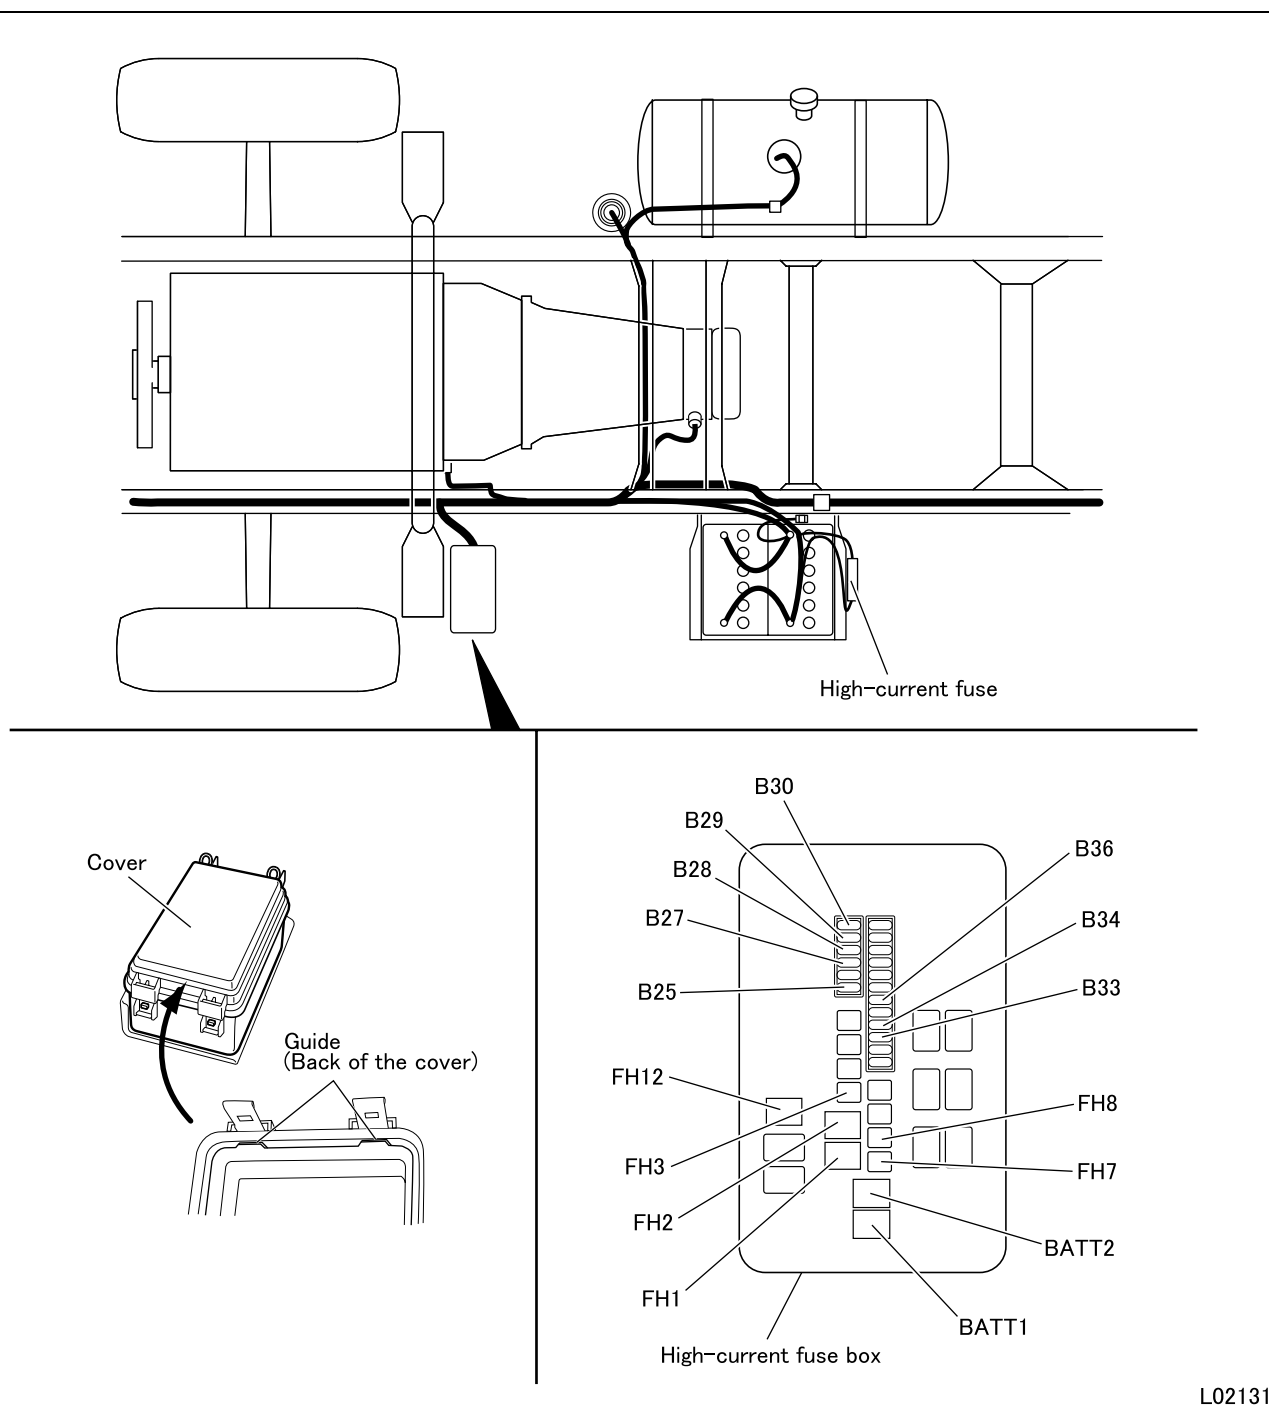
# HIGH-CURRENT FUSE BOX

- To prevent possible injury, be sure to disconnect the negative (–) cable of the battery and insulate it with tape before removing high-current fuses.

- With the negative (–) cable of the battery connected, some high-current fuses are always under battery voltage. An arc will be generated when any of these high-current fuses is replaced without disconnecting the battery negative cable, and this could cause the related electric devices to be damaged.
- If a fuse blows out, identify and remedy the cause, then replace the fuse.
- Be sure to use the fuse with the specified ampere.
- When installing the cover on the high-current fuse box, lightly press the cover directly down until the guide on the cover securely fits in the guide on the fuse box. Do not push the cover inward with excessive force, as doing so could easily damage the guides.

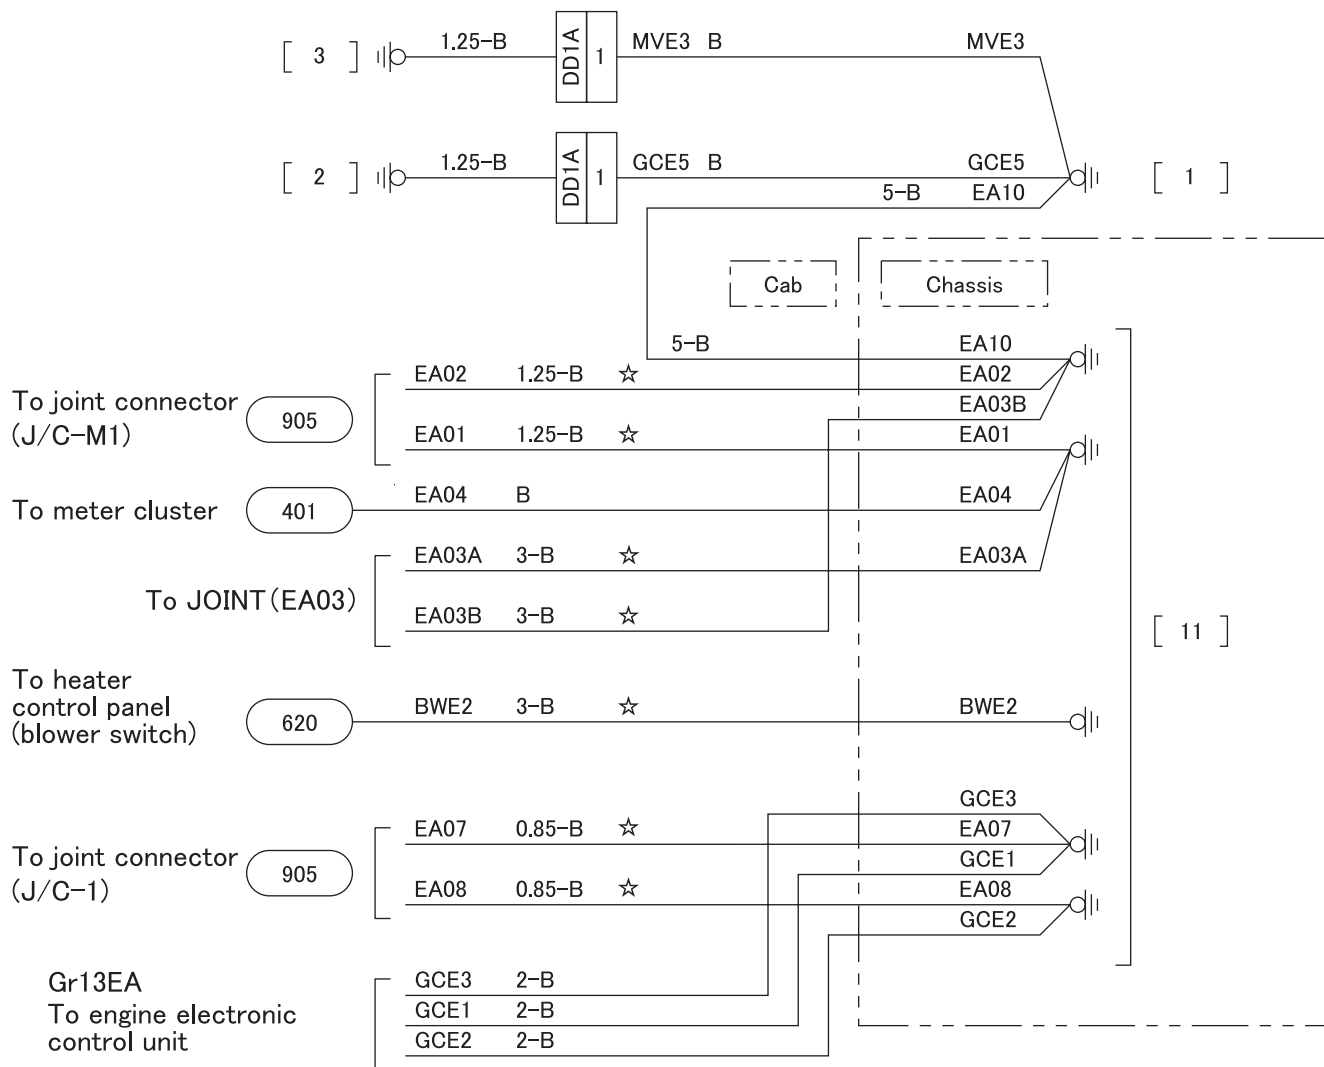
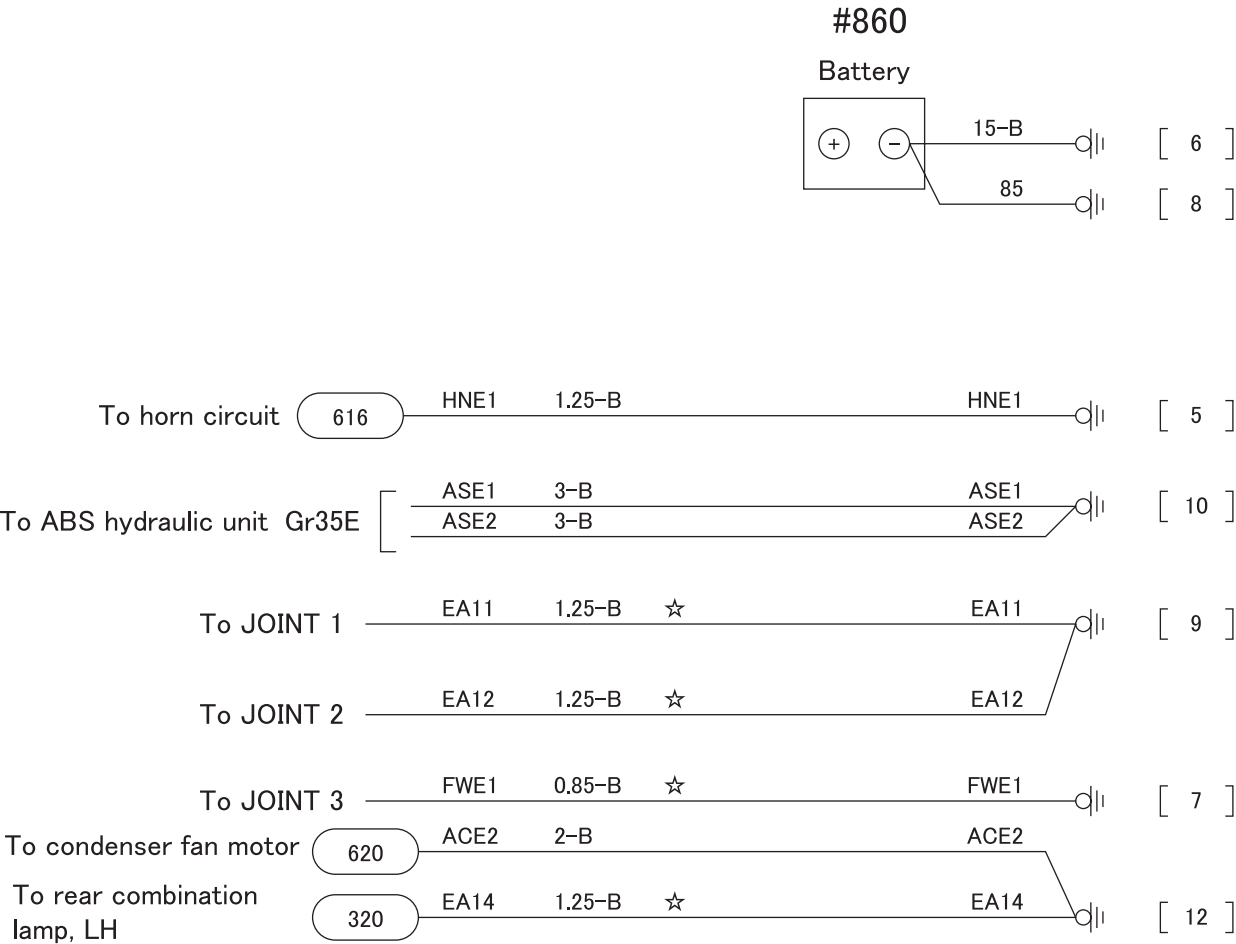
## Entire ground

- This diagram indicates grounding points.
- See the following pages for branching of grounding (wiring for ☆ ).  
(in circuit No. order)

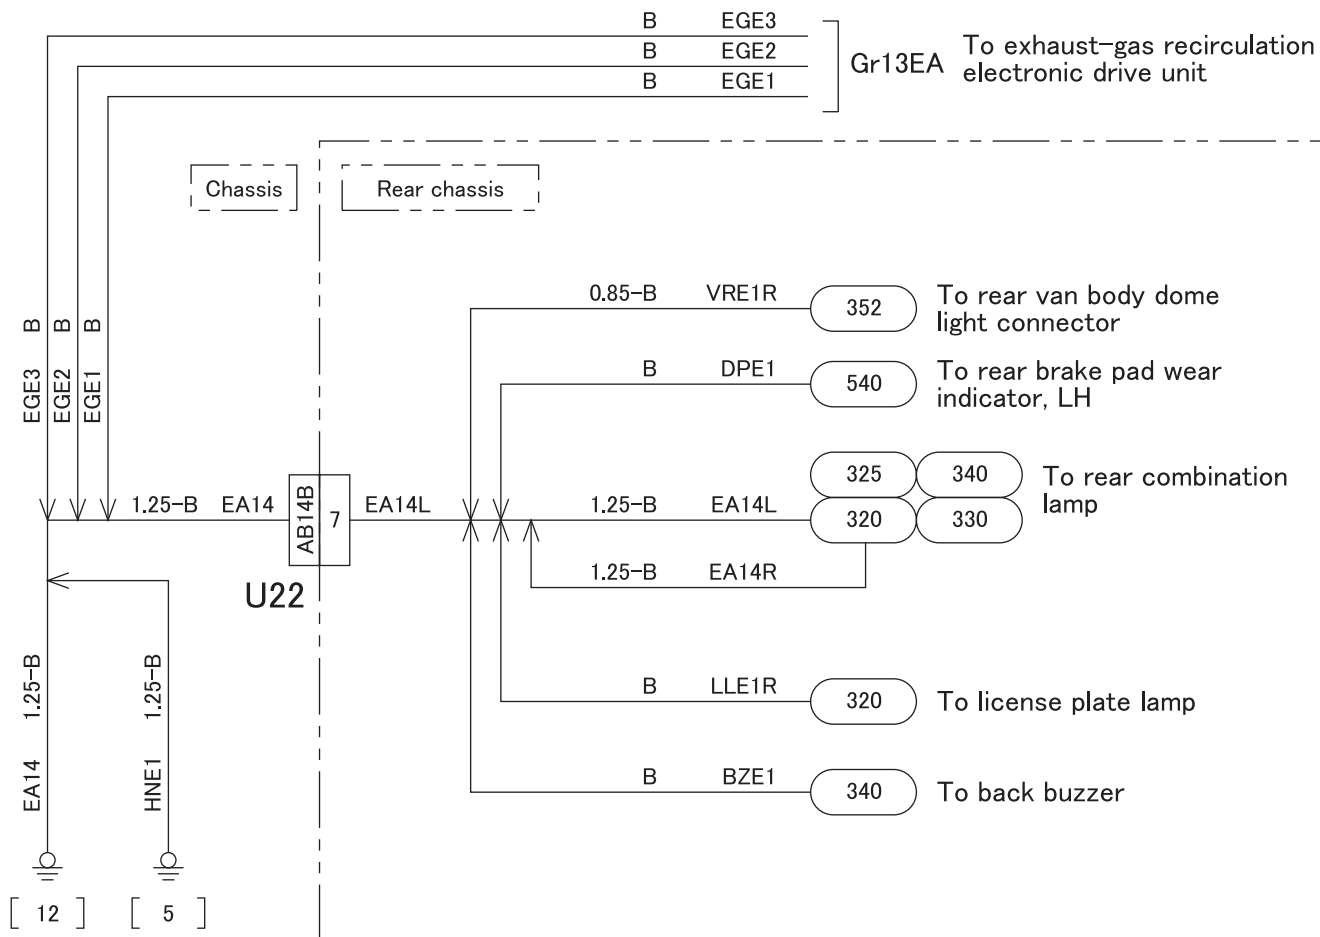
Circuit No.EA14 chassis ground

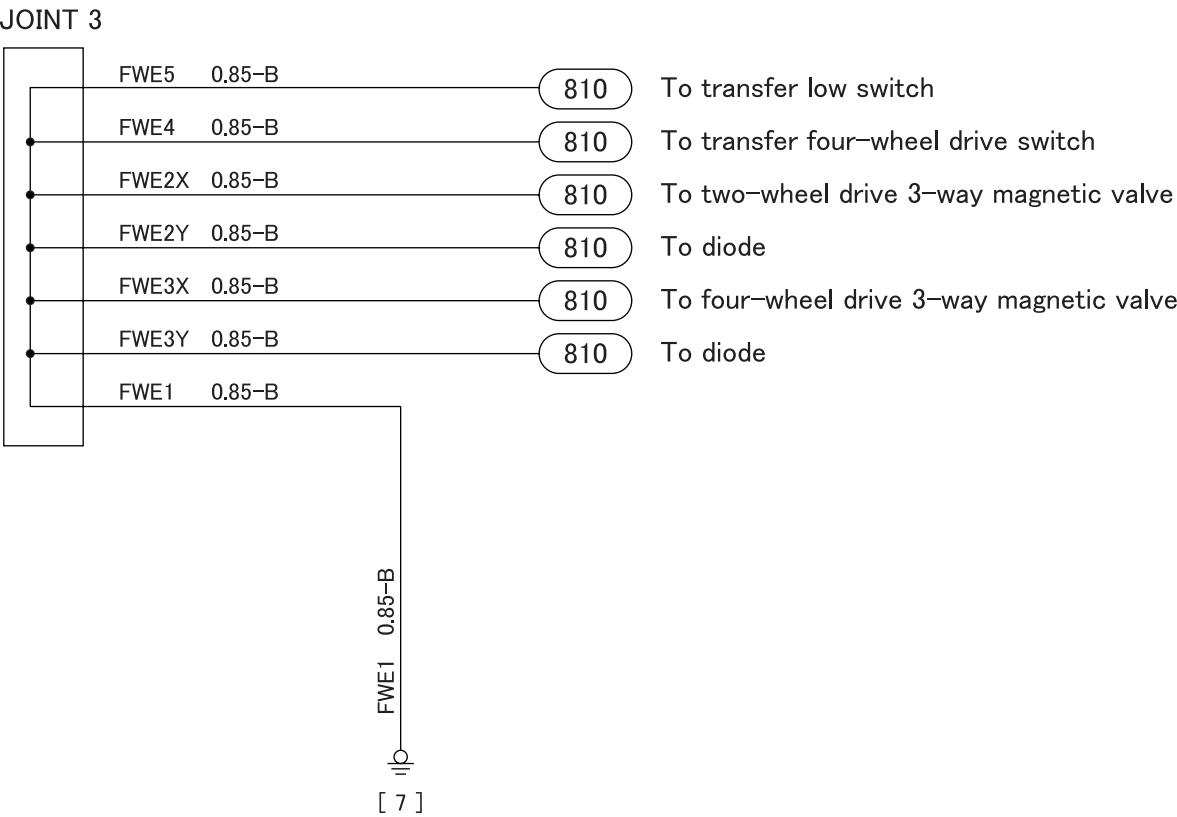
Circuit No.FWE1 chassis ground  
<FG>

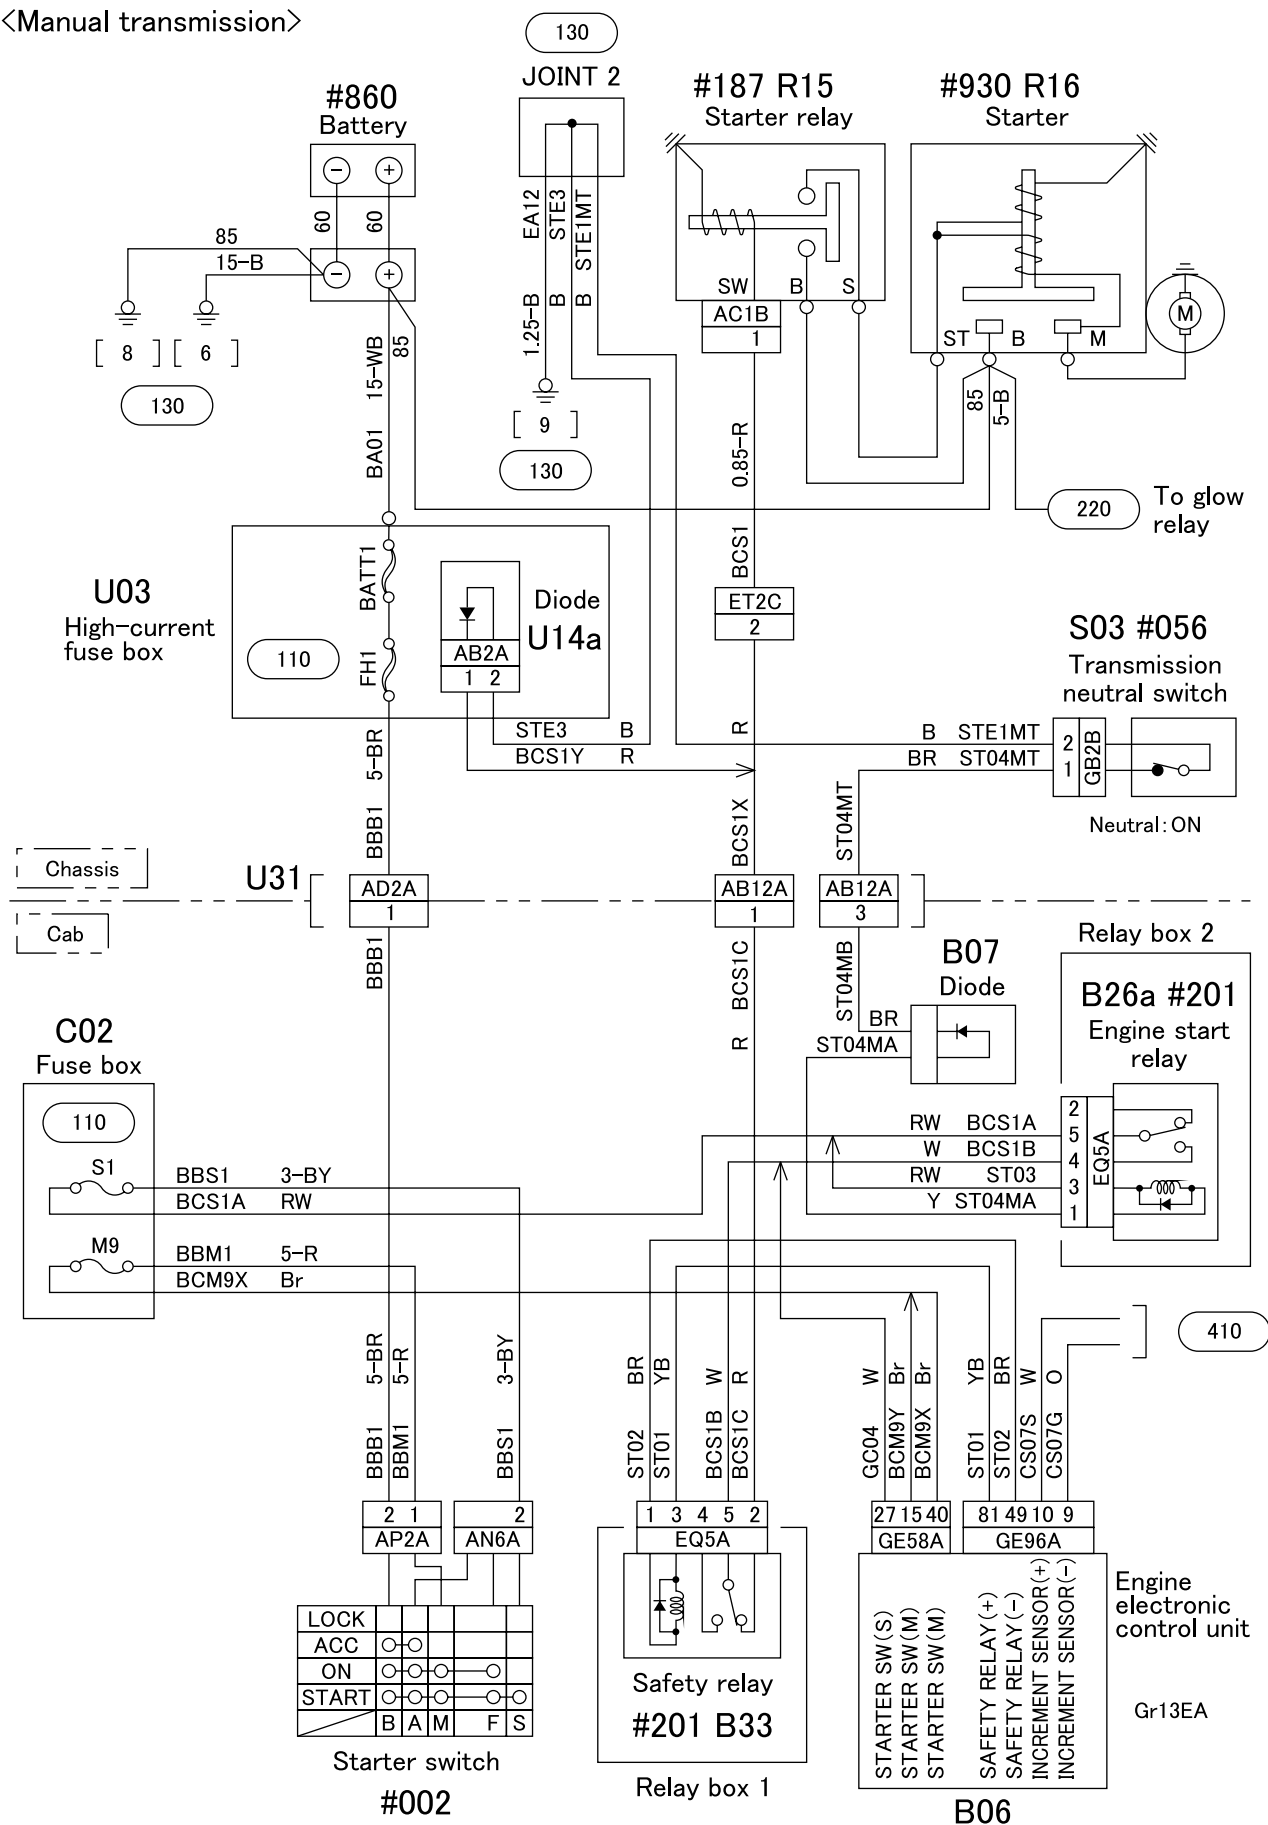
## 210 ENGINE STARTING CIRCUIT

<Manual transmission>

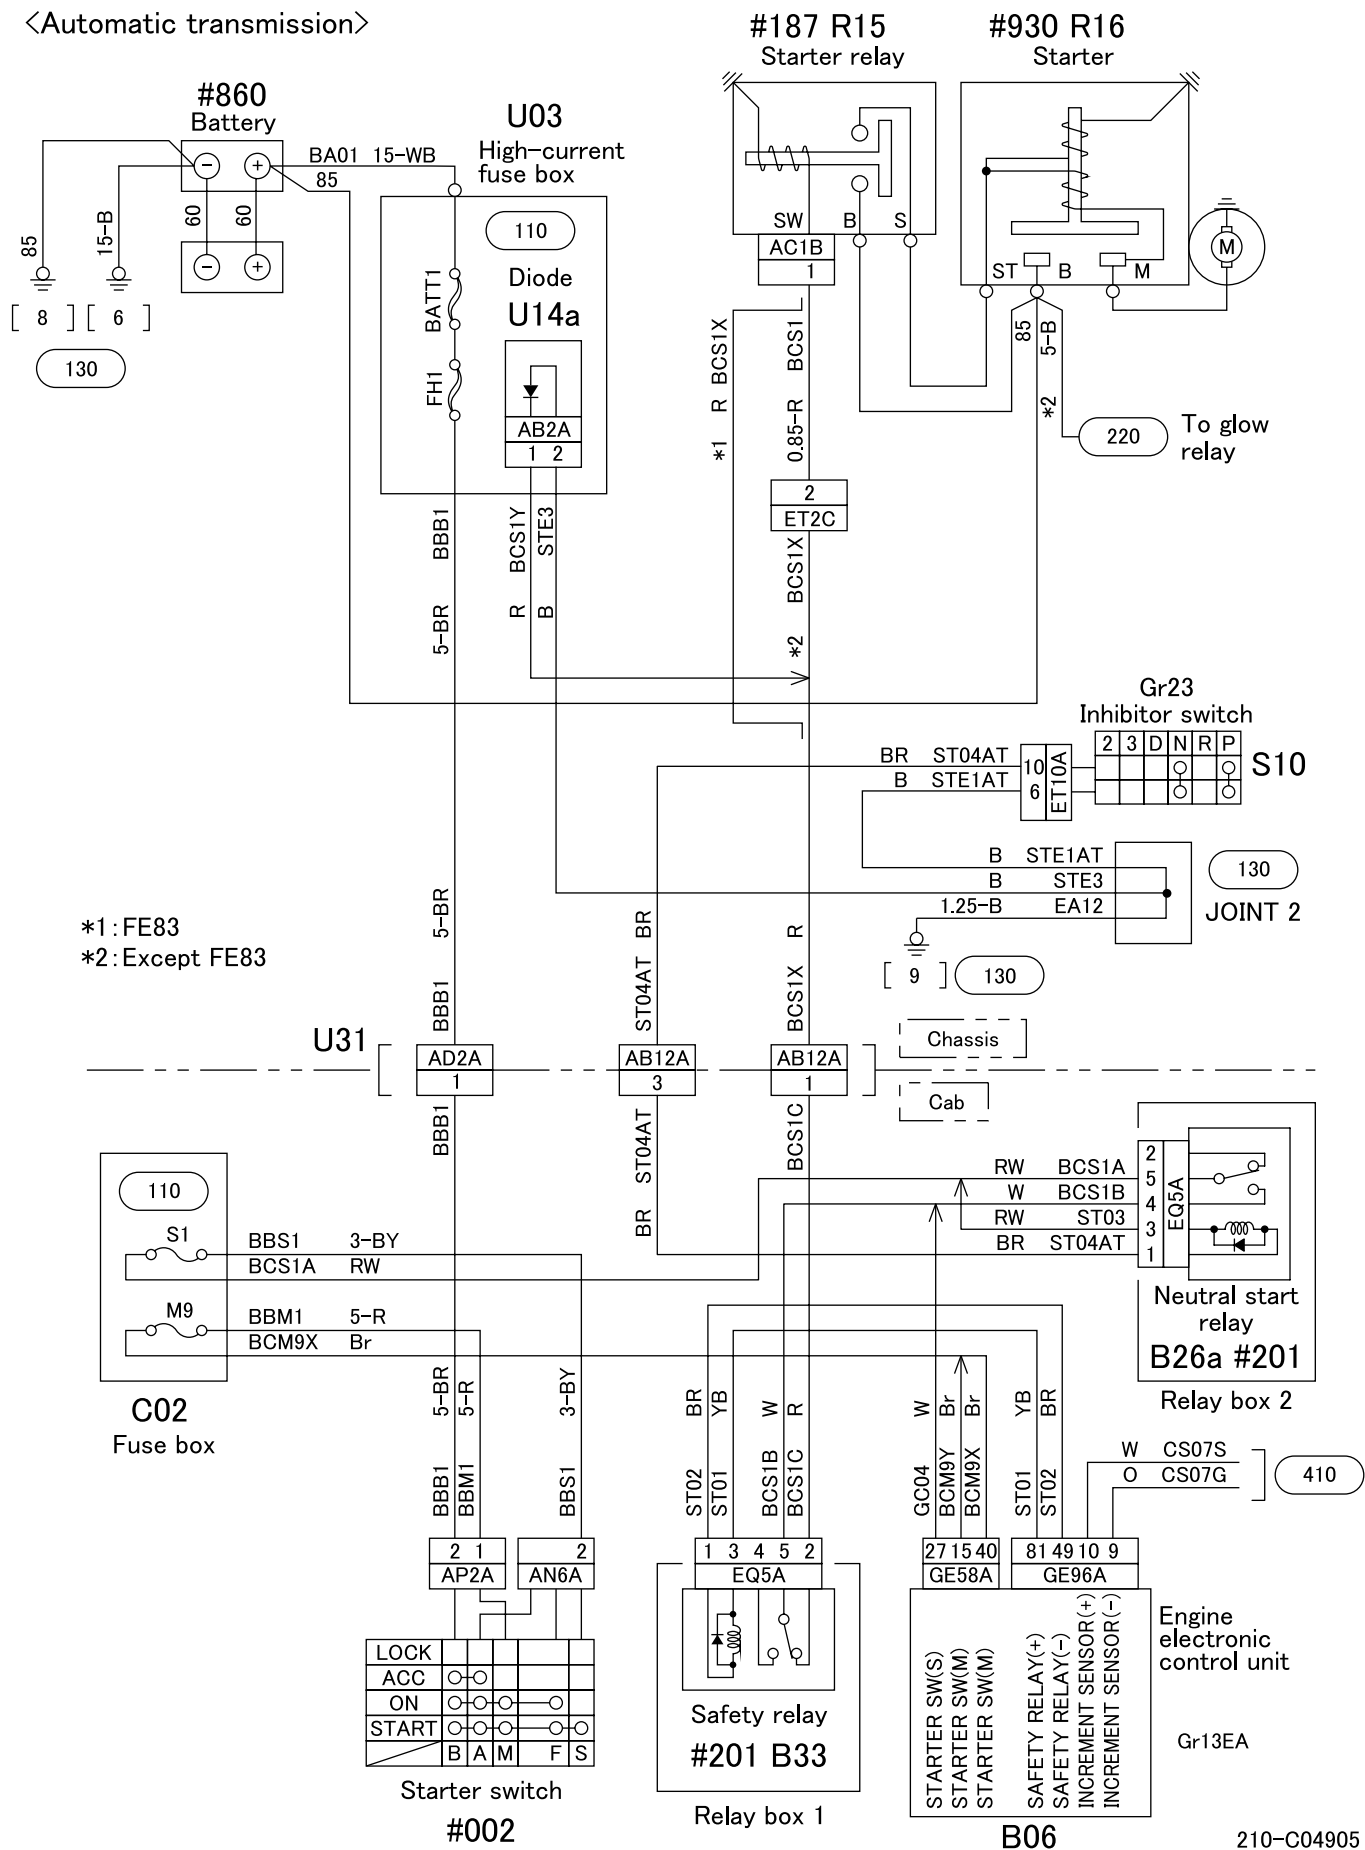
<Automatic transmission>

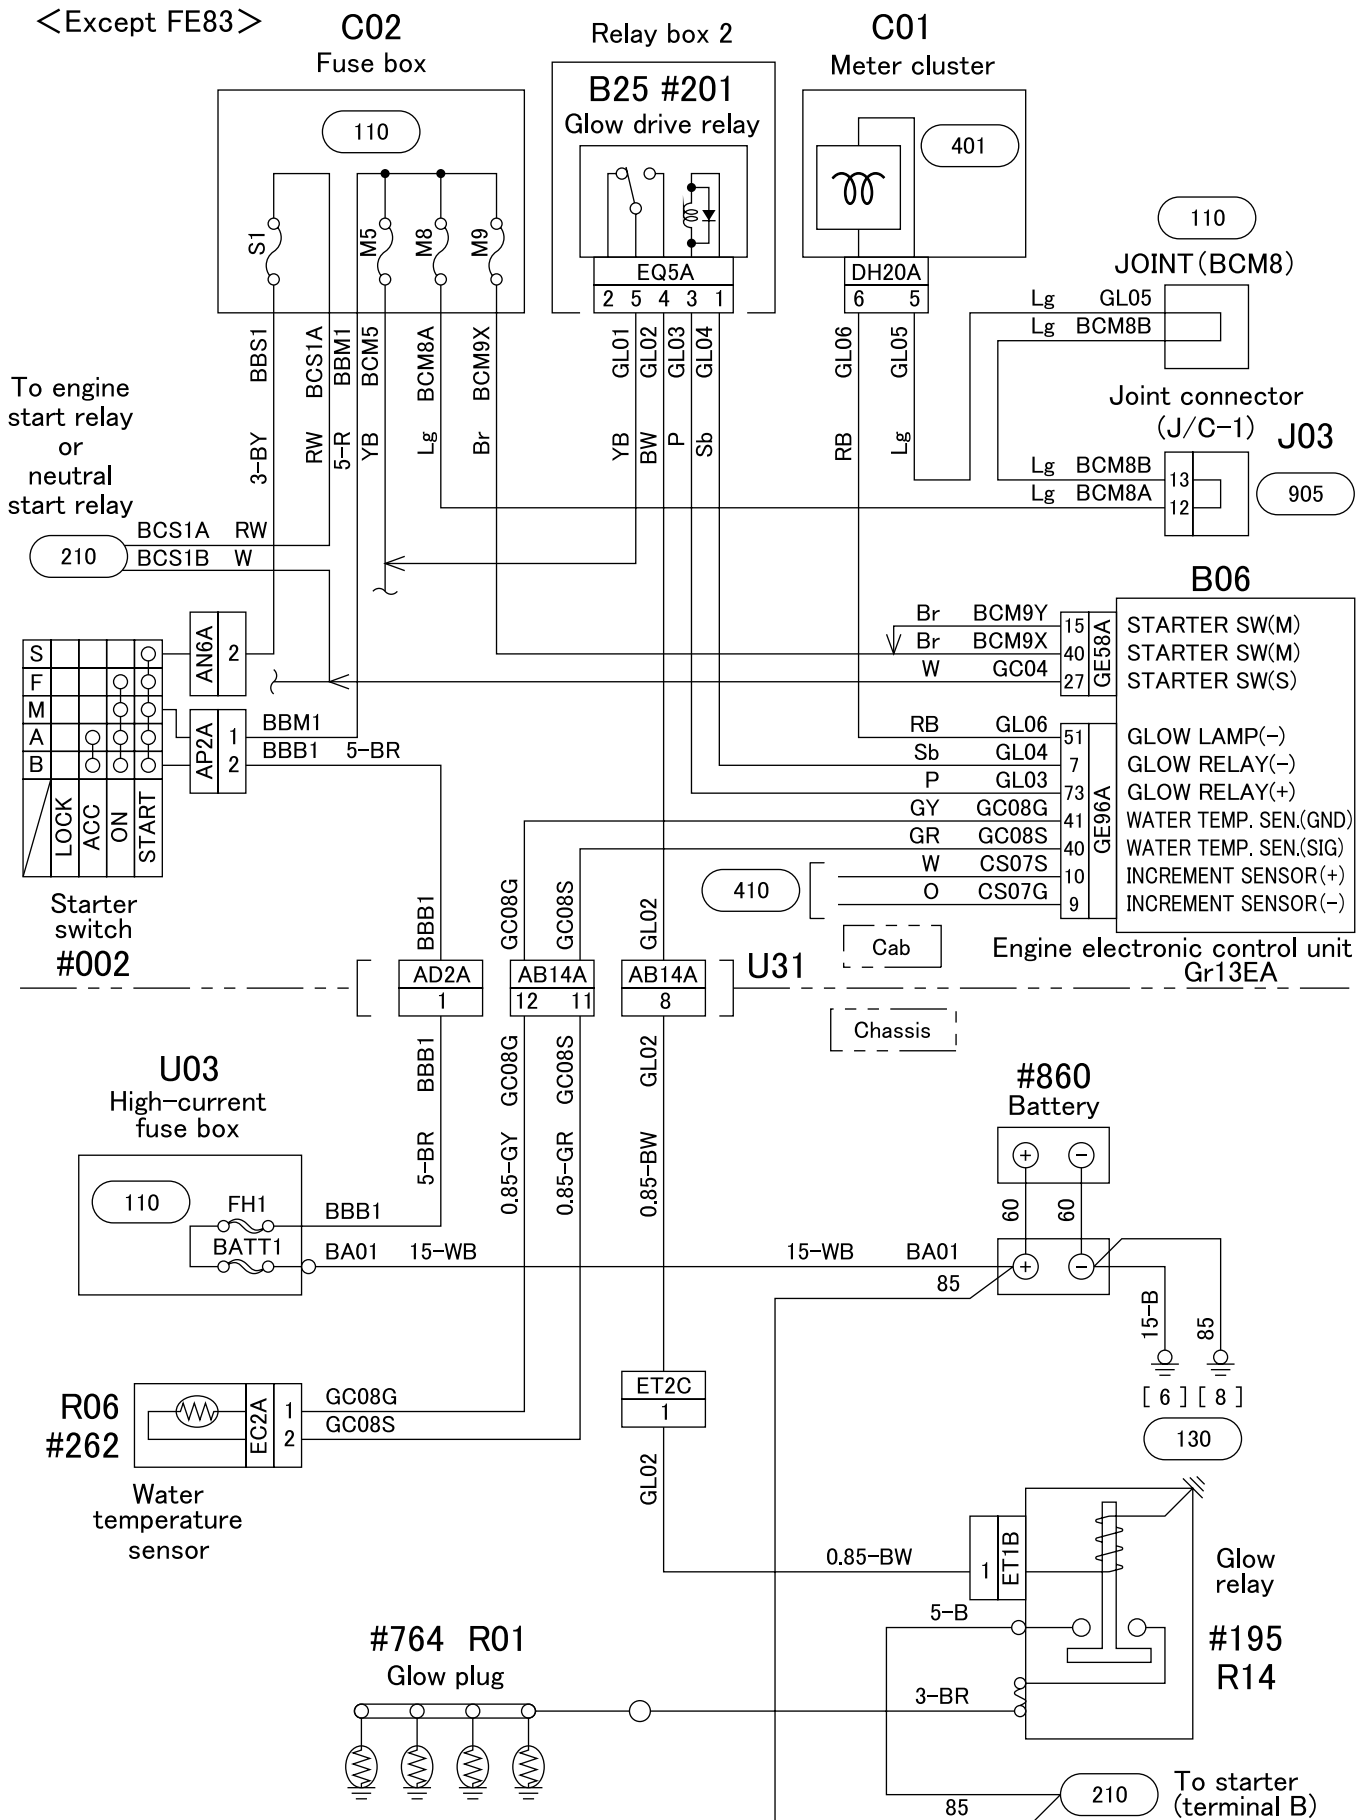
220-C04906

## 220 ENGINE PREHEATING CIRCUIT

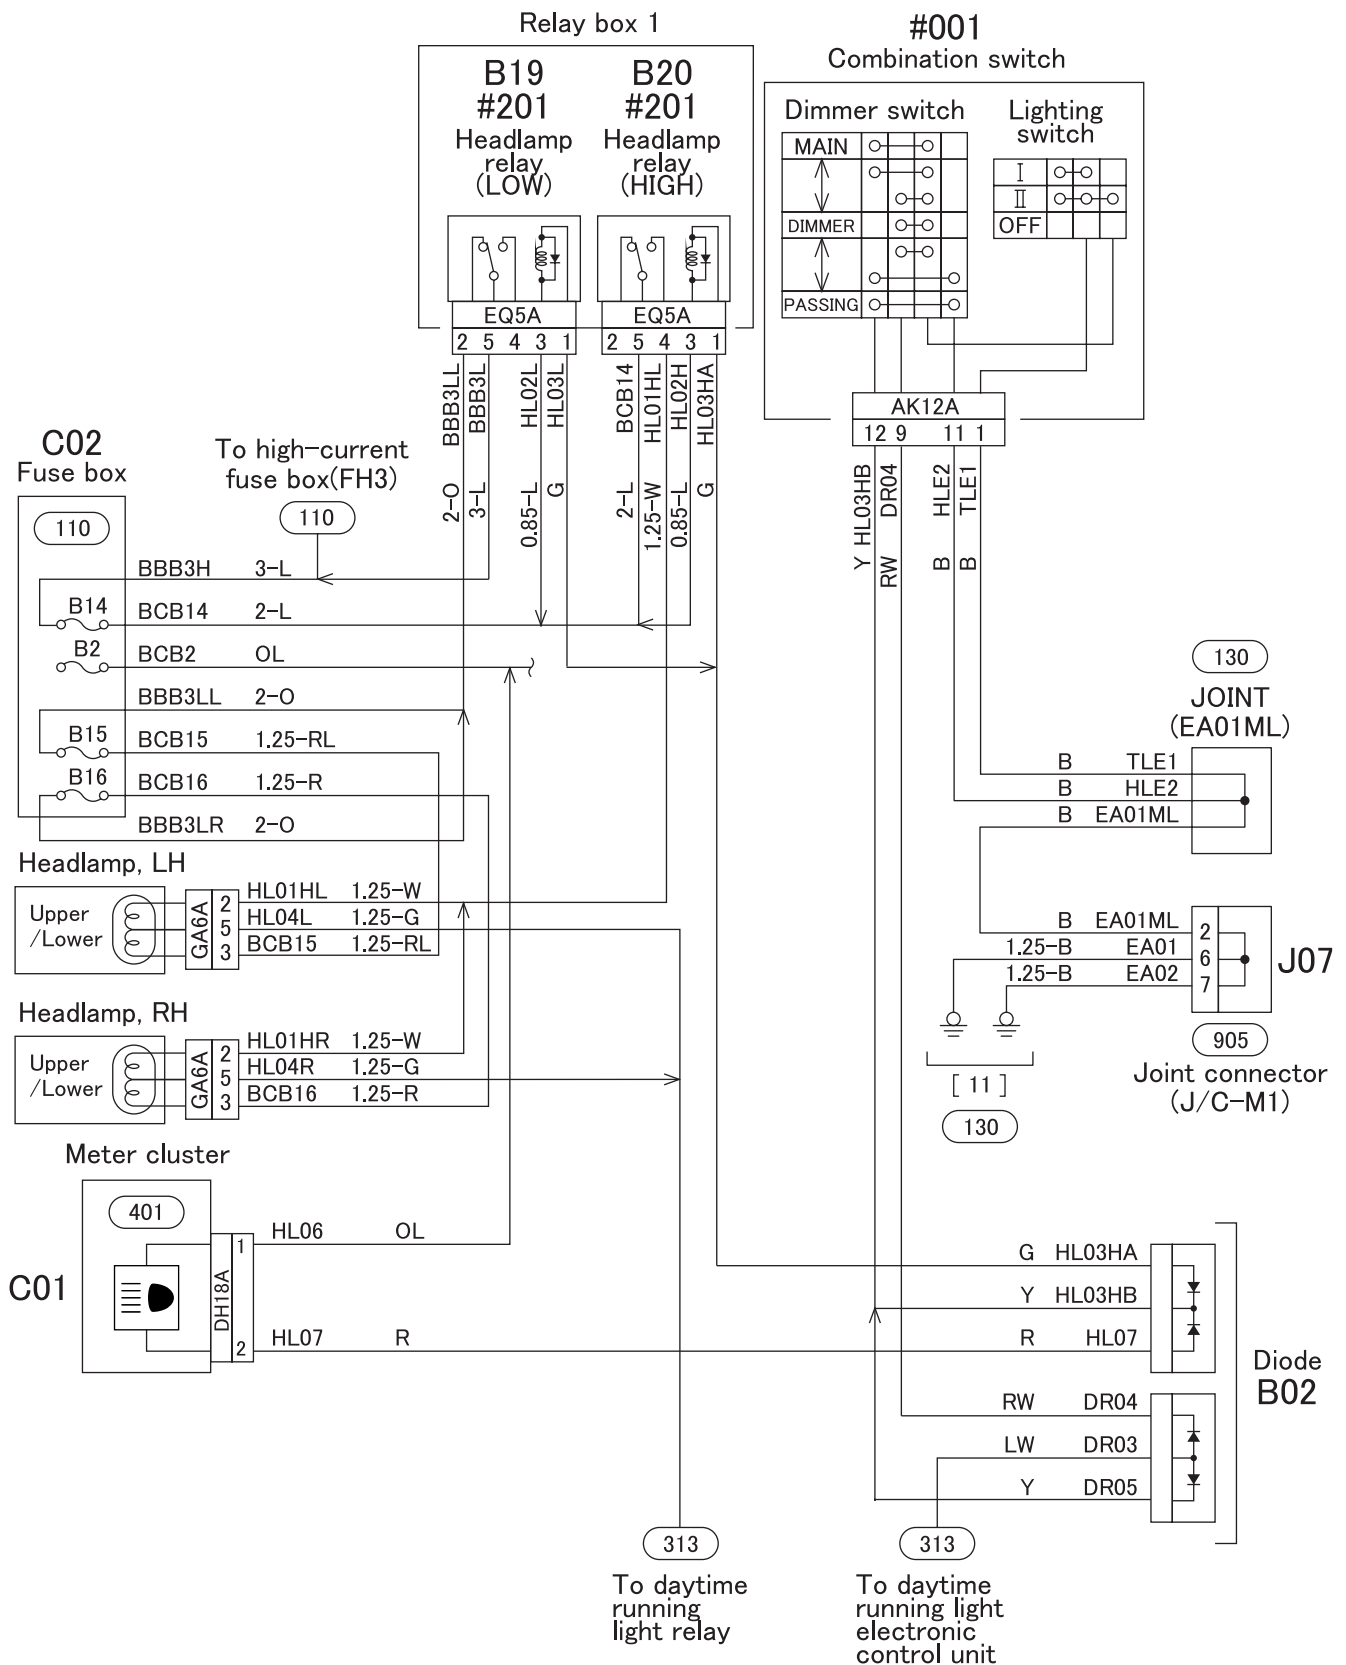
# 310 HEADLAMP CIRCUIT

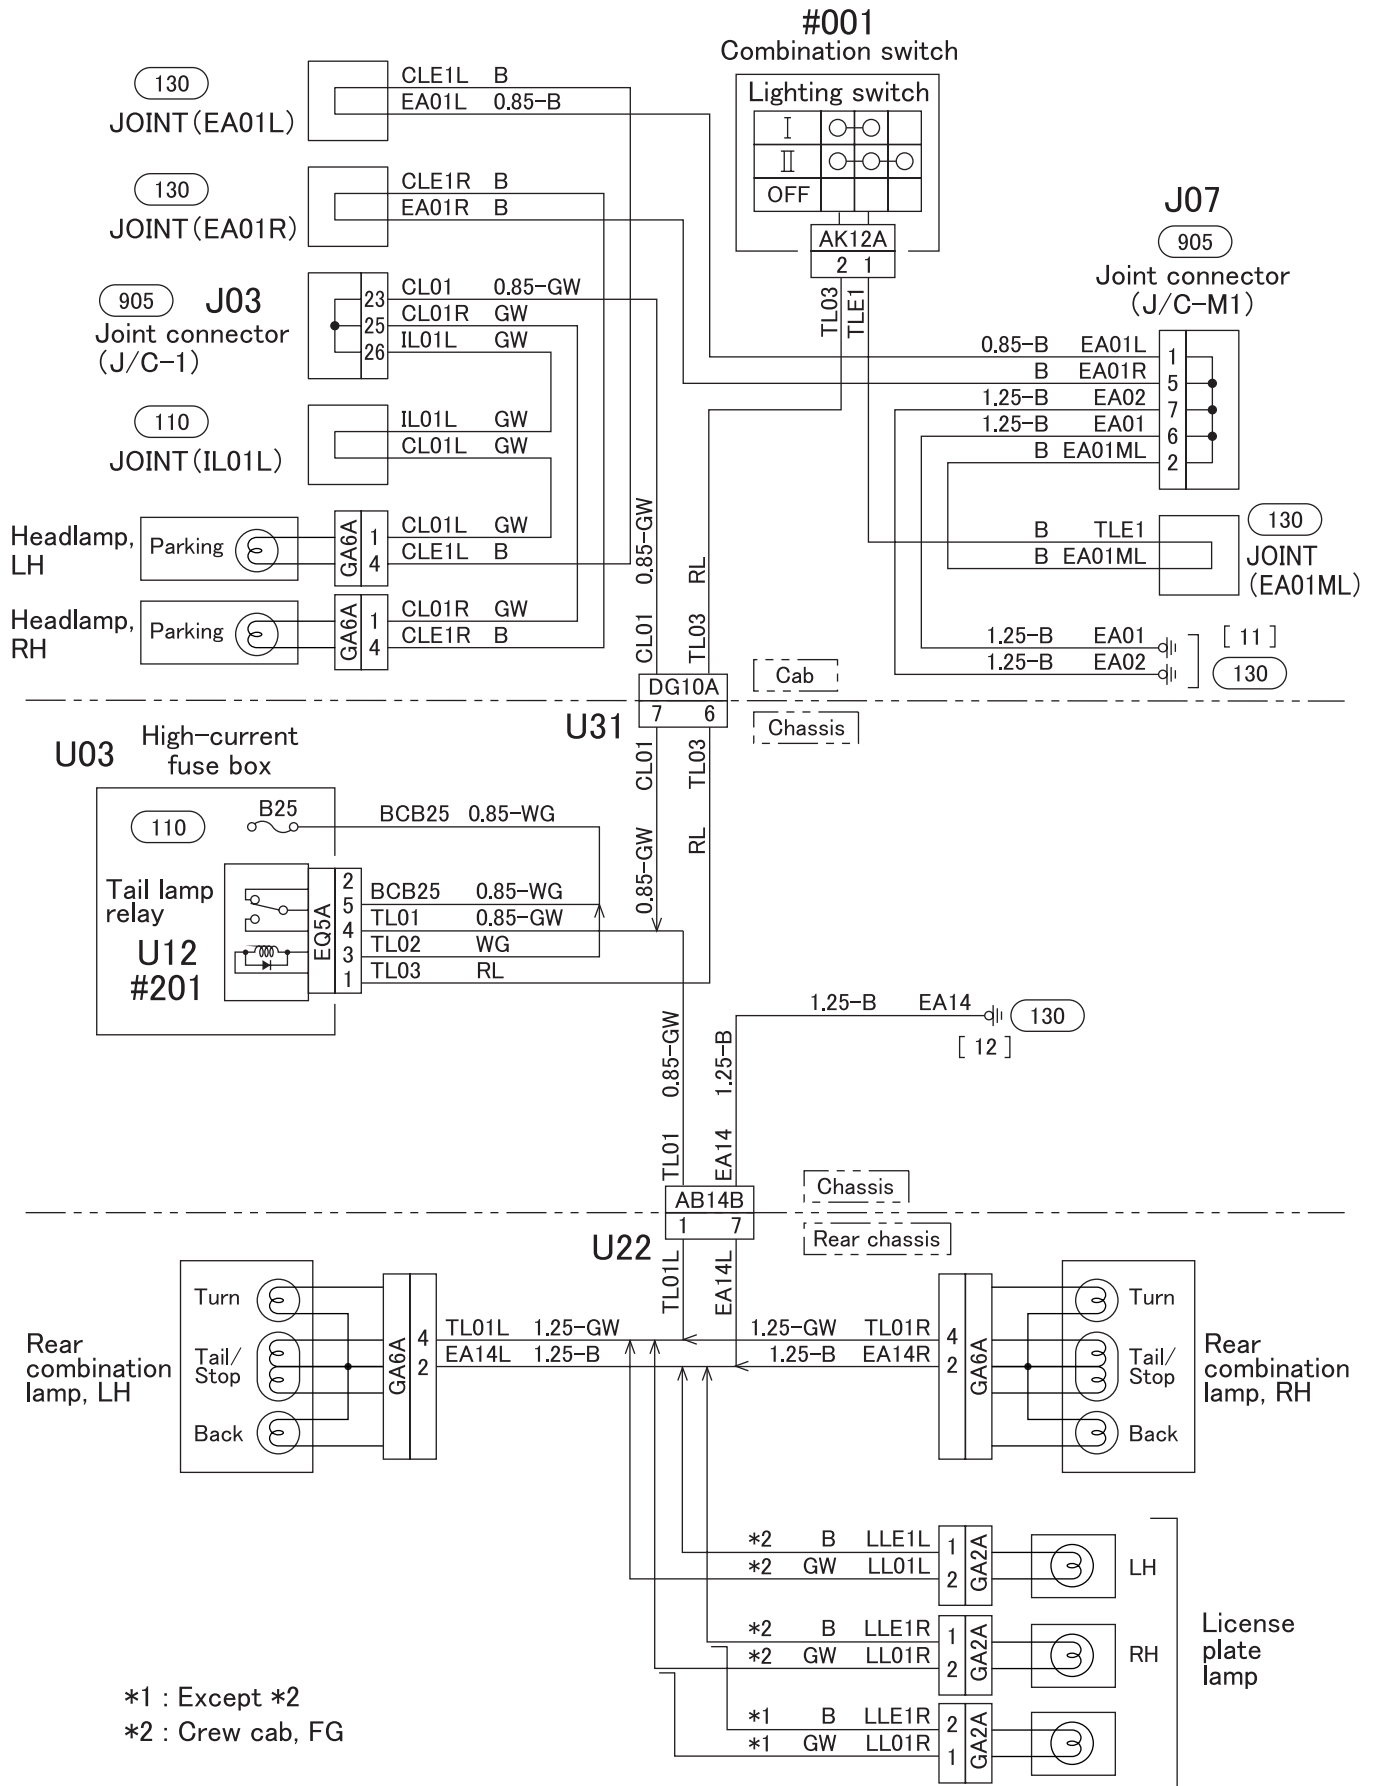
320-C04053

# 320 TAIL, CLEARANCE AND LICENSE PLATE LAMPS CIRCUIT

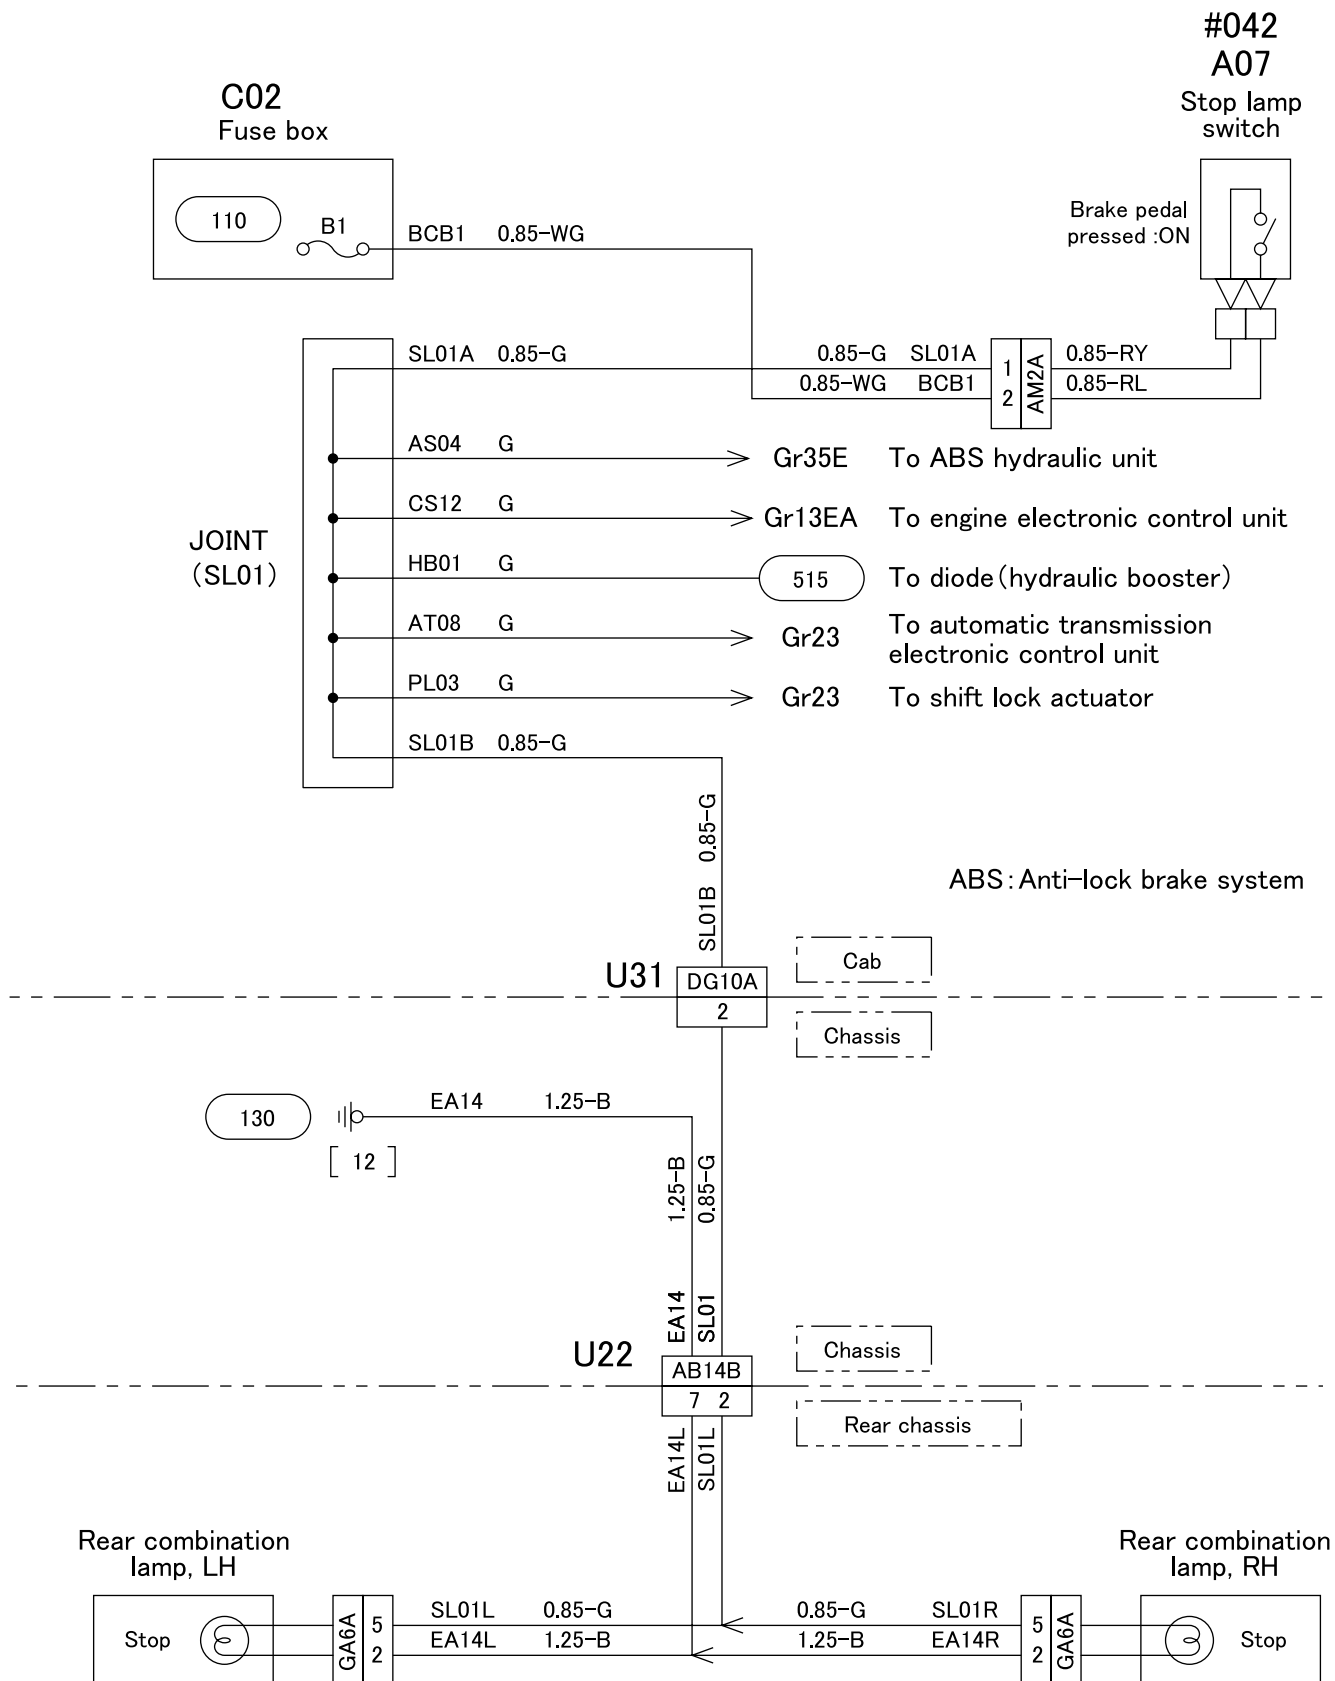
# 325 STOP LAMP CIRCUIT

<Without auto cruise>
