# FE.FG

## SERVICE MANUAL 2008 Model FOREWORD

This Service Manual contains maintenance and repair methods for the Mitsubishi Fuso Truck FE. FG Series. Read this manual carefully as an aid in providing correct, efficient maintenance. Please note that the information and specifications contained within this manual may change without notice. This is due to product modifications and continued vehicle improvements that are made throughout the model years. Should you encounter any discrepancy in the information provided, please do not hesitate to contact your nearest Mitsubishi Fuso Dealer or Mitsubishi Fuso Truck of America, Inc.

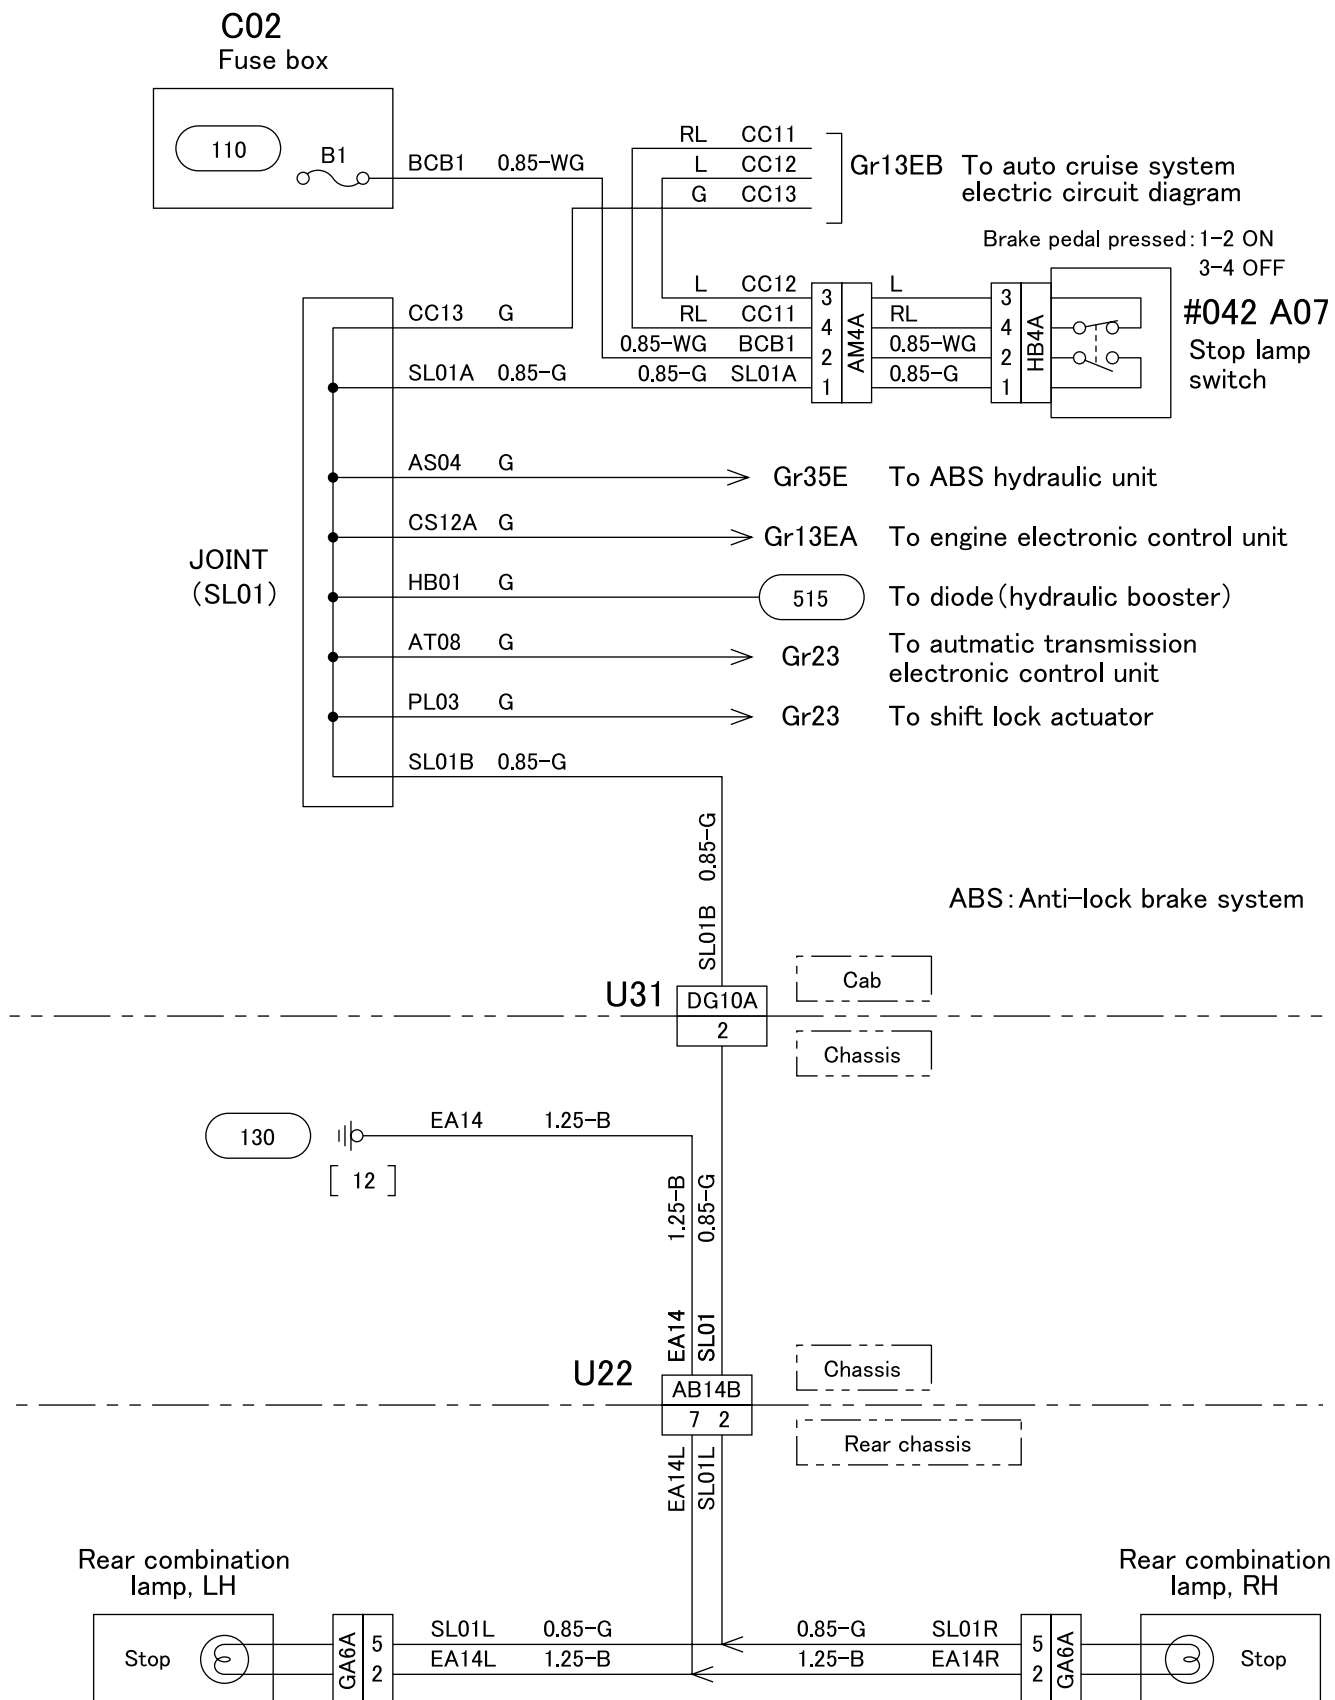
# 325 STOP LAMP CIRCUIT

&lt;With auto cruise&gt;

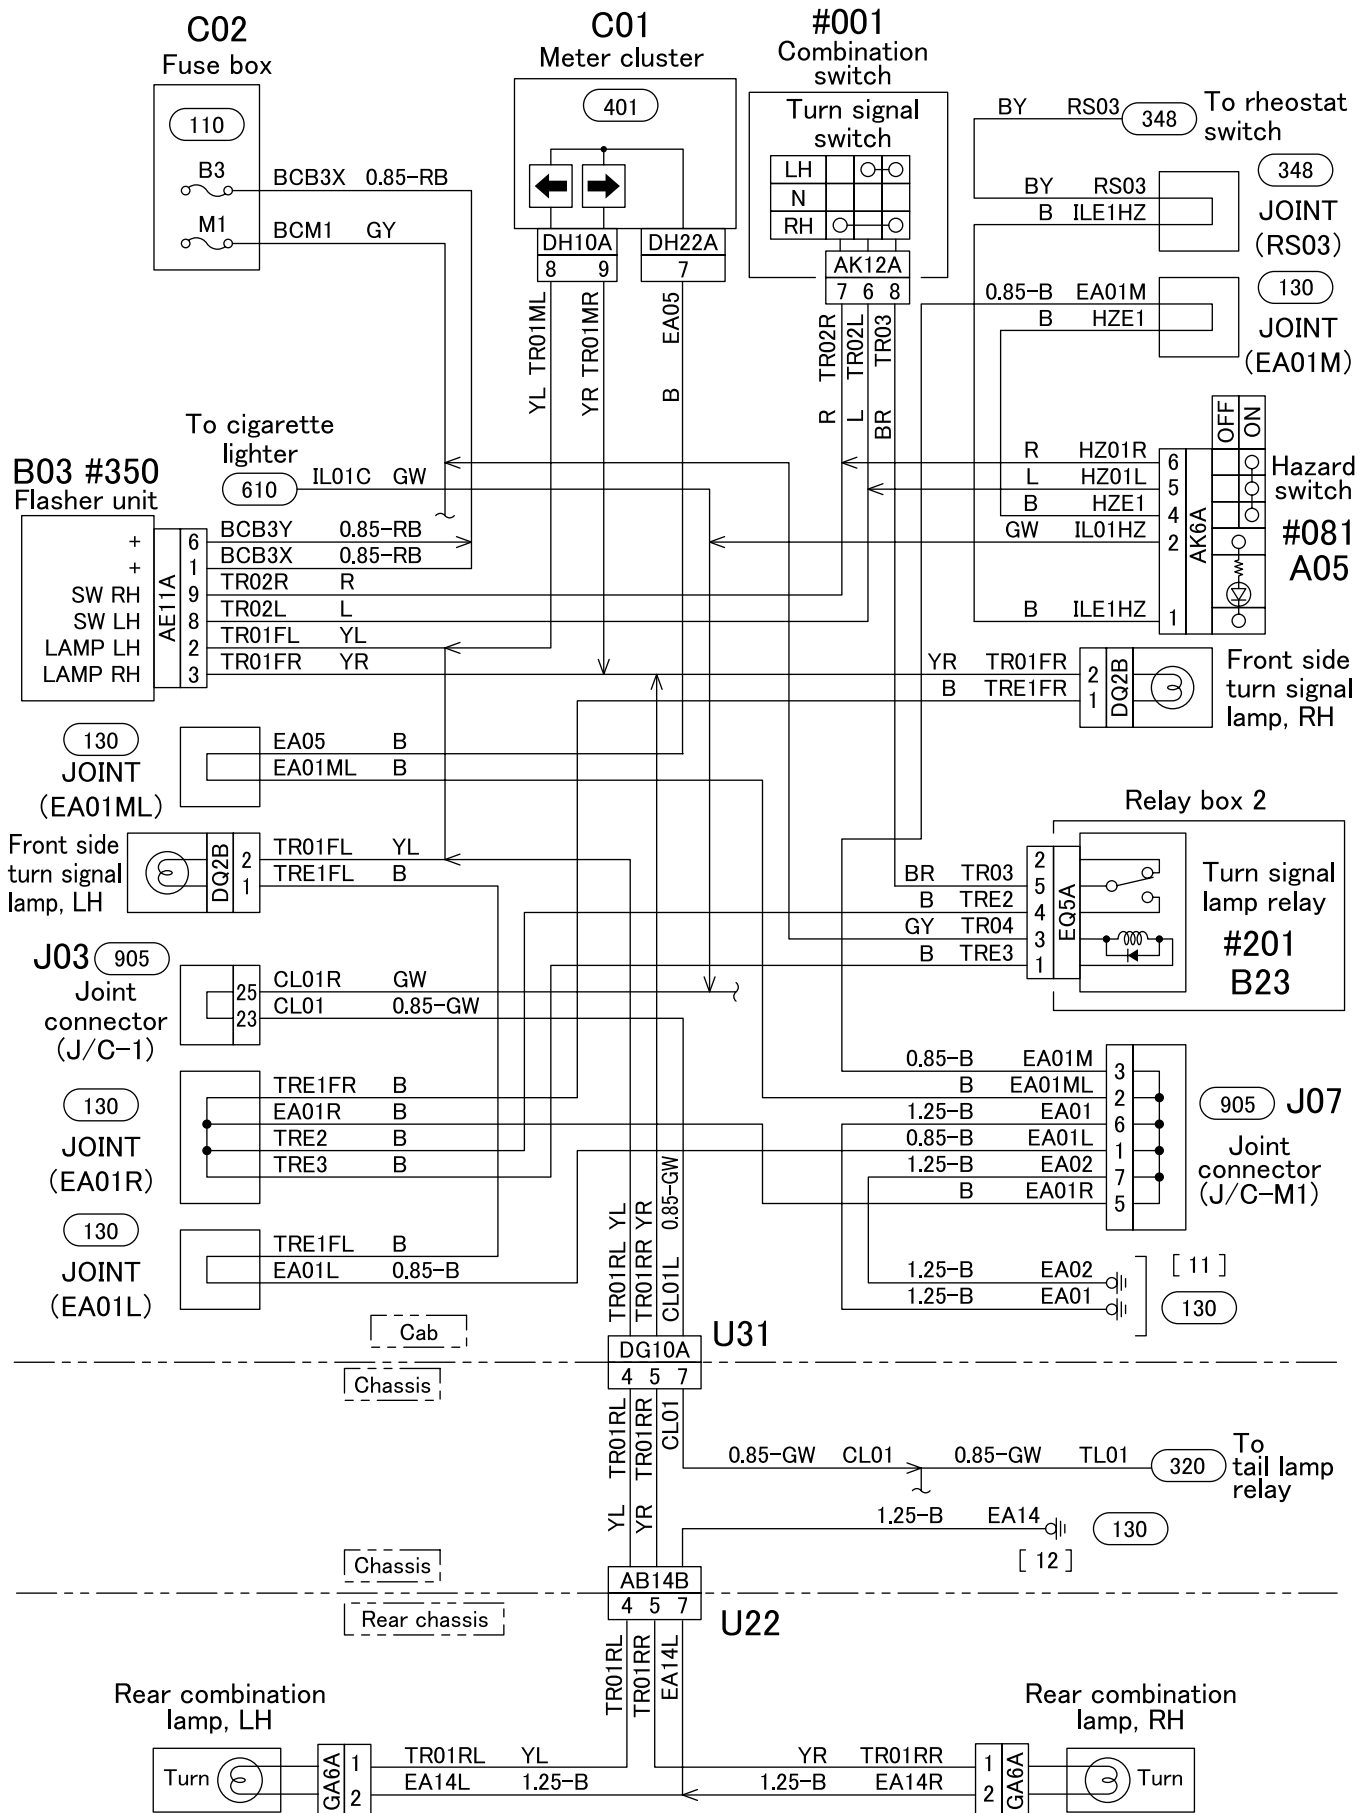
# 330 TURN SIGNAL AND HAZARD LAMP CIRCUIT

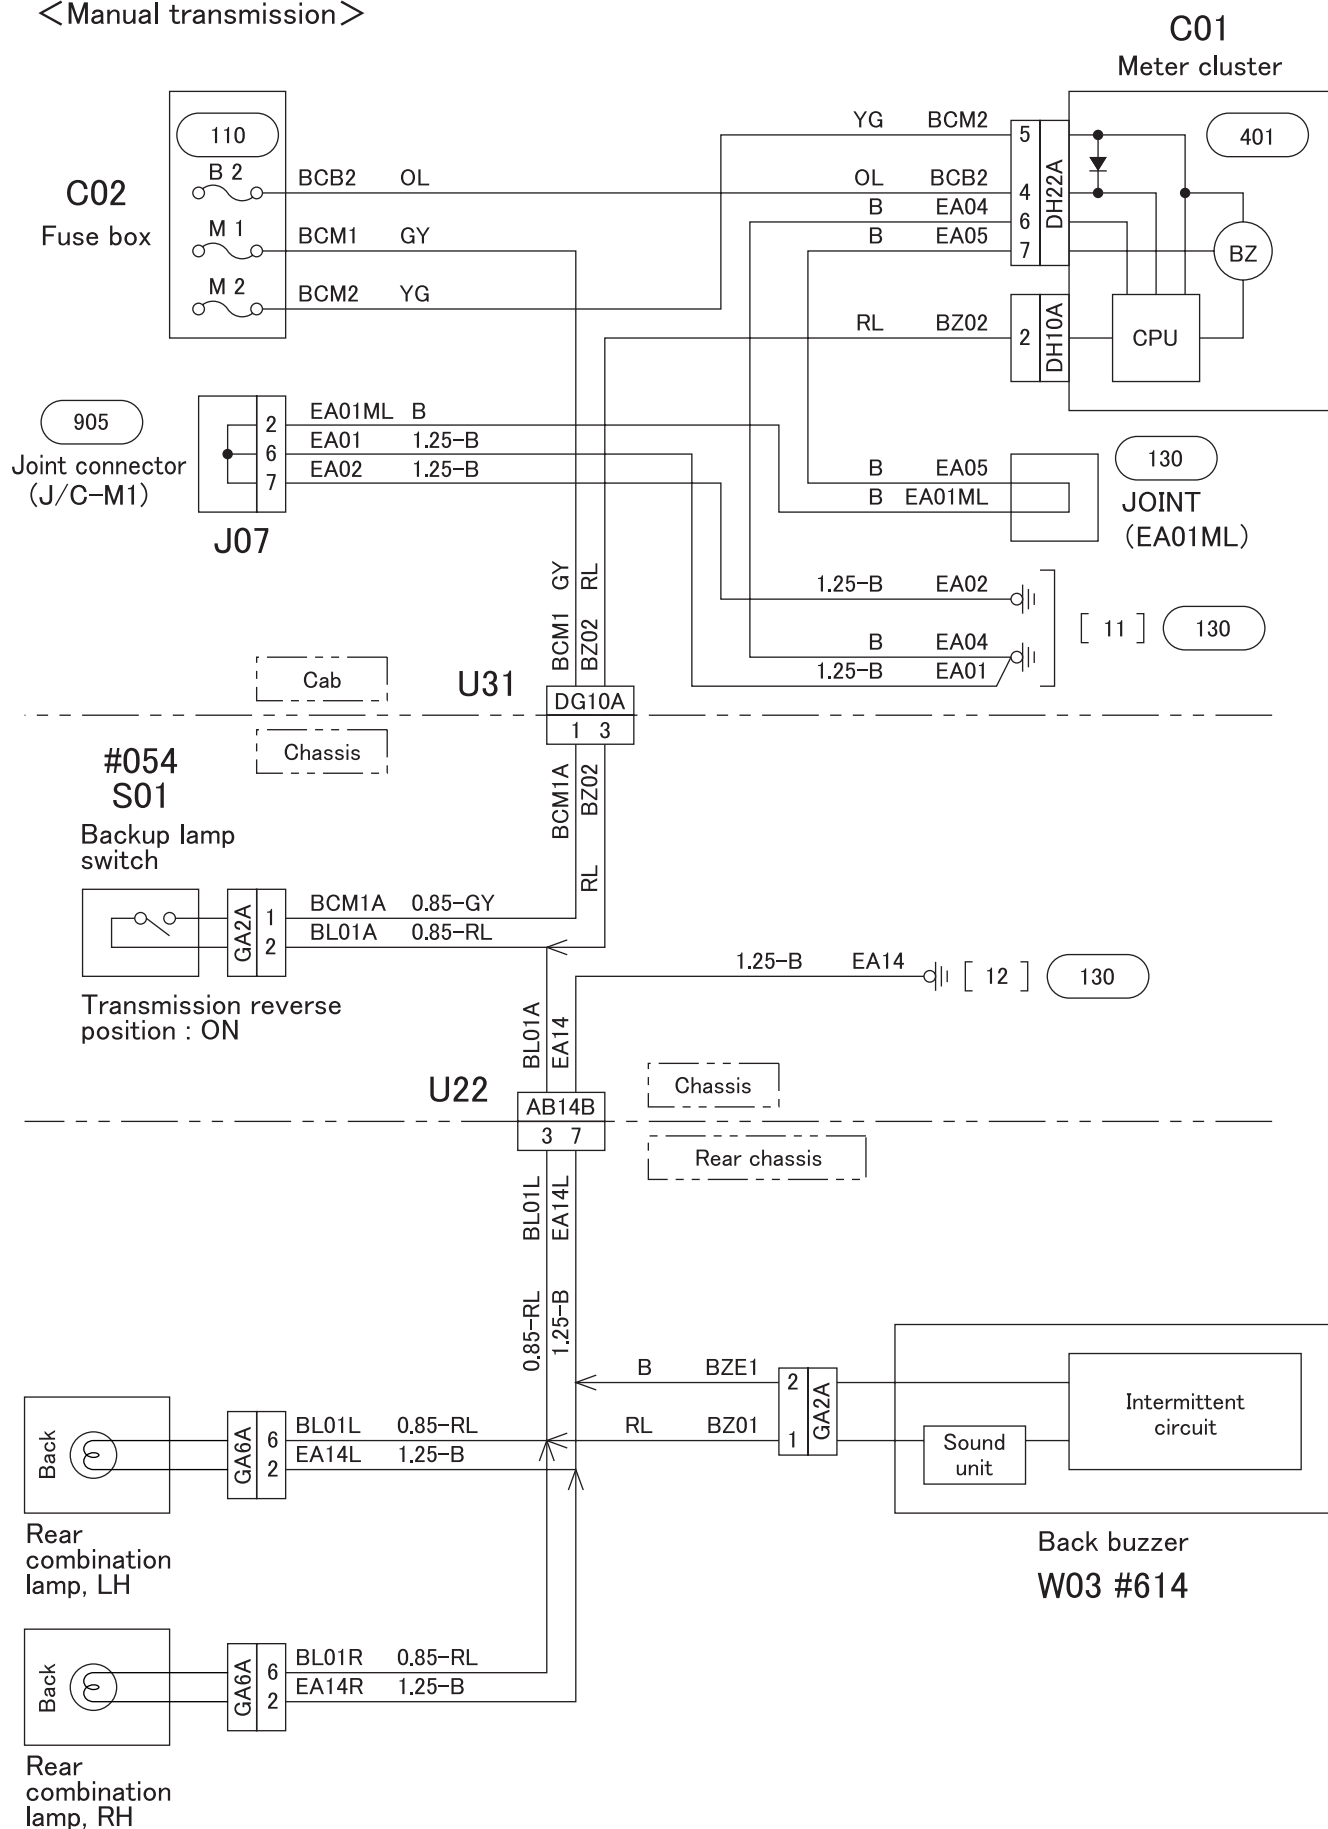
# 340 BACKUP LAMP CIRCUIT

<Manual transmission>

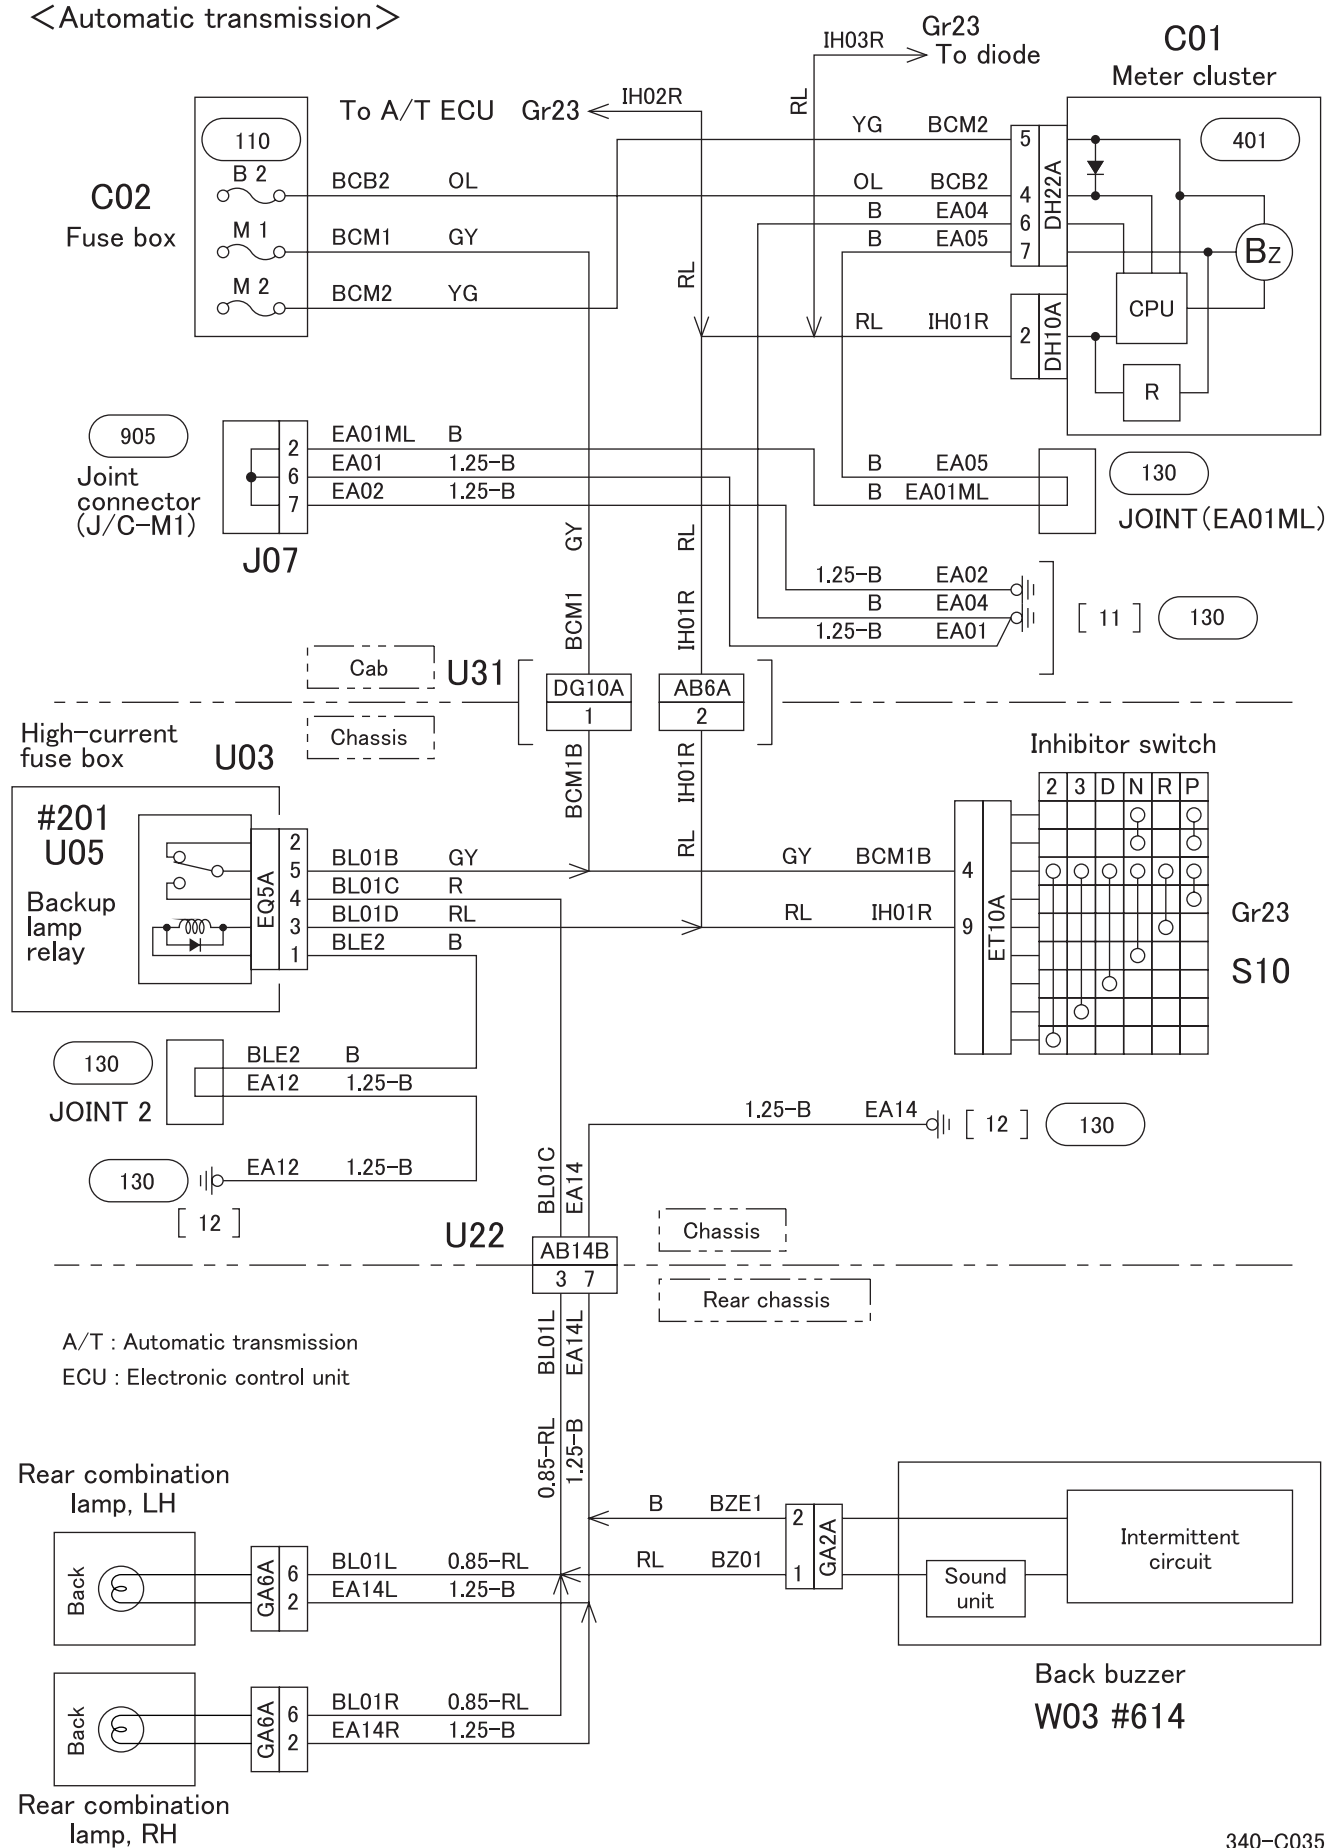
<Automatic transmission>

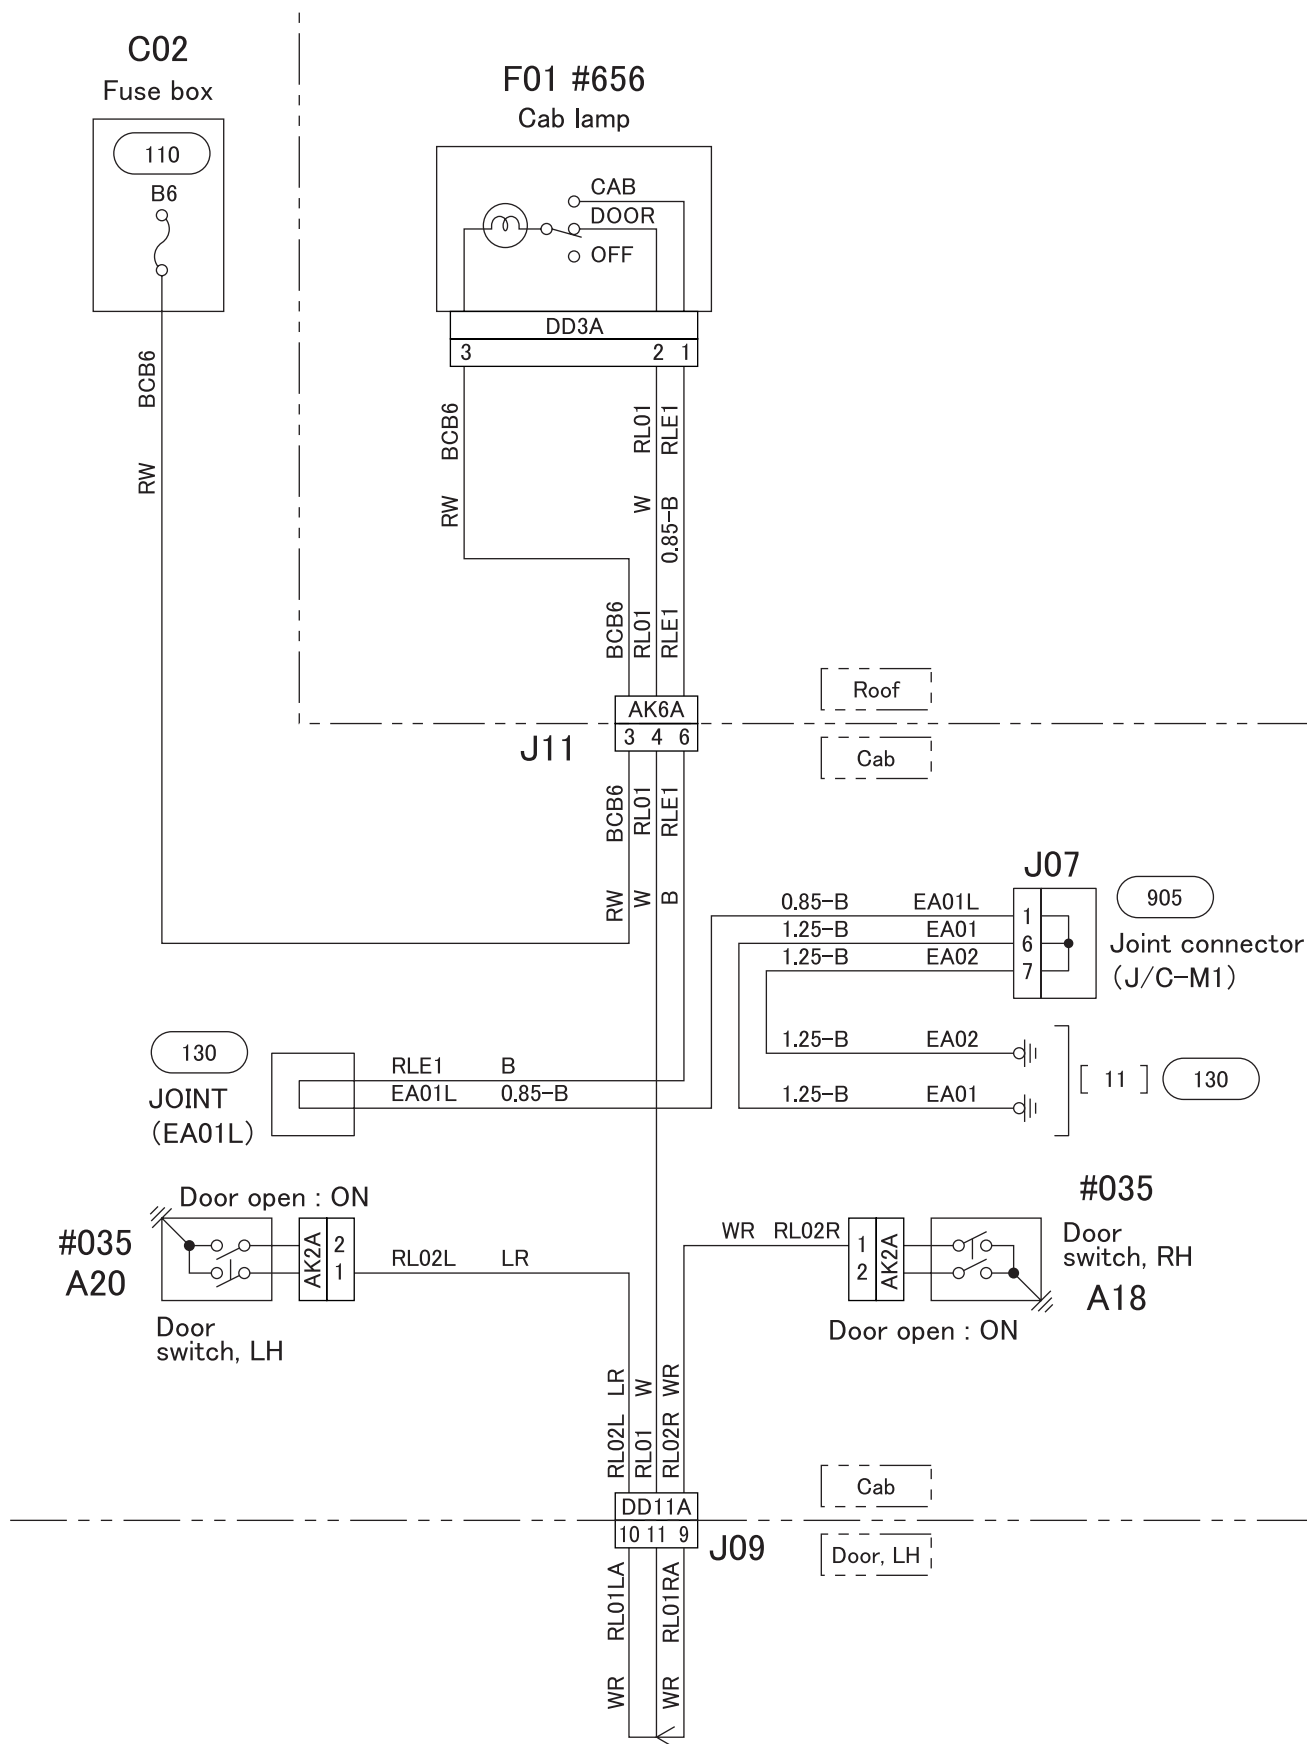
## 345 CAB LAMP CIRCUIT

<Except crew cab>

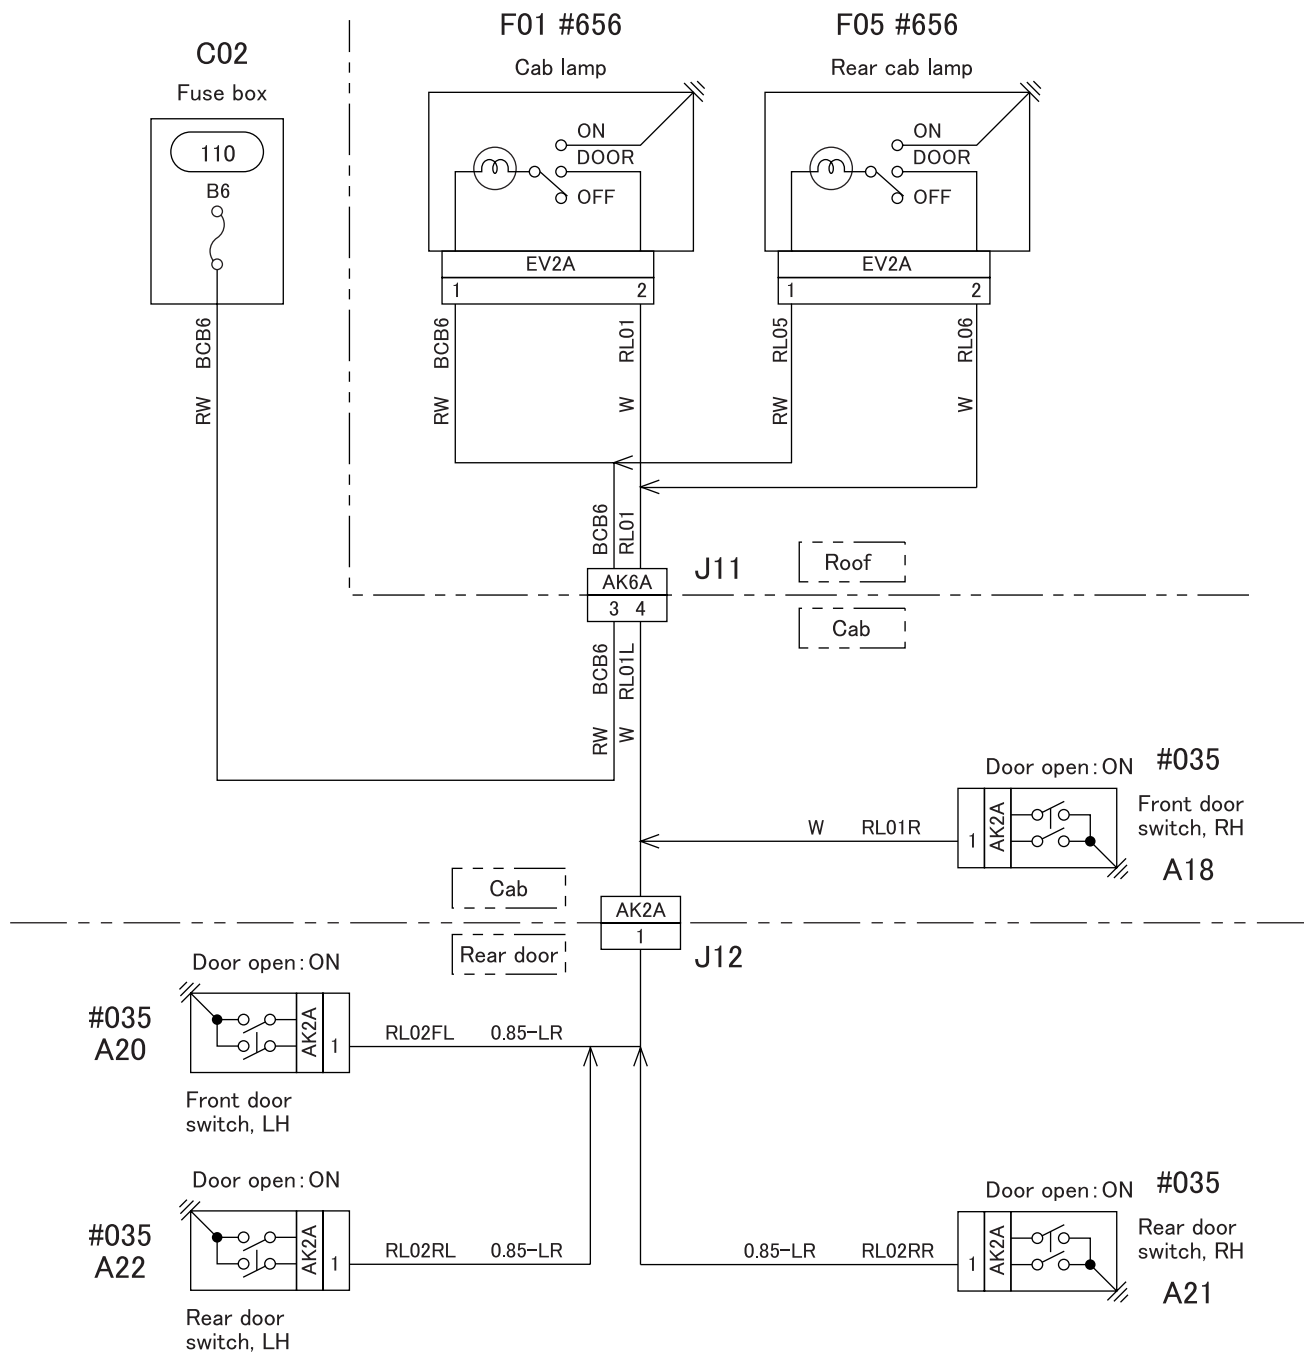
## &lt;Crew cab&gt;

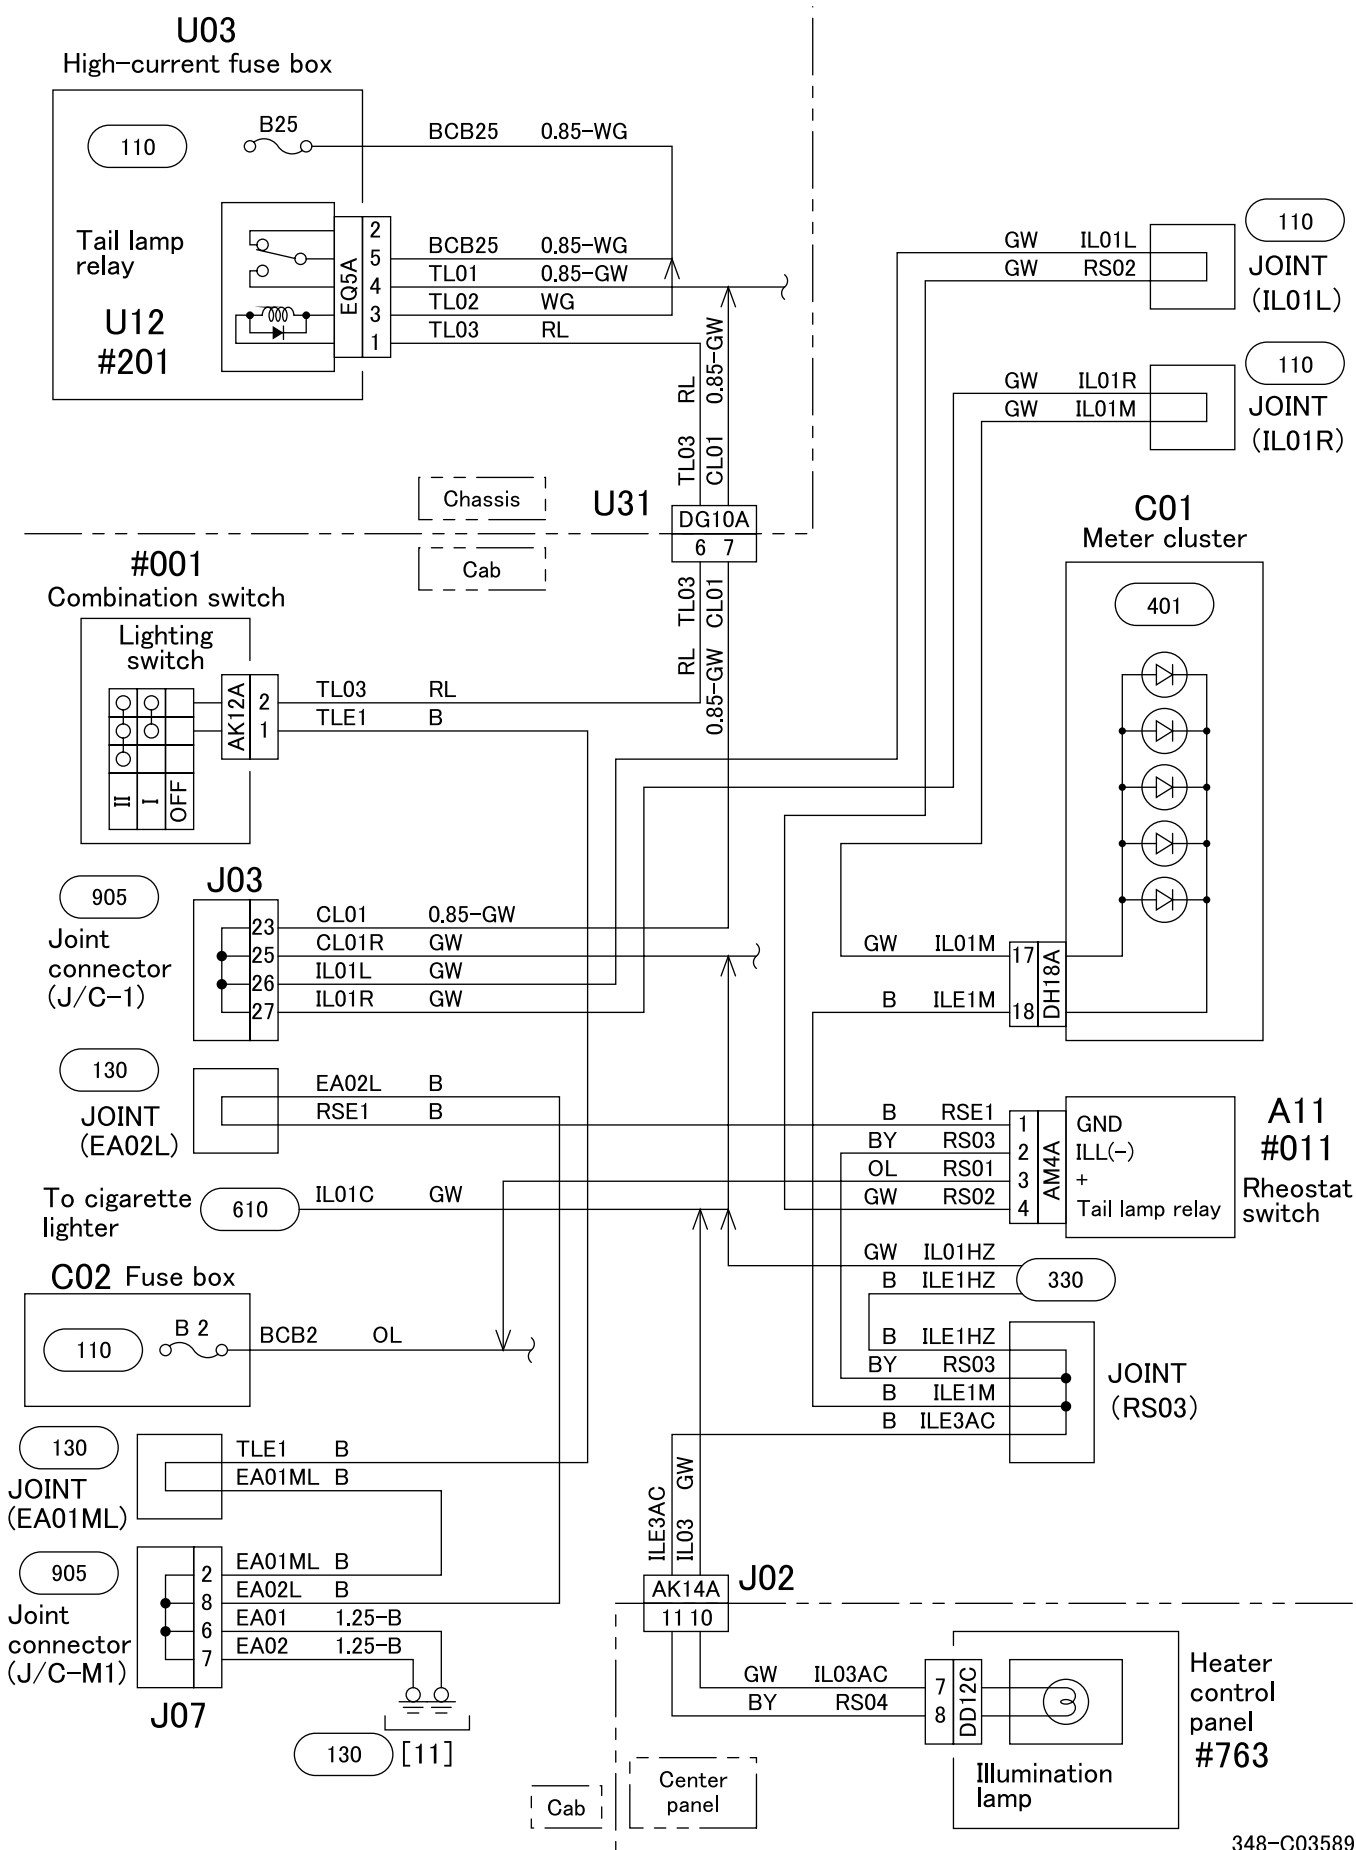
## 348 ILLUMINATION LAMP CIRCUIT

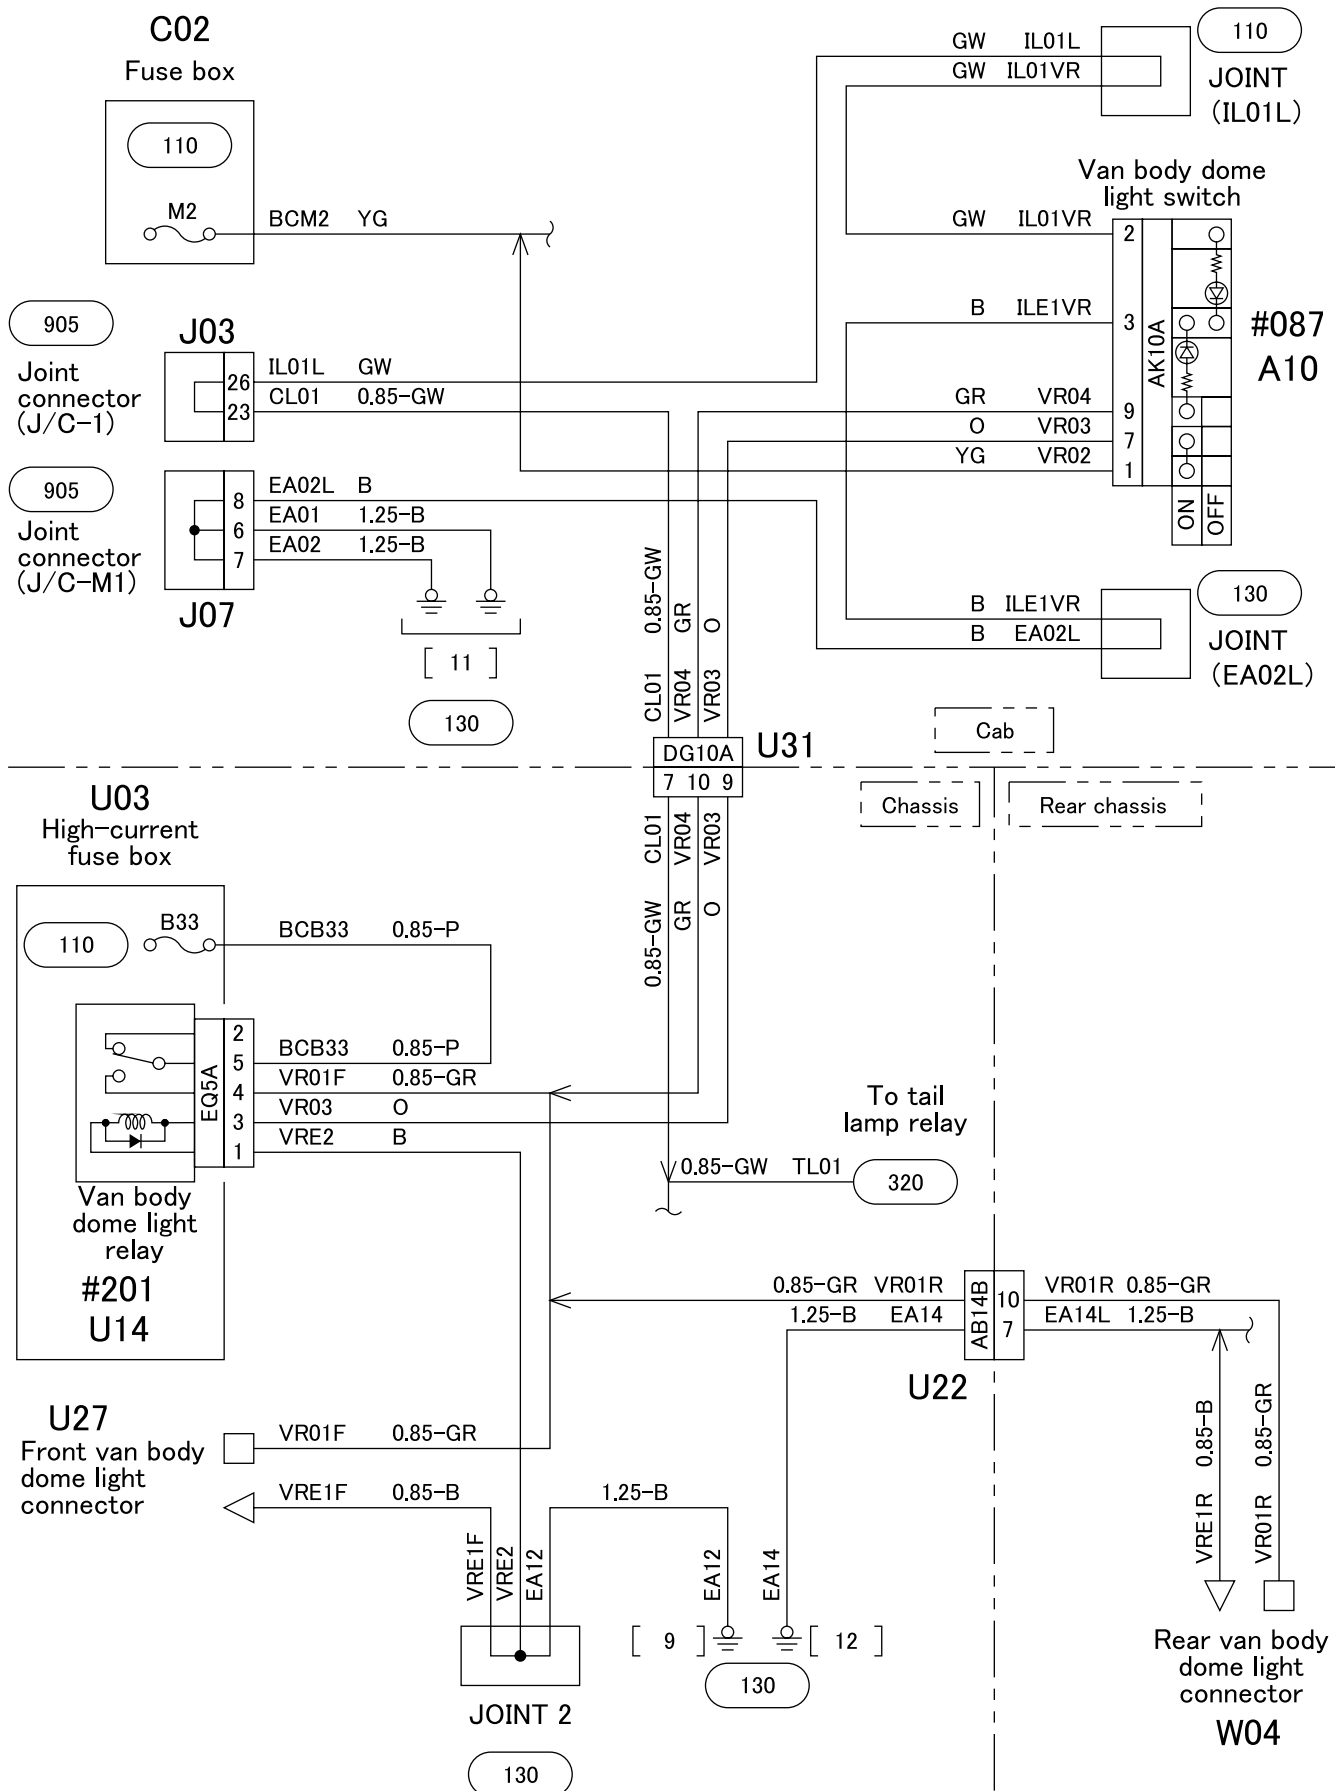
352-C03591

# 352 VAN BODY DOME LIGHT CIRCUIT

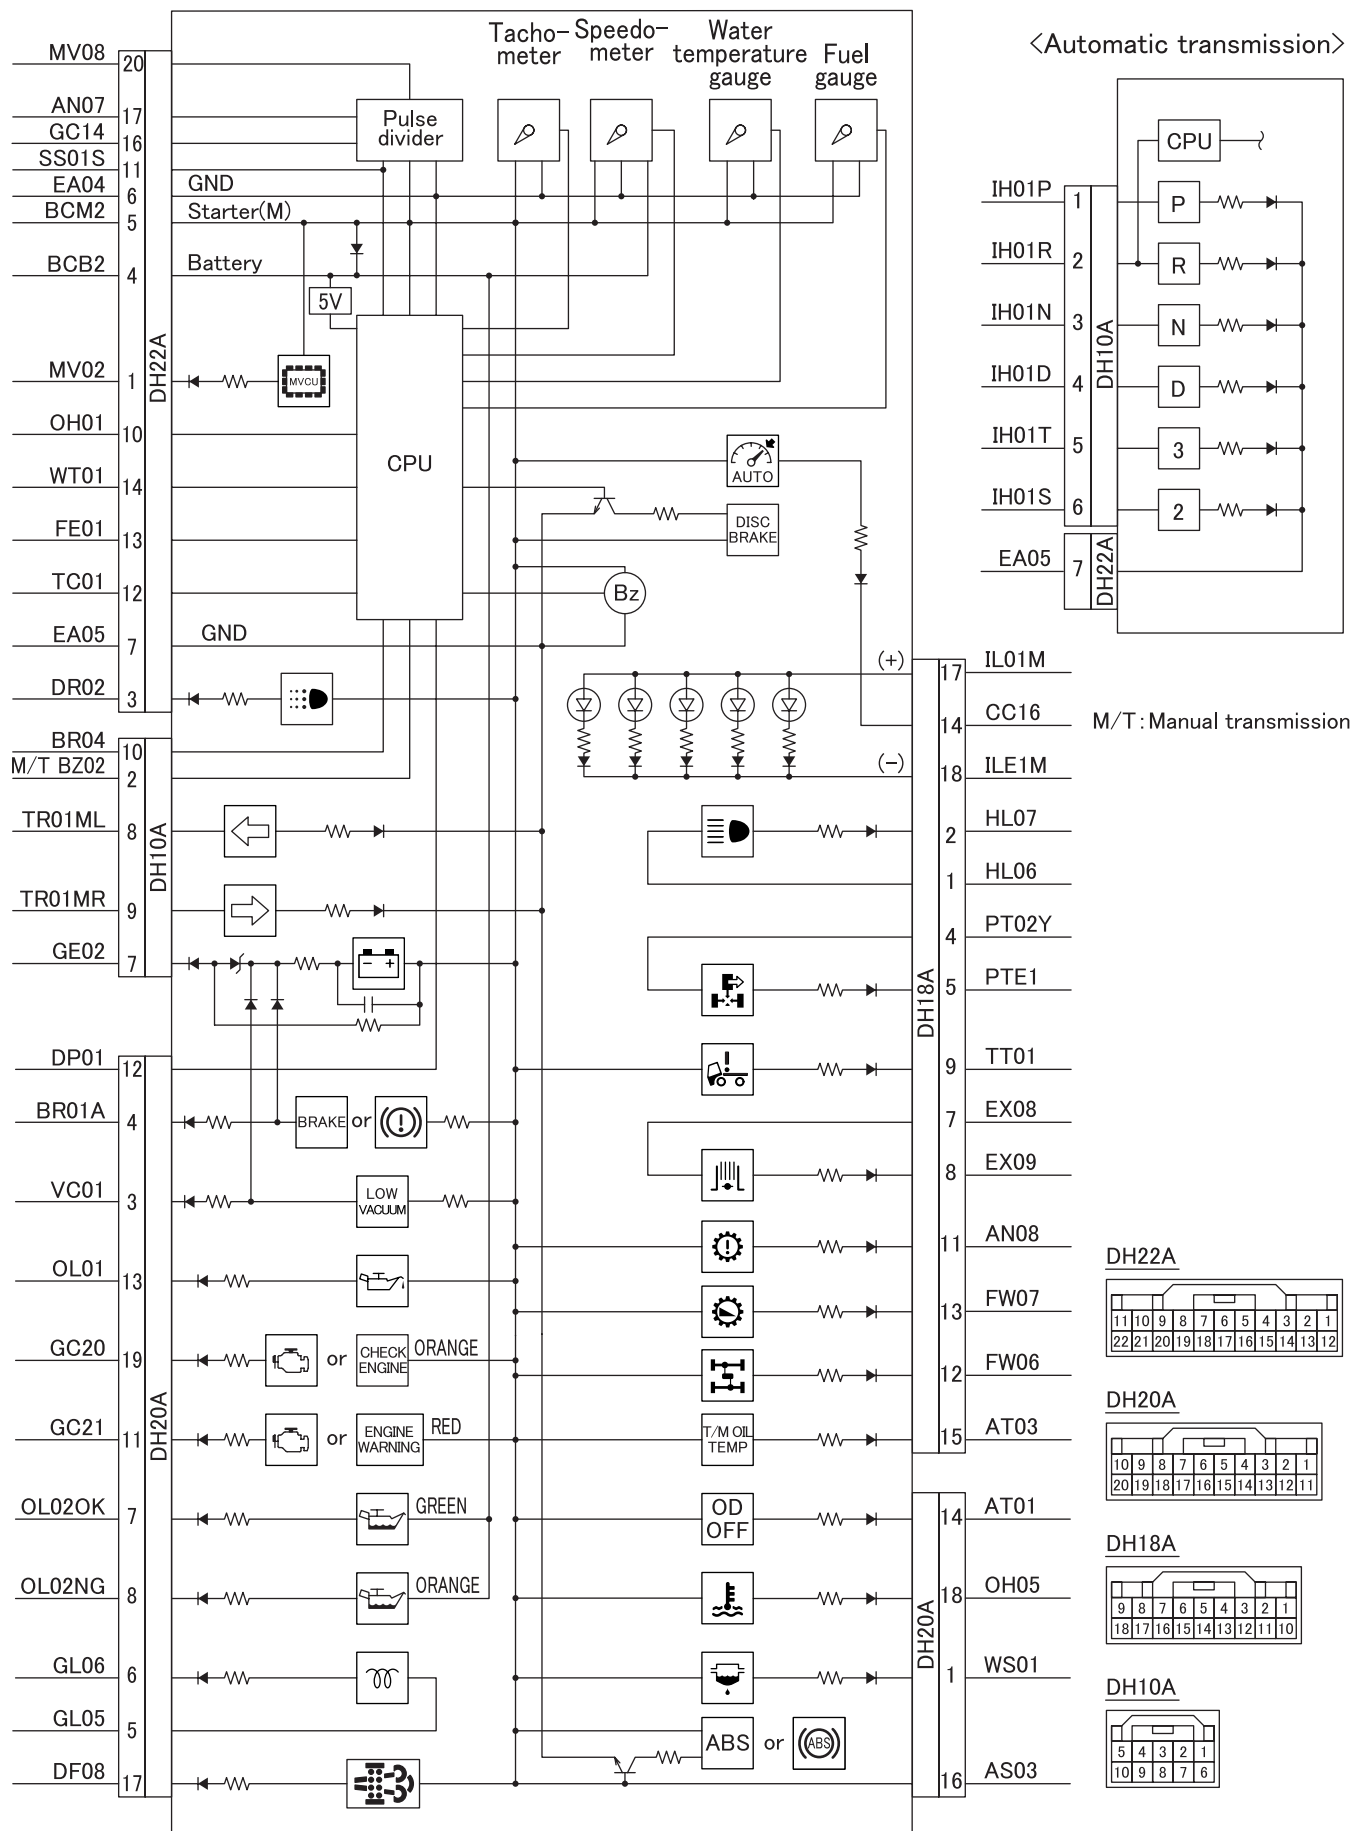
# 401 METER CLUSTER INTERNAL CIRCUIT

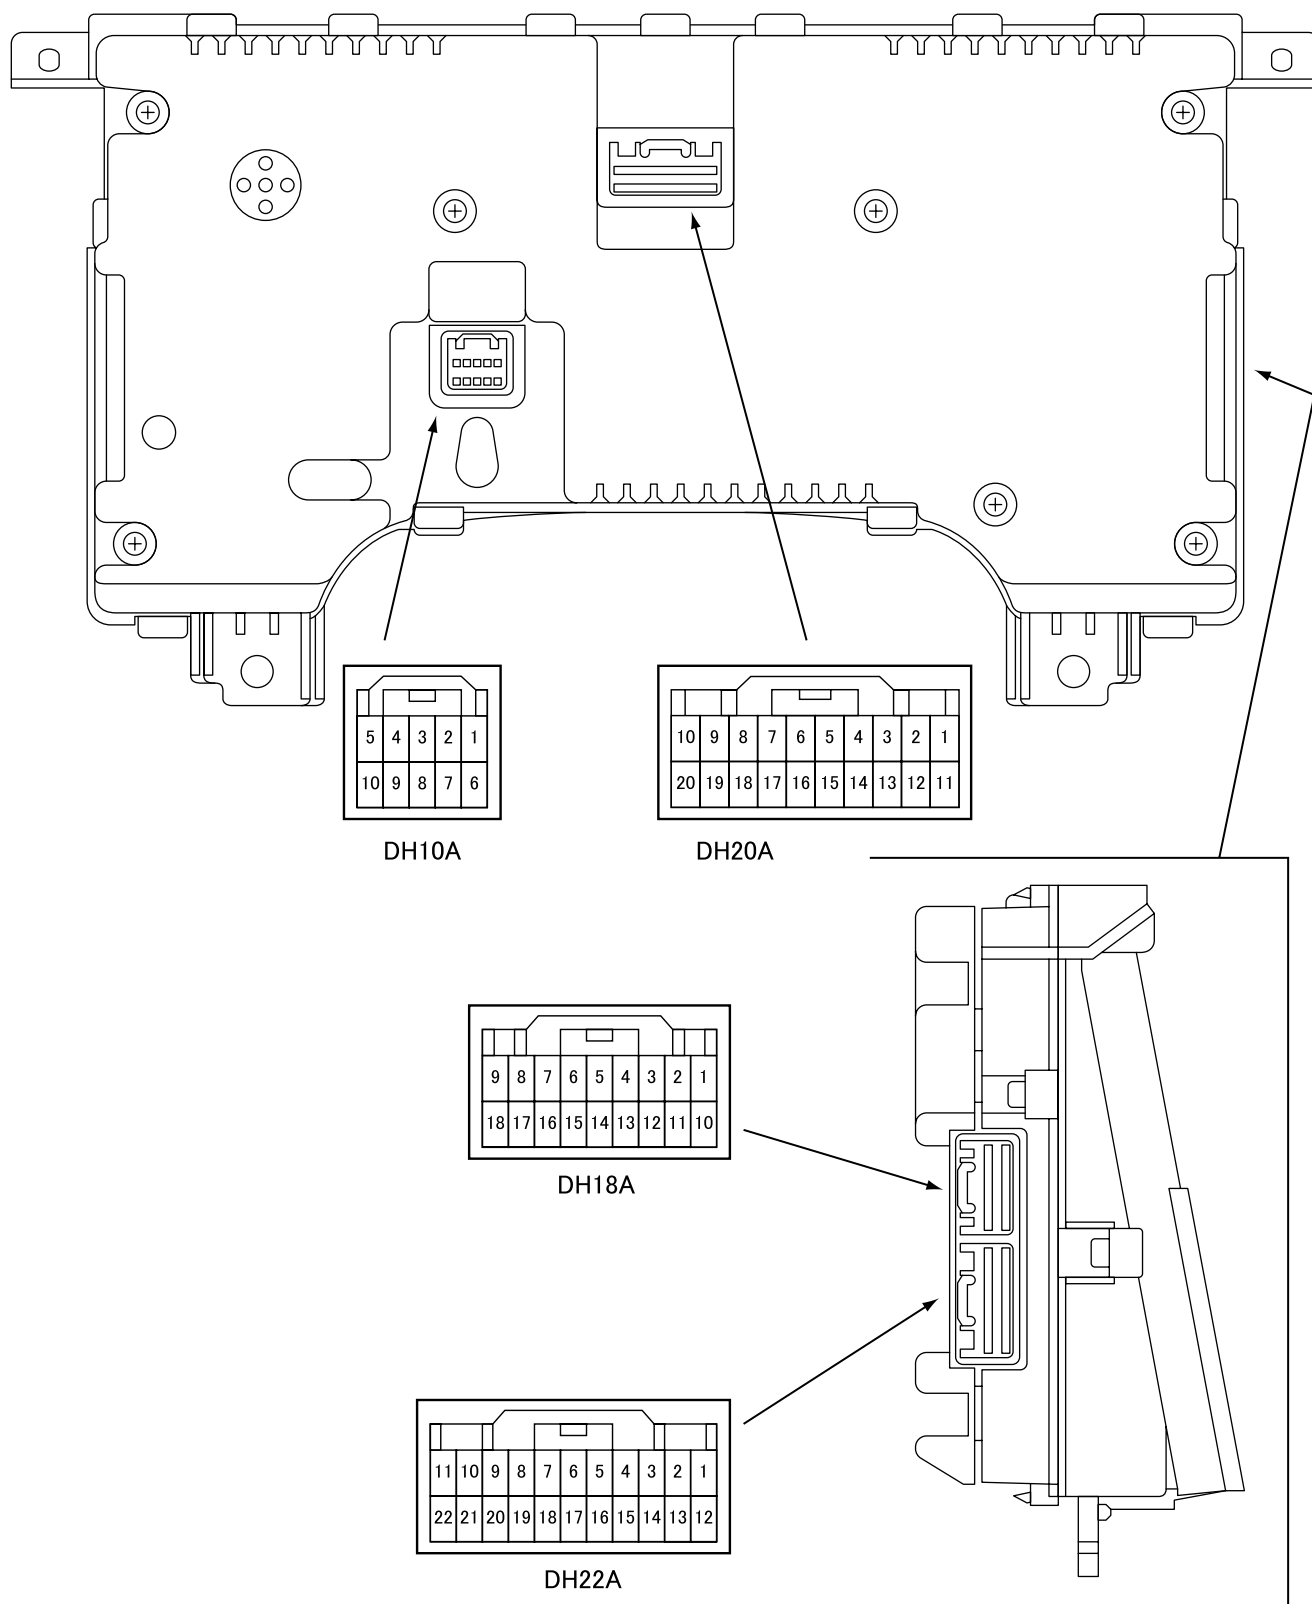
Meter cluster backward view

Because a CPU is built into the meter, the inner part of the meter body cannot be disassembled.
