# FE.FG

## SERVICE MANUAL 2008 Model FOREWORD

This Service Manual contains maintenance and repair methods for the Mitsubishi Fuso Truck FE. FG Series. Read this manual carefully as an aid in providing correct, efficient maintenance. Please note that the information and specifications contained within this manual may change without notice. This is due to product modifications and continued vehicle improvements that are made throughout the model years. Should you encounter any discrepancy in the information provided, please do not hesitate to contact your nearest Mitsubishi Fuso Dealer or Mitsubishi Fuso Truck of America, Inc.

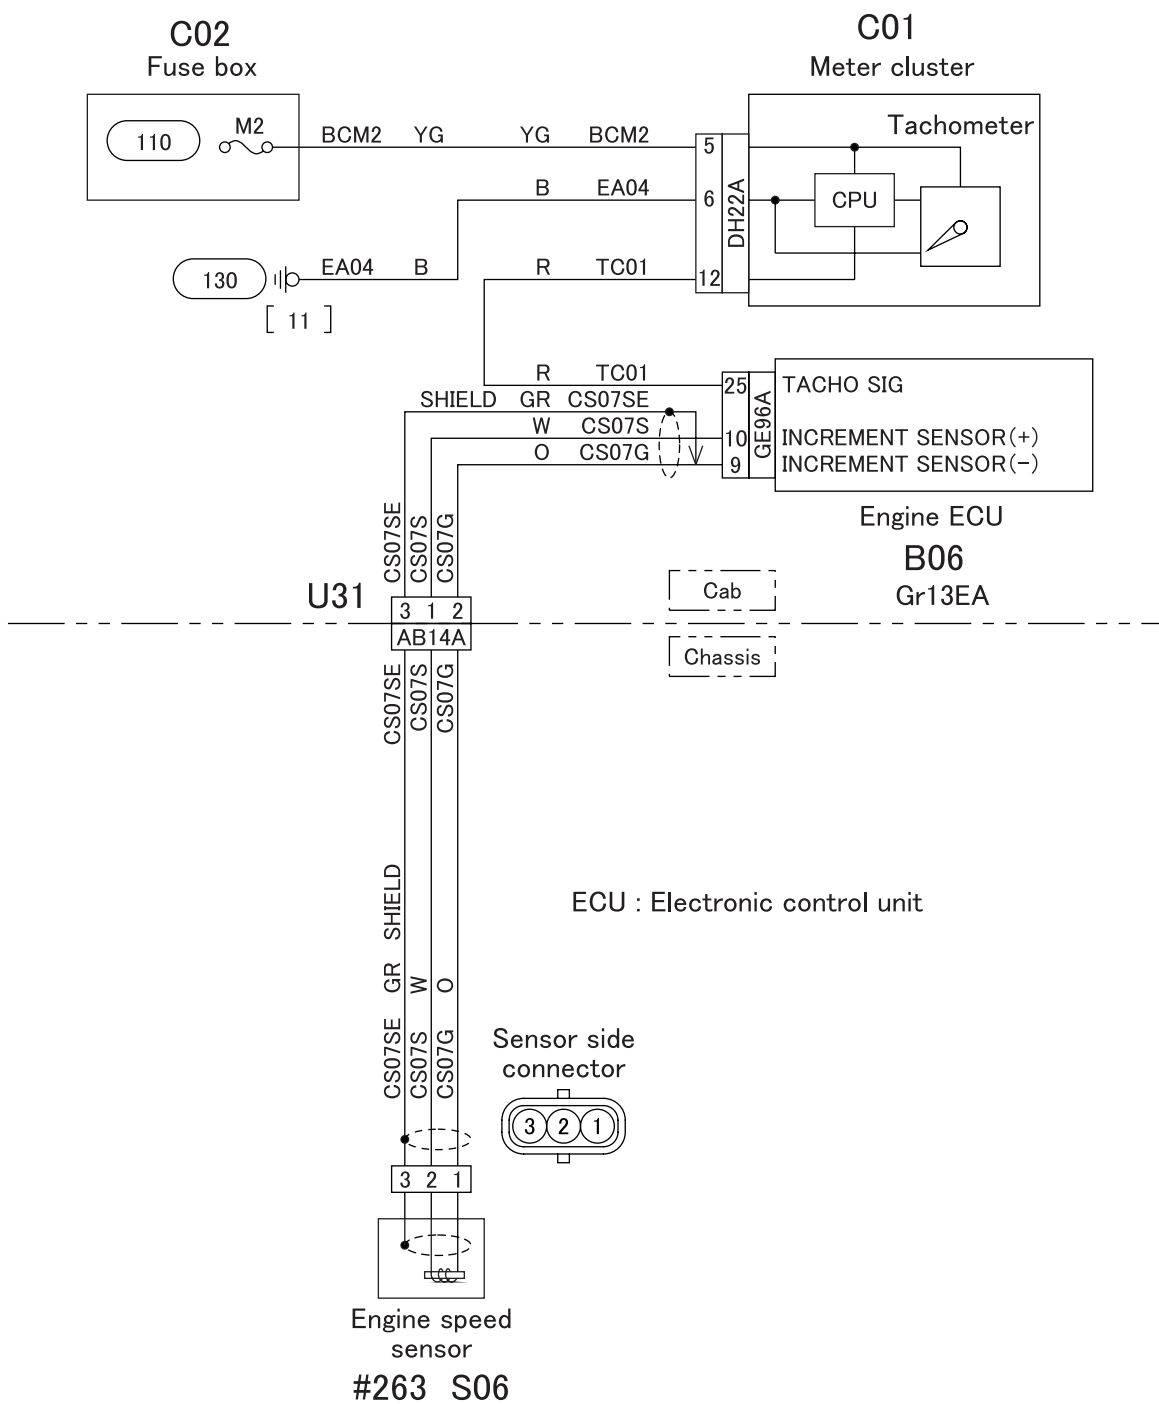
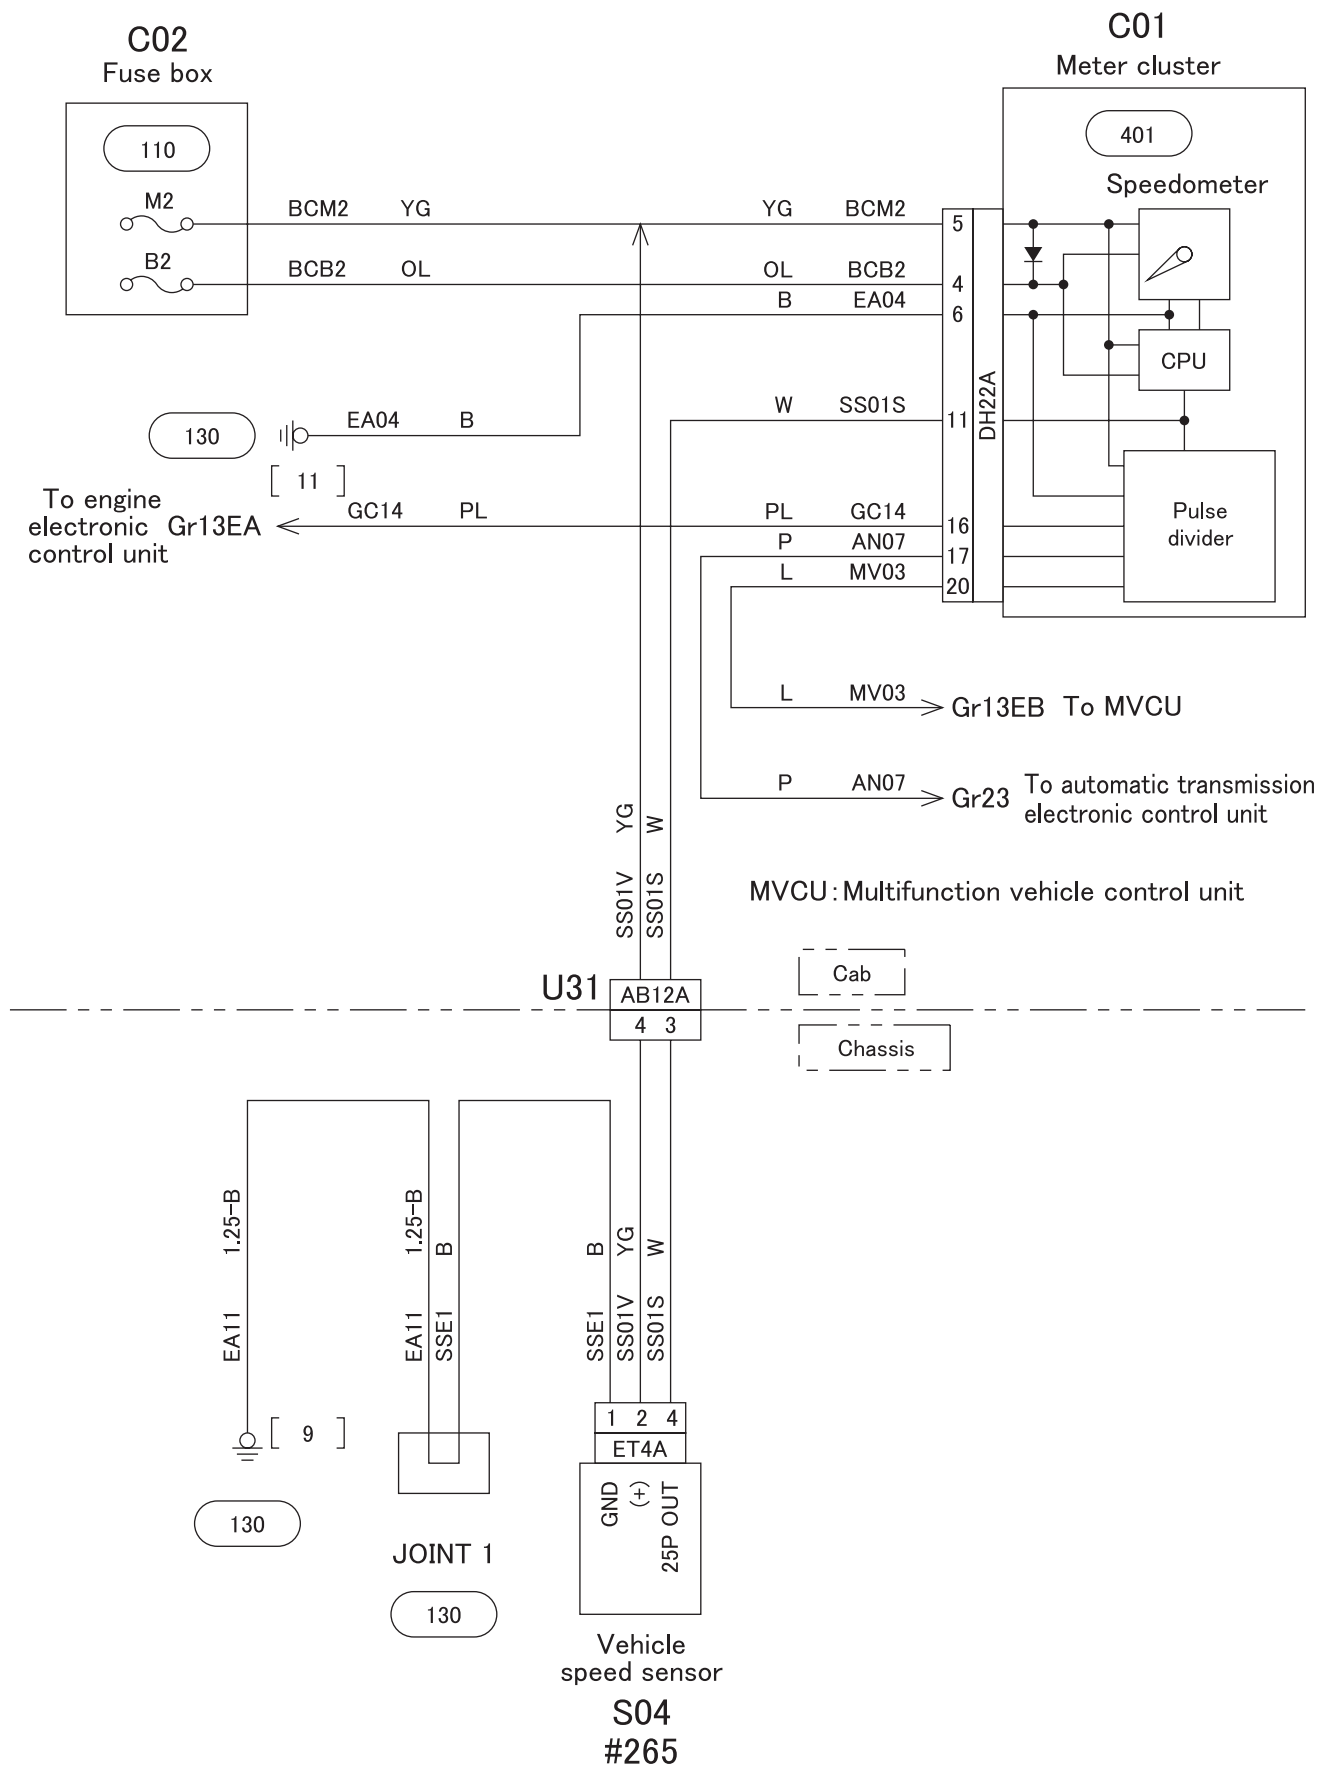
# 410 TACHOMETER CIRCUIT

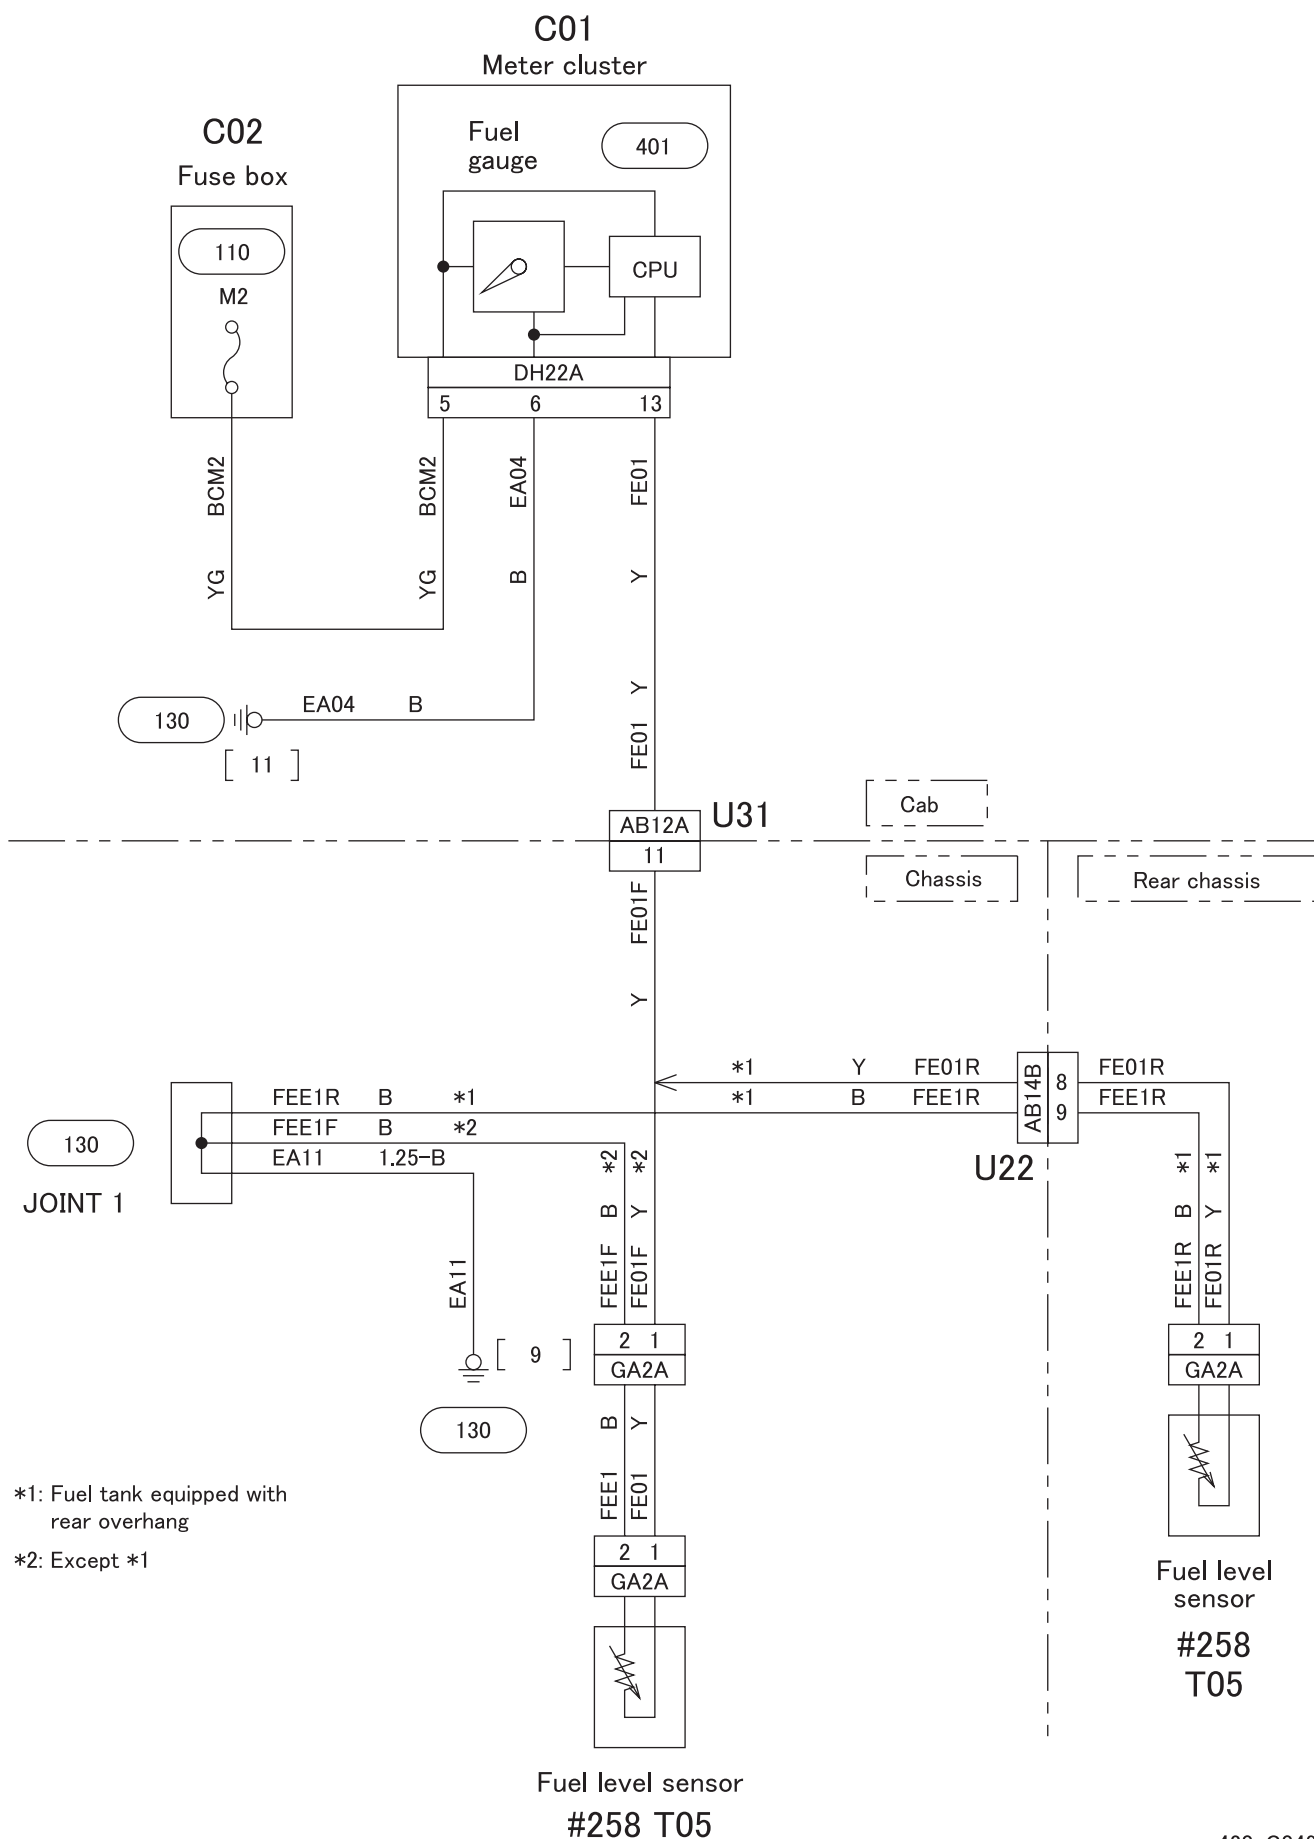
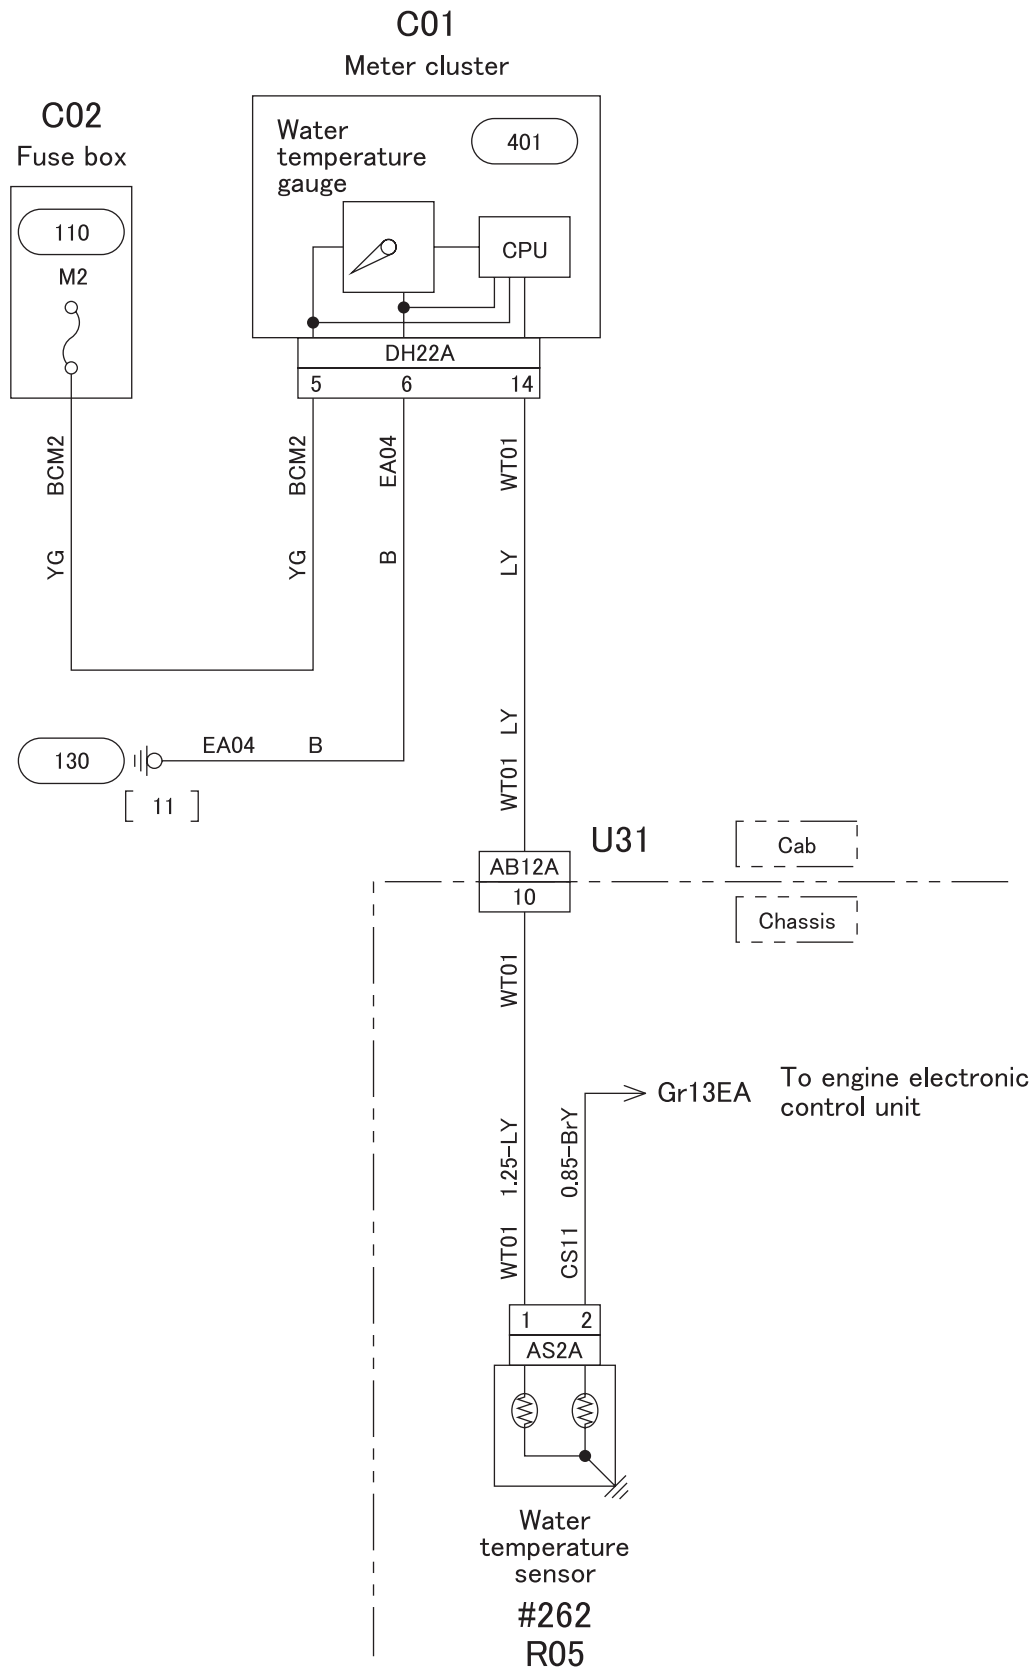
# 420 FUEL GAUGE CIRCUIT

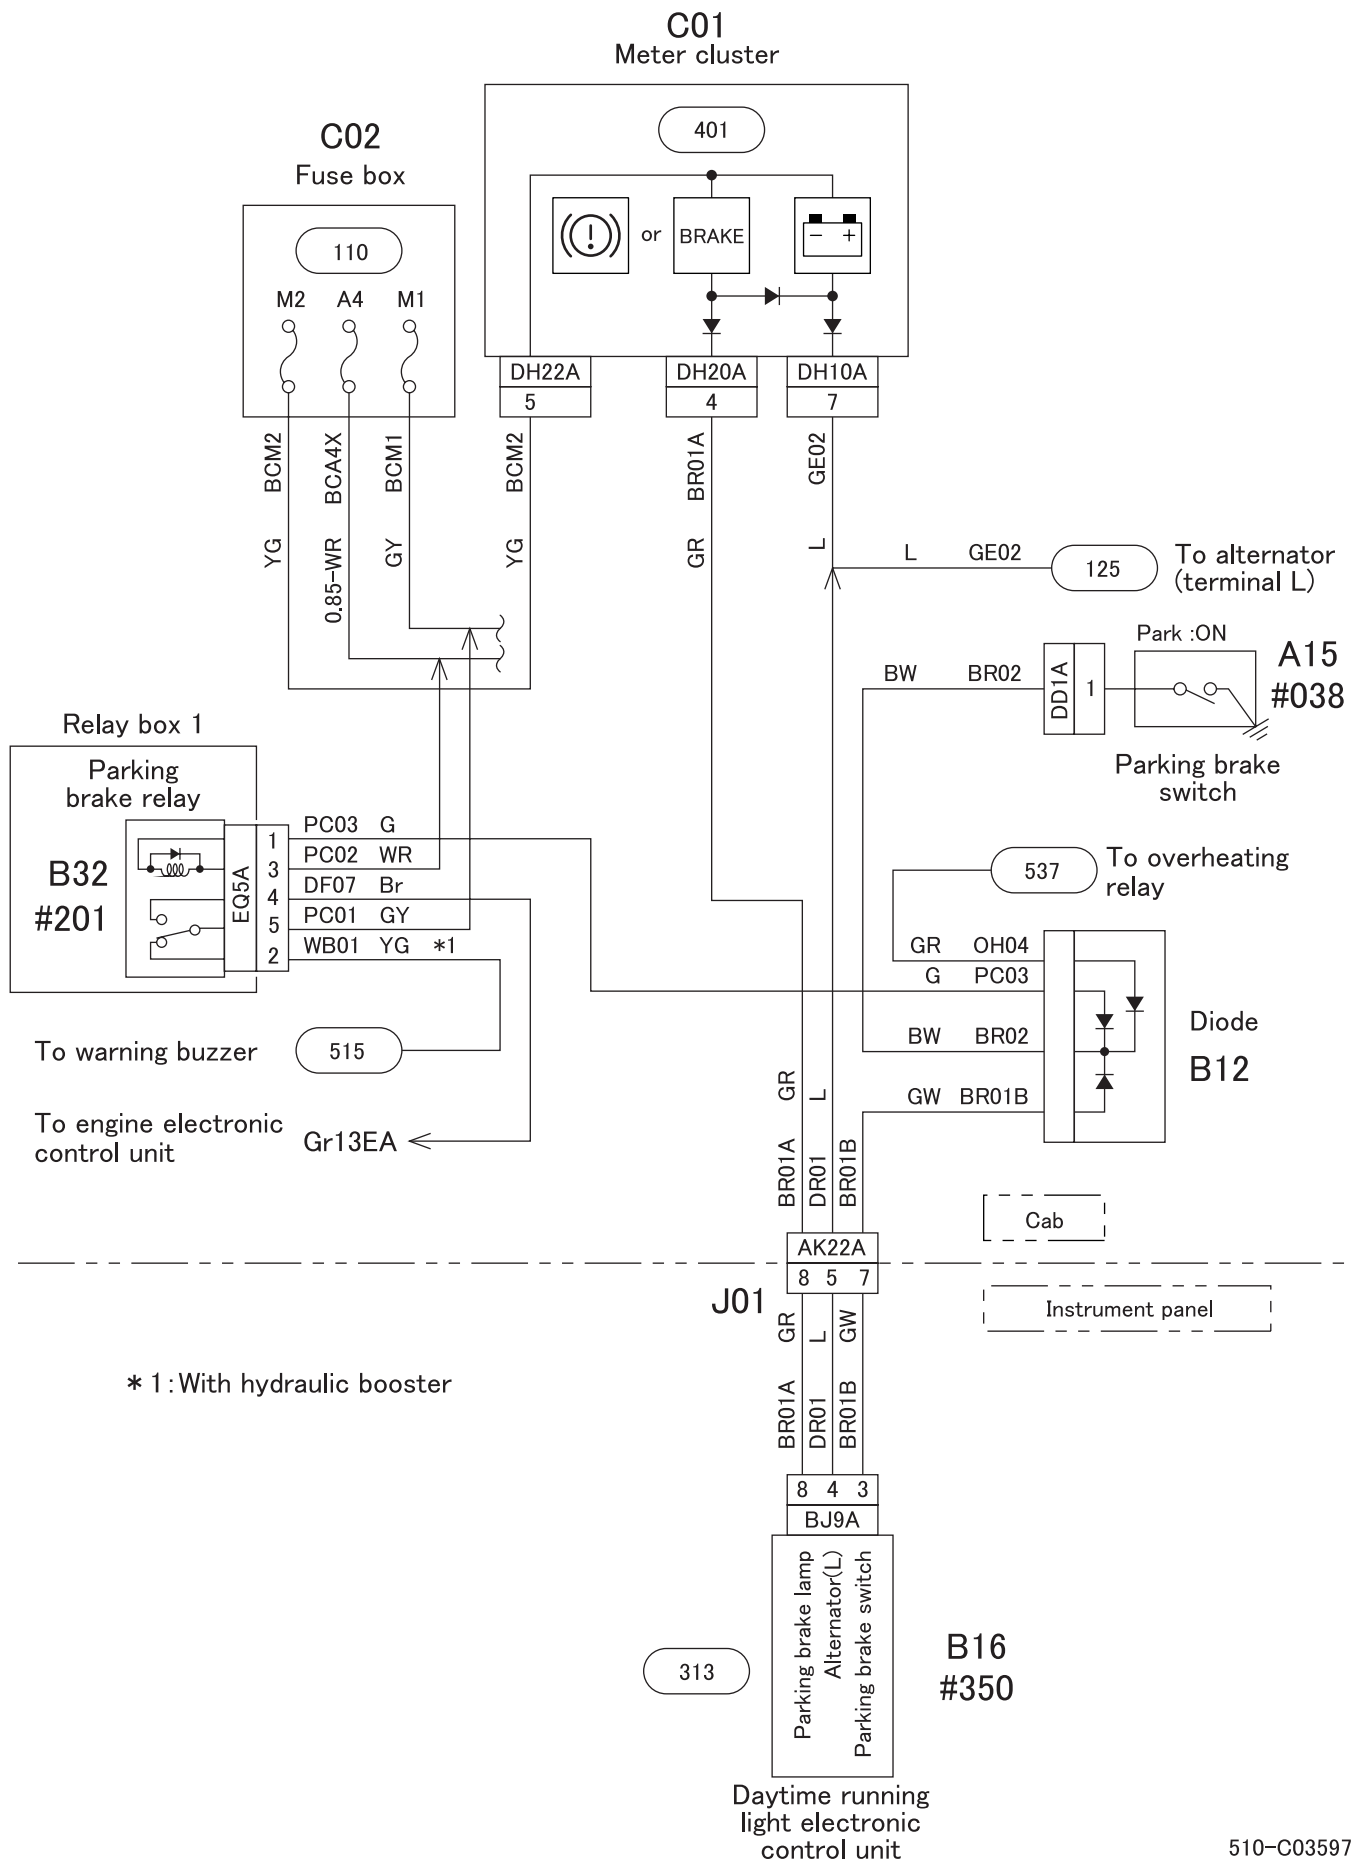
# 510 PARKING BRAKE INDICATOR CIRCUIT

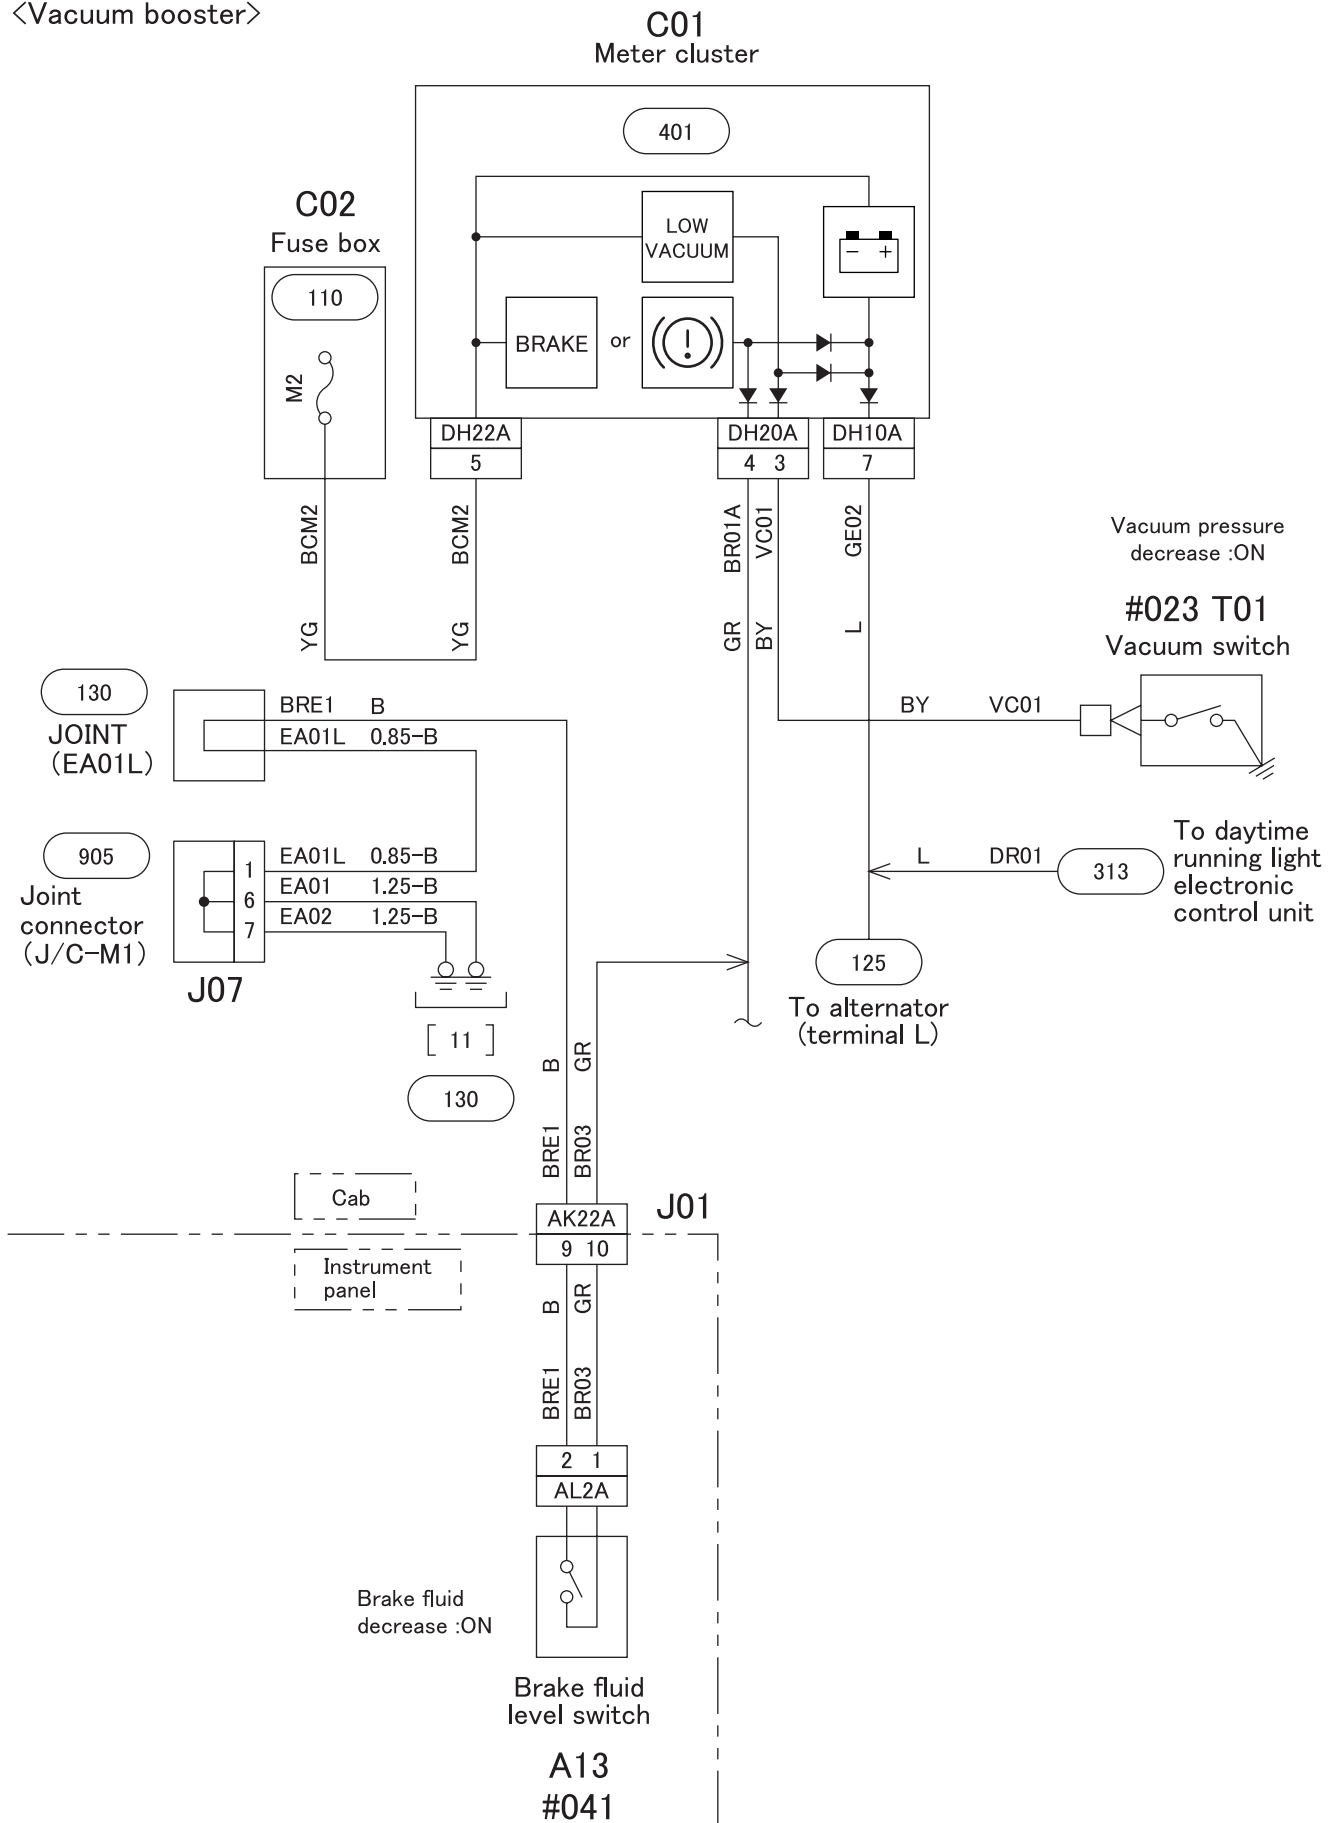
# 515 BRAKE WARNING CIRCUIT

<Vacuum booster>

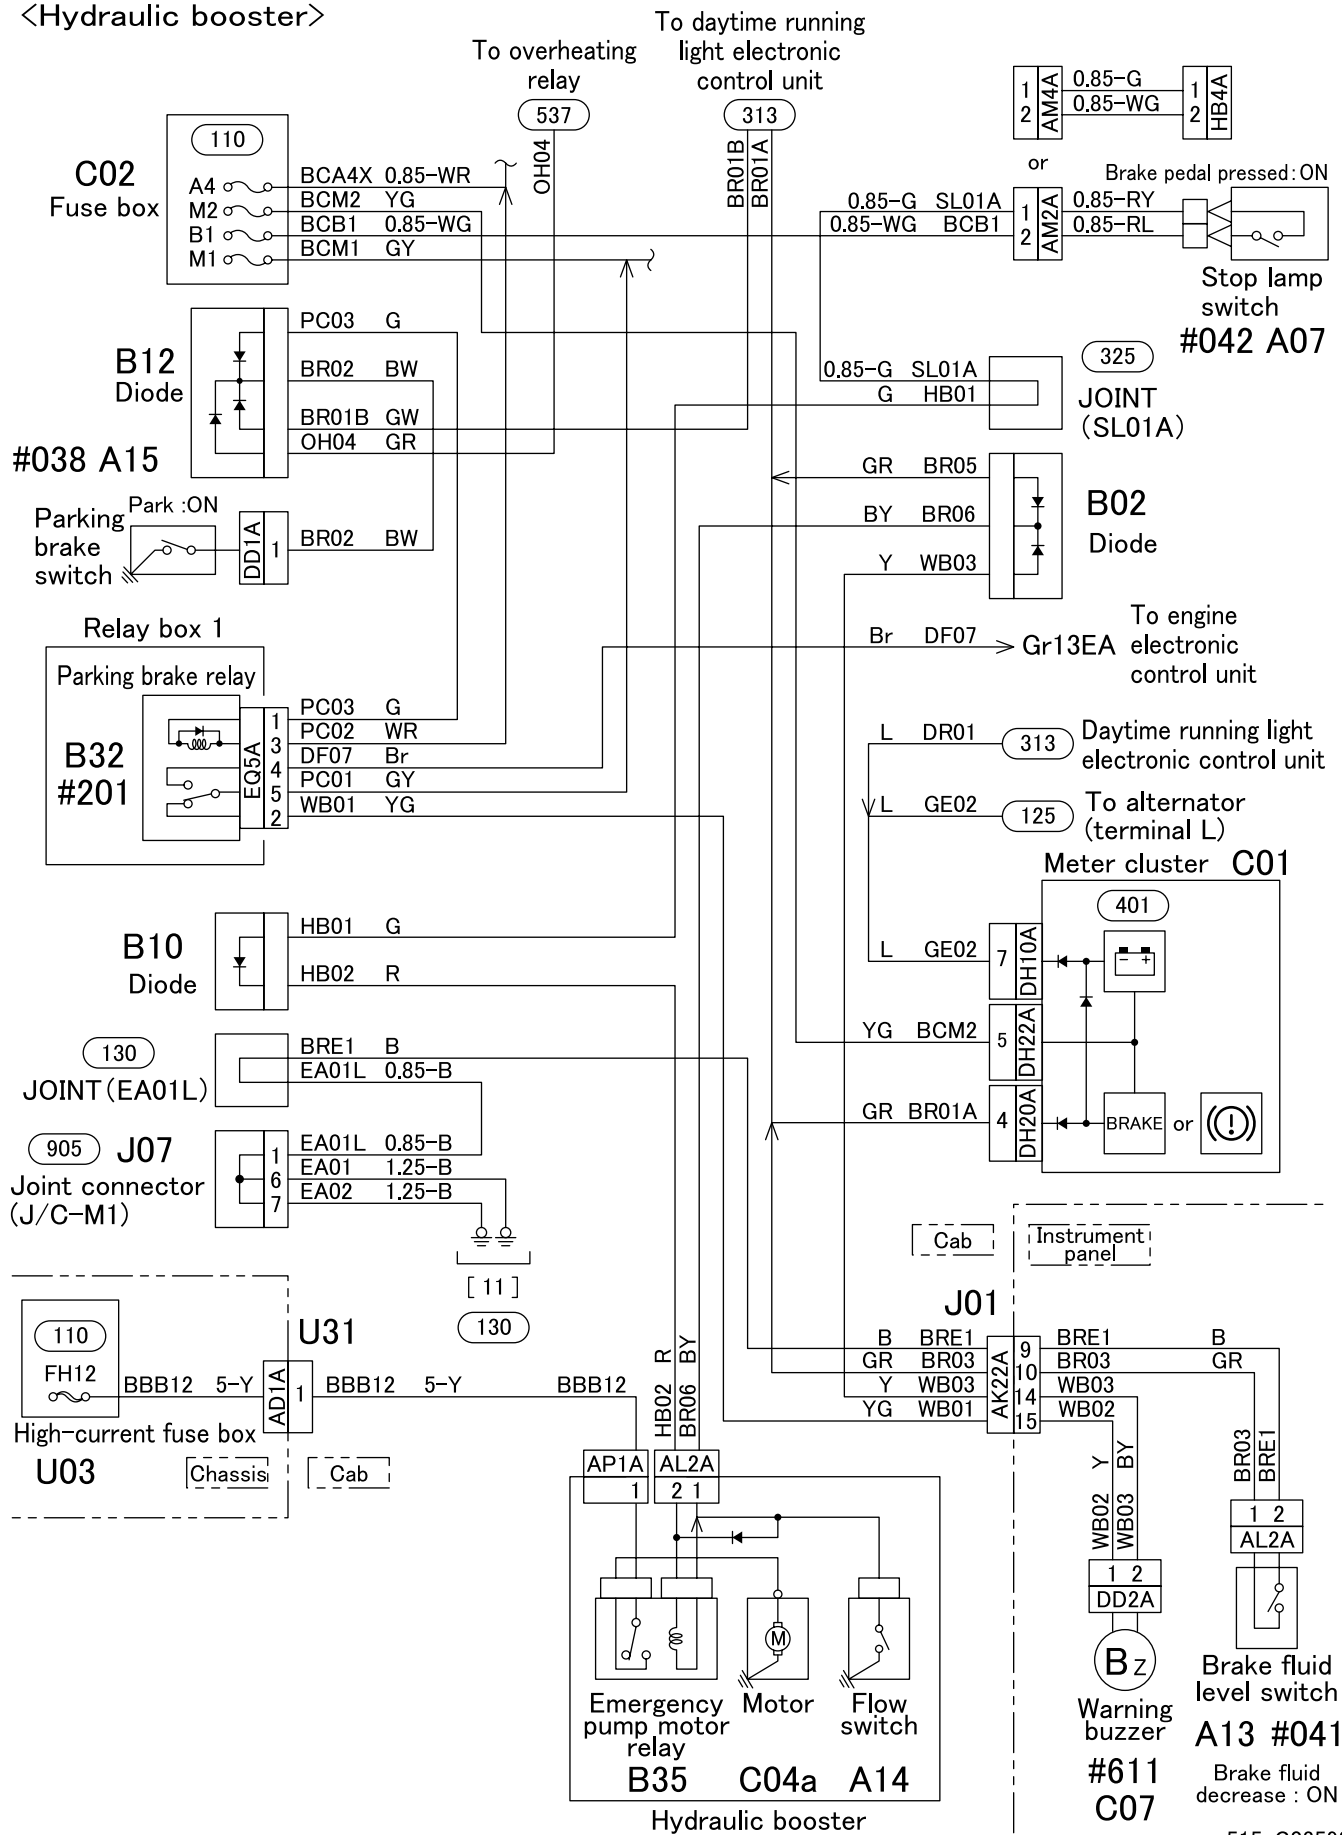
### <Hydraulic booster>

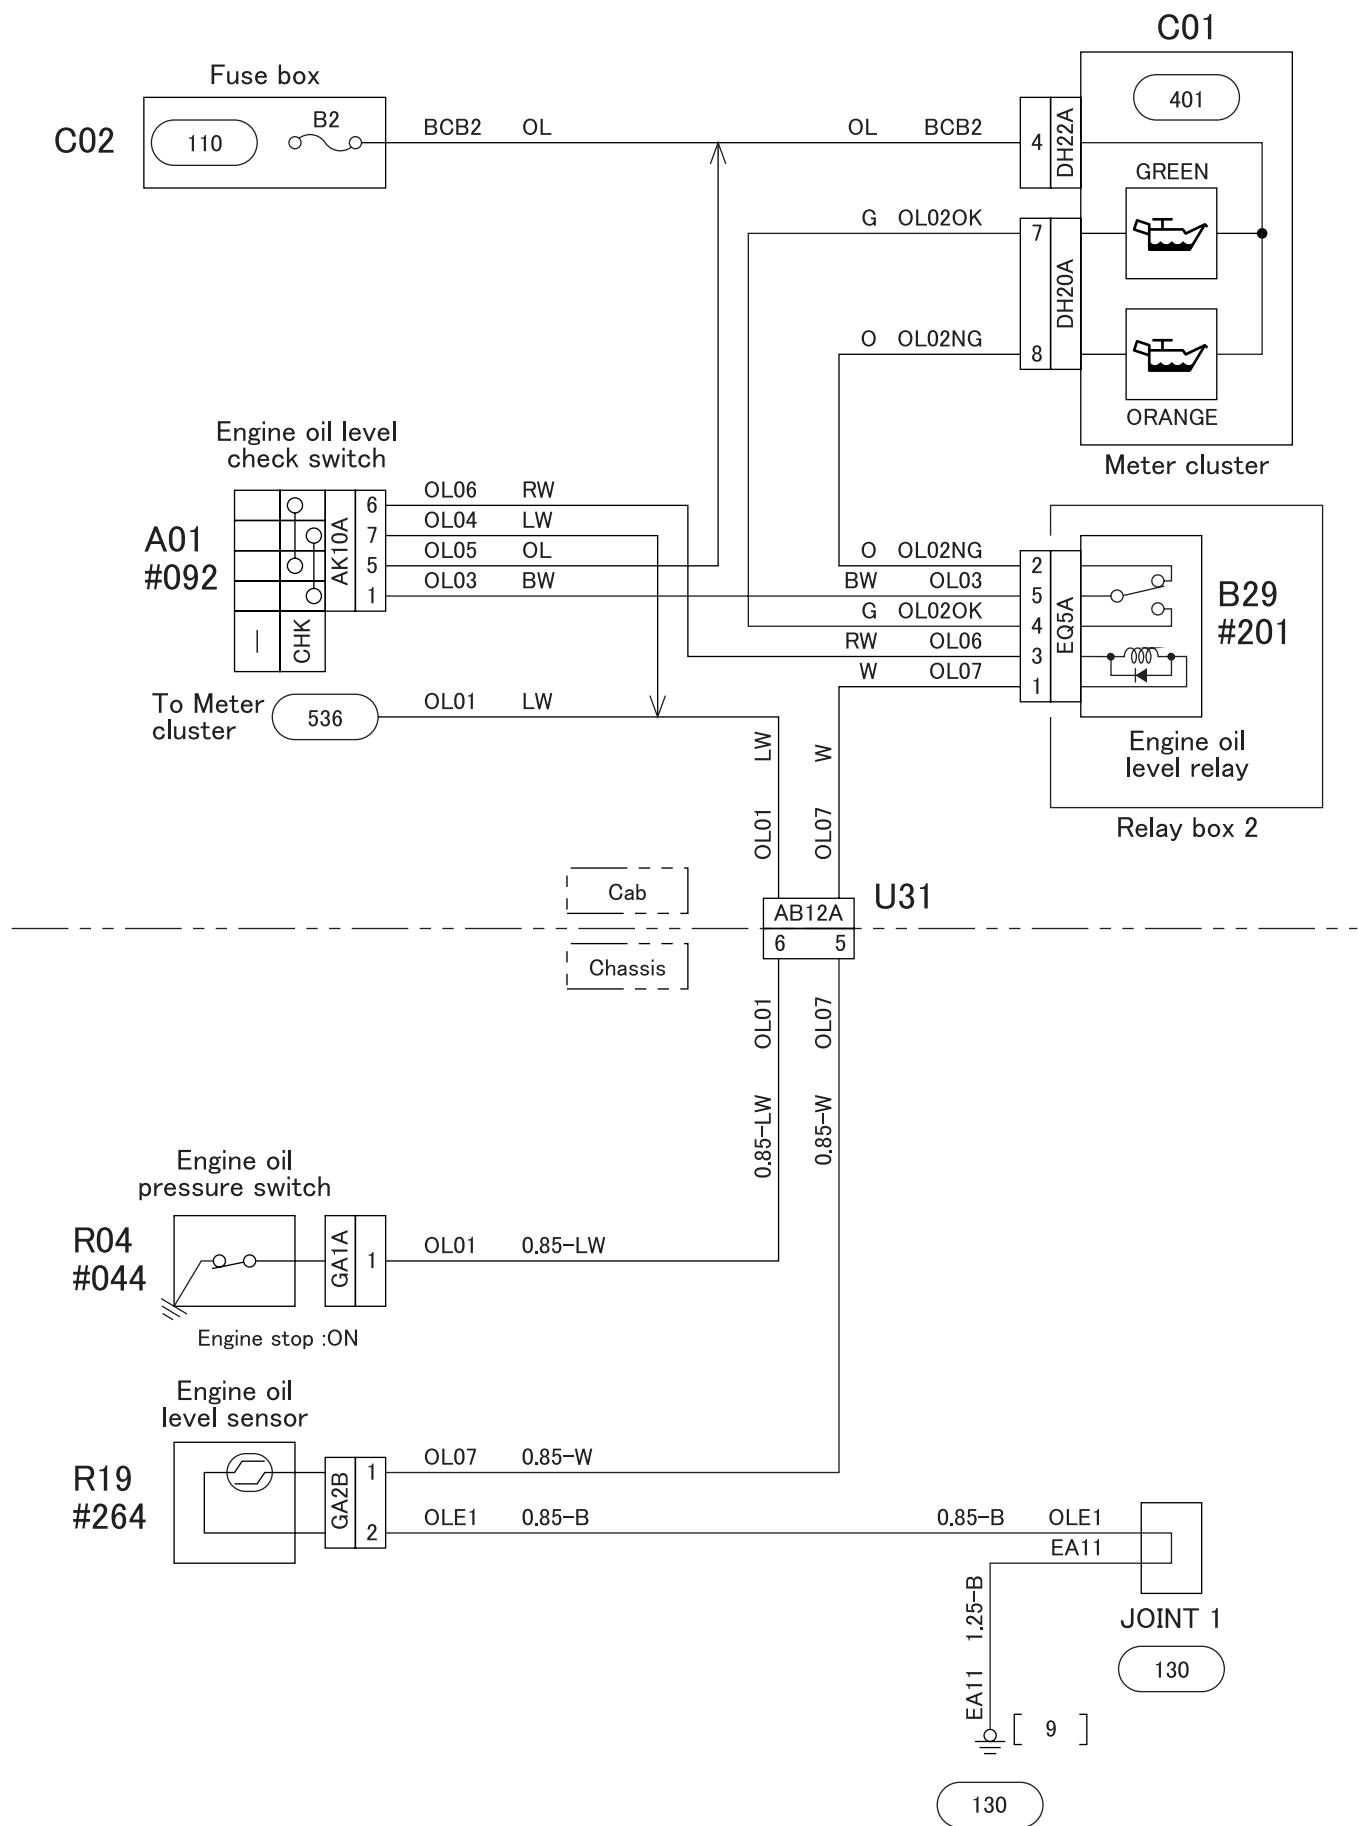
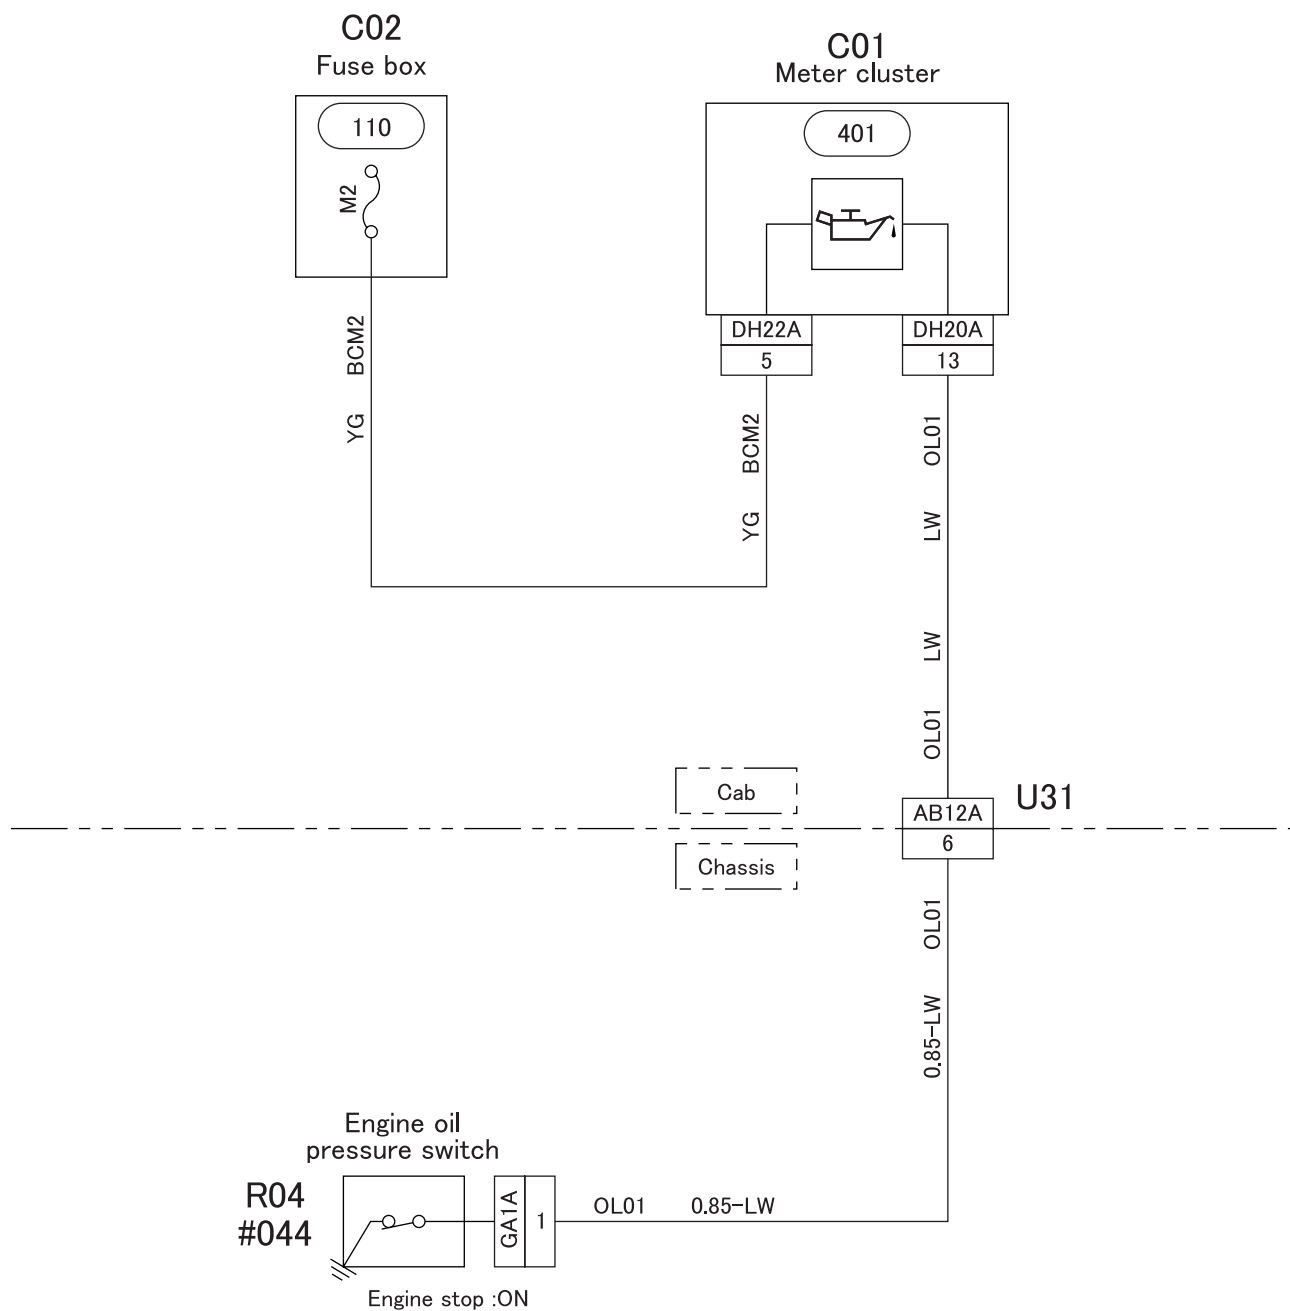
# 535 ENGINE OIL LEVEL WARNING CIRCUIT
