# FE.FG

## SERVICE MANUAL 2008 Model FOREWORD

This Service Manual contains maintenance and repair methods for the Mitsubishi Fuso Truck FE. FG Series. Read this manual carefully as an aid in providing correct, efficient maintenance. Please note that the information and specifications contained within this manual may change without notice. This is due to product modifications and continued vehicle improvements that are made throughout the model years. Should you encounter any discrepancy in the information provided, please do not hesitate to contact your nearest Mitsubishi Fuso Dealer or Mitsubishi Fuso Truck of America, Inc.

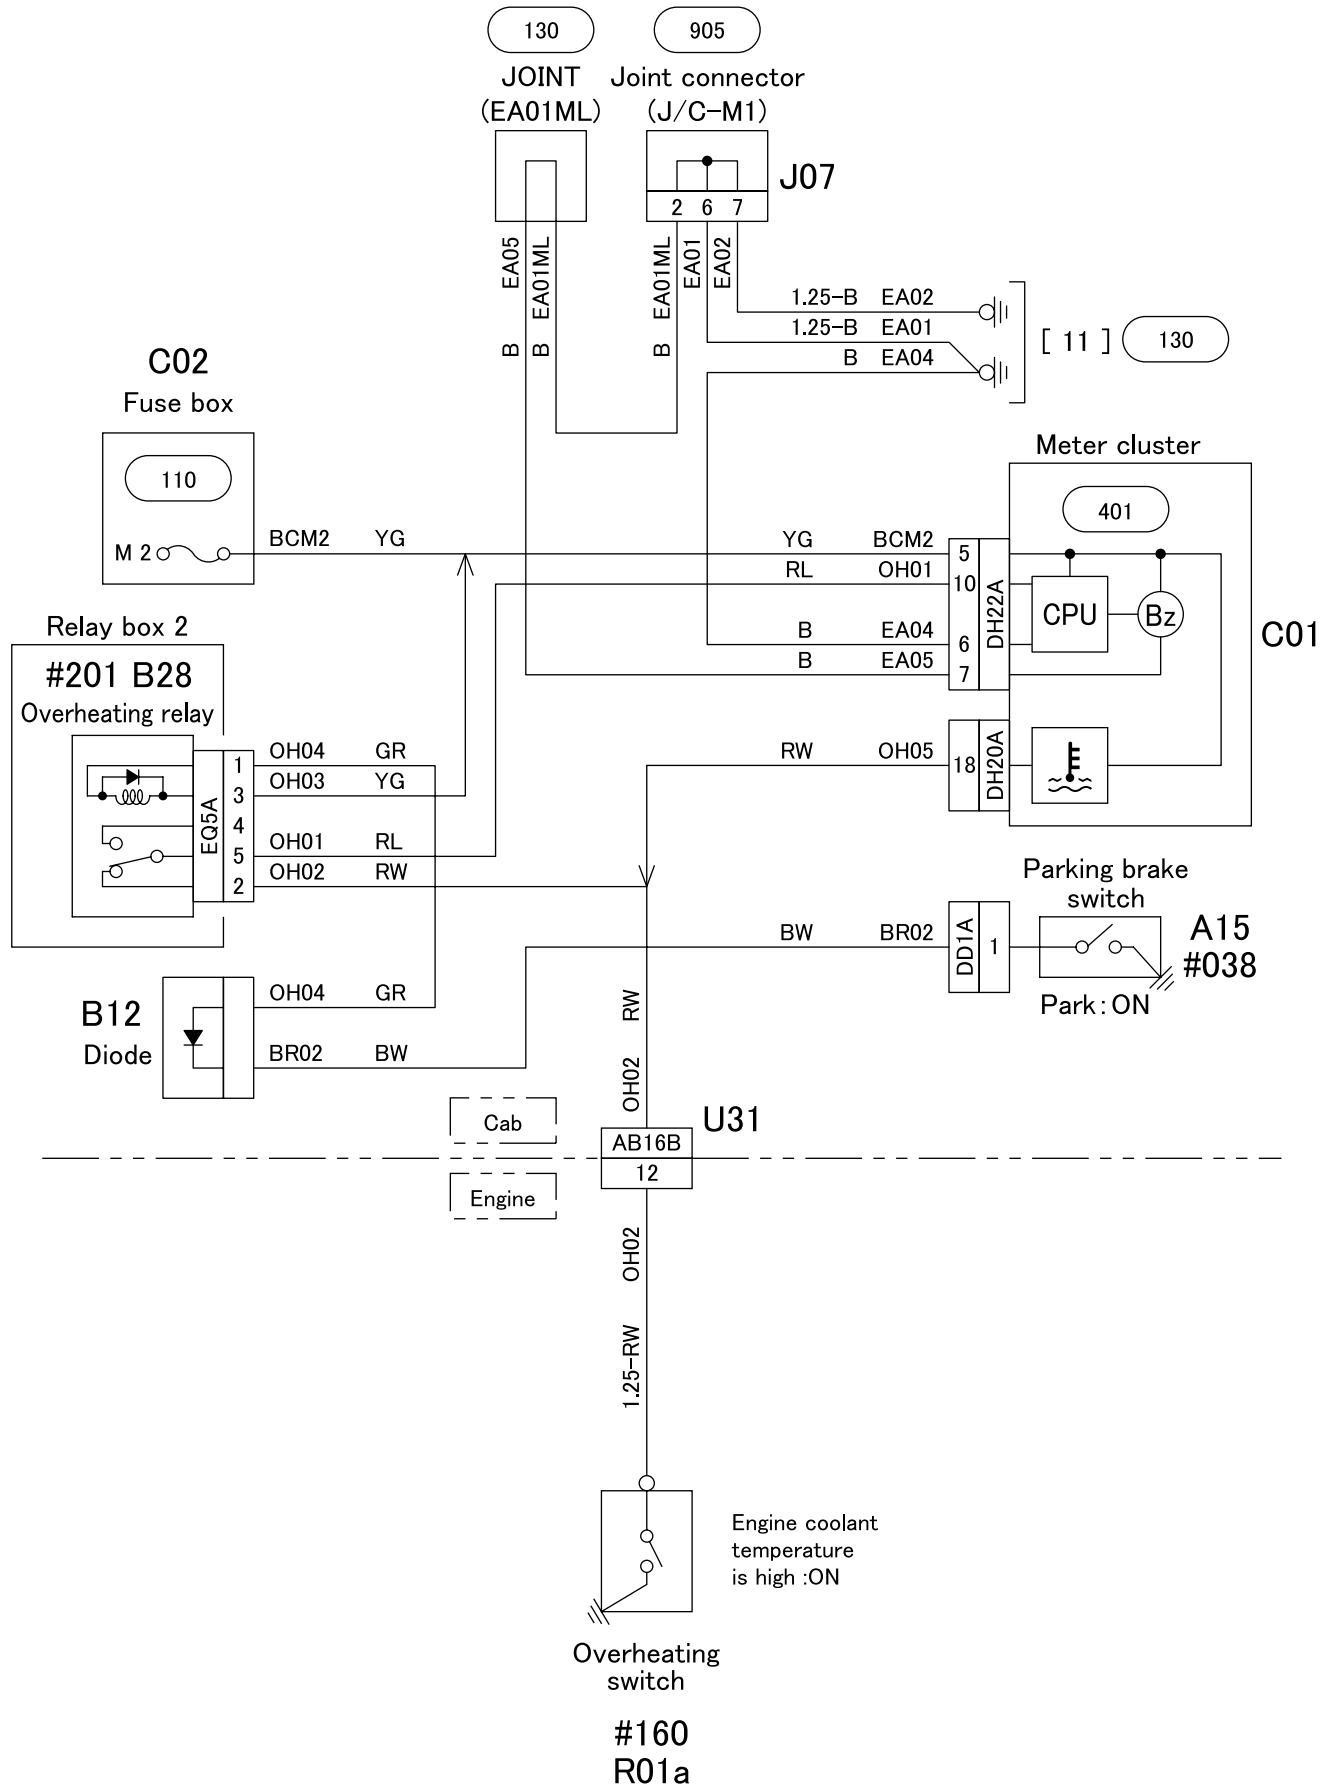
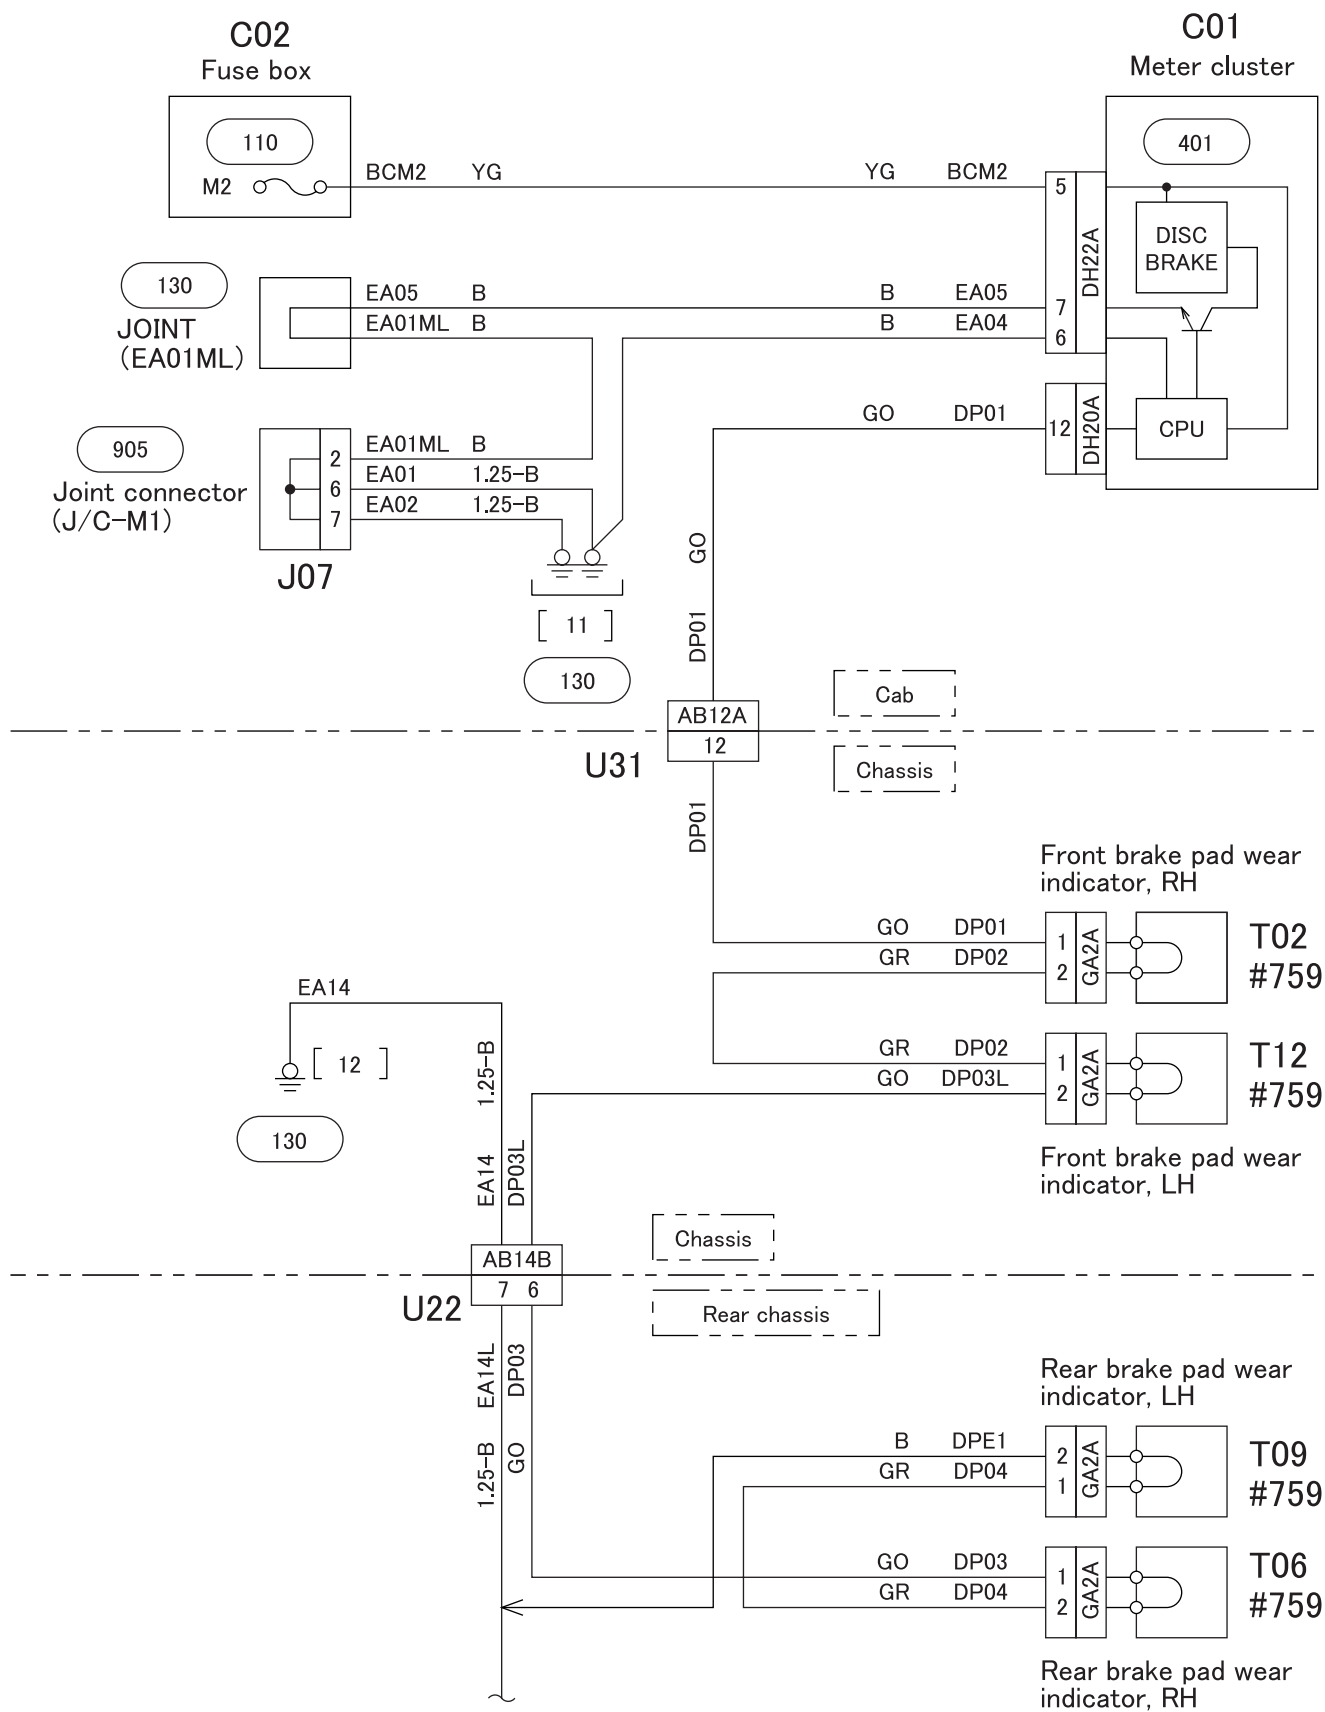
## 537 OVERHEATING WARNING CIRCUIT

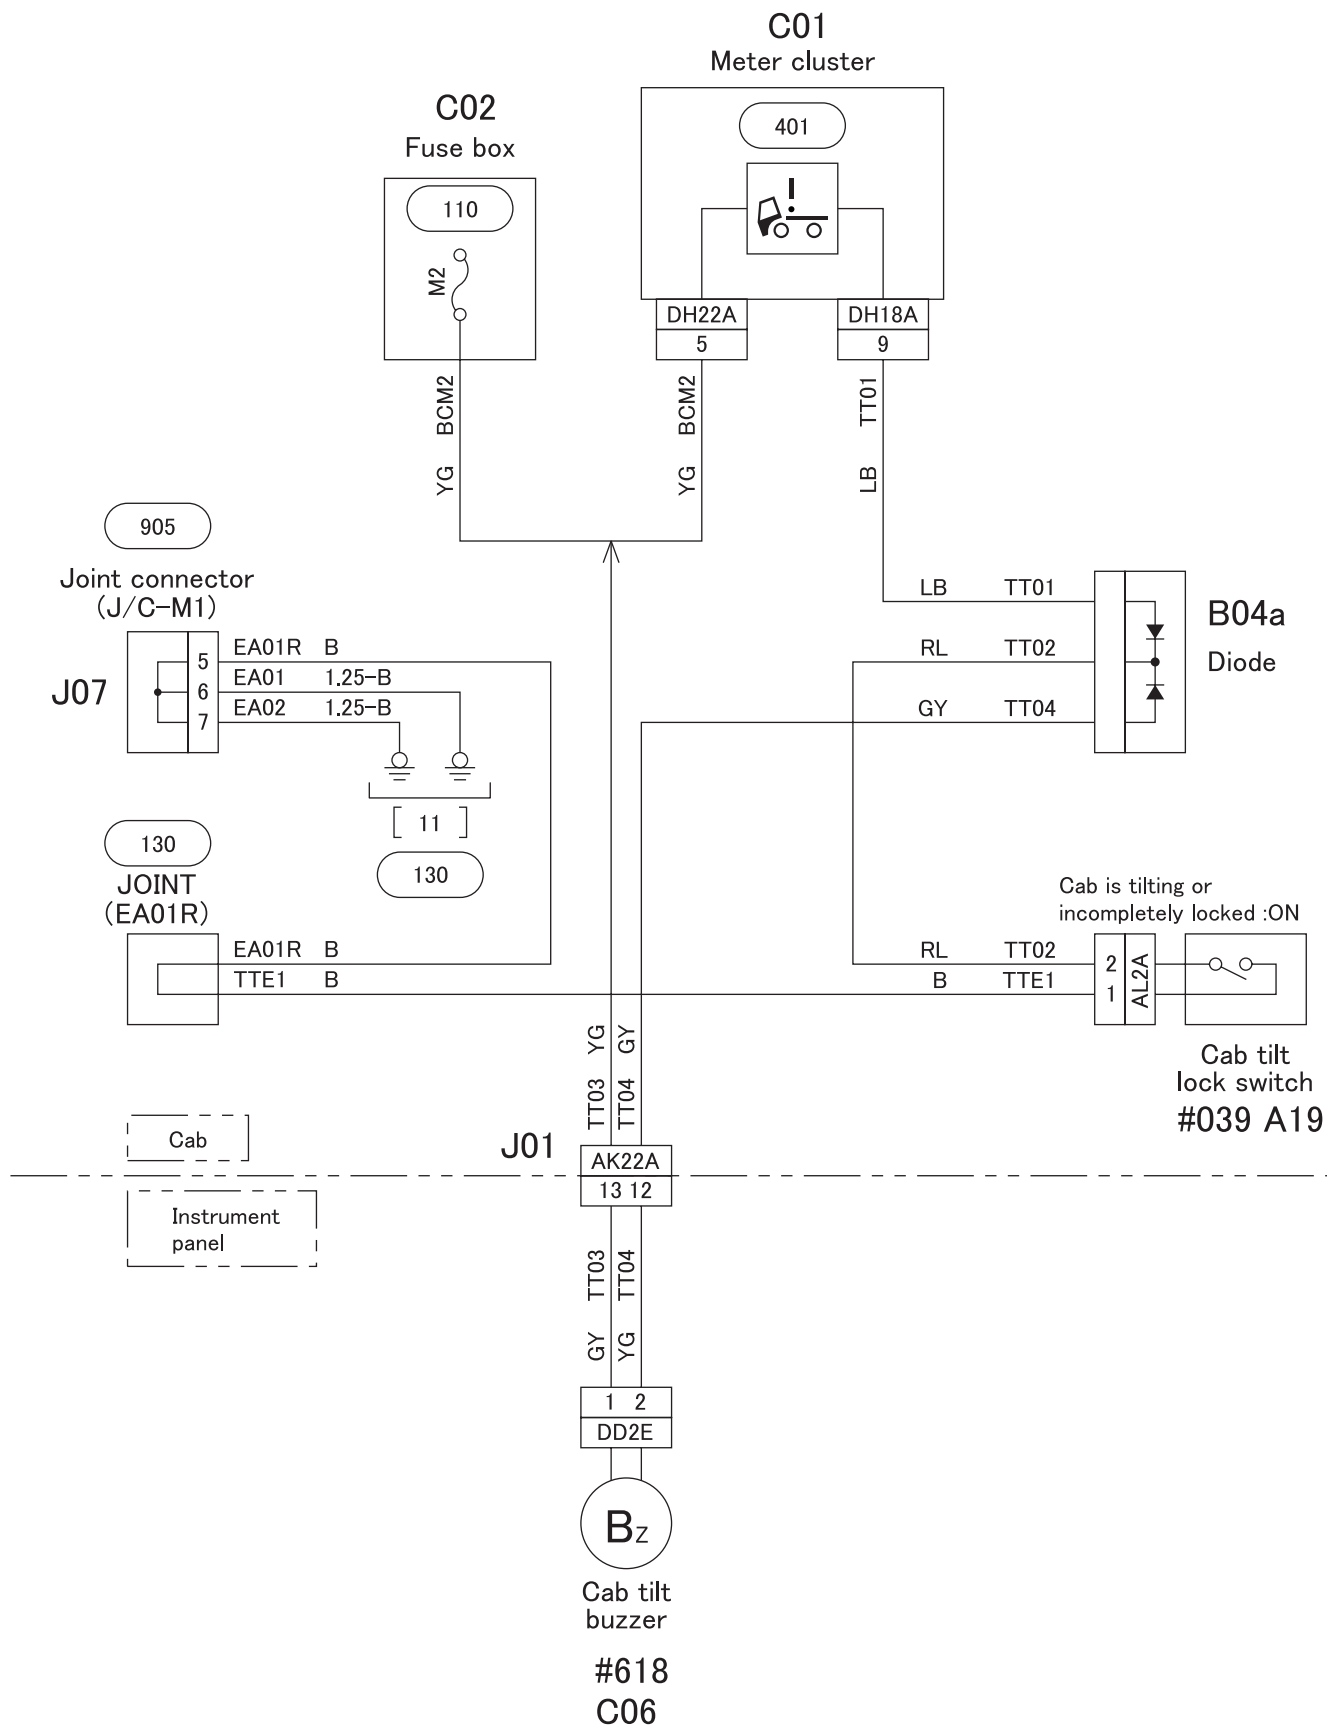
# 550 CAB TILT WARNING CIRCUIT

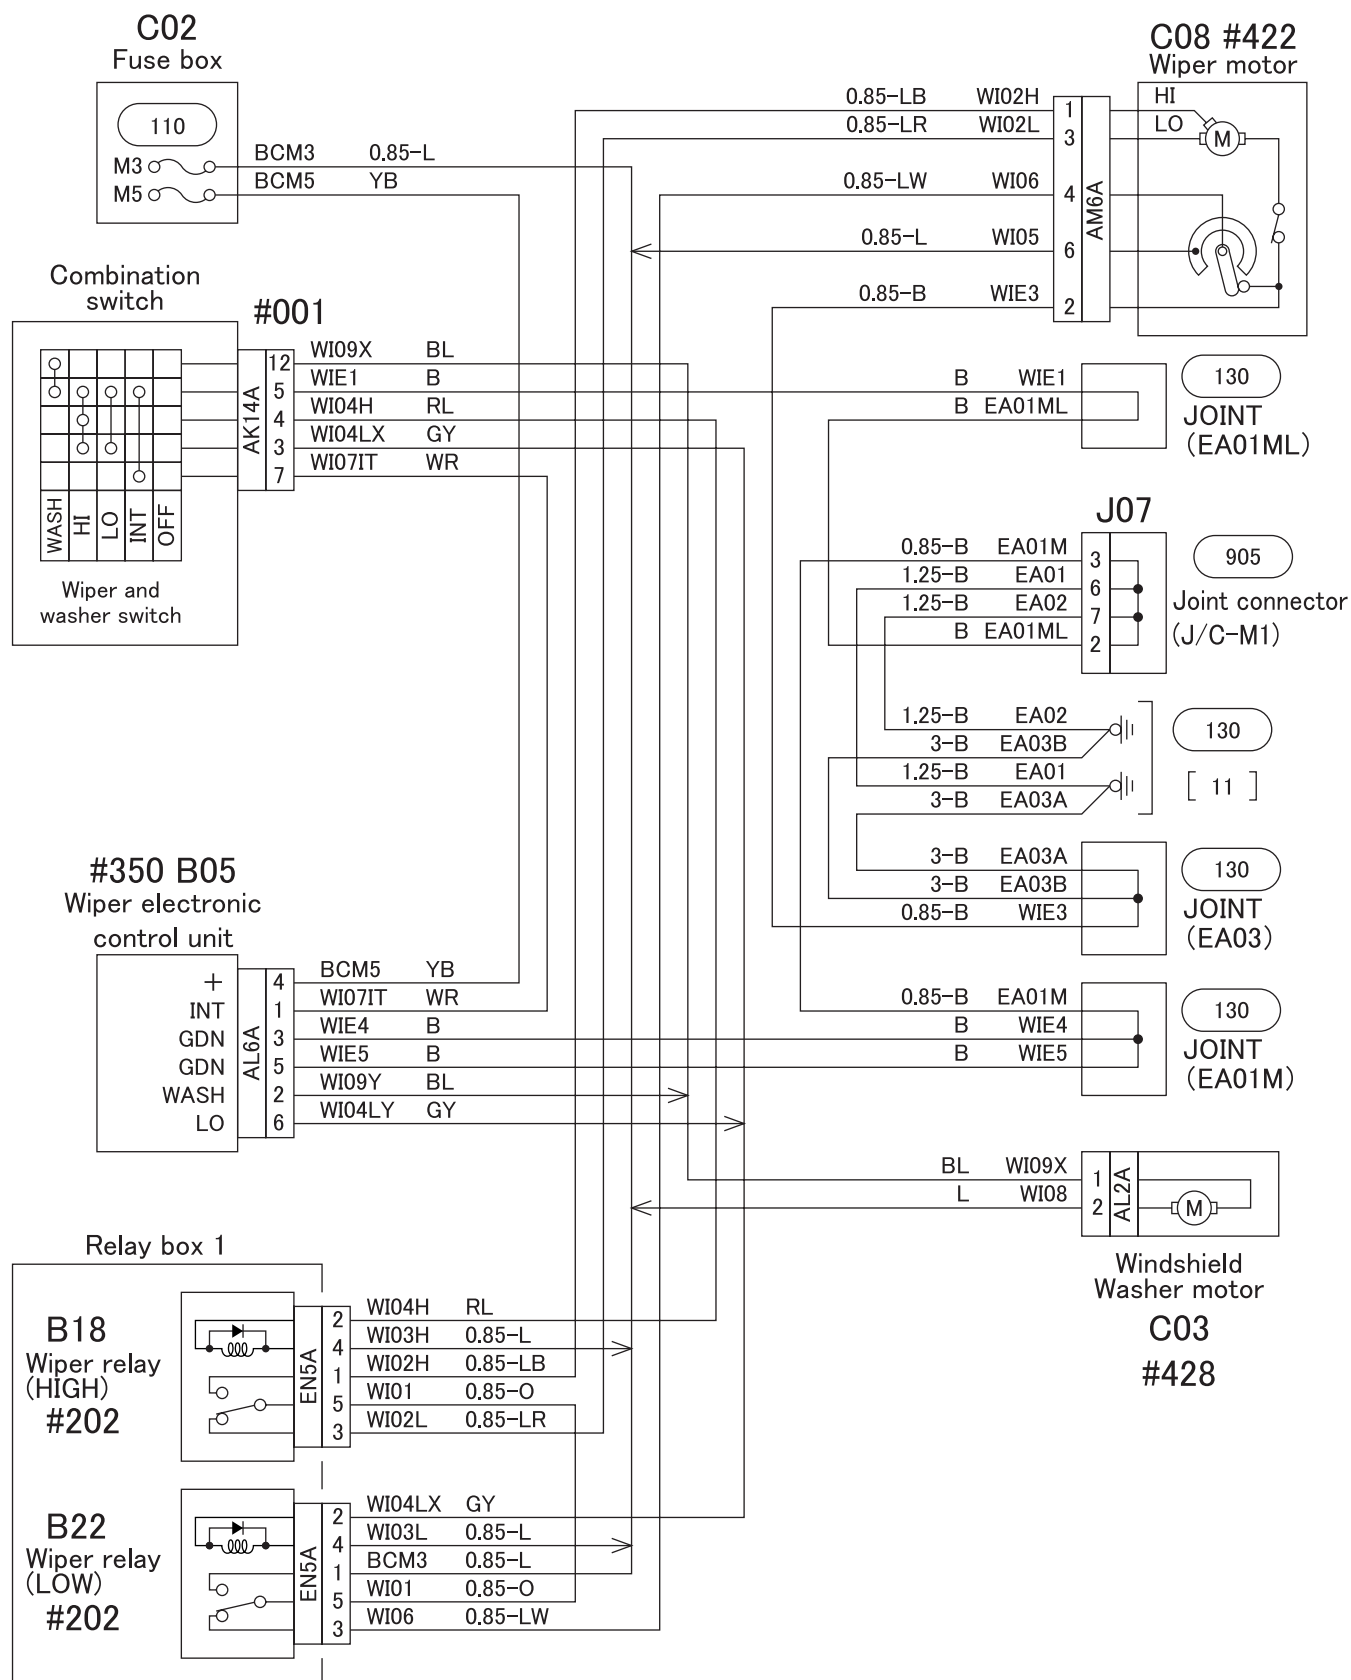
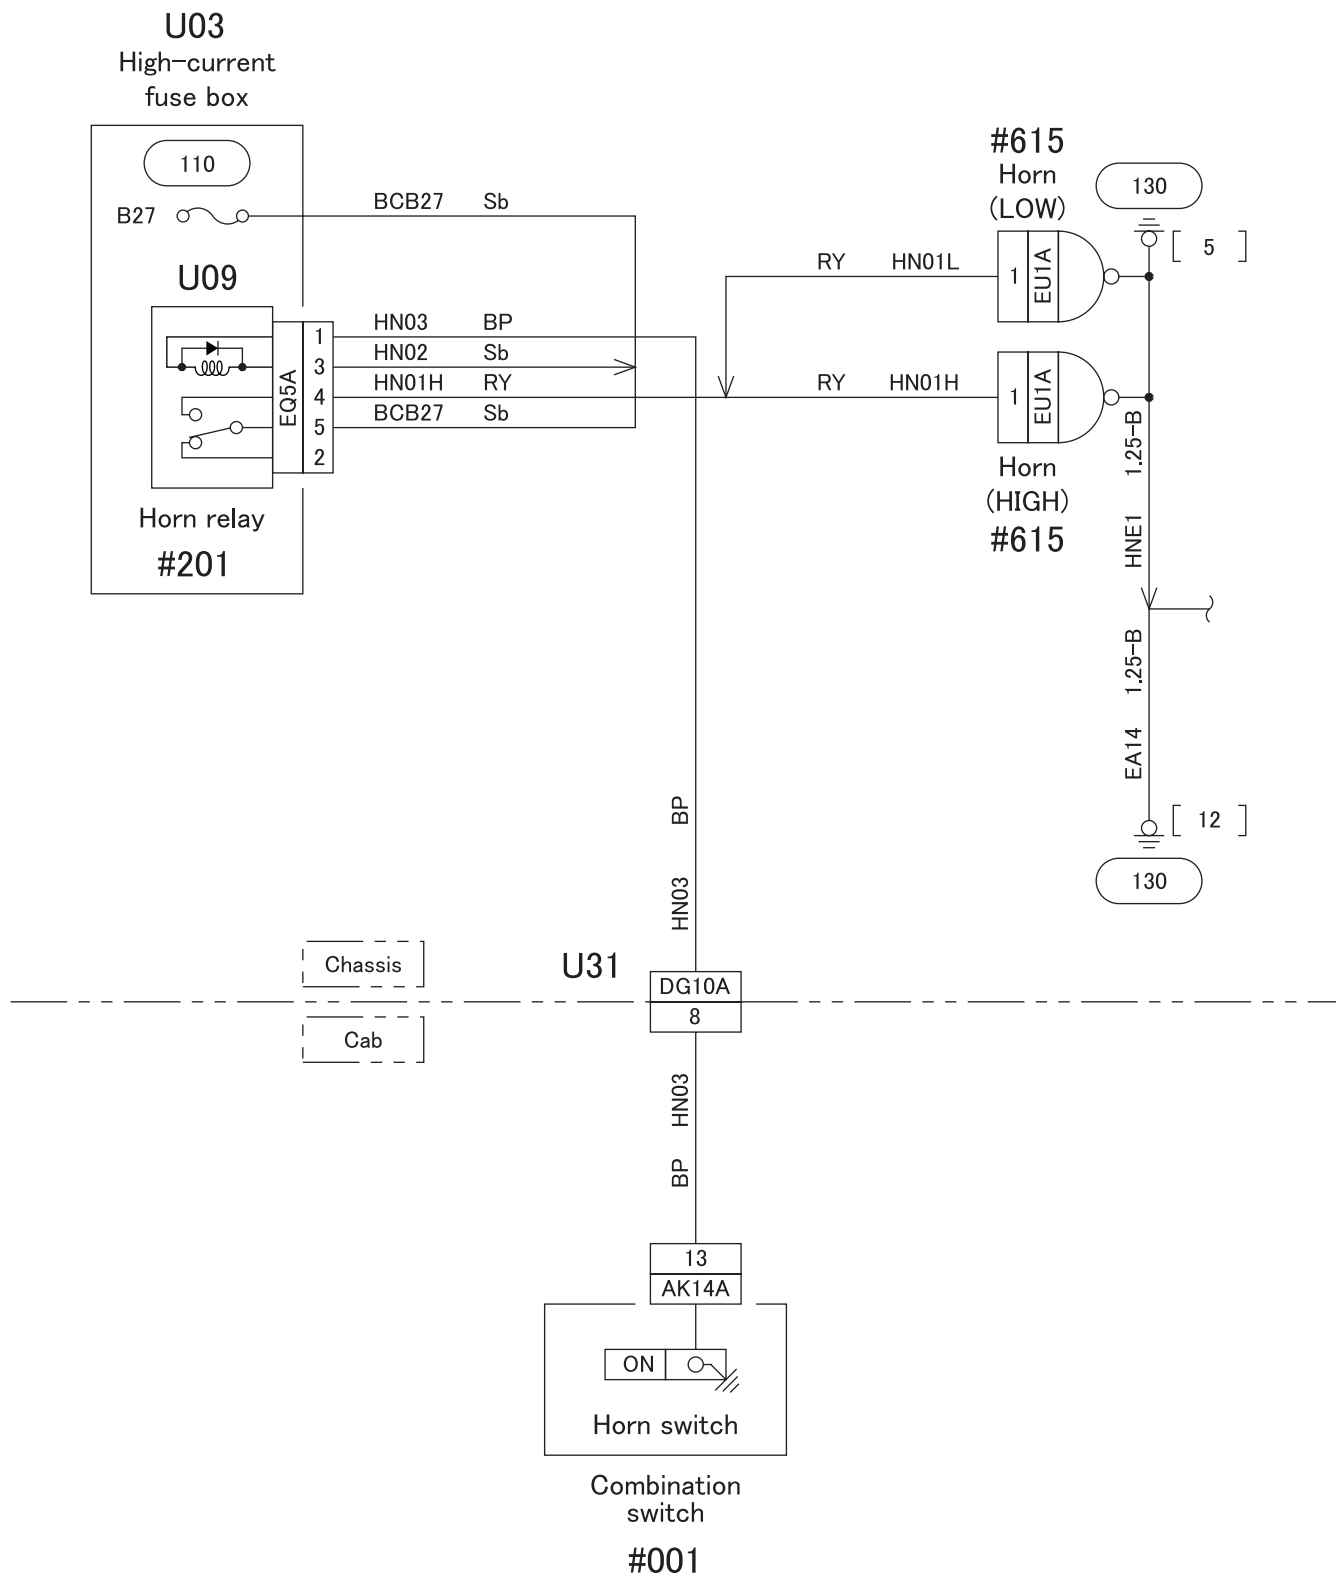
# 614 WIPER AND WASHER CIRCUIT

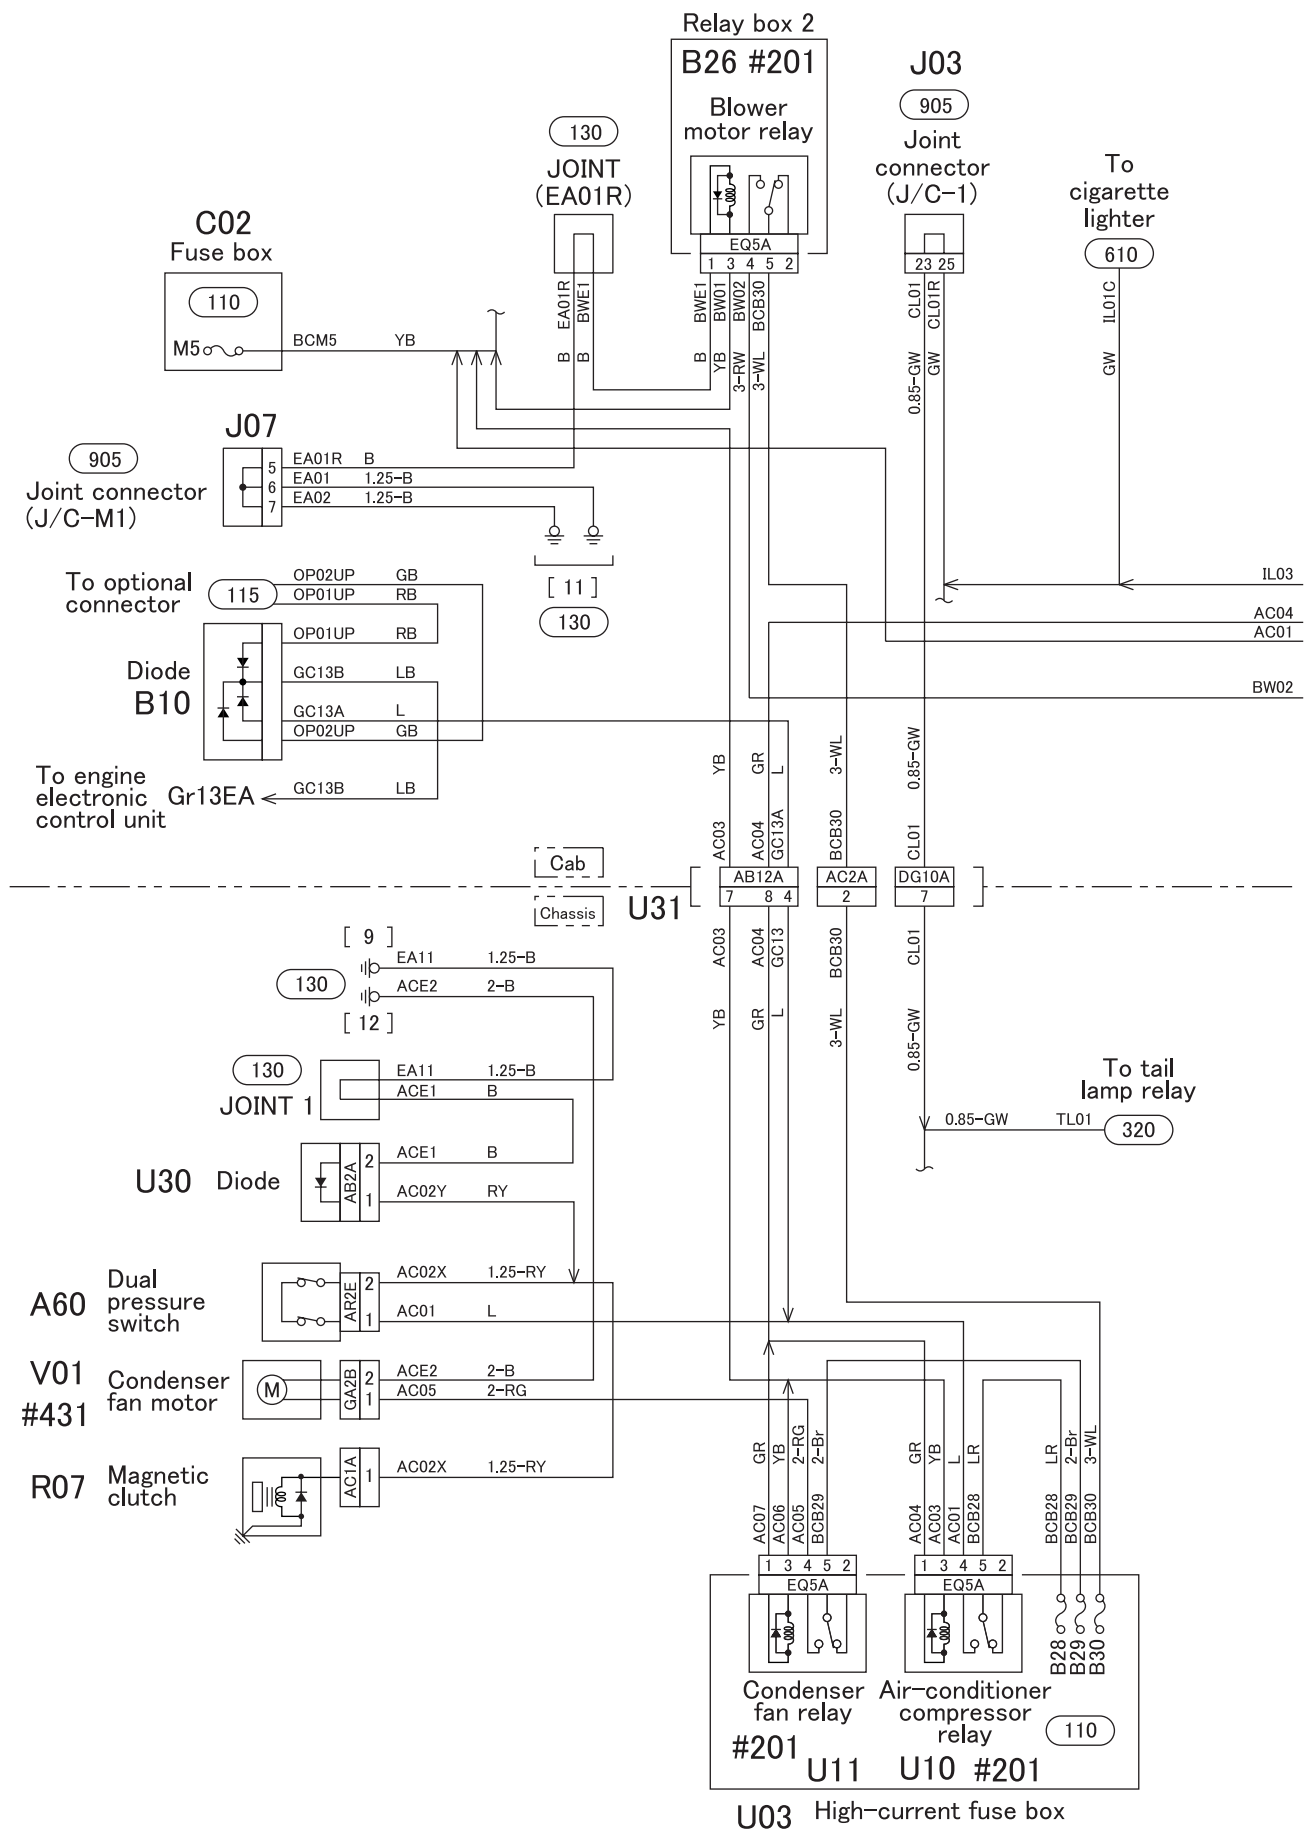
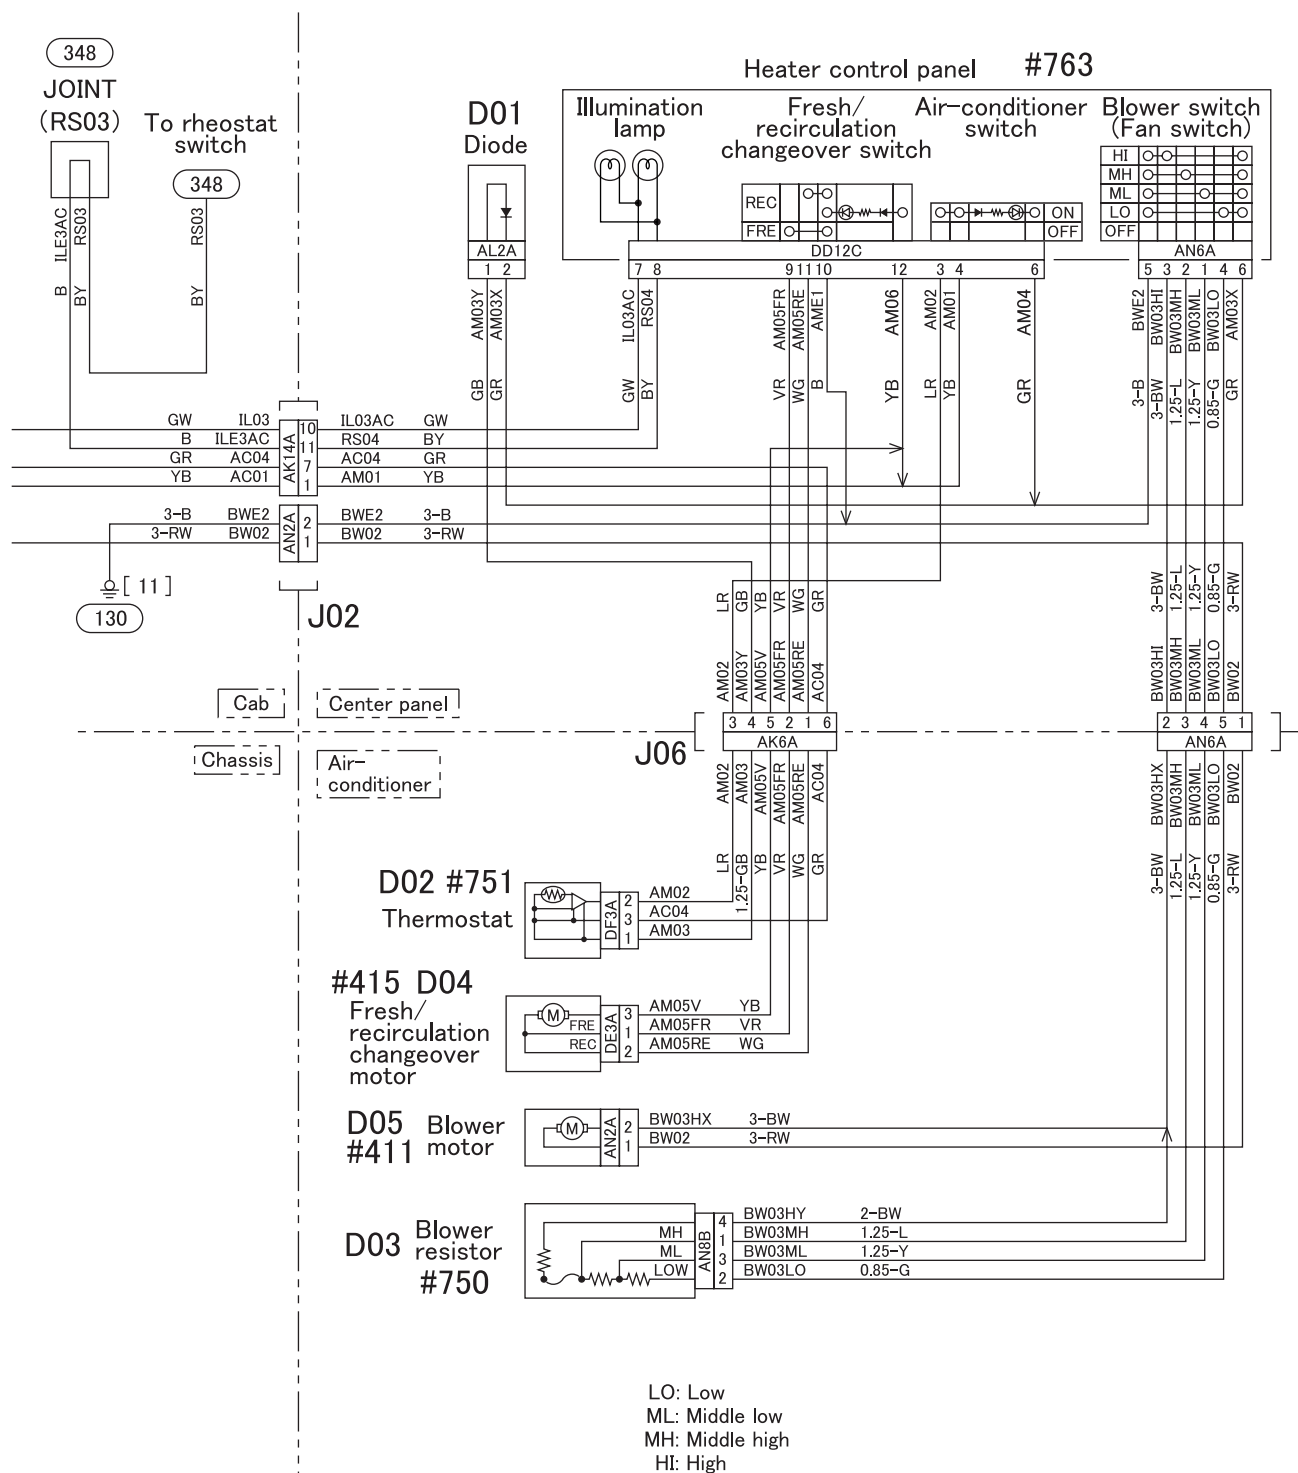
# 620 AIR-CONDITIONER CIRCUIT

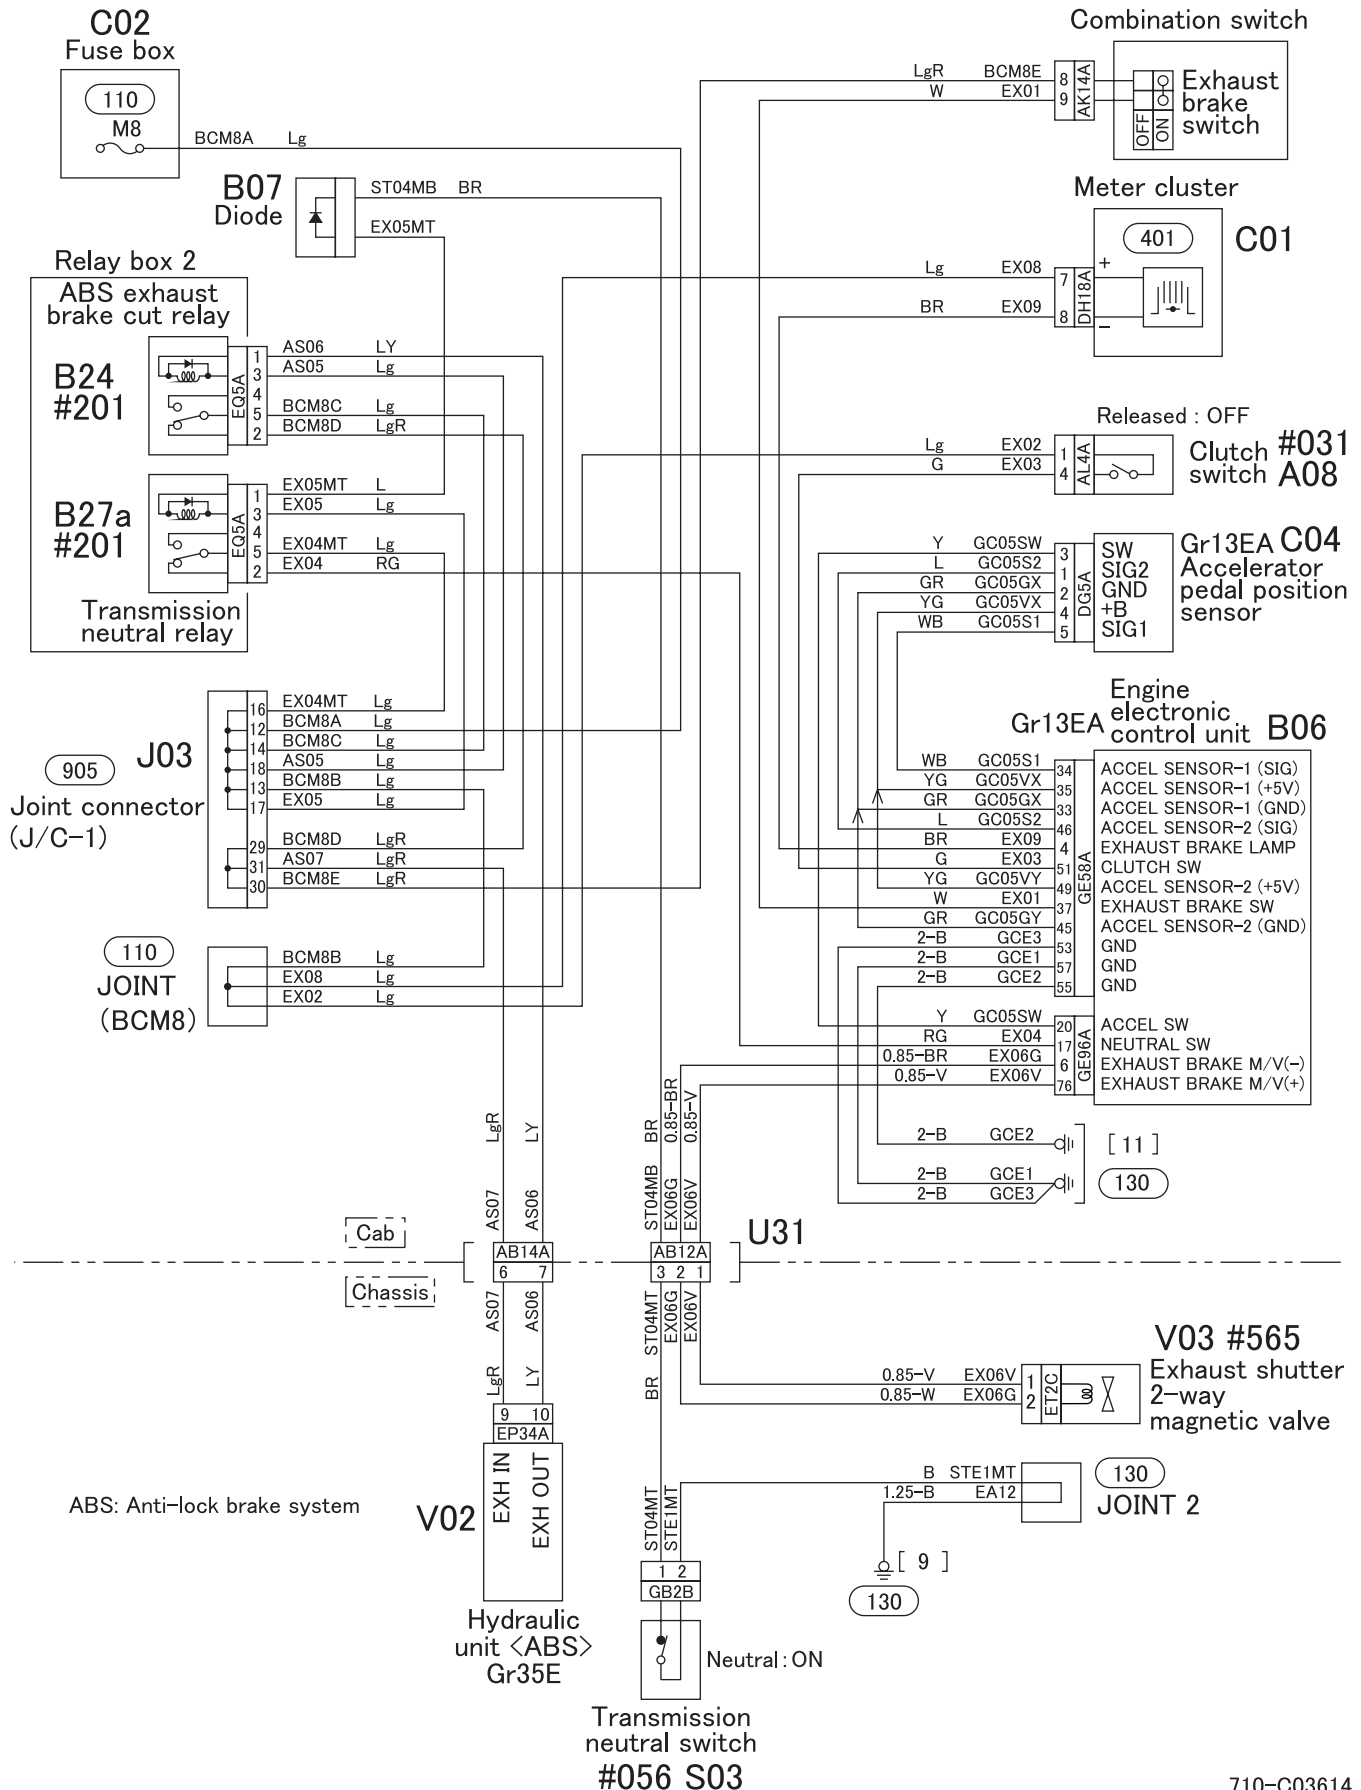
# 710 EXHAUST BRAKE CIRCUIT

<Manual transmission>

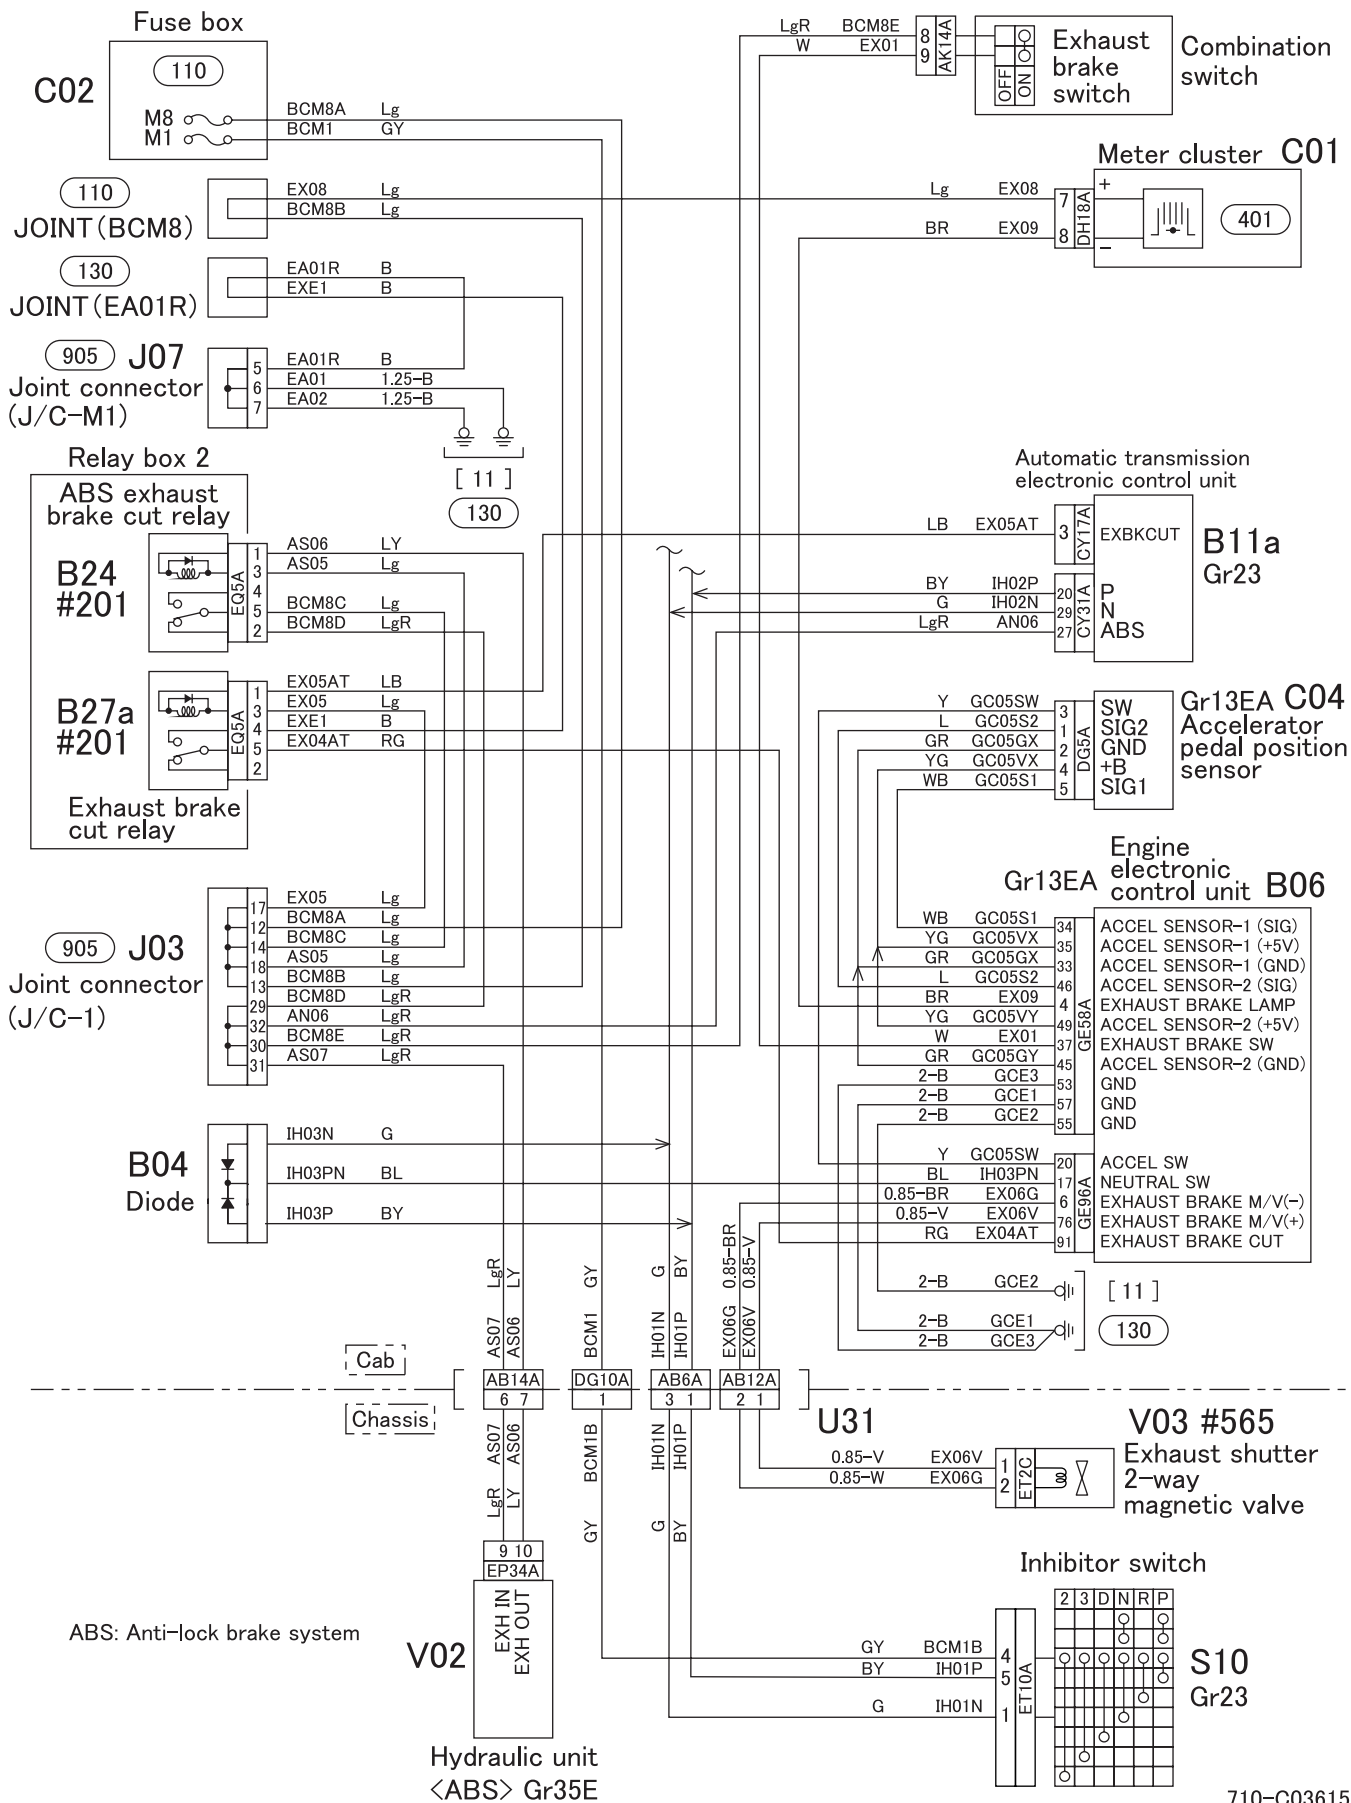
<Automatic transmission>

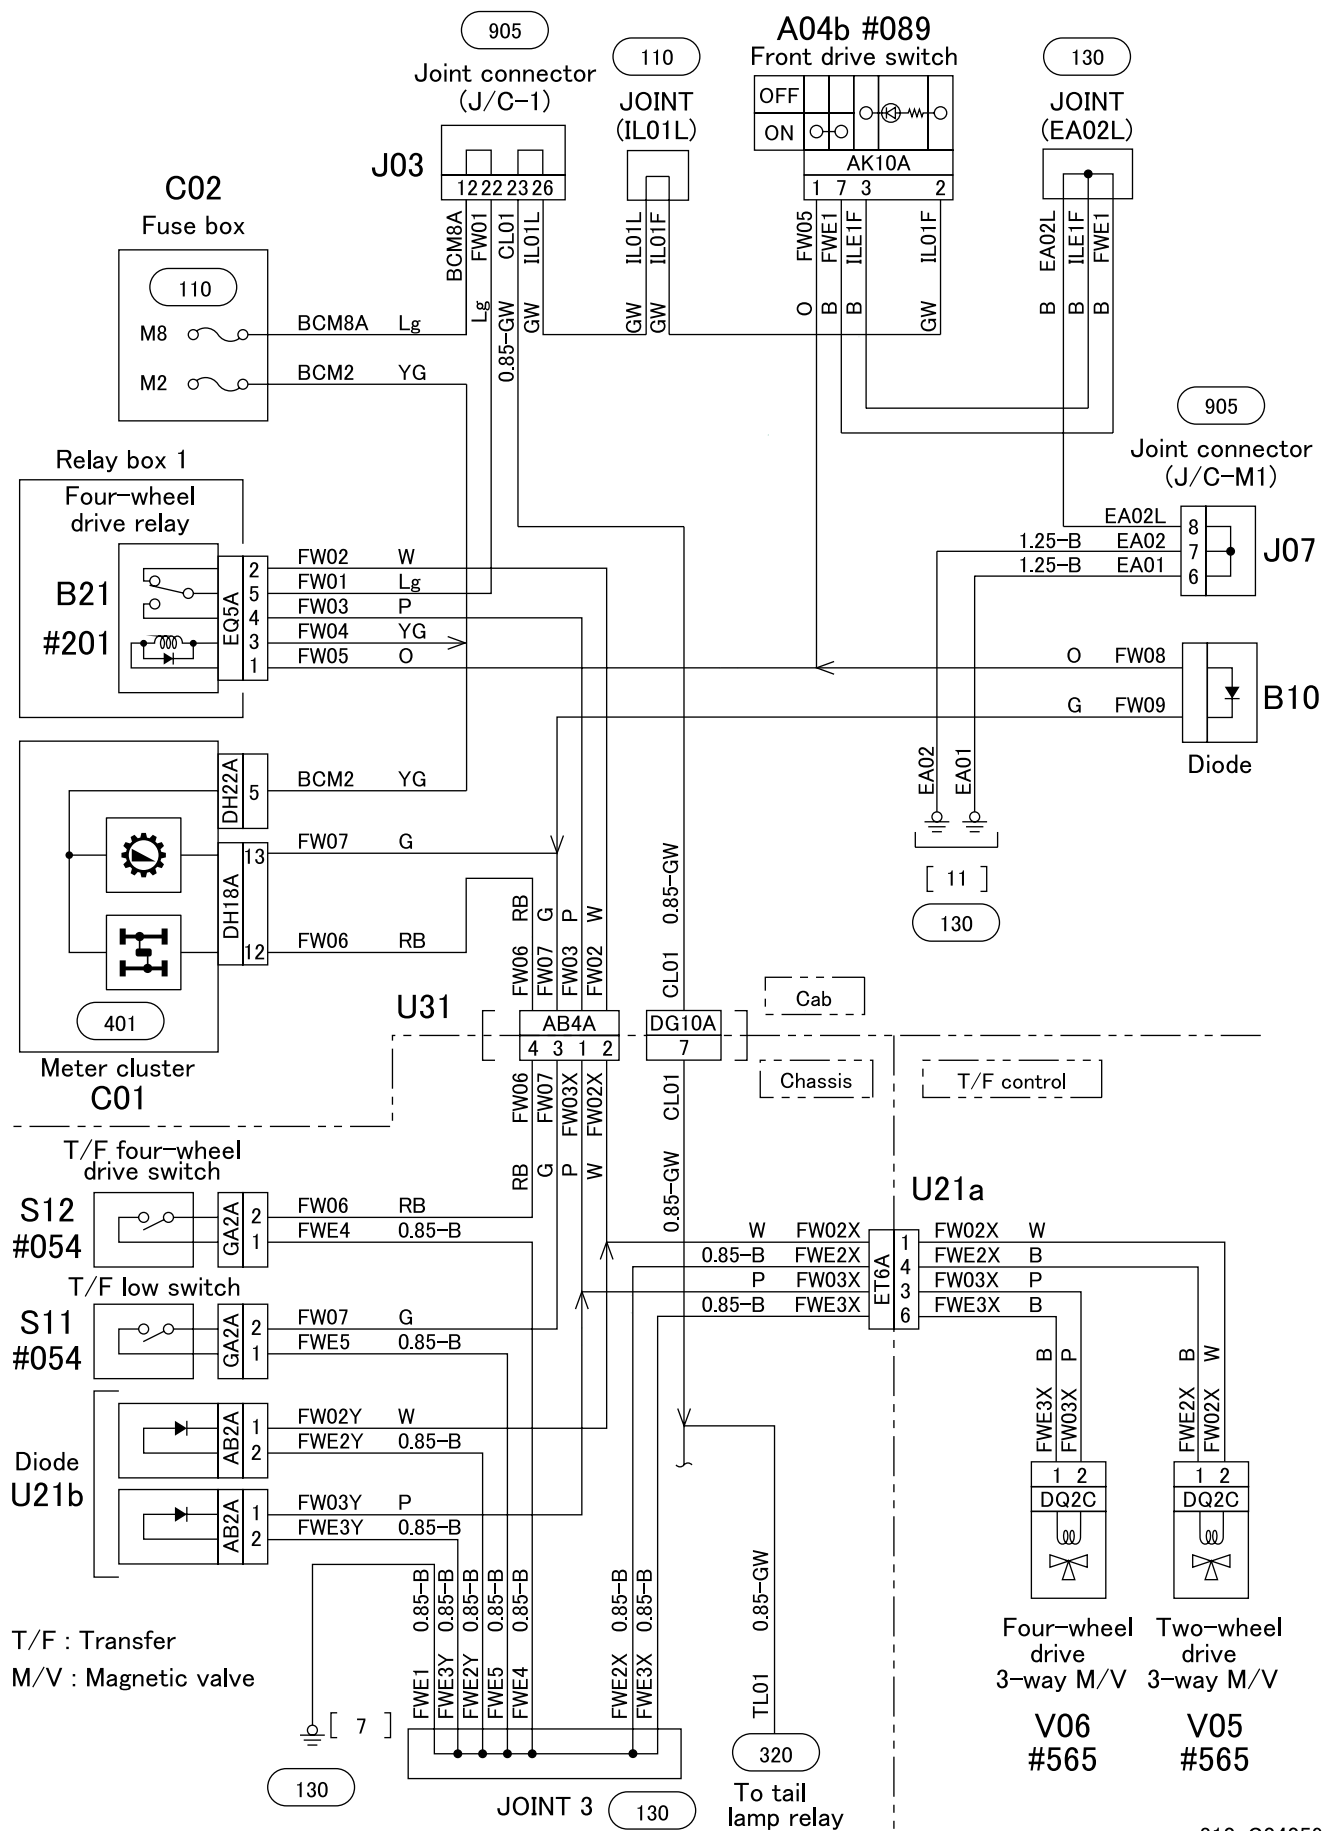
# 810 FOUR-WHEEL DRIVE CIRCUIT <FG>
