# FE.FG

## SERVICE MANUAL 2008 Model FOREWORD

This Service Manual contains maintenance and repair methods for the Mitsubishi Fuso Truck FE. FG Series. Read this manual carefully as an aid in providing correct, efficient maintenance. Please note that the information and specifications contained within this manual may change without notice. This is due to product modifications and continued vehicle improvements that are made throughout the model years. Should you encounter any discrepancy in the information provided, please do not hesitate to contact your nearest Mitsubishi Fuso Dealer or Mitsubishi Fuso Truck of America, Inc.

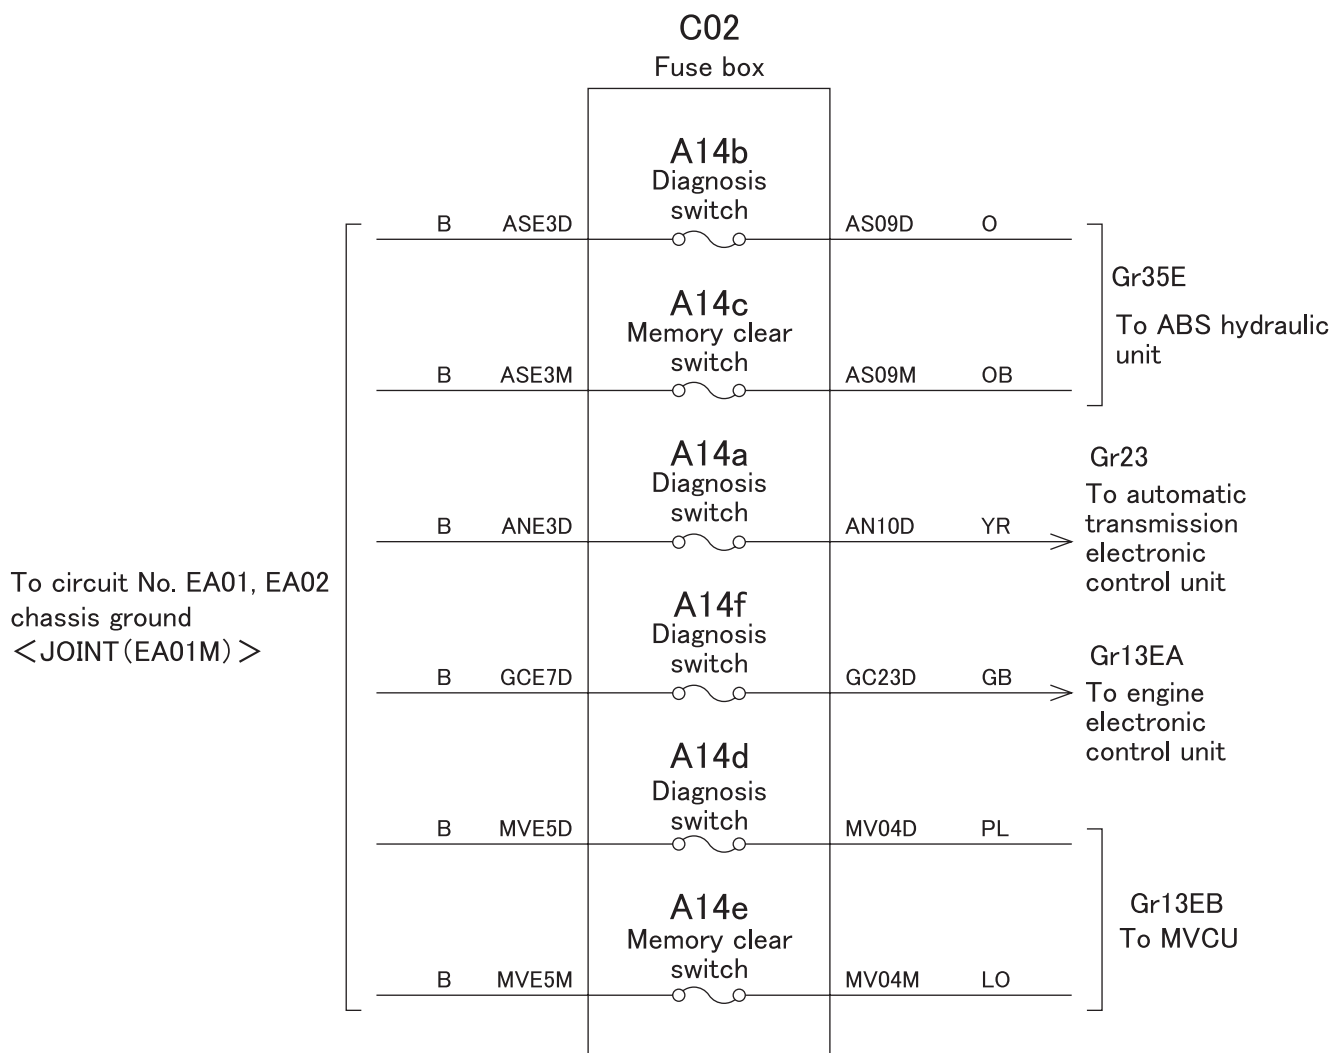
The fuse is substituted for diagnosis switch and the memory clear switch.

- A01 Engine oil level check switch
- A01a Cruise control main switch <A/T>
- A01b Set and resume switch <A/T>
- A04 Door lock switch
- A04a DPF cleaning switch
- A04b Front drive switch <FG>
- A05 Hazard switch
- A07 Stop lamp switch
- A08 Clutch switch (Upper)
- A10 Van body dome light switch
- A11 Rheostat switch
- A12 Mirror heater switch
- A13 Brake fluid level switch
- A14 Flow switch <With hydraulic booster>

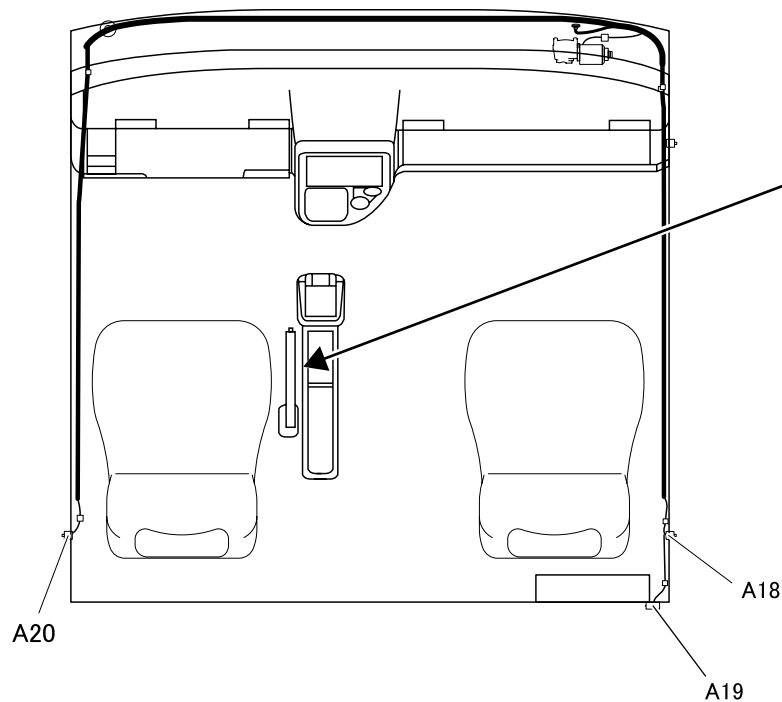
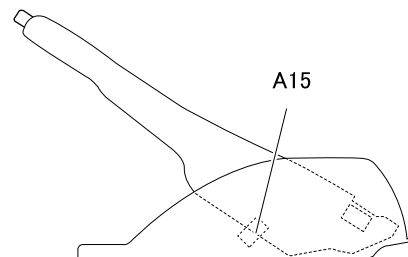
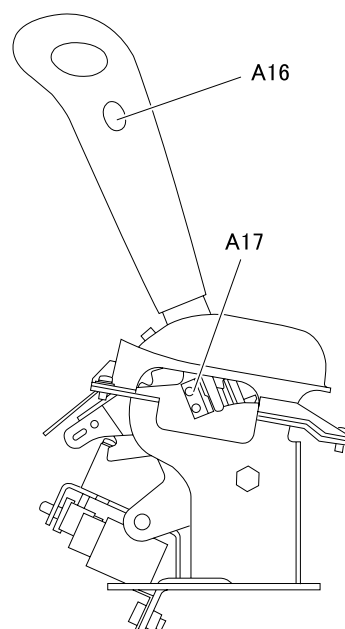
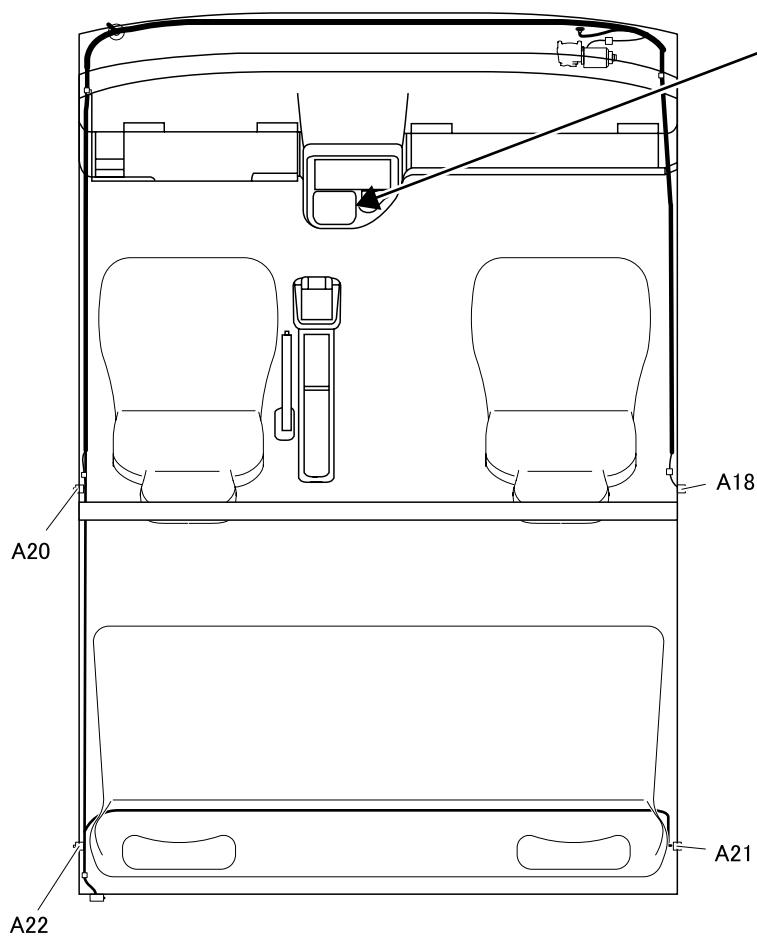
## A15 to 22

- A15 Parking brake switch
- A16 O/D switch <A/T>
- A17 P range switch <A/T>
- A18 Front door switch, RH
- A19 Cab tilt lock switch <Except crew cab>
- A20 Front door switch, LH
- A21 Rear door switch, RH <Crew cab>
- A22 Rear door switch, LH <Crew cab>

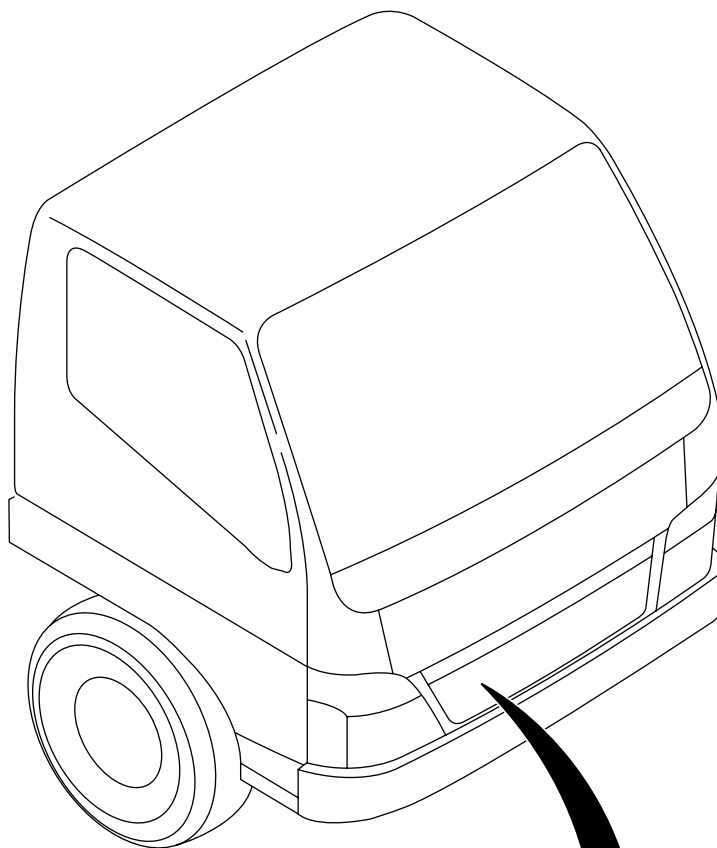
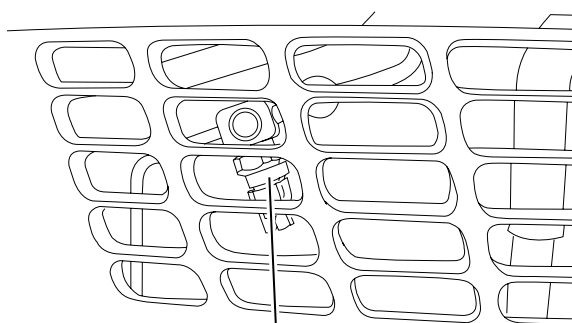
A60 Dual pressure switch <With air-conditioner>

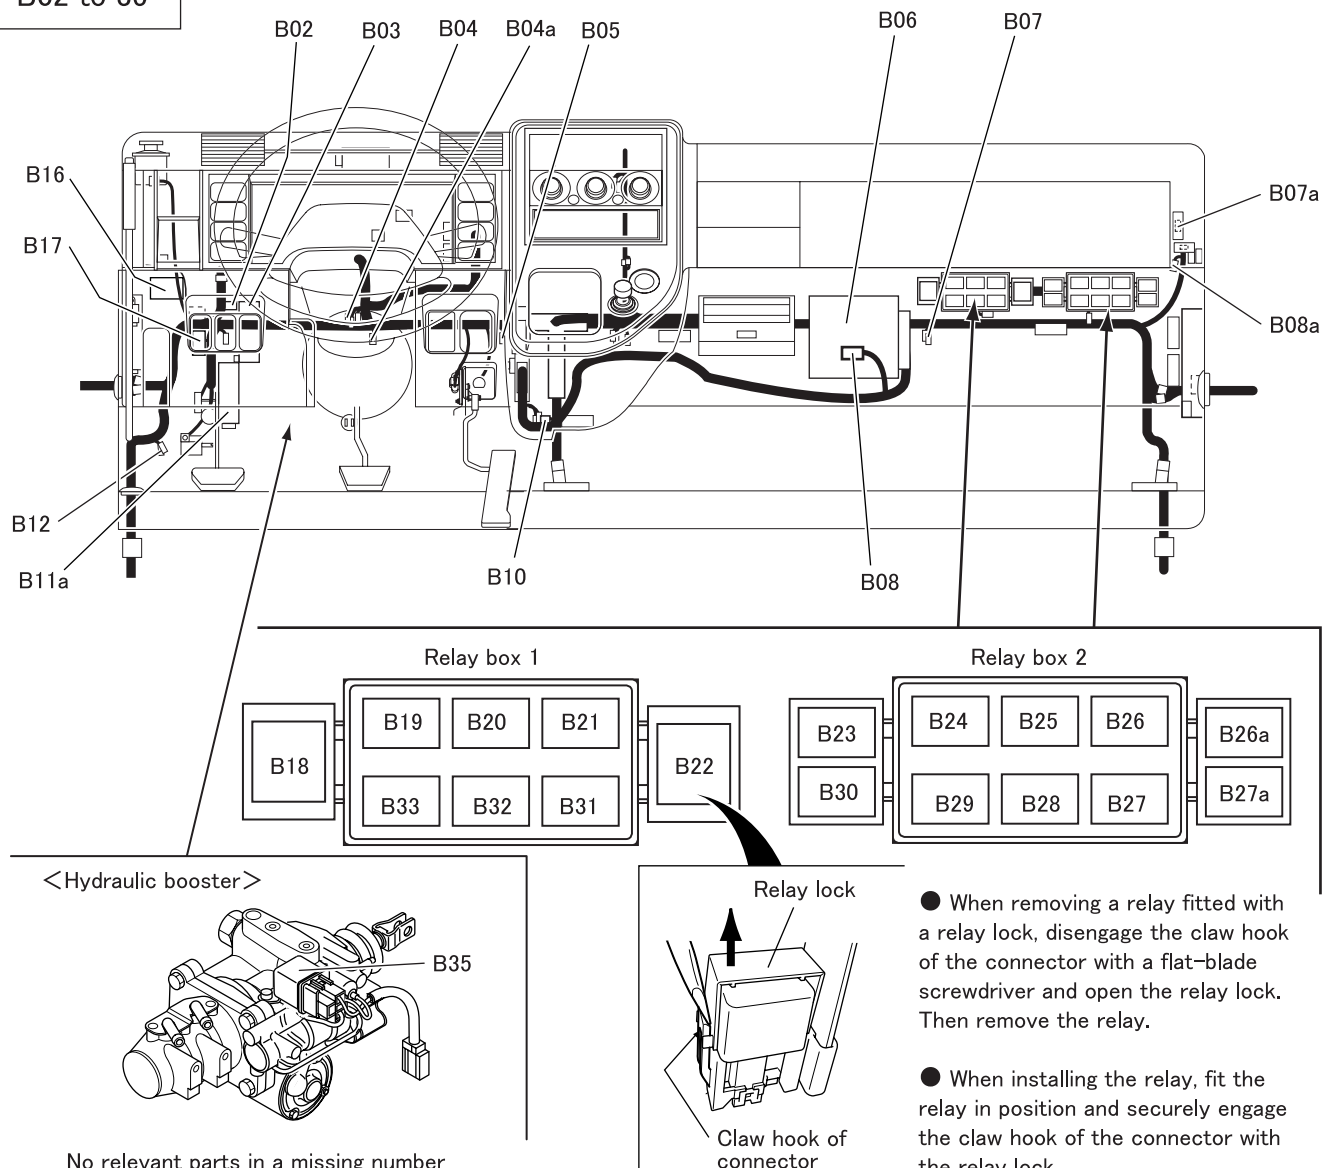
B02 to 35

● When removing a relay fitted with a relay lock, disengage the claw hook of the connector with a flat-blade screwdriver and open the relay lock. Then remove the relay.

● When installing the relay, fit the relay in position and securely engage the claw hook of the connector with the relay lock.

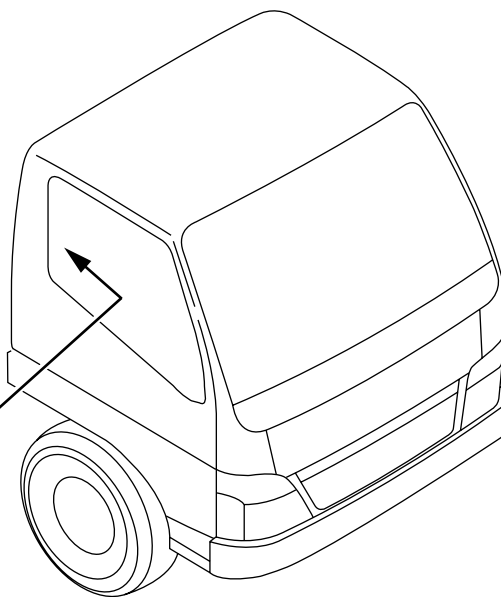
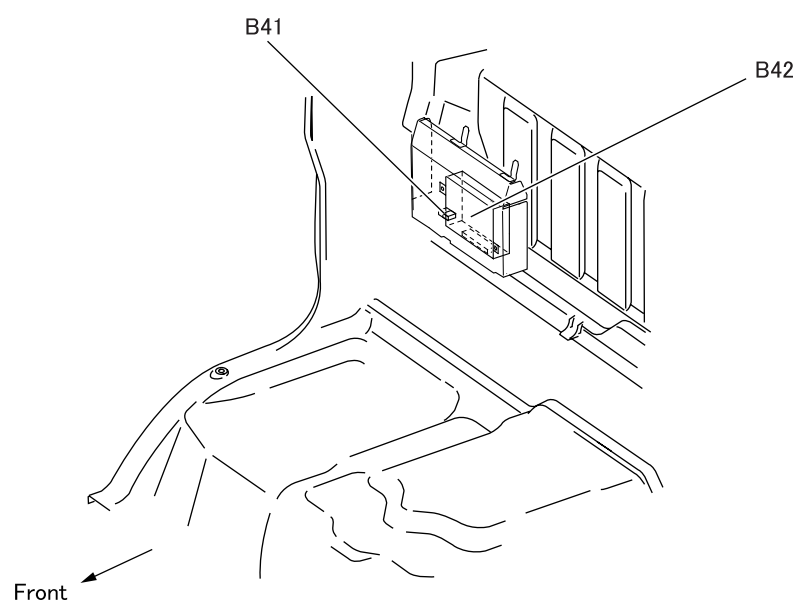
B41 to 42

B41 Resistor unit  
B42 MVCU

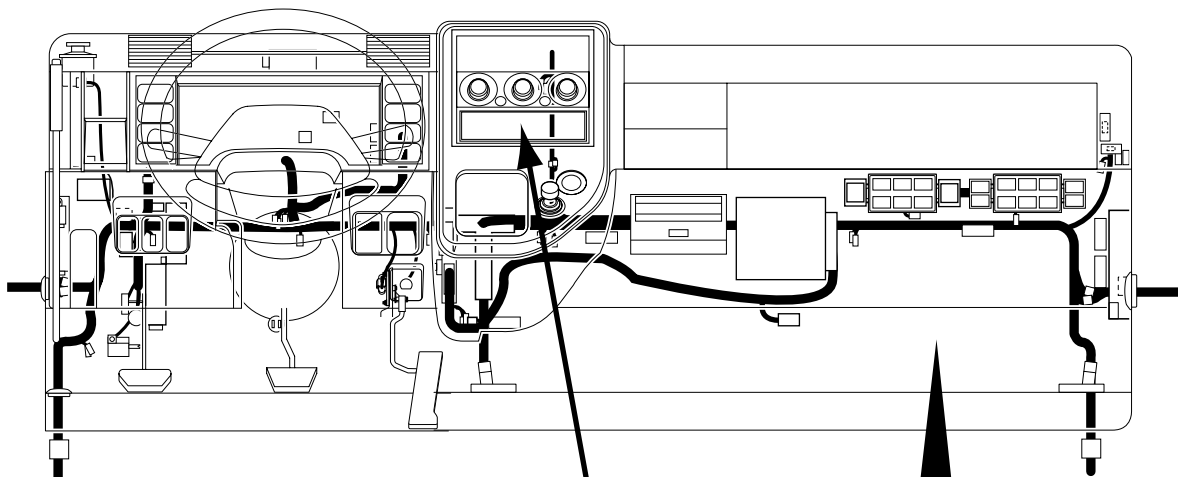
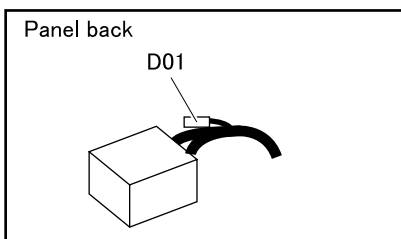
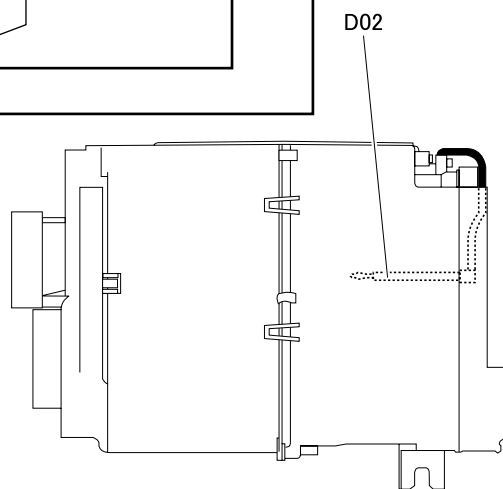
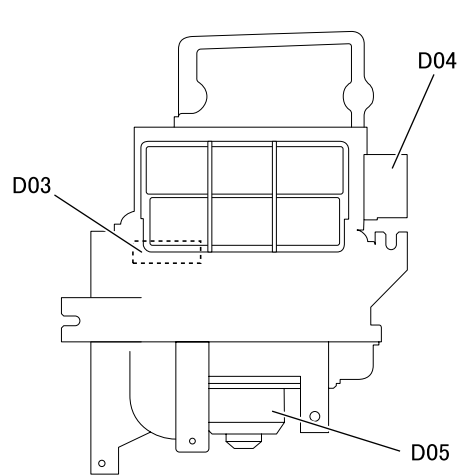
D01 to 05

- D01 Diode
- D02 Thermostat
- D03 Blower resistor
- D04 Fresh/recirculation changeover motor
- D05 Blower motor

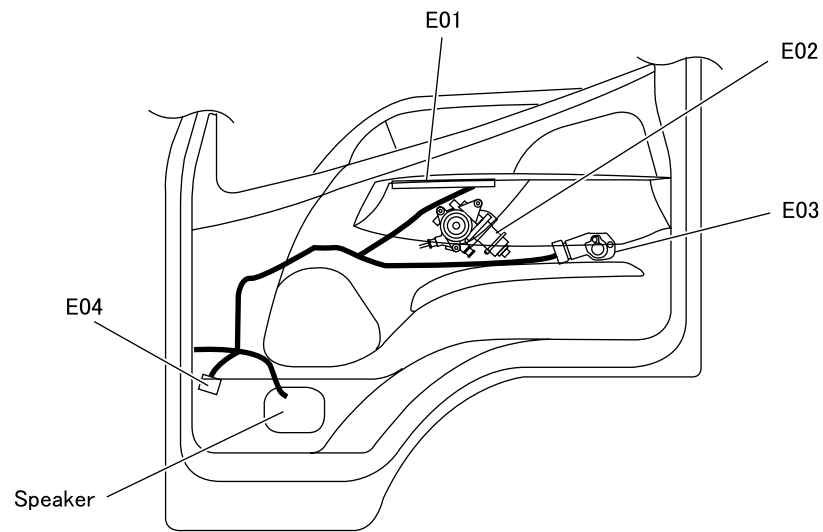
E01 to 04

This illustrations show the right side door, the left side door is symmetrical.

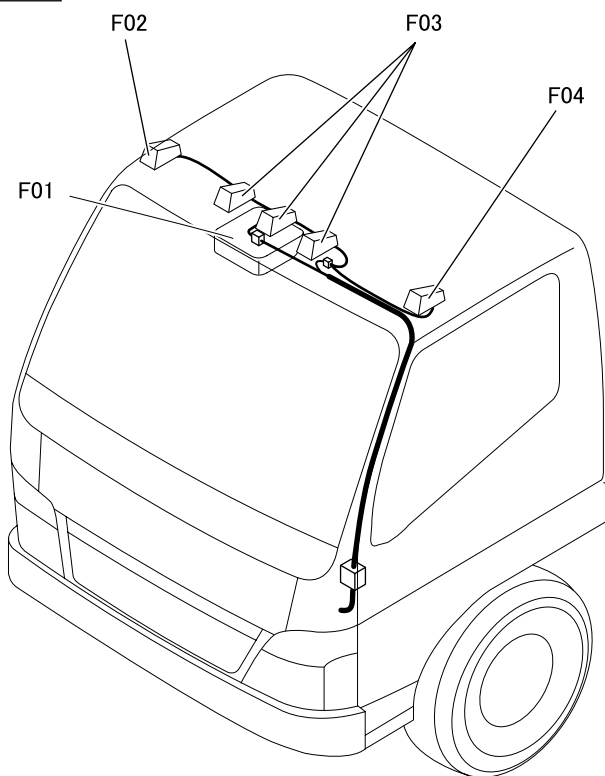
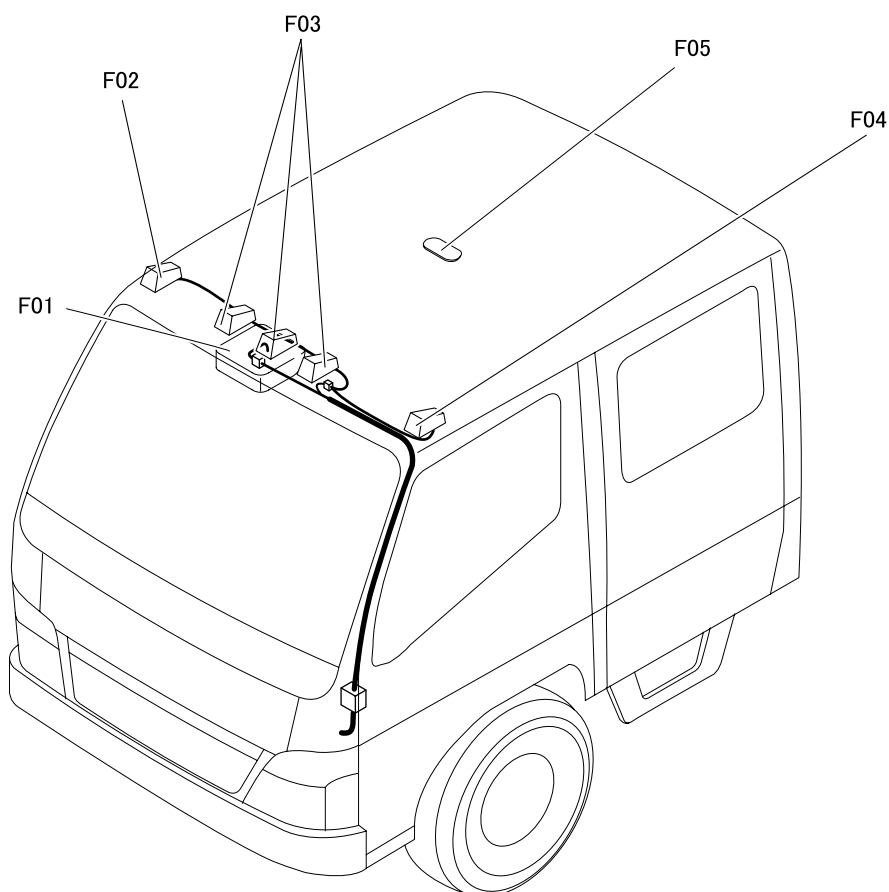
F01 to 05

- F01 Cab lamp
- F02 Clearance and side marker lamp, RH
- F03 Identification lamp
- F04 Clearance and side marker lamp, LH
- F05 Rear cab lamp <Crew cab>

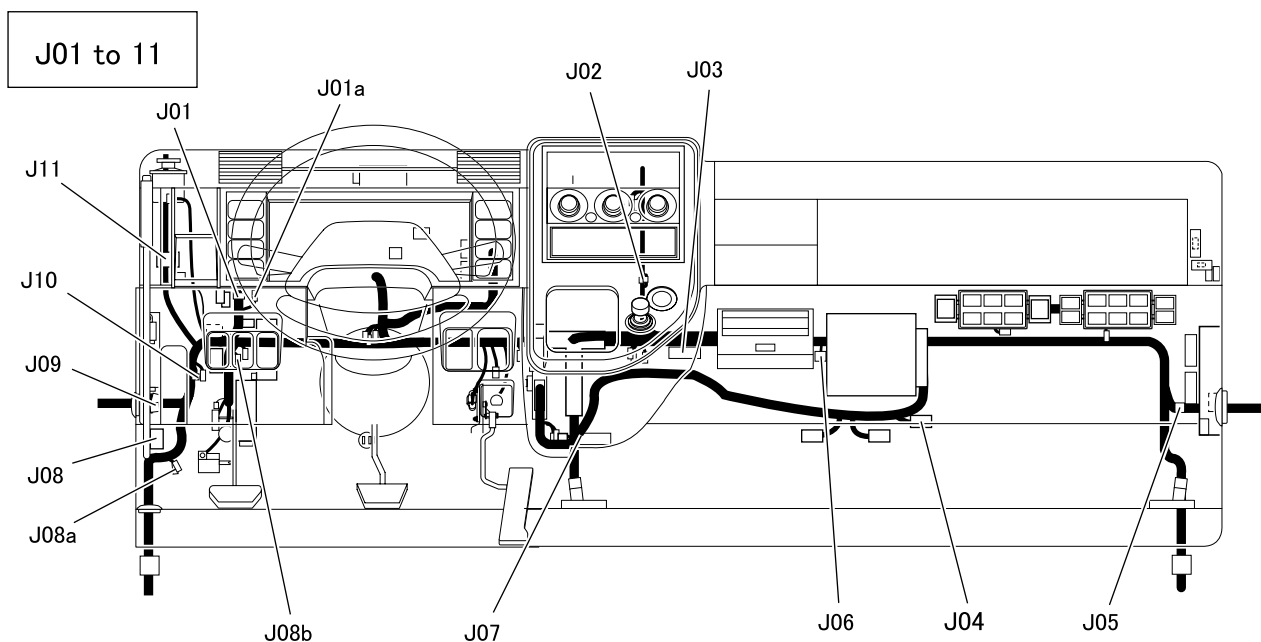
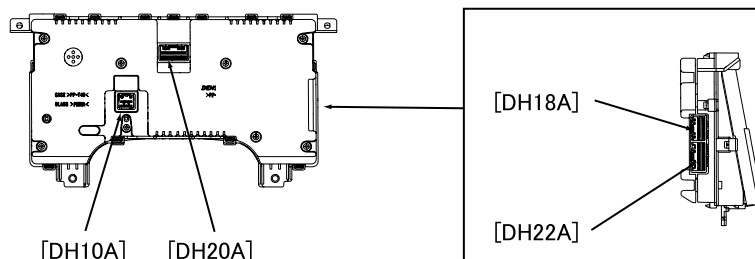
# J JOINTS OF MAIN HARNESS CONNECTORS

- J01 Connection of cab harness and instrument panel harness
- J01a Connector (For power take-off switch)
- J02 Connection of cab harness and center panel harness
- J03 Joint connector (J/C-1)
- J04 Joint connector (J/C-2)
- J05 Connection of cab harness and door harness, RH
- J06 Connection of center panel harness and air-conditioner harness
- J07 Joint connector (J/C-M1)
- J08 Diagnostic connector
- J08a Joint connector (J/C-040)
- J08b Joint connector (J/C-040) <A/T>
- J09 Connection of cab harness and door harness, LH
- J10 Optional connector
- J11 Connection of cab harness and roof harness

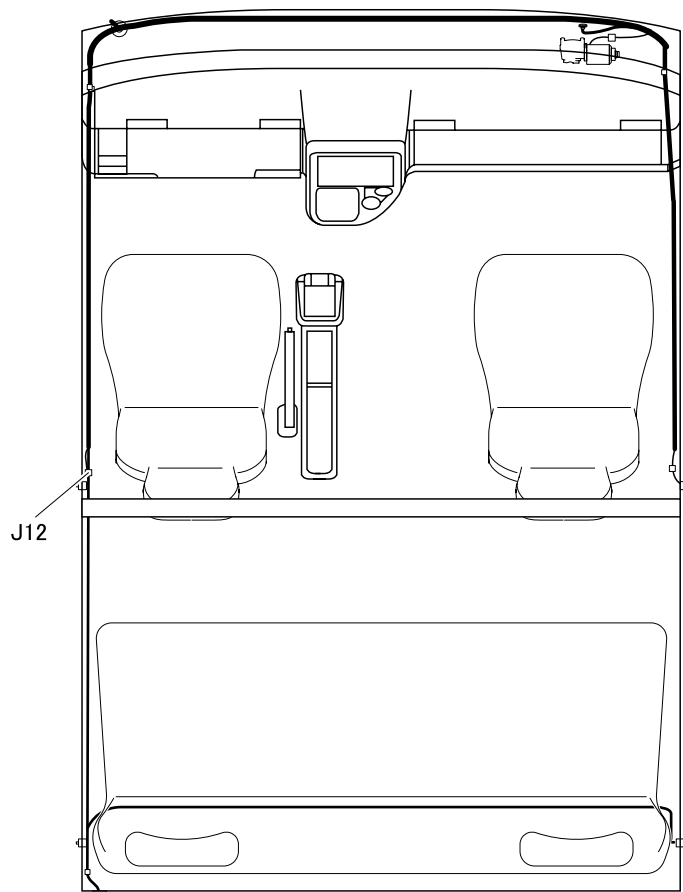
J12 Connection of cab harness and rear door switch harness <Crew cab>

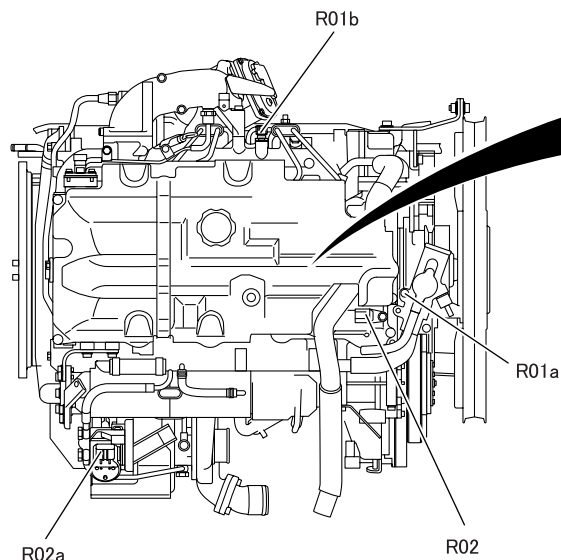
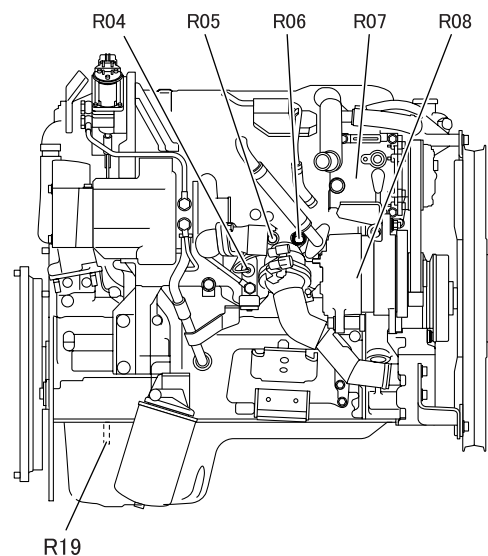
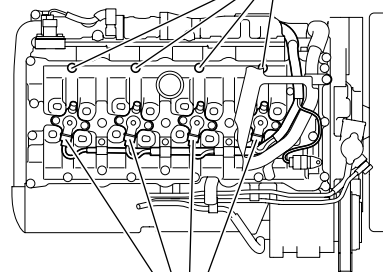
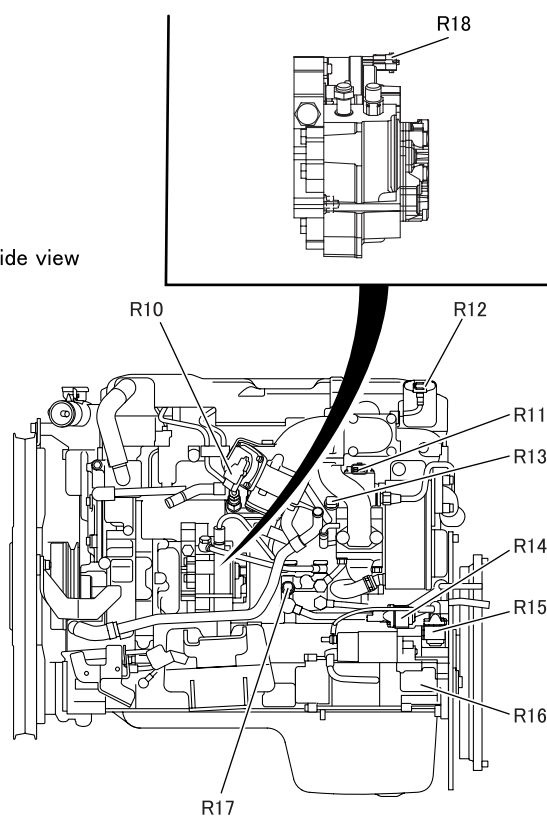
## R01 to 19

- R01 Glow plug
- R01a Overheating switch
- R01b Boost air temperature sensor
- R02 Cylinder recognition sensor
- R02a Turbocharger actuator
- R03 Injector magnetic valve
- R04 Engine oil pressure switch
- R05 Water temperature sensor  
(Connects to water temperature gauge and engine ECU)
- R06 Water temperature sensor  
(Connects to engine ECU)
- R07 Magnetic clutch
- R08 Alternator

- R10 Throttle actuator  
(Building into motor, position sensor)
- R11 EGR valve  
(Building into motor, position sensor)
- R12 Boost pressure sensor
- R13 Common rail pressure sensor
- R14 Glow relay <Except FE83>
- R15 Starter relay
- R16 Starter
- R17 Fuel temperature sensor
- R18 MPROP (Rail pressure control valve)
- R19 Engine oil level sensor

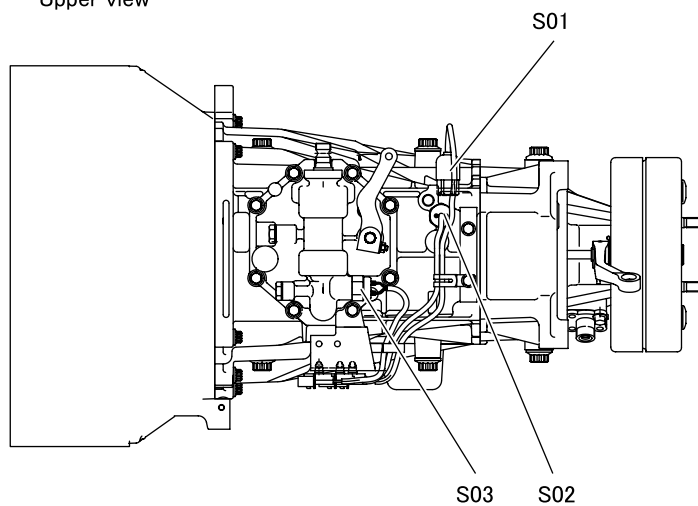
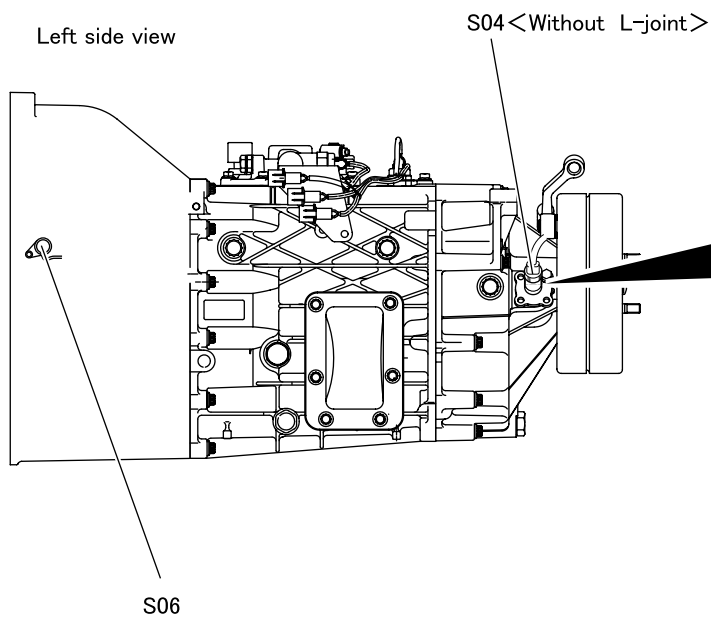
- S01 Backup lamp switch
- S02 Torque limit switch
- S03 Transmission neutral switch
- S04 Vehicle speed sensor
- S06 Engine speed sensor

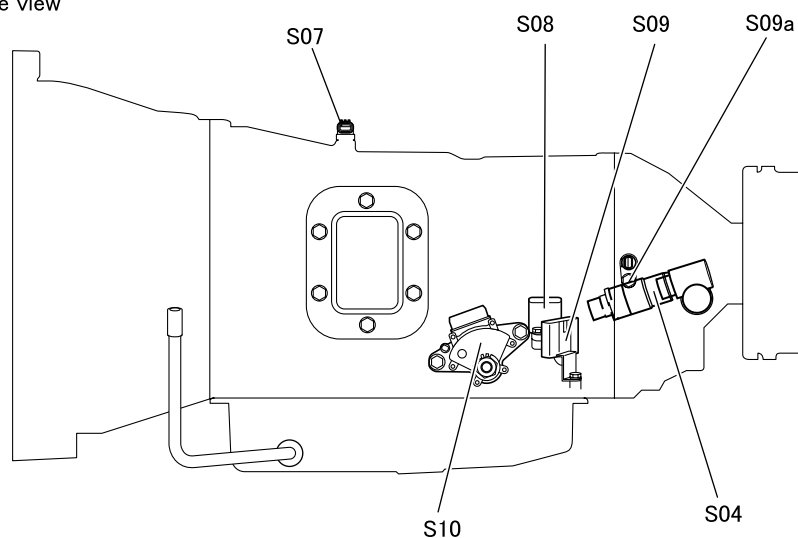
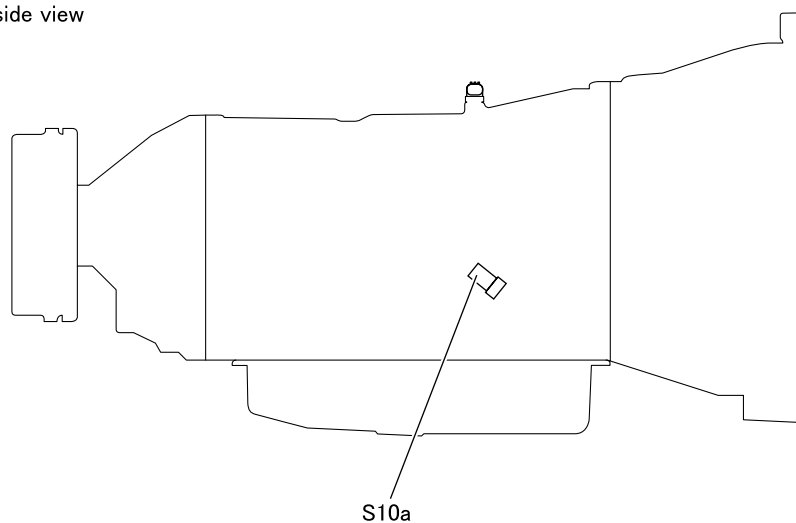
- S04 Vehicle speed sensor
- S07 Turbine revolution sensor
- S08 A/T solenoid connector
- S09 A/T solenoid connector
- S09a Output speed sensor
- S10 Inhibitor switch
- S10a A/T fluid temperature sensor

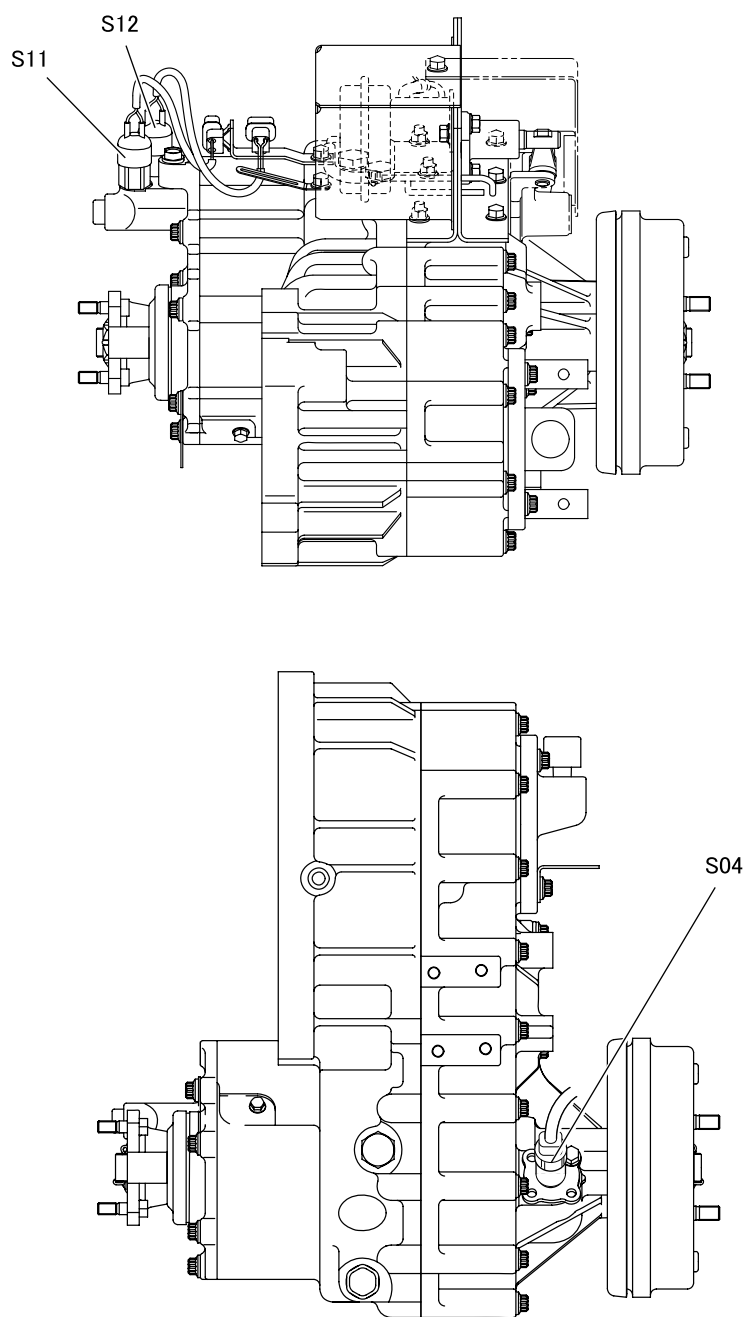
S04 to 12

- S04 Vehicle speed sensor
- S11 Transfer low switch
- S12 Transfer four-wheel drive switch

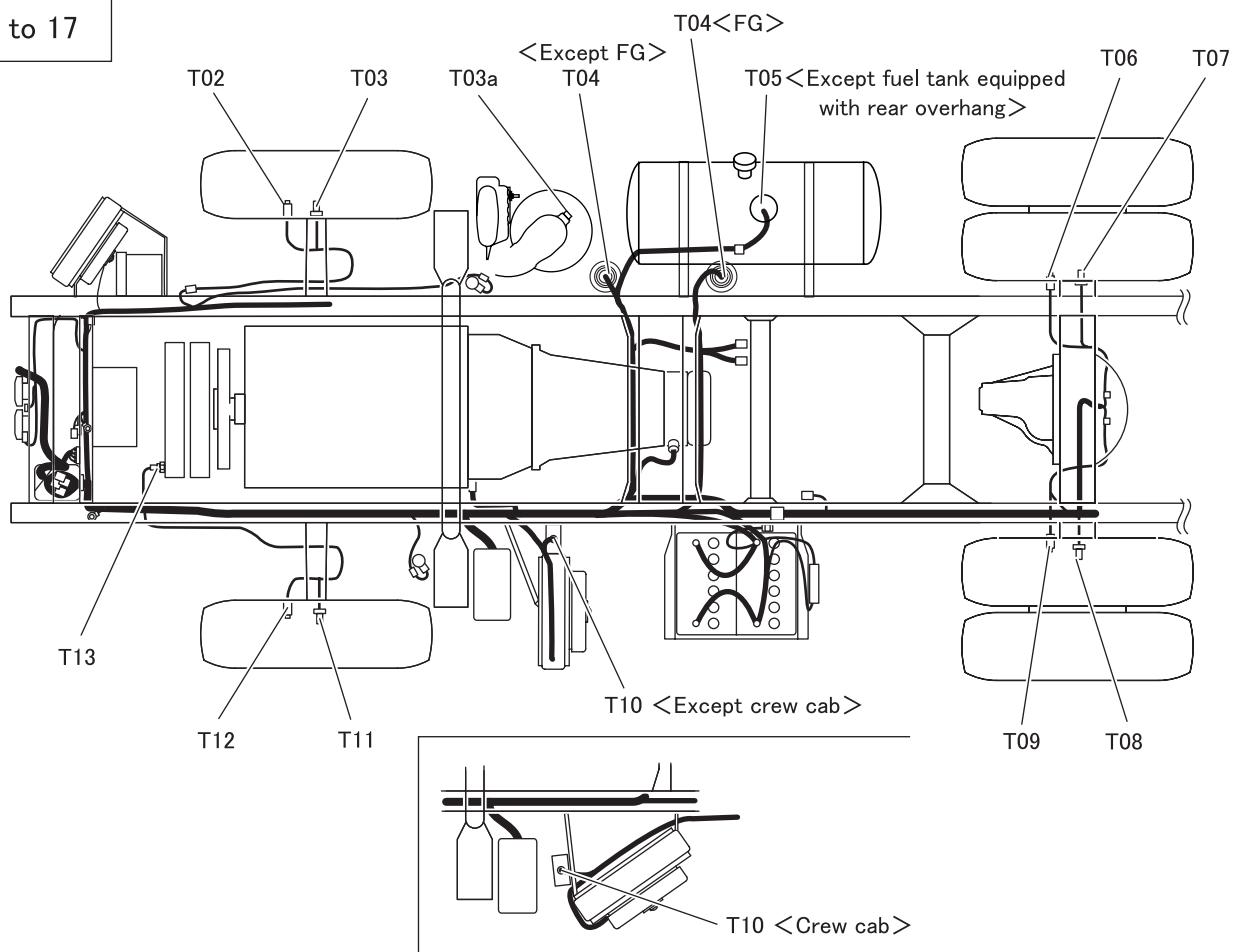
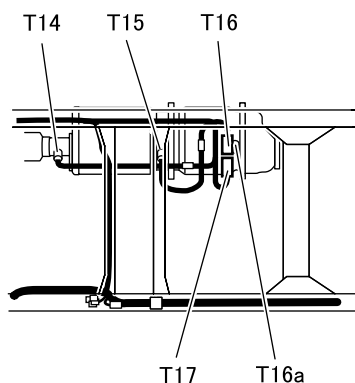
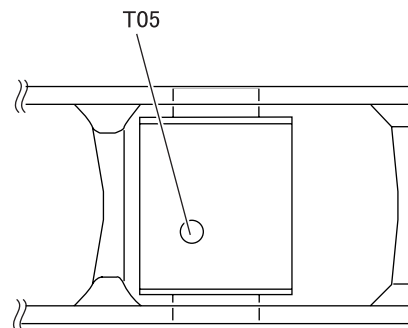
T01 to 17

T01 Vacuum switch  
 T02 Front brake pad wear indicator, RH  
 T03 Front wheel speed sensor, RH  
 T03a Air flow sensor  
 T04 Water separator sensor  
 T05 Fuel level sensor  
 T06 Rear brake pad wear indicator, RH  
 T07 Rear wheel speed sensor, RH  
 T08 Rear wheel speed sensor, LH  
 T09 Rear brake pad wear indicator, LH  
 T10 Automatic transmission fluid cooler fan thermo switch

T11 Front wheel speed sensor, LH  
 T12 Front brake pad wear indicator, LH  
 T13 Intake air temperature sensor  
 T14 Catalytic temperature sensor  
 T15 DPF temperature sensor 1  
 T16 DPF absolute pressure sensor  
 T16a DPF temperature sensor 2  
 T17 DPF differential pressure sensor

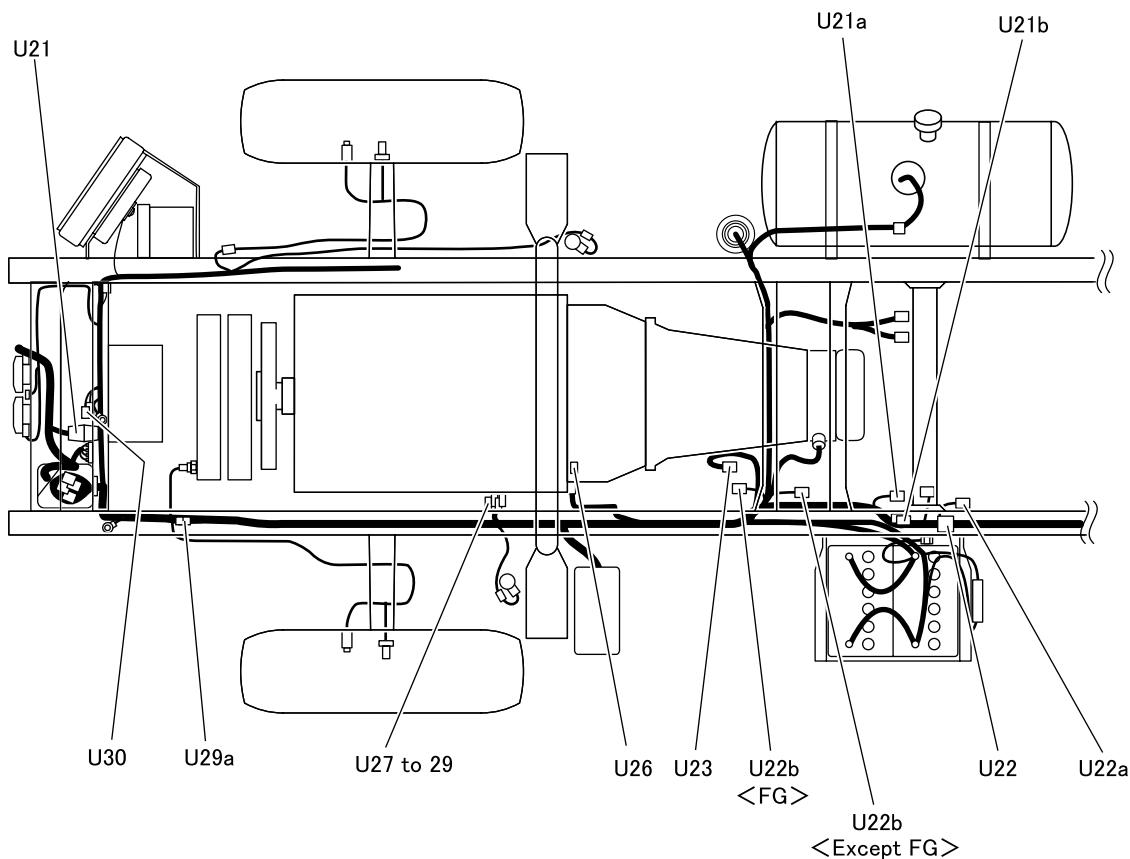
## U21 to 30

- U21 Connection of cab harness and engine harness
- U21a Connection of chassis harness and transfer control harness <FG>
- U21b Diode <FG>
- U22 Connection of chassis harness and rear chassis harness
- U22a Optional connector
- U22b Power take-off load sensor connector
- U23 Transmission power take-off control switch connector
- U26 Connection of chassis harness and starter harness
- U27 Front van body dome light connector
- U28 Front identification lamp connector
- U29 Front clearance lamp connector
- U29a Connection of chassis harness and engine harness
- U30 Diode

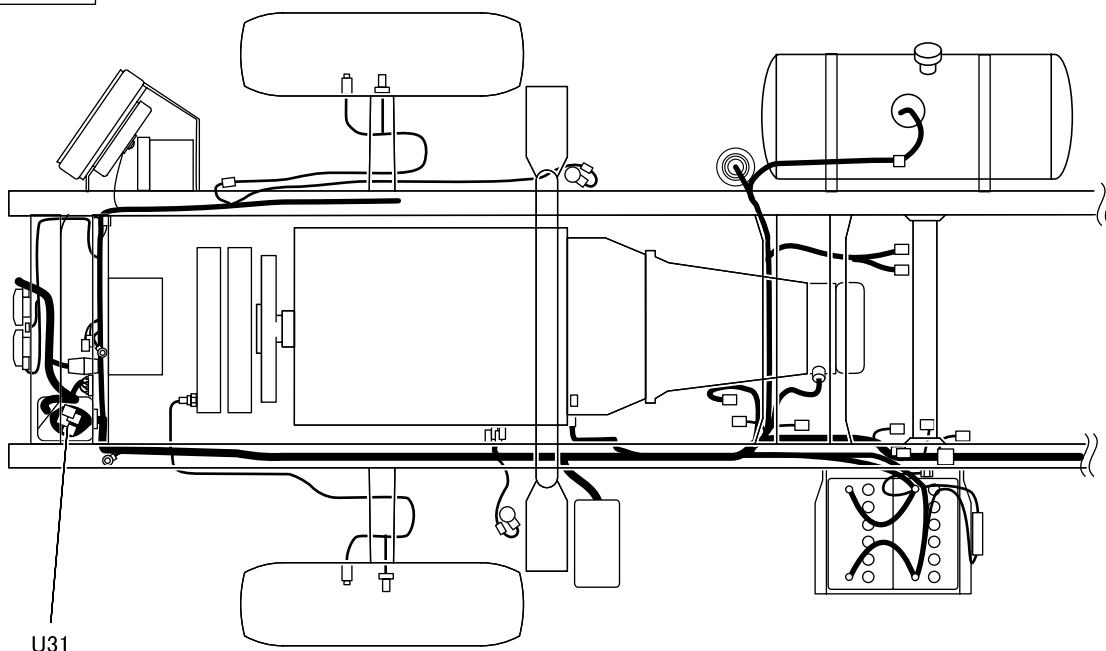
U31 Connection of chassis harness and cab harness <In connector box>

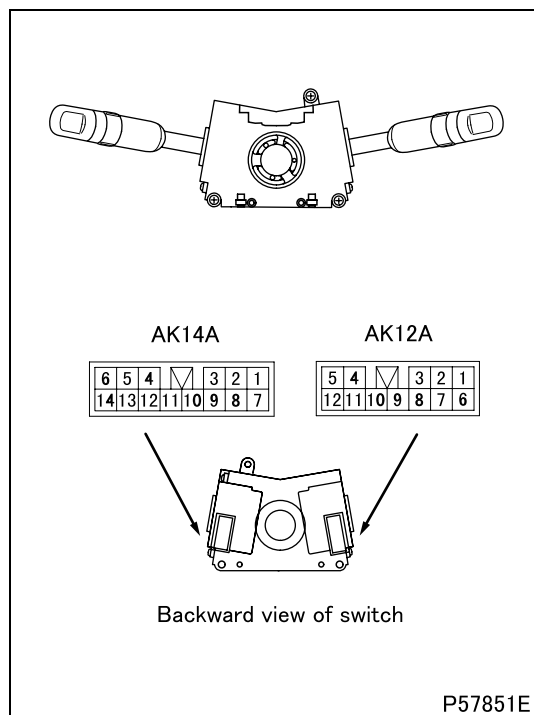
## #001 Inspection of combination switch

AK12A connector connection table

- If any fault is found, replace the switch. (See Gr37.)

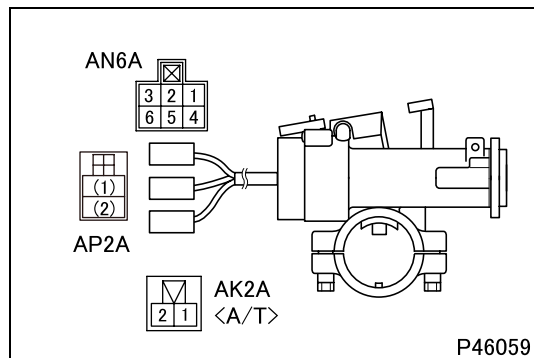
## #002 Inspection of starter switch

AP2A, AN6A connector connection table

- If any fault is found, replace the switch. (See Gr37.)

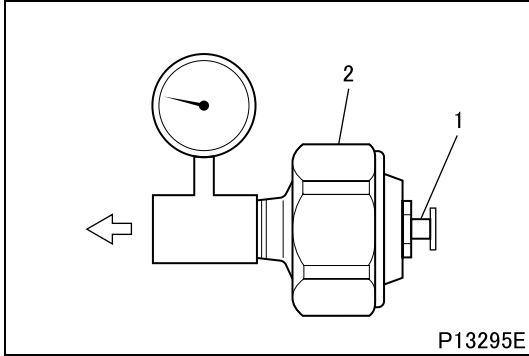
### #023 Inspection of vacuum switch

- Perform the following checks, and if any fault is found, replace the switch. (See Gr35A.)

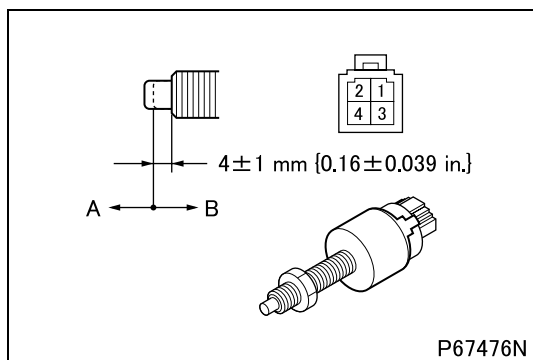
## #031 Inspection of clutch switch

| Switch position | Continuity terminal |
| B | 2-3 |

- If any fault is found, replace the switch. (See Gr21.)

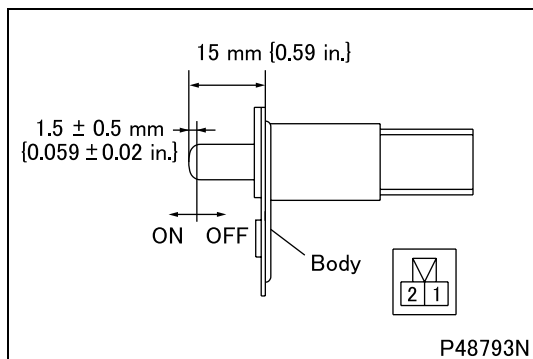
## #035 Inspection of door switch

| Switch position | Continuity terminal |
| ON | 1-body, 2-body |

- If any fault is found, replace the switch. (See Gr43.)

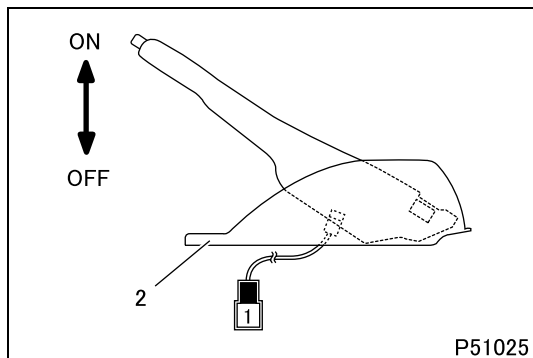
## #038 Inspection of parking brake switch

- Measure continuity between terminals 1 and 2 (body) ground.

| Release the parking brake lever | Continuity does not exist |

- If any fault is found, replace the switch. (See Gr36.)

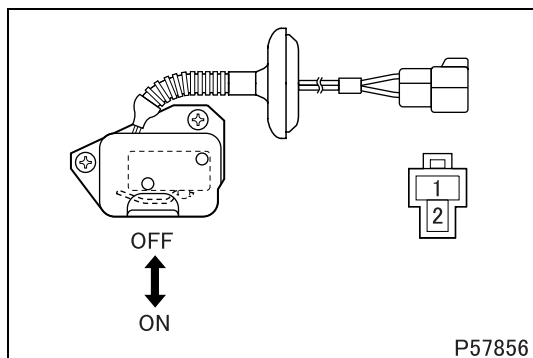
## #039 Inspection of cab tilt lock switch

| Switch position | Continuity terminal |
| ON | 1-2 |

- If any fault is found, replace the switch. (See Gr42.)

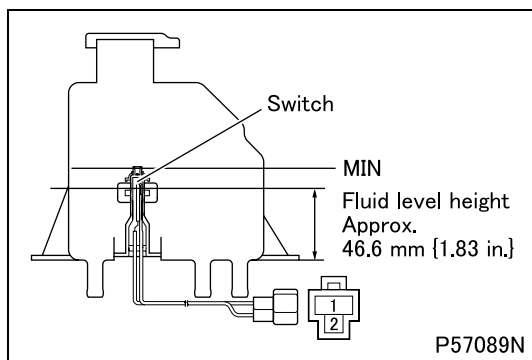
#### #041 Inspection of brake fluid level switch

- Gradually drain brake fluid from the brake fluid tank.

| Standard value | 46.6 mm {1.83 in.} |

- If the measured value deviates from the standard value, replace the brake fluid tank. (See Gr52.)

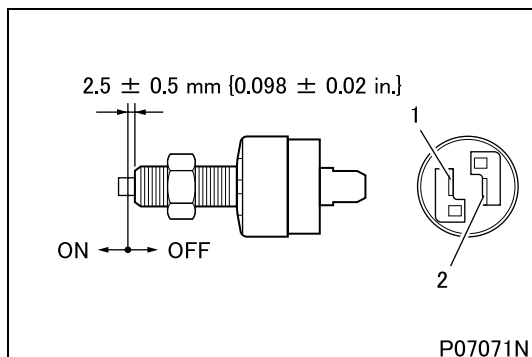
#### #042 Inspection of stop lamp switch

<Without auto cruise>

| Switch position | Continuity terminal |
|---|---|
| ON | 1-2 |

- If any fault is found, replace the switch. (See Gr35A.)

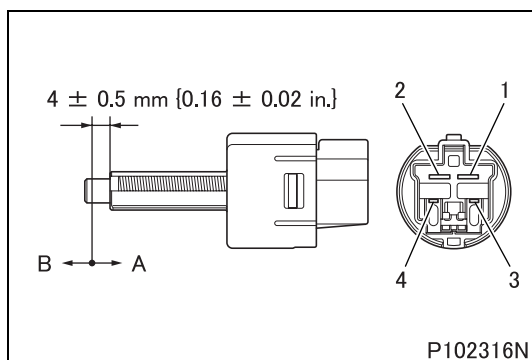
<With auto cruise>

| Switch position | Continuity terminal |
| B | 1-2 |

- If any fault is found, replace the switch. (See Gr35A.)

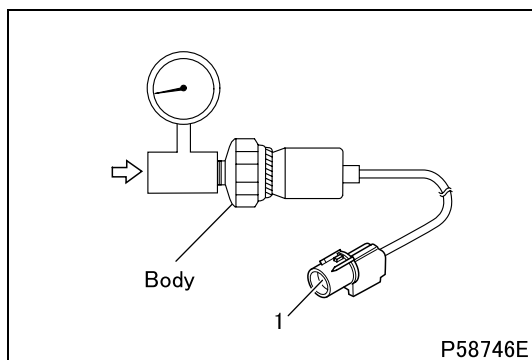
#### #044 Inspection of engine oil pressure switch

- Perform the following checks, and if any fault is found, replace the switch. (See Gr12.)

| Standard value<br>(operating pressure) | 50 ± 10 kPa {7.1 ± 1.4 psi, 0.5 ± 0.1 kgf/cm <sup>2</sup> } |

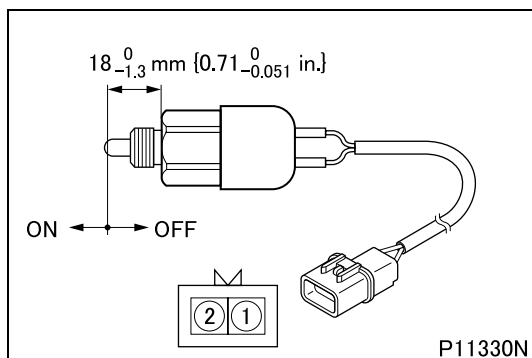
## #054 Inspection of switch

- Backup lamp switch. (See Gr22.)
- Transfer four-wheel drive switch. <FG> (See Gr24.)
- Transfer low switch. <FG> (See Gr24.)

| Switch position | Continuity terminal |
|---|---|
| ON | 1-2 |

- If any fault is found, replace the switch.

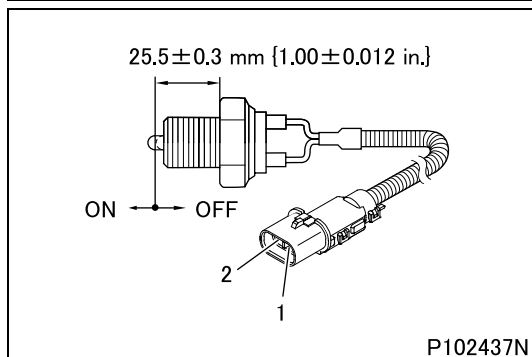
## #056 Inspection of transmission neutral switch

| Switch position | Continuity terminal |
| ON | 1-2 |

- If any fault is found, replace the switch. (See Gr22.)

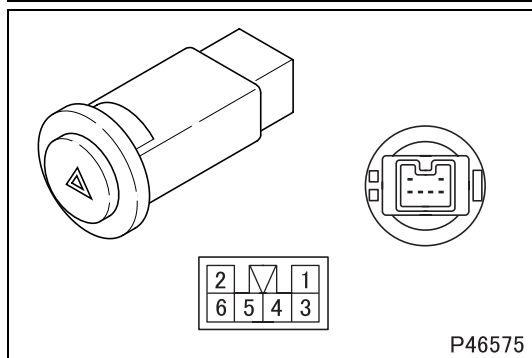
## #081 Inspection of hazard switch

| Switch position | Continuity terminal | Night illumination |
| ON | 4-5-6 | |

- If any fault is found, replace the switch. (See Gr52.)

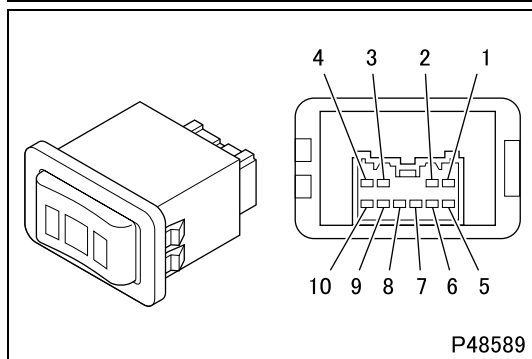
## #087 Inspection of van body dome light switch

| Switch position | Continuity terminal | Operation illumination | Night illumination |
| ON | 1-7 | (-) 3-9 (+) | |

- If any fault is found, replace the switch.

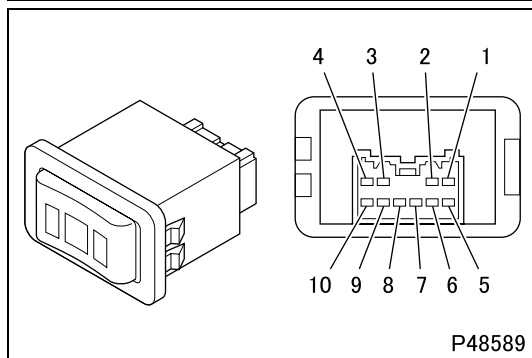
## #089 Inspection of switch

- Front drive switch
- Warm-up switch

| Switch position | Continuity terminal | Night illumination |
|---|---|---|
| ON | 1-7 | |

- If any fault is found, replace the switch. (See Gr52.)
