# FE.FG

## SERVICE MANUAL 2008 Model FOREWORD

This Service Manual contains maintenance and repair methods for the Mitsubishi Fuso Truck FE. FG Series. Read this manual carefully as an aid in providing correct, efficient maintenance. Please note that the information and specifications contained within this manual may change without notice. This is due to product modifications and continued vehicle improvements that are made throughout the model years. Should you encounter any discrepancy in the information provided, please do not hesitate to contact your nearest Mitsubishi Fuso Dealer or Mitsubishi Fuso Truck of America, Inc.

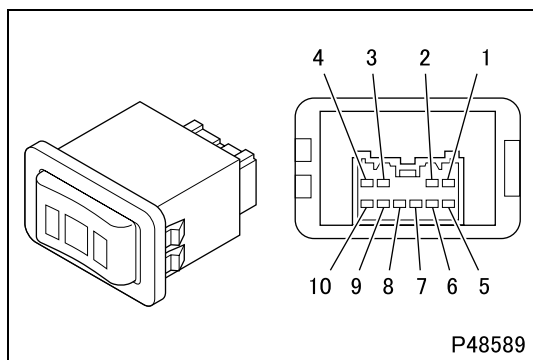
### #092 Inspection of engine oil level check switch

| Switch position | Continuity terminal |
| CHK | 1–7, 5–6 |

- If any fault is found, replace the switch. (See Gr52.)

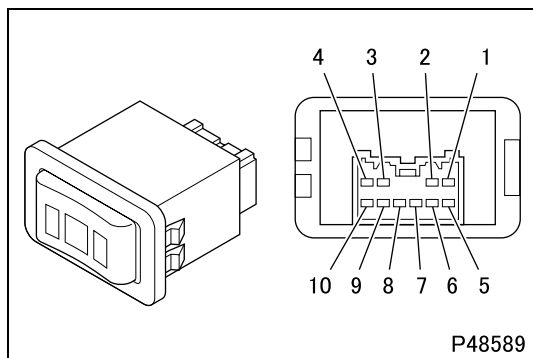
### #094 Inspection of door lock switch

| Switch position | Continuity terminal | Night illumination |
| UNLK | 1–8 | |

- If any fault is found, replace the switch. (See Gr43.)

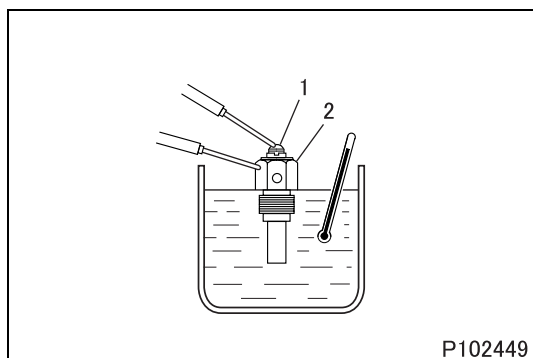
### #160 Inspection of overheating switch

- Dip the switch in a container filled with engine oil.
- Raise the oil temperature to the specified values and stir the oil.
- Measure the operating temperature between terminals 1 and 2 (body) respectively.

- If the measured value deviates from the standard value, replace the switch. (See Gr14.)

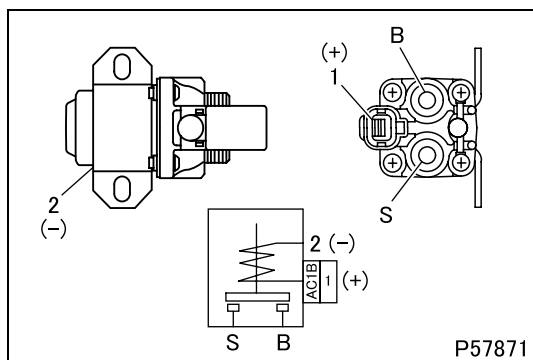
## #187 Inspection of starter relay

- Perform continuity check and operation check, and if any fault is found, replace the relay.

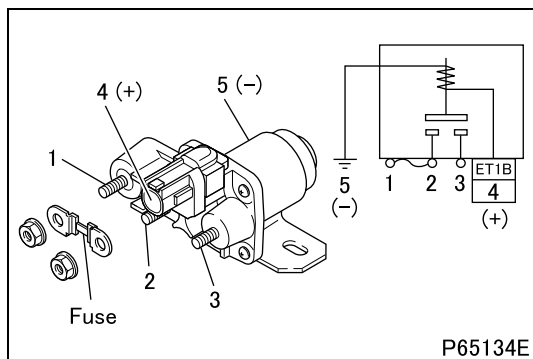
## #195 Inspection of glow relay

- Perform continuity check and operation check, and if any fault is found, replace the relay.

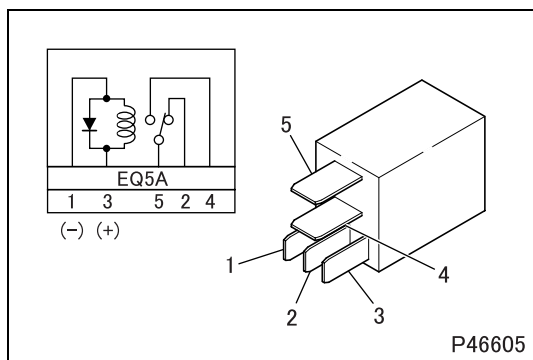
## #201 Inspection of relay (normally open type 5 pin)

- Perform continuity check and operation check, and if any fault is found, replace the relay.

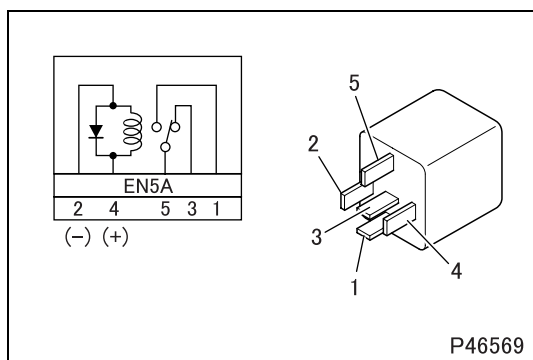
## #202 Inspection of relay (normally open type 5 pin)

- Perform continuity check and operation check, and if any fault is found, replace the relay.

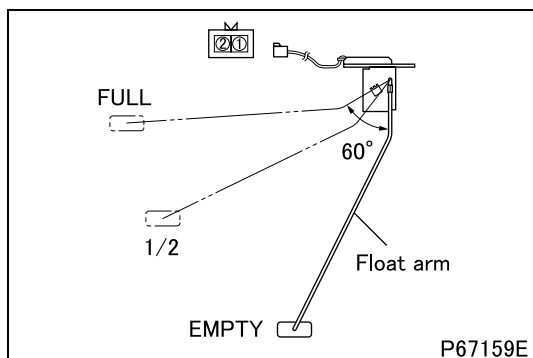
## #258 Inspection of fuel level sensor

- Measure resistance values between terminals 1 and 2 when bringing the float arm into contact with stoppers (at EMPTY and FULL positions) and placing it at the midpoint position.

| | at EMPTY position | $150 \pm 10 \Omega$ |

- If the measured value deviates from the standard value, replace the sensor. (See Gr13A.)

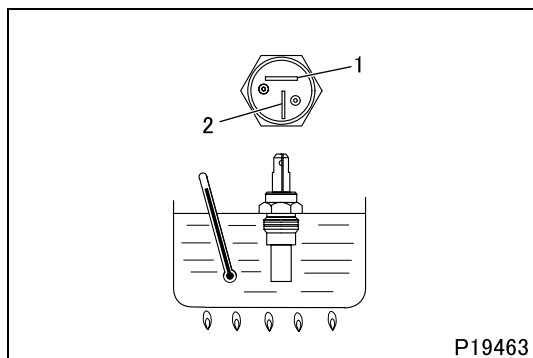
## #262 Inspection of water temperature sensor

<For water temperature gauge>

- If the measured value deviates from the standard value, replace the sensor. (See Gr14.)

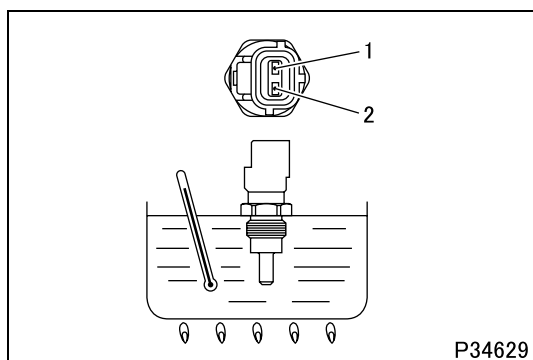
<For engine control>

- Place the sensor in engine oil in a container.
- Raise the oil temperature to the specified values and stir the oil.
- Measure the resistance between terminals 1 and 2.

- If the measured value deviates from the standard value, replace the sensor. (See Gr14.)

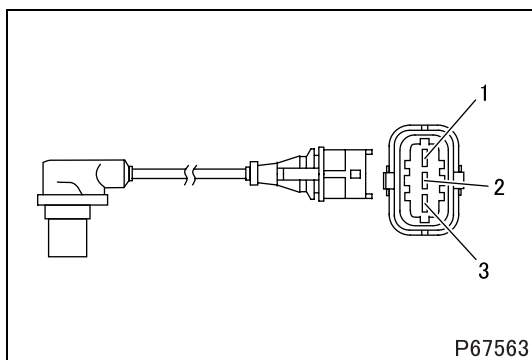
### #263 Inspection of engine speed sensor

- Measure the resistance between terminals 1 and 2.

| Standard value<br>(at 20°C {68°F}) | 860 ± 86 Ω |

- If the measured value deviates from the standard value, replace the sensor. (See Gr13E.)

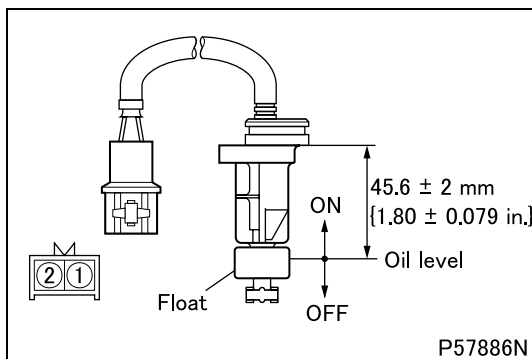
### #264 Inspection of engine oil level sensor

| Switch position | Continuity terminal |
| ON | 1-2 |

- If any fault is found, replace the sensor. (See Gr12.)

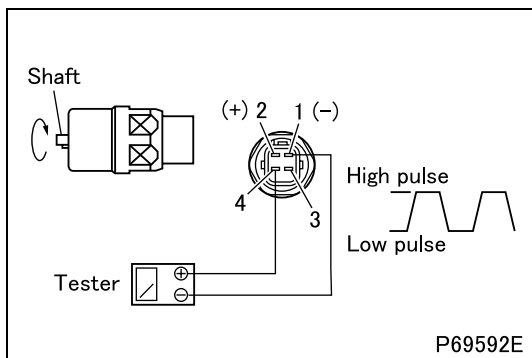
### #265 Inspection of vehicle speed sensor

- With the 12 volts DC applied to terminals 1 and 2, slowly turn the shaft of the vehicle speed sensor.
- Measure the maximum value (high pulse voltage) and the minimum value (low pulse voltage) of the voltage generated at each terminal.

| Standard value | Between 25 pulse output terminals 1 and 4 | Low pulse voltage | 0.5 V or less |
|---|---|---|---|
| | | High pulse voltage | 8 ± 1 V |

- If the measurement is not within the range of the standard value, replace the sensor. (See Gr22.)

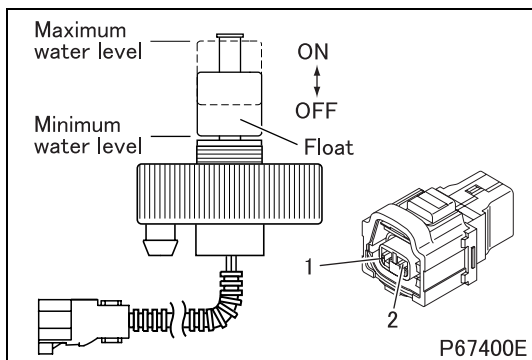
### #274 Inspection of water separator sensor

| Condition | Continuity terminal |

- If any fault is found, replace the sensor. (See Gr13A.)

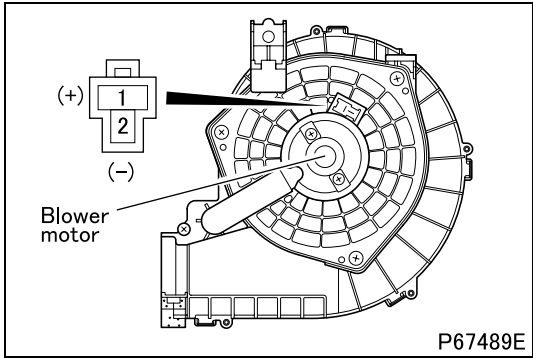
#411 Inspection of blower motor

- Make sure that the motor operates when battery voltage is applied between terminals 1 and 2.
- If any fault is found, replace the motor. (See Gr55.)

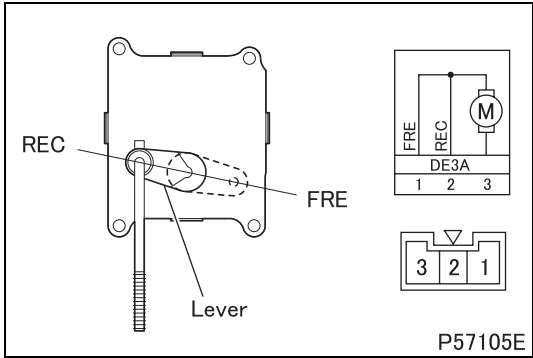
#415 Inspection of fresh/recirculation changeover motor

- Perform the following checks, and if any fault is found, replace the motor. (See Gr55.)
- Make sure that the motor operates when battery voltage is applied between each terminal.

- Stop applying battery voltage if the lever stops spontaneously at the REC or FRE position.

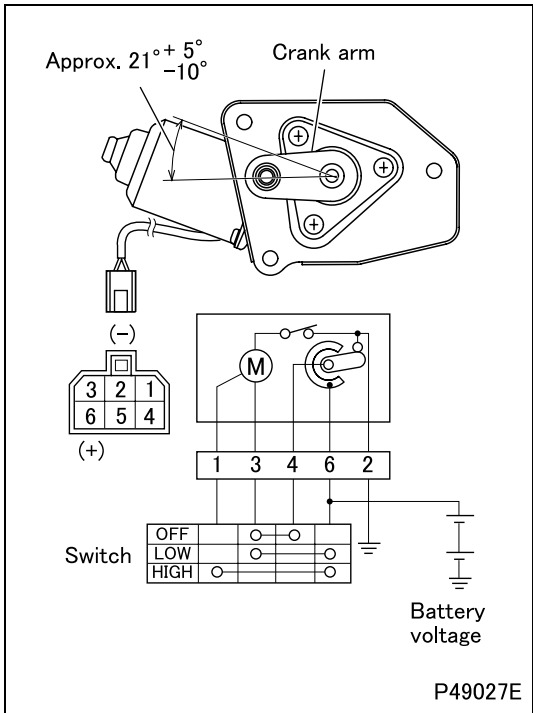
#422 Inspection of wiper motor

- Connect a switch to wiper motor as shown.
- Check the motor for correct operation as follows. If any fault is found, replace the motor. (See Gr51.)

- Set switch to LOW position to let the motor rotate at low speed.
- When the crank arm is in a position other than automatic stop position (outside the angles shown), set switch to OFF position.
- Check to see that the crank arm stops at the automatic stop position (within the angles range shown).

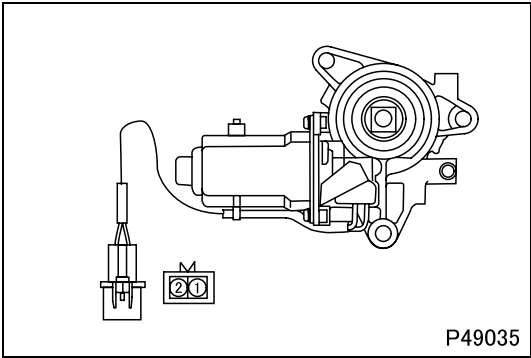
## #423 Inspection of power window motor

- Make sure that the motor operates when battery voltage is applied between terminals 1 and 2.

| Rotation direction | Terminal |
|---|---|
| Right | (+) 1-2 (-) |

- If any fault is found, replace the motor and the regulator as a set. (See Gr43.)

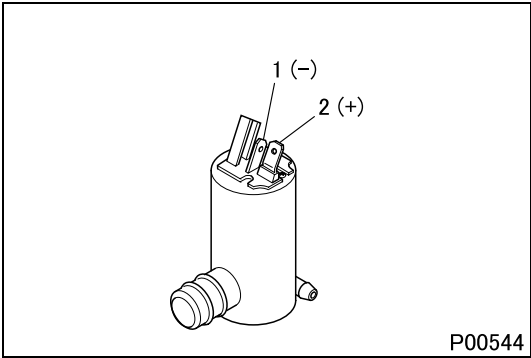
## #428 Inspection of windshield washer motor

- Make sure that the motor operates when battery voltage is applied between terminals 1 and 2.
- If any fault is found, replace the motor. (See Gr51.)

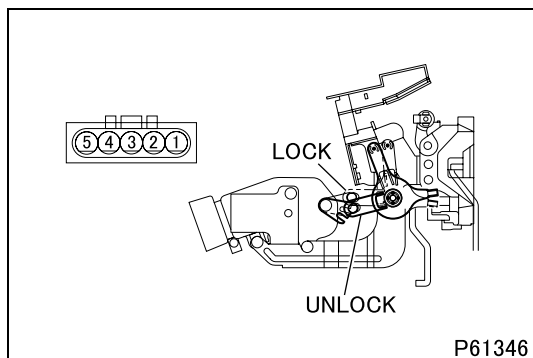
## #510 Inspection of door lock actuator (on assistant driver's side)

- Apply battery voltage between each terminals confirm that the actuator operates.

- If any fault is found, replace the actuator. (See Gr43.)

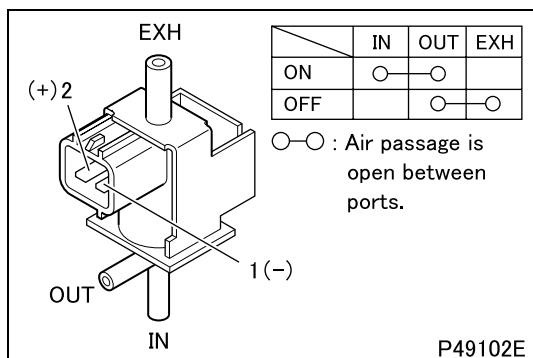
Measure the voltage at which the 3-way magnetic valve operates. (Determine ON/OFF of the magnetic valve by operating noises.)

| Standard value<br>(minimum operating voltage) | 8 V or less |

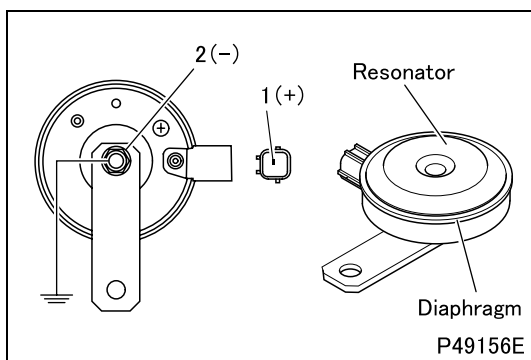
- Bending the stay changes the sound quality of the horn, degrading the horn performance.
- Never bend or damage the stay.

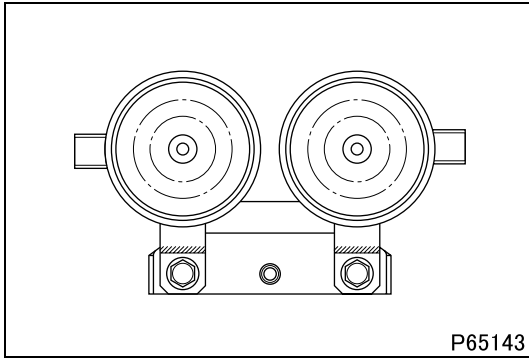
- Make sure to confirm whether the horn sounds by applying the battery voltage between terminals 1 and 2 (body).
- Remove foreign substances adhered to the resonator and diaphragm.
- If any fault is found, replace the horn.

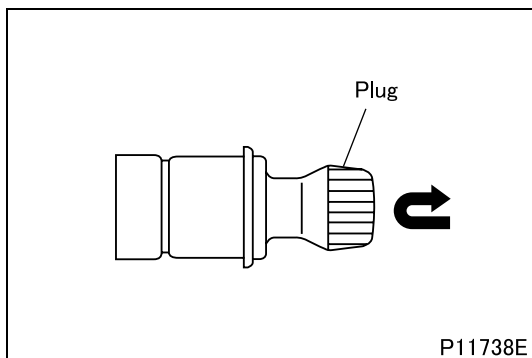
## #754 Inspection of cigarette lighter

- Perform the following checks, and if any fault is found, replace the cigarette lighter. (See Gr52.)
- Make sure that there is continuity between heater element and body.

- Make sure that when plug is pushed in by hand, it immediately returns to its original position.
- Place the starter switch at ACC or ON position.
- Push plug into the socket in the cab.
- Measure the time required for plug to automatically return.

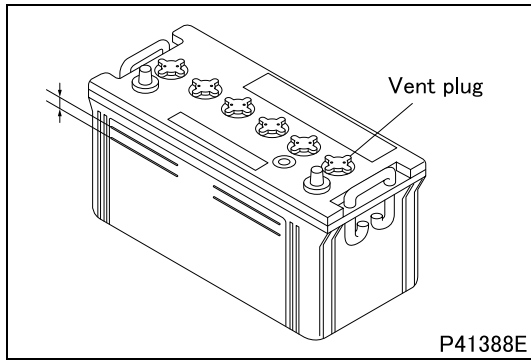
- If terminal is corroded, scrub off the corrosion from it using a wire brush.
  - If cracks or defects are found on battery, replace it since the cracks or defects can cause liquid spills.
- 
- If bleed hole of vent plug is clogged, clean the hole.

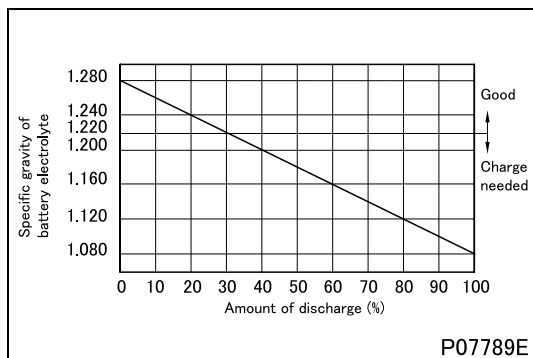
## (3) Measurement of specific gravity

You can tell the specific gravity of the battery electrolyte by the color shown in indicator.

White : Charge or replace

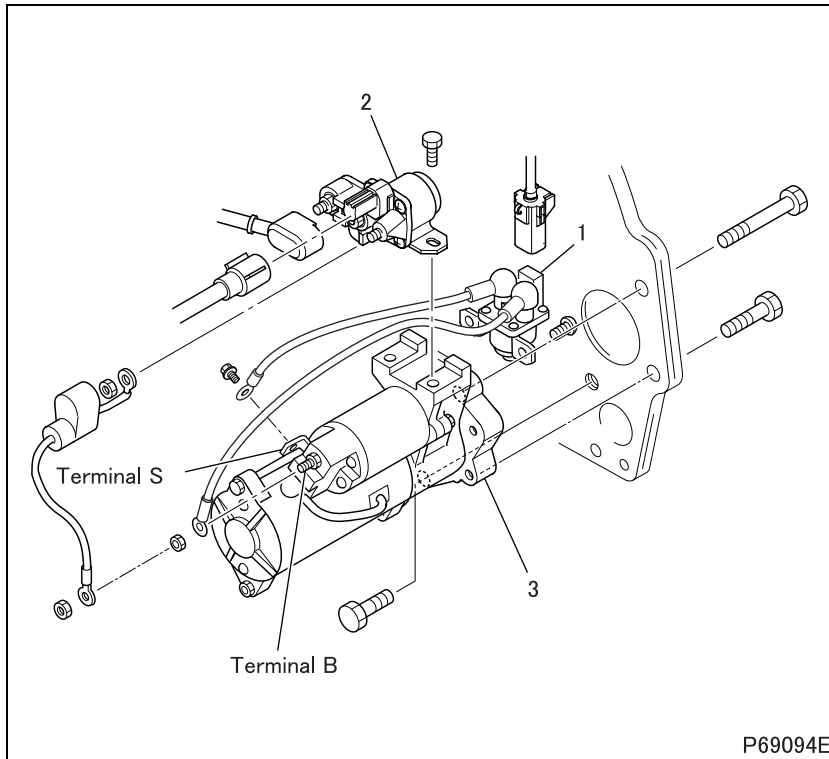
## ● Removal sequence

- 1 Starter relay
- 2 Glow relay <Except FE83>
- 3 Starter

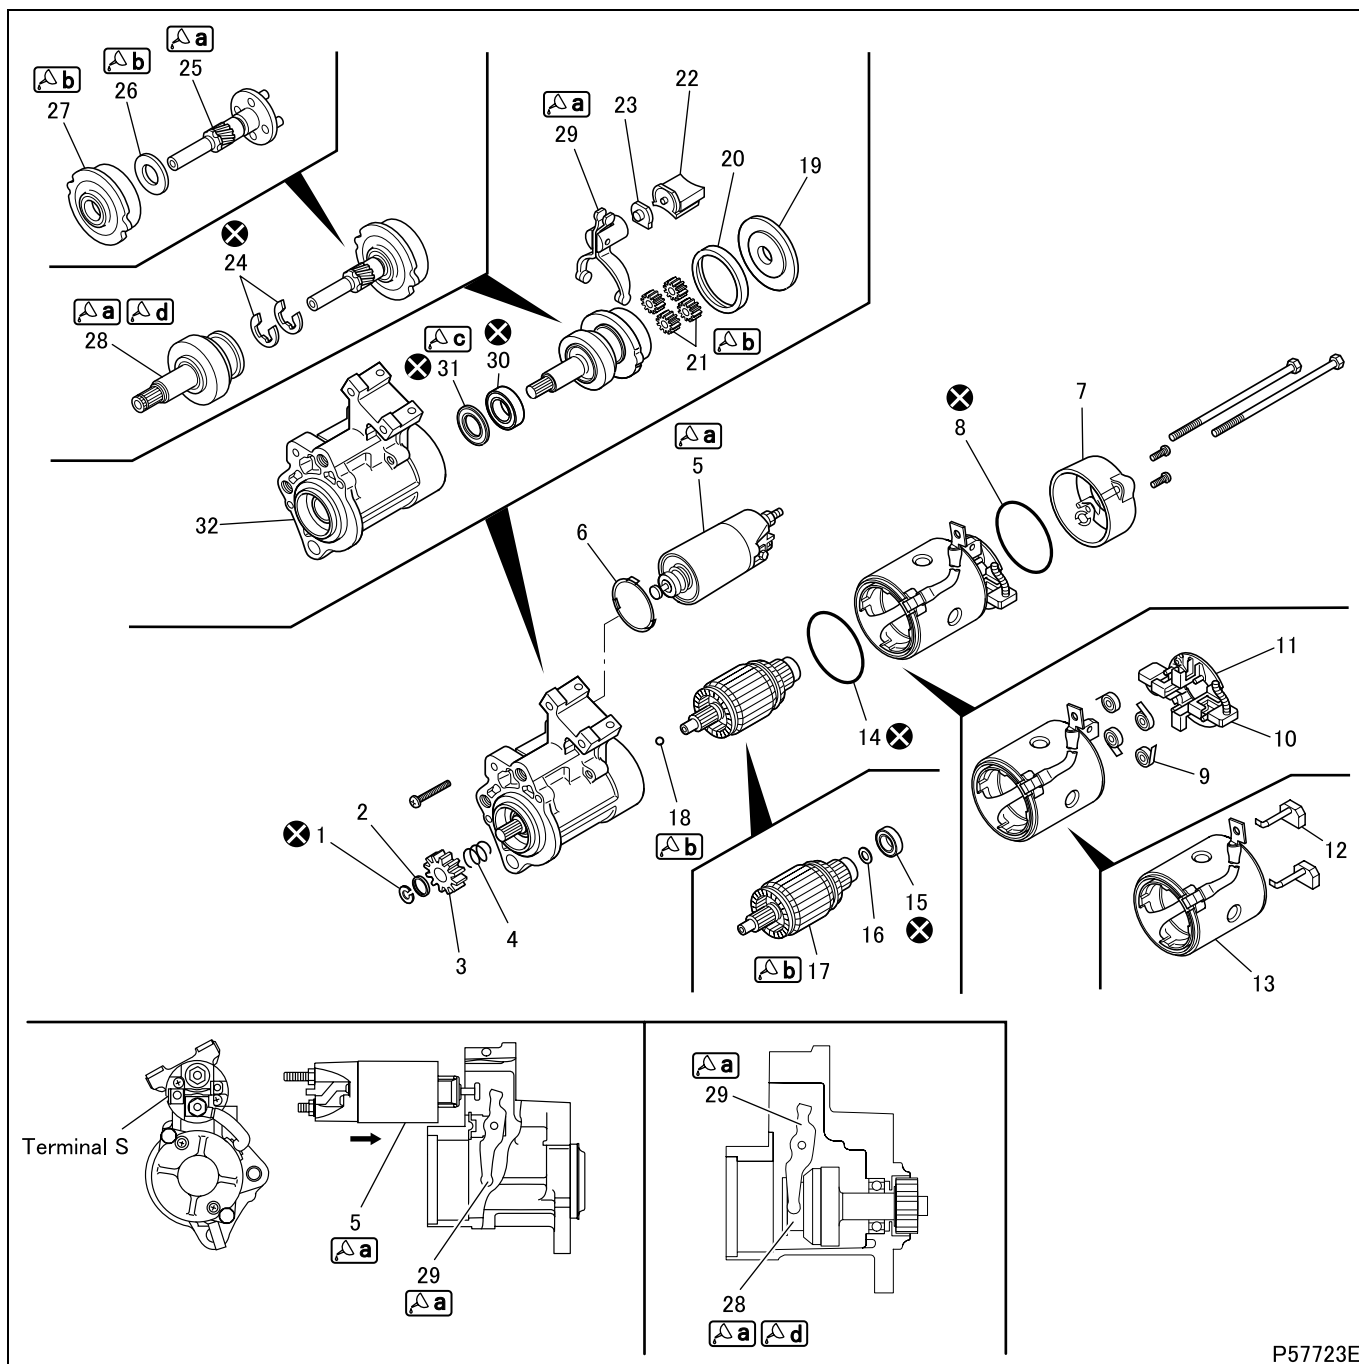
P57723E

## ● Disassembly sequence

- Do not remove the rear bearing unless defects are evident.
- It is not necessary to remove the pinion when only the motor section needs to be disassembled for inspection, like when inspecting brushes and related parts.
- Be sure to remove the pinion before disassembling any other parts.

- Whenever the magnetic switch is replaced, the pinion gap must be adjusted.
- The rubber packing is serviceable if any defect is not found.

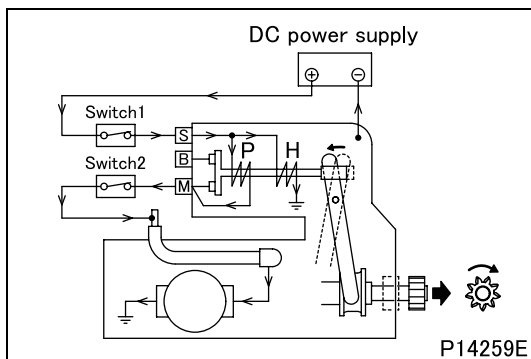
- Connect the starter as illustrated.

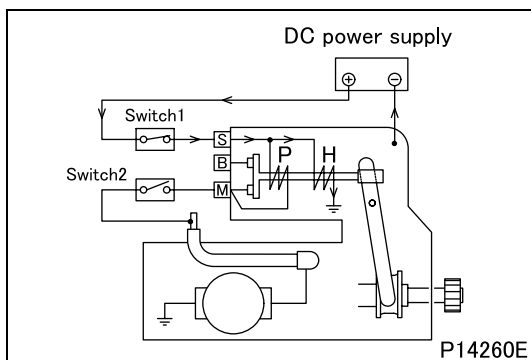
- The following operations are performed with current supplied to the starter. Thus, the entire procedure for removal of the pinion must be completed within 30 seconds.
- Turn ON switches 1 and 2 to supply current to the starter. The pinion will spring out and rotate.

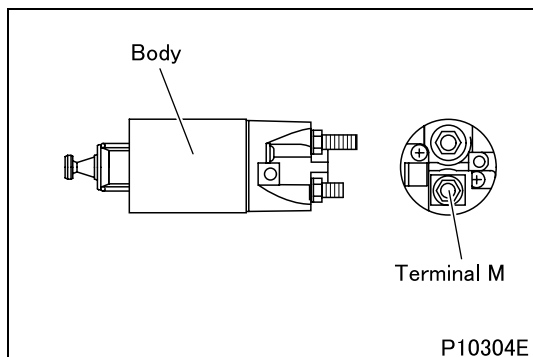
- Check that continuity exists between terminals S and M.

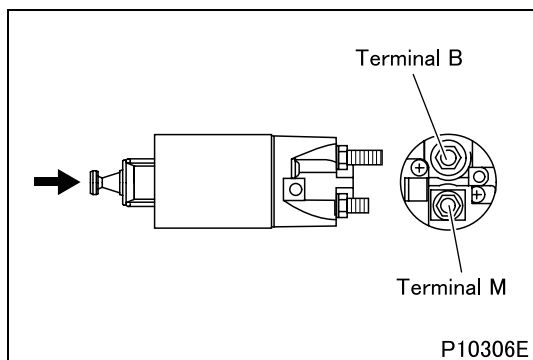
#### (3) Test for contact-to-contact continuity

- Push in the end of the magnetic switch to close the internal contacts. Then, check that continuity exists between terminals B and M.

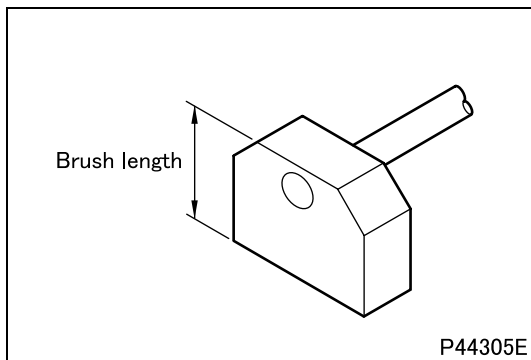
### ■ Inspection: Brush (+)

#### (1) Brush length

- If either brush (+) is shorter than the limit, it must be replaced.

#### (2) Armature commutator contact surface of brush

- If the commutator contact surface of either brush is rough or unevenly worn, rectify it with emery paper (#300 to 500).

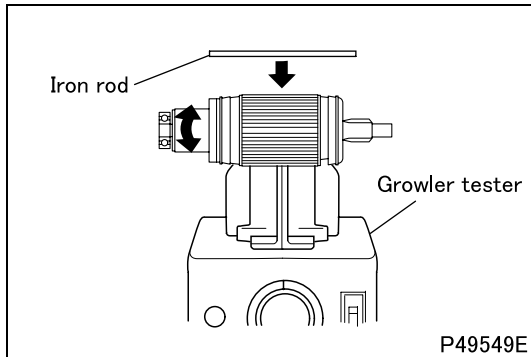
#### (1) Test for coil short circuit

- Hold an iron rod parallel with the armature.
- Slowly rotate the armature by hand.
- If the iron rod vibrates or is pulled toward the armature, the coil is short-circuited and the armature must be replaced.

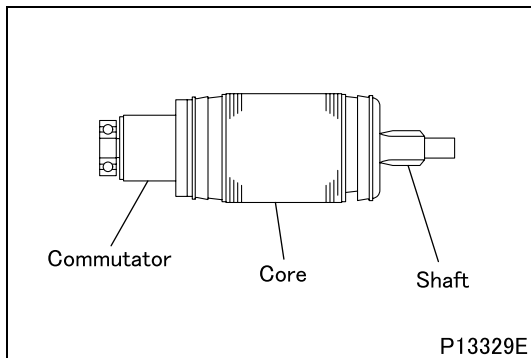
#### (2) Test for coil grounding

- Check that continuity does not exist between the commutator and the core (or shaft).
- If continuity exists, the coil is grounded and the armature must be replaced.

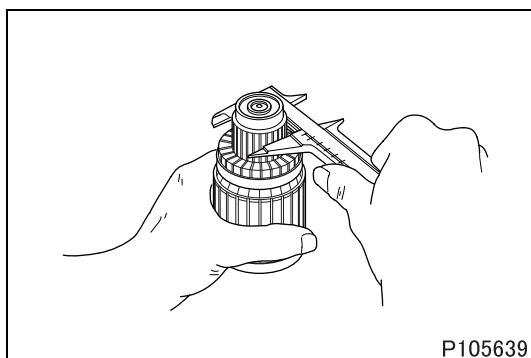
#### (3) Commutator outside diameter

- If the measurement is out of specification, replace the armature.

| Location | Maintenance item | | | Standard value | Limit | Remedy |
|---|---|---|---|---|---|---|
| 17 | Commutator outside diameter | | | 32 {1.26} | 31.4 {1.24} | Replace |

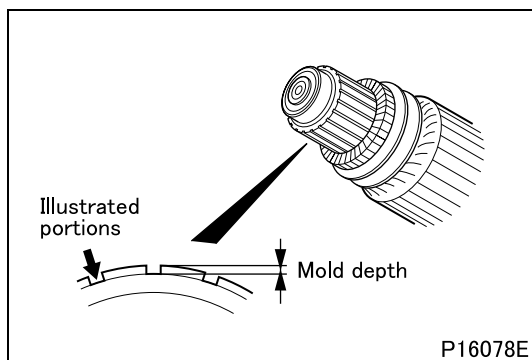
## (6) Mold depth between segments

- If the measurement is lower than the specified limit, rectify or replace the armature.
- To rectify the armature, grind the illustrated portions.

| Location | Maintenance item | | | Standard value | Limit | Remedy |
|---|---|---|---|---|---|---|
| | Mold depth between segments | | | 0.5 to 0.8 | 0.2 {0.0079} or less | Correct or replace |

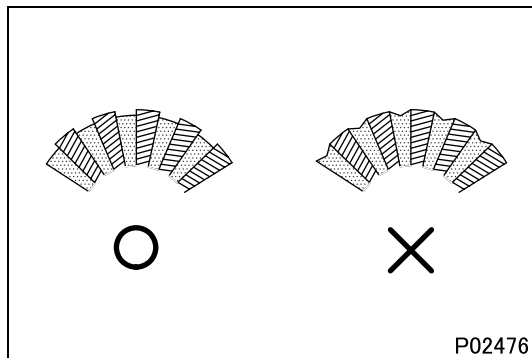
- If the mold is worn as illustrated, rectify or replace the armature.

O : Acceptable

× : Unacceptable

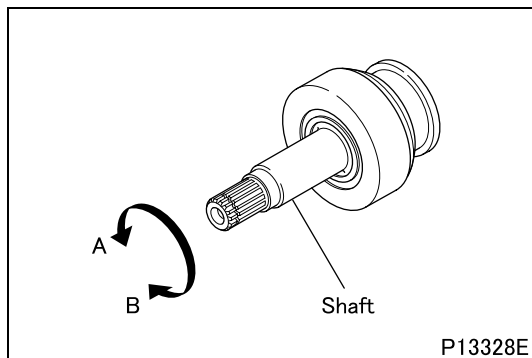
## ■ Inspection: Overrunning clutch

If the following inspections reveal any abnormality, replace the overrunning clutch.

- Turn the shaft in direction B and check that it rotates smoothly.
- Turn the shaft in direction A and check that it locks.

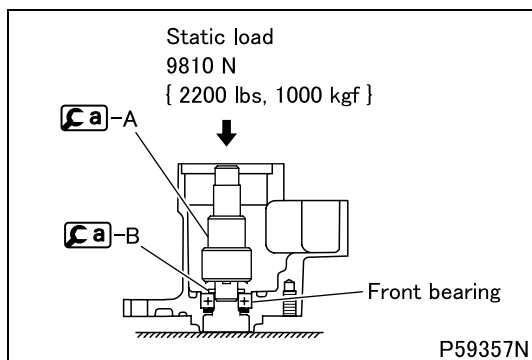
## ■ Assembly: Front bearing

- Press-fit the front bearing using **Ca**-A and **Ca**-B.

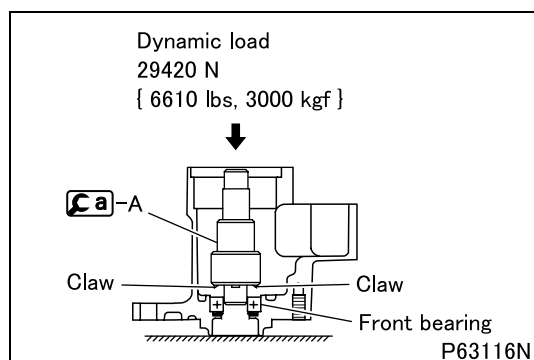
- After the press fitting, caulk the front bearing using the claw on Ca-A.

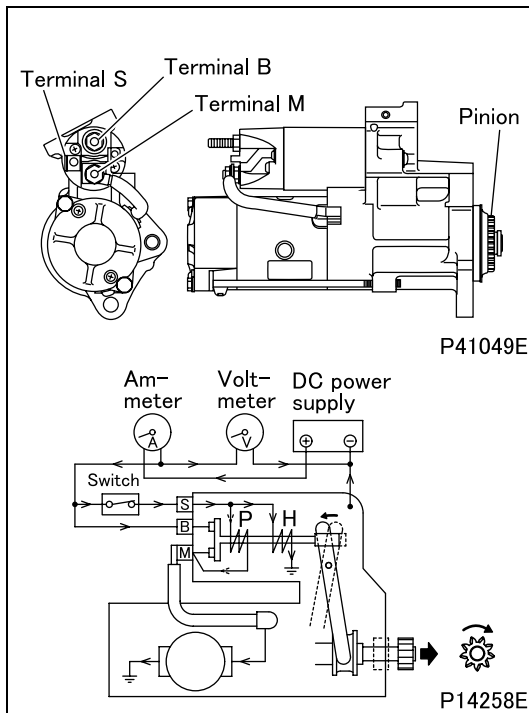
### (1) Performance test

- Connect the starter as illustrated.
- Set the voltage to 11 volts DC.

- When the switch is turned ON, the pull-in coil P and holding coil H are both energized. When the large current from the DC power supply flows from terminal B to terminal M, the supply of current to the pull-in coil P is cut; only the holding coil H remains energized. To prevent the holding coil from burning out, it is essential to complete all operations within 30 seconds.

- Measure the current and the starter's rotational speed. To measure the rotational speed, shine a stroboscope on the pinion.
- Turn OFF the switch to de-energize the starter.
- If either measurement is out of specification, disassemble and inspect the starter again.

| Location | Maintenance item | | | Standard value | Limit | Remedy |
|---|---|---|---|---|---|---|
| – | No-load characteristics | With 11 V applied | Current | 180 A or less | – | Correct or replace |

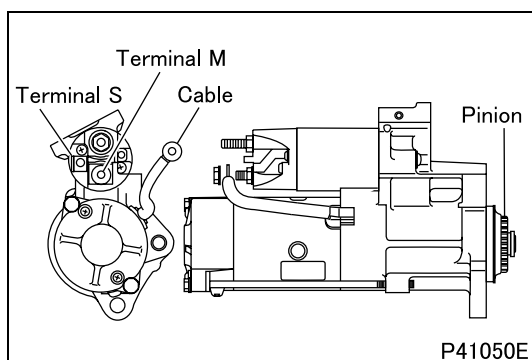
## (2) Pinion gap

- Connect the starter as illustrated.

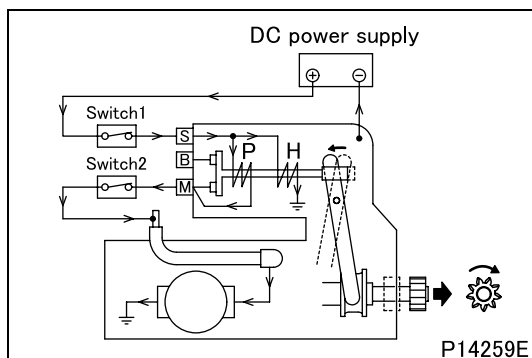
- The following operations are performed with current supplied to the starter. Thus, the entire procedure for measurement of the pinion gap must be completed within 30 seconds.
- Turn ON switches 1 and 2 to supply current to the starter. The pinion will spring out and rotate.

- When switches 1 and 2 are turned ON, the pull-in coil P and holding coil H are both energized. The circuit is connected such that no voltage is applied to starter terminal B, so current flows to the pull-in coil while the pinion rotates. To prevent the pull-in coil from burning out, it is essential to turn OFF switch 2 quickly (within five seconds) after the pinion starts to rotate.

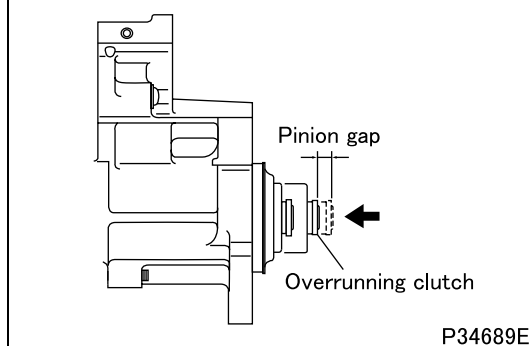
- Pull out the end of the overrunning clutch and then lightly push in the end of the overrunning clutch and measure the amount of movement in the axial direction, i.e., the pinion gap.
- Turn OFF switch 1 to de-energize the starter.
- If the measurement is out of specification, replace the lever.

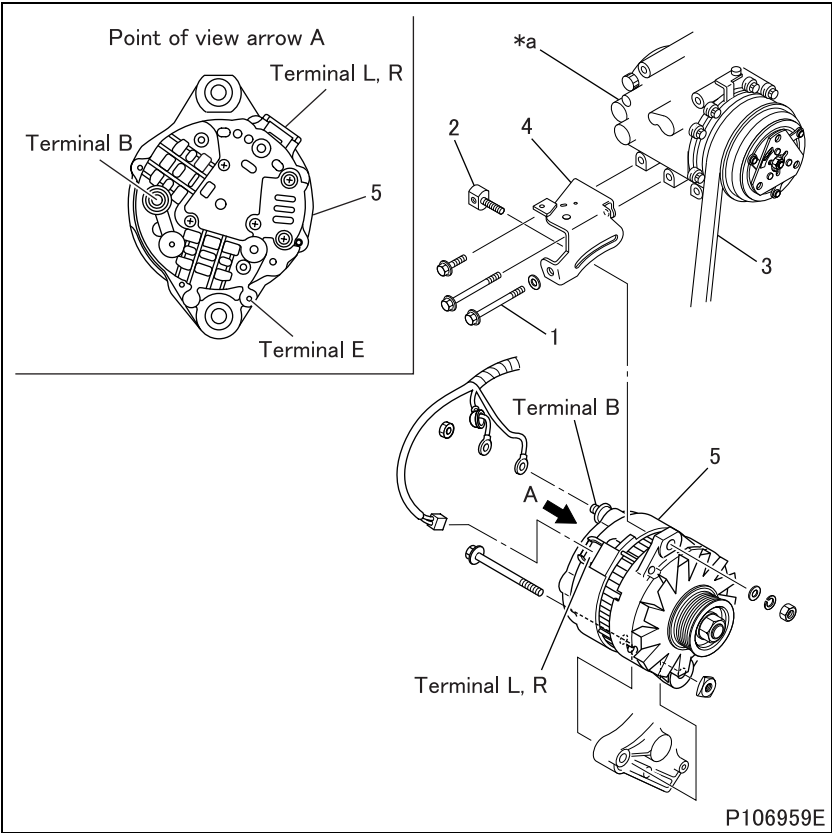
## ● Removal sequence

- 1 Adjusting bolt
- 2 Adjusting shaft
- 3 Belt
- 4 Adjusting plate
- 5 Alternator

\*a: Air-conditioner compressor

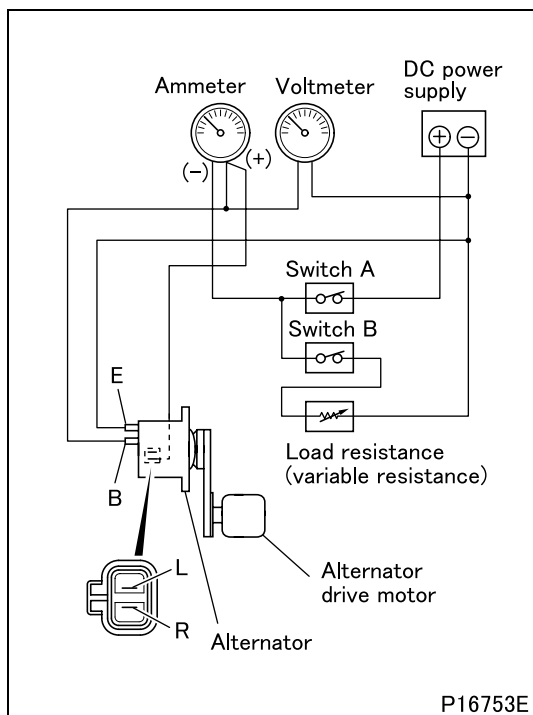
### ■ Inspection: Alternator

#### (1) Alternator output current (bench test)

- Increase load resistance to the maximum (condition under which the load current hardly flows).
- Turn switch A and B ON.
- Run alternator at 5000 rpm for 30 minutes by adjusting load resistance so that electric current can conform to the following standard.

- Measure the current at each specified revolution of alternator.
- If the measured value is lower than the standard value, disassemble and check alternator.

| Location | Maintenance item | | Standard value | Limit | Remedy |
|---|---|---|---|---|---|
| 5 | Alternator output current<br>(*when alternator is hot and producing 13.5 V) | At 1500 rpm | 51.5 A or more | – | Correct or replace |

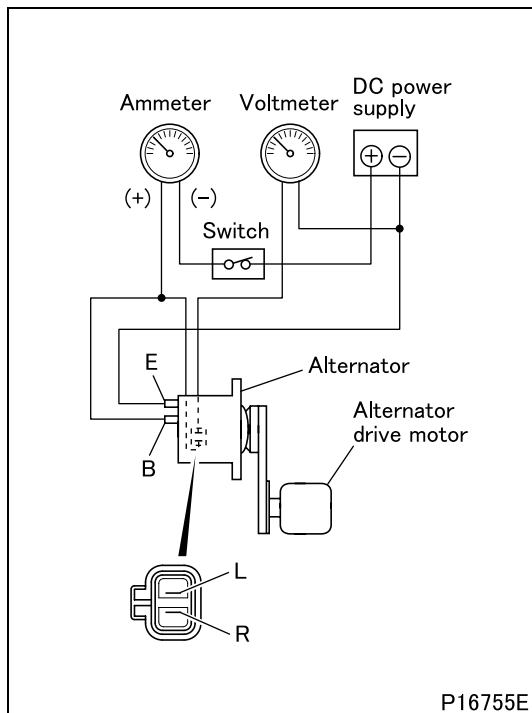
## (2) Adjustment voltage of regulator (bench test)

- Connect the alternator as illustrated.

- Turn switch ON.
- Run alternator at low speeds.
- Increase the speed of alternator to 5000 rpm and measure the voltage (adjustment voltage) at this speed. At the same time, make sure that the current is 10 amperes or less at 5000 rpm.
- If the measured value deviates from the standard value, do as follows:
  - If higher than the standard value: Replace the regulator.
  - If lower than the standard value: Inspect the alternator related parts before replacing the regulator.

| Location | Maintenance item | | Standard value | Limit | Remedy |
|---|---|---|---|---|---|
| | Adjustment voltage of regulator<br>(at 5000 rpm, 5 A is loaded) | | 14.7 ± 0.3 V | – | Replace |

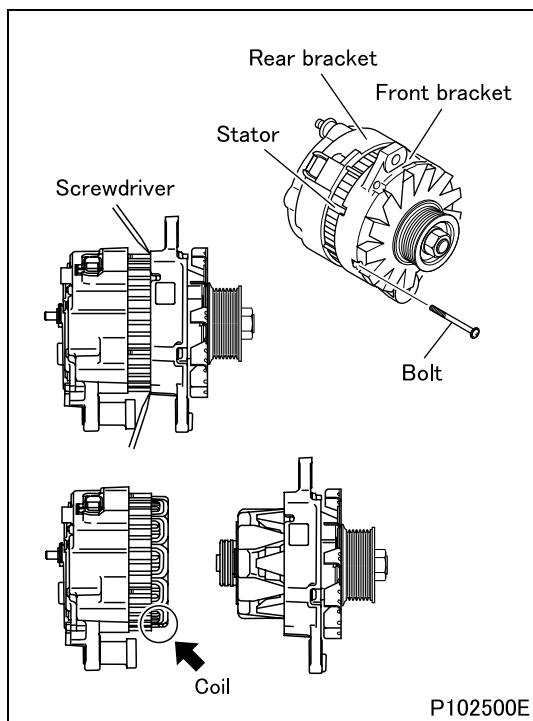
### ■ Disassembly: Rotor and front bracket

- Loosen the bolts retaining the front bracket and the rear bracket in position.
- Insert a screwdriver between front bracket and stator.
- Use the screwdriver to pry rotor and front bracket away from stator and rear bracket.

- Be careful not to insert the screwdriver too deep or it will damage coil of stator and might cause a short-circuit.

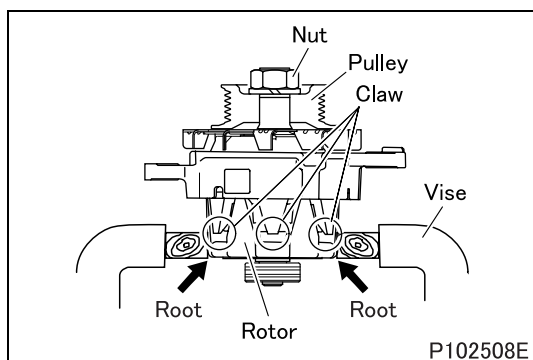
### ■ Disassembly: Pulley

- Hold the rotor in a vise and loosen the nuts to remove the pulley.

- Make sure to grip the root of the core claws when you hold the rotor in a vise. Gripping claws can damage them.

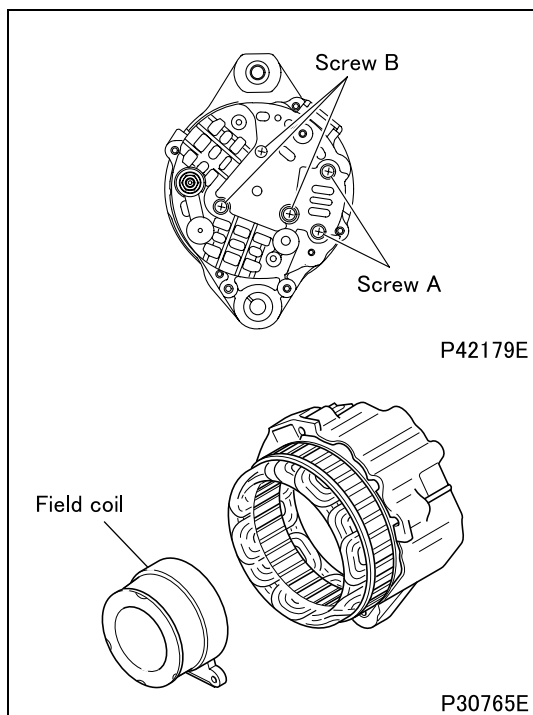
## ■ Disassembly: Field coil

- Remove screw A (2 places).

- Do not remove the field coil forcibly. Otherwise the portion that joins with the regulator may be caught by the stator coil.

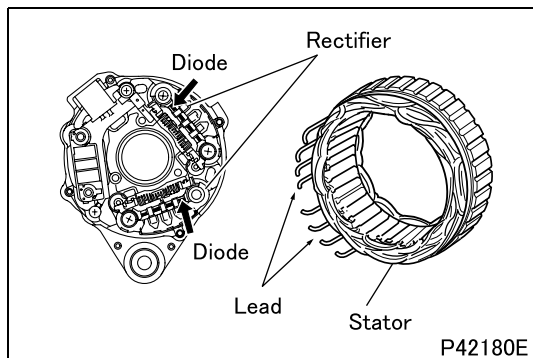
## ■ Disassembly: Stator

- Disconnect lead of stator from rectifier. The lead is soldered to diode of the rectifier at 8 places. (Each of the 2 rectifiers has 4 soldered sections.)

- Unsolder within as short a time period as possible (within 5 seconds), otherwise diode can be easily damaged by heat.

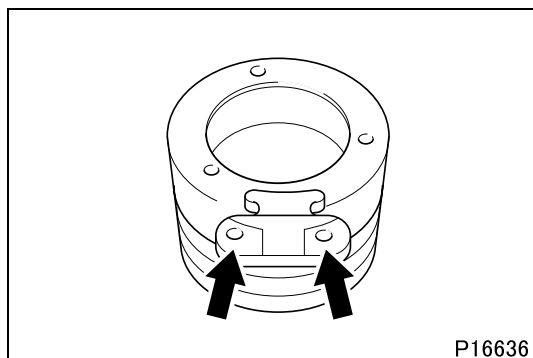
## ■ Inspection: Field coil

- Measure the resistance between the terminals of field coil.
- If the measured value deviates from the standard value, replace field coil.

| Location | Maintenance item | Standard value | Limit | Remedy |
|---|---|---|---|---|
| 9 | Field coil resistance (at 20°C {68°F}) | 1.9 to 2.3 Ω | — | Replace |

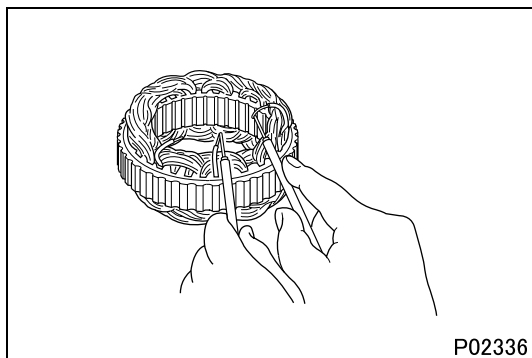
#### (1) Continuity between each lead wire

- Check that there is continuity between each stator lead.
- If there is no continuity, the lead has broken.

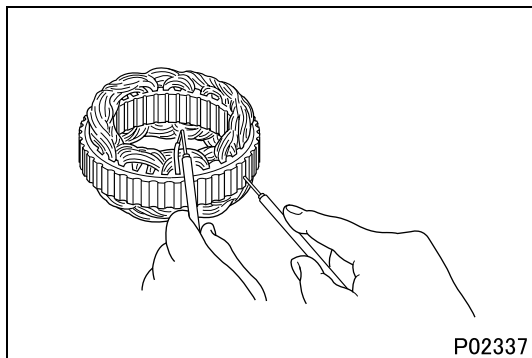
#### (2) Continuity between each lead wires and the core

- Check that there is no continuity between lead wires and the core.
- If there is continuity, the lead wire has short-circuited.

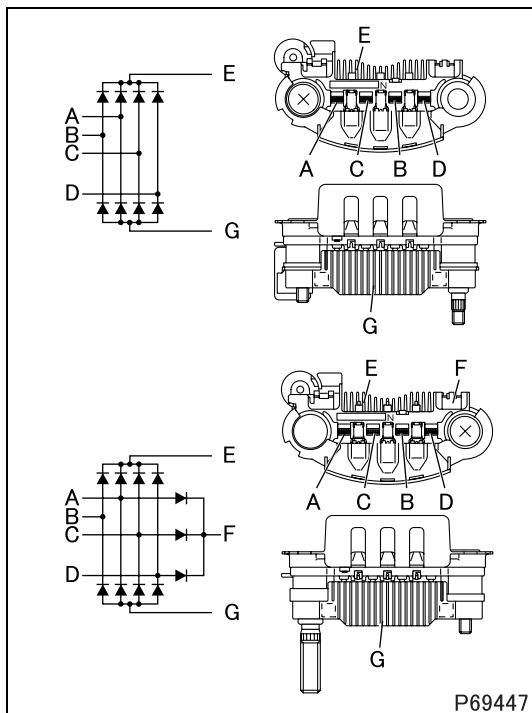
### ■ Inspection: Rectifier

- Check the function of diodes within rectifier properly. If any fault is found, replace the rectifier.

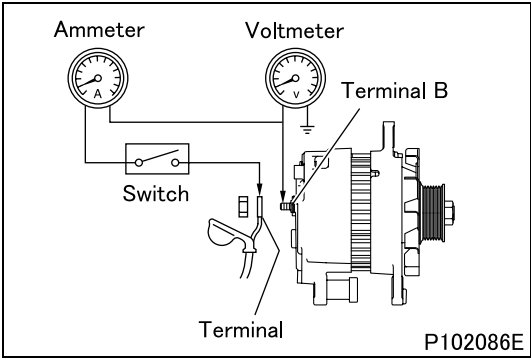
## Performance test

- The on-vehicle inspection is only a simplified check. Use a test bench for accurate checking.
- Connect the meters to the alternator as shown.

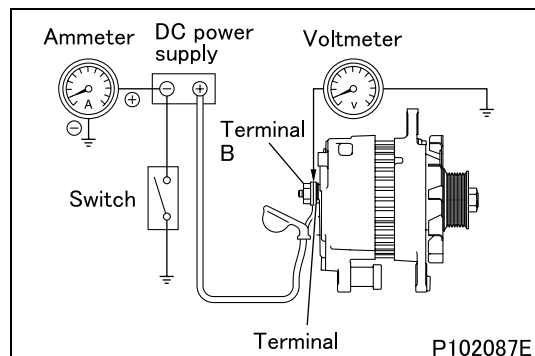
- Connect the meters to the alternator as shown.

- Turn off the switches for lamps, heater, etc. so that electric loads may not be applied during the inspection.
- Turn on switch and then start the engine.
- If the output current is 5 amperes or less when the engine speed is raised to the appropriate speed indicated below, then measure the voltage at terminal B.  
Approx. 2400 rpm
- If the output current is not less than 5 amperes, the measured value (regulated voltage) will be slightly lower.
- If the output current is 5 amperes or more, do one of the following:
  - Run the engine for a while to charge the battery.
  - Replace the battery with a fully-charged one.
- If the measured value deviates from the standard value, conduct checking again on the test bench.

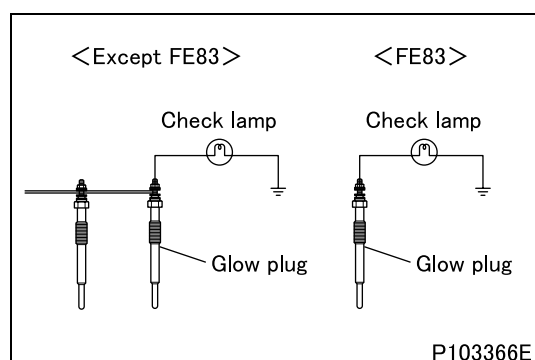
- Turn the starter switch to OFF.
- Connect a check lamp to the glow plug.
- In model FE83, the glow plugs are not connected to the connection plate. Check the glow plug by connecting the lamp to the glow plug one by one.

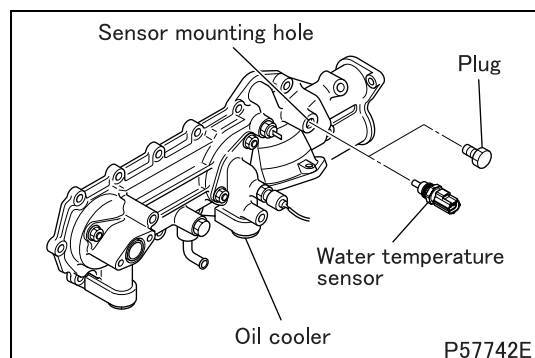
- Remove the water temperature sensor from the engine, and close the sensor mounting hole with the plug (M16 × 1.5 mm).

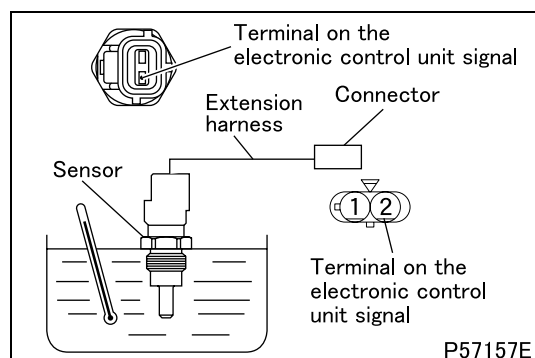
- Connect the extension harness between the water temperature sensor and connector.
- Place the water temperature sensor in a container of water.
- Conduct the following test while changing the temperature of water in the container. If anything abnormal is found, check relevant components.

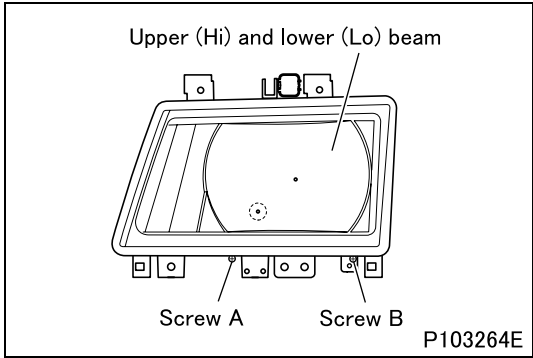
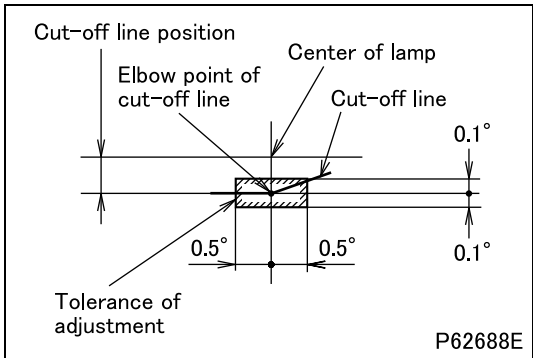
- Turn on lower beam.
- Make adjustment by the following procedure so that the elbow point of lower beam cut-off line is in the illustrated position.
- Vertical adjustment: Turn screw A.
- Horizontal adjustment: Turn screw B.

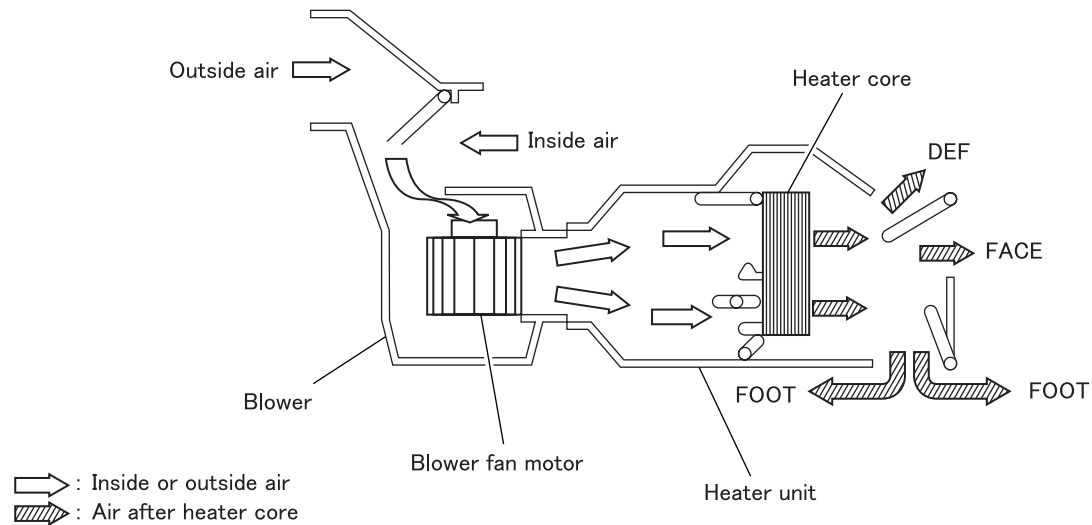
P56487E

- The blower sends air to the heater unit, where the air is heated by the heater core (heat exchanger). The warmed-up air is then sent through the ducts into the cab.
- Water (engine coolant) warmed up by the heat from the engine circulates permanently through the heater core, irrespective of whether the thermostat is open or closed.

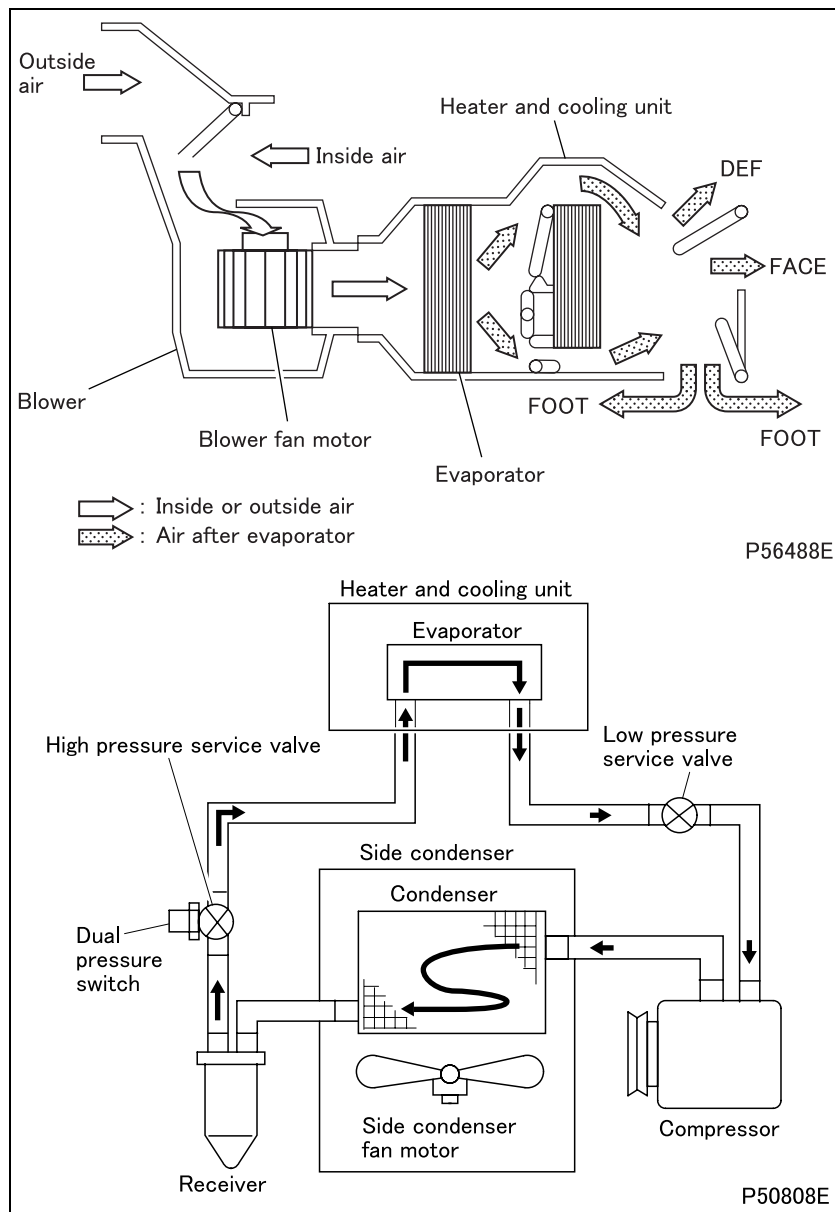
- The blower sends air to the heater and cooling unit, where the air is cooled by the evaporator. The cooled air is then sent through the ducts into the cab.
- Refrigerant in gas form is compressed by the compressor. The compressed gas is then sent to the side condenser, where it is cooled by outside air and condenses into liquid form.
- The liquid refrigerant is sprayed into the evaporator, where it quickly evaporates into gas form while at the same time absorbing heat from the surrounding air.
- The refrigerant in gas form is again sent to the compressor and is compressed there.
- When the refrigerant pressure in the high pressure line reaches the specified limit, the dual pressure switch senses this and turns itself OFF. At the same time, the magnet clutch is turned OFF.
