# FE.FG

## SERVICE MANUAL 2008 Model FOREWORD

This Service Manual contains maintenance and repair methods for the Mitsubishi Fuso Truck FE. FG Series. Read this manual carefully as an aid in providing correct, efficient maintenance. Please note that the information and specifications contained within this manual may change without notice. This is due to product modifications and continued vehicle improvements that are made throughout the model years. Should you encounter any discrepancy in the information provided, please do not hesitate to contact your nearest Mitsubishi Fuso Dealer or Mitsubishi Fuso Truck of America, Inc.

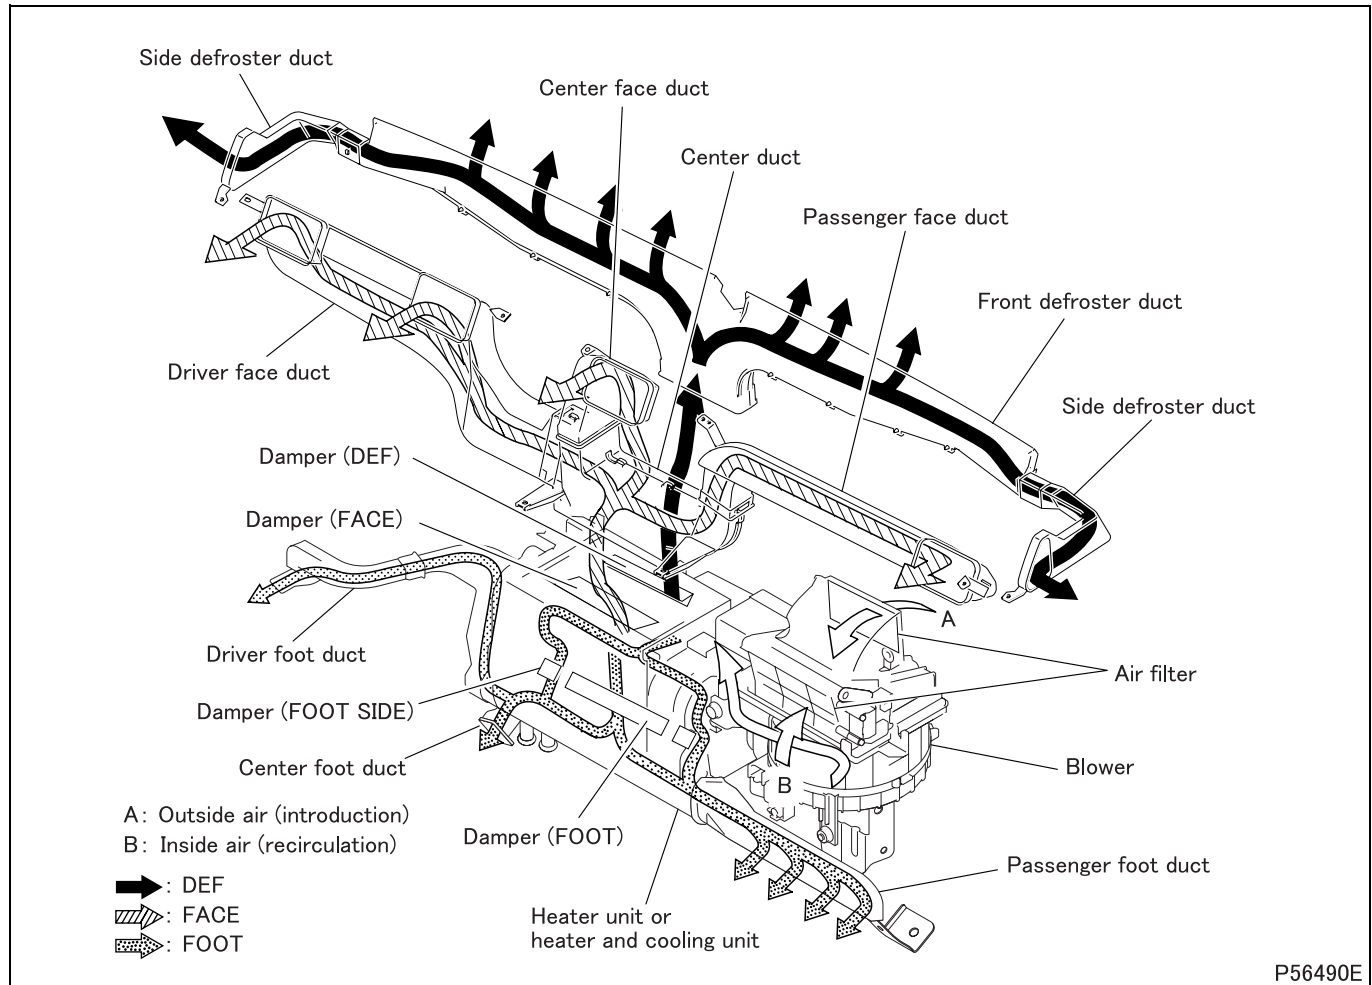
- The blower sends outside air A or inside air B through the heater unit or heater and cooling unit to the ducts. The flow of air is dependent on the open/closed positions of the various dampers.

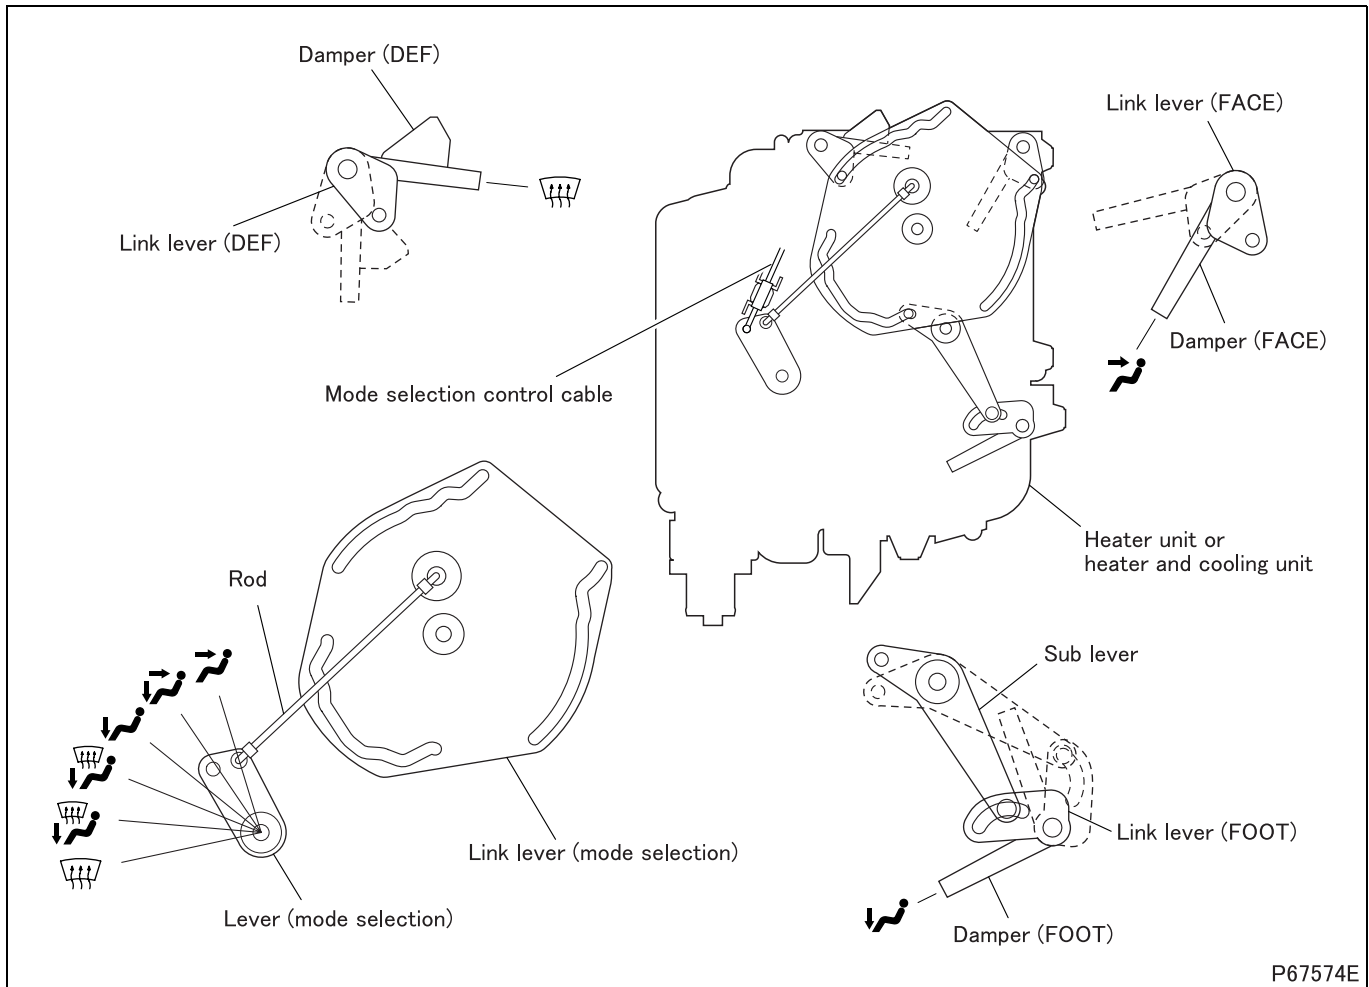
P67574E

- Mode selection (opening/closing the dampers) is achieved by the operation of the mode selection control cables and the resultant movement of the related parts linked to the cables.

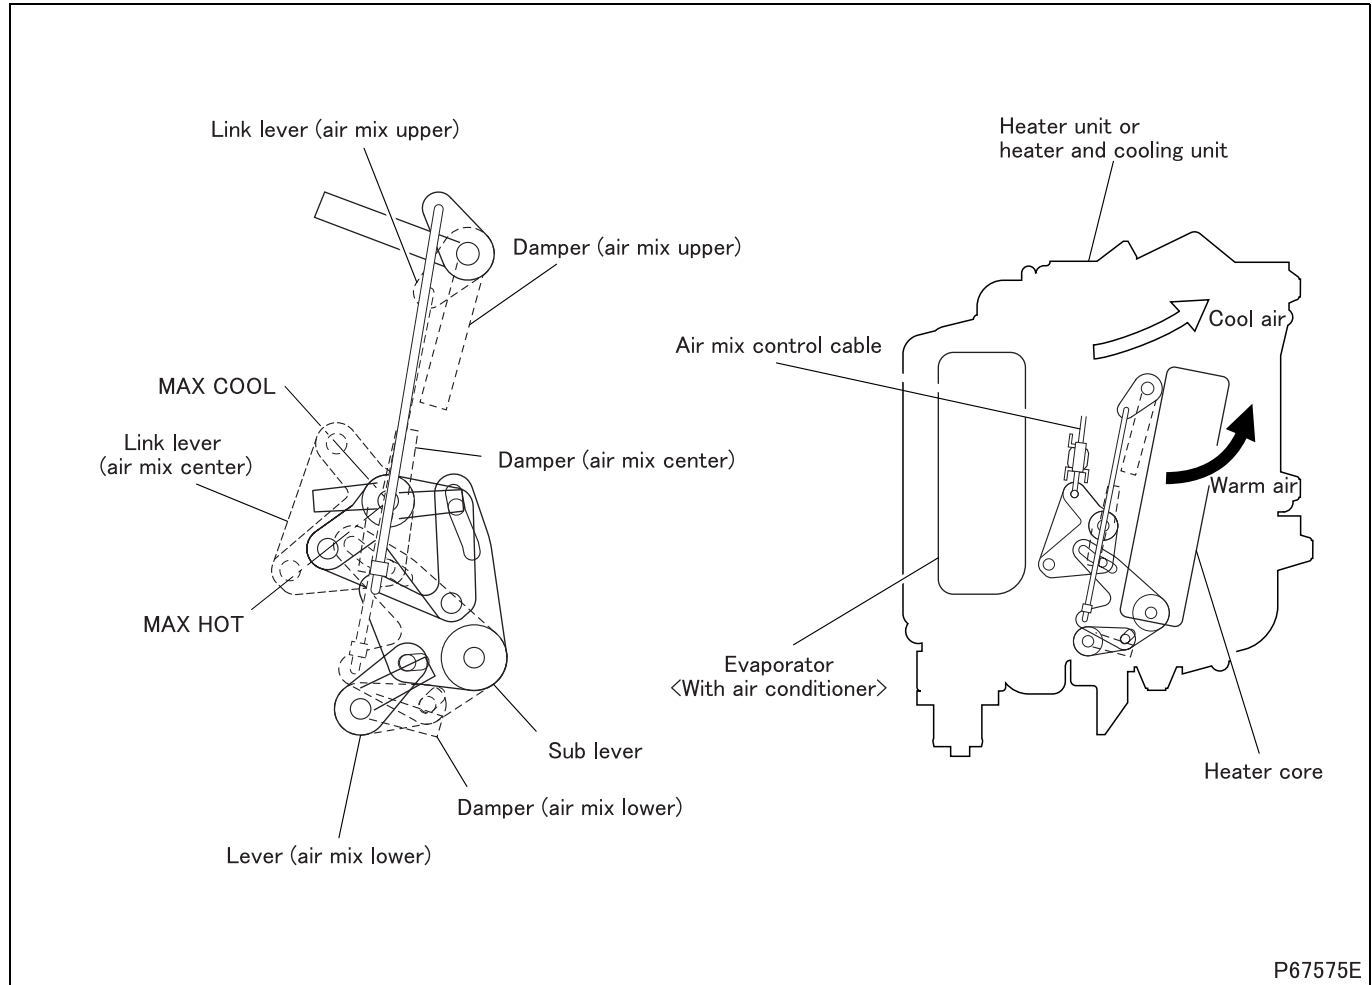
- Air mix selection is achieved by controlling the positions of the dampers, thereby proportioning the volumes of warm and cool air that is and is not sent through the heater core.

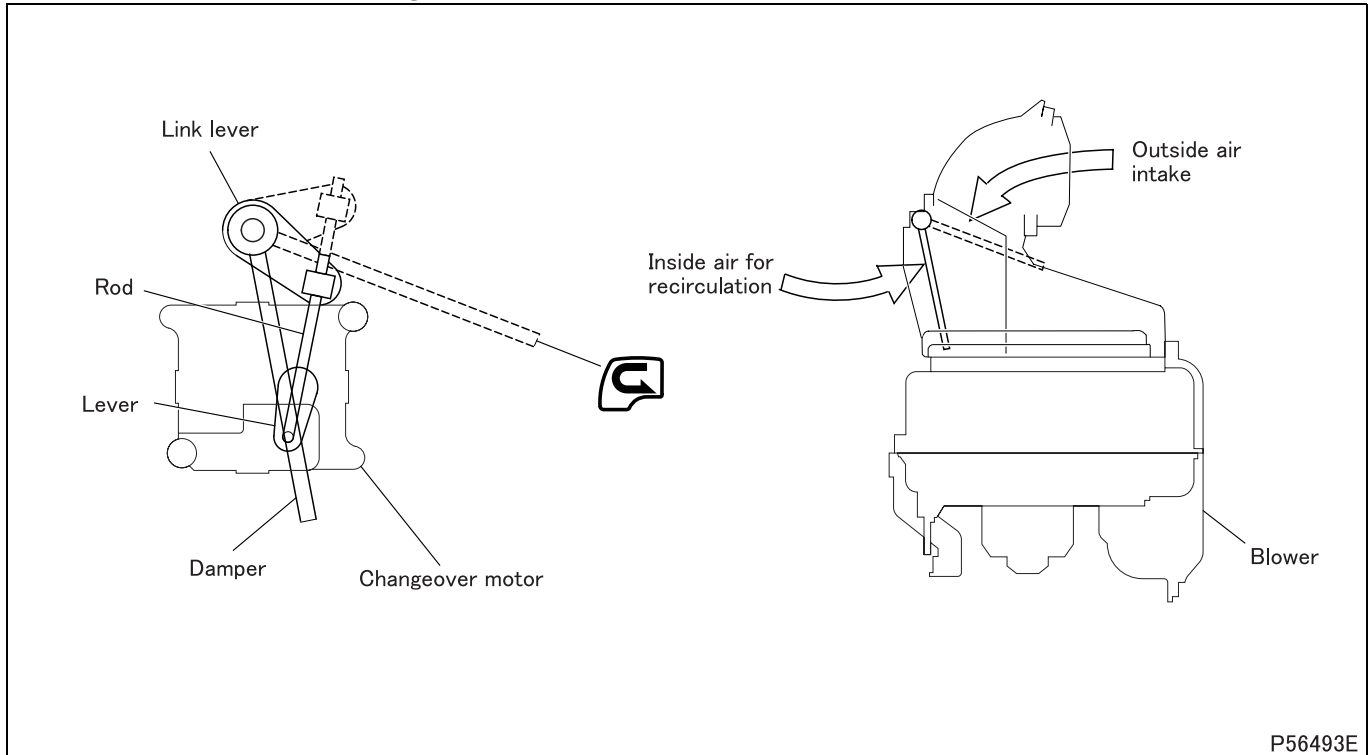
- The fresh/recirculation changeover damper is operated by means of motor.

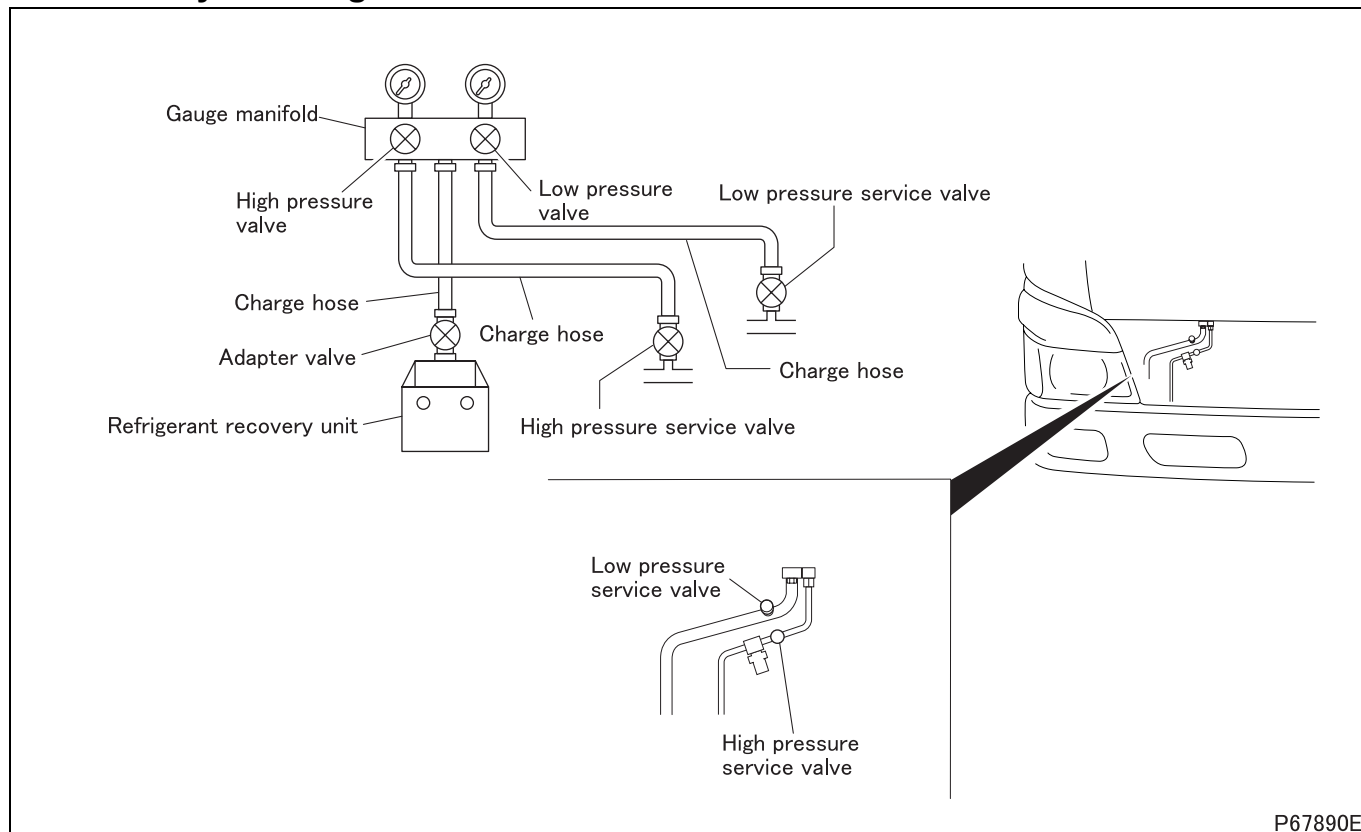
P67890E

- Recover refrigerant from the air conditioning system in accordance with the following flow chart.
- Installation of the refrigerant recovery unit

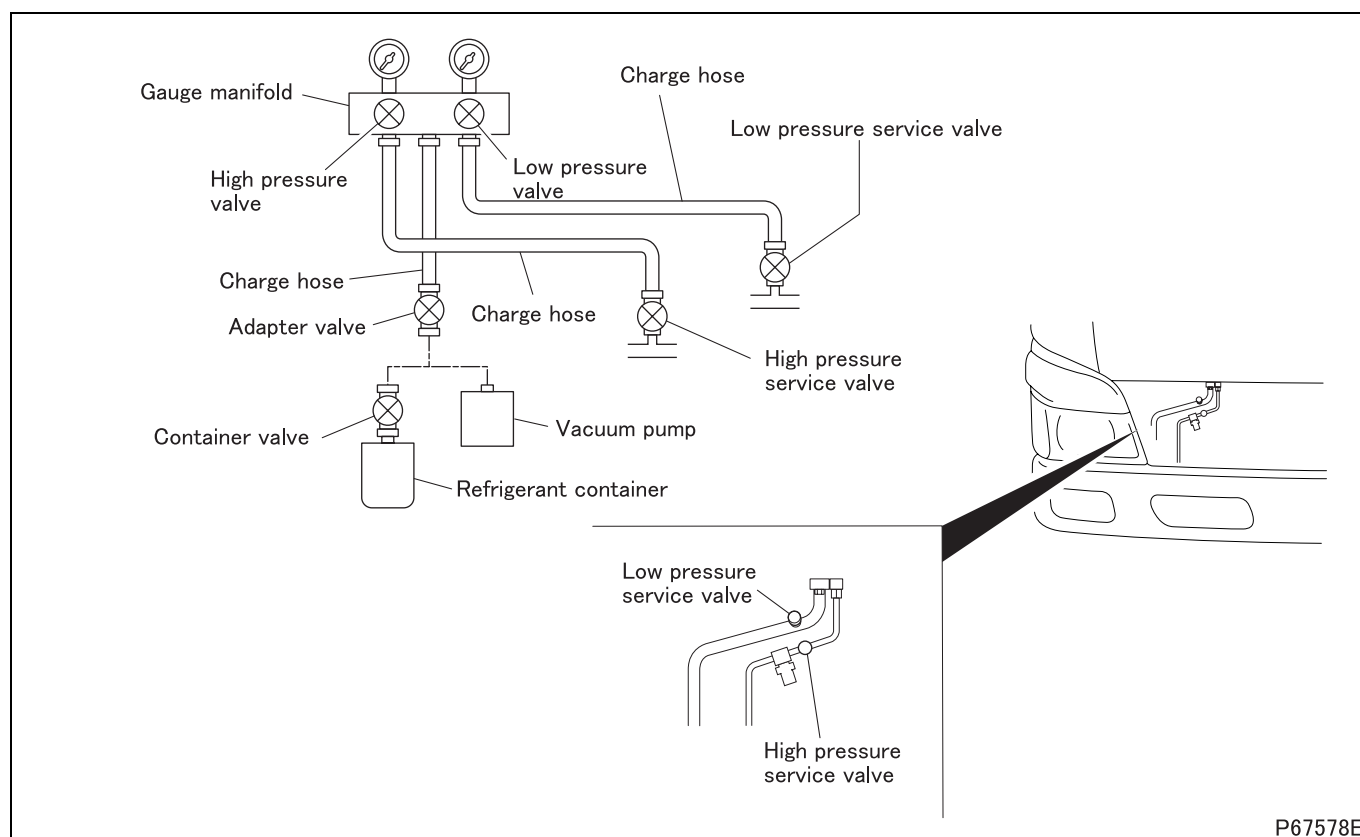
P67578E

- Recharge the system with refrigerant in accordance with the following flow chart.
- Installation of the refrigerant charge unit

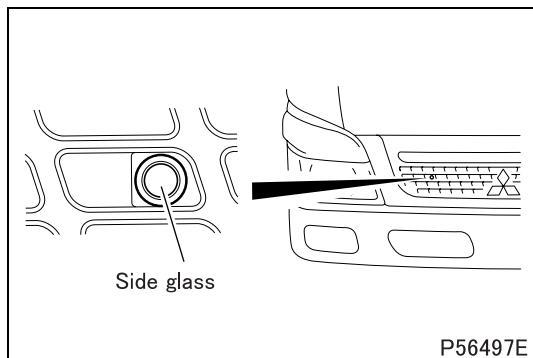
- To check the refrigerant charge level, observe the flow of refrigerant through the sight glass. If the visual inspection indicates a low charge level, add refrigerant.
- The visual check should be performed under the following conditions.
  - Engine speed: 1400 rpm
  - Air conditioner switch: ON
  - Fan speed control dial: 4 (MAX)
  - Temperature control dial: MAX COOL
  - Ventilation/recirculation changeover switch: Indicator lamp in the switch (OFF: Ventilation)
  - Doors: Fully open

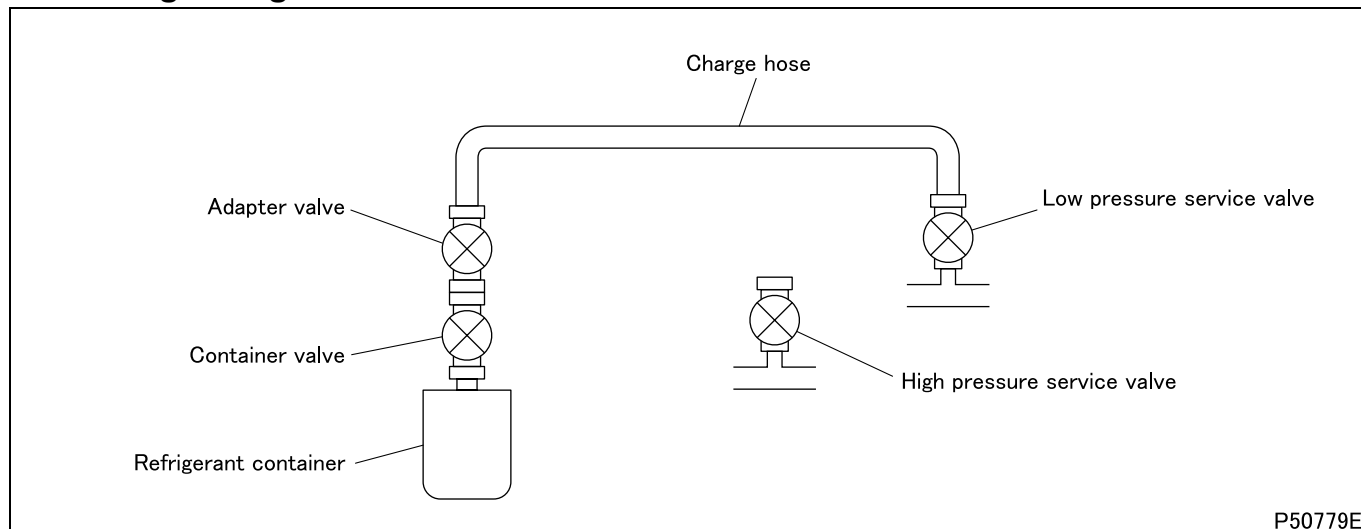
- Add refrigerant in accordance with the following flow chart.

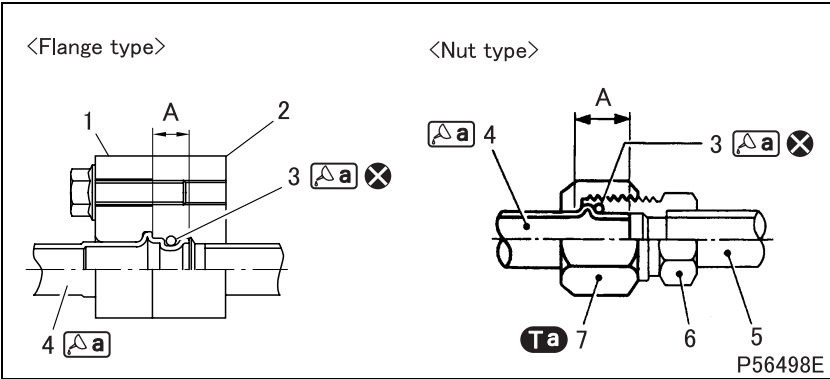
- 1 Flange (pipe end) <Flange type>
- 2 Flange (mating end) <Flange type>
- 3 O-ring
- 4 Pipe
- 5 Pipe <Nut type>
- 6 Union <Nut type>
- 7 Nut <Nut type>

A: Refrigerating machine oil application area  
 ⊗: Non-reusable parts

- The connected parts are sealed by the O-ring. Be careful not to damage the O-ring, such as by twisting.
- The O-rings are exclusively designed for HFC-134a refrigerant and are not reusable. The O-rings are available at the MITSUBISHI HEAVY INDUSTRIES, LTD. service stations.
- Never tighten the nut-type connection by rotating the union. This will deform the piping, allowing refrigerant to leak out. Tighten by rotating the nut while holding the union in position.

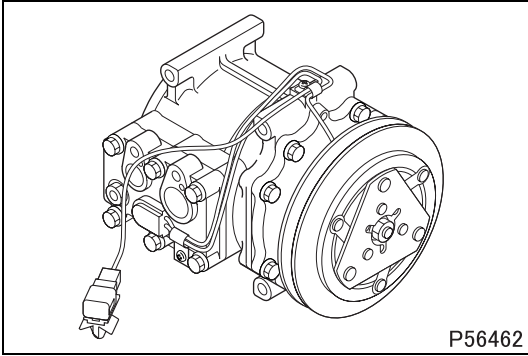
- Check the compressor proper for malfunction and oil leakage.
- If there is anything wrong with the compressor, replace it or have it overhauled at a nearest MITSUBISHI HEAVY INDUSTRIES, LTD. service station.

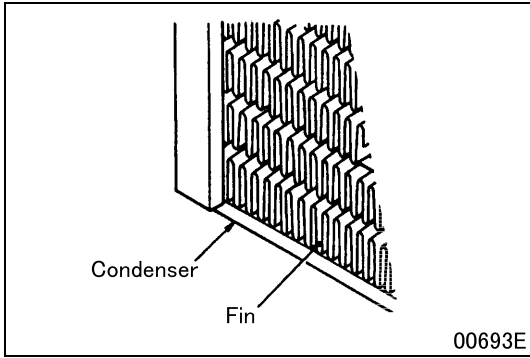
- If the condenser fins are clogged with dirt, dust or other foreign matter, wash it out. Any deformed fins should be straightened using a spatula or the like.

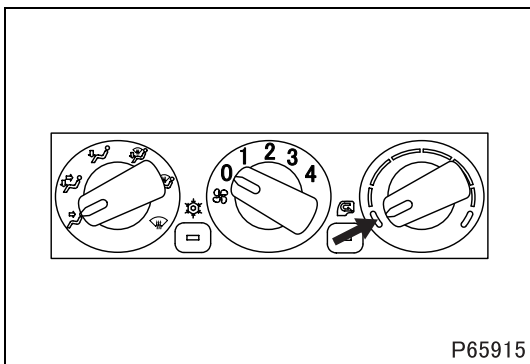
- Before disconnecting the control cables, turn the temperature control knob of the heater controls to the MAX-COOL position.

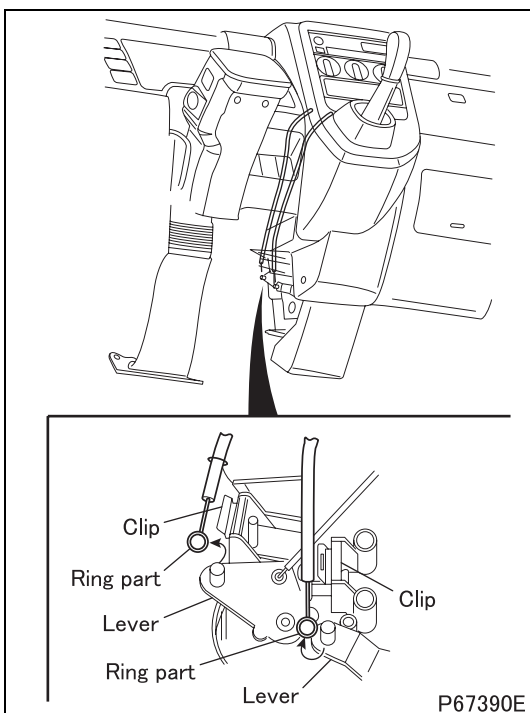
- Before disconnecting the cables from the levers, put pairing marks on each cable and its lever.
- Disconnect the control cables from the heater unit.

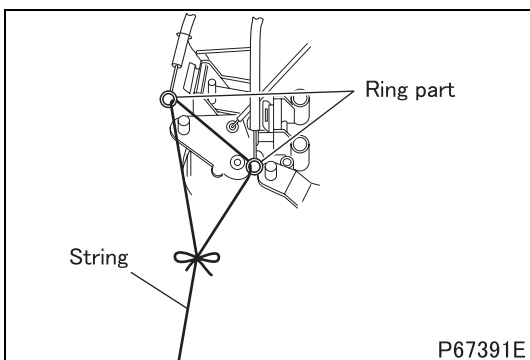
- In order that the control cables can be pulled back at the time of installation, attach string to the ring parts of the cables as shown in the illustration.

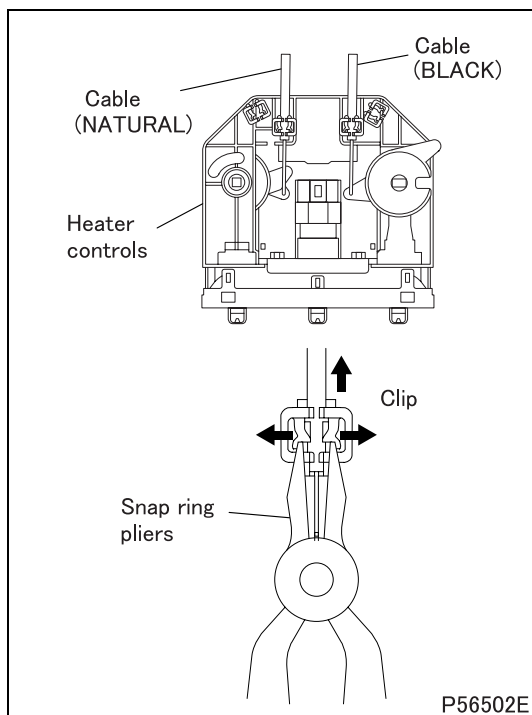
- Remove the heater controls from the instrument panel.
- Use snap ring pliers to disconnect the cable(s) from the heater controls.

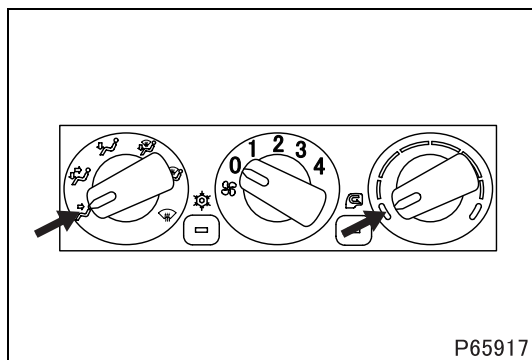
- At the heater controls, turn the temperature control knob to the MAX-COOL position and turn the mode selector knob to the face position before reconnecting the control cables.

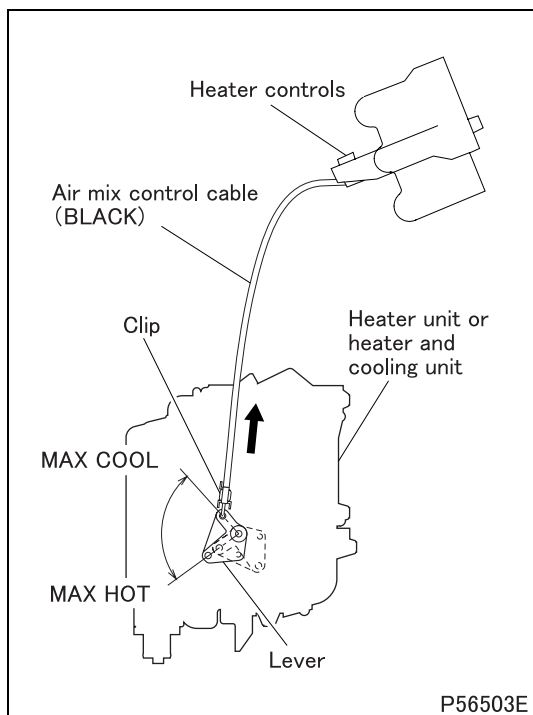
- Install one end of the air mix control cable to the heater control unit.
- Set the unit's temperature control dial to MAX COOL.
- Pull back the control cable using the string attached at the removal procedure.
- Install the other end of the air mix control cable to the lever on the heater unit or heater and cooling unit.
- With the air mix control cable connected to the lever, pull the cable in the direction of the arrow to move the lever to MAX COOL (upper) position. Clip the cable into the position.
- Move the temperature control knob to MAX COOL and MAX HOT. Make sure that the lever moves to the corresponding MAX COOL and MAX HOT positions. If not, repeat the above sequence to correctly install the cable. Also, make sure that the cable being installed is in the correct color.

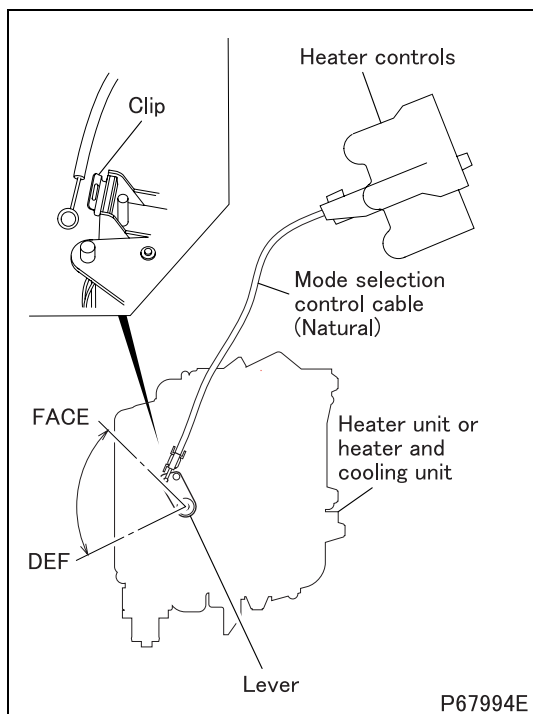
- Install one end of the mode selection control cable to the heater controls.
- Set the controls' mode control dial to FACE.
- Pull back the control cable using the string attached at the removal procedure.
- Install the other end of the mode selection control cable to the lever on the heater unit or heater and cooling unit.
- With the mode selection control cable connected to the lever, and push the cable into the clip.
- Move the mode control knob to FACE and DEF. Make sure that the lever moves to the corresponding FACE and DEF positions. If not, repeat the above sequence to correctly install the cable. Also, make sure that the cable being installed is in the correct color.

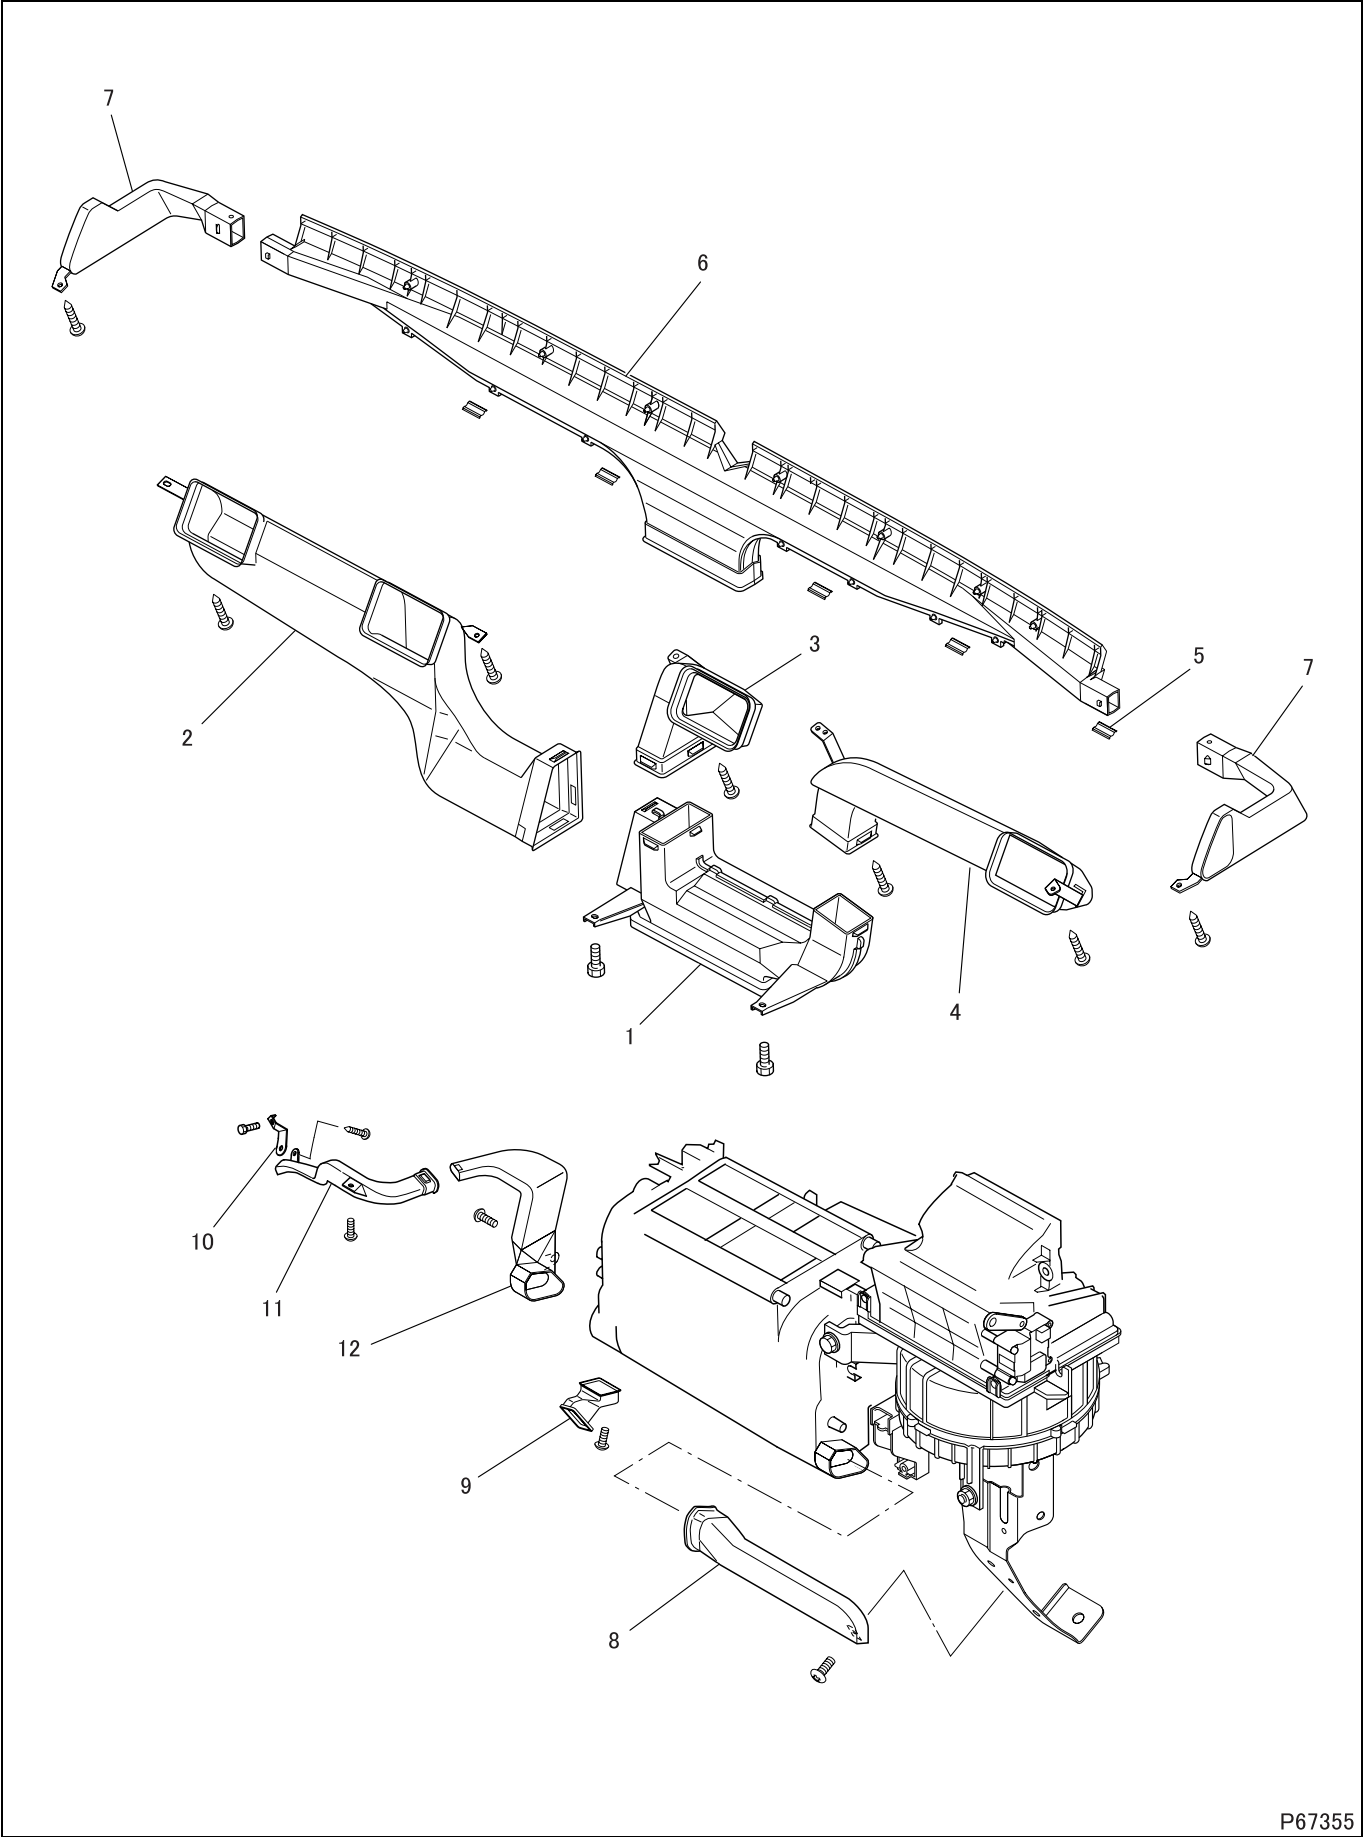
P67355

## ● Removal sequence

| 1 Center duct | 7 Side defroster duct |
| 6 Front defroster duct | 12 Driver foot duct A |

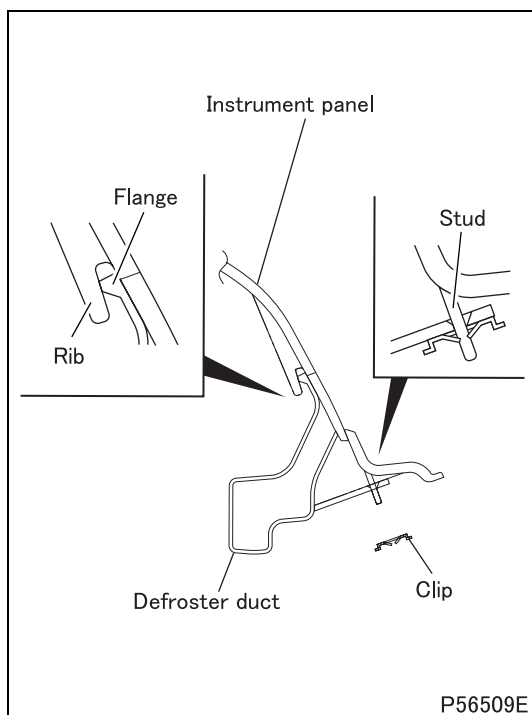
### ■ Installation: Front defroster duct

- Insert the front defroster duct flanges into the instrument panel ribs.
- Insert the instrument panel studs into the front defroster duct holes and clip them together.

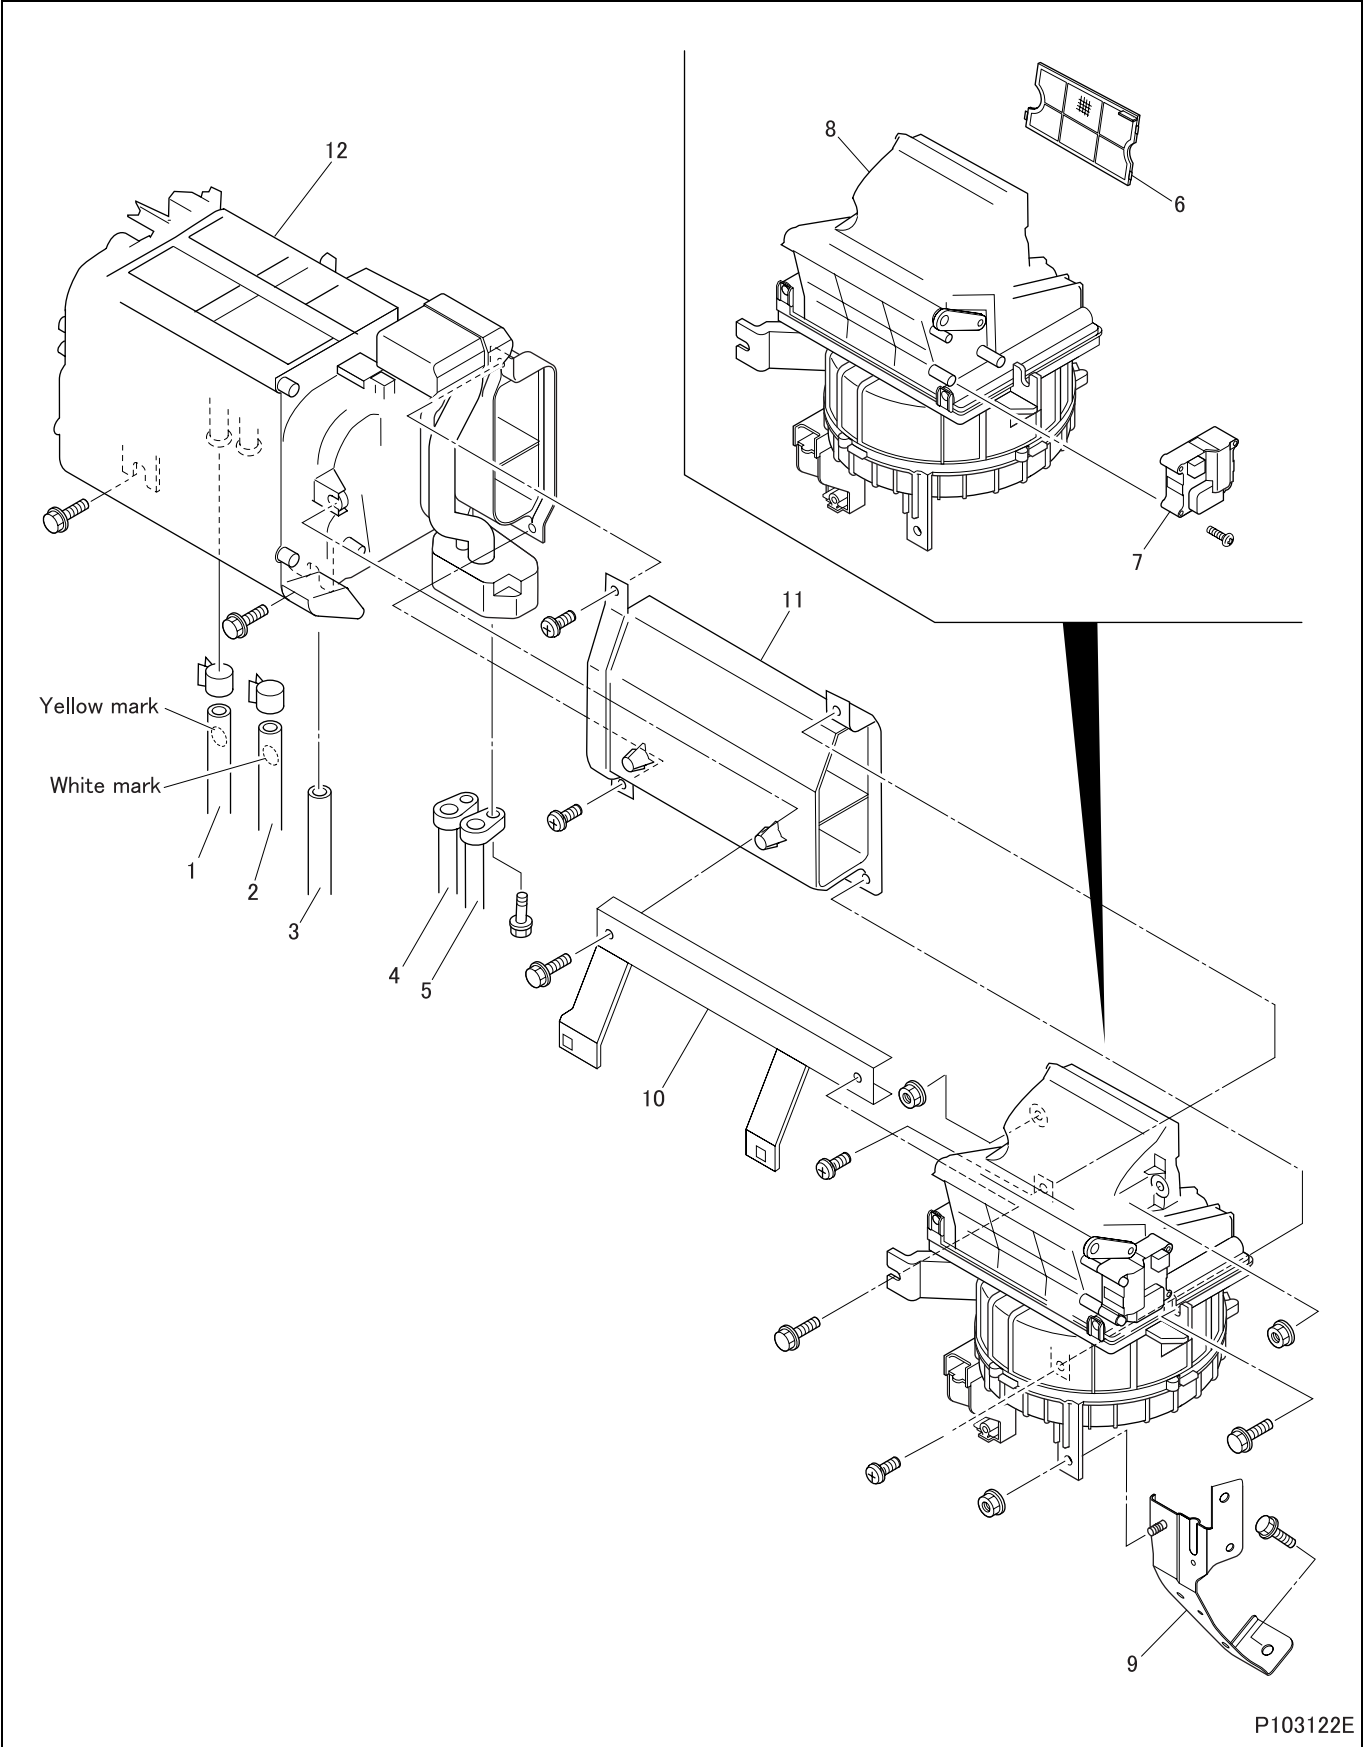
P103122E

## ● Removal sequence

- See the CONNECTING AIR CONDITIONER PIPING section for the installation of hose and pipe.

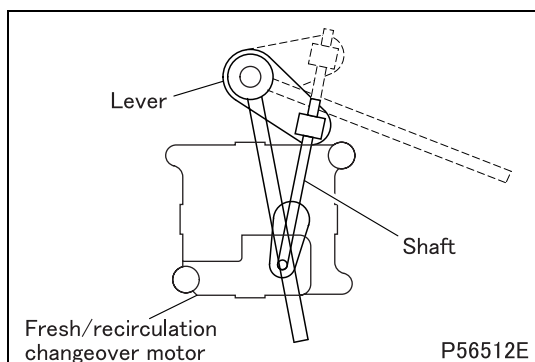
### ■ Installation: Fresh/recirculation changeover motor

- With the lever set to the “Ventilation” position, install the motor shaft through the lever.

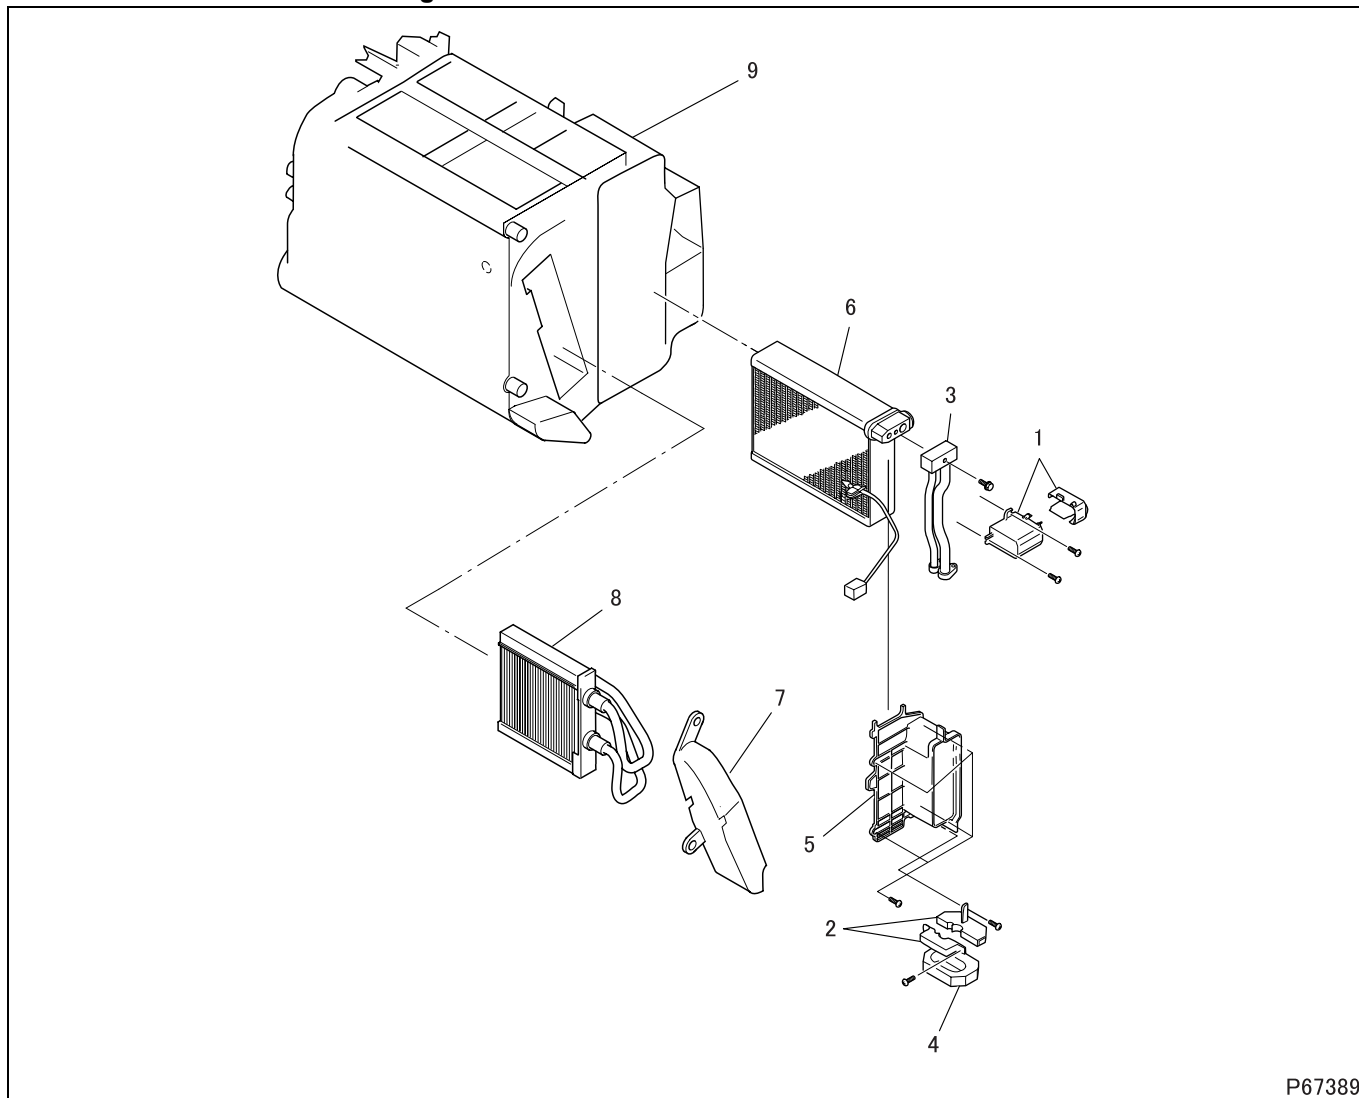
P67389

## Heater Unit or Heater and Cooling Unit

### ● Disassembly sequence

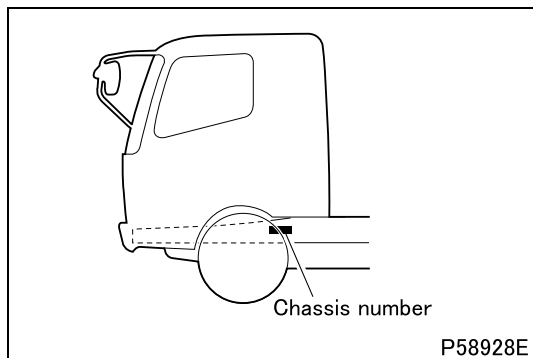
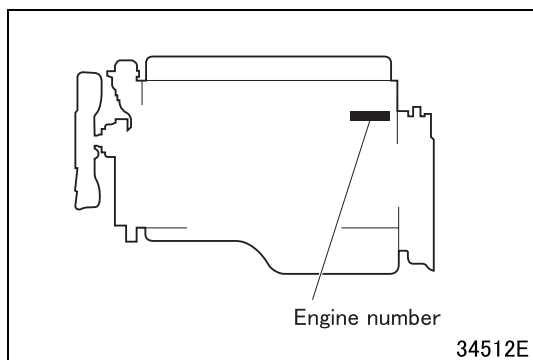
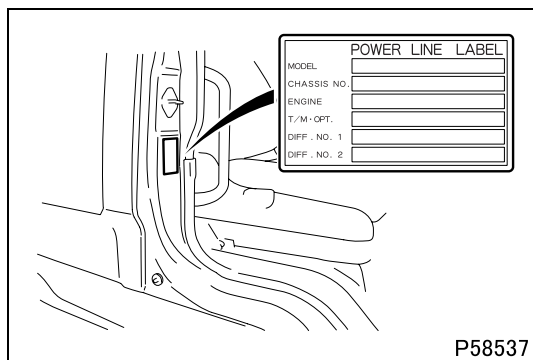
- Chassis and engine numbers are allocated to each vehicle and engine respectively in the order of production. These numbers are required at vehicle inspection for registration.

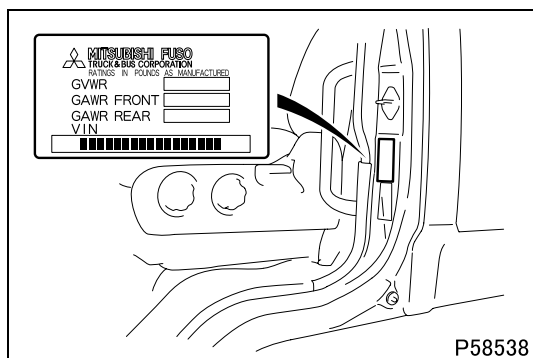
- The vehicle identification number is punch-marked on the plate, which is attached in the position as illustrated.

The vehicle identification number consists of a 17-digit set of alphanumeric characters. Each digit represents the following specifications.

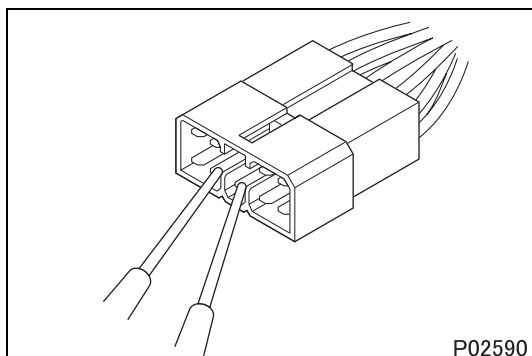
### (2.1) Inspections on female terminals

- Perform the inspection by carefully inserting a test probe into the terminals. Do not force the test probe into the terminals since this could deform them and cause poor connections.

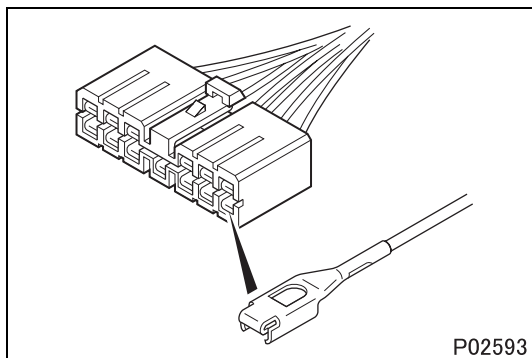
- Check that male and female terminals fit together tightly.

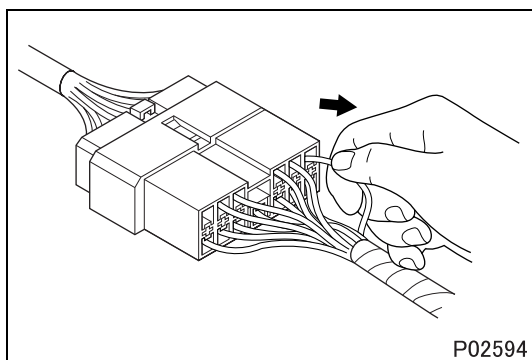
- Check for defective connections caused by loose terminals, by rust on terminals, or by contamination of terminals by foreign substances.

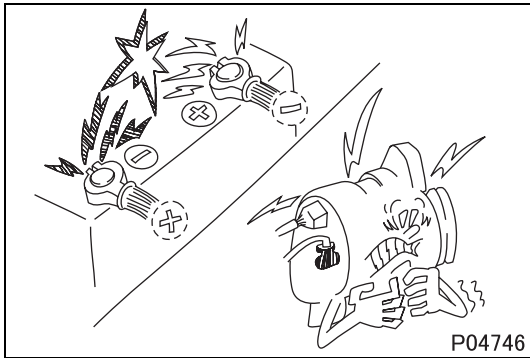
- When servicing alternators, observe the following precautions:
  - Never reverse the polarity of battery connections.  
If the polarity of the battery connections were to be reversed, a large current would flow from the battery to the alternator, damaging the diodes and regulator.

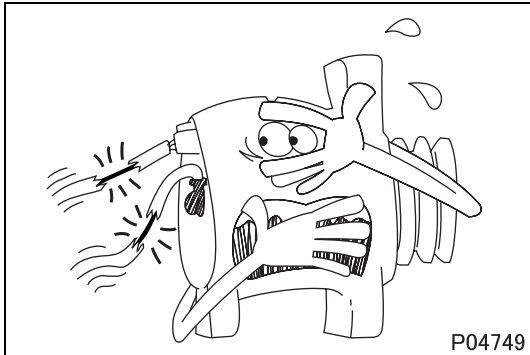
- Never operate an alternator with the B and L terminals short-circuited. Operation with the B and L terminals connected together would damage the diode trio.

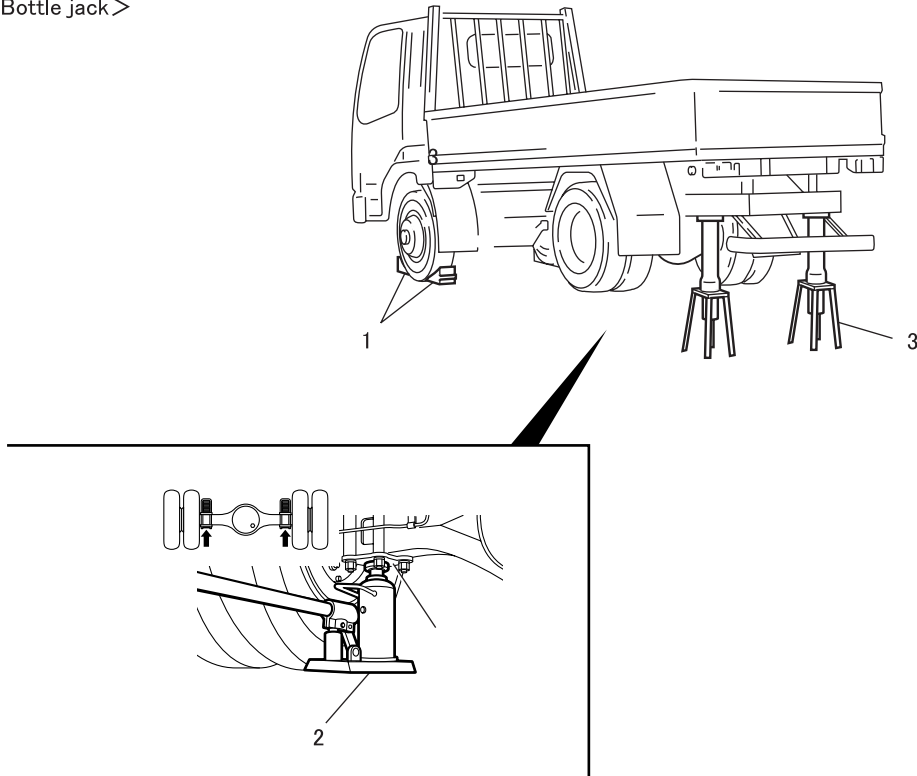
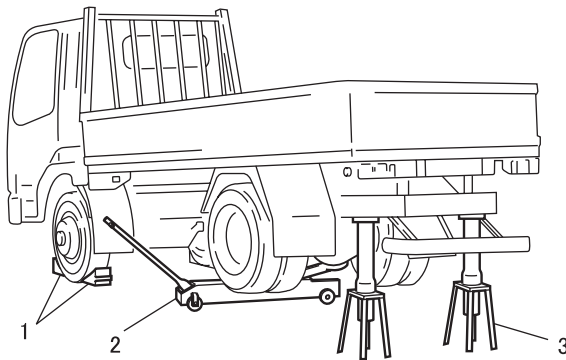
P68073E

## &lt;Rear of Vehicle&gt;

&lt;Bottle jack&gt;

&lt;Garage jack&gt;

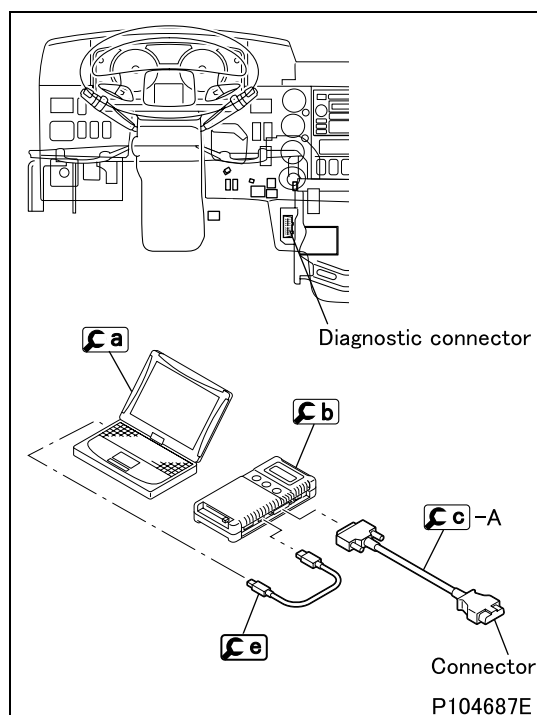
## (1.1) To perform system inspection

- Move the starter switch to the LOCK position.
- Connect **a**, **b**, **c**-A and **e** as shown.
- Connect **c**-A connector to the diagnostic connector on the vehicle.
