# FE.FG

## SERVICE MANUAL 2008 Model FOREWORD

This Service Manual contains maintenance and repair methods for the Mitsubishi Fuso Truck FE. FG Series. Read this manual carefully as an aid in providing correct, efficient maintenance. Please note that the information and specifications contained within this manual may change without notice. This is due to product modifications and continued vehicle improvements that are made throughout the model years. Should you encounter any discrepancy in the information provided, please do not hesitate to contact your nearest Mitsubishi Fuso Dealer or Mitsubishi Fuso Truck of America, Inc.

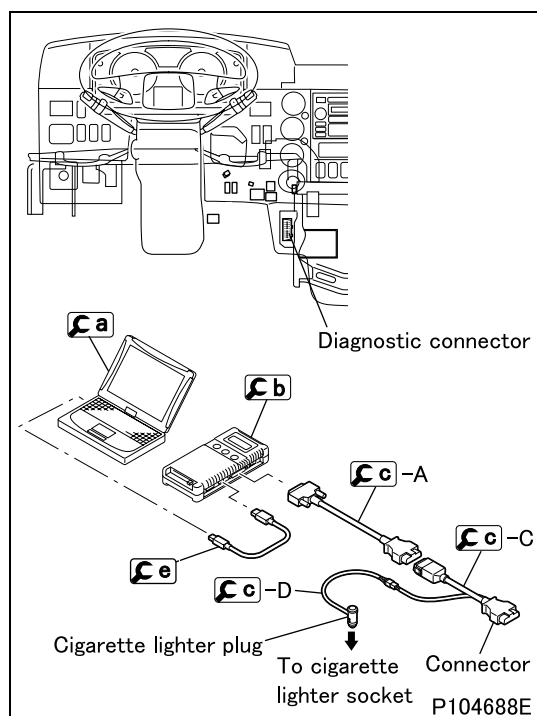
## (1.2) To use drive recorder function

- Move the starter switch to the LOCK position.
- Connect **a**, **b**, **c**-A, **c**-C, **c**-D and **e** as shown.
- Connect **c**-C connector to the diagnostic connector on the vehicle.
- Connect the cigarette lighter plug of **c**-D to the cigarette lighter socket on the vehicle.

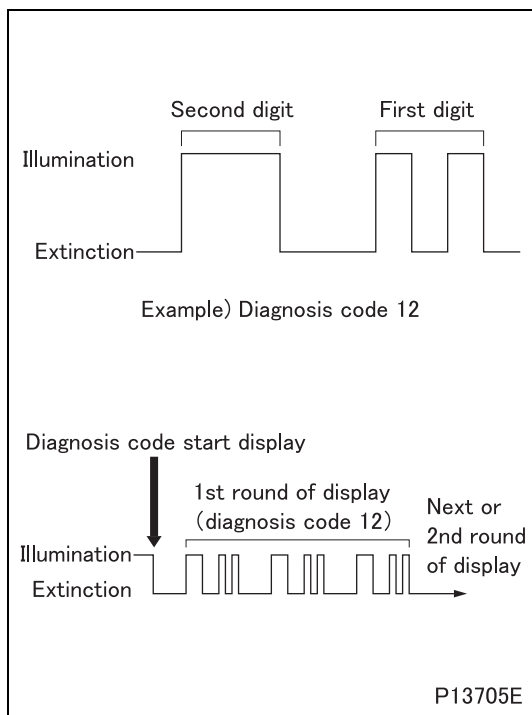
## (1.1) Reading diagnosis codes by flashing of warning lamp

- To read a diagnosis code, observe how many times the warning lamp flashes and how long each illumination lasts.
- The duration of illumination differs between the first and second digits.
  - Second digit: 1.2 sec.
  - First digit: 0.4 sec.
- A diagnosis code consists of the flashing of second digit and the flashing of first digit in that order. If a diagnosis code has "0" in the second digit, only the first digit will be displayed.
- The diagnosis code 01 will be displayed if the system is normal.
- The same diagnosis code will be displayed 3 times in a row before moving to the display of the next code.
- After the last diagnosis code is displayed, the first code will be displayed again 3 times in a row and then the subsequent codes. This will be repeated.

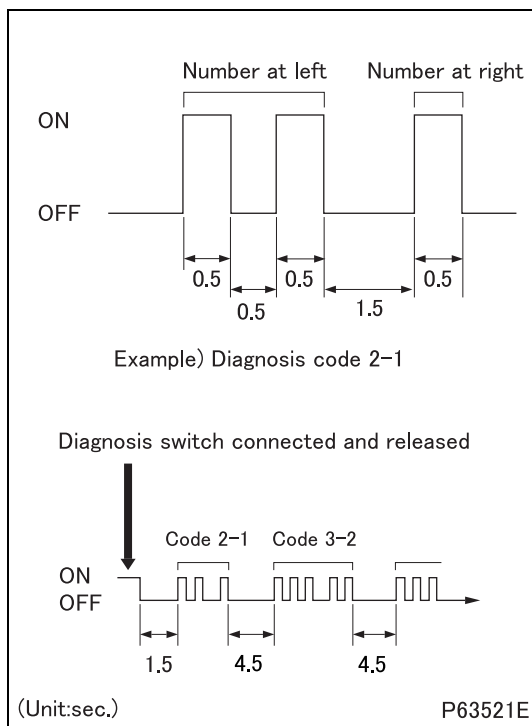
## (2.1) Observation of diagnosis code

- Observe diagnosis codes according to the number and time interval of blinks of the warning lamp.
- Diagnosis codes are indicated in the order of the numbers of blinks at left and right.
- Diagnosis codes are given, one at a time.

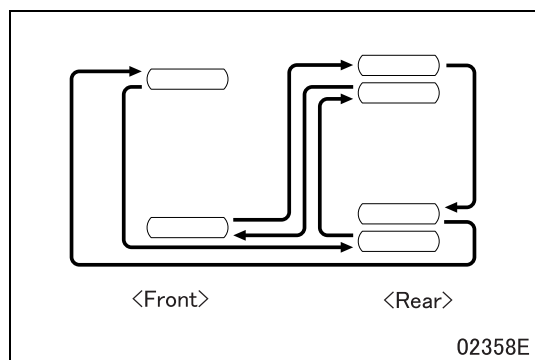
- When the tread patterns for all tires are identical:

Tires wear differently, according to the location where they are mounted. To make this wear uniform and prolong the life of your tires, they should be rotated every 10,000 km (6,000 miles) in the rotation order shown below:

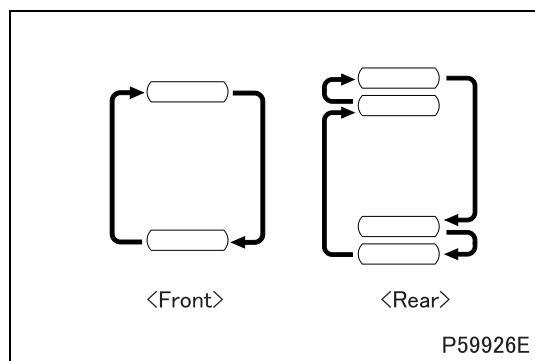
- When the tread patterns are different for the front and rear tires:

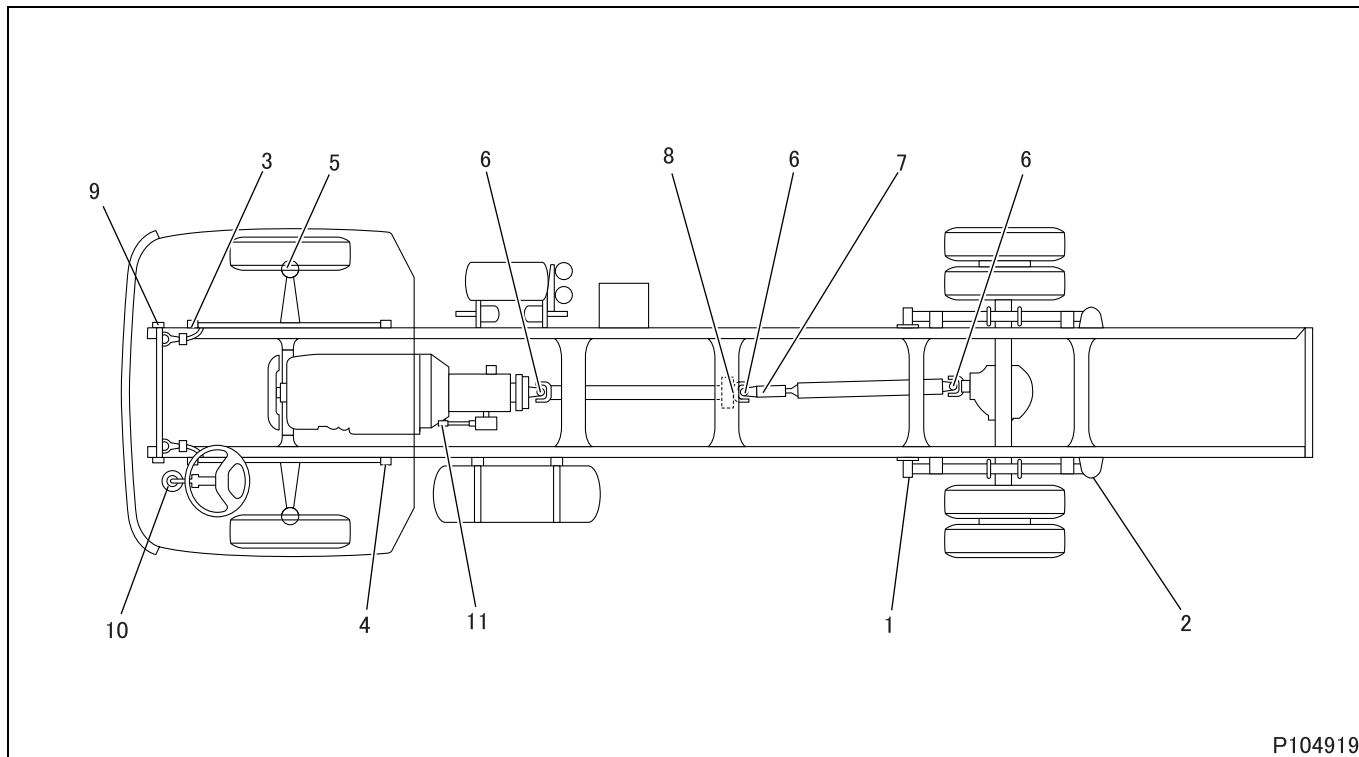
Carefully clean away all dust and dirt from the grease nipples, and use the specified type of grease. The areas to be greased are shown in the following illustration.

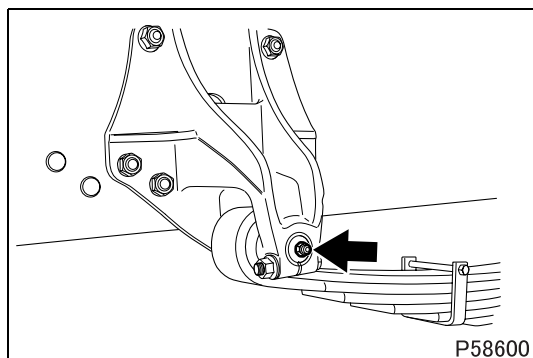
1. Rear spring pin front (left and right, 2 points)  
<Except air suspension>

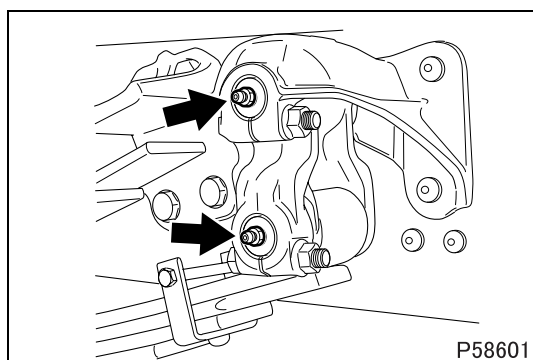
2. Rear spring pin rear (left and right, 4 points)  
<Except air suspension>

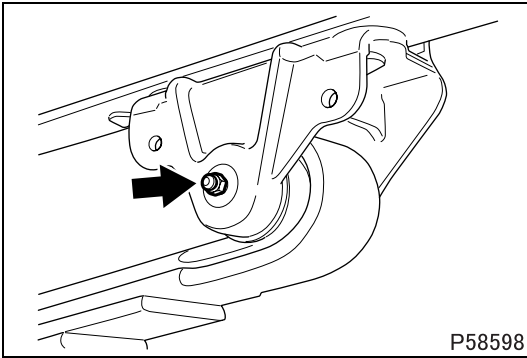
3. Front spring pin front (left and right, 2 points)

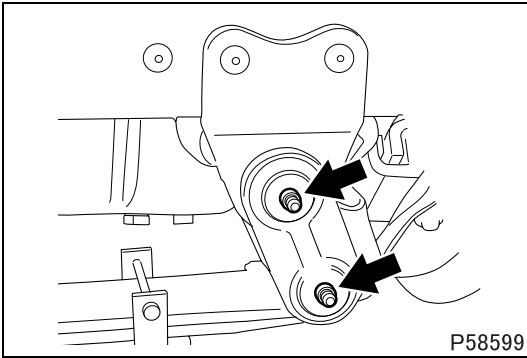
4. Front spring pin rear (left and right, 4 points)

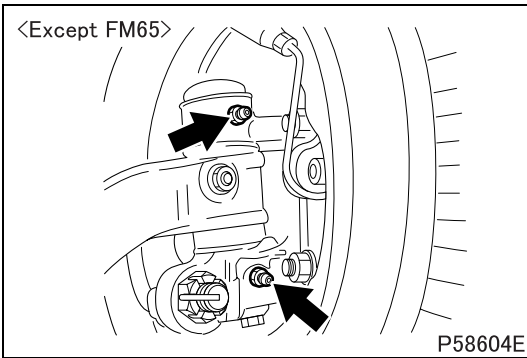
5. Kingpin bearing (left and right, 4 points <Except FM65>, 2 points <FM65>)

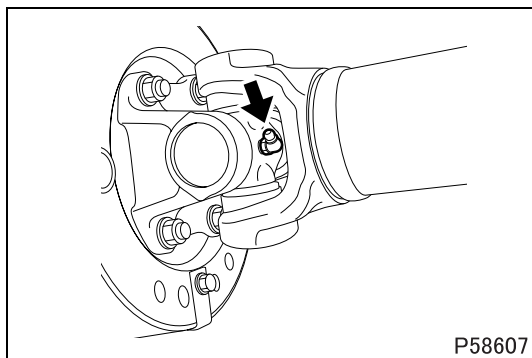
6. Propeller shaft universal joint

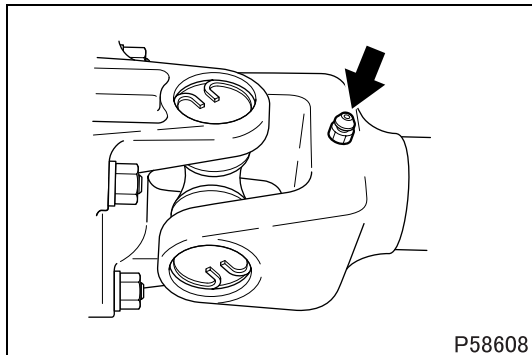
7. Propeller shaft slip joint

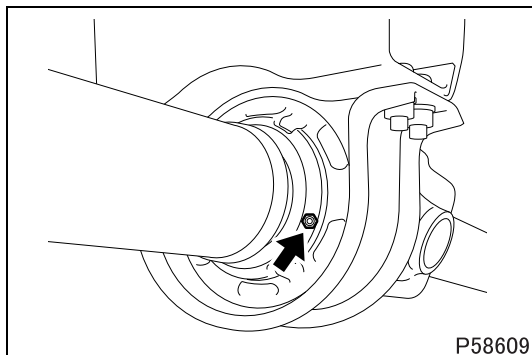
8. Propeller shaft center bearing

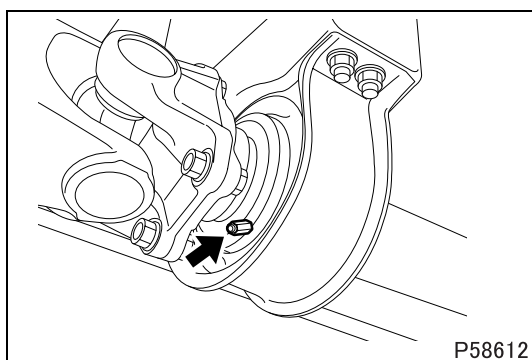
Supply grease to the center bearing until grease overflows from the relief valve at the back of the grease nipple.

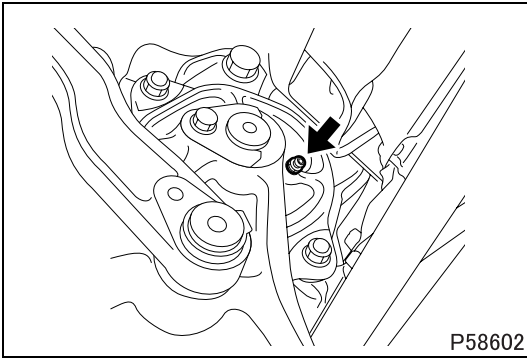
9. Cab hinge (left and right, 2 points)

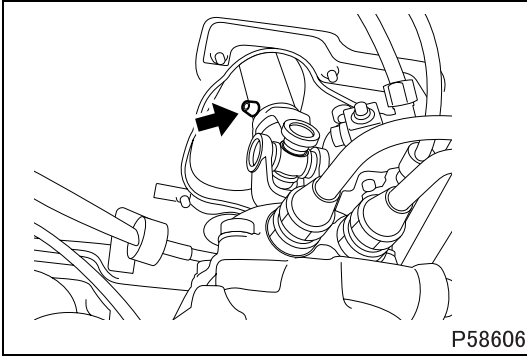
10. Steering shaft

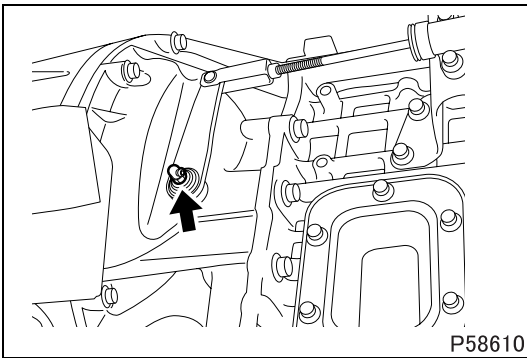
11. Clutch fork shaft (left and right, 2 points)

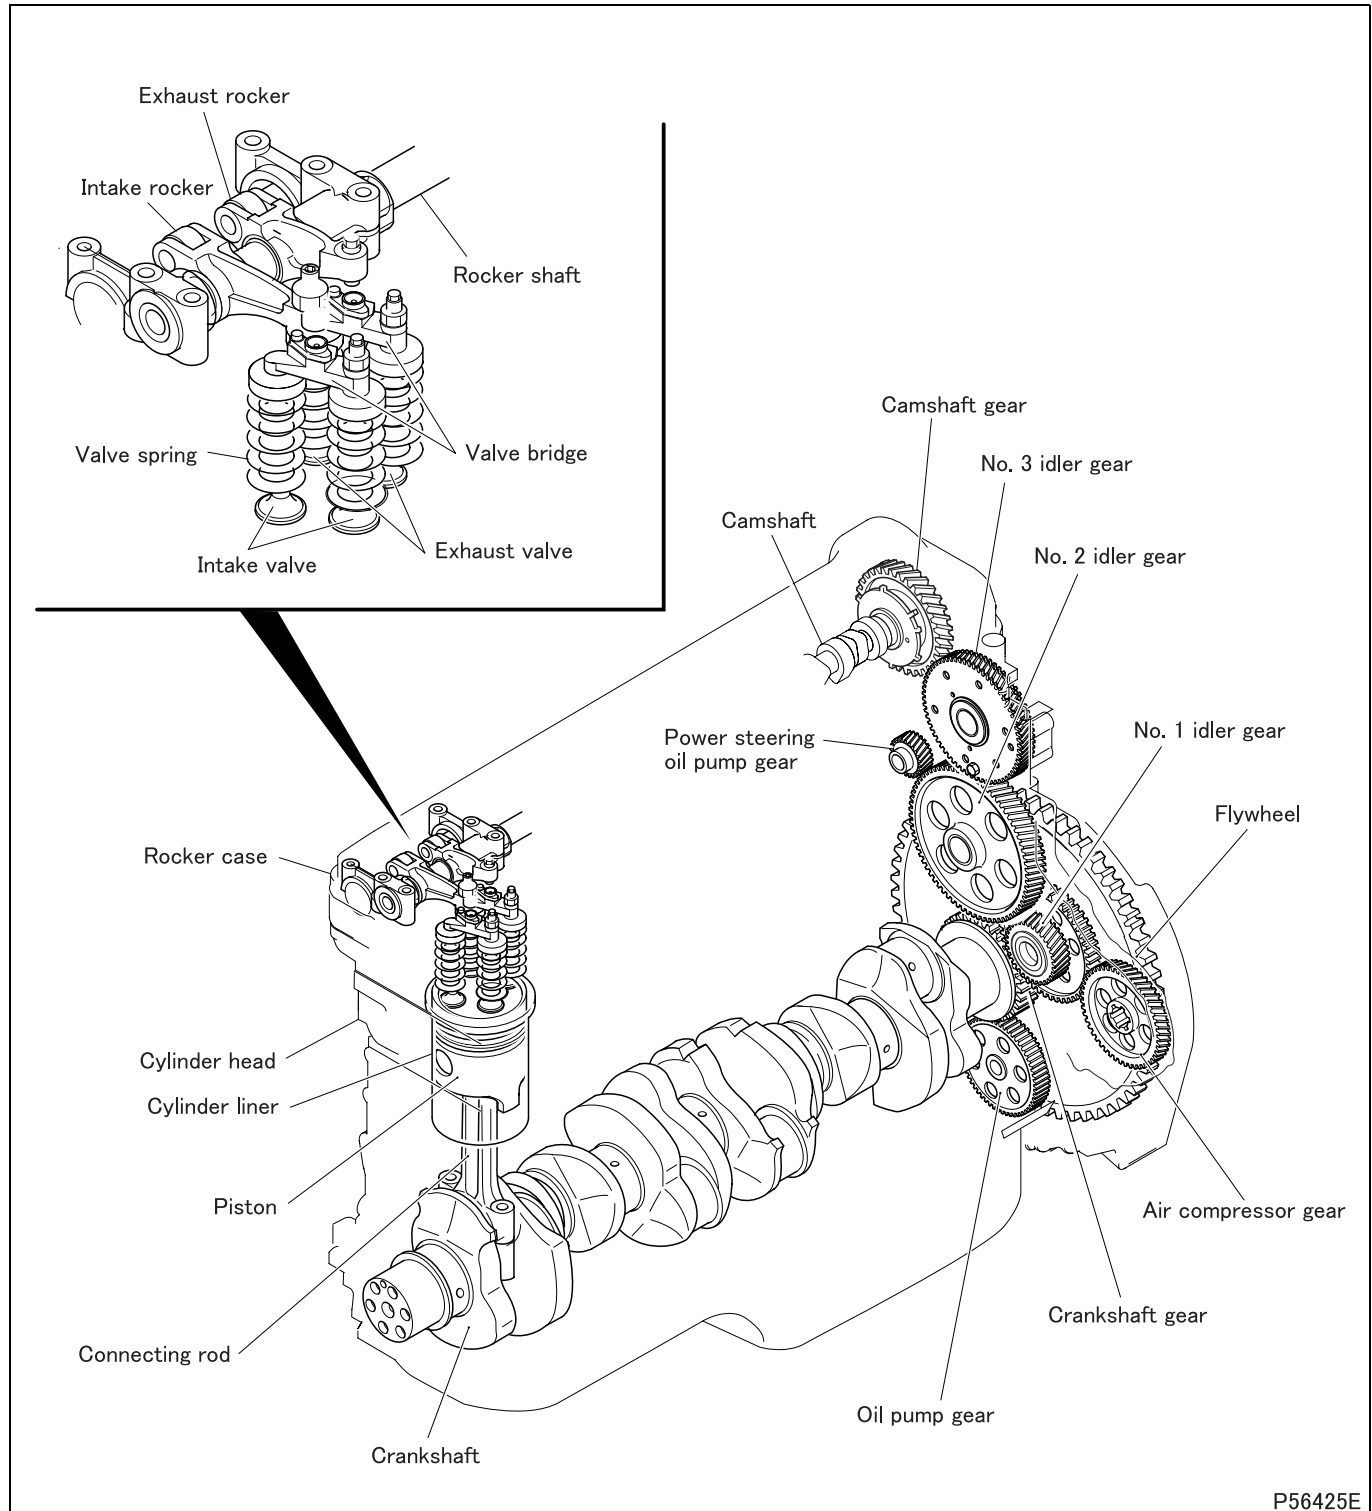
P56425E

- The 6M6 engine employs an overhead camshaft (OHC) system, with the valve mechanism and the timing gears arranged as shown above.

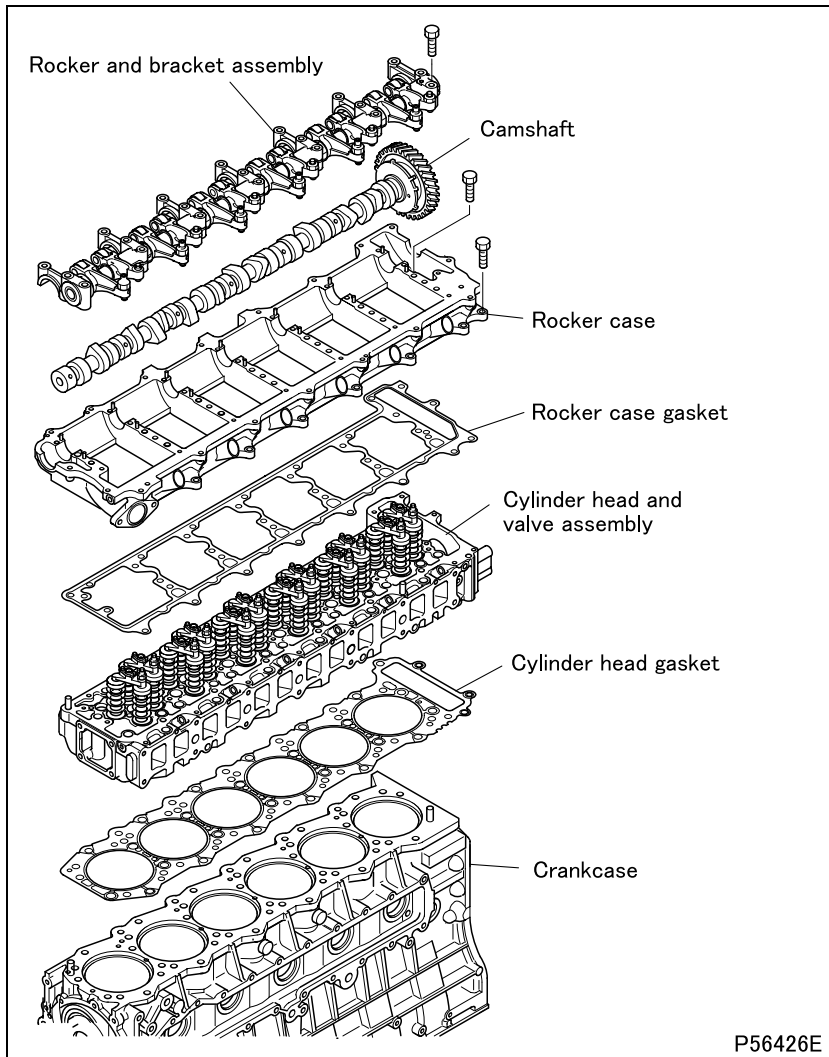
- The camshaft is directly supported at its journals by the rocker case, and is held in place from above by the rocker and bracket assembly.
- The camshaft journals are directly supported by the rocker case and the rocker and bracket assembly, without using any camshaft bearings. The rocker case and brackets have been machined together, meaning that they all need to be replaced for a new set when one of them becomes defective.

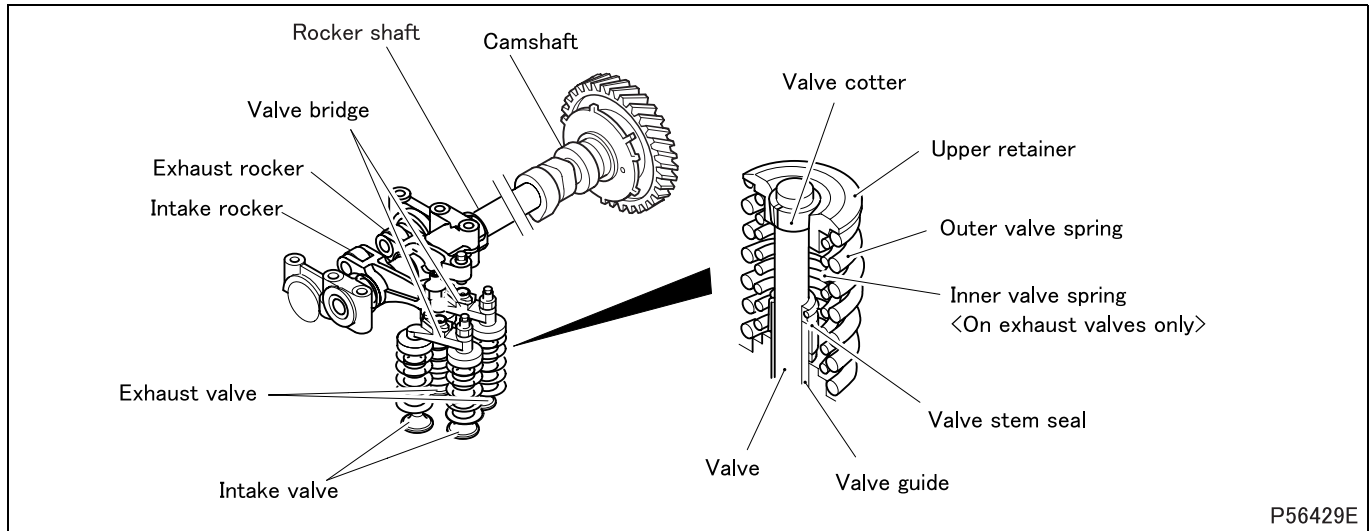
- Each valve has a valve stem seal, which regulates the flow of lubricating oil to the contact surface between the valve and the valve guide.
- The valve springs have a variable pitch to prevent abnormal vibration at high engine speed. The exhaust valves use a double spring, with the inner and outer springs coiled in different directions to prevent them from jamming each other.

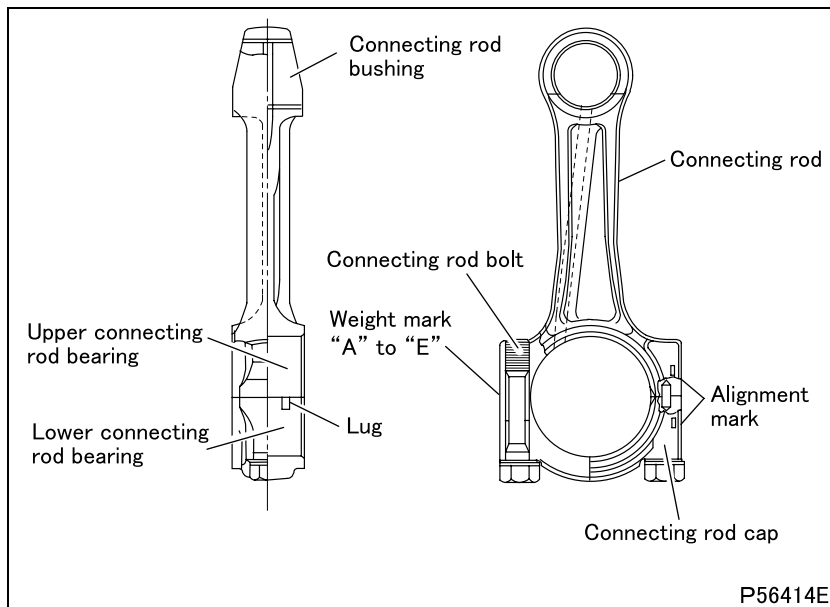
- Weight mark: "A" to "E"
- "E" indicates the greatest connecting rod mass.

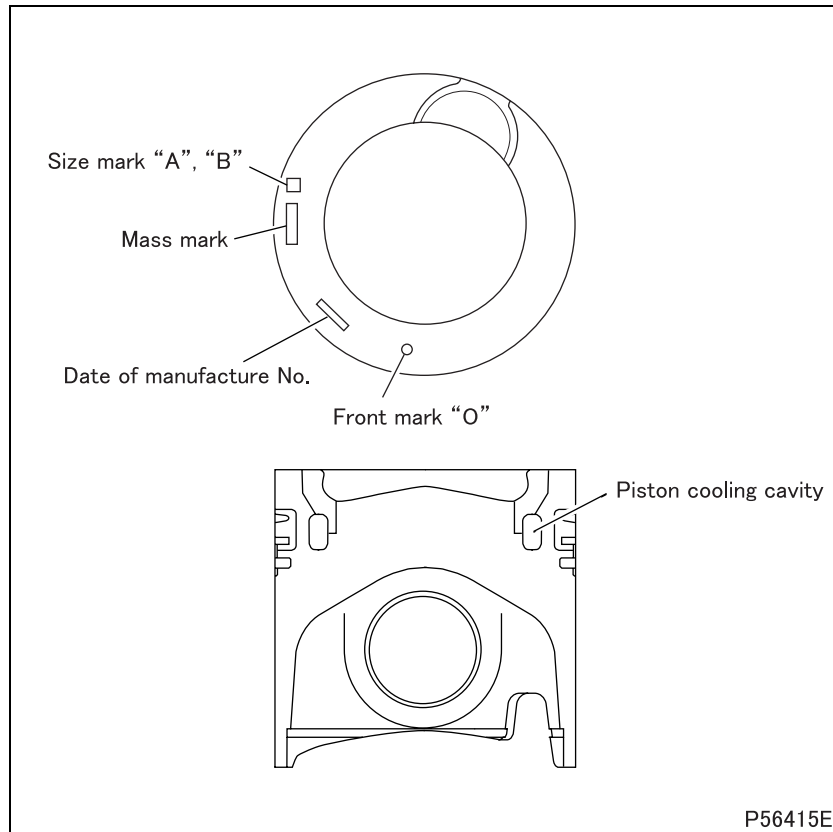
## 5. Piston

- The piston, the cylinder liner and the crankcase bore all must have the same size marks to ensure a good fit between them.
- The pistons are made of special aluminum alloy, and are provided with a recess on each end of the piston pin boss to reduce weight.

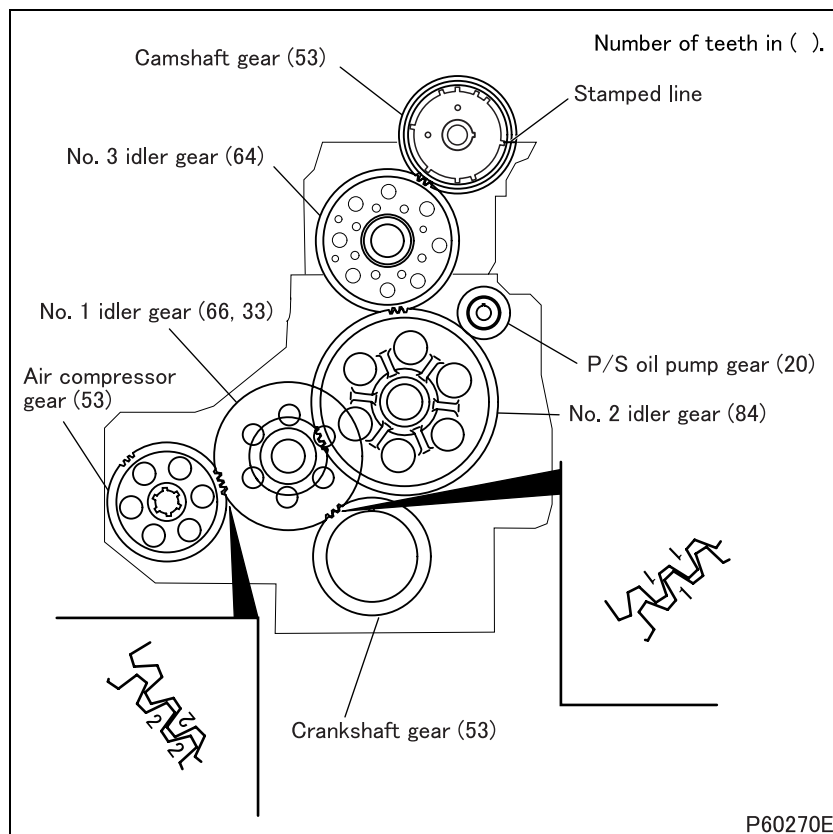
## 6. Timing Gears

- The timing gears are provided with timing marks to help ensure correct assembly.
- Timing marks are provided on the following gears.
  - Camshaft gear: stamped line
  - Crankshaft gear: "1"
  - Air compressor gear: "2"
  - No. 1 idler gear: "1", "2"

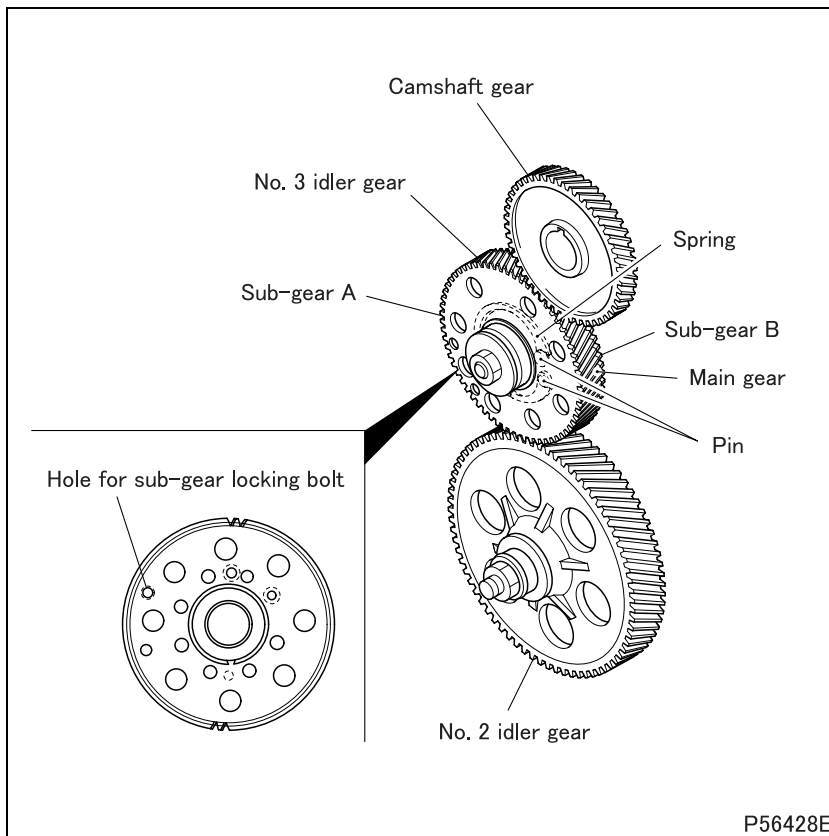
### 6.1 No. 3 idler gear

- The No. 3 idler gear consists of the sub-gear A, the sub-gear B and the main gear.
- A spring is installed between the sub-gear A and the main gear, as well as between the sub-gear B and the main gear. The springs are locked in place with pins.
- The sub-gears are installed as follows. The sub-gear A has been turned in such a way as to compress the spring before meshing with the camshaft gear. Likewise, the sub-gear B has been turned to compress the spring before meshing with the No. 2 idler gear.

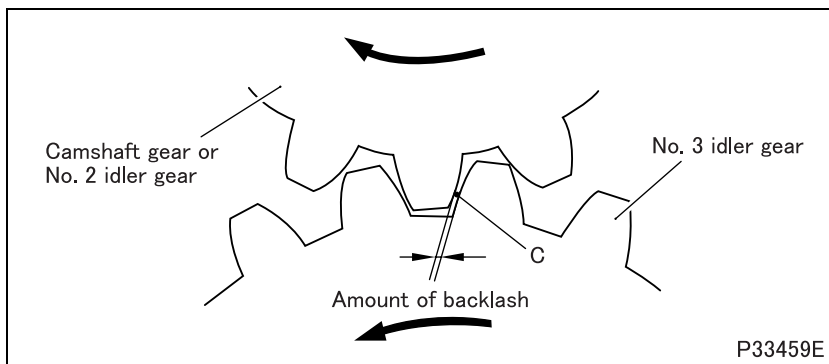
#### (1) Non-backlash mechanism

- Engine hunting during idling causes fluctuation in the speed of camshaft and No. 2 idler gears.
- Without the non-backlash mechanism, the backlash at C changes between zero and the maximum, generating gear rattle noise.

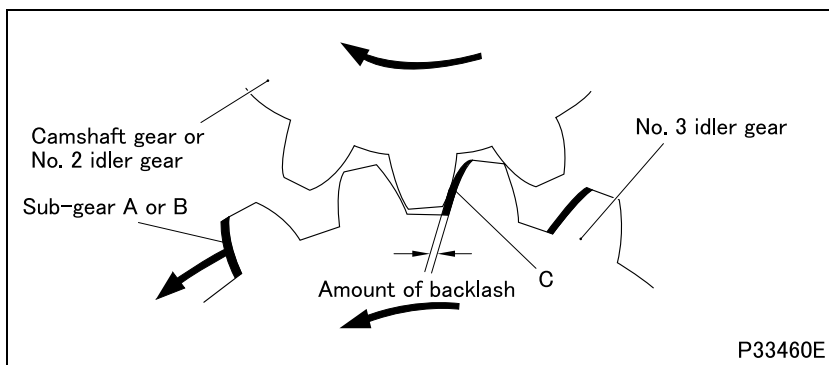
- With the non-backlash mechanism equipped on the engine, the sub-gears A and B maintain the backlash at C to zero even when the engine hunts, eliminating gear rattle during idling.

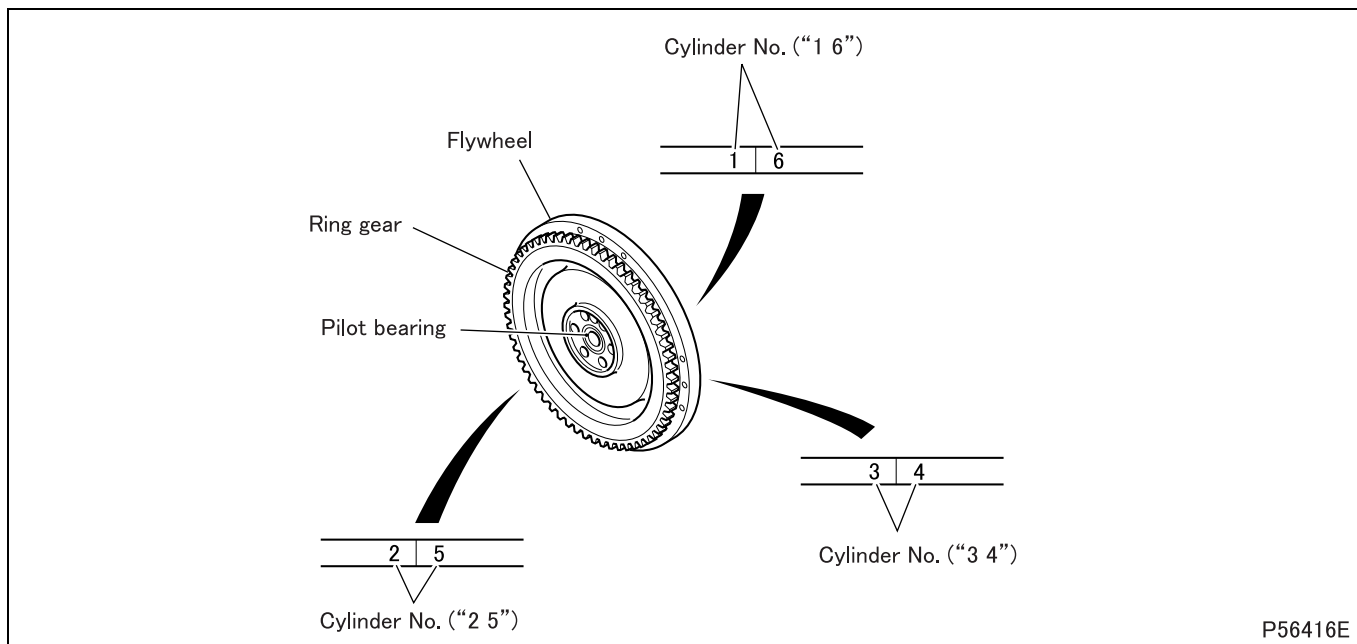
## 7. Flywheel

- One side of each flywheel ring gear tooth is chamfered to facilitate the engagement of the starter pinion.

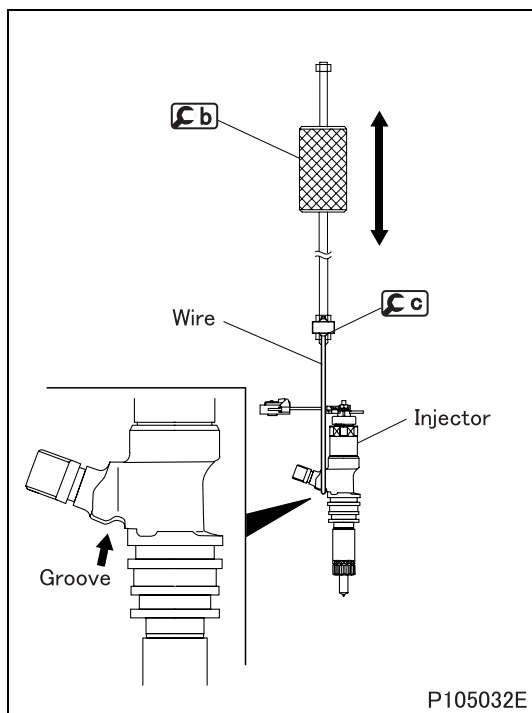
- Remove the injector using **b** and **c**, with the wire of **c** engaged in the groove on the injector.

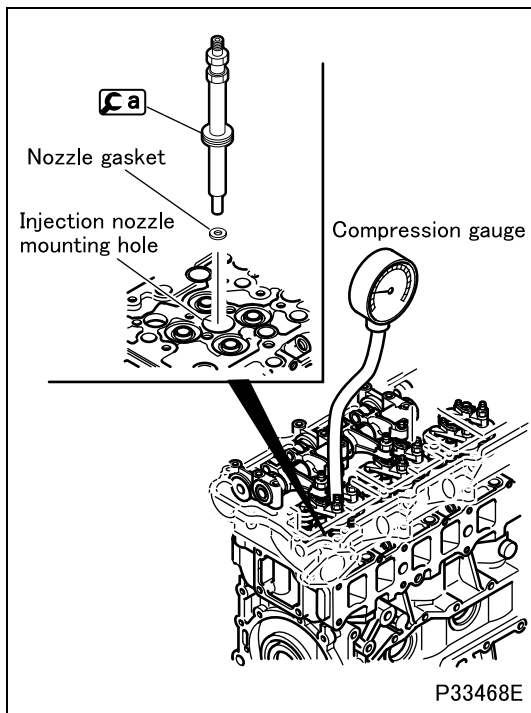
- Attach the nozzle gasket and **Ca** to one of the injection nozzle mounting holes. Then, connect a compression gauge to **Ca**.
  - Crank the engine and measure the compression pressure.

- Measure the compression pressure for all the cylinders one after another. Determine the compression pressure difference between the cylinders.
  - If the compression pressure is below the limit or the cylinder-to-cylinder pressure differences is not within the limit, pour a small amount of engine oil into the corresponding injection nozzle mounting hole and remeasure the compression pressure.

- If the compression pressure increases, the piston rings and cylinder surfaces may be badly worn or otherwise damaged.
  - If the compression pressure remains unchanged, there may be seizure in the valves, the valves may be incorrectly seated or the cylinder head gasket may be defective.

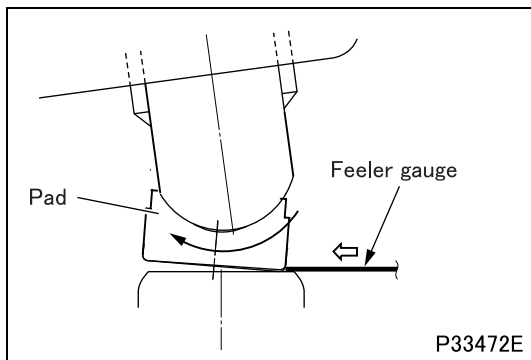
- Any attempt to insert a feeler gauge without first securing sufficient space, as described above, between the pad and the valve bridge will fail, as the pad will tilt as shown in the illustration, thus blocking the entry of a feeler gauge.

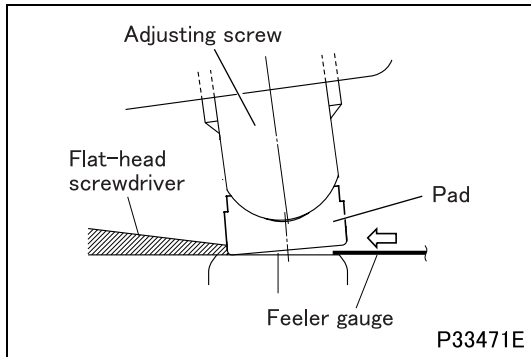
- Before inserting a feeler gauge, push the adjusting screw pad on the side opposite from where a feeler gauge is to be inserted, as shown in the illustration, using a flat-head screwdriver or other similar tool. This will create space necessary for the gauge to be inserted.
- The measurement is correct when the feeler gauge feels slightly resisted as it is inserted.
- The measurement is not yet correct if the feeler gauge can still be inserted smoothly.
- If the measurement deviates from the standard value, adjust as follows.

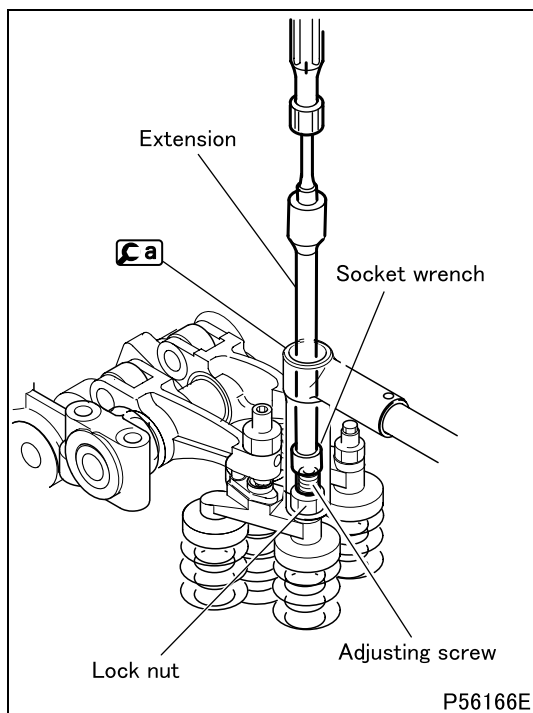
- While holding the adjusting screw in this position with a socket wrench and extension, tighten the lock nut to the specified torque using **Ca**.

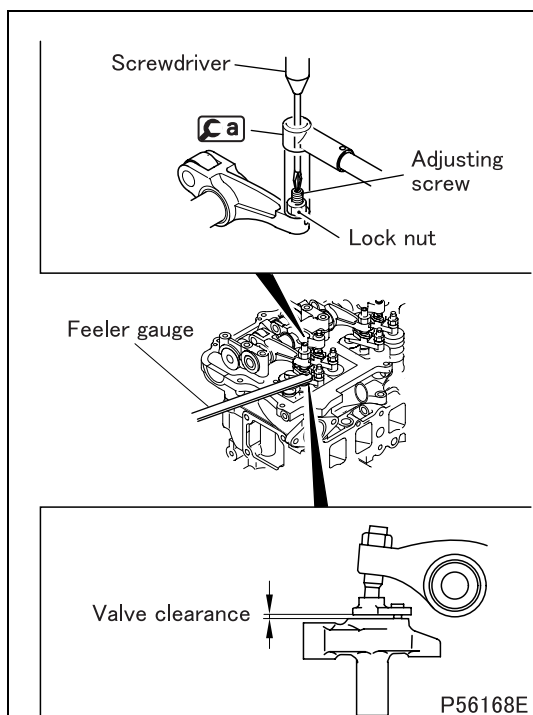
- Screw in or out the adjusting screw on the rocker arm until the correct feeler gauge can be inserted with a slight resistance.
- While holding the adjusting screw in this position with a screwdriver, tighten the lock nut to the specified torque using **Ca**.
- Recheck the valve clearance using the correct feeler gauge.

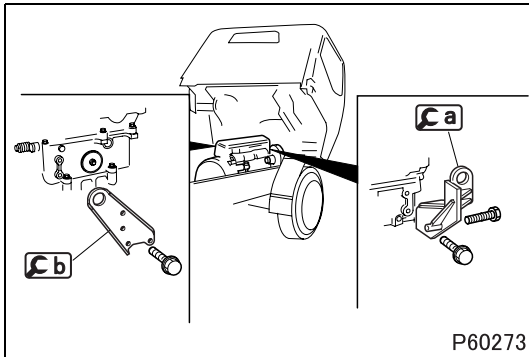
### ■ Preparation: Installation of engine hangers

- Install **(a)** onto the cylinder head and exhaust manifold using three flange bolts (2 × 22 mm-long M10 × 1.5 mm bolts and 1 × 76 mm-long M10 × 1.5 mm bolt). Tighten the bolts to a torque of 76 N·m {55 ft.lbs, 7.7 kgf·m}.
- Install **(b)** onto the cylinder head and flywheel housing using four flange bolts (22 mm-long M10 × 1.5 mm). Tighten the bolts to a torque of 76 N·m {55 ft.lbs, 7.7 kgf·m}.

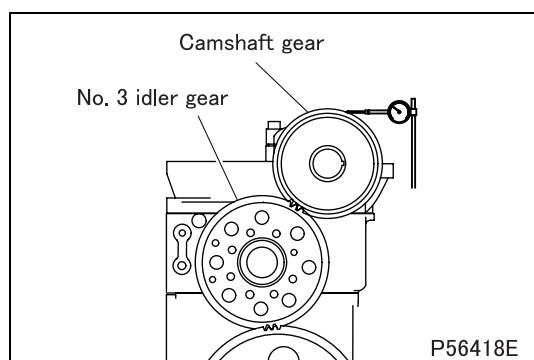
### ■ Inspection: Backlash between camshaft gear and No. 3 idler gear

- Measure the backlash at least at three different locations. If the measurement exceeds the limit, replace the defective part(s).

| Location | Maintenance item | Standard value | Limit | Remedy |
|---|---|---|---|---|
| 11, *b | Backlash between camshaft gear and No. 3 idler gear | 0.18 to 0.26<br>{0.0071 to 0.010} | 0.35<br>{0.014} | Replace |

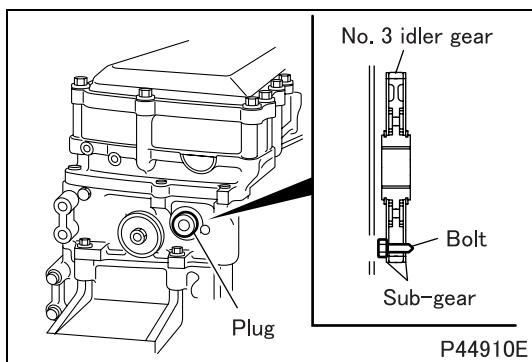
## ■ Removal: Camshaft

- Remove the plug at the rear end of the cylinder head.
- Insert a sub-gear locking bolt (M8 × 1.25 mm) into the dedicated hole in the No. 3 idler gear to lock the sub-gears. Remove the camshaft.

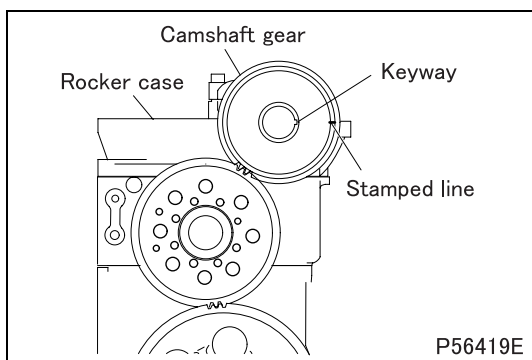
## ■ Installation: Camshaft

- Position the No. 1 cylinder at the top dead center in the compression stroke.
- Install the camshaft such that the stamped line on the camshaft gear is level with the top surface of the rocker case.

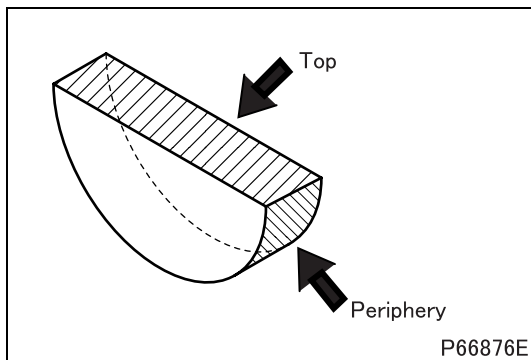
### ■ Installation: Packing

- Apply sealant to the periphery of the packing.
- Install the packing to the rocker case immediately after the sealant application.
- Apply sealant to the top of the packing after installing the rocker case.
- Install the rocker case upper and rocker cover immediately after the sealant application.

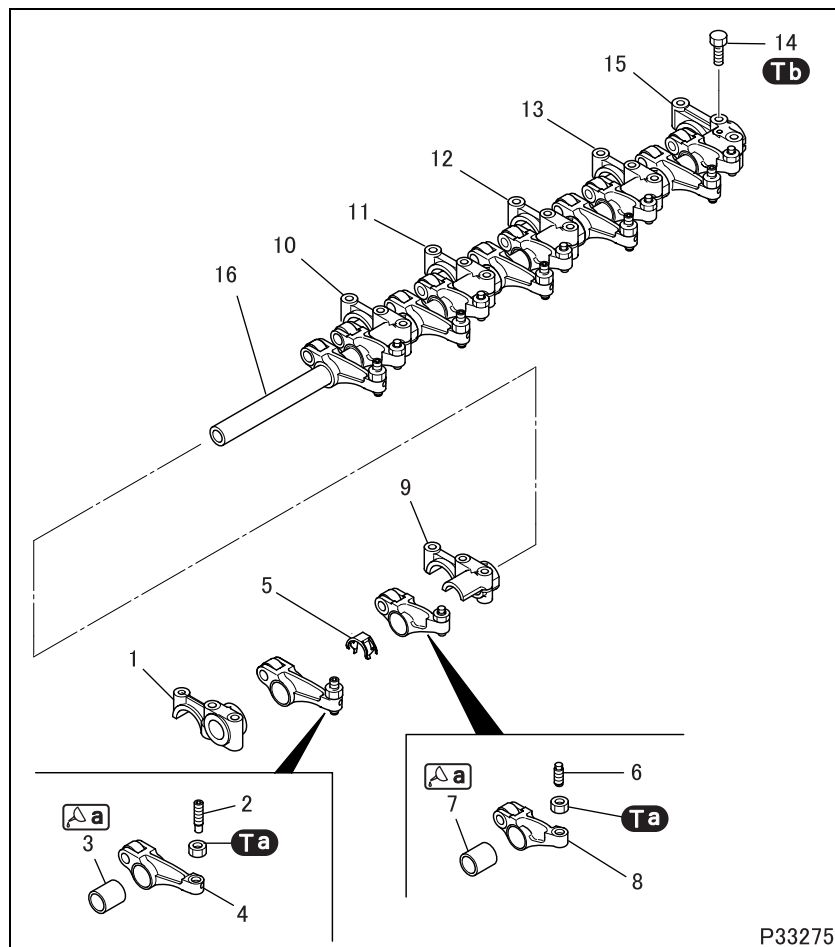
## Rocker and Bracket Assembly

- 1 Front bracket
- 2 Adjusting screw
- 3 Rocker bushing
- 4 Intake rocker
- 5 Rocker shaft spring
- 6 Adjusting screw
- 7 Rocker bushing
- 8 Exhaust rocker
- 9 No. 1 center bracket
- 10 No. 2 center bracket
- 11 No. 3 center bracket
- 12 No. 4 center bracket
- 13 No. 5 center bracket
- 14 Set screw
- 15 Rear bracket
- 16 Rocker shaft

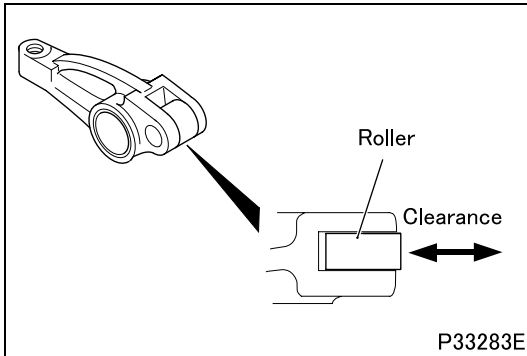
#### ■ Inspection: Radial clearance of rocker (roller)

- If the measurement deviates from the standard value, replace the defective part(s).

| Location | Maintenance item | Standard value | Limit | Remedy |
|---|---|---|---|---|
| 4, 8 | Radial clearance of rocker (roller) | 0.022 to 0.039<br>{0.00087 to 0.0015} | — | Replace |

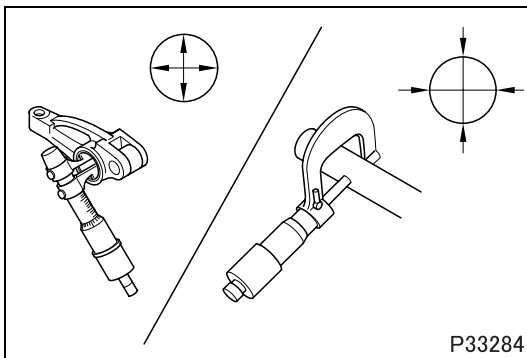
#### ■ Inspection: Clearance between rocker shaft and bushing

- If the measurement exceeds the limit, replace the bushing.

| Location | Maintenance item | Standard value | Limit | Remedy |
|---|---|---|---|---|
| 3, 7, 16 | Clearance between rocker shaft and bushing | 0.006 to 0.076<br>{0.00024 to 0.0030} | 0.114<br>{0.0045} | Replace |

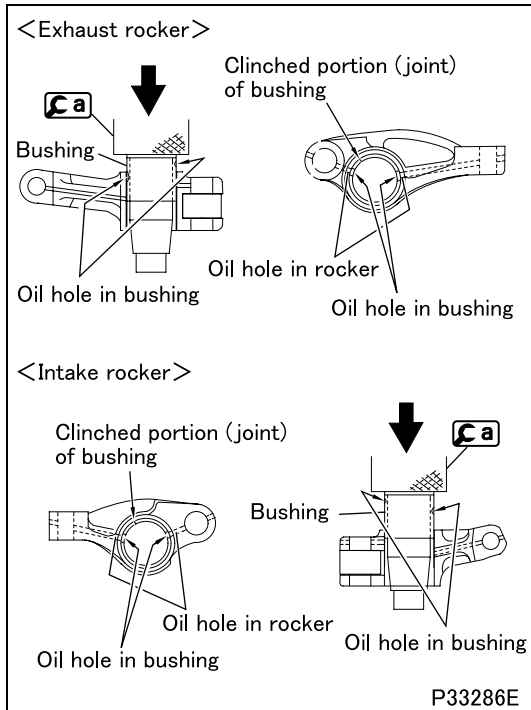
## [Installation]

- Assemble the bushing onto the rocker such that the oil holes are aligned as shown in the illustration.
- After assembly, recheck the clearance.
- If the measurement is less than the standard value, ream the bushing.

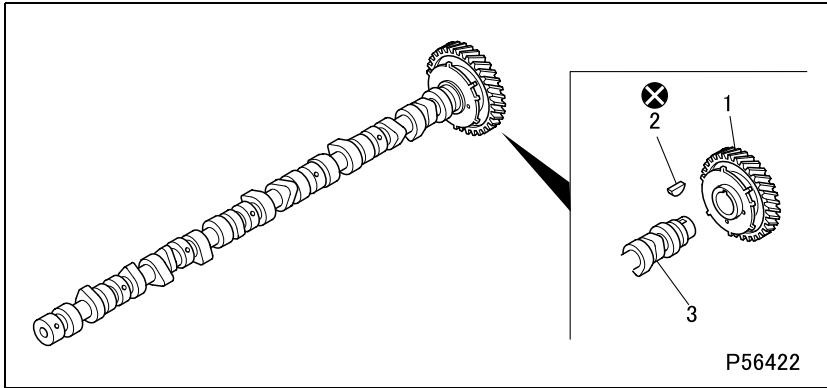
## Camshaft

- 1 Camshaft gear
- 2 Key
- 3 Camshaft

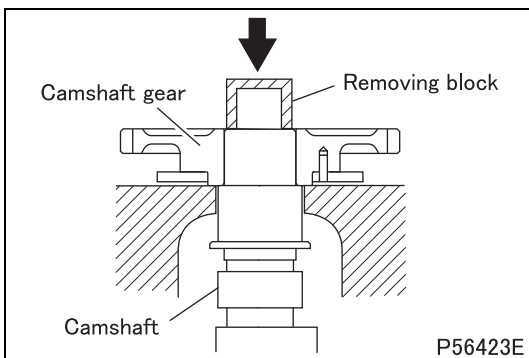
### ■ Removal: Camshaft gear

- Remove the camshaft gear by pushing on the end of the camshaft with a press or other similar tool.

- Do not attempt to remove the camshaft gear with a hammer as damage will result. Use a press or other similar tool.

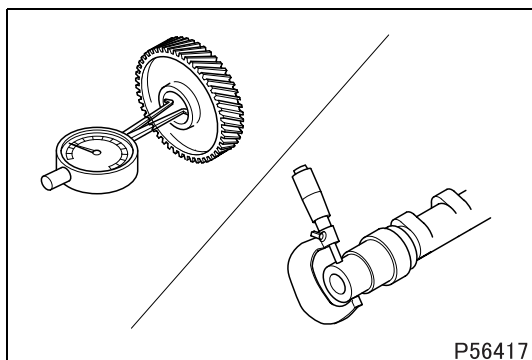
### ■ Inspection: Interference between camshaft gear and camshaft

- If the measurement deviates from the standard value, replace the defective part(s).

| Location | Maintenance item | | | | Standard value | Limit | Remedy |
|---|---|---|---|---|---|---|---|
| 1, 3 | Interference between camshaft gear and camshaft | | | | 0.017 to 0.062<br>{0.00067 to 0.0024} | — | Replace |

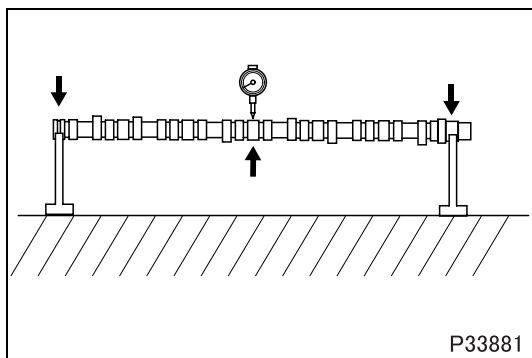
### ■ Inspection: Camshaft

#### (1) Cam lift

- If the measurement (difference between lobe diameter and base circle diameter) is less than the limit, replace the camshaft.

| Location | Maintenance item | | | | Standard value | Limit | Remedy |
|---|---|---|---|---|---|---|---|
| 3 | Camshaft | Cam lift | Intake | Lobe diameter : 45.110<br>{1.775}<br>Base circle diameter : 40.087<br>{1.578} | 5.023<br>{0.197} | 4.973<br>{0.195} | Replace |

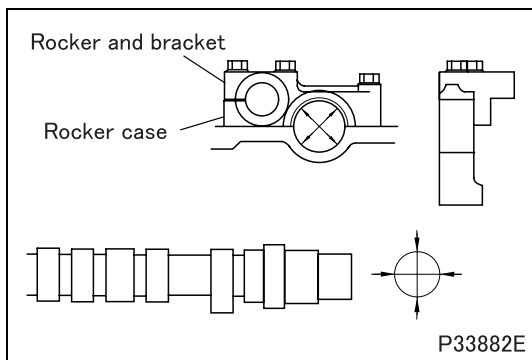
#### (2) Bend

- Place supports under the journals at the ends of the camshaft and measure the bend of the camshaft at the central journal. The amount of camshaft bend is obtained by giving the camshaft one turn and dividing the dial gauge reading by two.
- If the measurement exceeds the specified limit, replace the camshaft.

| Location | Maintenance item | | | | Standard value | Limit | Remedy |
|---|---|---|---|---|---|---|---|
| | | Bend | | | 0.02 {0.00079} | 0.04<br>{0.0016} | Replace |

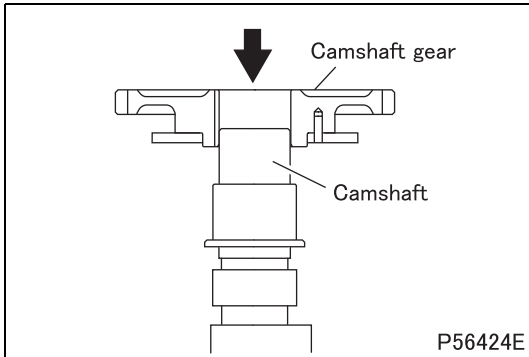
### ■ Installation: Camshaft gear

- Heat the camshaft gear to approximately 150°C {300°F} using a gas burner.

- **The camshaft is extremely hot. Be careful not to touch it.**
- While facing the camshaft gear as shown in the illustration, press it onto the camshaft until it seats snugly on the camshaft.

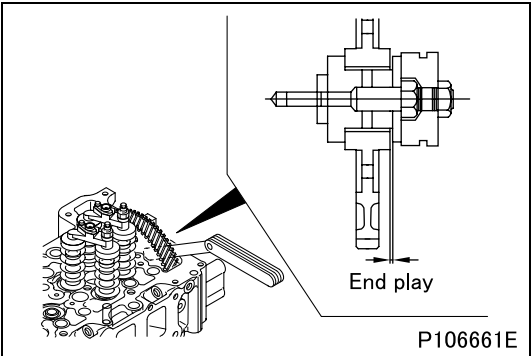
#### ■ Inspection: End play of No. 3 idler gear

- If the measurement exceeds the limit, replace the defective part(s).

| Location | Maintenance item | Standard value | Limit | Remedy |
|---|---|---|---|---|
| | No. 3 idler gear end play | 0.05 to 0.15<br>{0.0020 to 0.0059} | 0.3<br>{0.012} | Replace |

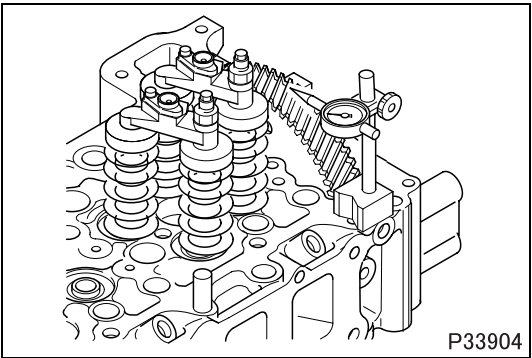
#### ■ Inspection: Backlash between No. 2 and No. 3 idler gears

- If the measurement exceeds the limit, replace the defective part(s).

| Location | Maintenance item | Standard value | Limit | Remedy |
|---|---|---|---|---|
| - | Backlash between No. 3 and No. 2 idler gears | 0.17 to 0.25<br>{0.0067 to 0.0098} | 0.35<br>{0.014} | Replace |

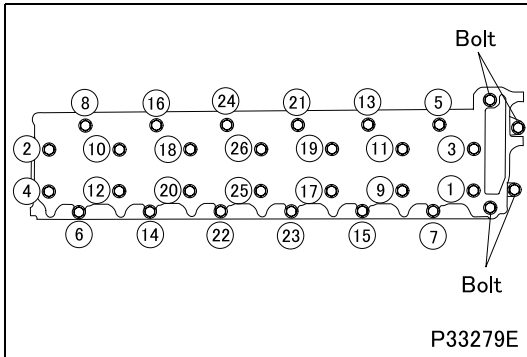
### ■ Removal: Cylinder head

- Remove the bolts (× 4).
- Progressively loosen the cylinder head bolts in the order shown in the illustration, going over them several times, before eventually removing them.

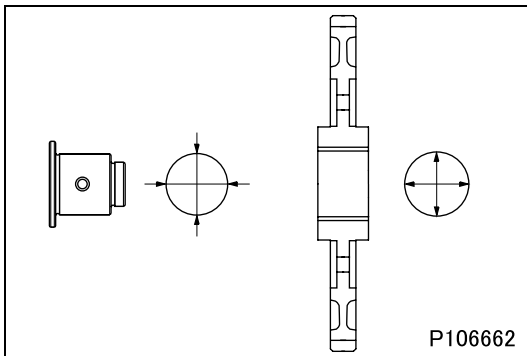
### ■ Inspection: Clearance between No. 3 idler shaft and No. 3 idler gear bushing

- If the measurement exceeds the limit, replace the bushing.

| Location | Maintenance item | Standard value | Limit | Remedy |
|---|---|---|---|---|
| 13, 14 | Clearance between No. 3 idler shaft and No. 3 idler gear bushing | 0.01 to 0.05<br>{0.00039 to 0.0020} | 0.2<br>{0.0079} | Replace |
