# FE.FG

## SERVICE MANUAL 2008 Model FOREWORD

This Service Manual contains maintenance and repair methods for the Mitsubishi Fuso Truck FE. FG Series. Read this manual carefully as an aid in providing correct, efficient maintenance. Please note that the information and specifications contained within this manual may change without notice. This is due to product modifications and continued vehicle improvements that are made throughout the model years. Should you encounter any discrepancy in the information provided, please do not hesitate to contact your nearest Mitsubishi Fuso Dealer or Mitsubishi Fuso Truck of America, Inc.

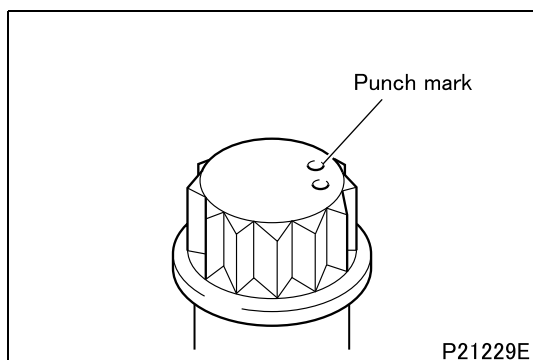
### ■ Installation: Cylinder head

- Before fitting the cylinder head bolts, check the punch marks on each bolt's head. Do not use the bolt if there are three punch marks.

The punch marks indicate the number of times each bolt has been tightened using the torque-turn tightening method. Any bolt that already has three punch marks must be replaced.

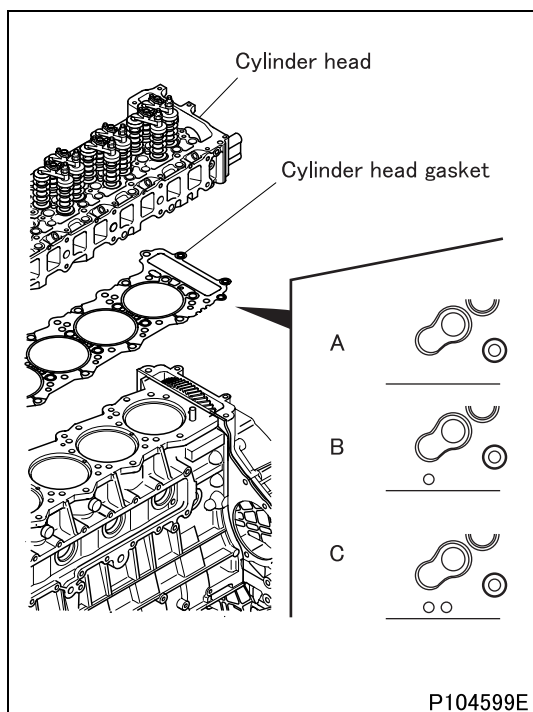
- The cylinder head gasket comes in three sizes. Choose the gasket appropriate for the cylinder head by the following procedure.
  - Measure the amount of piston projection for every cylinder. (See the PISTONS, CONNECTING RODS AND CYLINDER LINERS section.)
  - Select a cylinder head gasket with the appropriate thickness for the average of the piston projection measurements from the table below.
  - If any of the piston projection measurements is more than 0.05 mm {0.0020 in.} larger than the average value, than use the gasket one class higher than that class (A→B, B→C).

- The size class of the cylinder head gasket can be determined from the size mark or the shape of the notches cut on the gasket edge.

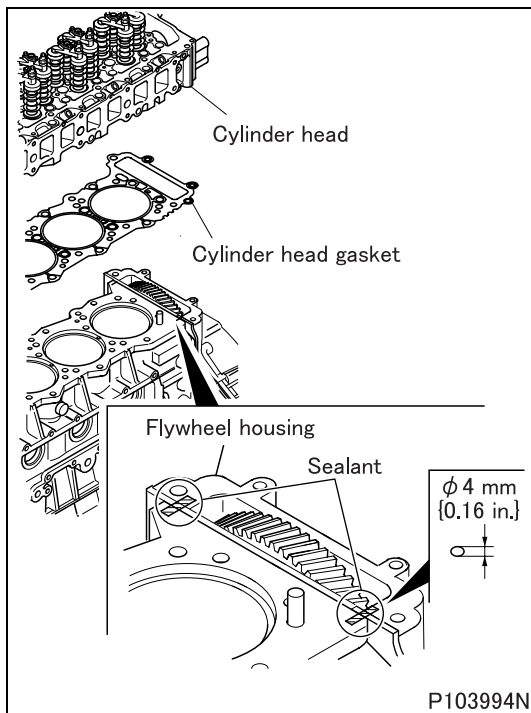
- Apply sealant onto the areas (shown in the illustration) on the top surfaces of the flywheel housing and crankcase.
- Within three minutes following the application, install the cylinder head onto the crankcase using the cylinder head bolts and a cylinder head gasket.

Ensure that the gasket is faced as shown in the illustration.

- Remove oil or any other contamination from the surfaces where sealant is to be applied.
- Take care not to spread the sealant beyond the application areas during installation.
- Do not start the engine for at least an hour after installation.
- Whenever the cylinder head bolts are subsequently loosened or removed, the cylinder head gasket must be replaced and sealant reapplied upon reassembly.
- The gasket being used must have a thickness appropriate for the protrusion of the pistons. If pistons, connecting rods or other relevant parts are replaced, check the pistons for any change in protrusion and select the correct gasket.

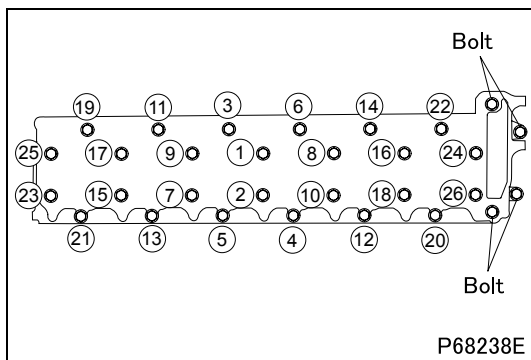
- Tighten the cylinder head bolts to a torque of 78 N·m {58 ft.lbs, 8 kgf·m} in the order shown in the illustration.
- Install the four bolts.
- Further tighten the bolts, in the order shown and as follows.

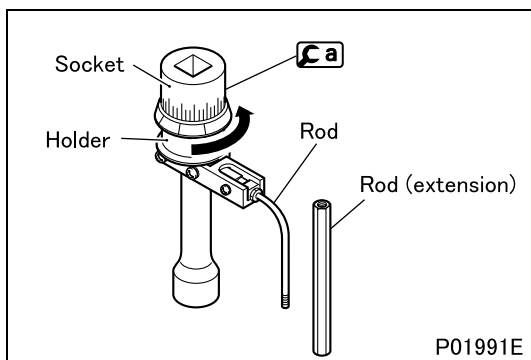
- Turn the holder of counterclockwise to pretension the internal spring.

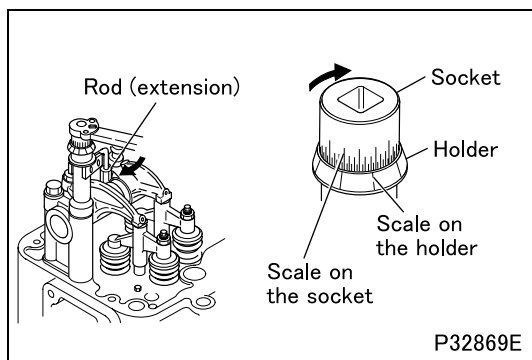
- Set **Ca** such that the rod (extension) is pressed against the rocker shaft bracket by the force of the spring.
- Align any line on the holder scale with any line on the socket scale. (This will be used as the reference point =  $0^\circ$ .)
- From the reference point, turn the socket by  $90^\circ +5^\circ_0$  in the direction shown. Each division on the holder scale represents  $5^\circ$ .
- Further turn the socket by  $90^\circ +5^\circ_0$ .
- After tightening the cylinder head bolts within the plastic region, punch a mark on the bolt heads to record the number of times that they have been tightened.

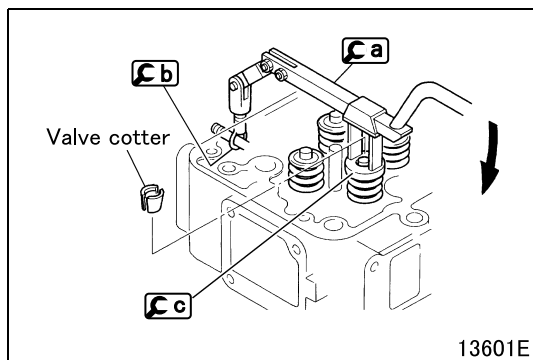
### ■ Removal: Valve cotters

- Using **Ca**, **Cb** and **Cc**, remove the valve cotter while compressing the valve spring(s) evenly.

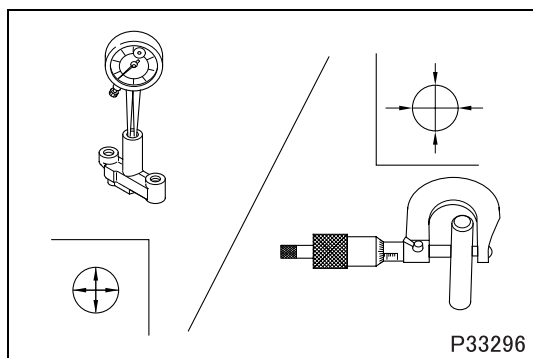
### ■ Inspection: Valve bridge and valve bridge guide

#### (1) Valve bridge-to-guide clearance

- If the measurement exceeds the limit, replace the defective part(s).

#### (2) Outside diameter of valve bridge guide

- If the measurement is less than the limit or the valve bridge guide is worn extremely unevenly, replace the valve bridge guide.

| Location | Maintenance item | | | Standard value | Limit | Remedy |
|---|---|---|---|---|---|---|
| 2, 10 | Valve bridge-to-valve bridge guide clearance | | | 0.01 to 0.04<br>{0.00039 to 0.0016} | 0.1<br>{0.0039} | Replace |
| 10 | Valve bridge guide in outside diameter | | | 9.989 to 10<br>{0.393 to 0.394} | 9.94<br>{0.391} | Replace |

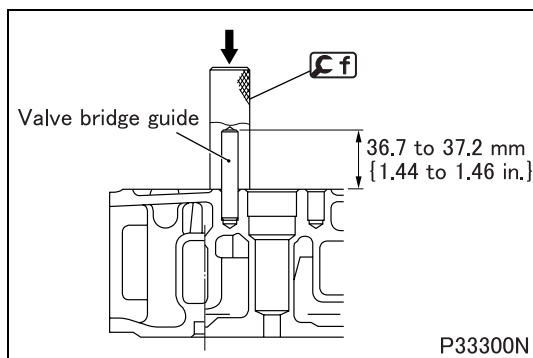
### Replacement of valve bridge guide

- The valve bridge guide must be installed to the specified depth of the cylinder head. Correct installation can only be possible by using **f**.
- Before installation, ensure that no water, oil or other foreign matter is in the installation hole.

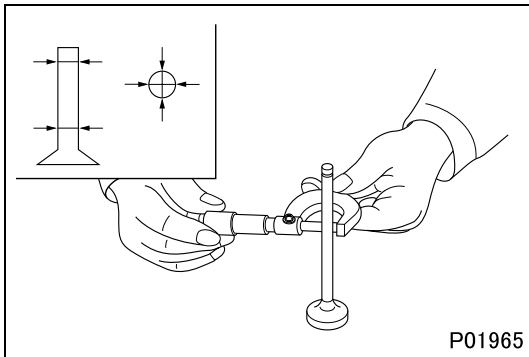
### ■ Inspection: Intake and exhaust valve

#### (1) Valve stem outside diameter

- Replace the valve if the stem's outside diameter is below the limit or is severely worn.

| Location | Maintenance item | | | Standard value | Limit | Remedy |
|---|---|---|---|---|---|---|
| 8 | Exhaust valve | Stem outside diameter | | $\phi 8 \begin{smallmatrix} -0.060 \\ -0.075 \end{smallmatrix} \{0.31 \begin{smallmatrix} -0.0024 \\ -0.0030 \end{smallmatrix}\}$ | $\phi 7.85$<br>{0.31} | Replace |
| 9 | Intake valve | Stem outside diameter | | $\phi 8 \begin{smallmatrix} -0.025 \\ -0.040 \end{smallmatrix} \{0.31 \begin{smallmatrix} -0.00098 \\ -0.0016 \end{smallmatrix}\}$ | $\phi 7.85$<br>{0.31} | Replace |

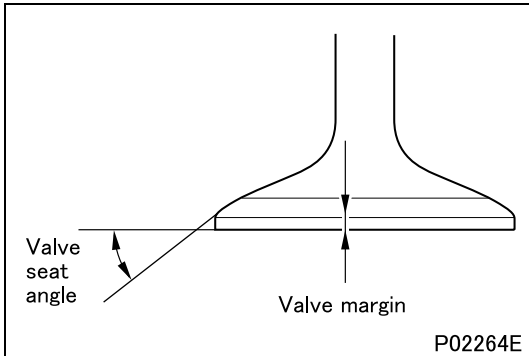
#### (2) Valve seat angle

- Reface the valve if the measured valve is not within the standard valve range.

#### (3) Valve margin

- Reface or replace the valve if the measured valve exceeds the specified limit.

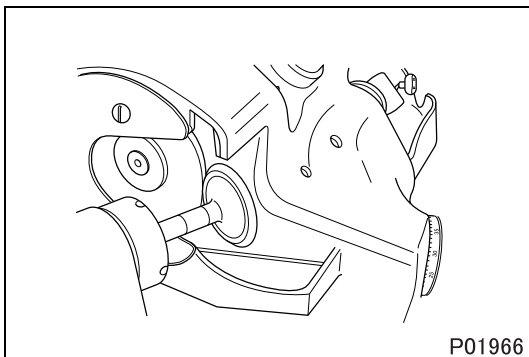
### Refacing

- Limit grinding to a necessary minimum.
- If the valve margin is below the limit after grinding, replace the valve.
- After grinding, make sure to lap the valve and valve seat.

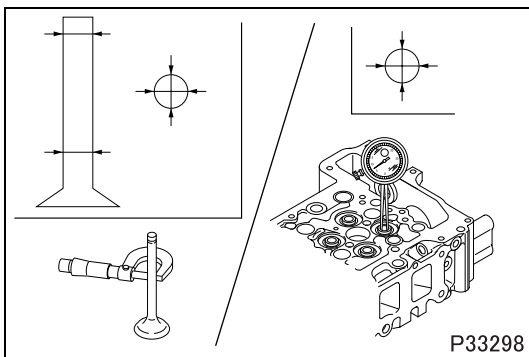
### ■ Inspection: Valve-to-valve guide clearance

- If the clearance exceeds the specified limit, replace the defective part(s).

| Location | Maintenance item | | | Standard value | Limit | Remedy |
|---|---|---|---|---|---|---|
| 8, 11 | Exhaust valve stem-to-valve guide clearance | | | 0.07 to 0.10<br>{0.0028 to 0.0039} | 0.2<br>{0.0079} | Replace |
| 9, 12 | Intake valve stem-to-valve guide clearance | | | 0.06 to 0.09<br>{0.0024 to 0.0035} | 0.2<br>{0.0079} | Replace |

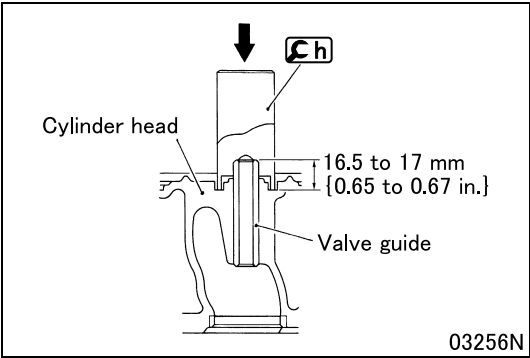
### [Installation]

- Install the valve guide until **Ch** sits snugly on the cylinder head.

- The valve guide must protrude from the cylinder head by the specified amount. Correct installation can only be possible by using **Ch**.
- The valve guides for the exhaust valves are longer than the valve guides for the inlet valves.

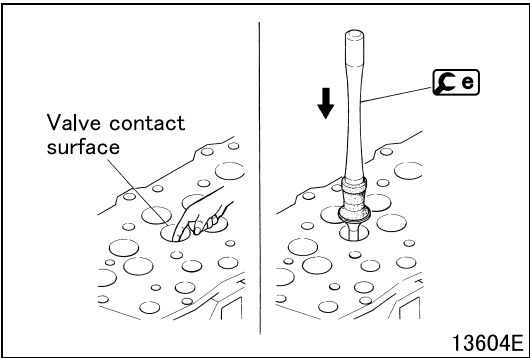
### ■ Inspection: Contact between valve and valve seat

- Before starting inspection, check that the valve and valve guide are intact.
- Apply an even coat of red lead to the valve contact surface of the valve seat.
- Strike the valve once against the valve seat. Do not rotate the valve during this operation.

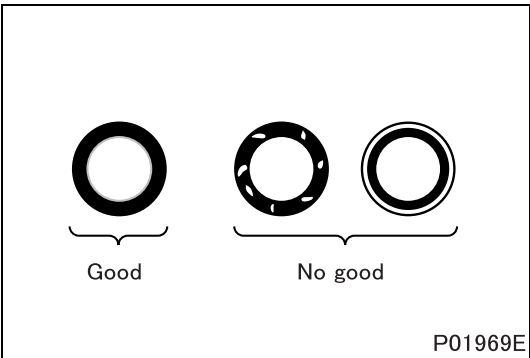
- If the red lead deposited on the valve indicates a poor contact pattern, take either of the following corrective actions.

| Contact pattern | Corrective action |
| Minor defect | Lapping |
| Serious defect | Reface or replace valve and valve seat |

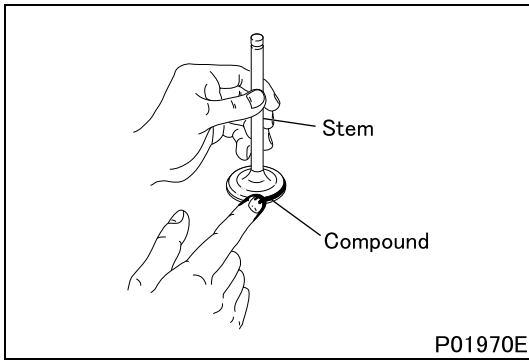
### Lapping

- Lap the valve in the following sequence.
- Apply a thin coat of lapping compound to the seat contact surface of the valve.
- Start with an intermediate-grit compound (120 to 150 grit) and finish with a fine-grit compound (200 grit or more).
- Adding a small amount of engine oil to the lapping compound can facilitate even application.

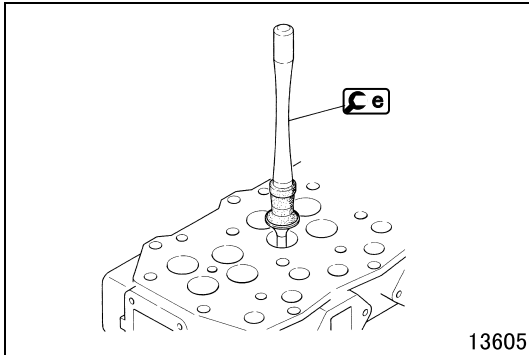
- Strike the valve several times against the valve seat while rotating the valve a little at a time.
- Wash away the compound with diesel fuel.
- Apply engine oil to the valve contact surface of the valve seat and rub in the valve and seat well.
- Inspect the contact pattern of the valve and valve seat again.
- If the contact pattern is still defective, replace the valve seat.

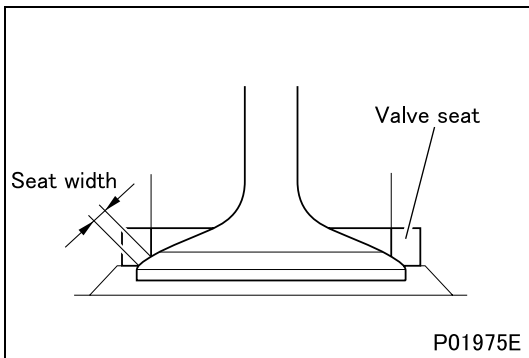
### ■ Inspection: Valve seats

#### (1) Valve seat width

- If the measurement exceeds the limit, reface or replace the valve seat.

| Location | Maintenance item | | | Standard value | Limit | Remedy |
|---|---|---|---|---|---|---|
| 13 | Exhaust valve seat width | | | 2.3 to 2.7<br>{0.091 to 0.11} | 3.3<br>{0.13} | Correct or<br>replace |
| 14 | Intake valve seat width | | | 1.8 to 2.2<br>{0.071 to 0.087} | 2.8<br>{0.11} | Correct or<br>replace |

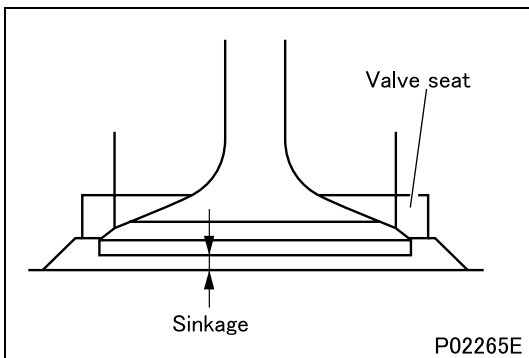
#### (2) Valve sinkage from cylinder head bottom surface

- Perform measurement keeping the valve in close contact with the valve seat.
- If the measurement exceeds the limit, adjust or replace the defective part(s).

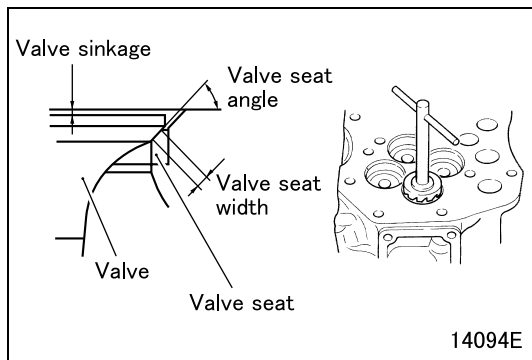
## Refacing the valve seat

- Grind the valve seat using a valve seat cutter or valve seat grinder.
- Place a piece of sandpaper of approximately #400 between the cutter and valve seat and grind the valve seat lightly.
- Use a 15° or 75° cutter to cut the valve seat to a width within the standard range.

- **Make sure that the valve seat refacing does not cause the valve sinkage to exceed the specified limit.**

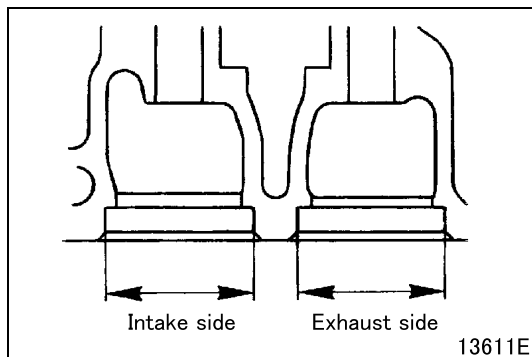
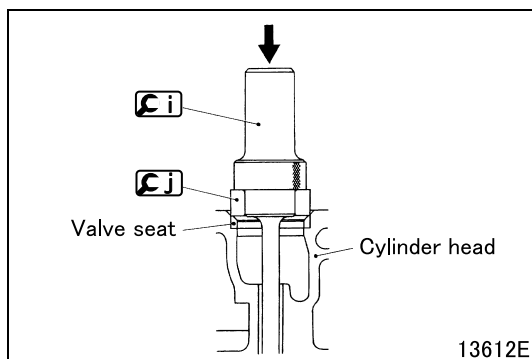
- Measure the diameter of the valve seat hole in the cylinder head.
- If the measurement deviates from the standard valve, replace the cylinder head.

- Chill the valve seat thoroughly by immersing it in liquid nitrogen.
- Install the valve seat in the cylinder head using **i** and **j**.
- Lap the valve seat and valve.

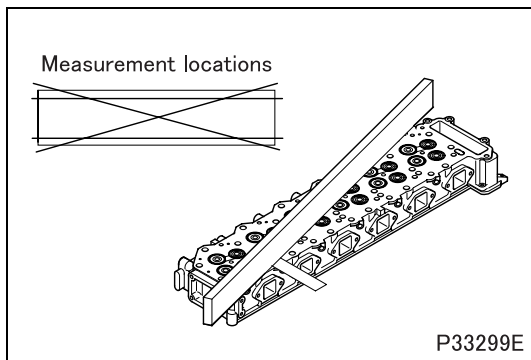
#### ■ Inspection: Cylinder head bottom surface distortion

- If the distortion exceeds the specified limit, rectify it using a surface grinder.

- Make sure that the height of the cylinder head from the top surface to the bottom surface is not reduced to a value below the specified limit.

| Location | Maintenance item | | | Standard value | Limit | Remedy |
|---|---|---|---|---|---|---|
| 18 | Cylinder head | Bottom surface distortion | | 0.08 {0.0031} or less | 0.2<br>{0.0079} | Correct or<br>replace |

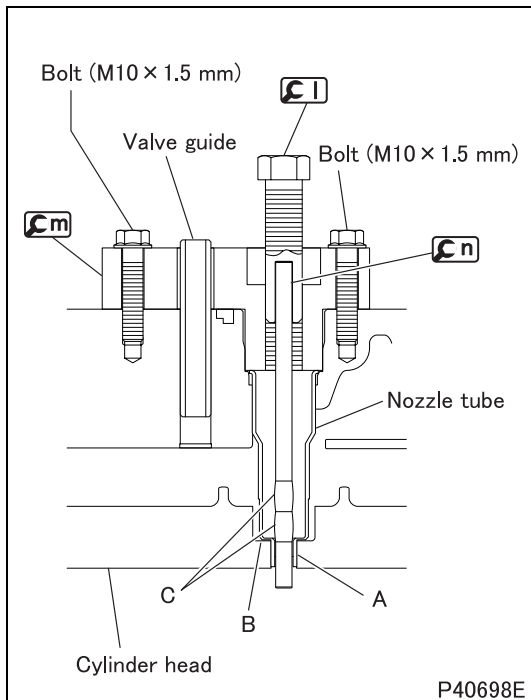
#### ■ Installation: Nozzle tube

- Clean the mounting holes of the nozzle tube on the cylinder head.
- Apply a sealant to the perimeter A of the tip of the nozzle tube.
- Push in the nozzle tube by hand until it contacts surface B of the cylinder head.
- Tighten **Cm** with the bolt and press the nozzle tube onto surface B of the cylinder head.
- Apply engine oil to section C of **Cn**.
- Screw in **Cl** until **Cn** can be pulled out from the bottom of the cylinder head.

- When installing the nozzle tube, be sure to perform a leak test to check for airtightness.

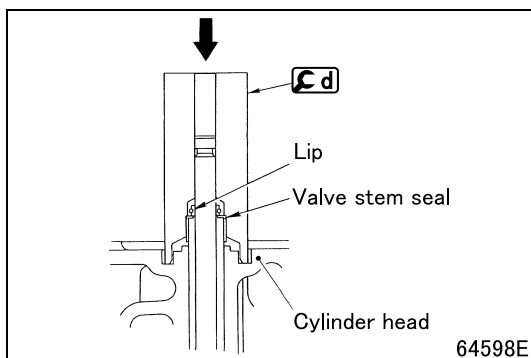
#### ■ Installation: Valve stem seal

- Apply engine oil to the lip of the valve stem seal.
- Install the valve stem seal until **Cd** sits snugly on the cylinder head.

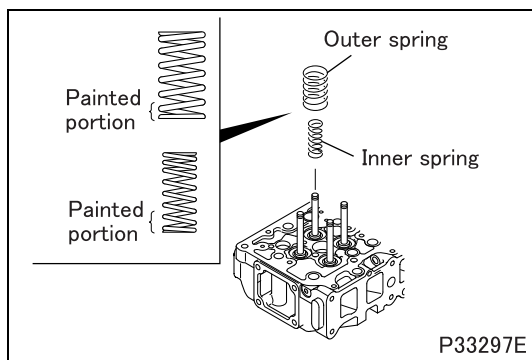
## ■ Installation: Valve spring

- Install the outer and inner valve springs onto the cylinder head while facing them as shown in the illustration.

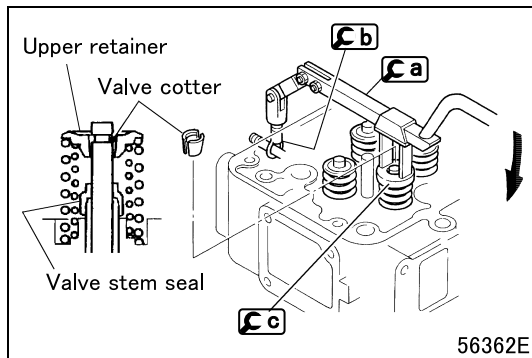
## ■ Installation: Valve cotter

- Using **a**, **b** and **c**, install the valve cotter while compressing the valve spring(s) evenly.

- Do not compress the valve spring(s) too much, or the upper retainer will contact the valve stem seal and damage will result.

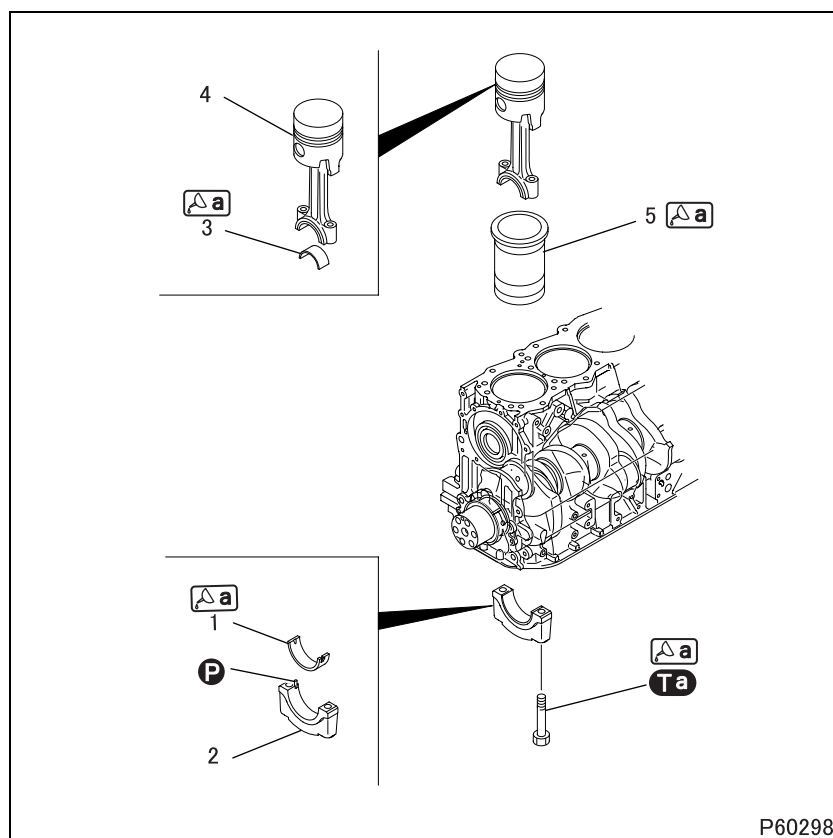
## ● Disassembly sequence

- 1 Lower connecting rod bearing
- 2 Connecting rod cap
- 3 Upper connecting rod bearing
- 4 Piston and connecting rod  
(See later sections.)
- 5 Cylinder liner

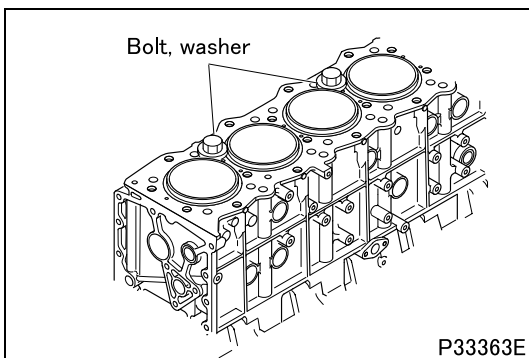
### ■ Retaining cylinder liners

- The cylinder liners may move up when the crankcase is turned over, or the crankshaft is rotated after the pistons are installed. To prevent this, retain the cylinder liners by holding their flanges with bolts and washers.

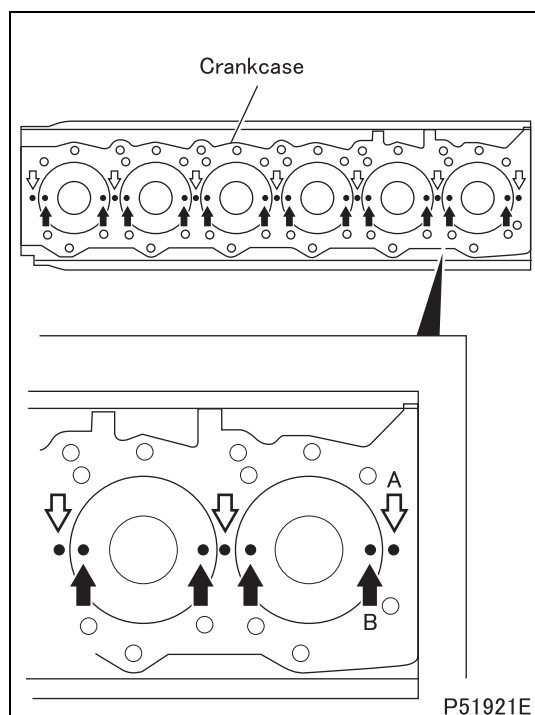
## ■ Inspection: Piston projection from crankcase top surface

- The amount of piston projection affects engine performance and must therefore be inspected without fail.

- Set the piston at the top dead center.
- Mark reference points A (seven points in total) on the top surface of the crankcase as shown in the illustration. Using each of the marks as a zero point, measure the amount of piston projection relative to the zero point (height of measurement point B – height of reference point A).
- Make the measurements at the two measurement points B for each cylinder (twelve points in total) using the reference point A nearest to each measurement point, and calculate the average value of all the measurements.
- If the average value is out of the standard value range, check the clearances between all relevant parts.
- Select and use a cylinder head gasket that can accommodate the average piston projection (average value of the twelve measurements).

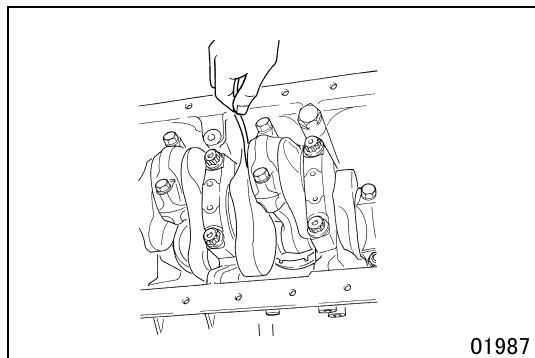
## ■ Inspection: Connecting rod end play

- Measure the end play for every connecting rod.
- If any measurement exceeds the specified limit, replace the defective part(s).

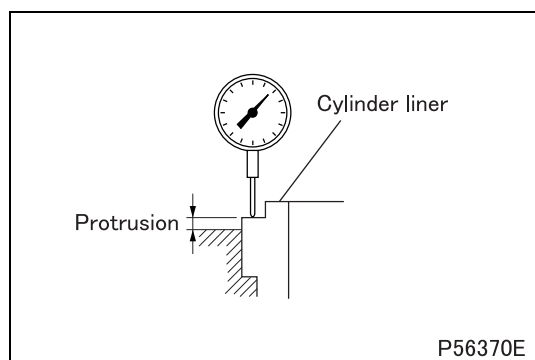
## ■ Inspection: Cylinder liner flange projection

- If the measurement deviates from the standard value, inspect the installation and replace the defective part(s).

- If the cylinder liner flange protrusion is less than the specified value, the contact pressure of the cylinder head gasket against the bore of the cylinder will not be high enough to prevent gas leakage.

| Location | Maintenance item | | Standard value | Limit | Remedy |
|---|---|---|---|---|---|
| 5 | Cylinder liner | Flange projection | 0.03 to 0.10<br>{0.0012 to 0.0039} | – | Replace |

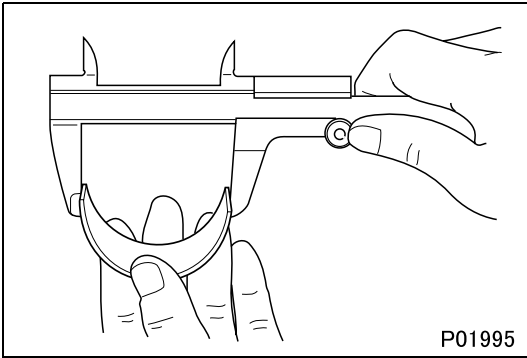
### ■ Inspection: Connecting rod bearing span when free

- Do not attempt to manually expand the bearings.
- If the measurement is less than the limit, replace upper and lower bearings as a set.

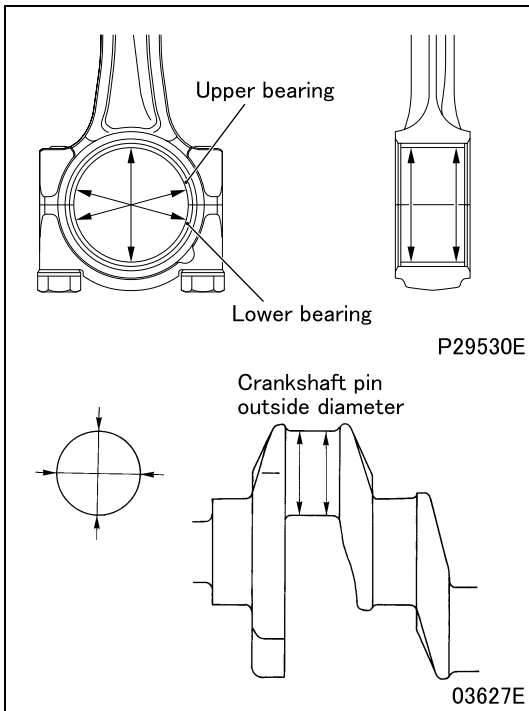
### ■ Inspection: Connecting rod bearing-to-crankshaft oil clearance

- Fit the lower bearing to the connecting rod cap and the upper bearing to the connecting rod, then tighten the nut to a torque of 29 N·m {21 ft.lbs, 3 kgf·m}.
- Measure the inside diameter of the bearing and the outside diameter of the crankshaft pin.
- If the clearance exceeds the limit, replace the defective part(s).
- If a bearing has to be replaced with an undersized one, machine the crankshaft pin to the specified undersize diameter.

| Location | Maintenance item | | Standard value | Limit | Remedy |
|---|---|---|---|---|---|
| 1, 3 | Connecting rod bearing | Oil clearance | 0.03 to 0.09<br>{0.0012 to 0.0035} | 0.2<br>{0.0079} | Replace |

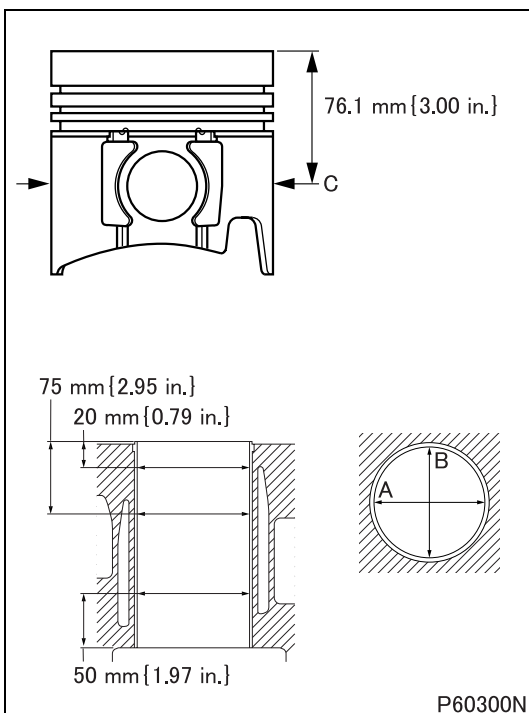
### ■ Inspection: Clearance between piston and cylinder sleeve

- If the measurement deviates from the standard value, replace the defective part(s).
  - A: Measuring point on the crankcase (in direction of the crankcase axis).
  - B: Measuring point on the crankcase (vertical to the crankcase axis).
  - C: Measuring point on the piston outer diameter (vertical to the piston pin hole).

| Location | Maintenance item | | Standard value | Limit | Remedy |
|---|---|---|---|---|---|
| 4, 5 | Piston and connecting rod-to-cylinder liner clearance | | 0.18 to 0.21<br>{0.0071 to 0.0083} | – | Replace |

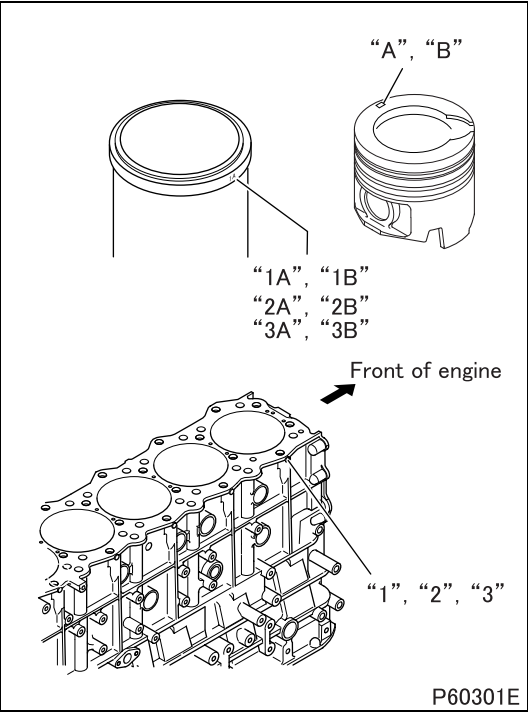
### [Installation]

- When replacing cylinder liners, select the cylinder liners which correspond to the size marks on the crankcase and the piston.

- Make sure to use pistons and cylinder liners of the same size. Failure to do may result in seizures in the engine.
- Apply a thin coat of engine oil onto the outside periphery (hatched area) of the cylinder liner.

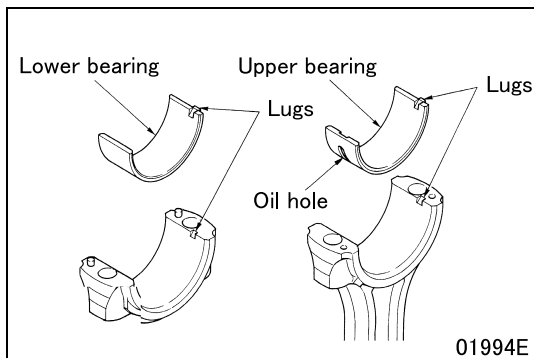
### ■ Installation: Connecting rod bearings

- **Do not reverse the positions of the lower bearing and the upper bearing (with oil hole) when installing, as this may cause seizure in the engine.**

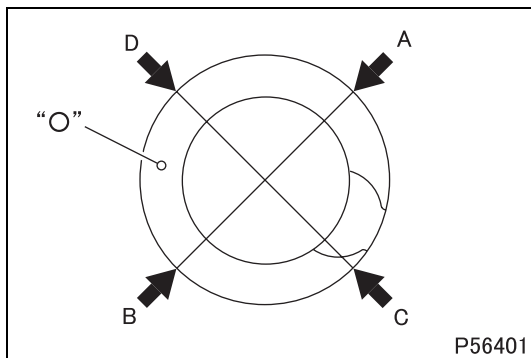
### ■ Installation: Piston and connecting rod

- Check that the piston ring end gaps are in their correct positions.  
A: 1st compression ring gap  
B: 2nd compression ring gap  
C: Oil ring gap  
D: Oil ring expander spring gap

“O”: Front mark on piston

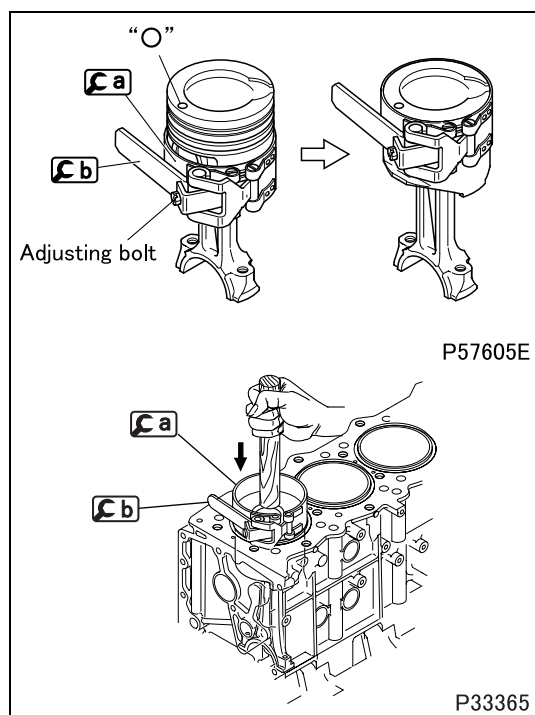
- Face the front mark “O” of the piston toward the front of the engine.
- With **a** and **b** installed around the piston skirt, tighten the adjusting bolt of **b** until the inside diameter of **a** matches the outside diameter of the piston skirt.
- Remove **a** and **b** from the piston. Apply engine oil to the following areas. Then, install **a** and **b** over the rings of the piston.
  - Outside surface of piston
  - Inside surface of **a**
  - Cylinder liner inside surface

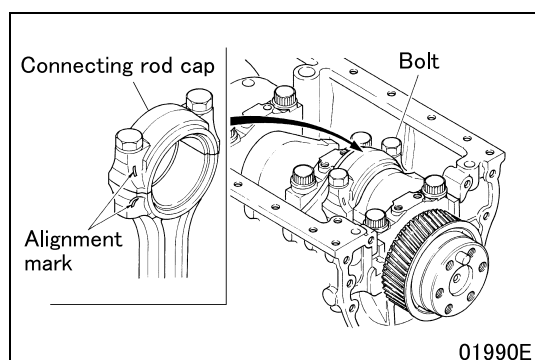
- After the piston and connecting rod have been installed, install the connecting rod cap onto the connecting rod, ensuring that the alignment marks are aligned. Tighten the bolts alternately as follows.
  - Tighten the bolts to a torque of 29 N·m {21 ft.lbs, 3 kgf·m}.
  - Further tighten the bolts in the following sequence.

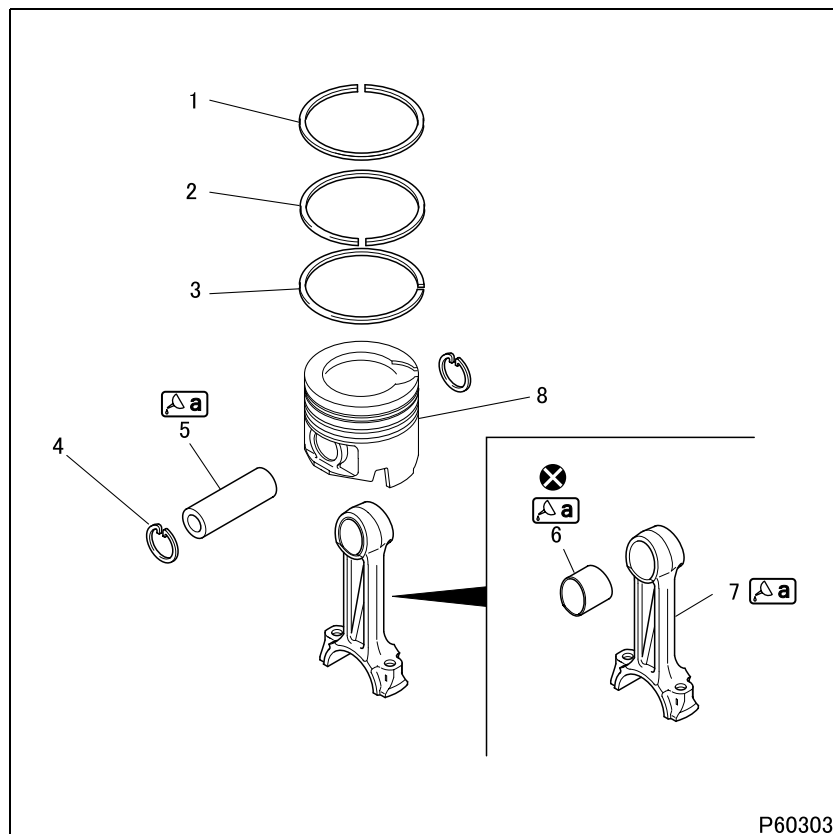
### ● Disassembly sequence

- 1 1st compression ring
- 2 2nd compression ring
- 3 Oil ring
- 4 Snap ring
- 5 Piston pin
- 6 Connecting rod bushing
- 7 Connecting rod
- 8 Piston

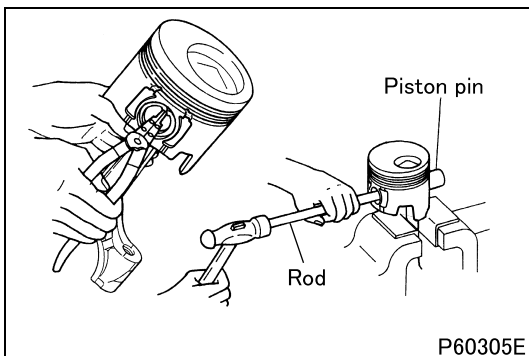
#### ■ Removal: Piston pin

- Remove the piston pin by striking it with a rod and hammer.
- If the piston pin is difficult to remove, first heat the piston in hot water or with a piston heater.

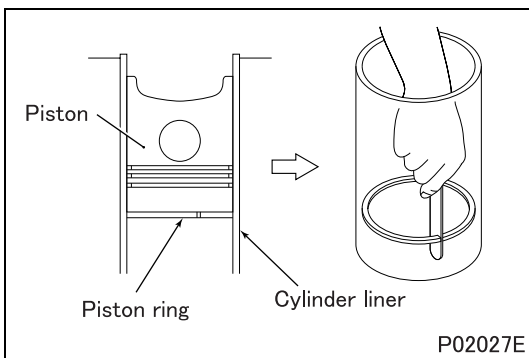
#### ■ Inspection: Piston ring end gap

- Using the crown of a piston, push the piston ring horizontally into a cylinder in the crankcase until it reaches the lower part of the cylinder liner, where there is relatively small wear.
- Taking care not to move the piston ring, measure the end gap.
- If any of the rings has a gap exceeding the specified limit, replace all the piston rings as a set.

| Location | Maintenance item | | Standard value | Limit | Remedy |
|---|---|---|---|---|---|
| 1 to 3 | Piston ring end gap | 1st compression ring | 0.45 <sup>+0.05</sup> <sub>-0.10</sub> | 1.5<br>{0.059} | Replace |

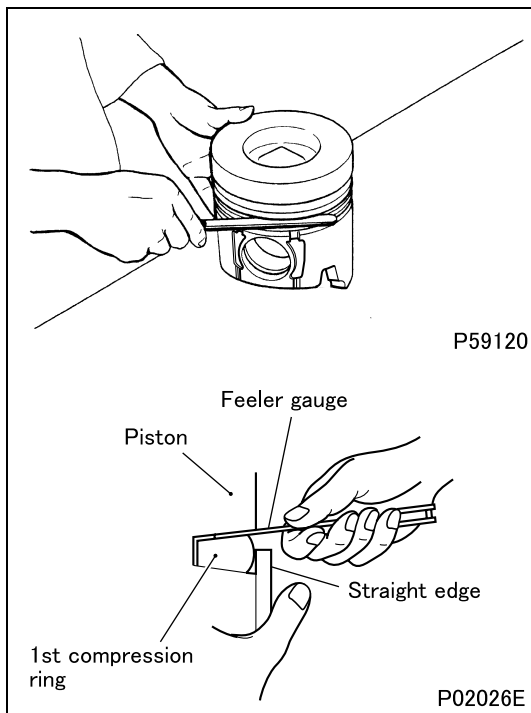
## ■ Inspection: Piston ring side clearance in piston groove

- Remove any carbon deposits from the ring groove in the piston.
- Measure the side clearance of each ring around the piston's entire periphery.
- If any of the measurements exceeds the specified limit, replace the defective part(s). If any of the piston rings is defective, replace all the rings on the piston as a set.
- The side clearance of the 1st compression ring must be measured using a feeler gauge while holding the ring against the piston ring groove with a straight edge.

| Location | Maintenance item | | Standard value | Limit | Remedy |
|---|---|---|---|---|---|
| 1 to 3, 8 | Piston ring side clear-<br>ance in piston groove | 1st compression ring | 0.13 to 0.18<br>{0.0051 to 0.0071} | 0.2<br>{0.0079} | Replace |

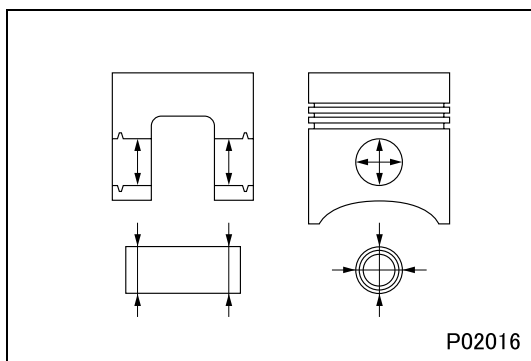
## ■ Inspection: Piston pin-to-piston clearance

- If the measurement exceeds the specified limit, replace the defective part(s).

| Location | Maintenance item | | Standard value | Limit | Remedy |
|---|---|---|---|---|---|
| 5, 8 | Piston pin-to-piston clearance | | 0.004 to 0.022<br>{0.00016 to 0.000079} | 0.05<br>{0.0020} | Replace |

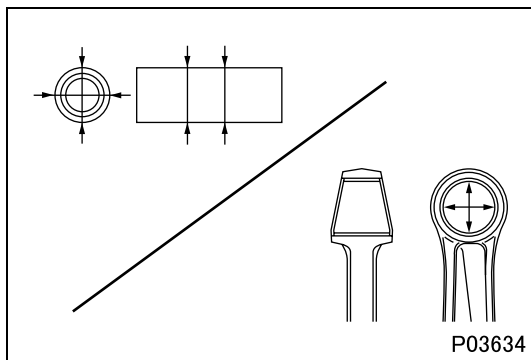
## ■ Inspection: Piston pin-to-connecting rod bushing clearance

- If any of the measurements exceeds the specified limit, replace the bushing.

| Location | Maintenance item | | Standard value | Limit | Remedy |
|---|---|---|---|---|---|
| 5, 6 | Piston pin-to-connecting rod bushing clearance | | 0.02 to 0.05<br>{0.00079 to 0.0020} | 0.1<br>{0.0039} | Replace |

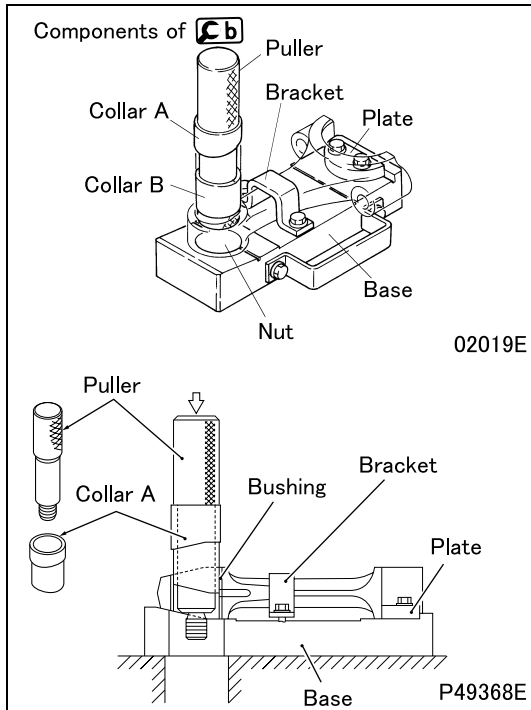
### Replacement of connecting rod bushing

- Remove the upper bearing (if fitted) from the large end of the connecting rod.
- Mount the connecting rod on the base and lock it in position with the bracket and plate.
- Fit collar A over the puller with its ends facing in the illustrated directions. Then, slowly apply a pressure of approximately 49 kN {11020 lbs, 5,000 kgf} to the puller with a press to force out the connecting rod bushing.

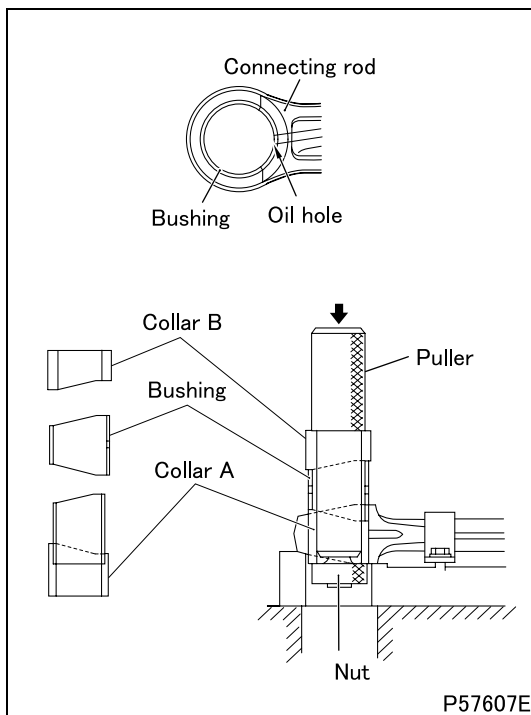
#### [Installation]

- Apply engine oil to the outside surface of the connecting rod bushing and the bushing fitting surface of the connecting rod.
- Fit collar B, the bushing, and collar A over the puller in the illustrated directions and lock this arrangement together with the nut.
- Align the oil holes in the connecting rod bushing and the connecting rod. Then, use a press to slowly apply a pressure of approximately 49 kN {11020 lbs, 5,000 kgf} to the puller until the bushing is forced into place.
- After press-fitting the connecting rod bushing, measure the clearance between the piston pin and connecting rod bushing.
- If the measurement is less than the standard clearance range, ream the bushing.

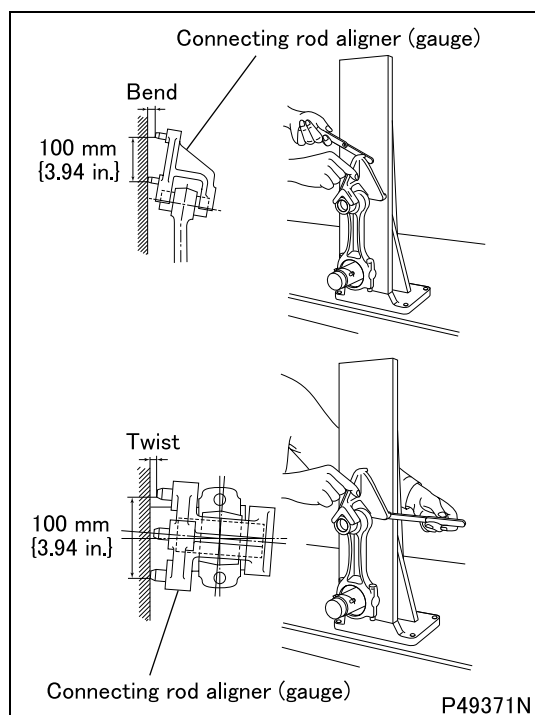
## ■ Inspection: Connecting rod bend and twist

- Mount the connecting rod on the connecting rod aligner. Also mount the connecting rod bearings, piston pin, and connecting rod cap to create the same conditions as are expected when the connecting rod is mounted on a crankshaft. Tighten the nuts of the connecting rod bearing cap to a torque of 29 N·m {21 ft.lbs, 3 kgf·m}.
- Measure the extent of bend and twist in the connecting rod.
- If either measurement exceeds the specified limit, replace the connecting rod.

| Location | Maintenance item | | Standard value | Limit | Remedy |
|---|---|---|---|---|---|
| 7 | Connecting rod | Bend | — | 0.05<br>{0.0020} | Replace |

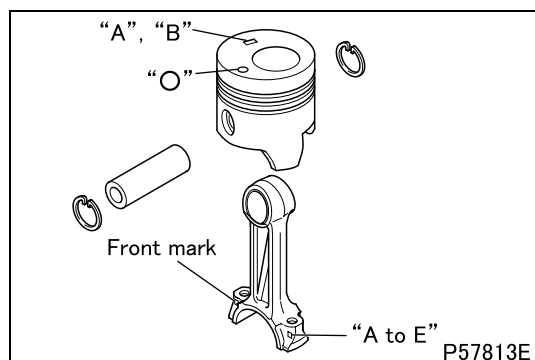
## ■ Installation: Piston to connecting rod

- Install pistons and connecting rods as follows when replacing them.
  - All connecting rods used in the same engine must be of the same weight size mark. Weight mark: "A" to "E"
  - Apply engine oil to the piston pin, and assemble the piston and connecting rod with their marks facing in the illustrated directions.
- "O": Front mark
- If the piston pin is difficult to insert, heat the piston in hot water or with a piston heater.

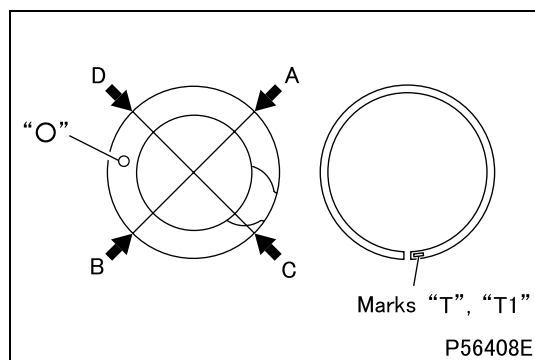
## ■ Installation: Piston rings

- With the manufacturer's marks (found near the piston ring end gaps) facing up, install the piston rings so that the end gap of each ring is positioned as illustrated.
  - A: 1st compression ring end gap
  - B: 2nd compression ring end gap
  - C: Oil ring end gap
  - D: Oil ring's expander spring end gap
- "O": Front mark on piston
- The manufacturer's marks are present only on the 1st ("T") and 2nd ("T1") compression rings.

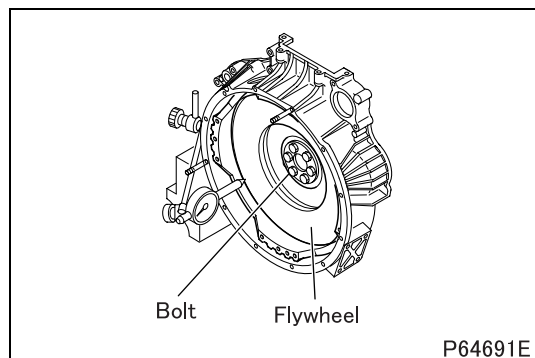
### ■ Inspection: Flywheel friction surface runout when fitted

- If the measurement exceeds the limit, check if the bolts are correctly tightened as well as the crankshaft mounting surface. Correct or replace the flywheel as required.

| Location | Maintenance item | | Standard value | Limit | Remedy |
|---|---|---|---|---|---|
| | | Friction surface runout (when fitted) | 0.05 {0.0020} or less | 0.2 {0.0079} | Correct or replace |

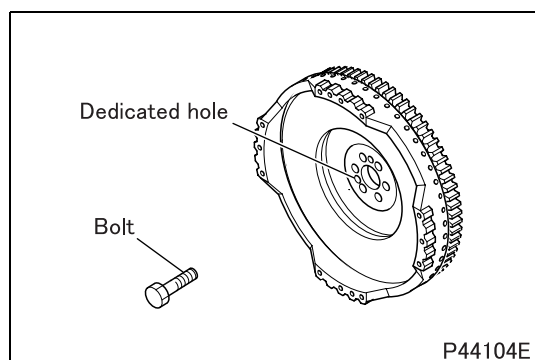
### ■ Removal: Flywheel

- To remove the flywheel, use bolts inserted into the dedicated holes in the flywheel.

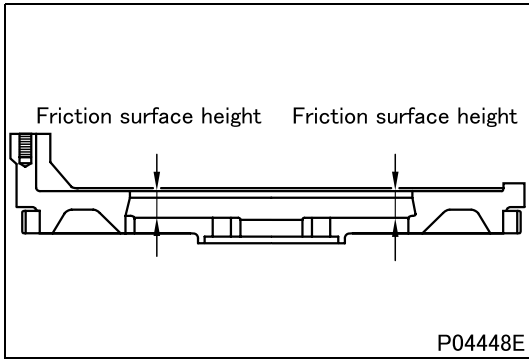
#### (1) Friction surface height

- If the height is less than the limit, replace the flywheel.

| Location | Maintenance item | | Standard value | Limit | Remedy |
|---|---|---|---|---|---|
| | | Friction surface height | 26.5 {1.04} | 25.5 {1.00} | Replace |

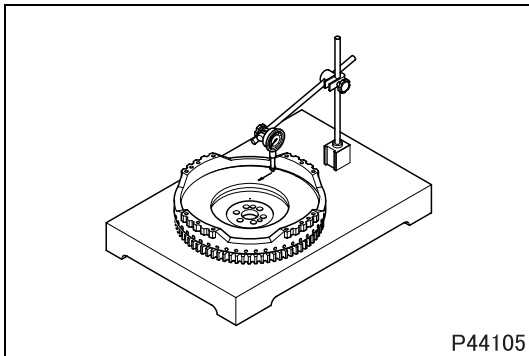
#### (2) Friction surface distortion

- If the measurement exceeds the limit, rectify or replace the flywheel.

- If the ring gear is evidently defective, replace the ring gear before inspecting the friction surface for distortion.

| Location | Maintenance item | | Standard value | Limit | Remedy |
|---|---|---|---|---|---|
| 4 | Flywheel | Friction surface distortion | 0.05 {0.0020} or less | 0.2 {0.0079} | Correct or replace |

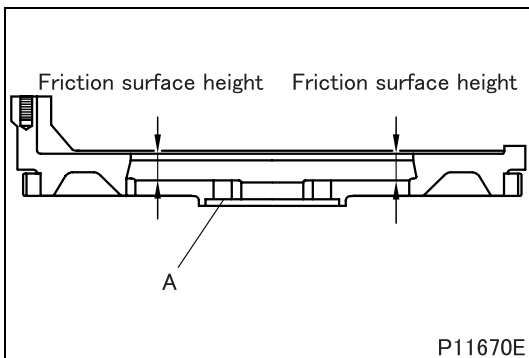
#### Rectification of friction surface

- Rectify the friction surface so that its height is not below the specified limit, and it is parallel with surface A within specification.

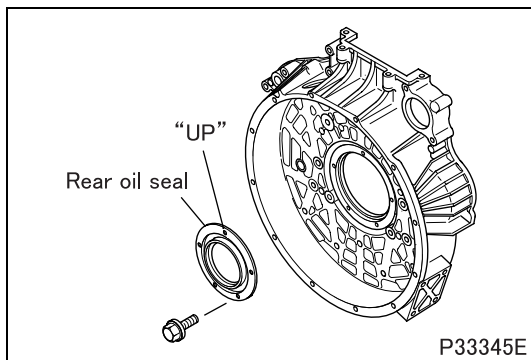
- Apply engine oil to the rear oil seal lip.
- Install the rear oil seal onto the flywheel housing ensuring that the seal is faced in the illustrated direction.

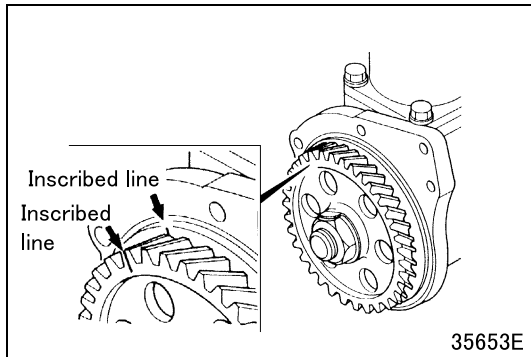
#### ■ Installation: Air compressor

- Bring the No. 1 cylinder of the engine to top dead center of the compression stroke.
- After aligning inscribed lines with each other, install the air compressor to the flywheel housing.

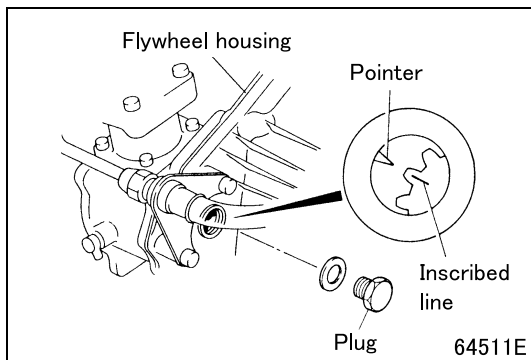
- Remove the inspection plug and check if the inscribed line is aligned with the pointer.
- If not aligned, remove and refit the air compressor.

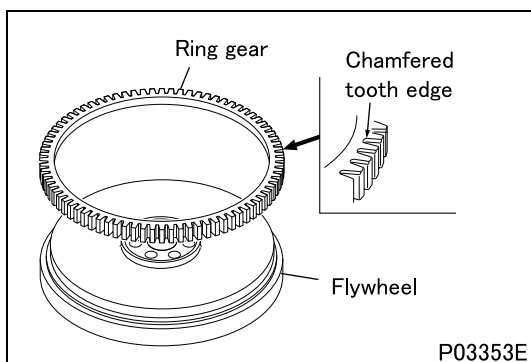
#### ■ Installation: Ring gear

- Heat the ring gear evenly with a gas burner or the like until it reaches approximately 200°C {390°F}.

- **You may burn yourself if you touch the heated ring gear.**
- Fit the ring gear with the side having non-chamfered tooth edges toward the flywheel.

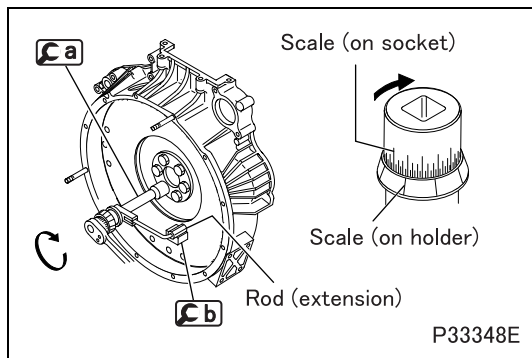
- Tighten the flywheel mounting bolts to a torque of 98 N·m {72 ft.lbs, 10 kgf·m}.
- Further tighten the bolts in the following procedure.
  - Turn the holder of **Ca** counterclockwise to preload the built-in spring.
  - Set **Ca** such that the rod (extension) is pressed against **Cb** by the force of the spring.
  - Align any line on the holder scale with any line on the socket scale. (This will be used as the reference point = 0°.)
  - From the reference point, turn the socket by  $150^{\circ} +10^{\circ}_0^{\circ}$  clockwise. Each division on the socket scale represents 5°.
  - After tightening the bolt within the plastic region, make a punch mark on the bolt head for subsequent identification.

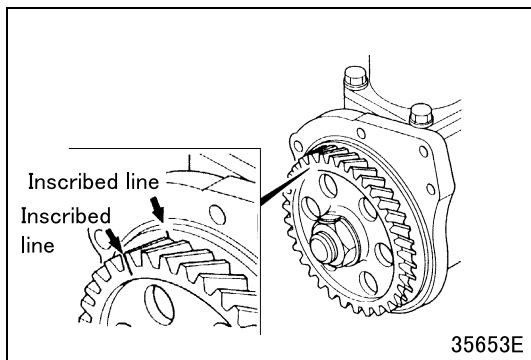
#### ■ Installation: Air compressor

- Bring the No. 1 cylinder of the engine to top dead center of the compression stroke.
- After aligning inscribed lines with each other, install the air compressor to the flywheel housing.

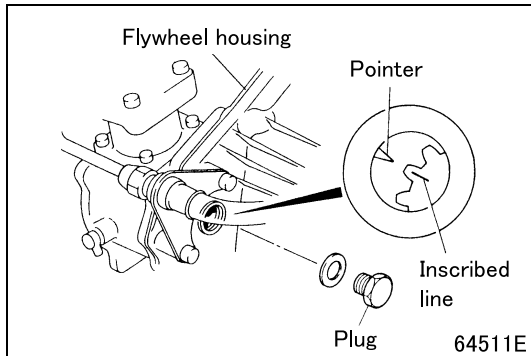
- Remove the inspection plug and check if the inscribed line is aligned with the pointer.
- If not aligned, remove and refit the air compressor.
