# FE.FG

## SERVICE MANUAL 2008 Model FOREWORD

This Service Manual contains maintenance and repair methods for the Mitsubishi Fuso Truck FE. FG Series. Read this manual carefully as an aid in providing correct, efficient maintenance. Please note that the information and specifications contained within this manual may change without notice. This is due to product modifications and continued vehicle improvements that are made throughout the model years. Should you encounter any discrepancy in the information provided, please do not hesitate to contact your nearest Mitsubishi Fuso Dealer or Mitsubishi Fuso Truck of America, Inc.

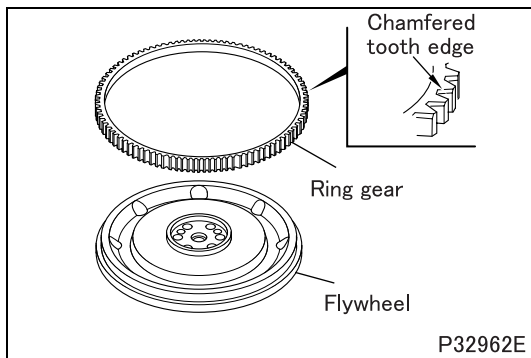
#### ■ Installation: Ring gear

- Heat the ring gear evenly with a gas burner or the like until it reaches approximately 200°C {390°F}.

- **You may burn yourself if you touch the heated ring gear.**
- Fit the ring gear with the side having non-chamfered tooth edges toward the flywheel.

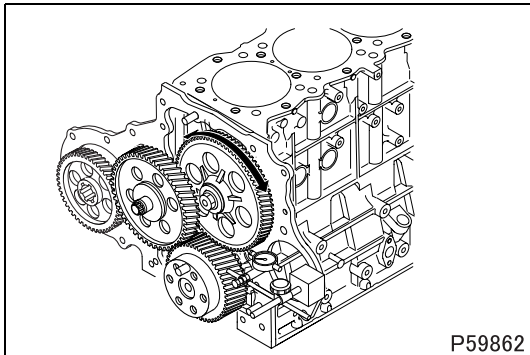
### ■ Inspection: Backlash between gears

- For each pair of gears, measure the backlash at more than three teeth.
- If any of the measurements exceeds the specified limit, replace the defective part(s).

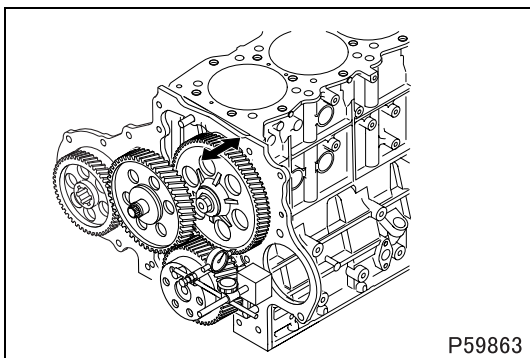
### ■ Inspection: Idler gear end play

- If the measurement exceeds the specified limit, replace the defective part(s).

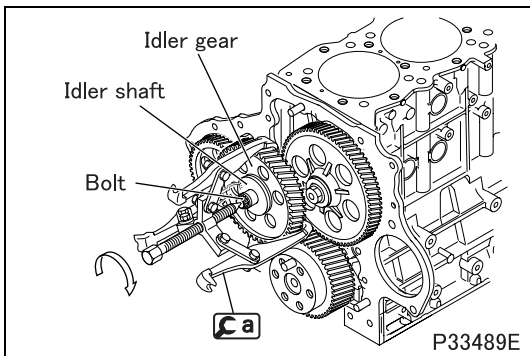
### ■ Removal: No. 1 idler shaft and No. 1 idler gear

- With the bolt loosened by approximately 15 mm {0.59 in.}, pull out the No. 1 idler shaft from the crankcase using **Ca**.
- Remove the bolt. Remove the No. 1 idler shaft and No. 1 idler gear.

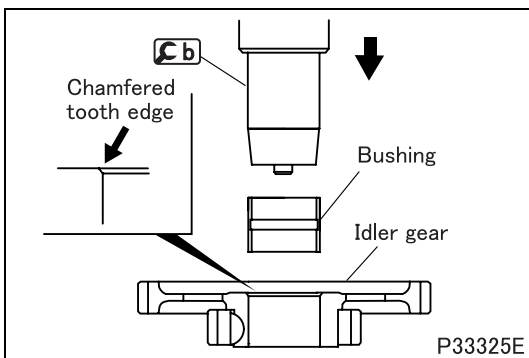
- Place the No. 1 idler gear as shown in the illustration. Using **Cb**, insert the bushing until **Cb** contacts the chamfered tooth edge of the gear.
- After installation, measure the clearance again.
- If the measurement is less than the standard value, ream the bushing.

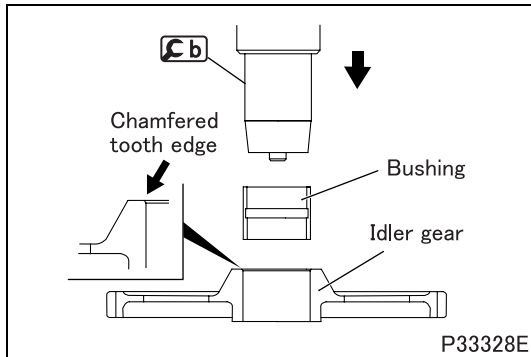
- Place the No. 2 idler gear as shown in the illustration. Using **Cb**, insert the bushing until **Cb** contacts the chamfered tooth edge of the gear.
- After installation, measure the clearance again.
- If the measurement is less than the standard value, ream the bushing.

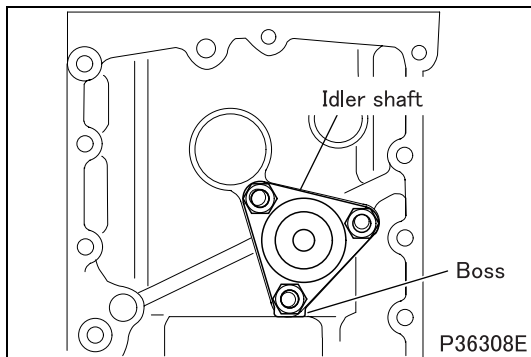
### ■ Installation: No. 2 idler shaft

- Install the No. 2 idler shaft onto the crankcase ensuring that the boss of the shaft faces down.

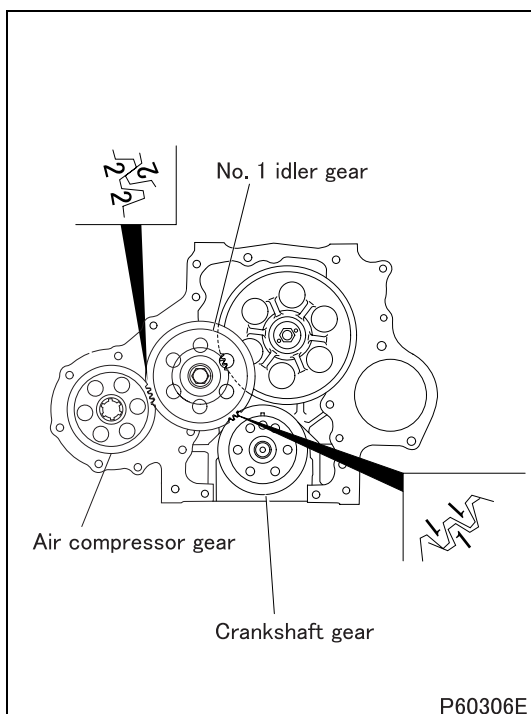
### ■ Installation: No. 1 idler gear

- Install the No. 1 idler gear such that the alignment mark "2" on the gear is aligned with the alignment mark "2 2" on the air compressor gear.
- When installing the No. 1 idler gear, also ensure that the alignment mark "1 1" on the gear is aligned with the alignment mark "1" on the crankshaft gear.

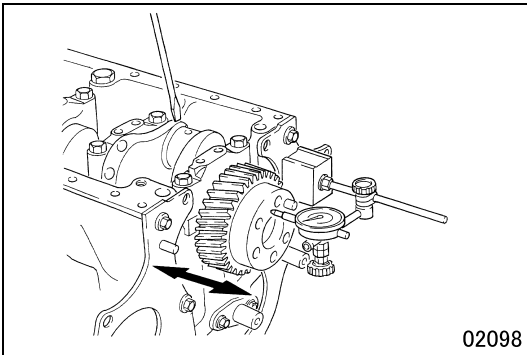
#### ■ Inspection: Crankshaft end play

- If the measurement exceeds the specified limit, replace the thrust plates with oversized ones.

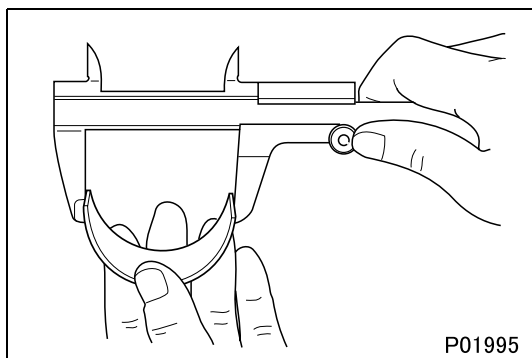
### ■ Inspection: Main bearing span when free

- If the measurement is less than the limit, replace upper and lower bearings as a set.

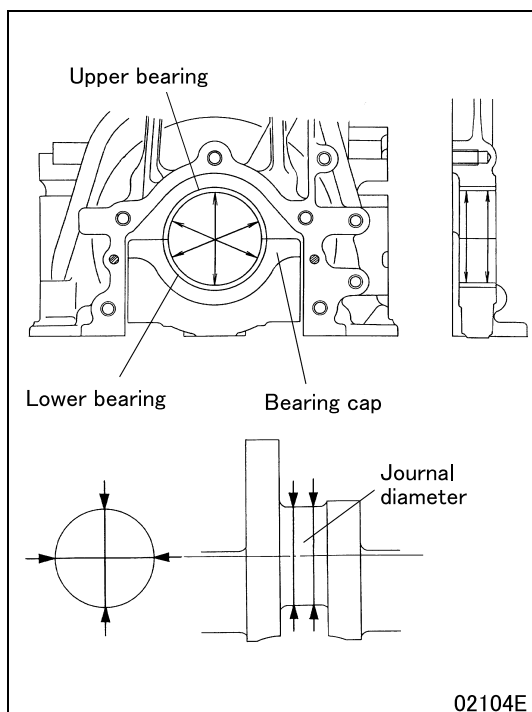
### (2) Main bearing-to-crankshaft oil clearance

- Fit the upper main bearing into the crankcase and the lower main bearing into the main bearing cap.
- Tighten the main bearing cap bolts to a torque of 78 N·m {58 ft.lbs, 8 kgf·m}.
- Measure the inside diameter of the main bearing and the diameter of the corresponding crankshaft journal.
- If the difference between the measurements exceeds the specified limit, machine the crankshaft journal to one of the specified undersize dimensions.

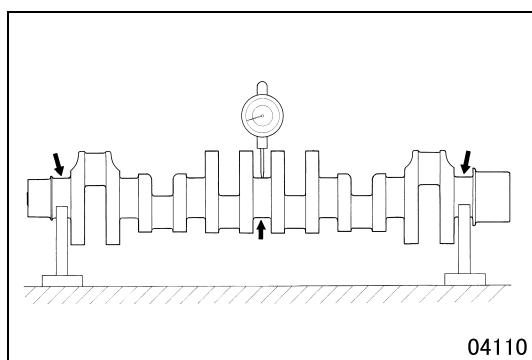
### ■ Inspection: Crankshaft

- Place supports under the journals at the ends of the crankshaft and measure the bend of the crankshaft at the center journal. The amount of crankshaft bend is obtained by giving the crankshaft one turn and dividing the dial gauge reading by two.
- If the measurement exceeds the specified limit, replace the crankshaft.

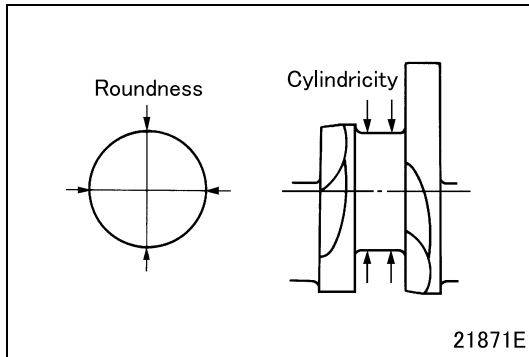
## (2) Roundness and cylindricity of crankshaft journals and pins

- If any of the measurements exceeds the specified limits, grind the crankshaft journal(s) and/or pin(s) to undersize(s) or replace the crankshaft.

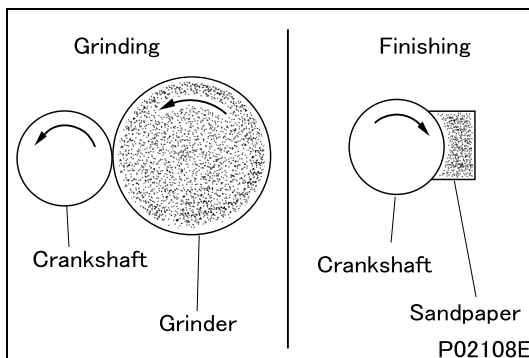
- When grinding, turn both the crankshaft and the grinder counter-clockwise as viewed from the crankshaft front end.
- When finishing the crankshaft with westone or sandpaper, rotate the crankshaft clockwise.

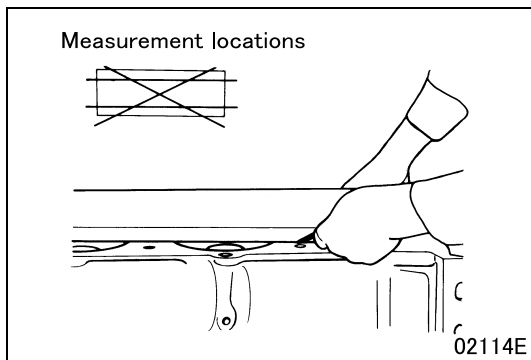
## ■ Inspection: Distortion of crankcase top surface

- If the measurement exceeds the limit, correct the crankcase top surface with a surface grinder.

- Do not grind the crankcase top surface so much as to compromise the correct piston projection.

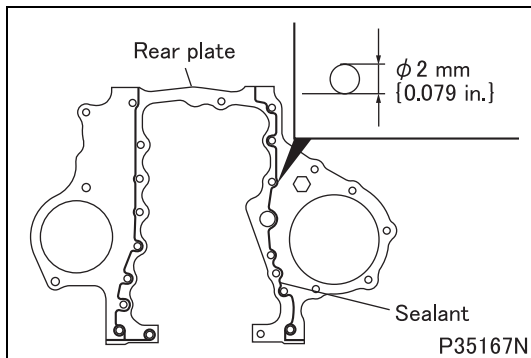
## ■ Installation: Rear plate

- Apply an even and continuous bead of sealant onto the rear plate surface where the crankcase is to be mounted.
- Install the rear plate onto the crankcase within 3 minutes following the application.

- Clean the rear plate surface where sealant is to be applied.
- When installing the rear plate, take care not to spread the sealant beyond the application area.
- Do not start the engine at least for an hour after the rear plate has been installed.
- If the rear plate mounting bolts are subsequently loosened, be sure to apply sealant again upon reassembly.

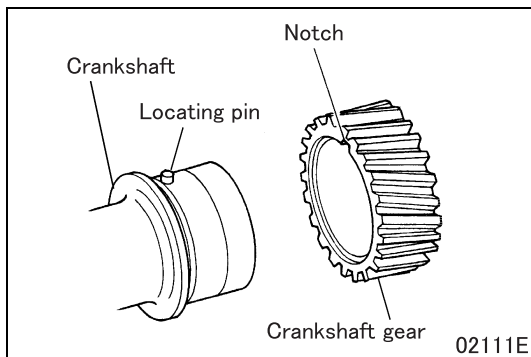
## ■ Installation: Crankshaft gear

- Heat the crankshaft gear to approximately 100°C {212°F} with a burner or the like.

- Align the key fitted in the crankshaft with the slot in the crankshaft gear. Drive the gear into position by lightly striking its end face with a plastic hammer.

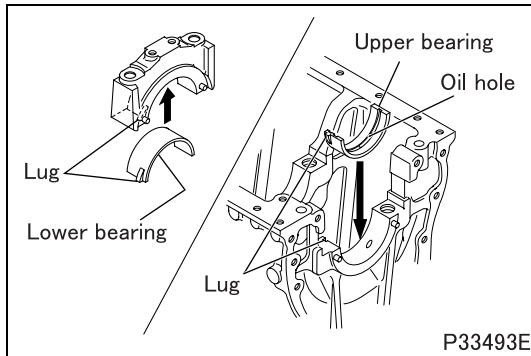
#### ■ Installation: Main bearing

- Install the main bearings with their lugs aligned as shown in the illustration. When the crankshaft journals have been ground to an undersize, use undersized main bearings.  
Available main bearing undersizes: 0.25 mm {0.0098 in.}, 0.50 mm {0.020 in.}, 0.75 mm {0.030 in.}, 1.00 mm {0.039 in.}

- The upper main bearing has an oil hole. The lower main bearing has no oil hole. Do not confuse the upper and lower bearings, as this can cause seizure in the engine.

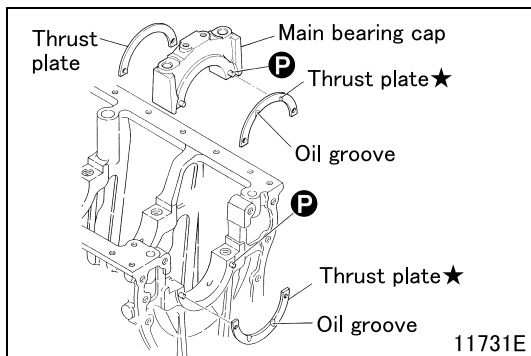
#### ■ Installation: Thrust plate

- Install thrust plates on both sides of the main bearing cap and the rear end of the crankcase, ensuring that the oil grooves face outside.

- If thrust plates are installed with the oil grooves facing inside, the engine may seize.

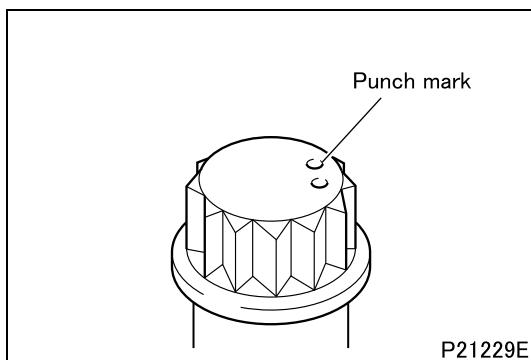
#### ■ Installation: Main bearing cap

- Before installing the main bearing cap bolts, check the number of punch marks on the head of each bolt. (A bolt with two or less marks is reusable.)
- The number of punch marks corresponds with the number of times the main cap bolt has been tightened using the torque-turn tightening method. Any bolt that has three marks (i.e. that has been used three times) must be replaced.

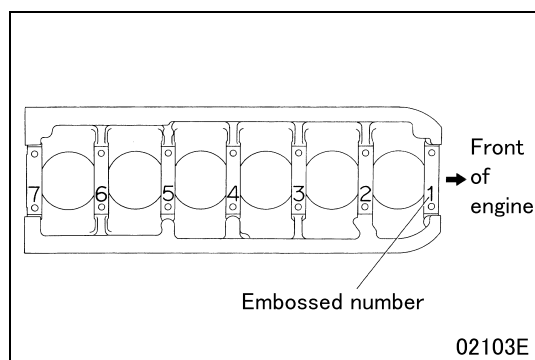
- Starting at the front of the engine, fit the main bearing caps in the order of the embossed numbers facing the illustrated direction.

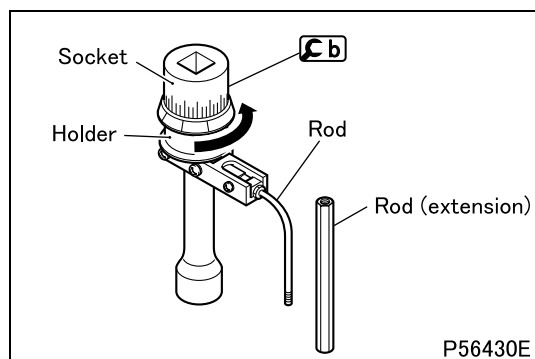
- Tighten all the bolts to 78 N·m {58 ft.lbs, 8 kgf·m}, then additionally tighten them according to the following procedure.
- Turn the holder of counterclockwise to pretension the internal spring.

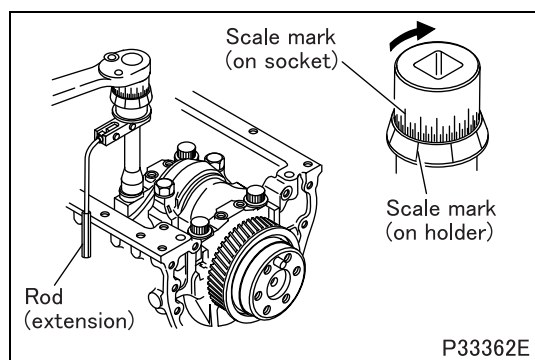
- Set such that the rod (extension) is pressed against the crankshaft by the force of the spring.
  - Align a scale mark on the socket with a scale mark on the holder. (This point will be the point of reference, or the 0° point.)
  - Starting with this point of reference, turn the socket with a wrench in the illustrated direction until the scale on the socket indicates 90°.
- One graduation on the socket-side scale represents 5°.
- After tightening the bolts using the above torque-turn tightening method, make a punch mark on the head of each bolt to indicate the number of times that it has been used.

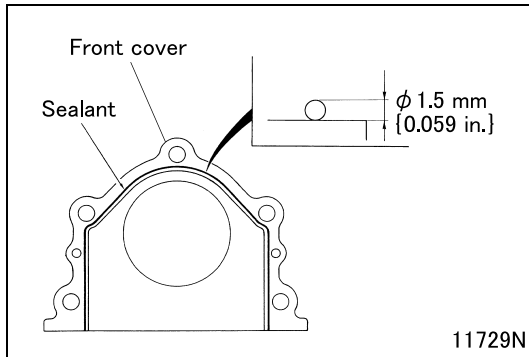
**■ Installation: Front cover**

- Apply an even and continuous bead of sealant onto the front cover surface where the crankcase is to be mounted.
- Install the front cover onto the crankcase within 3 minutes following the application.

- Clean the front cover surface where sealant is to be applied.
- When installing the front cover, take care not to spread the sealant beyond the application area.
- Do not start the engine at least for an hour after the front cover has been installed.
- If the front cover mounting bolts are subsequently loosened, be sure to apply sealant again upon reassembly.

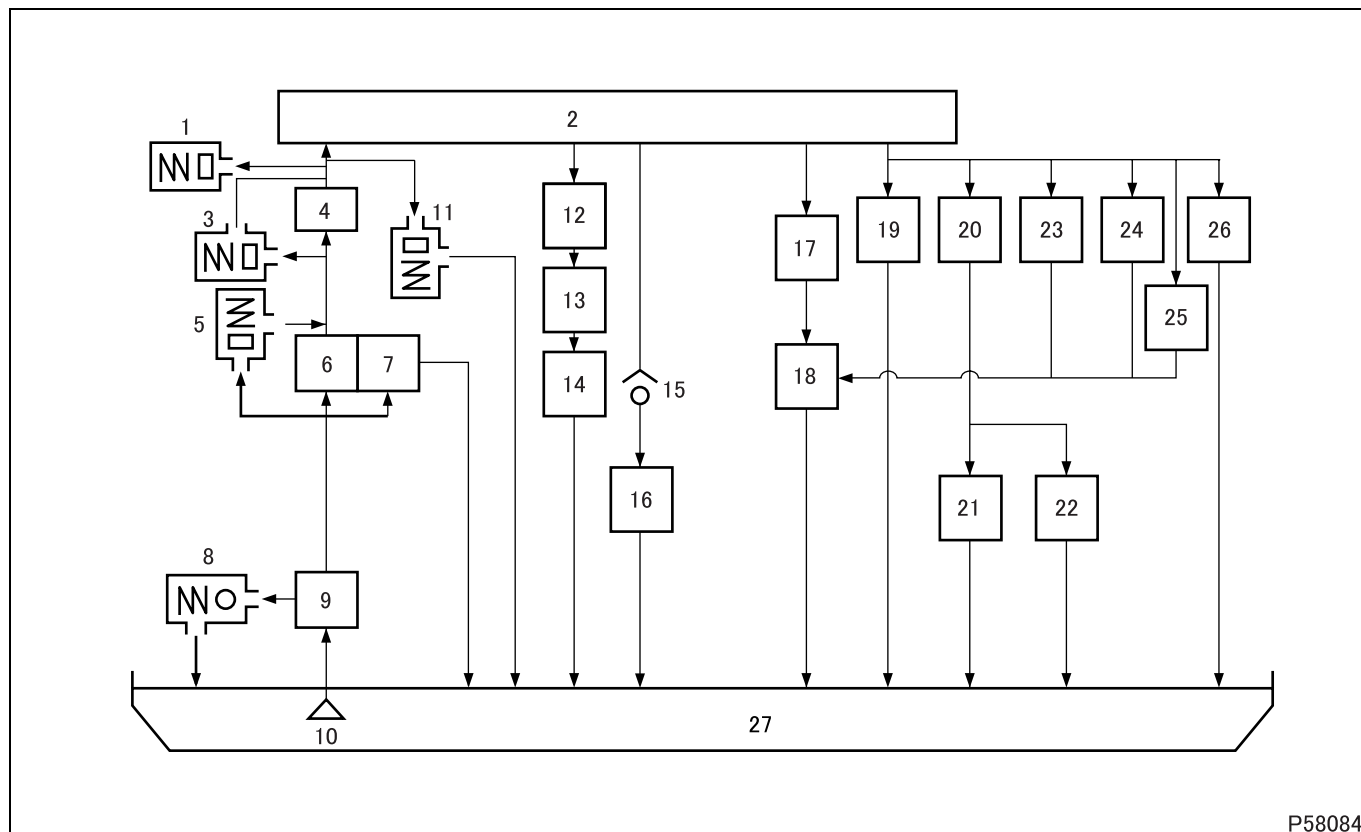
P58084

## 1. Lubrication System

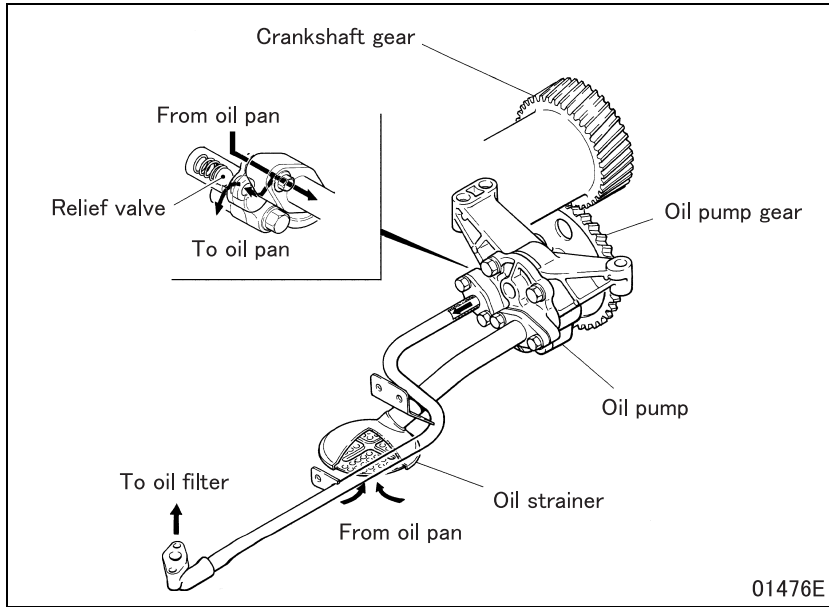
## 2. Oil Pump

- This engine uses a gear-type oil pump driven by the rotation of the crankshaft transmitted through the engagement of the crankshaft gear and the oil pump gear.
- The oil pump has a relief valve, which prevents excessive pressure from building up inside the lubricating system by allowing part of the engine oil to escape to the oil pan when the oil pressure exceeds a specified level.

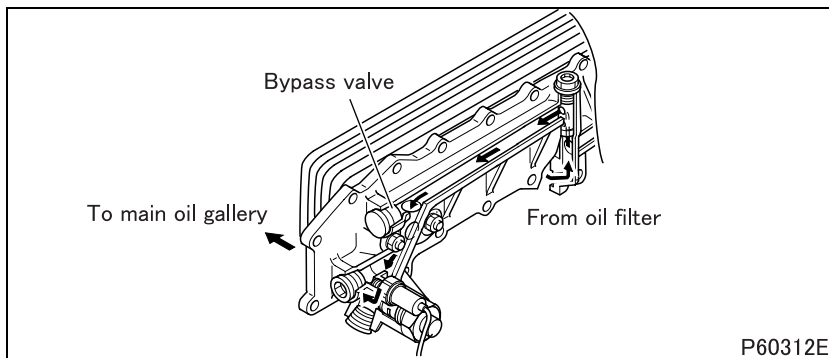
#### 3.1 Bypass valve

- When the engine oil is cool and its viscosity is high, or when the oil cooler element becomes clogged and restricts the flow of the engine oil, the bypass valve opens to let the engine oil bypass the oil cooler and flow directly to the oil filter.

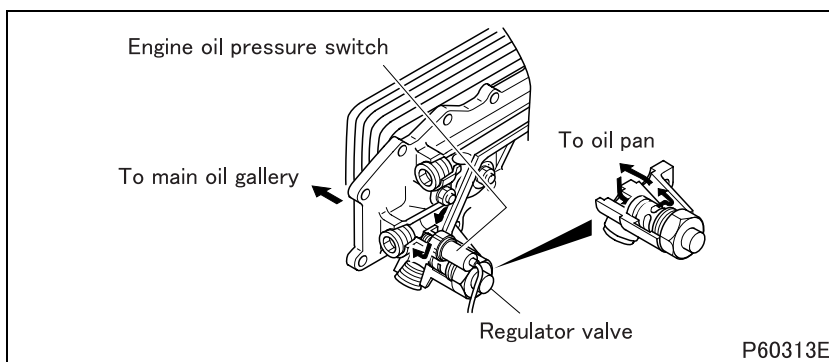
#### 3.2 Engine oil pressure switch and regulator valve

- When the pressure of the engine oil to the main oil gallery drops below the specified level, an electrical contact inside the engine oil pressure switch closes. This causes a warning lamp on the meter cluster to illuminate and notify the operator of the excessive pressure drop.
- When the oil pressure in the main oil gallery exceeds the specified level, the regulator valve opens to adjust the oil pressure by allowing part of the engine oil to escape to the oil pan.

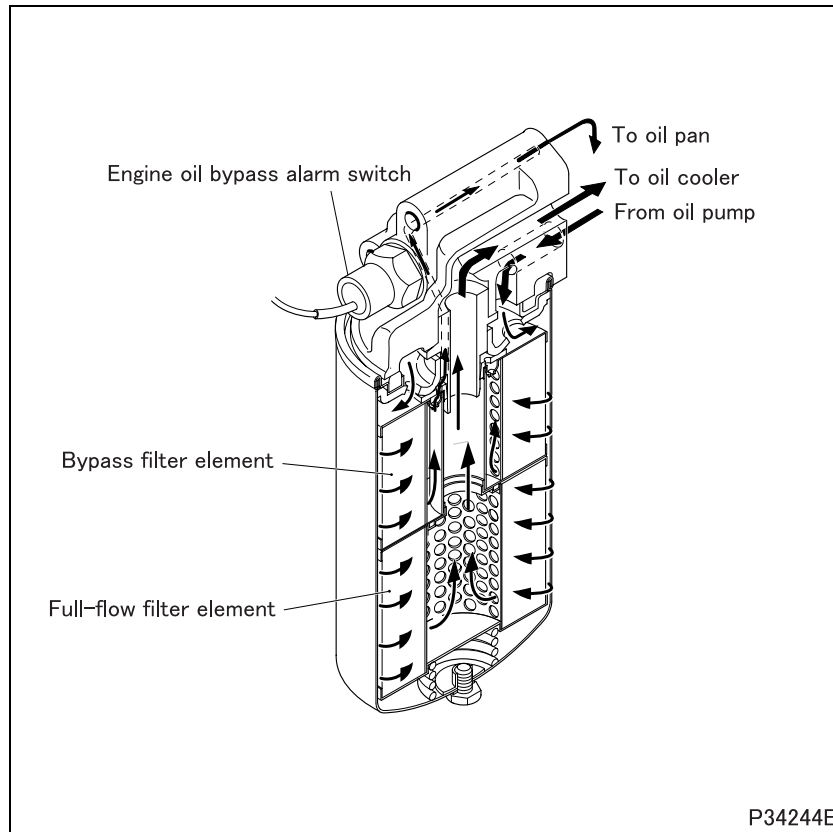
## 4. Oil Filter

- This oil filter is a spin-on paper-filter type that incorporates both a full-flow filter and a bypass filter.

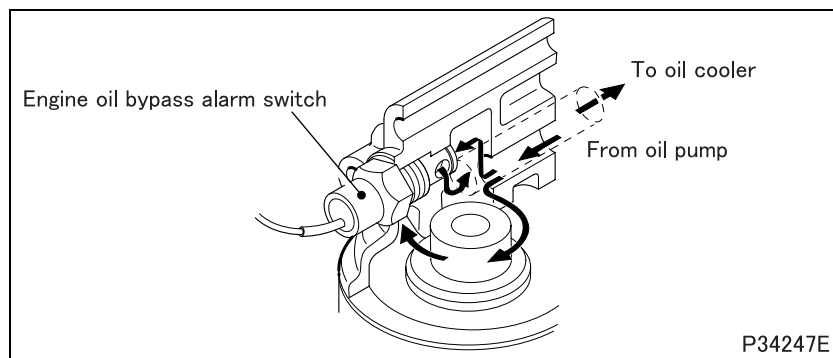
### 4.1 Engine oil bypass alarm switch

- If the oil filter elements clog up, this will restrict the flow of engine oil, causing the engine to seize. To prevent this, the oil filter is provided with the engine oil bypass alarm switch.
- If the oil filter clogs up, the engine oil bypass alarm switch trips in such a way as to direct the engine oil straight on to the oil cooler, bypassing the full-flow and bypass filter elements. When the switch trips, the relevant warning lamp illuminates to alert the operator to the clogged oil filter.

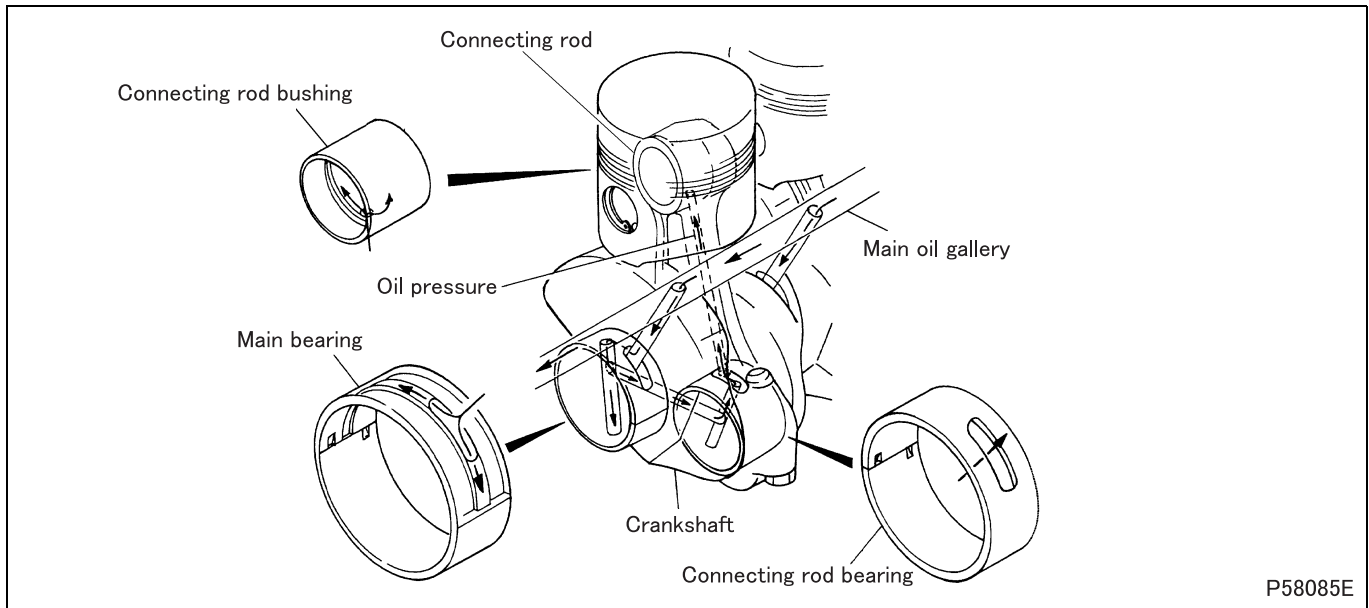
### 5.1 Main bearing and connecting rod bearing

- Engine oil supplied through an oil passage in the crankshaft lubricates the big end (connecting rod bearing) of each connecting rod. Simultaneously, engine oil supplied through an oil passage in the connecting rod lubricates the connecting rod's small end.

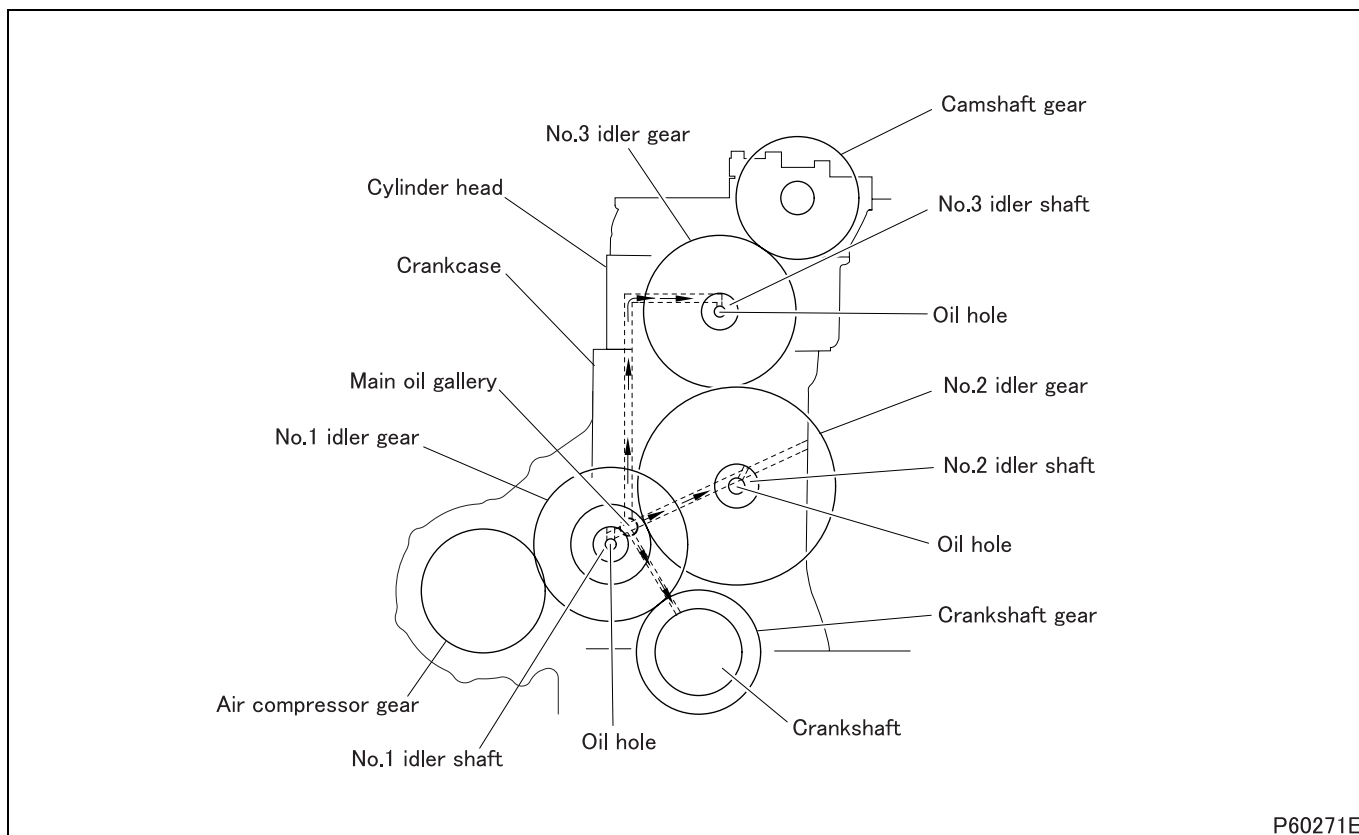
## 5.2 Timing gears

- Engine oil in the main oil gallery is directed through the oil passages in the crankcase and cylinder head and is used to lubricate the various gear shafts. After lubricating the gear shafts, the oil is used to lubricate the gears before returning the oil pan.

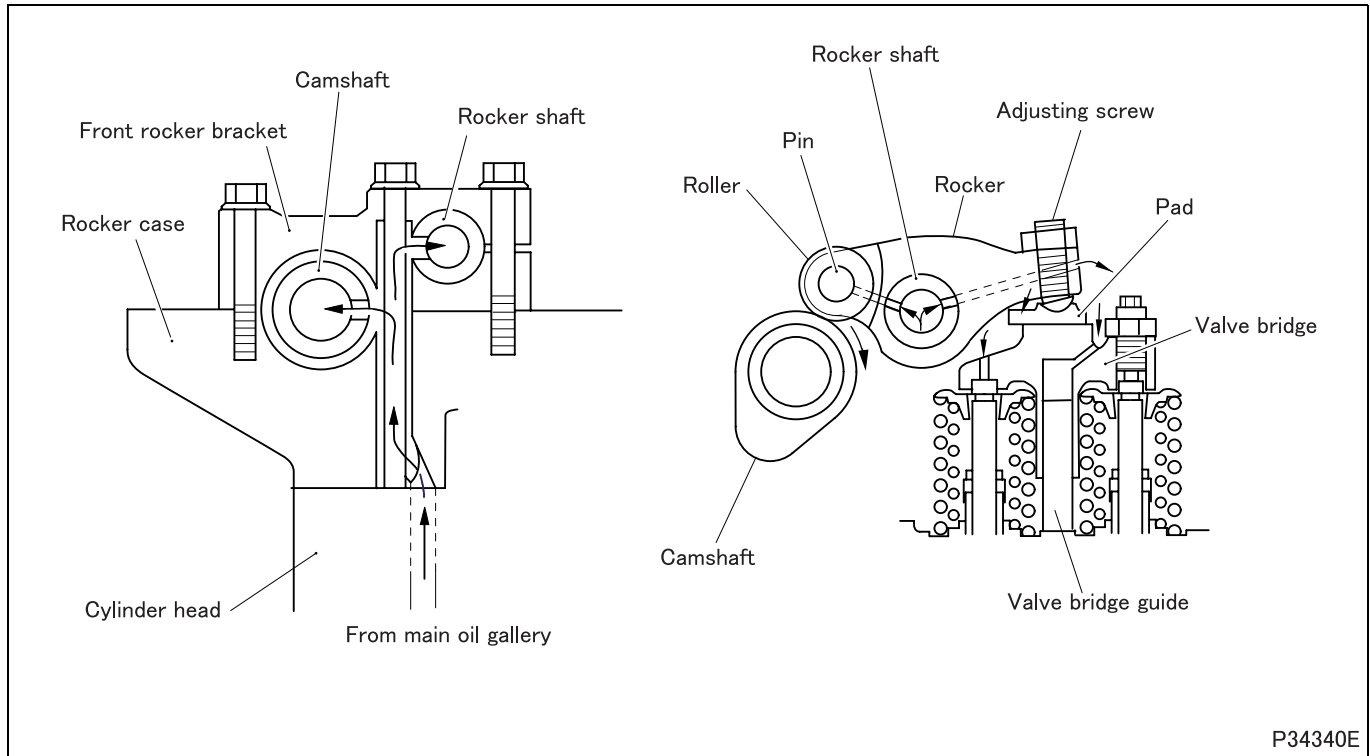
### 5.3 Valve mechanism

- Engine oil in the main oil gallery is directed through the oil passages in the cylinder head, rocker case and front rocker bracket. The oil is then supplied through the camshaft and rocker shaft. The oil flowing through the camshaft also lubricates the camshaft journals. The oil flowing through the rocker shaft also lubricates the rockers. The oil flowing to the adjusting screws on the rockers also lubricates the valve bridges. After lubricating the various parts, the oil returns to the oil pan.

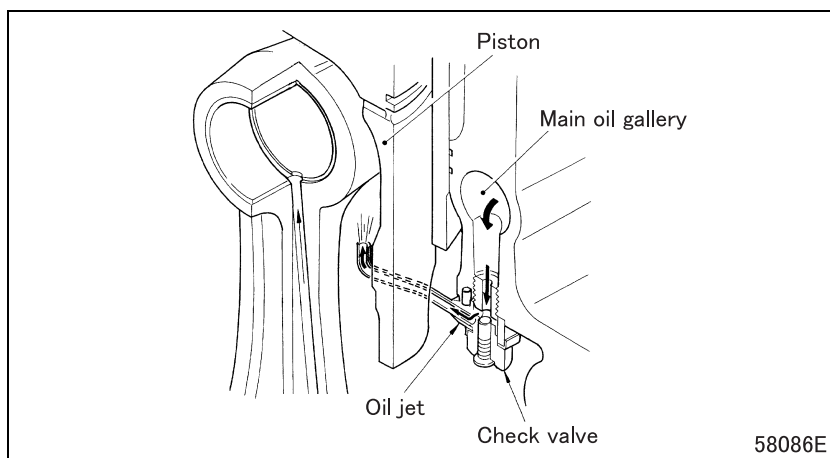
### 5.4 Check valves and oil jets

- An oil jet is fitted in the lower part of the main oil gallery for each cylinder.
- Engine oil is sprayed out of the oil jet into the piston to cool the piston.
- Each oil jet is fitted with a check valve that opens and closes at predetermined oil pressure levels. At low engine speeds, the check valve closes to maintain the required volume of oil in the lubrication system and prevent reductions in oil pressure.

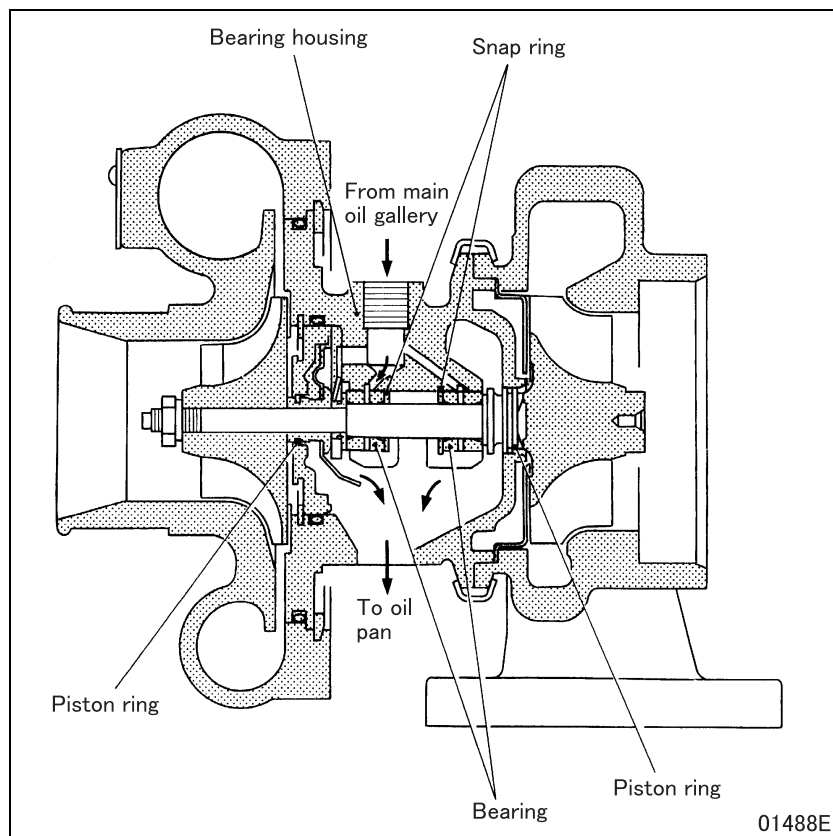
## 5.5 Turbocharger

- Engine oil in the main oil gallery is directed through a pipe to the bearing housing to lubricate the inner components.
- A piston ring is provided on each end of the turbine wheel shaft. The rings function as oil sealing.

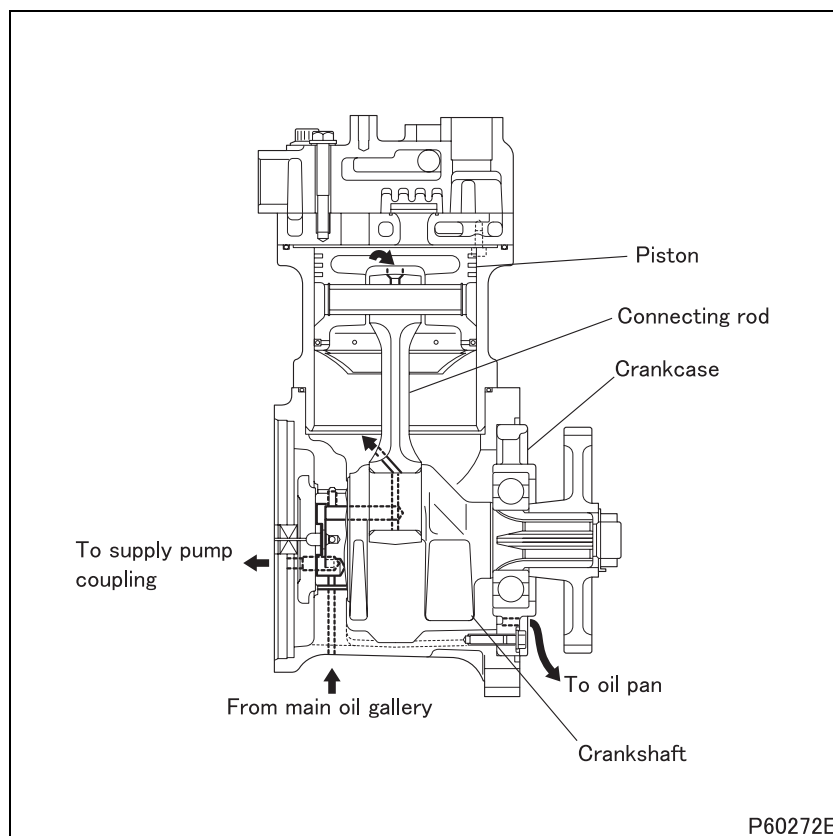
## 5.6 Air compressor

- Engine oil in the main oil gallery is directed through a passage in the crankshaft to the supply pump coupling and also to the big ends of the connecting rods to lubricate these parts. At the same time, the pistons and the small ends of the connecting rods are splash-lubricated with engine oil by the rotating crankshaft.

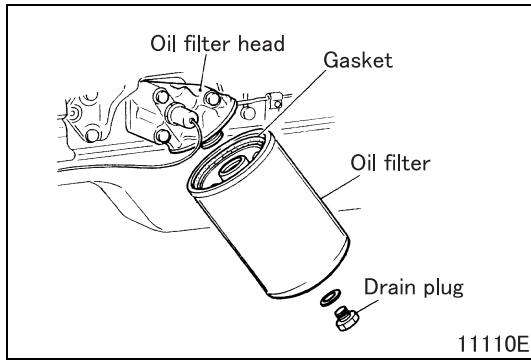
**[Installation]**

- Clean the surface of the oil filter head where the oil filter is to be mounted.
- Apply a thin coat of engine oil onto the oil filter gasket.
- Screw in the oil filter by hand until the gasket contacts the oil filter head. Tighten further by  $1 \frac{1}{8}$  to  $1 \frac{3}{8}$  of a turn.
- Install the drain plug.
- With the oil filter installed, start the engine and ensure that there is no oil leakage through the gasket.
- If oil is leaking, remove and reinstall the oil filter.
- Stop the engine and check the engine oil level.
- Add engine oil if the engine oil level is low.

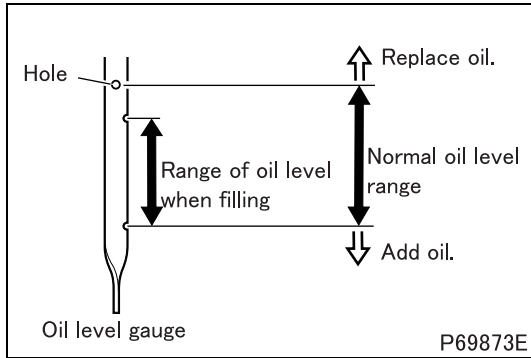
### 3. Engine Oil Level Inspection

- When regenerating the DPF (diesel particulate filter), a part of the injected fuel may mix into the engine oil and may increase the quantity of oil.
- If the oil level is out of the normal range, add or replace the engine oil.

- **If the engine oil level exceeds the hole on the oil level gauge, replace the engine oil immediately as the oil has deteriorated and may cause seizure.**
- If remarkable increase of the engine oil is observed, check the following even the oil level is within the normal range.
  - Seizure of piston ring and piston
  - Excessive clearance between piston and cylinder liner

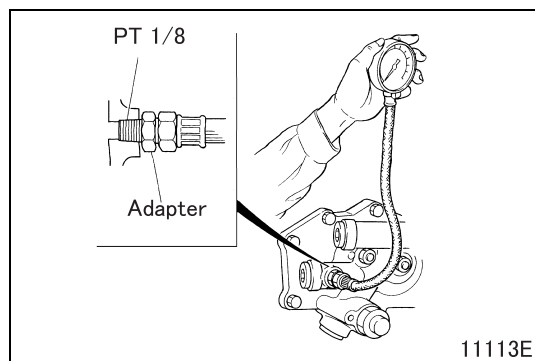
- Using an adapter, connect an oil pressure gauge to the engine oil pressure switch mounting hole.
- Warm up the engine until the oil temperature reaches 70 to 90°C {158 to 194°F}.
- Measure the oil pressure while running the engine at a minimum speed and then at maximum speed, both under no load.
- If the measurements are below the specified limits, overhaul the lubrication system.
- After taking the measurements, wrap the threads of the engine oil pressure switch with teflon tape and then tighten the switch to the specified torque.

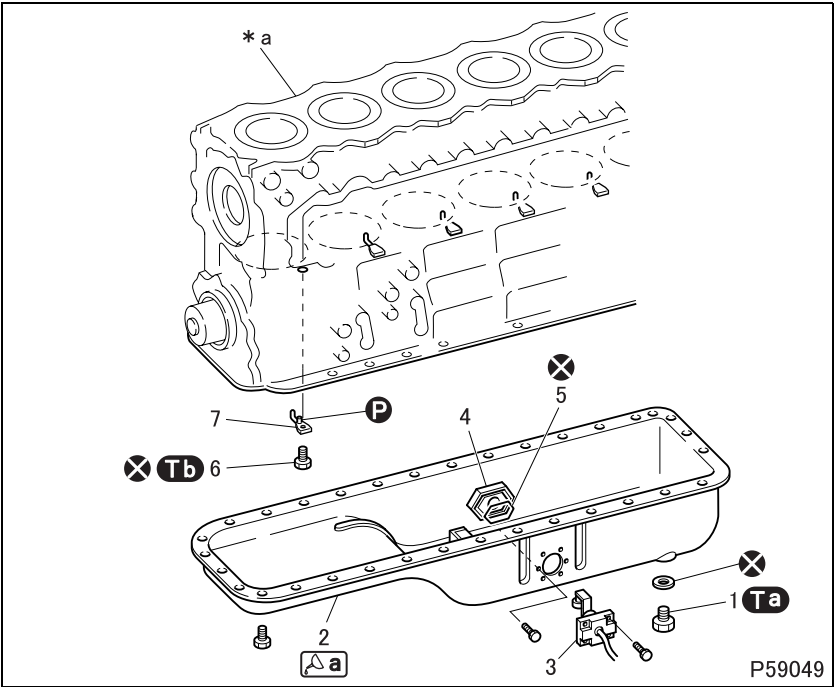
● Disassembly sequence

- 1 Drain plug
- 2 Oil pan
- 3 Engine oil level sensor
- 4 Retainer
- 5 O-ring
- 6 Check valve
- 7 Oil jet

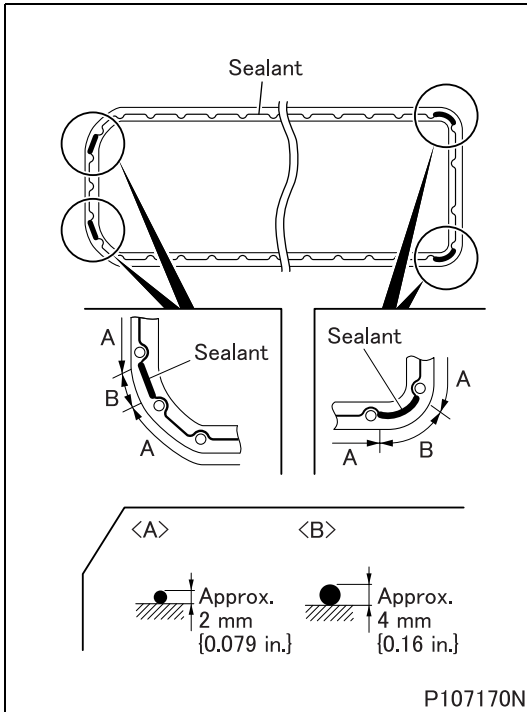
### ■ Installation: Oil pan

- Clean the mating surfaces of each part.
- Apply a bead of sealant to the mating surface of the oil pan evenly and without any breaks.
- Apply amount B of the sealant to the 4 corners and amount A to the other places as shown in the illustration.
- Mount the oil pan within three minutes of applying the sealant. Make sure that the sealant stays in place.

- Do not start the engine less than an hour after installation. If the oil pan mounting bolts were loosened or removed, be sure to reapply sealant.

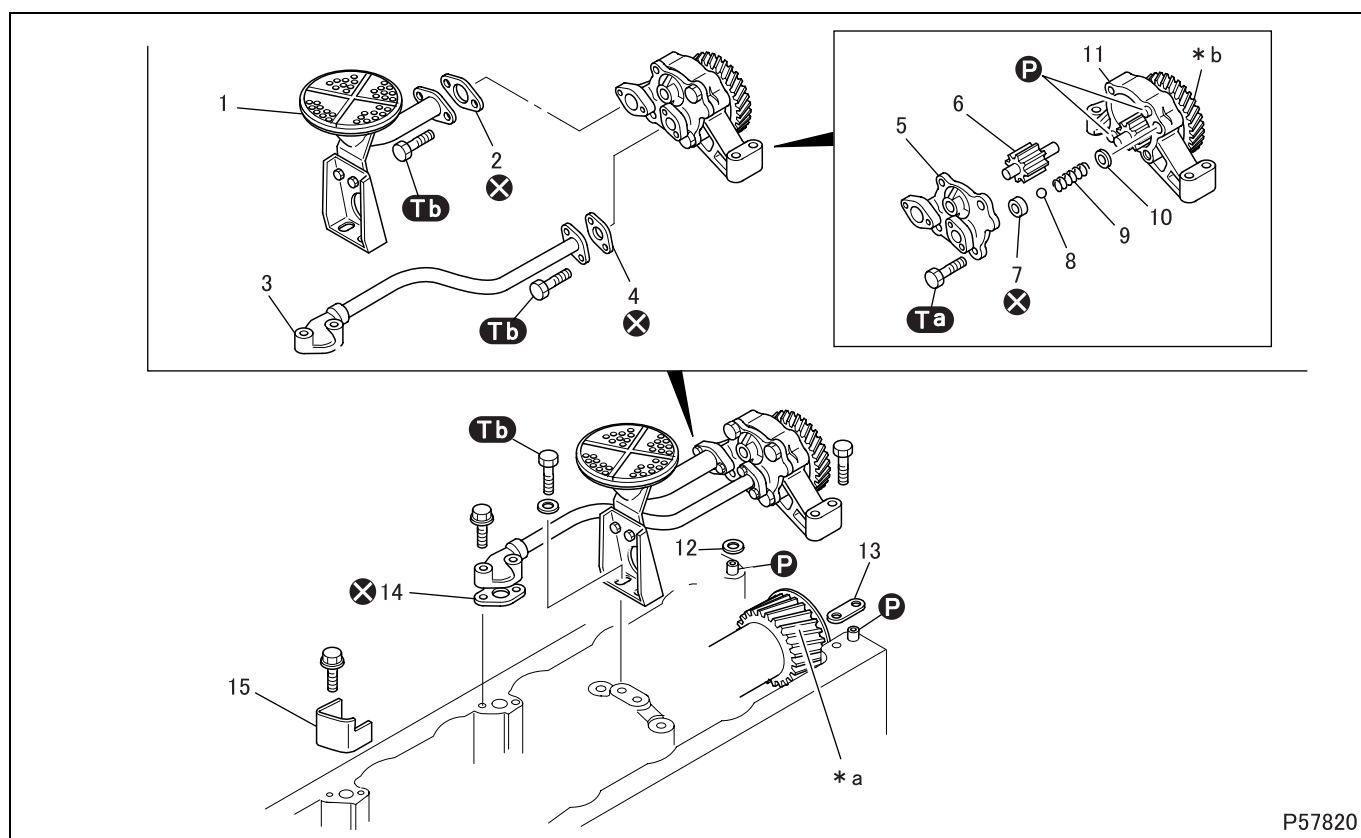
P57820

# OIL PUMP, OIL STRAINER

- The oil strainer, the oil pipe and the oil pump must all be removed together as an assembly. Do not remove the oil strainer or the oil pipe separately from the oil pump unless they are defective.
- Do not disassemble the oil pump unless defects are evident.
- The gear and case assembly is not serviceable. If the gear and case assembly appears defective, replace it.

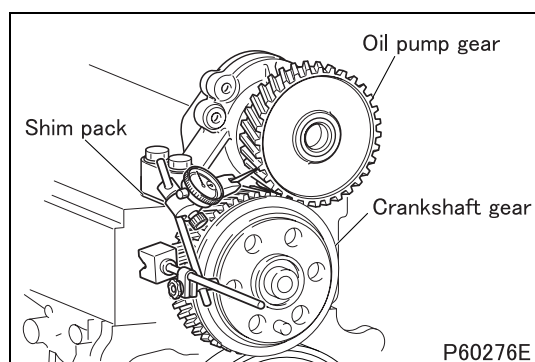
#### ■ Inspection: Backlash between oil pump gear and crankshaft gear

- If the measurement exceeds the limit, adjust by shimming.

- Perform shimming such that the shim packs on both sides will have the same thickness.

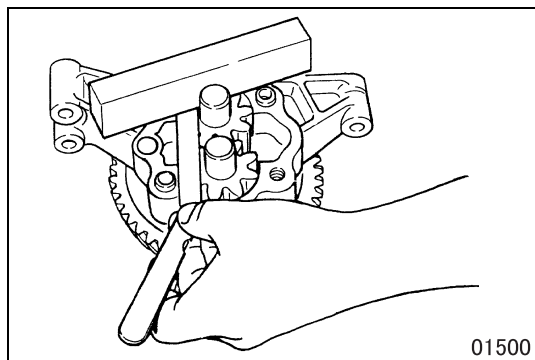
#### ■ Inspection: Driven gear, gear and case assembly

- Perform the following inspections. Replace the defective part(s) as required.

##### (1) Difference between case depth and height of each gear

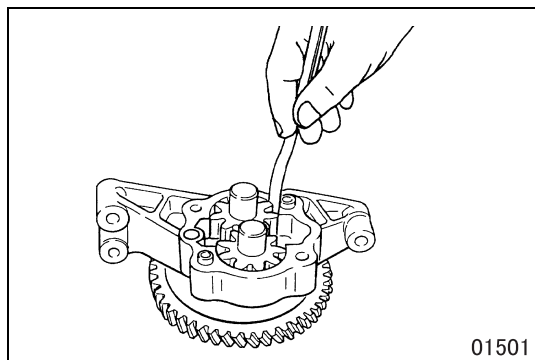
##### (2) Clearance between case and tooth tips of each gear

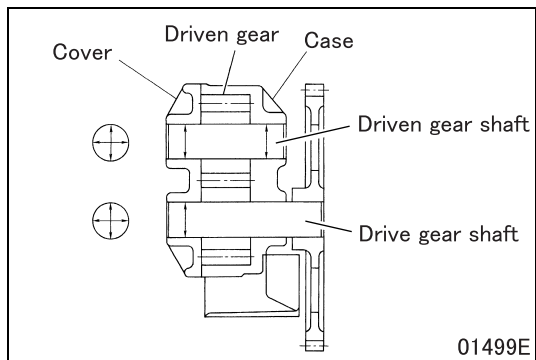
- (3) Clearance between drive gear shaft and cover
- (4) Clearance between driven gear shaft and case, and that between the shaft and cover

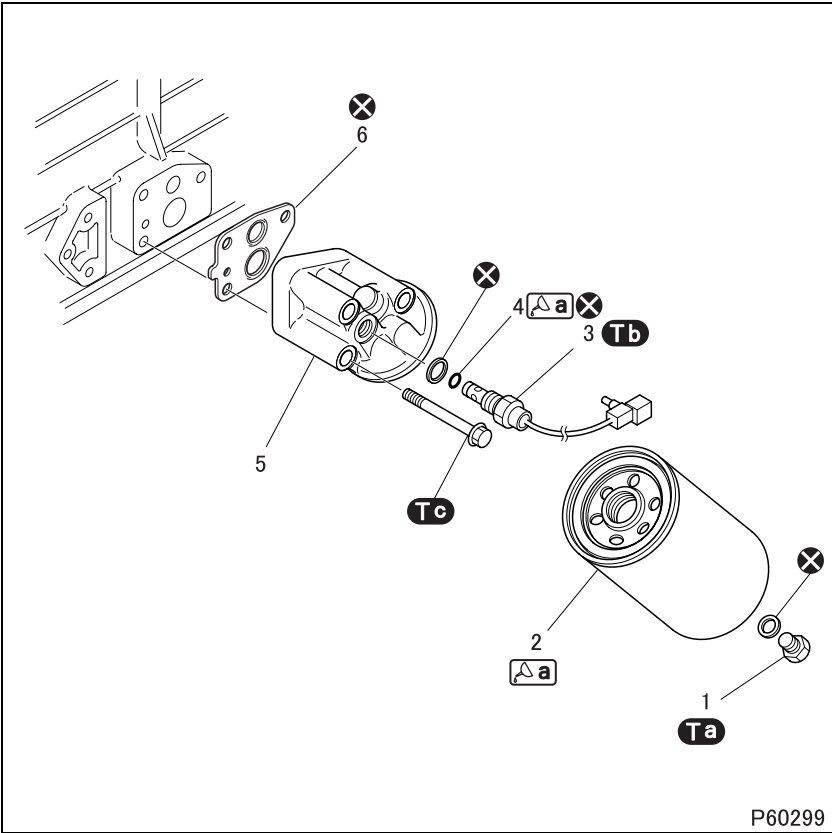
● Removal sequence

- 1 Drain plug
- 2 Oil filter
- 3 Engine oil bypass alarm switch
- 4 O-ring
- 5 Oil filter head
- 6 Gasket

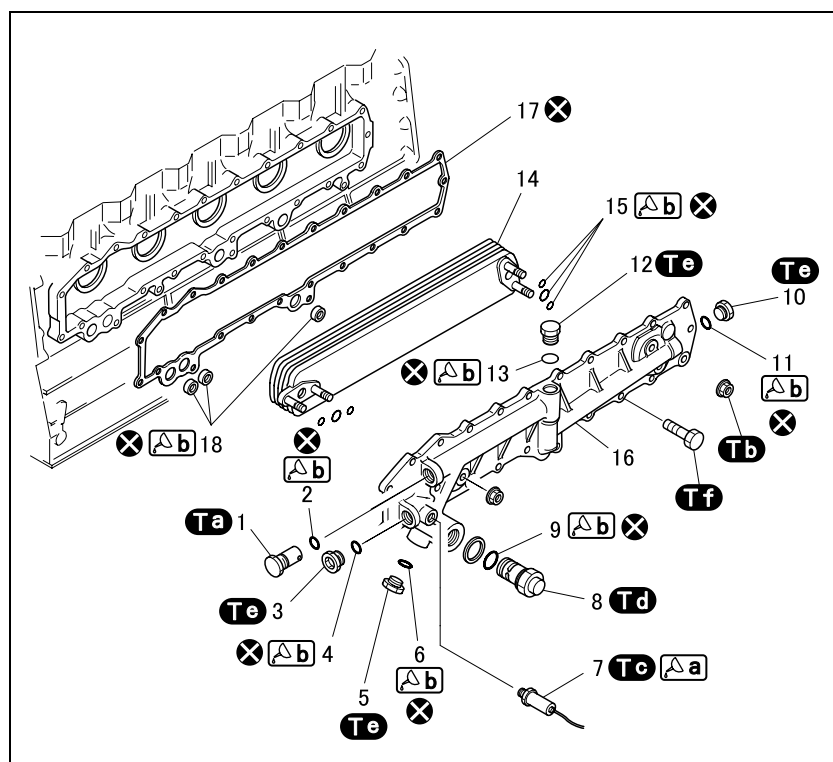
# OIL COOLER

## ● Removal sequence

- 1 Bypass valve
- 2 O-ring
- 3 Plug
- 4 O-ring
- 5 Plug
- 6 O-ring
- 7 Engine oil pressure switch
- 8 Regulator valve
- 9 O-ring
- 10 Plug
- 11 O-ring
- 12 Plug
- 13 O-ring
- 14 Oil cooler element
- 15 O-ring
- 16 Oil cooler cover
- 17 Gasket
- 18 O-ring

| Location | Maintenance item | Standard value | Limit | Remedy |
|---|---|---|---|---|
| 14 | Air leakage from oil cooler element (air pressure: 1470 kPa {215 psi, 15 kgf/cm <sup>2</sup> }) | 0 cm <sup>3</sup> {0 cu.in} | – | Replace |

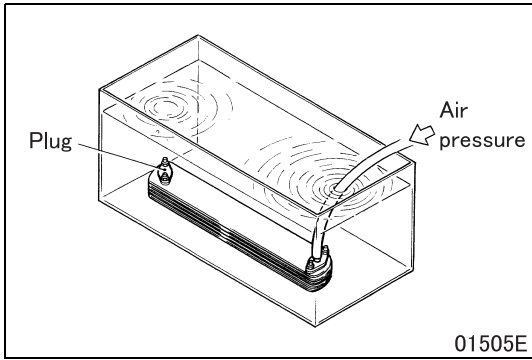
#### ■ Inspection: Oil cooler element

- Plug the outlet of the oil cooler element and connect a hose to the engine oil inlet port. Then, immerse the oil cooler element in a tank of water.
- Apply a specified air pressure for 15 seconds through the hose, and check for any air leaks.
- Replace the element if it leaks air.
