# FE.FG

## SERVICE MANUAL 2008 Model FOREWORD

This Service Manual contains maintenance and repair methods for the Mitsubishi Fuso Truck FE. FG Series. Read this manual carefully as an aid in providing correct, efficient maintenance. Please note that the information and specifications contained within this manual may change without notice. This is due to product modifications and continued vehicle improvements that are made throughout the model years. Should you encounter any discrepancy in the information provided, please do not hesitate to contact your nearest Mitsubishi Fuso Dealer or Mitsubishi Fuso Truck of America, Inc.

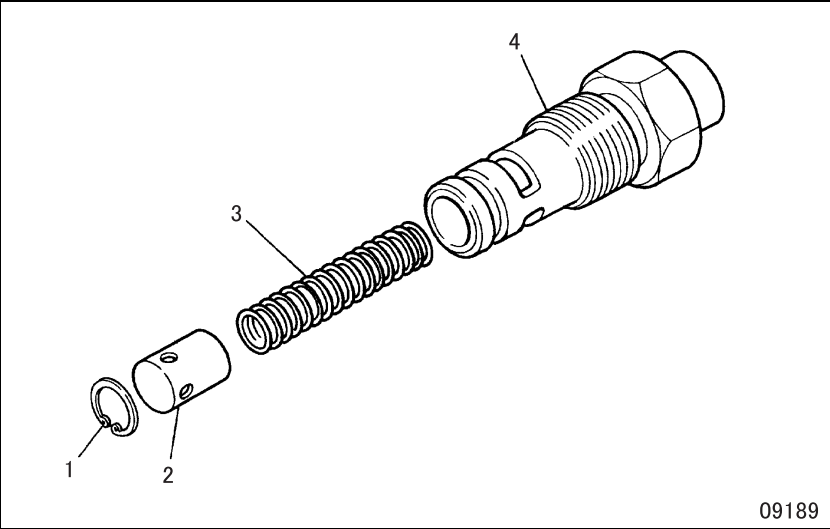
# REGULATOR VALVE

● **Disassembly sequence**

- 1 Snap ring
- 2 Valve
- 3 Spring
- 4 Body

| Location | Maintenance item | Standard value | Limit | Remedy |
|---|---|---|---|---|
| – | Regulator valve opening pressure | 392 ± 29 kPa<br>{57 ± 4.2 psi,<br>4.0 ± 0.3 kgf/cm <sup>2</sup> } | – | Replace |
| 3 | Spring installed load (installed length 48.3 {1.90}) | 78.5 ± 1.96 N<br>{18 ± 0.4 lbs,<br>8.0 ± 0.2 kgf} | – | Replace |

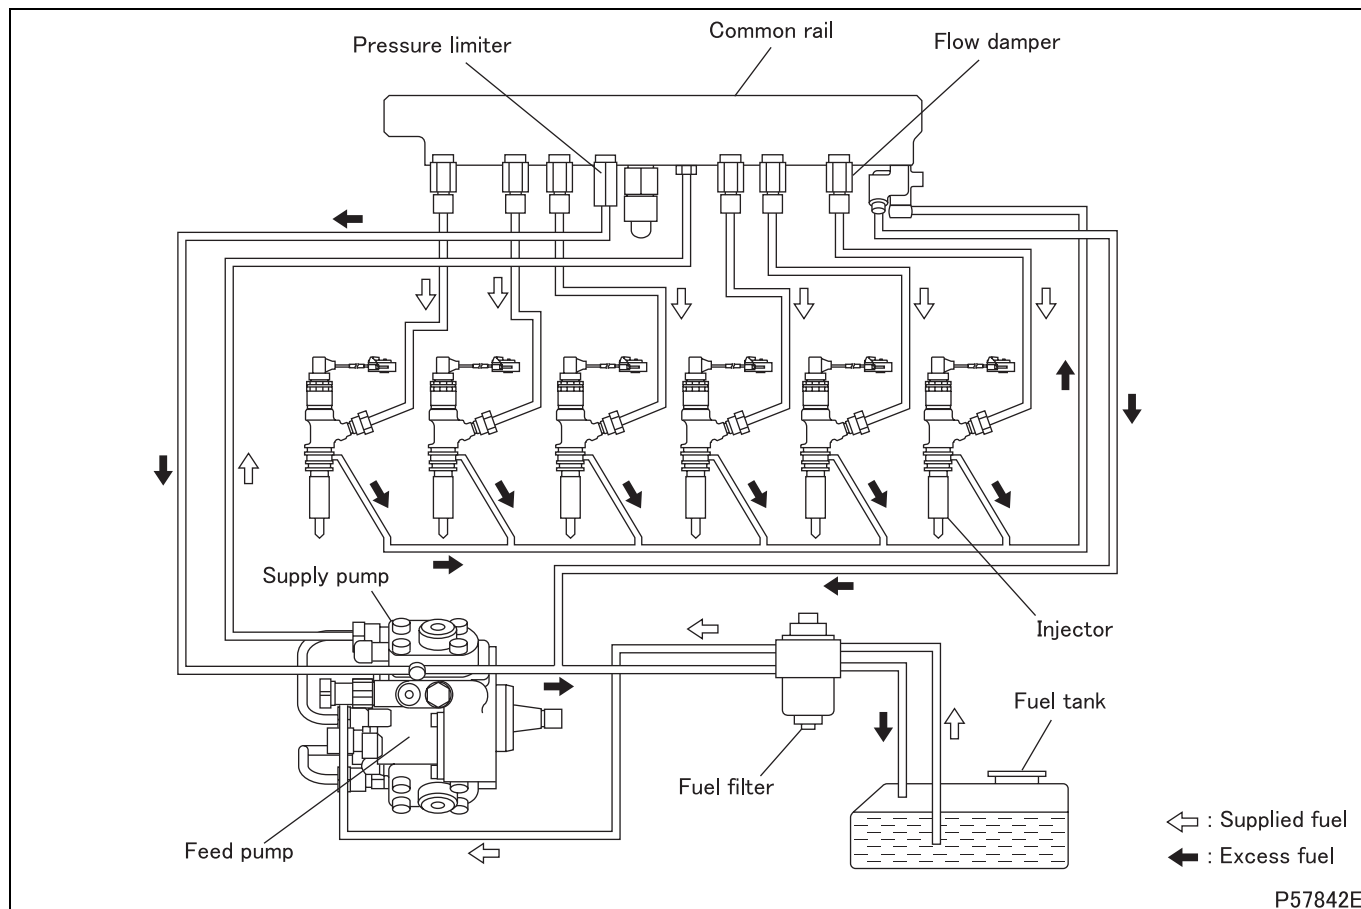
## 1. Fuel System (Flow of Fuel)

- Fuel in the fuel tank is sucked up by the feed pump, which is driven by the pump camshaft within the supply pump, and is fed through the fuel filter where foreign matter is filtered out.

- The filtered fuel is sent to the supply pump where it is pressurized, and then is accumulated in the common rail. The accumulated fuel is then delivered through the injectors into the combustion chambers.

- If fuel leakage occurs through any of the fuel line connections between the common rail and injectors, the relevant flow damper(s) will close, shutting off fuel supply and thus preventing any further fuel leakage out of the system.

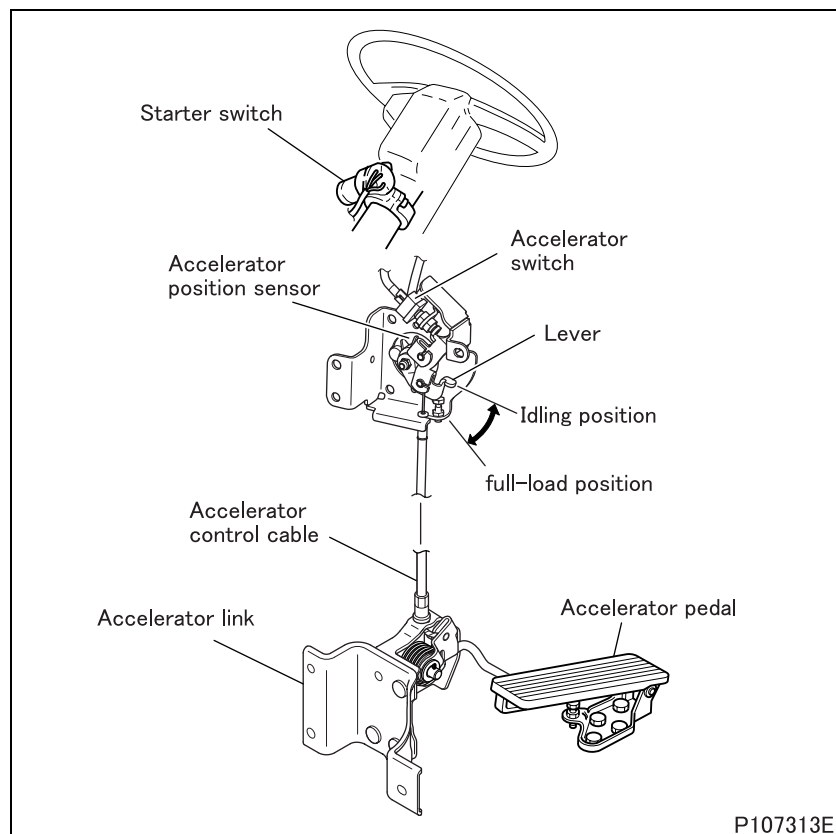
### 2.1 Accelerator switch

- The accelerator pedal switch is used to monitor whether or not the accelerator pedal is pressed.

- The accelerator position sensor monitors for change in the position of the accelerator pedal and sends relevant electric signals to the common rail electronic control unit. The lever is constantly pulled towards the idling position by a return spring.

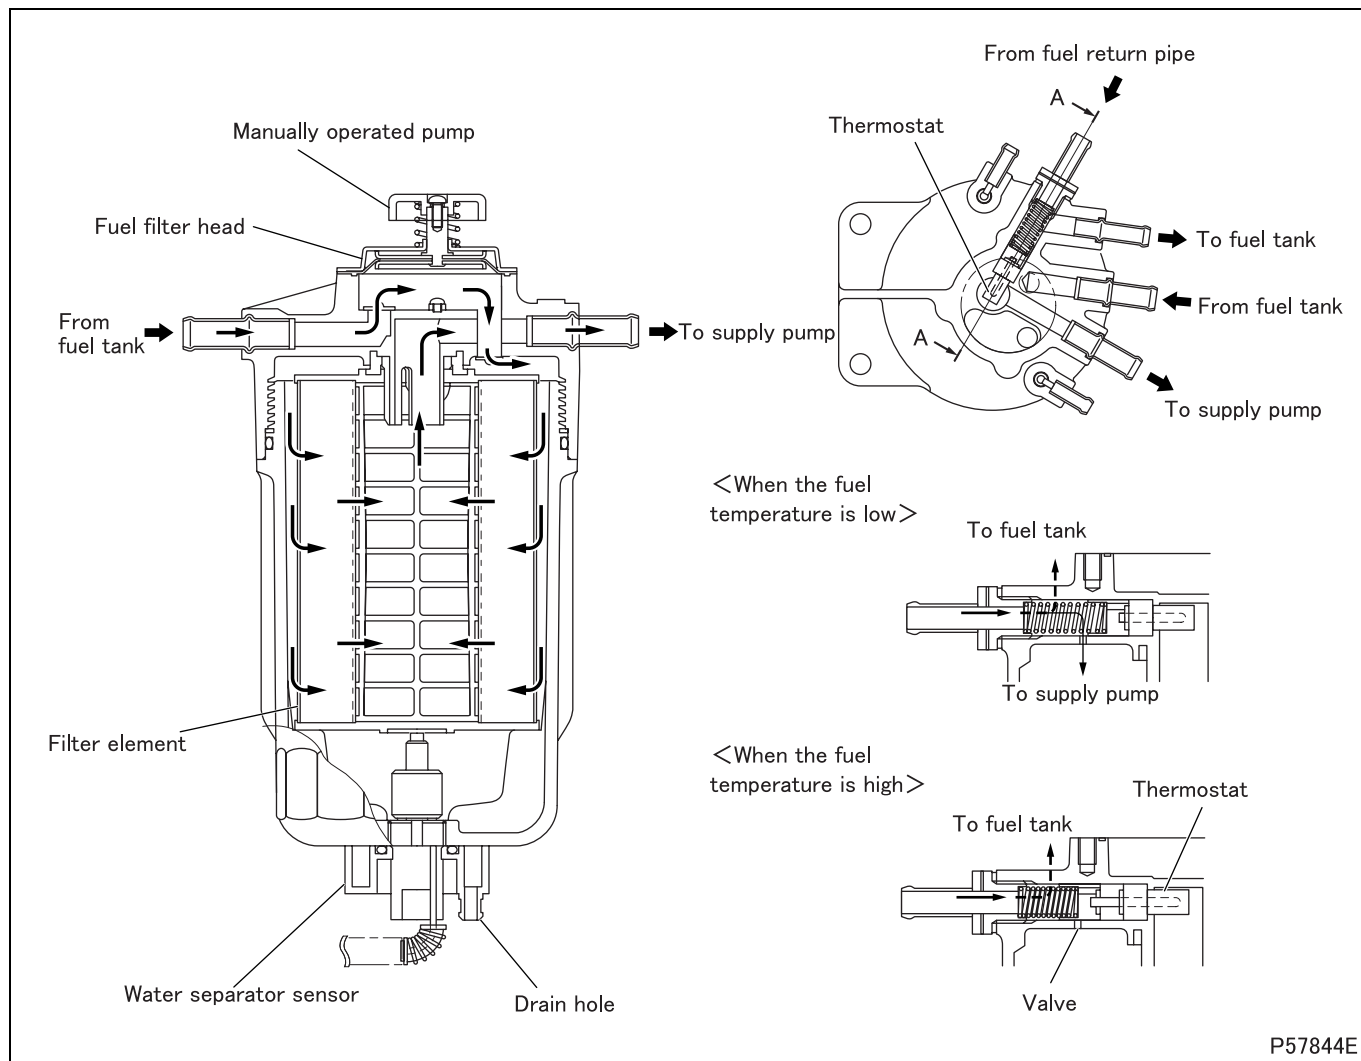
P57844E

- The fuel filter removes foreign matter from fuel via the filter element. The fuel filter also incorporates a water separator which separates any water from fuel.

- The water which has collected in the water separator can be drained through the drain hole by loosening the water separator sensor.
- To bleed air from the fuel system, a manually operated pump is provided on the fuel filter head.

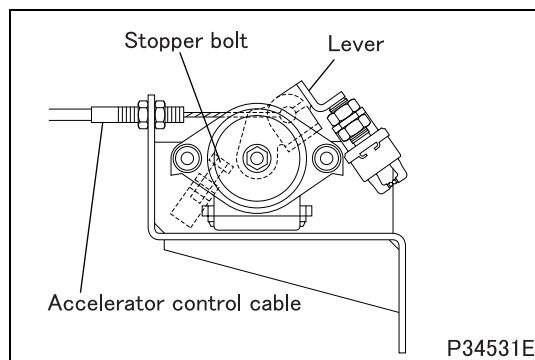
##### (2) No-load maximum speed

- Fully press the accelerator pedal.
- With the accelerator lever pressed against the stop bolt, measure the engine speed.
- If the measurement deviates from the standard value, check the accelerator position sensor and accelerator switch. (See Gr13EA.)
- If the sensor and switch are found to be normal, check for fuel system diagnosis codes as well as inspecting the supply pump and electronic control unit. (See Gr13EA.)

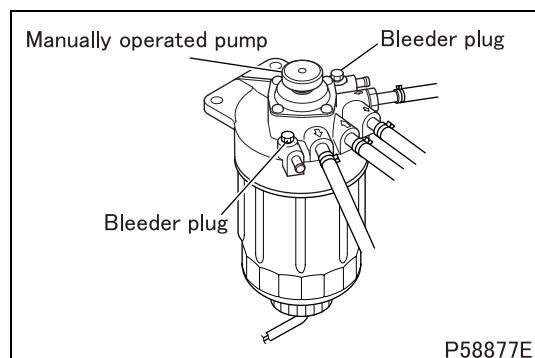
- Loosen one of the bleeder plugs on the fuel filter.
- Feed the system with fuel by manually operating the pump up and down.
- Continue pumping until fuel with no bubbles of air comes out of the bleeder plug.
- With no air bubbles coming out with fuel, tighten the bleeder plug to the specified torque.
- Continue operating the pump until there is strong pumping resistance.

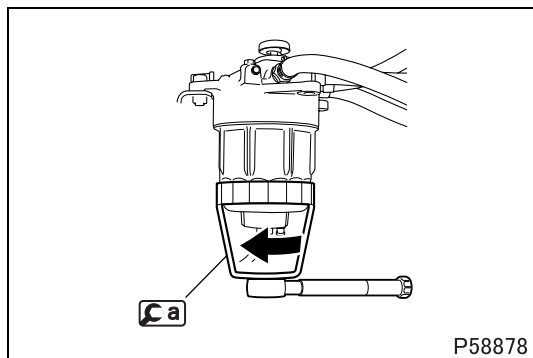
#### [Removal]

- Drain fuel from the case by loosening the water separator sensor.
- Using

, remove the case.

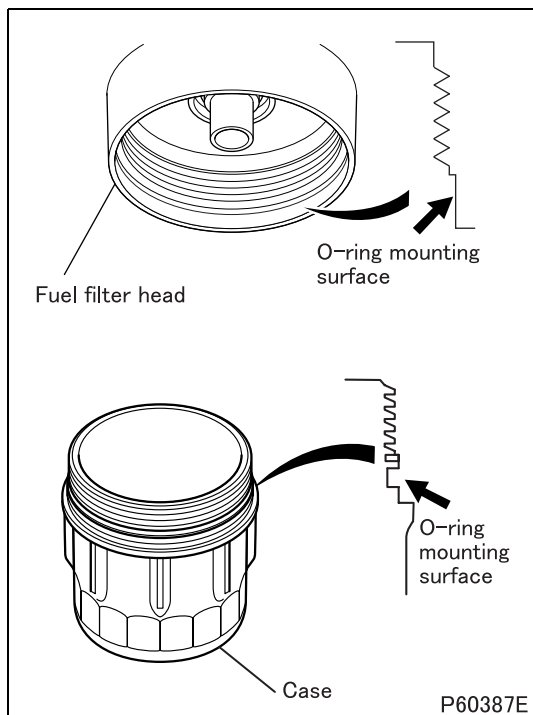
#### [Installation]

- Clean the surface of the fuel filter head and case where the O-ring is to be mounted.

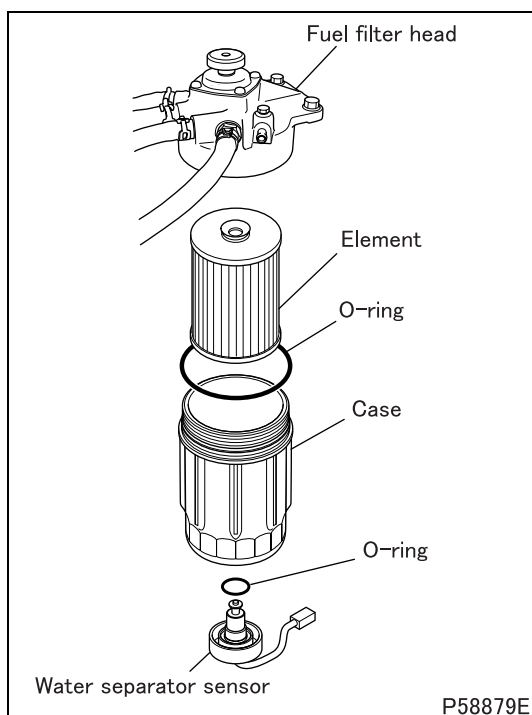
- Replace the filter element and O-rings with new parts.
- Apply a thin coat of engine oil to the O-rings. Install the O-rings onto the case and water separator sensor.

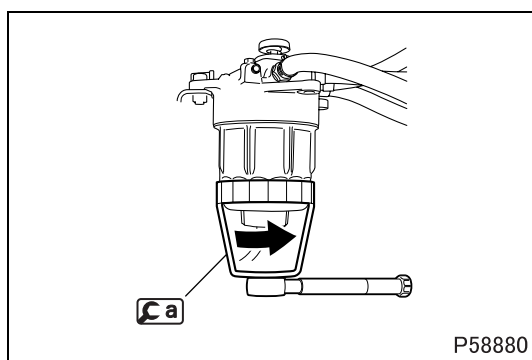
- Using

a, tighten the case to the specified torque.
- Tighten the water separator sensor to the specified torque. With the sensor correctly installed, bleed air from the fuel system.
- Start the engine and ensure that there is no fuel leakage.
- If there is fuel leakage, remove and install the fuel filter correctly.

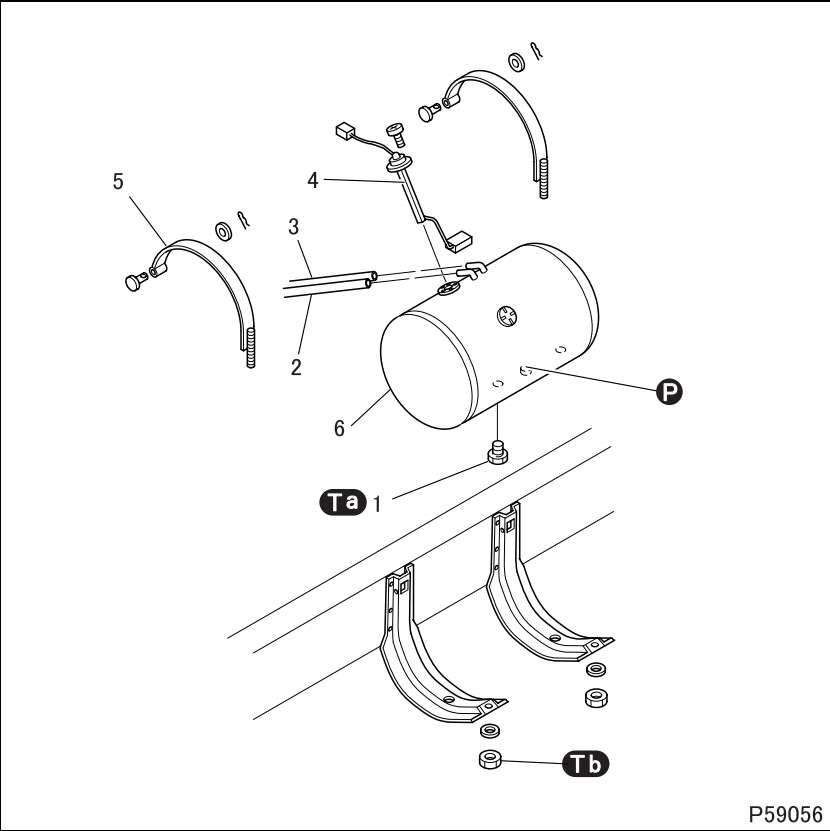
# FUEL TANK

● Removal sequence

- 1 Drain plug
- 2 Suction hose
- 3 Return hose
- 4 Fuel level sensor
- 5 Fuel tank strap
- 6 Fuel tank

| Mark | Parts to be tightened | Tightening torque | Remarks |
|---|---|---|---|
| Ta | Drain plug | 78 ± 19 {58 ± 14, 8.0 ± 1.9} | – |
| Tb | Nut (fuel tank strap mounting) | 12 to 15 {8.7 to 11, 1.2 to 1.5} | – |

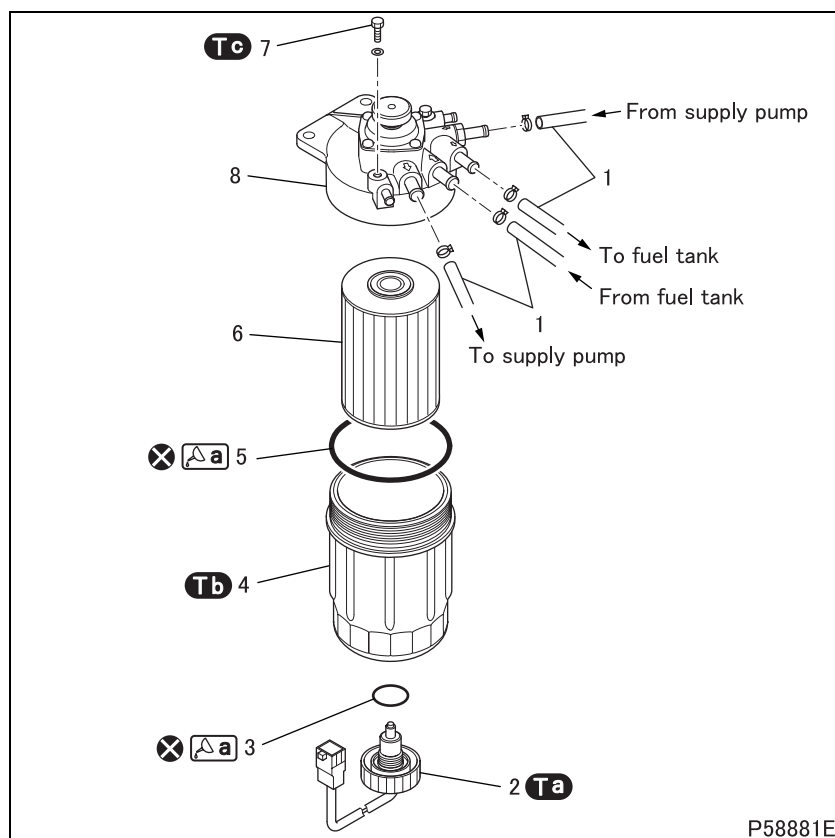
## ● Disassembly sequence

- 1 Fuel hose
- 2 Water separator sensor
- 3 O-ring
- 4 Case
- 5 O-ring
- 6 Element
- 7 Plug
- 8 Fuel filter head

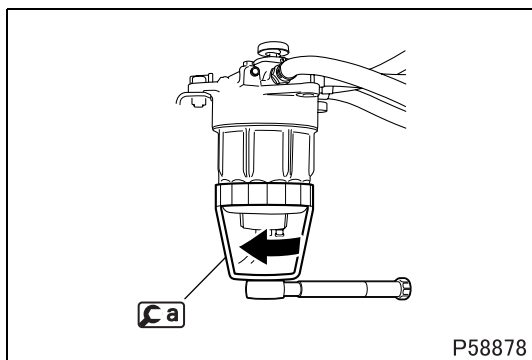
### ■ Removal: Case

- Drain fuel from the case by loosening the water separator sensor.
- Using

, remove the case.

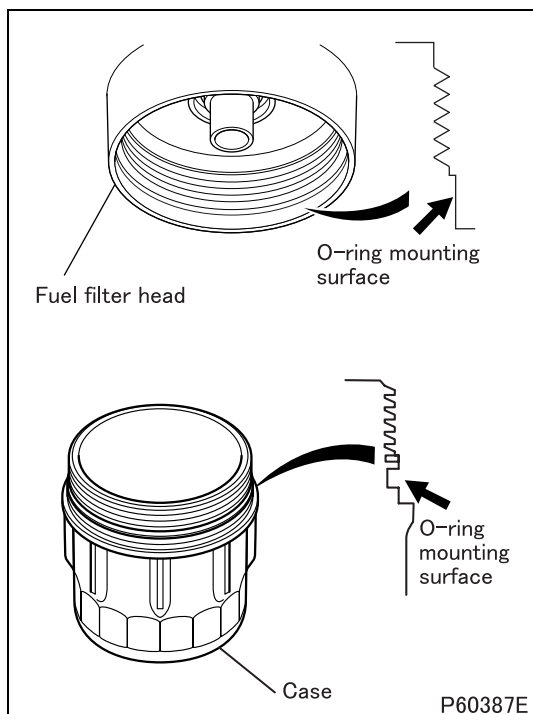
### ■ Installation: Case

- Clean the surface of the fuel filter head and case where the O-ring is to be mounted.

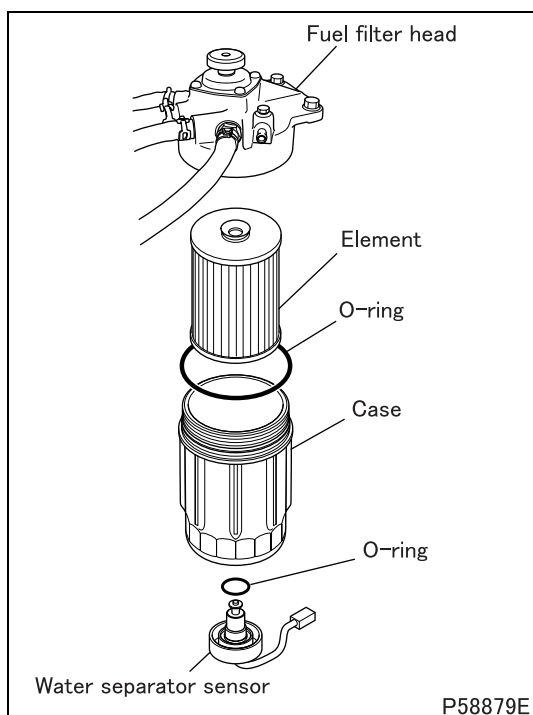
- Replace the filter element and O-rings with new parts.
- Apply a thin coat of engine oil to the O-rings. Install the O-rings onto the case and water separator sensor.

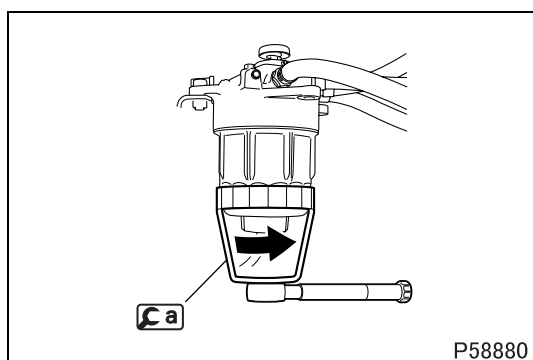
- Using

, tighten the case to the specified torque.
- Tighten the water separator sensor to the specified torque. With the sensor correctly installed, bleed air from the fuel system.
- If there is fuel leakage, remove and install the fuel filter correctly.

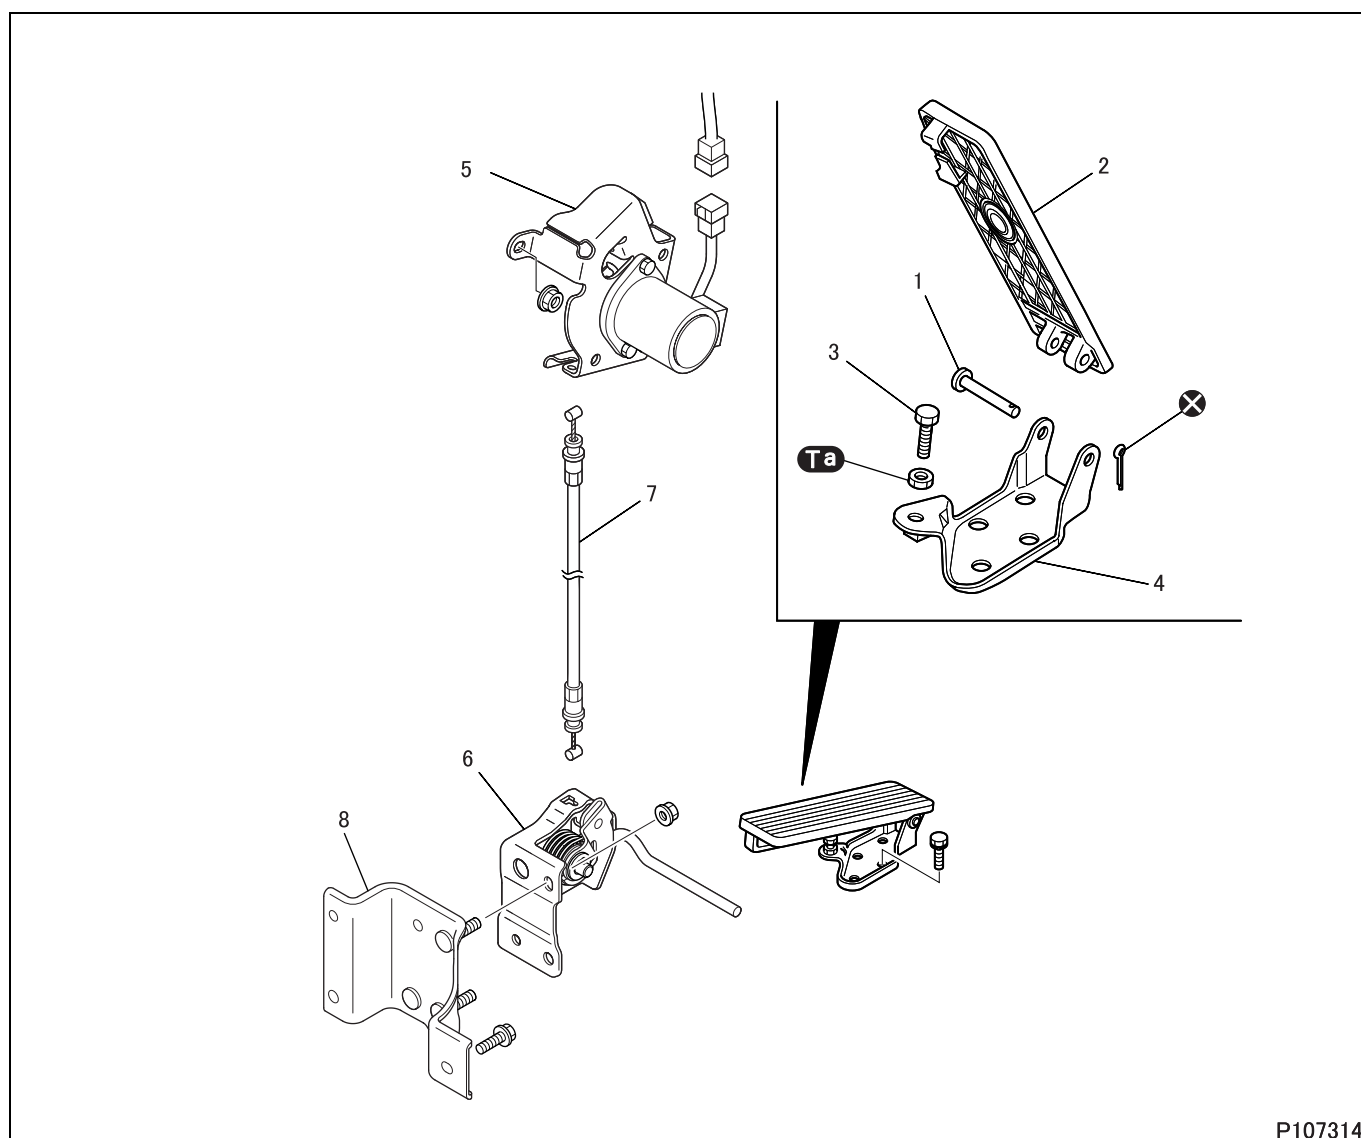
P107314

## ● Disassembly sequence

| Mark | Parts to be tightened | Tightening torque | Remarks |
|---|---|---|---|
| <b>Ta</b> | Lock nut | 4 to 6 {0.9 to 1.3, 0.4 to 0.6} | — |

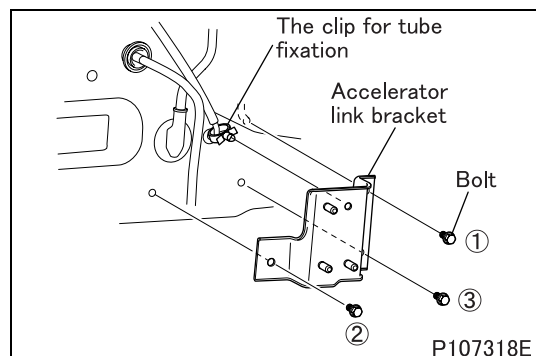
#### ■ Installation: Accelerator link bracket

- Insert the accelerator link bracket to the clip for tube fixation.
- Install the accelerator link bracket by tightening the bolts in the order shown in the illustration.

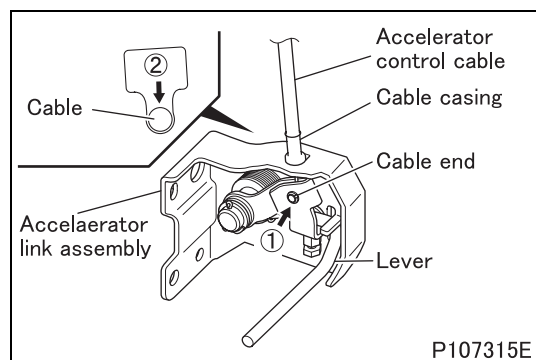
#### ■ Installation: Accelerator control cable

- Install the accelerator control cable to the accelerator link assembly as follows:
  - ① Insert the accelerator control cable end into the lever of the accelerator link assembly. Do not bend the cable. (minimum bending radius: 30 mm)
  - ② Insert the accelerator control cable casing into the slit in the bracket of the accelerator link assembly until it clicks and is secured in position.

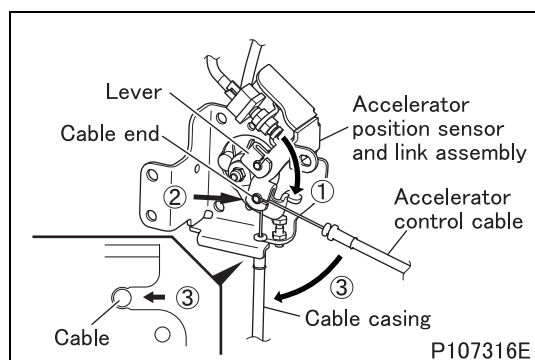
- Install the accelerator control cable to the accelerator position sensor and link assembly as follows:
  - ① Bring the lever of the accelerator position sensor and link assembly into the state of full stroke.
  - ② Insert the accelerator control cable end into the lever of the accelerator position sensor and link assembly.
  - ③ Insert the accelerator control cable casing into the slit in the bracket of the accelerator position sensor and link assembly until it clicks and is secured in position.

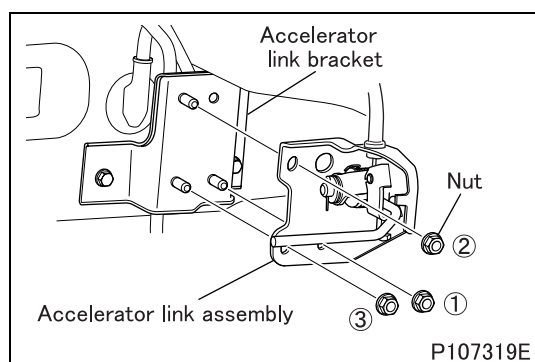
## ■ Installation: Accelerator link assembly

- Install the accelerator link assembly by tightening the nuts in the order shown in the illustration.

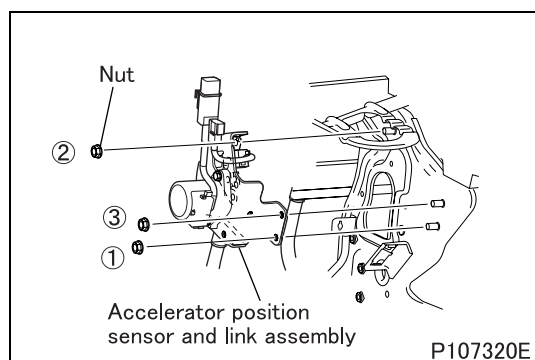
## ■ Installation: Accelerator position sensor and link assembly

- Install the accelerator position sensor and link assembly by tightening the nuts in the order shown in the illustration.

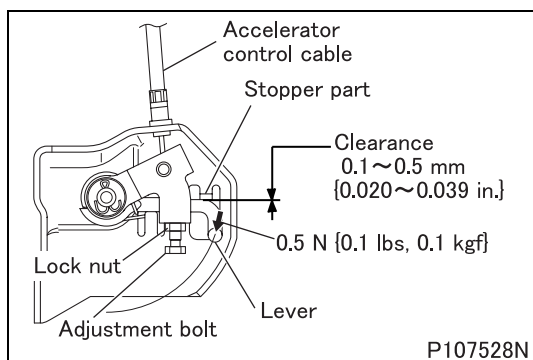
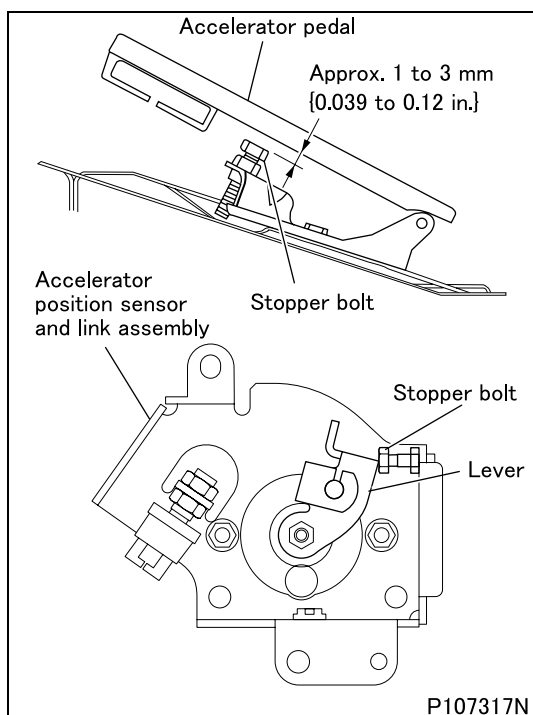
### ■ Adjustment: Clearance between the accelerator pedal and stopper bolt

- Press the accelerator pedal to contact the lever of the accelerator position sensor and link assembly with the stopper bolt. In this condition, adjust the clearance between the accelerator pedal and the stopper bolt under the pedal to the value specified in the drawing by adjusting the stopper bolt height.

- Loosen the lock nut.
- Adjust the clearance to the value specified in the drawing with the adjustment bolt. (Turning the bolt clockwise reduces the clearance.)
- After adjustment, tighten the lock nut.

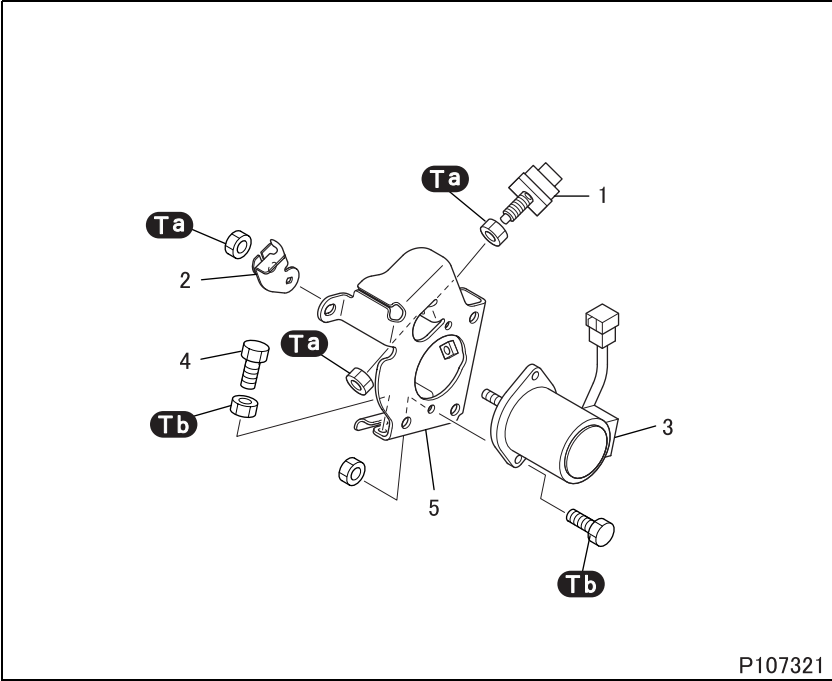
## Accelerator position sensor and link assembly

### ● Disassembly sequence

- 1 Accelerator position switch
- 2 Accelerator position sensor lever
- 3 Accelerator position sensor
- 4 Stopper bolt
- 5 Accelerator position sensor bracket

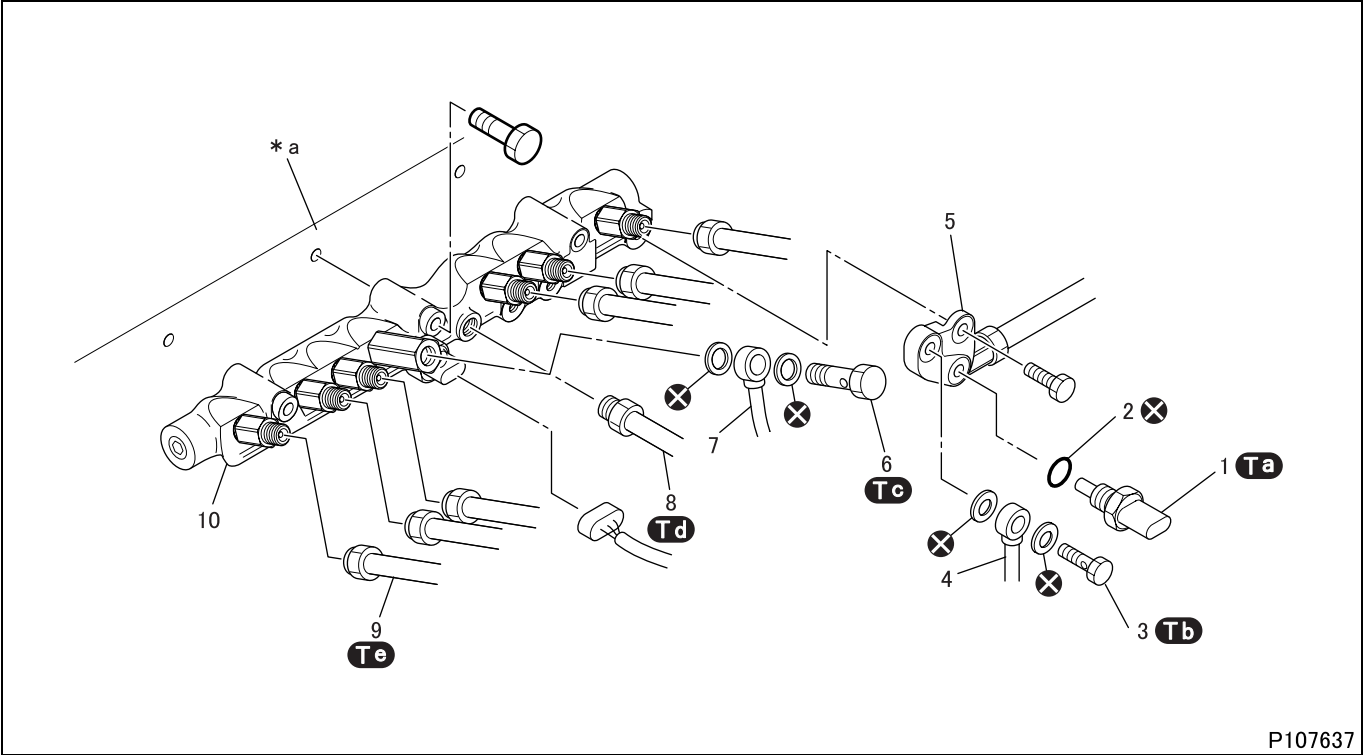
P107637

## ● Disassembly sequence

| Mark | Parts to be tightened | Tightening torque | Remarks |
|---|---|---|---|
| <b>Te</b> | Injection pipe | 39.2 to 49 {29 to 36, 4.0 to 5.0} | — |

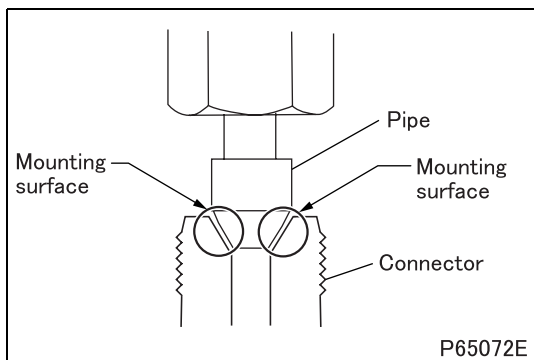
### ■ Installation: Injection pipe and fuel pipe

- Ensure that the pipe and mounting surfaces of the connector are flat and free from damage.
- Bring the pipe into intimate contact with mounting surfaces of the connector evenly, and temporarily tighten it without applying an excessive force.
- Tighten it to the specified torque after temporary tightening.

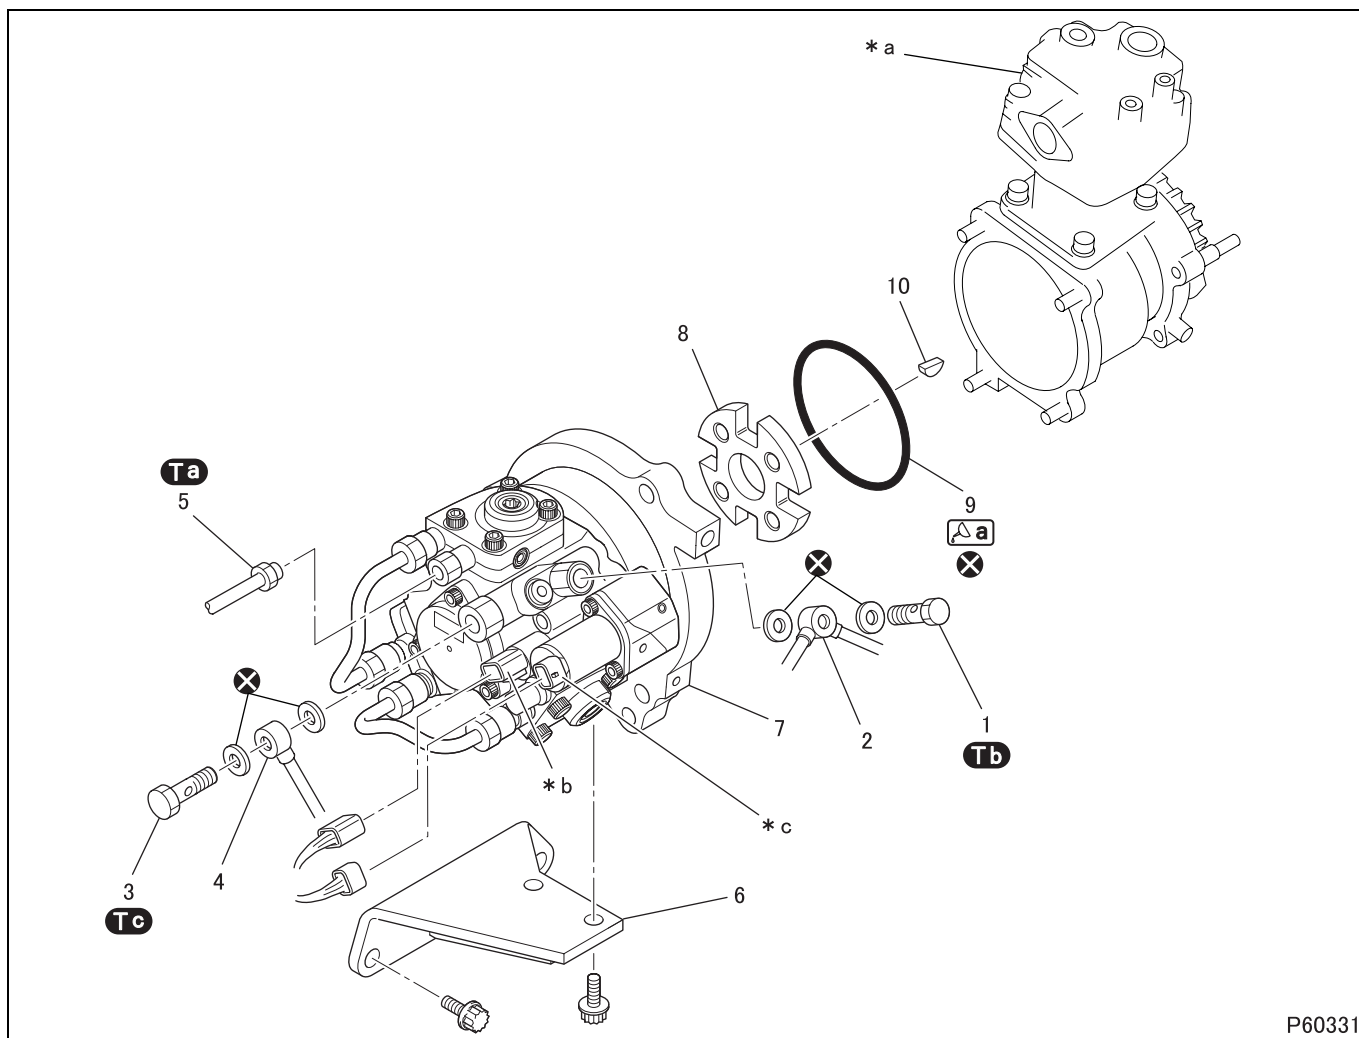
P60331

## ● Disassembly sequence

- If the supply pump has been replaced, perform the “initialization of supply pump unit difference learning value” using Multi-Use Tester in order to clear the correction data (learned pump unit difference) from the engine electronic control unit. (See Gr13EA.)

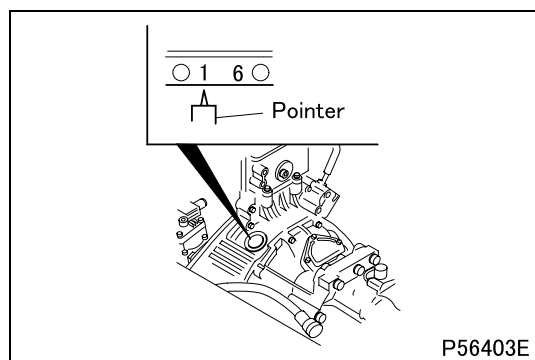
**■ Installation: Supply pump**

- Position the No. 1 piston to the top dead center in the compression stroke in the following manner.
  - Crank the engine to align the pointer with the “1 6” mark on the flywheel.
  - This will bring either the No. 1 piston or the No. 6 piston to the top dead center in the compression stroke. If both the inlet and exhaust rockers can be moved by hand by the amount of valve clearance, that cylinder is at the top dead center in the compression stroke. From that position, every turn of the crankshaft will alternately bring the No. 1 and No. 6 pistons to the top dead center in the compression stroke. (See Gr11.)

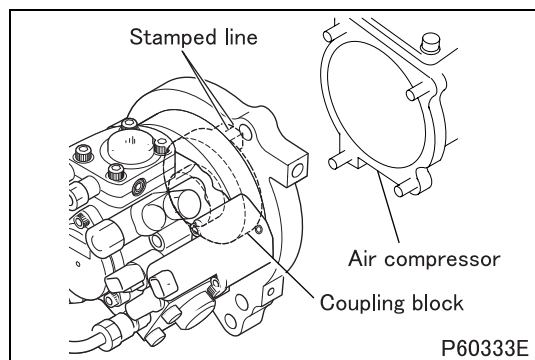
- Install the supply pump while ensuring that the stamped line on the supply pump timing cover is aligned with the stamped line on the coupling block.

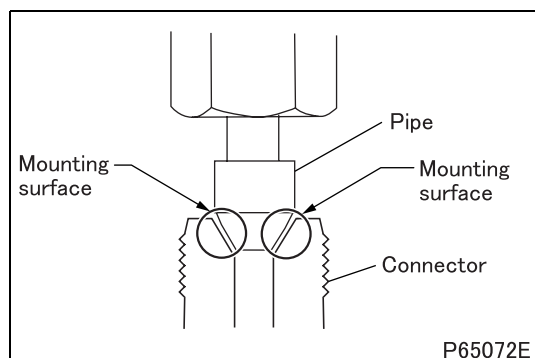
**■ Installation: Fuel pipe**

- Ensure that the pipe and mounting surfaces of the connector are flat and free from damage.
- Bring the pipe into intimate contact with mounting surfaces of the connector evenly, and temporarily tighten it without applying an excessive force.
- Tighten it to the specified torque after temporary tightening.

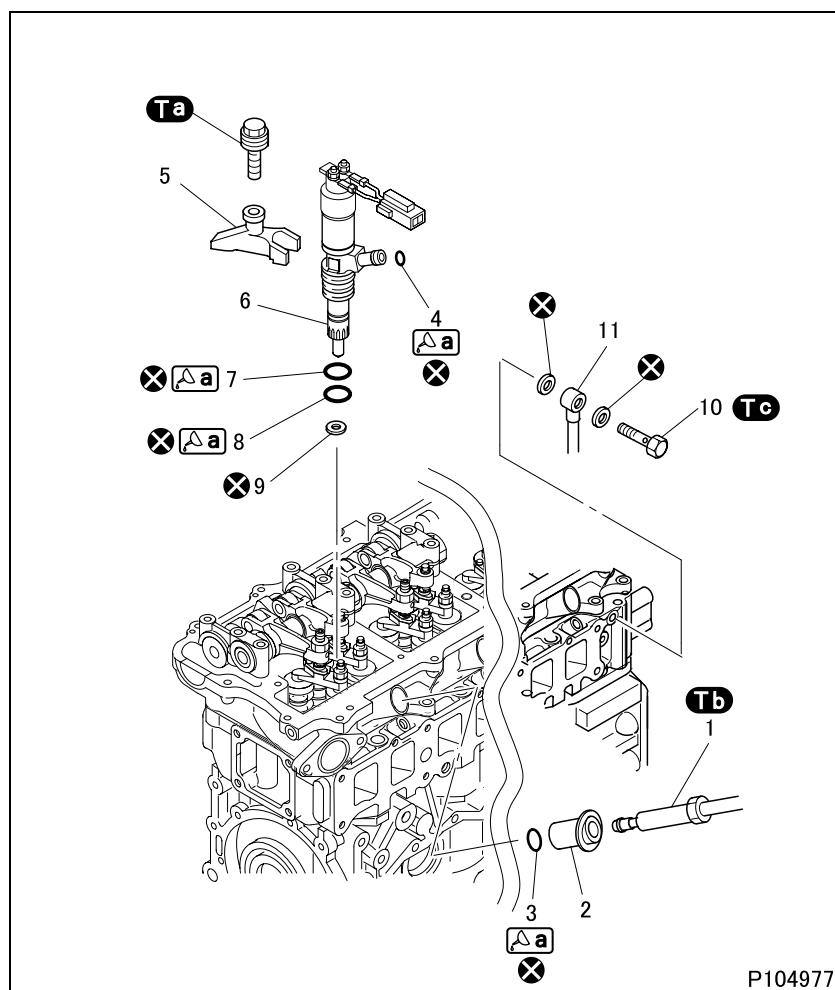
# INJECTOR

## ● Disassembly sequence

- 1 Injection pipe
- 2 Injection pipe seal
- 3 O-ring
- 4 O-ring
- 5 Nozzle bridge
- 6 Injector
- 7 O-ring
- 8 O-ring
- 9 Nozzle tip gasket
- 10 Eyebolt
- 11 Fuel return pipe

- Do not attempt to clean the nozzle hole with a wire brush or other similar tools, or the hole can be damaged.
- Be sure to tighten the nozzle bridge bolts to the specified torque. Overtightening the bolts can deform the injectors, resulting in incorrect fuel injection.
- If an injector is replaced with a new one, the injector correction data must be written in the engine electronic control unit.
- For the data writing work, consult your nearest MITSUBISHI FUSO dealer or MITSUBISHI FUSO TRUCK OF AMERICA, Inc.

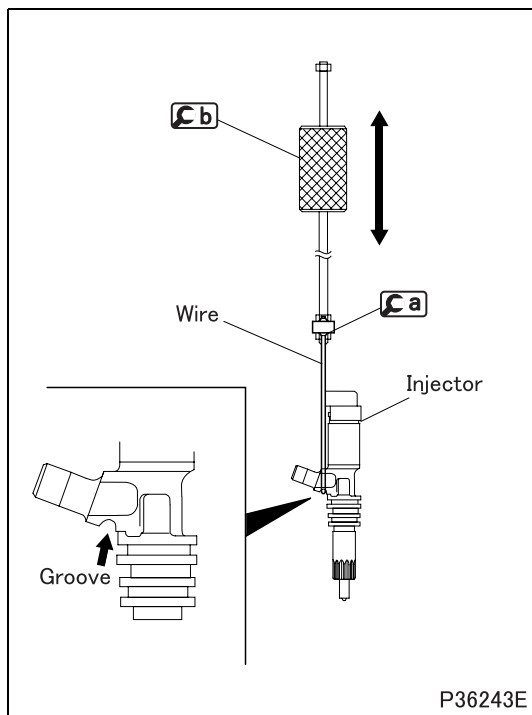
### ■ Removal: Injector

- Using **a** and **b** and with the wire of **a** engaged in the groove on the injector, remove the injector.

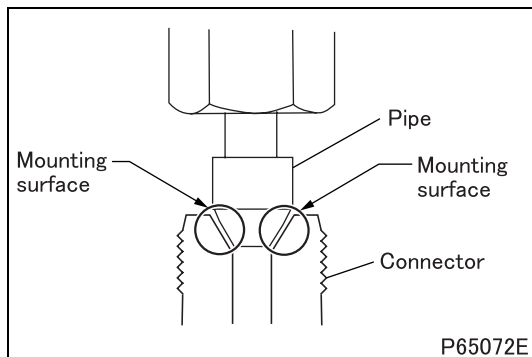
### ■ Installation: Injection pipe

- Ensure that the pipe and mounting surfaces of the connector are flat and free from damage.
- Bring the pipe into intimate contact with mounting surfaces of the connector evenly, and temporarily tighten it without applying an excessive force.
- Tighten it to the specified torque after temporary tightening.

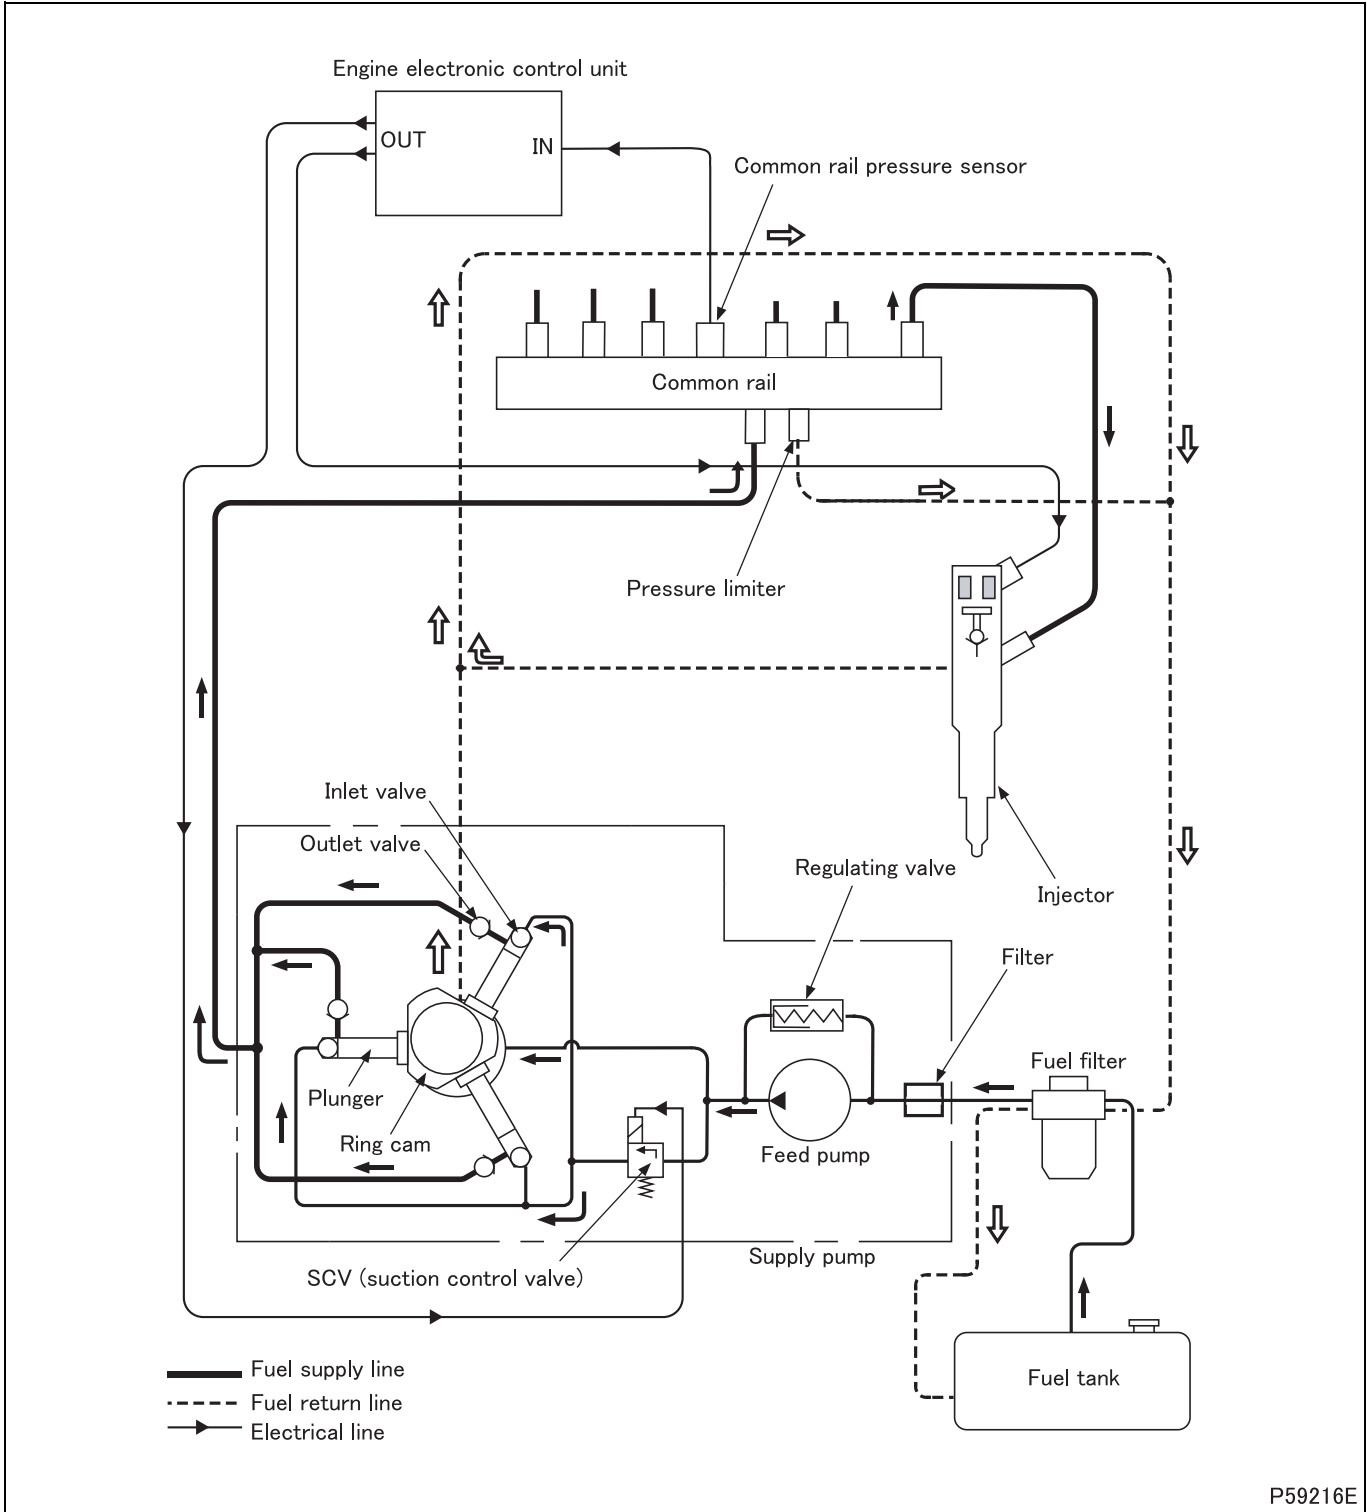
13EA-4

- In the common rail system, an electronic control unit monitors various aspects of the engine (engine speed, throt-

- When the engine is cranked by means of the starter switch, the feed pump (this is located inside the supply pump) simultaneously draws fuel from the fuel tank and feeds it via the fuel filter to the SCV (suction control valve). A quantity of fuel metered by the SCV (suction control valve) is supplied via the inlet valves to the plunger chambers.
- The fuel in the plunger chambers is pressurized. The outlet valves are then opened, and the fuel is fed under pressure to the common rail.
- The pressurized fuel is held in the common rail and then uniformly fed to the injectors.
- In response to signals from the engine electronic control unit, a solenoid valve in each injector causes the injector to inject fuel into the relevant combustion chamber at the optimal timing and in the optimal quantity.
